Your Ref: TP/IP/17963/2022  
Our Ref : CI/TPD22008679/N

**Fatal Accident Investigation Team**

**INSPECTION REPORT OF POWER ASSISTED BICYCLE PAB- TRAFFIC  
POLICE POUND REPORT NO. 2218/22**

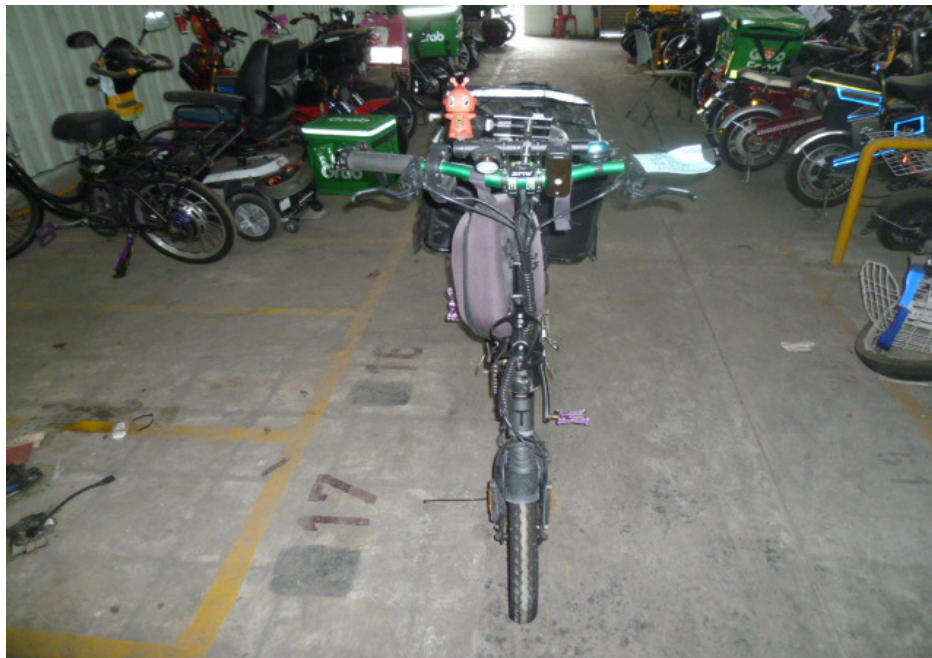
**Photo 1** shows the identification of the PAB with reference to Traffic Police Pound Report No. 2218/22 (arrowed).

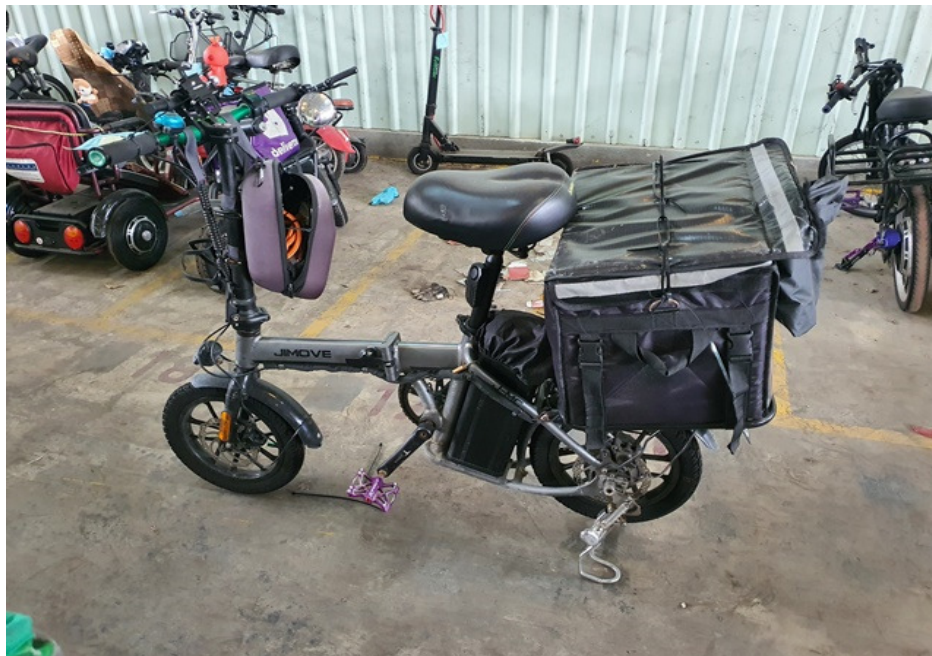
**Photo 3** shows the right body of the PAB at the time of our inspection. The PAB was observed to have sustained damages all around.

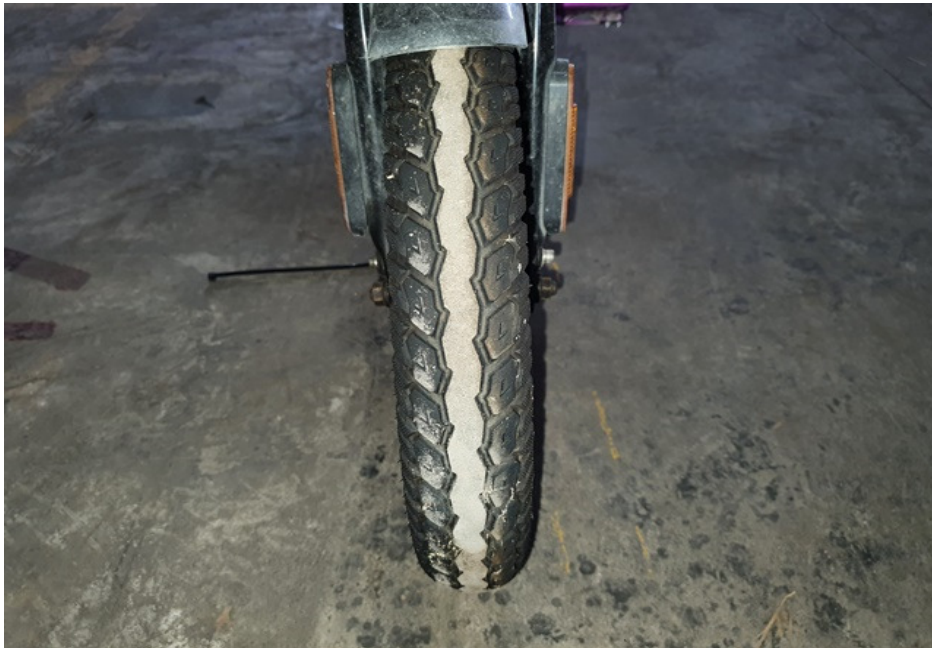
**Photo 11** shows the front tyre of the PAB at the time of our inspection. The front tyre was observed to be in serviceable condition with remaining tread depth of approximately 3mm. The tyre was also observed to be sufficiently inflated for vehicular operation. We did not observe any tear, burst mark(s) and/or punctured hole(s) on the sidewalls as well as across the tread of the front tyre.

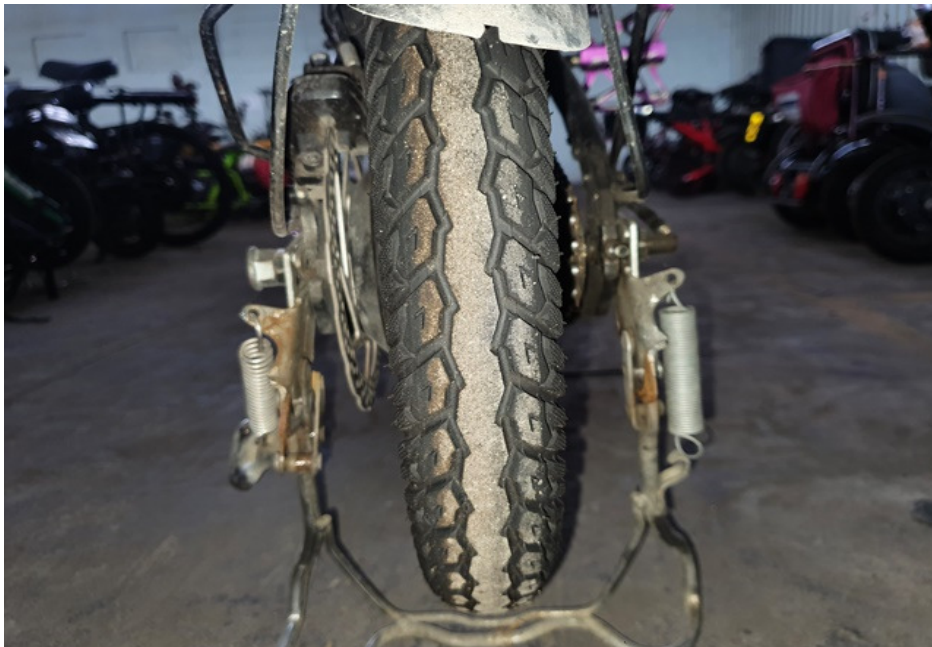
**Photo 12** shows the rear tyre of the PAB at the time of our inspection. The rear tyre was observed to be in serviceable condition with remaining tread depth of approximately 2mm. The tyre was also observed to be sufficiently inflated for vehicular operation. We did not observe any tear, burst mark(s) and/or punctured hole(s) on the sidewalls as well as across the tread of the rear tyre.

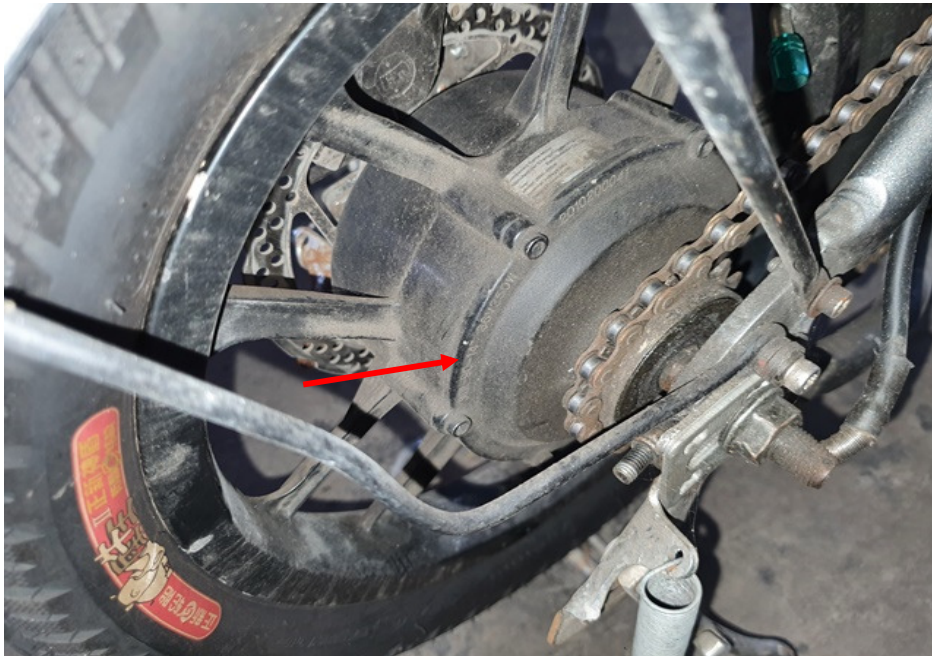
**Photo 13** shows the general view of the drive motor (arrowed) of the PAB which was observed to be intact with no misalignment.

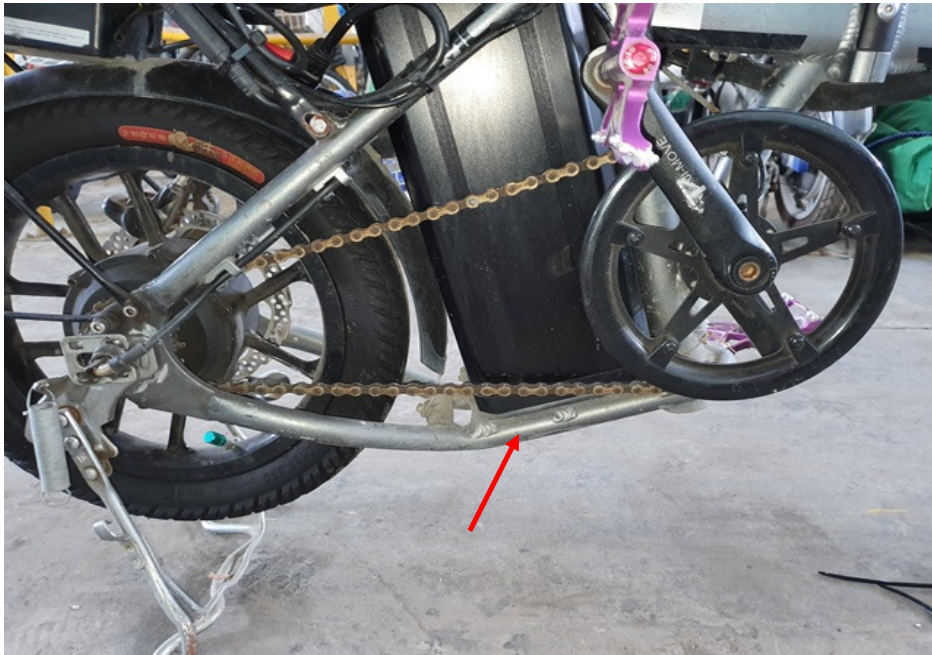
**Photo 14** shows the general view of the gear train of the PAB, which was observed to be intact with no misalignment (arrowed). It was also adequately lubricated for operating purposes.

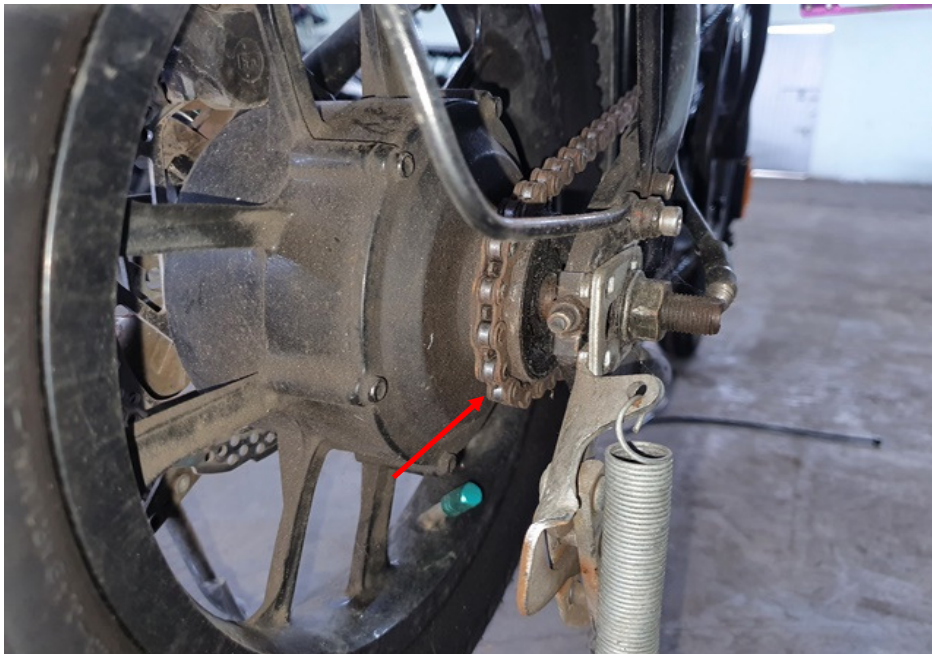
**Photo 15** shows a closer view of the gear train of the PAB, which was observed to be intact with no misalignment (arrowed). It was also adequately lubricated for operating purposes.

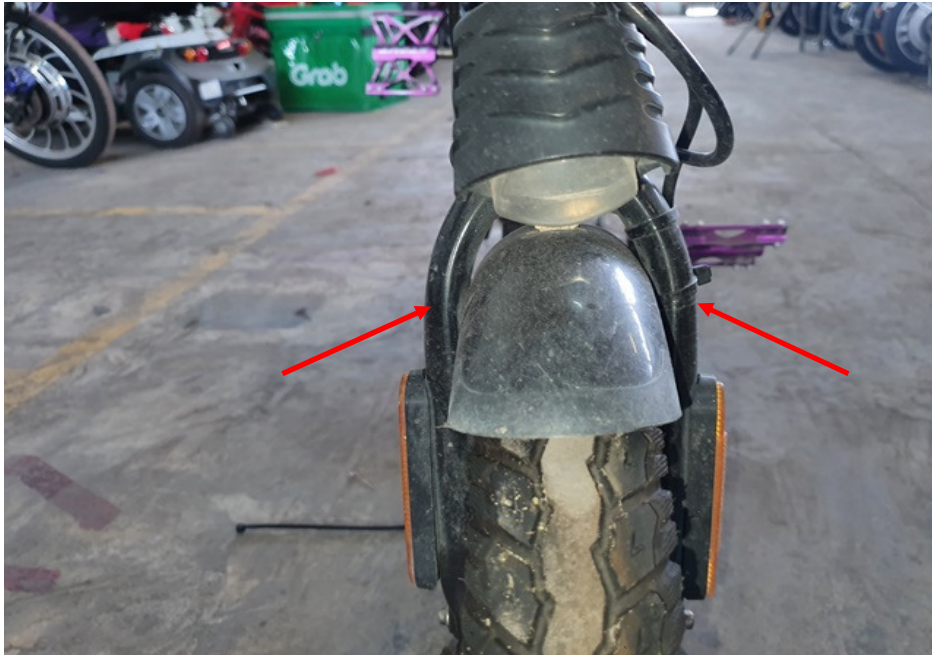
**Photo 16** shows the front fork assembly (arrowed) of the PAB. The front forks and fork bracket of the PAB were both found to be intact and undamaged. Turning the PAB's handle bar towards the left and right did not produce any abnormal free play. The steering system of the PAB was in serviceable condition at the time of our inspection.

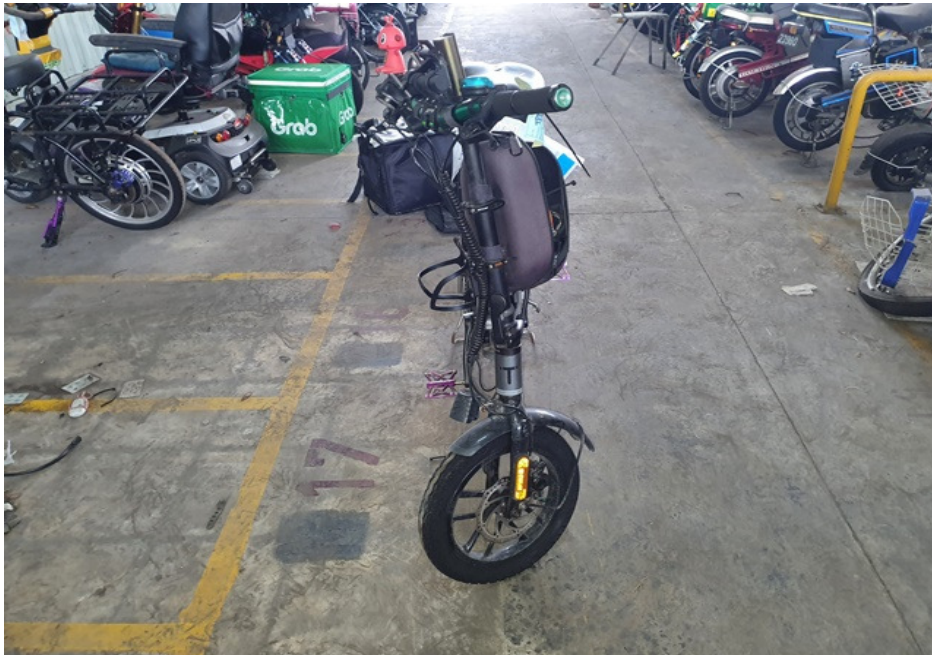
**Photo 17** shows the front wheel of the PAB turned towards its full right. Turning the PAB's handle bar towards the right did not produce any abnormal free play and/or resistance. This would indicate that the steering system of the PAB was in serviceable condition at the time of our inspection.

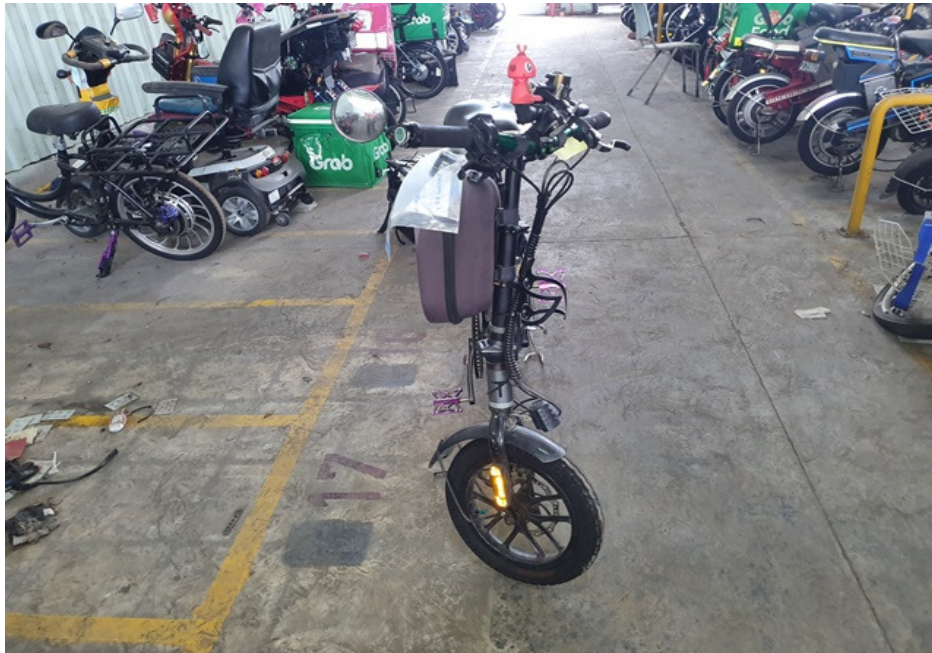
**Photo 18** shows the front wheel of the PAB turned towards its full left. Turning the PAB's handle bar towards the left did not produce any abnormal free play and/or resistance. This would indicate that the steering system of the PAB was in serviceable condition at the time of our inspection.

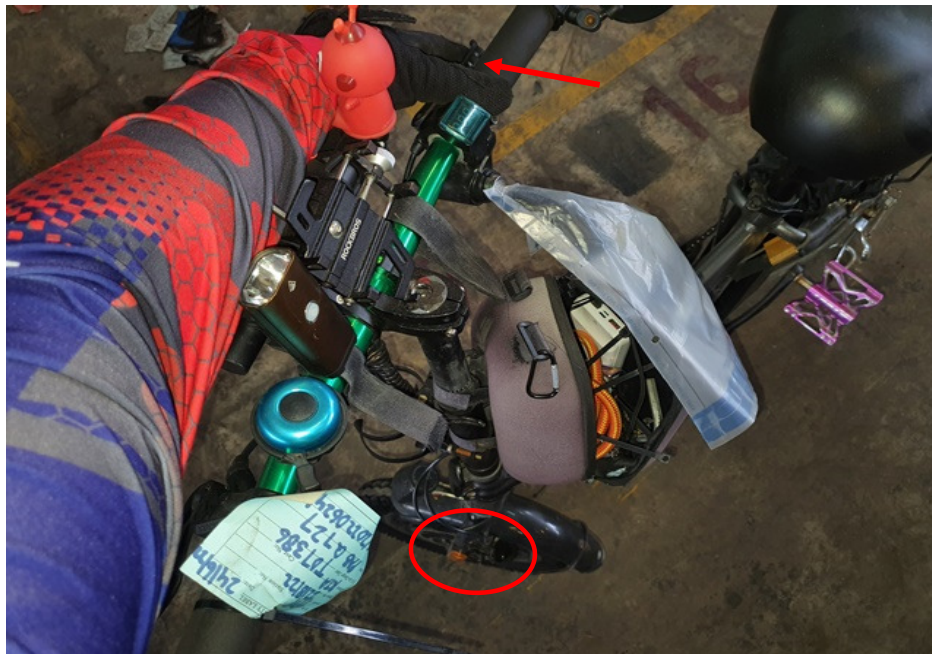
10. A static brake test was conducted on the front brake of the PAB. There was some resistance felt upon pressing the right hand brake lever. This was further confirmed by looking at the front brake pads while we pressed the right hand brake lever. It shows that the front brake pads responded to the gripping action. The front brake pads pressed against the front brake disc. This had appeared to indicate that the front brake of the PAB was in serviceable condition.

**Photo 19** shows a static brake test conducted on the PAB's front brake. There was some resistance felt upon pressing the right hand brake lever (arrowed). It also shows that the front brake pads responded to the gripping action (circled) after depressing the right hand brake lever.

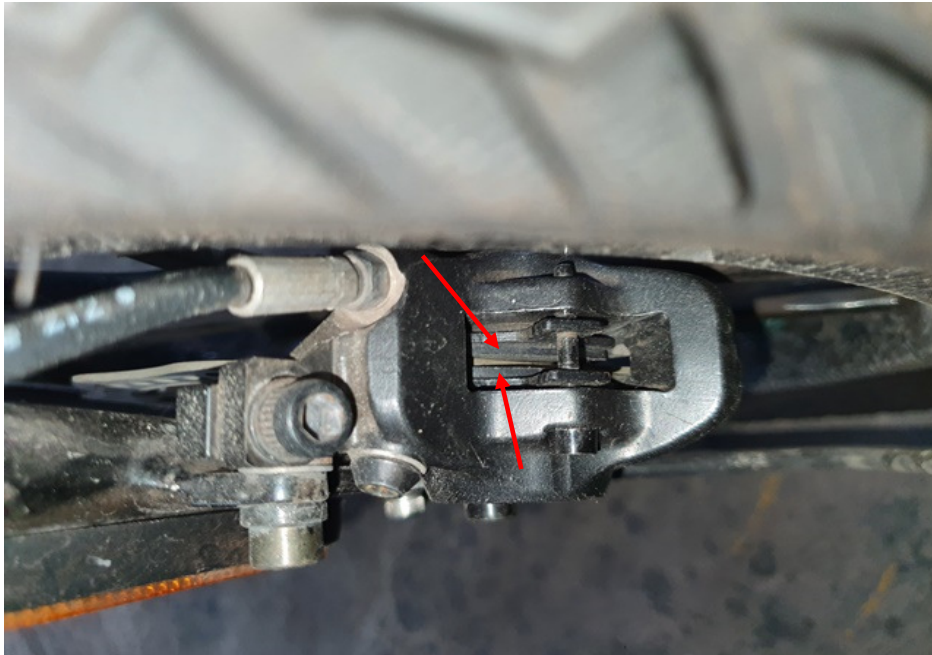
**Photo 20** shows a close up view of the front brake pads responding to the gripping action. The front brake pads pressed against the front brake disc (arrowed) upon depressing the right hand brake lever. This had appeared to indicate that the front brake of the PAB was in serviceable condition.

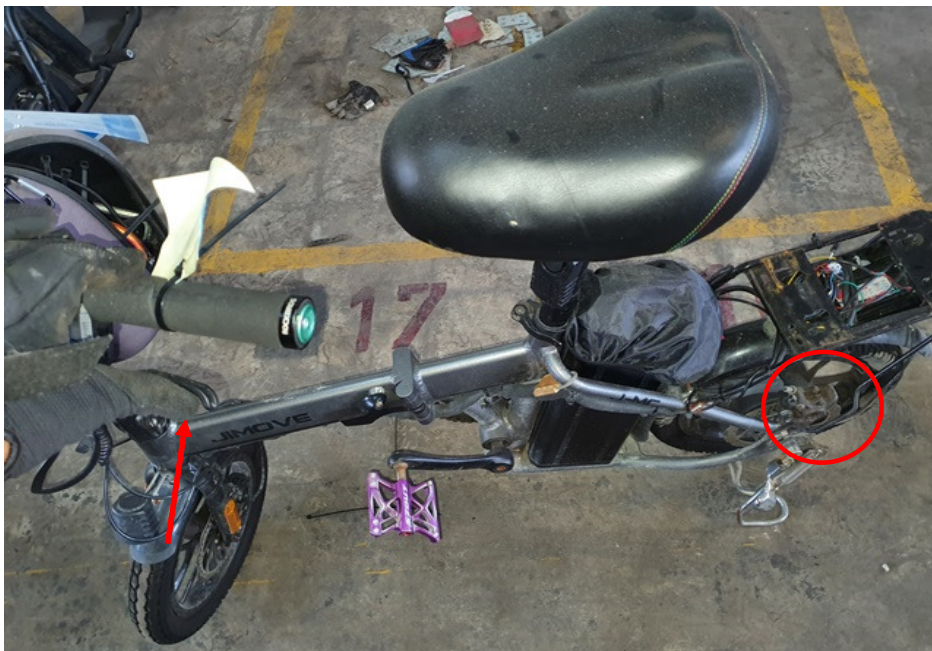
11. A static brake test was conducted on the rear brake of the PAB. There was some resistance felt upon pressing the left hand brake lever. This was further confirmed by looking at the rear brake pads while we pressed the left hand brake lever. It shows that the rear brake pads responded to the gripping action. The rear brake pads pressed against the rear brake disc. This had appeared to indicate that the rear brake of the PAB was in serviceable condition.

**Photo 21** shows a static brake test conducted on the PAB's rear brake. There was some resistance felt upon pressing the left hand brake lever (arrowed). It also shows that the rear brake pads responded to the gripping action (circled) after depressing the left hand brake lever.

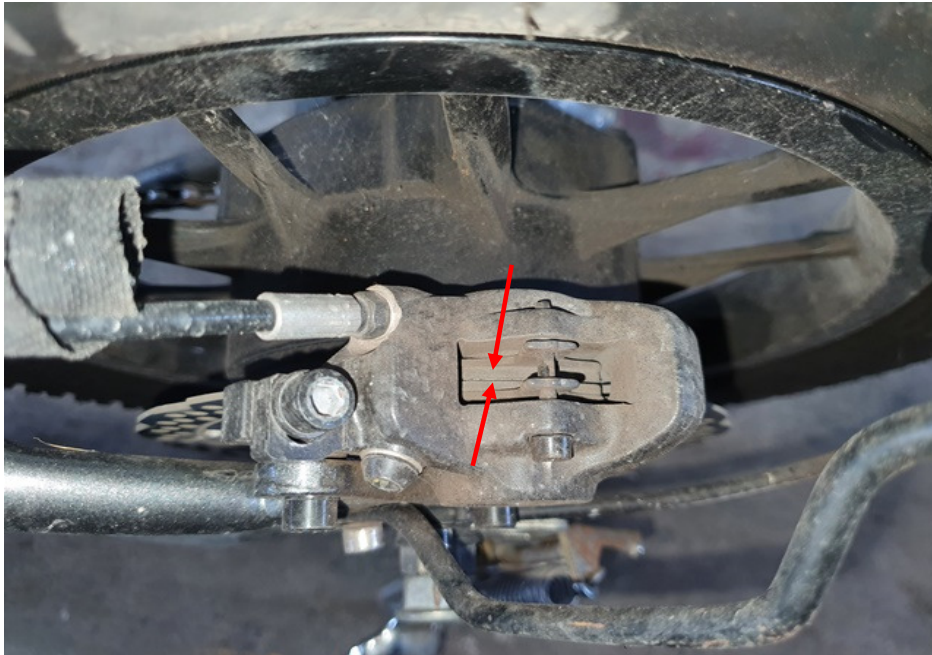
**Photo 22** shows a close up view of the rear brake pads responding to the gripping action. The rear brake pads pressed against the rear brake disc (arrowed) upon depressing the left hand brake lever. This had appeared to indicate that the rear brake of the PAB was in serviceable condition.
