Your Ref: TP/IP/18686/2022
Our Ref : CI/TPD22008681/N

Fatal Accident Investigation Team

MECHANICAL INSPECTION REPORT OF MOTORCYCLE FBE 5989P

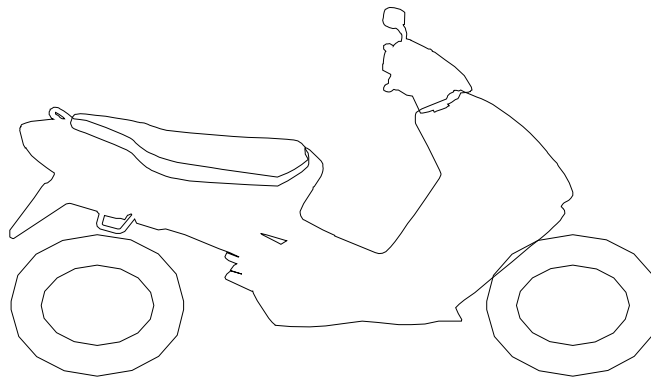
7. The tyre brand, tyre size and remaining tread depth of the 2 tyres of the Motorcycle were recorded as follows:-

Dunlop 90/80 R17 (2mm)

Dunlop 70/90 R17 (3mm)

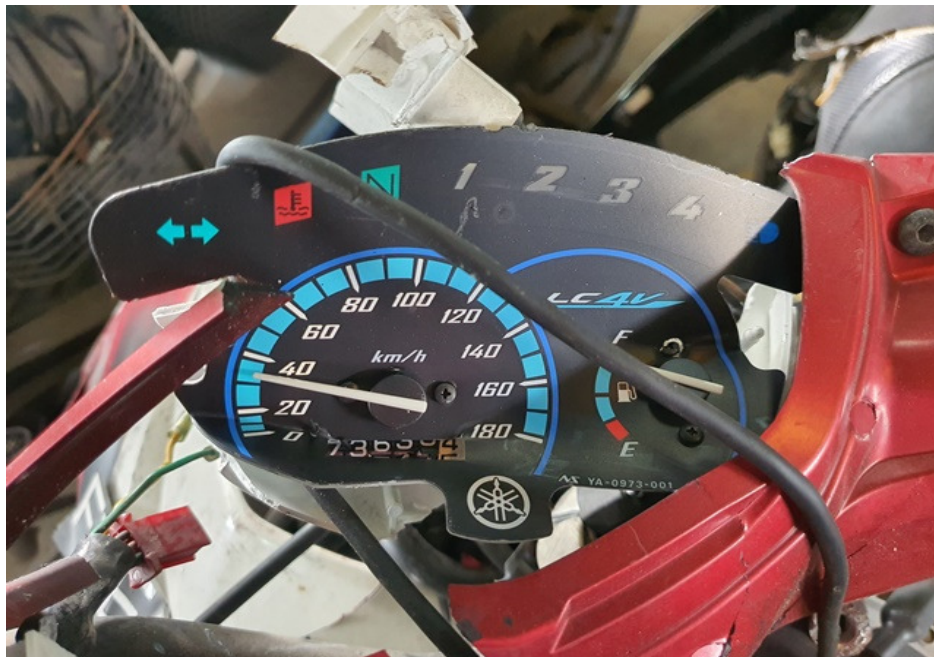
4. The mileage of the Motorcycle could not be recorded at the time of our inspection due to the damages sustained to the speedometer gauge.
5. The Motorcycle had sustained damages all around. Body parts that were found to have been damaged include its headlight assembly, front cowling, steering stem, front mudguard, handlebar, side mirrors, side cowlings, front footrests, front basket, rear side covers and exhaust muffler, amongst others.

Photo 1 shows the mileage of the Motorcycle which could not be recorded at the time of our inspection due to the damages sustained to the speedometer gauge.

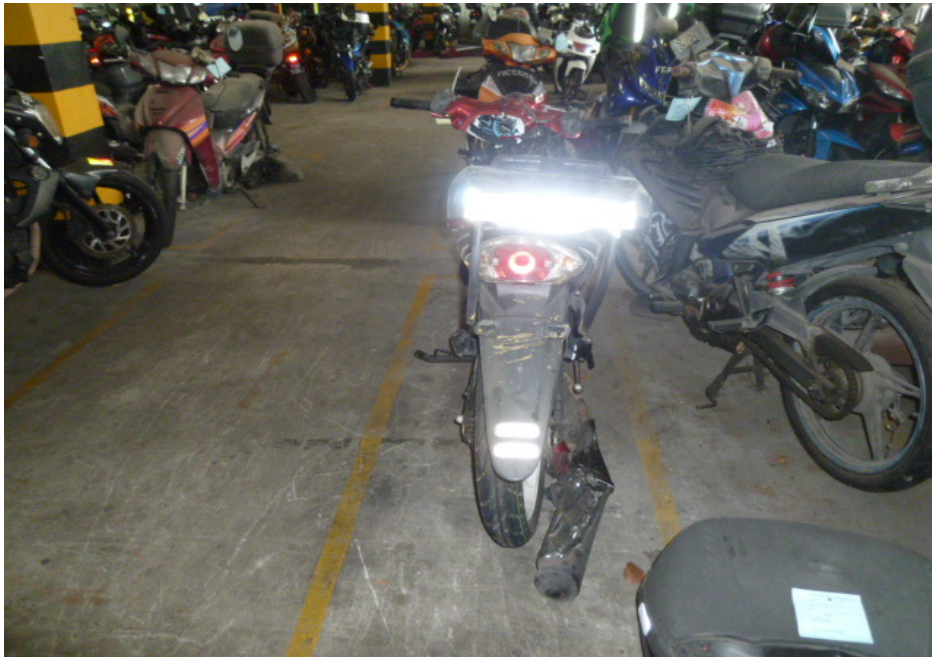
Photo 2 shows a general view of the rear portion of the Motorcycle at the time of our inspection. The Motorcycle had sustained damages all around.

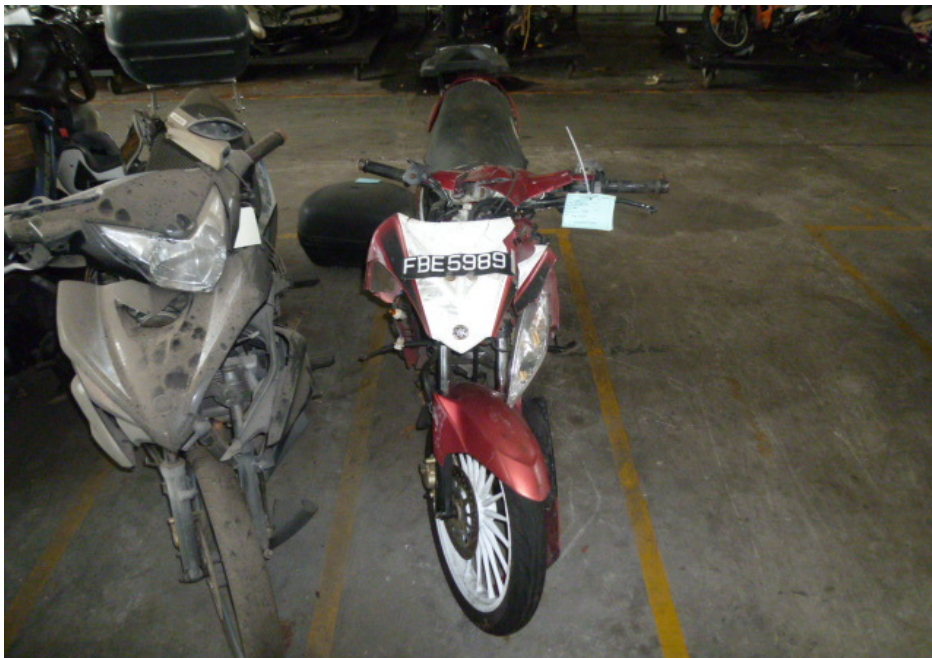
Photo 3 shows a general view of the frontal portion of the Motorcycle at the time of our inspection. The Motorcycle had sustained damages all around.

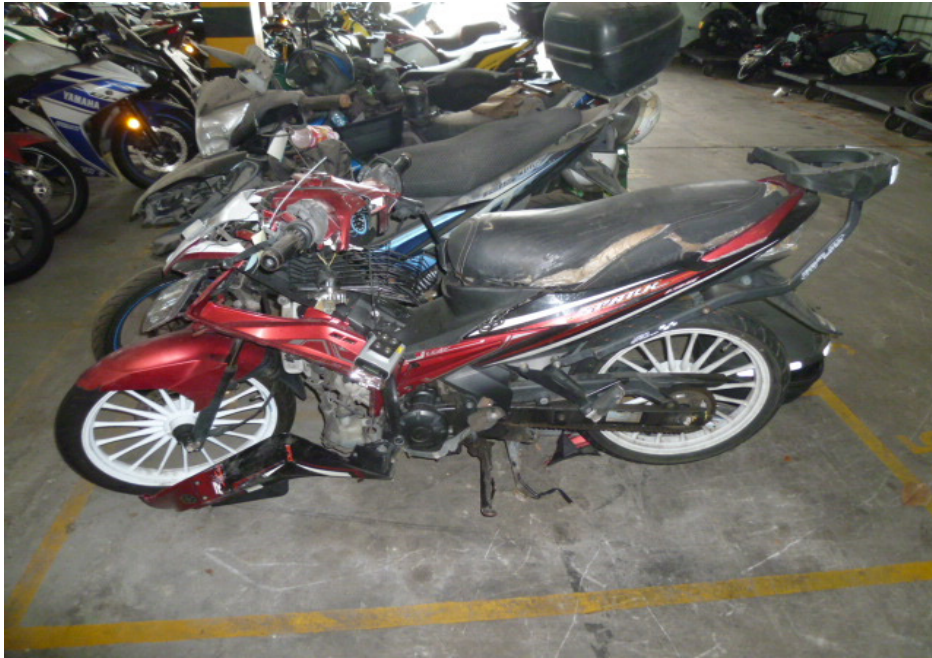
Photo 4 shows a general view of the left body of the Motorcycle at the time of our inspection. The Motorcycle had sustained damages all around. Body parts that were found to have been damaged include its headlight assembly, front cowlings, steering stem, front mudguard, handlebar, side mirrors, side cowlings, front footrests, front basket, rear side covers and exhaust muffler, amongst others.

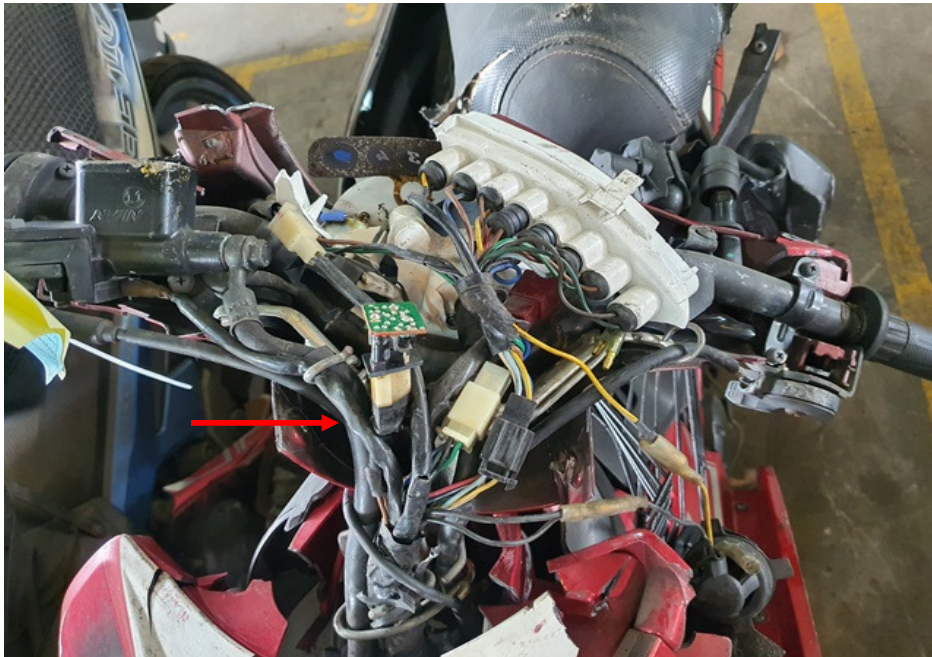
Photo 5 shows a closer view of the missing headlight assembly of the Motorcycle as a result of the accident (arrowed).

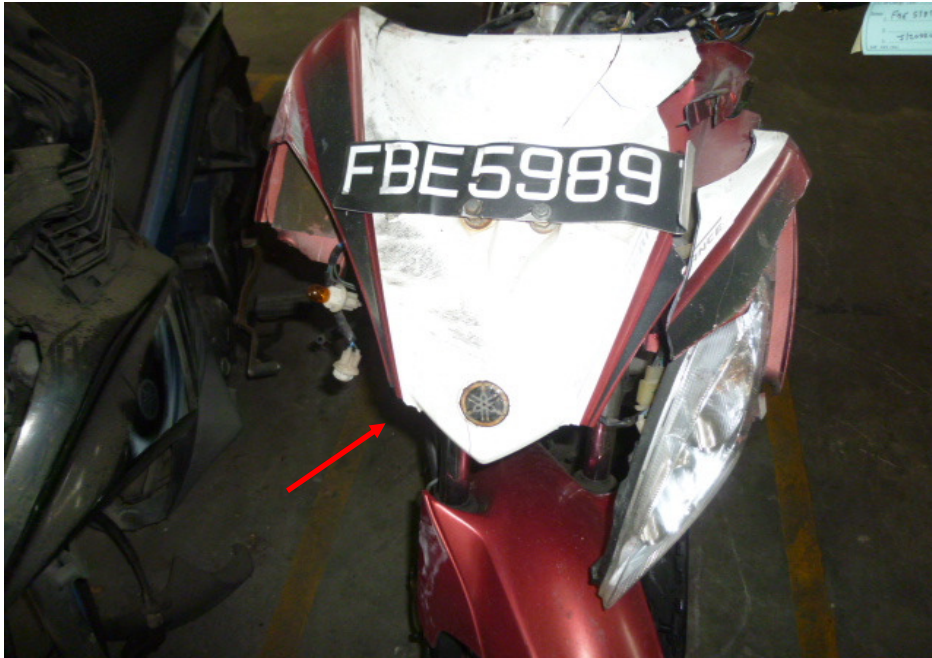
Photo 6 shows the cracked front cowling of the Motorcycle at the time of our inspection (arrowed).

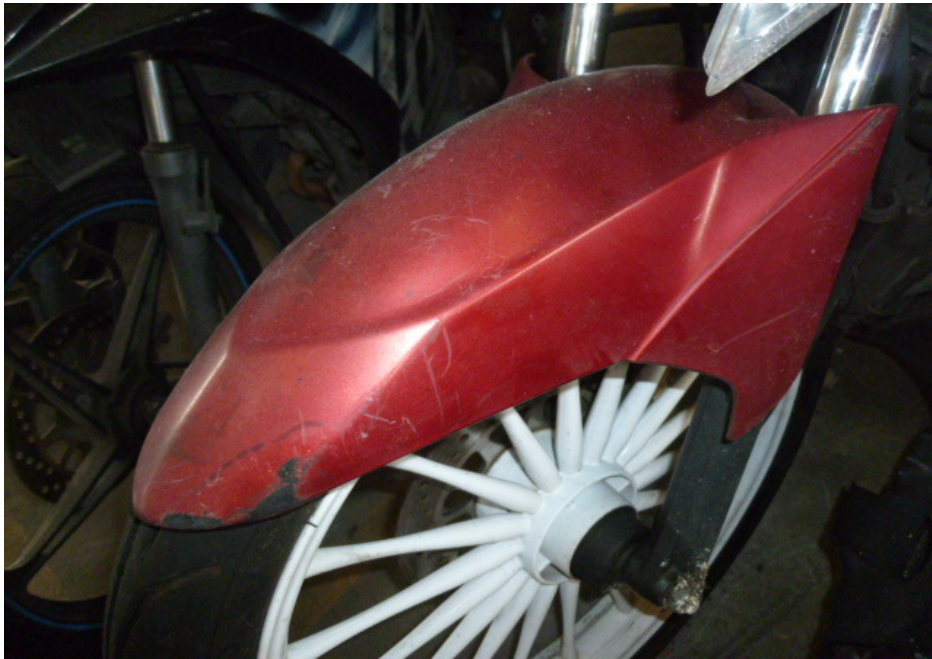
Photo 7 shows a closer view of the front mudguard, which was amongst the body parts of the Motorcycle that had sustained damage as a result of the accident.

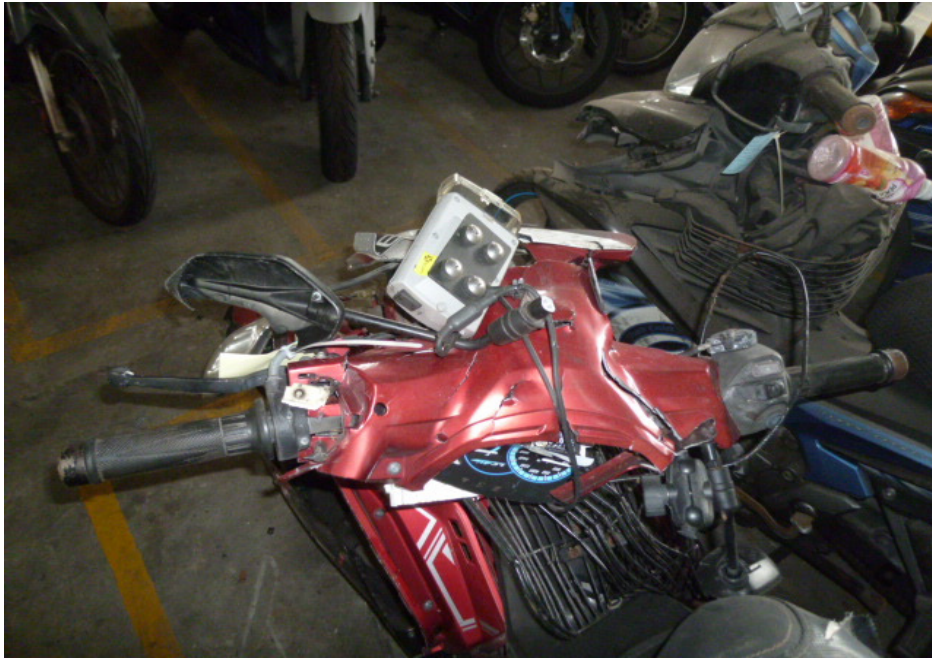
Photo 8 shows a closer view of the handlebar, handlebar ends, side mirrors, clutch lever and front brake lever which were amongst the body parts of the Motorcycle that had sustained damage as a result of the accident.

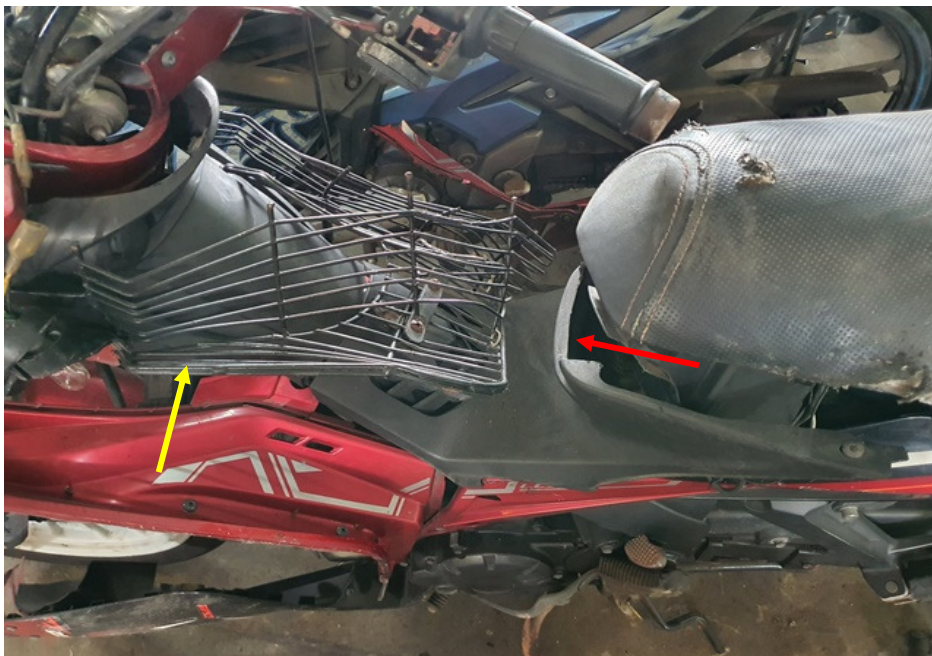
Photo 9 shows a closer view of the front basket and centre inner panel of the Motorcycle (arrowed). These parts were amongst the body parts of the Motorcycle which were damaged as a result of the accident.

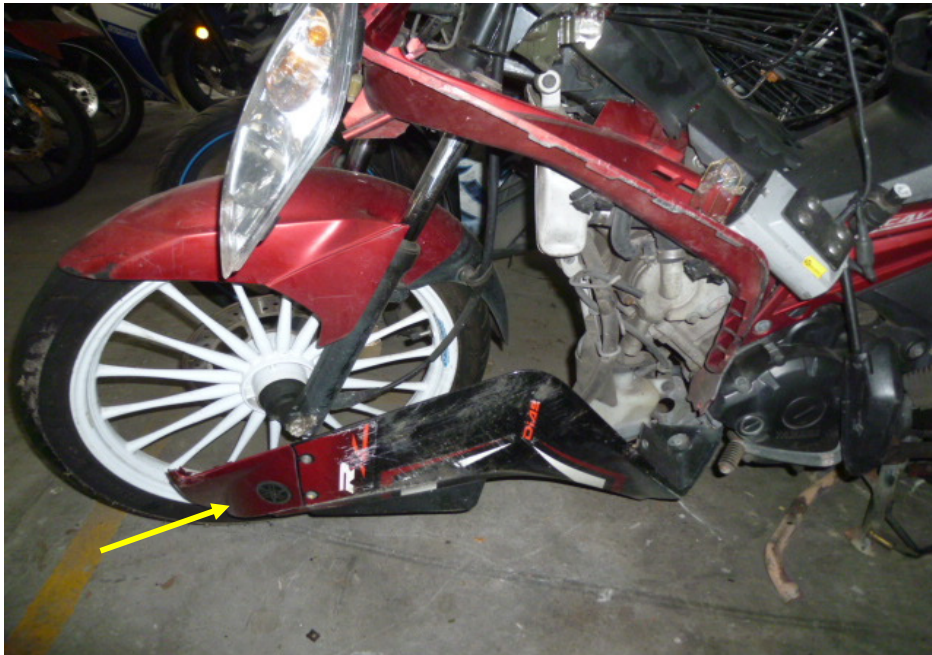
Photo 10 shows a closer view of the cracked left cowling which was amongst the body parts at the front body of the Motorcycle that had sustained damages as a result of the accident (arrowed).

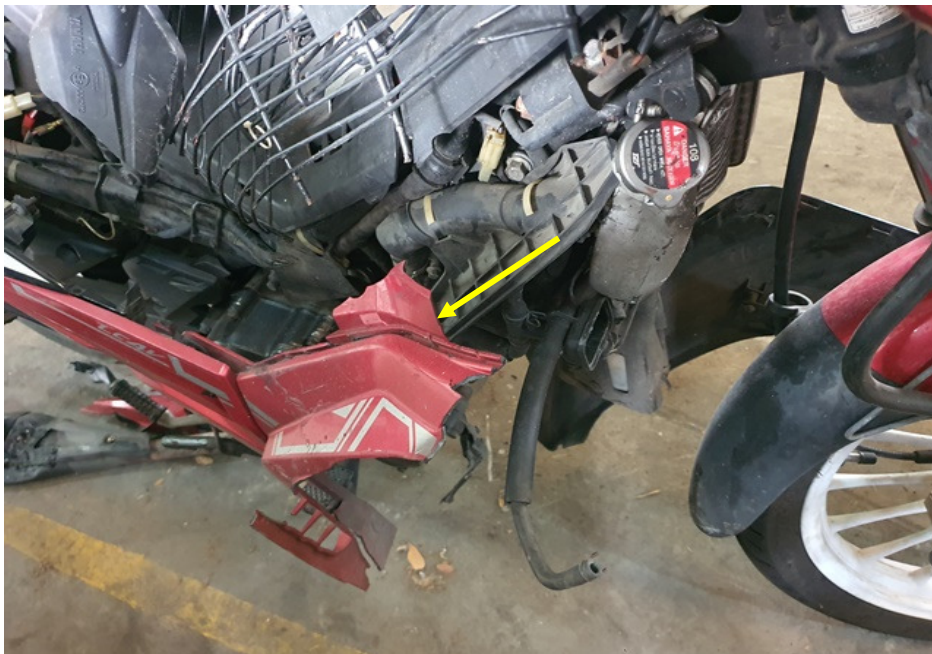
Photo 11 shows a closer view of the cracked right cowling of the Motorcycle as a result of the accident (arrowed).

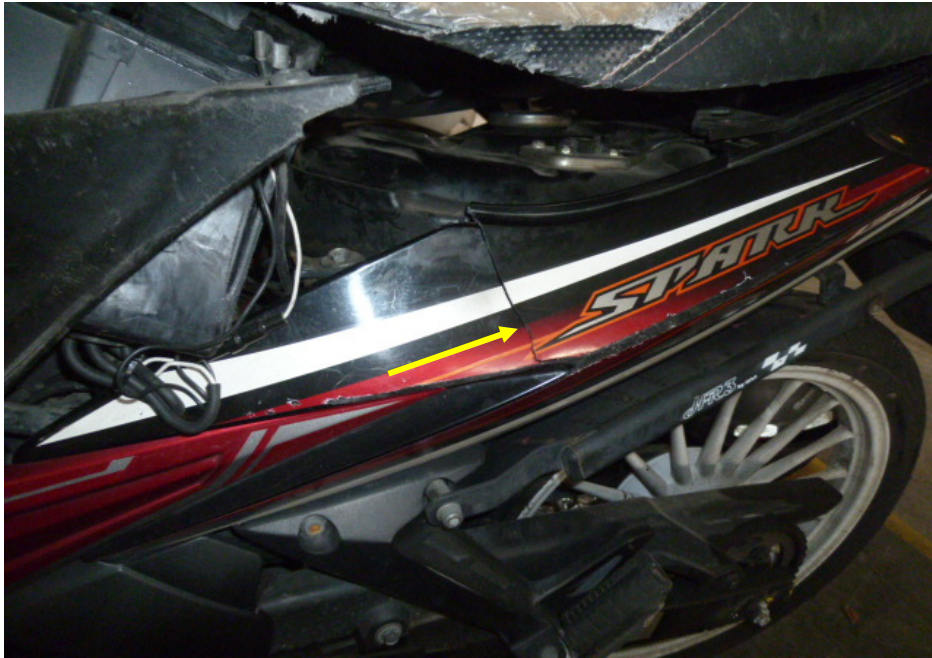
Photo 12 shows a closer view of the cracked left rear side cover which was amongst the body parts of the Motorcycle as a result of the accident (arrowed).

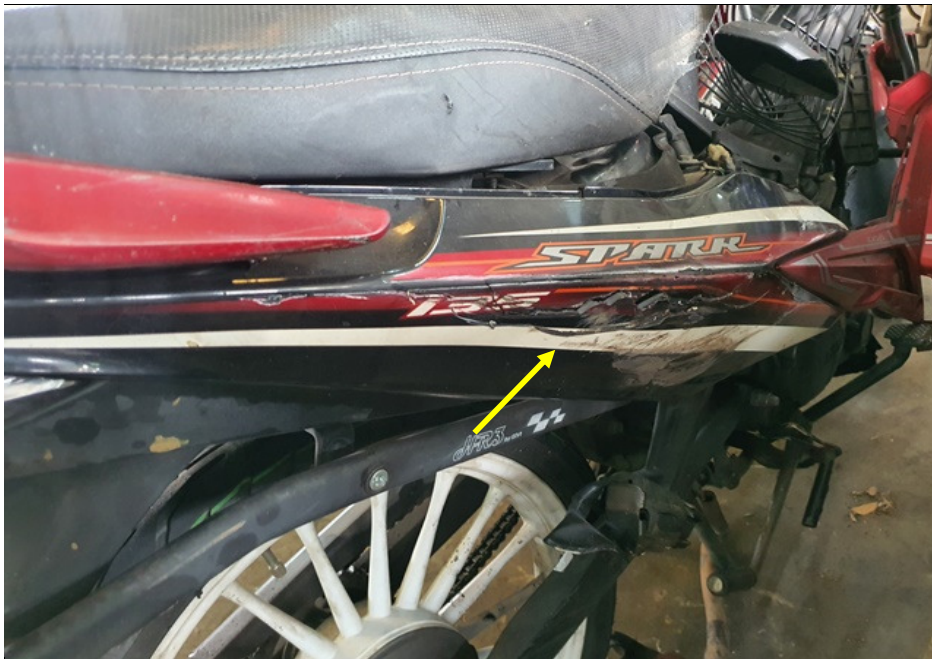
Photo 13 shows a closer view of the cracked right rear side cover which was amongst the body parts of the Motorcycle as a result of the accident (arrowed).

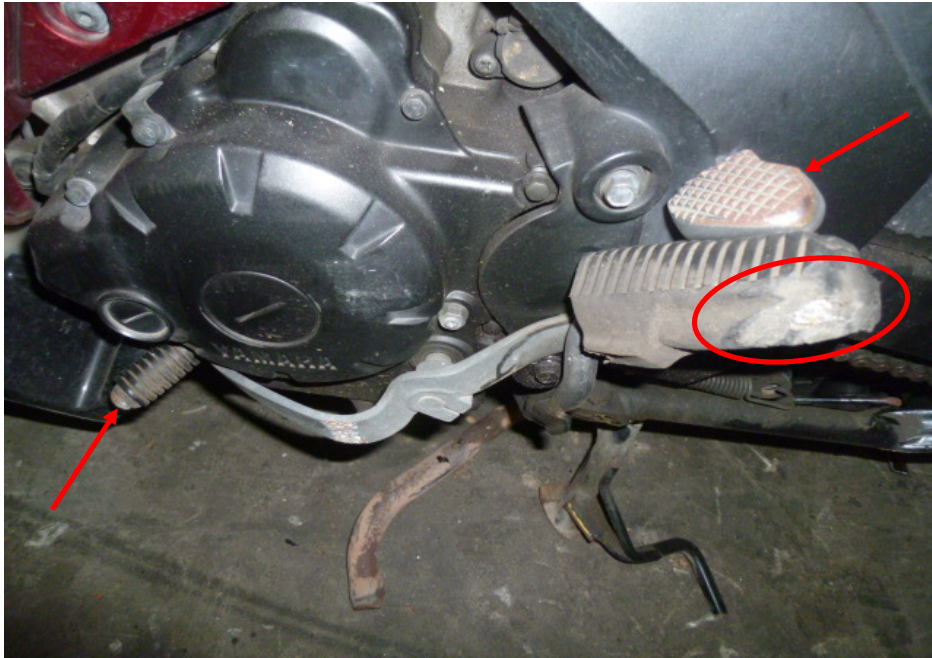
Photo 14 shows a closer view of the gear shift pedal (arrowed) and right front footrest (circled) which were amongst the body parts of the Motorcycle that had sustained damage as a result of the accident.

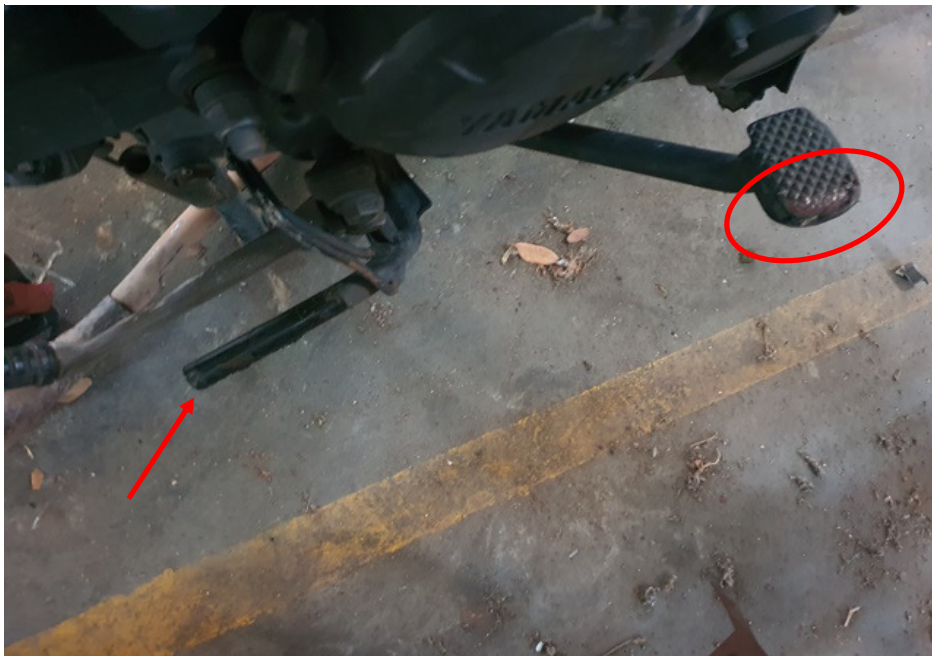
Photo 15 shows a closer view of the rear brake pedal (circled) and right front footrest (arrowed) which were amongst the body parts of the Motorcycle that had sustained damage as a result of the accident.

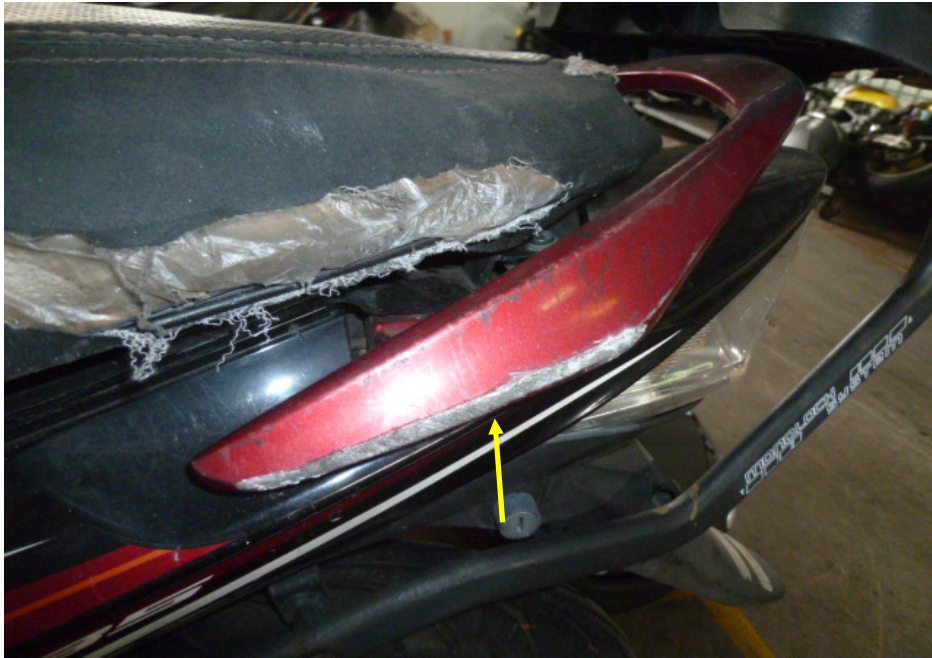
Photo 16 shows a closer view of the left pillion grab rail which was amongst the body parts of the Motorcycle that had sustained damages of grazing nature as a result of the accident (arrowed).

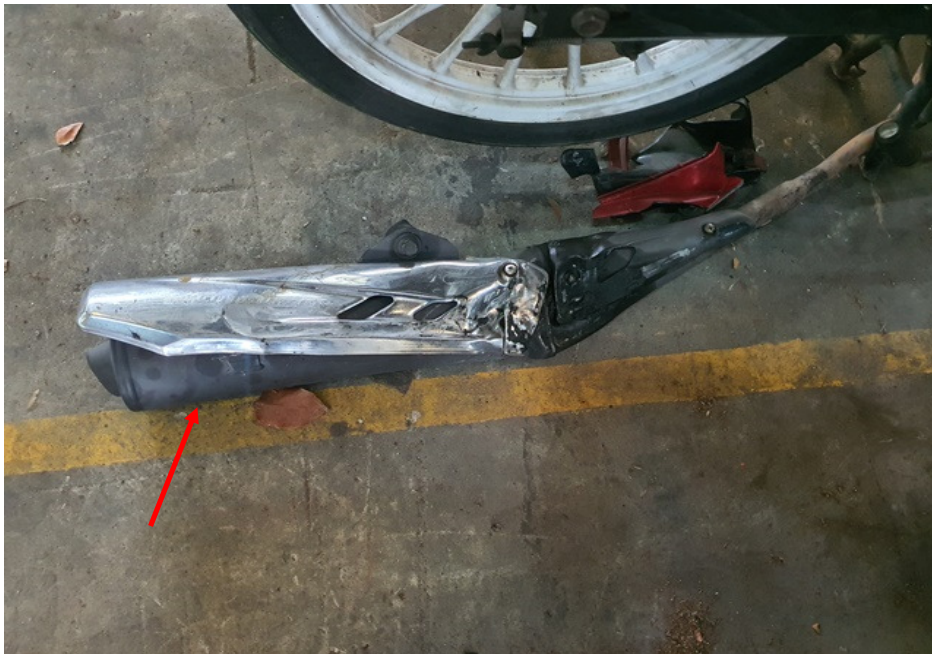
Photo 17 shows a closer view of the dislodged exhaust muffler of the Motorcycle as a result of the accident (arrowed).

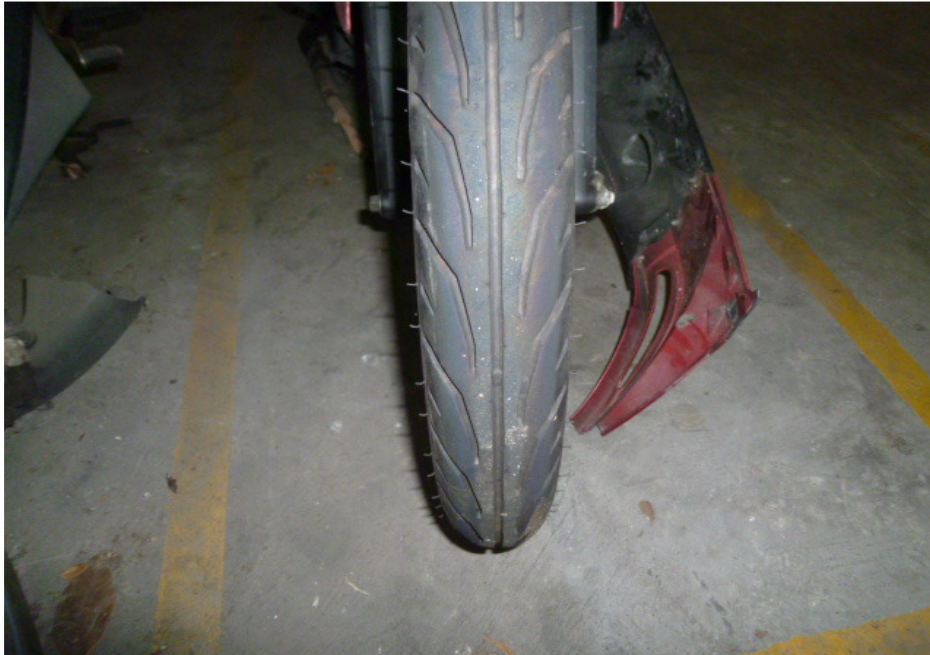
Photo 18 shows the front tyre of the Motorcycle at the time of our inspection. The front tyre was observed to be in serviceable condition with remaining tread depth of approximately 3mm. The pattern of the tread was also clearly visible. There was no tear, burst mark(s) and/or punctured hole(s) on the sidewalls as well as across the tread of the front tyre.

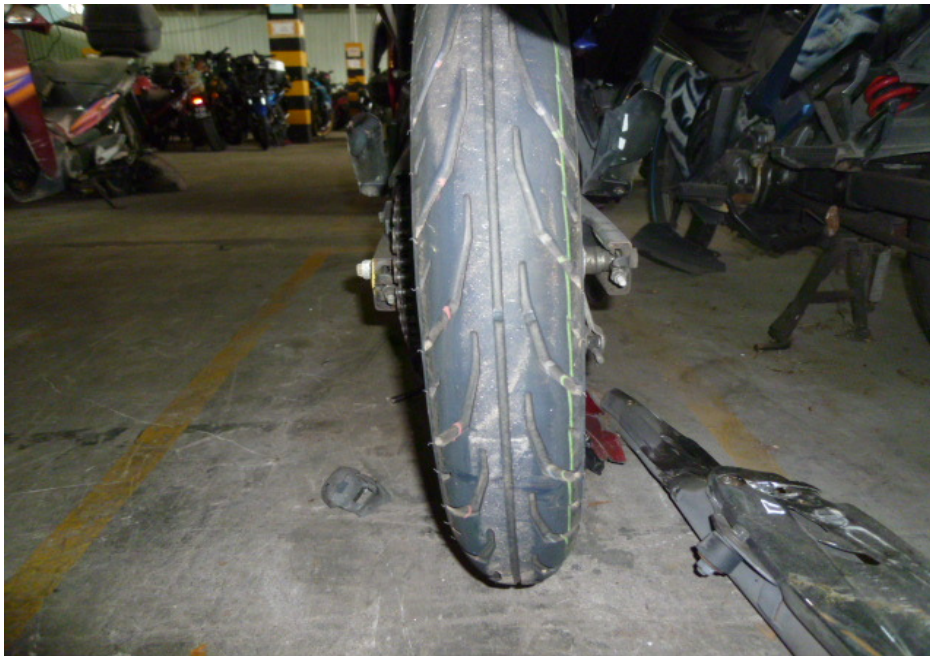
Photo 19 shows the condition of the Motorcycle's rear tyre. The rear tyre was observed to be in serviceable condition with remaining tread depth of approximately 2mm. The tyre was also observed to be sufficiently inflated for vehicular operation. We did not observe any tear, burst mark(s) and/or punctured hole(s) on the sidewalls as well as across the tread of the rear tyre.

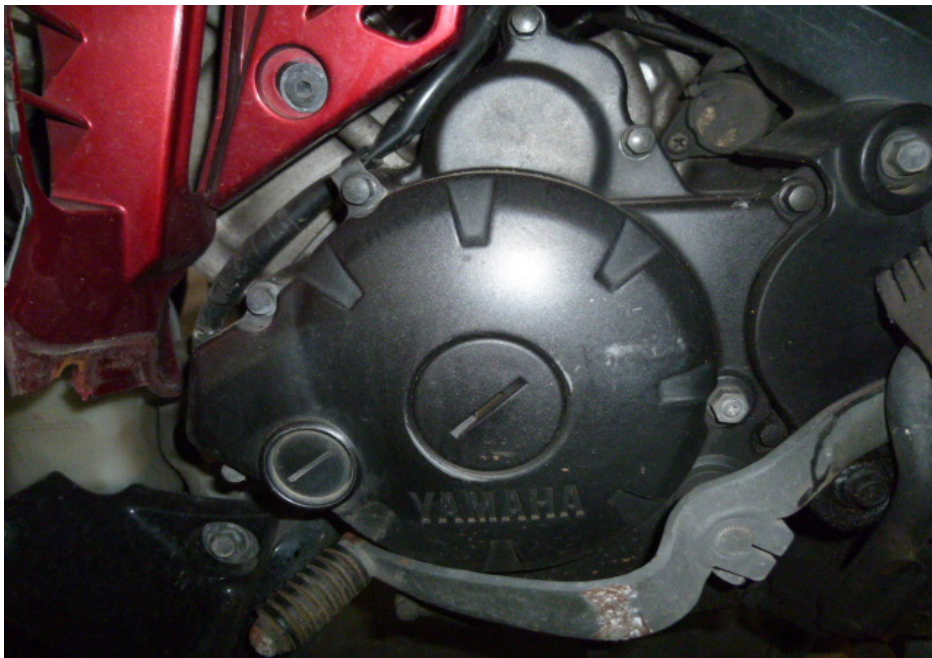
Photo 20 shows the left side of the engine of the Motorcycle at the time of our inspection. The various engine related parts and components were found to be intact with no visible damage. There was also no sign(s) or indication(s) of fluid leak observed around the left engine area of the Motorcycle.

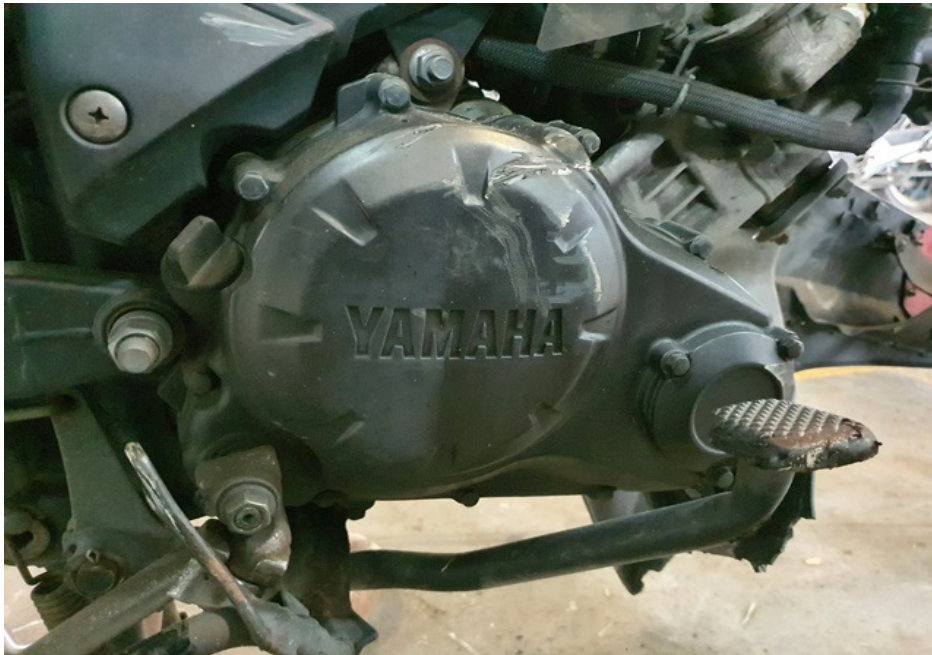
Photo 21 shows the right side of the engine of the Motorcycle at the time of our inspection. The various engine related parts and components were found to be intact with no visible damage. There was also no sign(s) or indication(s) of fluid leak observed around the right engine area of the Motorcycle.

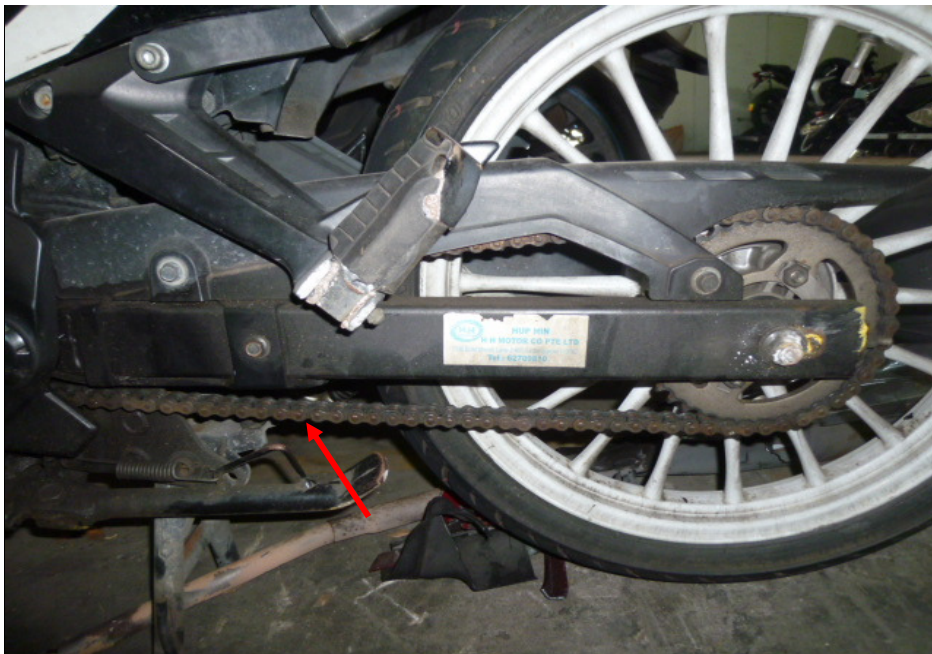
Photo 22 shows the gear train (arrowed) of the Motorcycle, which was observed to be intact with no misalignment. It was also adequately lubricated for operating purposes. The gear train rotates the rear wheel of the Motorcycle.

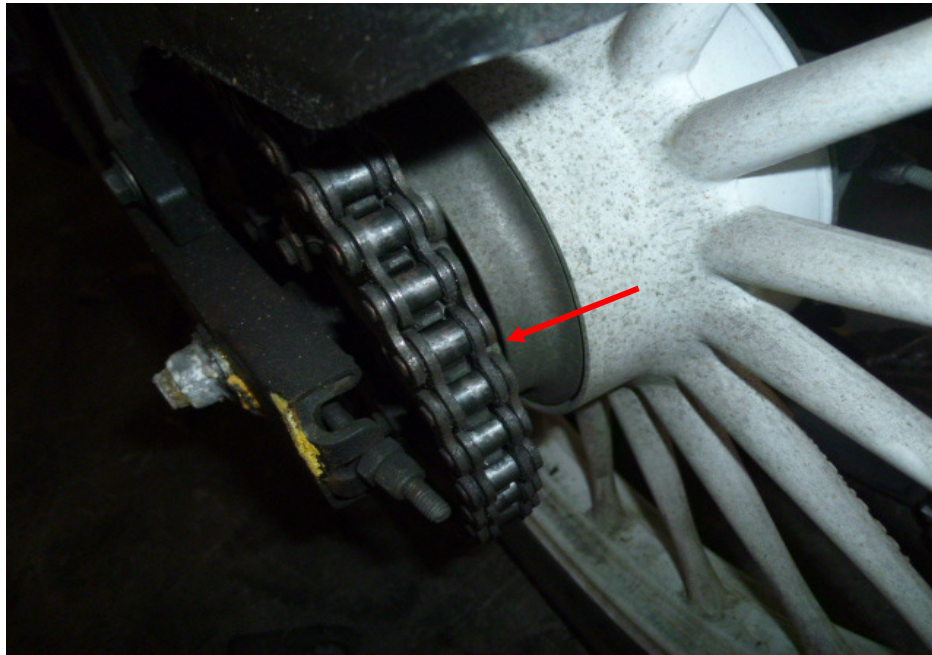
Photo 23 shows the closer view of the gear train (arrowed) of the Motorcycle, which was observed to be intact with no misalignment. It was also adequately lubricated for operating purposes.

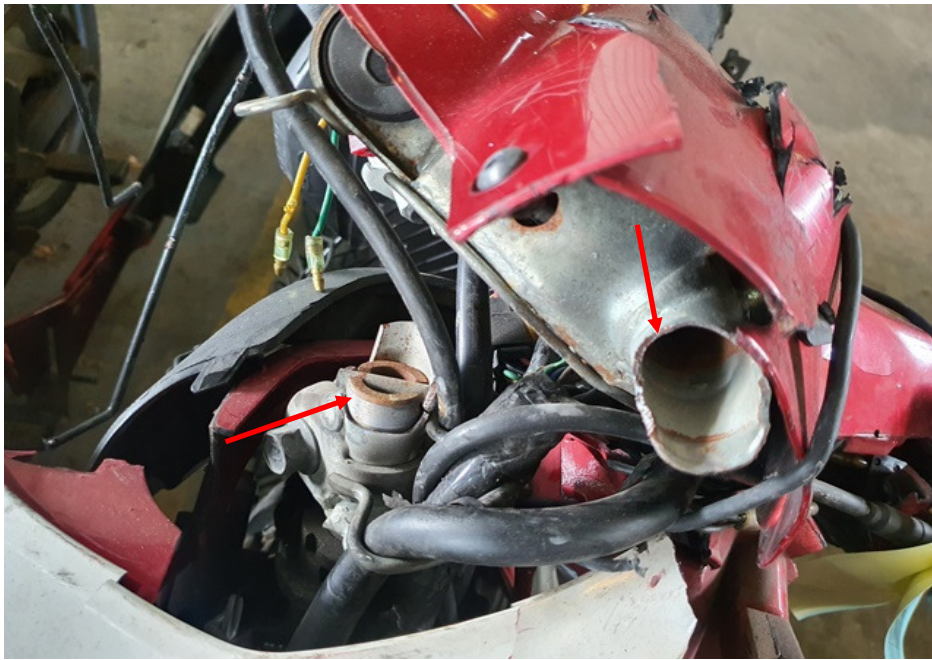
11. For this case, we were not able to conduct any test(s) on the steering system of the Motorcycle due to the damage to its steering stem. The steering stem was observed to be broken as a result of the accident.

Photo 24 shows the steering stem of the Motorcycle. The steering stem was observed to be broken as a result of the accident (arrowed). We were hence not able to conduct any tests on the steering system of the Motorcycle.

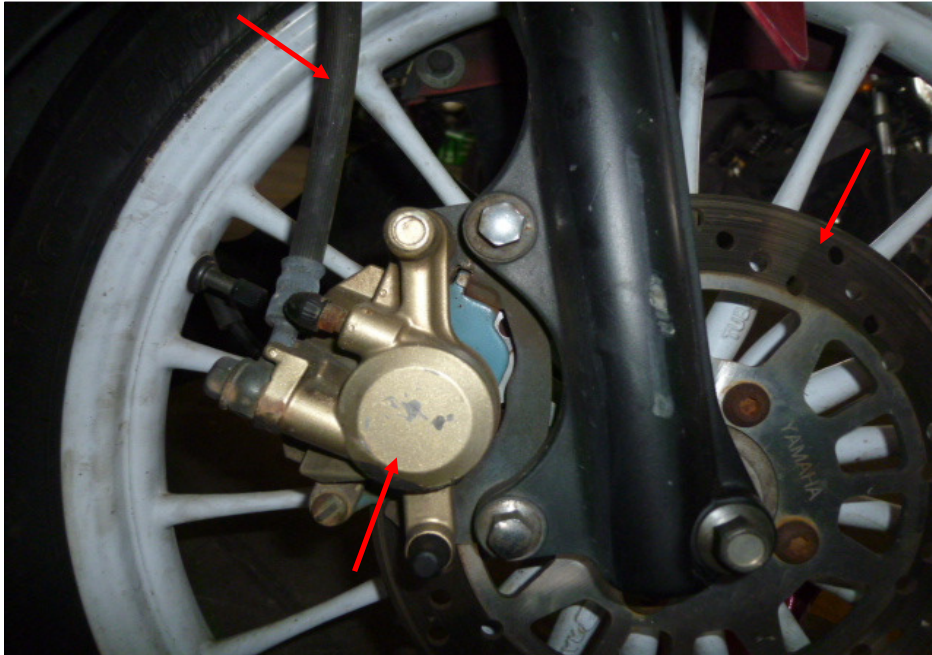
Photo 25 shows a close up view of the front brake caliper, front brake disc and front brake hose (arrowed) of the Motorcycle, which are all part of the components in the hydraulic front brake system of the Motorcycle. Our visual checks of these various components had revealed all to be intact with no visible damage. No leakage of brake fluid was also observed.

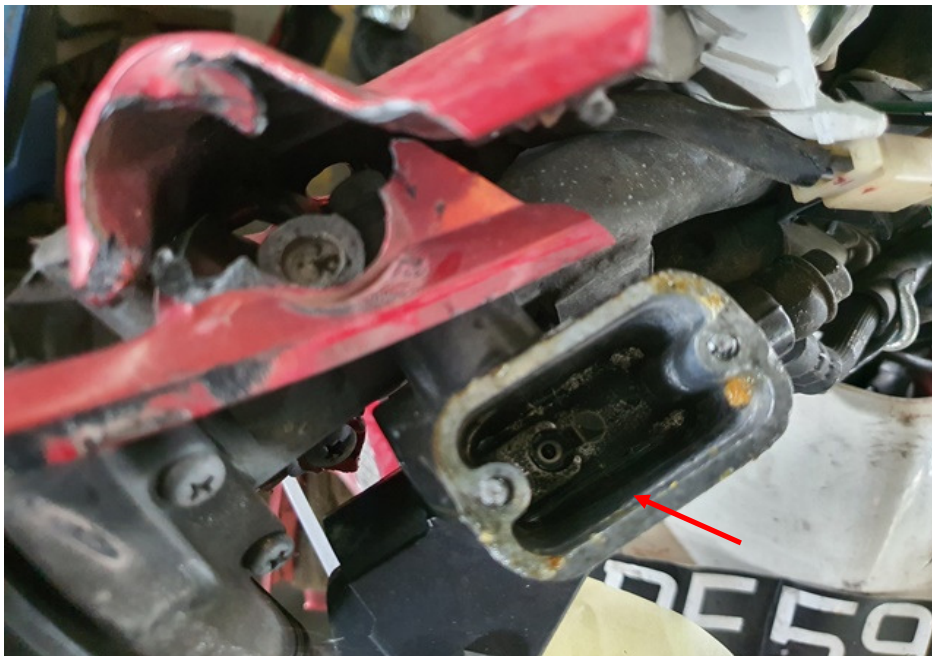
Photo 26 shows the brake fluid reservoir for the front brake of the Motorcycle. The front brake reservoir was observed to be empty (arrowed).

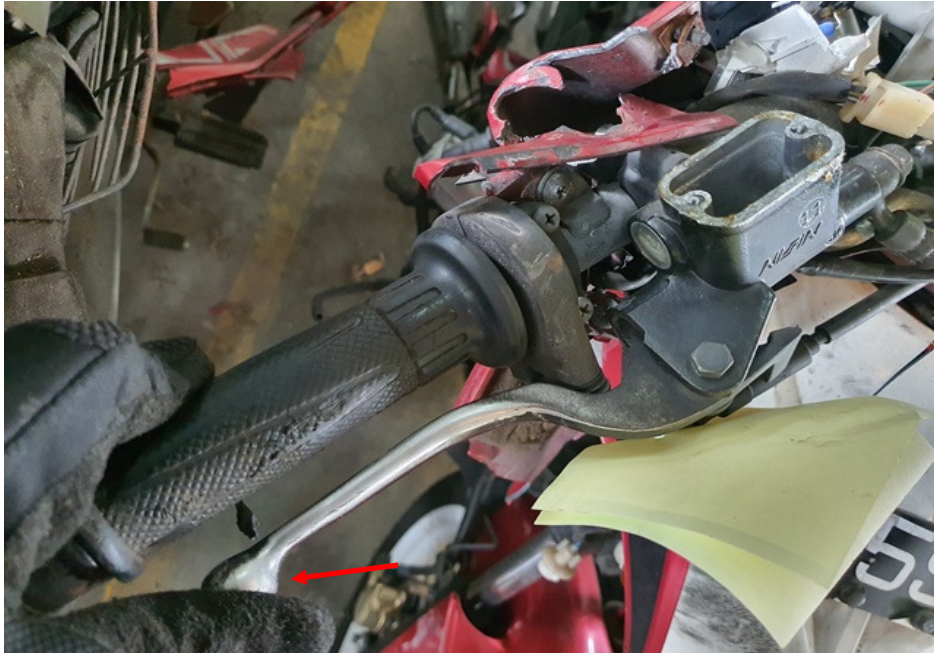
13. Static brake tests conducted on the Motorcycle had appear to indicate that the front braking system of the Motorcycle was not in serviceable condition. There was no resistance felt (spongy like feel) upon pressing the brake lever. This would indicate that there may be a leakage of pressure/vacuum in the front braking system.

Photo 27 shows the front brake lever being depressed. There was no resistance felt (spongy like feel) upon pressing the front brake lever (arrowed). This would indicate that there may be a leakage of pressure/vacuum in the front brake system.

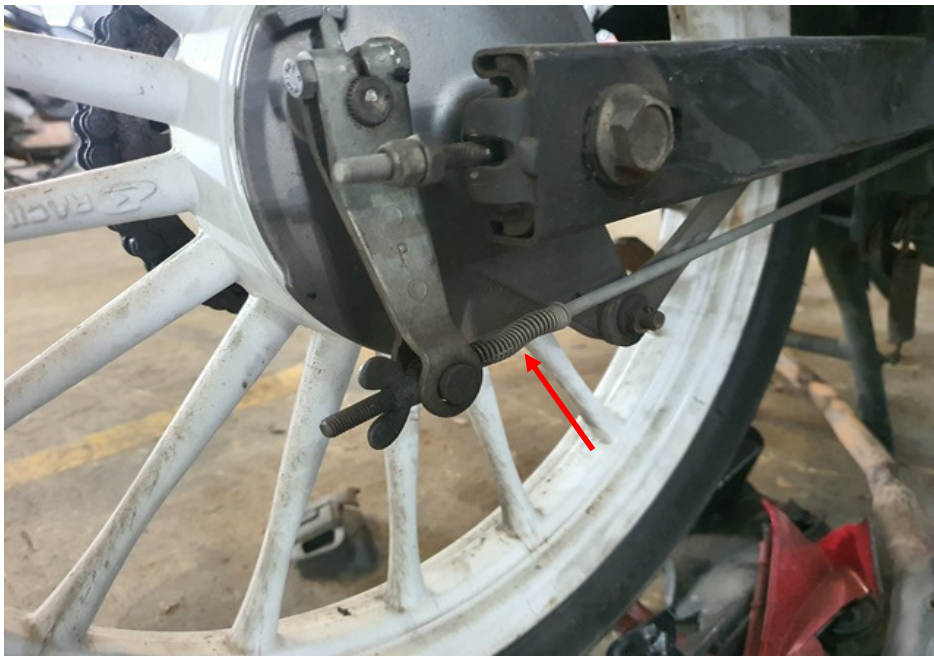
Photo 28 shows the rear wheel of the Motorcycle. The type of brake system for the rear wheel was of a mechanical type, controlled by the brake foot pedal of the Motorcycle. Our checks of the cable (arrowed), spring and drum which are all part of the components in the rear brake system of the Motorcycle reveal all to be intact and without damage.
