Your Ref: TP/IP/15076/2022
Our Ref : CI/TPD22008684/N

16 September 2022

MECHANICAL INSPECTION REPORT OF MOTORCYCLE JVH 8057

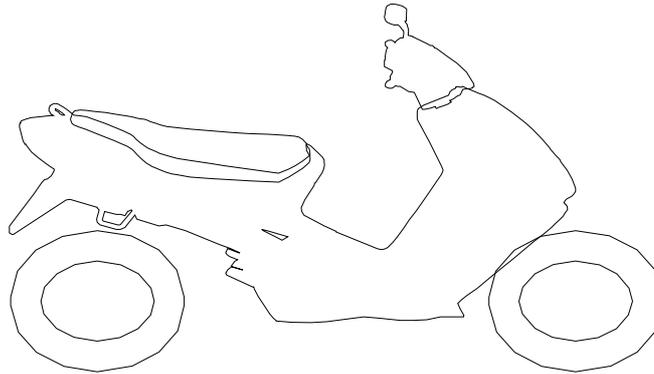
7. The tyre brand, tyre size and remaining tread depth of the 2 tyres of the Motorcycle were recorded as follows:-

Vee Rubber 80/90 R17 (5mm)

Vee Rubber 70/90 R17 (3mm)

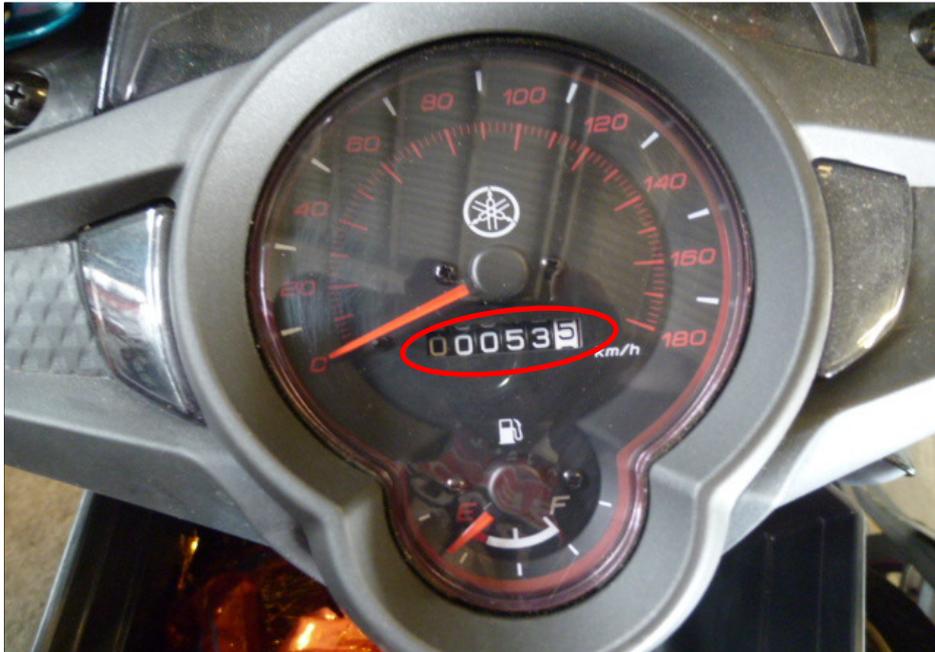
Photo 1 shows the speedometer gauge of the Motorcycle where the mileage recorded at the time of our inspection was 53km (circled).

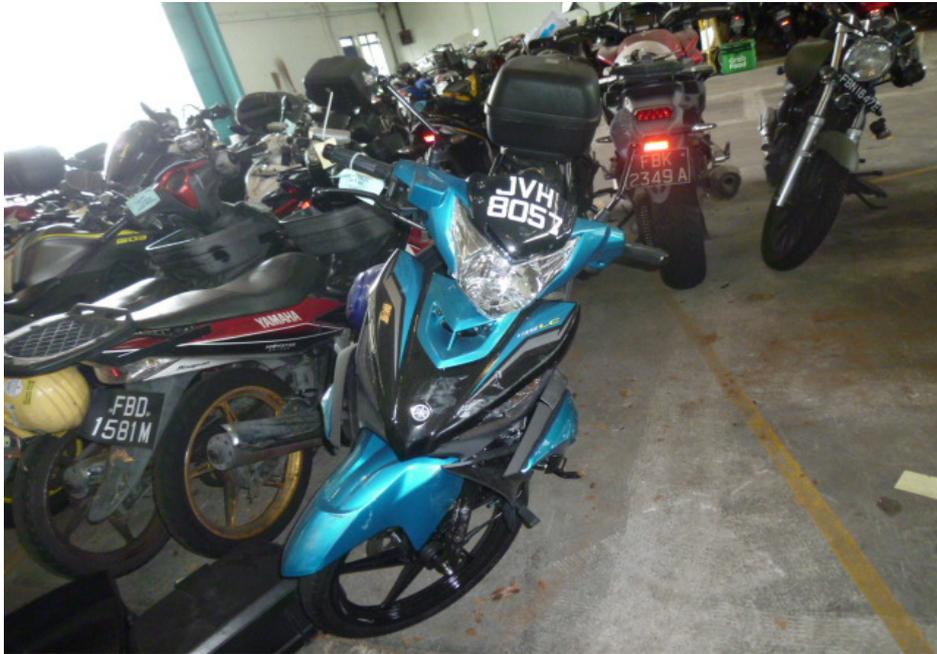
Photo 2 shows a general view of the frontal portion of the Motorcycle at the time of our inspection. The Motorcycle had sustained damages at its frontal portion and left body.

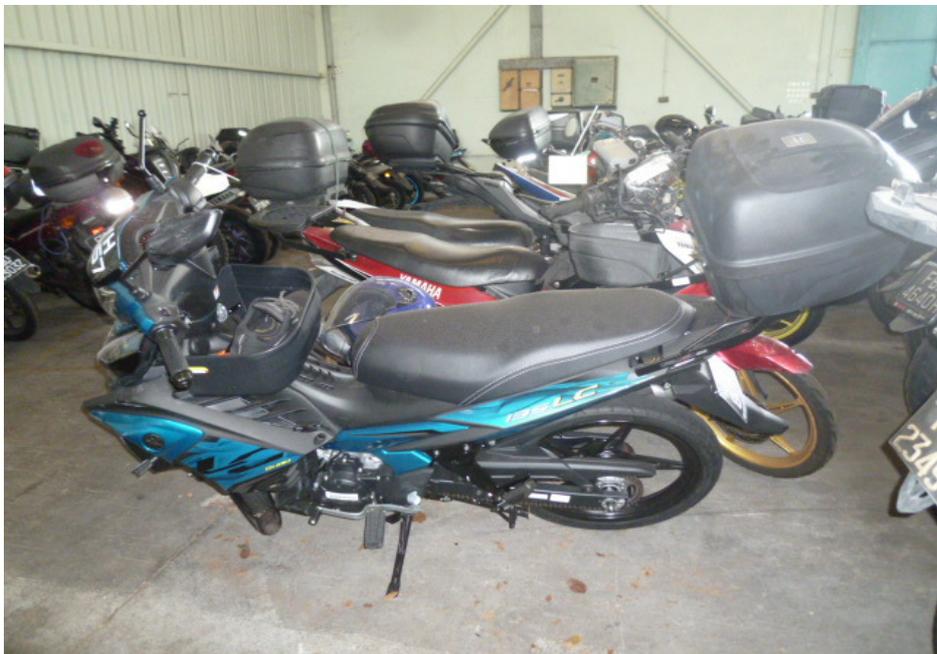
Photo 3 shows a general view of the left body of the Motorcycle at the time of our inspection. The Motorcycle had sustained damages at its frontal portion and left body.

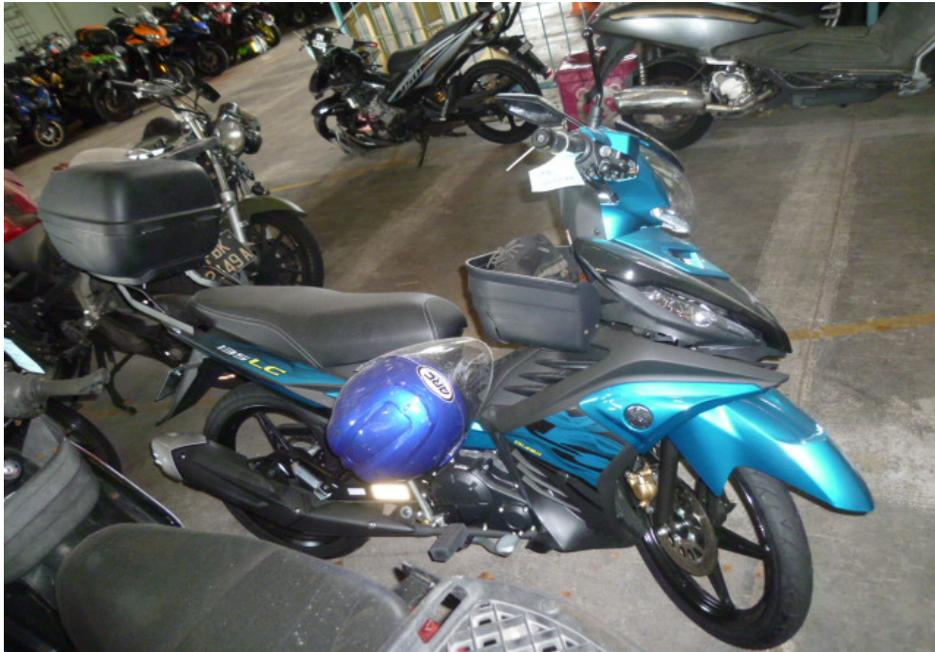
Photo 4 shows a general view of the right body of the Motorcycle at the time of our inspection. The Motorcycle had sustained damages at its frontal portion and left body.

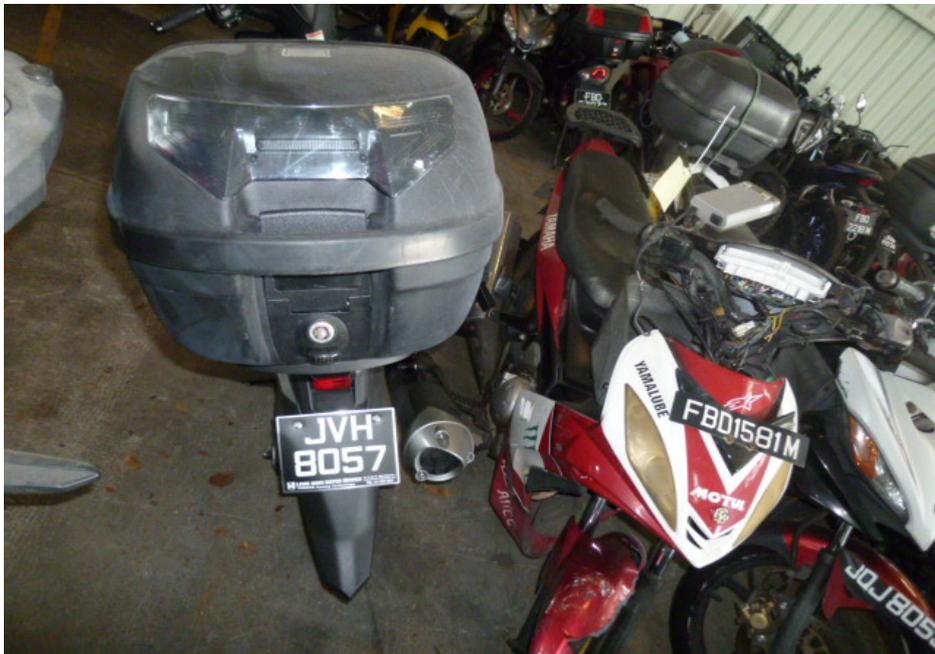
Photo 5 shows a general view of the frontal portion of the Motorcycle at the time of our inspection. The Motorcycle had sustained damages at its frontal portion and left body. Body parts that were found to have been damaged include its windshield, headlight, front mudguard, left front fork outer tube, front cowling, left handlebar end, left side mirror, left side cowling, front basket, radiator and belly pan, amongst others.

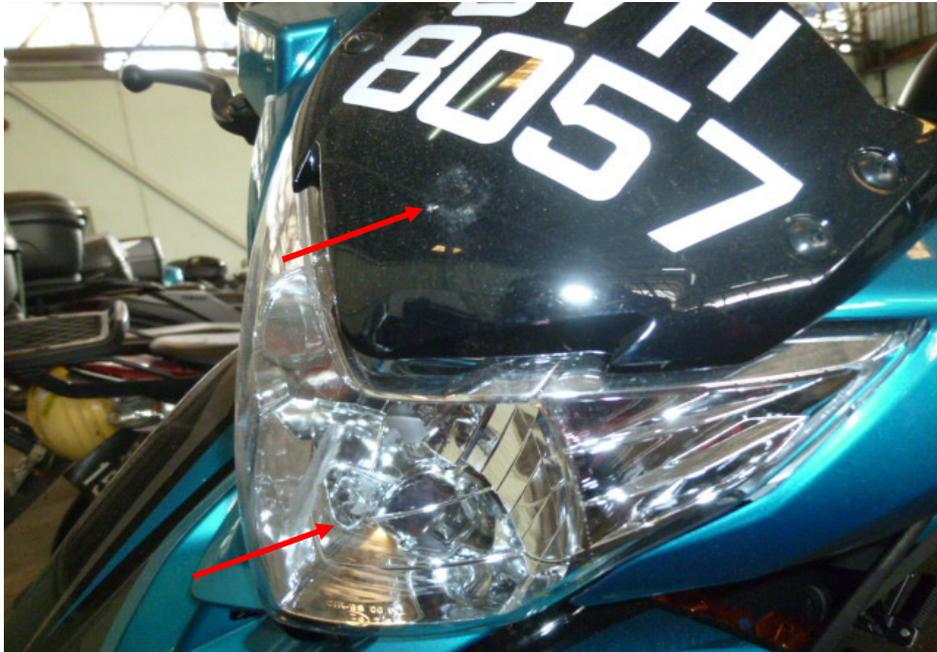
Photo 6 shows a closer view of the cracked headlight assembly and grazed windshield of the Motorcycle as a result of the accident (arrowed).

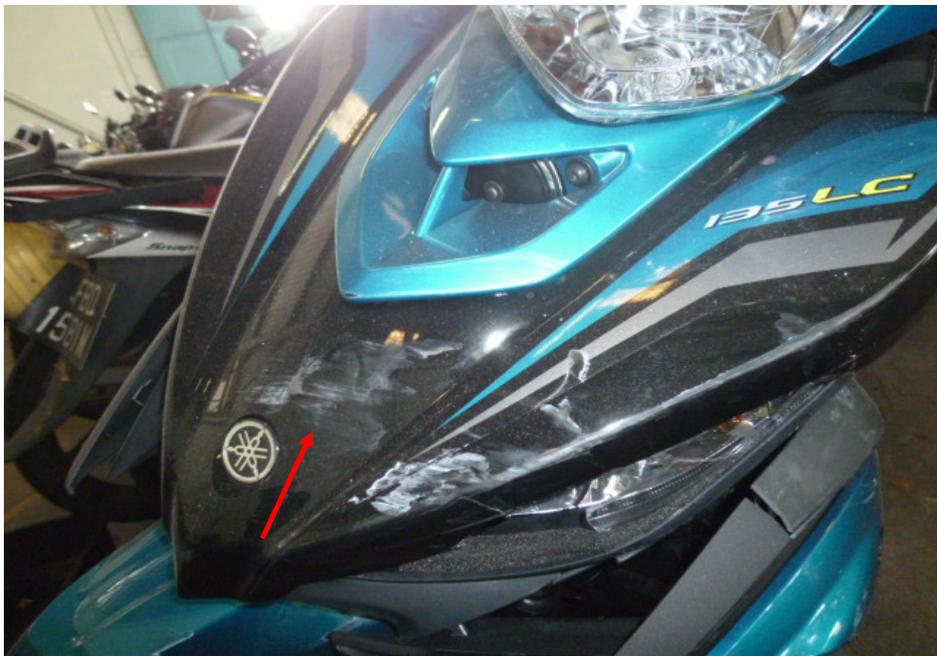
Photo 7 shows the grazed front cowling of the Motorcycle at the time of our inspection (arrowed).

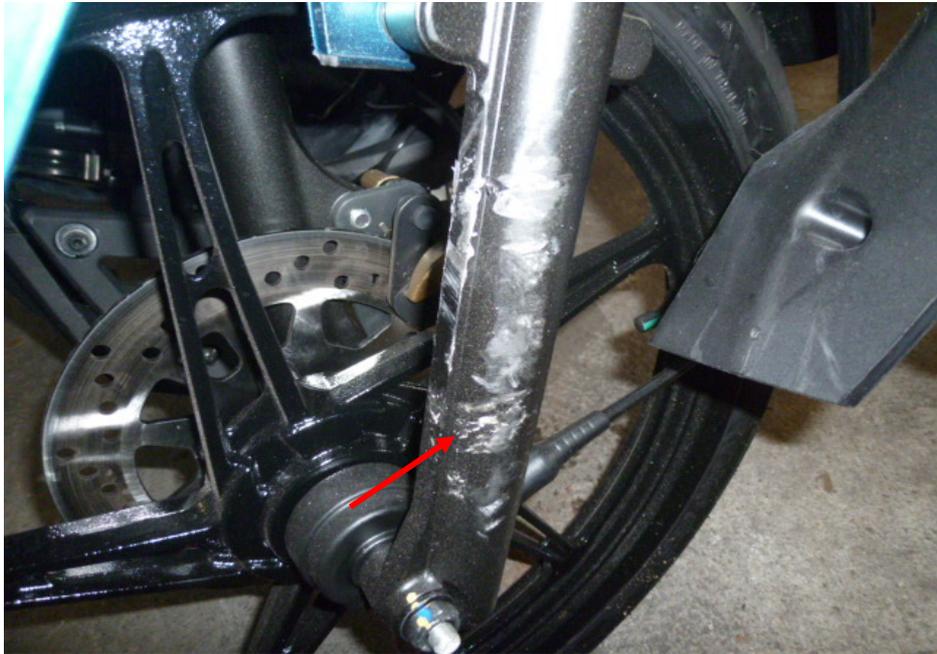
Photo 8 shows a closer view of the left fork outer tube of the Motorcycle (arrowed). This part was amongst the body parts of the Motorcycle which was damaged as a result of the accident.

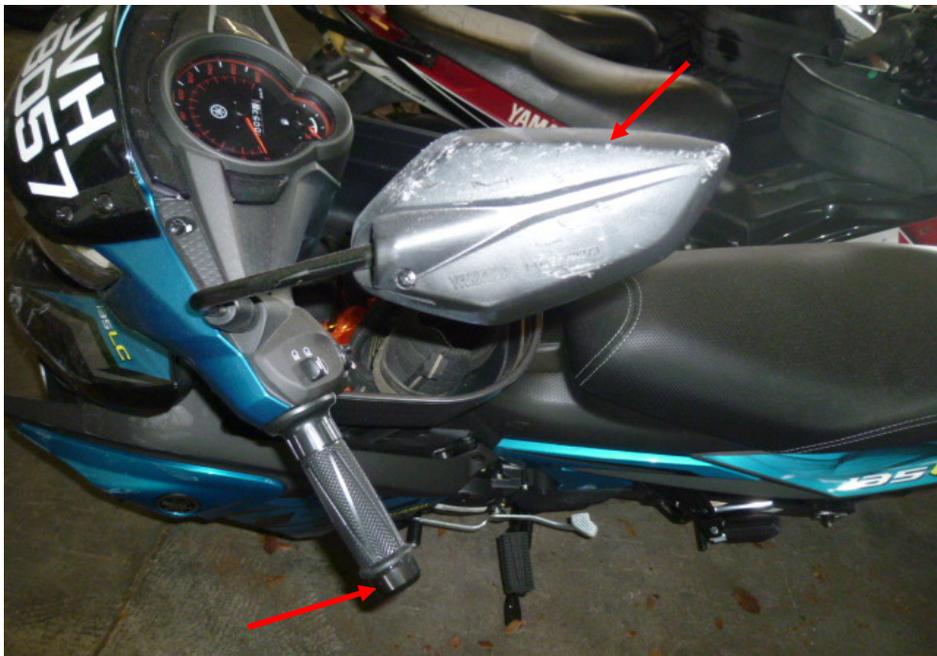
Photo 9 shows a closer view of the left side mirror and left handlebar end of the Motorcycle (arrowed). These parts were amongst the body parts of the Motorcycle which were damaged as a result of the accident.

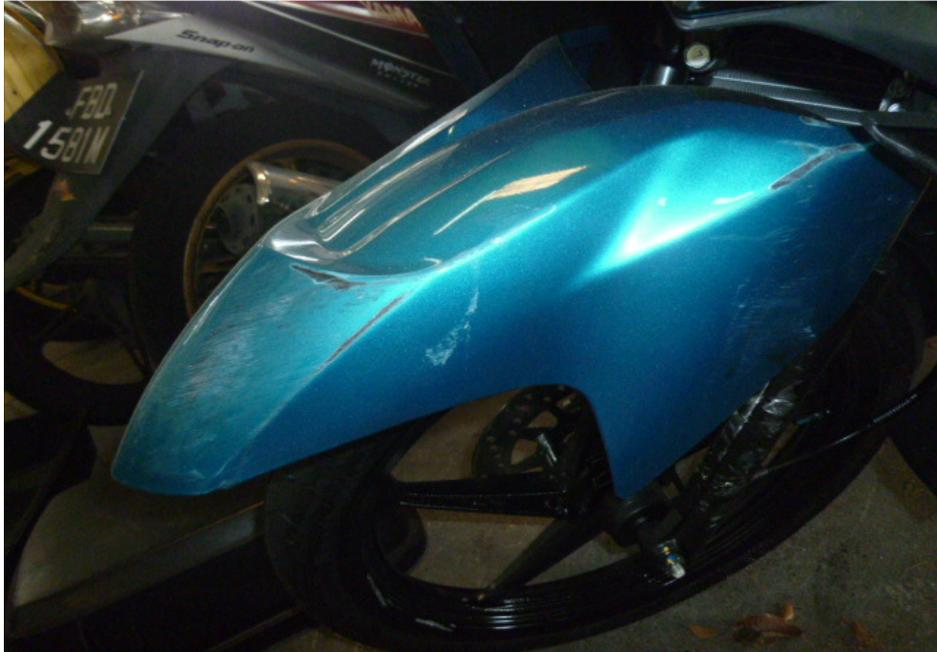
Photo 10 shows a closer view of the front mudguard which was amongst the body parts of the Motorcycle that had sustained damages of grazing nature as a result of the accident.

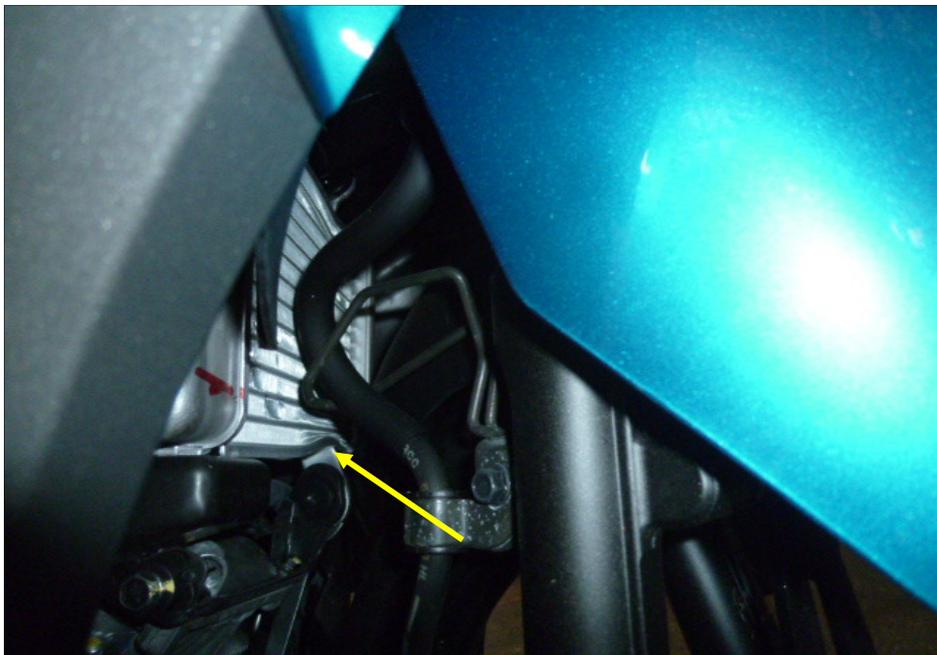
Photo 11 shows a closer view of the radiator which was amongst the body parts at the front body of the Motorcycle that had sustained damages as a result of the accident (arrowed).

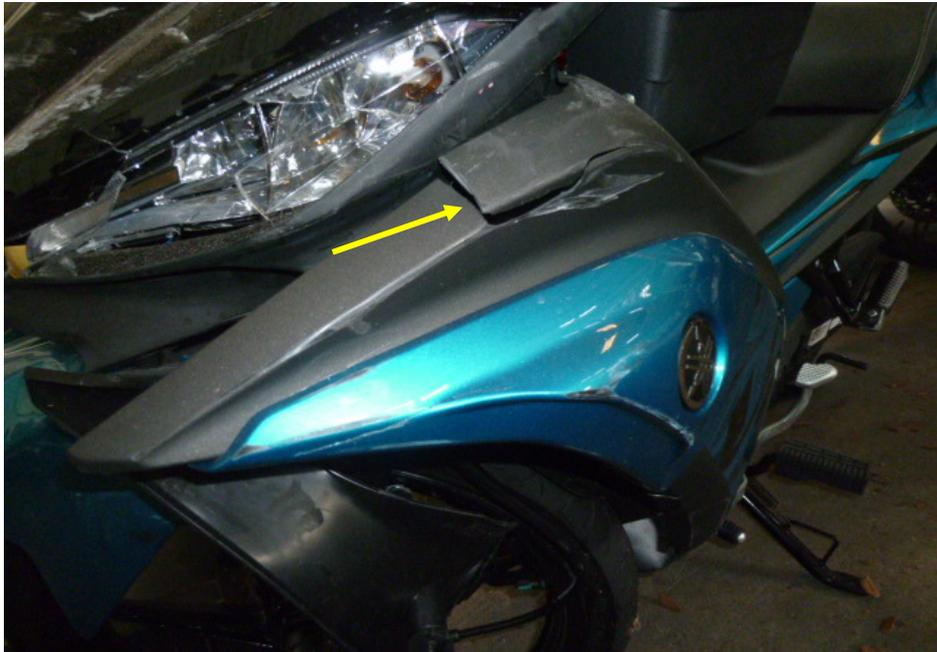
Photo 12 shows a closer view of the cracked left cowling which was amongst the body parts at the front body of the Motorcycle that had sustained damages as a result of the accident (arrowed).

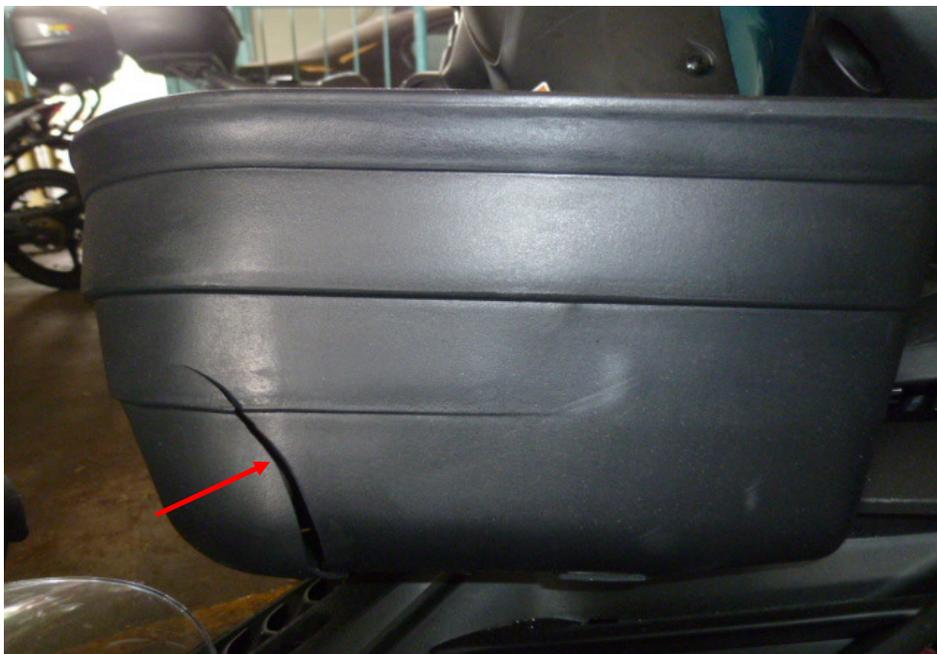
Photo 13 shows a closer view of the front basket (arrowed) which was amongst the body parts of the Motorcycle that had sustained damage as a result of the accident.

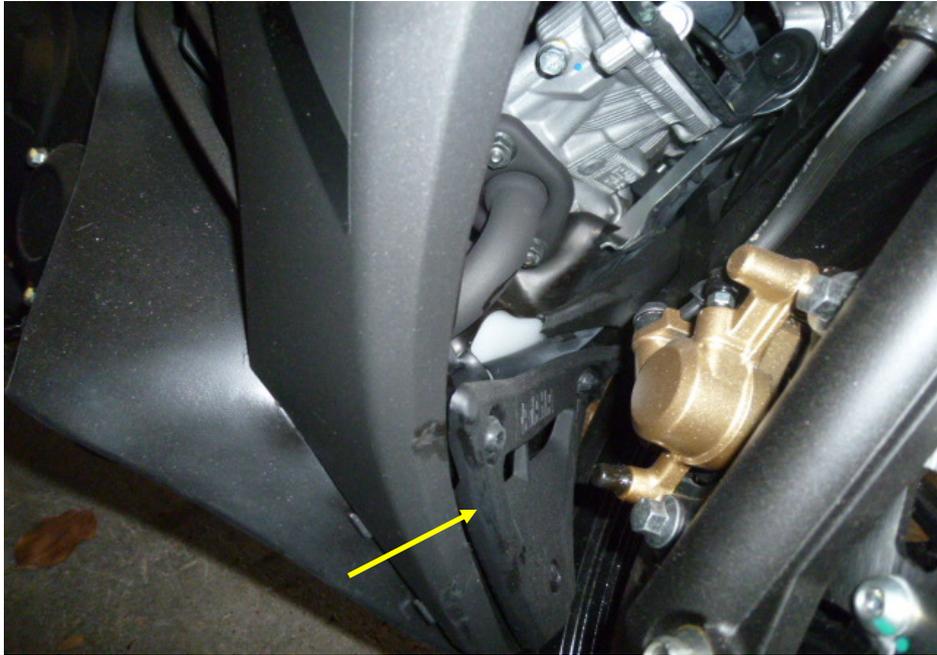
Photo 14 shows a closer view of the deformed belly pan of the Motorcycle as a result of the accident (arrowed).

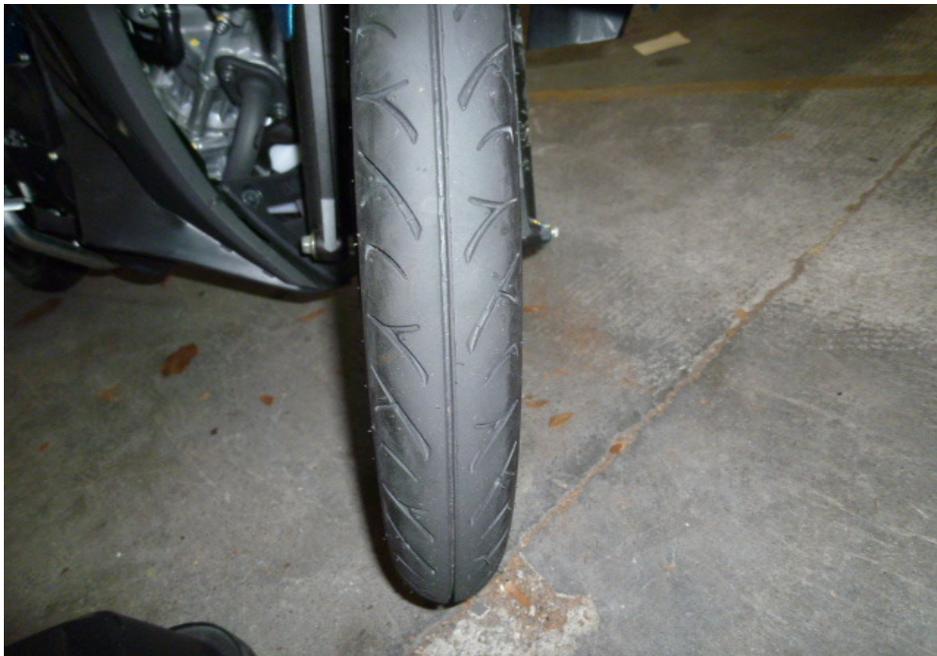
Photo 15 shows the front tyre of the Motorcycle at the time of our inspection. The front tyre was observed to be in serviceable condition with remaining tread depth of approximately 3mm. The pattern of the tread was also clearly visible. There was no tear, burst mark(s) and/or punctured hole(s) on the sidewalls as well as across the tread of the front tyre. The front tyre was also observed to be sufficiently inflated for vehicular operation.

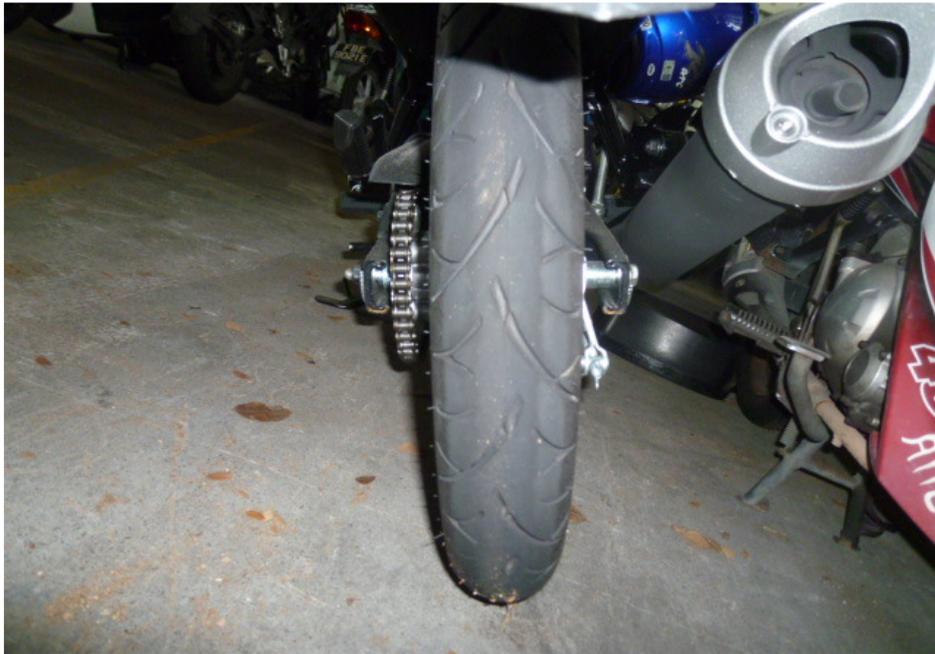
Photo 16 shows the condition of the Motorcycle's rear tyre. The rear tyre was observed to be in serviceable condition with remaining tread depth of approximately 5mm. The rear tyre was also observed to be sufficiently inflated for vehicular operation. We did not observe any tear, burst mark(s) and/or punctured hole(s) on the sidewalls as well as across the tread of the rear tyre.

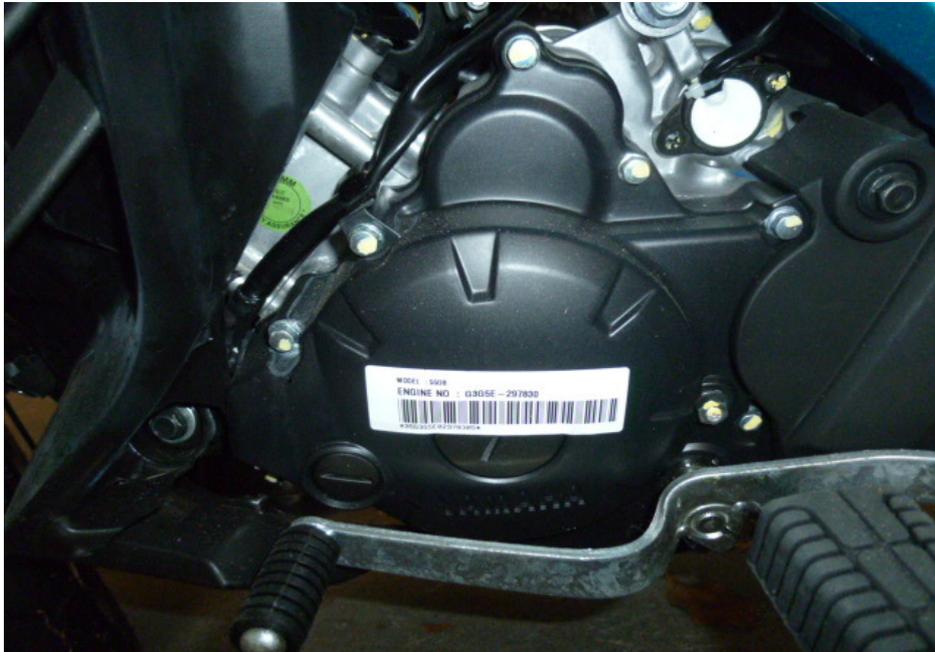
Photo 17 shows the left side of the engine of the Motorcycle at the time of our inspection. The various engine related parts and components were found to be intact with no visible damage. There was also no sign(s) or indication(s) of fluid leak observed around the left engine area of the Motorcycle.

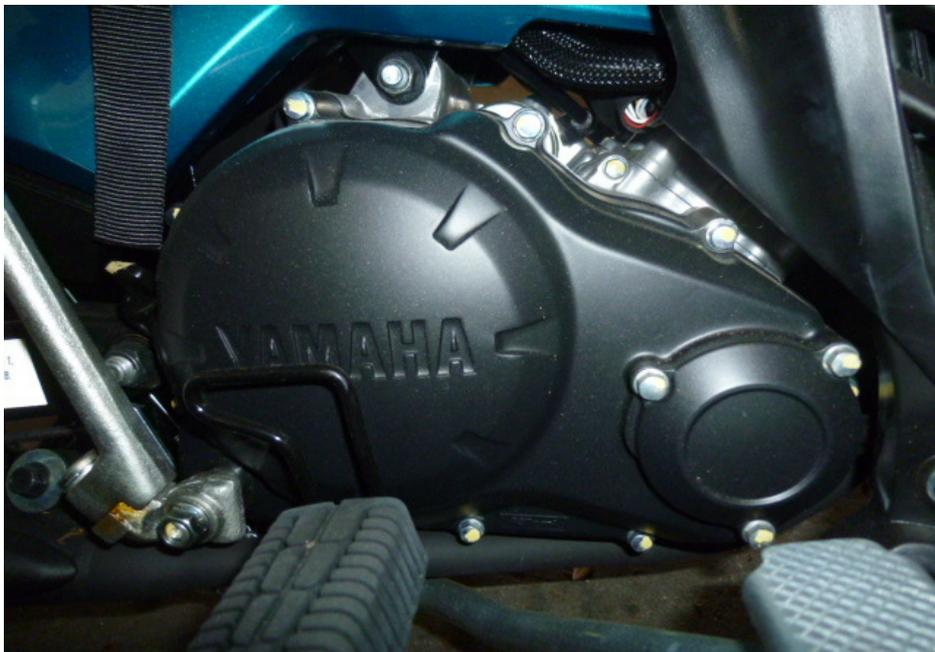
Photo 18 shows the right side of the engine of the Motorcycle at the time of our inspection. The various engine related parts and components were found to be intact with no visible damage. There was also no sign(s) or indication(s) of fluid leak observed around the right engine area of the Motorcycle.

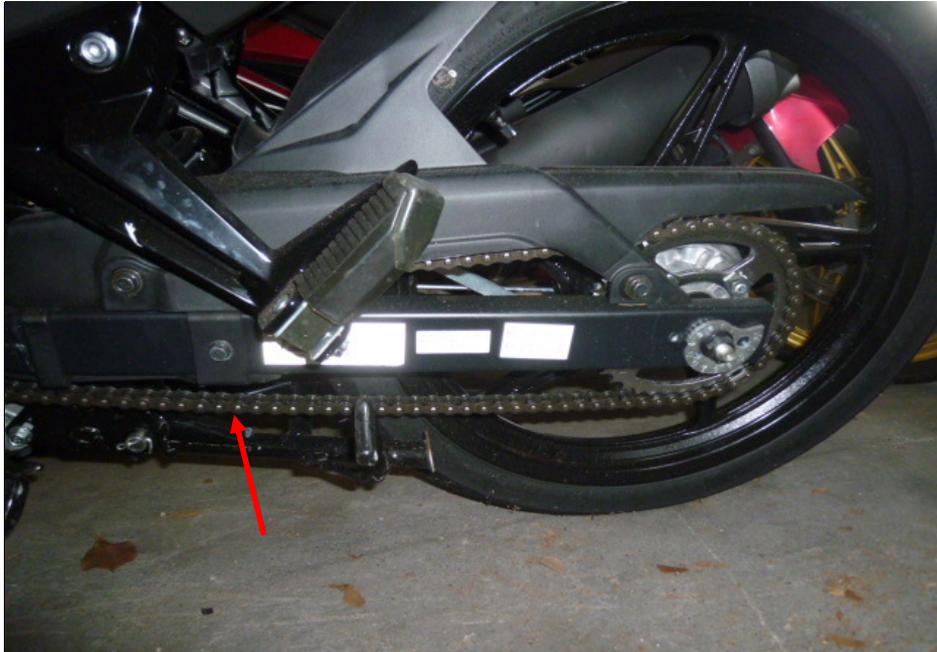
Photo 19 shows the gear train (arrowed) of the Motorcycle, which was observed to be intact with no misalignment. It was also adequately lubricated for operating purposes. The gear train rotates the rear wheel of the Motorcycle.

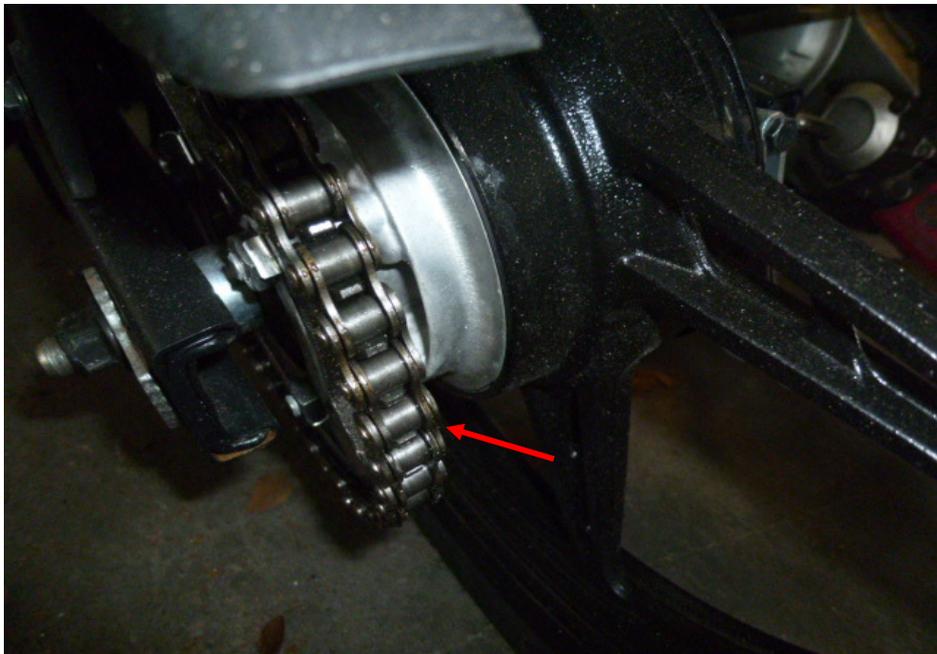
Photo 20 shows the closer view of the gear train (arrowed) of the Motorcycle, which was observed to be intact with no misalignment. It was also adequately lubricated for operating purposes.

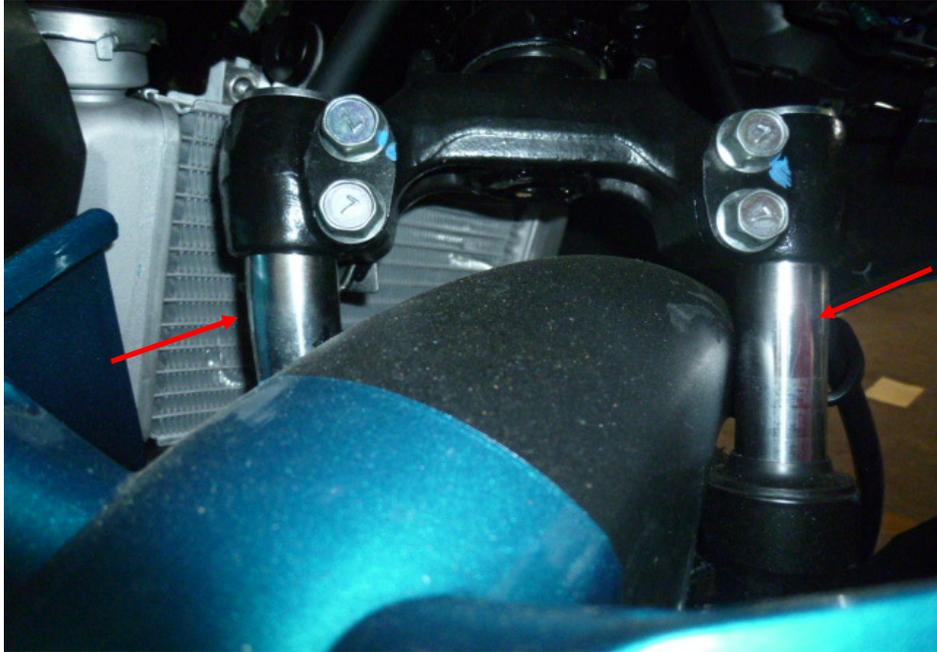
11. For this case, we were not able to conduct any test(s) on the steering system of the Motorcycle due to the damage to its front forks. The front forks were observed to be bent as a result of the accident.

14. For this case, we were not able to carry out any operational tests to the steering system and braking system of the Motorcycle due to the damage of its front forks, which had rendered the Motorcycle immobile for the operational tests. We were not able to push the Motorcycle manually forward and backward, simulating movement of the Motorcycle, for the operational tests. See photos 21 – 25 below.

Photo 21 shows a closer view of the front forks of the Motorcycle. The front forks were observed to be bent (arrowed) as a result of the accident. We were hence not able to conduct any tests on the steering system of the Motorcycle.

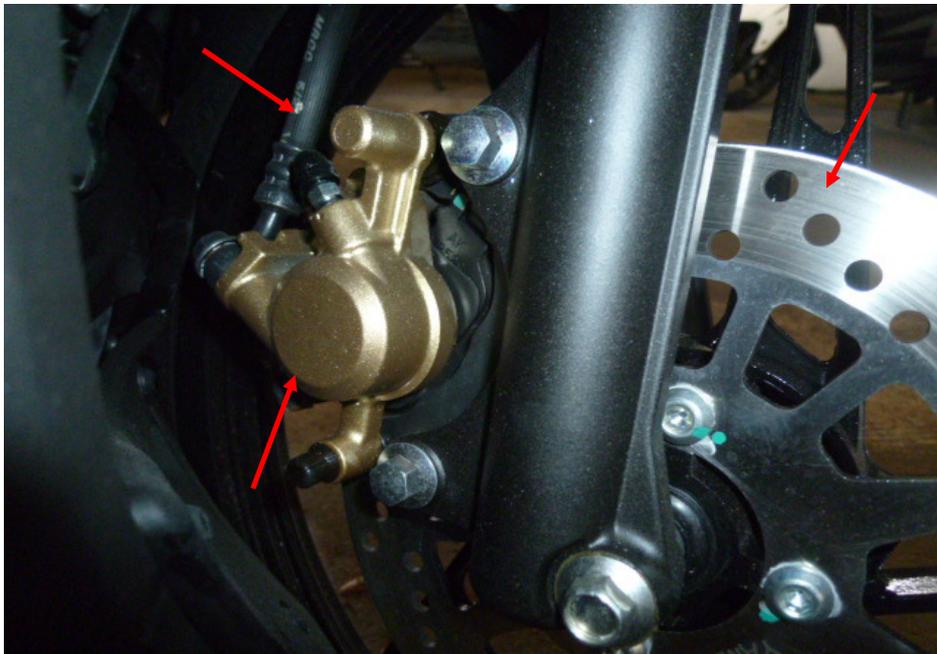
Photo 22 shows a close up view of the front brake caliper, front brake disc and front brake hose (arrowed) of the Motorcycle, which are all part of the components in the hydraulic front brake system of the Motorcycle. Our visual checks of these various components had revealed all to be intact with no visible damage. No leakage of brake fluid was also observed.

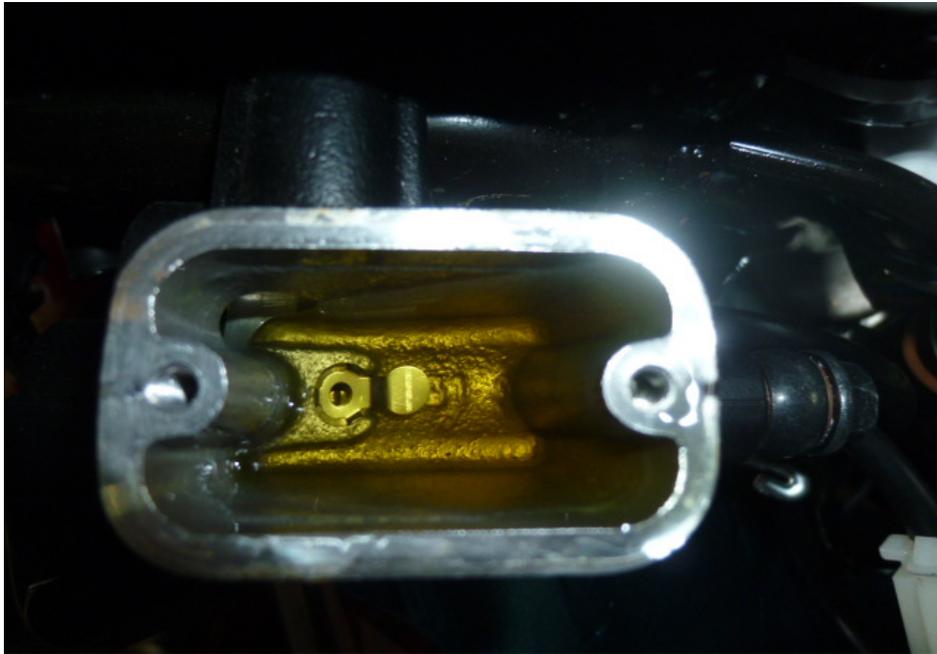
Photo 23 shows the brake fluid reservoir for the front brake of the Motorcycle. The brake fluid was observed to be of sufficient level for operating purposes and without contamination.

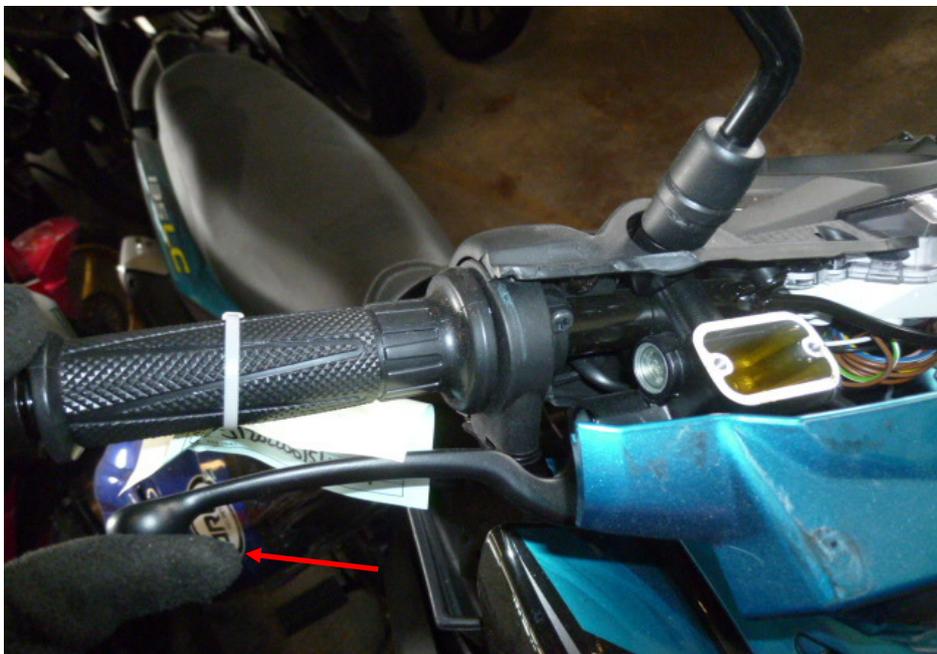
13. Static brake tests conducted on the Motorcycle had appeared to indicate that the brake system of the Motorcycle was in serviceable condition. There was some resistance felt (spongy like feel) upon pressing the front brake lever. This would indicate that there's no leakage of pressure/vacuum in the front brake system.

Photo 24 shows the front brake lever being depressed. There was some resistance felt (spongy like feel) upon pressing the front brake lever (arrowed). This would indicate that there is no leakage of pressure/vacuum in the brake system.

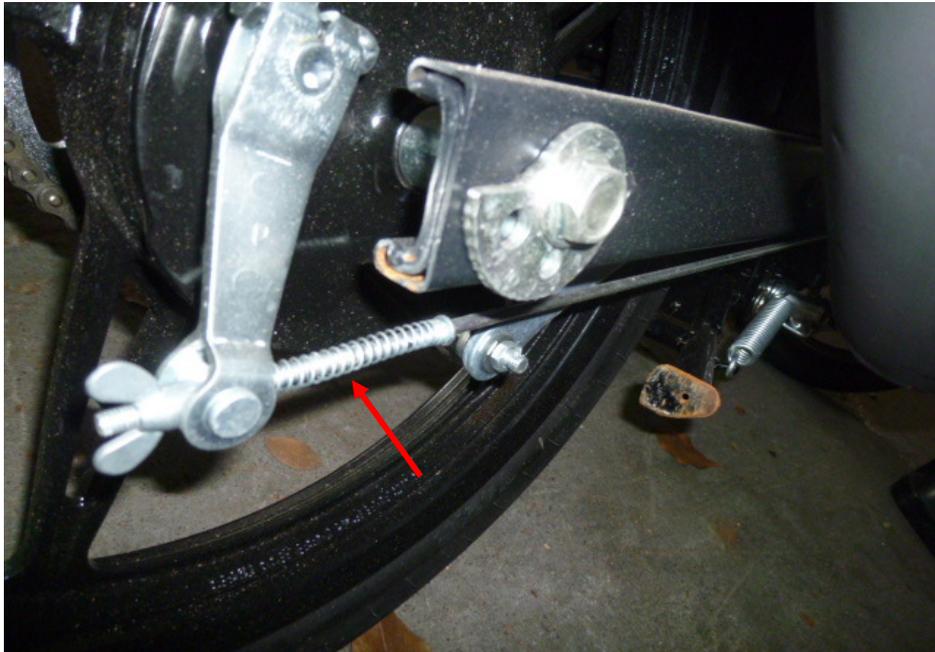
Photo 25 shows the rear wheel of the Motorcycle. The type of brake system for the rear wheel was of a mechanical type, controlled by the brake foot pedal of the Motorcycle. Our checks of the cable (arrowed), spring and drum which are all part of the components in the rear brake system of the Motorcycle reveal all to be intact and without damage.
