Your Ref: TP/IP/17223/2022
Our Ref : CI/TPD22008685/N

16 September 2022

INSPECTION REPORT OF MOTORCYCLE FBR 8195A

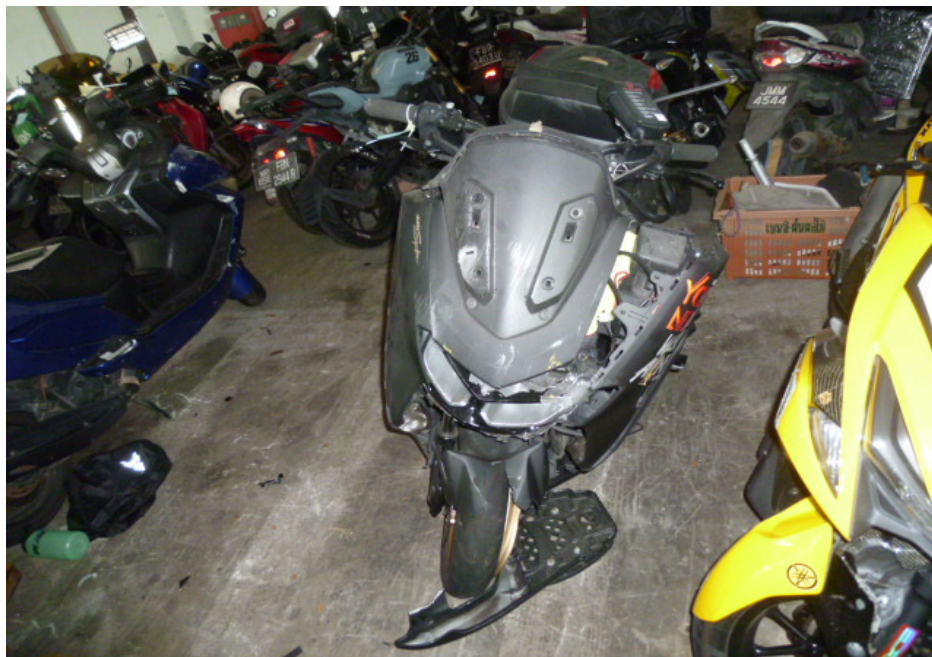
Photo 2 shows a general view of the frontal portion of the Motorcycle at the time of our inspection. The Motorcycle was observed to have sustained damages all around.

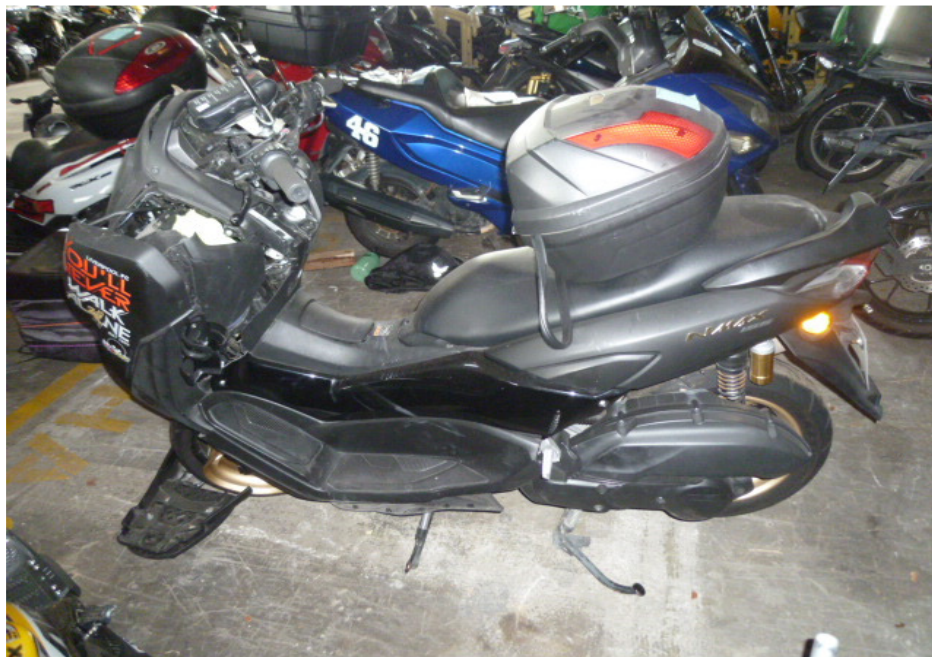
Photo 3 shows a general view of the left body of the Motorcycle at the time of our inspection. The Motorcycle was observed to have sustained damages all around. The body parts that were found to have been damaged include its front cowling, side cowlings, handlebar, handlebar ends, side mirrors, front mudguard, hand brake levers, bottom cowlings, left pillion grab rail, right rear side cover, tail light and exhaust muffler heat shield, amongst others as a result of the accident.

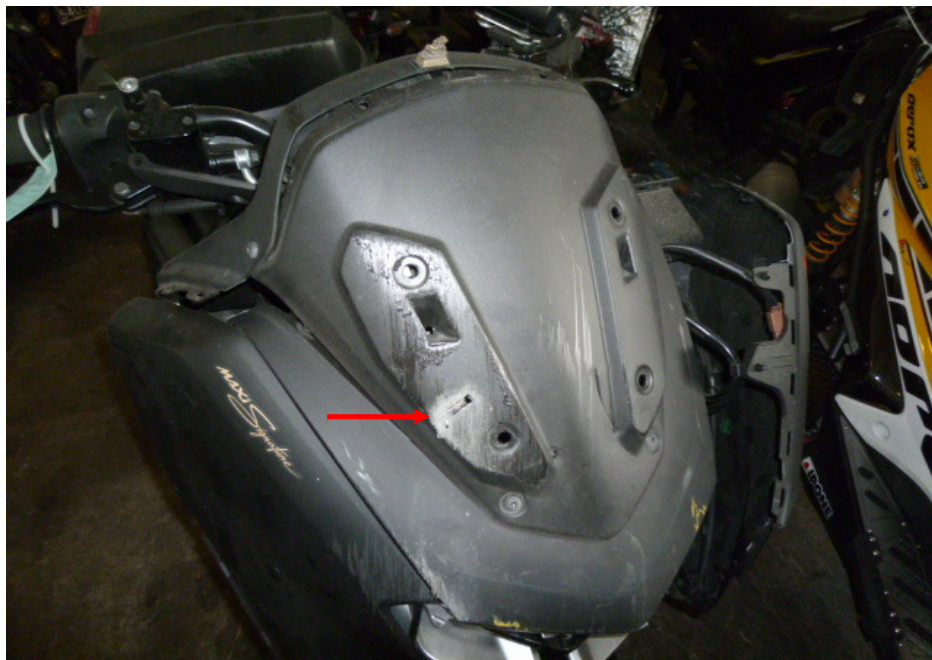
Photo 4 shows a closer view of the grazed front cowling of the Motorcycle as a result of the accident (arrowed).

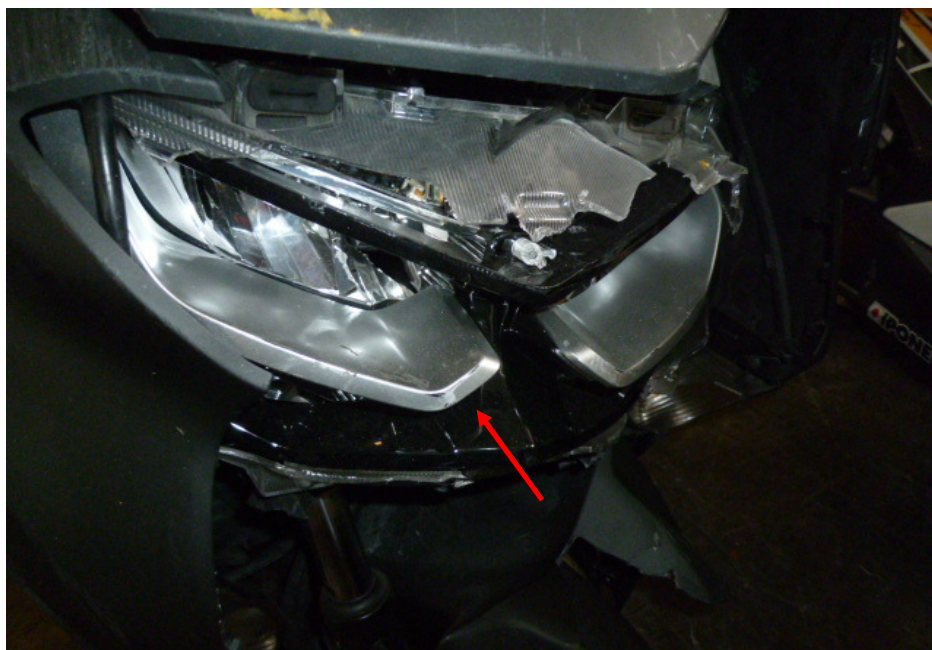
Photo 5 shows a closer view of the cracked headlight (arrowed) which was amongst the body parts at the front body of the Motorcycle that had sustained damage as a result of the accident.

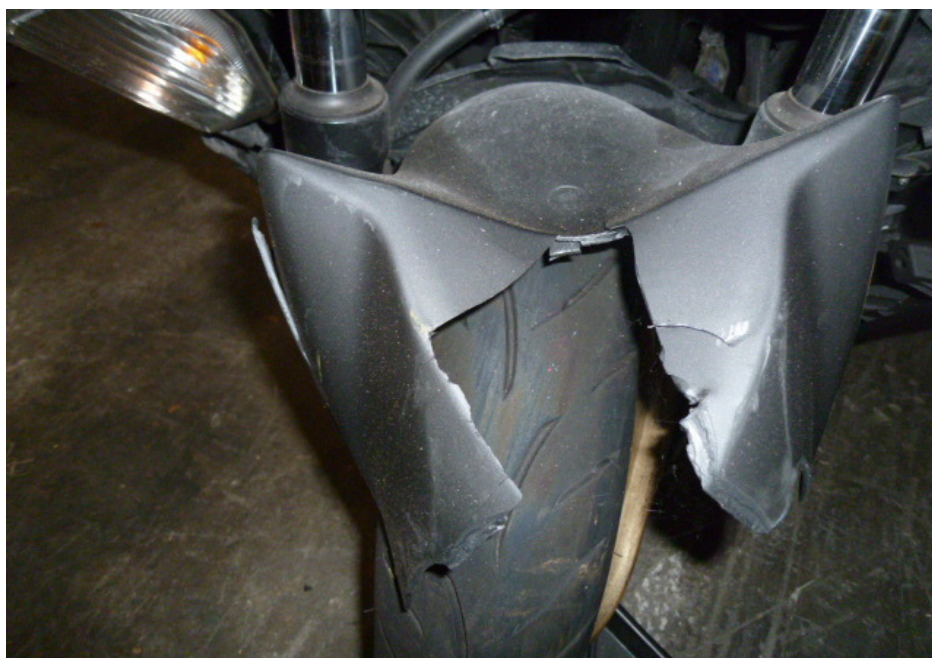
Photo 6 shows a closer view of the cracked front mudguard of the Motorcycle as a result of the accident.

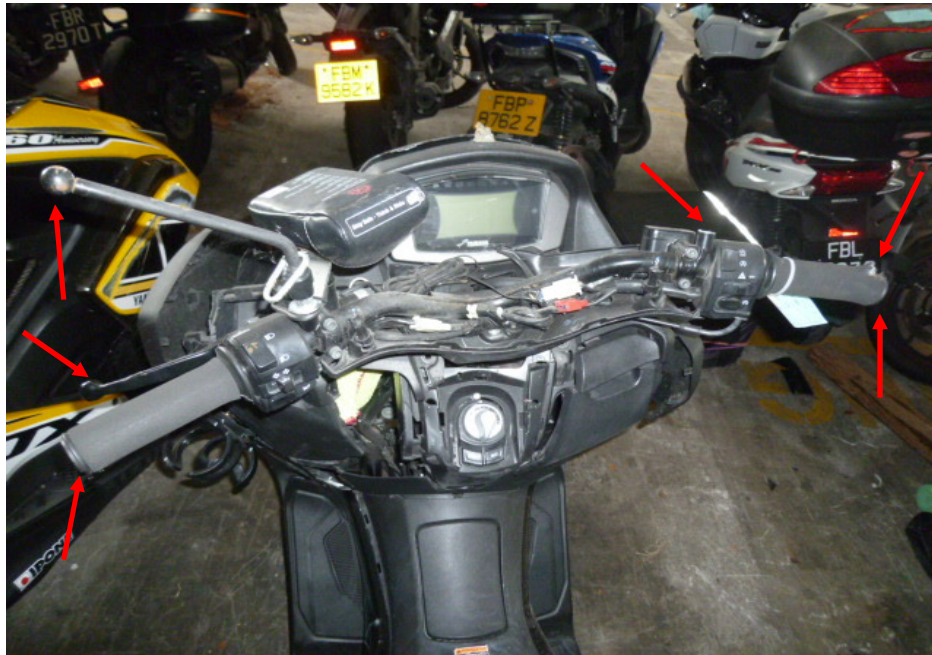
Photo 7 shows a closer view of the handlebar, hand brake levers, side mirrors and handlebar ends of the Motorcycle which were observed to be damaged due to the accident (arrowed).

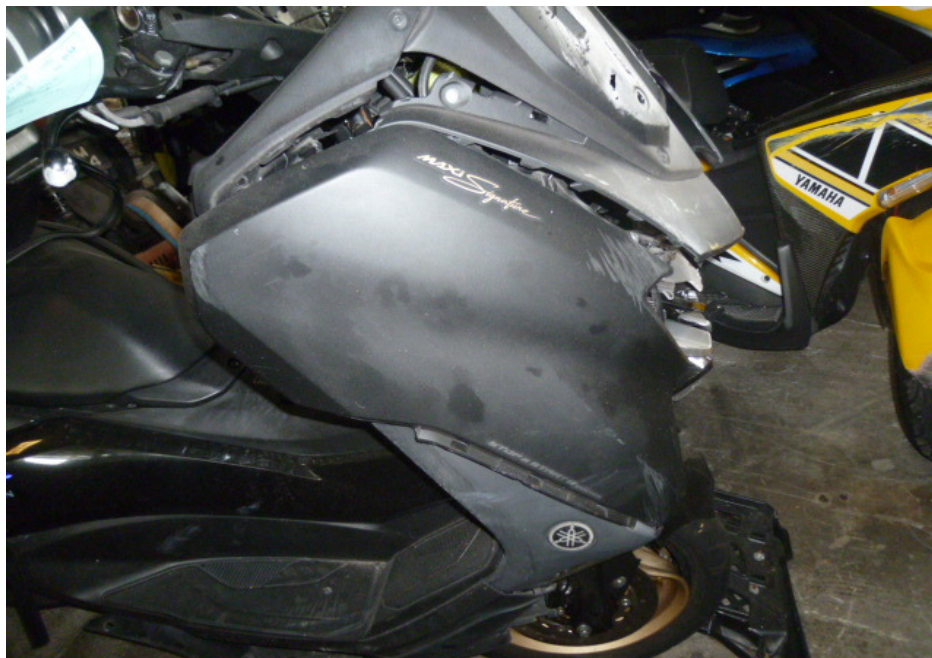
Photo 8 shows a closer view of the right cowling of the Motorcycle that had sustained damage as a result of the accident.

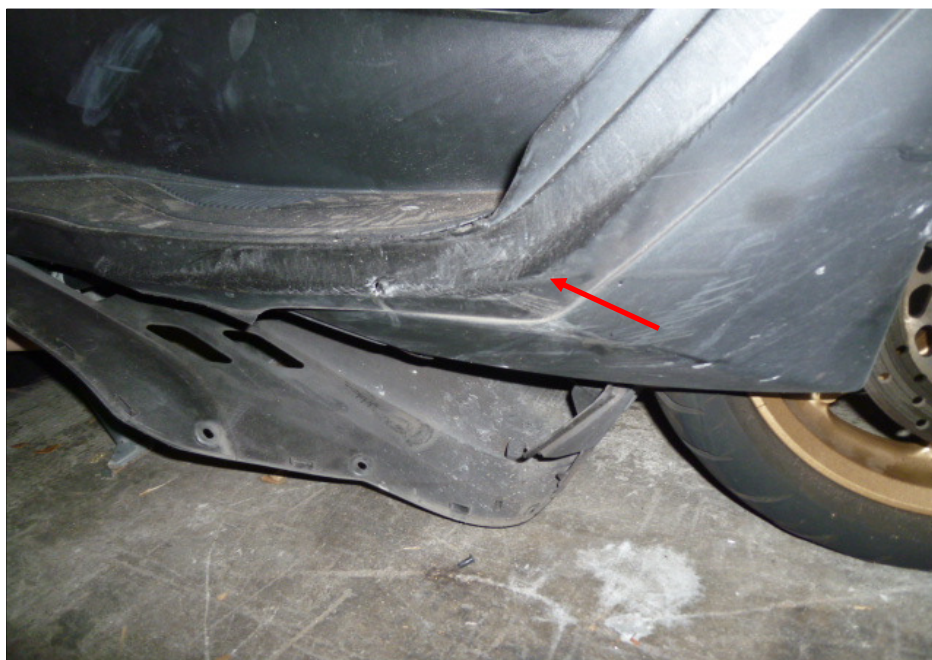
Photo 9 shows a closer view of the grazed right bottom cowling of the Motorcycle as a result of the accident (arrowed).

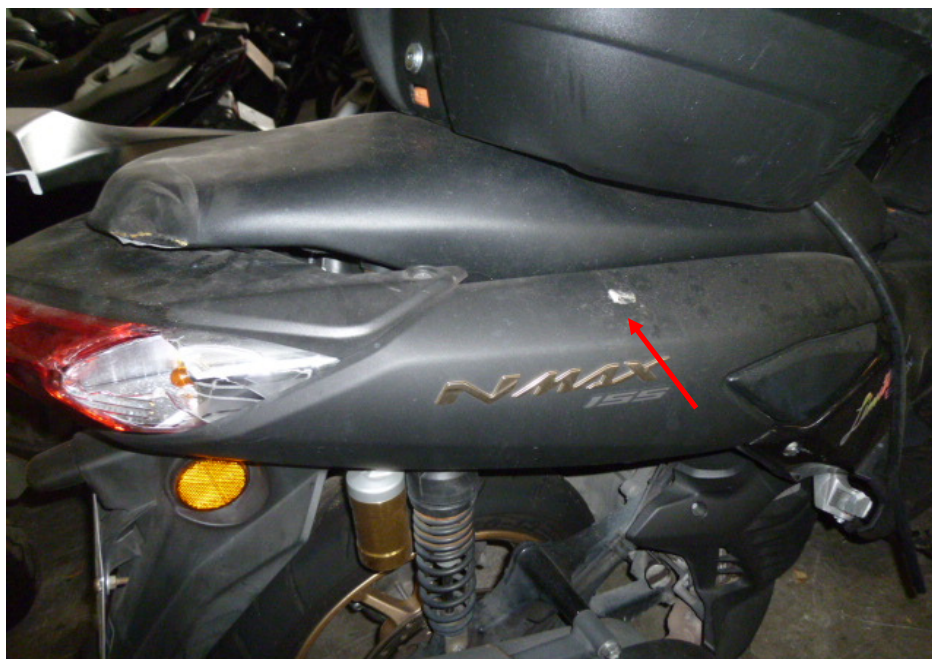
Photo 10 shows a closer view of grazed right rear side cover (arrowed) of the Motorcycle at the time of our inspection.

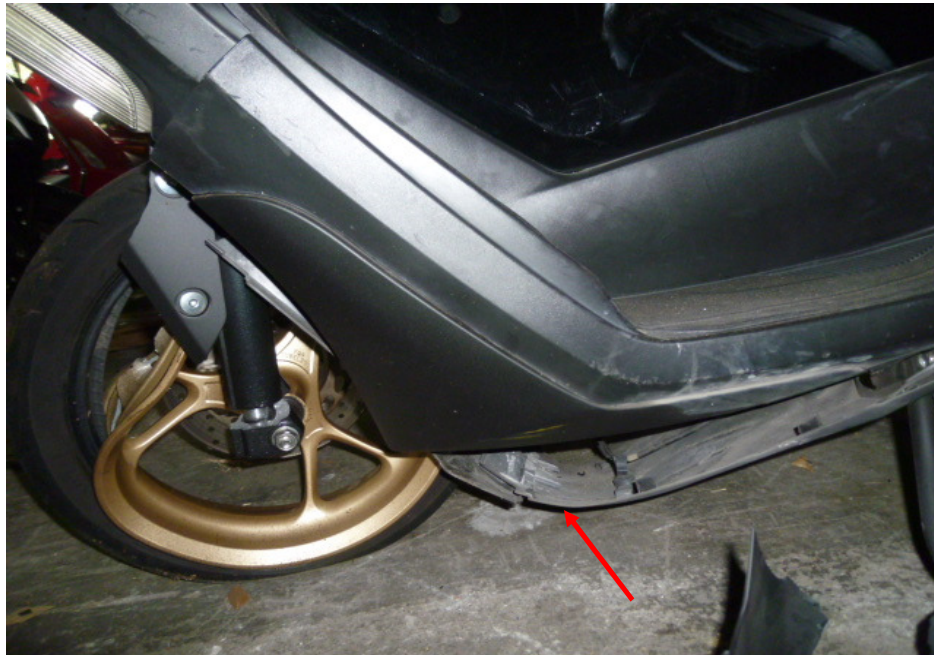
Photo 11 shows a closer view of the deformed left bottom cowling of the Motorcycle as a result of the accident (arrowed).

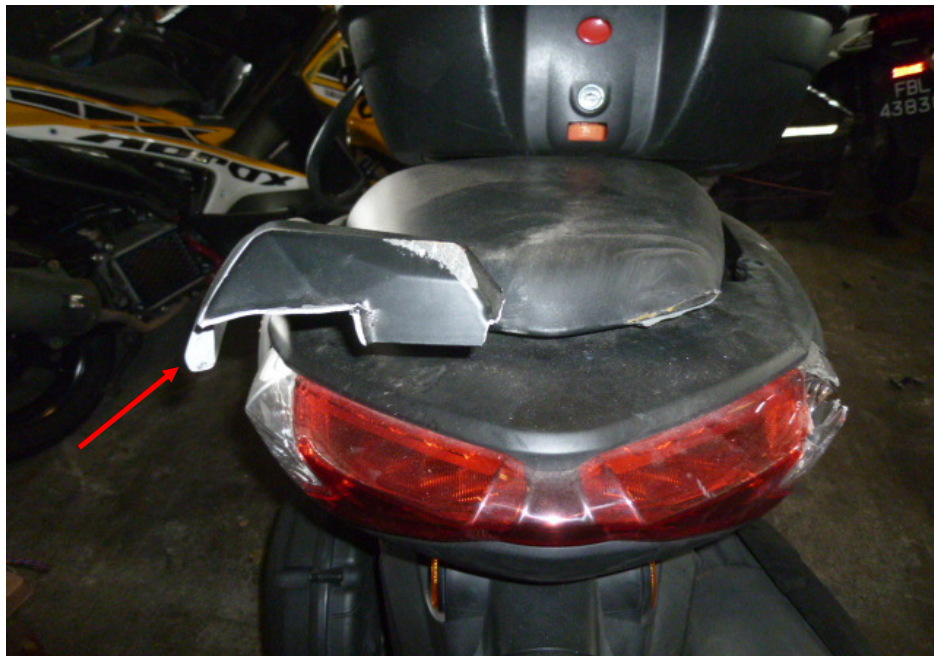
Photo 12 shows the broken left pillion grab rail of the Motorcycle as a result of the accident (arrowed).

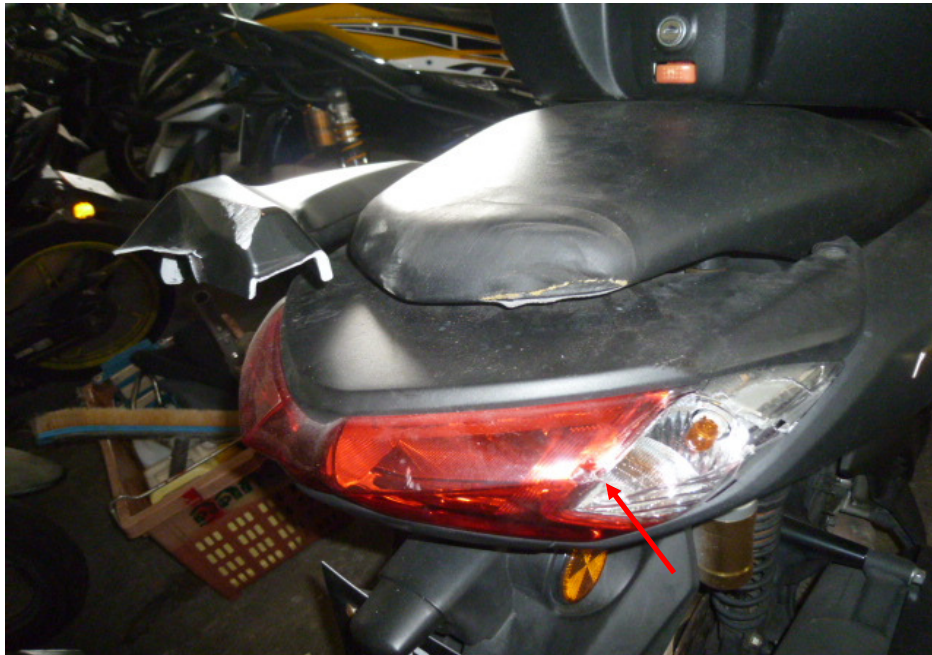
Photo 13 shows a closer view of the cracked tail light of the Motorcycle as a result of the accident (arrowed).

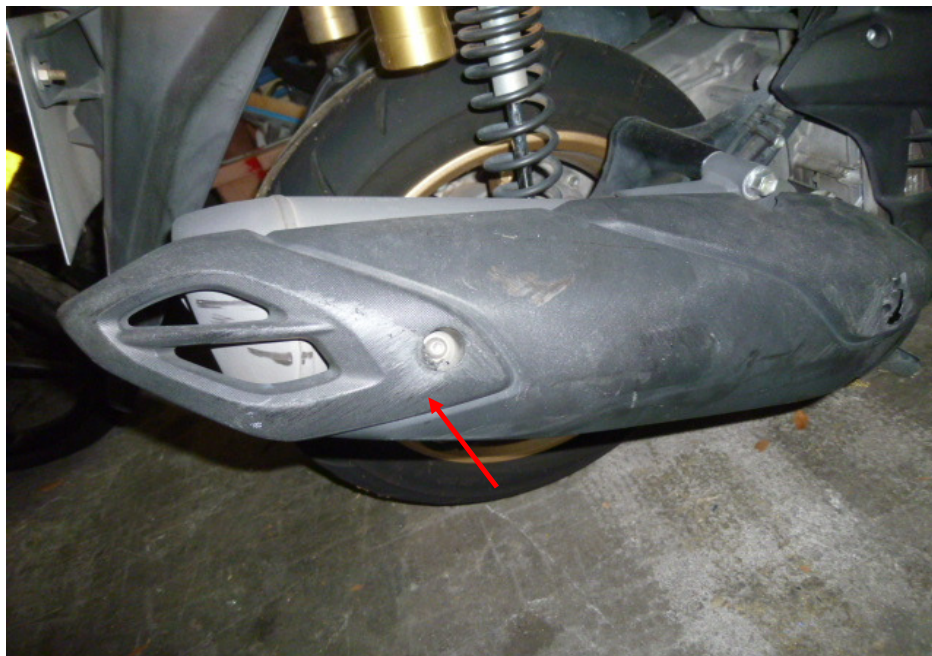
Photo 14 shows a closer view of the grazed exhaust muffler heat shield of the Motorcycle at the time of our inspection.

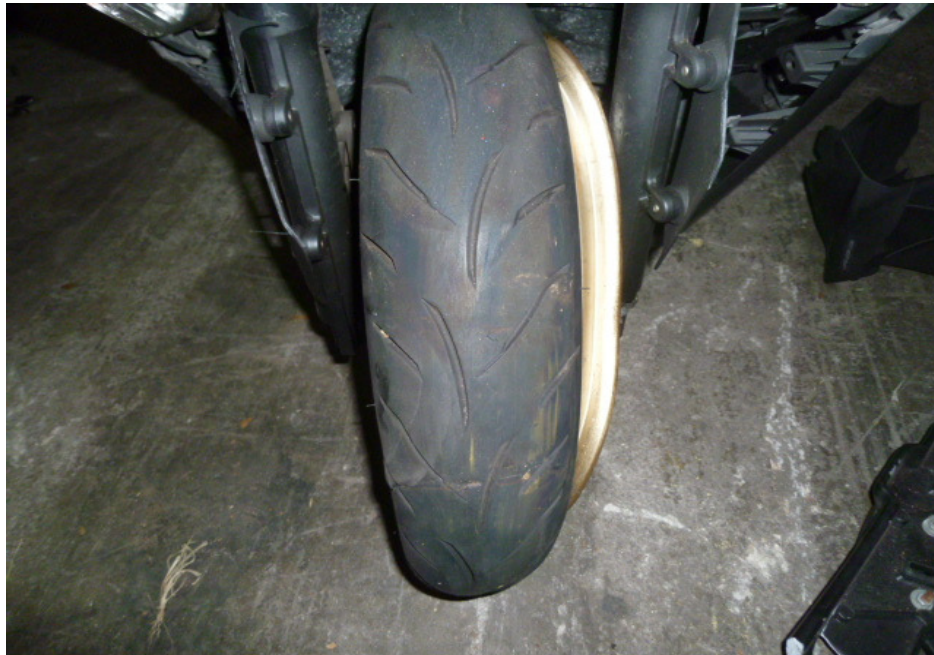
Photo 15 shows the condition of the Motorcycle's front tyre. The front tyre was observed to be in serviceable condition with remaining tread depth of approximately 4mm. There was no tear, burst mark(s) and/or punctured hole(s) on the sidewalls as well as across the tread of the front tyre. However the front tyre was observed to be deflated.

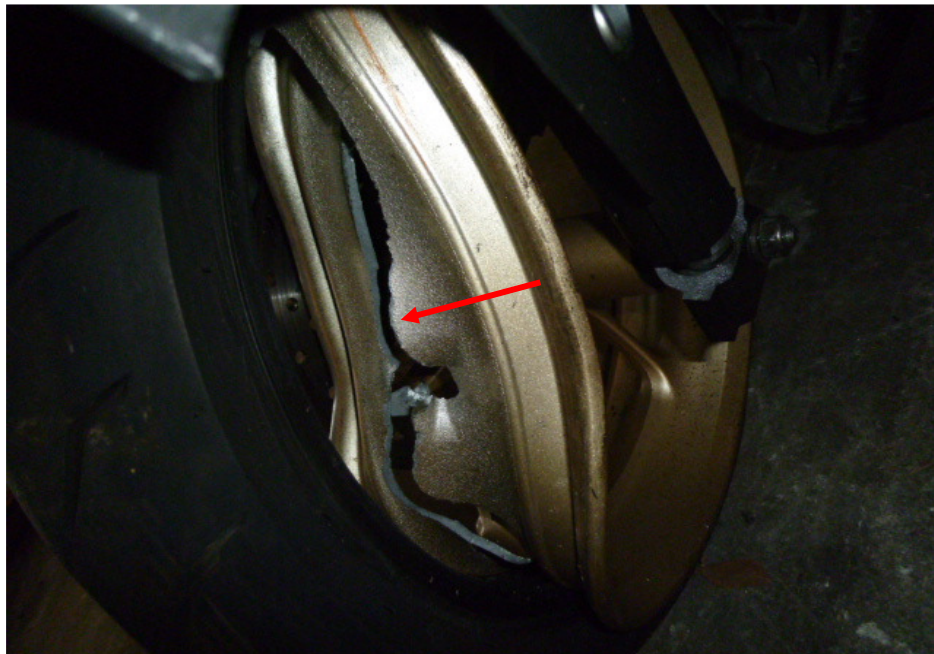
7. The 2 tyres were wrapped around alloy wheel rims. At the time of our inspection, we did not observe any visible damage on the rear wheel rim of the Motorcycle. However we did observe that the front wheel rim was broken. See photos 15 - 17 below.

Photo 16 shows the broken front wheel rim and deflated front tyre (arrowed) of the Motorcycle at the time of our inspection.

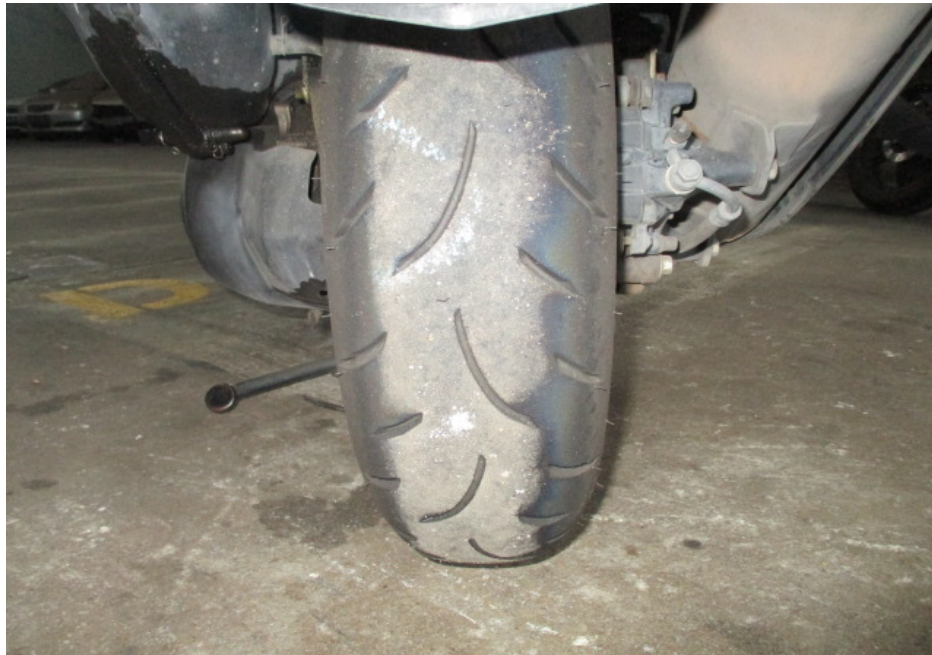
Photo 17 shows the condition of the Motorcycle's rear tyre. The rear tyre was observed to be in serviceable condition with remaining tread depth of approximately 3mm. The tyre was also observed to be sufficiently inflated for vehicular operation. We did not observe any tear, burst mark(s) and/or punctured hole(s) on the sidewalls as well as across the tread of the rear tyre.

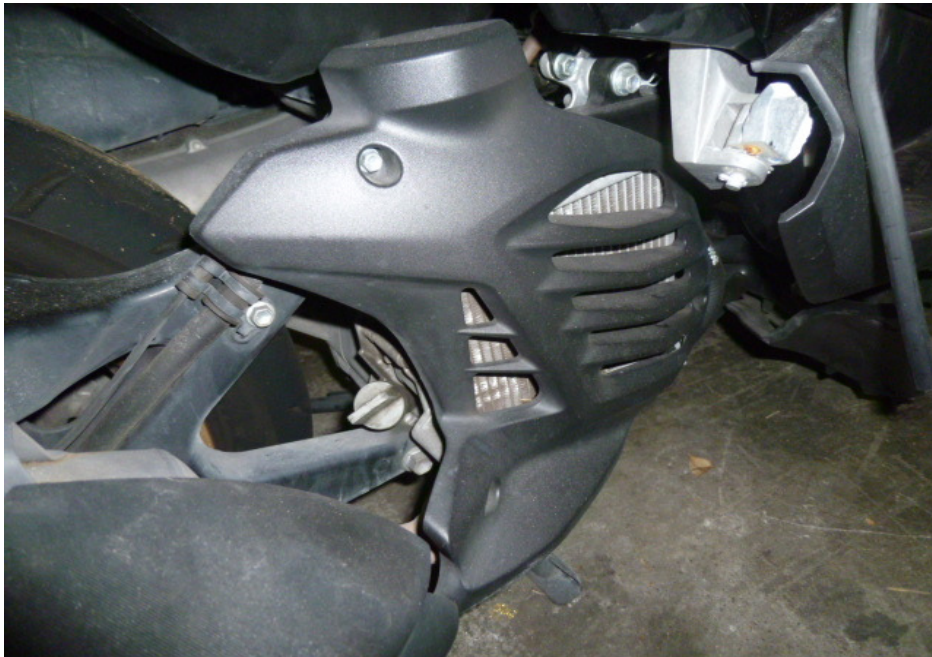
Photo 18 shows the radiator of the Motorcycle at the time of our inspection. The radiator was found to be intact with no visible damage. There was also no sign(s) or indication(s) of fluid leak observed around the radiator of the Motorcycle.

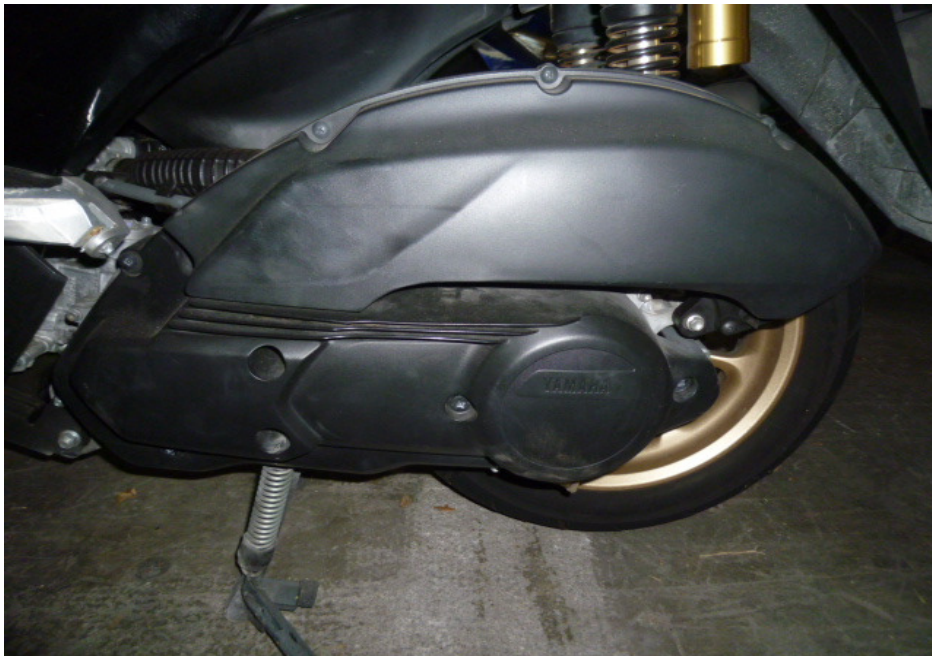
Photo 19 shows the drive train cover of the Motorcycle which was found to be intact without any misalignment.

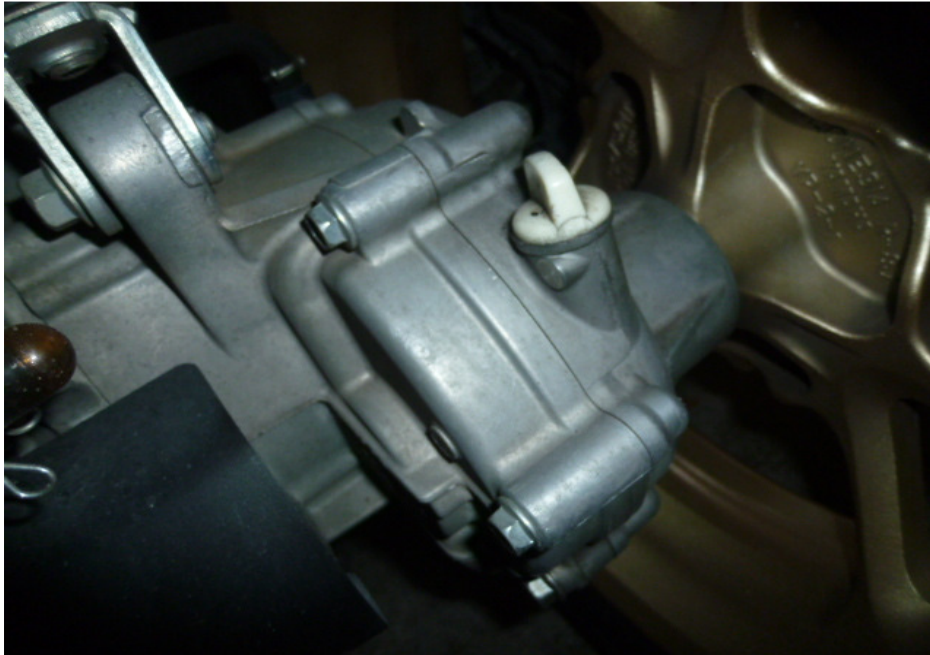
Photo 20 shows the drive train of the Motorcycle which was found to be intact without any misalignment.

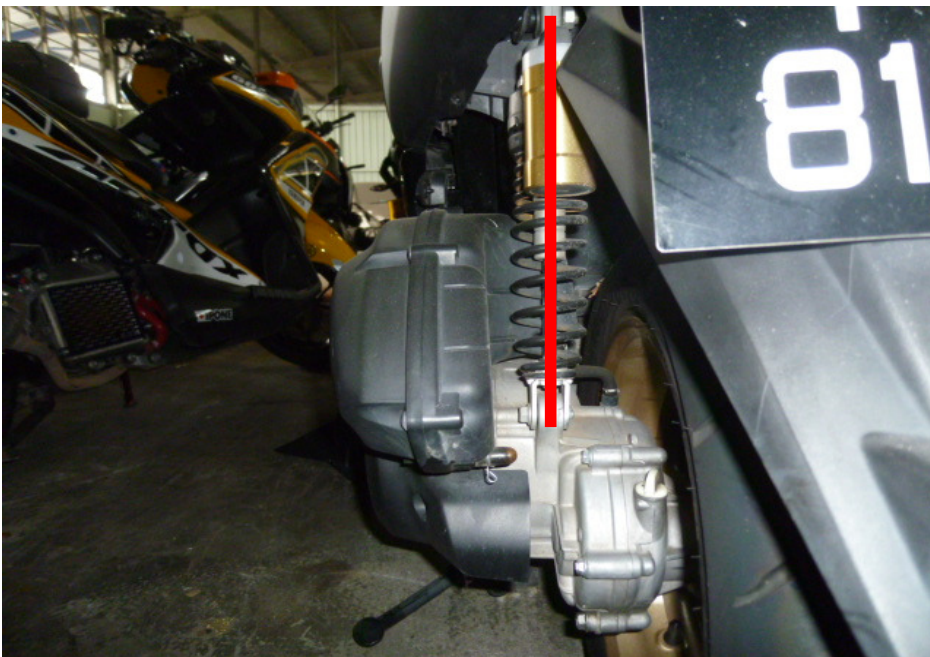
Photo 21 shows the left shock absorber of the Motorcycle which was found to be intact without any misalignment.

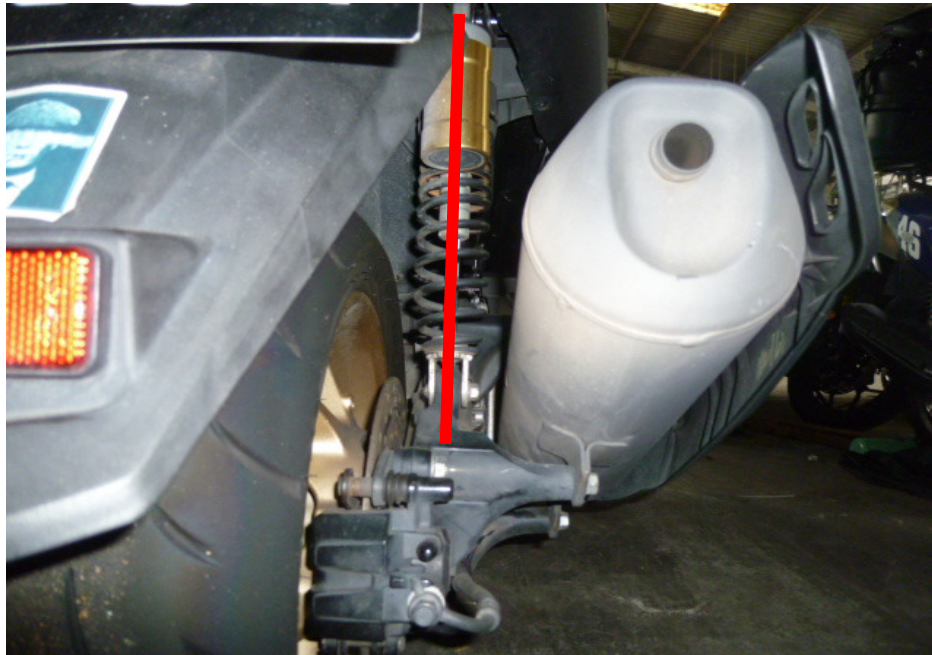
Photo 22 shows the right shock absorber of the Motorcycle which was found to be intact without any misalignment.

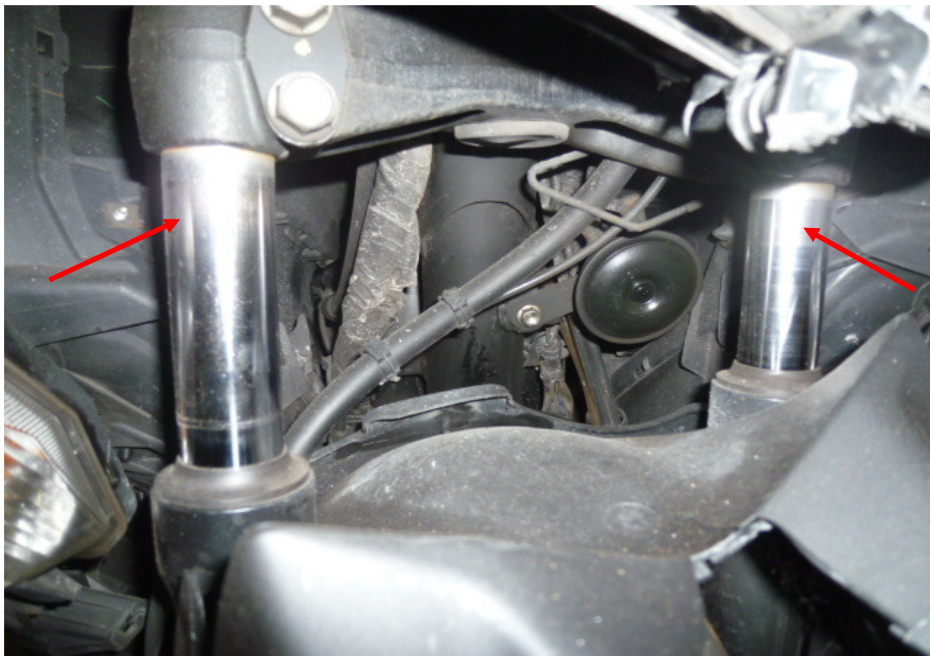
10. For this case, we were not able to conduct any test(s) on the steering system of the Motorcycle due to the damage to its front forks. The front forks were observed to be bent as a result of the accident.

15. For this case, we were not able to carry out any operational tests to the steering system and braking system of the Motorcycle due to the damage of its front right fork, which had rendered the Motorcycle immobile for the operational tests. We were not able to push the Motorcycle manually forward and backward, simulating movement of the Motorcycle, for the operational tests. See photos 23 – 29 below.

Photo 23 shows the front forks of the Motorcycle. The right front fork was observed to be bent as a result of the accident (arrowed). Hence we were not able to conduct any test(s) on the steering system of the Motorcycle.

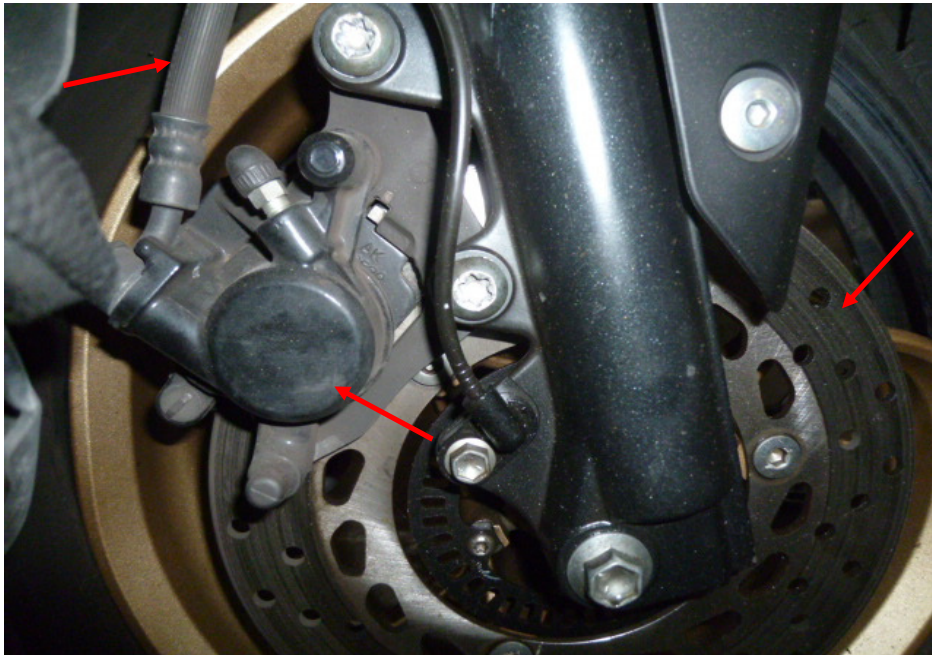
Photo 24 shows a close up view of the front brake caliper, front brake disc and front brake hose (arrowed) of the Motorcycle, which are all part of the components in the hydraulic front brake system of the Motorcycle. Our visual checks of these various components had revealed all to be intact with no visible damage. No leakage of brake fluid was also observed.

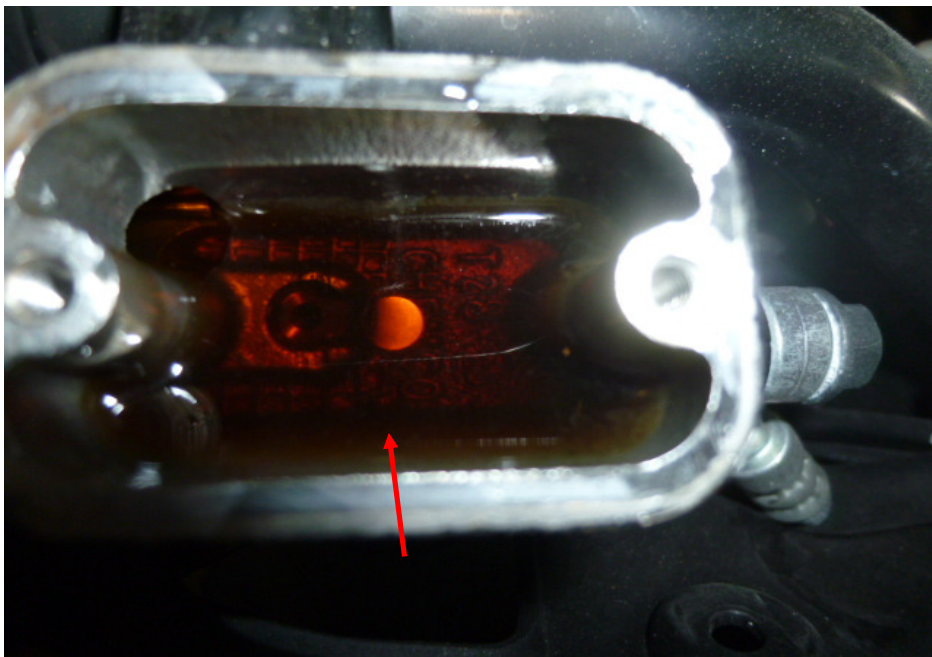
13. Our checks on the rear brake fluid had also indicated that the rear brake fluid was of sufficient level for operational purposes and without contamination. Our checks on the front brake fluid had also indicated that the front brake fluid was of sufficient level for operational purposes. However the front brake fluid was observed to be slightly contaminated.

Photo 25 shows the brake fluid reservoir for the front brake of the Motorcycle. The brake fluid was observed to be of sufficient level for operational purposes. However it was observed to be slightly contaminated (arrowed).

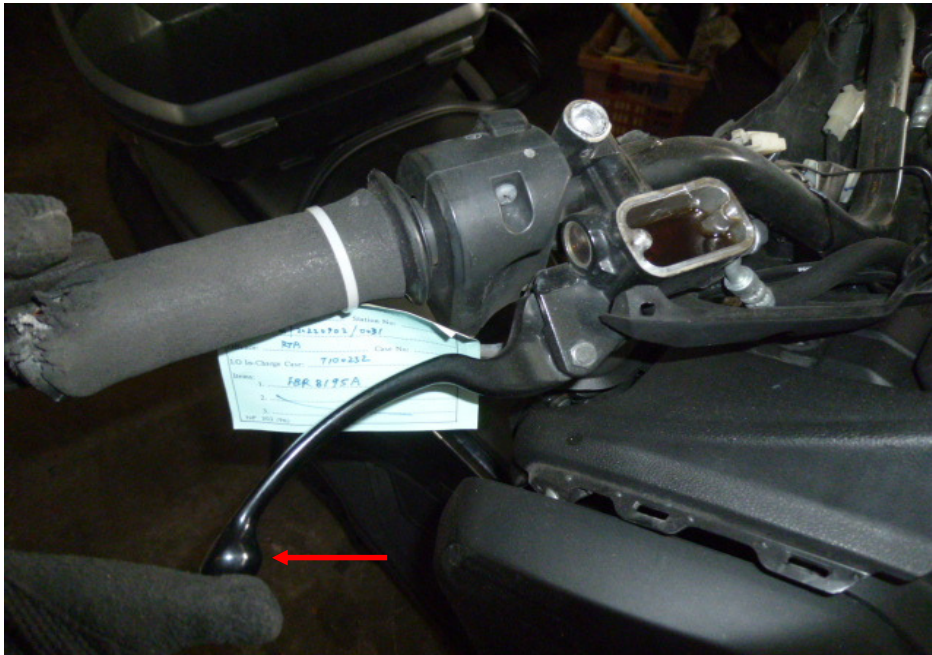
Photo 26 shows the front brake lever being depressed. There was some resistance felt (spongy like feel) upon pressing the front brake lever (arrowed). This would indicate that there is no leakage of pressure/vacuum in the front brake system.

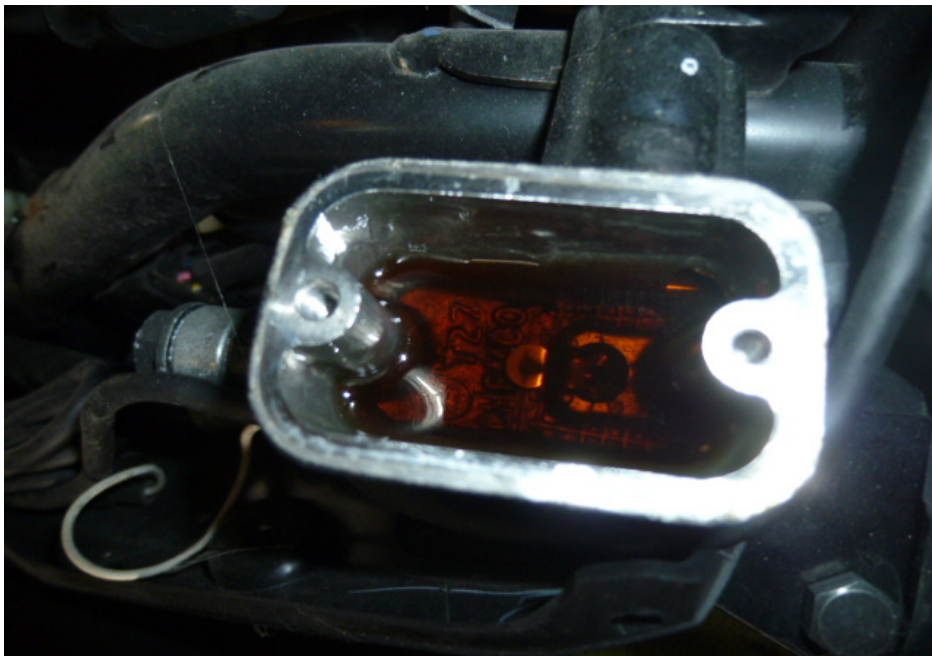
Photo 27 shows the brake fluid reservoir for the rear brake of the Motorcycle. The brake fluid was observed to be of sufficient level and without contamination for operational purposes.

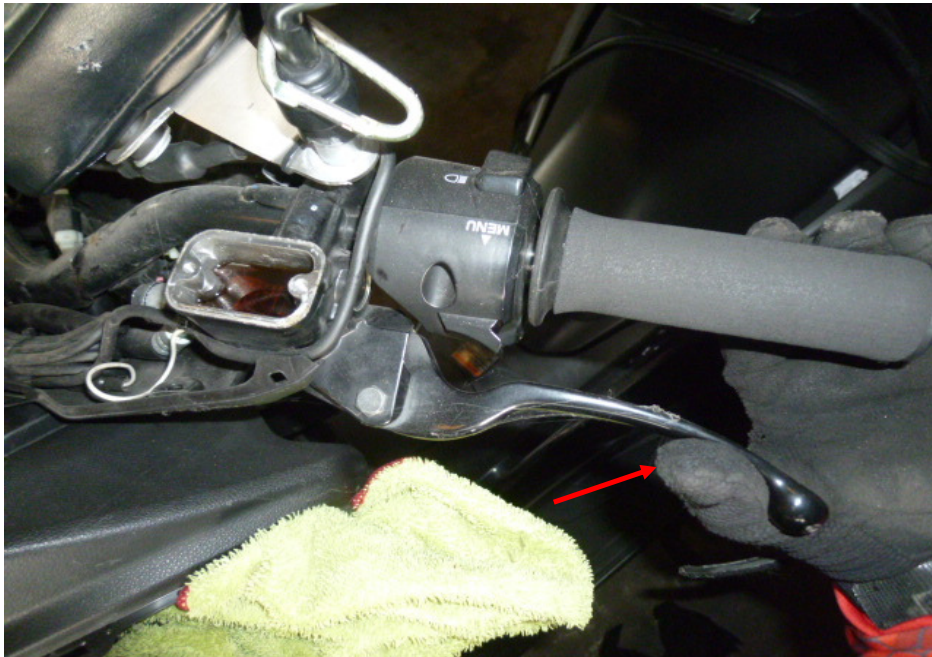
Photo 28 shows the rear brake lever being depressed. There was some resistance felt (spongy like feel) upon pressing the front brake lever (arrowed). This would indicate that there is no leakage of pressure/vacuum in the brake system.

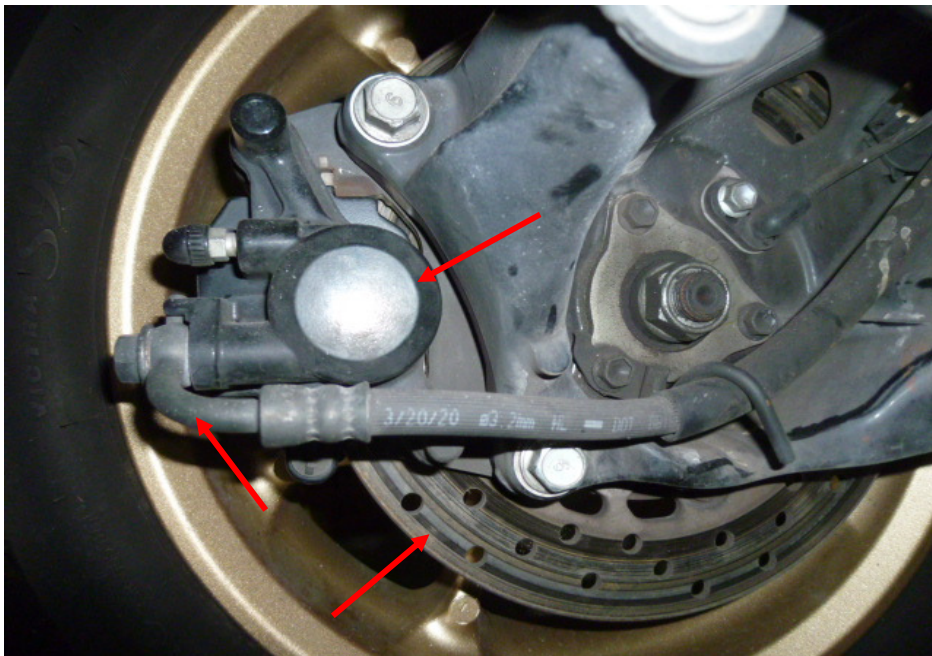
Photo 29 shows a close up view of the rear brake caliper, rear brake disc and rear brake hose (arrowed) of the Motorcycle, which are all part of the components in the hydraulic rear brake system of the Motorcycle. Our visual checks of these various components revealed all to be intact with no visible damage. No leakage of brake fluid was also observed.
