Your Ref: TP/IP/19901/2022
Our Ref : CI/TPD22008688/N

15 September 2022

Fatal Accident Investigation Team

INSPECTION REPORT OF MOTORCYCLE FBJ 5070M

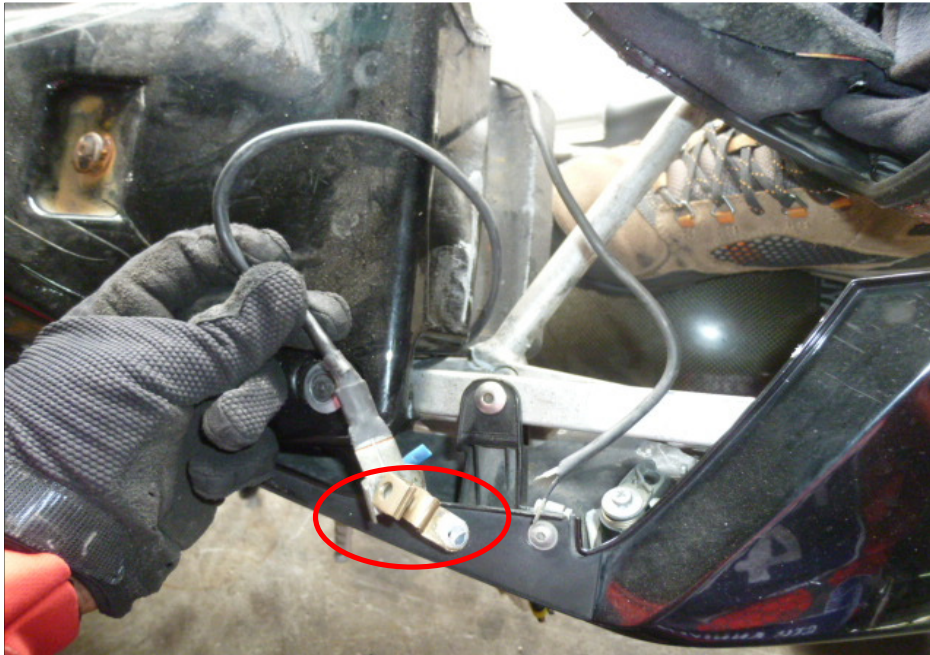
4. The mileage of the Motorcycle could not be recorded at the time of our inspection due to a missing battery as a result of the accident.
5. The Motorcycle was observed to have sustained damages all around. The body parts that were found to have been damaged include its windshield, petrol tank, handlebar ends, side mirrors, front brake lever, clutch lever, frame sliders, gear shift pedal and exhaust muffler, amongst others.

Photo 1 shows the battery connector wire (circled). The mileage of the Motorcycle could not be recorded at the time of our inspection due to a missing battery as a result of the accident.

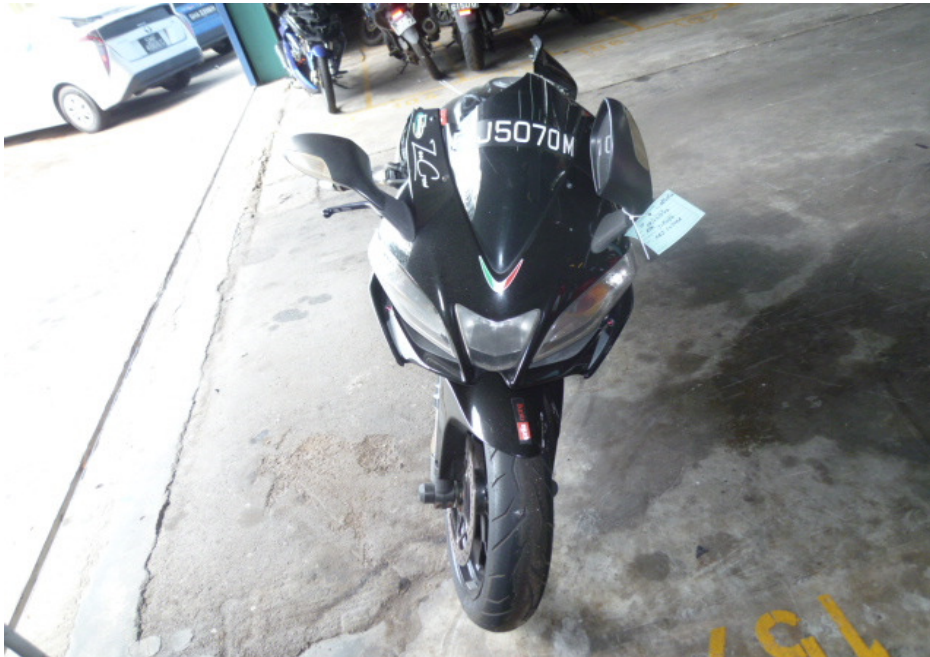
Photo 2 shows a general view of the frontal portion of the Motorcycle at the time of our inspection. The Motorcycle was observed to have sustained damages all around.

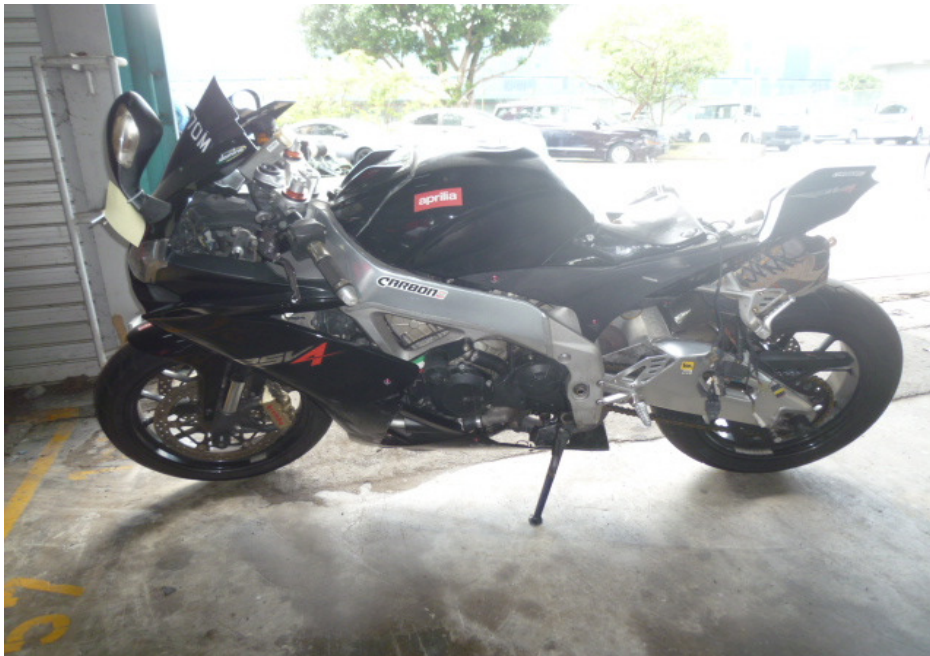
Photo 3 shows a general view of the left body of the Motorcycle at the time of our inspection. The Motorcycle was observed to have sustained damages all around.

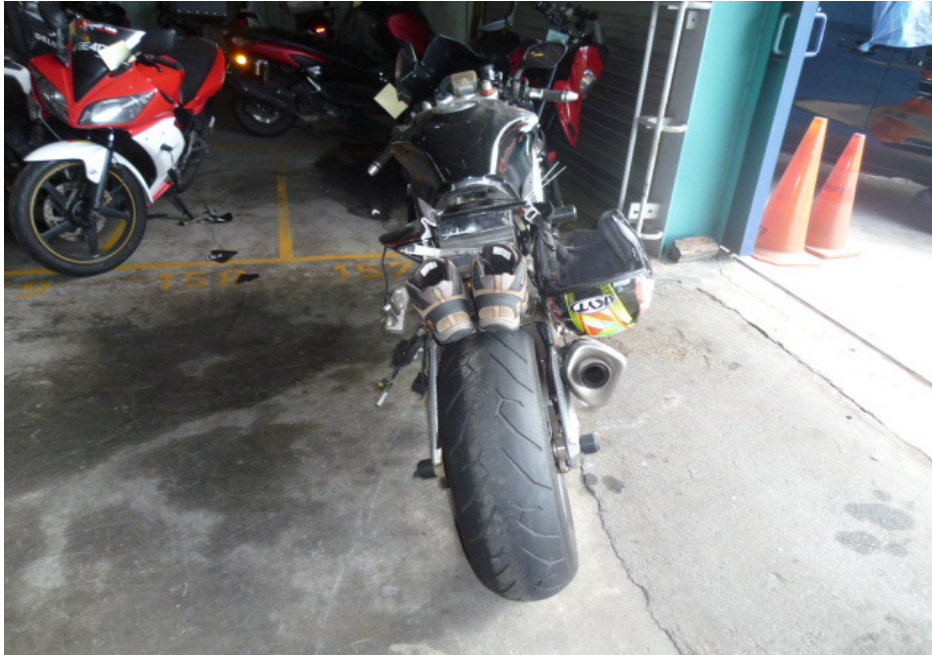
Photo 4 shows a general view of the rear portion of the Motorcycle at the time of our inspection. The Motorcycle was observed to have sustained damages all around. The body parts that were found to have been damaged include its windshield, petrol tank, handlebar ends, side mirrors, front brake lever, clutch lever, frame sliders, gear shift pedal and exhaust muffler, amongst others.

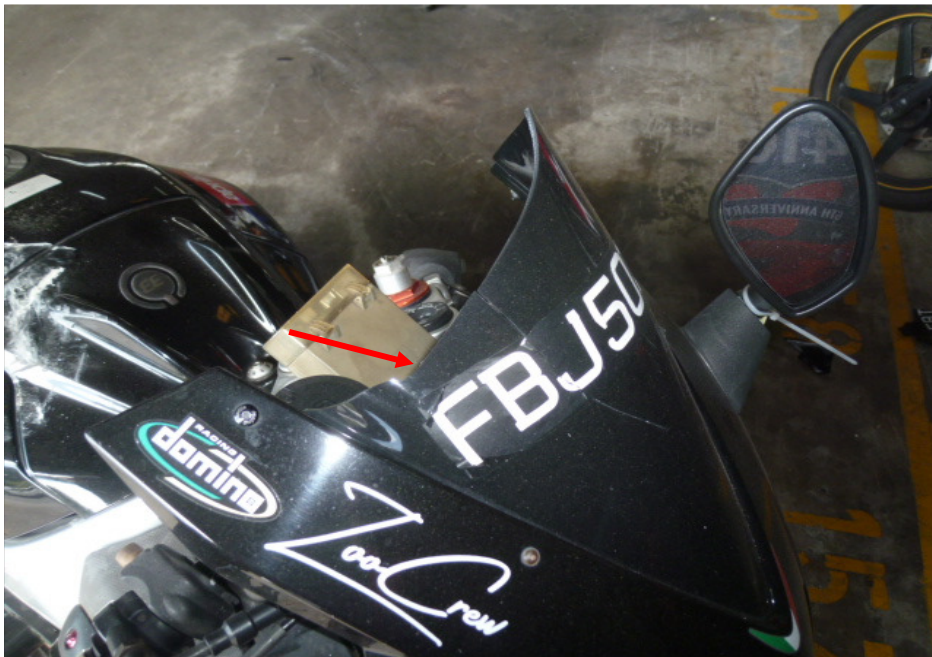
Photo 5 shows a closer view of the cracked windshield (arrowed) of the Motorcycle as a result of the accident.

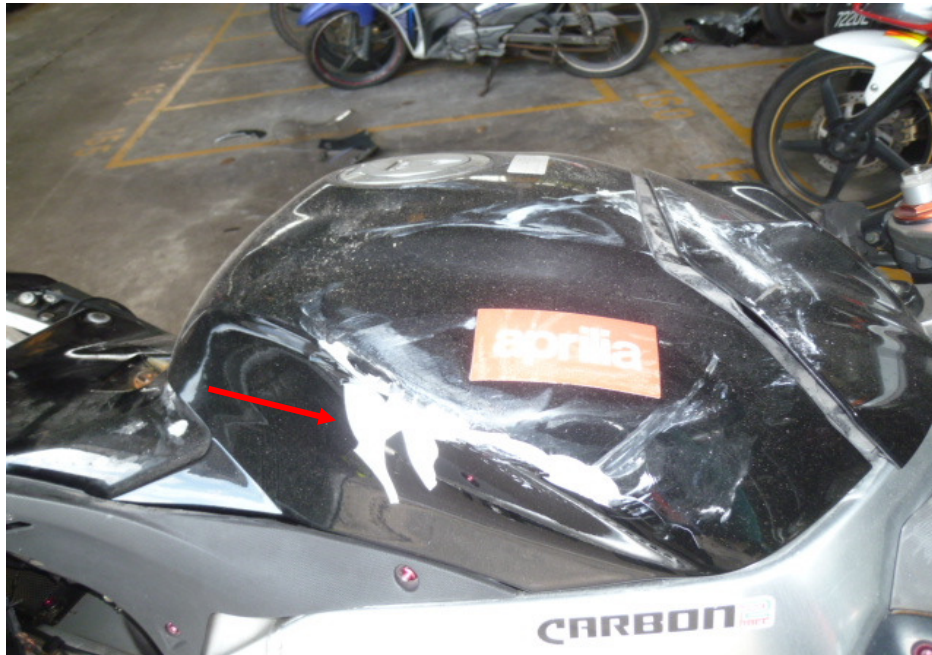
Photo 6 shows a closer view of the petrol tank which was amongst the body parts at the front body of the Motorcycle that had sustained damage as a result of the accident (arrowed).

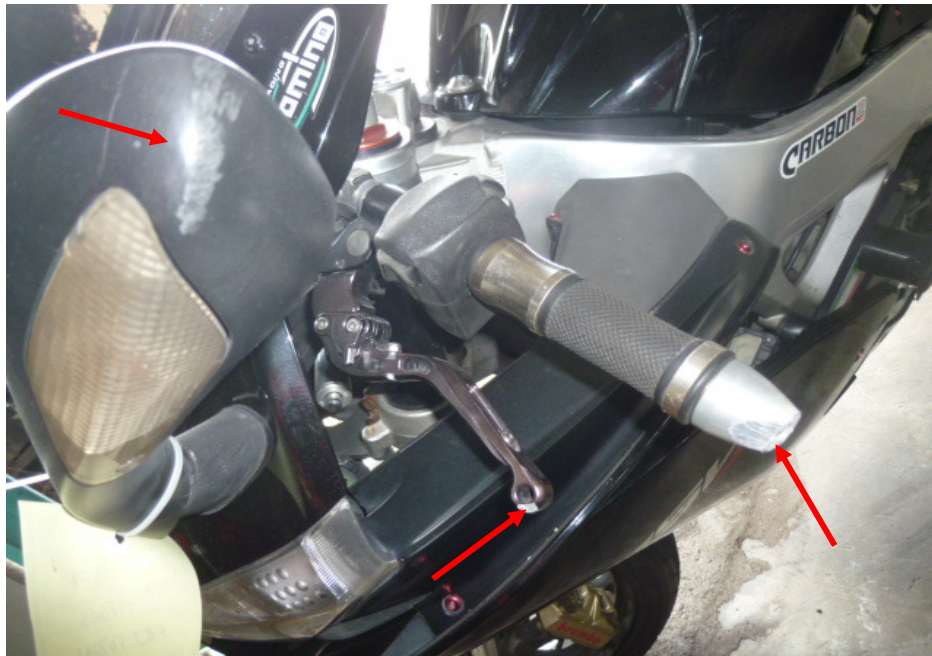
Photo 7 shows a closer view of the clutch lever, left side mirror and left handlebar end (arrowed) which were amongst the body parts at the front body of the Motorcycle that had sustained damage as a result of the accident.

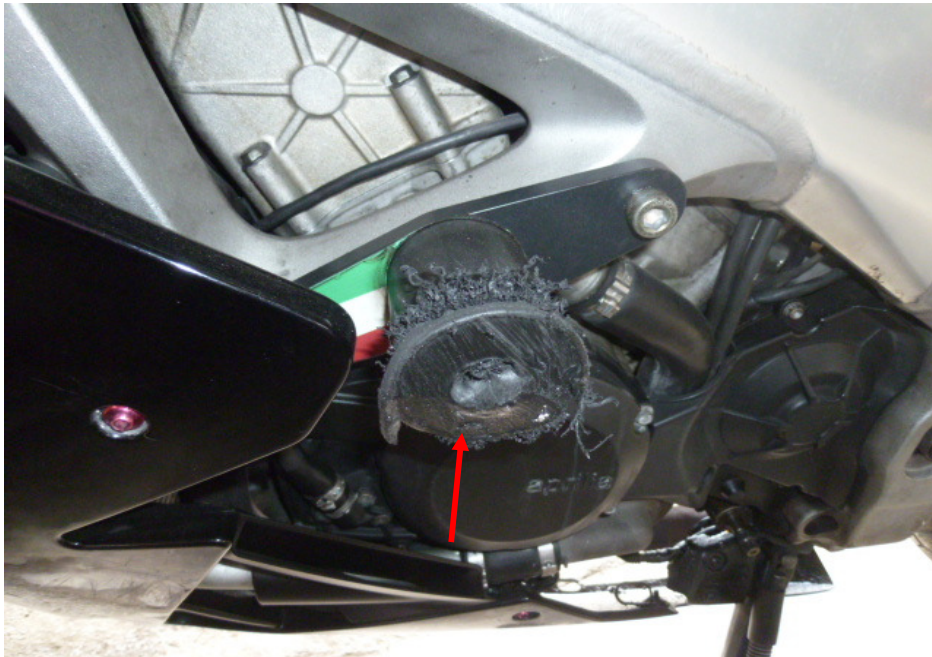
Photo 8 shows the grazed left frame slider of the Motorcycle as a result of the accident (arrowed).

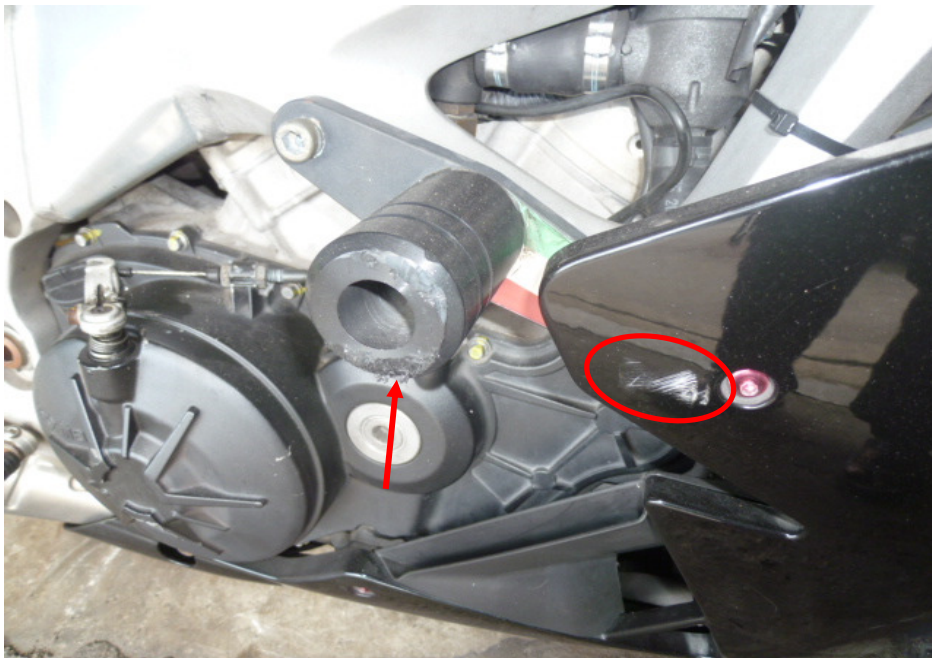
Photo 9 shows the grazed left frame slider (arrowed) and right cowling (circled) of the Motorcycle as a result of the accident

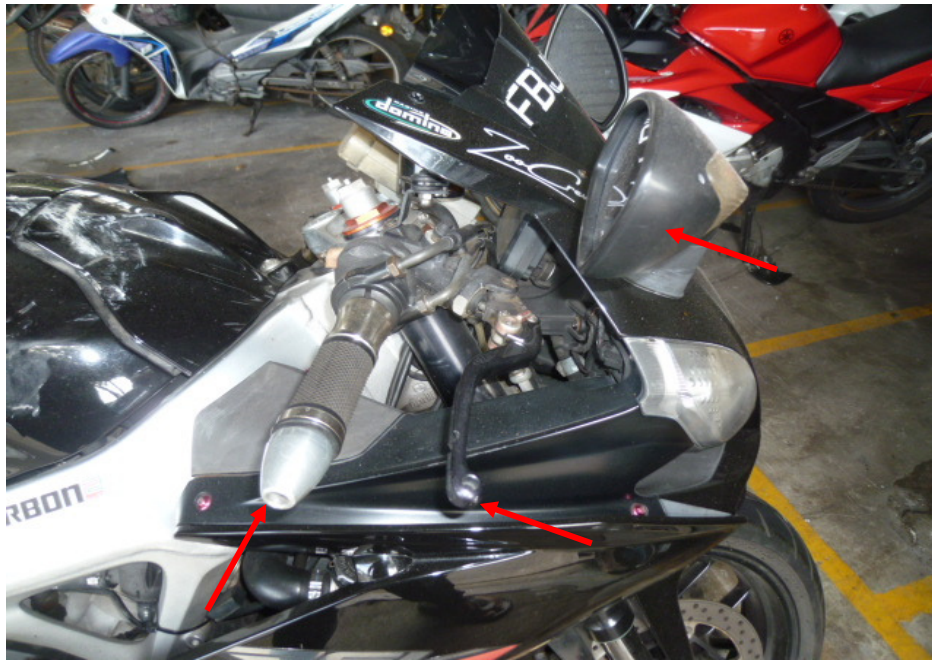
Photo 10 shows a closer view of the front brake lever, right side mirror and right handlebar end (arrowed) which were amongst the body parts at the front body of the Motorcycle that had sustained damage as a result of the accident.

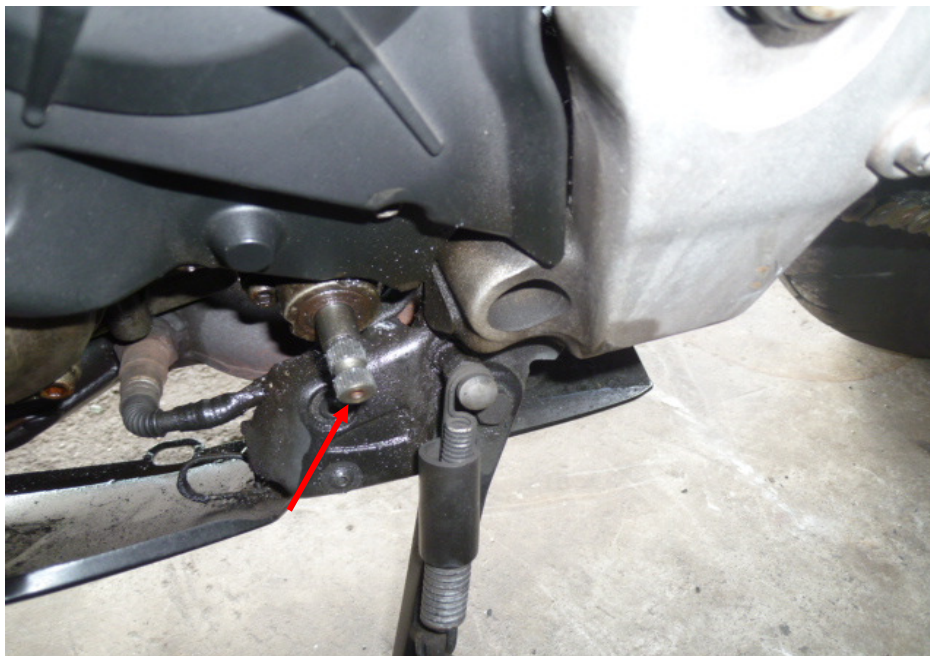
Photo 11 shows a closer view of the broken gear shift pedal (arrowed) which was amongst the body parts of the Motorcycle that had sustained damage as a result of the accident.

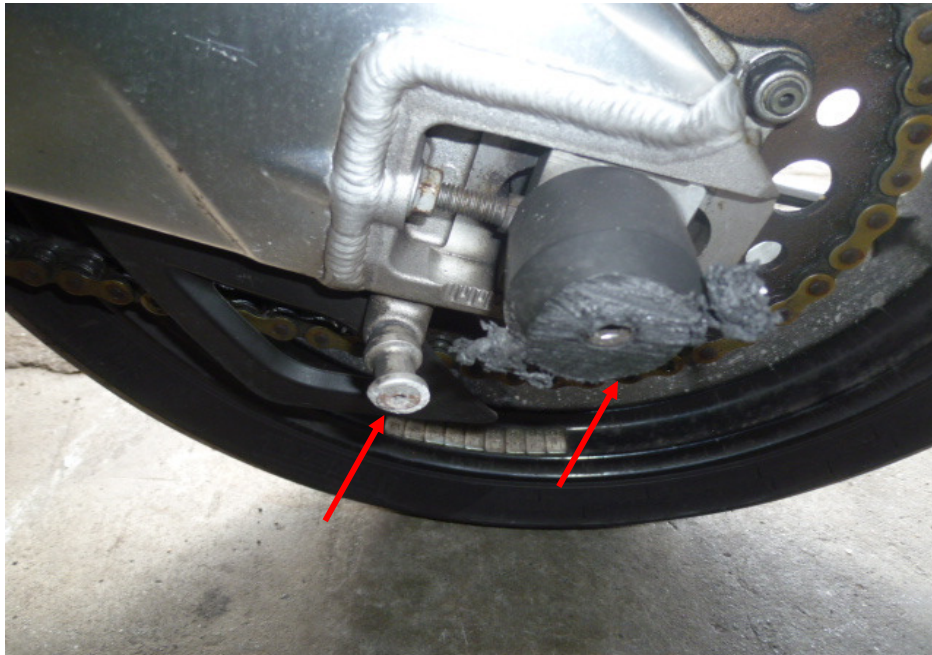
Photo 12 shows a closer view of the grazed left swingarm spool and slider (arrowed) which were amongst the body parts of the Motorcycle that had sustained damage as a result of the accident.

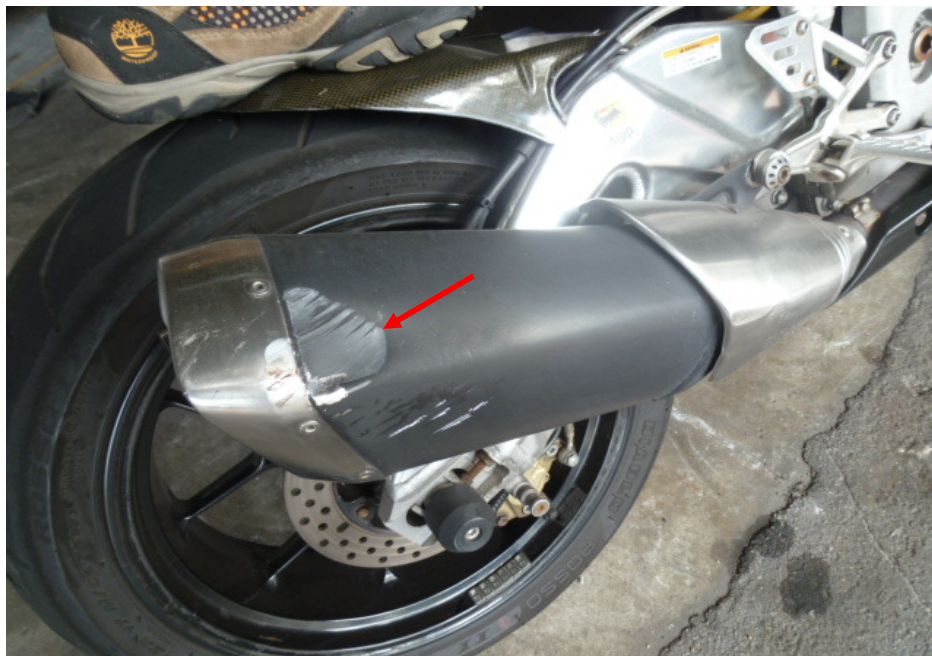
Photo 13 shows the dented exhaust muffler (arrowed) of the Motorcycle as a result of the accident.

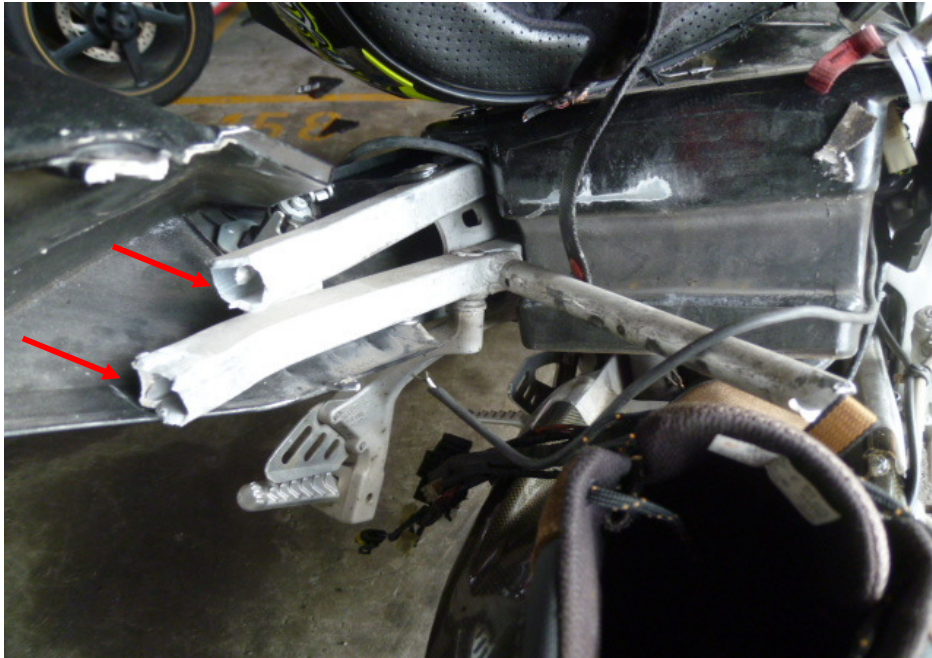
Photo 14 shows the broken rear subframe (arrowed) of the Motorcycle as a result of the accident.

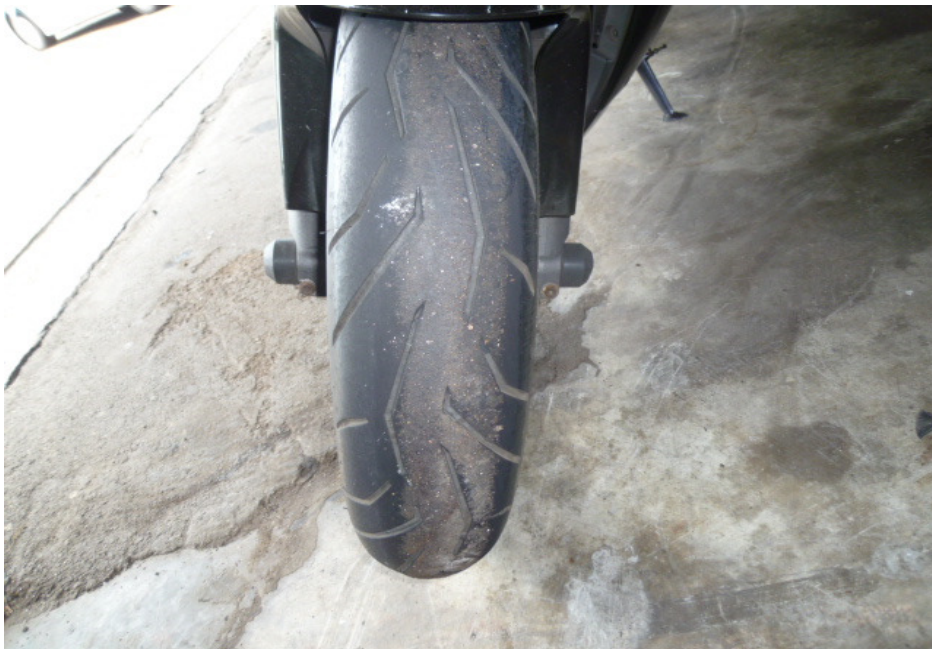
Photo 15 shows the front tyre of the Motorcycle at the time of our inspection. The front tyre was observed to be in serviceable condition with remaining tread depth of approximately 3mm. The pattern of the tread was also clearly visible. There was no tear, burst mark(s) and/or punctured hole(s) on the sidewalls as well as across the tread of the front tyre.

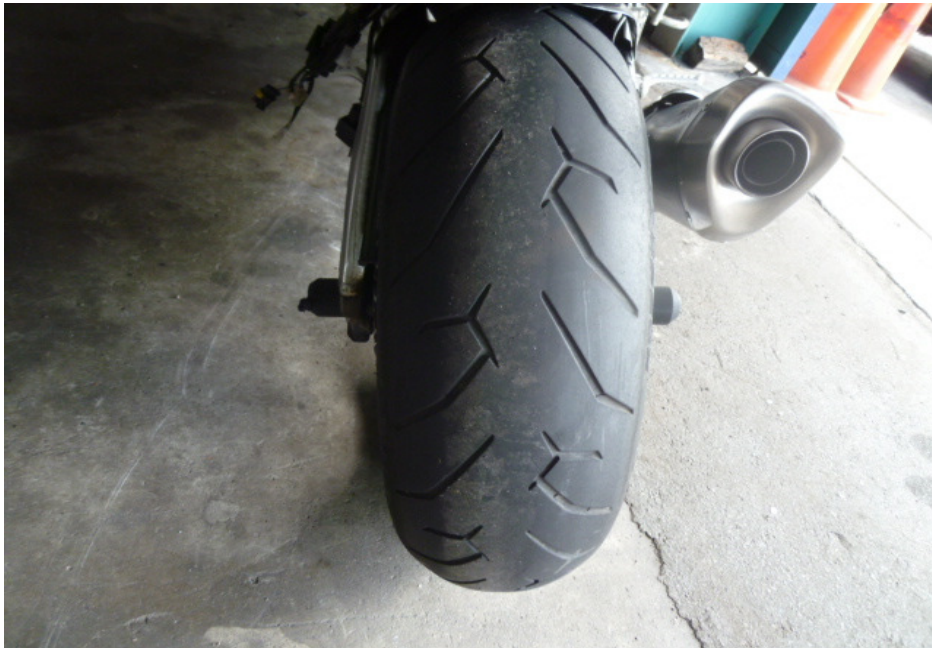
Photo 16 shows the condition of the Motorcycle's rear tyre. The rear tyre was observed to be in serviceable condition with remaining tread depth of approximately 3mm. The tyre was also observed to be sufficiently inflated for vehicular operation. We did not observe any tear, burst mark(s) and/or punctured hole(s) on the sidewalls as well as across the tread of the rear tyre.

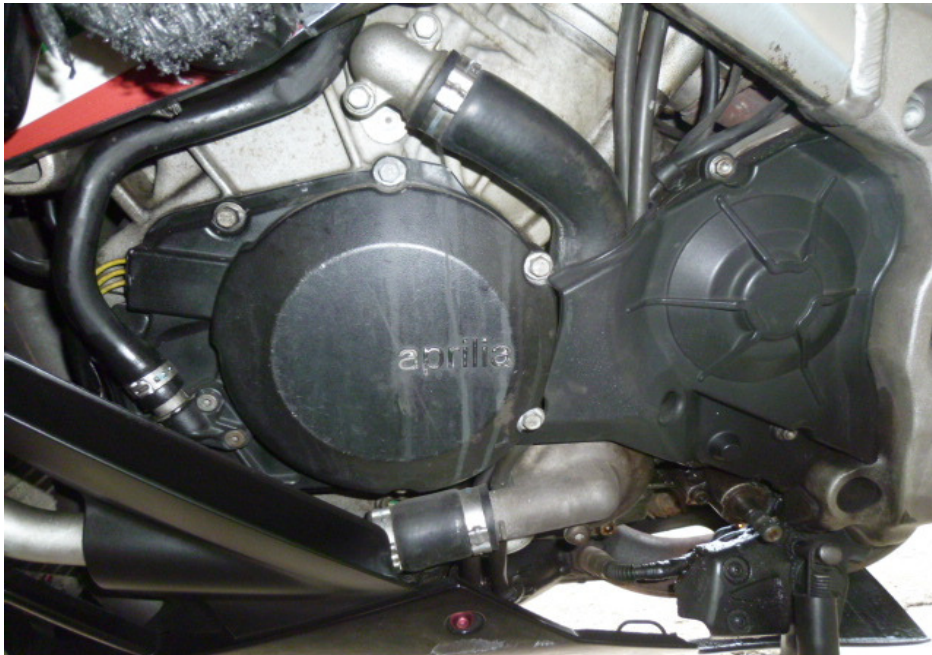
Photo 17 shows the left side of the engine of the Motorcycle at the time of our inspection. The various engine related parts and components were found to be intact with no visible damage. There was also no sign(s) or indication(s) of fluid leak observed around the left engine area of the Motorcycle.

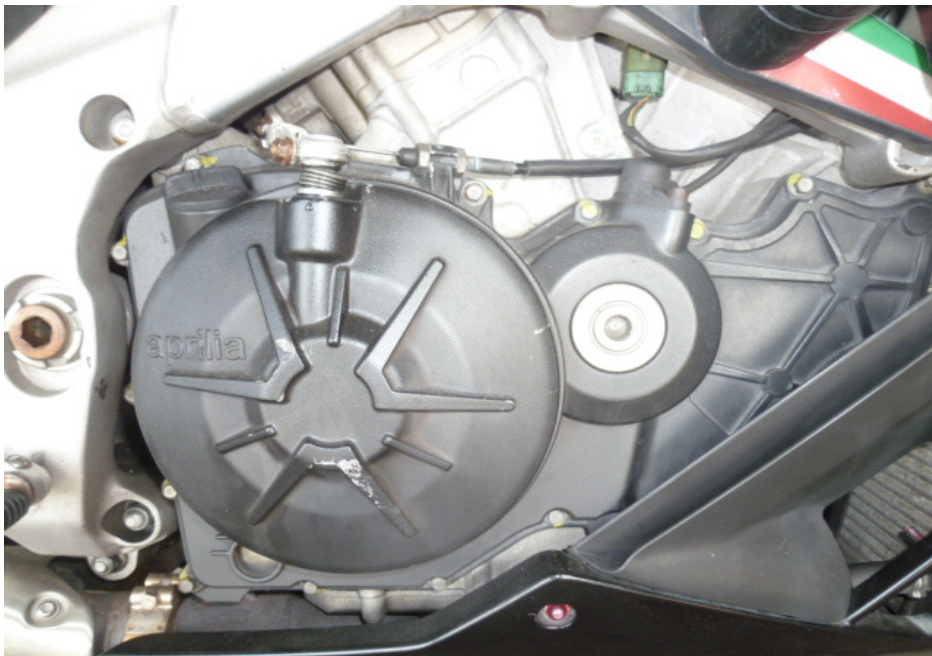
Photo 18 shows the right side of the engine of the Motorcycle at the time of our inspection. The various engine related parts and components were found to be intact with no visible damage. There was also no sign(s) or indication(s) of fluid leak observed around the right engine area of the Motorcycle.

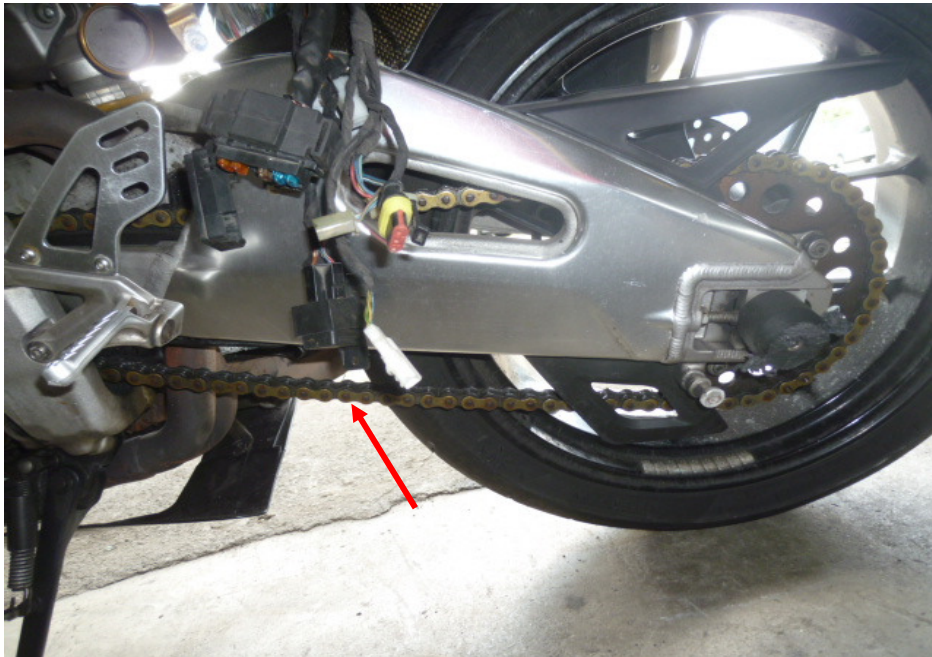
Photo 19 shows the general view of the gear train (arrowed) of the Motorcycle, which was observed to be intact with no misalignment. It was also adequately lubricated for operating purposes.

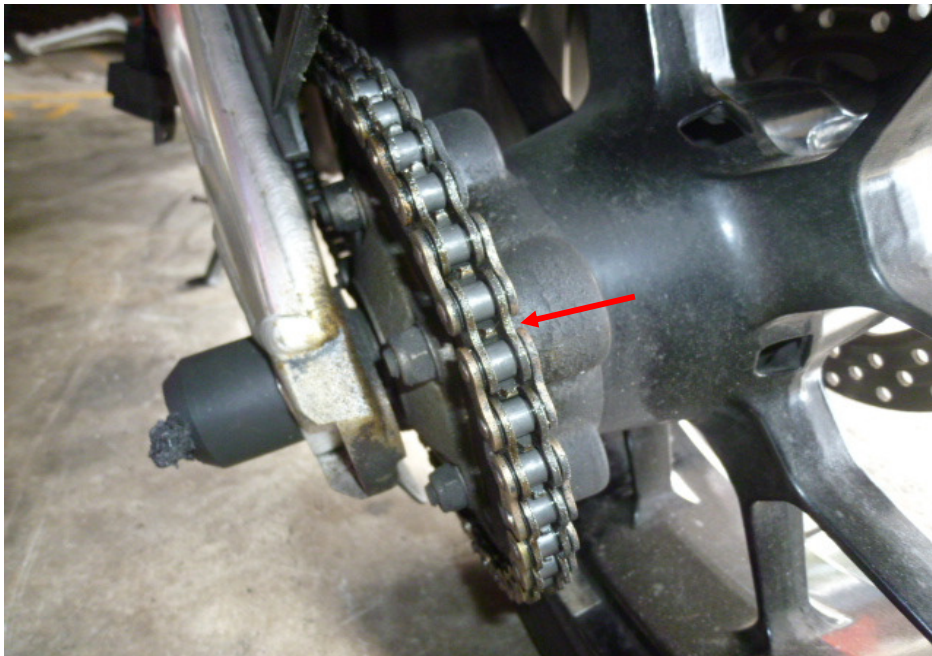
Photo 20 shows a closer view of the gear train (arrowed) of the Motorcycle, which was observed to be intact with no misalignment. It was also adequately lubricated for operating purposes.

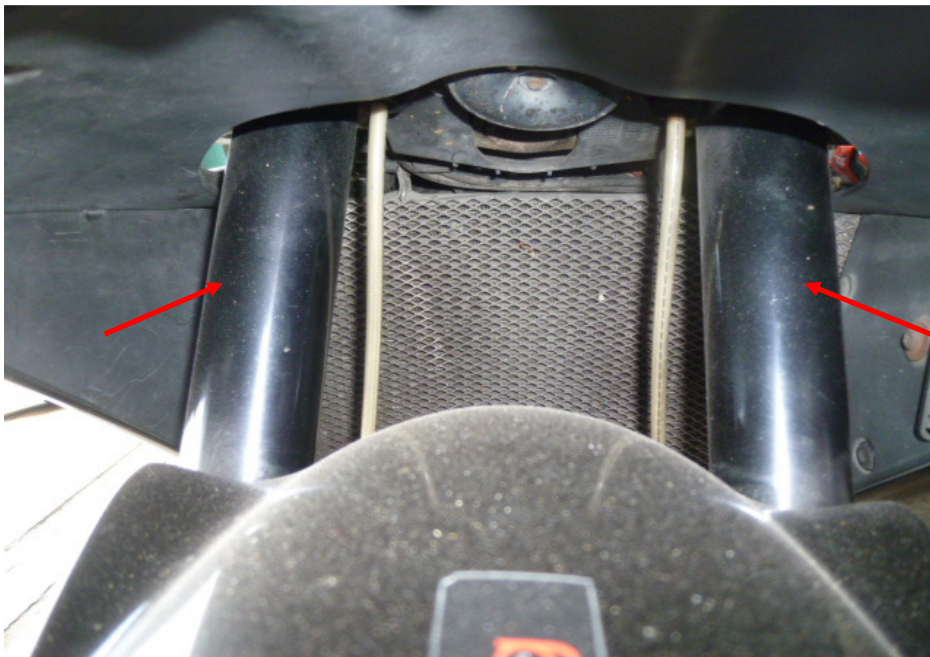
Photo 21 shows the front fork (arrowed) of the Motorcycle. The front fork and fork bracket of the Motorcycle were both found to be intact and undamaged. Turning the Motorcycle's handle bar towards the left and right did not produce any abnormal free play and/or resistance. The steering system of the Motorcycle was in serviceable condition at the time of our inspection.

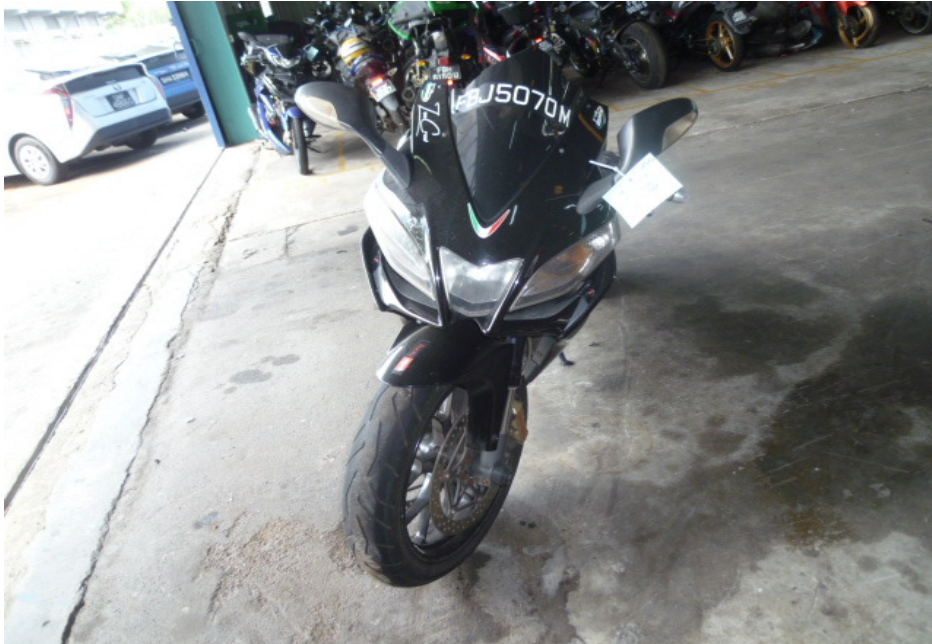
Photo 22 shows the front wheel of the Motorcycle turned towards its full right. Turning the Motorcycle's handle bar towards the left and right did not produce any abnormal free play and/or resistance. This would indicate that the steering system of the Motorcycle was in serviceable condition at the time of our inspection.

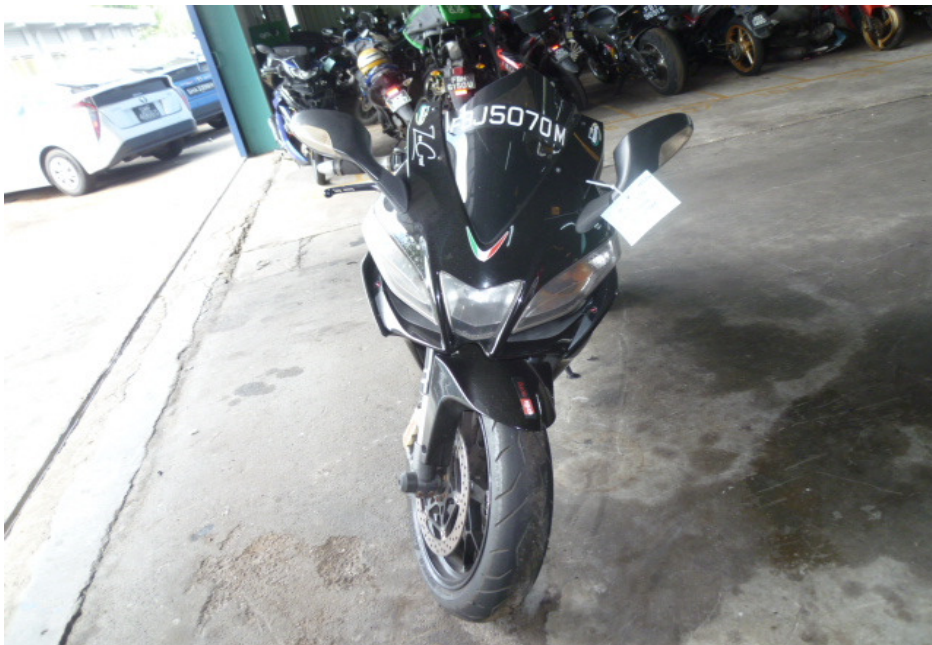
Photo 23 shows the front wheel of the Motorcycle turned towards its full left. Turning the Motorcycle's handle bar towards the left and right did not produce any abnormal free play and/or resistance. This would indicate that the steering system of the Motorcycle was in serviceable condition at the time of our inspection.

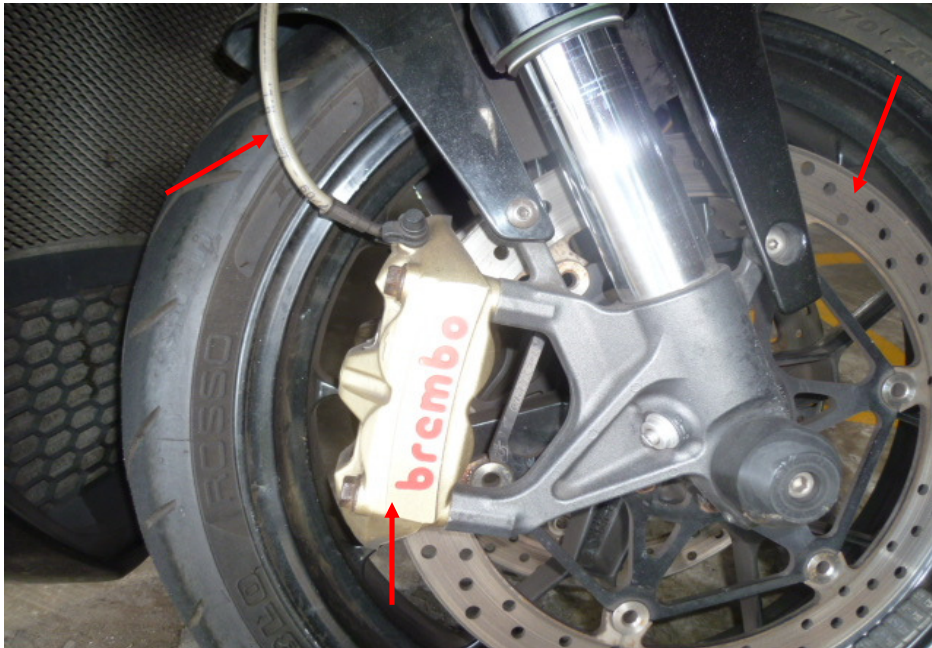
Photo 24 shows a close up view of the front brake caliper, front brake disc and front brake hose (arrowed) at the right side of the Motorcycle's front wheel, which are all part of the components in the hydraulic front brake system of the Motorcycle. Our visual checks of these various components had revealed all to be intact with no visible damage. No leakage of brake fluid was also observed.

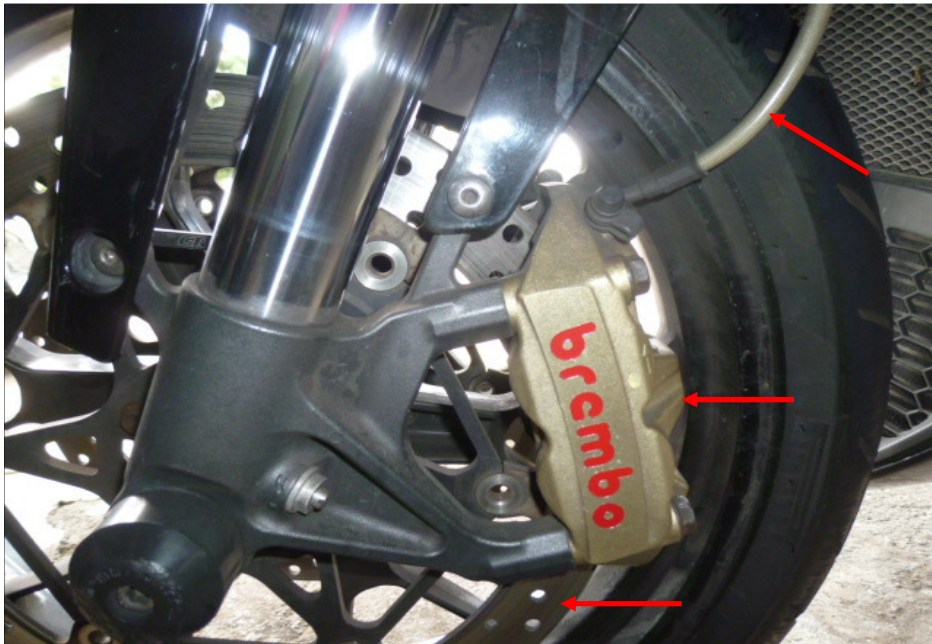
Photo 25 shows a close up view of the front brake caliper, front brake disc and front brake hose (arrowed) at the left side of the Motorcycle's front wheel, which are all part of the components in the hydraulic front brake system of the Motorcycle. Our visual checks of these various components had revealed all to be intact with no visible damage. No leakage of brake fluid was also observed.

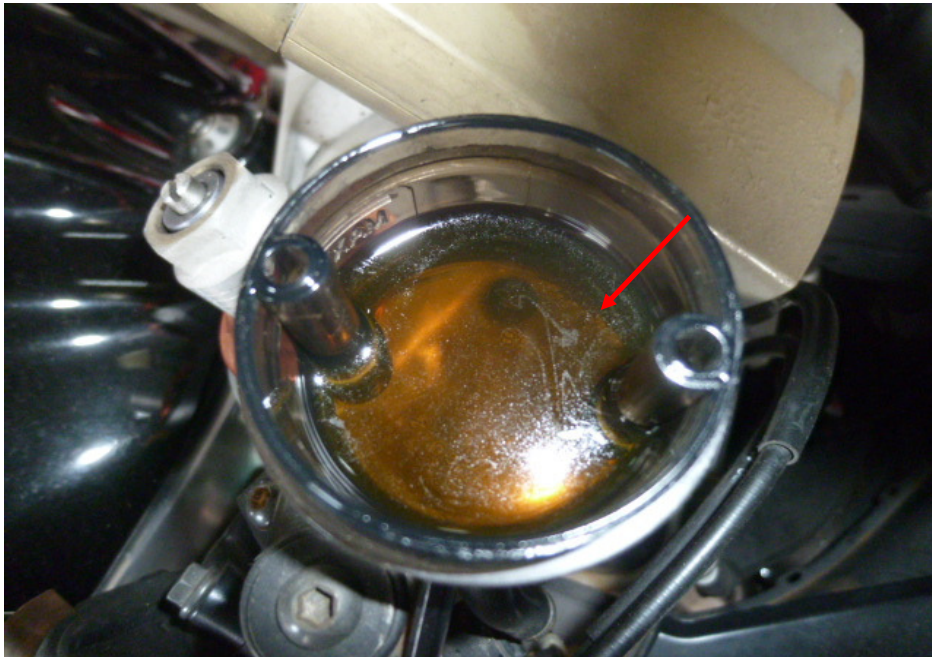
14. The brake fluid for the front brake was observed to be of sufficient level for operational purposes. However it was found to be slightly contaminated. and without any contamination. The brake fluid for the rear brake was observed to be of sufficient level for operational purposes. However we were unable to determine if it was contaminated as we were unable to remove the rear brake reservoir cover.

Photo 26 shows the brake fluid reservoir for the front brake of the Motorcycle. The brake fluid was observed to be of sufficient level for operational purposes. However it was found to be slightly contaminated (arrowed).

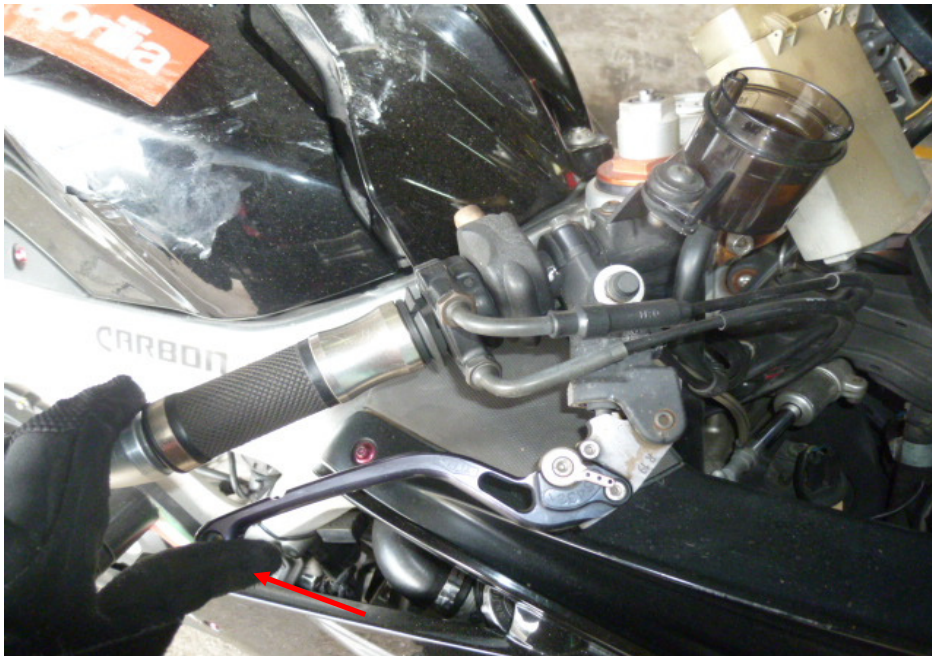
15. Static brake tests conducted on the Motorcycle had appear to indicate that the braking system of the Motorcycle was in serviceable condition. There was some resistance felt (spongy like feel) upon pressing the brake lever and upon stepping on the brake pedal. This would indicate that there was no leakage of pressure/vacuum in the brake system.

Photo 27 shows the front brake lever being depressed. There was some resistance felt (spongy like feel) upon pressing the front brake lever (arrowed). This would indicate that there is no leakage of pressure/vacuum in the front brake system.

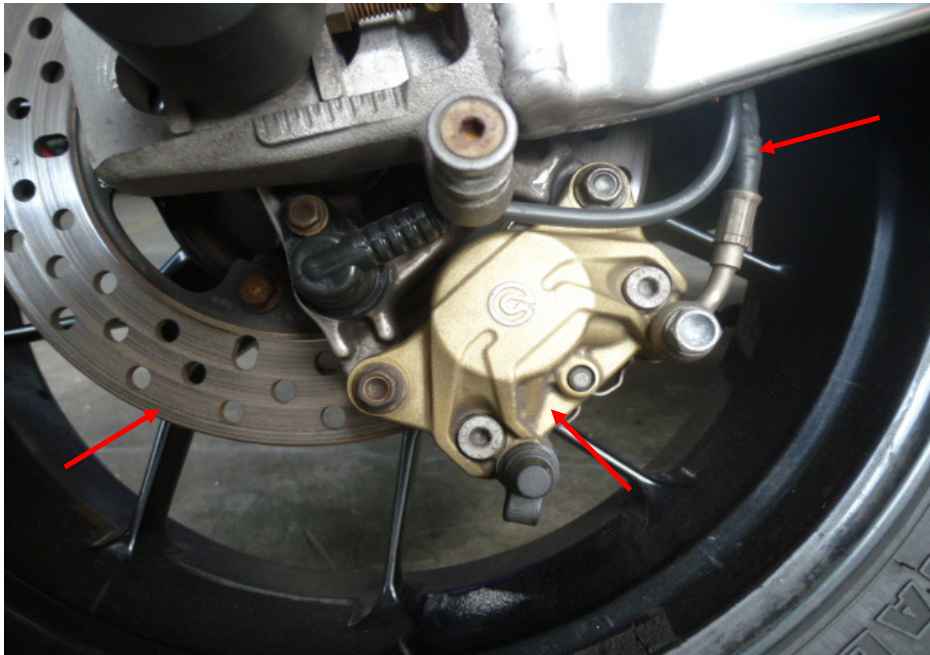
Photo 28 shows a close up view of the rear brake caliper, rear brake disc and rear brake hose (arrowed) of the Motorcycle, which are all part of the components in the hydraulic rear brake system of the Motorcycle. Our visual checks of these various components had revealed all to be intact with no visible damage. No leakage of brake fluid was also observed.

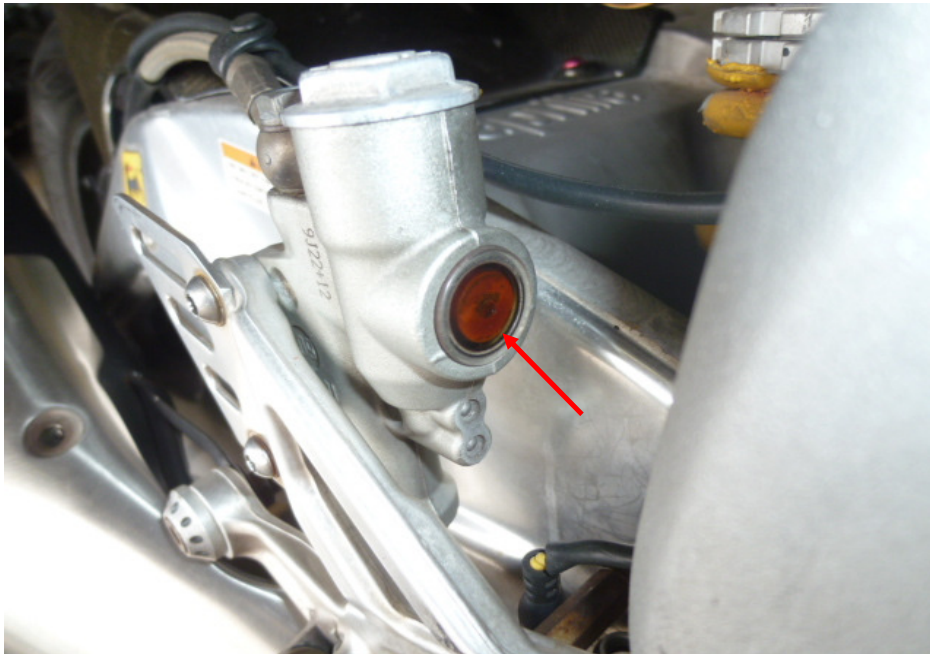
Photo 29 shows the brake fluid reservoir for the rear brake of the Motorcycle. The brake fluid was observed to be of sufficient level for operational purposes (arrowed). However we were unable to determine if it was contaminated as we were unable to remove the rear brake reservoir cover.
