Your Ref: TP/IP/06245/2022
Our Ref : CI/TPD22008689/N

5 September 2022

**INSPECTION REPORT OF BICYCLE (BLUE FOLDABLE) - TRAFFIC POLICE
POUND REPORT NO. PR 3202/22**

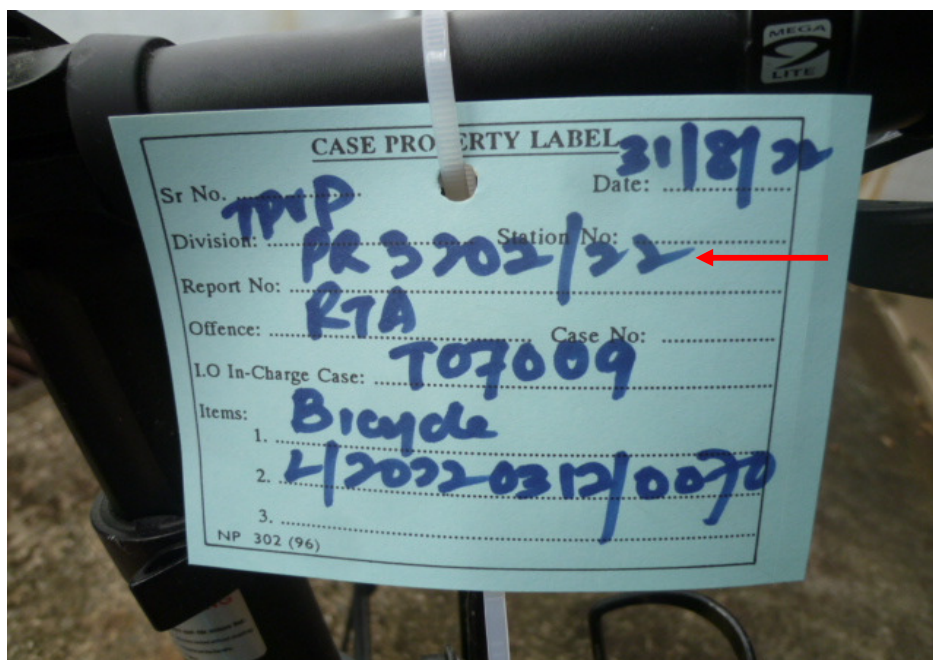
Photo 1 shows the identification of the Bicycle with reference to Traffic Police Pound Report No. PR 3202/22 (arrowed).

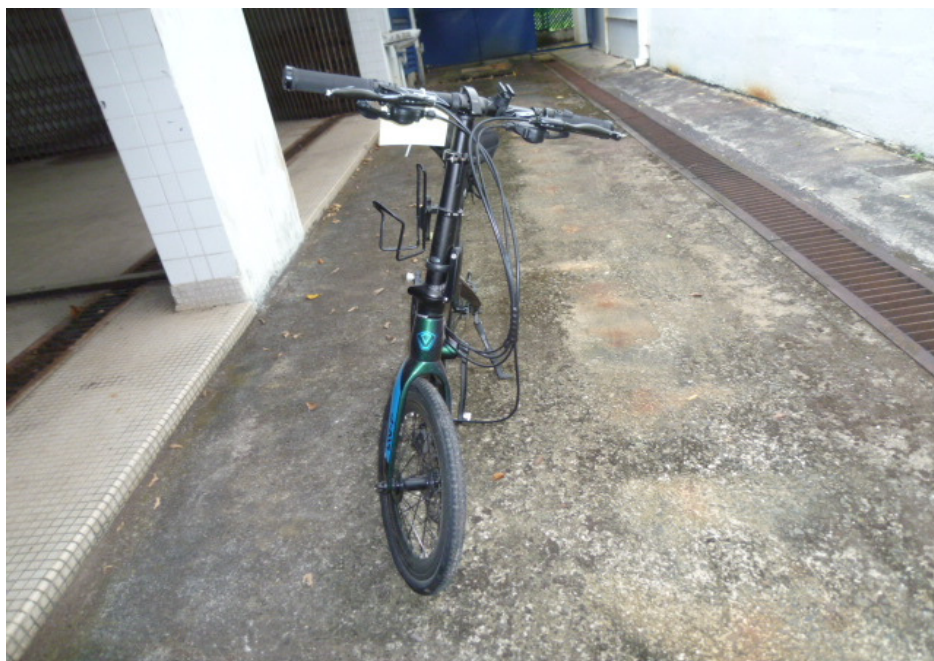
Photo 2 shows the frontal portion of the Bicycle at the time of our inspection. The Bicycle had sustained damages all around.

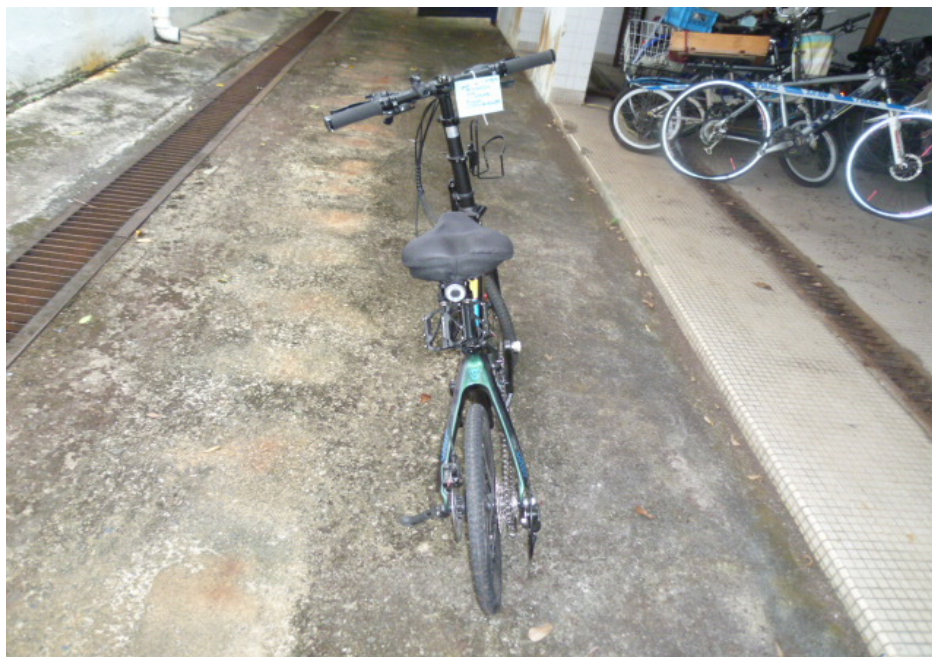
Photo 3 shows the rear portion of the Bicycle at the time of our inspection. The Bicycle had sustained damages all around.

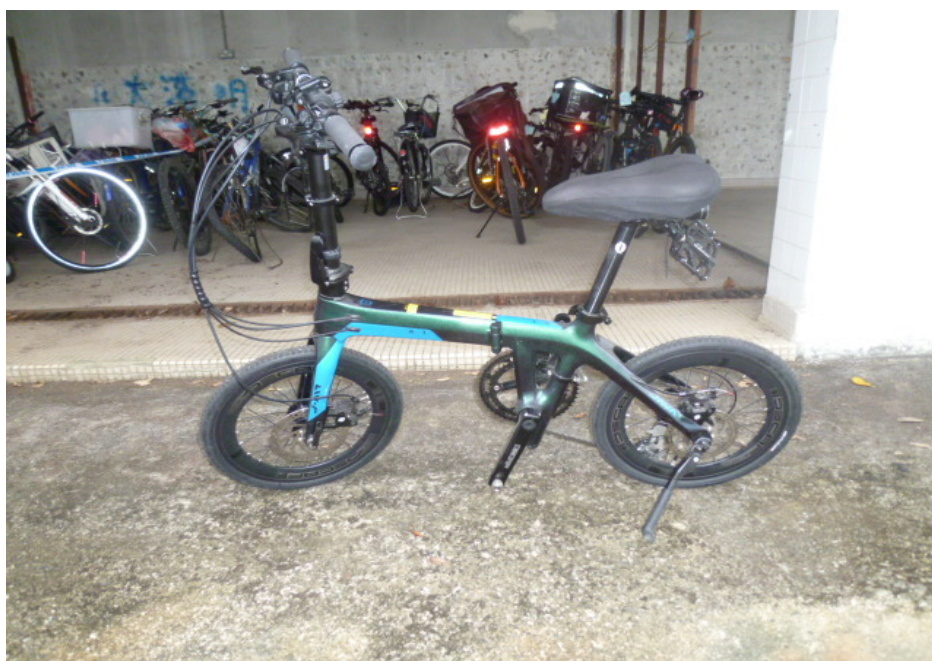
4. The Bicycle was observed to have sustained damages all around. The body parts that were found to have been damaged include its left hand brake lever, right hand brake lever, handlebar grips, left front fork, front wheel axle nut and side stand, amongst others as a result of the accident. See photos 1 – 10 below.

Photo 4 shows the left body of the Bicycle at the time of our inspection. The Bicycle had sustained damages all around. The body parts that were found to have been damaged include its left hand brake lever, right hand brake lever, handlebar grips, left front fork, front wheel axle nut and side stand, amongst others as a result of the accident.

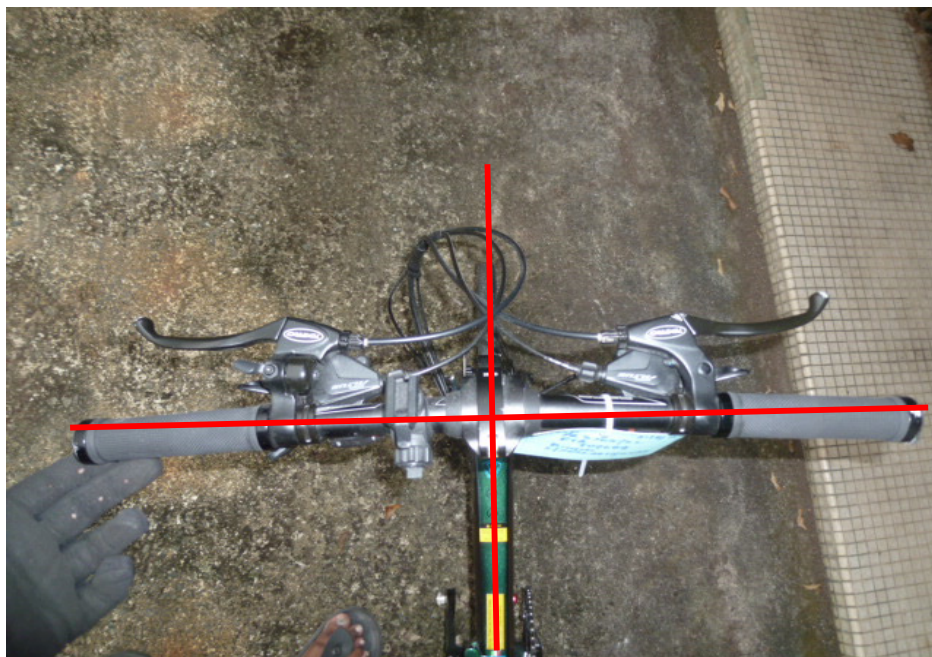
Photo 5 shows the frontal portion of the Bicycle (top view) at the time of our inspection. There was no misalignment of the handlebar & front tyre observed.

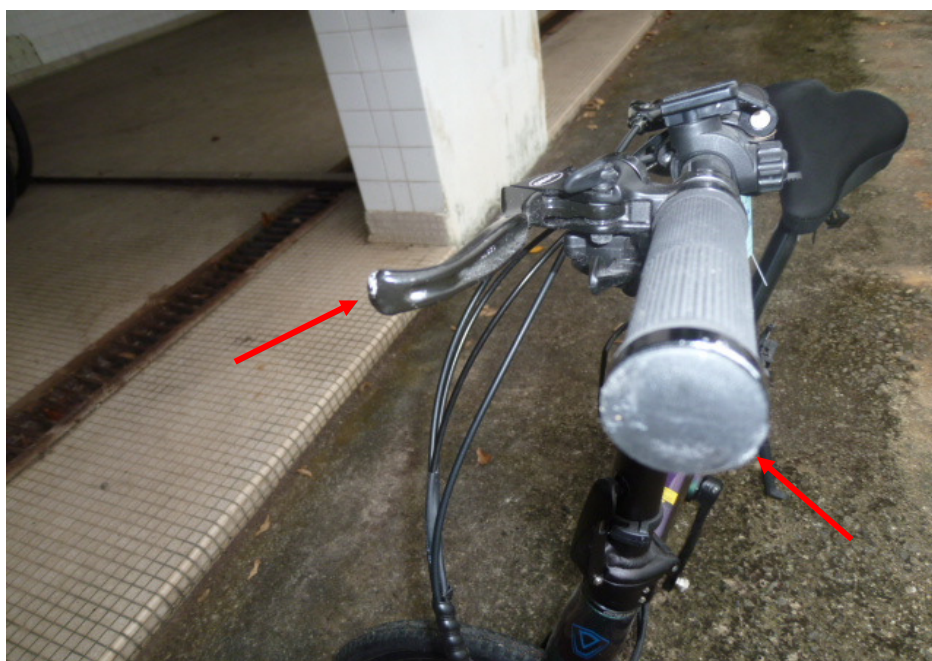
Photo 6 shows the damages of grazing nature on the left hand brake lever and left handlebar grip of the Bicycle at the time of our inspection (arrowed).

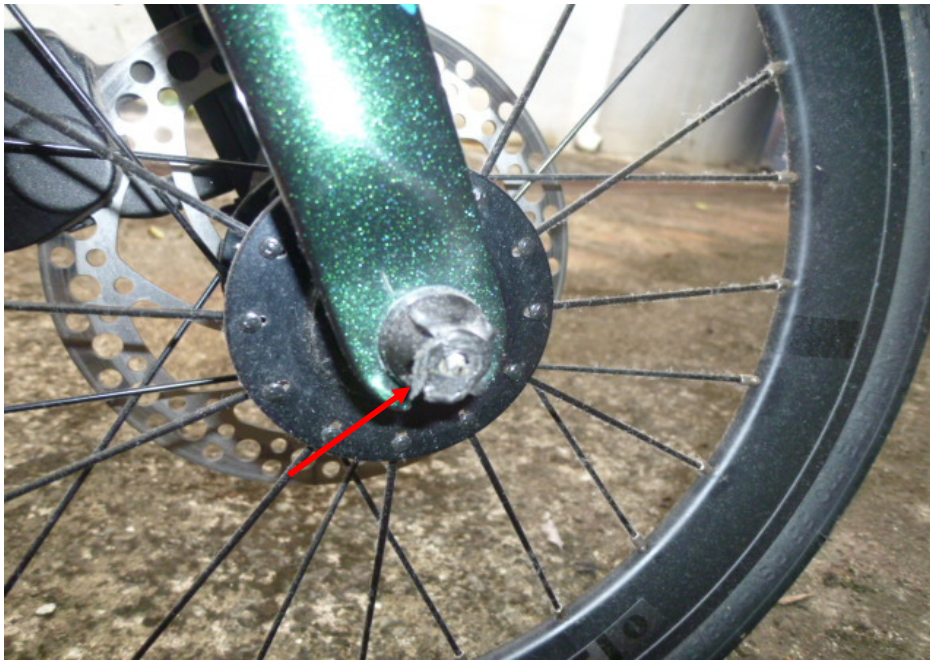
Photo 7 shows the grazed front wheel axle nut (arrowed) of the Bicycle as a result of the accident.

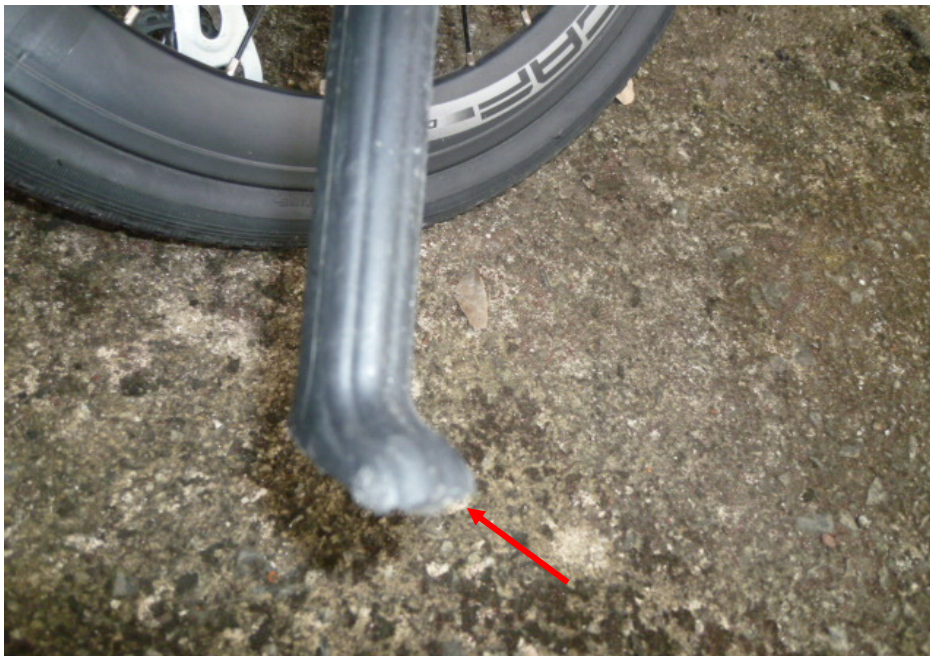
Photo 8 shows the grazed side stand of the Bicycle at the time of our inspection (arrowed).

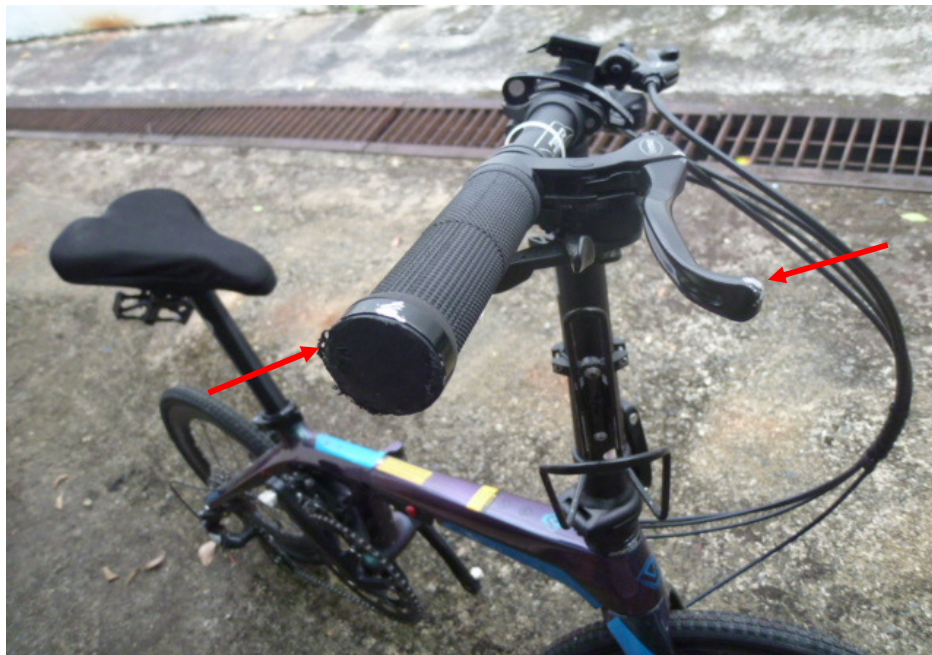
Photo 9 shows the damages of grazing nature on the right hand brake lever and right handlebar grip of the Bicycle at the time of our inspection (arrowed).

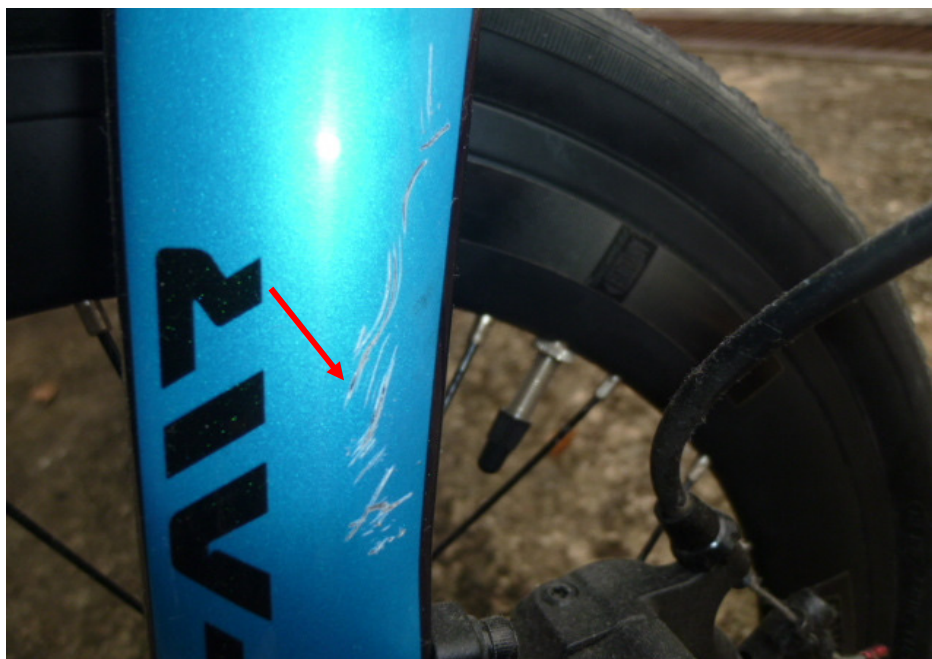
Photo 10 shows a close-up view of the grazed left front fork of the Bicycle as a result of the accident (arrowed).

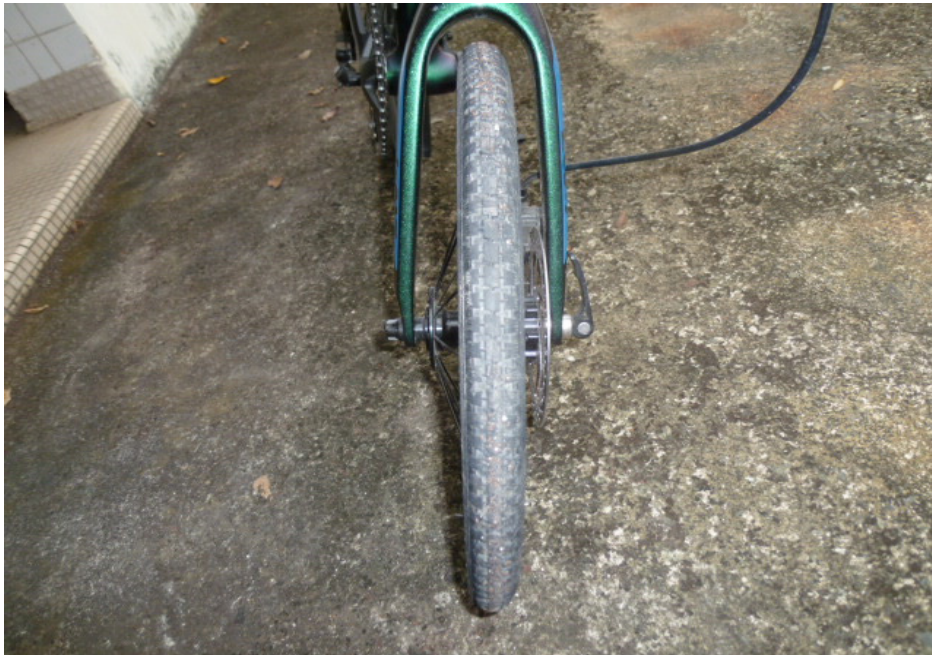
6. Both tyres were wrapped around alloy spoke wheel rims. At the time of our inspection, we did not observe any visible damage on the front and rear wheel rim of the Bicycle. See photos 11 & 12 below.

Photo 11 shows the front tyre of the Bicycle. The pattern of the tread was clearly visible. There was no tear, burst mark(s) and/or punctured hole(s) on the sidewalls as well as across the tread of the front tyre. The front tyre was also observed to be sufficiently inflated for vehicular operation.

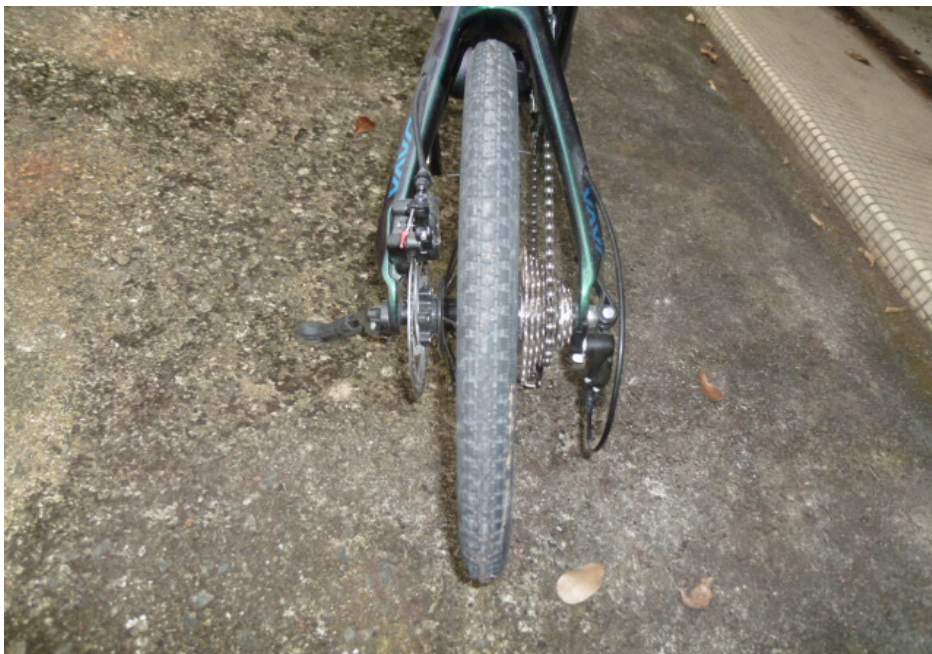
Photo 12 shows the rear tyre of the Bicycle. The pattern of the tread was clearly visible. There was no tear, burst mark(s) and/or punctured hole(s) on the sidewalls as well as across the tread of the rear tyre. The rear tyre was also observed to be sufficiently inflated for vehicular operation.

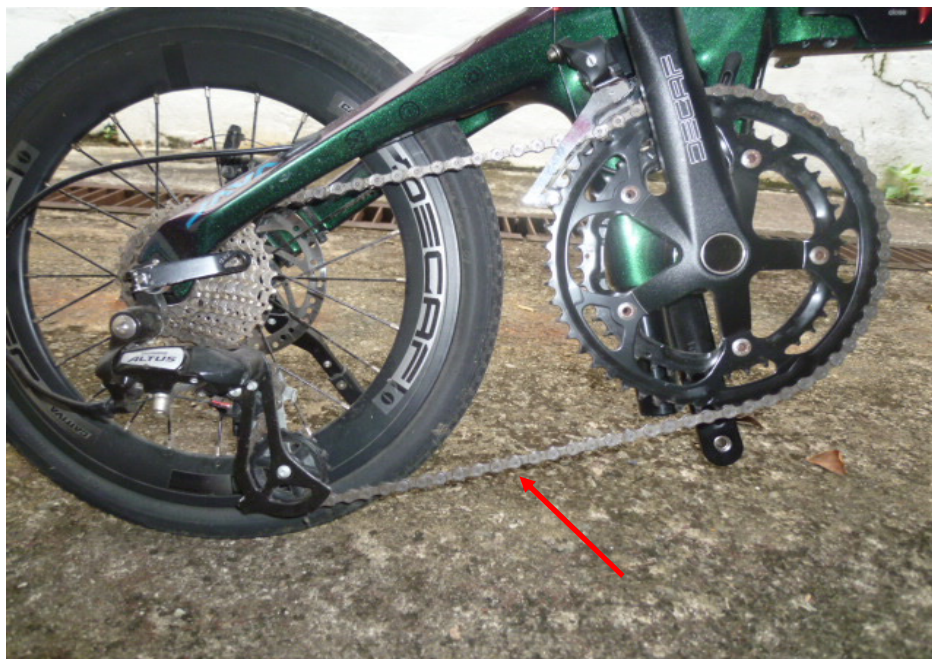
7. The gear train of the Bicycle was found to be intact without any misalignment. It was also adequately lubricated for operating purposes. See photos 13 & 14 below.

Photo 13 shows the general view of the gear train of the Bicycle, which was observed to be intact with no misalignment (arrowed). It was also adequately lubricated for operating purposes.

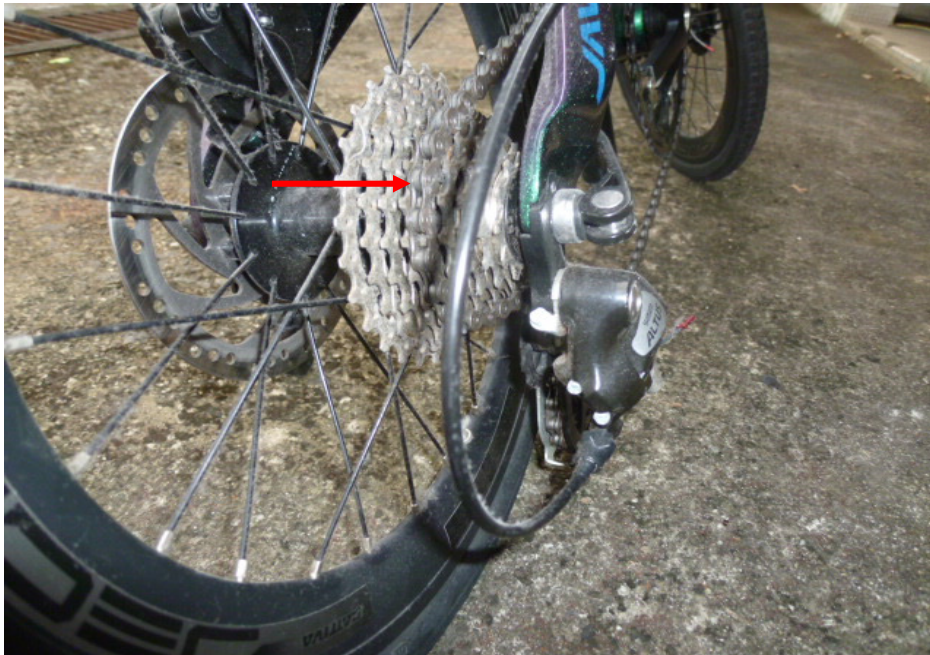
Photo 14 shows a closer view of the gear train of the Bicycle, which was observed to be intact with no misalignment (arrowed). It was also adequately lubricated for operating purposes.

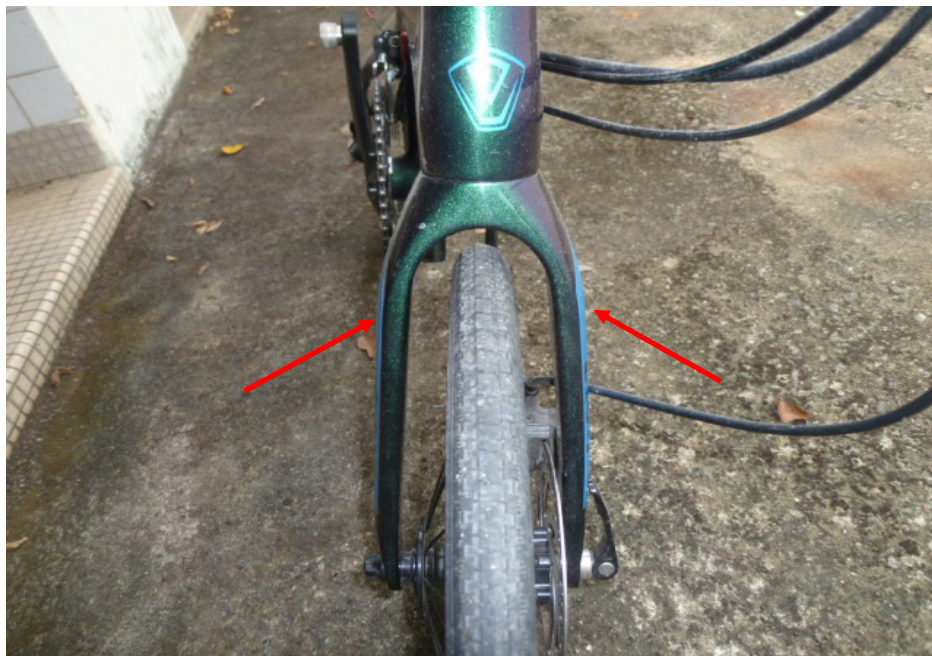
8. Our checks on the various steering components of the Bicycle revealed that its steering system was in serviceable condition. Its front fork assembly was found to be intact and undamaged. Turning the handle bar towards the left and right did not produce any abnormal free play and/or resistance.

Photo 15 shows the front fork assembly (arrowed) of the Bicycle. The front forks and fork bracket of the Bicycle were both found to be intact and undamaged. Turning the Bicycle's handle bar towards the left and right did not produce any abnormal free play. The steering system of the Bicycle was in serviceable condition at the time of our inspection.

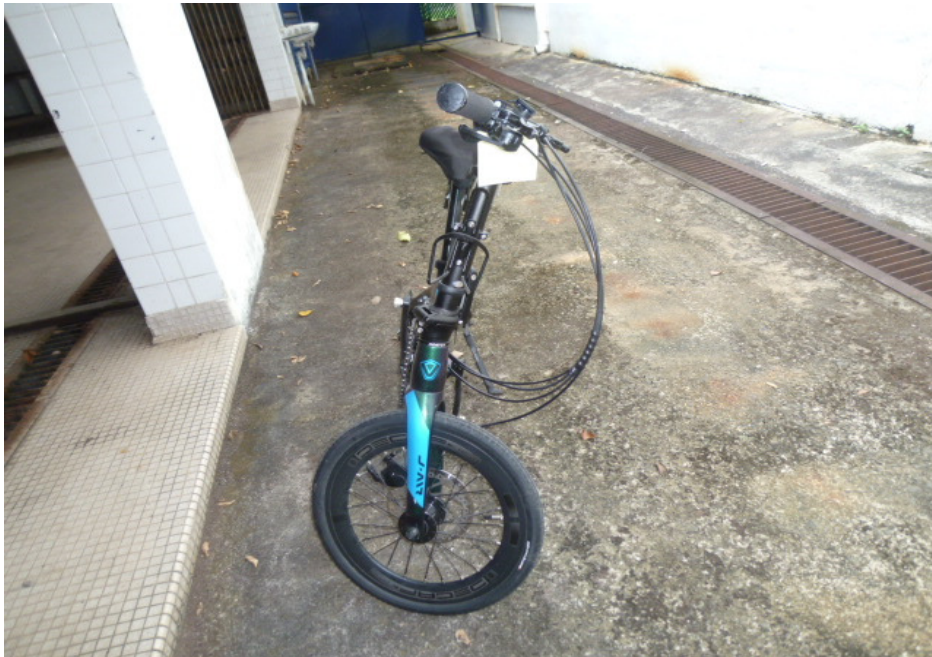
Photo 16 shows the front wheel of the Bicycle turned towards its full left. Turning the Bicycle's handle bar towards the left did not produce any abnormal free play and/or resistance. This would indicate that the steering system of the Bicycle was in serviceable condition at the time of our inspection.

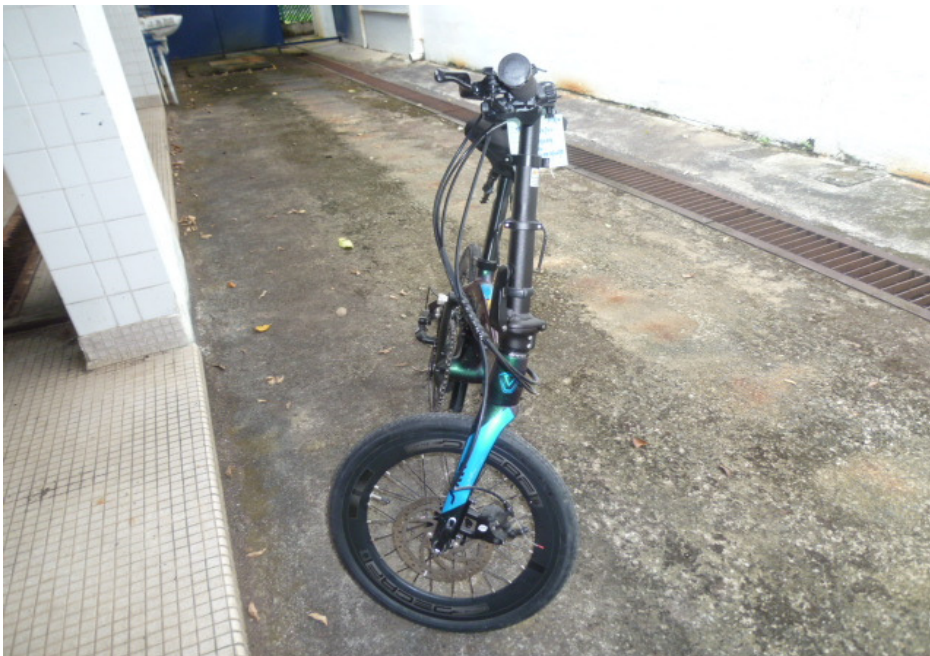
Photo 17 shows the front wheel of the Bicycle turned towards its full right. Turning the Bicycle's handle bar towards the right did not produce any abnormal free play and/or resistance. This would indicate that the steering system of the Bicycle was in serviceable condition at the time of our inspection.

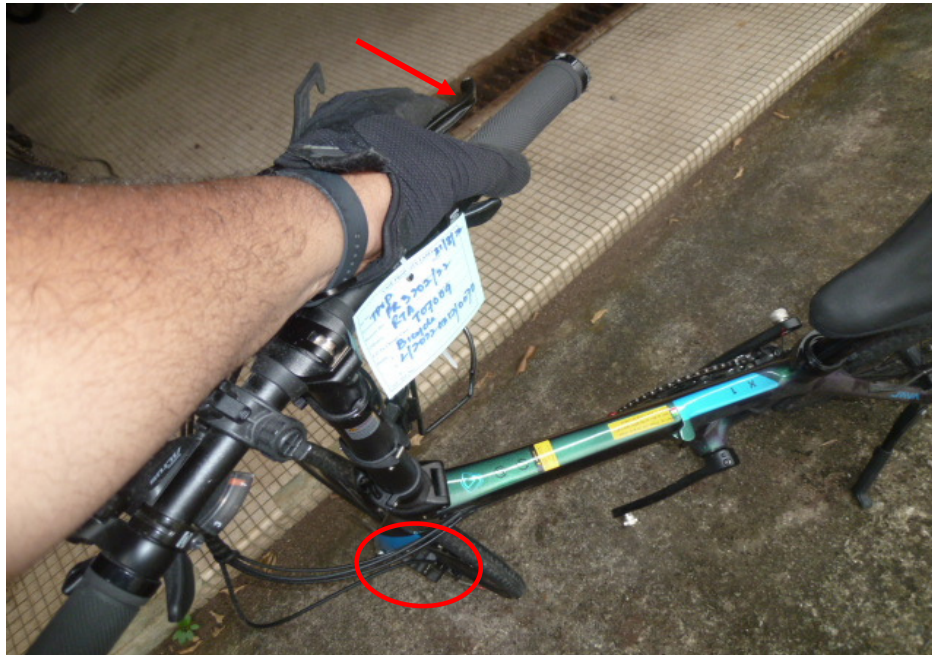
10. A static brake test was conducted on the front brake of the Bicycle. There was some resistance felt upon pressing the right hand brake lever. This was further confirmed by looking at the front brake pads while we pressed the right hand brake lever. It shows that the front brake pads responded to the gripping action. The front brake pads pressed against the front brake disc. This had appeared to indicate that the front brake of the Bicycle was in serviceable condition.

Photo 18 shows a static brake test conducted on the Bicycle's front brake. There was some resistance felt upon pressing the right hand brake lever (arrowed). It also shows that the front brake pads responded to the gripping action (circled) after depressing the right hand brake lever.

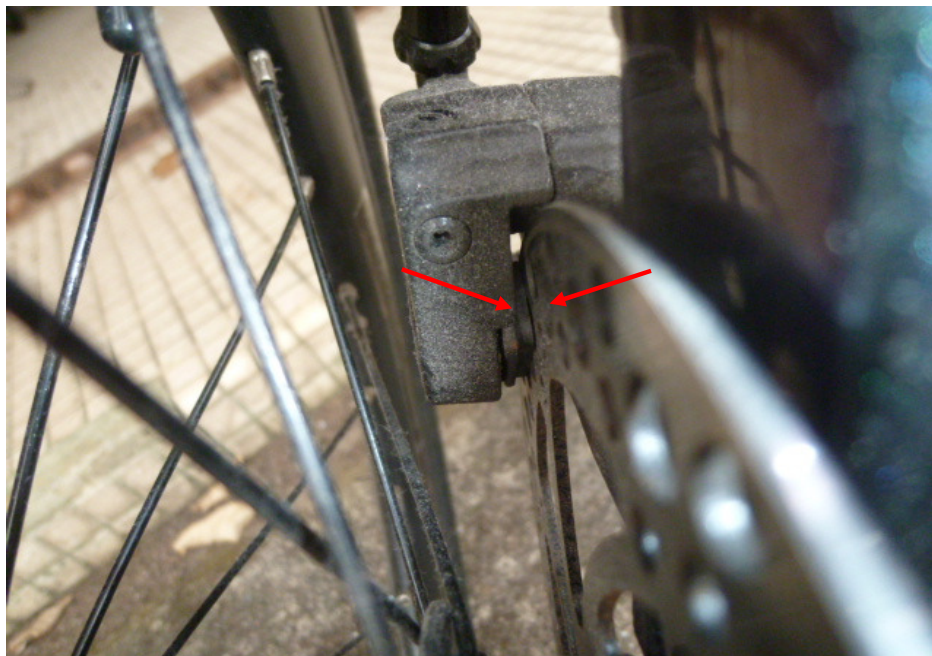
Photo 19 shows a close up view of the front brake pads responding to the gripping action. The front brake pads pressed against the front brake disc (arrowed) upon depressing the right hand brake lever. This had appeared to indicate that the front brake of the Bicycle was in serviceable condition.

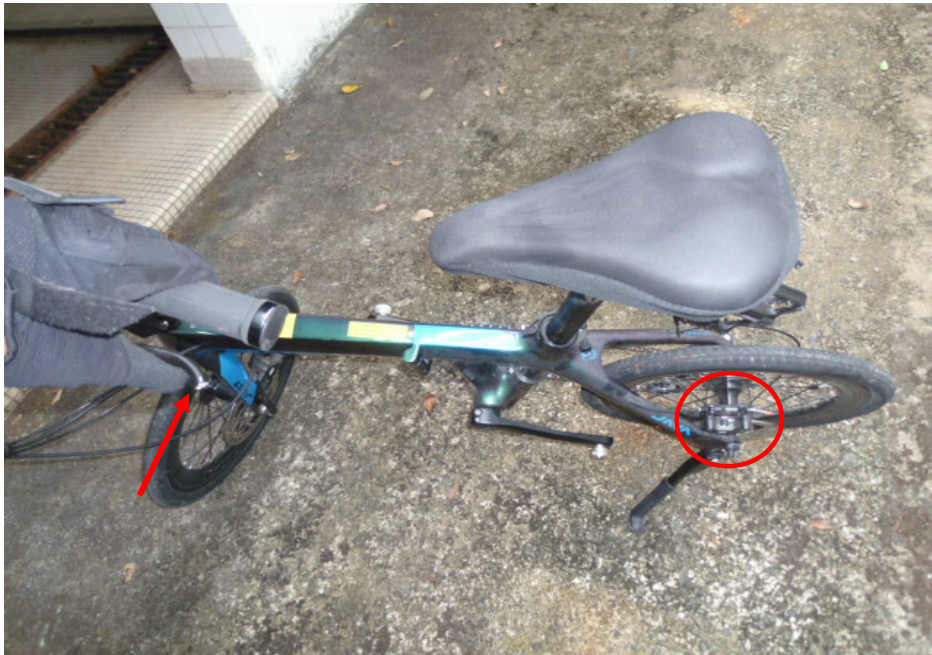
11. A static brake test was conducted on the rear brake of the Bicycle. There was some resistance felt upon pressing the left hand brake lever. This was further confirmed by looking at the rear brake pads while we pressed the left hand brake lever. It shows that the rear brake pads responded to the gripping action. The rear brake pads pressed against the rear brake disc. This had appeared to indicate that the rear brake of the Bicycle was in serviceable condition.

Photo 20 shows a static brake test conducted on the Bicycle's rear brake. There was some resistance felt upon pressing the left hand brake lever (arrowed). It also shows that the rear brake pads responded to the gripping action (circled) after depressing the left hand brake lever.

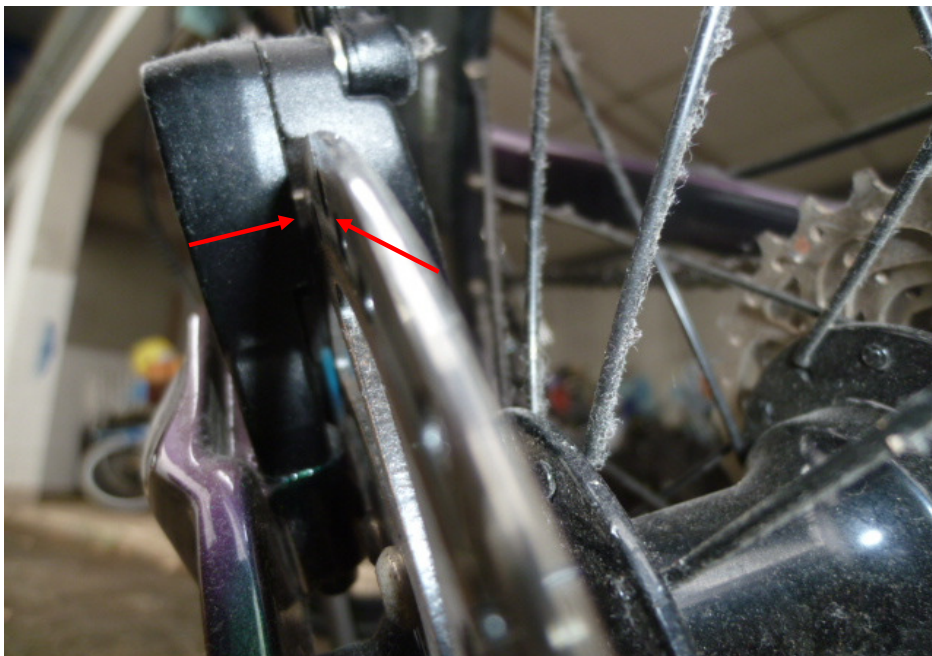
Photo 21 shows a close up view of the rear brake pads responding to the gripping action. The rear brake pads pressed against the rear brake disc (arrowed) upon depressing the left hand brake lever. This had appeared to indicate that the rear brake of the Bicycle was in serviceable condition.
