Your Ref: TP/IP/20003/2022
Our Ref : CI/TPD22008690/N

Fatal Accident Investigation Team

INSPECTION REPORT OF MOTORCYCLE FBG 2559G

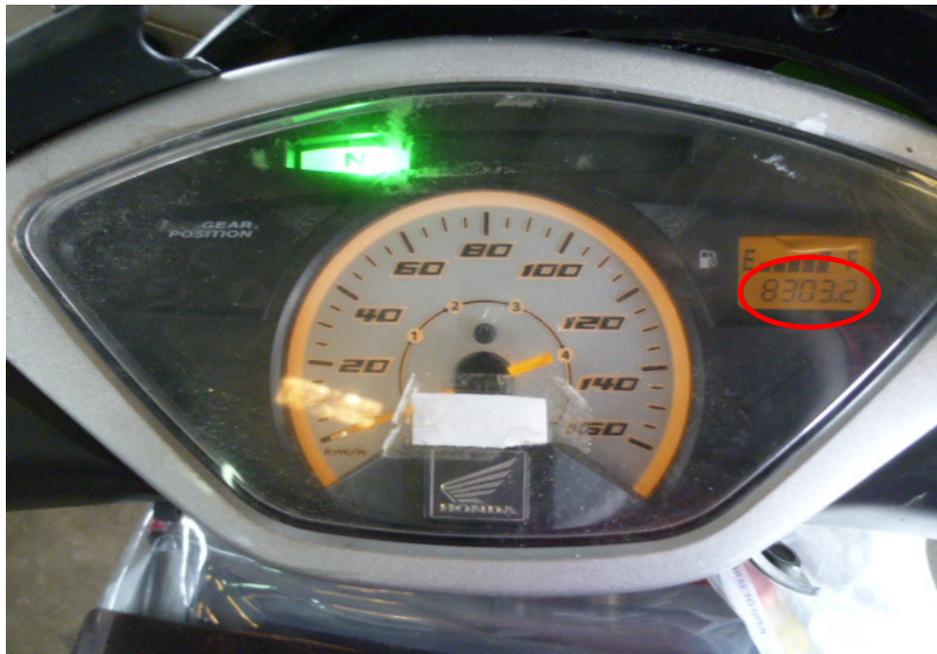
Photo 1 shows the speedometer gauge of the Motorcycle. The mileage of the Motorcycle at the time of our inspection was 8, 303km (circled).

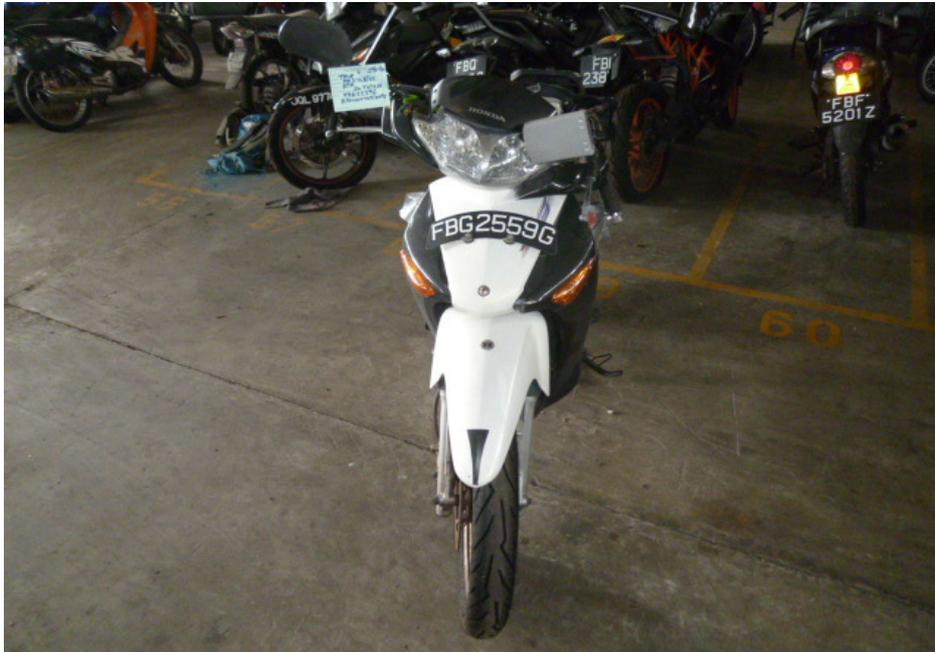
Photo 2 shows a general view of the frontal portion of the Motorcycle at the time of our inspection. The Motorcycle was observed to have sustained damages at its frontal portion and left body.

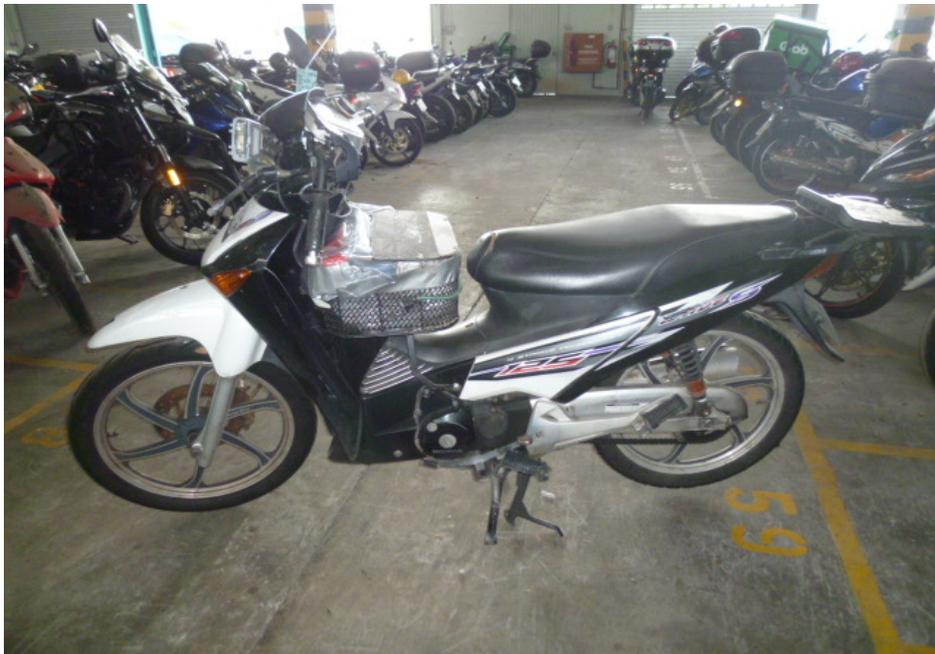
Photo 3 shows a general view of the left body of the Motorcycle at the time of our inspection. The Motorcycle was observed to have sustained damages at its frontal portion and left body. The body parts that were found to have been damaged include its headlight, front cowling, left cowling, left side mirror, left handlebar end, handlebar, gear shift pedal, left front footrest, left pillion foot peg bracket, left rear side cover and top box rack, amongst others.

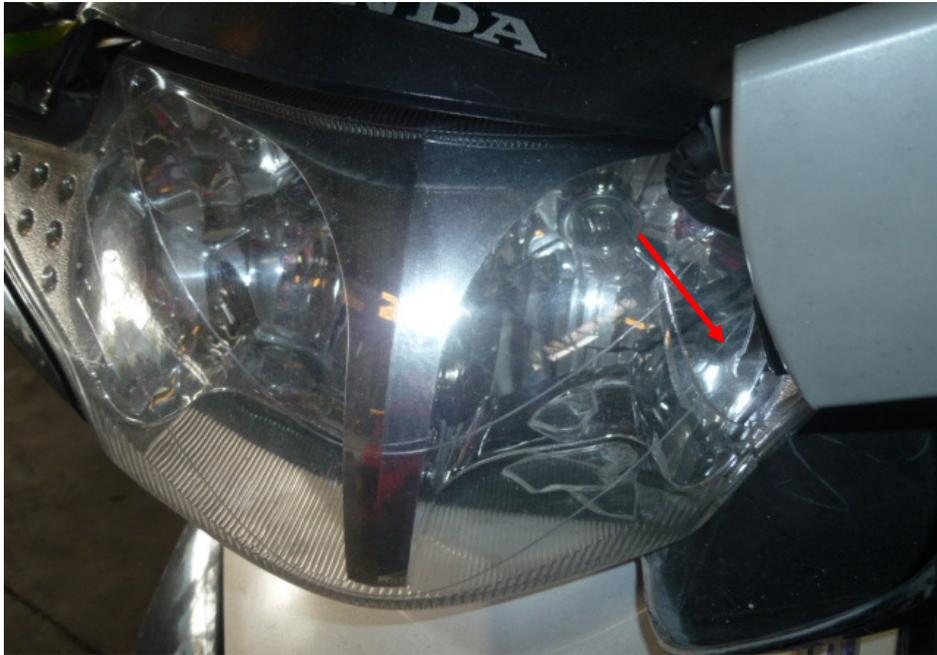
Photo 4 shows a closer view of the headlight (arrowed) which was amongst the body parts of the Motorcycle that had sustained damage as a result of the accident.

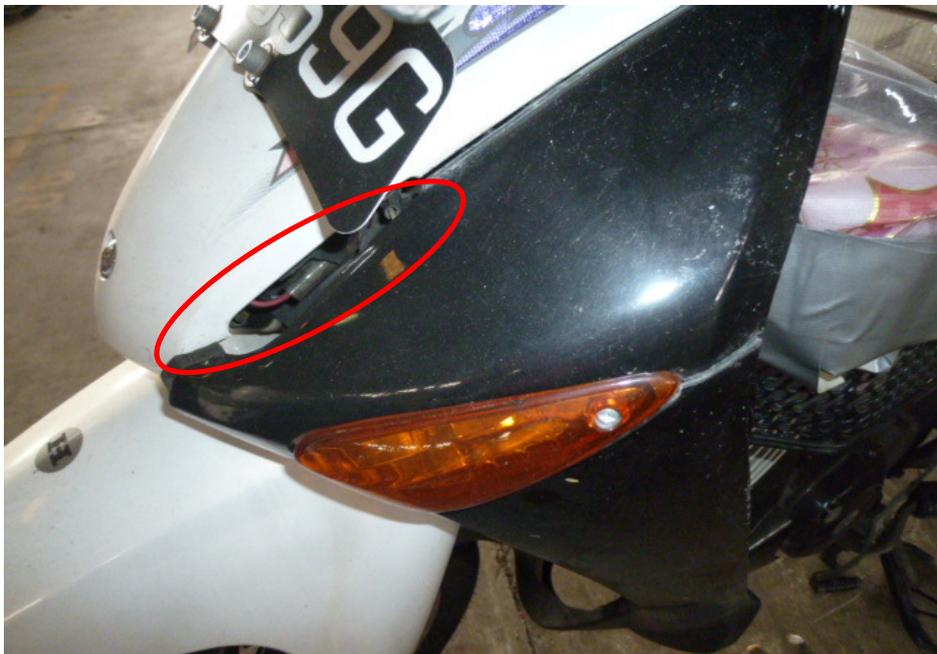
Photo 5 shows a closer view of the cracked front cowling (circled) which was amongst the body parts of the Motorcycle that had sustained damage as a result of the accident.

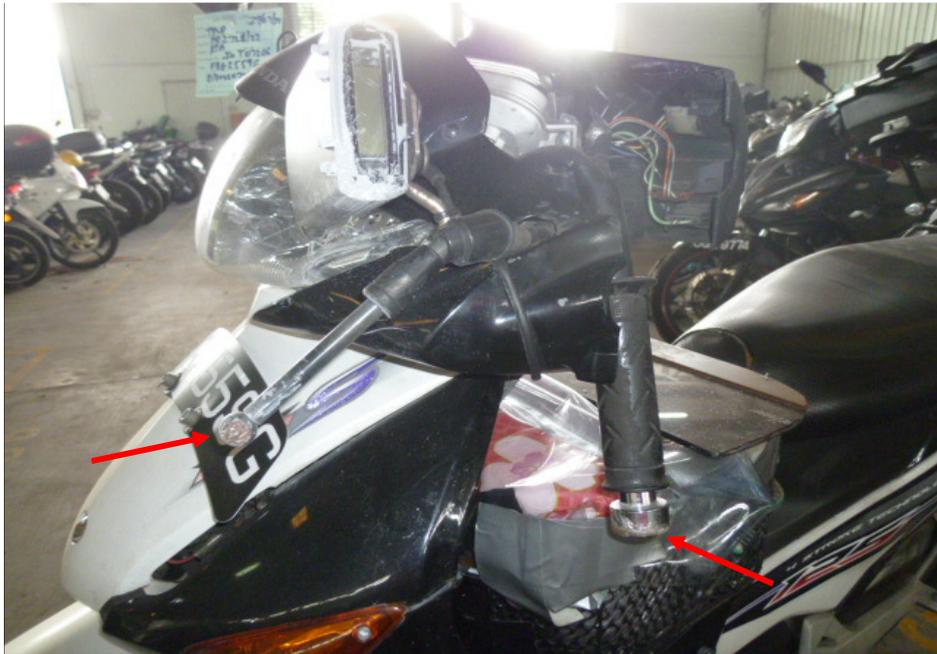
Photo 6 shows the left handlebar end and left side mirror (arrowed), which were amongst the body parts of the Motorcycle that had sustained damage as a result of the accident.

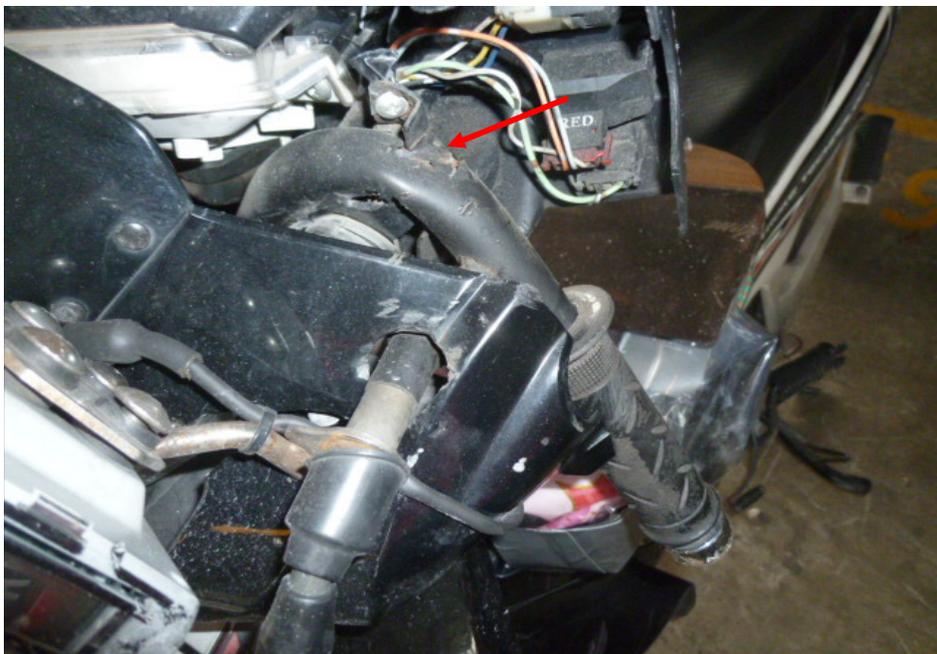
Photo 7 shows the bent handlebar (arrowed) of the Motorcycle as a result of the accident.

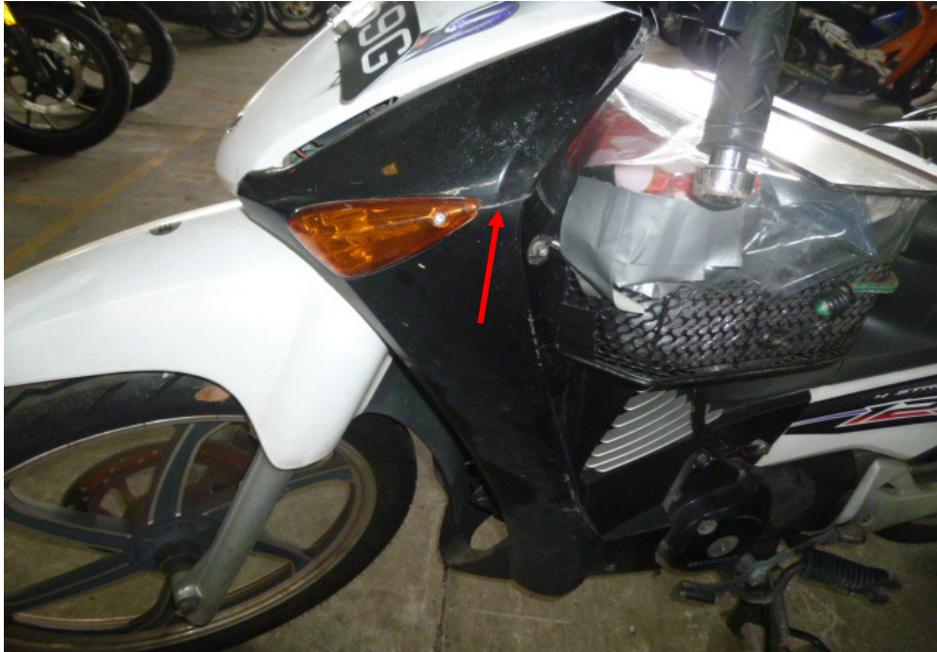
Photo 8 shows the left cowling (arrowed), which were amongst the body parts of the Motorcycle that had sustained damage as a result of the accident.

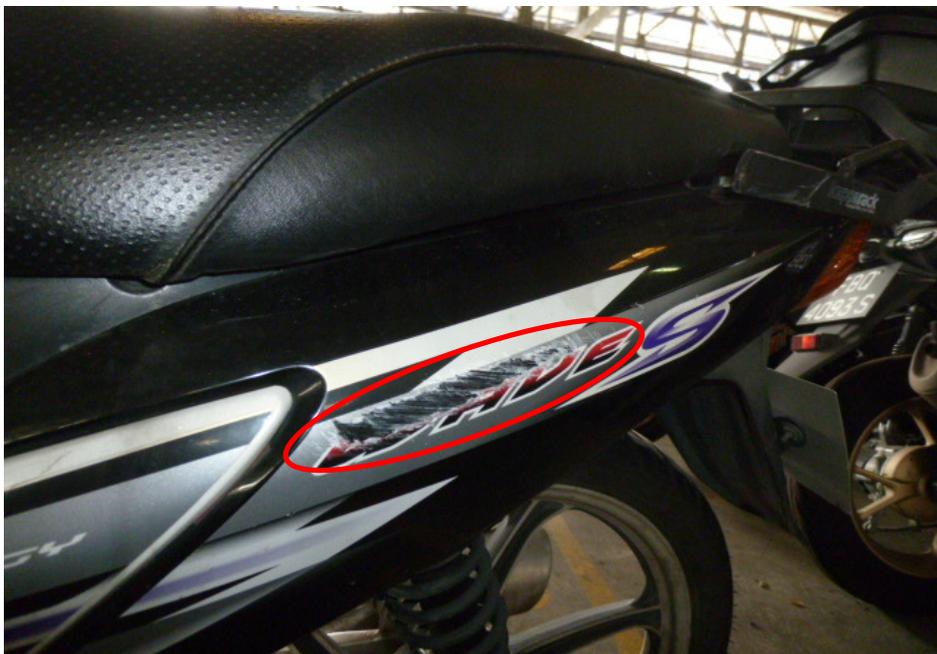
Photo 9 shows a closer view of the left rear side cover which was amongst the body parts of the Motorcycle that had sustained damages of grazing nature as a result of the accident (circled).

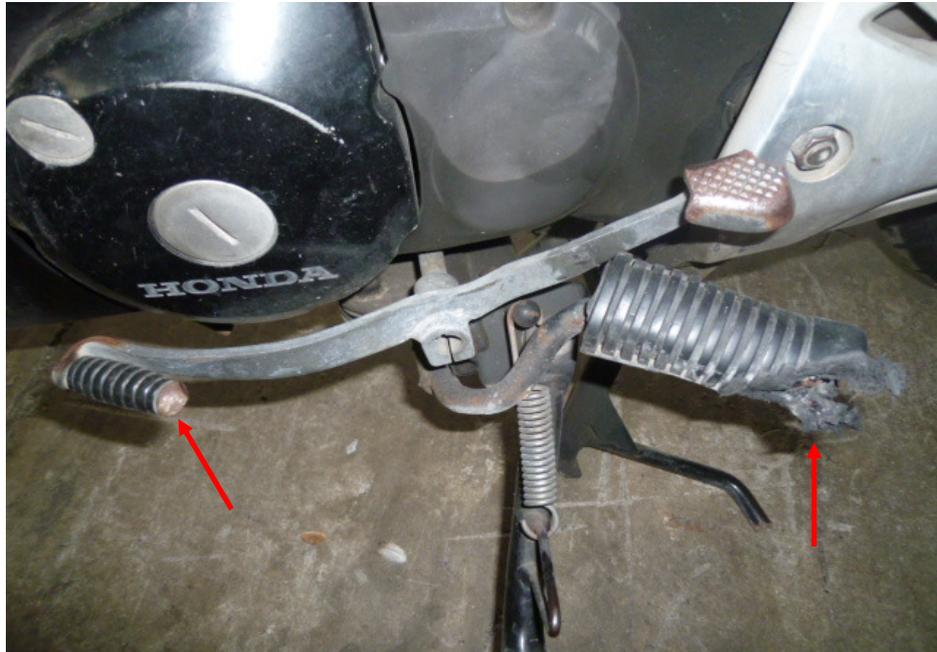
Photo 10 shows the grazed gear shift pedal and bent left front footrest of the Motorcycle as a result of the accident (arrowed).

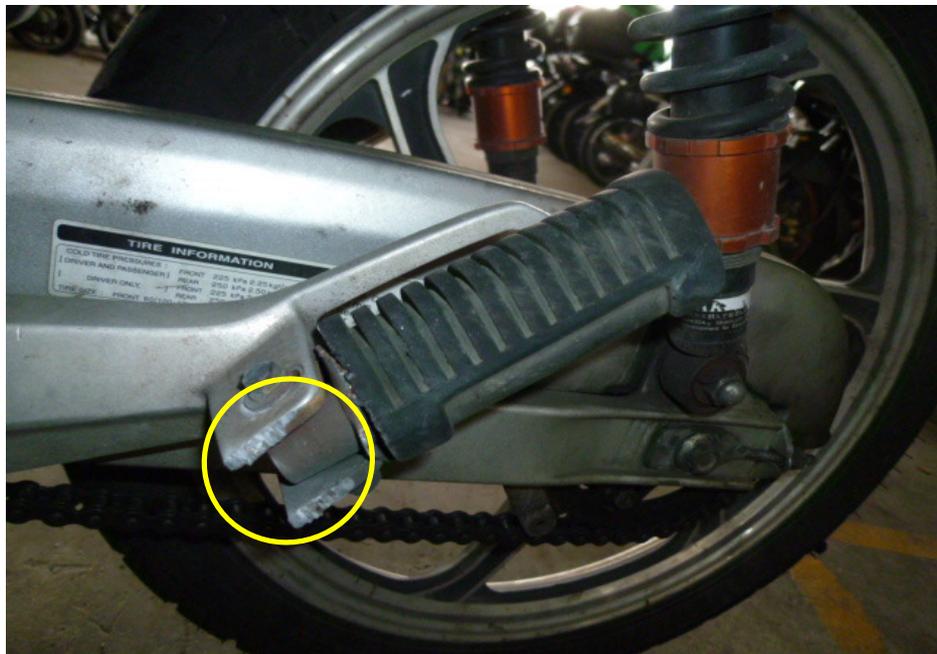
Photo 11 shows a closer view of the left pillion foot peg bracket which was amongst the body parts of the Motorcycle that had sustained damages of grazing nature as a result of the accident (circled).

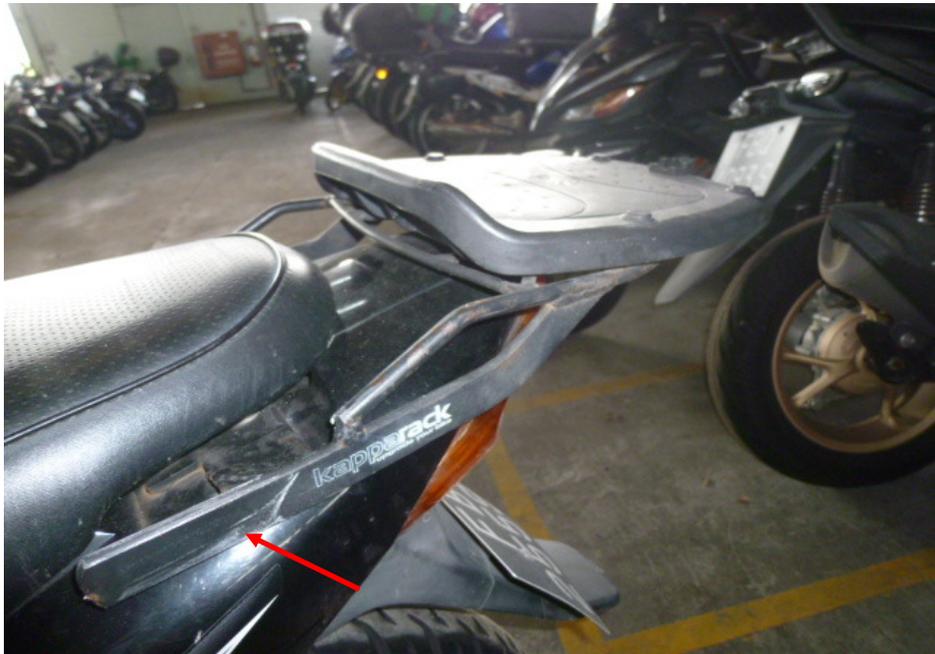
Photo 12 shows the top box rack of the Motorcycle that had sustained damage as a result of the accident (arrowed).

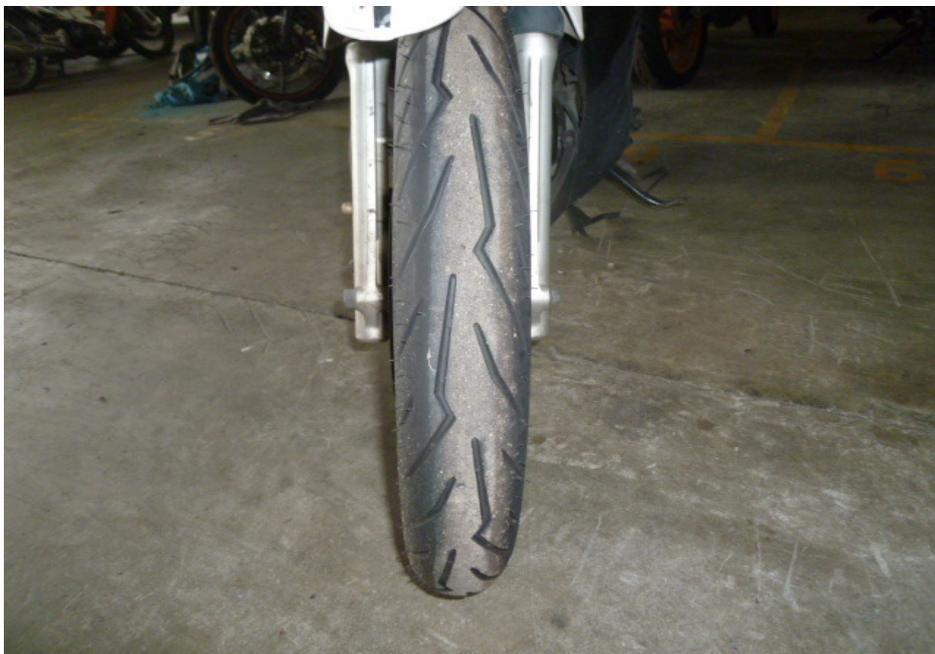
Photo 13 shows the front tyre of the Motorcycle at the time of our inspection. The front tyre was observed to be in serviceable condition with remaining tread depth of approximately 3mm. The pattern of the tread was also clearly visible. There was no tear, burst mark(s) and/or punctured hole(s) on the sidewalls as well as across the tread of the front tyre.

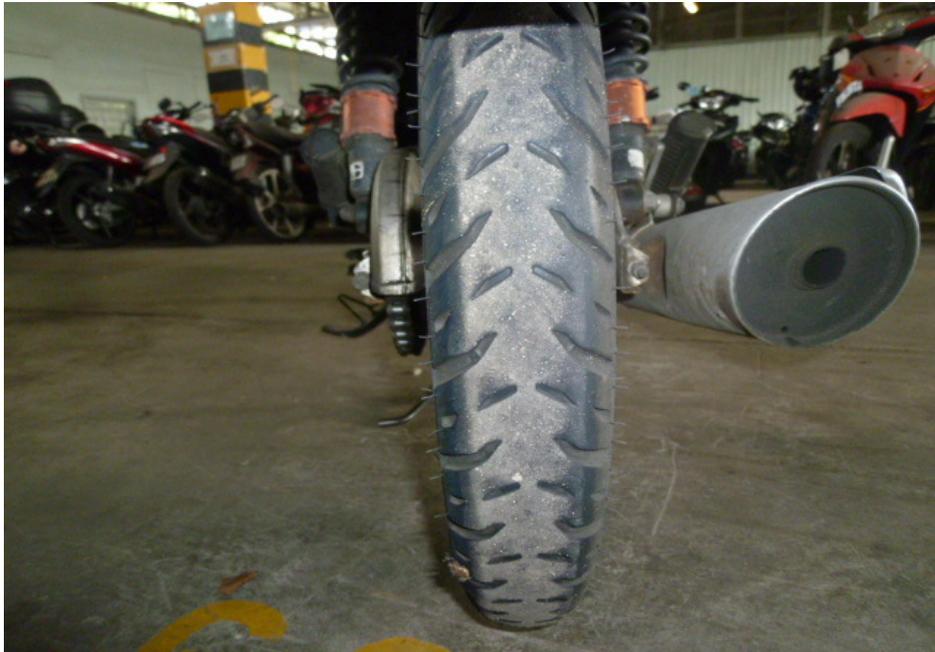
Photo 14 shows the condition of the Motorcycle's rear tyre. The rear tyre was observed to be in serviceable condition with remaining tread depth of approximately 2mm. The tyre was also observed to be sufficiently inflated for vehicular operation. We did not observe any tear, burst mark(s) and/or punctured hole(s) on the sidewalls as well as across the tread of the rear tyre.

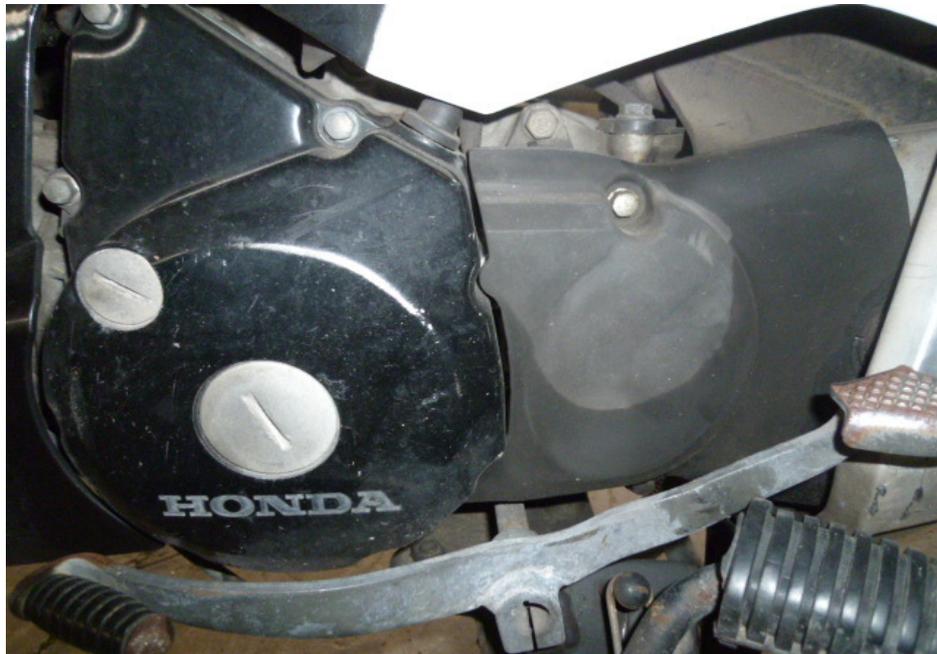
Photo 15 shows the left side of the engine of the Motorcycle at the time of our inspection. The various engine related parts and components were found to be intact with no visible damage. There was also no sign(s) or indication(s) of fluid leak observed around the left engine area of the Motorcycle.

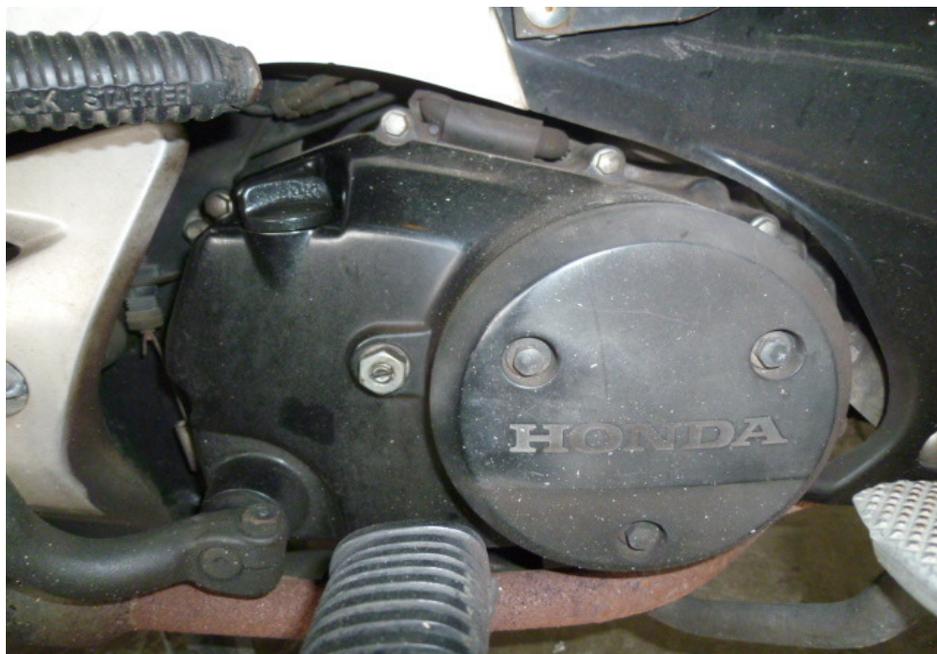
Photo 16 shows the right side of the engine of the Motorcycle at the time of our inspection. The various engine related parts and components were found to be intact with no visible damage. There was also no sign(s) or indication(s) of fluid leak observed around the right engine area of the Motorcycle.

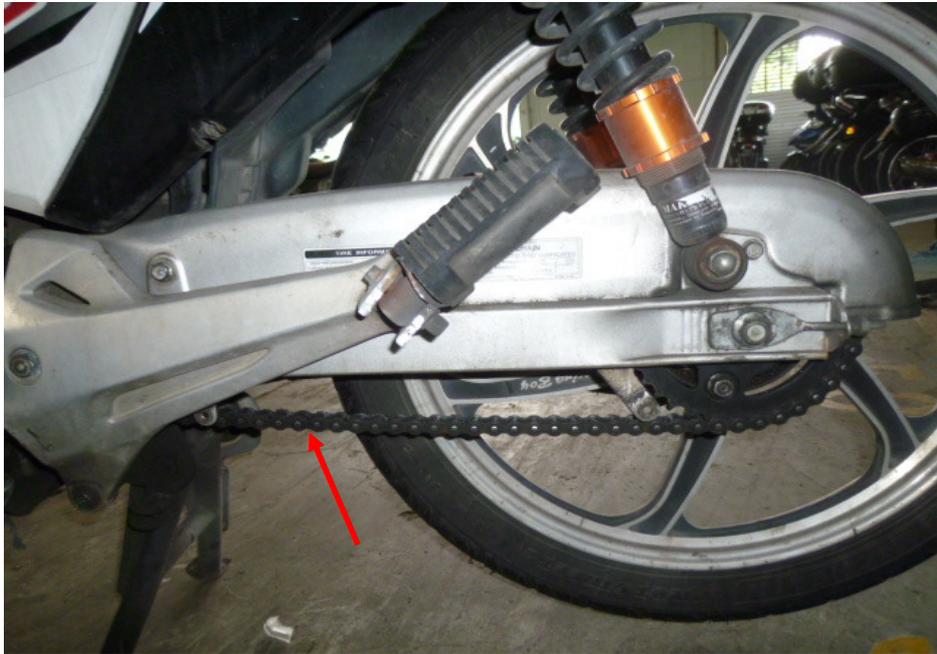
Photo 17 shows the general view of the gear train (arrowed) of the Motorcycle, which was observed to be intact with no misalignment. It was also adequately lubricated for operating purposes.

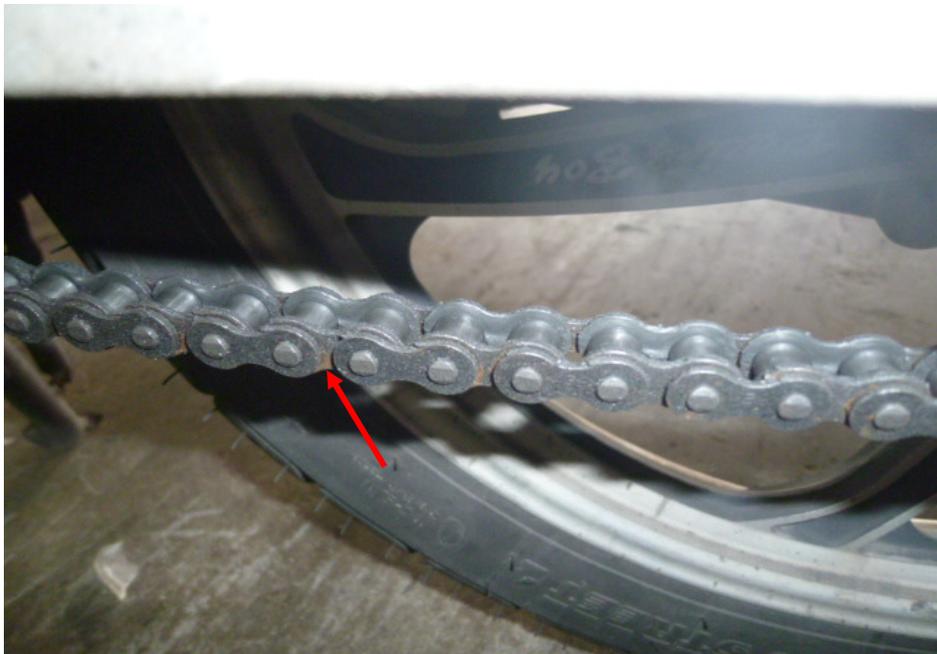
Photo 18 shows a closer view of the gear train (arrowed) of the Motorcycle, which was observed to be intact with no misalignment. It was also adequately lubricated for operating purposes.

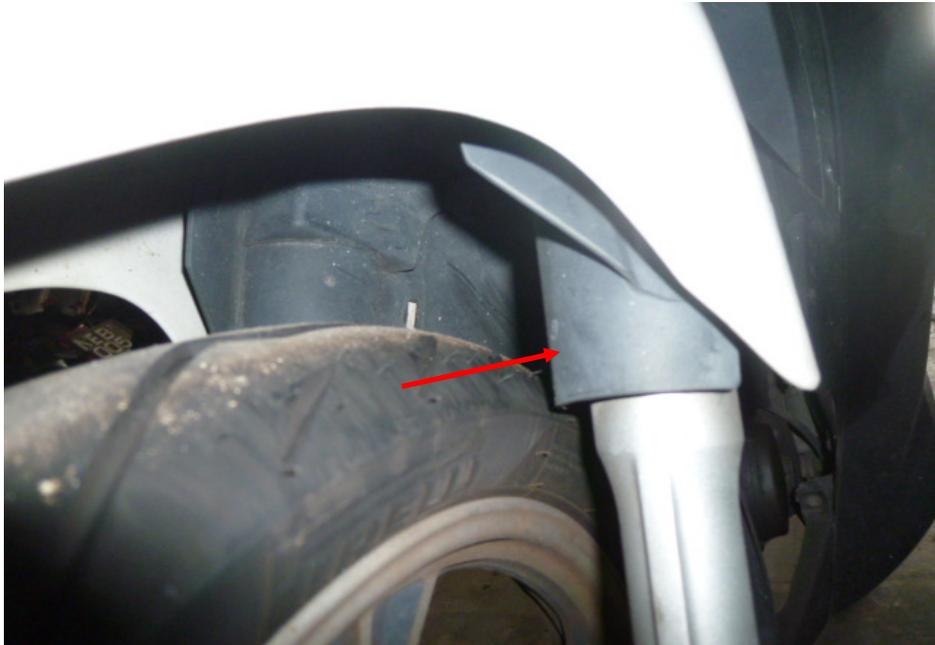
Photo 19 shows the left front fork (arrowed) of the Motorcycle. The left front fork and fork bracket of the Motorcycle were both found to be intact and undamaged. Turning the Motorcycle's handle bar towards the left and right did not produce any abnormal free play. The steering system of the Motorcycle was in serviceable condition at the time of our inspection.

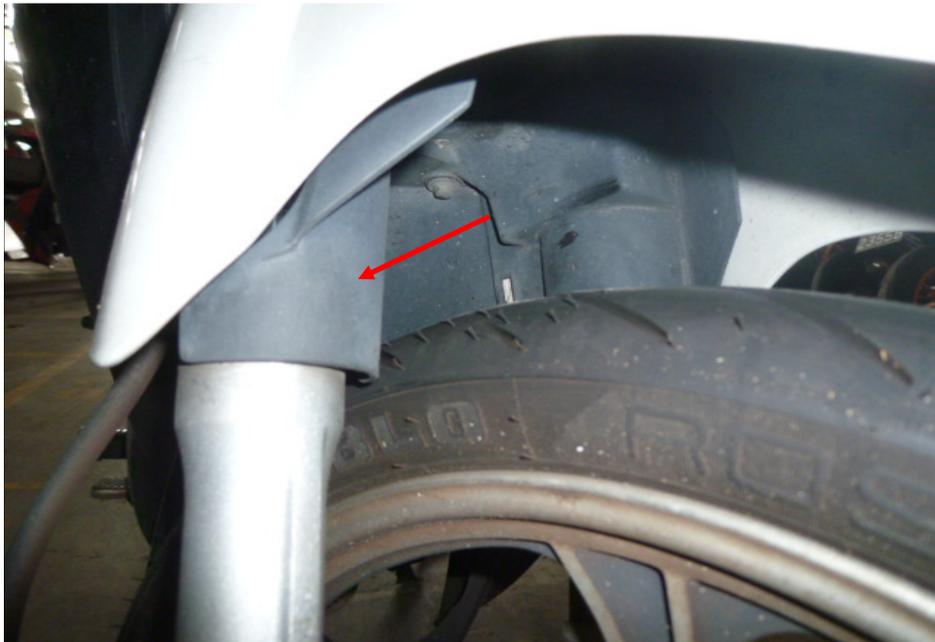
Photo 20 shows the right front fork (arrowed) of the Motorcycle. The right front fork and fork bracket of the Motorcycle were both found to be intact and undamaged. Turning the Motorcycle's handle bar towards the left and right did not produce any abnormal free play. The steering system of the Motorcycle was in serviceable condition at the time of our inspection.

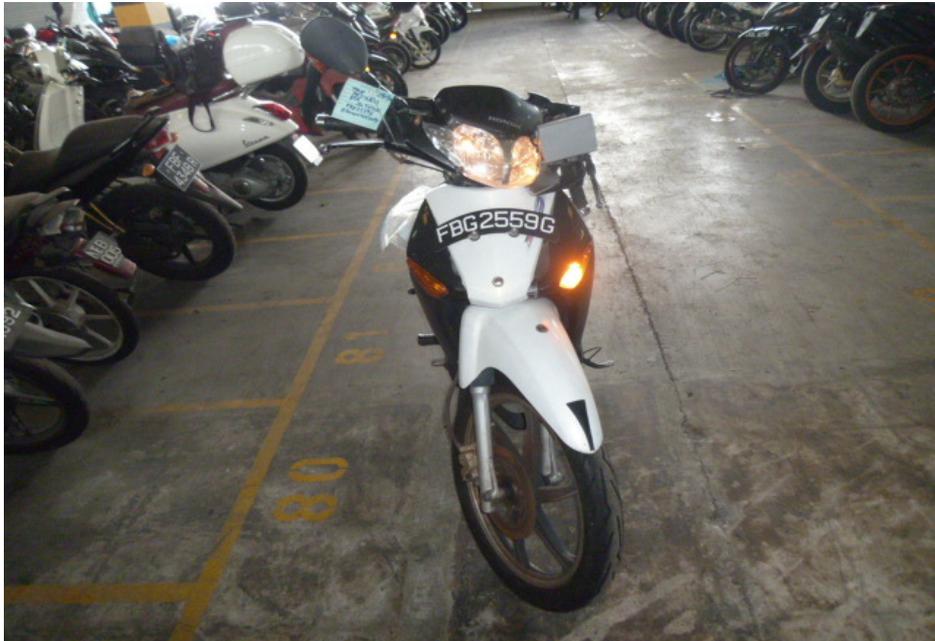
Photo 21 shows the front wheel of the Motorcycle turned towards its full left. Turning the Motorcycle's handle bar towards the left did not produce any abnormal free play and/or resistance. This would indicate that the steering system of the Motorcycle was in serviceable condition at the time of our inspection.

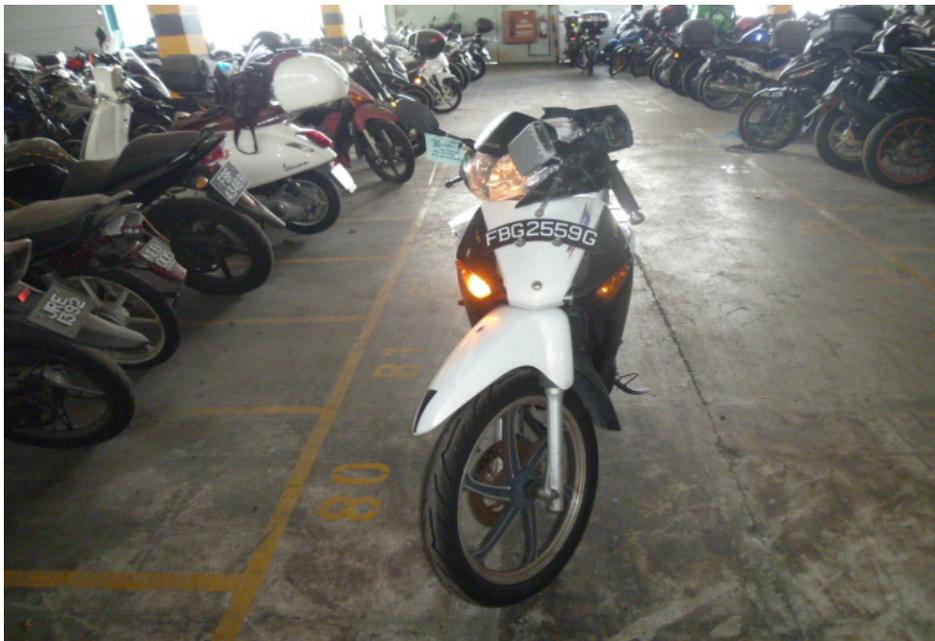
Photo 22 shows the front wheel of the Motorcycle turned towards its full right. Turning the Motorcycle's handle bar towards the right did not produce any abnormal free play and/or resistance. This would indicate that the steering system of the Motorcycle was in serviceable condition at the time of our inspection.

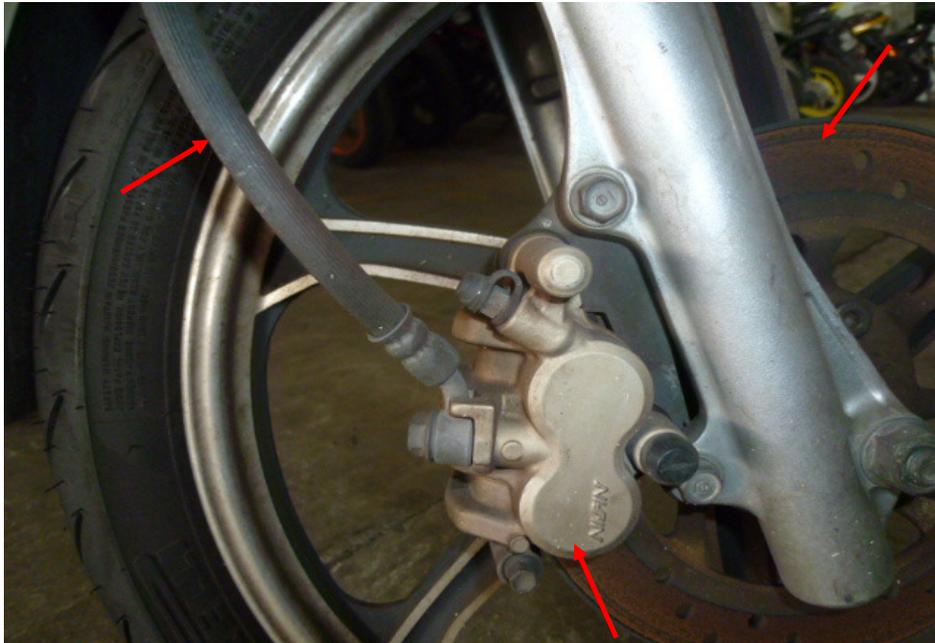
Photo 23 shows a close up view of the front brake caliper, front brake disc and front brake hose (arrowed) of the Motorcycle, which are all part of the components in the hydraulic front brake system of the Motorcycle. Our visual checks of these various components had revealed all to be intact with no visible damage. No leakage of brake fluid was also observed.

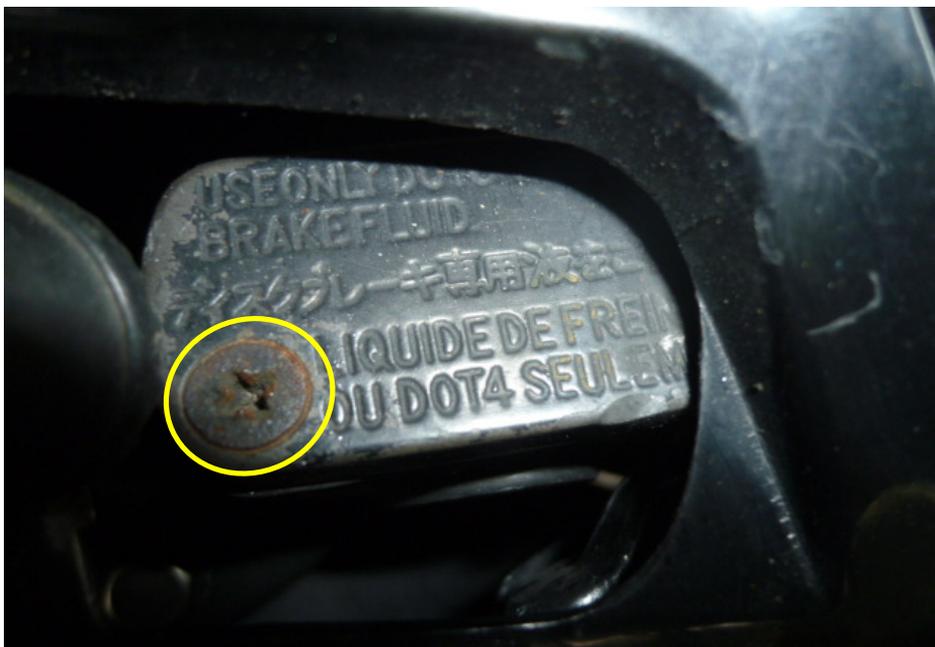
Photo 24 shows the brake fluid reservoir cover for the front brake of the Motorcycle. We were unable to examine whether the front brake fluid was without contamination due to a worn out screw (circled). We were also unable to remove the head cowl to determine if the front brake fluid was of sufficient level for operational purposes due to the bent handlebar.

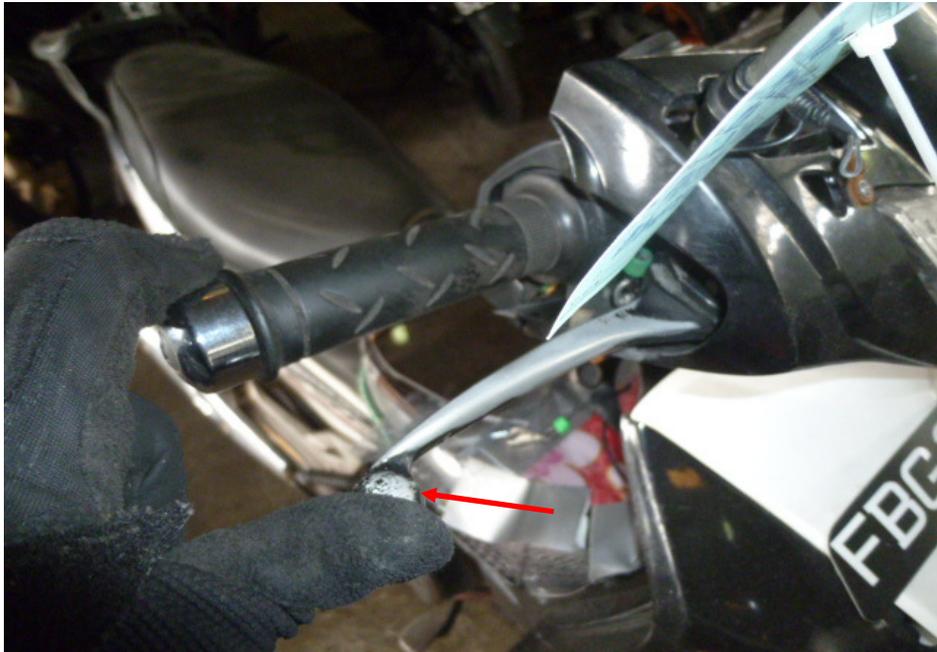
Photo 25 shows the front brake lever being depressed. There was some resistance felt (spongy like feel) upon pressing the front brake lever (arrowed). This would indicate that there is no leakage of pressure/vacuum in the front brake system.

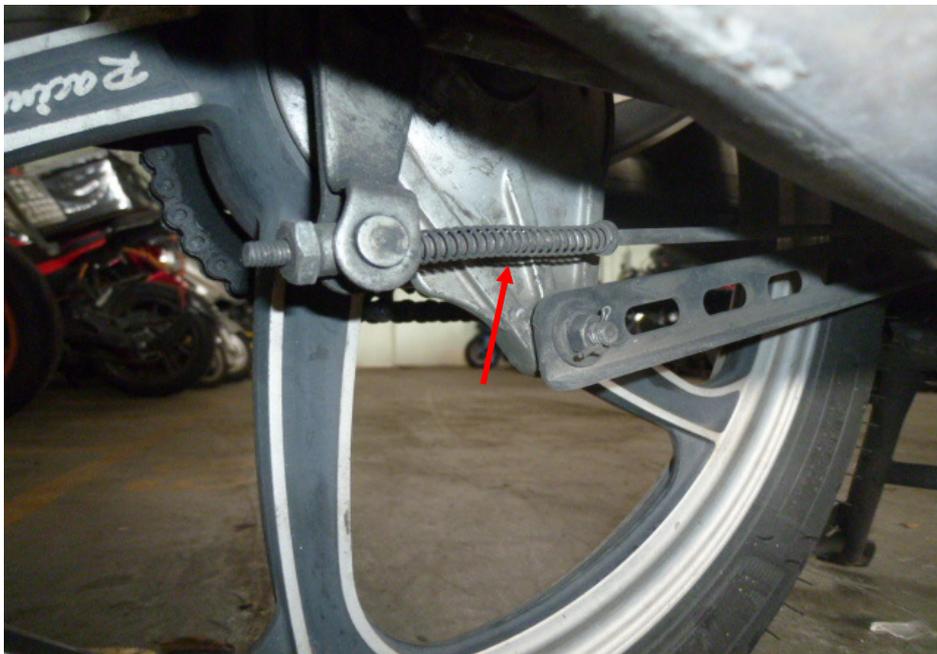
Photo 26 shows the rear wheel of the Motorcycle. The type of brake system for the rear wheel was of a mechanical type, controlled by the brake foot pedal of the Motorcycle. Our checks of the cable (arrowed), spring and drum which are all part of the components in the rear brake system of the Motorcycle reveal all to be intact and without damage.
