Your Ref: TP/IP/14557/2022
Our Ref: CI/TPD22008718/N

7 September 2022

INSPECTION REPORT OF MOTORCYCLE TP 418H

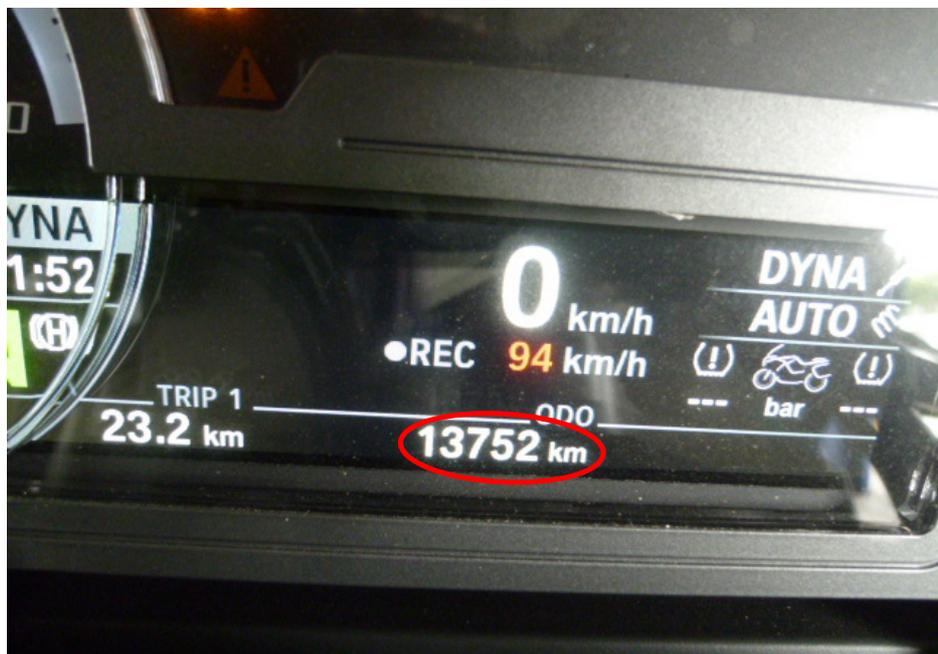
4. The mileage of the Motorcycle at the time of our inspection was 13, 752km.
5. The Motorcycle was observed to have sustained damages all around. The body parts that were found to have been damaged include its windshield, front blinker lamps, side mirrors, left engine crashbar, rear crashbars, left side pannier, top box and right cowling, amongst others.

Photo 1 shows the speedometer gauge of the Motorcycle where the mileage recorded at the time of our inspection was 13, 752km (circled).

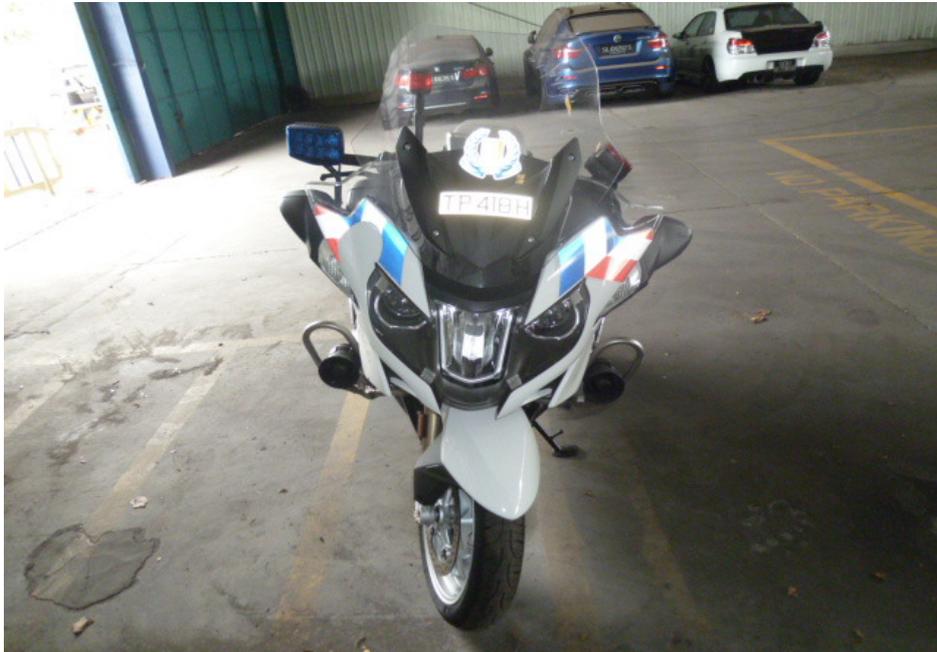
Photo 2 shows a general view of the frontal portion of the Motorcycle at the time of our inspection. The Motorcycle was observed to have sustained damages all around.

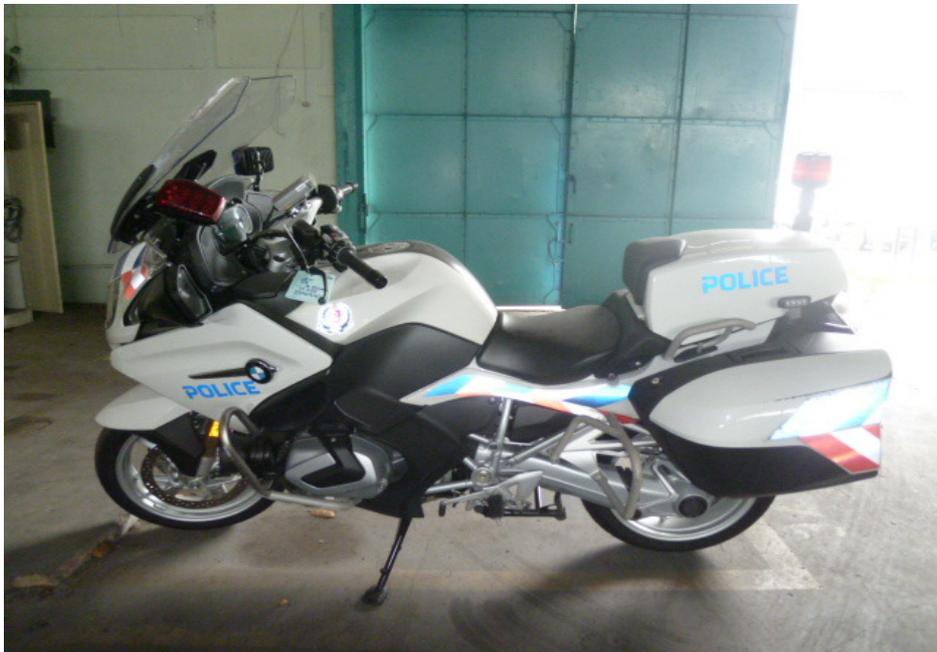
Photo 3 shows a general view of the left body of the Motorcycle at the time of our inspection. The Motorcycle was observed to have sustained damages all around.

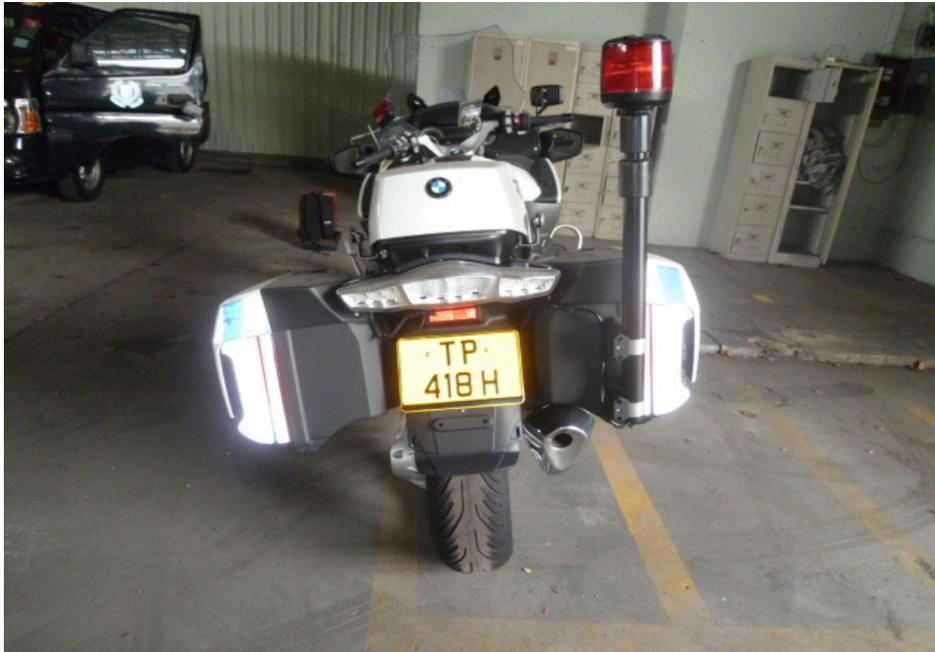
Photo 4 shows a general view of the rear portion of the Motorcycle at the time of our inspection. The Motorcycle was observed to have sustained damages all around. Amongst the body parts that were found to have been damaged include its windshield, front blinker lamps, side mirrors, left engine crashbar, rear crashbars, left side pannier, top box and right cowling, amongst others.

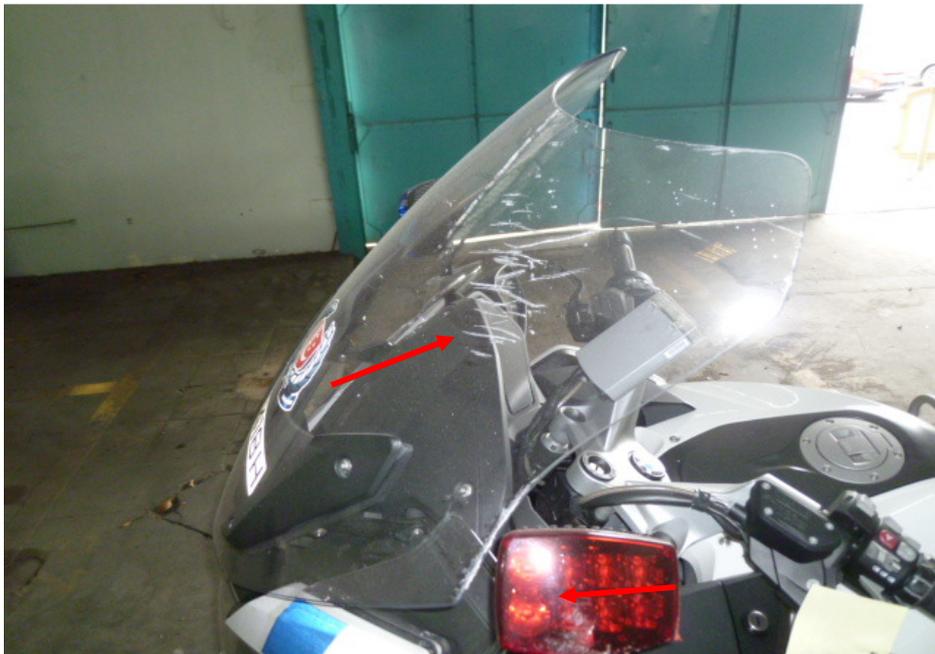
Photo 5 shows a closer view of the windshield (arrowed) which was amongst the body parts at the front body of the Motorcycle that had sustained damage as a result of the incident.

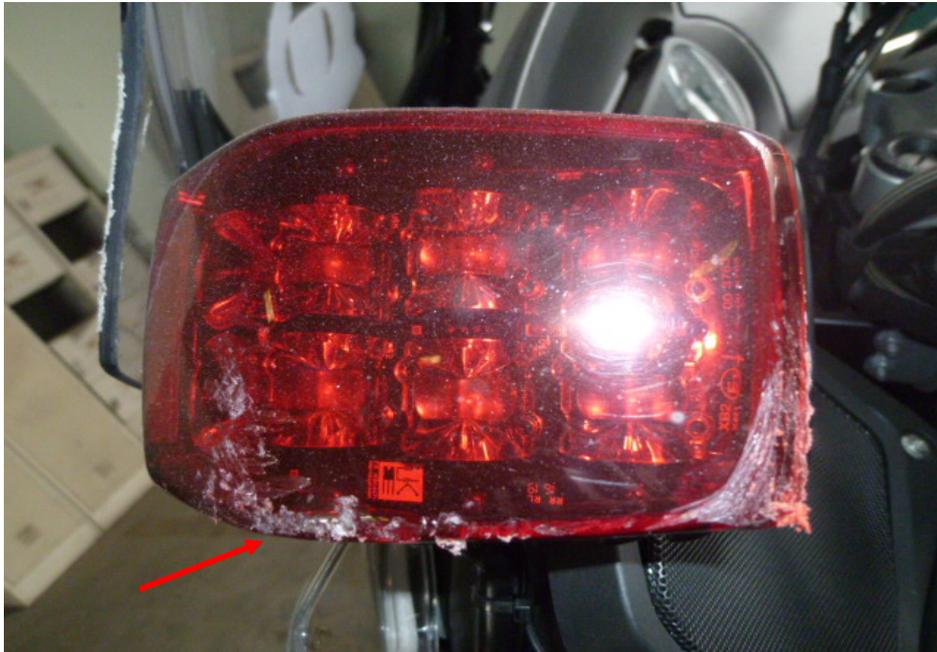
Photo 6 shows a closer view of the grazed left front blinker lamp of the Motorcycle as a result of the incident (arrowed).

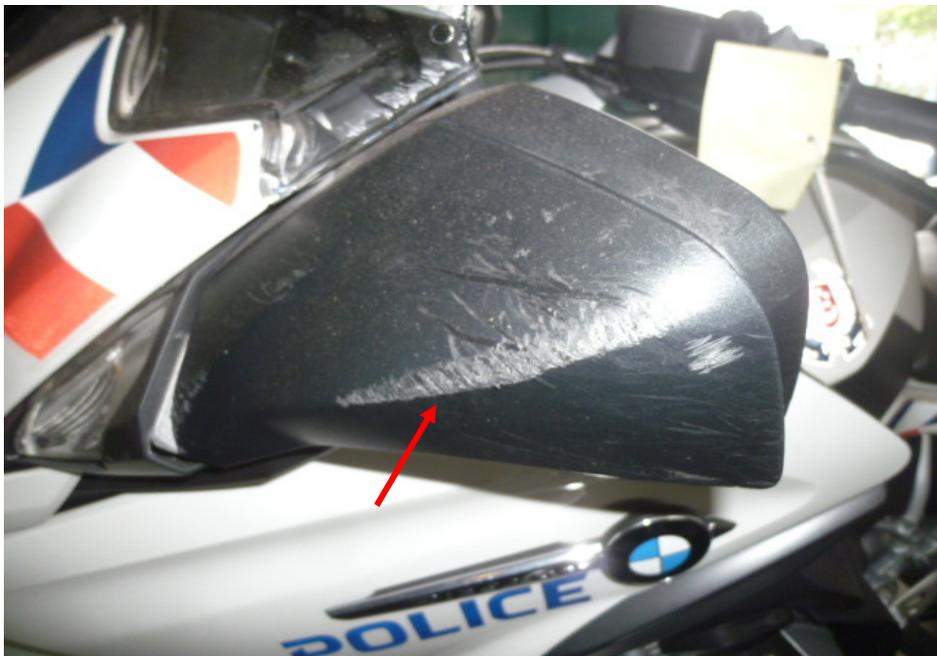
Photo 7 shows a closer view of the left side mirror of the Motorcycle that had sustained damage as a result of the incident (arrowed).

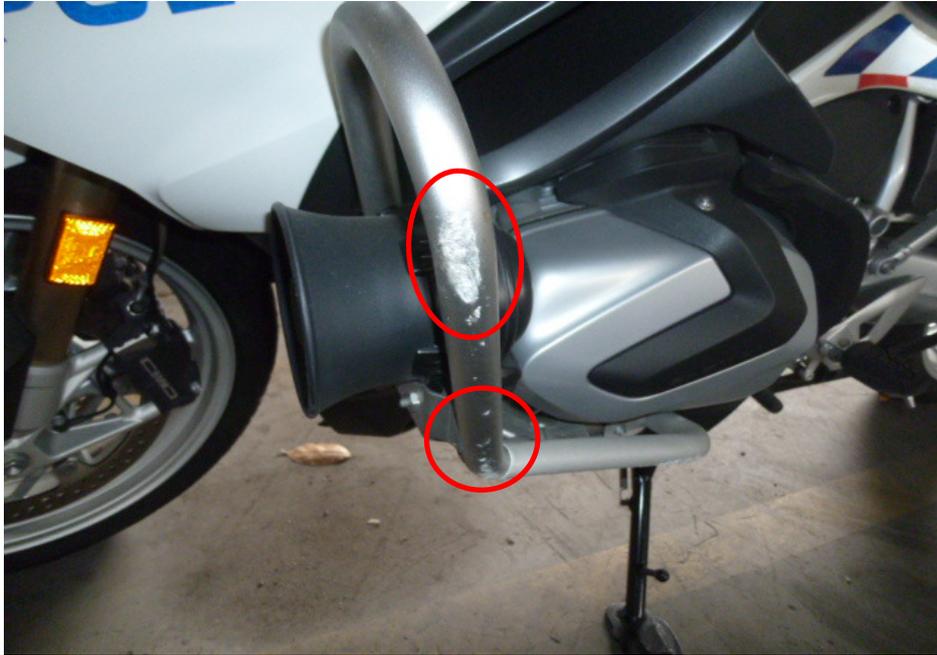
Photo 8 shows a closer view of the left side crash bar (circled) which were amongst the body parts of the Motorcycle that had sustained damages of grazing nature as a result of the incident.

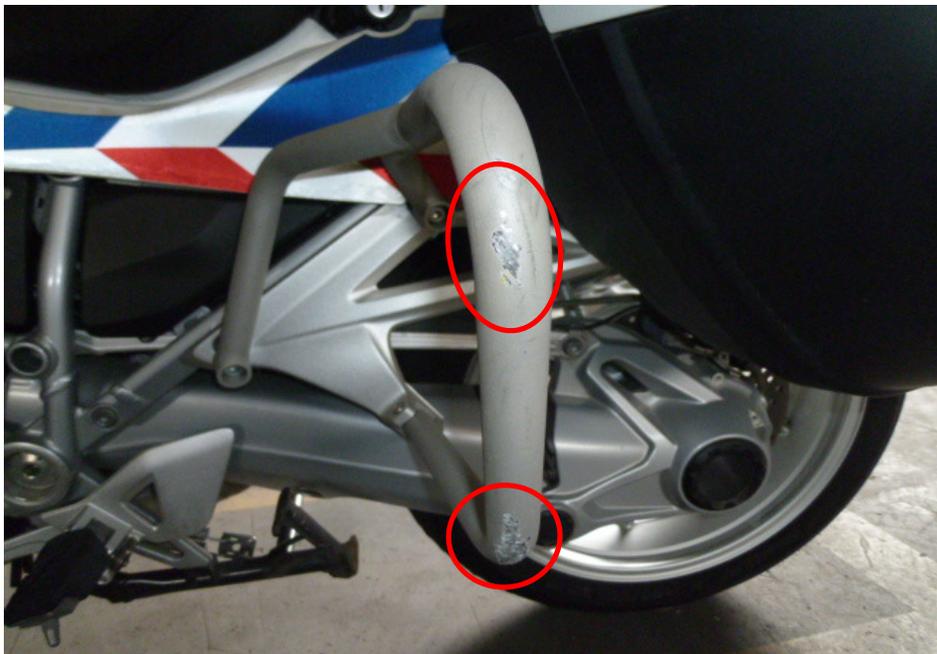
Photo 9 shows a closer view of the left side rear crash bar (circled) which were amongst the body parts of the Motorcycle that had sustained damages of grazing nature as a result of the incident.

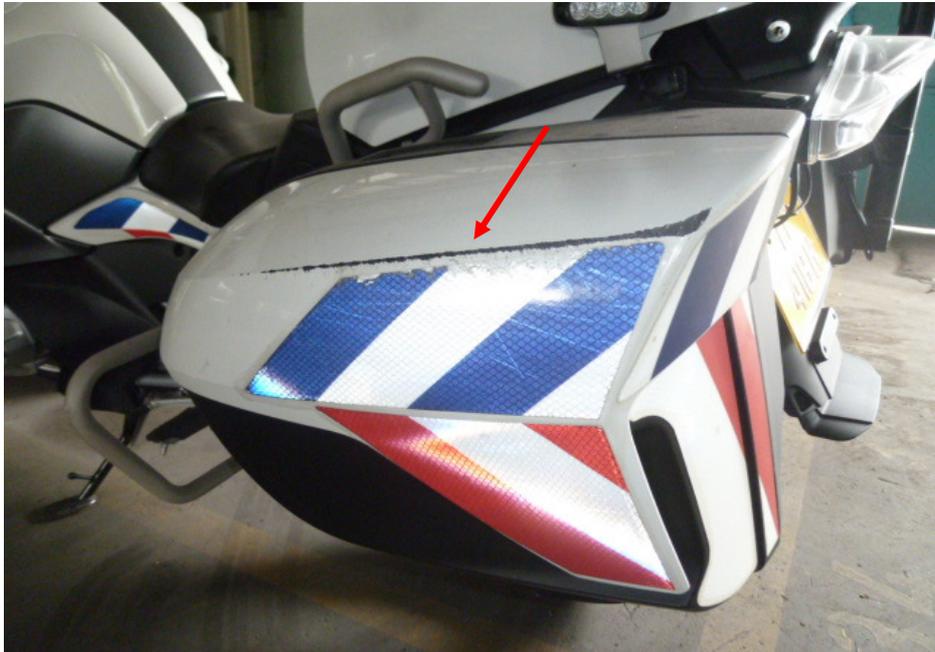
Photo 10 shows a closer view of the left pannier (arrowed) which was amongst the body parts of the Motorcycle that had sustained damages of grazing nature as a result of the incident.

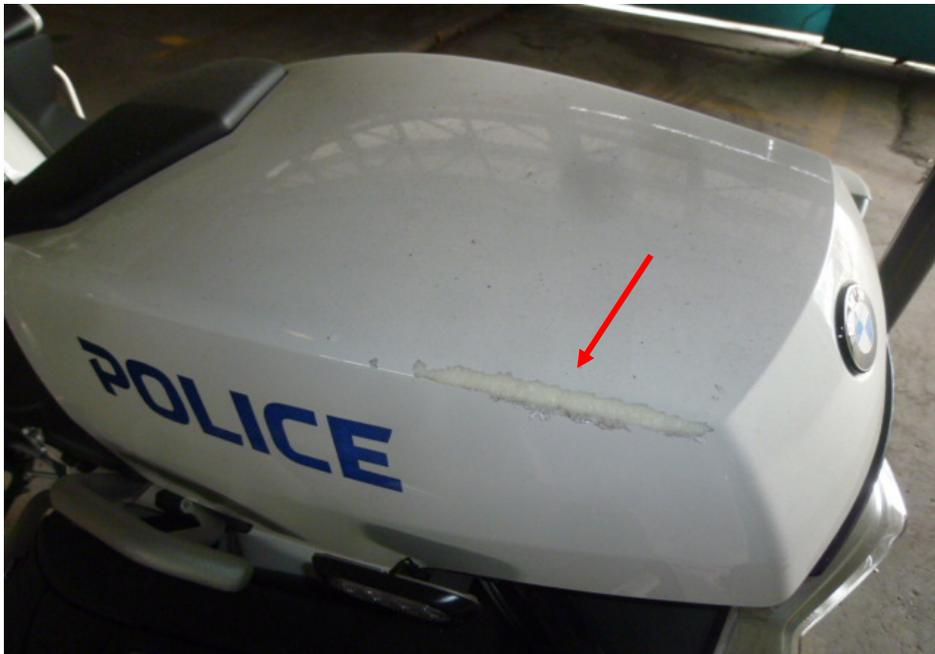
Photo 11 shows a closer view of the top box (arrowed) which was amongst the body parts of the Motorcycle that had sustained damages of grazing nature as a result of the incident.

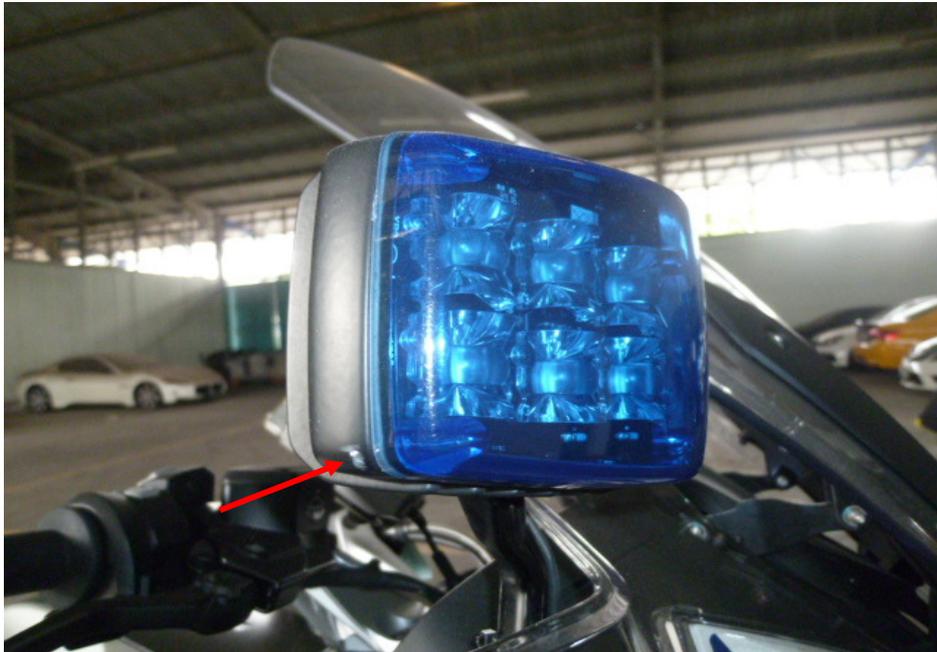
Photo 12 shows a closer view of the grazed right front blinker lamp of the Motorcycle as a result of the incident (arrowed).

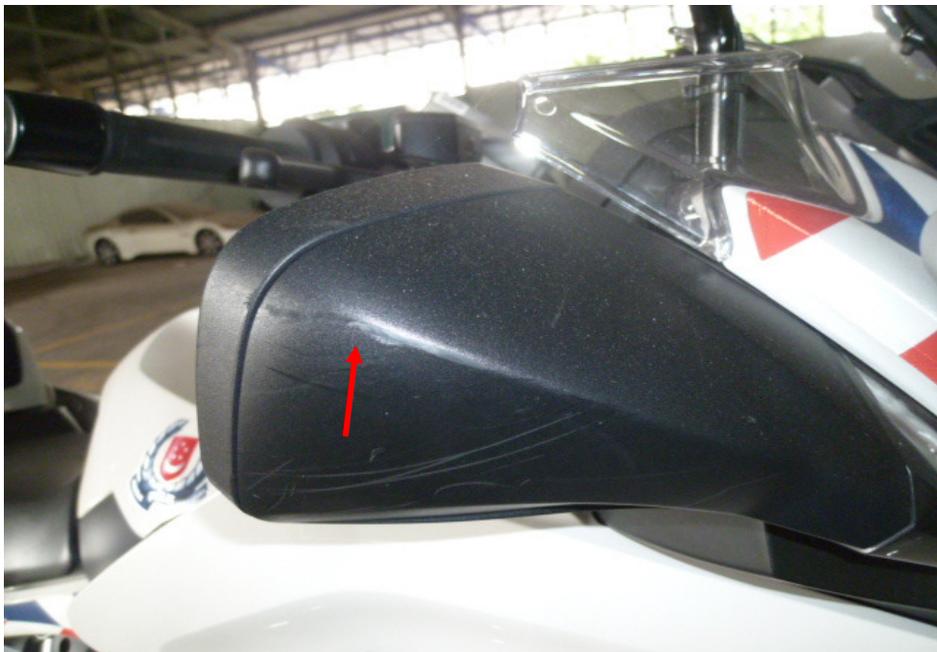
Photo 13 shows a closer view of the right side mirror (arrowed) which was amongst the body parts of the Motorcycle that had sustained damages of grazing nature as a result of the incident.

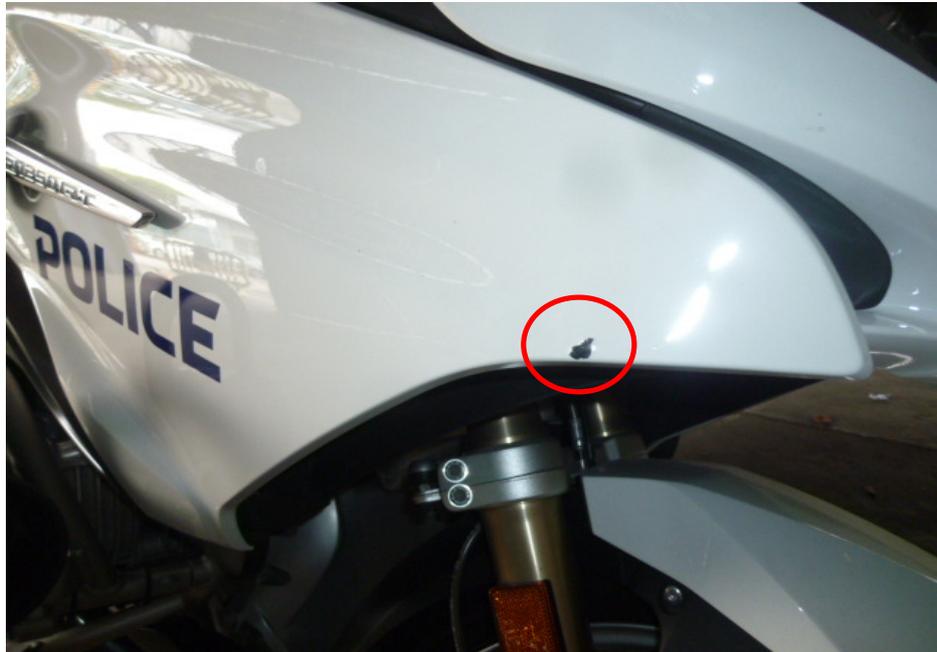
Photo 14 shows a closer view of the right cowling of the Motorcycle that had sustained damage as a result of the incident (circled).

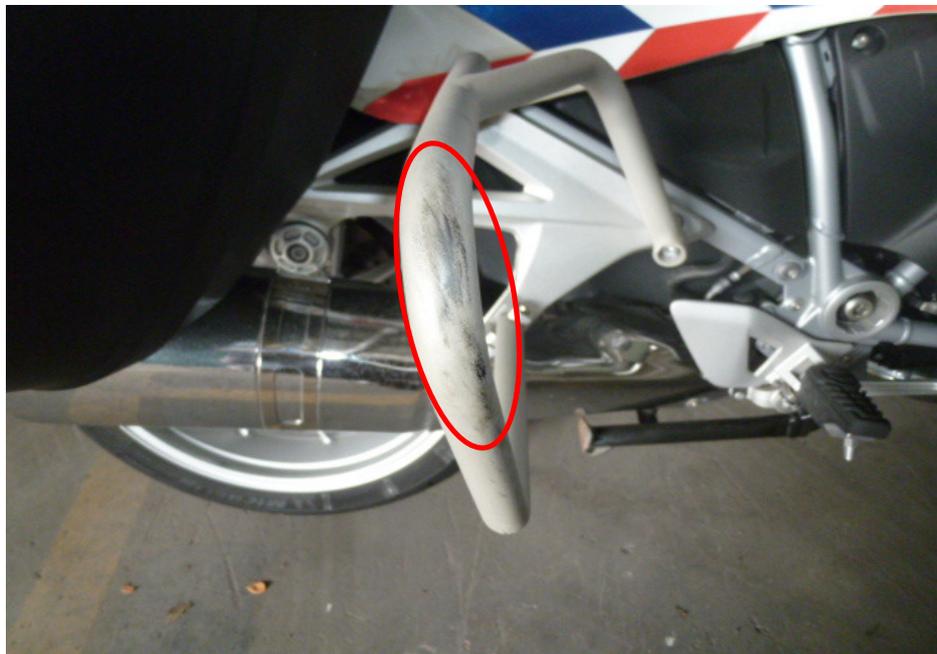
Photo 15 shows a closer view of the right side rear crash bar (circled) which were amongst the body parts of the Motorcycle that had sustained damages of grazing nature as a result of the incident.

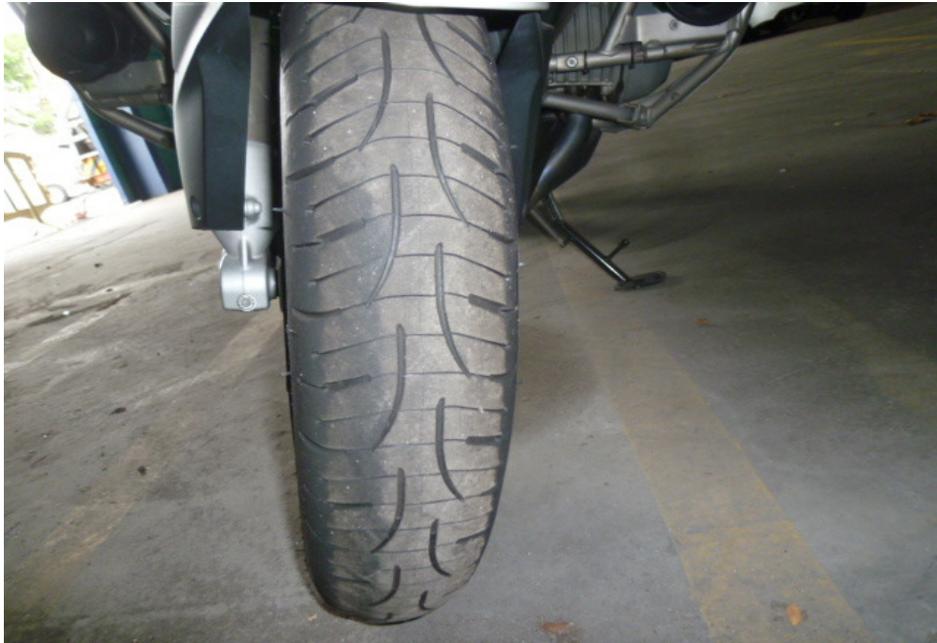
Photo 16 shows the front tyre of the Motorcycle at the time of our inspection. The front tyre was observed to be in serviceable condition with remaining tread depth of approximately 2mm. The pattern of the tread was also clearly visible. There was no tear, burst mark(s) and/or punctured hole(s) on the sidewalls as well as across the tread of the front tyre.

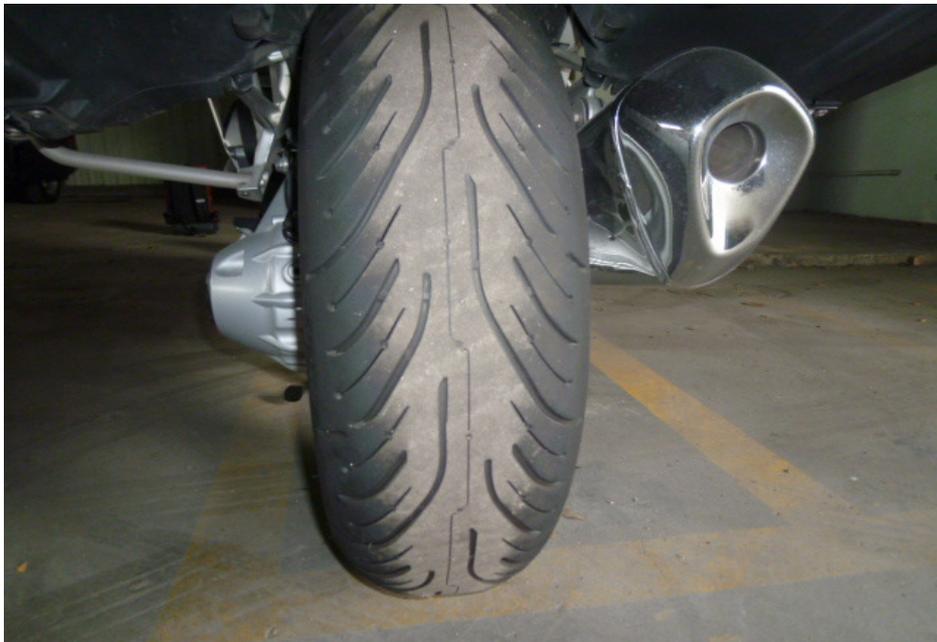
Photo 17 shows the condition of the Motorcycle's rear tyre. The rear tyre was observed to be in serviceable condition with remaining tread depth of approximately 2mm. The tyre was also observed to be sufficiently inflated for vehicular operation. We did not observe any tear, burst mark(s) and/or punctured hole(s) on the sidewalls as well as across the tread of the rear tyre.

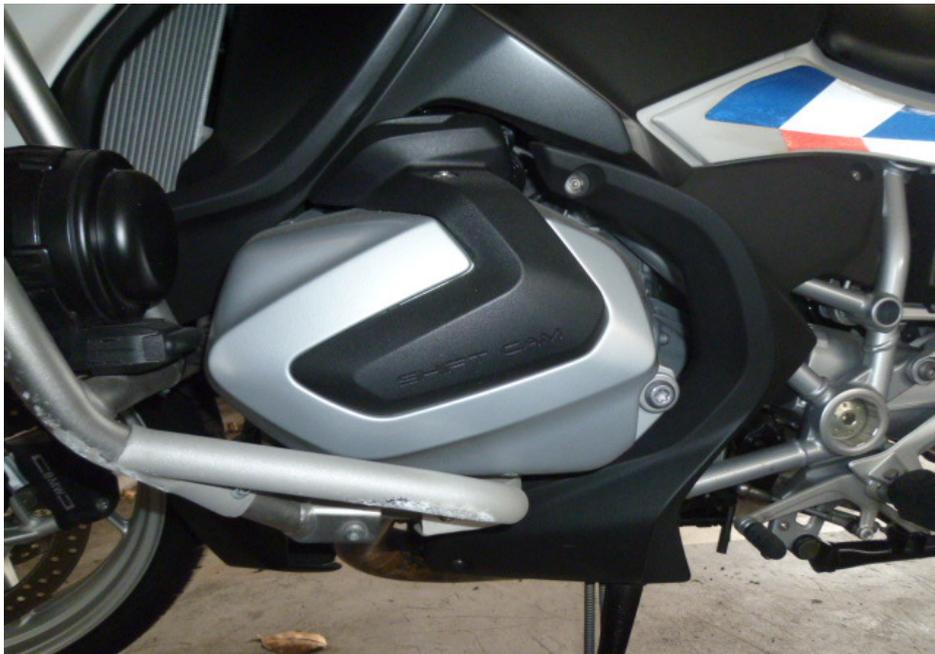
Photo 18 shows the left side of the engine of the Motorcycle at the time of our inspection. The various engine related parts and components were found to be intact with no visible damage. There was also no sign(s) or indication(s) of fluid leak observed around the left engine area of the Motorcycle.

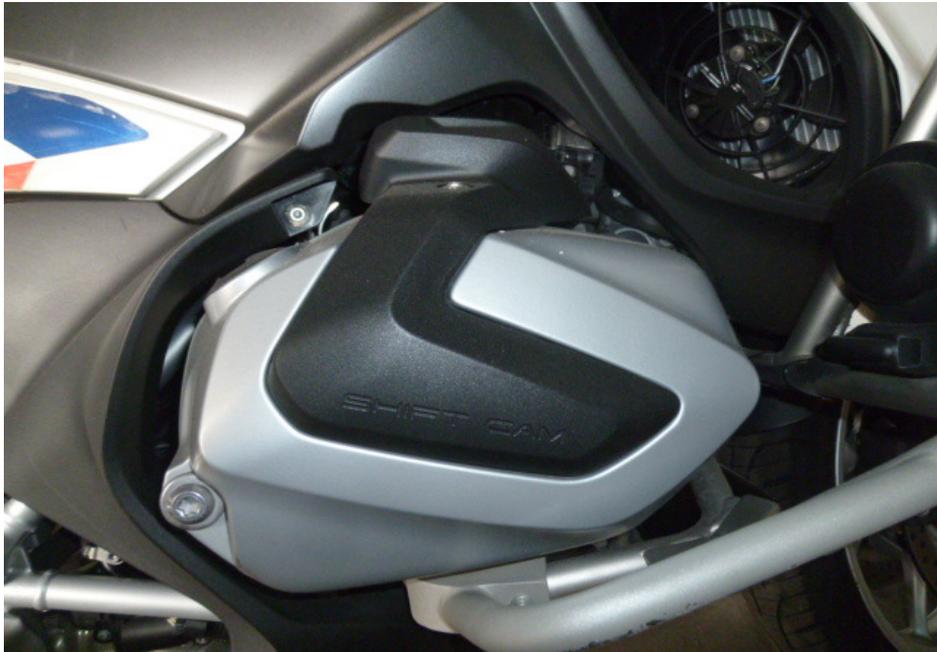
Photo 19 shows the right side of the engine of the Motorcycle at the time of our inspection. The various engine related parts and components were found to be intact with no visible damage. There was also no sign(s) or indication(s) of fluid leak observed around the right engine area of the Motorcycle.

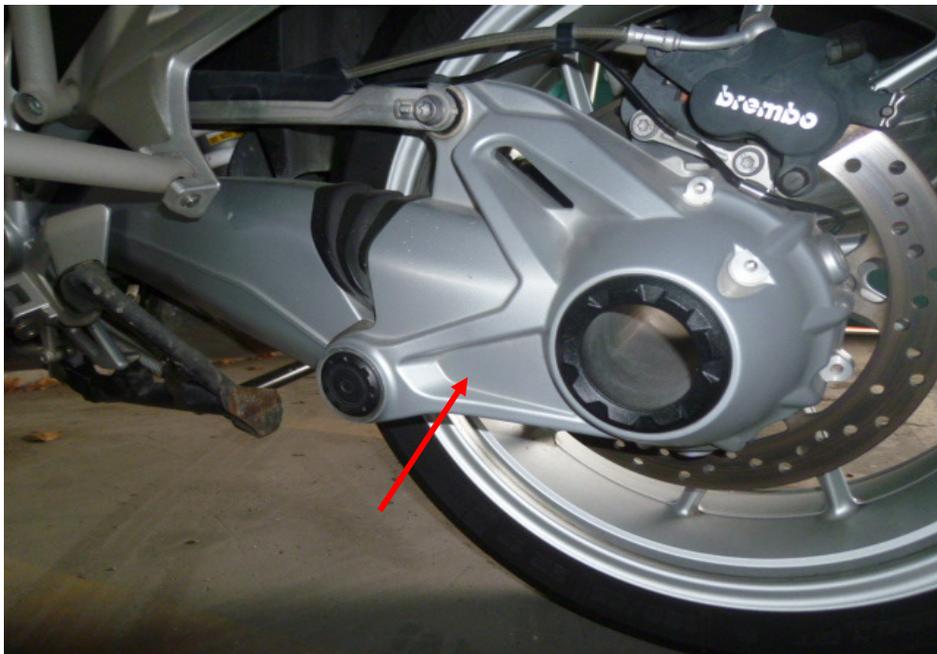
Photo 20 shows the general view of the shaft (arrowed) of the Motorcycle, which was observed to be intact with no misalignment.

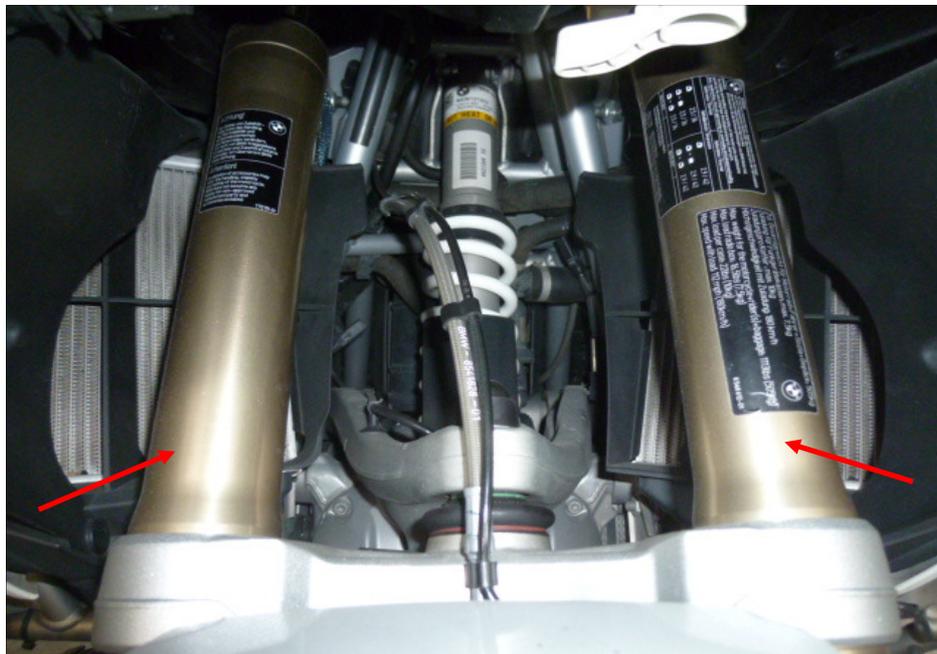
Photo 21 shows the front forks (arrowed) of the Motorcycle. The front forks and fork bracket of the Motorcycle were both found to be intact and undamaged. Turning the Motorcycle's handle bar towards the left and right did not produce any abnormal free play and/or resistance. The steering system of the Motorcycle was in serviceable condition at the time of our inspection.

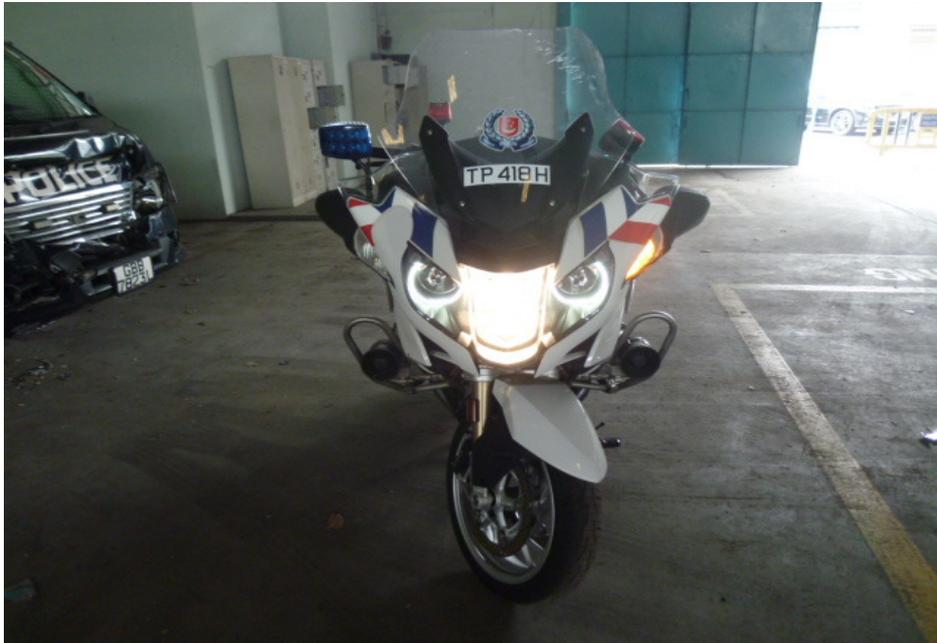
Photo 22 shows the front wheel of the Motorcycle turned towards its full left. Turning the Motorcycle's handle bar towards the left and right did not produce any abnormal free play and/or resistance. This would indicate that the steering system of the Motorcycle was in serviceable condition at the time of our inspection.

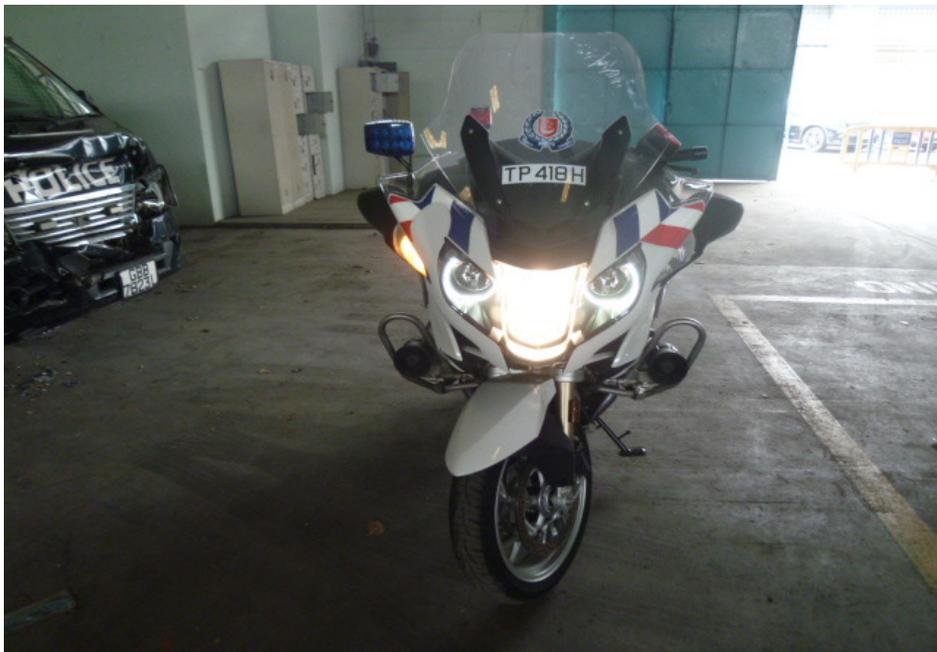
Photo 23 shows the front wheel of the Motorcycle turned towards its full right. Turning the Motorcycle's handle bar towards the left and right did not produce any abnormal free play and/or resistance. This would indicate that the steering system of the Motorcycle was in serviceable condition at the time of our inspection.

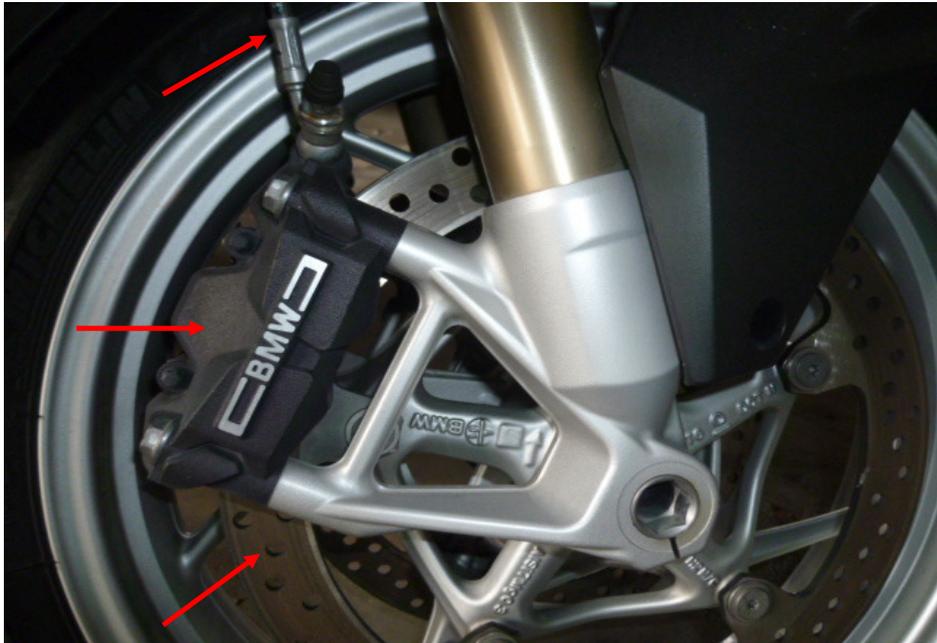
Photo 24 shows a close up view of the front brake caliper, front brake disc and front brake hose (arrowed) at the right side of the Motorcycle's front wheel, which are all part of the components in the hydraulic front brake system of the Motorcycle. Our visual checks of these various components had revealed all to be intact with no visible damage. No leakage of brake fluid was also observed.

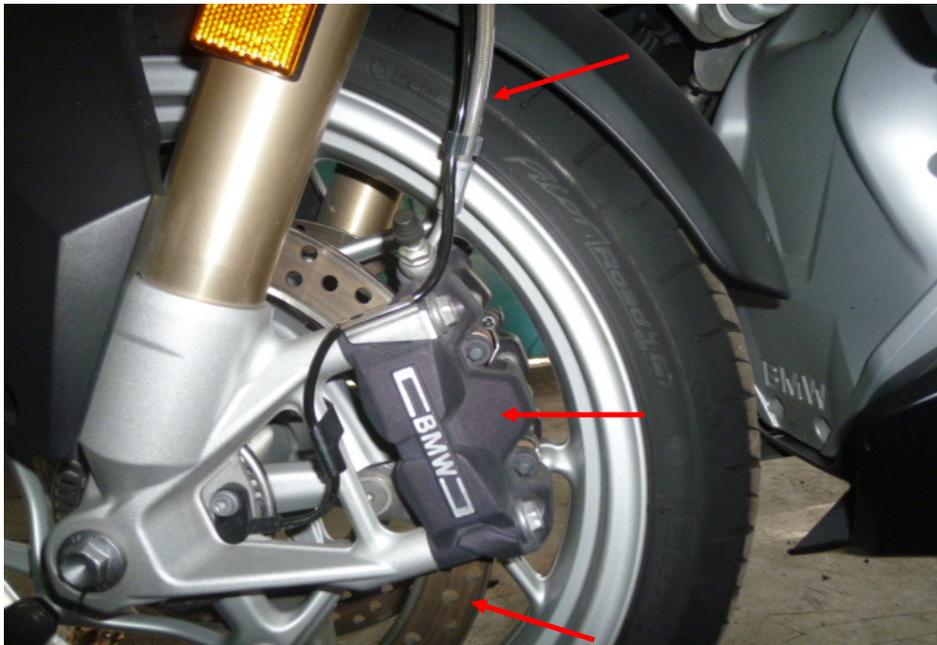
Photo 25 shows a close up view of the front brake caliper, front brake disc and front brake hose (arrowed) at the left side of the Motorcycle's front wheel, which are all part of the components in the hydraulic front brake system of the Motorcycle. Our visual checks of these various components had revealed all to be intact with no visible damage. No leakage of brake fluid was also observed.

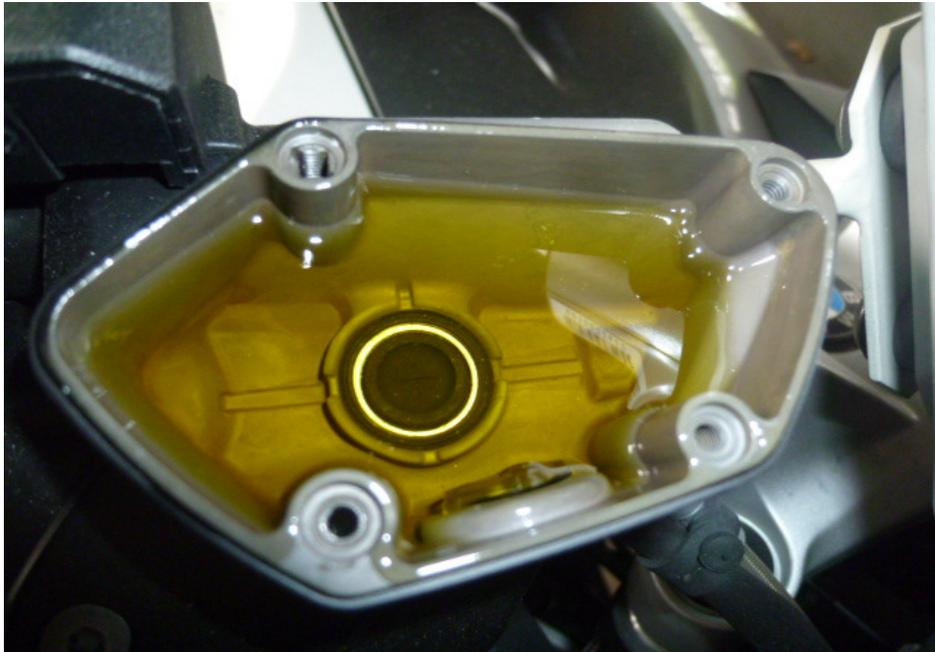
Photo 26 shows the brake fluid reservoir for the front brake of the Motorcycle. The brake fluid was observed to be of sufficient level for operational purposes and without contamination.

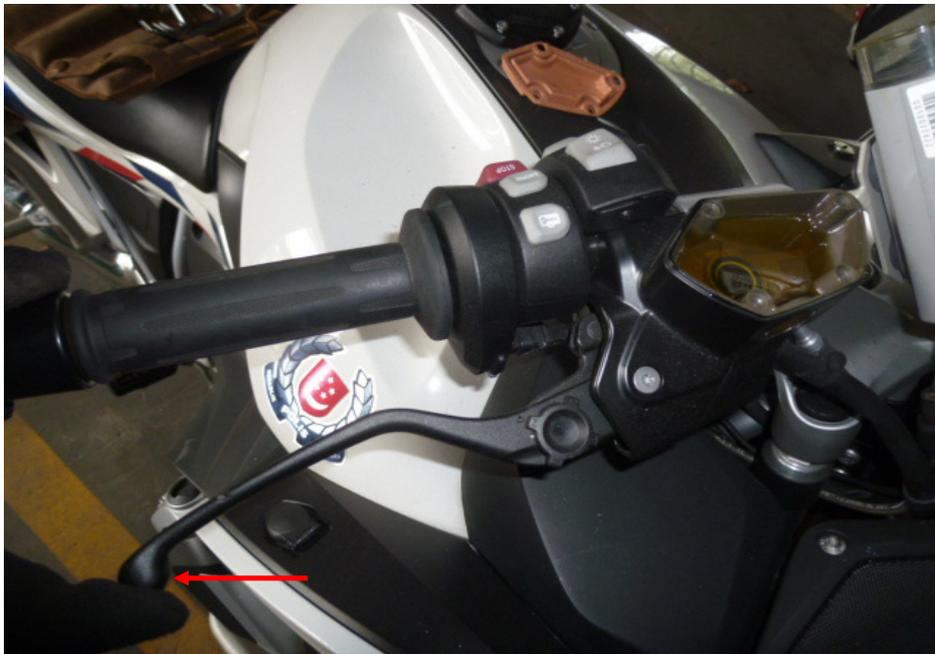
Photo 27 shows the front brake lever being depressed. There was some resistance felt (spongy like feel) upon pressing the front brake lever (arrowed). This would indicate that there is no leakage of pressure/vacuum in the brake system.

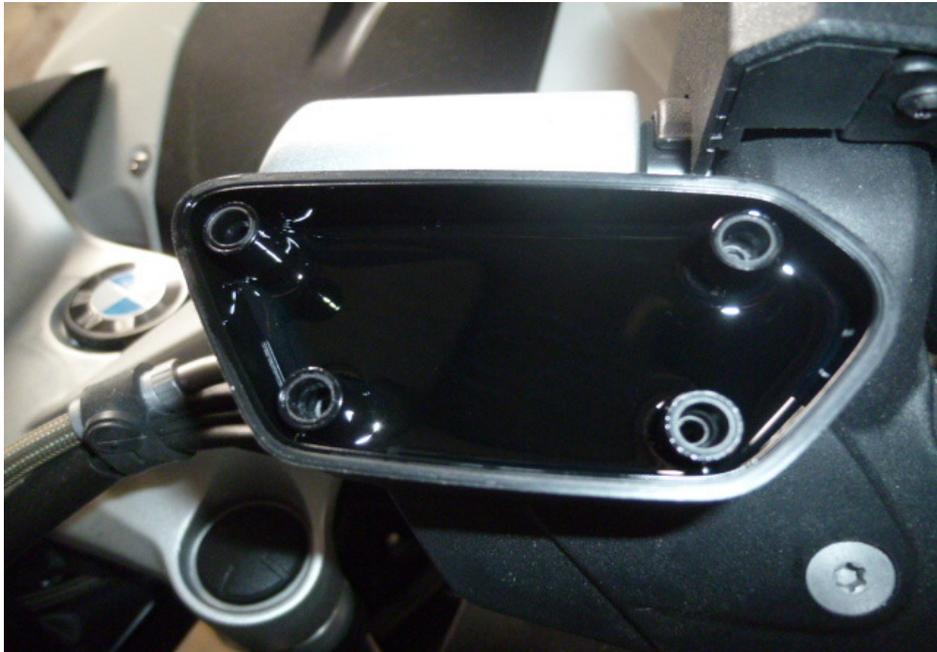
Photo 28 shows the hydraulic clutch fluid reservoir for the hydraulic clutch system of the Motorcycle. The hydraulic clutch fluid was observed to be of sufficient level for operational purposes and without contamination.

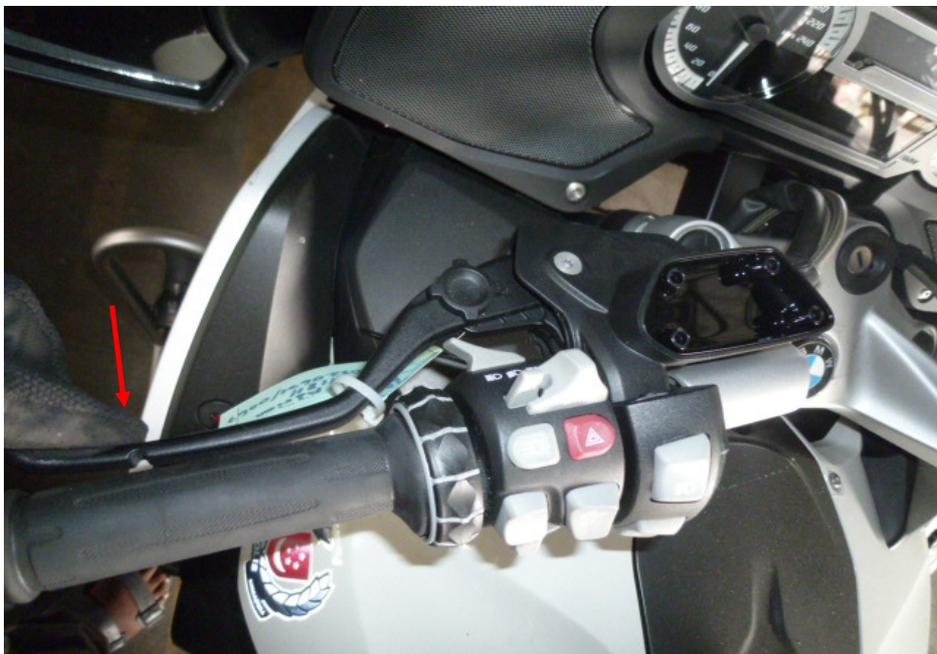
Photo 29 shows the clutch lever being depressed. There was some resistance felt (spongy like feel) upon pressing the clutch lever (arrowed). This would indicate that there is no leakage of pressure/vacuum in the hydraulic clutch system.

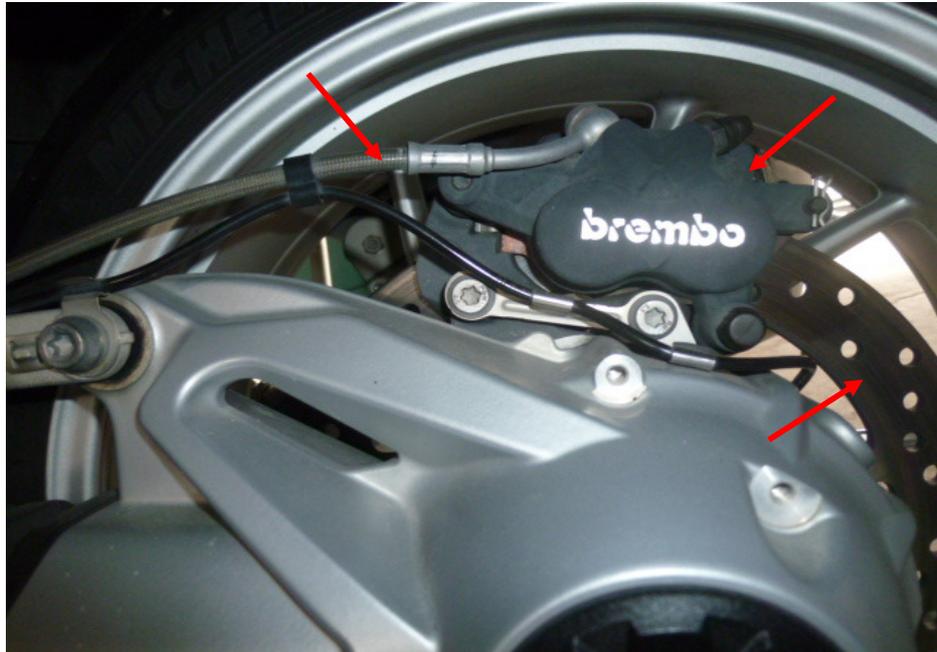
Photo 30 shows a close up view of the rear brake caliper, rear brake disc and rear brake hose (arrowed) of the Motorcycle, which are all part of the components in the hydraulic rear brake system of the Motorcycle. Our visual checks of these various components had revealed all to be intact with no visible damage. No leakage of brake fluid was also observed.

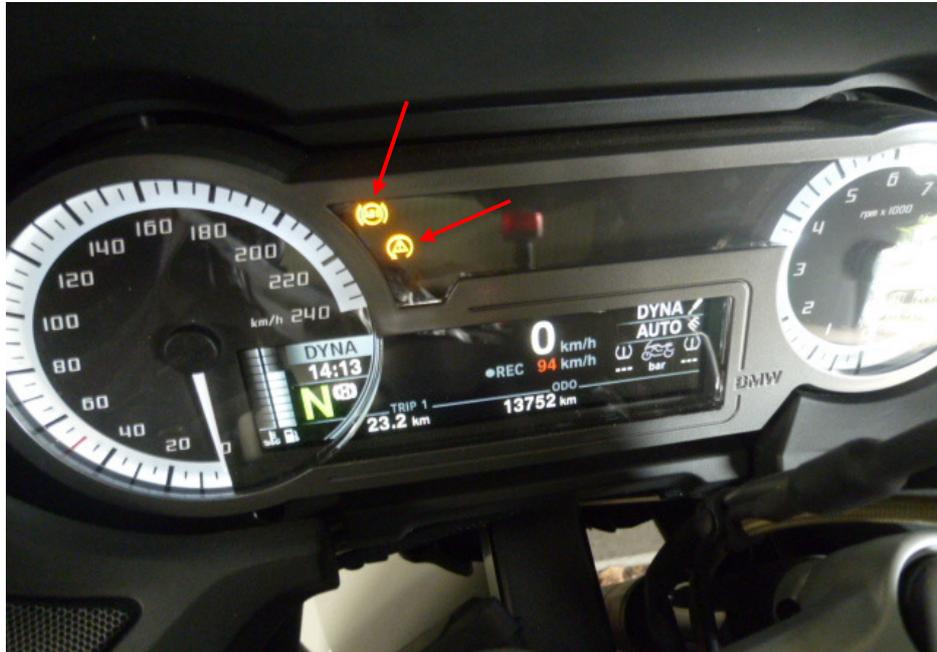
Photo 31 shows the warning lights for the various electronic operating systems of the Motorcycle appearing on its instrument panel during the self-test when the engine is cranked, in particular the ABS light and TCS light (arrowed).

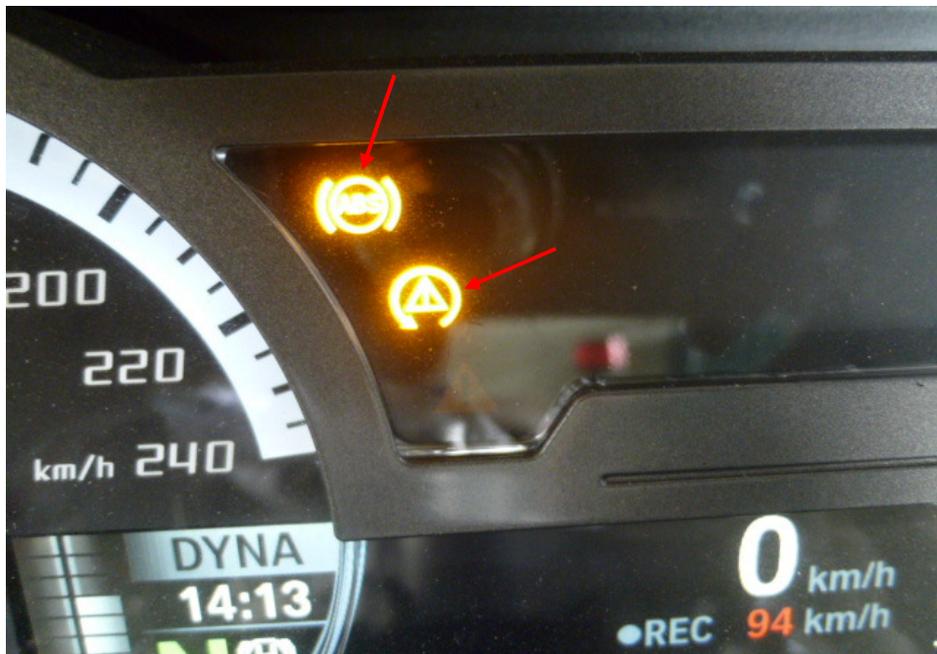
Photo 32 shows a close up view of the warning lights for the various electronic operating systems of the Motorcycle appearing on its instrument panel during the self-test when the engine is cranked, in particular the ABS light and TCS light (arrowed).

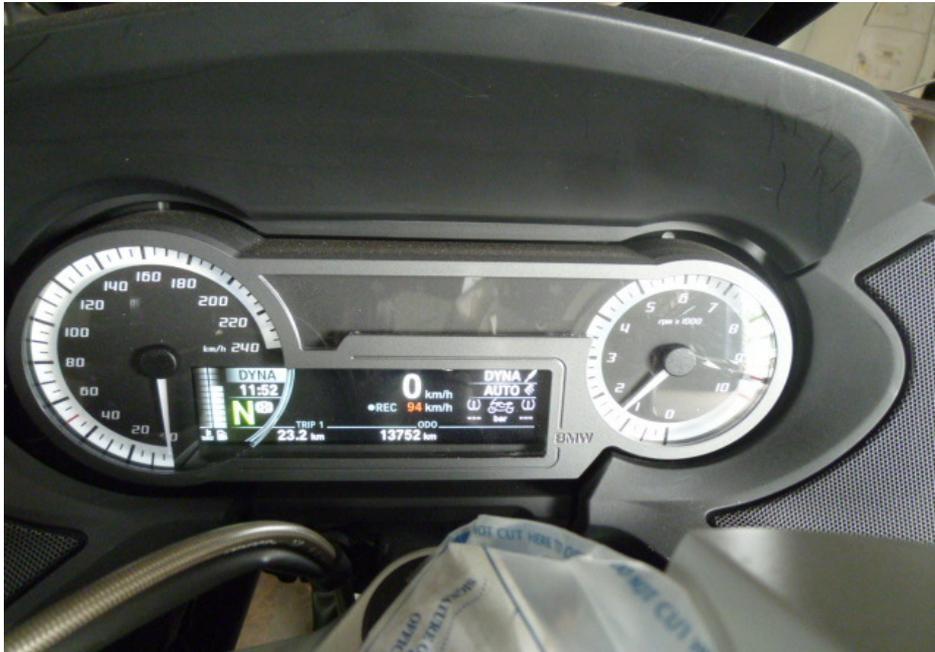
Photo 33 shows no warning lights illuminated on the instrument panel of the Motorcycle after the engine was cranked. This would suggest that there was no abnormality to the various electronic operating systems of the Motorcycle, like the ABS and TCS etc.
