**PRO  
PLUS  
AUTOMOBILE  
ENGINEERS**

**Re: Third Party Claim  
Vehicle Registration No. SLT8181K**

**VEHICLE INSPECTION REPORT**

Registration No: SLT8181K

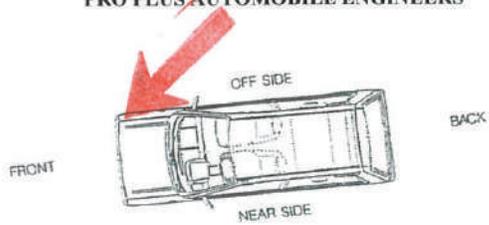
Direction of Impact [ → ]

Damages sustained were consistent with the subject vehicle being involved in a collision with another vehicle, sustaining damages at its o/s front portion.
