Our Ref : PP/ET/ST.8181.TP.07-21

**Re: Third Party Claim
Vehicle Registration No. SLT8181K**

VEHICLE INSPECTION REPORT

Registration Number	: SLT8181K	Odometer Reading	: 65909	Km
Make/Model	: Toyota Previa Aeras 2.4	Radio/Cassette/CD	: Fitted	
Year of Manuf/Reg	: 2017	Air Conditioner	: Fitted	
Engine Number	: 2AZ4A98552	View Mirrors	: Fitted-o/s & n/s	
Chassis Frame Number	: JTEGDS6M107152902	Seat Belts	: Fitted-front & rear	
Class/Type	: Passenger [MPV]	Other Assessories		
Colour	: Metallic Grey	(Specify)	: Fitted

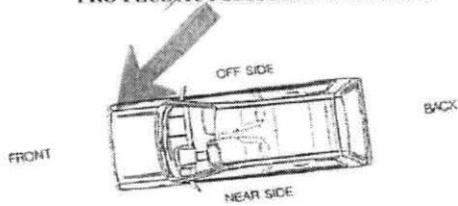
IMPACT OF VEHICLE

Damages sustained were consistent with the subject vehicle being involved in a collision with another vehicle, sustaining damages at its o/s front portion.
