**SKC3537C - Submitted by: Lai Huat (Meng Kee) Motor Pte Ltd (Sin Ming)**

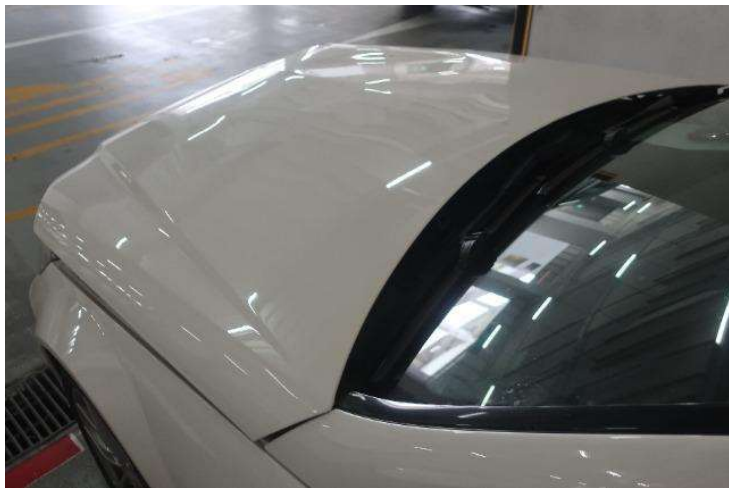
**4/32: Photographs of Damaged Parts**

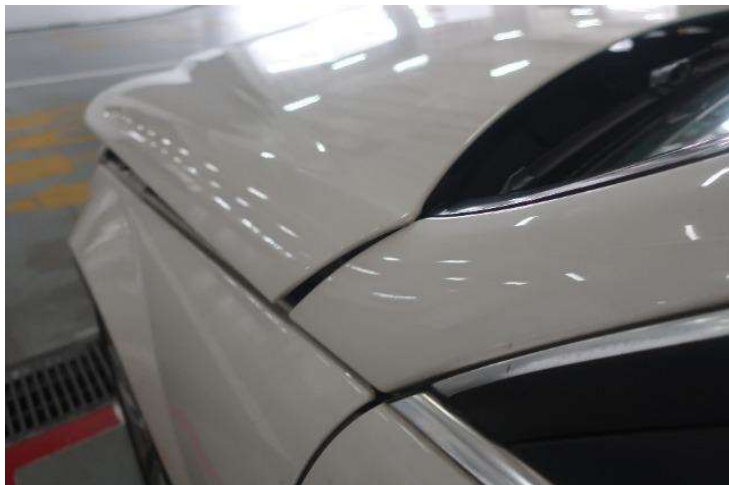
**5/32: Photographs of Damaged Parts**

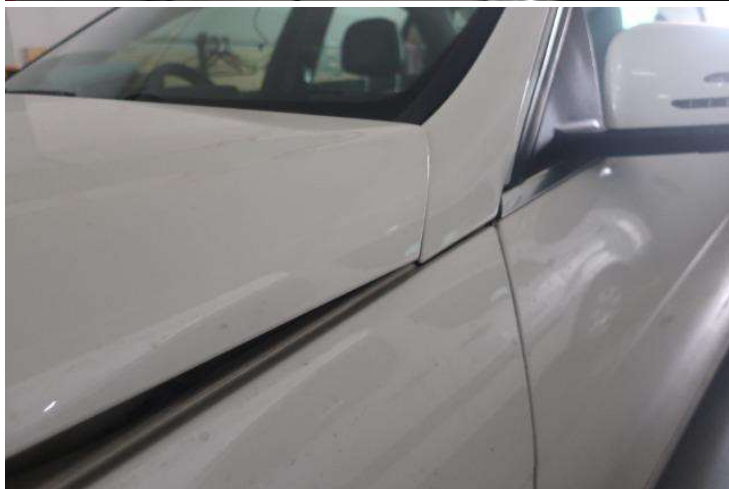
**6/32: Photographs of Damaged Parts**

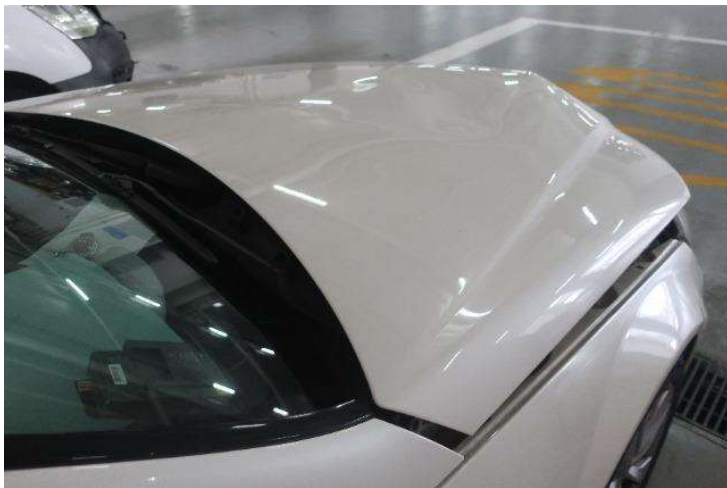
7/32: Photographs of Damaged Parts

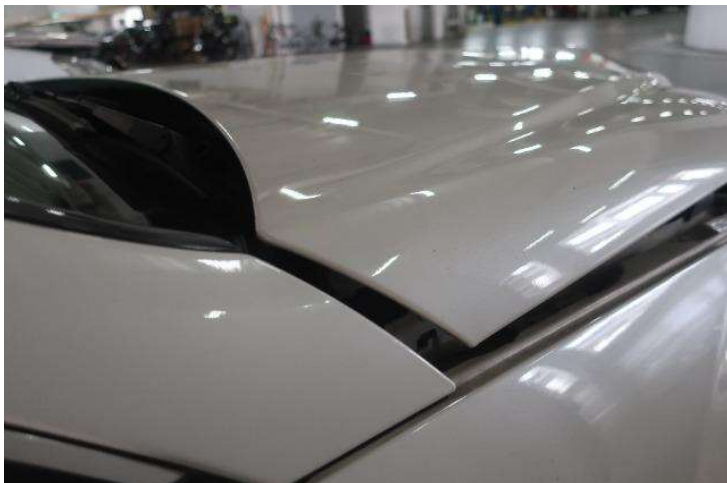
8/32: Photographs of Damaged Parts

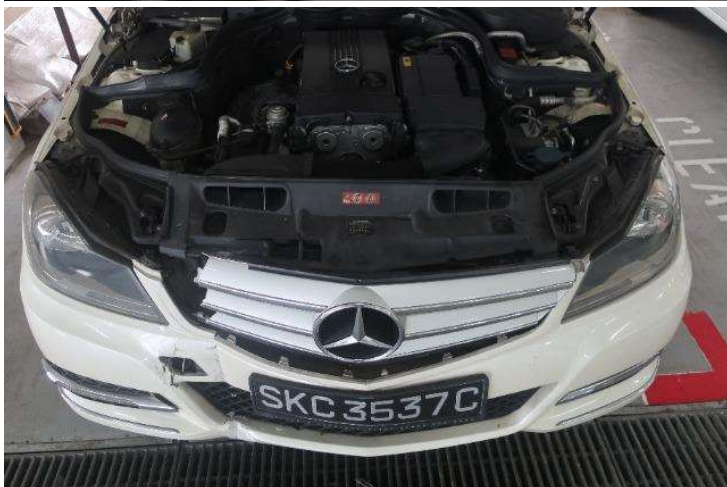
9/32: Photographs of Damaged Parts

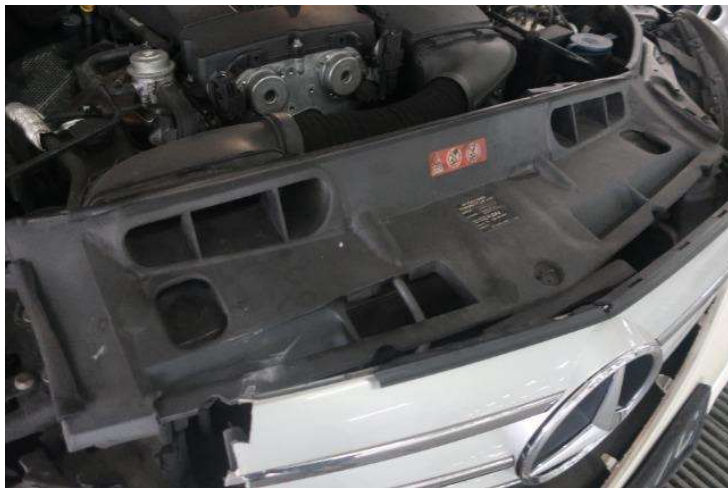
10/32: Photographs of Damaged Parts

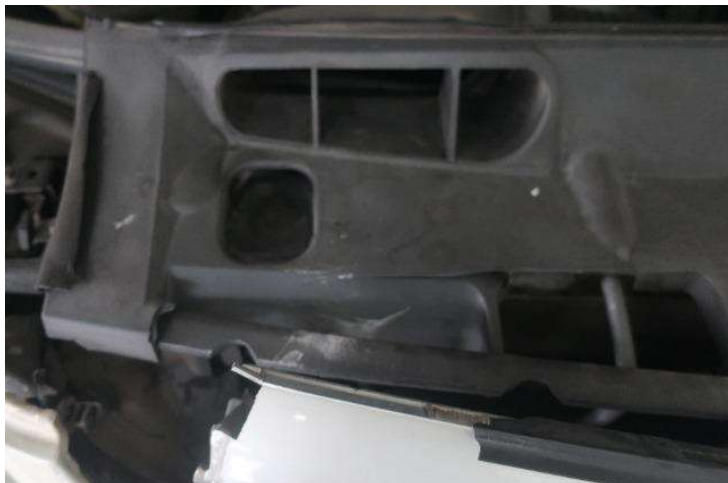
11/32: Photographs of Damaged Parts

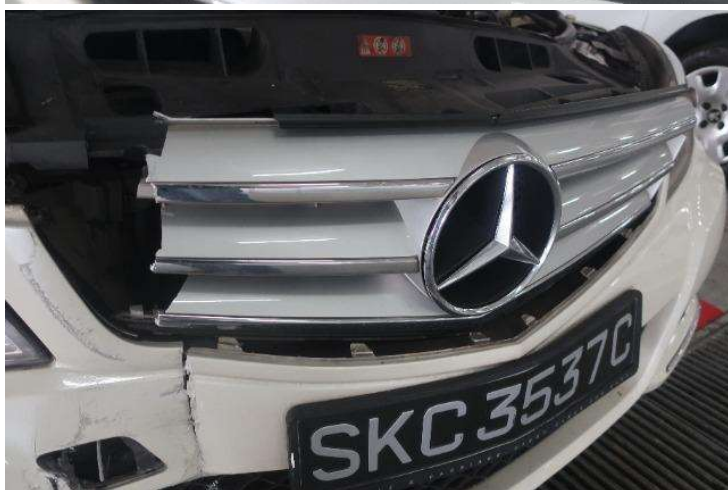
12/32: Photographs of Damaged Parts

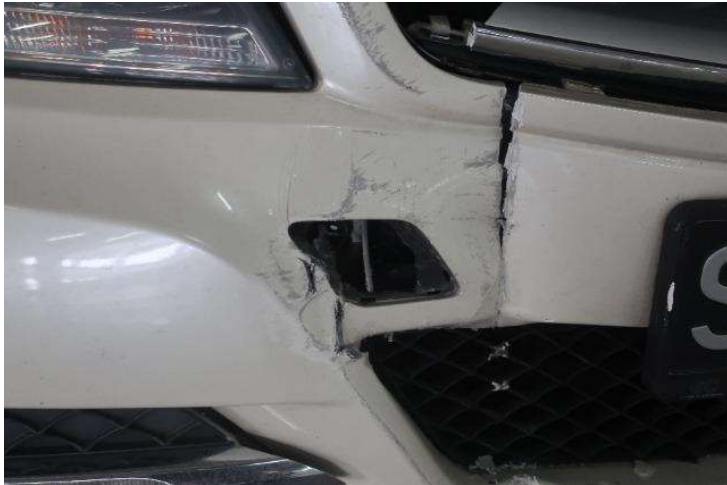
13/32: Photographs of Damaged Parts

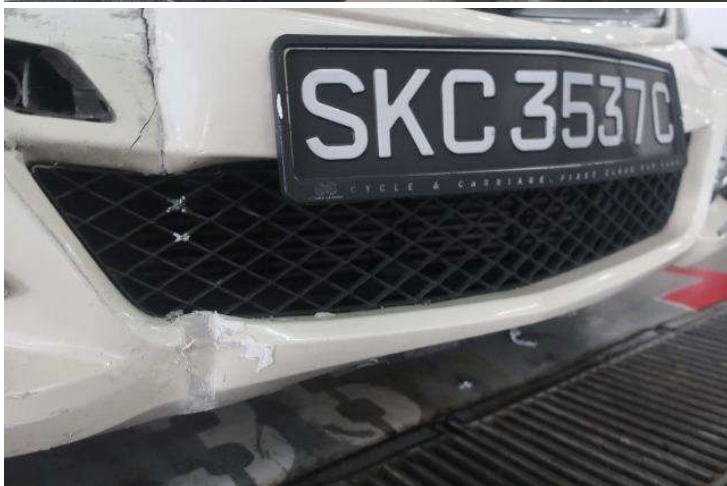
14/32: Photographs of Damaged Parts

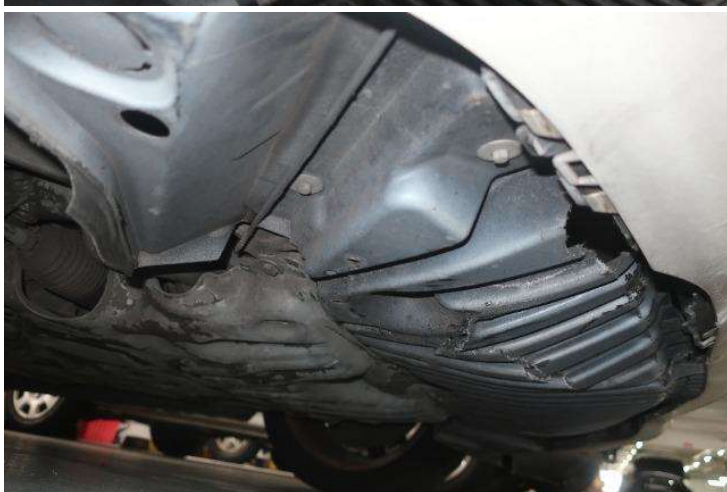
15/32: Photographs of Damaged Parts

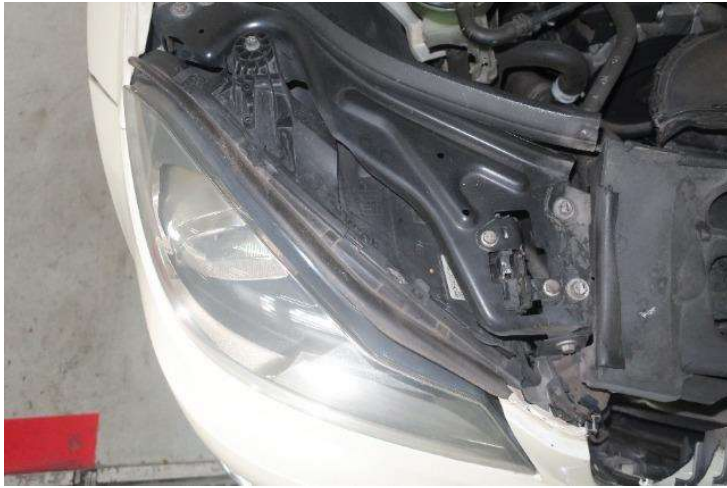
16/32: Photographs of Damaged Parts

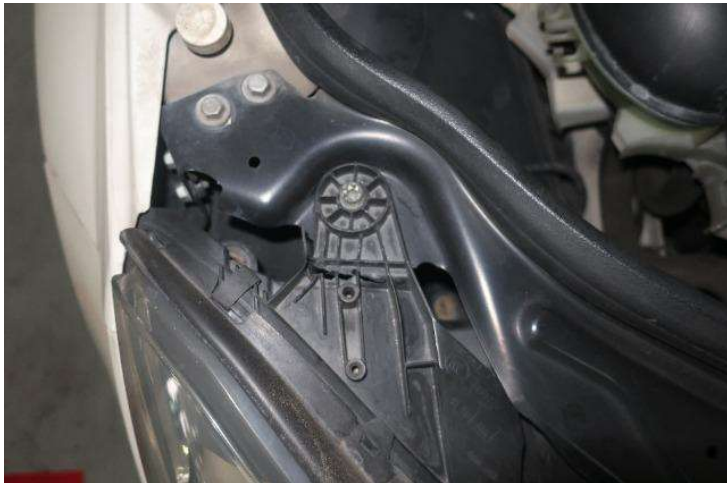
17/32: Photographs of Damaged Parts

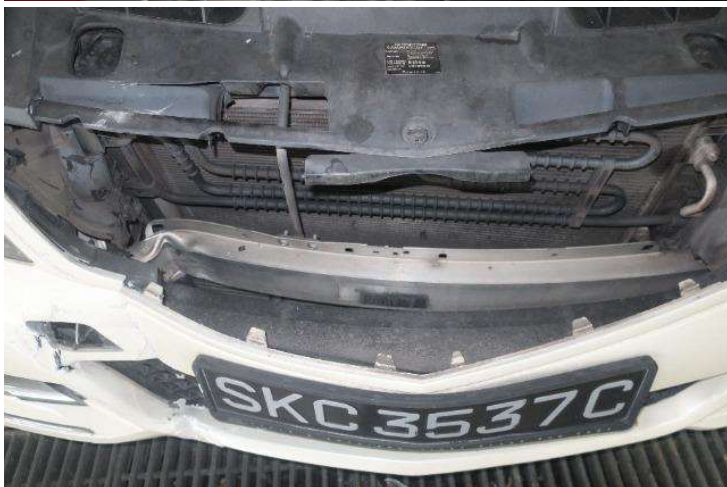
18/32: Photographs of Damaged Parts

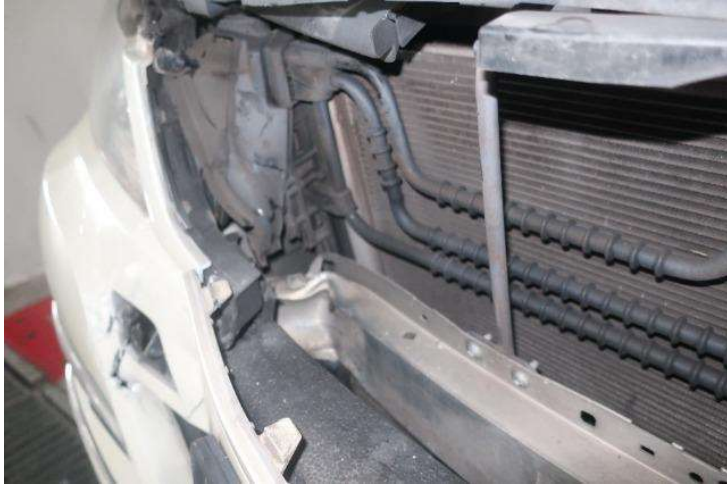
19/32: **Photographs of Damaged Parts**

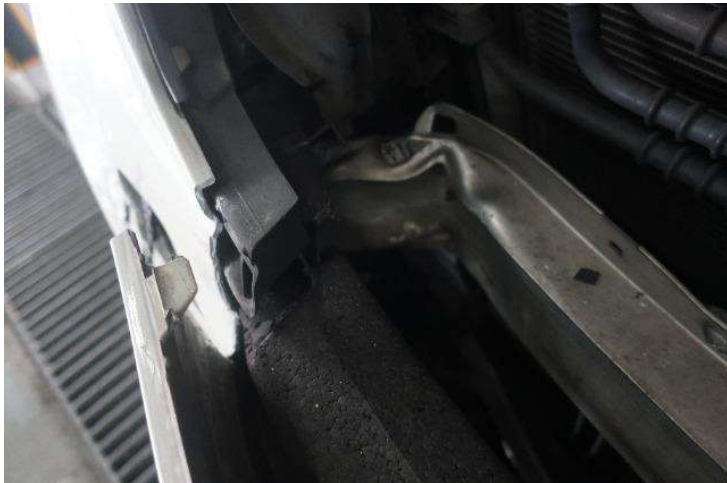
20/32: **Photographs of Damaged Parts**

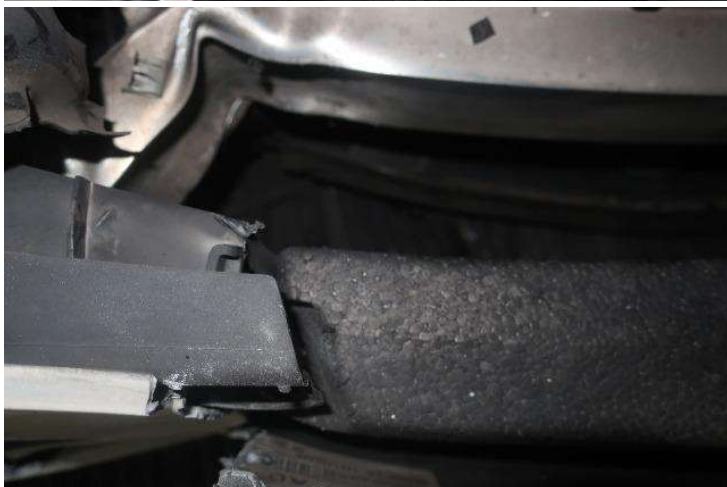
21/32: **Photographs of Damaged Parts**

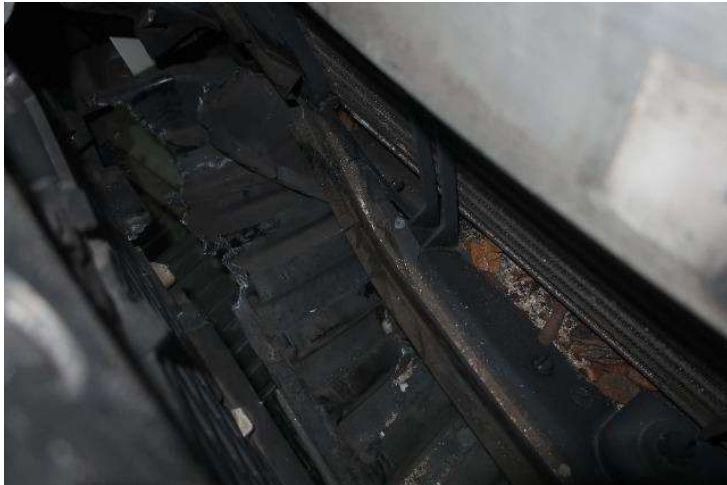
22/32: Photographs of Damaged Parts

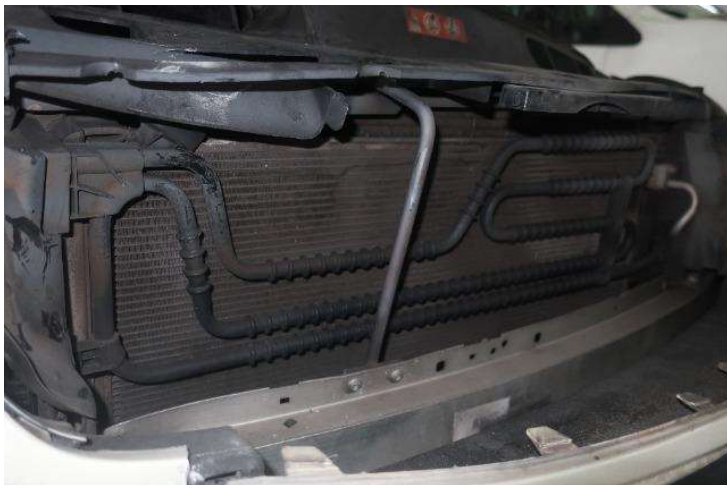
23/32: Photographs of Damaged Parts

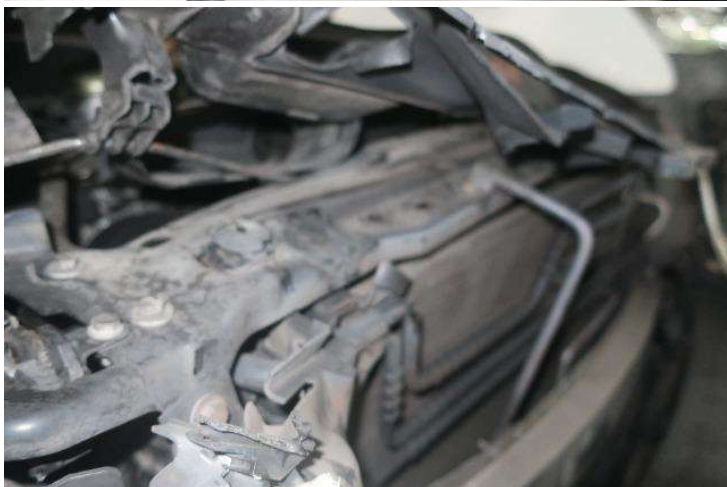
24/32: Photographs of Damaged Parts

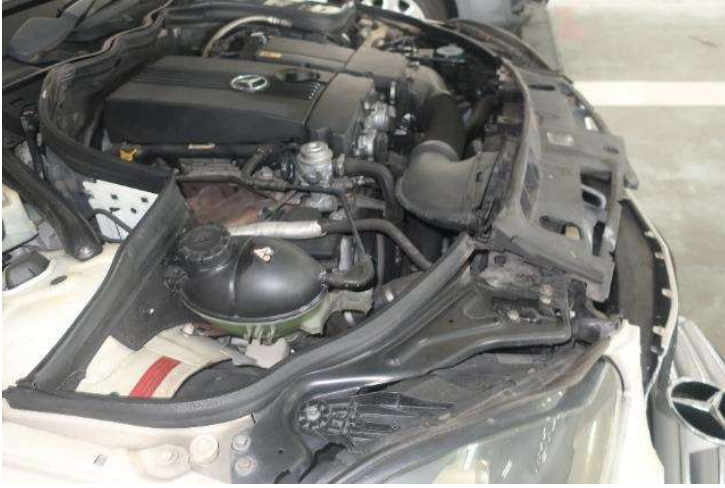
25/32: Photographs of Damaged Parts

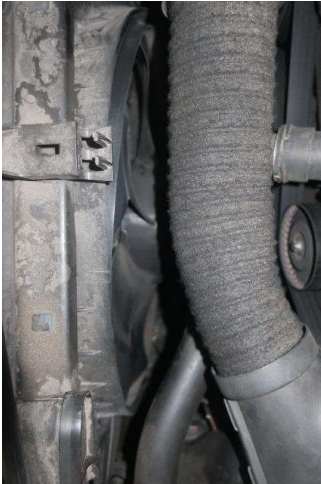
26/32: Photographs of Damaged Parts

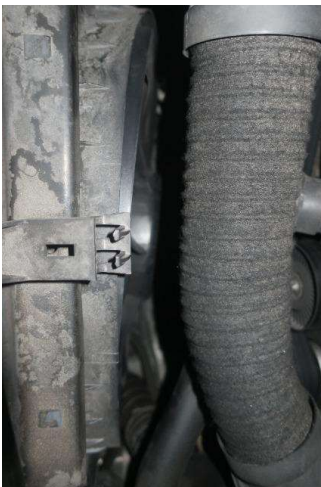
27/32: Photographs of Damaged Parts

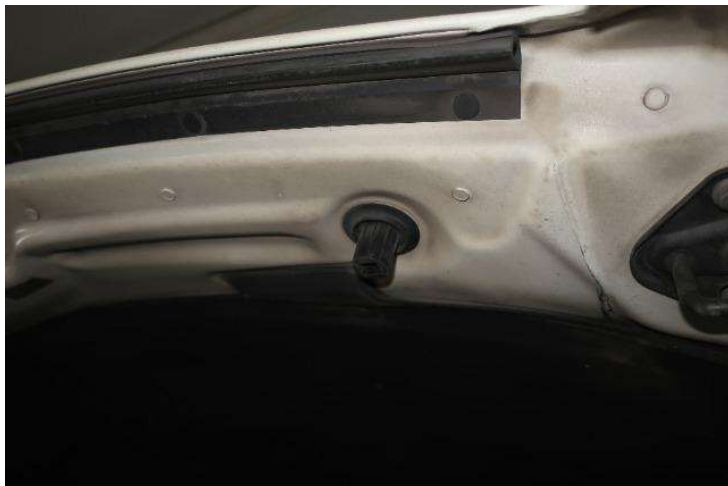
28/32: Photographs of Damaged Parts

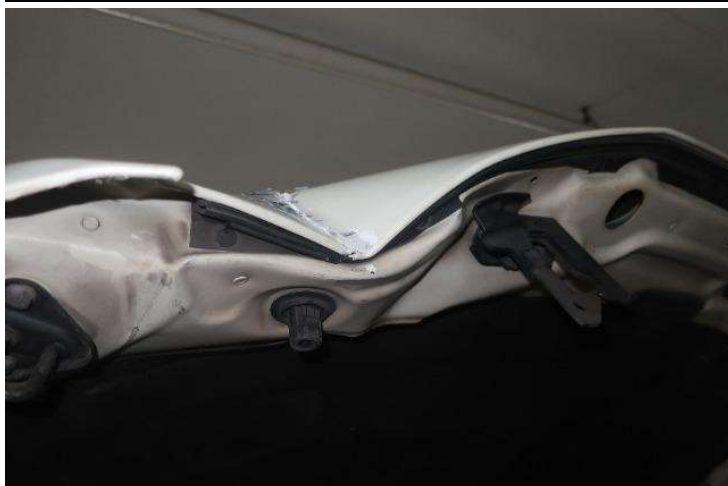
29/32: Photographs of Damaged Parts

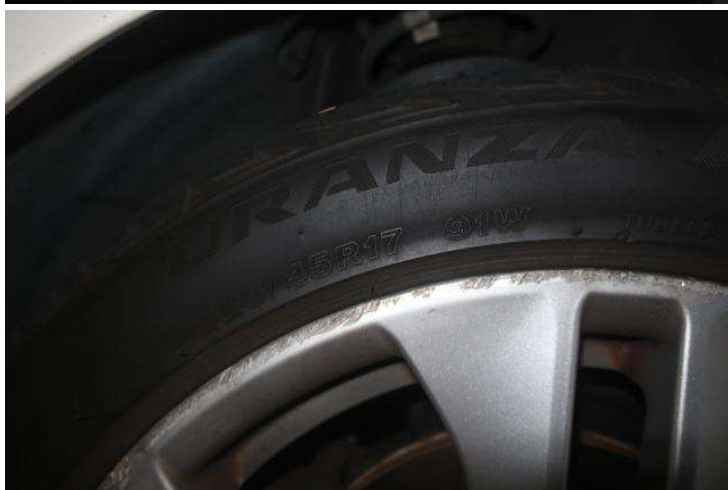
30/32: Tyre - Bridgestone; Tyre size - 225 45 R17
