SAFETY SPECIALIST'S ACCIDENT INVESTIGATION REPORT

| EXACT LOCATION TPE toward SLE Lane 1 Opp LP80 | DATE OF OCCURRENCE 25.03.2019 | TIME √ AM □ PM | DATE REPORTED 25.03.2019 |

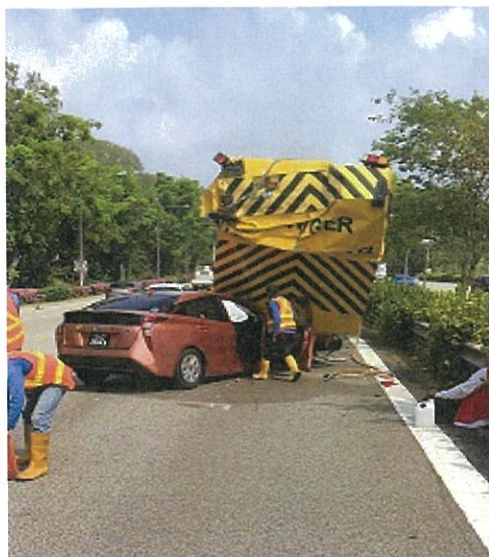
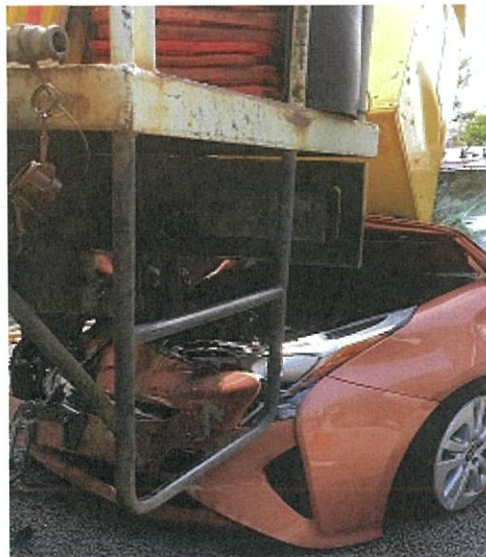
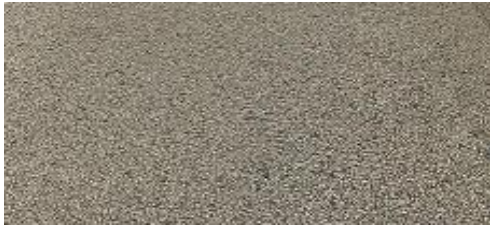
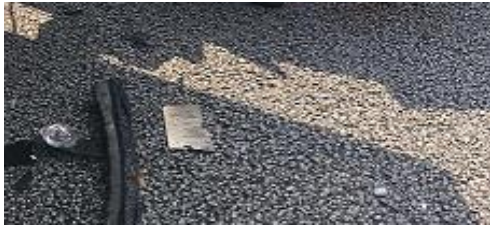
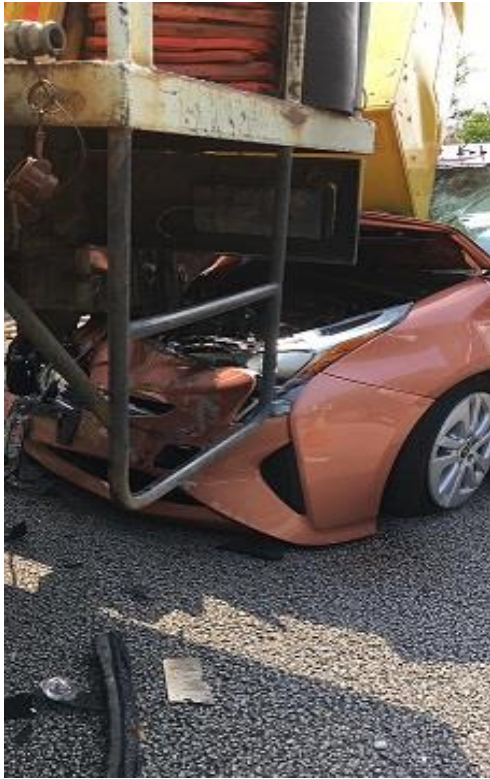
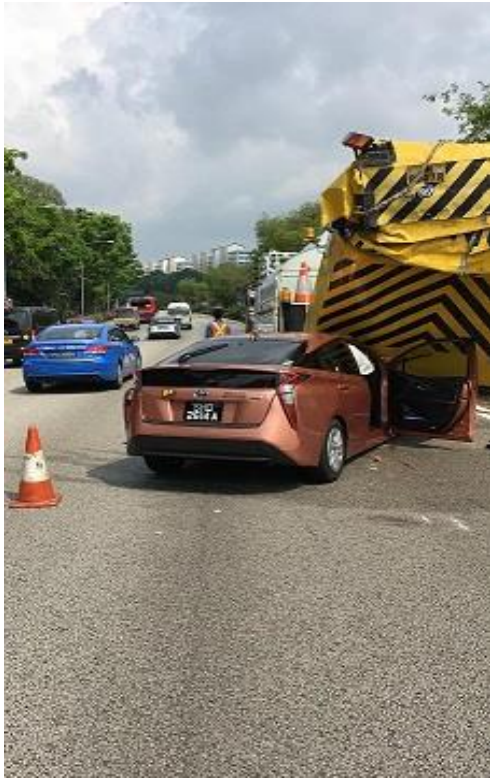
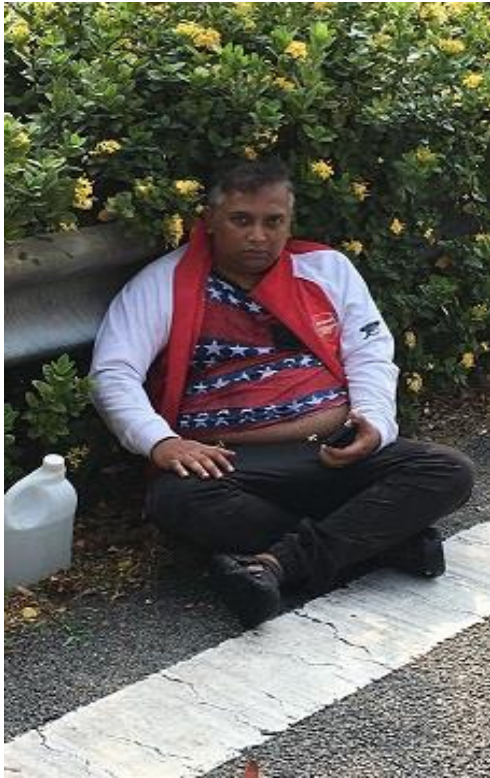
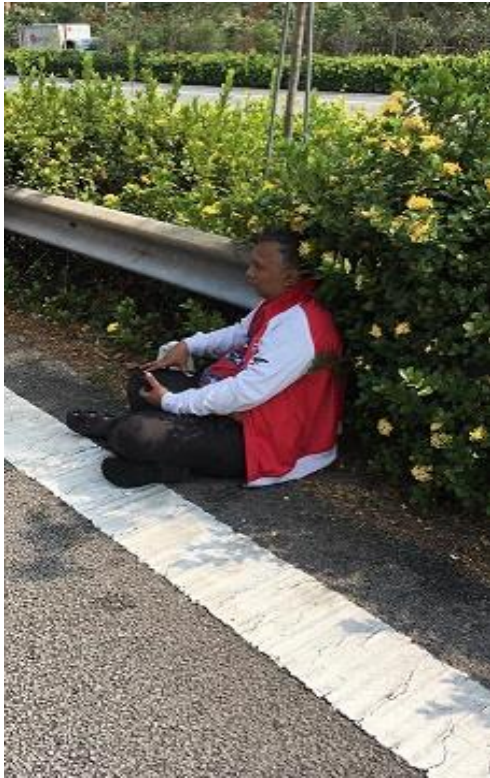
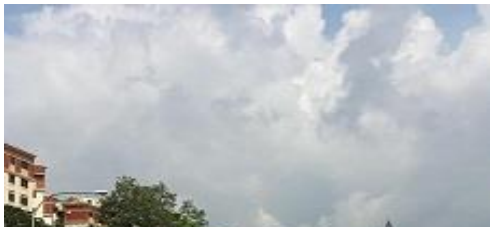
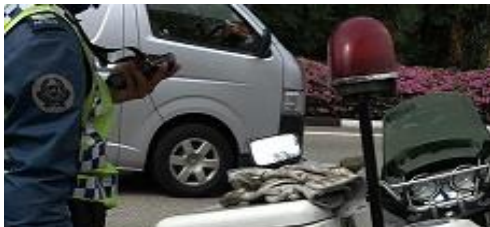
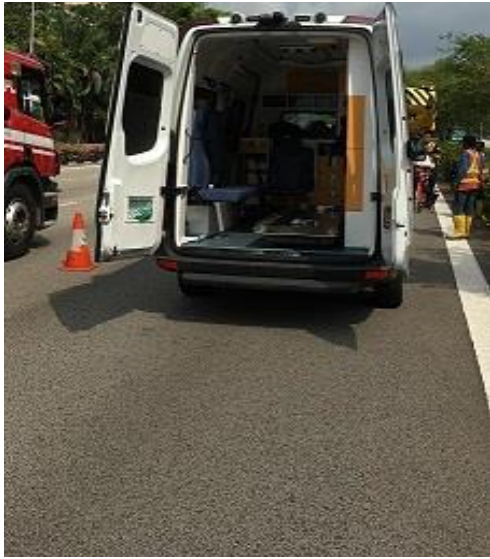
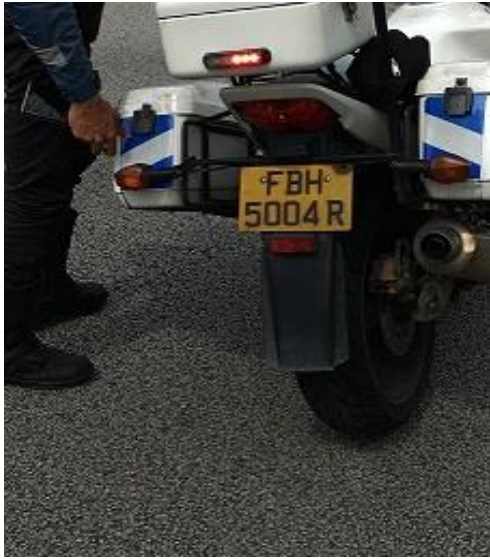
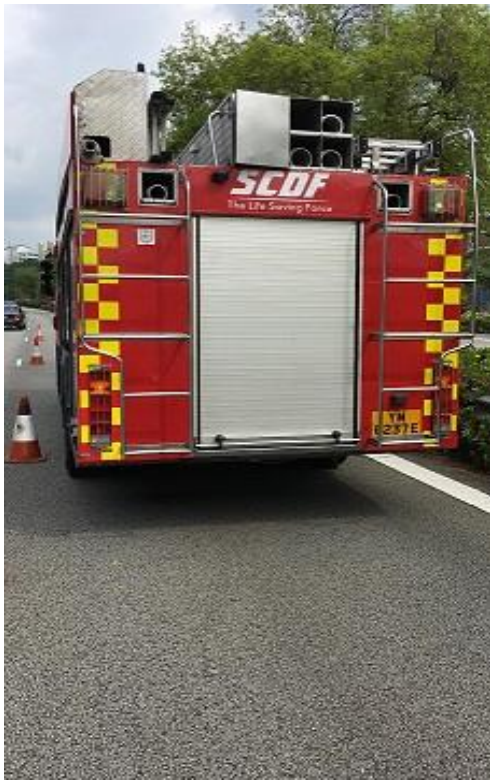
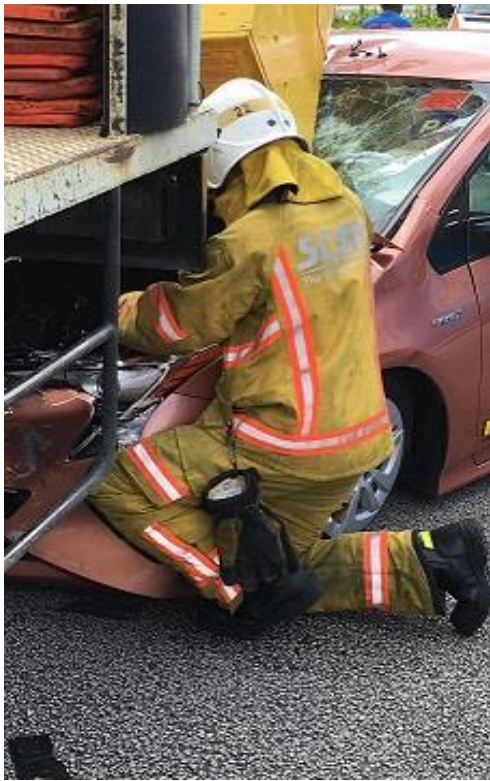
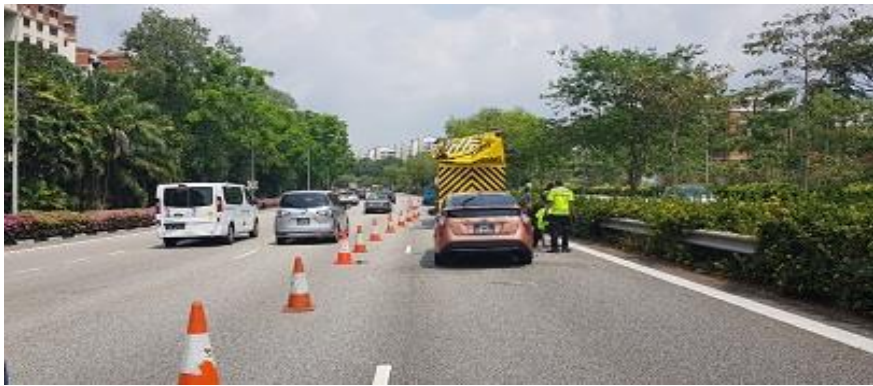
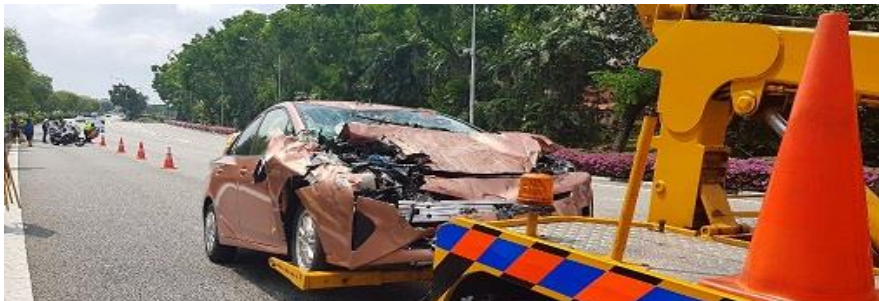
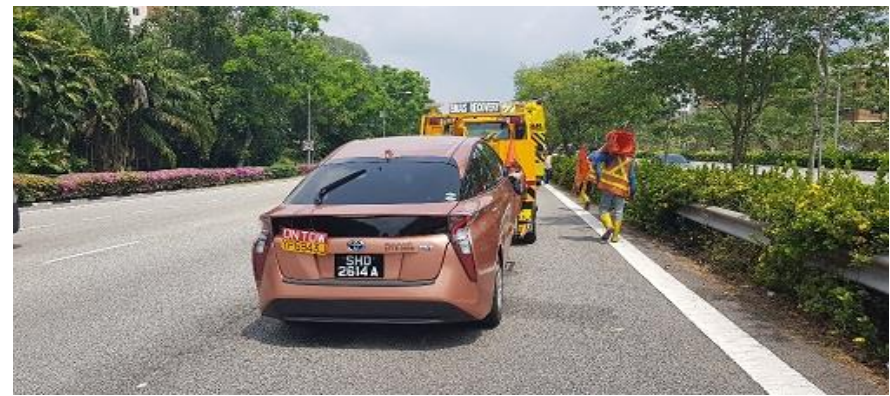
PHOTOS OF THE ACCIDENT

| PERSONAL INJURY | | | PROPERTY DAMAGE | |
|--|---|---|--|---|
| NATURE OF INJURY NIL | PART OF BODY INJURED NIL | | NATURE OF DAMAGE Traffic accident | |

| D E S C R I P T I O N | <p>DESCRIBE CLEARLY HOW THE ACCIDENT OCCURRED: ATTACHED ACCIDENT DIAGRAM FOR ALL MOTOR VEHICLE ACCIDENTS</p> <p>On 25.03.2019 @ 10.07am, we called EMAS to get permission to carry out watering at TPE lane 1 from 1.50km – 3.00km toward SLE.</p> <p>At 10.15am called 2nd time EMAS to confirmed we are move in slowly moving lorry with TMA to carry out the watering work.</p> <p>We then move in to proceed the watering works.</p> <p>Suddenly at 10.28am, a Taxi (SHD2614A) had collided into our rear of our water tanker lorry TMA.</p> <p>Our supervisor immediately called 999 to reported the accident case and inform the Ambulance and EMAS recovery/Marshal Police & Civil Defence.</p> <p>The Ambulance and EMAS recovery/Marshal Police & Civil Defence vehicle arrived to the accident site about 10 mins later.</p> <p>Our company Safety Supervisor reached the accidentsite at about 11.20am to carry out investigation.</p> <p>When I reach the site, the Ambulance, Civil Defence vehicle had left already.</p> |
| | <p>Our company recovery team arrived on sit about 11.40am to remove our Lorry</p> <p>We then tidy up the site left about 12pm.</p> <p>We then make a insuarncce report to our insurance company and followed by a police report at Thmomson NPP @ Sin Ming Road</p> <p>WHAT ARE THE BASIC OR FUNDAMENTAL REASONS FOR THE EXISTENCE OF THESE ACTS AND/ OR CONDITIONS?</p> <p>The Taxi Driver could be over worked or not looking at the EMAS road sign warnings that watering works are being carried out on the 1st lane.</p> |

| | We will always get EMAS Permission before we enter the site. As Watering tanker is moving constantly, |
| | EMAS Have to make sure warning is placed on the EMAS board thru the entire report watering distance to |
| | ensure drivers have sufficient distance of warning. |
