AUTOMOBILE ASSESSMENT REPORT

Our Reference: 0822/VT229
Date: 30-Aug-2022

ASSESSMENT OF VEHICLE NO. SMQ 1774 A

DATE OF LOSS: 04-Aug-2022

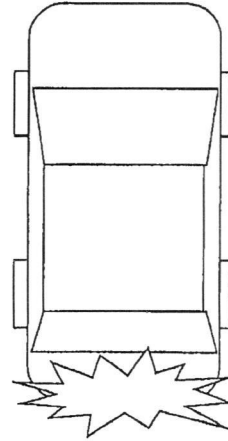
At the time of the inspection, the vehicle sustained damages to the REAR portion.
