LKK Auto Consultants Pte Ltd

Affiliated to Federation Internationale Des Experts En Automobile			
CHINA TAIPING INSURANCE (S) PTE LTD 3 ANSON ROAD #16-00 SPRINGLEAF TOWERSINGAPORE 079909		Ref: CC3/CTI22009609/Kya3q2 Date: 28/03/2023 Code: CTI

ADJUSTMENT ON REPAIR COST FOR VEHICLE NO. SHB 1161G

PHOTOGRAPHS FOR VEHICLE NO. SHB 1161G

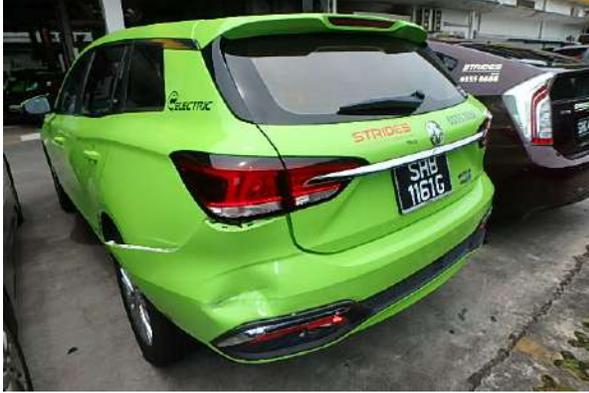
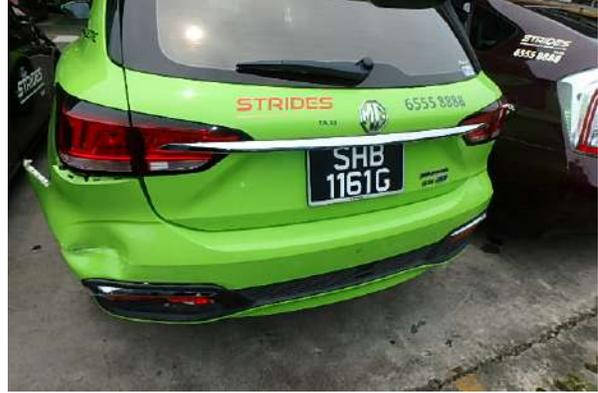
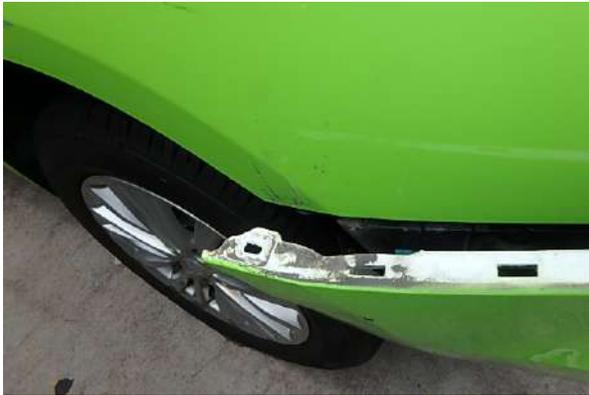
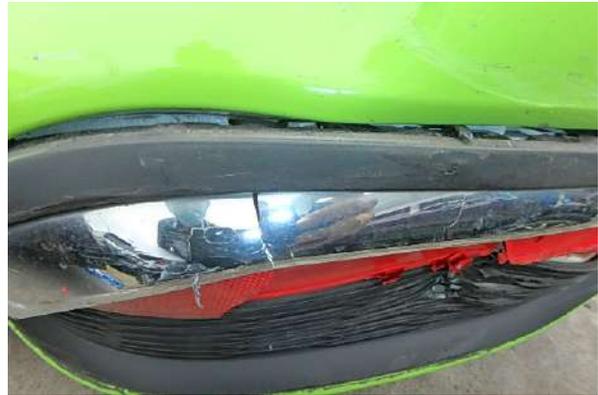
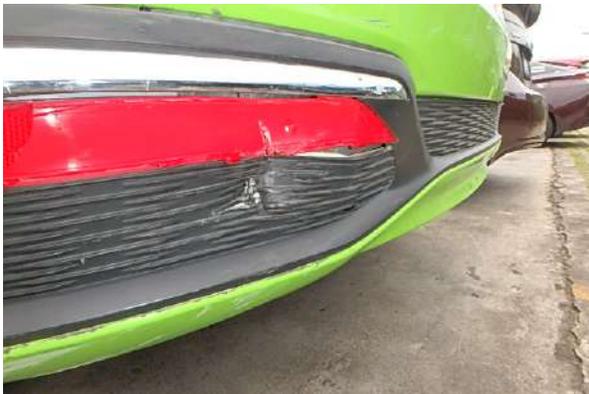
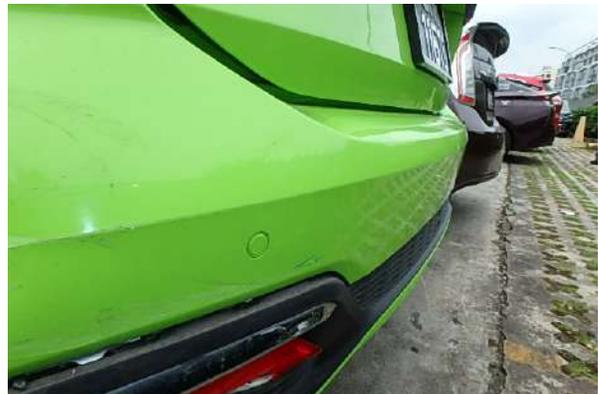
4. Description of Damages			
	THE VEHICLE SUSTAINED DAMAGES AT THE REAR N/S PORTION. DAMAGES SEE DETAILS.		
5. General Information			
Accident Date	28/09/2022	Inspection Date	29/09/2022
Survey held at	STRIDES AUTOMOTIVE SERVICES PL. 60 WOODLANDS INDUSTRIAL PARK E4 SINGAPORE 757705		
5a. Remarks			
	A)THE INSPECTION WAS CONDUCTED ON A"WITHOUT PREJUDICE" BASIS. B)IN ACCORDANCE TO YOUR INSTRUCTIONS, WE HAVE NOT AUTHORISED REPAIRS.		
5b. Estimate Days of Repair			
	ESTIMATED NORMAL PERIOD FOR REPAIR:		2 Working Days
