Your Ref: CDMCG22001802-001
Our Ref : CS4/EGI22009833/P

TECHNICAL INVESTIGATION REPORT OF FIRE INCIDENT INVOLVING THE INSURED VEHICLE XE 6849T ON 30th AUGUST 202

Vehicle Registration No.	: XE 6849T
Make / Model	: SCANIA P450B8X4HZ
Chassis No	: YS2P8X40005625329
Year of Registration	: NOV 2021
Mileage	: 19,163KM

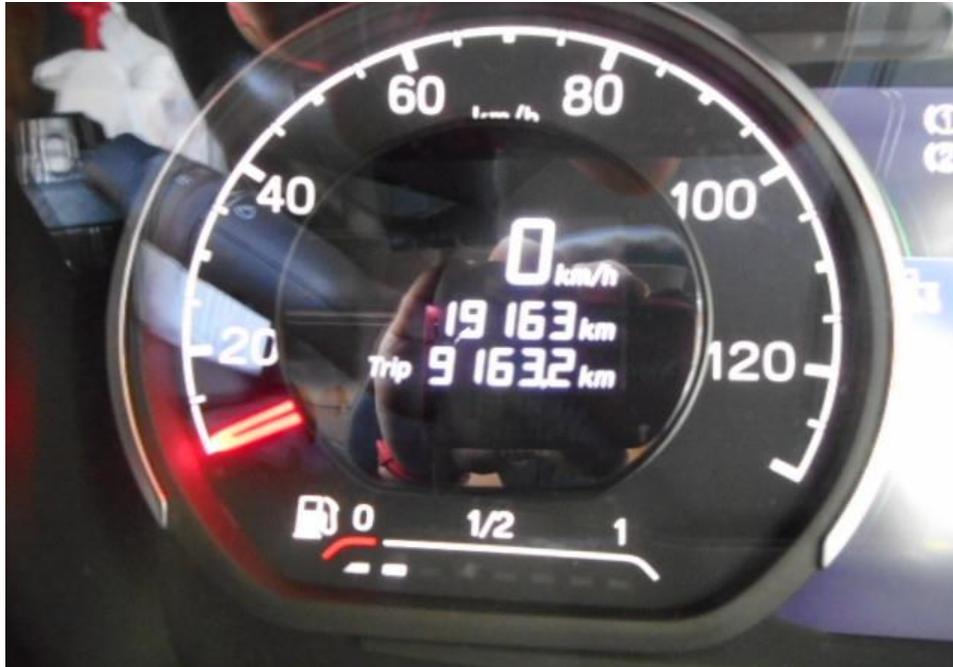
Photo 1 shows the mileage of the Insured Vehicle at the time of our inspection 19,163KM.

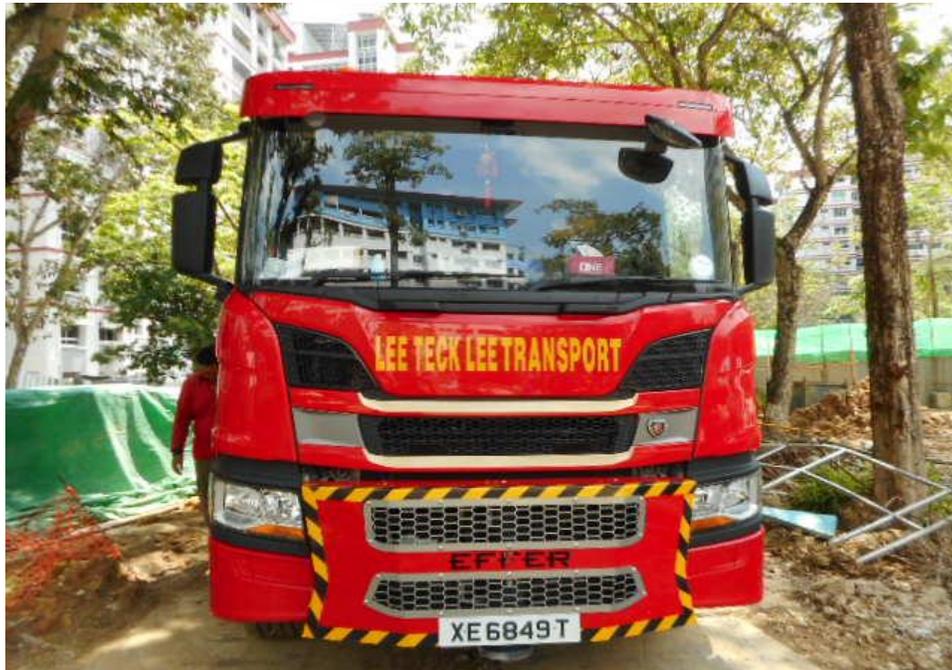
Photo 2 shows the general view of the front portion of the Insured Vehicle at the time of our inspection. The fire damage to the Insured Vehicle was confined to its interior portion. Its exterior is observed to be unaffected by the fire.

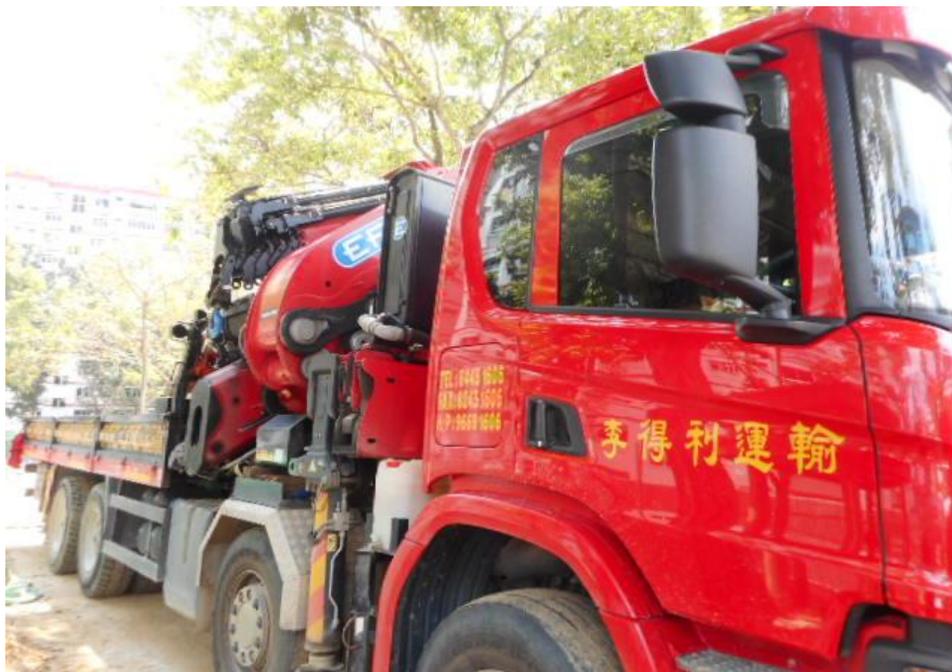
Photo 3 shows the general view of the right portion of the Insured Vehicle at the time of our inspection. The fire damage to the Insured Vehicle was confined to its interior portion. Its exterior is observed to be unaffected by the fire.

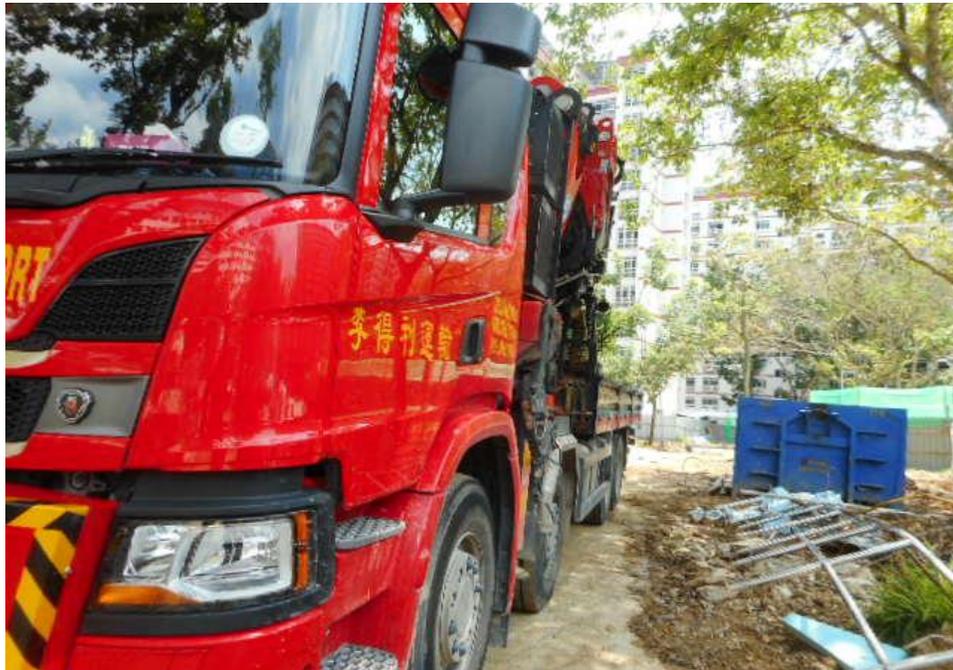
Photo 4 shows the general view of the left portion of the Insured Vehicle at the time of our inspection. The fire damage to the Insured Vehicle was confined to its interior portion. Its exterior is observed to be unaffected by the fire.

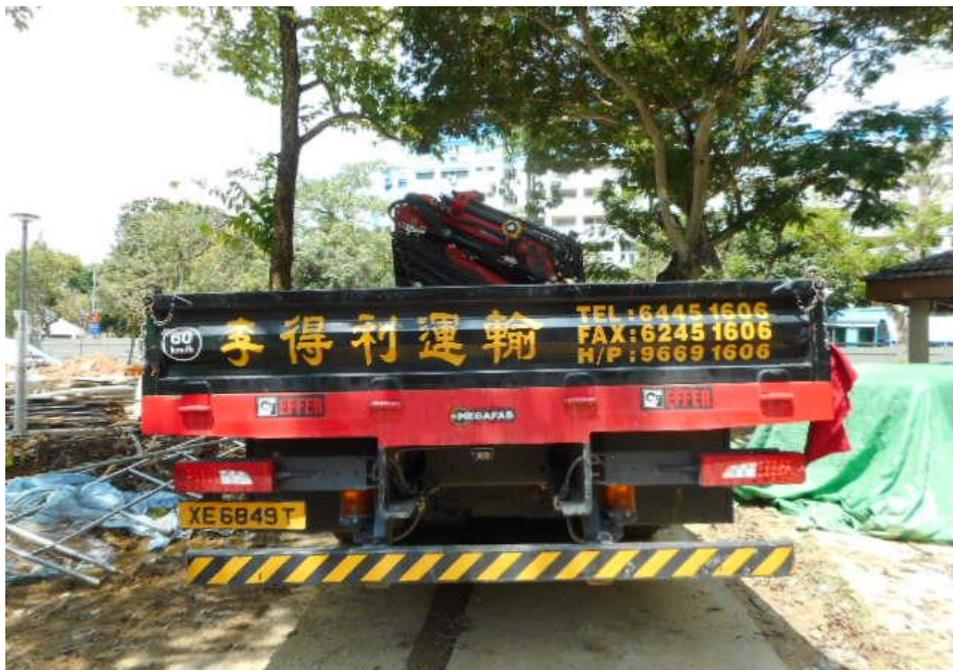
Photo 5 shows the general view of the rear portion of the Insured Vehicle at the time of our inspection. The fire damage to the Insured Vehicle was confined to its interior portion. Its exterior is observed to be unaffected by the fire.

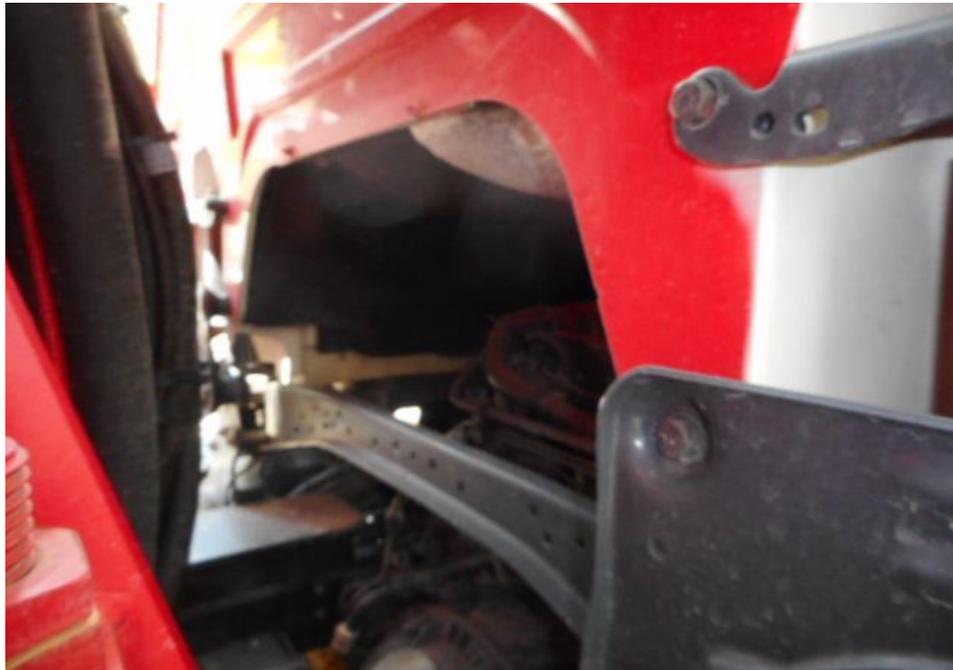
Photo 6 shows the general view of the engine portion of the Insured Vehicle at the time of our inspection. The fire damage to the Insured Vehicle was confined to its interior portion. Its engine compartment is observed to be unaffected by the fire.

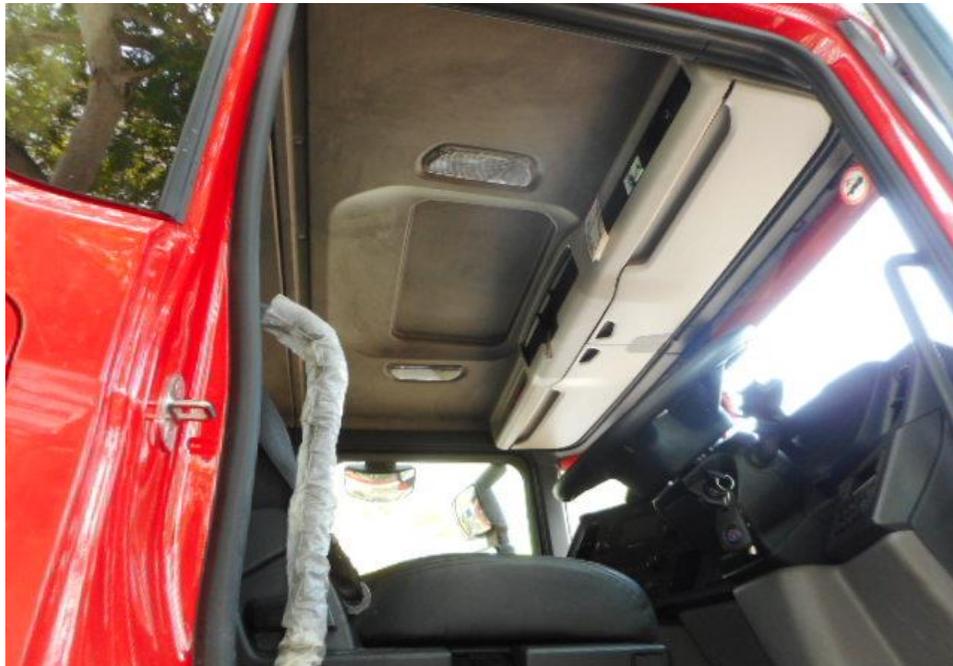
Photo 7 shows the general view of the interior compartment of the Insured Vehicle at the time of our inspection. The fire was confined to its centre console closer to the driver side seat portion, however the fire had resulted in the various components located in the interior of the Insured Vehicle suffer from heat and smoke damages, this includes the centre console cover, driver seat, and the roof panel lining.

7. Based on the circumstances for this particular case, the fire appears to have originated from the interior portion of the Insured Vehicle, somewhere around the centre console cover. This can be determined basing on the area where the extent of fire damage was most severe, the circumstances of the fires' origin at the material time of incident and also the burn marks and melting of material that were found on the surface of centre console cover and the driver seat.

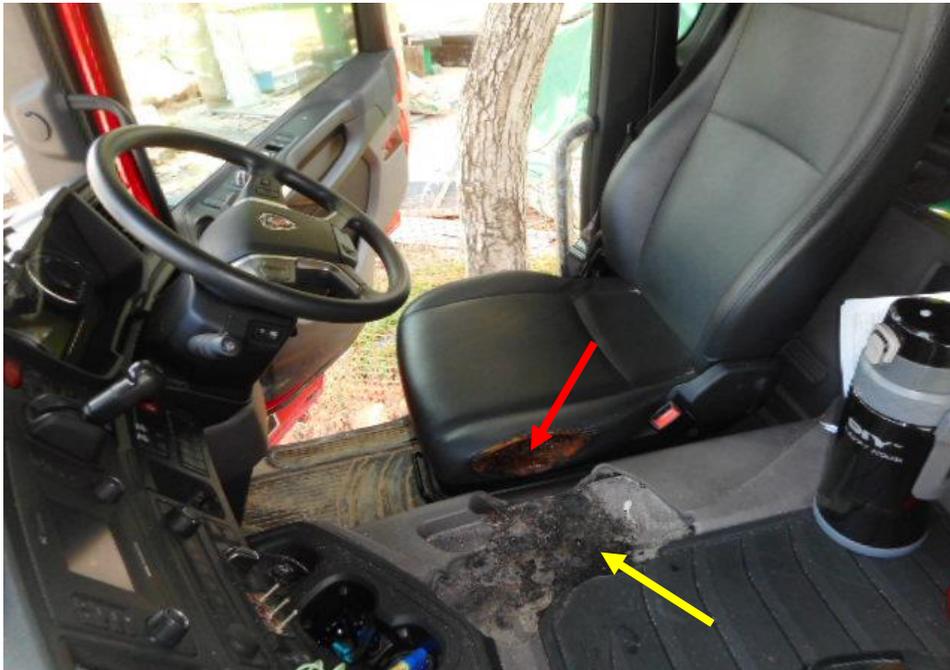
Photo 8 shows the general view of the interior components of the Insured Vehicle at the time of our inspection. The centre console cover (yellow arrow) and the driver seat (red arrow) had suffered heat and smoke damages as a result of the fire.

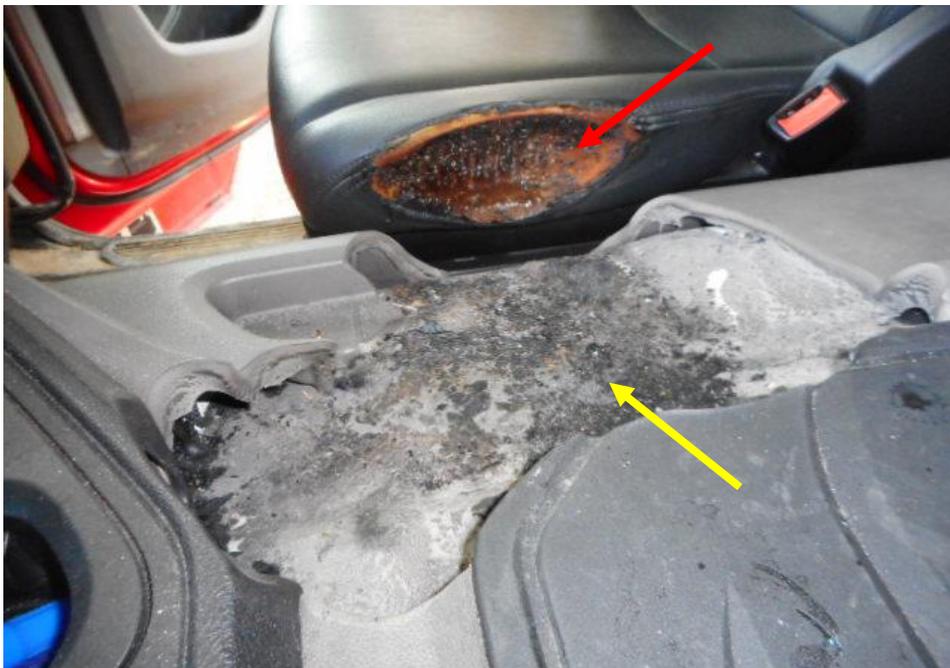
Photo 9 shows the close up view of the interior components of the Insured Vehicle at the time of our inspection. The centre console cover (yellow arrow) and the driver seat (red arrow) had suffered heat and smoke damages as a result of the fire.

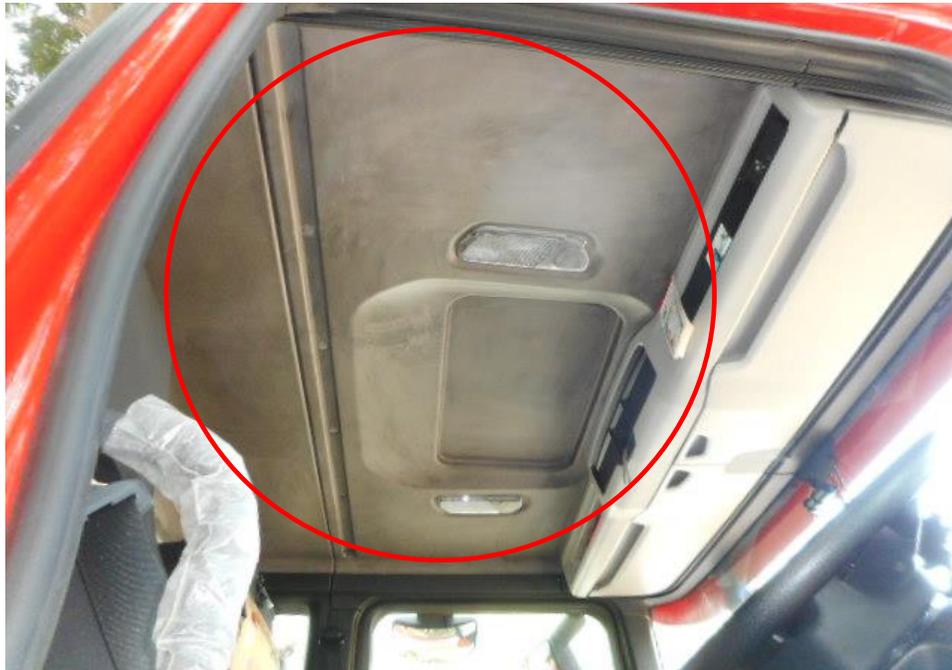
Photo 10 shows the close up view of the roof panel of the Insured Vehicle at the time of our inspection. The surface of the roof lining (circled) had suffered smoke damages as a result of the fire.

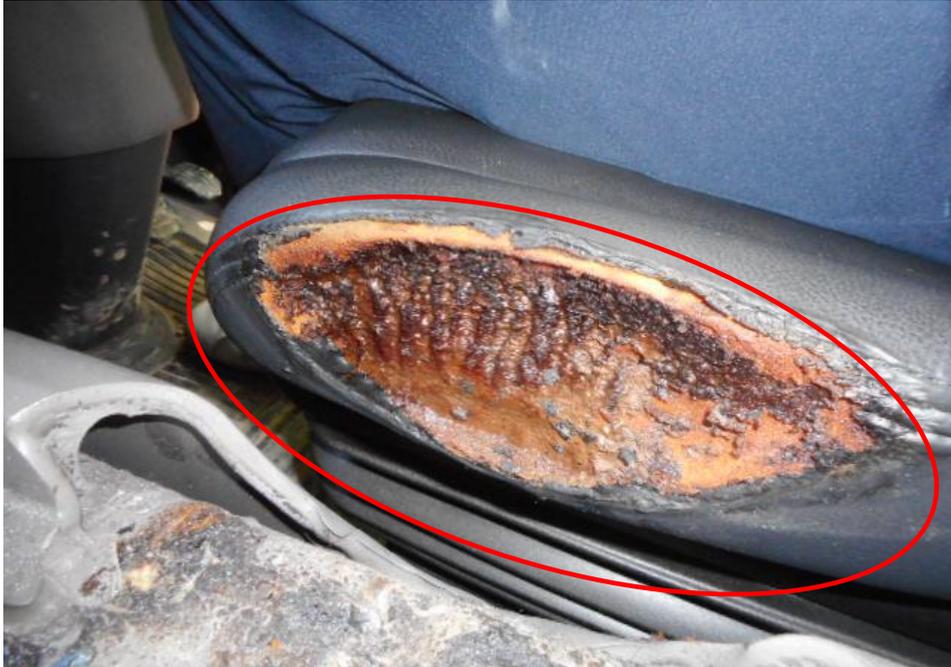
Photo 11 shows the close up view of the from driver seat of the Insured Vehicle at the time of our inspection. Its centre console armrest (circled) was found to have been burnt and melt as a result of the fire.

13. Mr Loh informed us that upon closer examination of the Insured Vehicle's interior he found the aftermath of an exploded wireless earphones and its charging case which was placed on the centre console cover, located right beside the driving seat. The explosion had burnt and damaged the centre console cover and the driver seat in the Insured Vehicle.

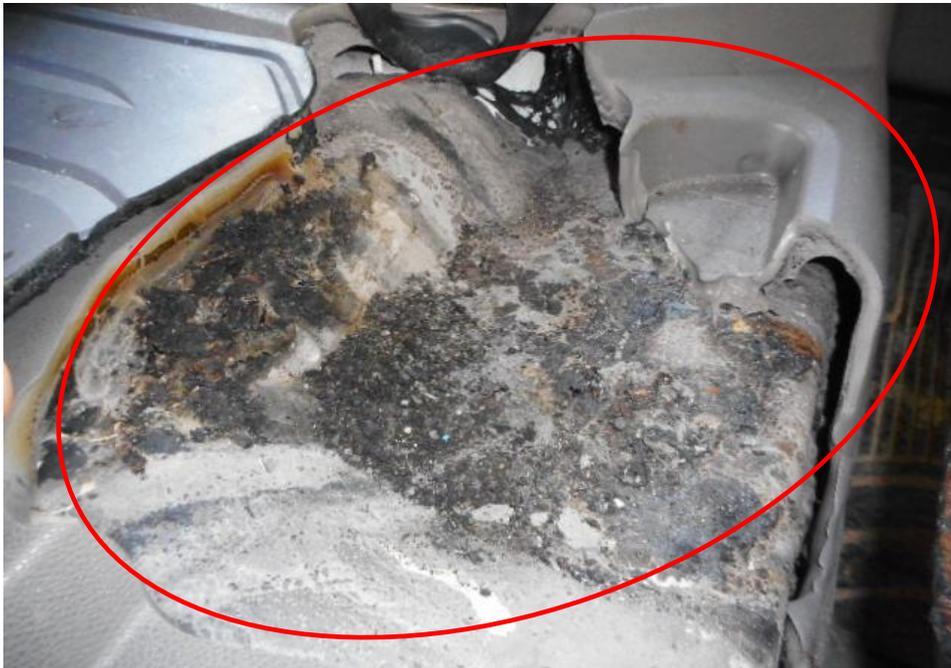
Photo 12 shows the close up view of the from rear left passenger seating compartment of the Insured Vehicle at the time of our inspection. Its rear left foot well (circled) was found to have been burnt as a result of the fire.

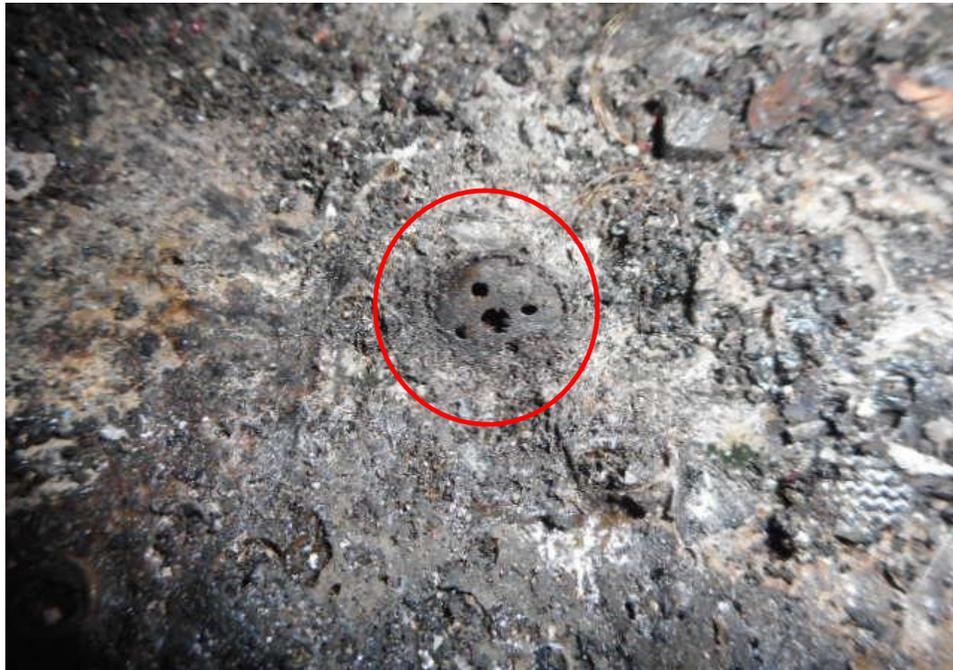
9. Upon closer observations of the centre console cover portion. We have noticed copper strip and a metal component that was burnt and embedded into the centre console cover of the Insured Vehicle See photo 11-15 below.

Photo 13 shows the close up view of the centre console cover of the Insured Vehicle at the time of our inspection. A metal component was (circled) was found to have been burnt and embedded into the centre console as a result of the fire.

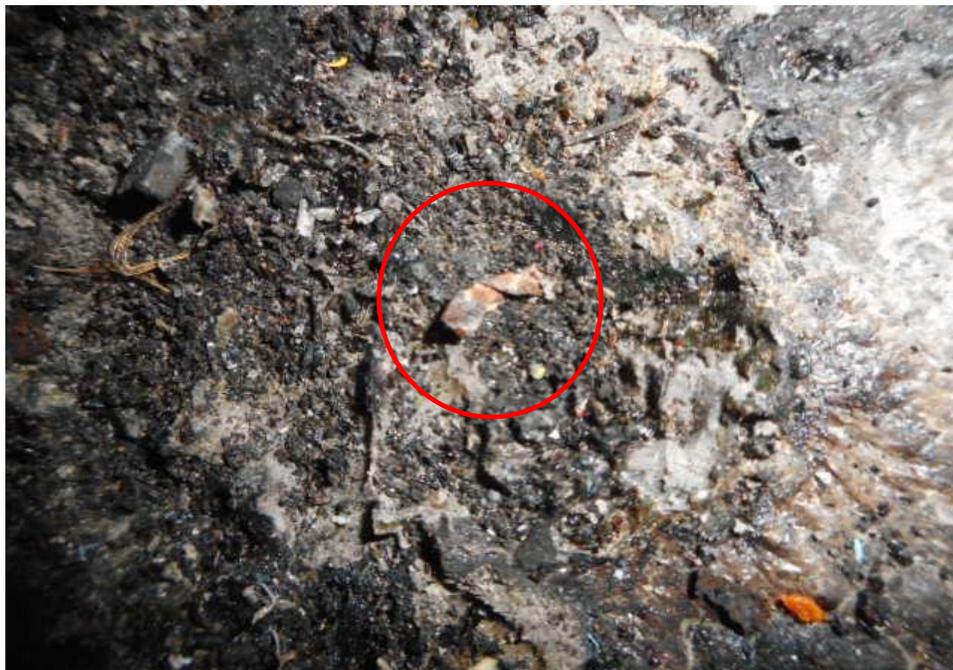
Photo 14 shows the close up view of the centre console cover of the Insured Vehicle at the time of our inspection. A copper strip was (circled) was found to have been burnt and embedded into the centre console as a result of the fire.

19. Having investigated and technically analysed the damages of burnt nature to the Insured Vehicle. We are in view that, the fire had originated from a wireless earphone and charging case placed on the centre console cover of the Insured Vehicle. Fire to the Insured Vehicle was hence due to external factor.
20. Our investigations had also revealed that at the time of writing this report, there is no manufacturer recall to similar make and model vehicle as the Insured Vehicle that may possibly be related to this incident.

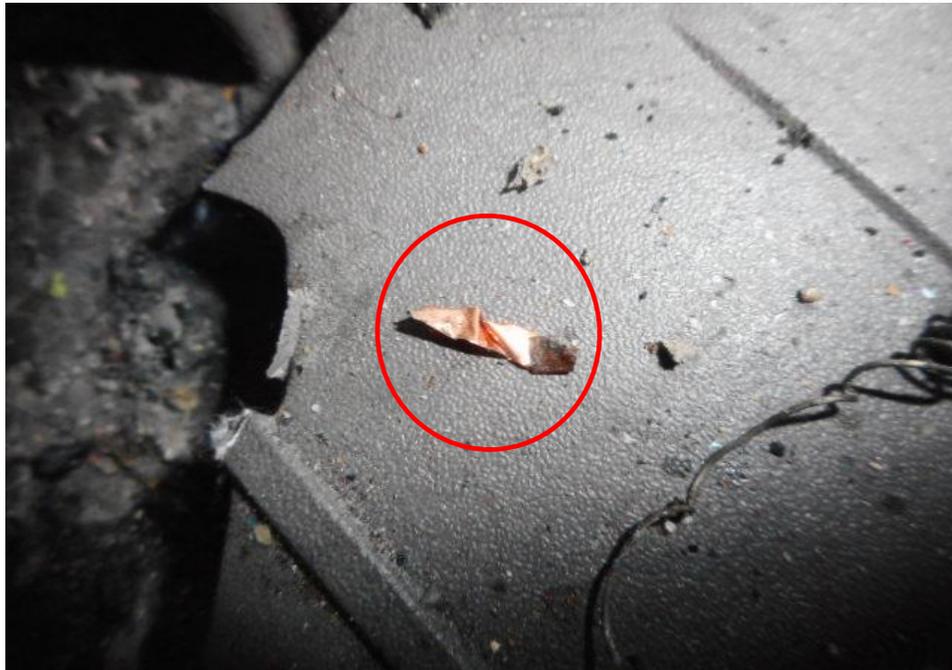
Photo 15 shows the close up view of the centre console cover of the Insured Vehicle at the time of our inspection. The copper strip that was embedded into the centre console cover was removed out (circled) for photo taking purposes.
