# LKK Auto Consultants Pte Ltd

Affiliated to Federation Internationale Des Experts En Automobile				
CHINA TAIPING INSURANCE (S) PTE LTD 3 ANSON ROAD #16-00 SPRINGLEAF TOWERSINGAPORE 079909			Ref: CC6/CTI22009947/Kpa3q2	
			Date: 04/05/2023	
			Code: CTI	
<b>1. Policy Particulars :- THIRD PARTY CLAIM</b>				
Insured Veh.	GBH 4283H	Veh. Inspected	EL 1628K	
Policy No.	DMCVSNW00061472204	Coverage (\$)	0.00	
Claim No.	SNM22D207131/C02	Excess (\$)	0.00	
Assign From		Assign Date	06/10/2022	
<b>2. Vehicle Particulars &amp; Condition</b>				
Make & Model	MAZDA 5 (A)	c.c	1998	
Engine No.	HIDDEN	Year of Reg.	2016	
Chassis No.	JM6CW1071G0123717	Colour	METALLIC GREY	
Odometer	97392 KM	Steering	IN ORDER	
Brakes	IN ORDER	Modification	STANDARD ALLOY RIM	
General	GOOD			
<b>3. Conditions of Tyres</b>				
	Size	Make	Balance	
R/H Front Tyre	205/55 R16	MICHELIN	6 mm	
L/H Front Tyre	205/55 R16	MICHELIN	6 mm	
R/H Rear Tyre	205/55 R16	MICHELIN	6 mm	
L/H Rear Tyre	205/55 R16	MICHELIN	6 mm

## ADJUSTMENT ON REPAIR COST FOR VEHICLE NO. EL 1628K

### PHOTOGRAPHS FOR VEHICLE NO. EL 1628K

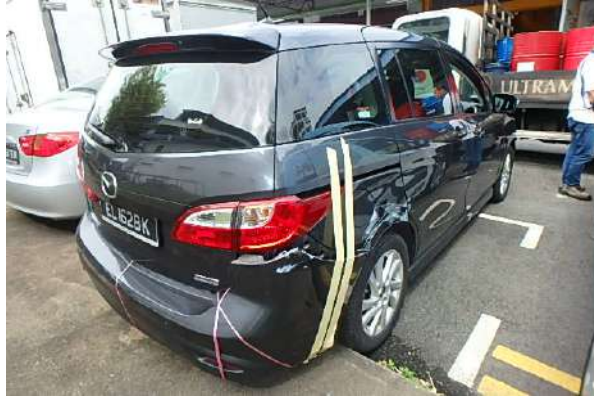
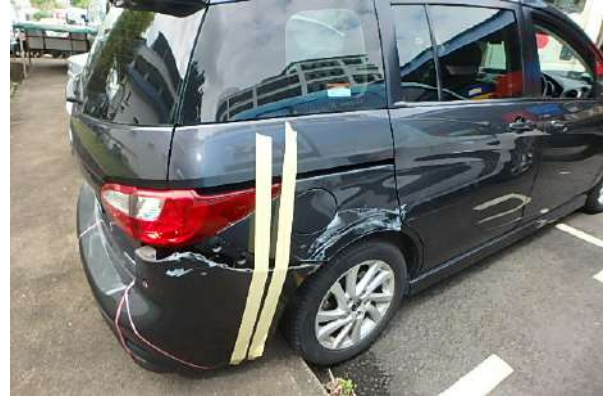
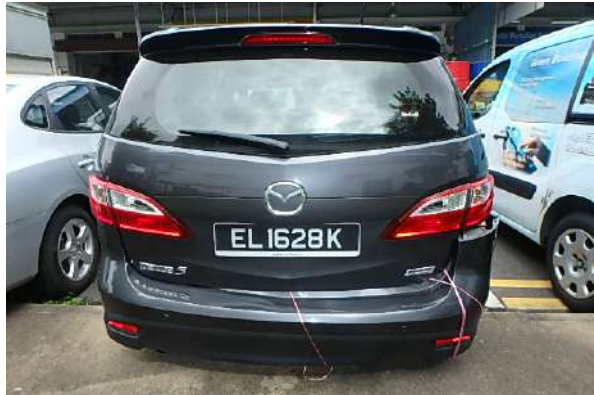
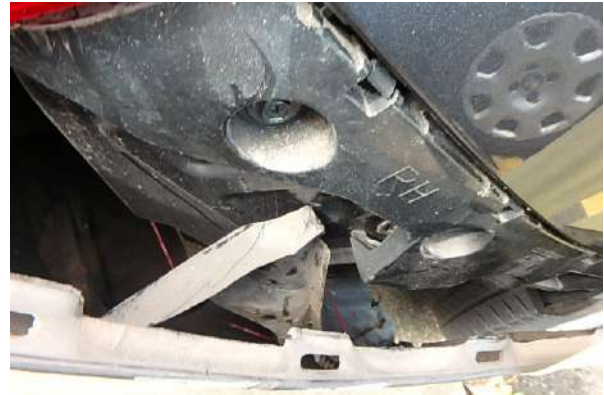
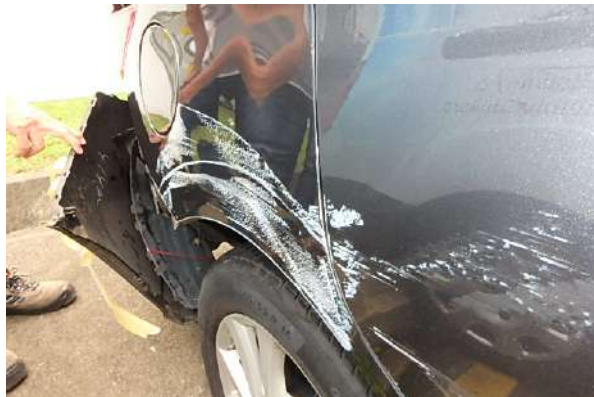
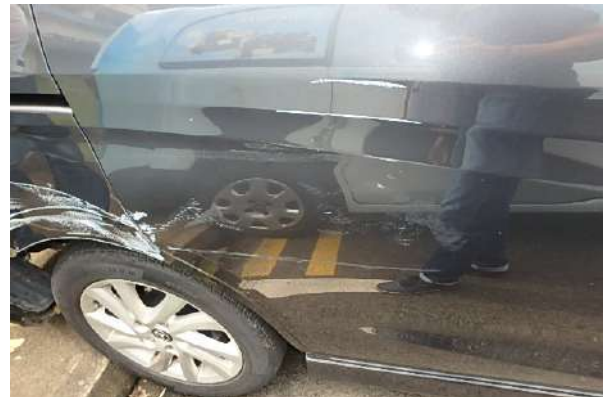
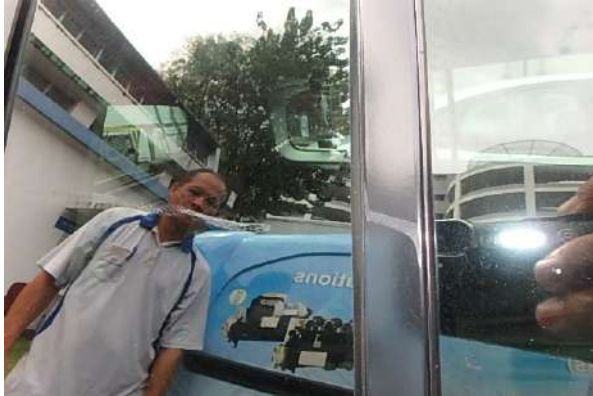
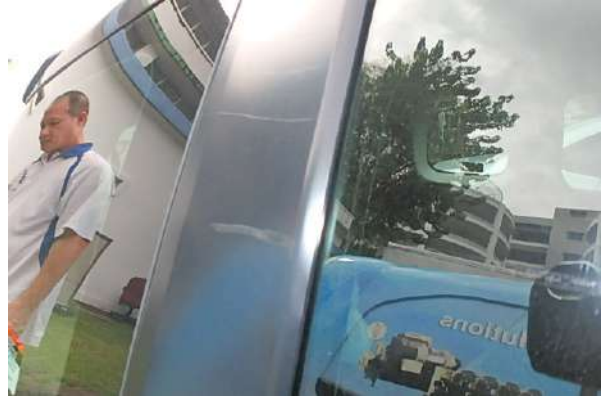
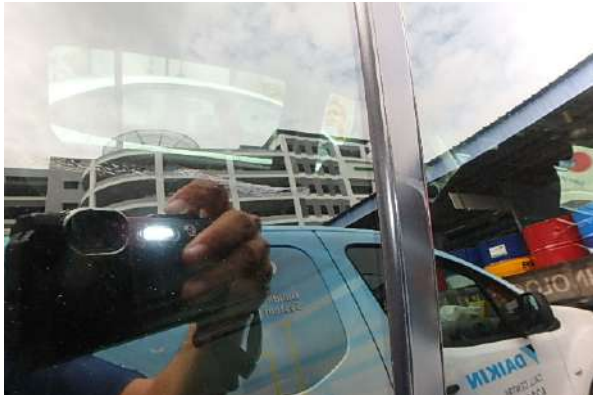
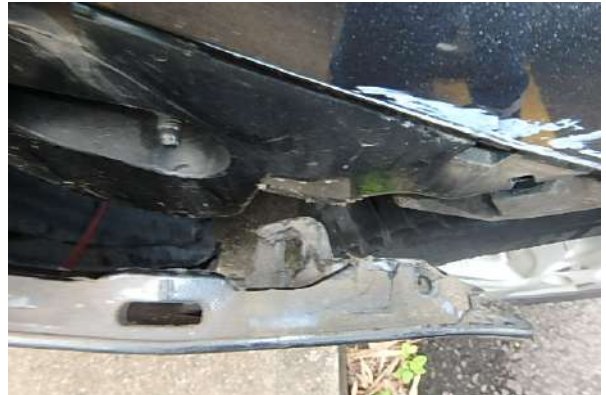
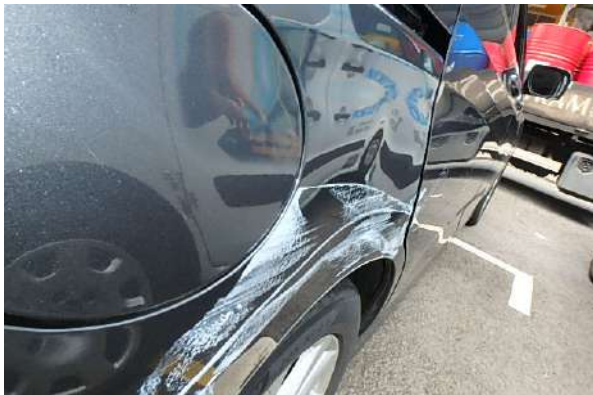
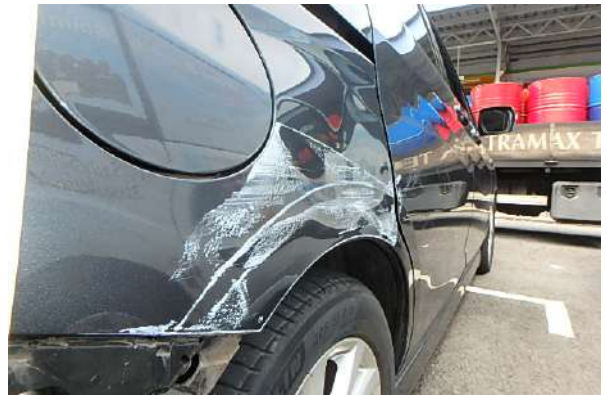
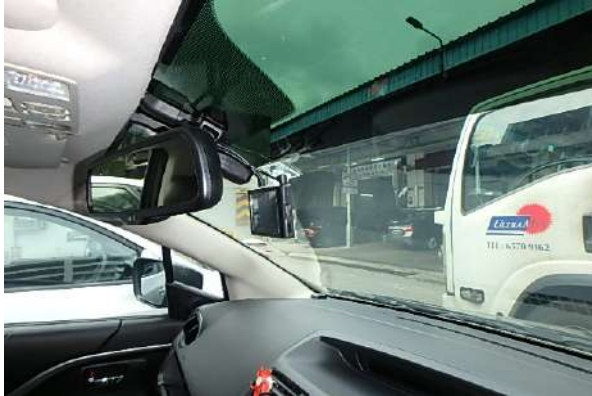
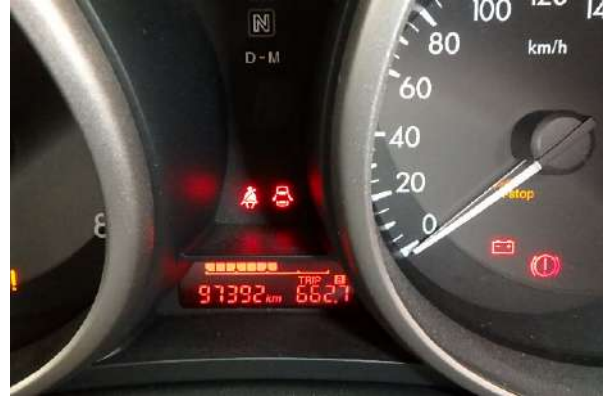
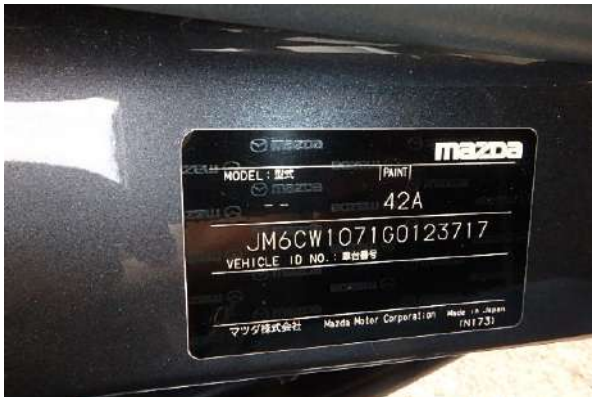
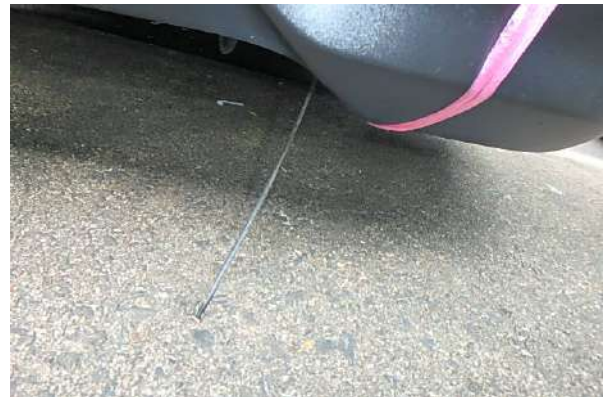
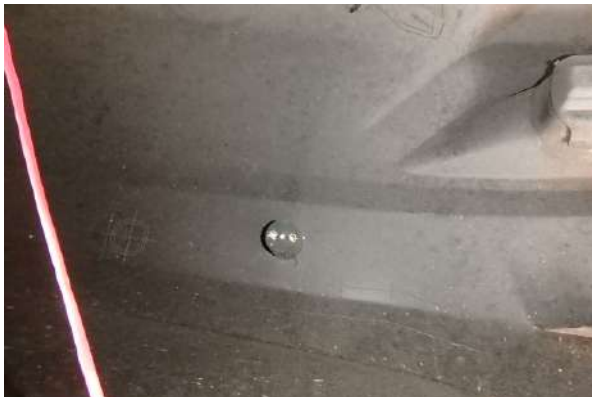
### INSPECTION

<b>4. Description of Damages</b>				
THE VEHICLE SUSTAINED DAMAGES AT THE O/S REAR PORTION.  DAMAGES SEE DETAILS.				
<b>5. General Information</b>				
Accident Date	05/10/2022	Inspection Date	06/10/2022	
Survey held at	ALAN'S UNITED AUTO PTE LTD BLK 7 SIN MING INDUSTRIAL ESTATE #01-76 SINGAPORE 575642			
<b>5a. Remarks</b>				
A)THE INSPECTION WAS CONDUCTED ON A"WITHOUT PREJUDICE" BASIS. B)IN ACCORDANCE TO YOUR INSTRUCTIONS, WE HAVE NOT AUTHORISED REPAIRS.				
<b>5b. Estimate Days of Repair</b>				
ESTIMATED NORMAL PERIOD FOR REPAIR:			6 Working Days

Qty	Description of Parts	Condition	Estimate By Workshop (\$)	Our Adjusted (\$)
	<b><u>REPLACEMENT OF PARTS</u></b>			
1	REAR O/S FENDER	BENT	2,467.00	2,428.00
1	REAR O/S MUDFLAT	CRACKED	59.00	59.00
1	REAR BUMPER FASCIA	MTG CRACKED	962.00	962.00
1	REAR O/S BUMPER SIDE RETAINER	DISTORTED	48.00	48.00
1	REAR O/S TAILLAMP	SERVICEABLE	607.00	-
1	REAR O/S FENDER GLASS SEAL	NECESSARY	32.00	32.00
1	O/S SLIDING DOOR	TO REPAIR SEE LABOUR	1,432.00	-
1	O/S SLIDING DOOR FRAME TAPE	CUT	65.40	65.40
1	O/S SLIDING DOOR GLASS	CUT	281.20	281.20
	LESS 20% DISCOUNT		-1,190.72	-775.12
			4,762.88	3,100.48
	<b><u>SPECIAL NETT ITEMS</u></b>			
1	REAR O/S QUARTER GLASS SEALANT (SN)	NECESSARY	60.00	40.00
1	SET REAR BUMPER REVERSE SENSOR (SN)	TORN	300.00	200.00

360.00	240.00
	<b><u>LABOUR</u></b>			
	TO REMOVE & REFIX O/S QUARTER GLASS .		100.00	60.00
	TO APPLY UNDERSEALING.		60.00	30.00
	TO PUTTY AND SPRAY REPLACED PARTS.		900.00	700.00
	TO REMOVE, CUT -OUT DAMAGED PARTS ,PANEL BEATING ,WELDING ,ALIGN,REFIX AND TO RENEW ABOVE PARTS.INCLUSIVE OF THE REPAIR OF O/S SLIDING DOOR .		800.00	700.00
			1,860.00	1,490.00
	<b>GRAND TOTAL</b>		<b>6,982.88</b>	<b>4,830.48</b>

<b>RECOMMENDED COST OF LUMP SUM REPAIRS (TO ITS PRE-ACCIDENT CONDITION)</b>			<b>3,850.00</b>
---	--	--	-----------------
