Your Ref: BVS22/1170
Our Ref : CS4/LIP22009955/P

18th November 2022

TECHNICAL INVESTIGATION REPORT OF FIRE INCIDENT INVOLVING THE INSURED VEHICLE PC 21J ON 1st OCTOBER 2022

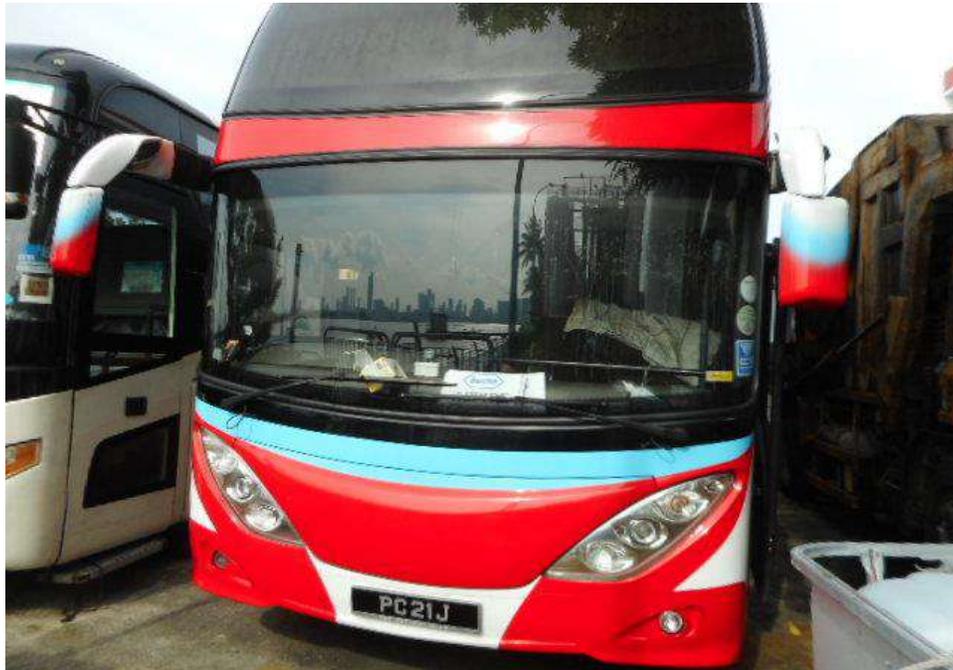
Photo 1 shows the general view of the front portion of the Insured Vehicle at the time of our inspection. The front portion of the Insured Vehicle was unaffected by the fire.

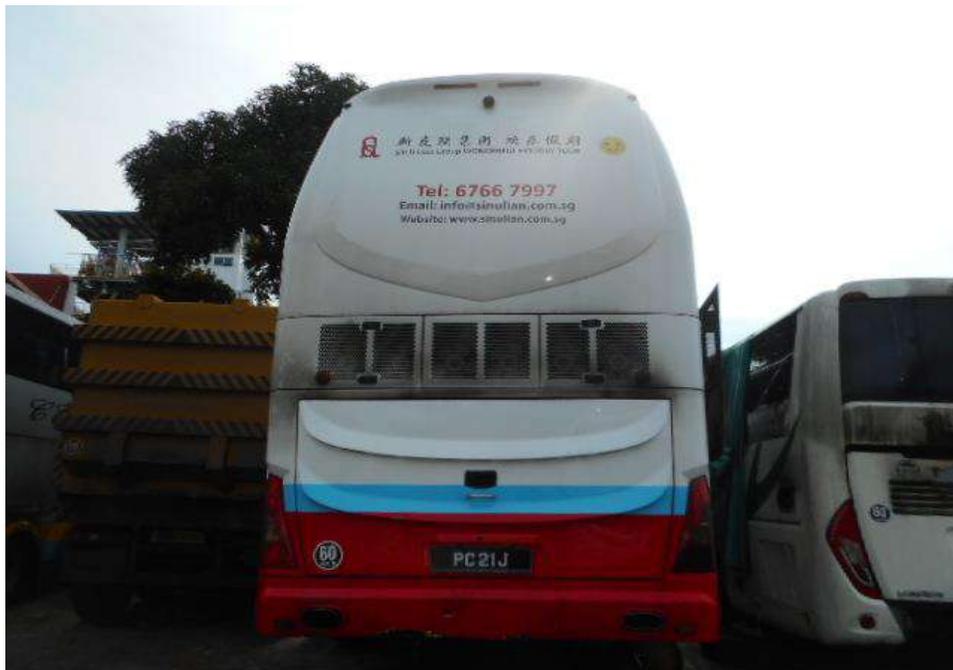
Photo 2 shows the general view of the rear portion of the Insured Vehicle at the time of our inspection. The rear portion of the Insured Vehicle was unaffected by the fire.

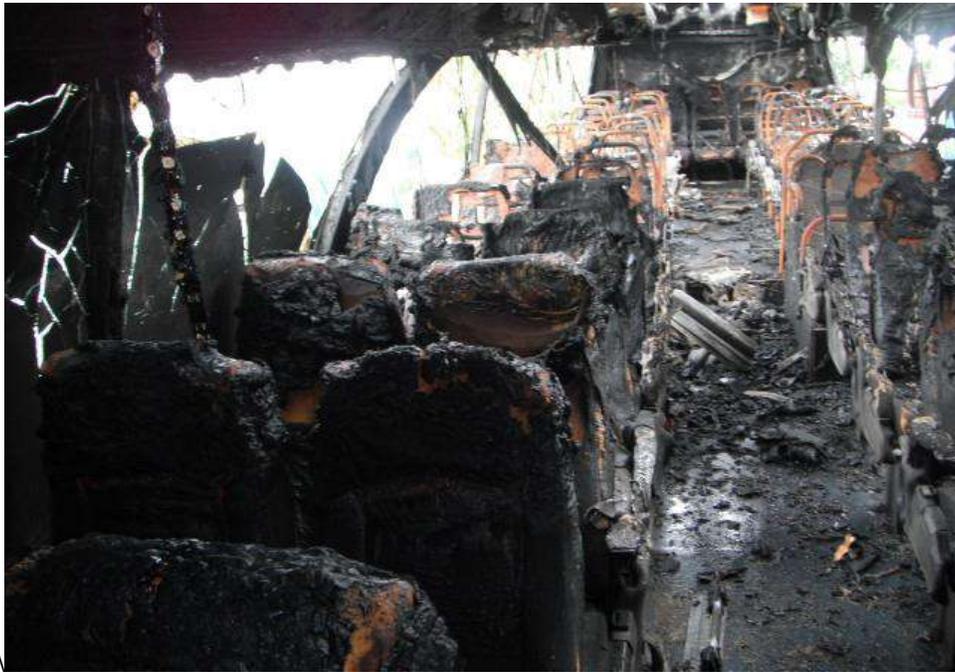
Photo 3 shows the interior cabin of the Insured Vehicle at the time of inspection. The interior rear cabin including its seats and windows was completely burnt.

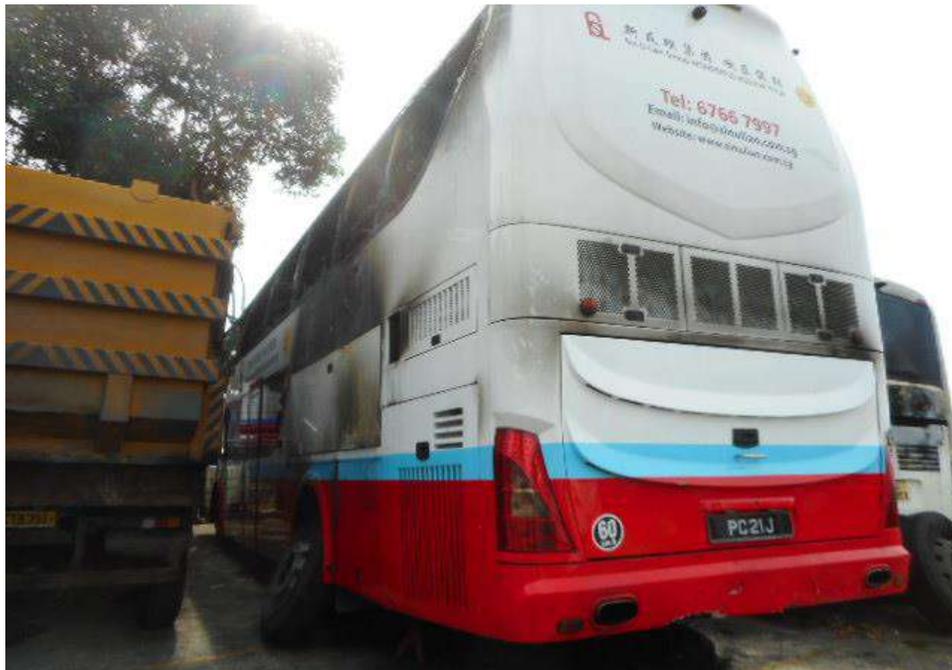
Photo 4 shows the general view of the left portion of the Insured Vehicle at the time of our inspection. The exterior body of the Insured Vehicle had sustained fire damage at the rear portion. Affected parts had included the rear windows and rear left panels.

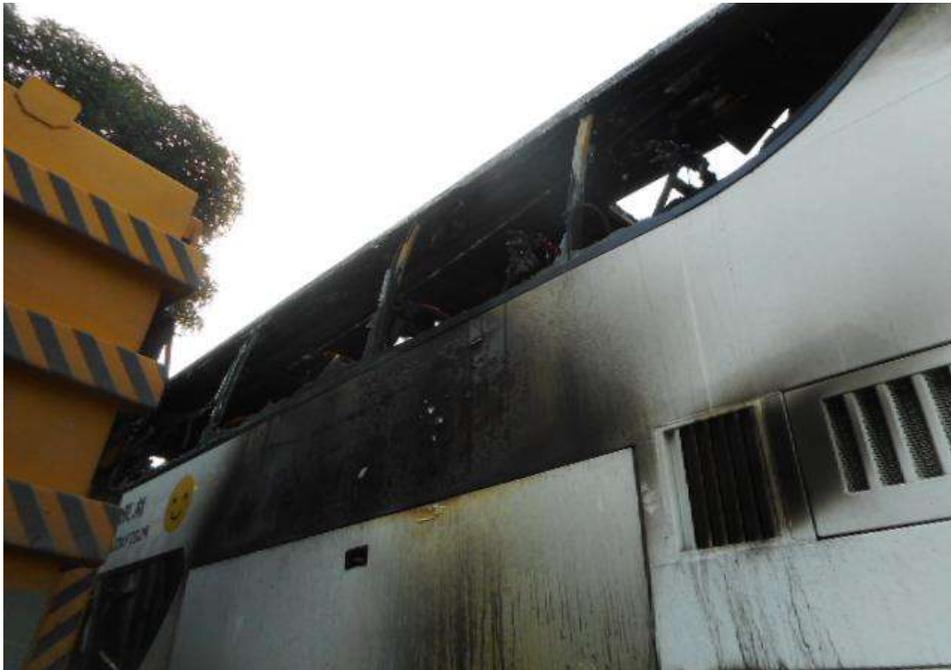
Photo 5 shows the close up view of the left portion of the Insured Vehicle at the time of our inspection. The exterior body of the Insured Vehicle had sustained fire damage at the rear portion. Affected parts had included the rear windows and rear left panels.

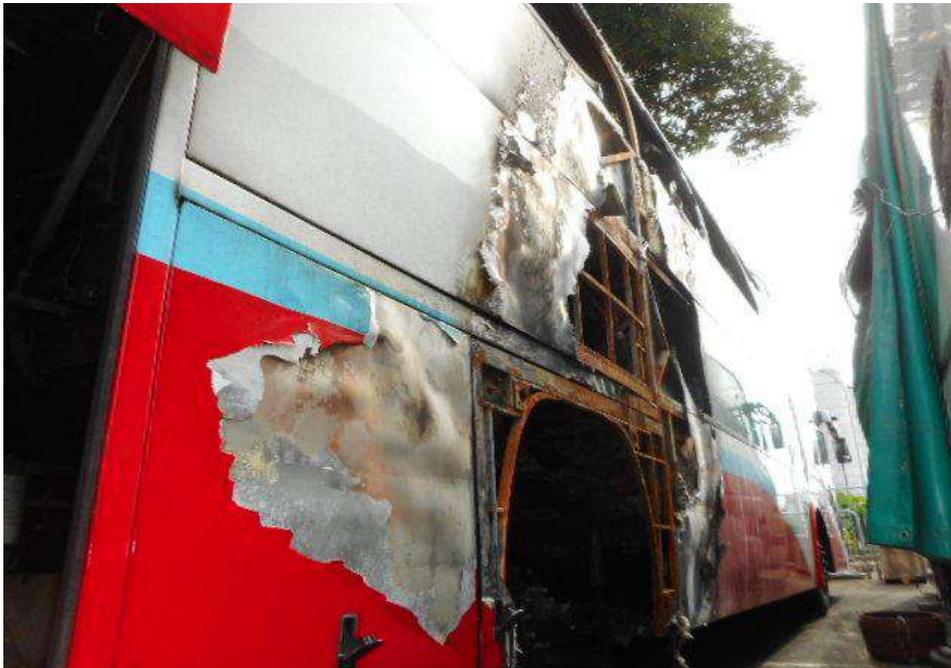
Photo 6 shows the general view of the right portion of the Insured Vehicle at the time of our inspection. The exterior body of the Insured Vehicle had sustained fire damages at the rear right wheel and rim area as well as its rear right body panel portion. Affected parts had included the right rear panels, rear right windows and the rear right wheel and rims.

7. For this particular case, the fire appears to have originated from rear right portion of the Insured Vehicle, around the rear right wheel rims and tyres portion of the Insured Vehicle. This can be determined from the nature of the fire damage which was more extensive at the rear right portion. Basing on the circumstances of the fires' origin at the material time of incident as well as examining the area where the extent of fire damage was most severe, we can determine that the fire had likely started from the rear right wheel rims and tyres portion of the Insured Vehicle.

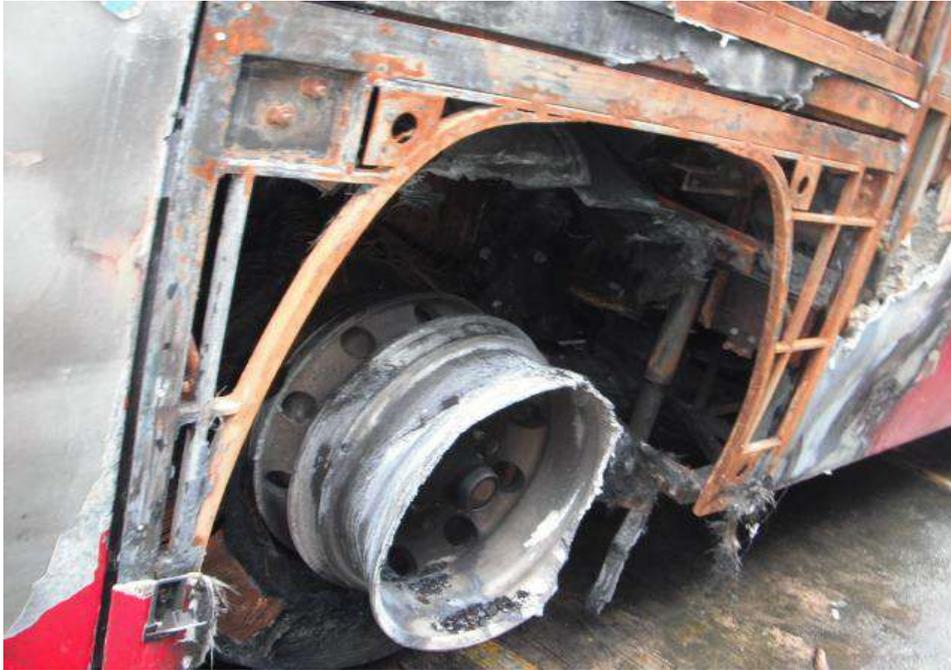
Photo 7 shows the close up view of the rear right portion of the Insured Vehicle at the time of our inspection. The wheel rims and the tyres of the Insured Vehicle had sustained severe fire damage.

8. Upon closer examination of the rear right portion of the wheel rims and its tyres of the Insured Vehicle as well as around the immediate vicinity to where the fire had likely started, we had observed that the outer wheel rim had sustained the highest heat intensity burn marks (whitish burn marks) that were found on the surface of it and it was also dented and cracked.

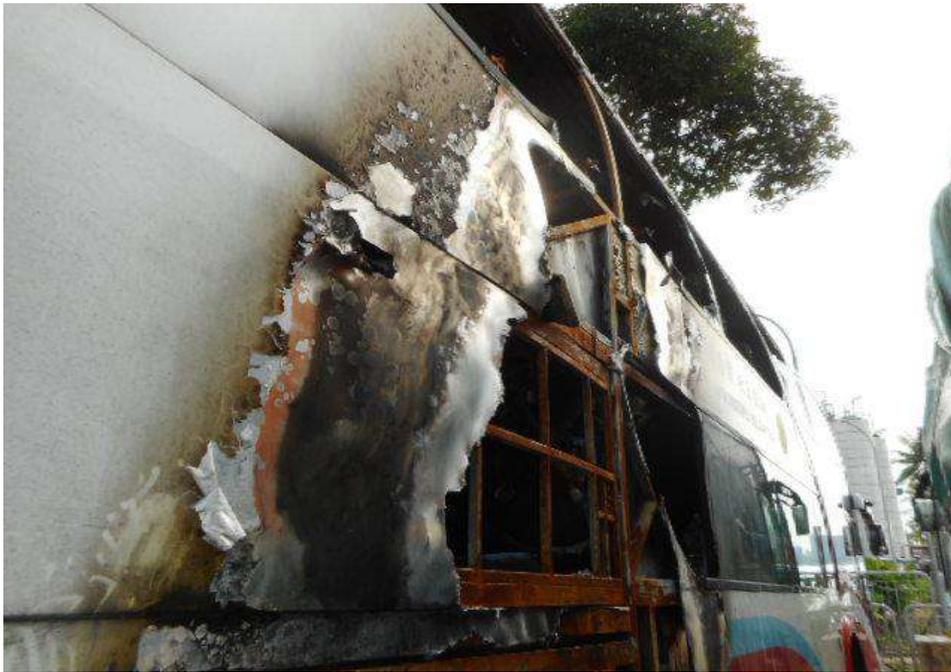
Photo 8 shows a closer view of the right rear portion of the Insured Vehicle at the time of our inspection. The fire damage was observed to be at its rear right portion. The rear right body panel was observed to be affected by the fire.

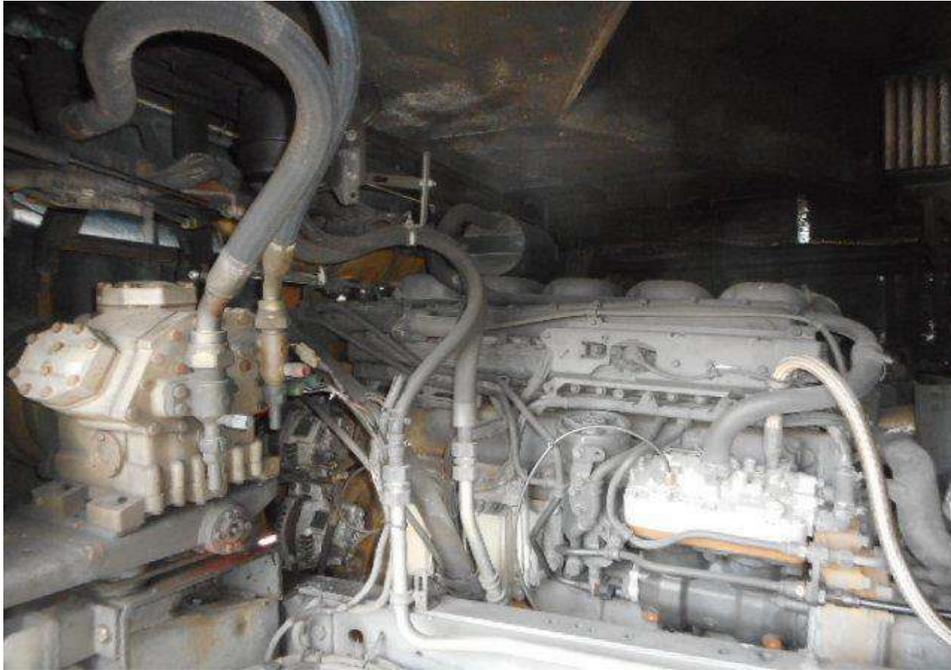
Photo 9 shows a general view of the engine compartment of the Insured Vehicle at the time of our inspection. The engine compartment of the Insured Vehicle was observed to be unaffected by the fire.

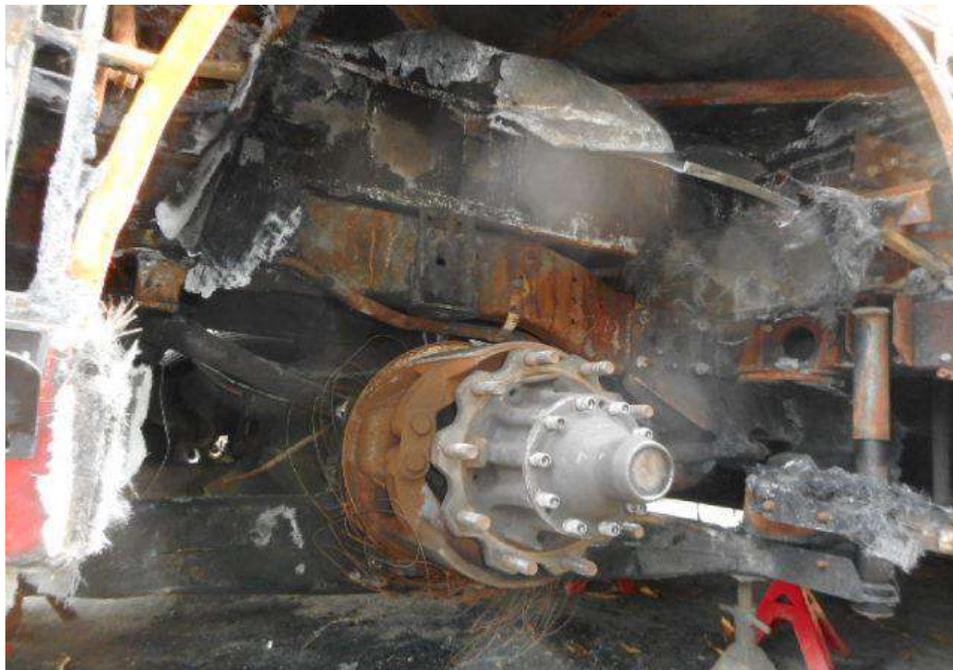
10. Firstly, we have removed the right wheel rims of the Insured Vehicle to inspect their drum brakes and brake pads and we did not notice any signs of brakes lock up or burn to either the exterior or interior surface of the rear right brake drums and top or bottom of the brake pads on the Insured Vehicle.

Photo 10 shows a general view of the rear right brake drum and brake pad of the Insured Vehicle after the wheel rim was removed. Upon closer examination, we did not observe any damages to the brake drum or the brake pad.

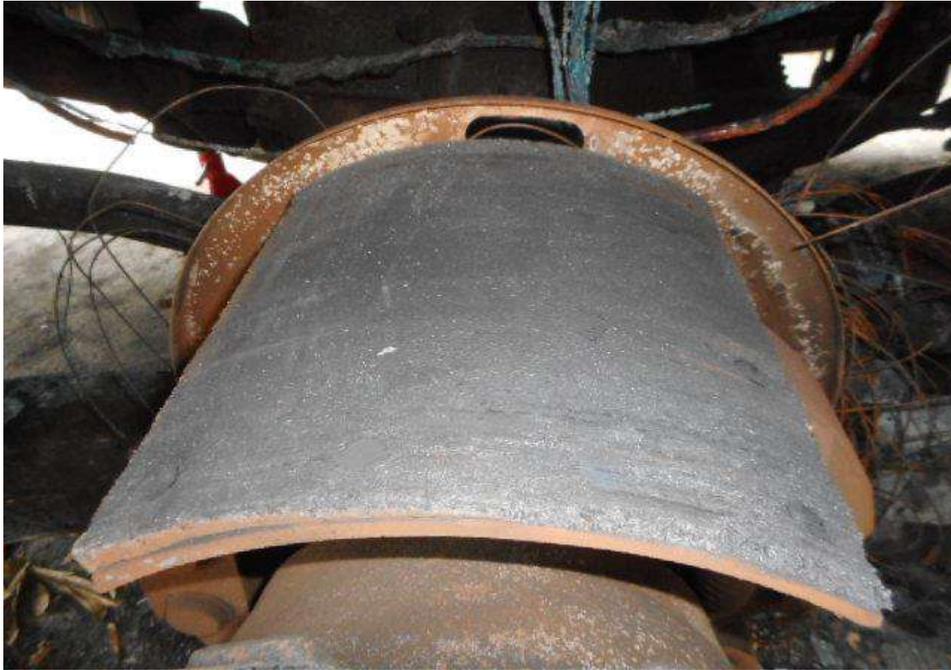
Photo 11 shows a close up view of the rear left top brake drum pad of the Insured Vehicle. Upon closer examination, we did not observed any damages to the brake drum pad.

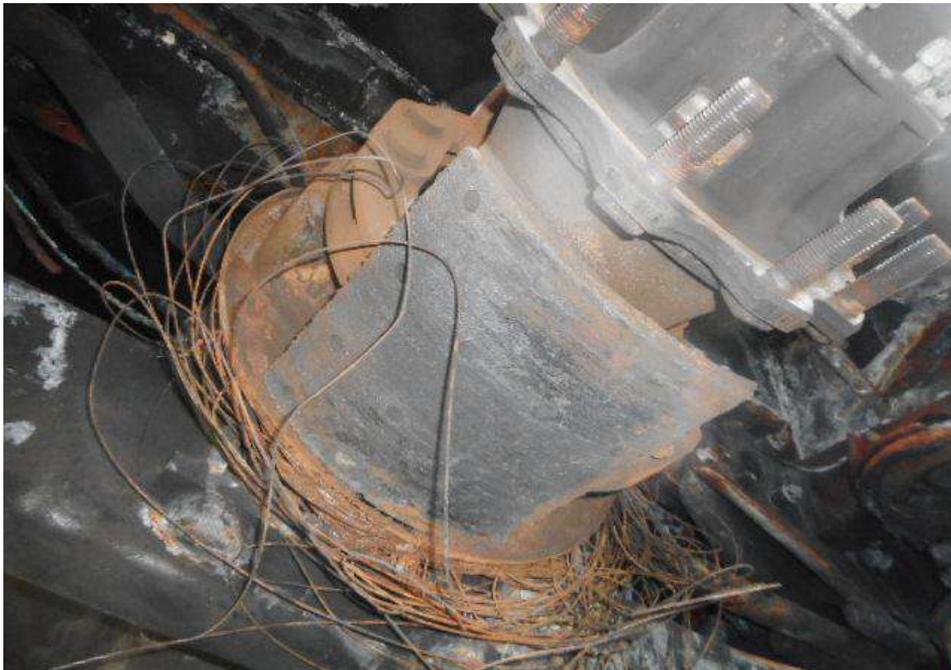
Photo 12 shows a general view of the rear left bottom brake drum pad of the Insured Vehicle. Upon closer examination, we did not observed any damages to the brake drum pad.

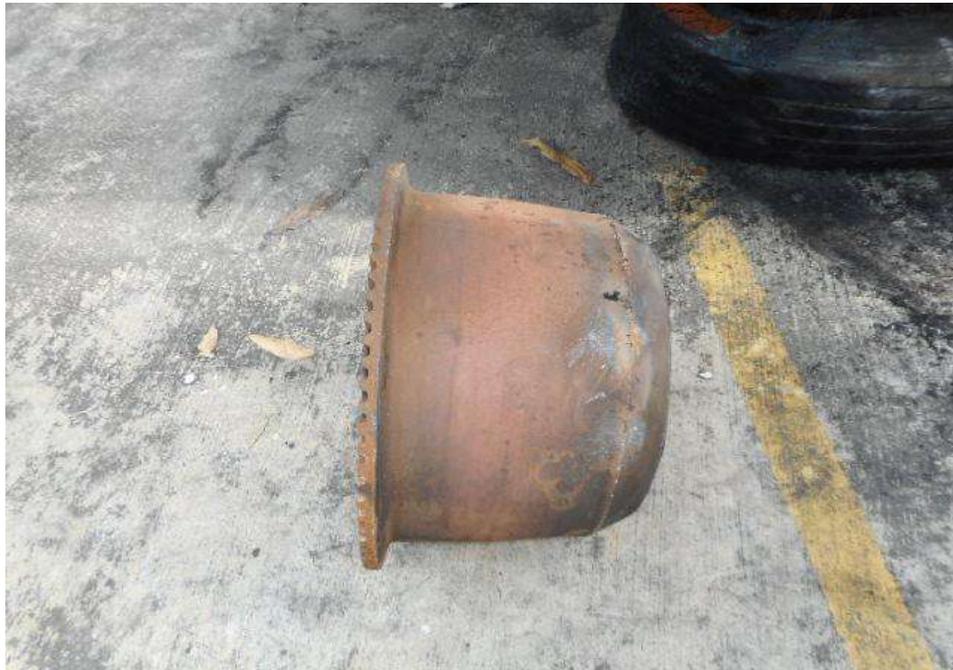
Photo 13 shows a general view of the rear left brake drum of the Insured Vehicle. Upon closer examination, we did not observe any damages to the exterior surface of the brake drum.

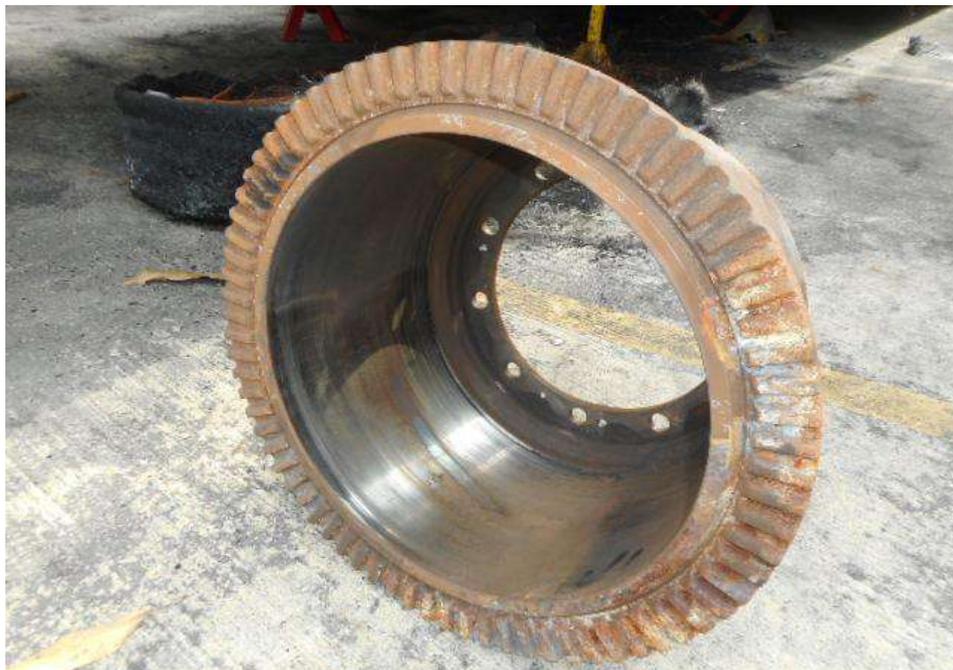
Photo 14 shows a general view of the rear left brake drum of the Insured Vehicle. Upon closer examination, we did not observe any damages to the interior surface of the brake drum.

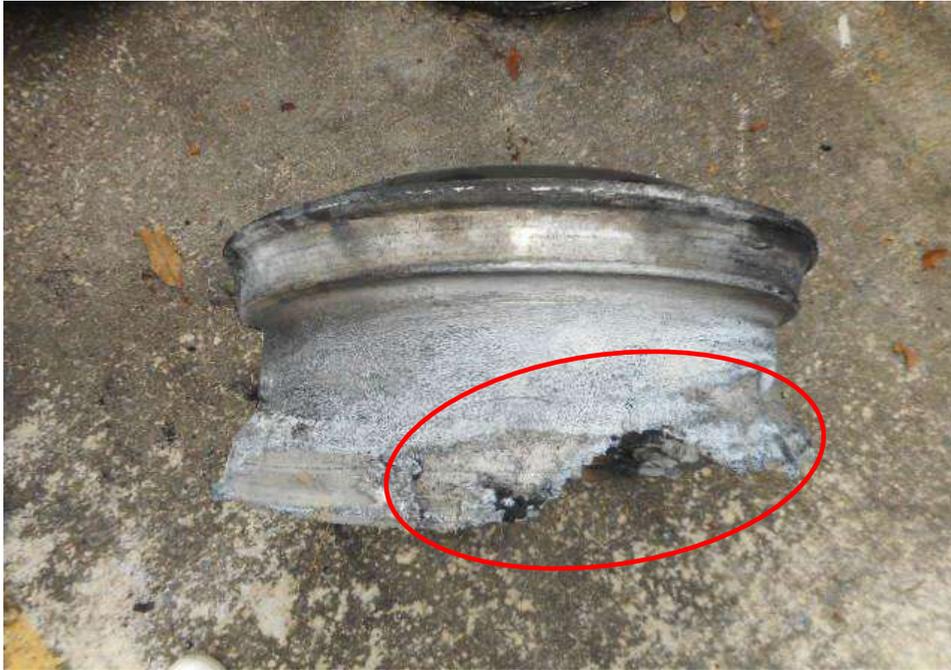
9. In our opinion, the dent and cracked damages observed on the rear right outer wheel rim was likely not the result of the fire. In support to this claim we have investigated further; we focus on our findings to the wheel rim and tyres area and identify that the moving components in the area are the drum brakes system and the wheel drum itself.

Photo 15 shows a general view of the rear right outer wheel rim of the Insured Vehicle. Upon closer examination, we observed that the dent and cracked wheel rim (circled) was caused by an impact that had caused the deformed damage to it.

28. Although we are unable to inspect the rear right outer tyre as it was burnt by the fire. We are in view that the rear right outer tyre had suffered a puncture causing the rear right outer wheel rim to contact the road surfaces resulting in the fire. As we observed that the dent and cracked damages on the rear right outer wheel rim was due to an impact resulting in the damages. The puncture to the rear right outer tyre had caused the bus to tilt down slightly to the right result in the rear right outer wheel rim to contact the road surfaces and causing the damages as well.

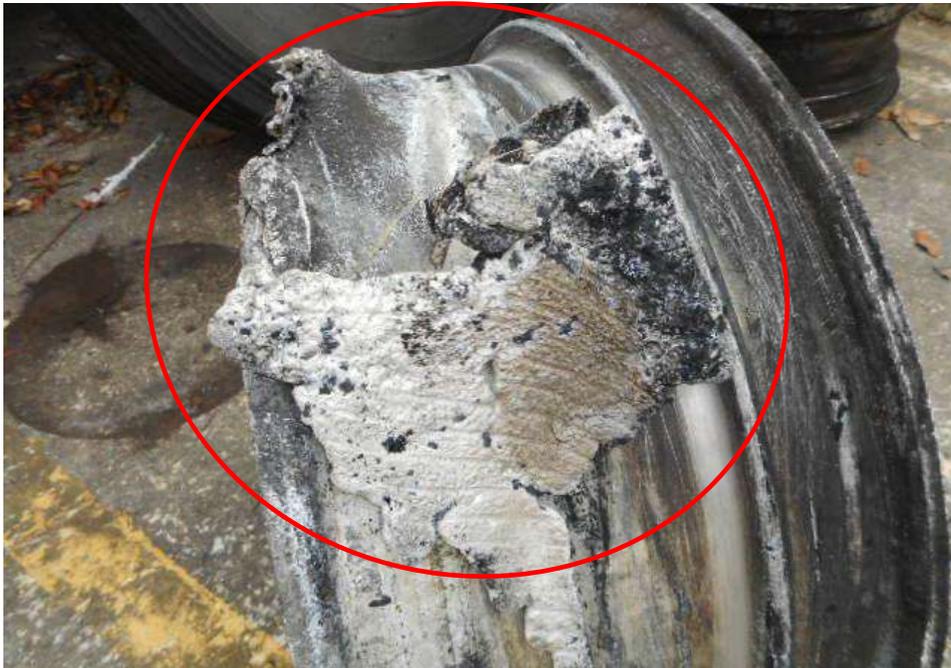
Photo 16 shows a close up view of the rear right outer wheel rim of the Insured Vehicle. Upon closer examination, we observed that the dent and cracked wheel rim (circled) was caused by an impact that had caused the deformed damage to it.

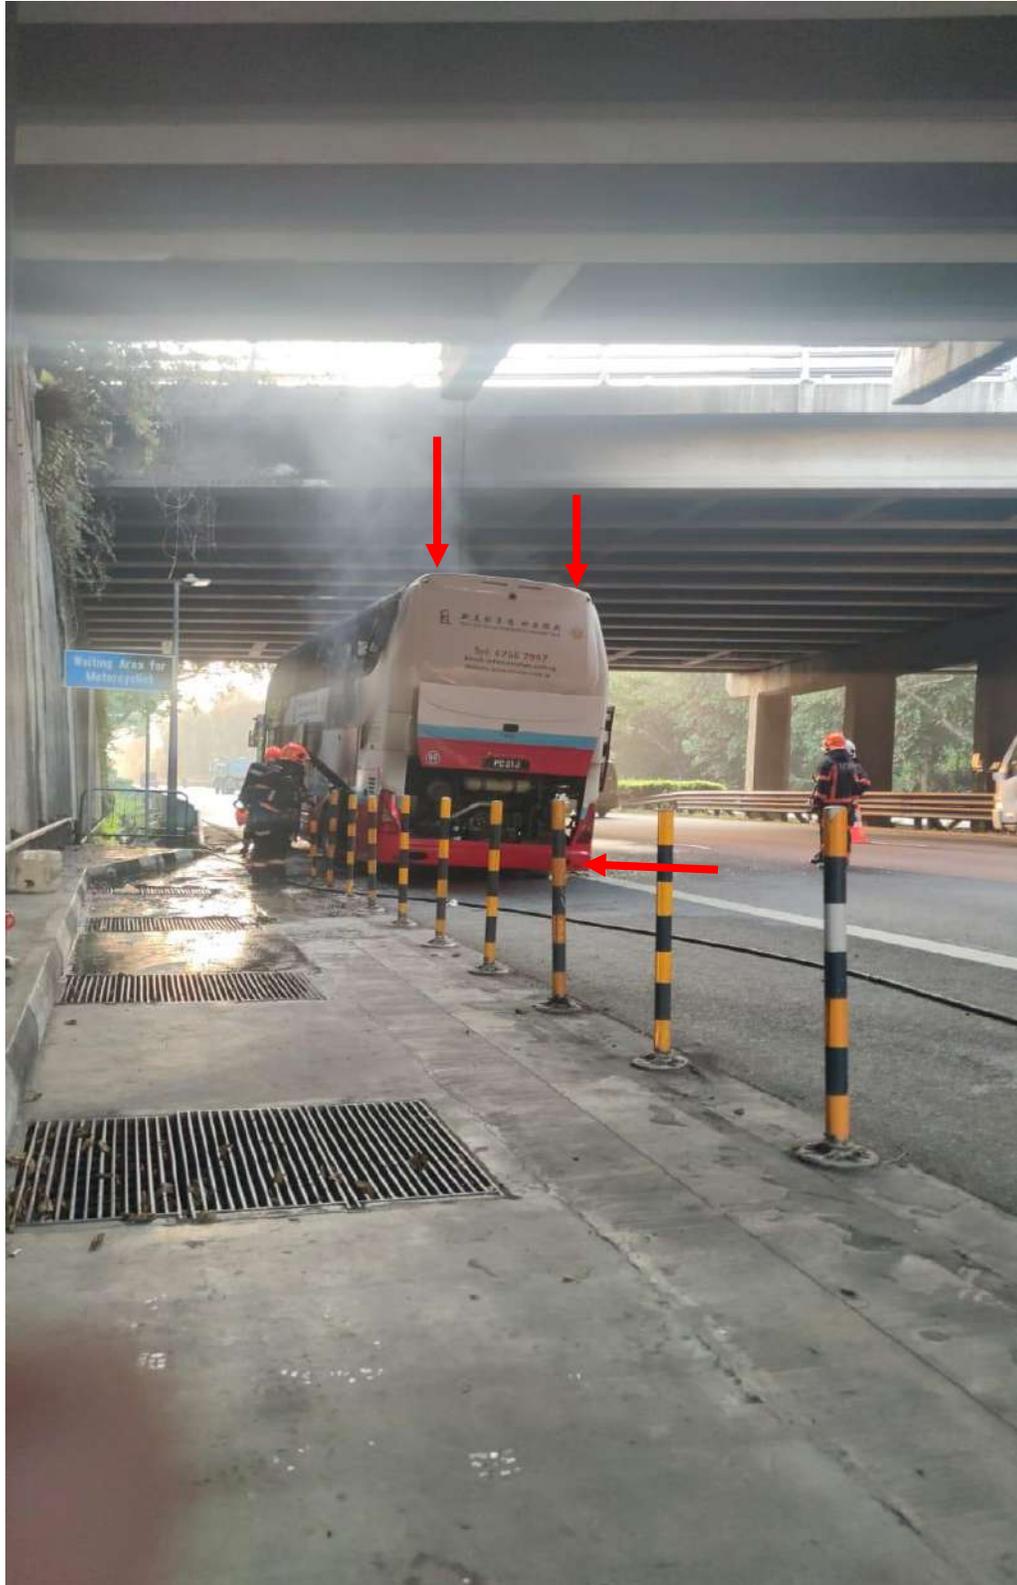
24. Our examination of the photograph revealed that the Insured Vehicle was observed to be tilted down to right side and the fire at the material time of incident. The photographs had also showed the Insured Vehicle on fire and similar extent of damage and burn pattern to the Insured Vehicle as per what we had observed during our physical inspection of the Insured Vehicle. Apart from the aforesaid, there was no further notable information that could be gathered from these photographs. See photo17 below.

Photo 17 shows that the Insured Vehicle was observed to be tilted down to the right side (arrowed) of the Insured Vehicle at the material time of incident. The photographs had also showed the Insured Vehicle on fire and similar extent of damage and burn pattern to the Insured Vehicle as per what we had observed during our physical inspection of the Insured Vehicle.
