Your Ref: BVS22/1170  
Our Ref : CS4/LIP22009955/P

18<sup>th</sup> November 2022

## **TECHNICAL INVESTIGATION REPORT OF FIRE INCIDENT INVOLVING THE INSURED VEHICLE PC 21J ON 1<sup>st</sup> OCTOBER 2022**

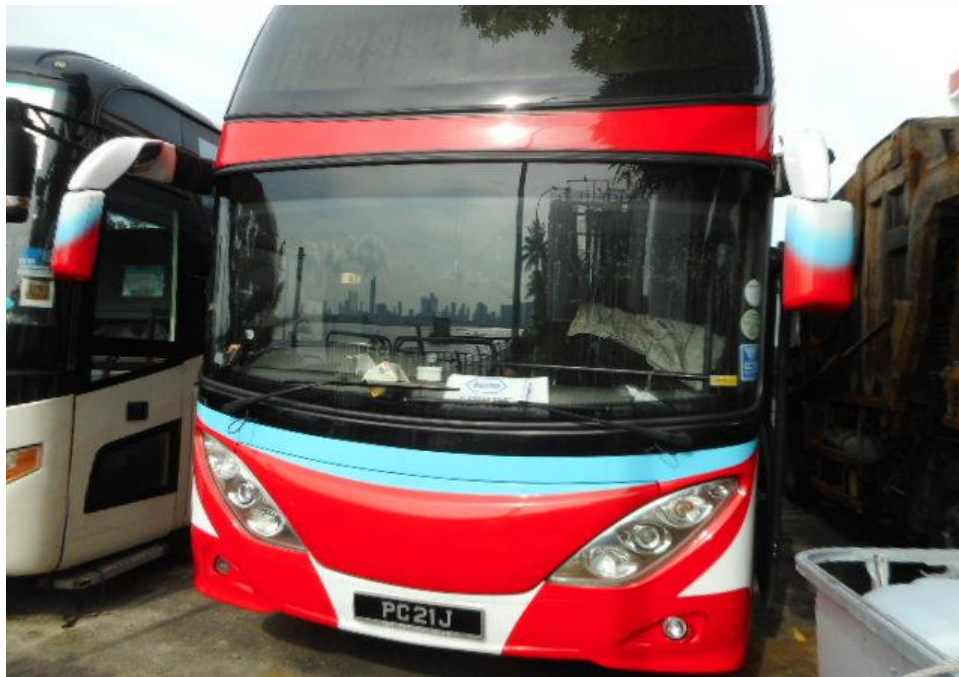
**Photo 1** shows the general view of the front portion of the Insured Vehicle at the time of our inspection. The front portion of the Insured Vehicle was unaffected by the fire.

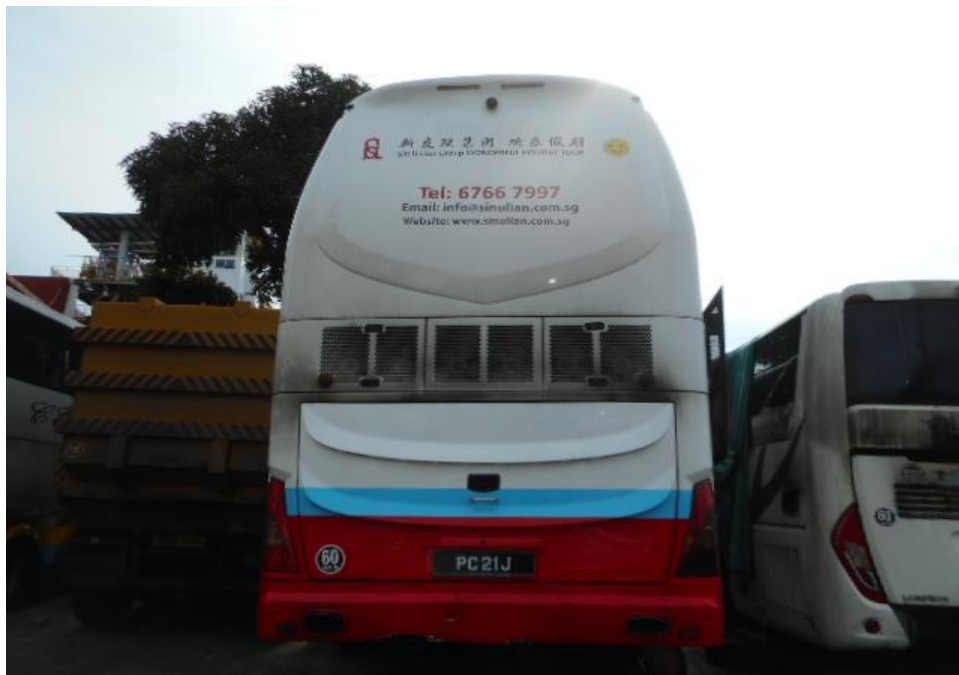
**Photo 2** shows the general view of the rear portion of the Insured Vehicle at the time of our inspection. The rear portion of the Insured Vehicle was unaffected by the fire.

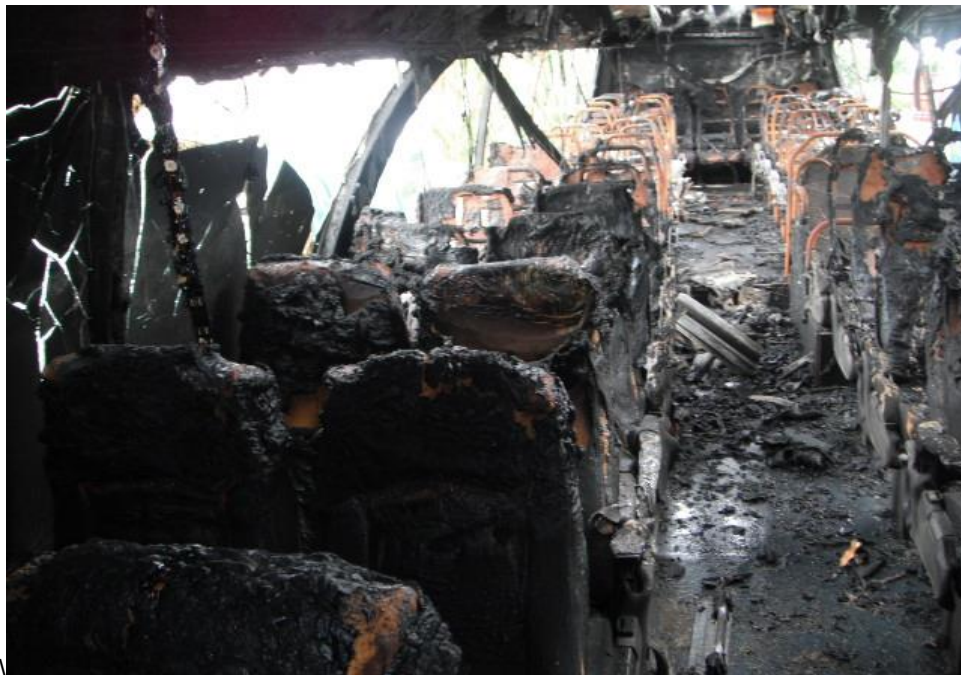
**Photo 3** shows the interior cabin of the Insured Vehicle at the time of inspection. The interior rear cabin including its seats and windows was completely burnt.

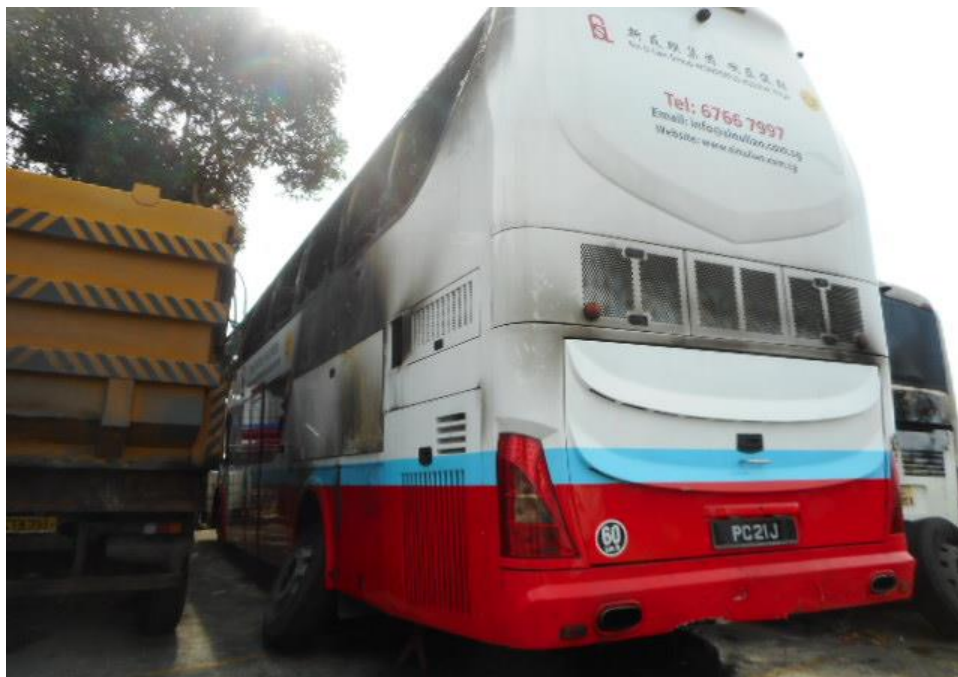
**Photo 4** shows the general view of the left portion of the Insured Vehicle at the time of our inspection. The exterior body of the Insured Vehicle had sustained fire damage at the rear portion. Affected parts had included the rear windows and rear left panels.

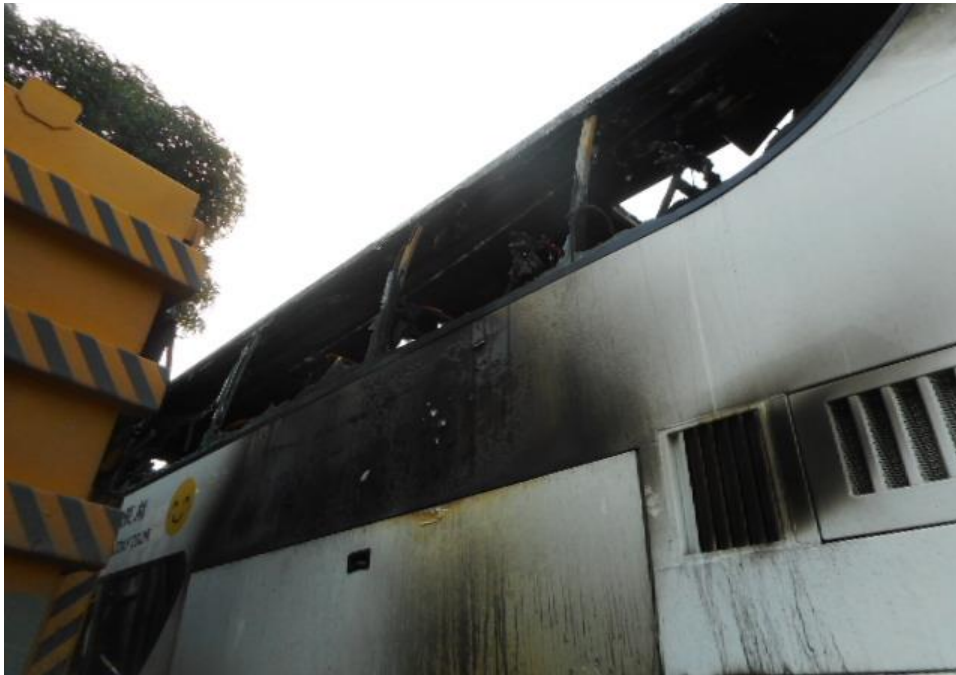
**Photo 5** shows the close up view of the left portion of the Insured Vehicle at the time of our inspection. The exterior body of the Insured Vehicle had sustained fire damage at the rear portion. Affected parts had included the rear windows and rear left panels.

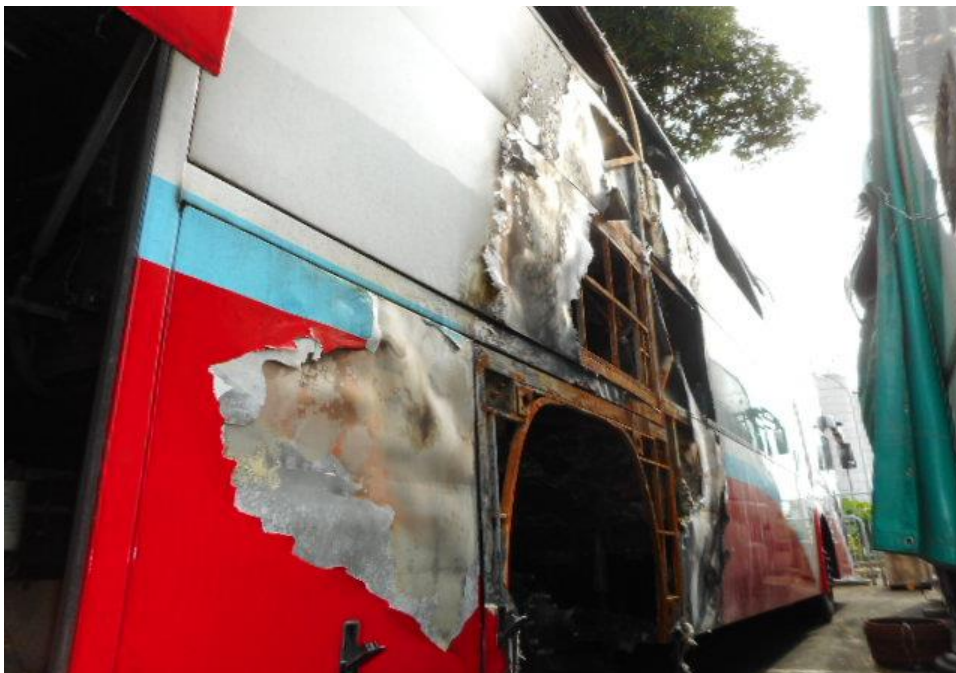
**Photo 6** shows the general view of the right portion of the Insured Vehicle at the time of our inspection. The exterior body of the Insured Vehicle had sustained fire damages at the rear right wheel and rim area as well as its rear right body panel portion. Affected parts had included the right rear panels, rear right windows and the rear right wheel and rims.

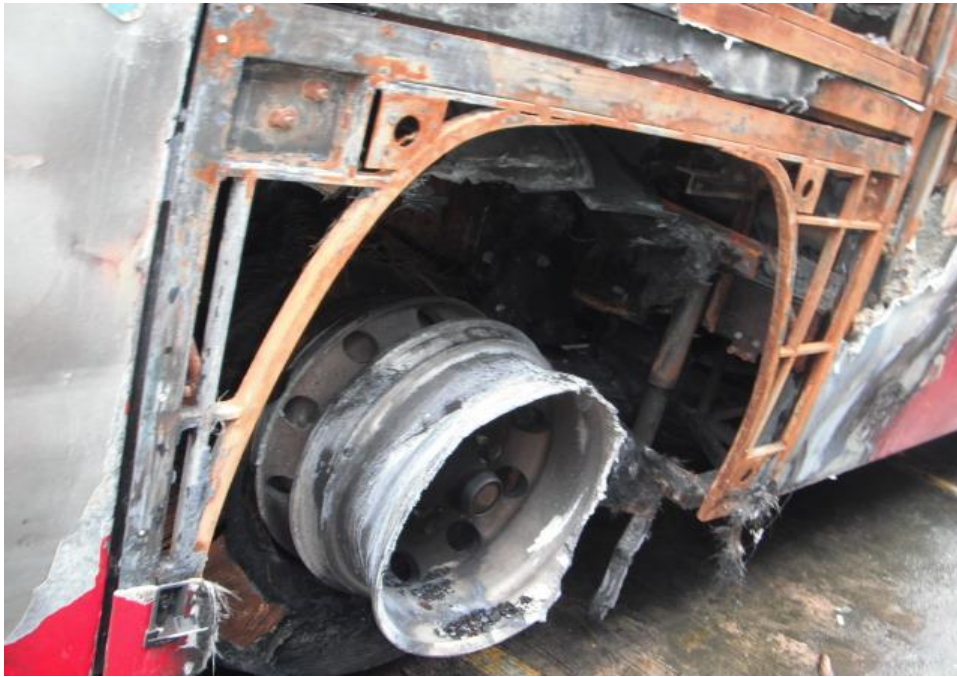
**Photo 7** shows the close up view of the rear right portion of the Insured Vehicle at the time of our inspection. The wheel rims and the tyres of the Insured Vehicle had sustained severe fire damage.

7. For this particular case, the fire appears to have originated from rear right portion of the Insured Vehicle, around the rear right wheel rims and tyres portion of the Insured Vehicle. This can be determined from the nature of the fire damage which was more extensive at the rear right portion. Basing on the circumstances of the fires' origin at the material time of incident as well as examining the area where the extent of fire damage was most severe, we can determine that the fire had likely started from the rear right wheel rims and tyres portion of the Insured Vehicle.

8. Upon closer examination of the rear right portion of the wheel rims and its tyres of the Insured Vehicle as well as around the immediate vicinity to where the fire had likely started, we had observed that the outer wheel rim had sustained the highest heat intensity burn marks (whitish burn marks) that were found on the surface of it and it was also dented and cracked.

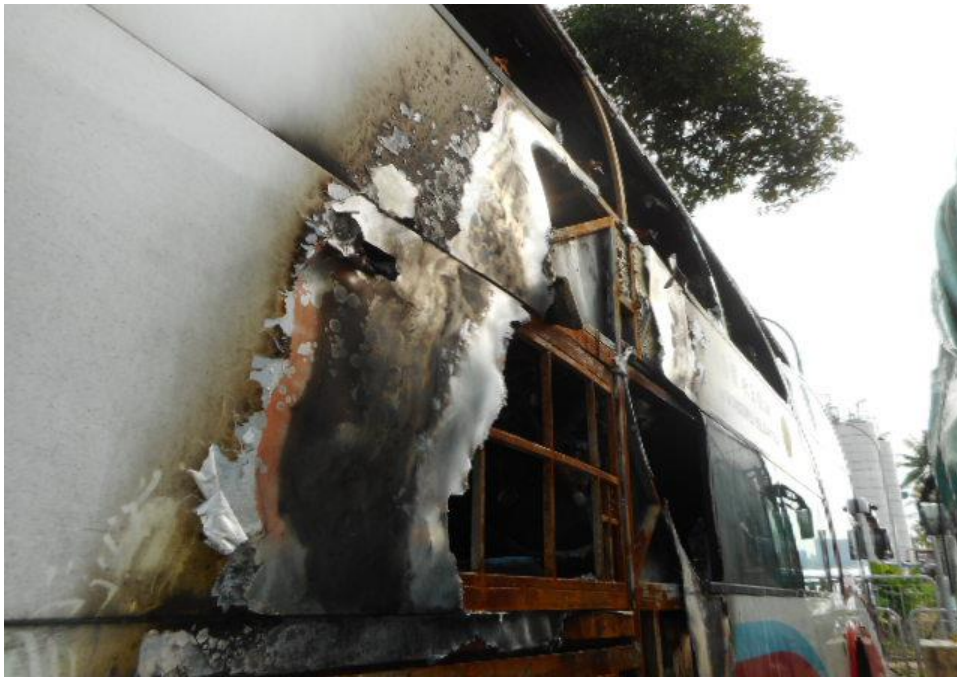
**Photo 8** shows a closer view of the right rear portion of the Insured Vehicle at the time of our inspection. The fire damage was observed to be at its rear right portion. The rear right body panel was observed to be affected by the fire.

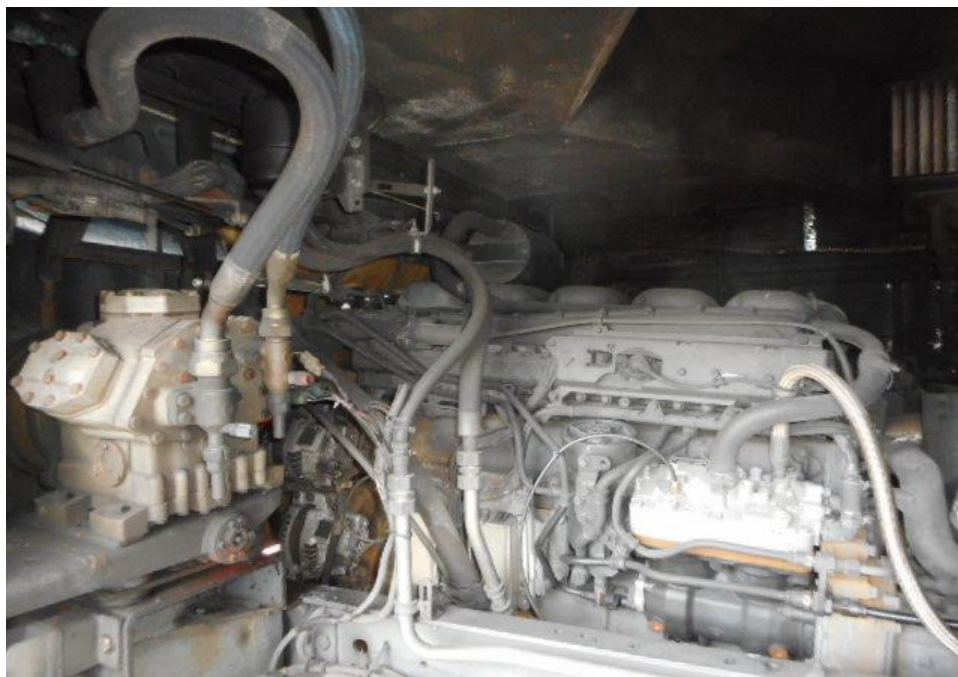
**Photo 9** shows a general view of the engine compartment of the Insured Vehicle at the time of our inspection. The engine compartment of the Insured Vehicle was observed to be unaffected by the fire.

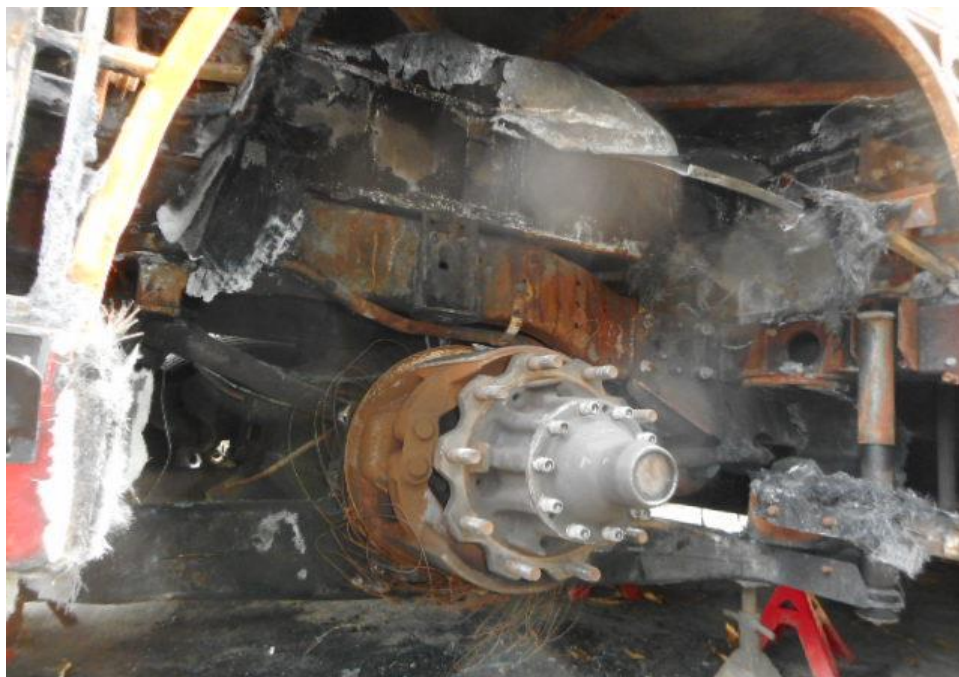
10. Firstly, we have removed the right wheel rims of the Insured Vehicle to inspect their drum brakes and brake pads and we did not notice any signs of brakes lock up or burn to either the exterior or interior surface of the rear right brake drums and top or bottom of the brake pads on the Insured Vehicle.

**Photo 10** shows a general view of the rear right brake drum and brake pad of the Insured Vehicle after the wheel rim was removed. Upon closer examination, we did not observe any damages to the brake drum or the brake pad.

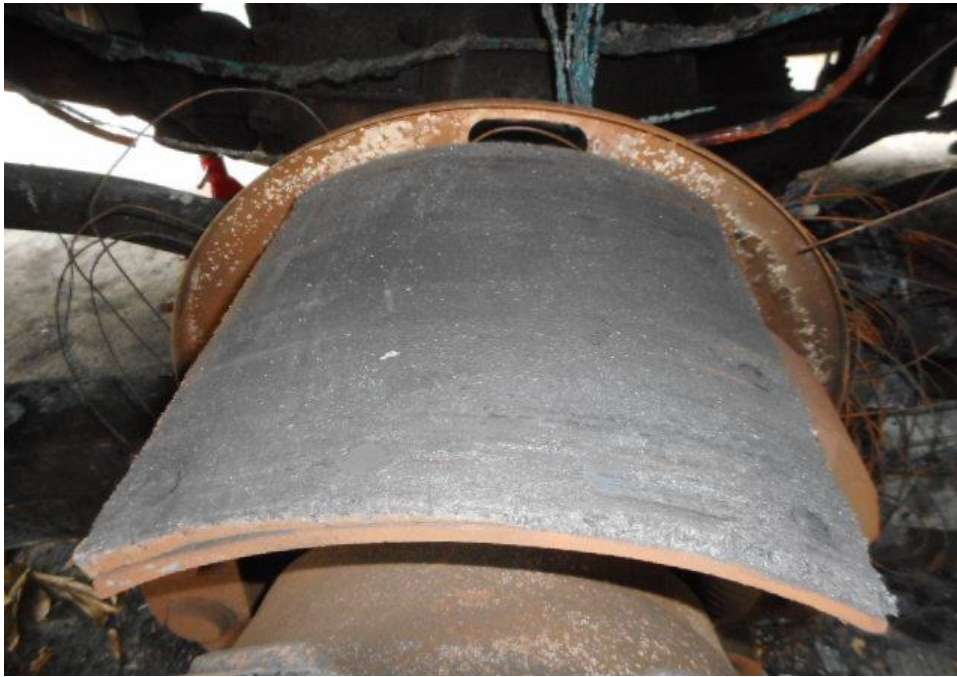
**Photo 11** shows a close up view of the rear left top brake drum pad of the Insured Vehicle. Upon closer examination, we did not observed any damages to the brake drum pad.

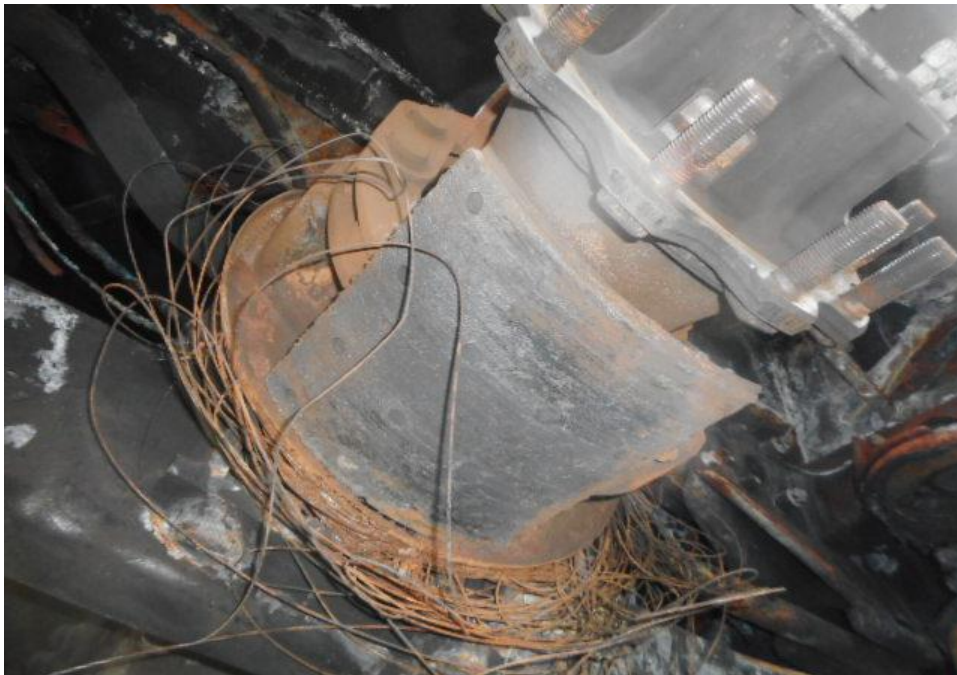
**Photo 12** shows a general view of the rear left bottom brake drum pad of the Insured Vehicle. Upon closer examination, we did not observed any damages to the brake drum pad.

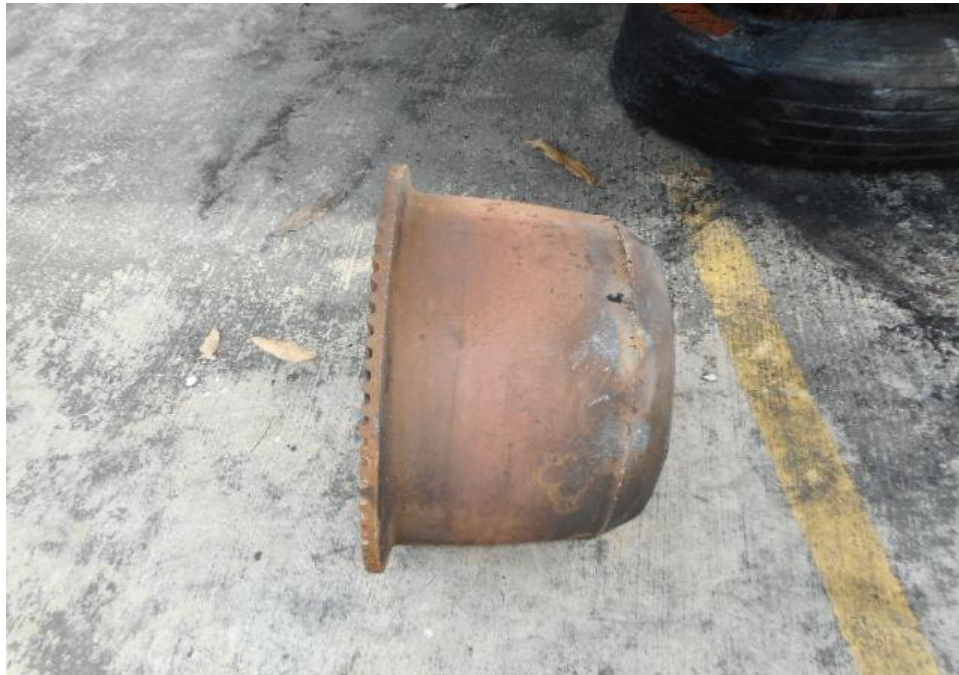
**Photo 13** shows a general view of the rear left brake drum of the Insured Vehicle. Upon closer examination, we did not observe any damages to the exterior surface of the brake drum.

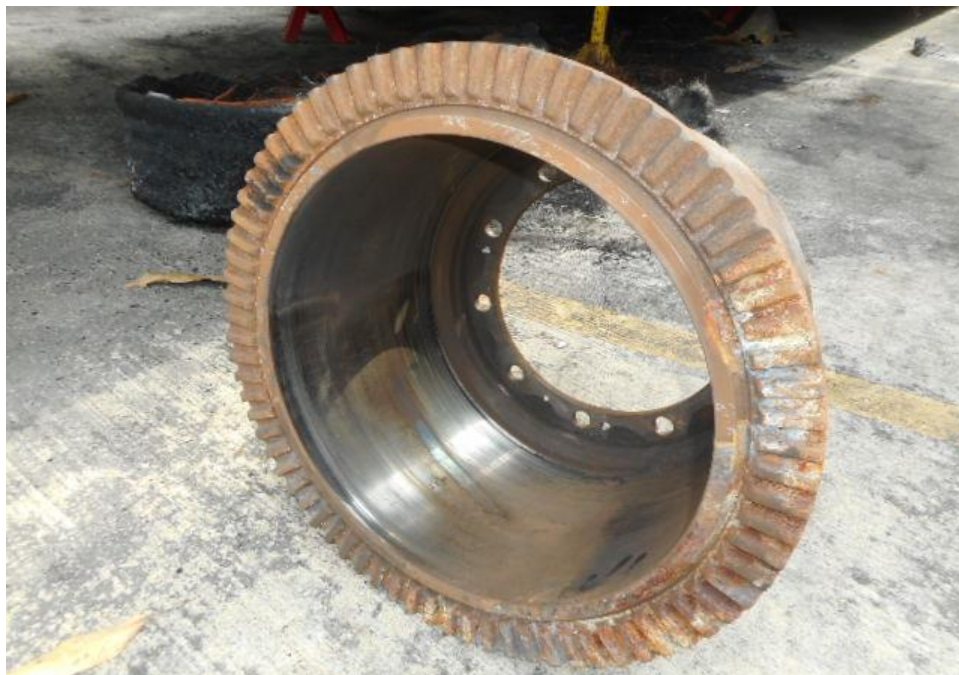
**Photo 14** shows a general view of the rear left brake drum of the Insured Vehicle. Upon closer examination, we did not observe any damages to the interior surface of the brake drum.

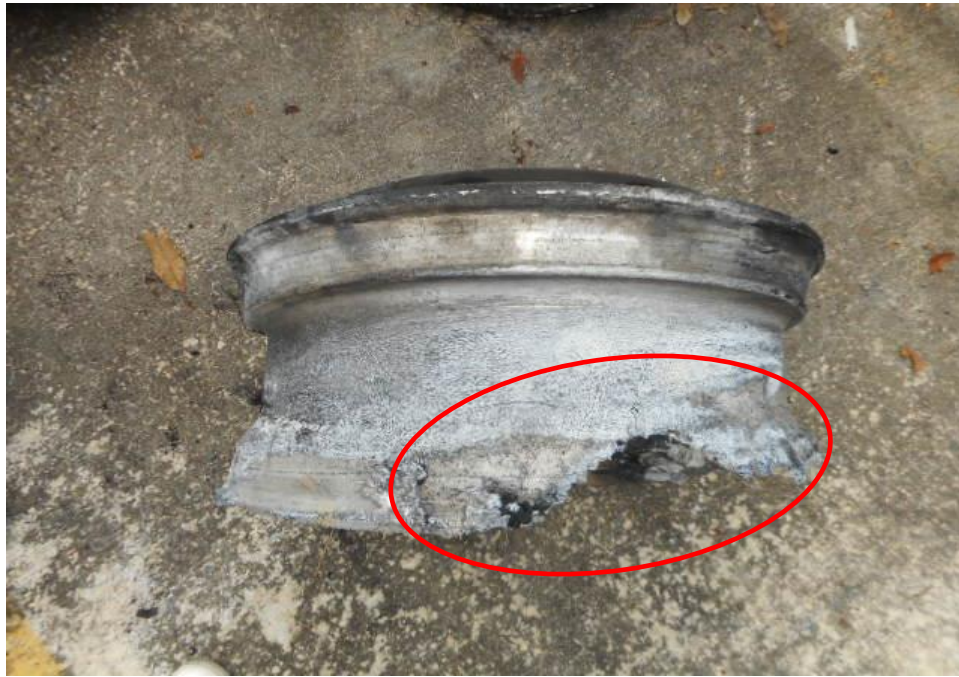
9. In our opinion, the dent and cracked damages observed on the rear right outer wheel rim was likely not the result of the fire. In support to this claim we have investigated further; we focus on our findings to the wheel rim and tyres area and identify that the moving components in the area are the drum brakes system and the wheel drum itself.

**Photo 15** shows a general view of the rear right outer wheel rim of the Insured Vehicle. Upon closer examination, we observed that the dent and cracked wheel rim (circled) was caused by an impact that had caused the deformed damage to it.

28. Although we are unable to inspect the rear right outer tyre as it was burnt by the fire. We are in view that the rear right outer tyre had suffered a puncture causing the rear right outer wheel rim to contact the road surfaces resulting in the fire. As we observed that the dent and cracked damages on the rear right outer wheel rim was due to an impact resulting in the damages. The puncture to the rear right outer tyre had caused the bus to tilt down slightly to the right result in the rear right outer wheel rim to contact the road surfaces and causing the damages as well.

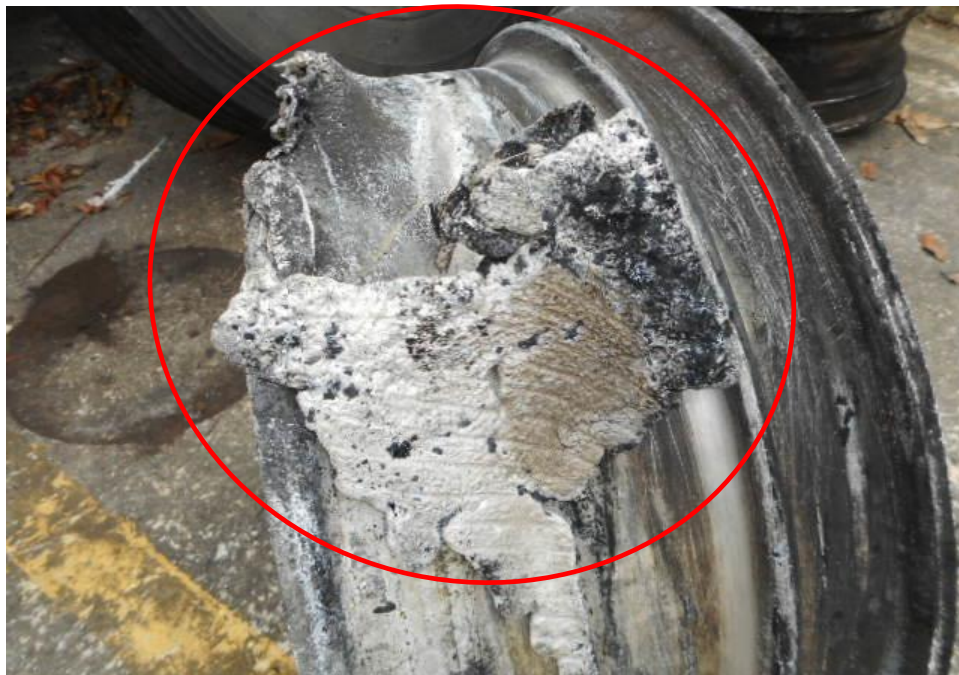
**Photo 16** shows a close up view of the rear right outer wheel rim of the Insured Vehicle. Upon closer examination, we observed that the dent and cracked wheel rim (circled) was caused by an impact that had caused the deformed damage to it.

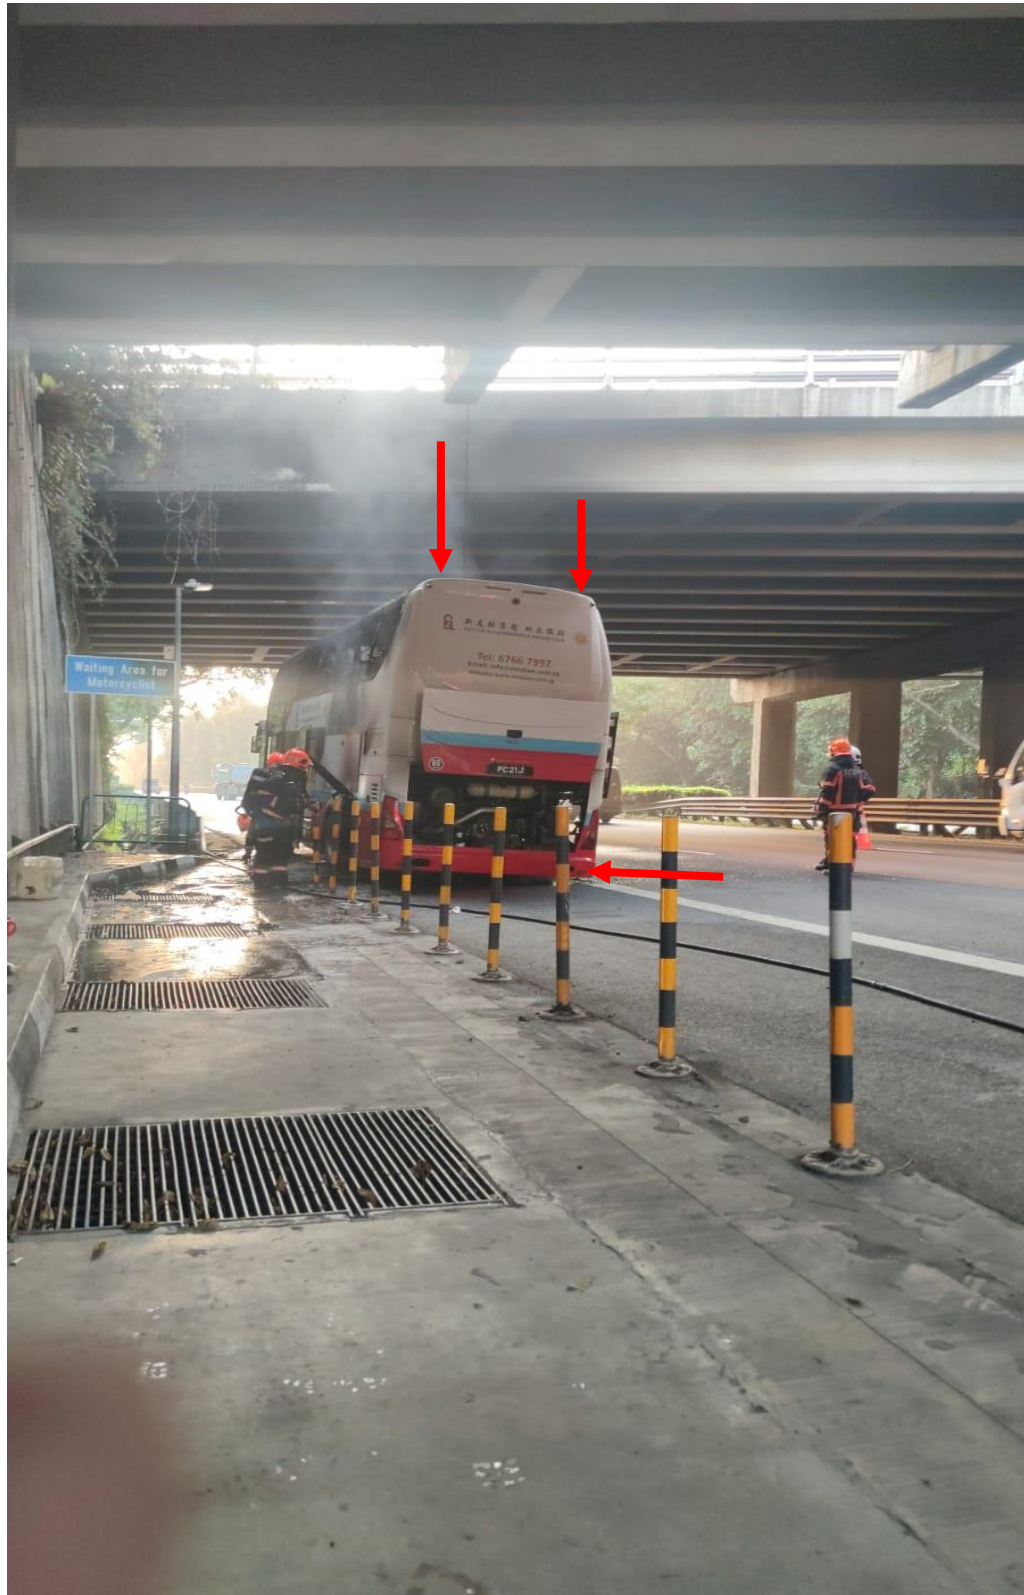
24. Our examination of the photograph revealed that the Insured Vehicle was observed to be tilted down to right side and the fire at the material time of incident. The photographs had also showed the Insured Vehicle on fire and similar extent of damage and burn pattern to the Insured Vehicle as per what we had observed during our physical inspection of the Insured Vehicle. Apart from the aforesaid, there was no further notable information that could be gathered from these photographs. See photo17 below.

**Photo 17** shows that the Insured Vehicle was observed to be tilted down to the right side (arrowed) of the Insured Vehicle at the material time of incident. The photographs had also showed the Insured Vehicle on fire and similar extent of damage and burn pattern to the Insured Vehicle as per what we had observed during our physical inspection of the Insured Vehicle.
