Your Ref: SBP 2L
Our Ref : CI/TP22010085/D

AUTOMOBILE INSPECTION REPORT OF MOTOR CAR SBP 2L

Vehicle Registration No.	: SBP 2L
Make / Model	: Nissan 300ZX
Chassis No	: GCZ32505910
Year of Registration	: 1989 (November)
Mileage	: 38,633km

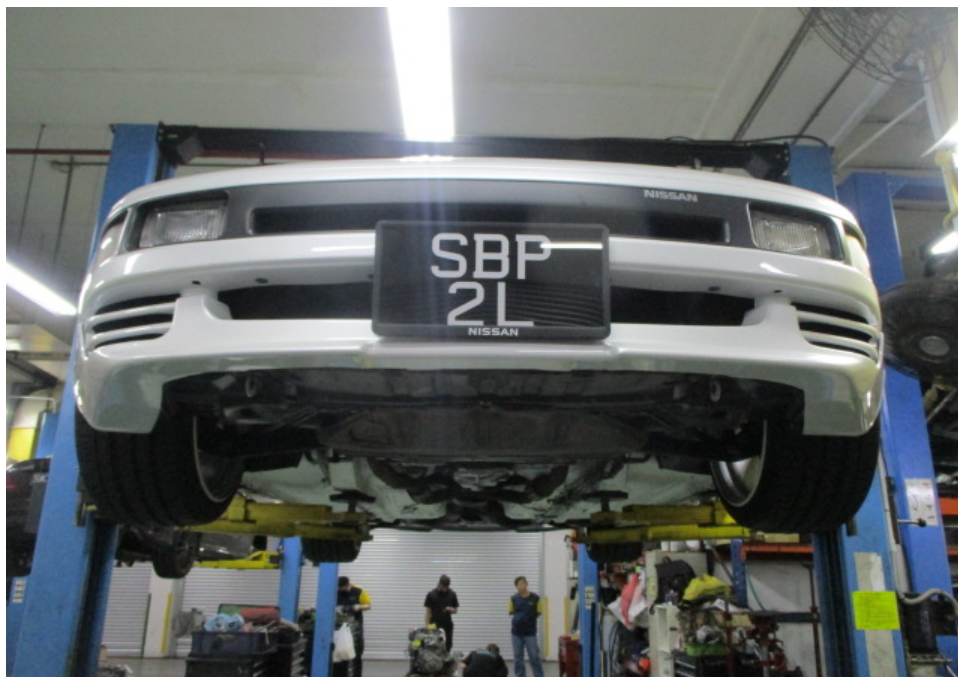
Photo 1 shows the Motor Car hoisted up for checks on its undercarriage, in particular to its transmission assembly. It was noted that the Motor Car was fitted with a 5-speed manual transmission system.

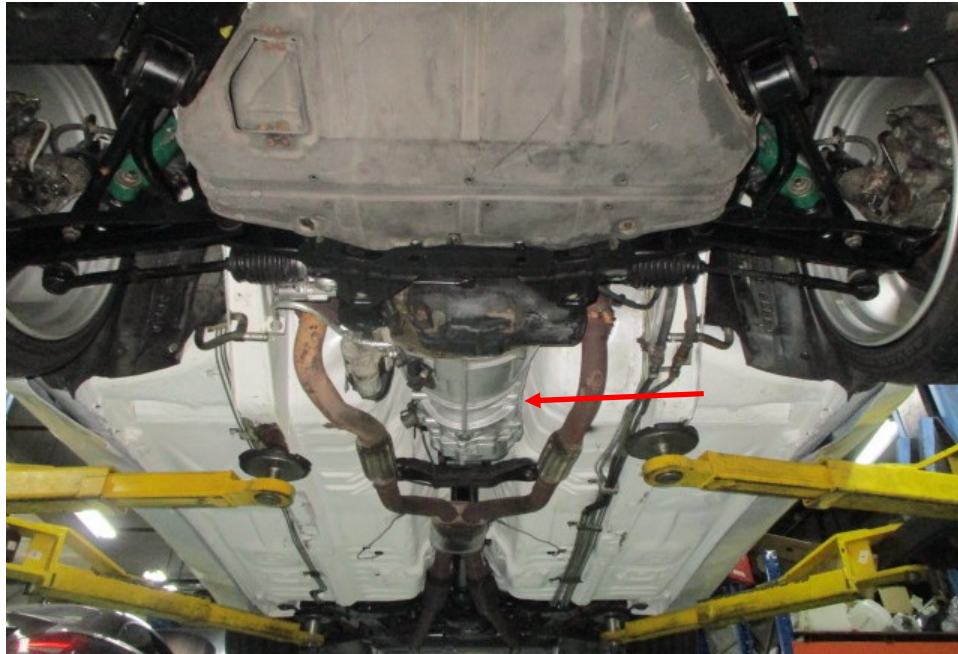
Photo 2 shows a general view of the transmission assembly (arrowed) that was fitted on the Motor Car, as viewed from the front to rear. The front (input) side of the transmission assembly is bolted to the crankshaft side of the engine block while the rear (output) side of the transmission assembly, connects to the propeller shaft, which links to the differential at the rear axle of the Motor Car.

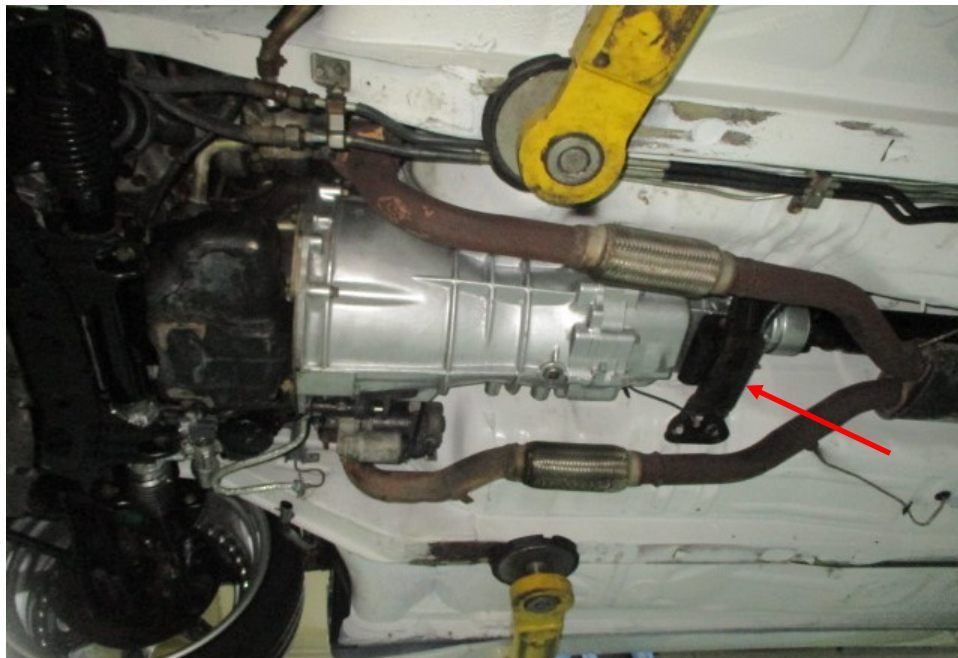
Photo 3 shows another view of the transmission assembly that was fitted on the Motor Car. The front (input) side of the transmission assembly is bolted to the crankshaft side of the engine block while the rear (output) side of the transmission assembly, connects to the propeller shaft, which links to the differential at the rear axle of the Motor Car. A bracket (arrowed) mounted to the underside of the Motor Car's floorboard, via bolts and nuts, supports the rear (output) side of the transmission assembly.

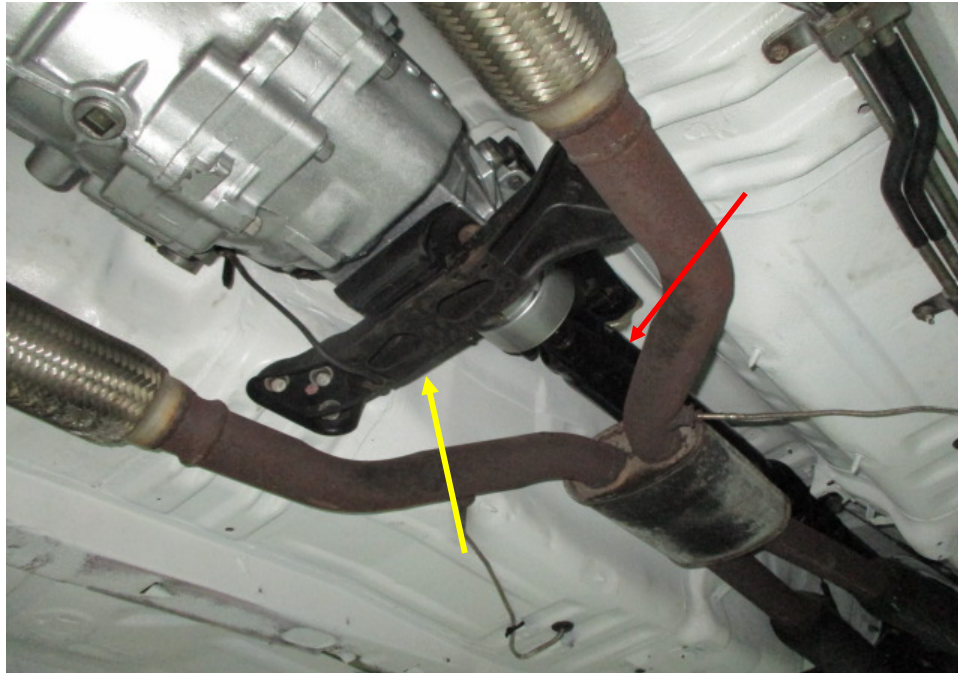
Photo 4 shows the rear (output) side of the transmission assembly that was fitted on the Motor Car. The rear (output) side of the transmission assembly connects to the propeller shaft (red arrow), which links to the differential at the rear axle of the Motor Car. The transmission assembly is supported by a bracket (yellow arrow) that is mounted to the underside of the Motor Car's floorboard, via bolts and nuts.

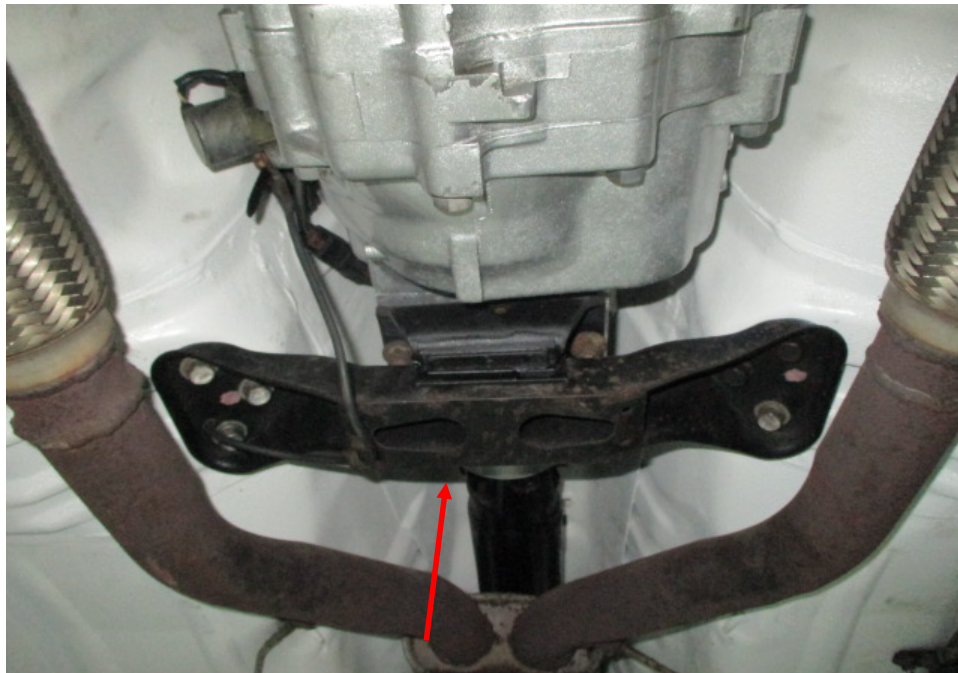
Photo 5 shows a closer view of the bracket (arrowed) that was mounted to the underside of the Motor Car's floorboard, via bolts and nuts. The bracket supports the rear (output) side of the transmission assembly. The bracket was also with rubber bushings that absorb any vibrations arising from the rotation of the transmission gears, minimising any stress to the bracket.

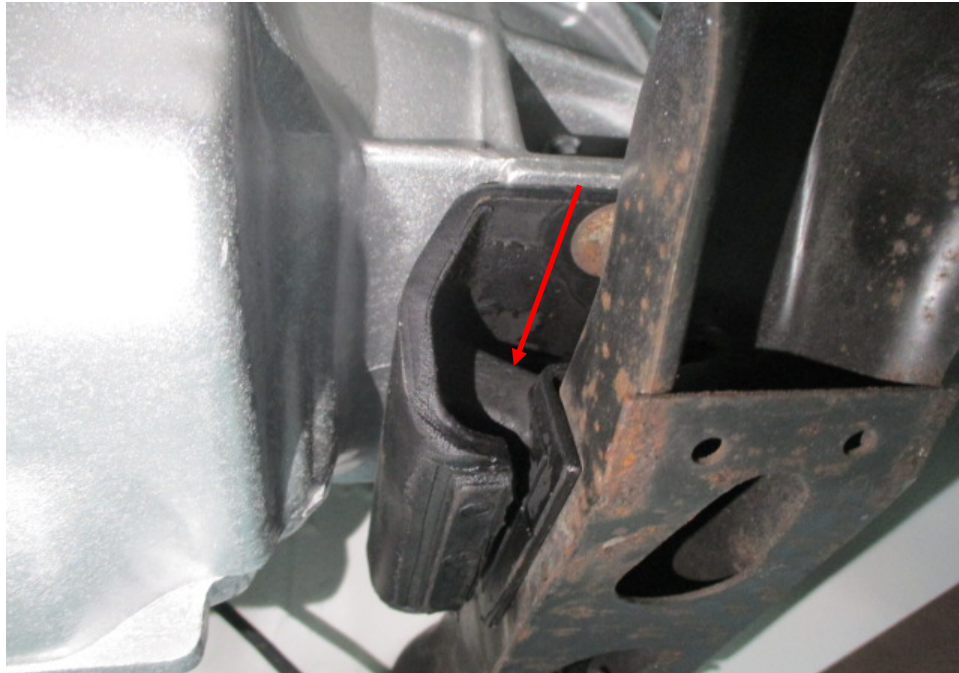
Photo 6 shows the rubber bushing (arrowed), sitting between the transmission assembly and the bracket. The rubber bushing absorbs any vibrations arising from the rotation of the transmission gears, minimising any stress to the bracket.

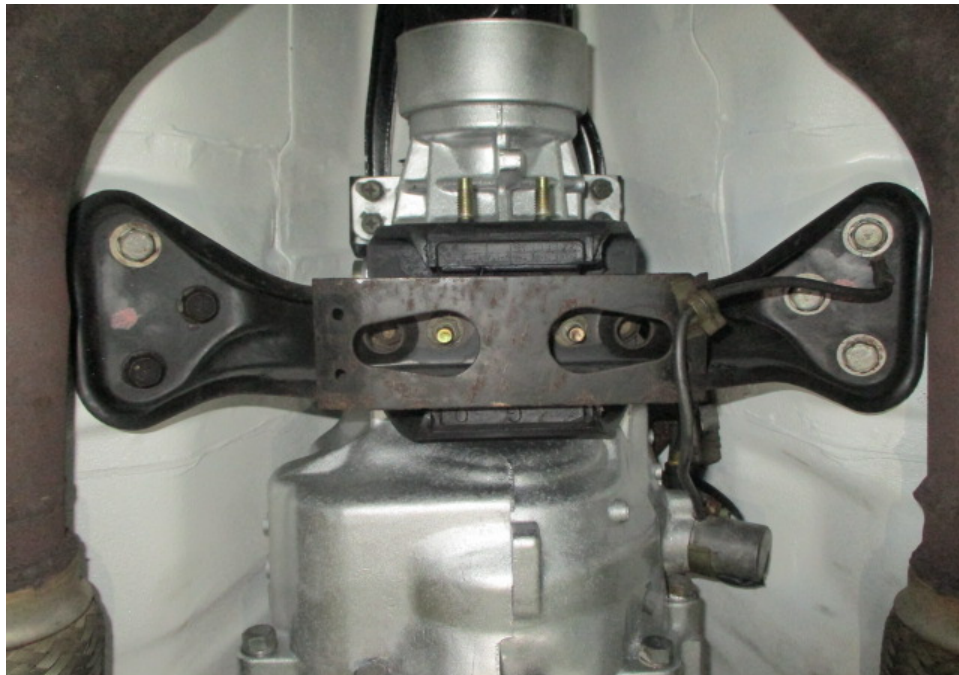
Photo 7 shows the bracket supporting the rear of the transmission assembly that was mounted to the underside of the Motor Car's floorboard, via bolts and nuts (as viewed from bottom to top).

11. In general, the transmission assembly of the Motor Car was found to be secured properly. It was not mounted onto the chassis body or any integral body part of the Motor Car. The structural integrity of the Motor Car is not compromised by the fitment of this particular transmission assembly. Overall, the operating condition of the Motor Car's transmission system was satisfactory throughout the Motor Car's test drive.

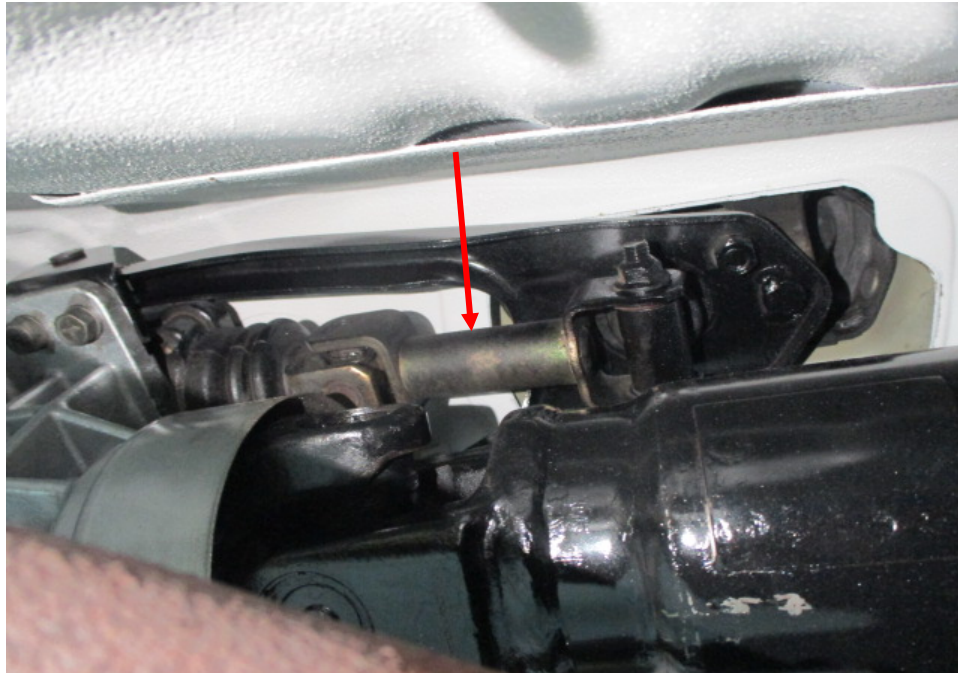
Photo 8 shows the gear selector shaft (arrowed) from the transmission assembly to the gear shifter of the Motor Car. The gear selector shaft was observed to be securely fitted to the underside of the Motor Car. This gear selector shaft connects to the gear shifter in the interior compartment of the Motor Car through the floorboard.

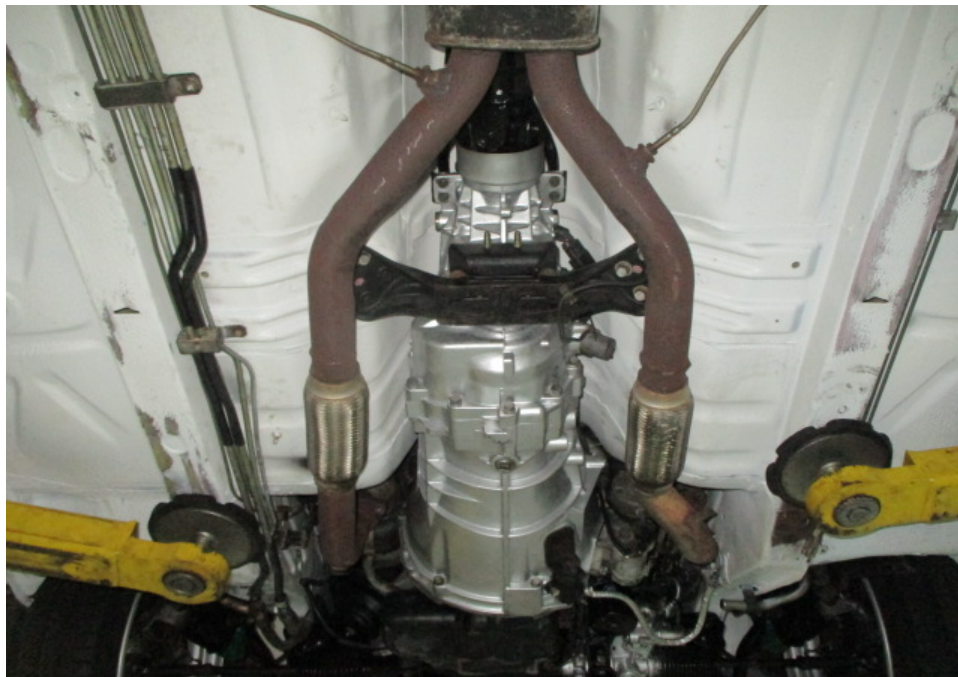
Photo 9 shows a general view of the transmission assembly that was fitted on the Motor Car, as viewed from the rear to front. The front (input) side of the transmission assembly is bolted to the crankshaft side of the engine block while the rear (output) side of the transmission assembly, connects to the propeller shaft, which links to the differential at the rear axle of the Motor Car.

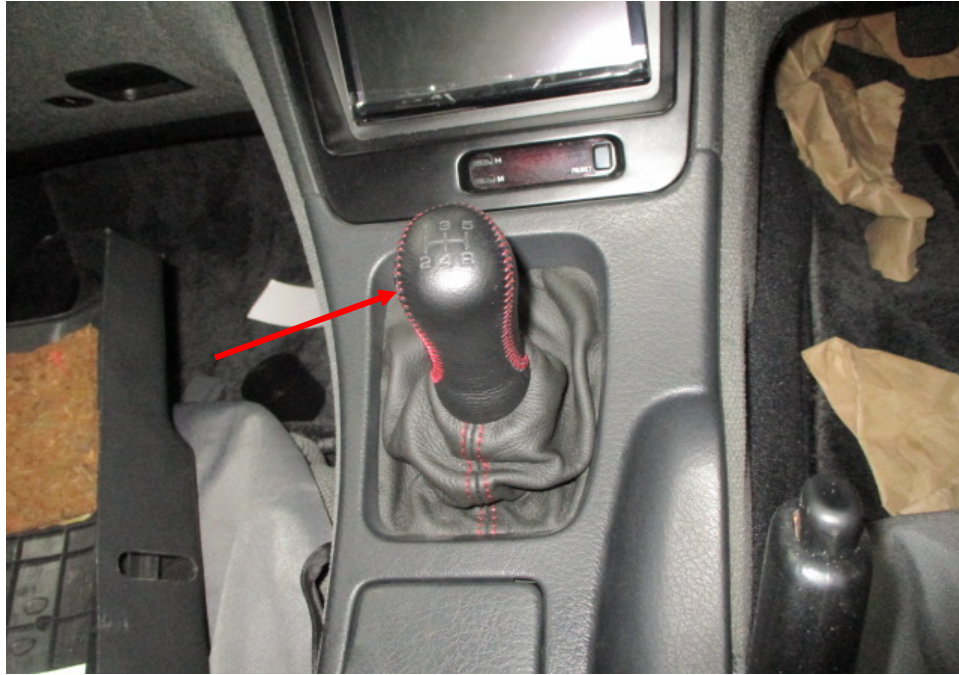
Photo 10 shows the Motor Car's manual gear shifter (arrowed) for manually selecting the transmission gear to be engaged.

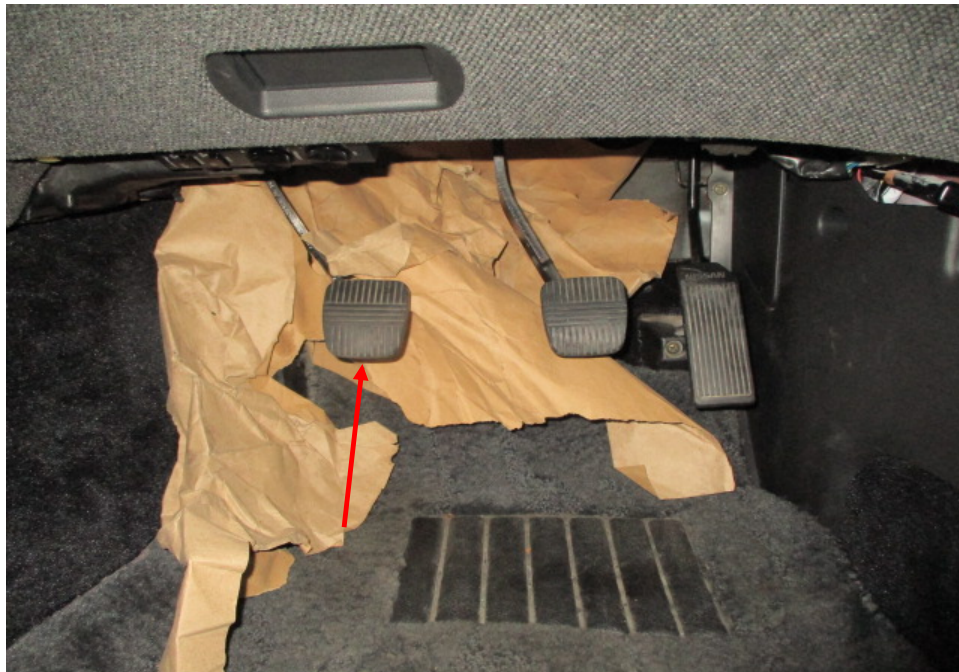
Photo 11 shows the Motor Car's clutch pedal (arrowed) for engaging and disengaging the transmission gears.
