You're Ref: SMG 5349X  
Our Ref: CS4/TP22010112/P

## **MECHANICAL INSPECTION REPORT OF MOTOR CAR SMG 5349X**

1. I refer to your request on 12<sup>th</sup> September 2022 to conduct a physical inspection of a Motor Car bearing registration number SMG 5349X (herein referred to as "**Motor Car**").
2. The objective of the inspection is to determine the general road worthiness of the Motor Car as well as whether there was any abnormality to the various operating systems like the engine system, steering system and braking system amongst others.
3. Following the request, I had carried out a physical inspection of the Motor Car on 2<sup>nd</sup> November 2022 at the premises of Eurokars Aftersales Centre, 27A Tanjong Penjuru, Singapore 609042. A test drive of the Motor Car was also carried out during this inspection. I now set out below my observations and comments with respect to this inspection.

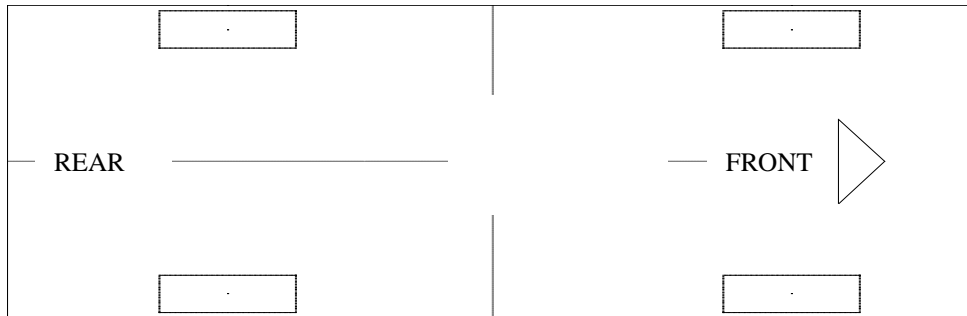
6. The condition of the Motor Car's 4 tyres was observed to be in serviceable condition. I did not find any tear, cut or burst mark(s) on the outer and the inner sidewalls as well as across the tread of the 4 tyres. The 4 tyres were also observed to be sufficiently inflated for vehicular operation. The tyre brand, tyre size and remaining tread depth of the 4 tyres were recorded as follows: -

Bridgestone 225/50R18 (5mm)

Bridgestone 225/50R18 (6.9mm)

Bridgestone 225/50R18 (6.6mm)

Bridgestone 225/50R18 (6.7mm)

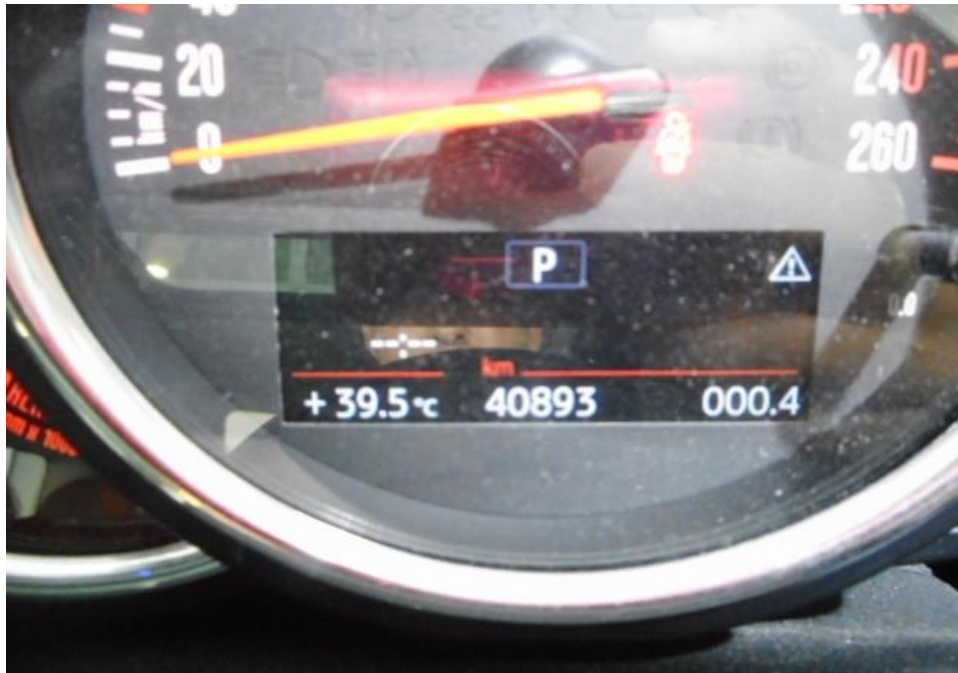
**Photo 1** shows the mileage of the Motor Car at the time of my inspection. The mileage observed was 40,893km.

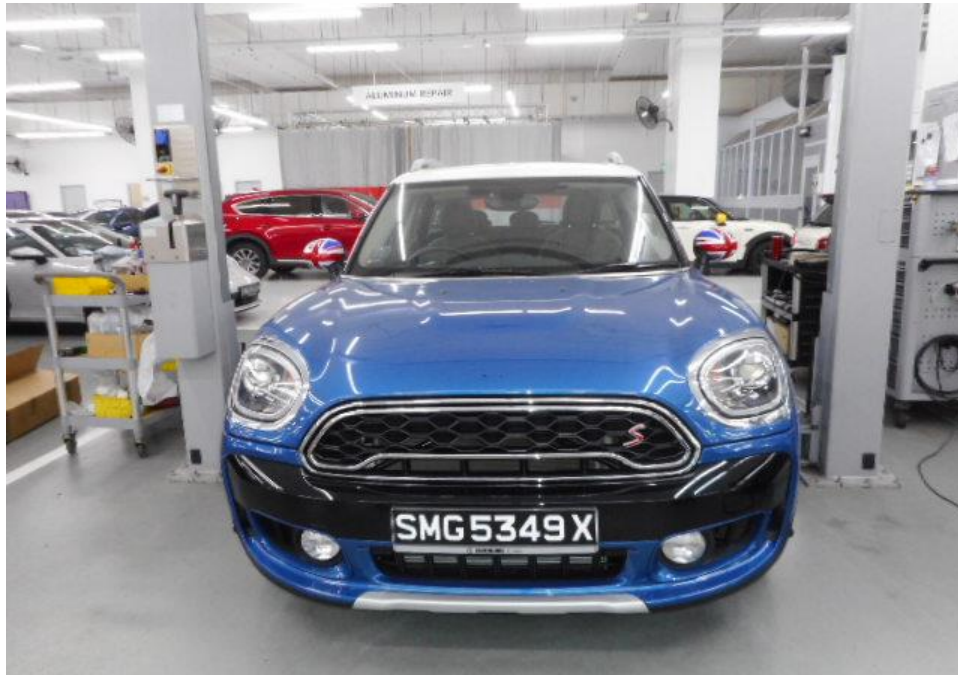
**Photo 2** shows a general view of the Motor Car's front body at the time of my inspection. The Motor Car was observed to be in a relatively good general condition with no loose exterior fittings observed

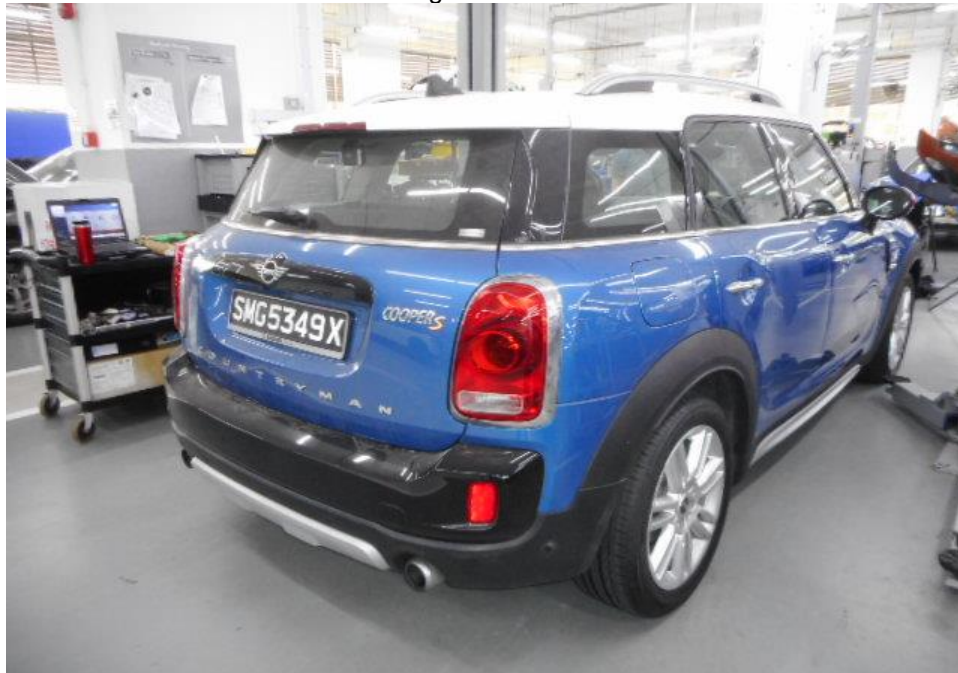
**Photo 3** shows a general view of the Motor Car's right body at the time of my inspection. The Motor Car was observed to be in a relatively good general condition with no loose exterior fittings observed

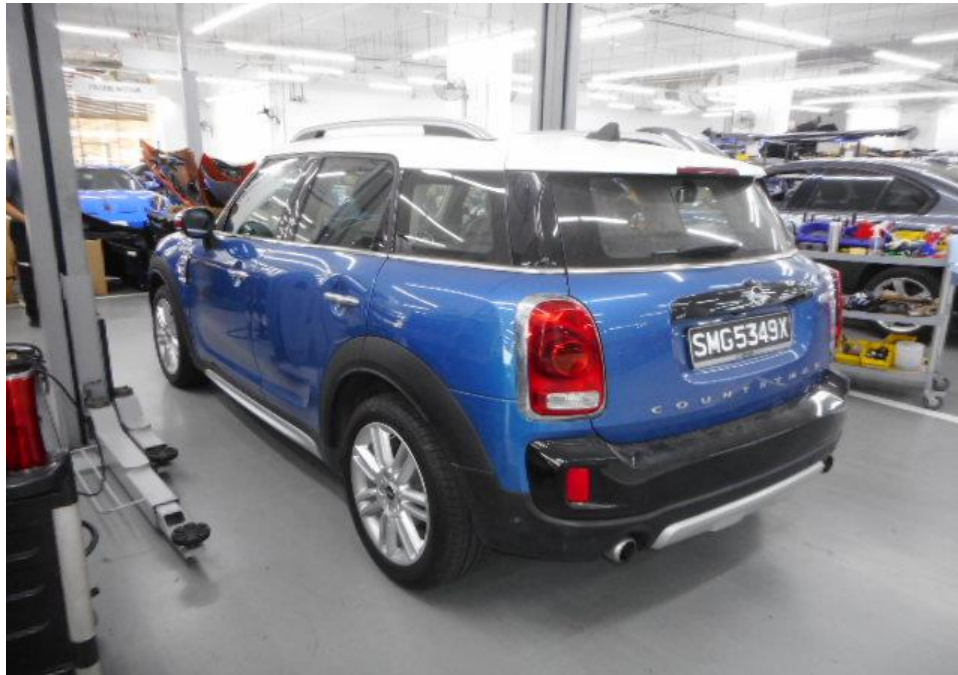
**Photo 4** shows the general view of the Motor Car's left body at the time of my inspection. The Motor Car was observed to be in a relatively good general condition with no loose exterior fittings observed

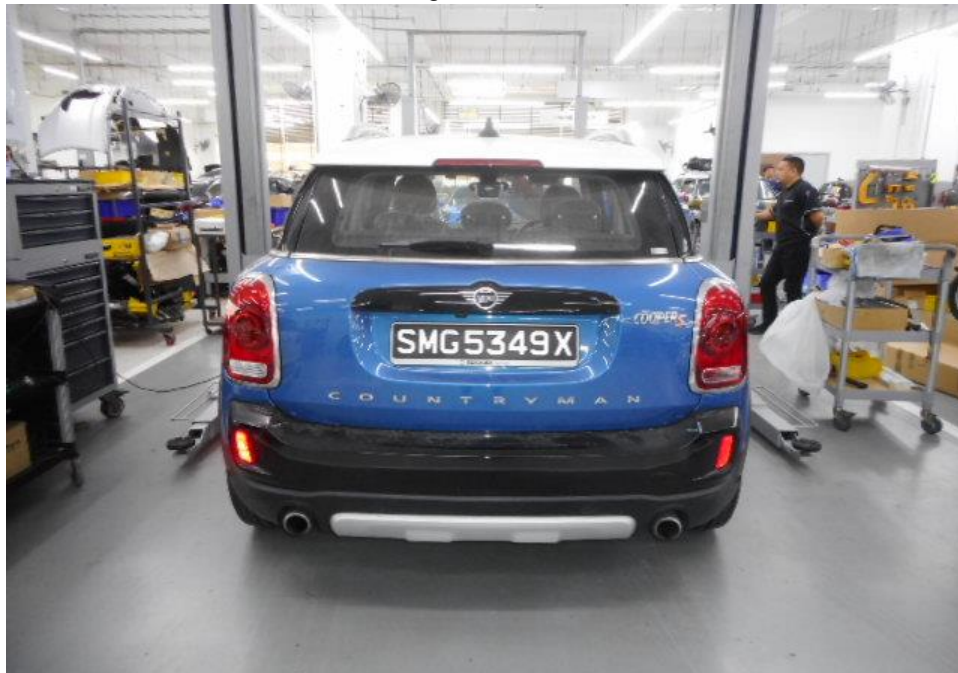
**Photo 5** shows the general view of the Motor Car's rear body at the time of my inspection. The Motor Car was observed to be in a relatively good general condition with no loose exterior fittings observed

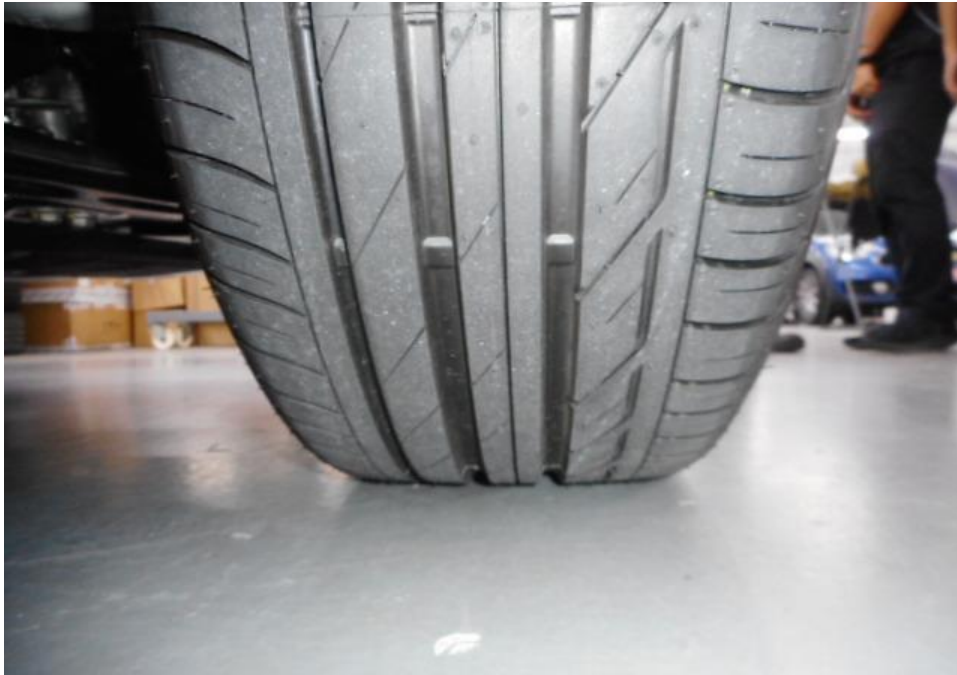
**Photo 6** shows the condition of the front right tyre of the Motor Car, which was observed to be in serviceable condition with remaining tread depth of approximately 6.7mm. The tyre was also observed to be sufficiently inflated for vehicular operation with no tear, cut or burst mark(s).

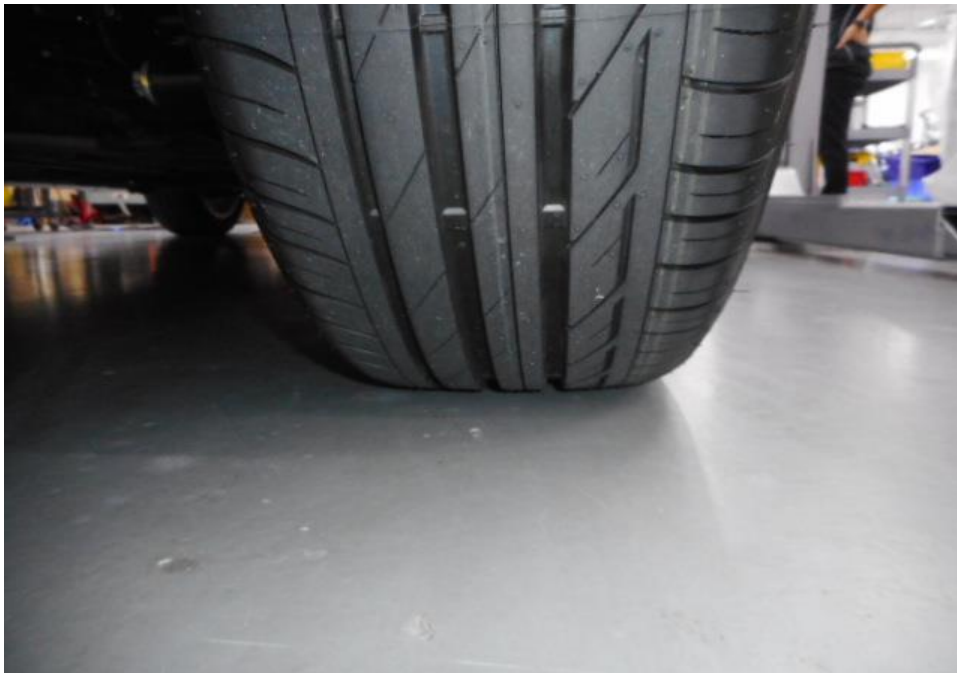
**Photo 7** shows the condition of the rear right tyre of the Motor Car, which was observed to be in serviceable condition with remaining tread depth of approximately 6.6mm. The tyre was also observed to be sufficiently inflated for vehicular operation with no tear, cut or burst mark(s).

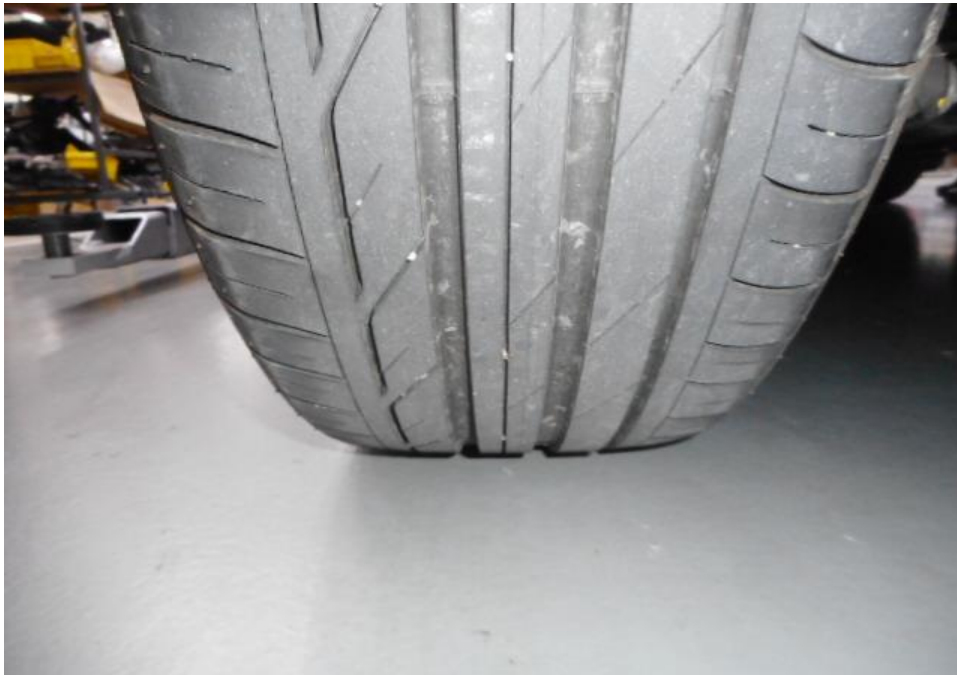
**Photo 8** shows the condition of the rear left tyre of the Motor Car, which was observed to be in serviceable condition with remaining tread depth of approximately 5mm. The tyre, which was wrapped around alloy wheel rim, was also observed to be sufficiently inflated for vehicular operation. The 4 tyres of the Motor Car were wrapped around standard alloy wheel rims.

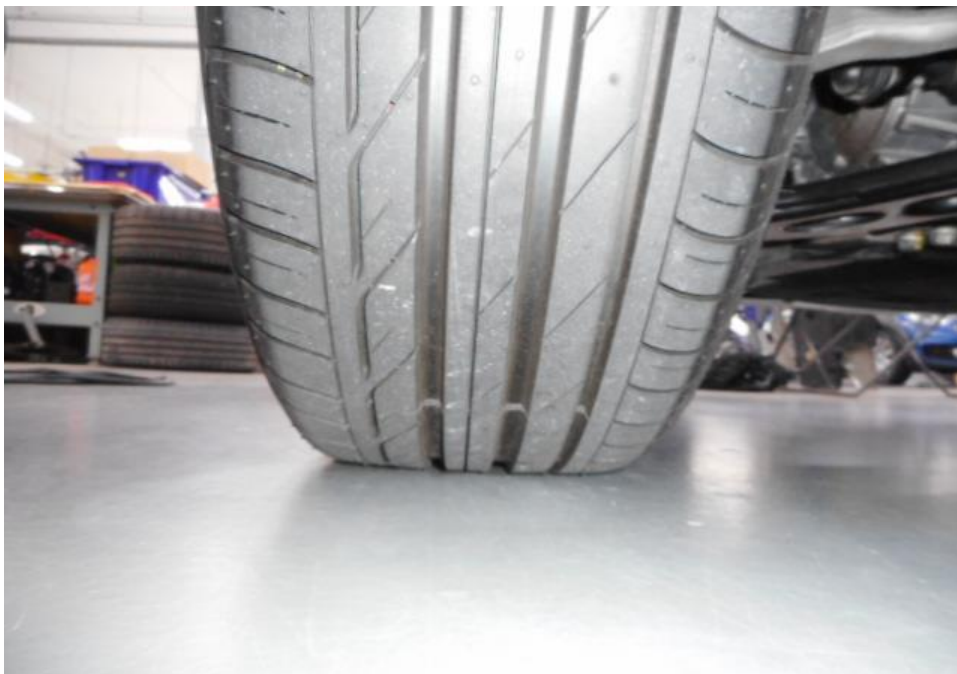
**Photo 9** shows the condition of the front left tyre of the Motor Car, which was observed to be in serviceable condition with remaining tread depth of approximately 6.9mm. There was also no tear, cut or burst mark(s) on the outer and the inner sidewalls as well as across the tread of the Motor Car's 4 tyres.

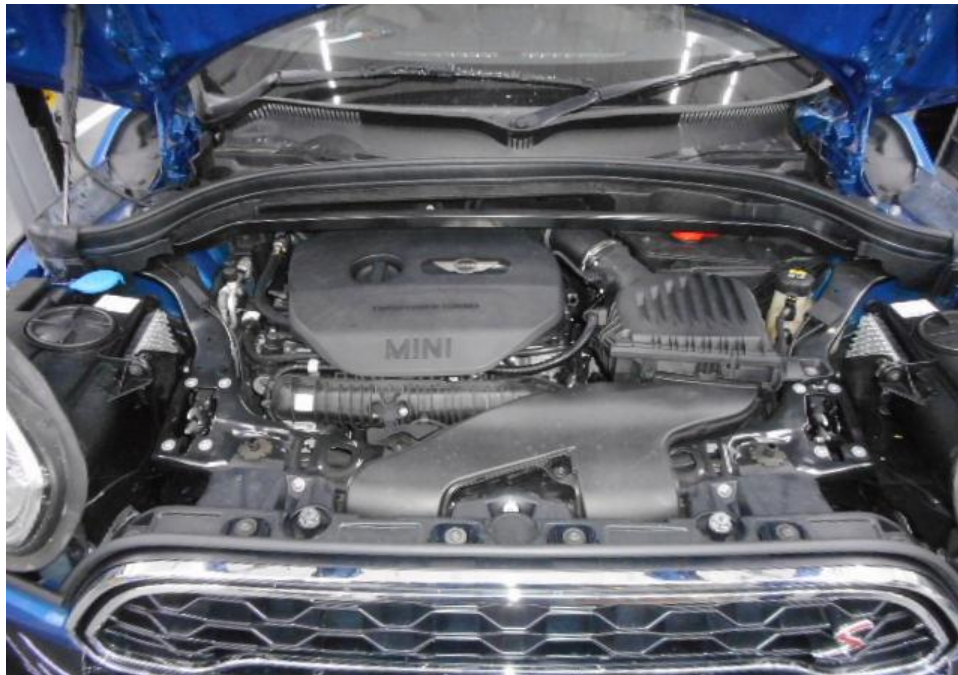
**Photo 10** shows a general view of the Motor Car's engine compartment. The various parts and components inside the engine compartment were intact. There was also no sign(s) or indication(s) of fluid leakage and/or fluid stain within the engine compartment.

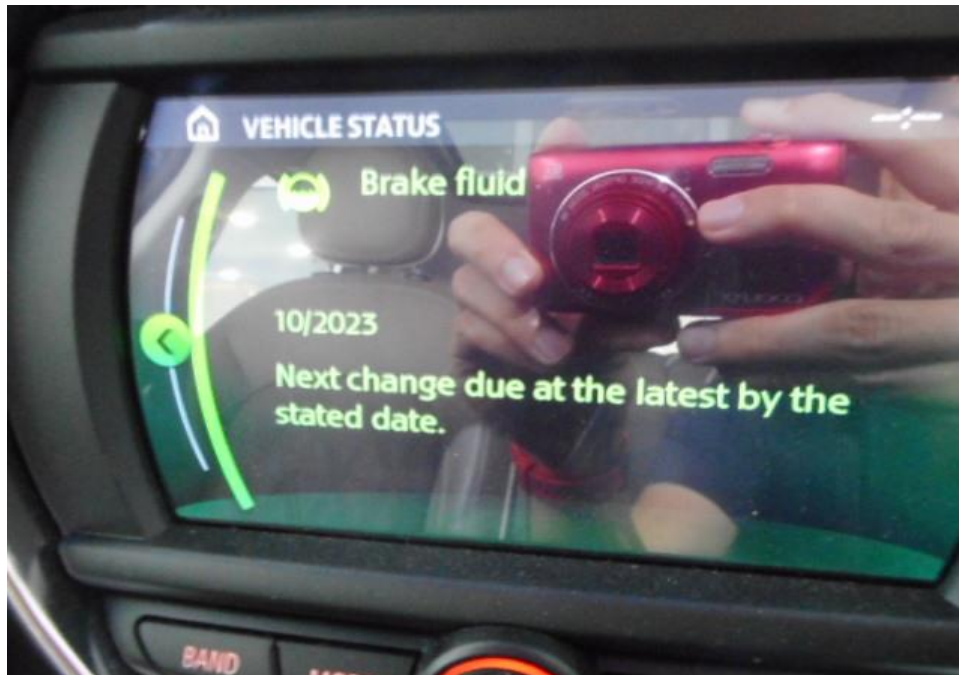
**Photo 11** shows the instrument panel display brake fluid level sensor of the Motor Car at the time of my inspection. The brake fluid was observed to be of sufficient level.

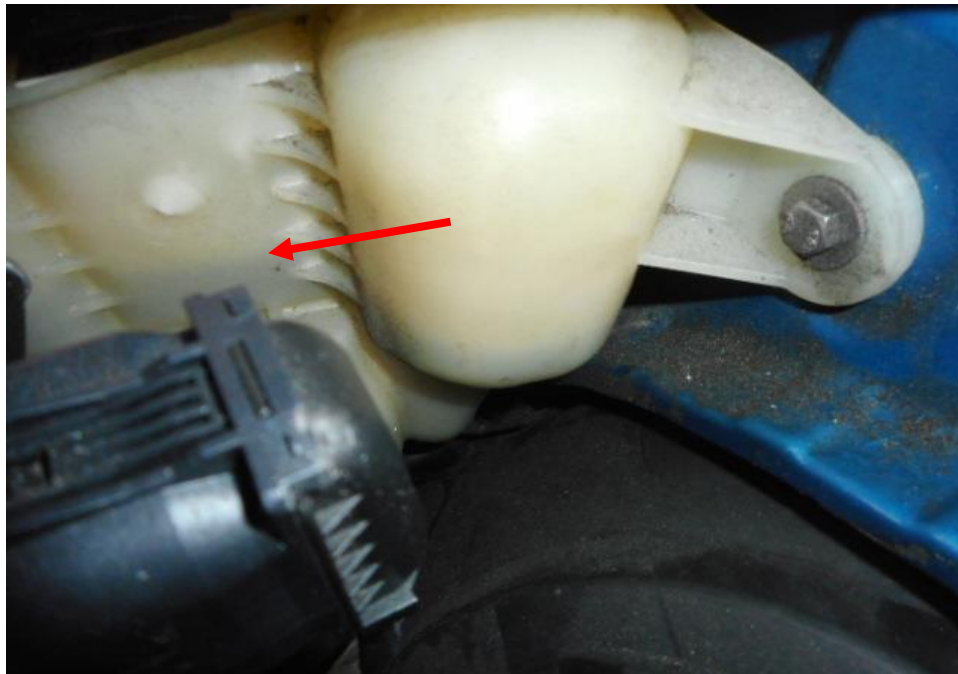
**Photo 12** shows checks being carried out to the engine coolant of the Motor Car at the time of my inspection. The engine coolant was observed to be of sufficient level (arrowed) and without any visible contamination.

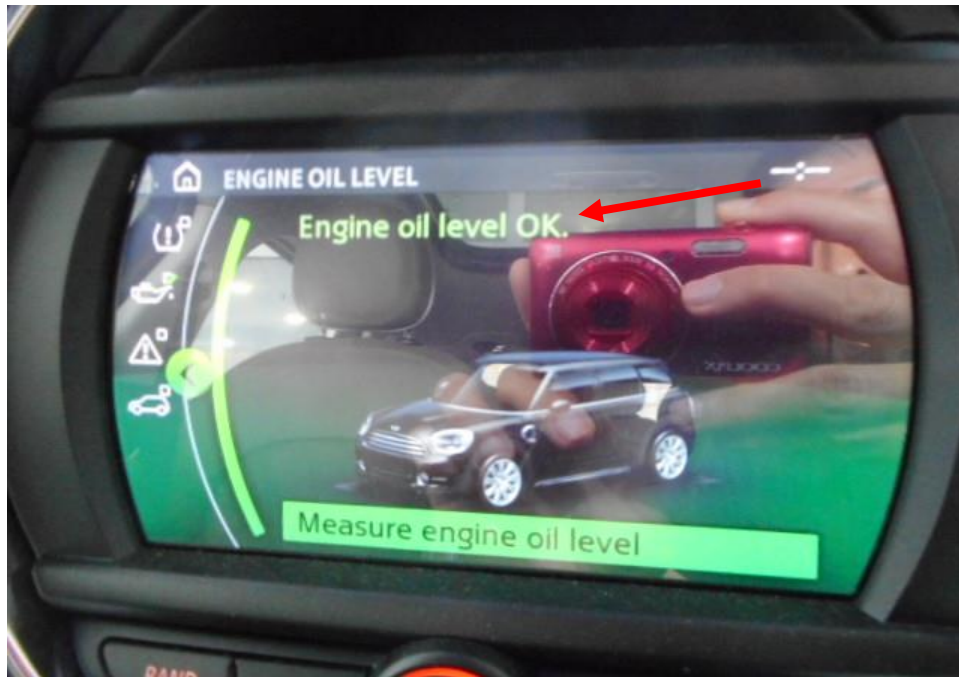
**Photo 13** shows the instrument panel display of the engine oil level (arrowed) of the Motor Car at the time of my inspection. The engine oil was observed to be of sufficient level and without any visible contamination.

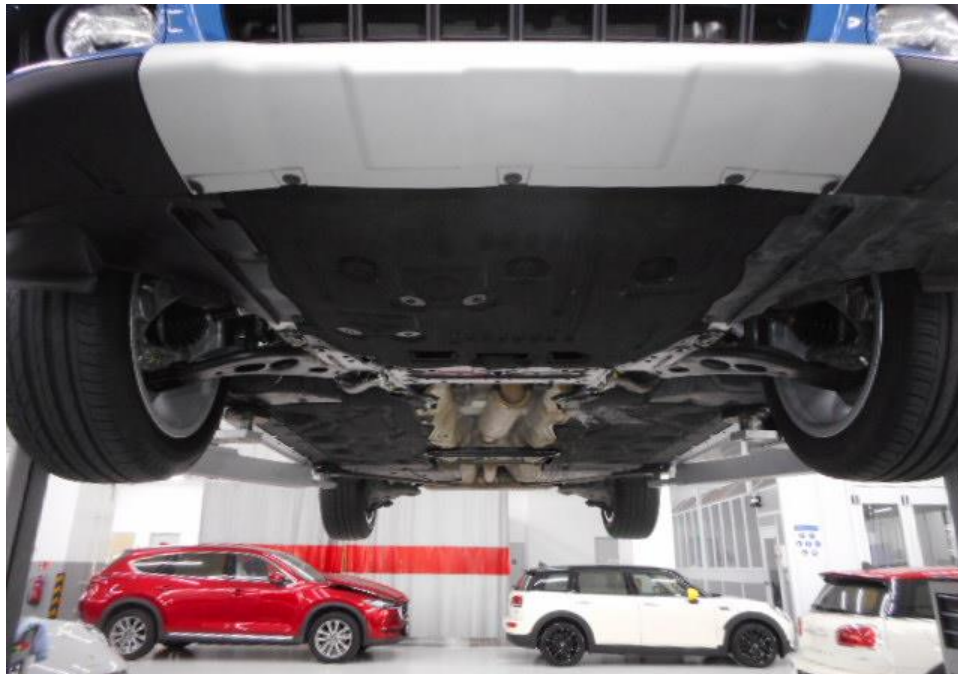
**Photo 14** shows the undercarriage of the Motor Car, at the area where the engine housing and transmission housing are located. I did not find any sign(s) or indication(s) of fluid leak and/or fluid stain(s) on the underside of the Motor Car.

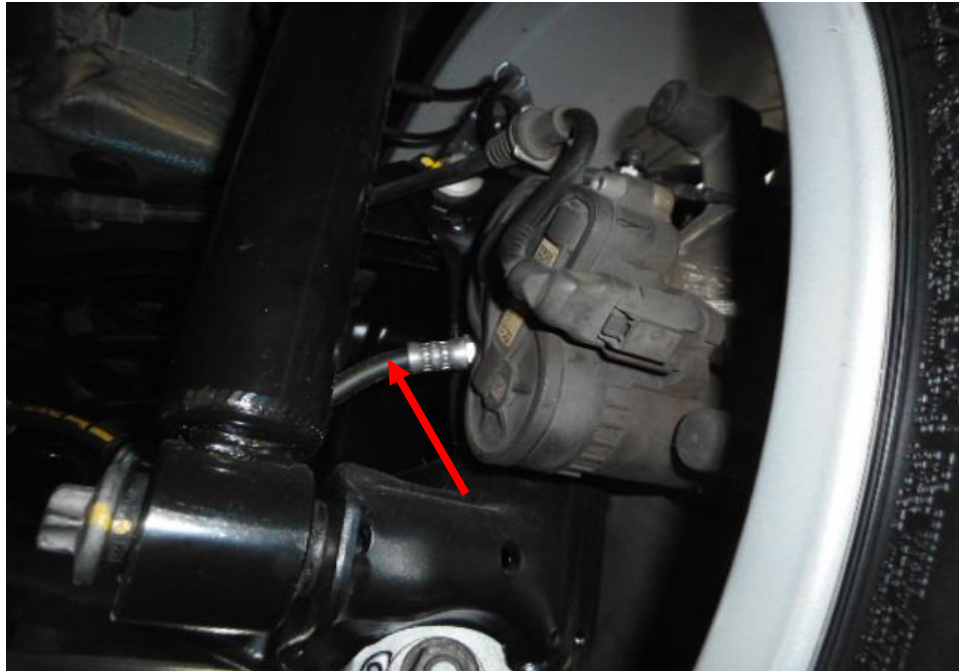
**Photo 15** shows the brake hose/pipe (arrowed) at the rear right wheel of the Motor Car. No leakage of brake fluid was observed. Visual examination of the various components of the braking system like the drum brake, brake booster, brake pedal etc. had revealed all to be intact and without visible damage.

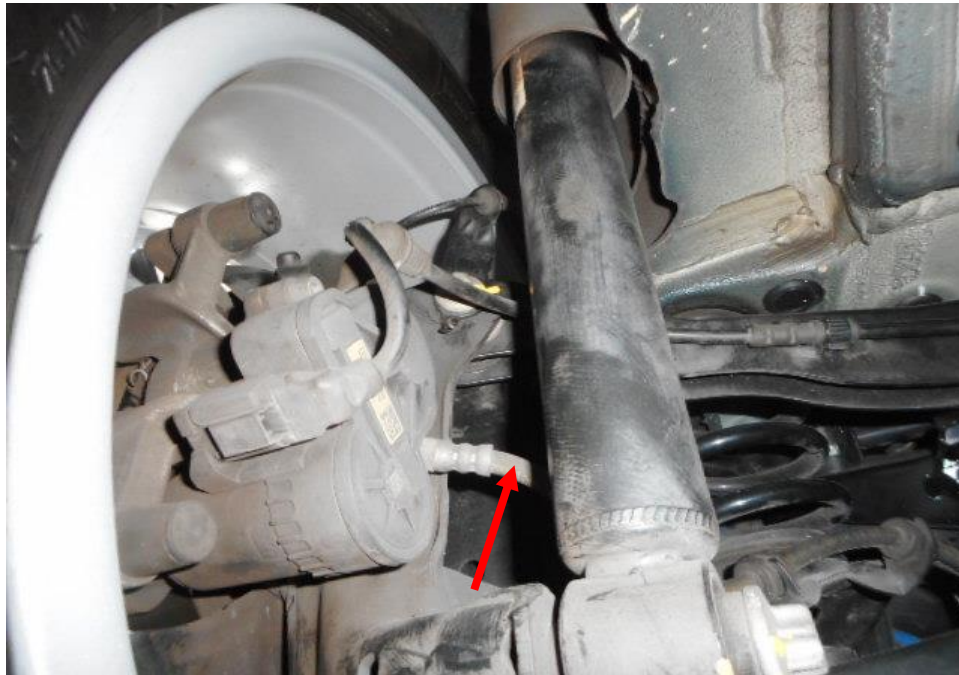
**Photo 16** shows the brake hose/pipe (arrowed) at the rear left wheel of the Motor Car. I did not observe any leakage of brake fluid at the time of my inspection of the Motor Car. Static tests of the Motor Car's braking system had indicated that there was no internal leakage of pressure/vacuum. The undercarriage components of the Motor Car were also all found to be intact and without any visible damage.

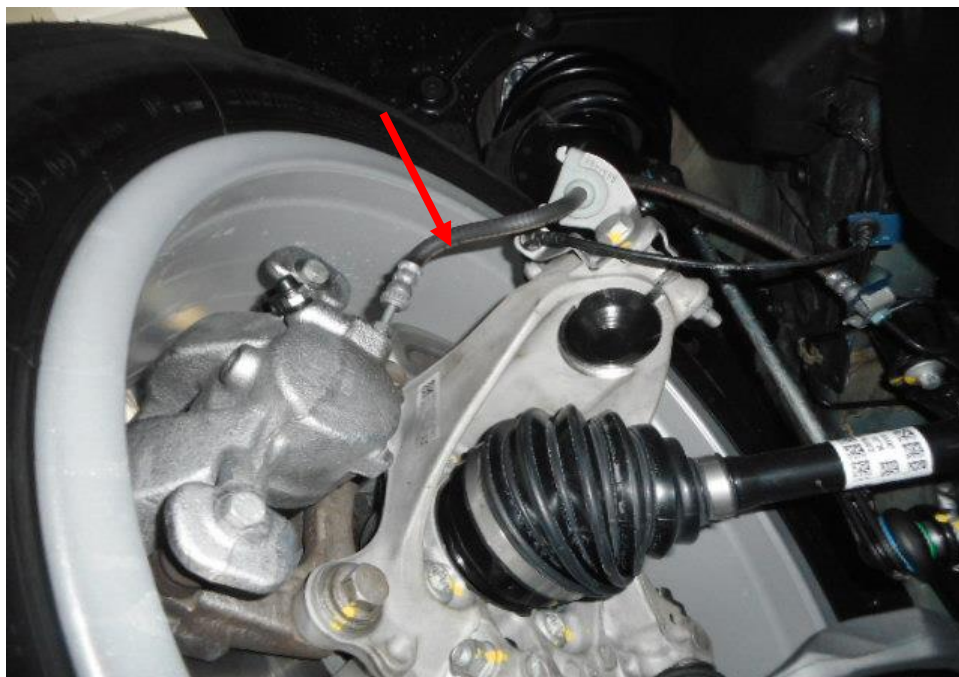
**Photo 17** shows the brake hose/pipe (arrowed) at the front right wheel of the Motor Car. I did not observe any leakage of brake fluid at the time of my inspection of the Motor Car. Static tests of the Motor Car's braking system had indicated that there was no internal leakage of pressure/vacuum.

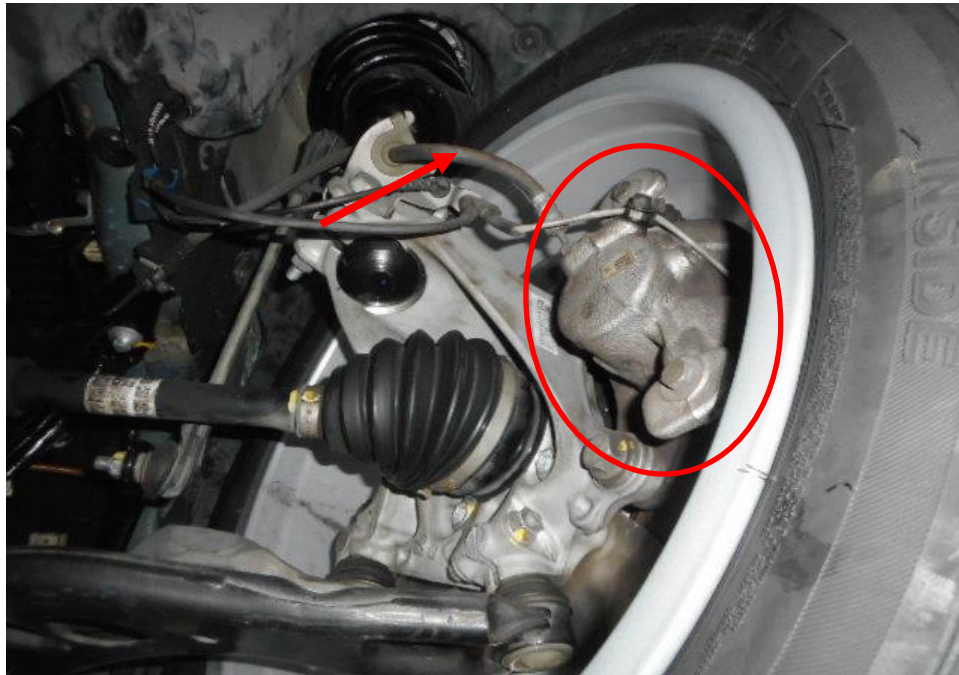
**Photo 18** shows the brake hose/pipe (arrowed) at the front left wheel of the Motor Car. No leakage of brake fluid was observed. Visual examination of the various components of the braking system like the brake caliper (circled), brake booster, brake pedal etc had revealed all to be intact and without visible damage.

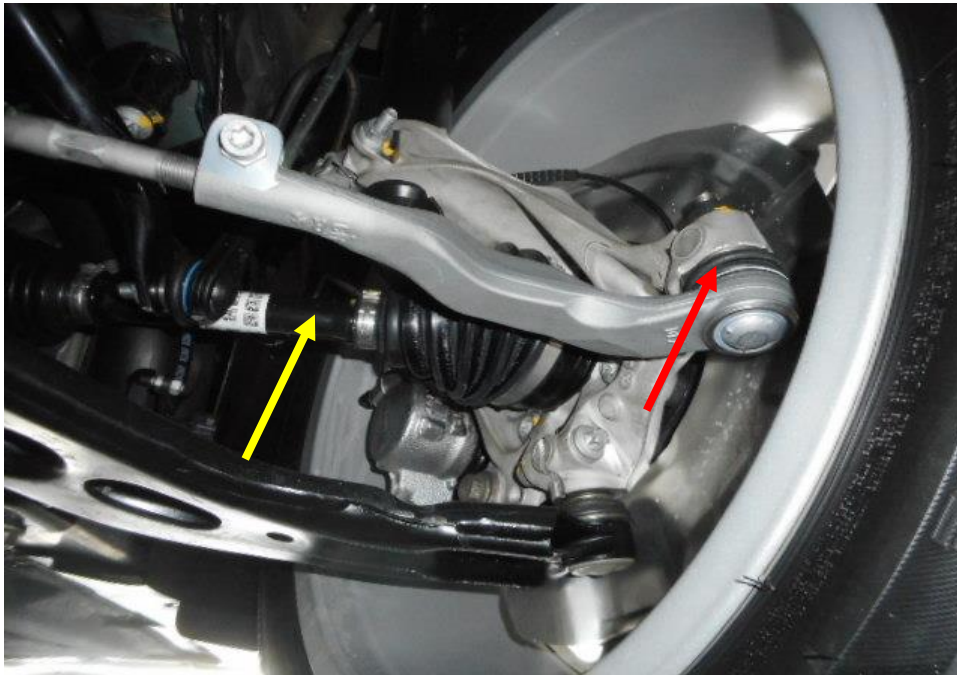
**Photo 20** shows the various undercarriage components at the front right wheel of the Motor Car, in particular the steering tie rod (red arrow) and in particular the drive shaft (yellow arrow). The various steering components were all found to be intact, suggesting that the steering system of the Motor Car was in serviceable condition. There was also no sign of fluid stain observed on the various undercarriage components at the front right wheel of the Motor Car.

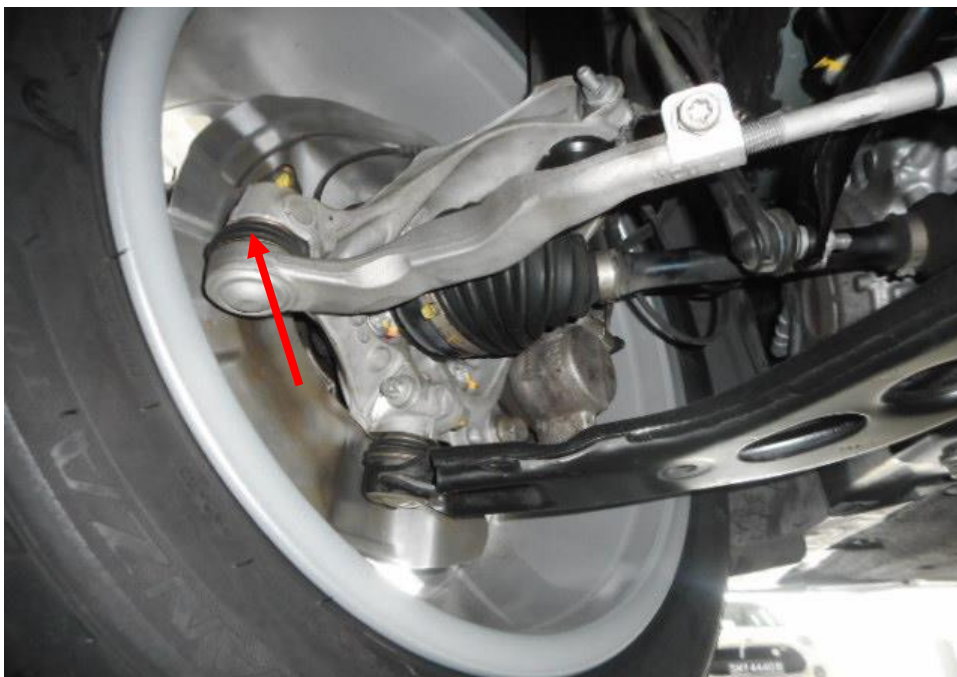
**Photo 21** shows the various undercarriage components at the front left wheel of the Motor Car, which had included the steering tie rod (arrowed). The various undercarriage components of the Motor Car were all found to be intact without any visible damage.

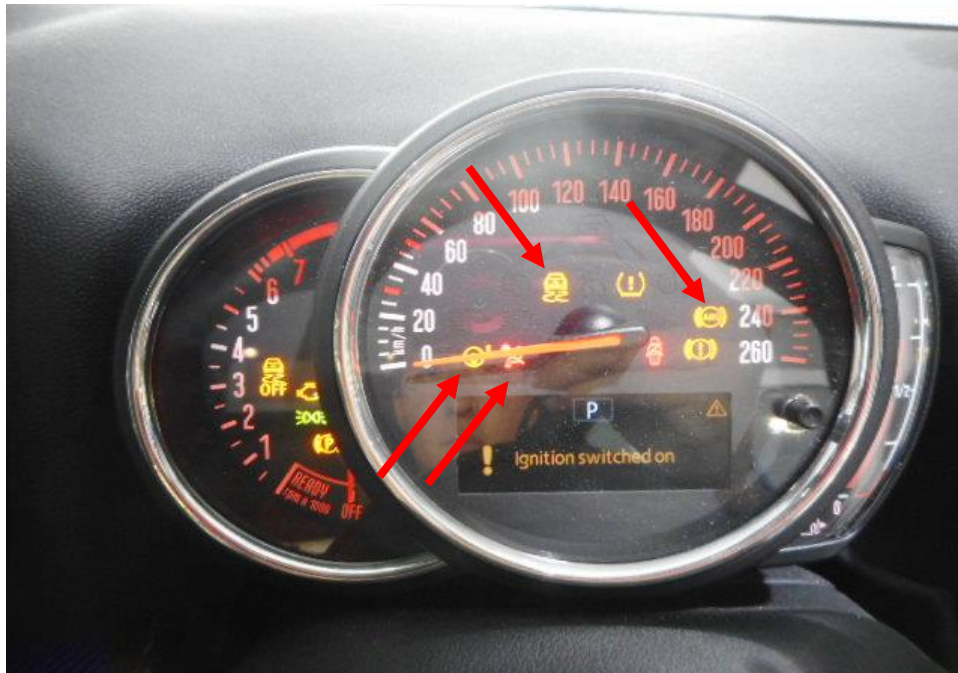
**Photo 22** shows the warning light for Anti-Lock Brake System (ABS), Traction Control System (TCS), Electrical Power Steering (EPS) and Supplemental Restraint System (SRS) (arrowed) appearing on the instrument panel of the Motor Car during the self-test of its various electronic operating systems when its engine was cranked.

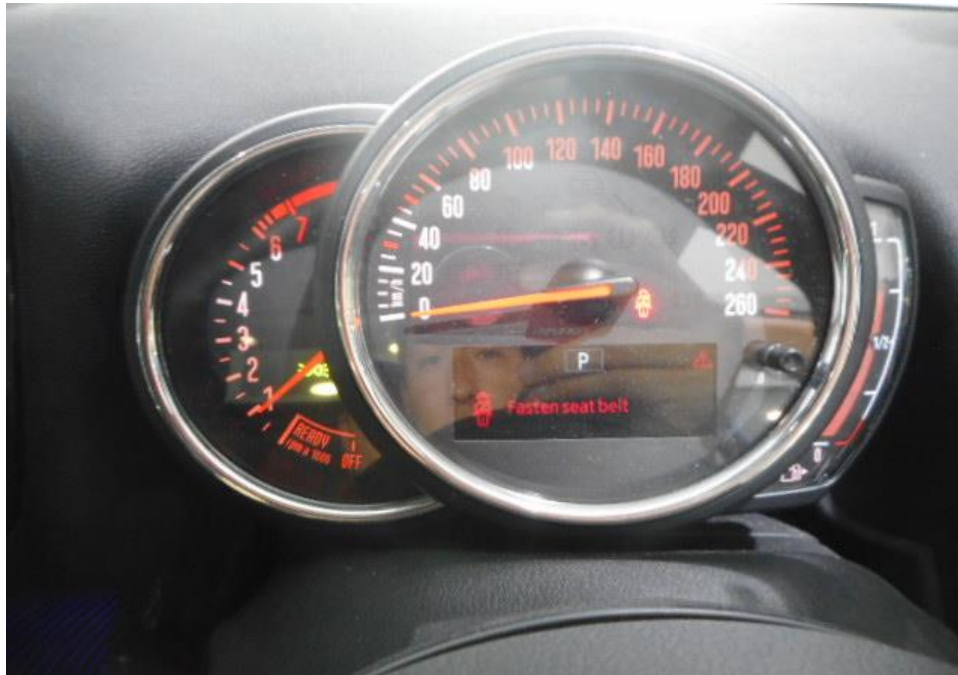
**Photo 23** shows no warning lights illuminated on the instrument panel of the Motor Car after the engine was cranked. This would suggest that there was no abnormality to the electronic operating system of the Motor Car, like the ABS, TCS, EPS and SRS etc.

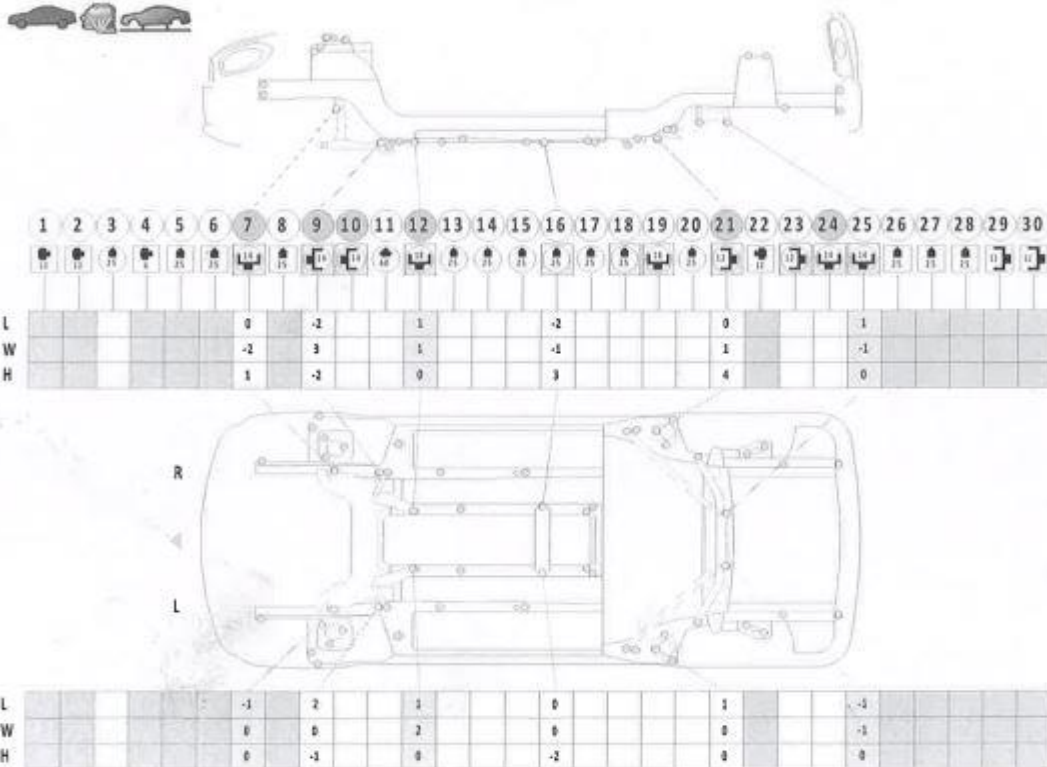
19. A lower body chassis alignment measurements of the Motor Car carried out by STA Inspection Pte Ltd on 15 November 2022 showed the chassis/structural measurements of the Motor Car to be within acceptable tolerance (refer to Appendix 1 at page 18 and 19 of this report).

Appendix 1 shows the lower body chassis measurements of the Motor Car that was carried out by STA Inspection Pte Ltd on 15 November 2022. I note that the chassis/structural measurements of the Motor Car were within acceptable tolerance (arrowed).
