Your Ref: SNM22D207285/C01/LEWLC
Our Ref : CS4/CTI22010135/N

21 October 2022

TECHNICAL INVESTIGATION REPORT OF FIRE INCIDENT INVOLVING THE INSURED VEHICLE XE 5826R ON 7 OCTOBER 2022

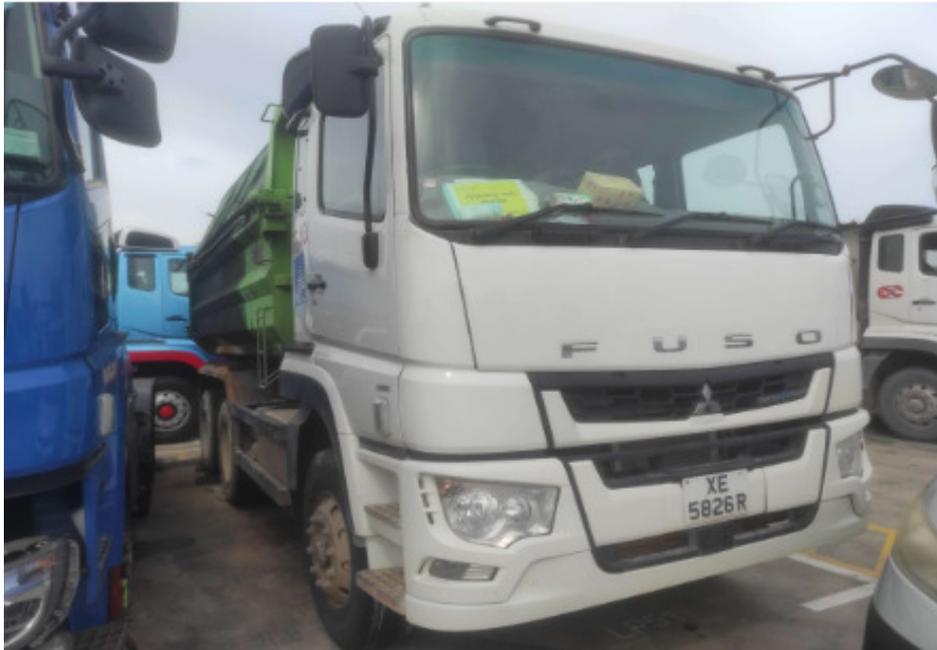
Photo 1 shows the general view of the frontal portion of the Insured Vehicle at the time of our inspection. The frontal portion of the Insured Vehicle was unaffected by the fire.

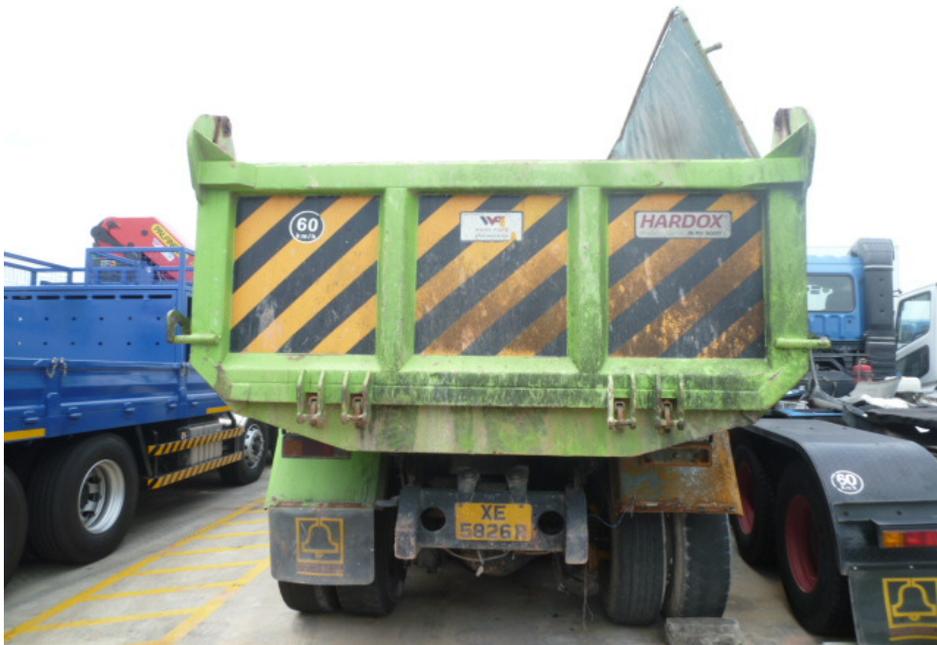
Photo 2 shows the general view of the rear portion of the Insured Vehicle at the time of our inspection. The rear portion of the Insured Vehicle was unaffected by the fire.

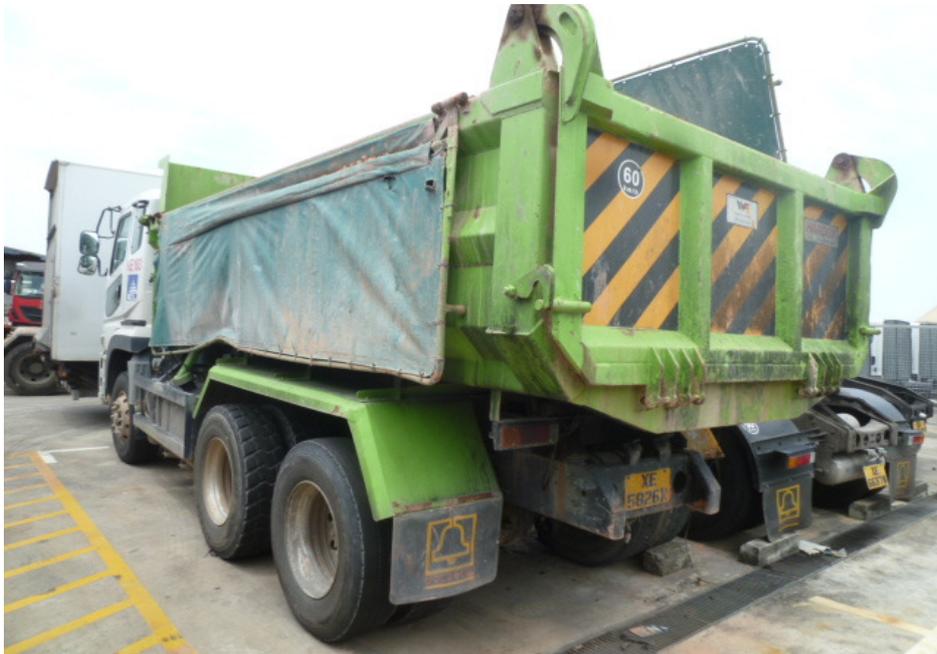
Photo 3 shows the general view of the left rear portion of the Insured Vehicle at the time of our inspection. The left portion of the Insured Vehicle was relatively unaffected by the fire.

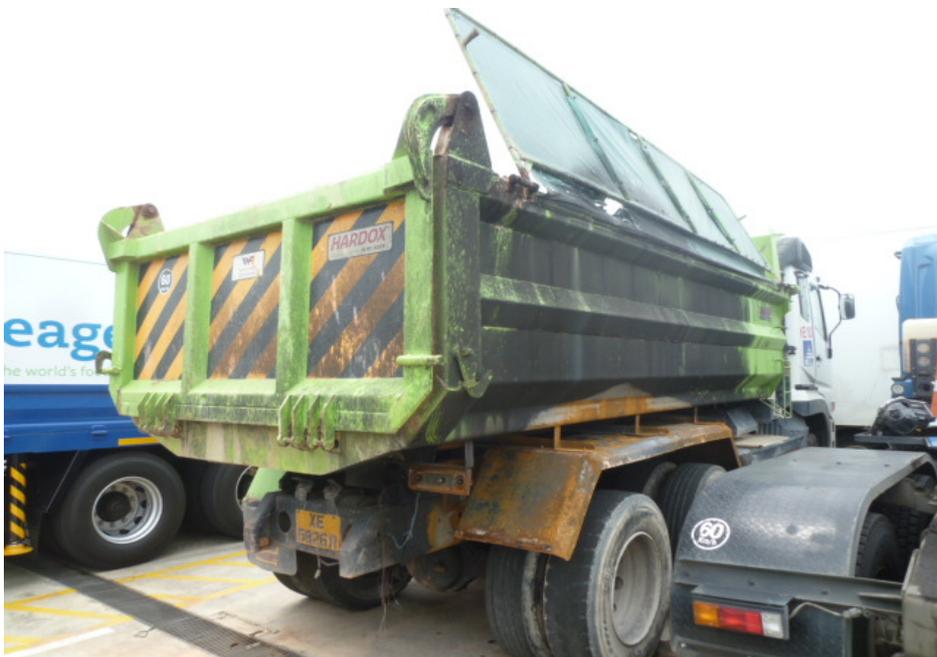
Photo 4 shows the general view of the right rear portion of the Insured Vehicle at the time of our inspection. The exterior body of the Insured Vehicle had sustained fire damages at the right rear wheel and rim area as well as its right rear portion. Affected parts had included the right rear panels, right rear wheels and rims.

7. For this particular case, the fire appears to have originated from the right rear portion of the Insured Vehicle, around the right rear wheel rims and tyres of the Insured Vehicle. This can be determined from the nature of the fire damage which was more extensive at the rear right portion. Basing on the circumstances of the fires' origin at the material time of incident as well as examining the area where the extent of fire damage was most severe, we can determine that the fire had likely started from the rear right wheel rims and tyres of the Insured Vehicle.

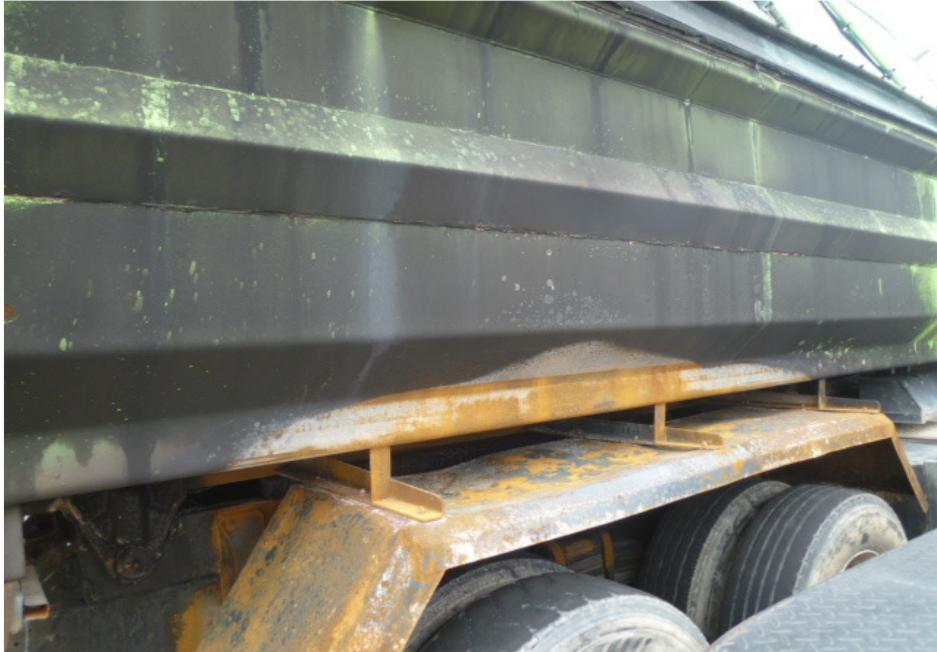
Photo 5 shows a closer view of the right rear portion of the Insured Vehicle at the time of our inspection. The fire damage was observed to be at its right rear portion. The container bin was observed to be affected by the fire.

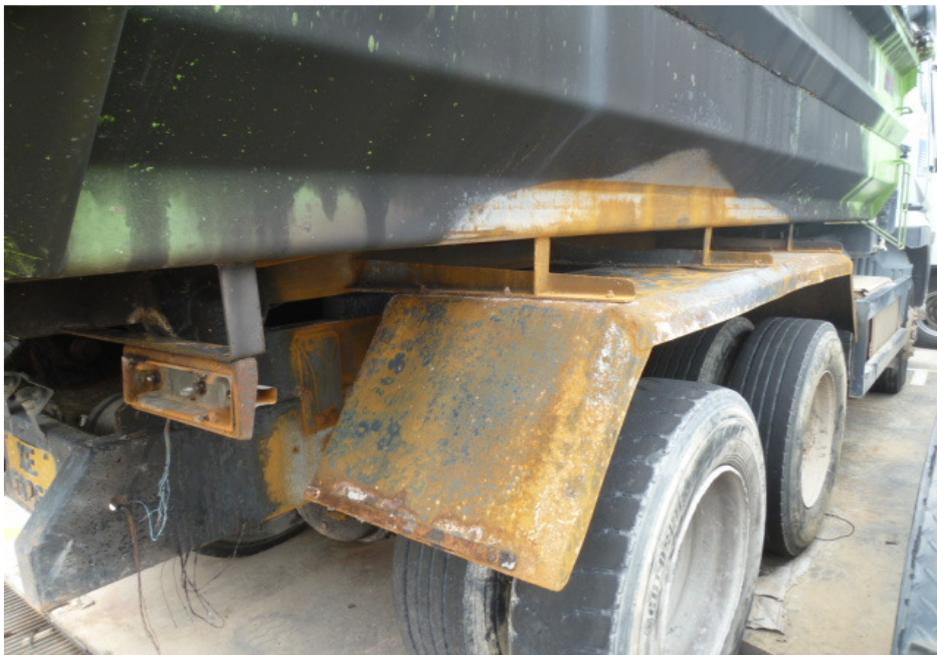
Photo 6 shows a closer view of the right rear portion of the Insured Vehicle at the time of our inspection. The fire damage was observed to be at its rear right portion. The rear right body panel was observed to be affected by the fire.

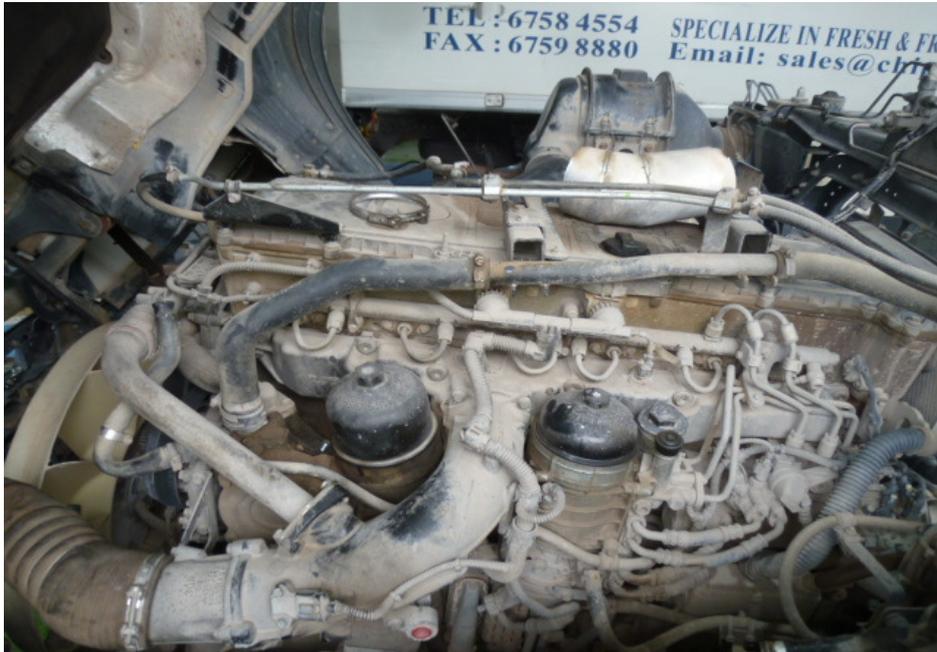
Photo 7 shows a general view of the engine compartment of the Insured Vehicle at the time of our inspection. The engine compartment of the Insured Vehicle was observed to be unaffected by the fire.

23. Given the circumstances of the incident as reported, the possibility of the cause of fire to the Insured Vehicle being due to engine overheating would seem unlikely as Mr Karupiah had mentioned to us there were no indications of abnormally high temperatures when he was driving the Insured Vehicle on the day of the incident. Moreover, an overheated engine would have caused the Insured Vehicle to stall. However in this case, Mr Karupiah was the one who heard a loud sound from the right rear portion while he was driving and stopped the Insured Vehicle. Therefore, we are of the opinion that the fire was not caused by an overheated engine.

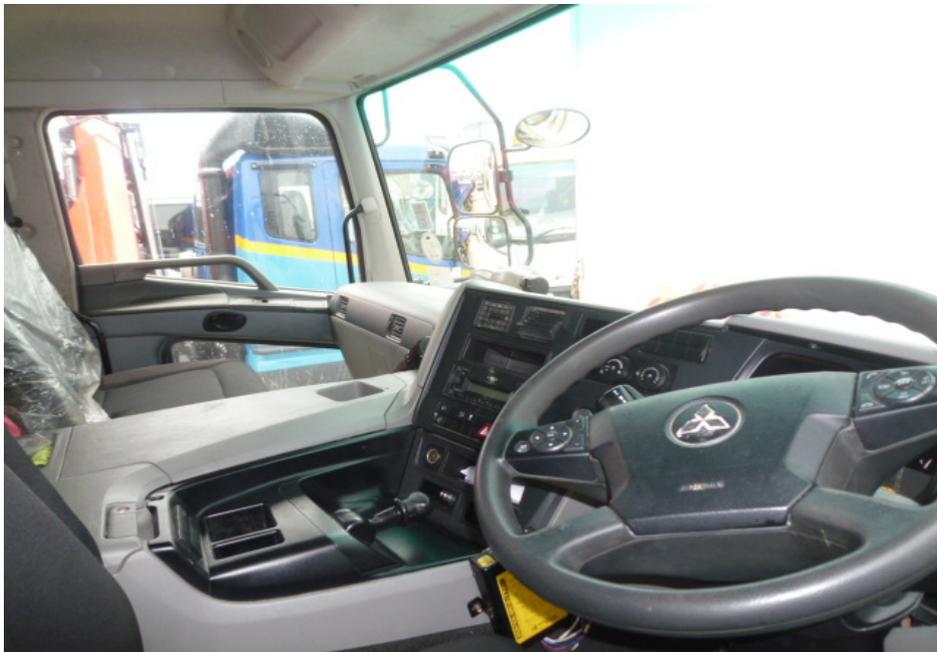
Photo 8 shows the interior compartment of the Insured Vehicle at the time of inspection. The interior compartment was relatively unaffected by the fire.

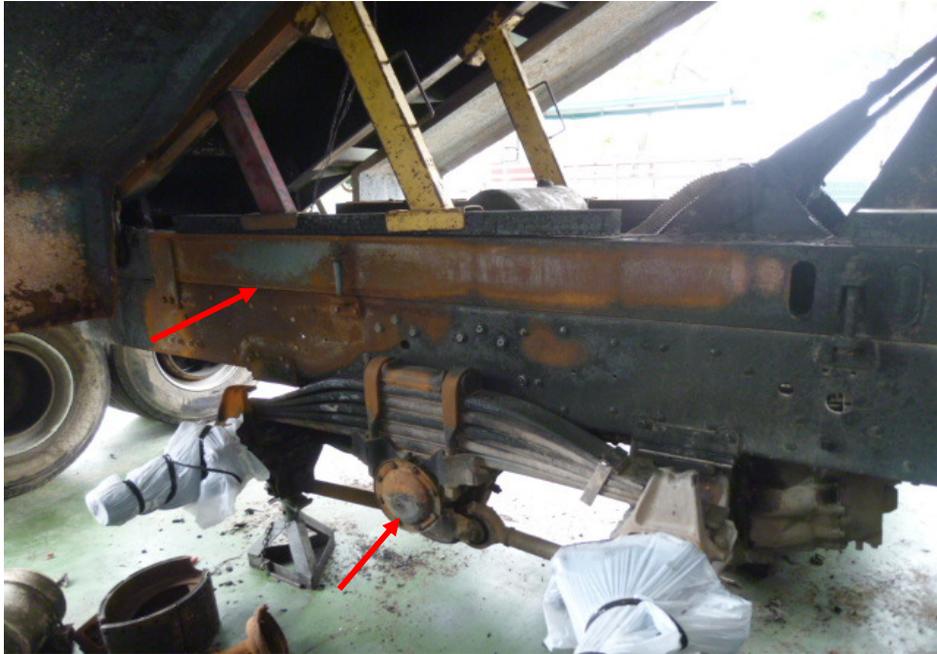
8. Upon closer examination of the right rear portion of the Insured Vehicle as well as around the immediate vicinity to where the fire had likely started, we had observed that the right rear portion had sustained the highest heat intensity burn marks (whitish burn marks) that were found on the surface of it. We focused our findings to the right rear wheel rim and tyres area and identify that the moving components in the area are the drum brakes system and the wheel drum itself.

Photo 9 shows the right rear portion of the Insured Vehicle after the right rear wheel rims and tyres had been removed. The whitish burn marks (arrowed) are a result of exposure to prolonged heat intensity.

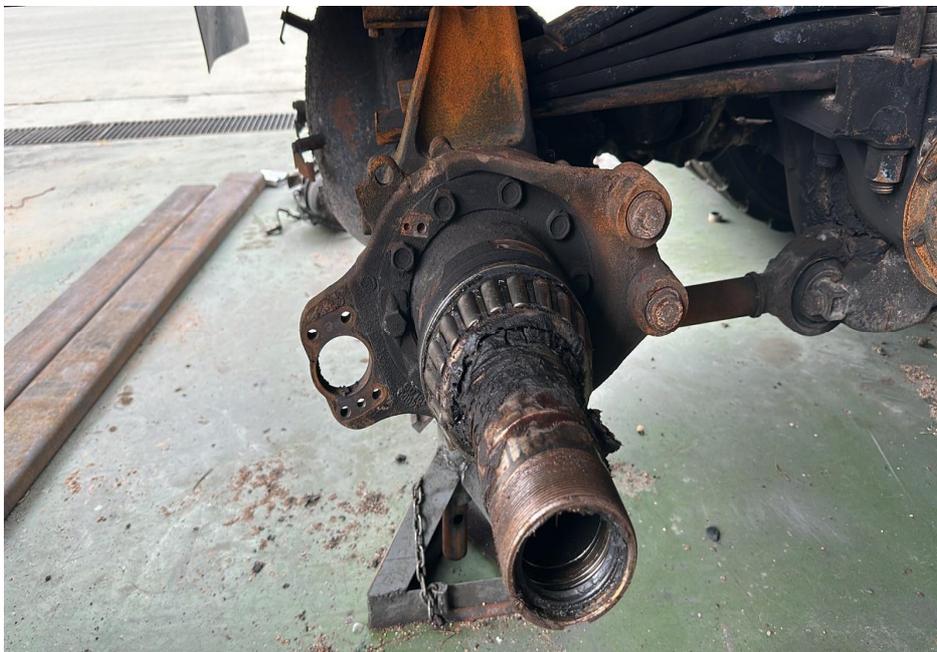
Photo 10 shows a general view of the right rear axle of the Insured Vehicle after the wheel rim was removed. Upon closer examination, we did not observe any damages to the right rear axle.

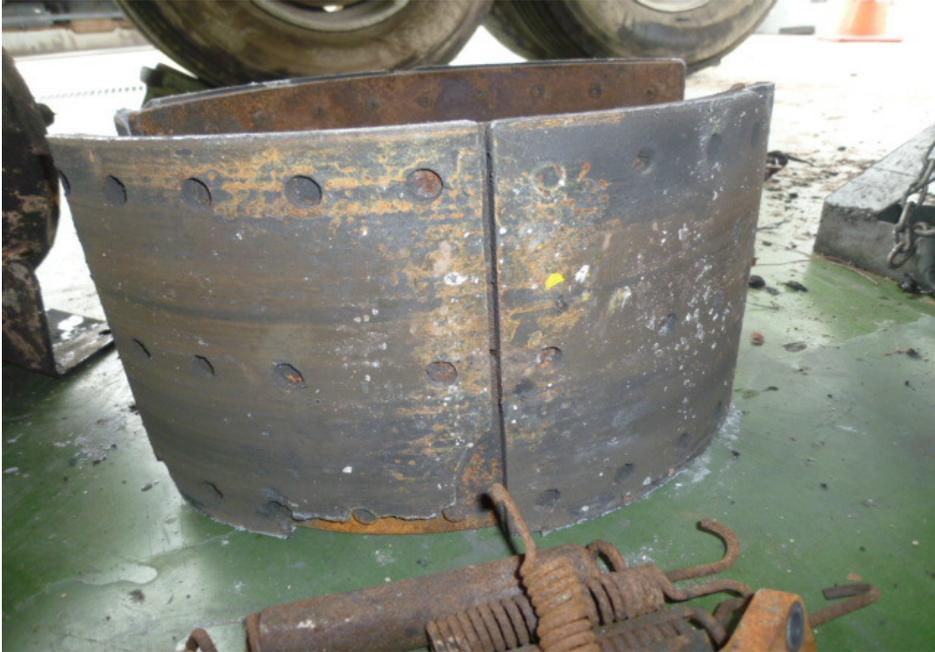
Photo 11 shows a close up view of the right rear top brake drum pad of the Insured Vehicle. Upon closer examination, we did not observed any damages to the brake drum pad.

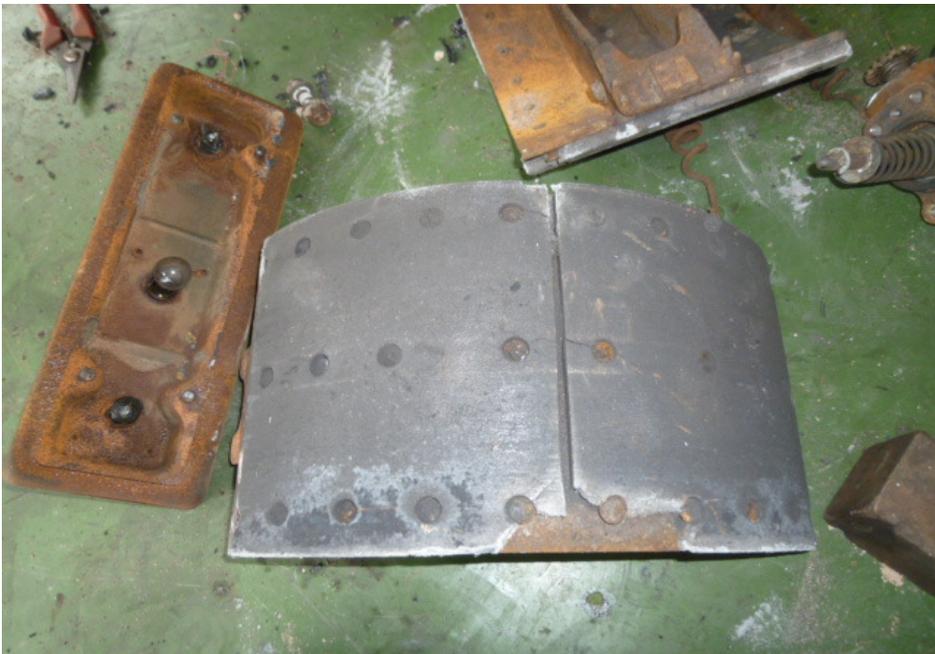
Photo 12 shows a general view of the right rear bottom brake drum pad of the Insured Vehicle. Upon closer examination, we did not observed any damages to the brake drum pad.

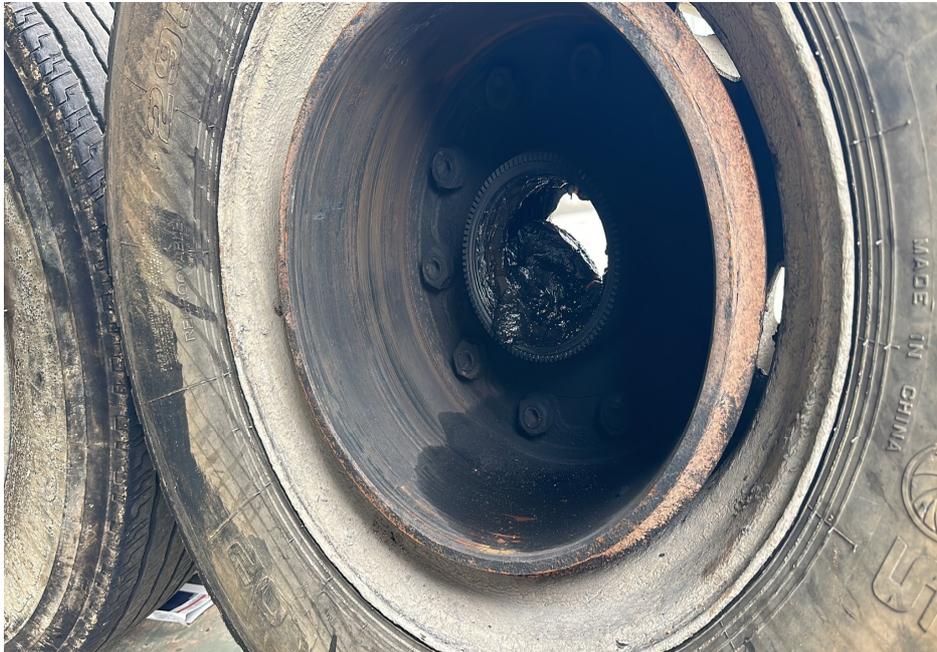
Photo 13 shows a general view of the right rear brake drum of the Insured Vehicle. Upon closer examination, we did not observe any damages to the exterior surface of the brake drum.

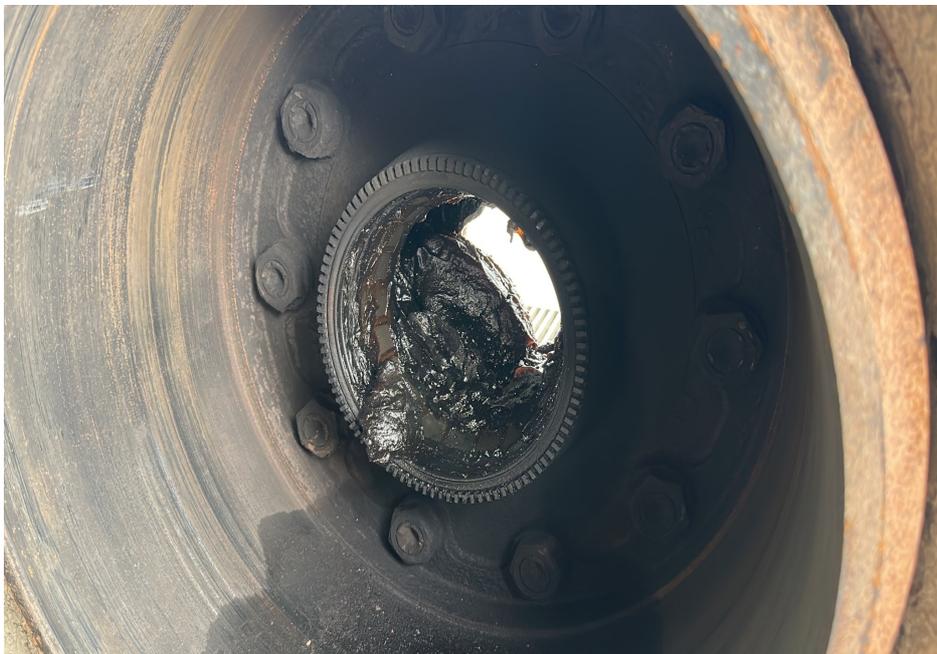
Photo 14 shows a close up view of the right rear brake drum of the Insured Vehicle. Upon closer examination, we did not observe any damages to the exterior surface of the brake drum.

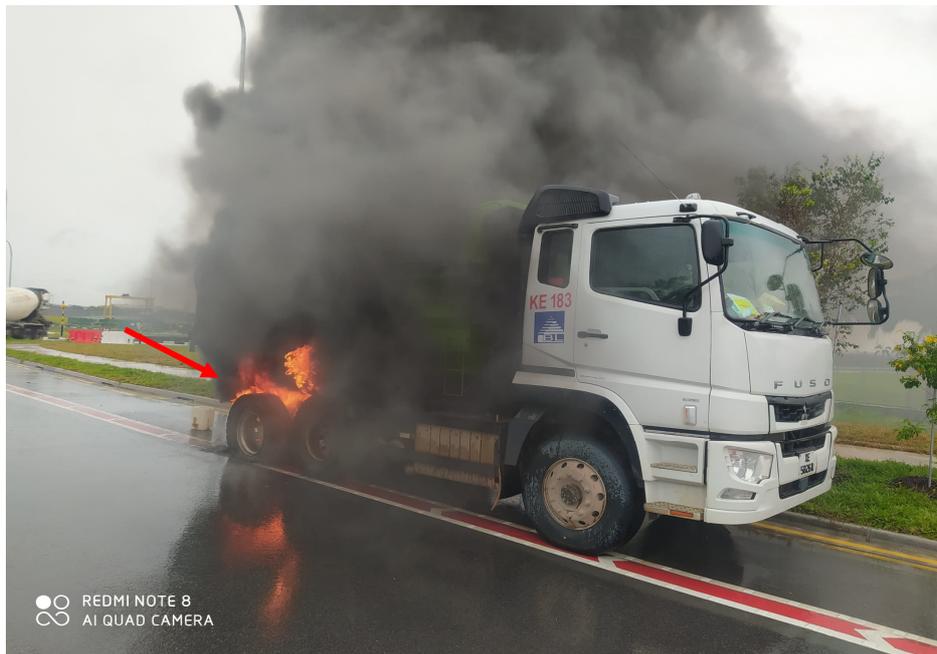
Photo 15 shows the Insured Vehicle on fire before the arrival of the SCDF. In general, the information that could be gathered from this photograph had corresponded to the events that were related to us by Mr Karuppiah, which is the fire had started from the right rear portion of the Insured Vehicle (arrowed).

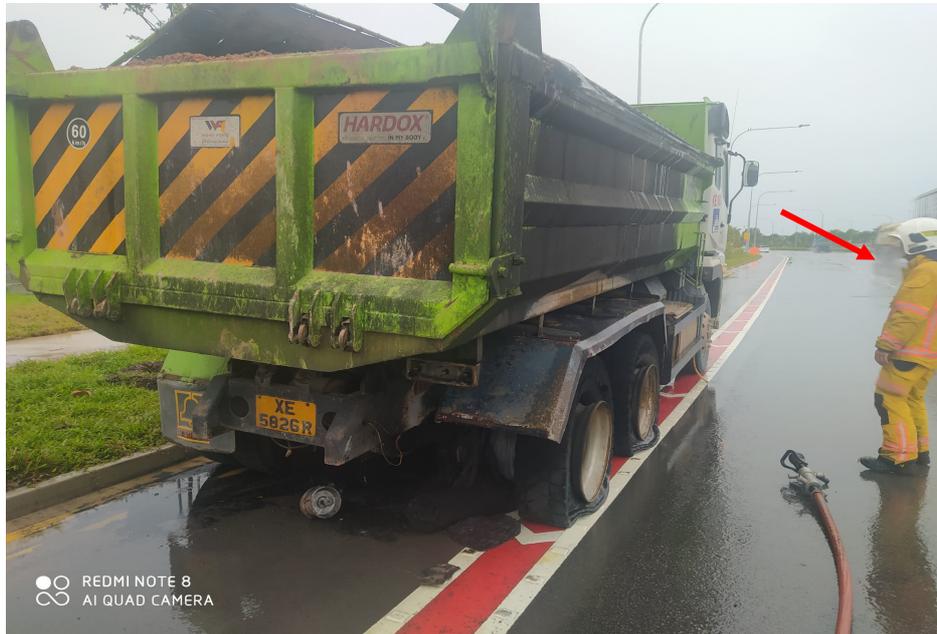
Photo 16 shows the Insured Vehicle at the incident scene after the fire was extinguished. In general, the information that could be gathered from this photograph had corresponded to the events that were related to us by Mr Karuppiah, which is the SCDF was present at the incident location (arrowed).

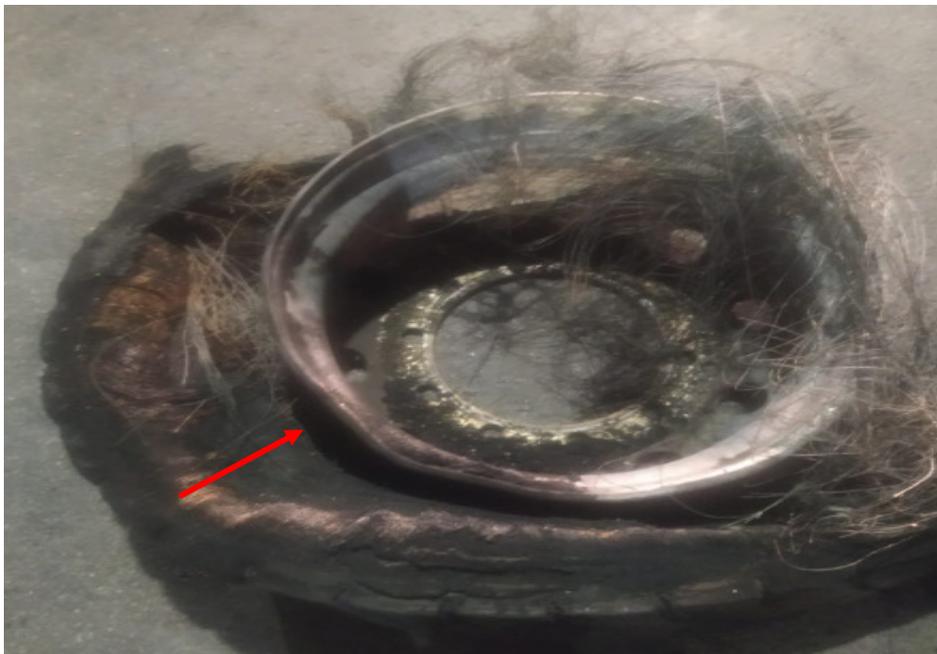
Photo 17 shows the damaged right rear rim and tyre of the Insured Vehicle at the incident scene after the fire was extinguished (arrowed). In general, the information that could be gathered from this photograph had corresponded to the events that were related to us by Mr Karuppiah, which is the right rear rims and tyres of the Insured Vehicle had been completely burnt as a result of the fire and had to be replaced before the insured Vehicle could be towed to Goldbell.

25. The possibility of the fire being due to external factors (foreign material(s) stuck on hot surfaces, arson and sabotage amongst others) would seem likely as in our opinion, the fire was due to the right rear outer wheel rim contacting the road surfaces where it was travelling on, where metal material of the wheel rim rubbing on the road surfaces causing sparks that had ignited the combustible materials in the vicinity like the rubber tyres, wirings and spreading into the cabin of the Insured Vehicle. We are in view that the right rear outer tyre had suffered a puncture causing the right rear outer wheel rim to contact the road surface resulting in the fire. As we observed that the dent and cracked damages on the right rear outer wheel rim was due to an impact resulting in the damages. The puncture to the right rear outer tyre had caused the Insured Vehicle to tilt down slightly to the right result in the right rear outer wheel rim to come into contact with the road surface, causing damages as well.
