Your Ref: TP/IP/14599/2022
Our Ref : CI/TPD22010139/N

7 October 2022

INSPECTION REPORT OF MOTORCYCLE FBG 8621U

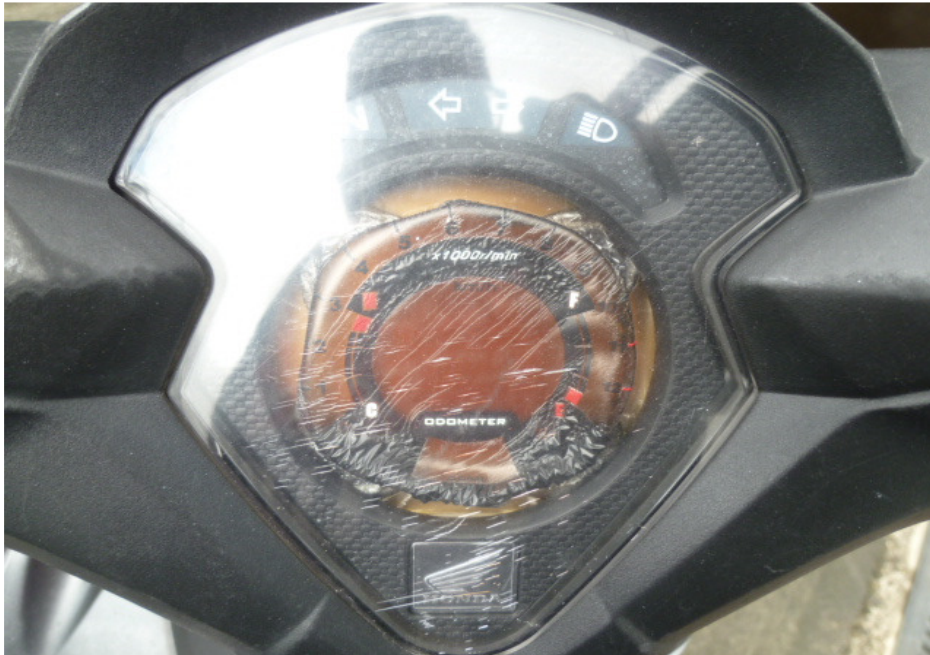
4. The mileage of the Motorcycle could not be recorded at the time of our inspection due to the damaged speedometer display screen.
5. The Motorcycle was observed to have sustained damages all around. The body parts that were found to have been damaged include its head cowling, front mudguard, left cowling, side mirrors, front brake lever, clutch lever, gear shift pedal, right front footrest and exhaust muffler, amongst others.

Photo 1 shows the damaged screen of the speedometer gauge of the Motorcycle. Hence the mileage of the Motorcycle could not be recorded at the time of our inspection.

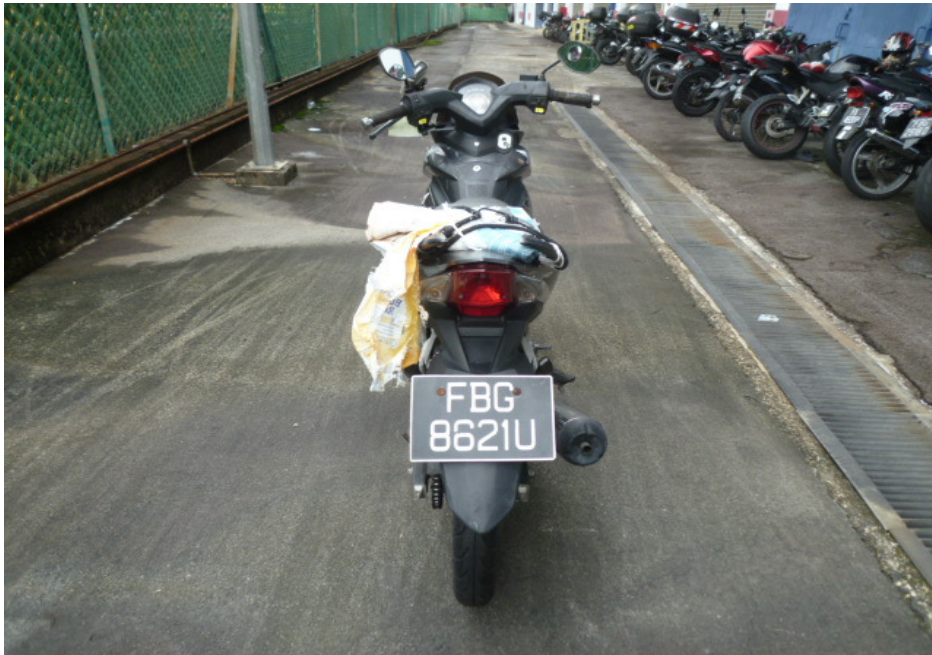
Photo 2 shows a general view of the rear portion of the Motorcycle at the time of our inspection. The Motorcycle was observed to have sustained damages all around.

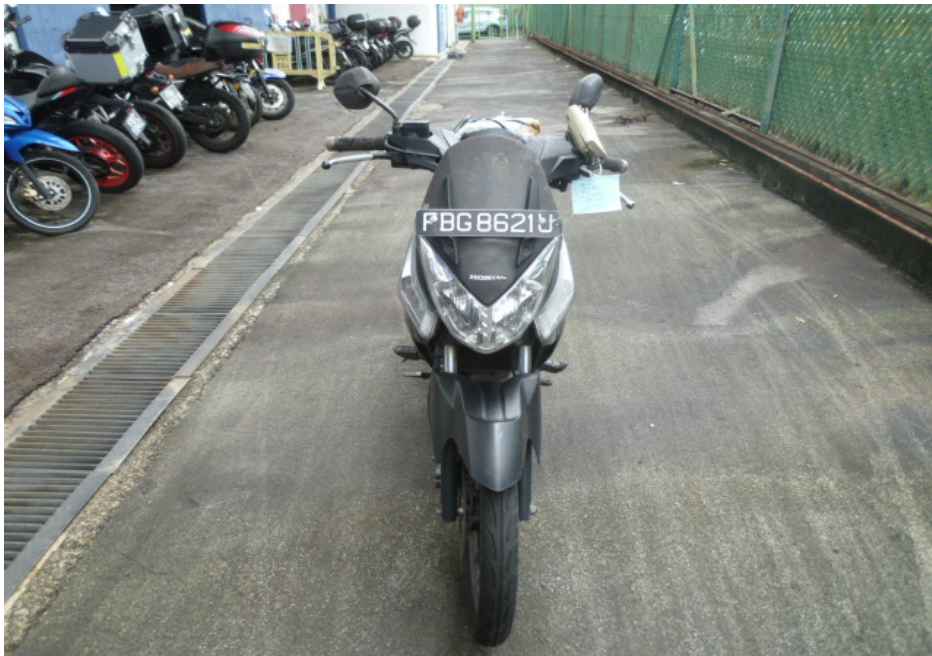
Photo 3 shows a general view of the frontal portion of the Motorcycle at the time of our inspection. The Motorcycle was observed to have sustained damages all around.

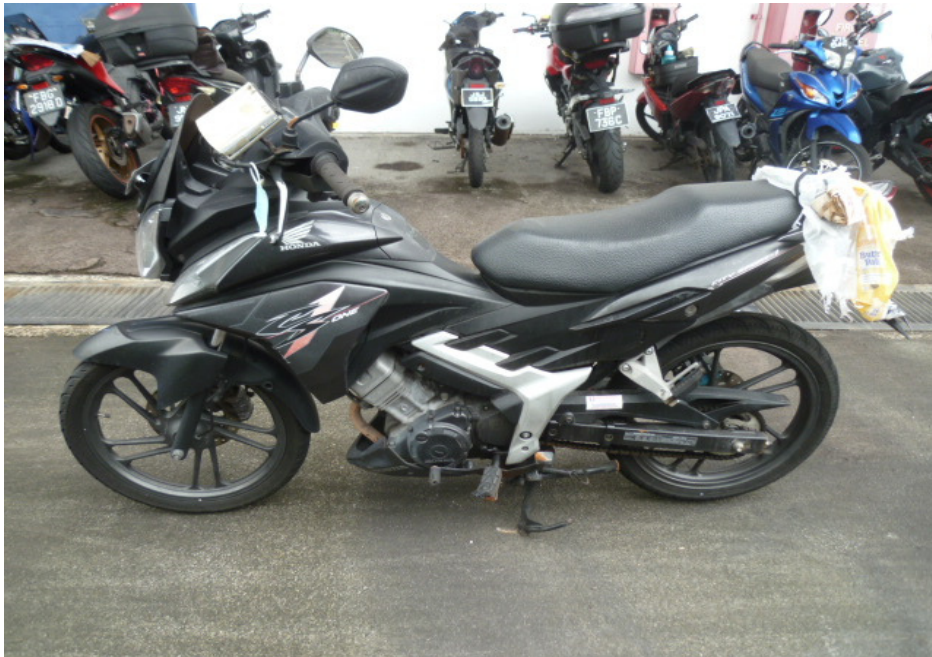
Photo 4 shows a general view of the left body of the Motorcycle at the time of our inspection. The Motorcycle was observed to have sustained damages all around.

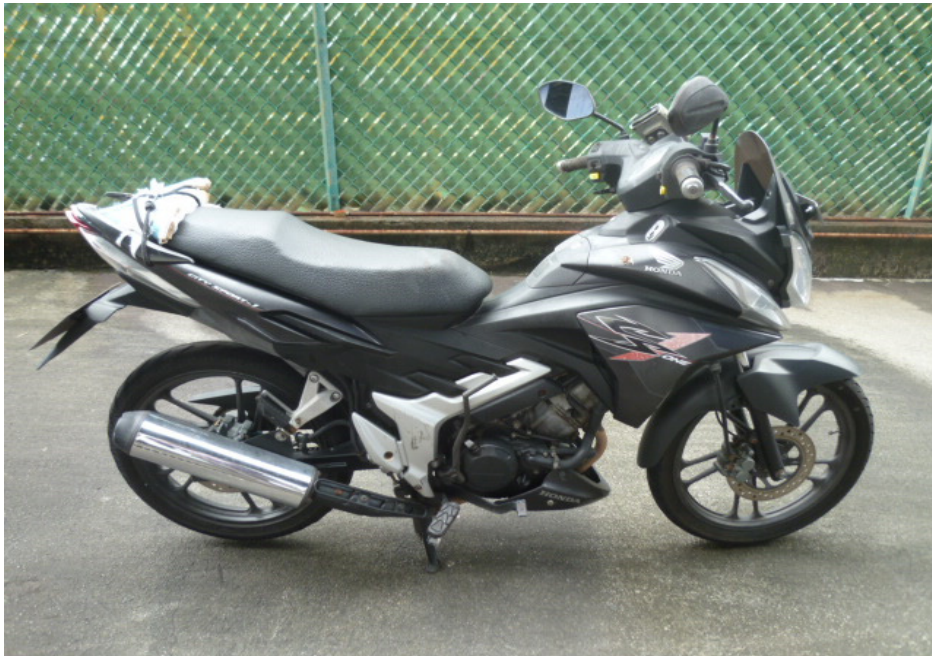
Photo 5 shows a general view of the right body of the Motorcycle at the time of our inspection. The Motorcycle was observed to have sustained damages all around. The body parts that were found to have been damaged include its head cowl, front mudguard, left cowl, side mirrors, front brake lever, clutch lever, gear shift pedal, right front footrest and exhaust muffler, amongst others.

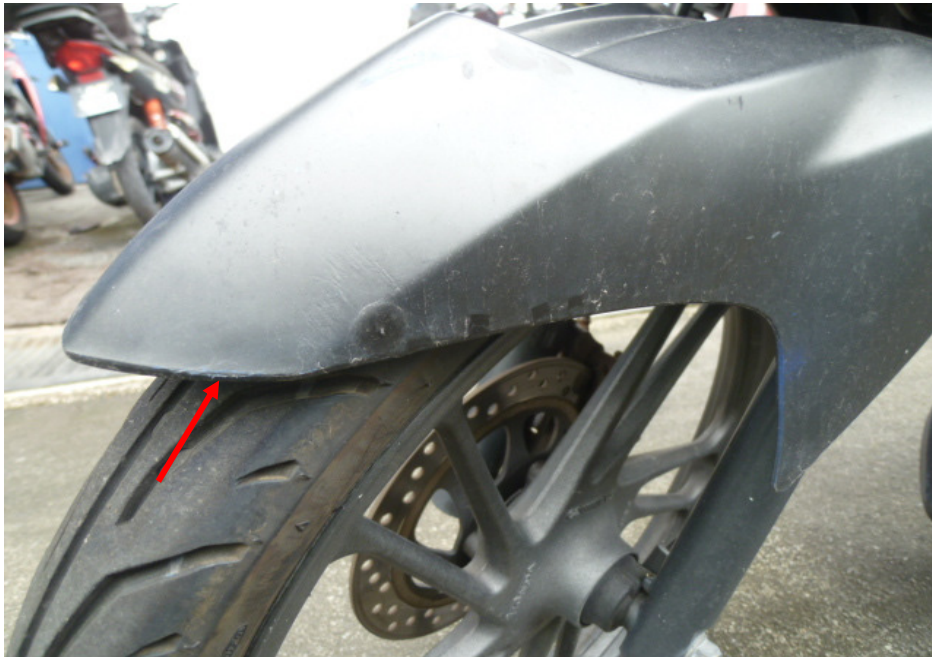
Photo 6 shows a closer view of the front mudguard (arrowed) which was amongst the body parts of the Motorcycle that had sustained damage as a result of the accident.

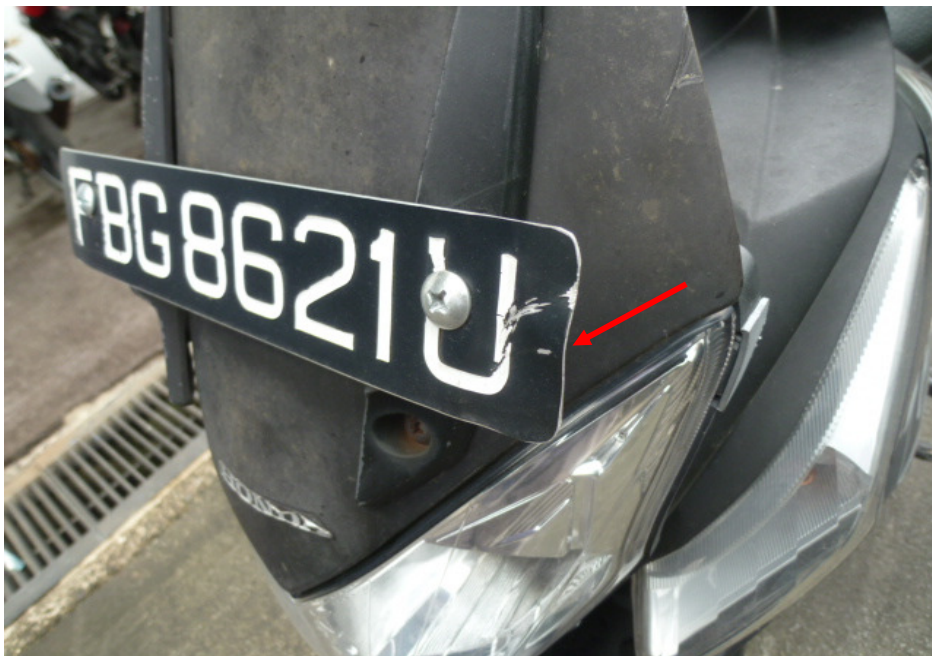
Photo 7 shows the dented front number plate (arrowed) of the Motorcycle as a result of the accident.

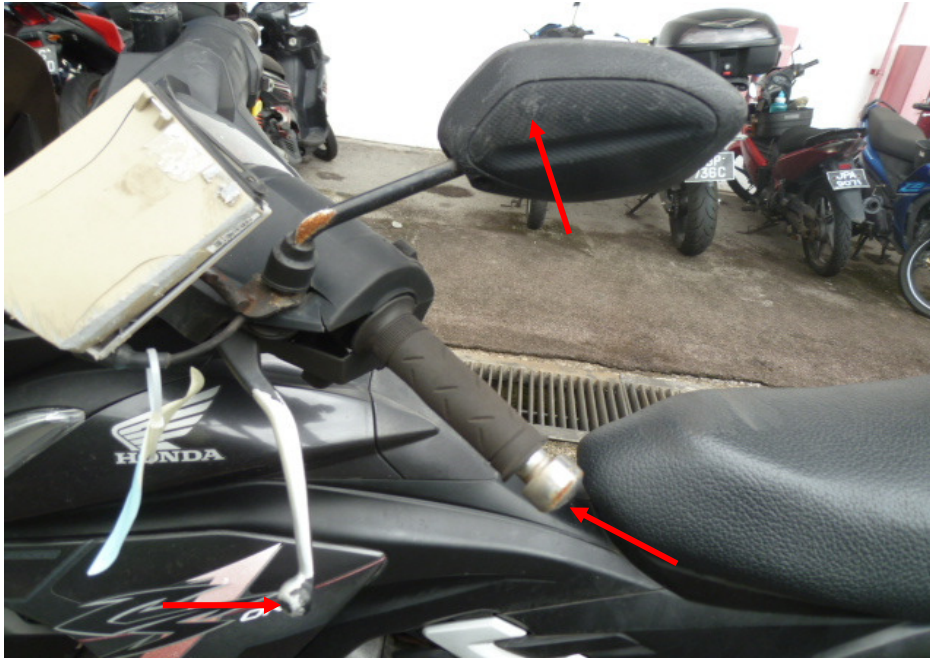
Photo 8 shows the left handlebar end, clutch lever and left side mirror (arrowed), which were amongst the body parts of the Motorcycle that had sustained damage as a result of the accident.

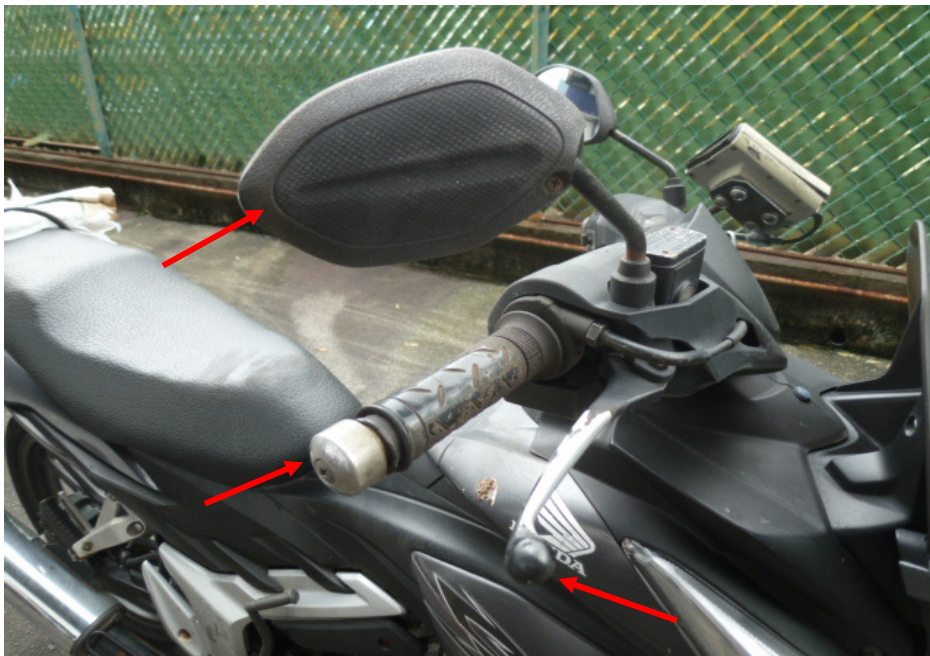
Photo 9 shows the right handlebar end, front brake lever and right side mirror (arrowed), which were amongst the body parts of the Motorcycle that had sustained damage as a result of the accident.

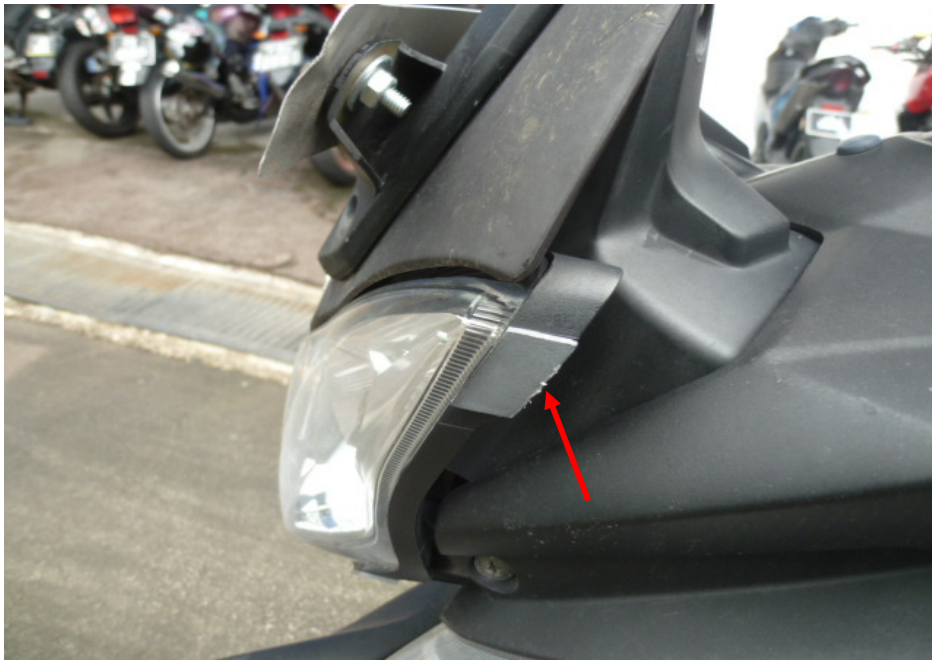
Photo 10 shows a closer view of the grazed head cowl of the Motorcycle as a result of the accident (arrowed).

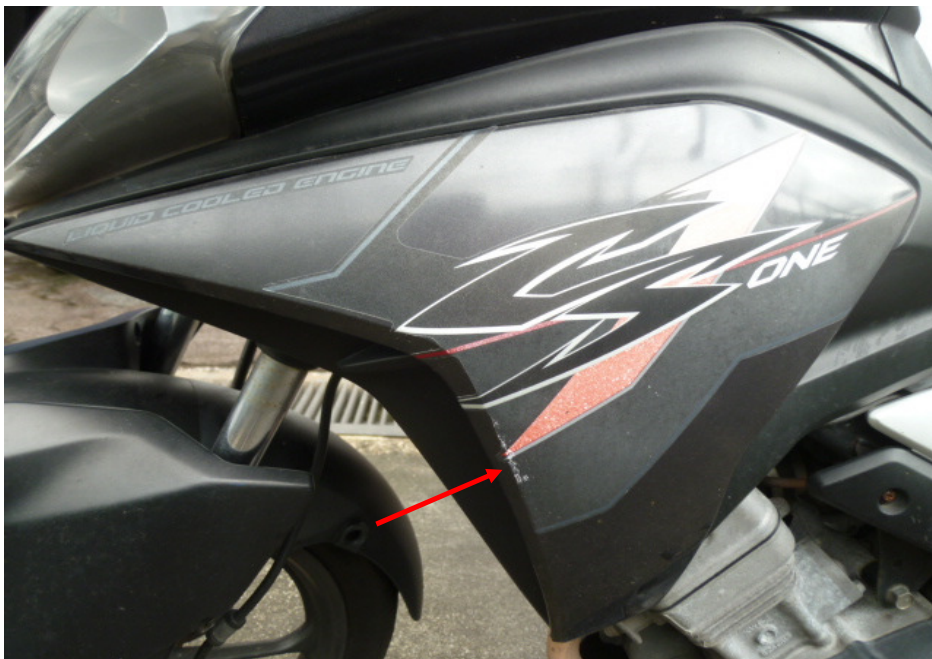
Photo 11 shows a closer view of the grazed left cowling of the Motorcycle as a result of the accident (arrowed).

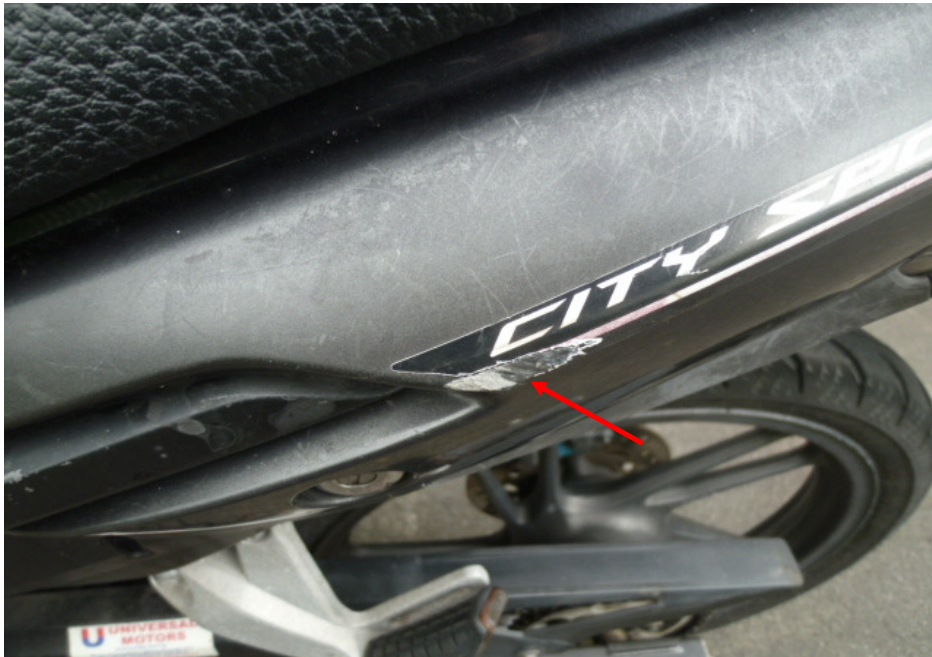
Photo 12 shows a closer view of the grazed left rear side cover of the Motorcycle as a result of the accident (arrowed).

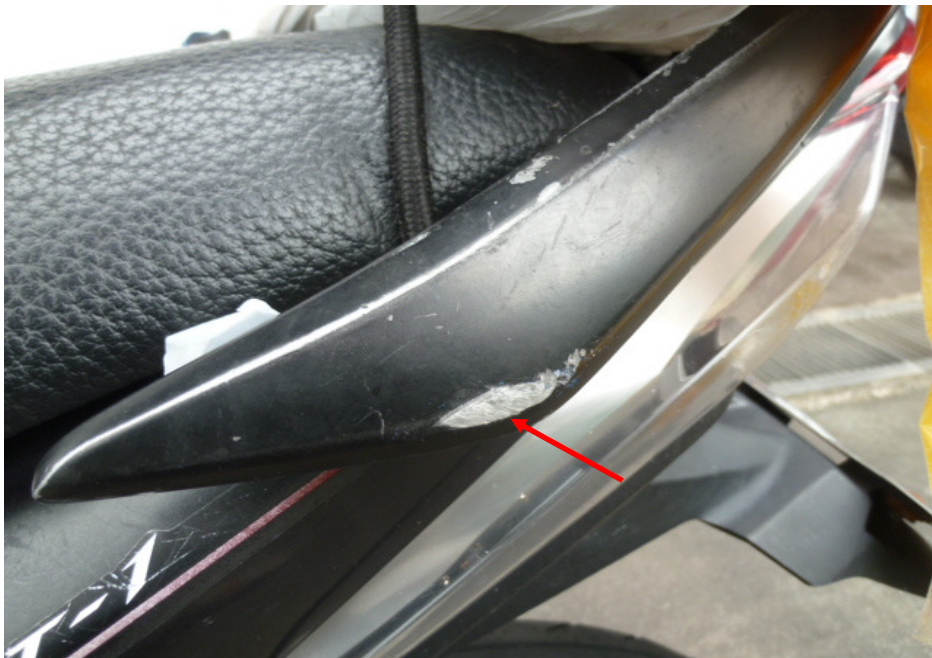
Photo 13 shows a closer view of the grazed left pillion grab rail of the Motorcycle as a result of the accident (arrowed).

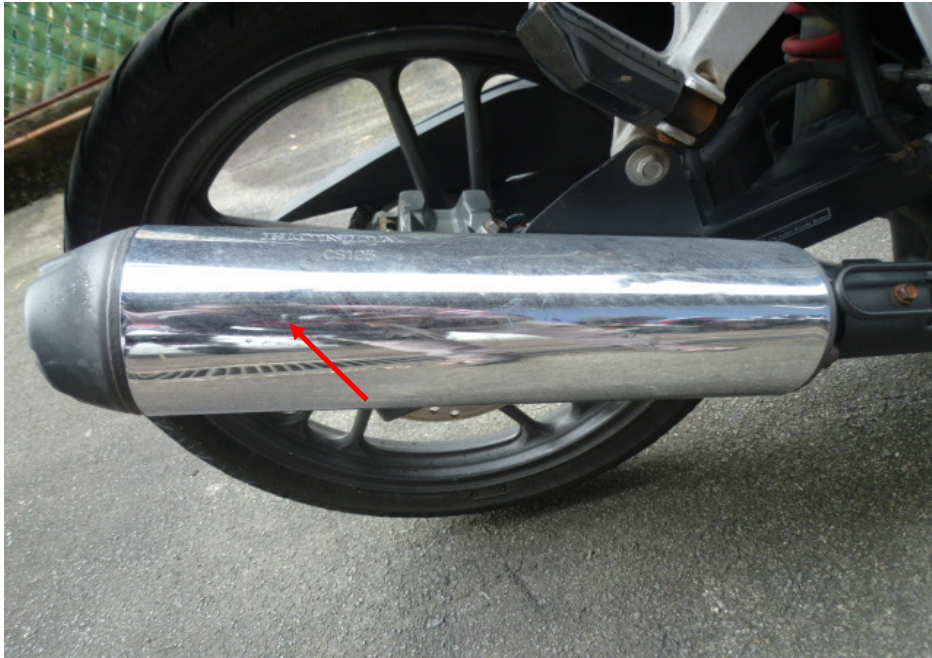
Photo 14 shows a closer view of the grazed exhaust muffler (arrowed) of the Motorcycle as a result of the accident.

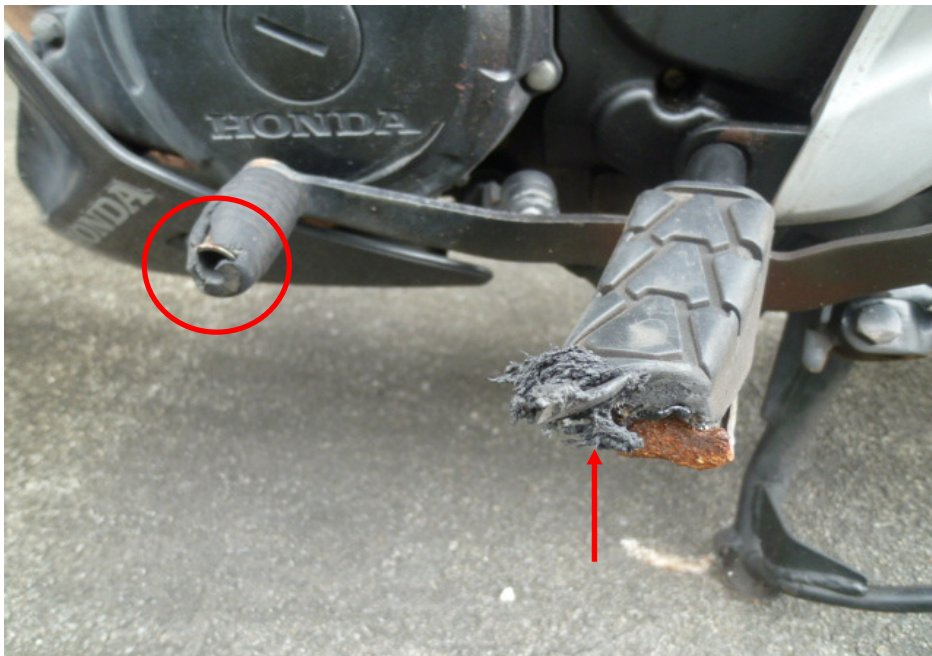
Photo 15 shows the grazed gear shift pedal (circled) and deformed left front footrest (arrowed) of the Motorcycle as a result of the accident.

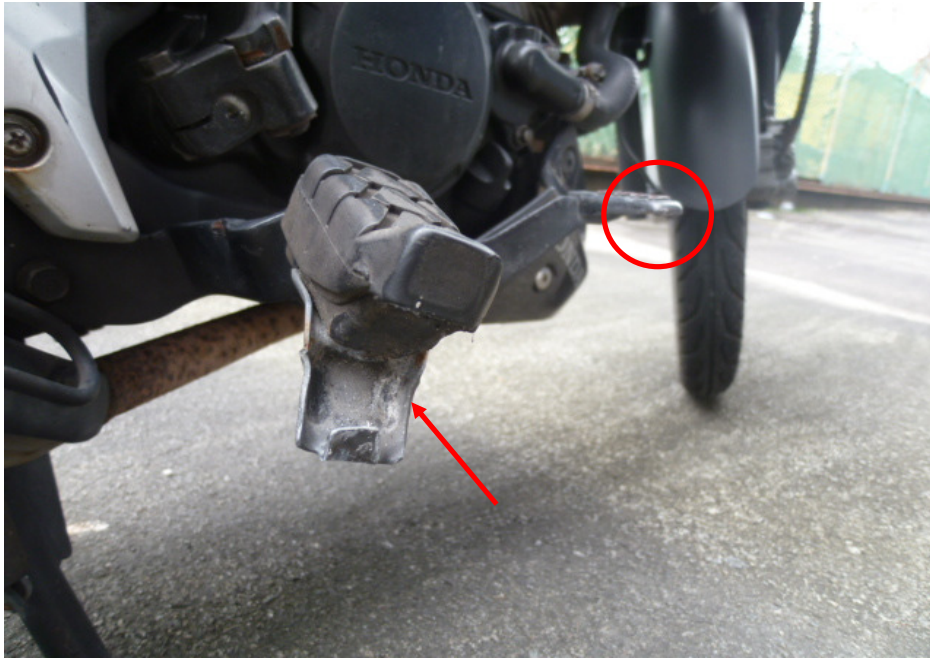
Photo 16 shows the grazed rear brake pedal (circled) and deformed right front footrest (arrowed) of the Motorcycle as a result of the accident.

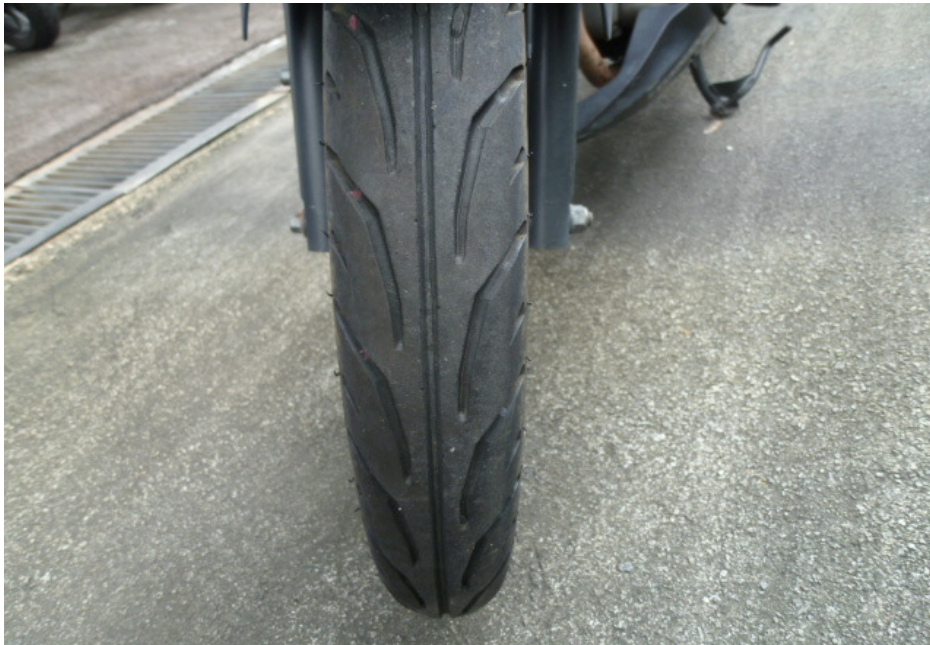
Photo 17 shows the front tyre of the Motorcycle at the time of our inspection. The front tyre was observed to be in serviceable condition with remaining tread depth of approximately 2mm. The pattern of the tread was also clearly visible. There was no tear, burst mark(s) and/or punctured hole(s) on the sidewalls as well as across the tread of the front tyre.

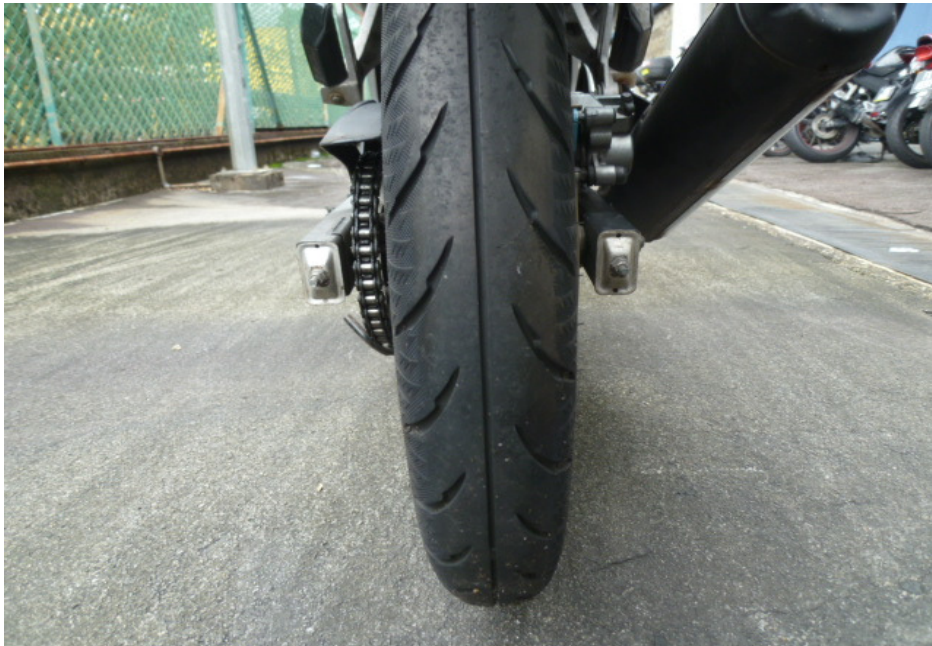
Photo 18 shows the condition of the Motorcycle's rear tyre. The rear tyre was observed to be in serviceable condition with remaining tread depth of approximately 2mm. The tyre was also observed to be sufficiently inflated for vehicular operation. We did not observe any tear, burst mark(s) and/or punctured hole(s) on the sidewalls as well as across the tread of the rear tyre.

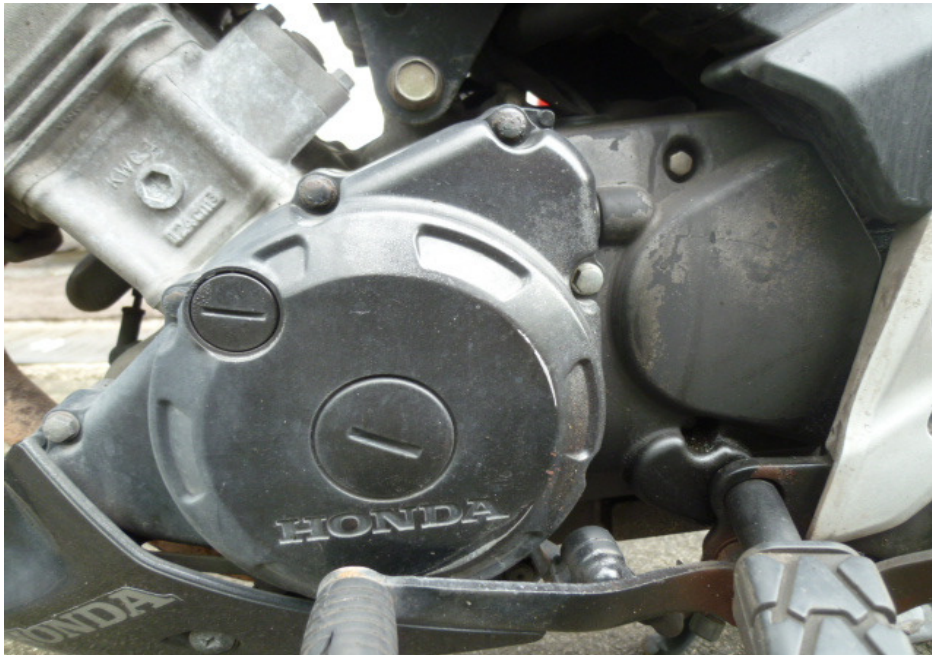
Photo 19 shows the left side of the engine of the Motorcycle at the time of our inspection. The various engine related parts and components were found to be intact with no visible damage. There was also no sign(s) or indication(s) of fluid leak observed around the left engine area of the Motorcycle.

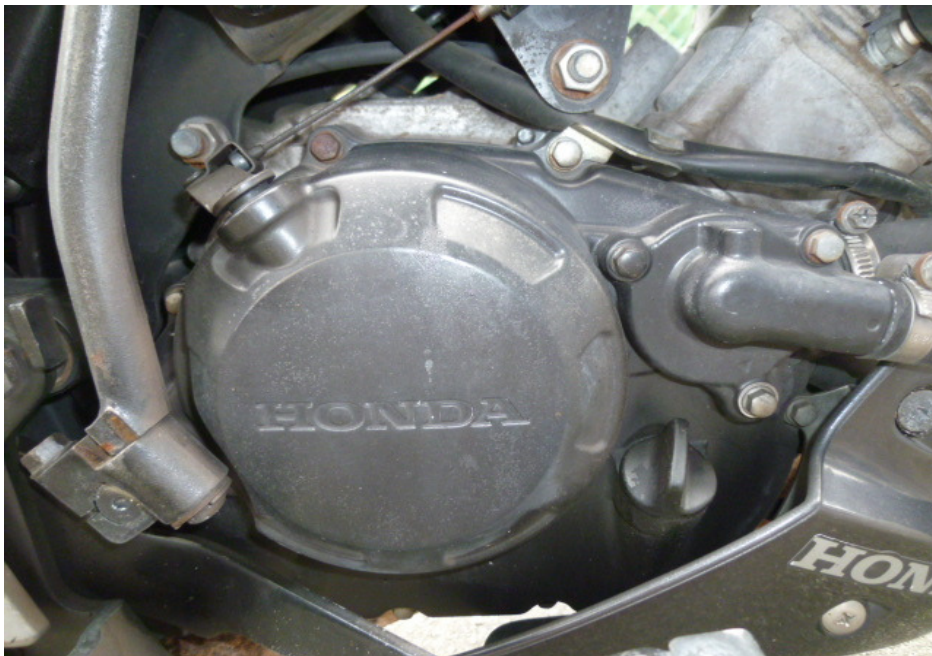
Photo 20 shows the right side of the engine of the Motorcycle at the time of our inspection. The various engine related parts and components were found to be intact with no visible damage. There was also no sign(s) or indication(s) of fluid leak observed around the right engine area of the Motorcycle.

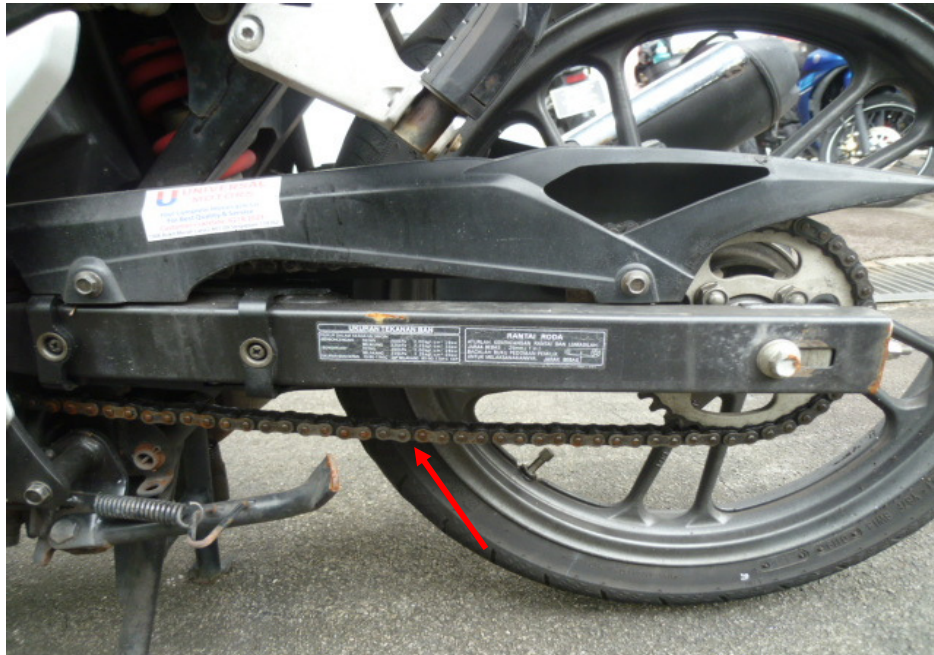
Photo 21 shows the general view of the gear train (arrowed) of the Motorcycle, which was observed to be intact with no misalignment. It was also adequately lubricated for operating purposes. The gear train rotates the rear wheel of the Motorcycle

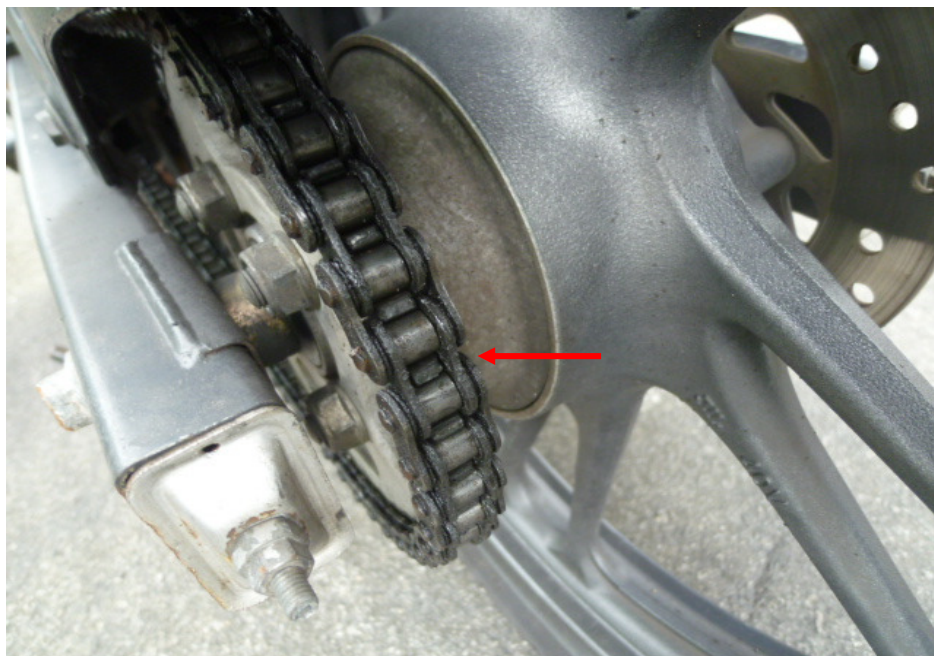
Photo 22 shows a closer view of the gear train (arrowed) of the Motorcycle, which was observed to be intact with no misalignment. It was also adequately lubricated for operating purposes.

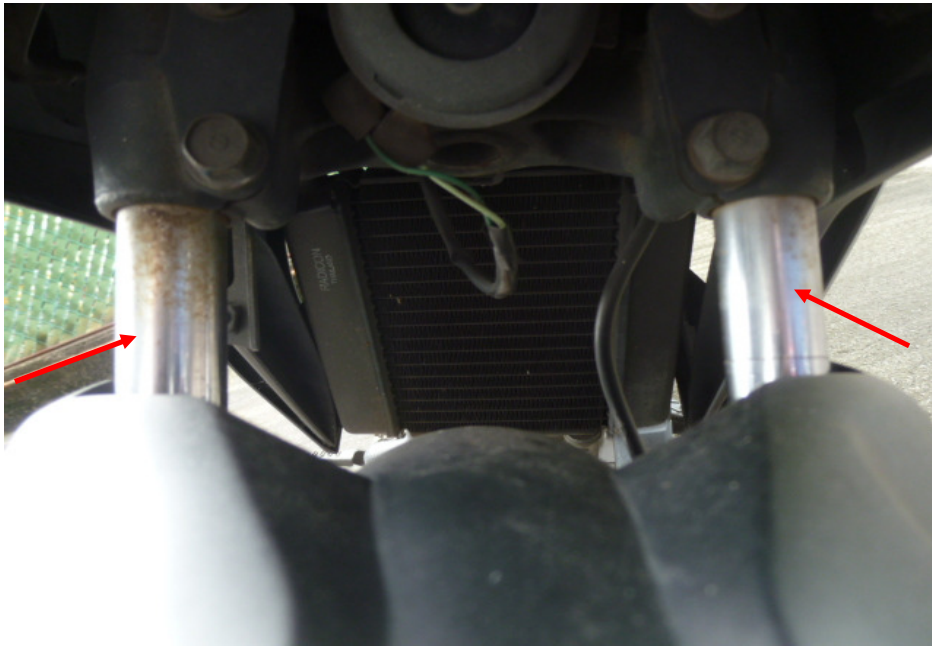
Photo 23 shows the front forks (arrowed) of the Motorcycle. The front forks and fork bracket of the Motorcycle were both found to be intact and undamaged. Turning the Motorcycle's handle bar towards the left and right did not produce any abnormal free play. The steering system of the Motorcycle was in serviceable condition at the time of our inspection.

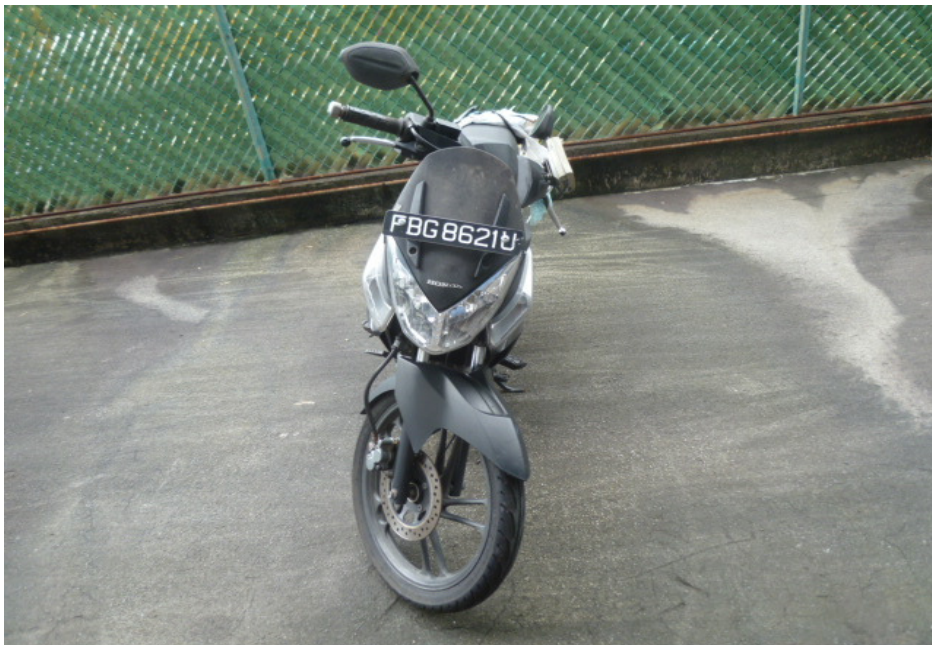
Photo 24 shows the front wheel of the Motorcycle turned towards its full left. Turning the Motorcycle's handle bar towards the left did not produce any abnormal free play and/or resistance. This would indicate that the steering system of the Motorcycle was in serviceable condition at the time of our inspection.

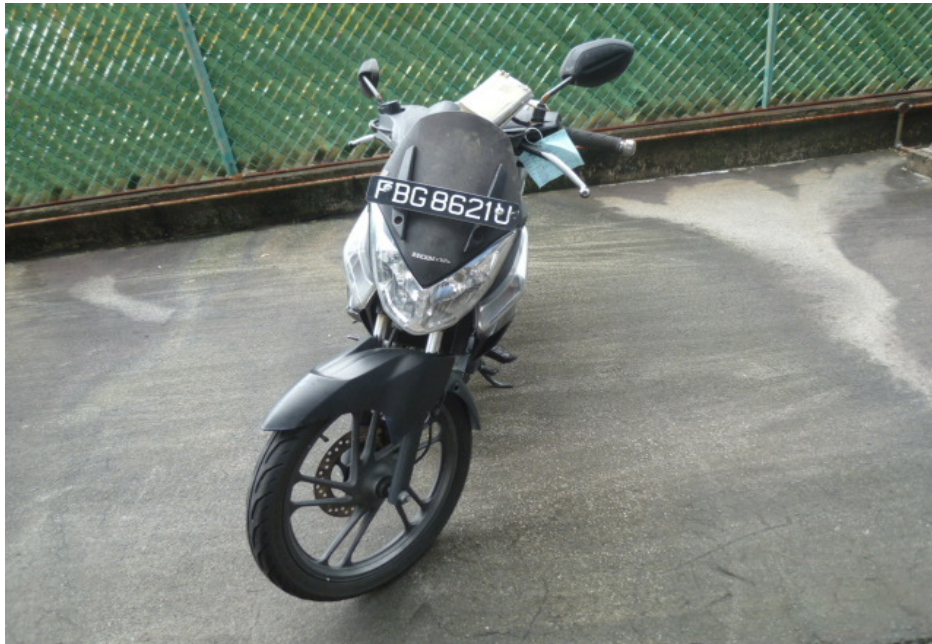
Photo 25 shows the front wheel of the Motorcycle turned towards its full right. Turning the Motorcycle's handle bar towards the right did not produce any abnormal free play and/or resistance. This would indicate that the steering system of the Motorcycle was in serviceable condition at the time of our inspection.

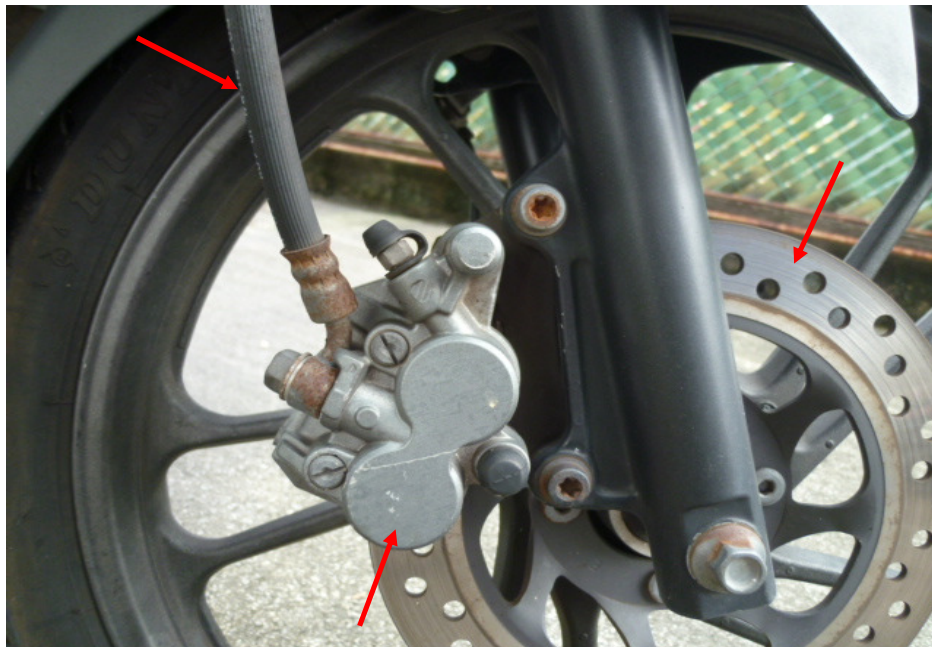
Photo 26 shows a close up view of the front brake caliper, front brake disc and front brake hose (arrowed) of the Motorcycle, which are all part of the components in the hydraulic front brake system of the Motorcycle. Our visual checks of these various components had revealed all to be intact with no visible damage. No leakage of brake fluid was also observed.

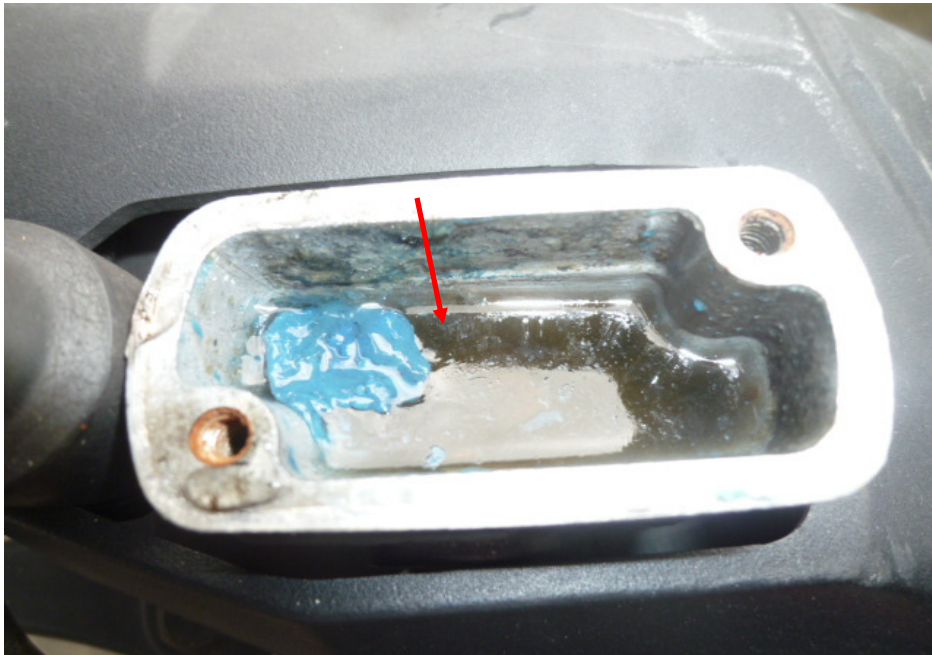
14. The brake fluid for the front brake and rear brake was observed to be of sufficient level for operational purposes. However the brake fluid for the front brake was found to be contaminated.

Photo 27 shows a close up view of the brake fluid reservoir for the front brake of the Motorcycle. The front brake fluid was observed to be of sufficient level for operational purposes. However it was found to be contaminated (arrowed).

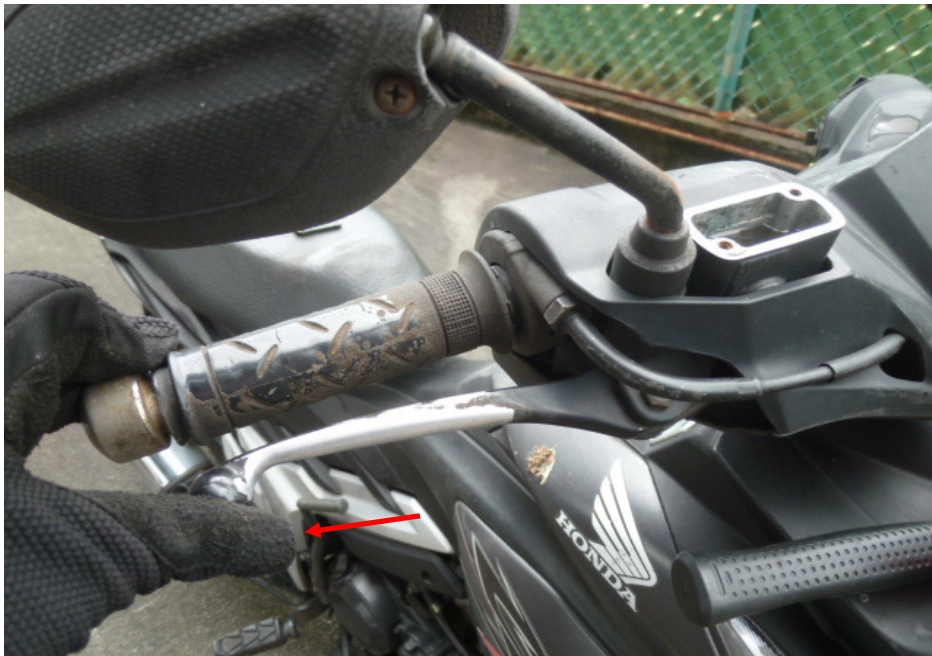
15. Static brake tests conducted on the Motorcycle had appear to indicate that the braking system of the Motorcycle was in serviceable condition. There was some resistance felt (spongy like feel) upon pressing the brake lever and upon stepping on the brake pedal. This would indicate that there was no leakage of pressure/vacuum in the braking system.

Photo 28 shows the front brake lever being depressed. There was some resistance felt (spongy like feel) upon pressing the front brake lever (arrowed). This would indicate that there is no leakage of pressure/vacuum in the front brake system.

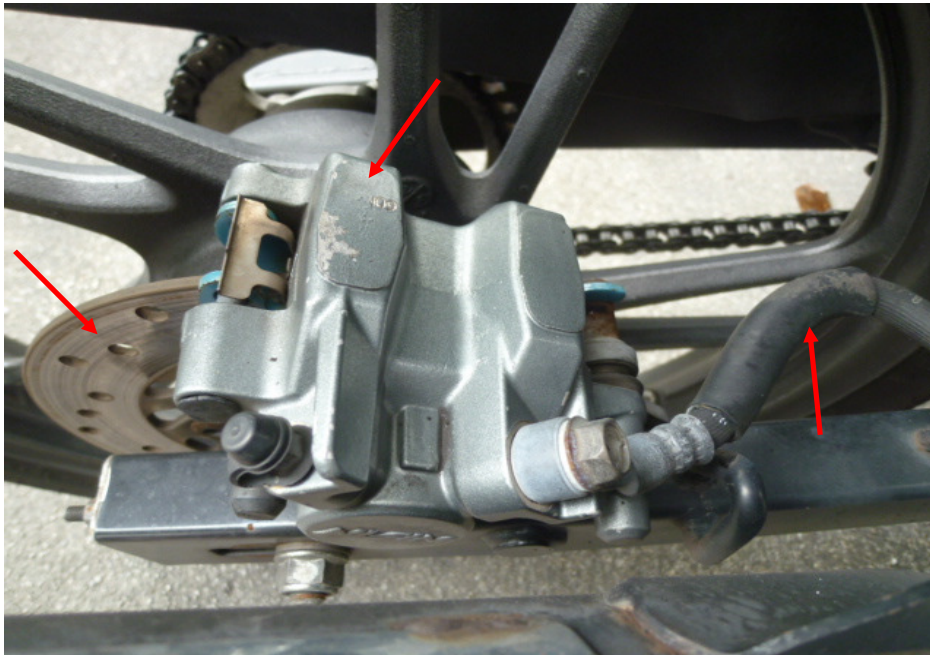
Photo 29 shows a close up view of the rear brake caliper, rear brake disc and rear brake hose (arrowed) of the Motorcycle, which are all part of the components in the hydraulic rear brake system of the Motorcycle. Our visual checks of these various components had revealed all to be intact with no visible damage. No leakage of brake fluid was also observed.
