Your Ref: TP/IP/14027/2022
Our Ref : CI/TPD22010187/N

Fatal Accident Investigation Team

INSPECTION REPORT OF MOTORCYCLE FBA 1696G

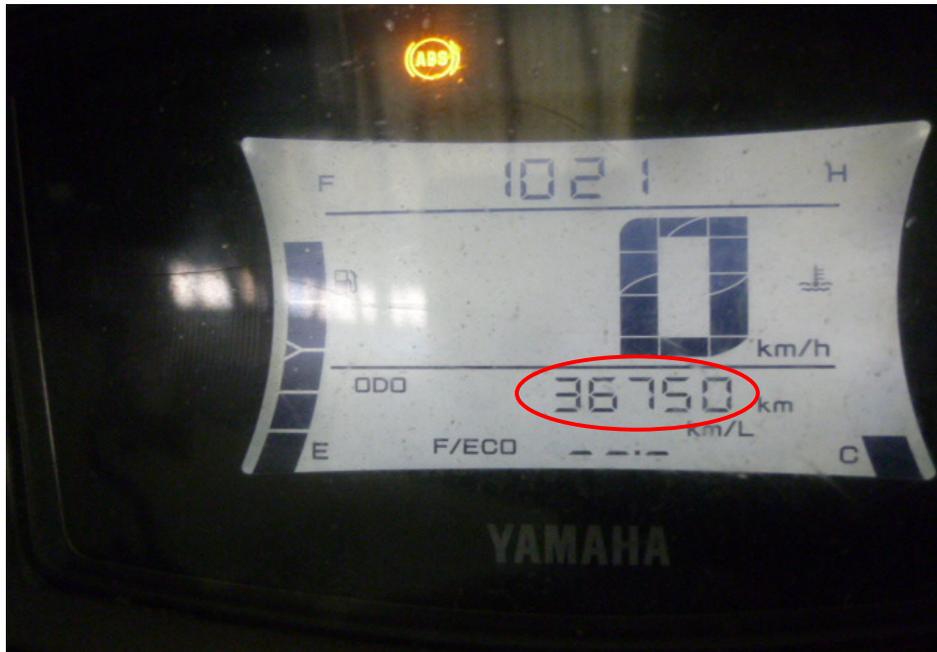
Photo 1 shows the speedometer gauge of the Motorcycle where the mileage recorded at time of our inspection was 36, 750km (circled).

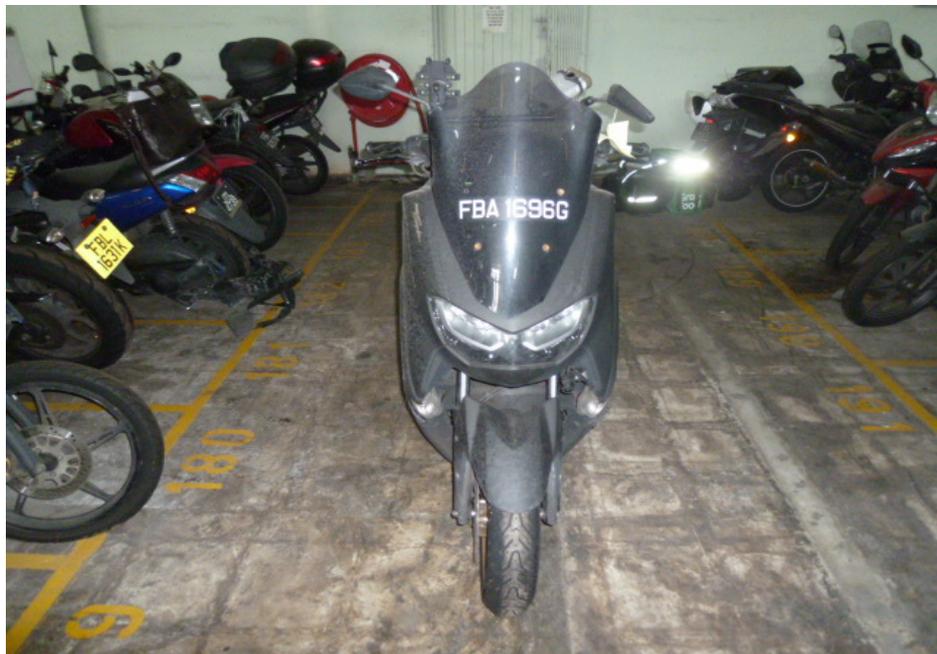
Photo 2 shows a general view of the frontal portion of the Motorcycle at the time of our inspection. The Motorcycle was observed to have sustained damages all around.

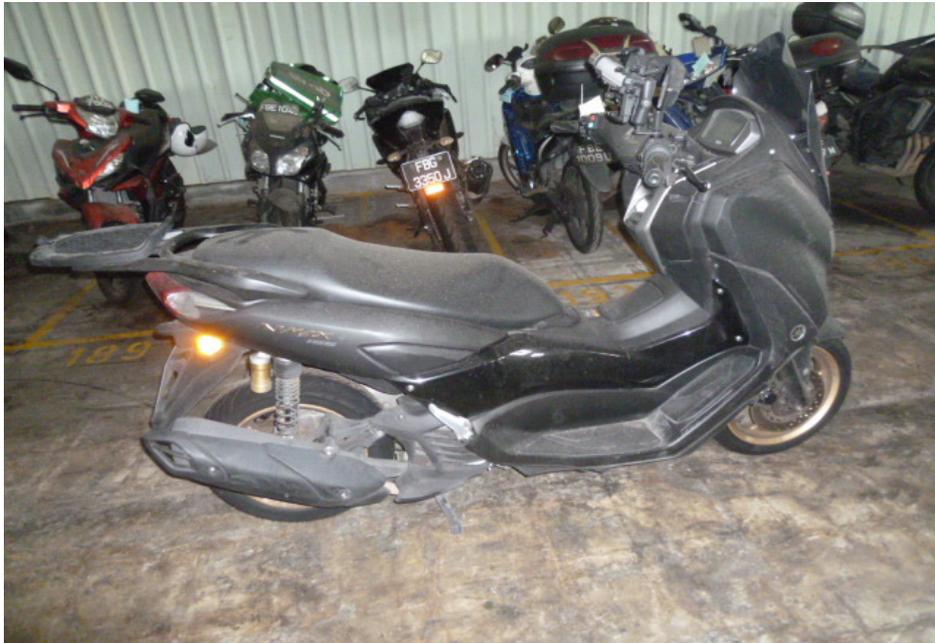
Photo 3 shows a general view of the right body of the Motorcycle at the time of our inspection. The Motorcycle was observed to have sustained damages all around.

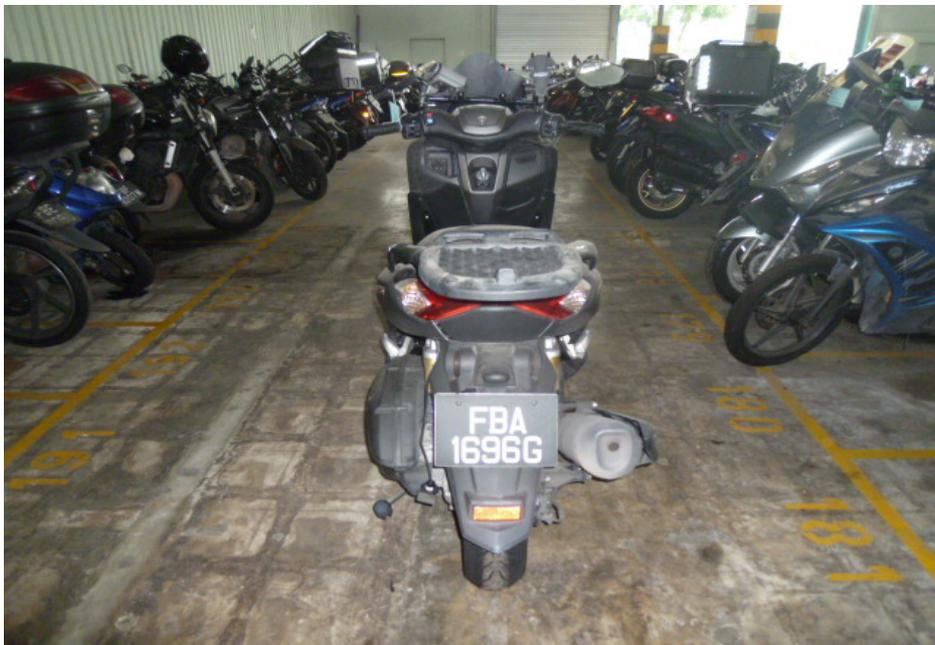
Photo 4 shows a general view of the rear portion of the Motorcycle at the time of our inspection. The Motorcycle was observed to have sustained damages all around. The body parts that were found to have been damaged include its right cowling, front mudguard, right bottom cowling, front brake lever, right side mirror, right handlebar end, side stand, main stand, right pillion foot peg, right rear side cover and exhaust muffler heat shield, amongst others as a result of the accident.

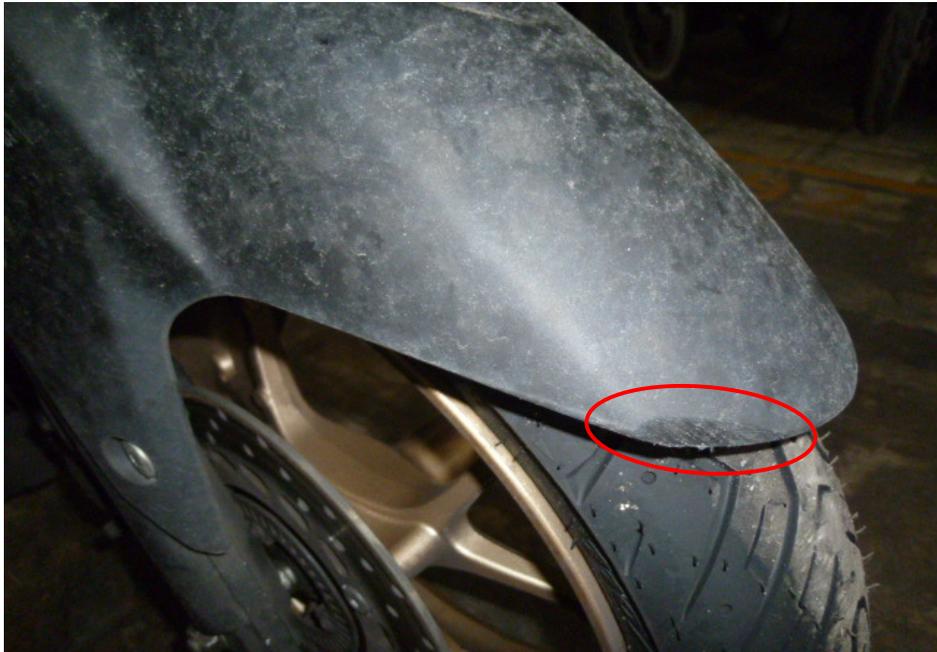
Photo 5 shows a closer view of the front mudguard which was amongst the body parts at the front body of the Motorcycle that had sustained damage as a result of the accident (circled).

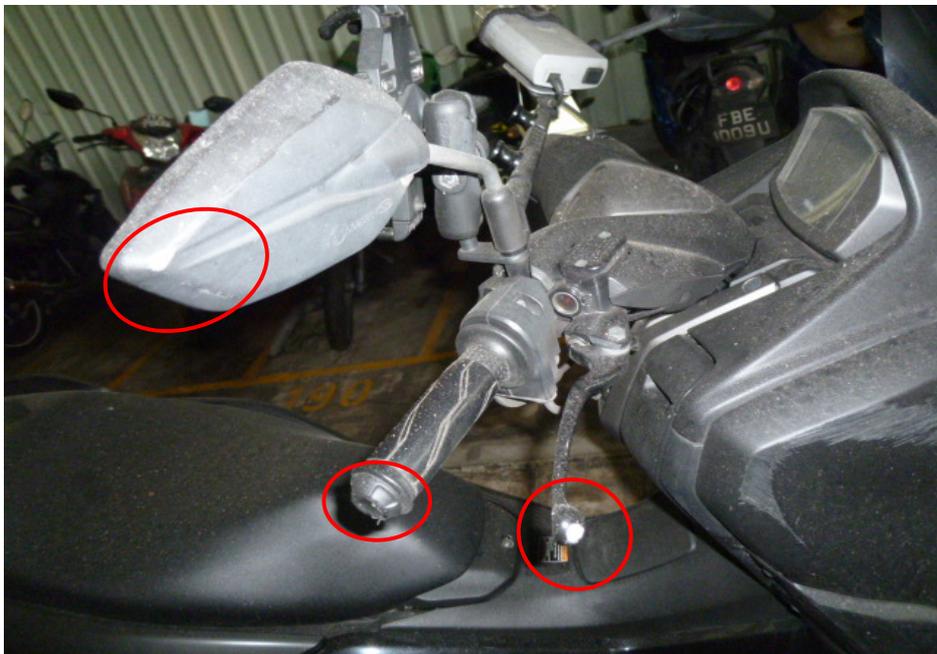
Photo 6 shows a closer view of the right side mirror, right handlebar end and front brake lever of the Motorcycle which were observed to be damaged due to the accident (circled).

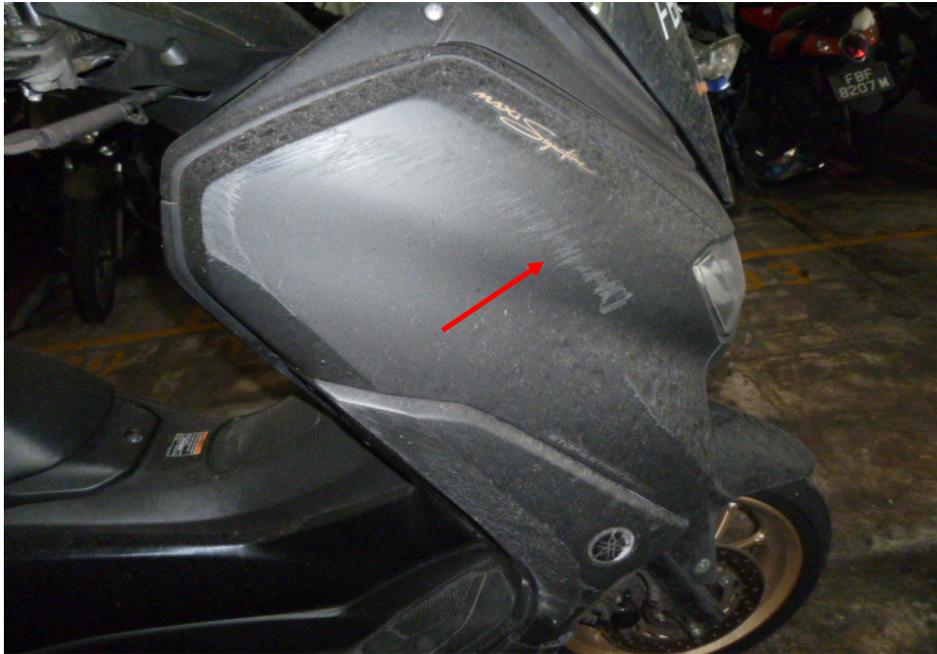
Photo 7 shows a close-up view of the grazed left cowling of the Motorcycle at the time of our inspection (arrowed).

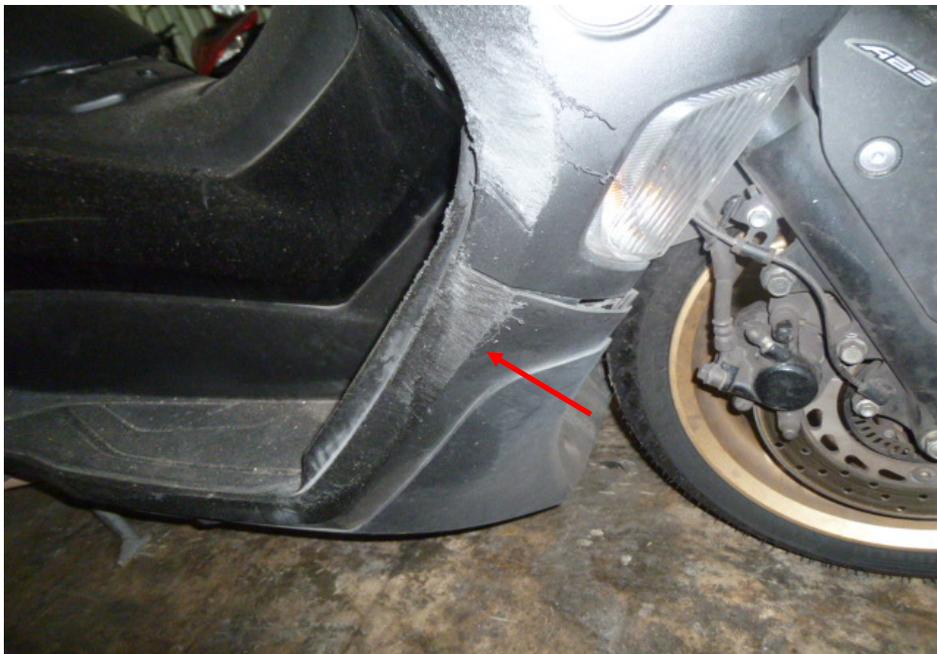
Photo 8 shows a closer view of the grazed right bottom cowling of the Motorcycle at the time of our inspection (arrowed).

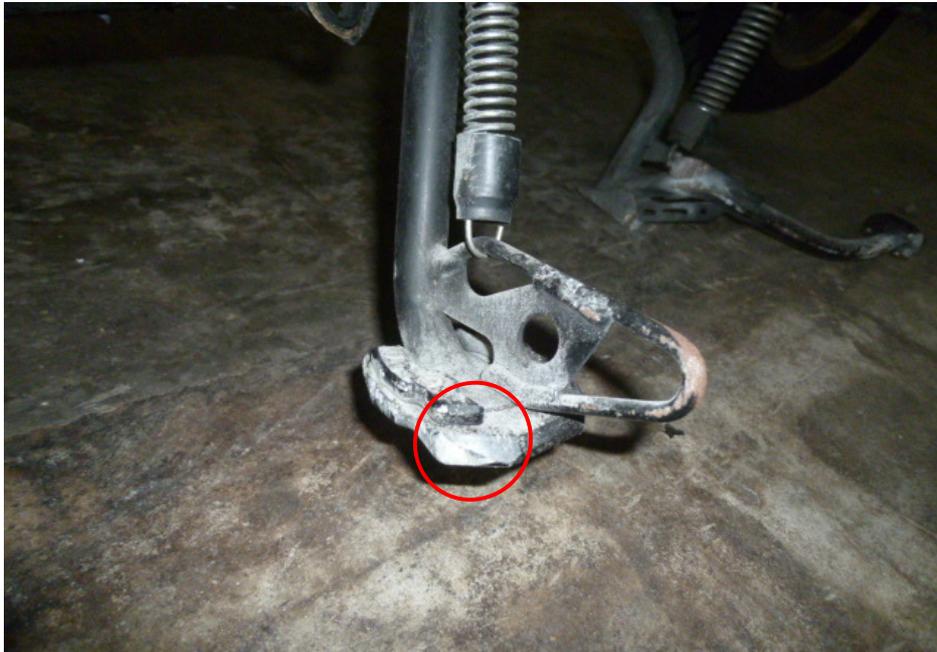
Photo 9 shows the grazed side stand (circled) of the Motorcycle as a result of the accident.

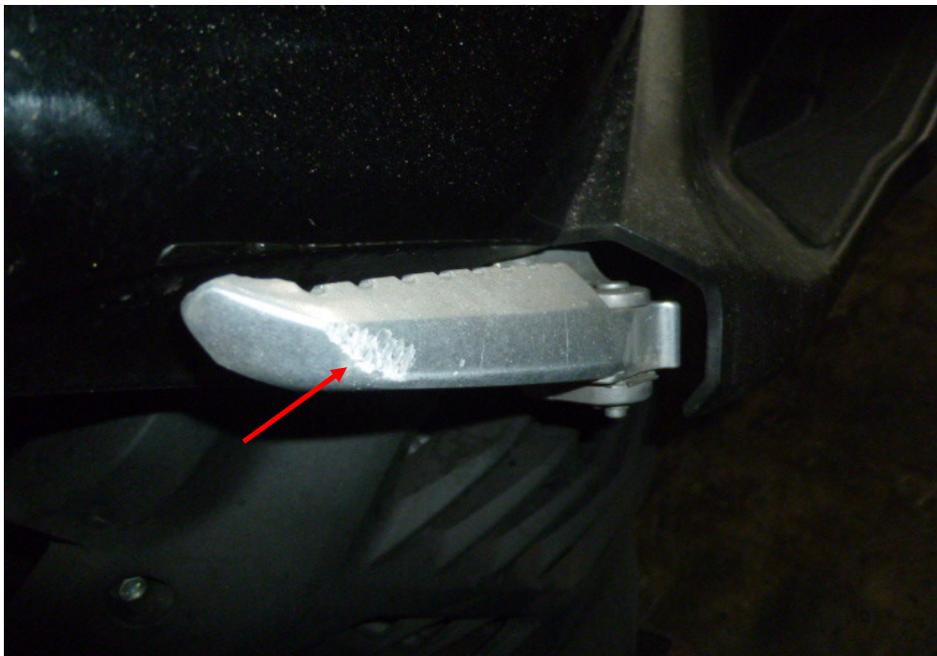
Photo 10 shows a closer view of the grazed right pillion foot peg of the Motorcycle as a result of the accident (arrowed).

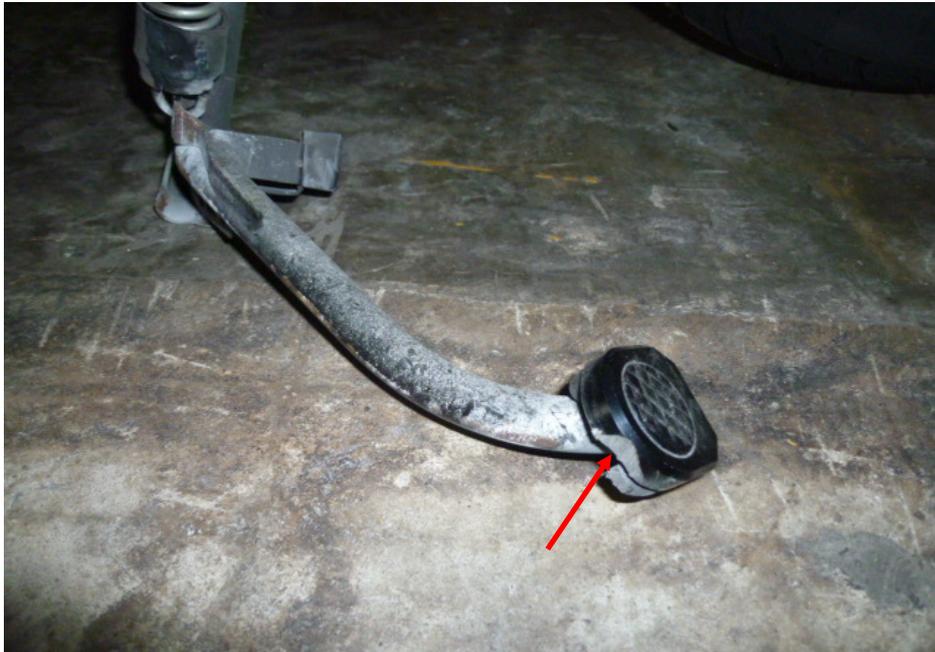
Photo 11 shows a closer view of the grazed main stand (arrowed) of the Motorcycle as a result of the accident.

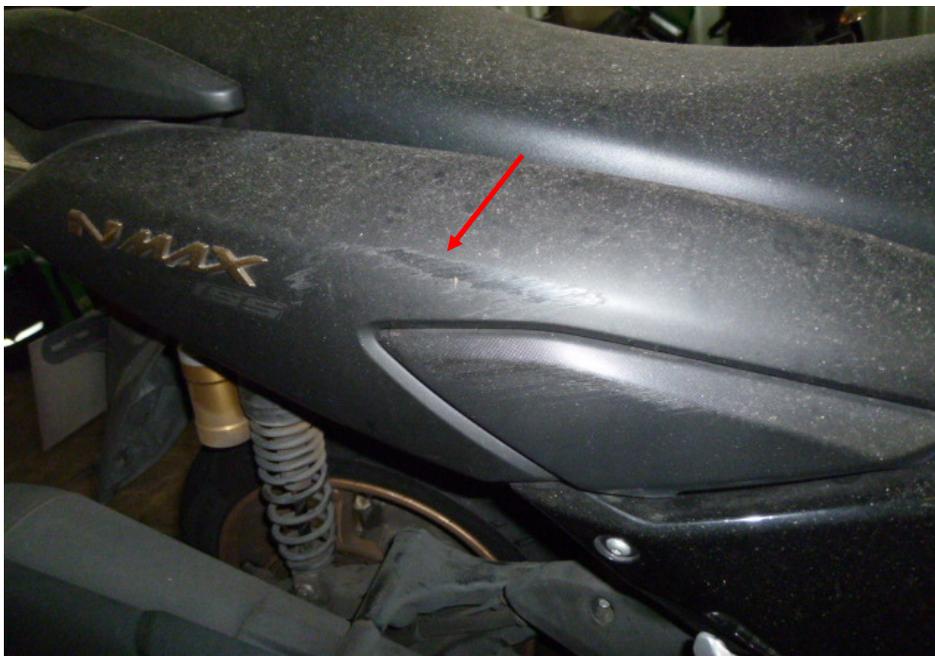
Photo 12 shows a closer view of the grazed right rear side cover of the Motorcycle at the time of our inspection (arrowed).

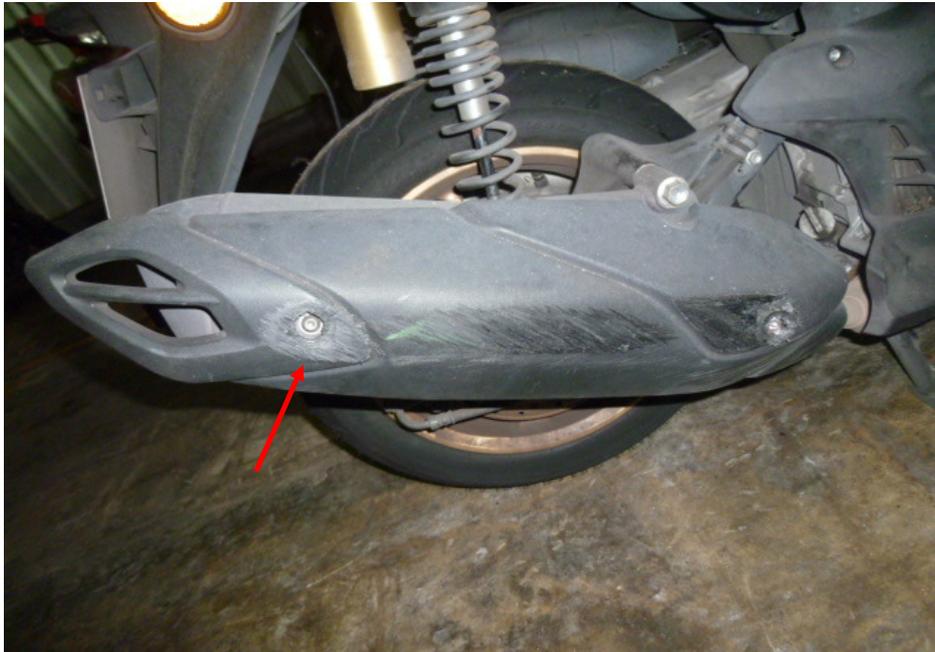
Photo 13 shows a closer view of the grazed exhaust muffler heat shield of the Motorcycle as a result of the accident (arrowed).

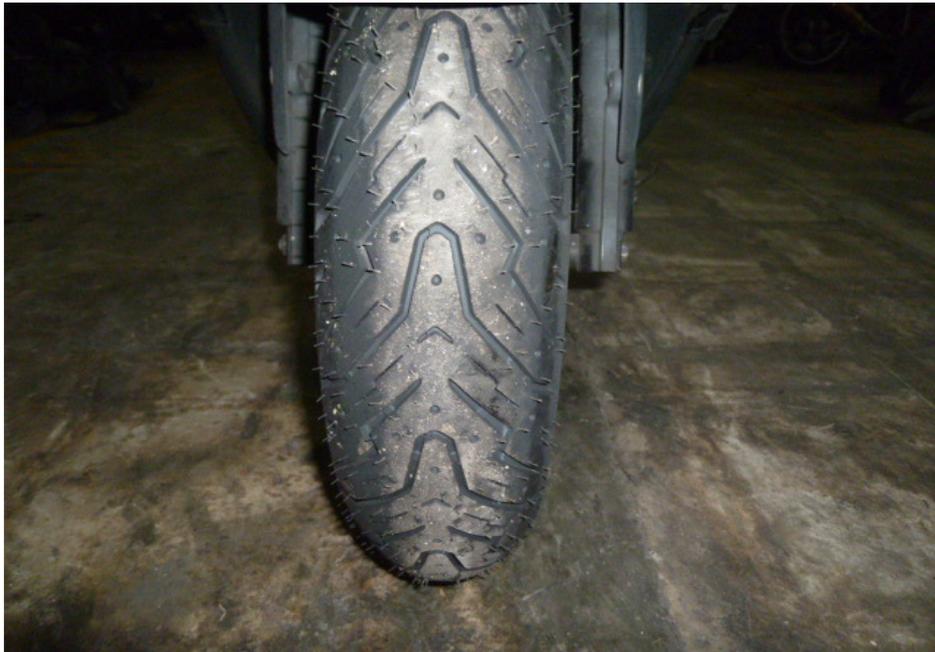
Photo 14 shows the condition of the Motorcycle's front tyre. The front tyre was observed to be in serviceable condition with remaining tread depth of approximately 3mm. There was no tear, burst mark(s) and/or punctured hole(s) on the sidewalls as well as across the tread of the front tyre.

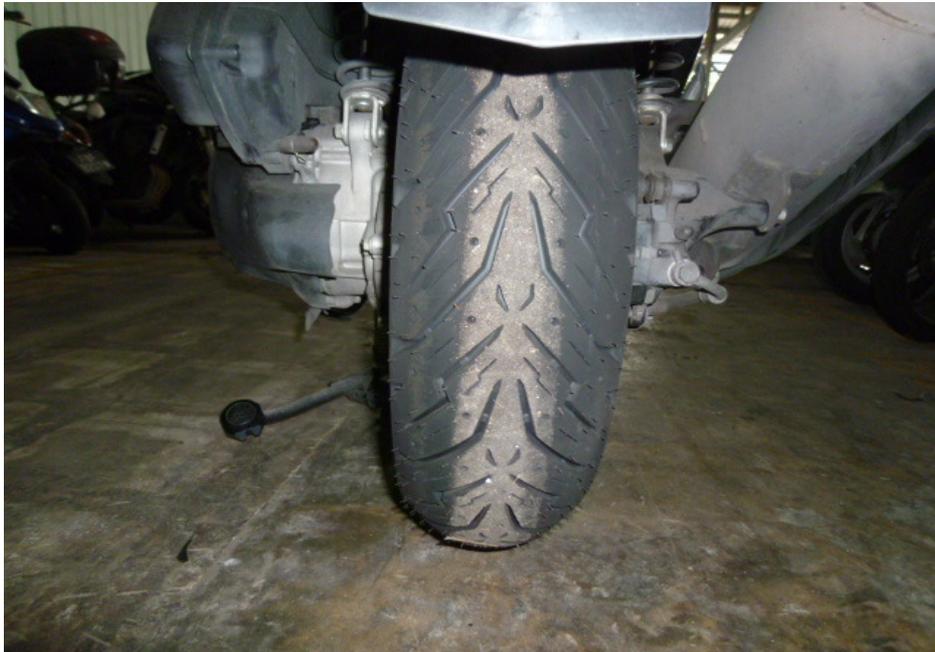
Photo 15 shows the condition of the Motorcycle's rear tyre. The rear tyre was observed to be in serviceable condition with remaining tread depth of approximately 4mm. The tyre was also observed to be sufficiently inflated for vehicular operation. We did not observe any tear, burst mark(s) and/or punctured hole(s) on the sidewalls as well as across the tread of the rear tyre.

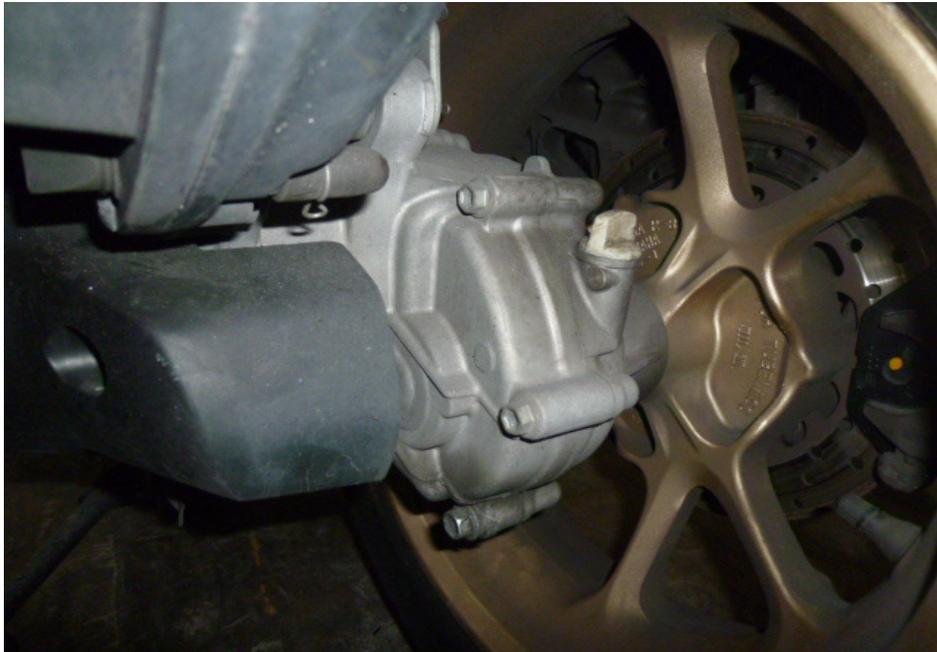
Photo 16 shows the left side of the engine of the Motorcycle at the time of our inspection. The various engine related parts and components were found to be intact with no visible damage. There was also no sign(s) or indication(s) of fluid leak observed around the left engine area of the Motorcycle.

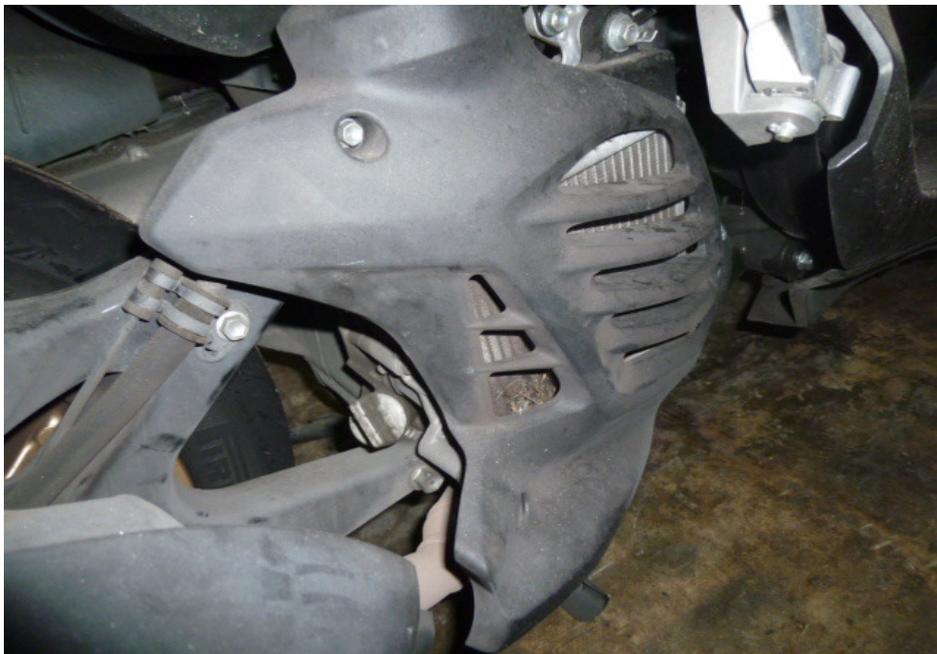
Photo 17 shows the right side of the engine of the Motorcycle at the time of our inspection. The various engine related parts and components were found to be intact with no visible damage. There was also no sign(s) or indication(s) of fluid leak observed around the right engine area of the Motorcycle.

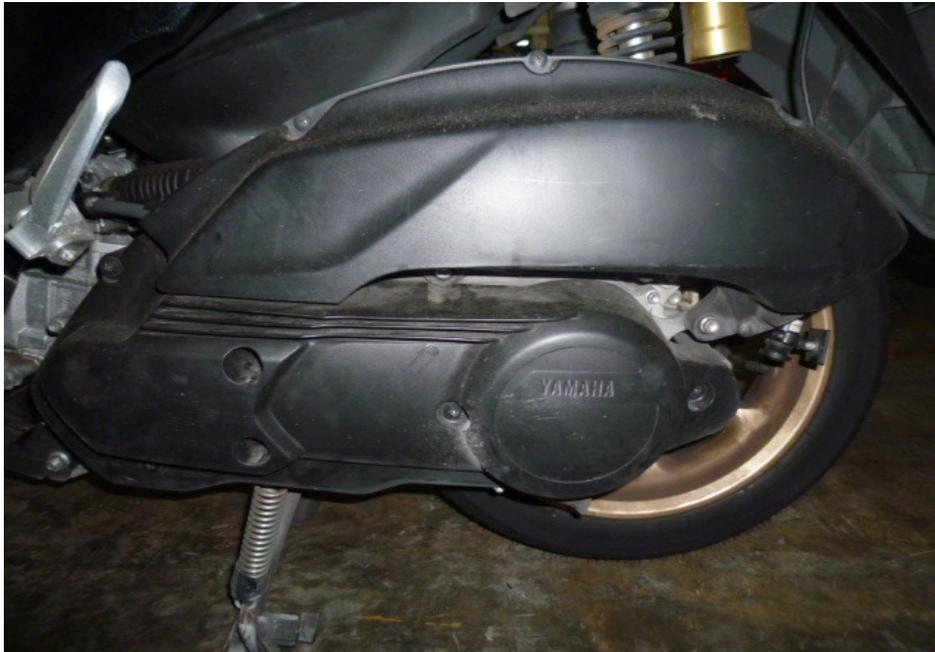
Photo 18 shows the drive train cover of the Motorcycle which was found to be intact without any misalignment. Upon examination of the Motorcycle's engine area, we had observed that the various engine related parts and components were intact with no visible damage. There was also no sign(s) or indication(s) of fluid leak observed around the engine area of the Motorcycle.

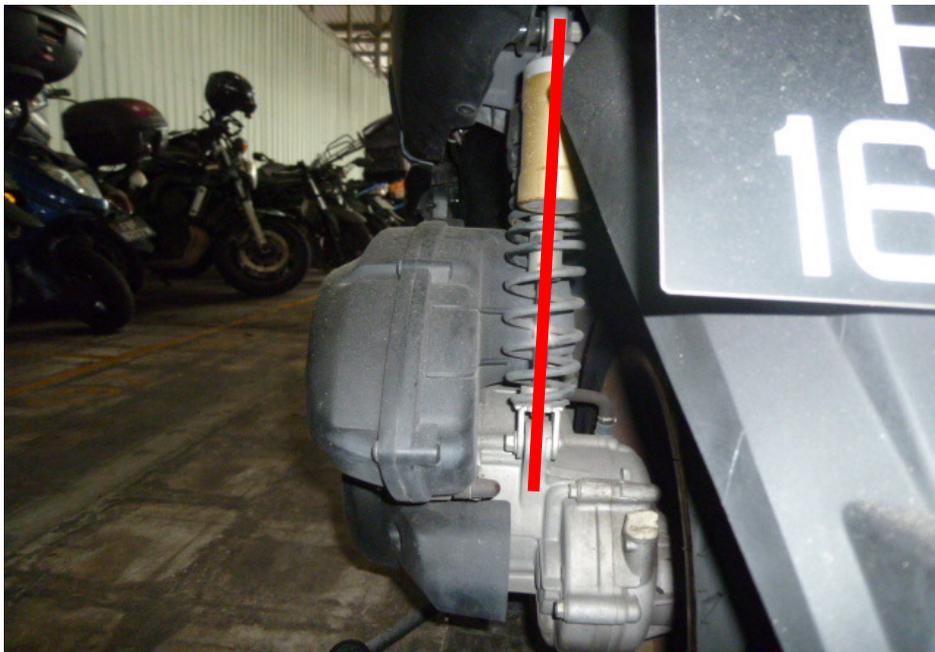
Photo 19 shows the left shock absorber of the Motorcycle which was found to be intact without any misalignment.

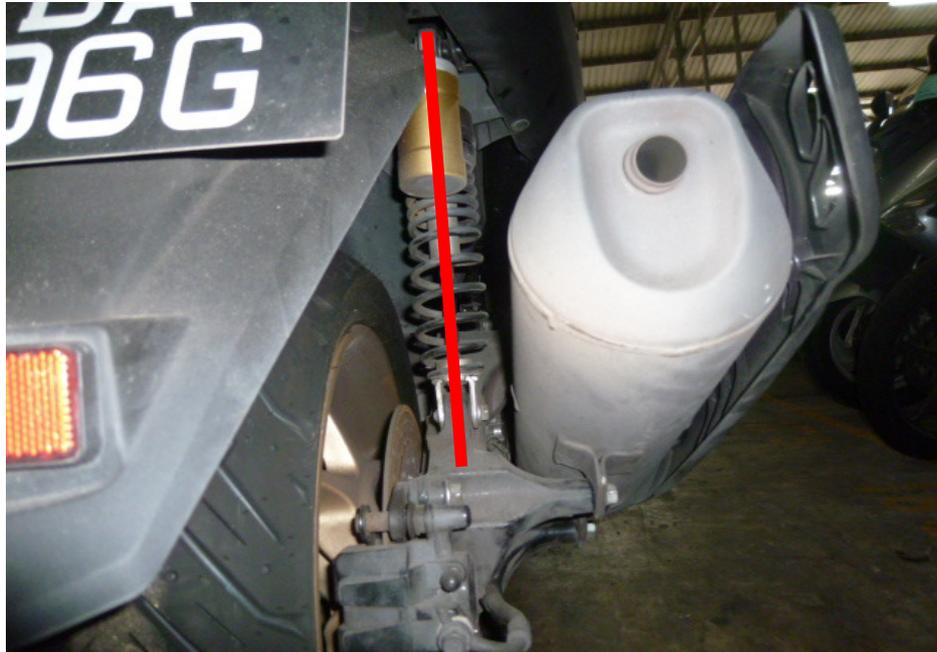
Photo 20 shows the right shock absorber of the Motorcycle which was found to be intact without any misalignment.

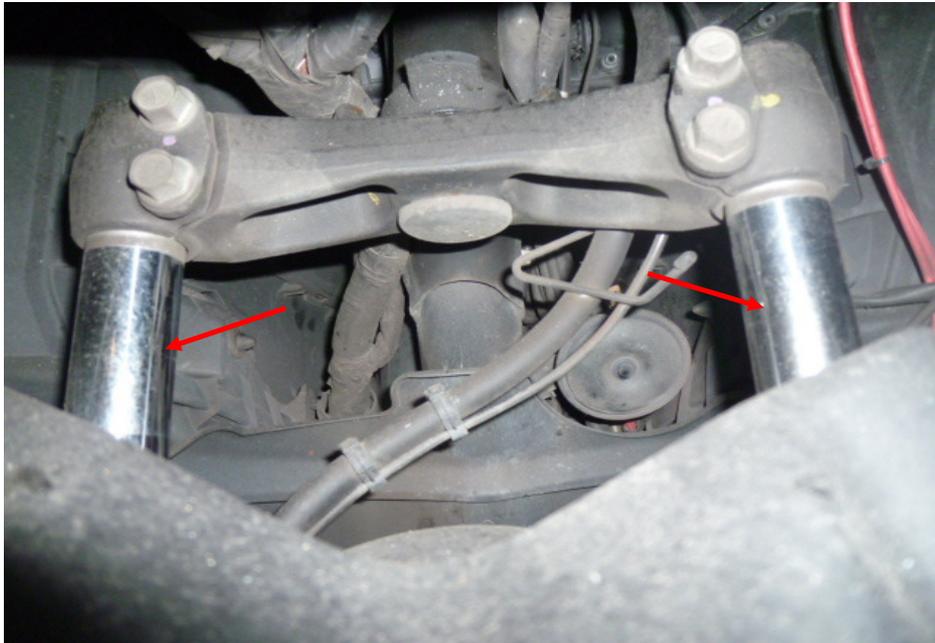
Photo 21 shows the front forks (arrowed) of the Motorcycle. The front forks and fork brackets of the Motorcycle were both found to be intact and undamaged. Turning the Motorcycle's handle bar towards the left and right did not produce any abnormal free play and/or resistance. The steering system of the Motorcycle was in serviceable condition at the time of our inspection.

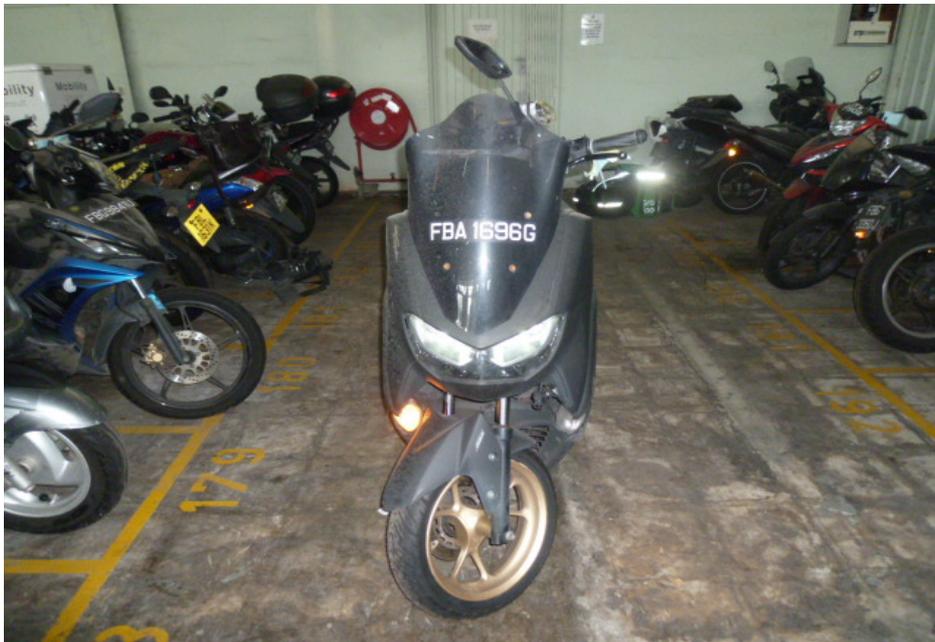
Photo 22 shows the front wheel of the Motorcycle turned towards its full right. Turning the Motorcycle's handle bar towards the left and right did not produce any abnormal free play and/or resistance. This would indicate that the steering system of the Motorcycle was in serviceable condition at the time of our inspection.

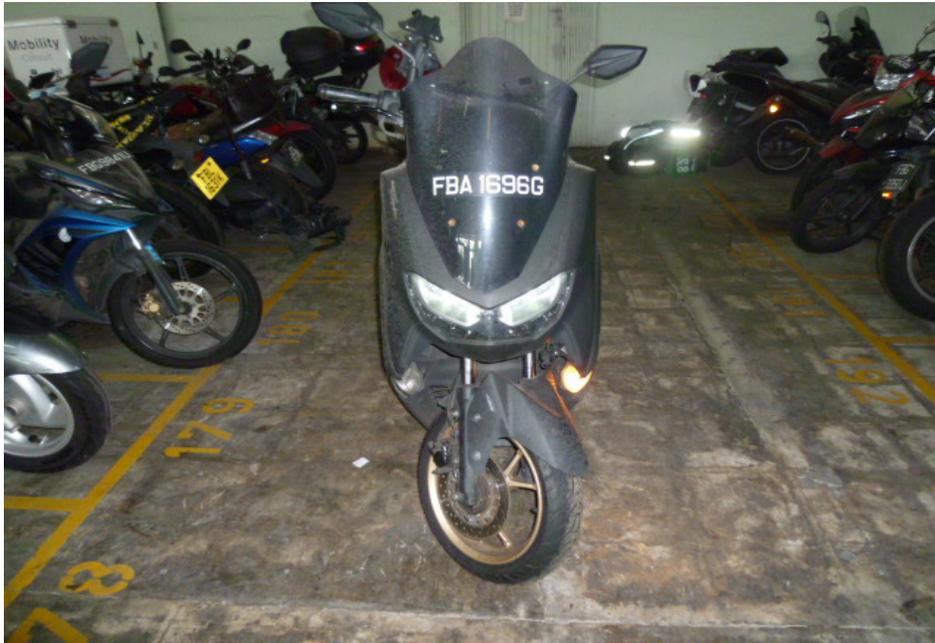
Photo 23 shows the front wheel of the Motorcycle turned towards its full left. Turning the Motorcycle's handle bar towards the left and right did not produce any abnormal free play and/or resistance. This would indicate that the steering system of the Motorcycle was in serviceable condition at the time of our inspection.

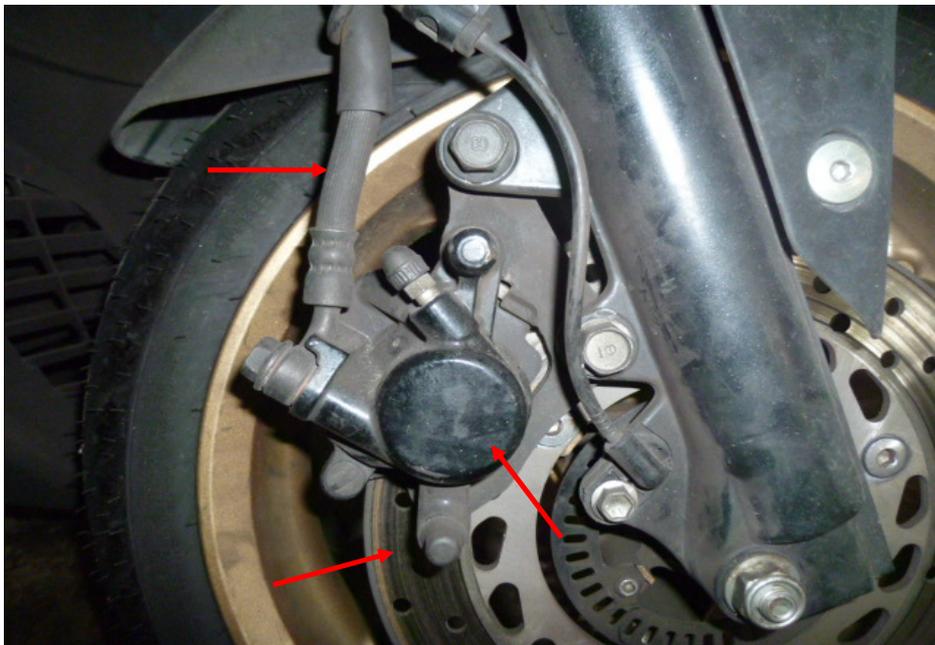
Photo 24 shows a close up view of the front brake caliper, front brake disc and front brake hose (arrowed) of the Motorcycle, which are all part of the components in the hydraulic front brake system of the Motorcycle. Our visual checks of these various components had revealed all to be intact with no visible damage. No leakage of brake fluid was also observed.

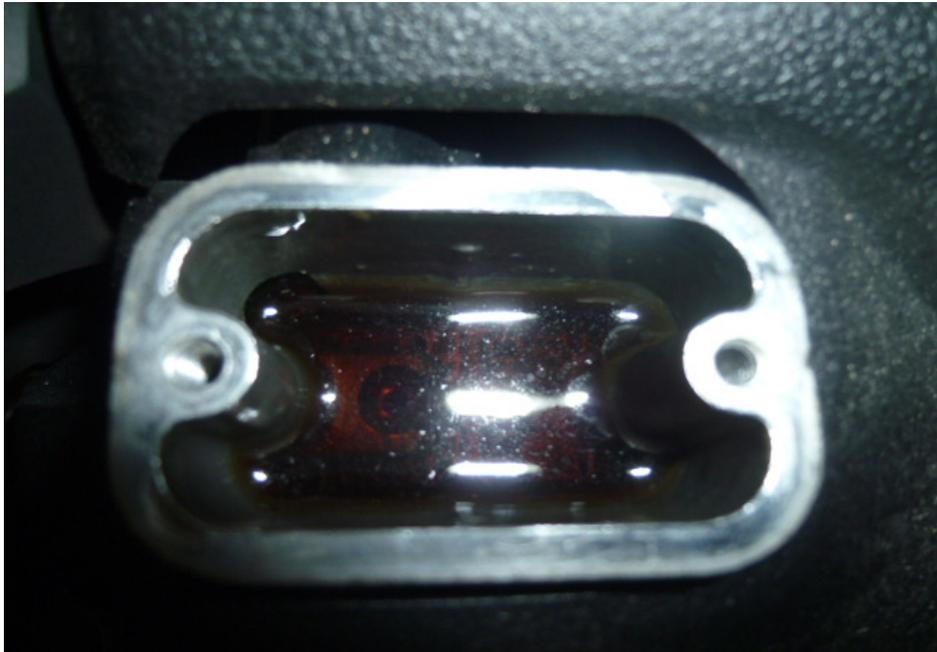
13. Our checks on the front brake fluid had indicated that the front brake fluid was of sufficient level for operational purposes and without any contamination.

Photo 25 shows the brake fluid reservoir for the front brake of the Motorcycle. The brake fluid was observed to be of sufficient level for operational purposes and without any contamination.

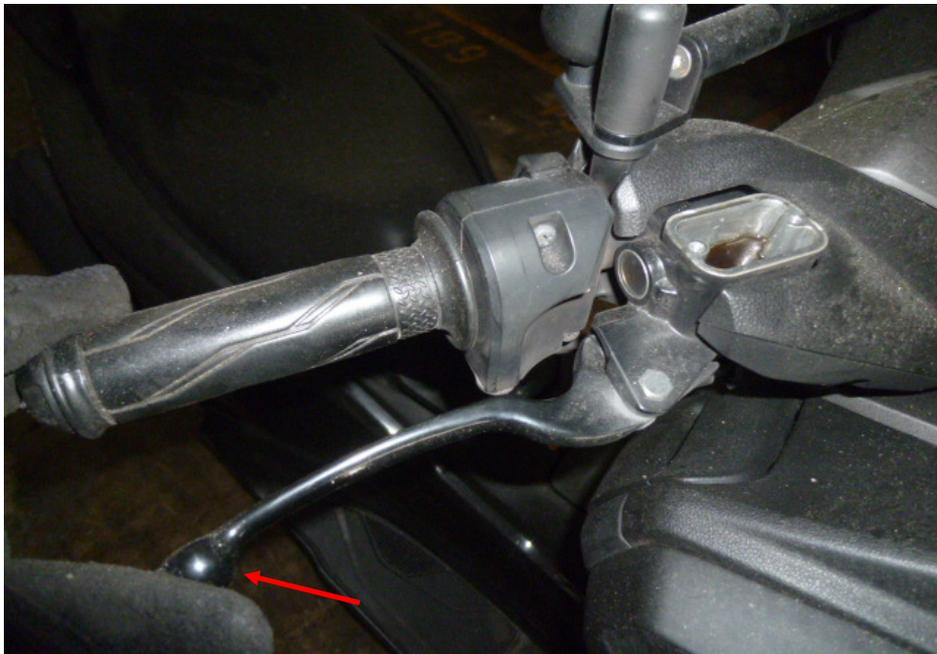
Photo 26 shows the front brake lever being depressed. There was some resistance felt (spongy like feel) upon pressing the front brake lever (arrowed). This would indicate that there is no leakage of pressure/vacuum in the front brake system.

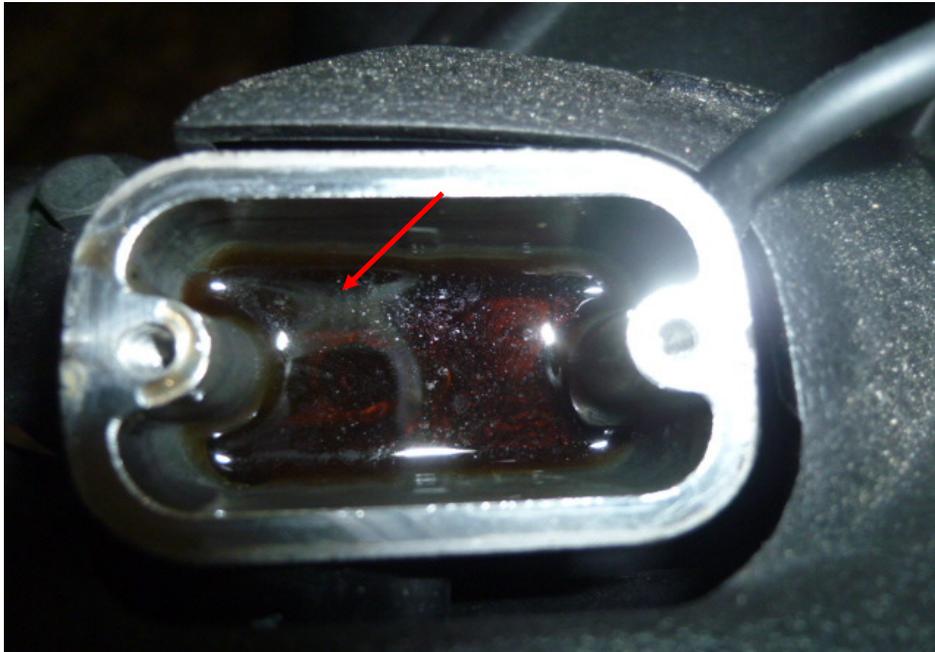
14. Our checks on the rear brake fluid had also indicated that the rear brake fluid was of sufficient level for operational purposes. However the brake fluid for the rear brake was found to be slightly contaminated.

Photo 27 shows the brake fluid reservoir for the rear brake of the Motorcycle. The brake fluid was observed to be of sufficient level for operational purposes. However it was found to be slightly contaminated (arrowed).

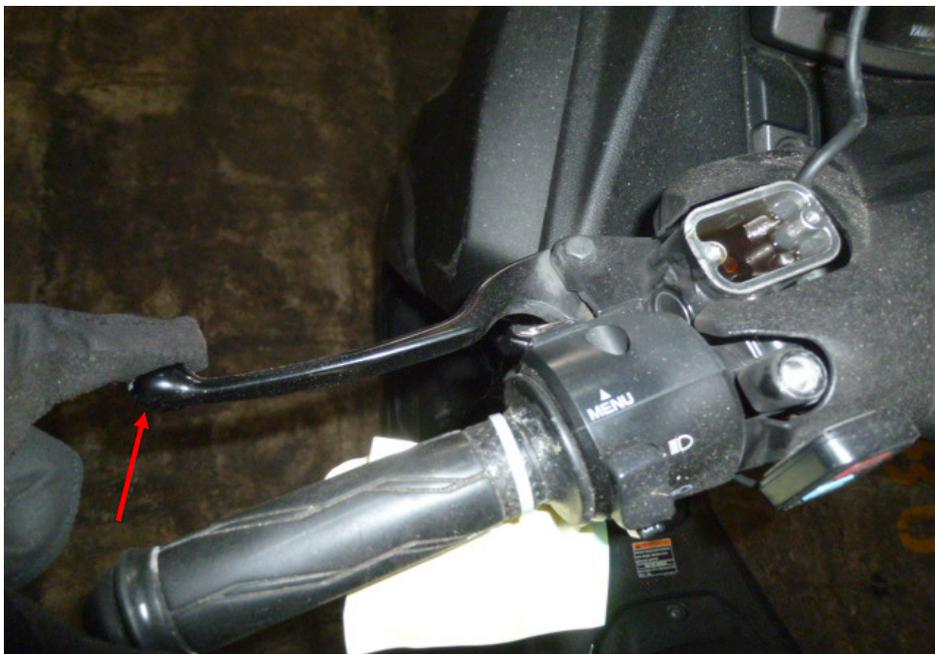
Photo 28 shows the rear brake lever being depressed. There was some resistance felt (spongy like feel) upon pressing the rear brake lever (arrowed). This would indicate that there is no leakage of pressure/vacuum in the rear brake system.

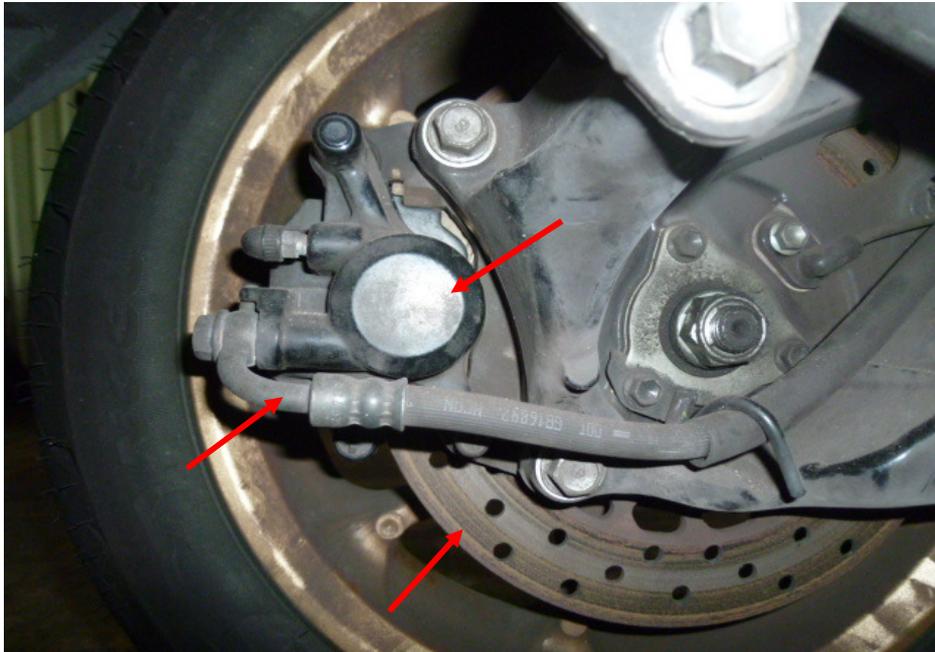
Photo 29 shows a close up view of the rear brake caliper, rear brake disc and rear brake hose (arrowed) of the Motorcycle, which are all part of the components in the hydraulic rear brake system of the Motorcycle. Our visual checks of these various components revealed all to be intact with no visible damage. No leakage of brake fluid was also observed.
