Your Ref: Porsche Cayenne
(chassis number WP1ZZZ9YZLDA03330)
Our Ref : CI/TP22010250/D

13 October 2022

**INSPECTION REPORT OF AN UNREGISTERED PORSCHE CAYENNE
MOTOR CAR WITH CHASSIS NUMBER WP1ZZZ9YZLDA03330**

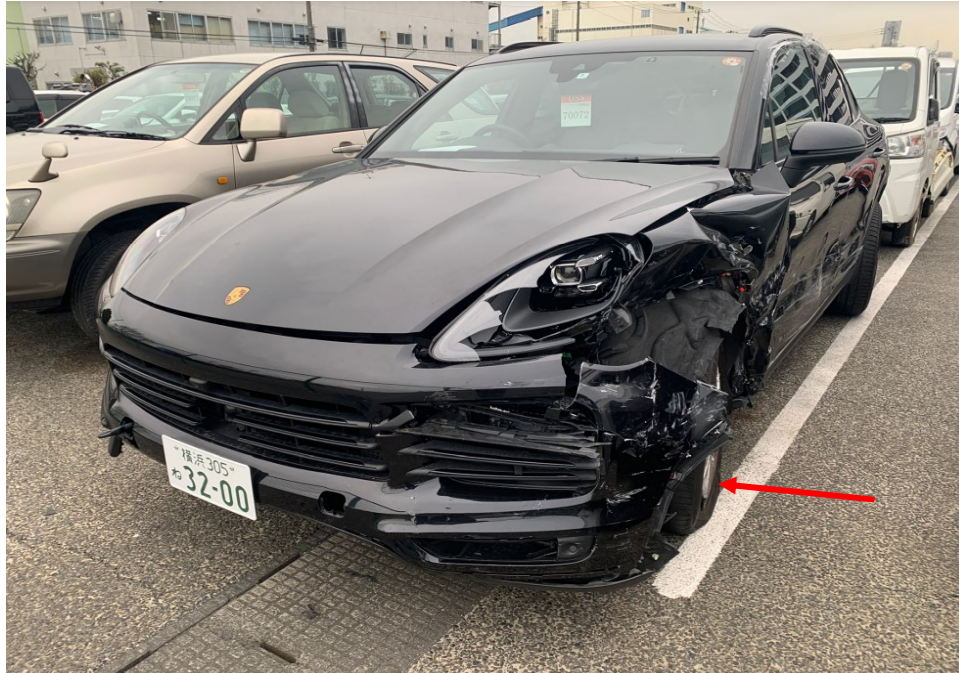
4. The orientation of the Motor Car's front left wheel and rear left wheel indicates damage to the undercarriage parts at its front left wheel and rear left wheel. Undercarriage parts that may possibly be damage include the front left lower arm, front left knuckle arm, front left steering tie rod, rear left lower arm, rear left knuckle arm and rear left shock absorber amongst others.

Photo 1 shows the front left body of the Motor Car (photograph provided to me). The photographs provided to me had showed damage along the entire left side portion of the Motor Car. The front bumper, front bumper lower cover, front bumper left lower grille, front bumper left upper grille, front bumper left bracket, front bumper left sensor, front left headlamp, front left day light, front left fender, front left fender wheel arc garnish and front left fender inner shield were amongst the body parts that were observed to have been damaged. The front left wheel (arrowed) was observed to be orientated towards the left while the front right wheel (refer to photograph 6 below) was observed to be orientated straight. This would suggest damage to the undercarriage parts at the front left wheel of the Motor Car.

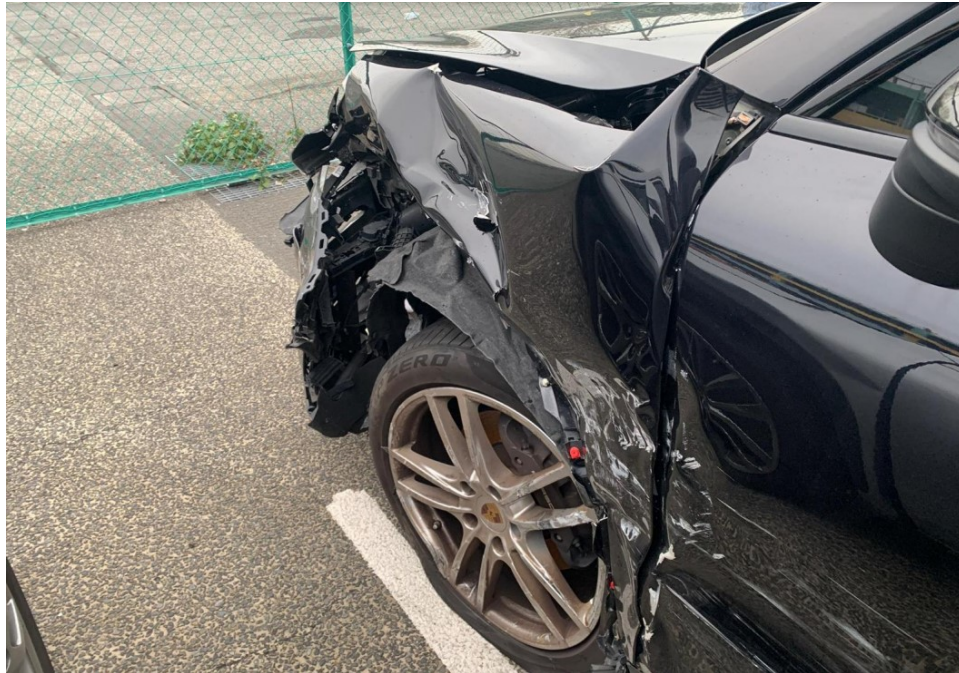
Photo 2 shows a closer view of the damage at the left front portion of the Motor Car (photograph provided to me). The front left door, front left fender, front left fender wheel arc garnish, front left fender inner shield, front left wheel rim and front left tyre were amongst the body parts that were observed to have been damaged. The front left wheel was observed to be orientated towards the left while the front right wheel (refer to photograph 6 below) was observed to be orientated straight. This would suggest damage to the undercarriage parts at the front left wheel of the Motor Car.

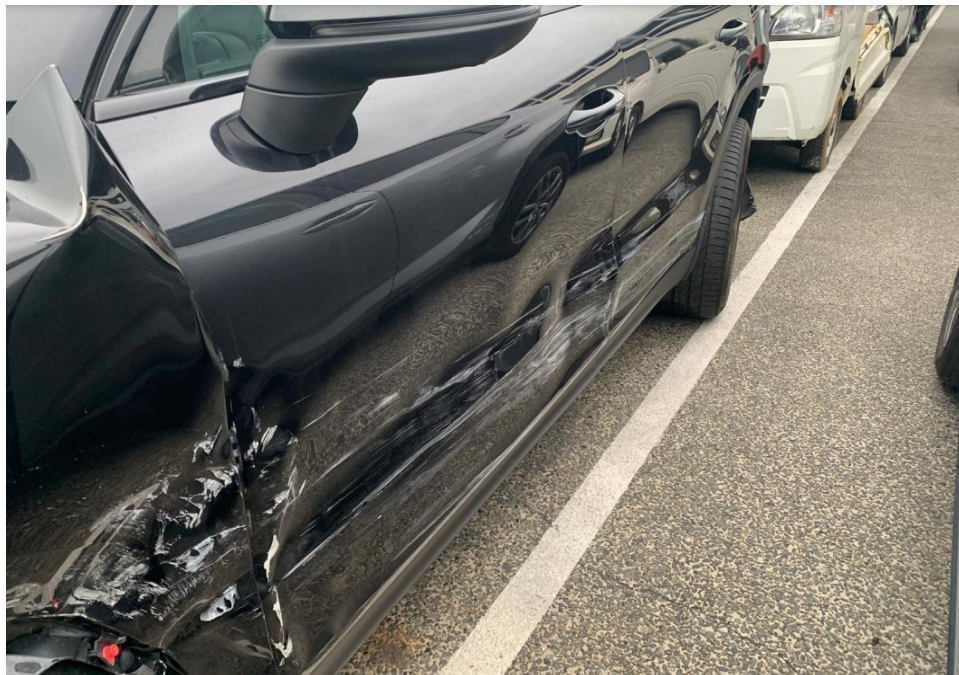
Photo 3 shows a closer view of the damage at the left centre portion of the Motor Car (photograph provided to me). The front left door and rear left door were amongst the body parts that were observed to have been damaged.

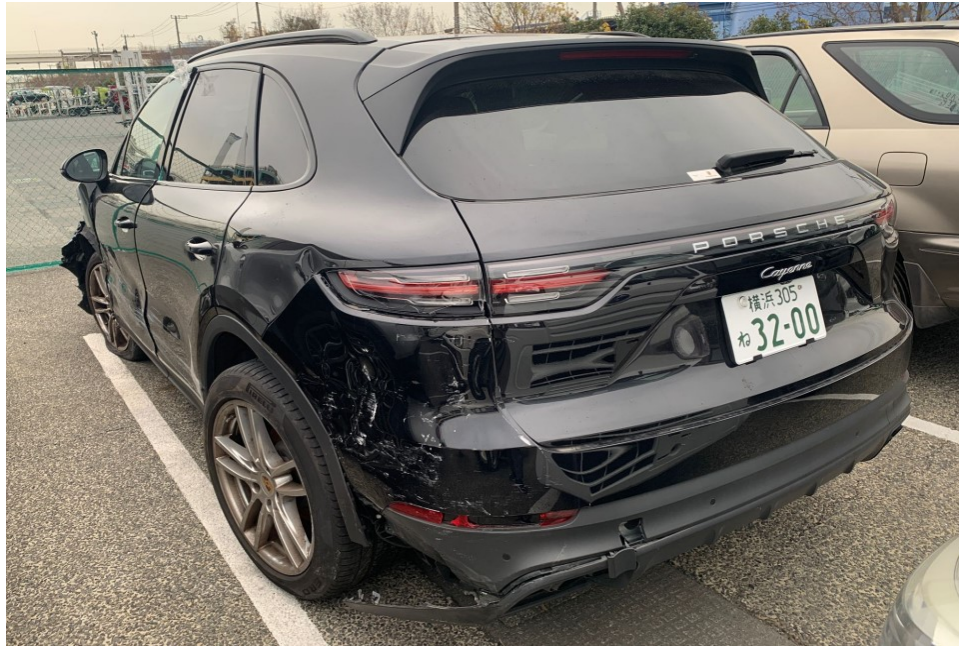
Photo 4 shows the rear left body of the Motor Car (photograph provided to me). The photographs provided to me had showed damage along the entire left side portion of the Motor Car. The rear left wheel rim, rear left fender, rear left fender wheel arc garnish, rear bumper, rear bumper lower cover, rear bumper left reflector, rear left taillamp and rear left tailgate lamp were amongst the body parts that were observed to have been damaged.

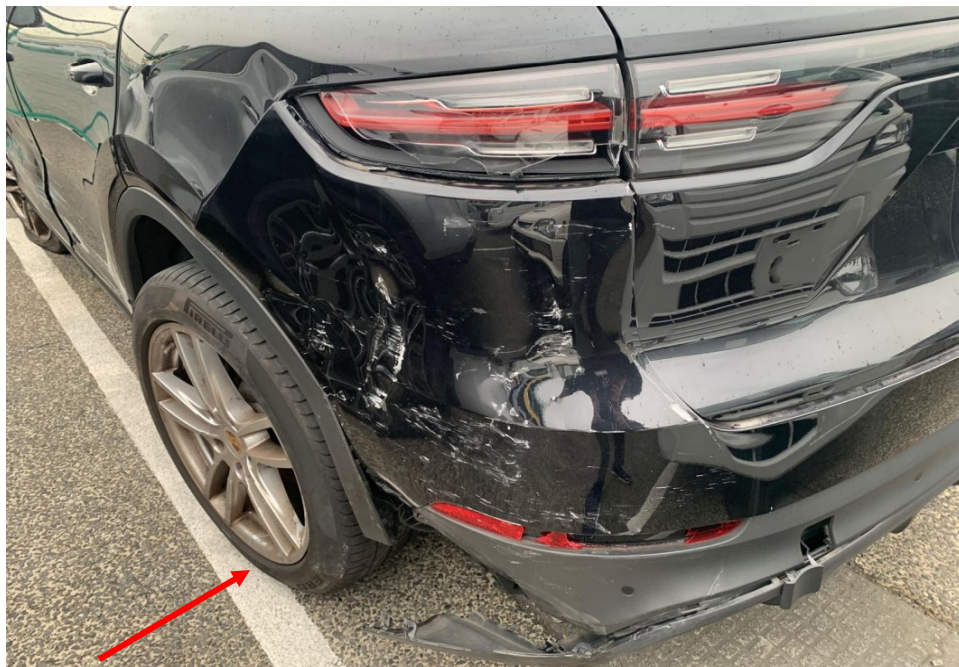
Photo 5 shows a closer view of the damage at the left rear portion of the Motor Car (photograph provided to me). The rear left wheel rim, rear left fender, rear left fender wheel arc garnish, rear bumper and rear left taillamp were amongst the body parts that were observed to have been damaged. The rear left wheel (arrowed) was observed to be orientated towards the left, suggesting damage to the undercarriage parts at the rear left wheel of the Motor Car.

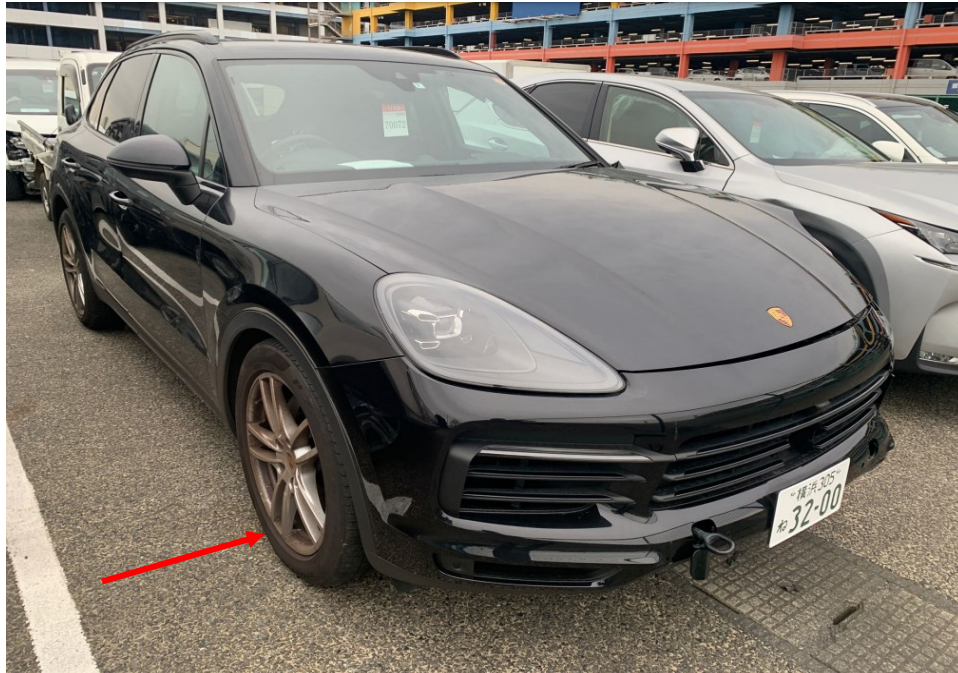
Photo 6 shows the front right body of the Motor Car (photograph provided to me). Apart for the left side portion, there was no physical damage observed to other areas of the Motor Car. The front right wheel (arrowed) was observed to be orientated straight while the front left wheel (refer to photograph 1 & 2 above) was orientated towards the left, suggesting damage to the undercarriage parts at the front left wheel of the Motor Car.

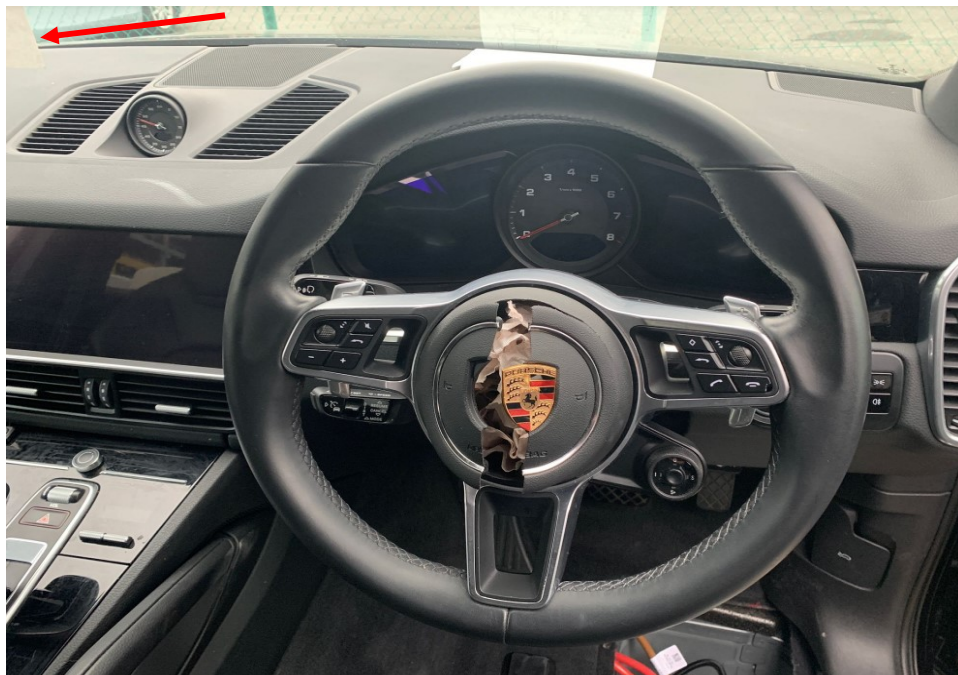
Photo 7 shows the interior compartment of the Motor Car (photograph provided to me). The driver's airbag and front left passenger airbag (arrowed) were deployed as seen from the photographs that were provided to me.

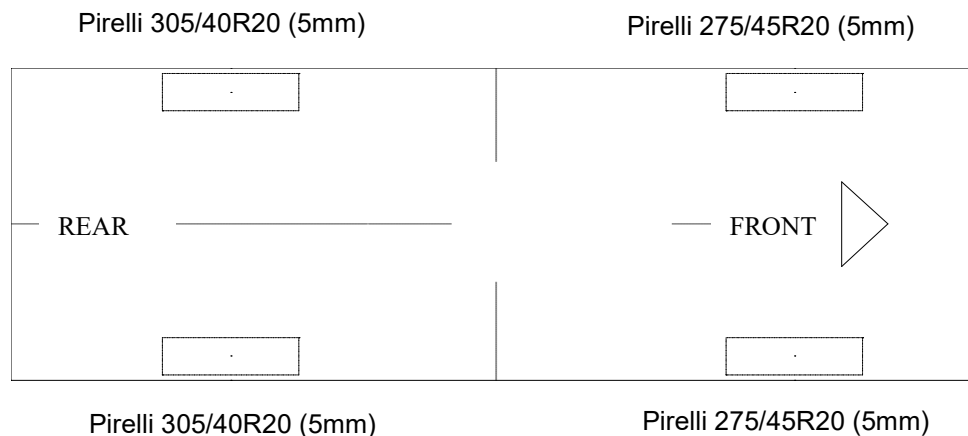
9. It was fitted with 20inch sport wheel rims that were wrapped with tyres that were observed to be of serviceable condition. The tyres were also sufficiently inflated for vehicular operation. The tyre brand, tyre size and approximate remaining tread depth of the 4 tyres of the Motor Car were recorded as follows: -

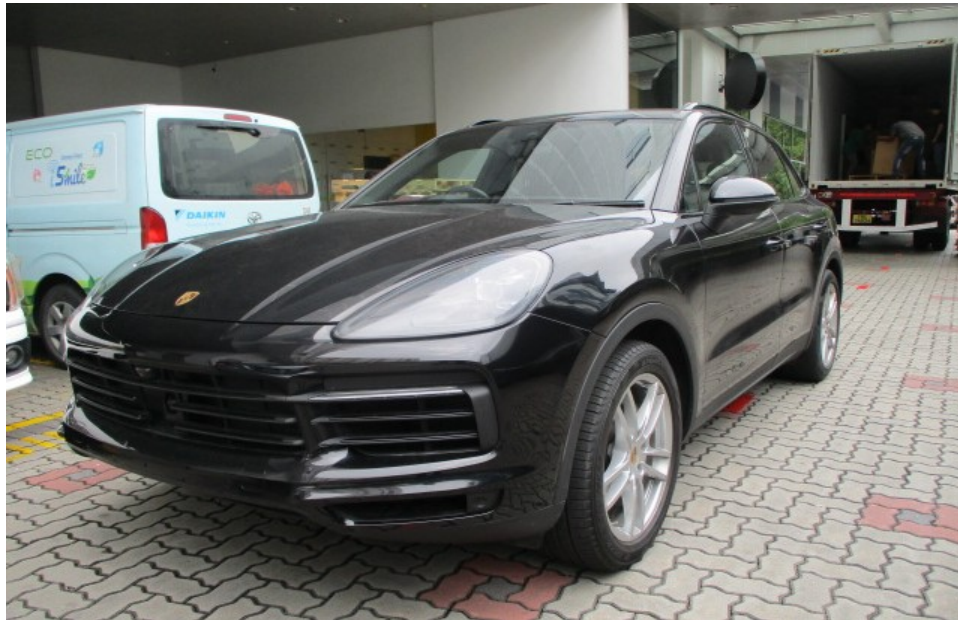
Photo 8 shows a general view of the front left body of the Motor Car at the time of my inspection. The Motor Car was observed to be in a relatively good general condition with no loose exterior fittings observed. The body parts along the entire left side portion of the Motor Car were visually examined and it was observed that the repair/restoration works carried out to the damaged area of the Motor Car (refer to photograph 1 – 5 above) were reasonably adequate and in order.

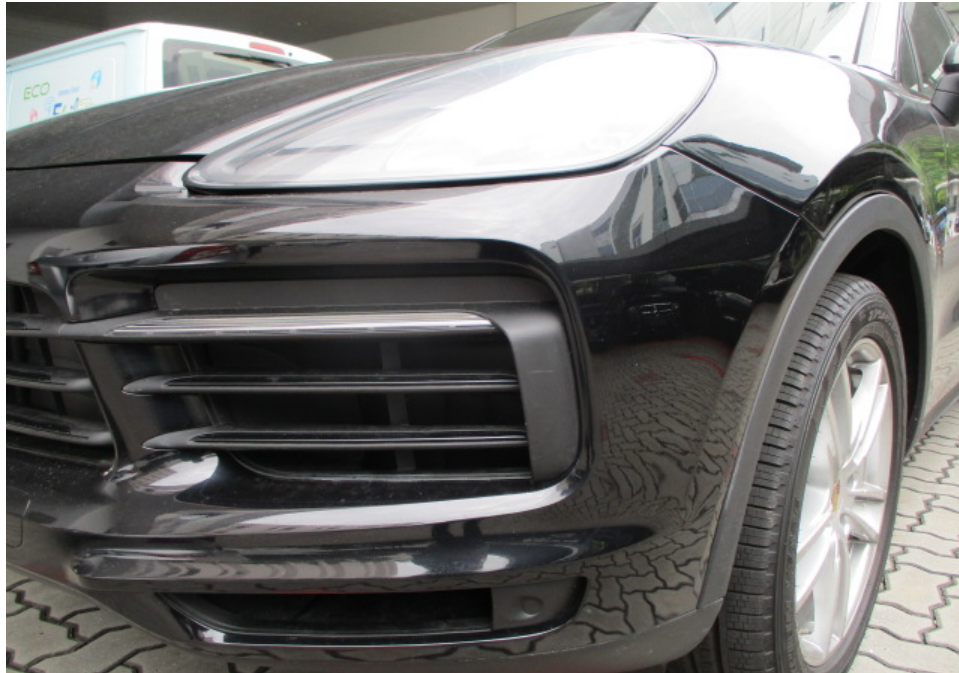
Photo 9 shows a closer view of the Motor Car's front bumper, front bumper left upper grille, front bumper left lower grille, front bumper left sensor, front left day light and front left headlamp. The body parts at the left front portion of the Motor Car were visually examined and it was observed that the repair/restoration works carried out to the damaged area of the Motor Car (refer to photograph 1 & 2 above) were reasonably adequate and in order.

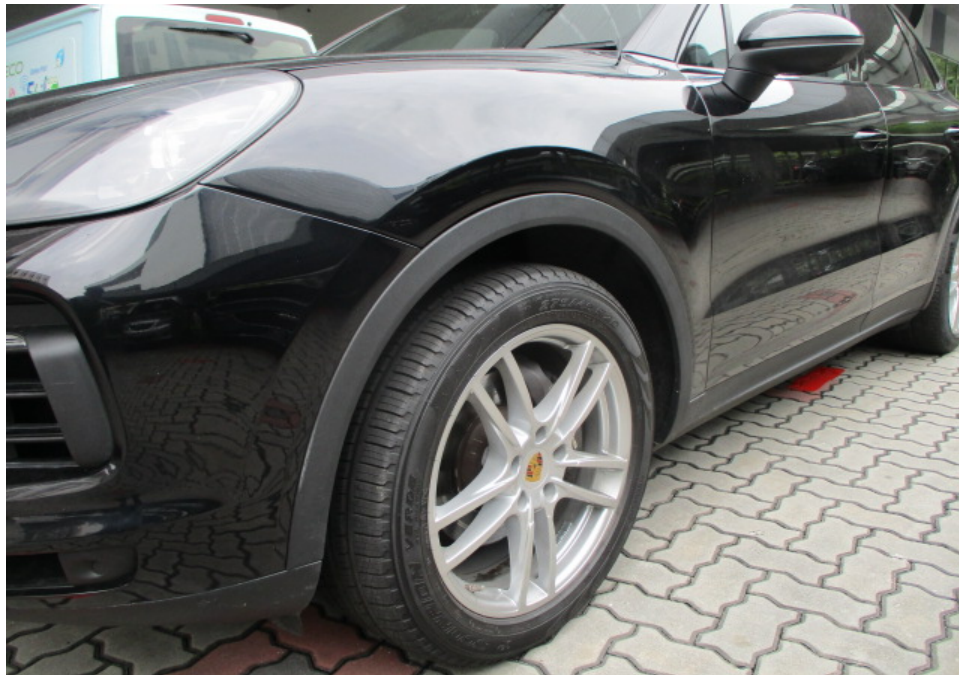
Photo 10 shows a closer view of the Motor Car's front left fender, front left fender wheel arc garnish, front left wheel rim and front left tyre. The body parts at the left front portion of the Motor Car were visually examined and it was observed that the repair/restoration works carried out to the damaged area of the Motor Car (refer to photograph 1 & 2 above) were reasonably adequate and in order.

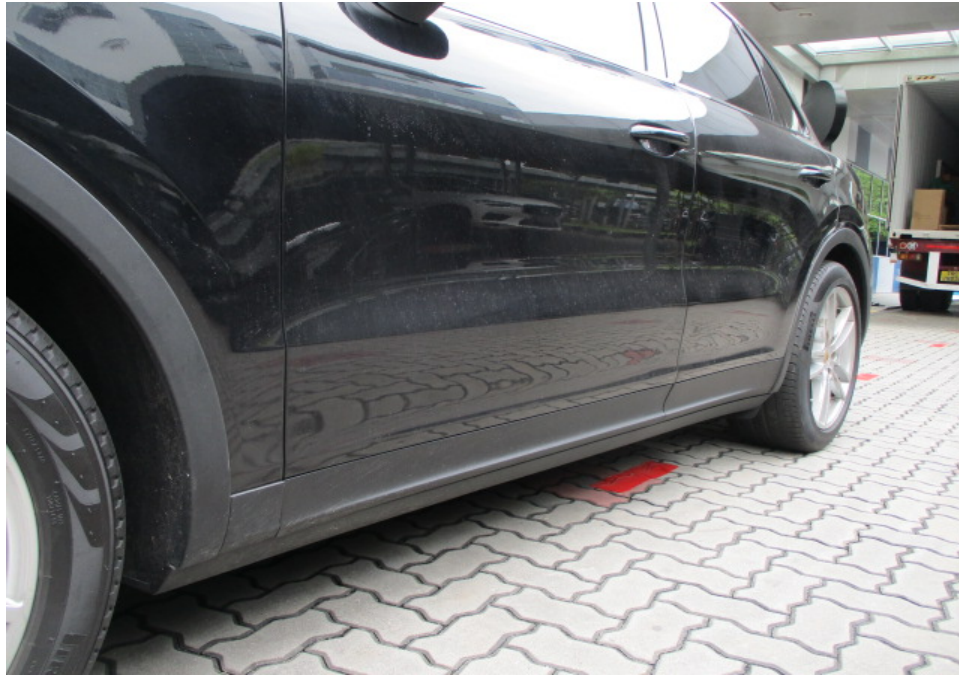
Photo 11 shows a closer view of the Motor Car's front left fender, front left door, rear left door and left side rocker panel garnish. The body parts at the left centre portion of the Motor Car were visually examined and it was observed that the repair/restoration works carried out to the damaged area of the Motor Car (refer to photograph 3 above) were reasonably adequate and in order.

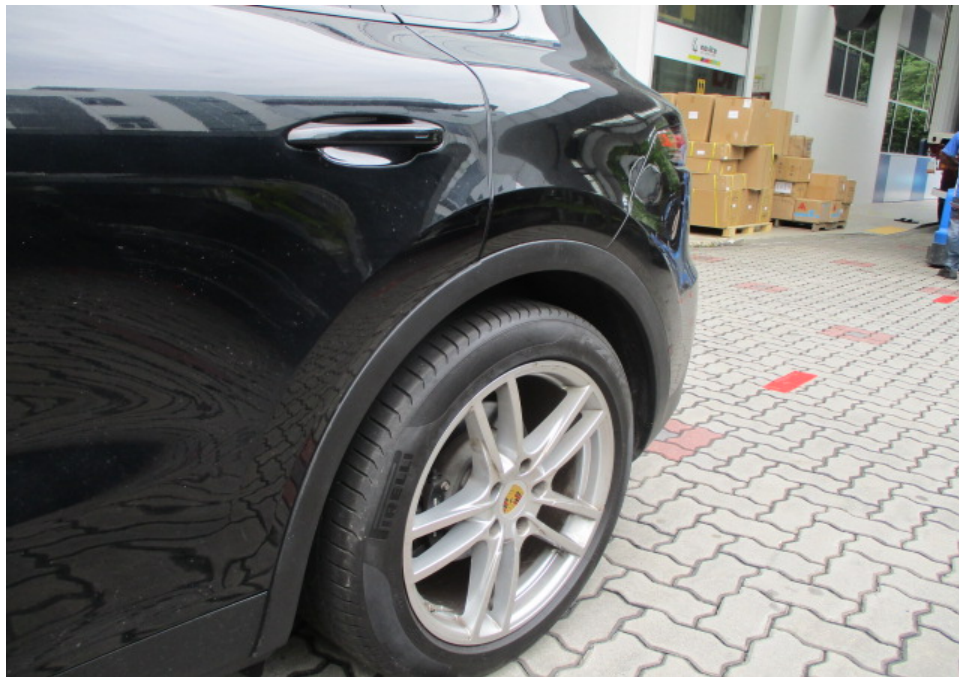
Photo 12 shows a closer view of the Motor Car's rear left door, rear left fender, rear left fender wheel arc garnish and rear left wheel rim. The body parts at the left rear portion of the Motor Car were visually examined and it was observed that the repair/restoration works carried out to the damaged area of the Motor Car (refer to photograph 4 & 5 above) were reasonably adequate and in order.

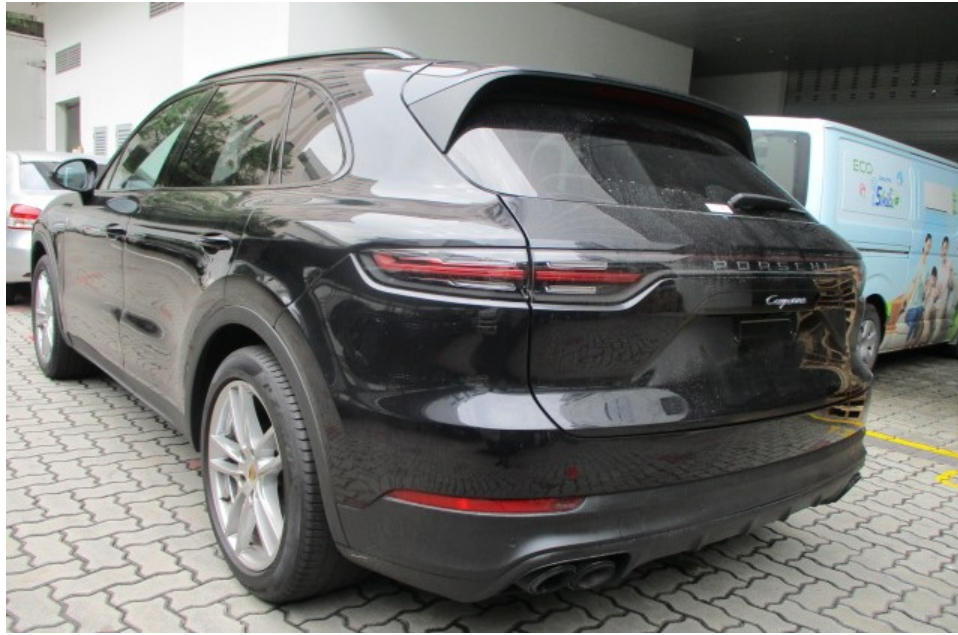
Photo 13 shows a general view of the rear left body of the Motor Car at the time of my inspection. The Motor Car was observed to be in a relatively good general condition with no loose exterior fittings observed. The body parts along the entire left side portion of the Motor Car were visually examined and it was observed that the repair/restoration works carried out to the damaged area of the Motor Car (refer to photograph 1 – 5 above) were reasonably adequate and in order.

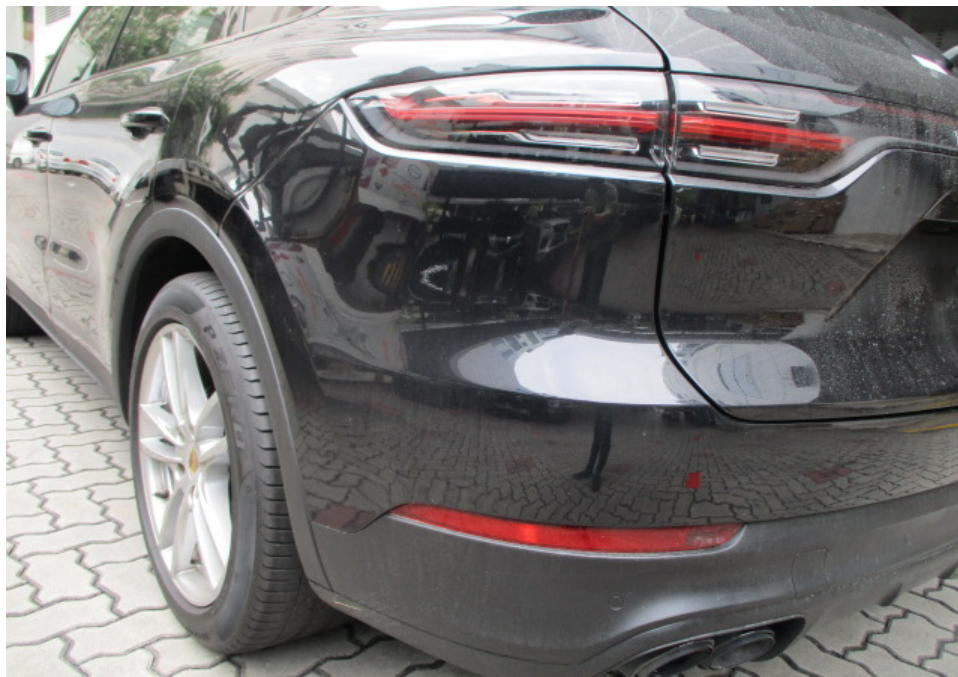
Photo 14 shows a closer view of the Motor Car's rear bumper, rear bumper lower cover, rear bumper left reflector, rear left taillamp and rear left bootlid lamp. The body parts at the left rear portion of the Motor Car were visually examined and it was observed that the repair/restoration works carried out to the damaged area of the Motor Car (refer to photograph 4 & 5 above) were reasonably adequate and in order.

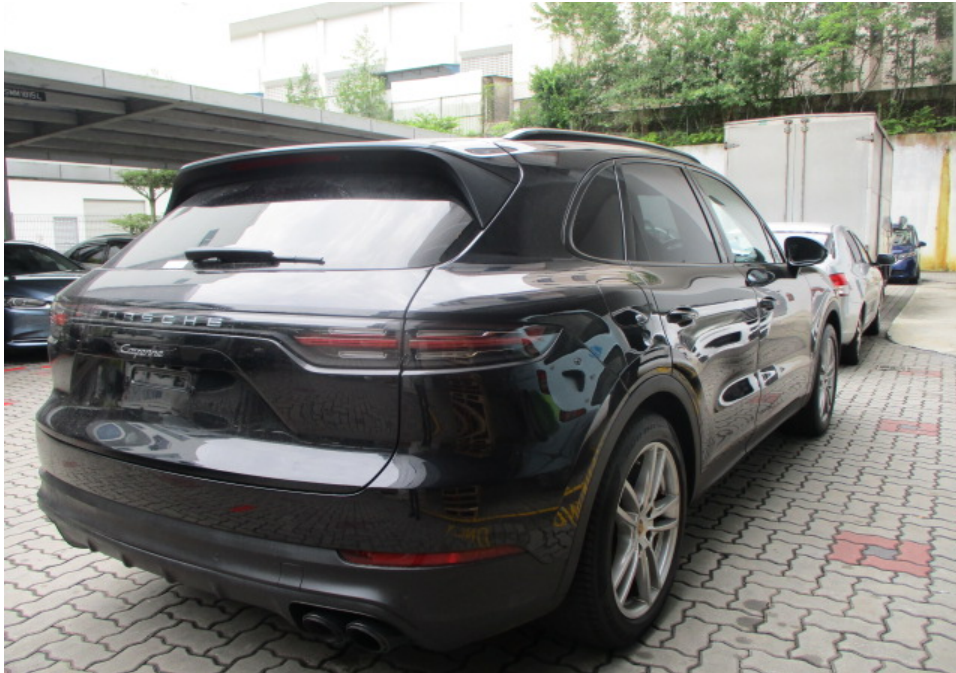
Photo 15 shows a general view of the rear right body of the Motor Car at the time of my inspection. The Motor Car was observed to be in a relatively good general condition with no loose exterior fittings observed. The mileage of the Motor Car recorded at the time of my inspection was 23,785km.

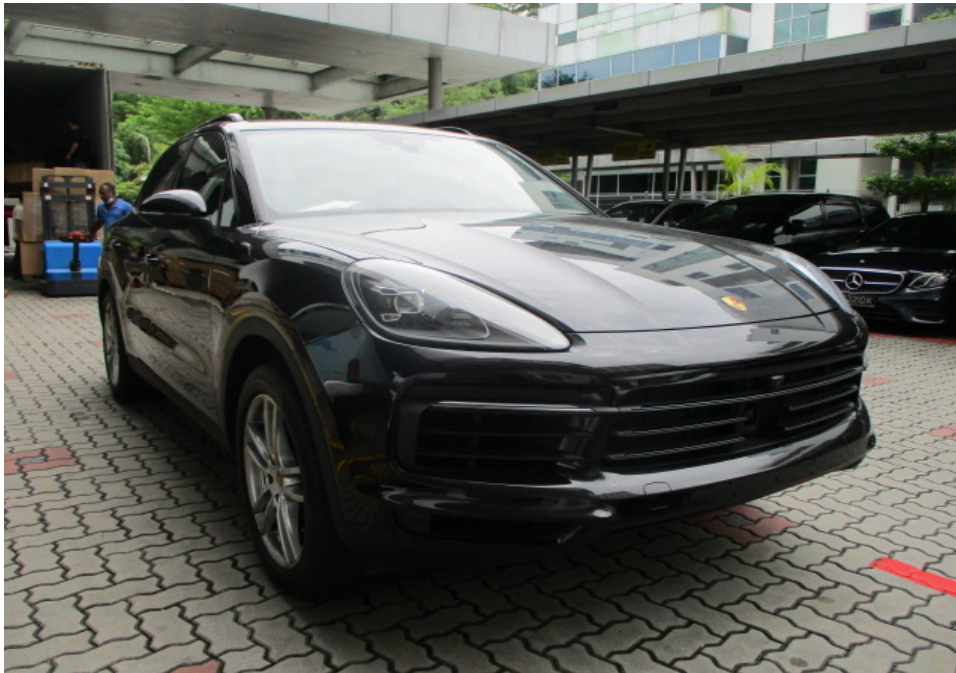
Photo 16 shows a general view of the front right body of the Motor Car at the time of my inspection. The Motor Car was observed to be in a relatively good general condition with no loose exterior fittings observed. The mileage of the Motor Car recorded at the time of my inspection was 23,785km.

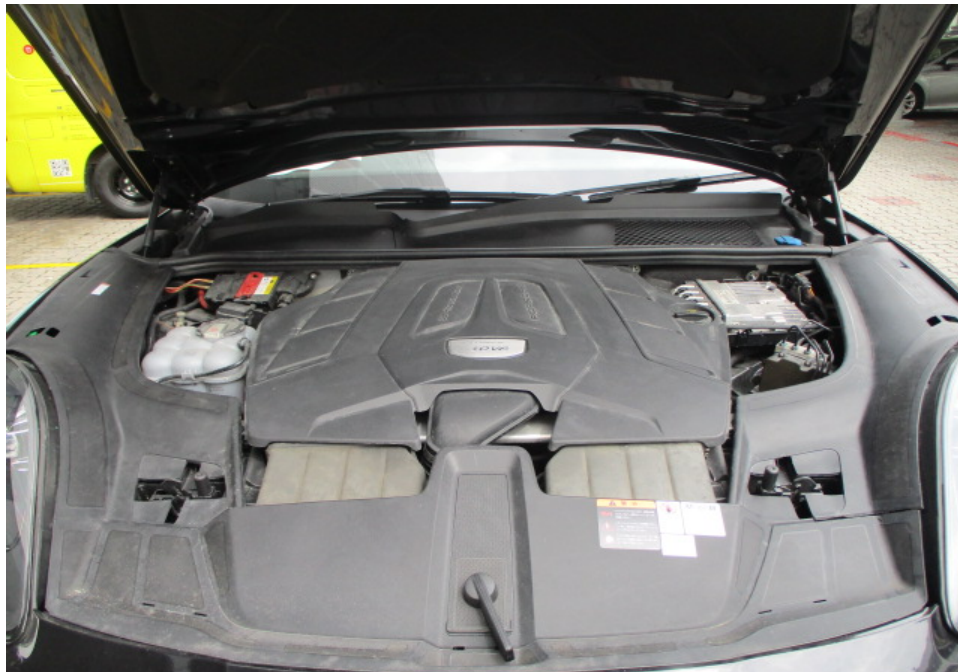
Photo 18 shows a general view of the engine compartment of the Motor Car at the time of my inspection. The various parts and components inside the engine compartment were all observed to be intact and properly fitted. There was also no sign(s) or indication(s) of fluid leak and/or fluid stain found inside the engine compartment.

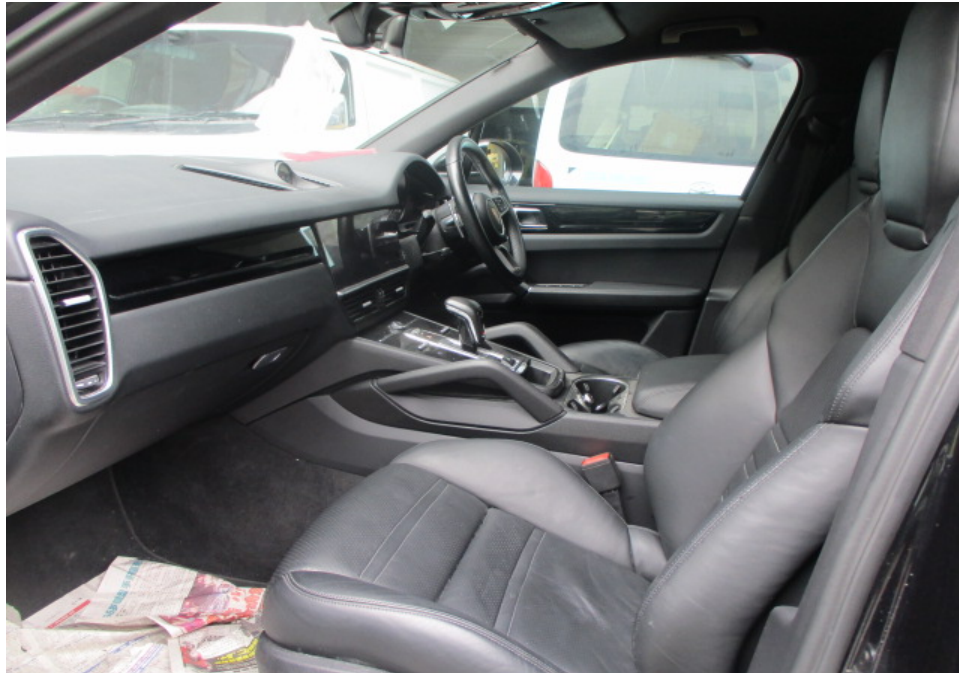
Photo 19 shows the interior compartment of the Motor Car at the time of my inspection. The various parts and components, trims, carpet, and upholstery inside the interior compartment were all observed to be intact and properly fitted.

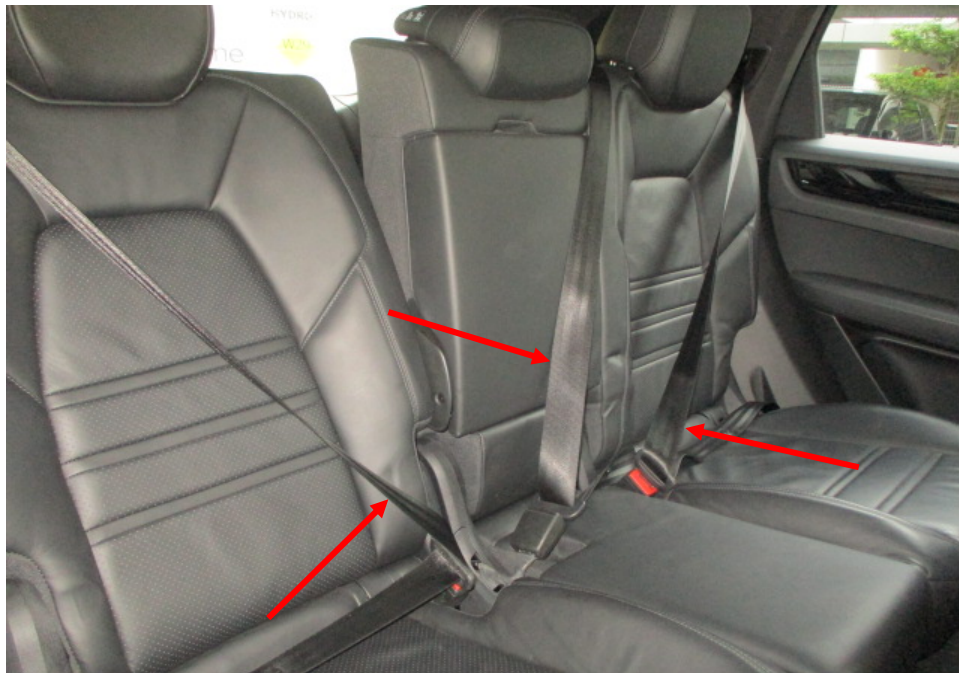
Photo 20 shows the rear seats of the Motor Car. All the seats of the Motor Car were secured via seat rails to the floorboard. They were also fitted with a retractable seat belt reel and a pre-tensioner. The seat belts (arrowed) were tested and were able to be fastened into the respective pre-tensions that were fitted on the side of each individual seat.

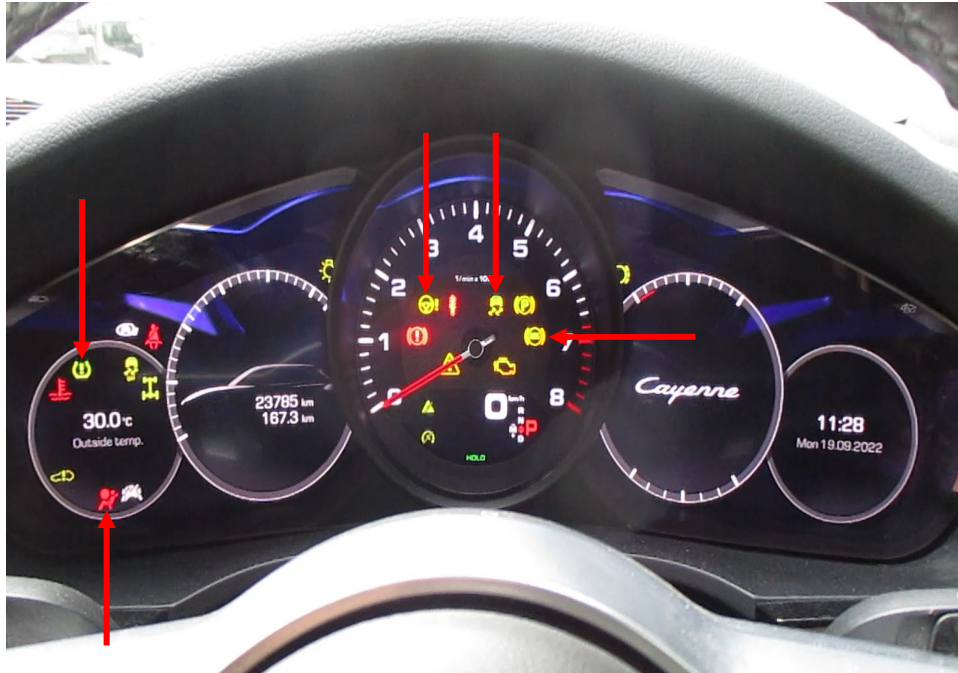
Photo 21 shows the warning lights for the various electronic safety features appearing on the instrument panel of the Motor Car during its self-test when the engine is cranked, in particular the ABS, SRS, EPS, TPM and TCS lights (arrowed).

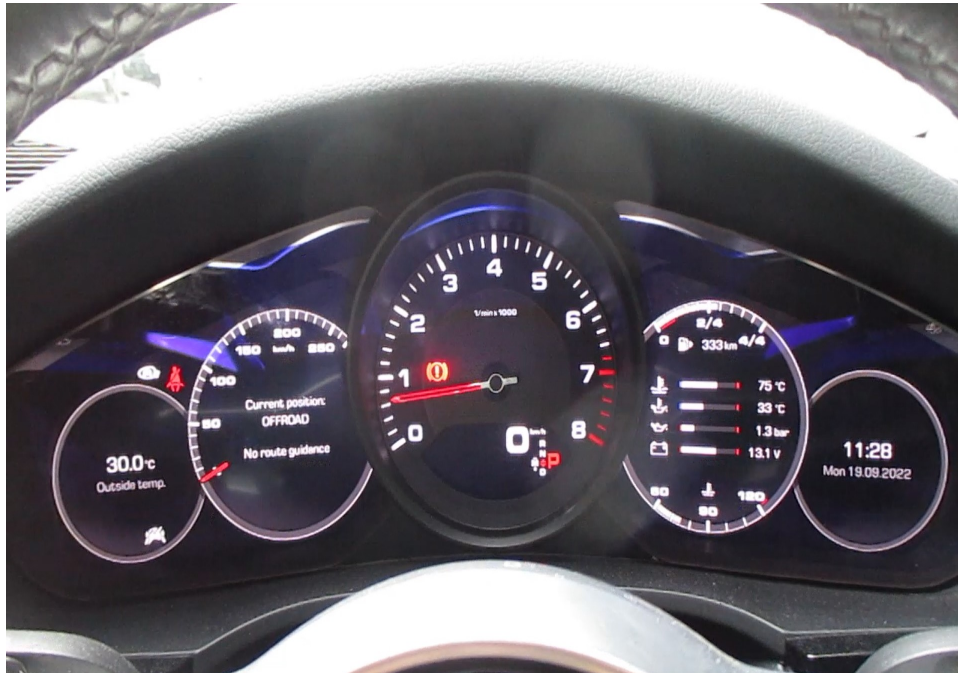
Photo 22 shows the respective warning lights no longer illuminated, indicating that there is no fault detected to the ABS, SRS, EPS, TPM and TCS systems of the Motor Car during the self-test. These electronic systems were hence in working condition at the time of my inspection.

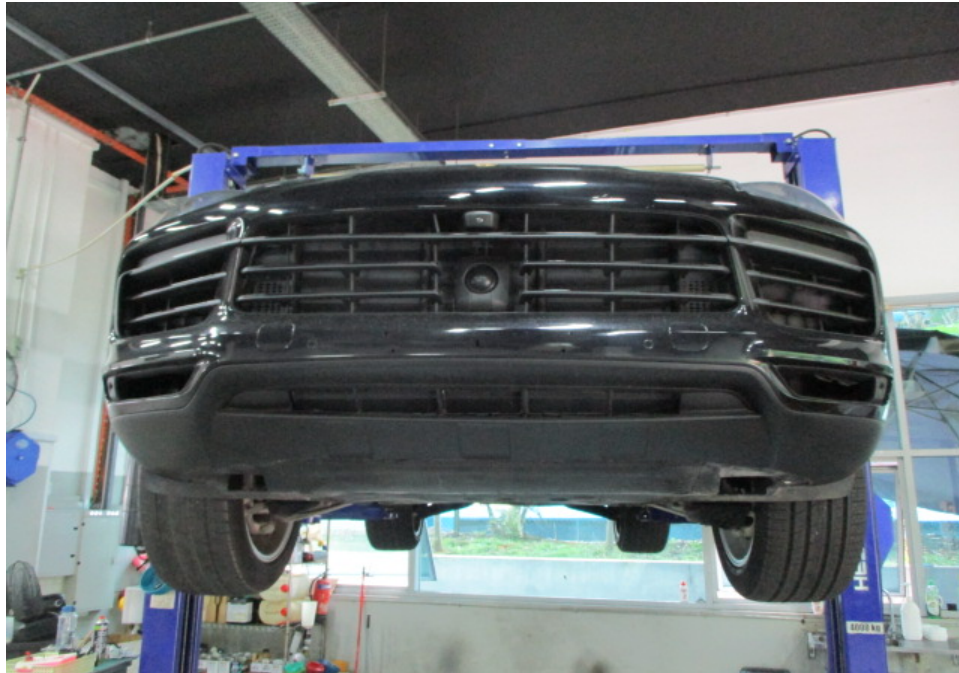
Photo 23 shows the Motor Car hoisted up for checks on its undercarriage. There was no sign(s) or indication(s) of fluid leakage and/or fluid stain(s) on the underside of the Motor Car. The undercarriage components of the Motor Car were also all observed to be intact and secured in an appropriate manner.

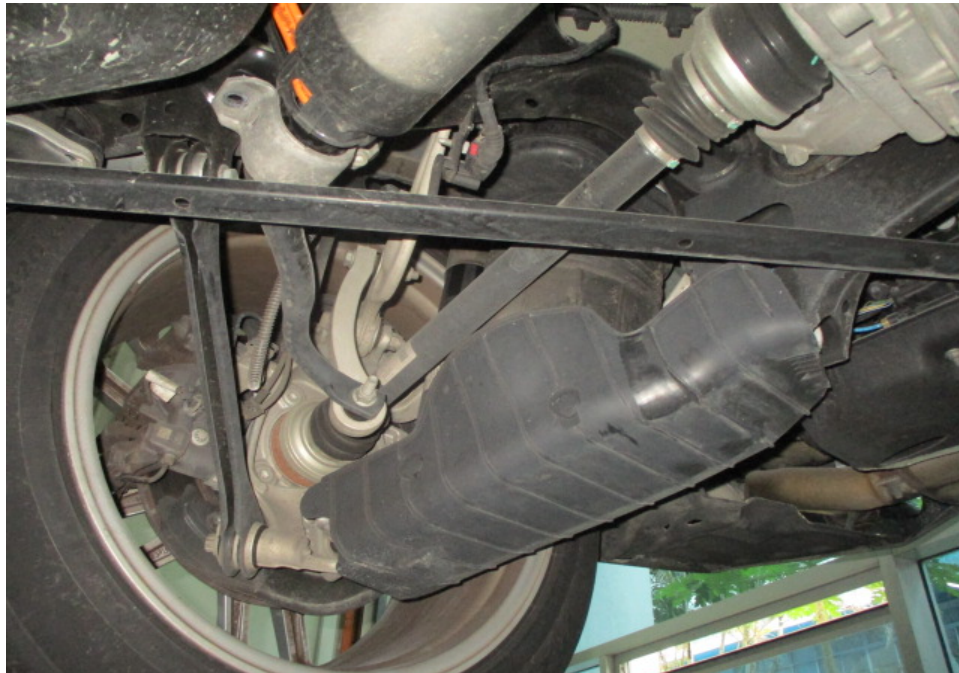
Photo 24 shows a general view of the control arms and linkages at the rear right wheel of the Motor Car. I did not observe any fluid leak and/or fluid stain on the underside of the Motor Car. All of the Motor Car's undercarriage components were observed to be intact and secured in an appropriate manner.

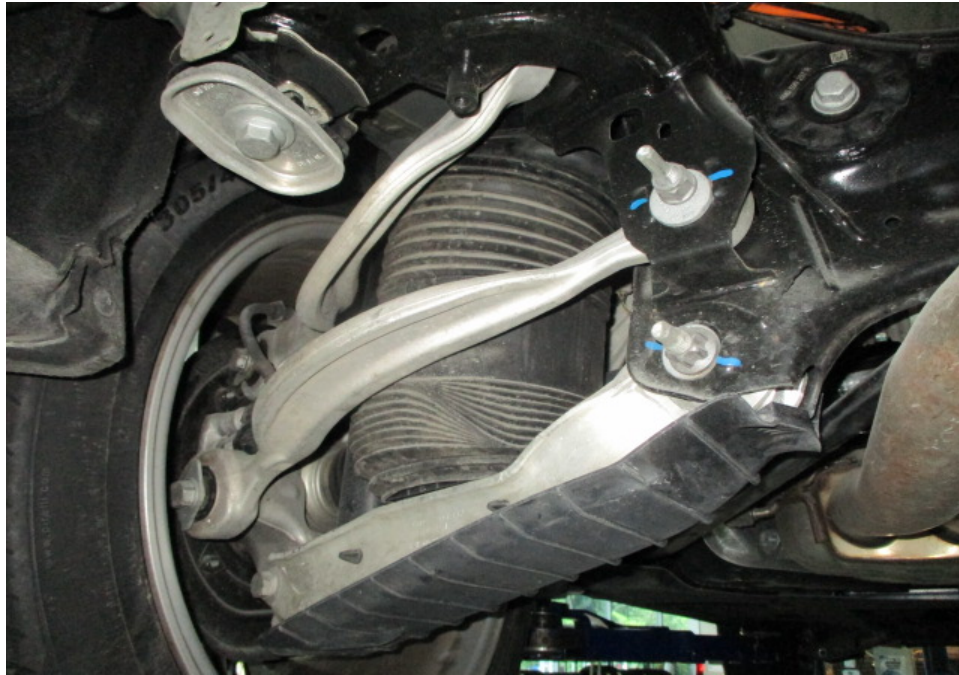
Photo 25 shows a general view of the control arms and linkages at the rear left wheel of the Motor Car. I did not observe any fluid leak and/or fluid stain on the underside of the Motor Car. All of the Motor Car's undercarriage components were observed to be intact and secured in an appropriate manner.

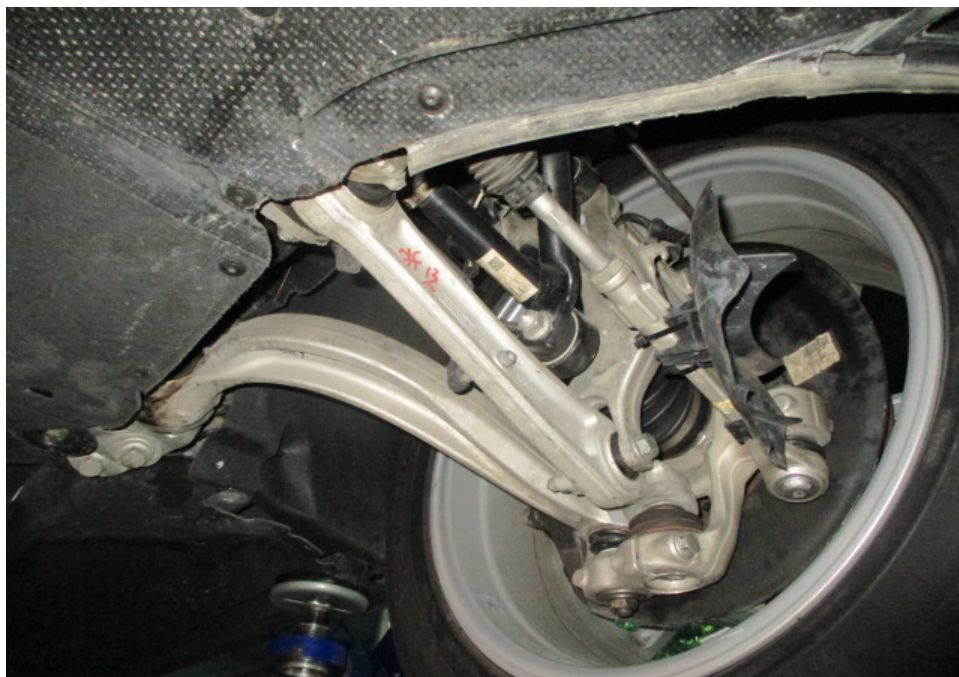
Photo 26 shows the various undercarriage components at the front left wheel of the Motor Car. The mechanical components, control arms and linkages were all found to be intact and secured in an appropriate manner.

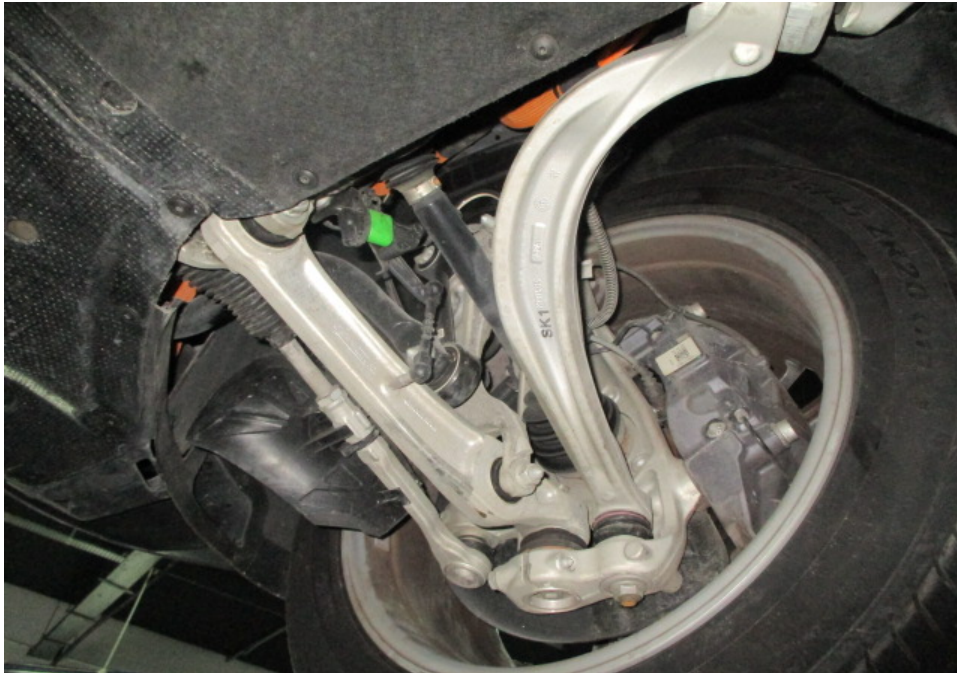
Photo 27 shows the various undercarriage components at the front right wheel of the Motor Car. The mechanical components, control arms and linkages were all found to be intact and secured in an appropriate manner. I also did not observe any fluid leak and/or fluid stain on the underside of the Motor Car.

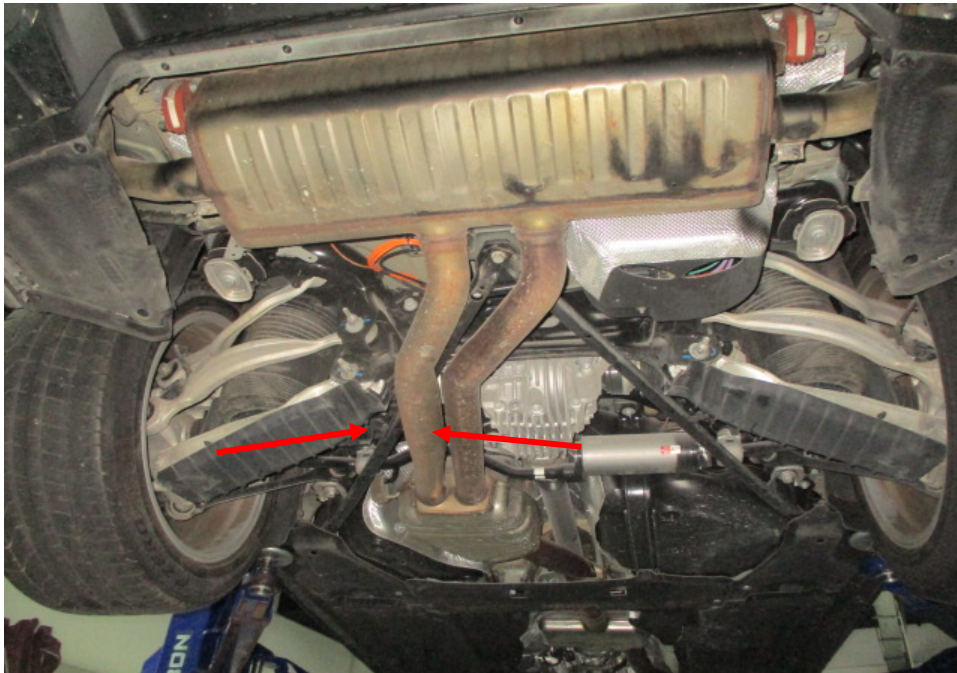
Photo 28 shows the rear section of the Motor Car's exhaust system. My examination of the Motor Car's exhaust system revealed no sign(s) or indication(s) of any cut or weld marks along its exhaust pipes (arrowed), on its rear muffler, on its centre resonator boxes and on its catalytic converter.

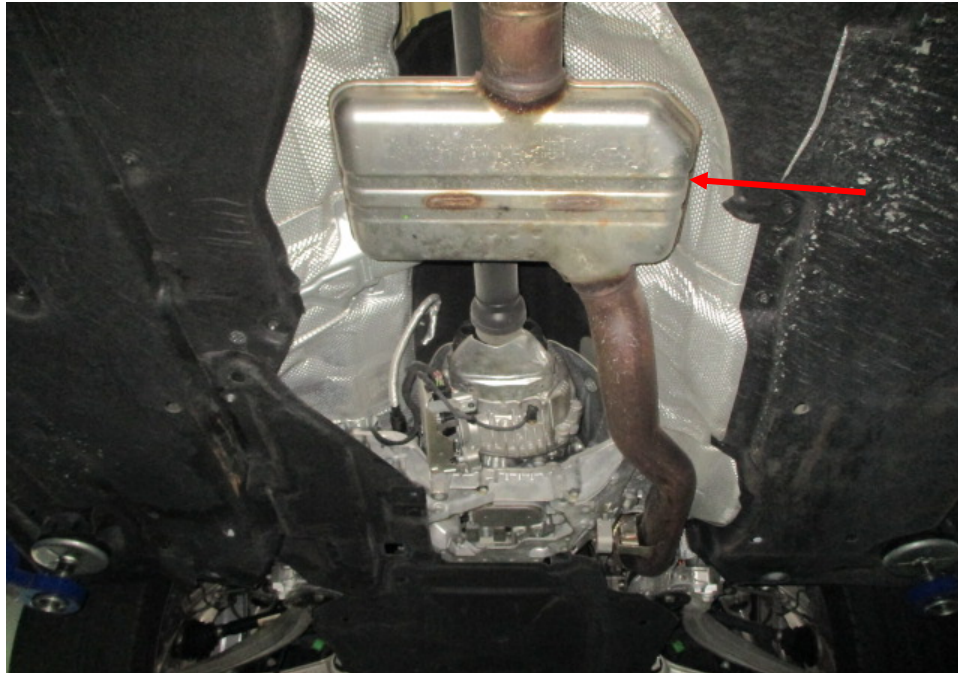
Photo 29 shows the front section of the Motor Car's exhaust system. My examination of the Motor Car's exhaust system revealed no sign(s) or indication(s) of any cut or weld marks along its exhaust pipes, on its rear muffler, on its centre resonator boxes (arrowed) and on its catalytic converter.

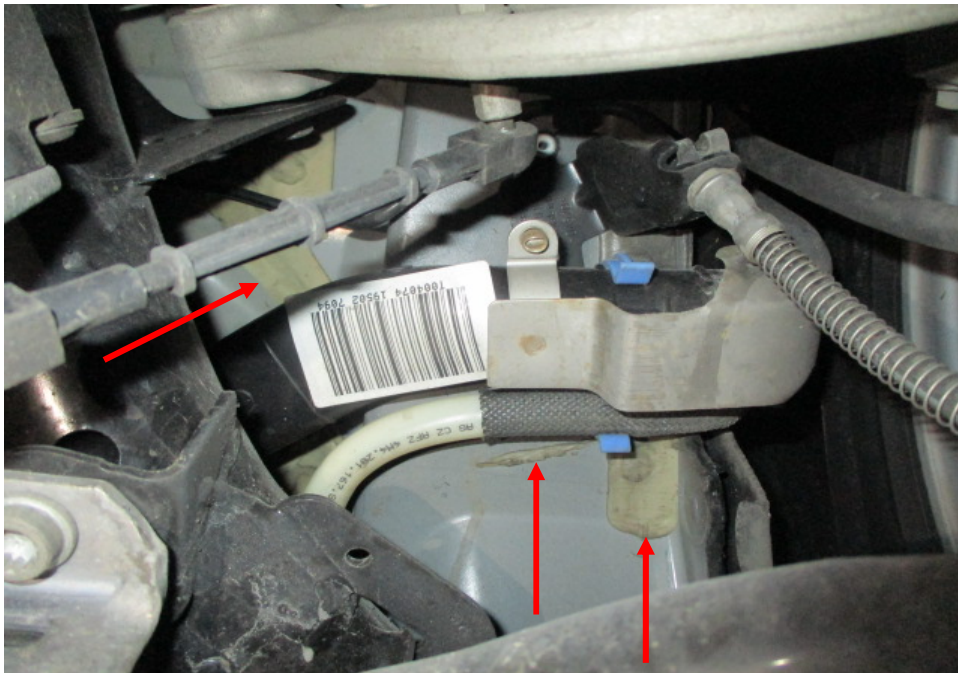
Photo 30 shows the chassis/structural body at the underside rear right of the Motor Car. I did not find any weld marks other than original spot weld marks on the chassis/structural body of the Motor Car. The original factory sealant (arrowed) at the joints along the chassis/structural body was untouched, indicating no work was done on the chassis/structural body of the Motor Car and that the chassis/structural body was originally fitted.

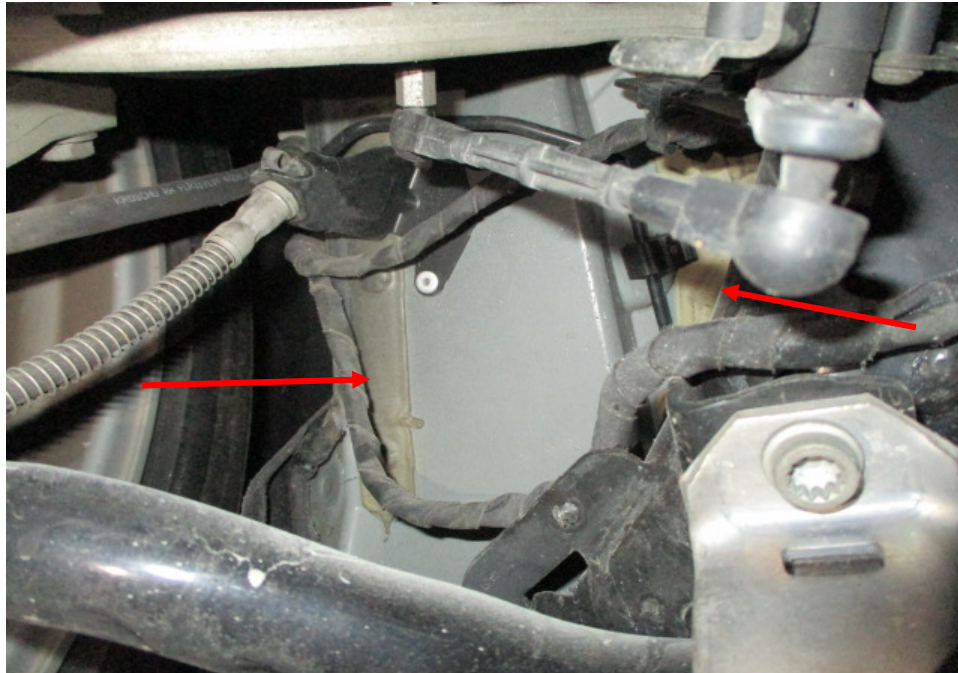
Photo 31 shows the chassis/structural body at the underside rear left of the Motor Car. I did not find any weld marks other than original spot weld marks on the chassis/structural body of the Motor Car. The original factory sealant (arrowed) at the joints along the chassis/structural body was untouched, indicating no work was done on the chassis/structural body of the Motor Car and that the chassis/structural body was originally fitted.
