Your Ref: Porsche Cayenne
(chassis number WP1ZZZ9YZLDA03330)
Our Ref : CI/TP22010250/D

13 October 2022

**INSPECTION REPORT OF AN UNREGISTERED PORSCHE CAYENNE
MOTOR CAR WITH CHASSIS NUMBER WP1ZZZ9YZLDA03330**

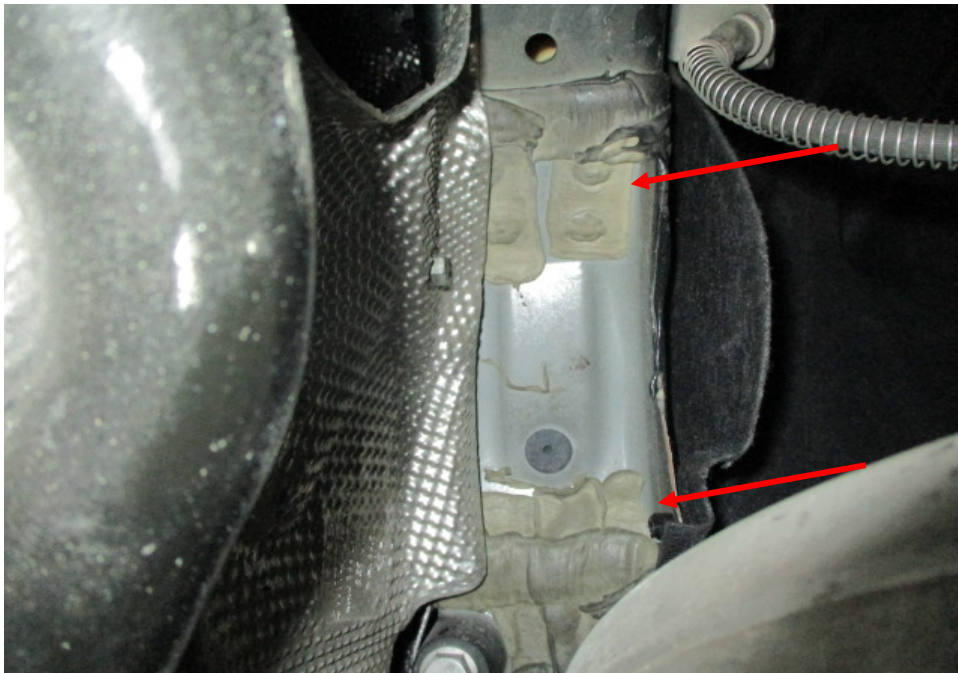
Photo 32 shows the chassis/structural body at the underside front left of the Motor Car. The original factory sealant (arrowed) at the joints along the chassis/structural body was observed to be untouched. In general, I had found no work was carried out on the chassis/structural body of the Motor Car. The chassis/structural body of the Motor Car was originally fitted.

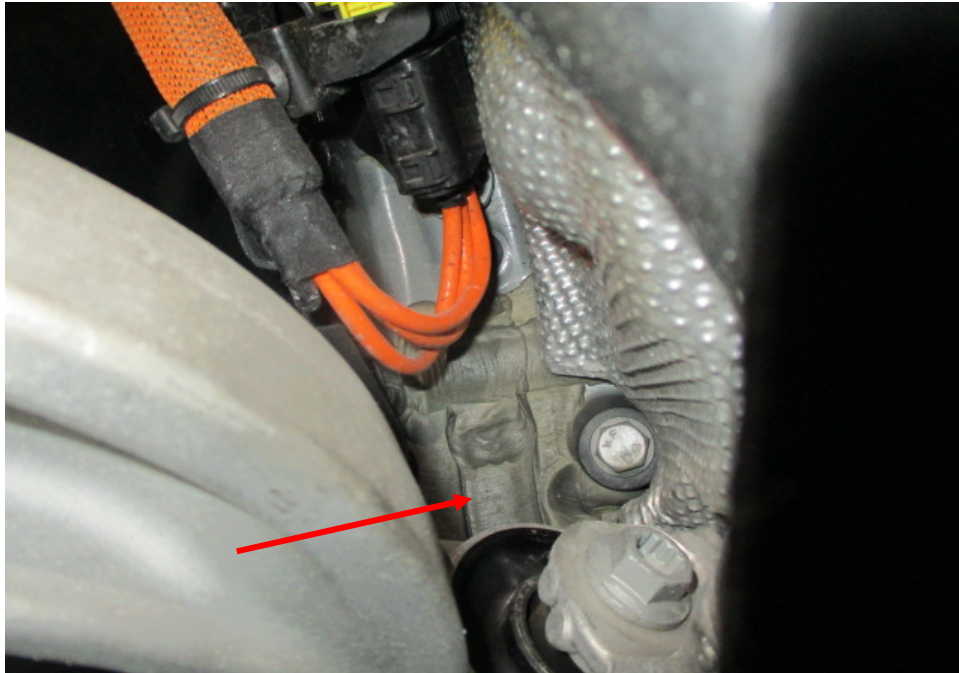
Photo 33 shows the chassis/structural body at the underside front right of the Motor Car. The original factory sealant (arrowed) at the joints along the chassis/structural body was observed to be untouched. In general, I had found no work was carried out on the chassis/structural body of the Motor Car. The chassis/structural body of the Motor Car was originally fitted.
