Your Ref: BMW M3
(chassis number WBS32AY0X0FL33085)
Our Ref : CI/TP22010265/D

17 October 2022

INSPECTION REPORT OF AN UNREGISTERED BMW M3 MOTOR CAR WITH CHASSIS NUMBER WBS32AY0X0FL33085

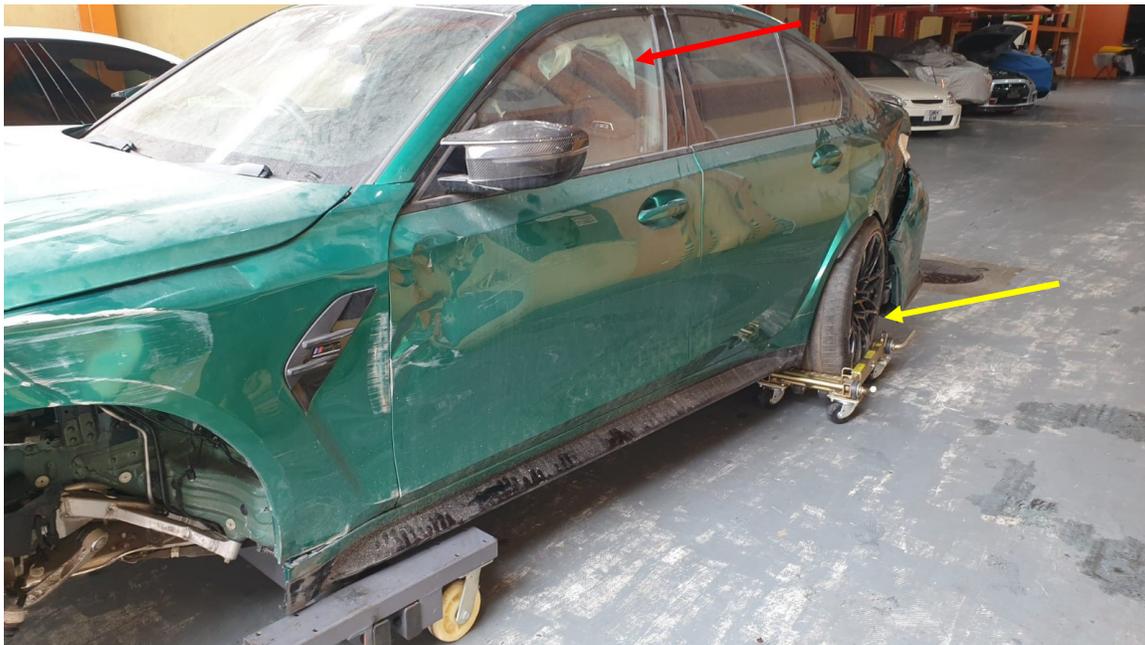
3. The photographs provided to me had showed damage along the entire left side portion of the Motor Car. Body parts damaged include the front left fender, front left fender garnish, front left fender inner shield, front left door, rear left door, rear left wheel rim, rear left fender, rear left taillamp, rear bumper, rear bootlid and left side rocker panel garnish amongst others.
4. The front left wheel rim and front left tyre were also observed to be damaged/dislodged/missing, resulting in damage to the undercarriage parts at the front left wheel of the Motor Car. Undercarriage parts that may possibly be damage include the front left lower arm, front left knuckle arm, front left steering tie rod, front left upper arm and front left shock absorber amongst others.

5. The Motor Car's rear left wheel was further observed to be orientated towards the left, which indicates damage to the undercarriage parts at its rear left wheel. Undercarriage parts that may possibly be damage include the rear left lower arm, rear left knuckle arm and rear left shock absorber amongst others.
6. Apart for the left side portion, there was no physical damage observed to other areas of the Motor Car. The left curtain airbag was deployed as seen from the photographs that were provided to me. See photo 1 – 4 below.

Photo 1 shows the front left body of the Motor Car (photograph provided to me). The Motor Car was observed to have sustained damage along its entire left side portion. The front left fender, front left fender garnish, front left fender inner shield, front left door, rear left door and left side rocker panel garnish were amongst the body parts that were observed to have been damaged. The left curtain airbag (red arrow) was deployed as seen from the photographs that were provided to me. The front left wheel rim and front left tyre were also observed to be damaged/dislodged/missing, resulting in damage to the undercarriage parts at the front left wheel of the Motor Car. Undercarriage parts that may possibly be damage include the front left lower arm, front left knuckle arm, front left upper arm, front left steering tie rod and front left shock absorber amongst others. The Motor Car's rear left wheel (yellow arrow) was also observed to be orientated towards the left, which indicates damage to the undercarriage parts at its rear left wheel.

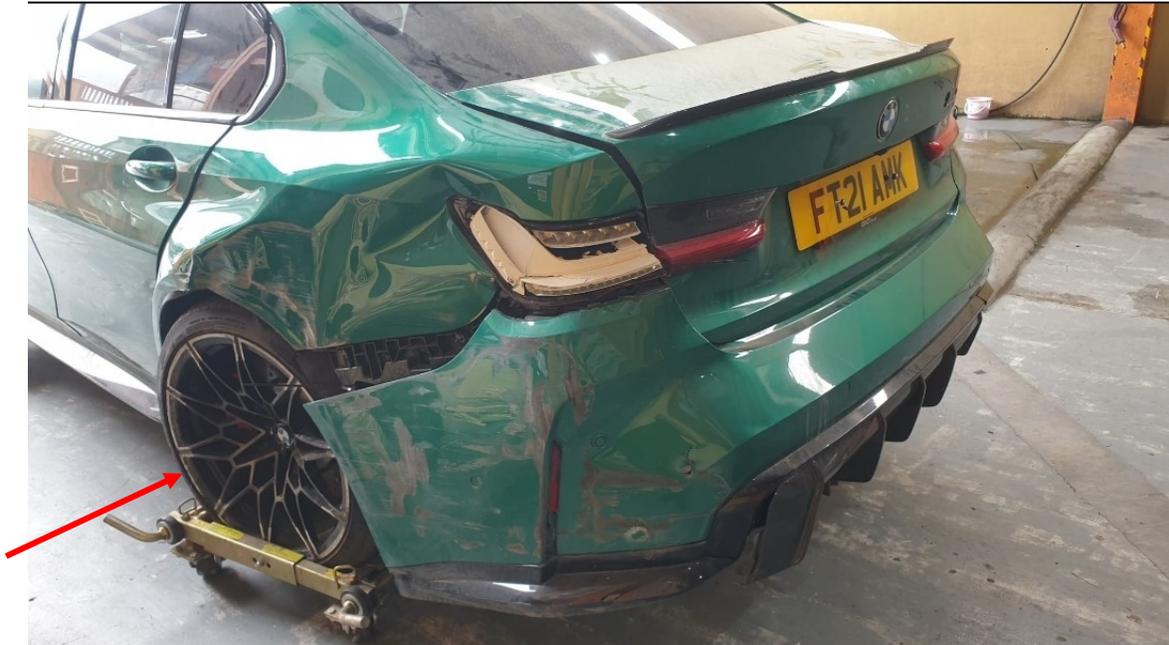
Photo 2 shows the rear left body of the Motor Car (photograph provided to me). The Motor Car was observed to have sustained damage along its entire left side portion. The rear bumper, rear bootlid, rear left taillamp, rear left fender, rear left wheel rim and rear left door were amongst the body parts that were observed to have been damaged. The Motor Car's rear left wheel (arrowed) was also observed to be orientated towards the left, which indicates damage to the undercarriage parts at its rear left wheel. Undercarriage parts that may possibly be damage include the rear left lower arm, rear left knuckle arm and rear left shock absorber amongst others.

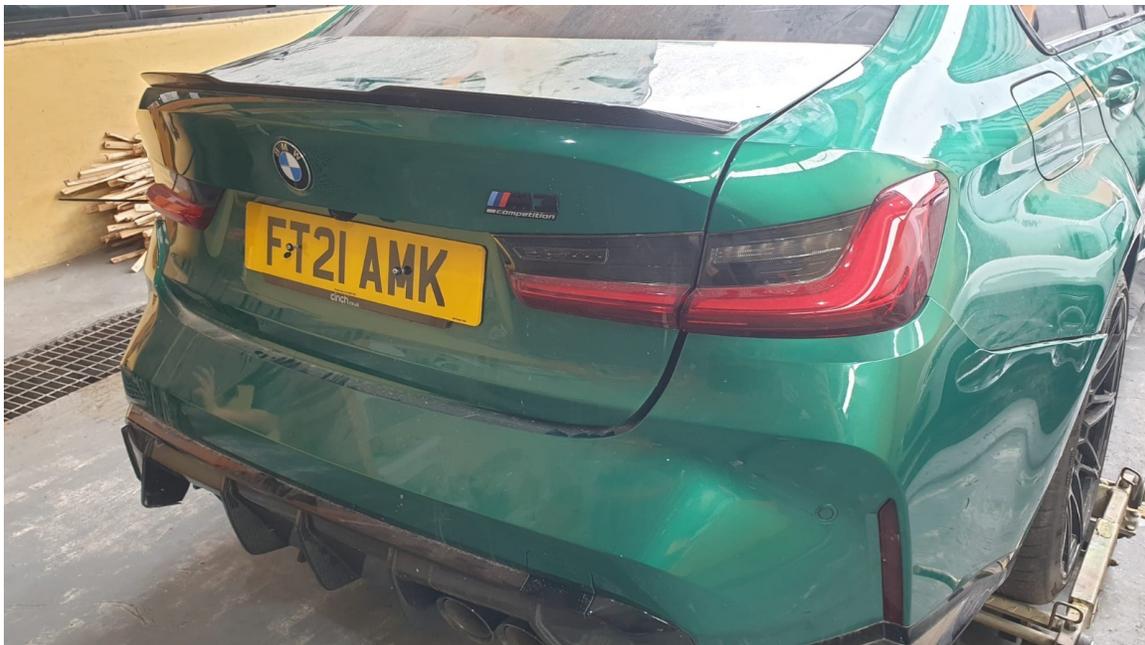
Photo 3 shows the rear right body of the Motor Car (photograph provided to me). Apart for the left side portion, there was no physical damage observed to other areas of the Motor Car.

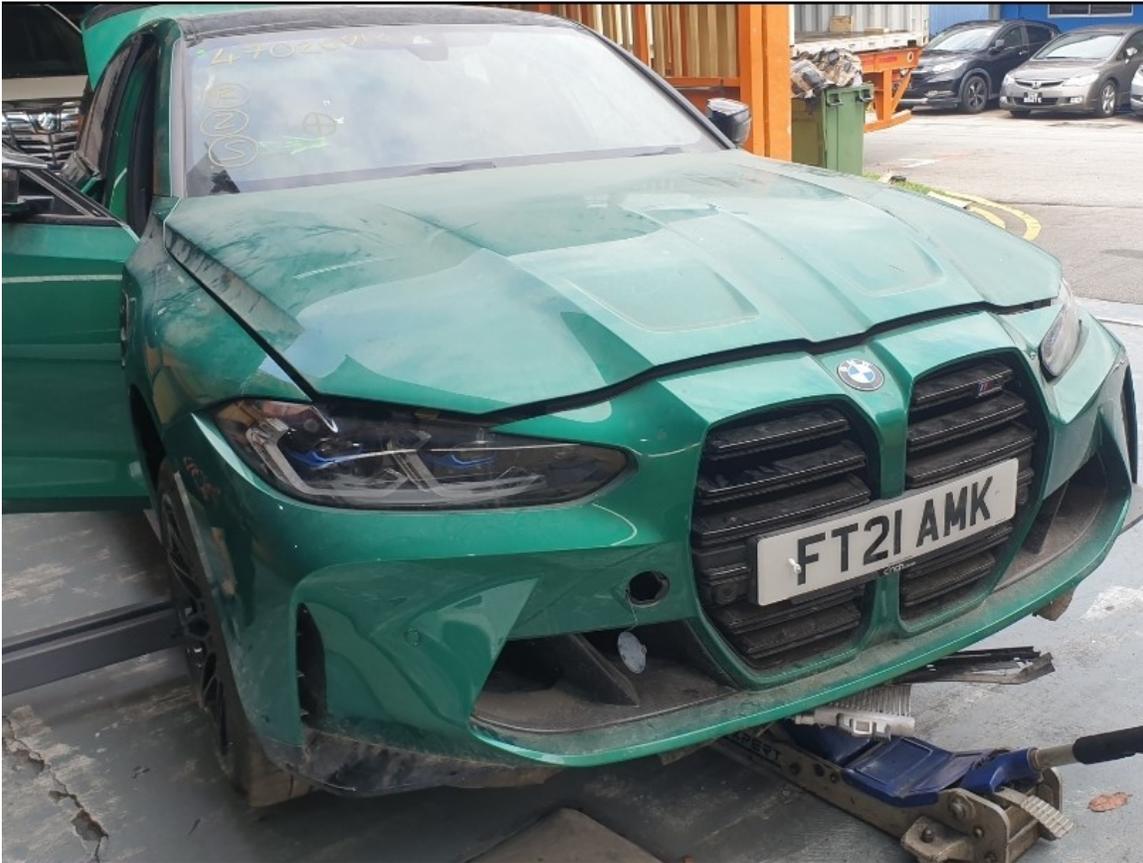
Photo 4 shows the front right body of the Motor Car (photograph provided to me). Apart for the left side portion, there was no physical damage observed to other areas of the Motor Car.

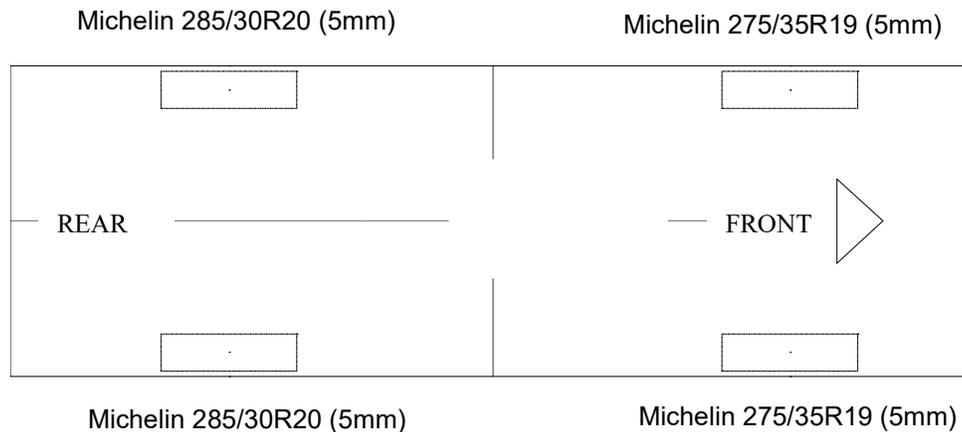
10. It was fitted with 19inch (front) and 20inch (rear) sport wheel rims that were wrapped with tyres that were observed to be of serviceable condition. The tyres were also sufficiently inflated for vehicular operation. The tyre brand, tyre size and approximate remaining tread depth of the 4 tyres of the Motor Car were recorded as follows: -

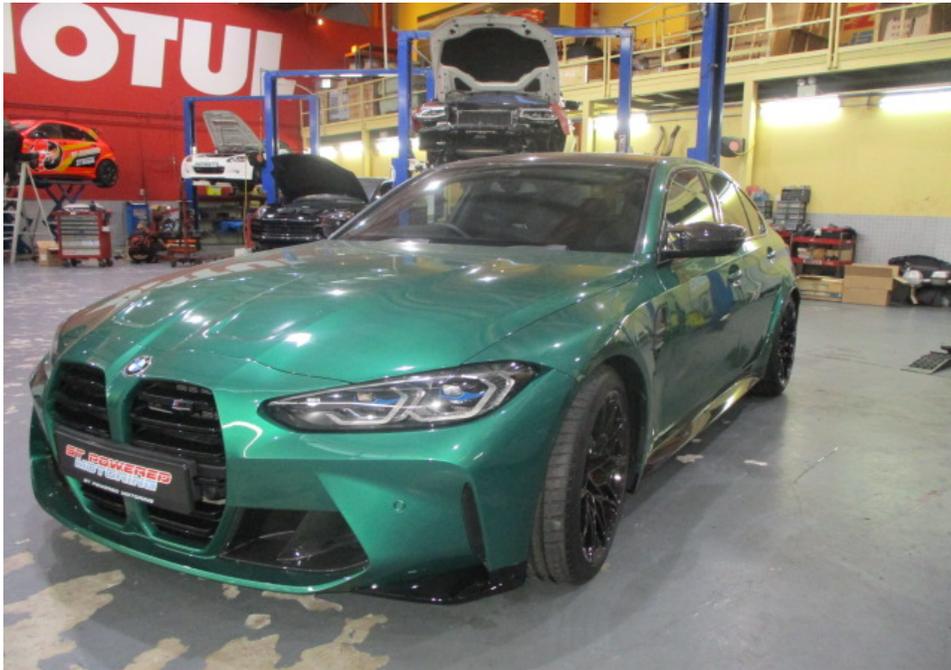
Photo 5 shows a general view of the front left body of the Motor Car at the time of my inspection. The Motor Car was observed to be in a relatively good general condition with no loose exterior fittings observed. The body parts along the entire left side portion of the Motor Car were visually examined and it was observed that the repair/restoration works carried out to the damaged area of the Motor Car (refer to photograph 1 & 2 above) were reasonably adequate and in order.

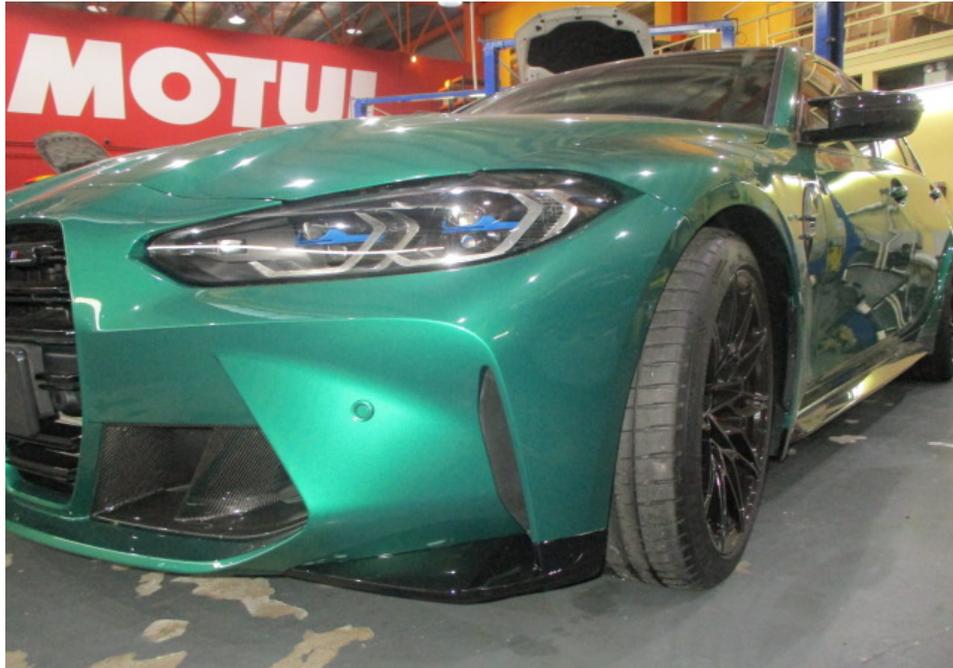
Photo 6 shows a closer view of the Motor Car's front bumper, front bumper left sensor and front left headlamp. The body parts along the entire left side portion of the Motor Car were visually examined and it was observed that the repair/restoration works carried out to the damaged area of the Motor Car (refer to photograph 1 & 2 above) were reasonably adequate and in order.

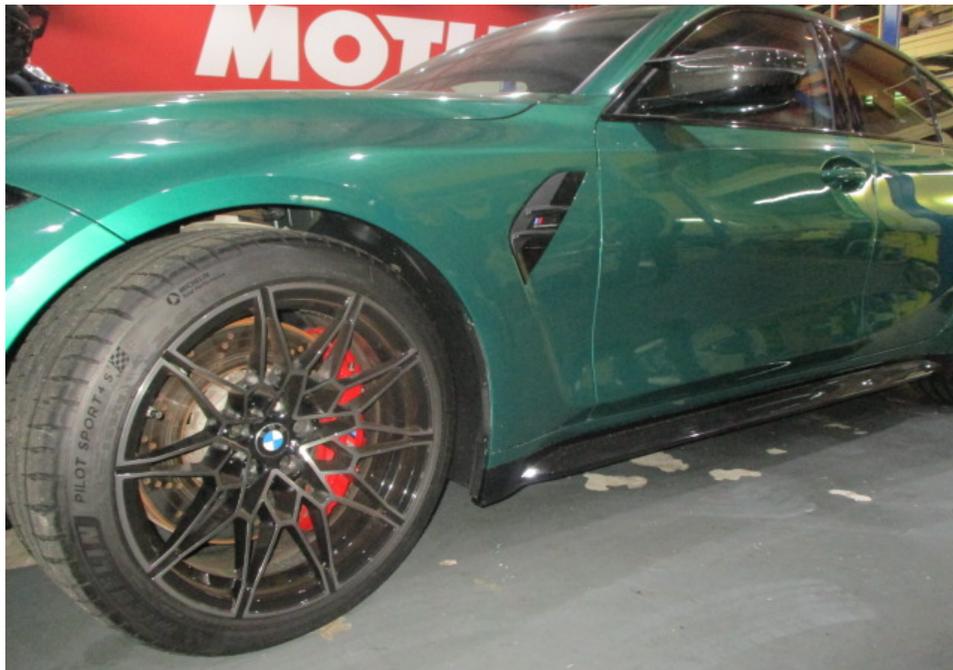
Photo 7 shows a closer view of the Motor Car's front left wheel rim, front left tyre and front left fender at the time of my inspection. The body parts at the left front portion of the Motor Car were visually examined and it was observed that the repair/restoration works carried out to the damaged area of the Motor Car (refer to photograph 1 above) were reasonably adequate and in order.

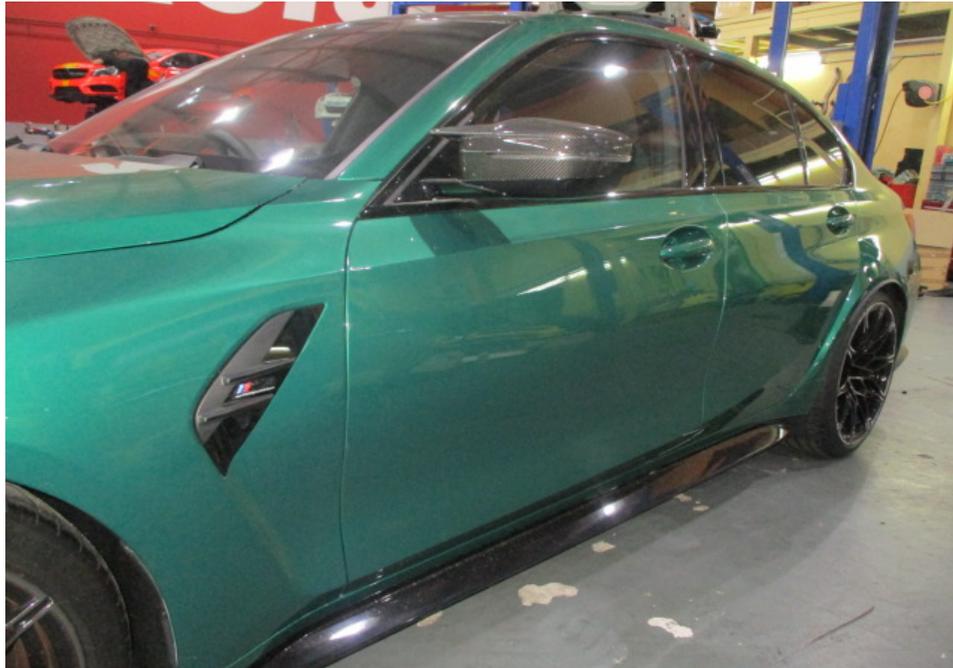
Photo 8 shows a closer view of the Motor Car's front left fender, front left fender garnish, front left door and left side rocker panel garnish at the time of my inspection. The body parts at the left front portion of the Motor Car were visually examined and it was observed that the repair/restoration works carried out to the damaged area of the Motor Car (refer to photograph 1 above) were reasonably adequate and in order.

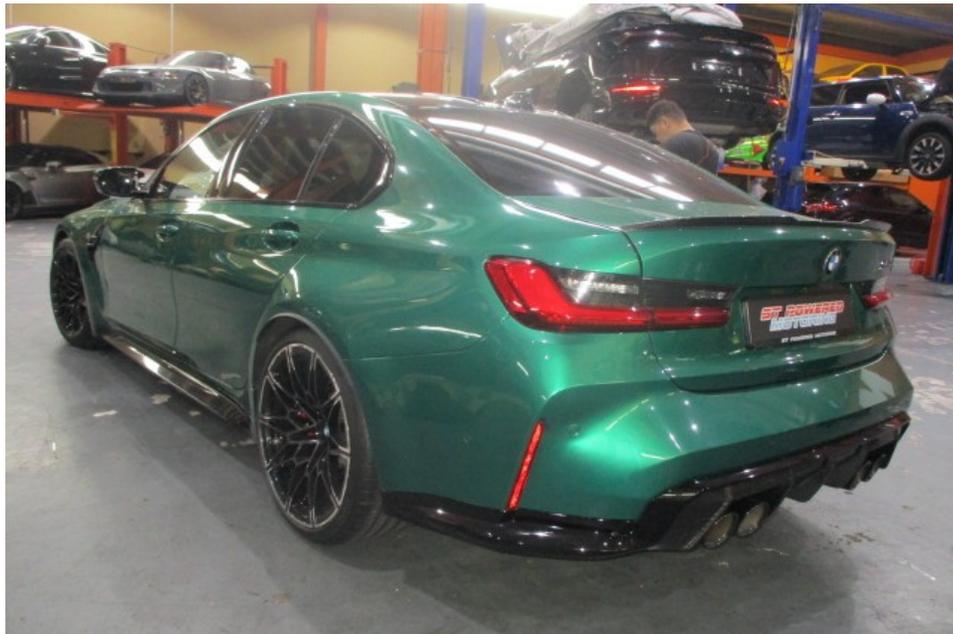
Photo 9 shows a general view of the rear left body of the Motor Car at the time of my inspection. The Motor Car was observed to be in a relatively good general condition with no loose exterior fittings observed. The body parts along the entire left side portion of the Motor Car were visually examined and it was observed that the repair/restoration works carried out to the damaged area of the Motor Car (refer to photograph 1 & 2 above) were reasonably adequate and in order.

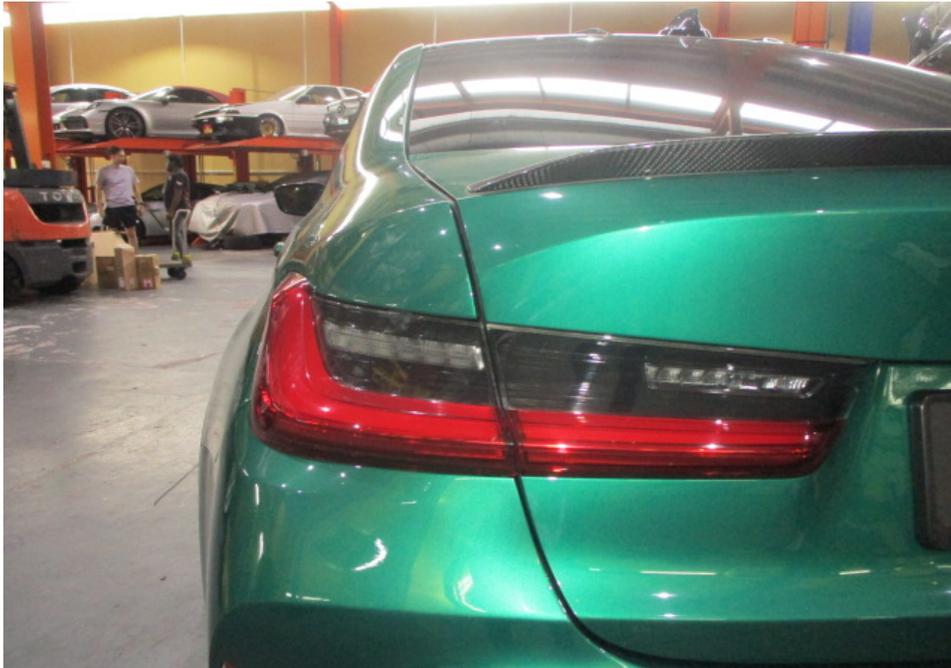
Photo 10 shows a closer view of the Motor Car's rear bootlid, rear left bootlid lamp and rear left taillamp at the time of my inspection. The body parts at the left rear portion of the Motor Car were visually examined and it was observed that the repair/restoration works carried out to the damaged area of the Motor Car (refer to photograph 2 above) were reasonably adequate and in order.

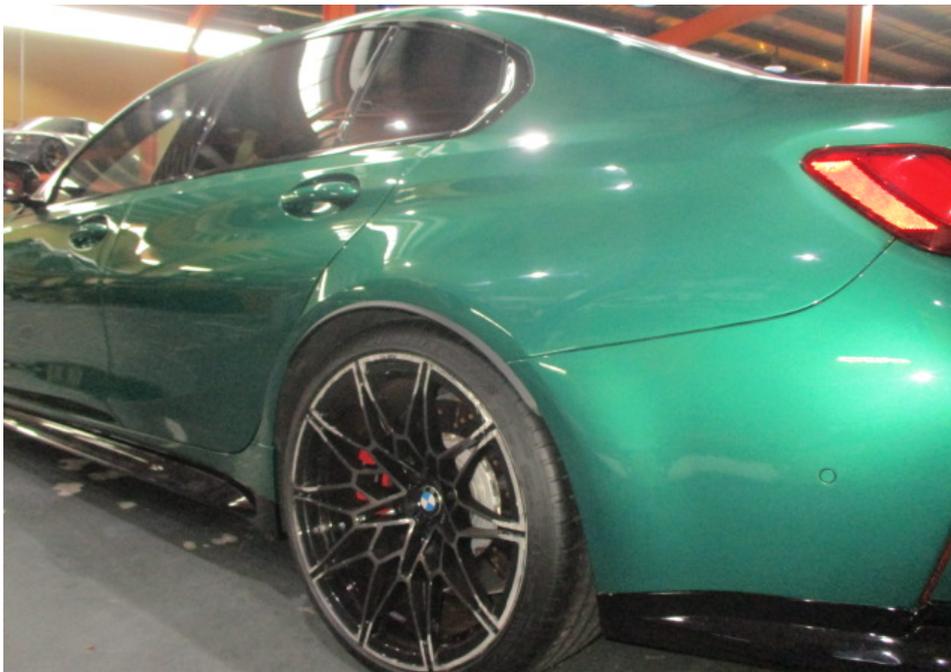
Photo 11 shows a closer view of the Motor Car's rear bumper, rear bumper left sensor, rear left fender and left rear wheel rim. The body parts at the left rear portion of the Motor Car were visually examined and it was observed that the repair/restoration works carried out to the damaged area of the Motor Car (refer to photograph 2 above) were reasonably adequate and in order.

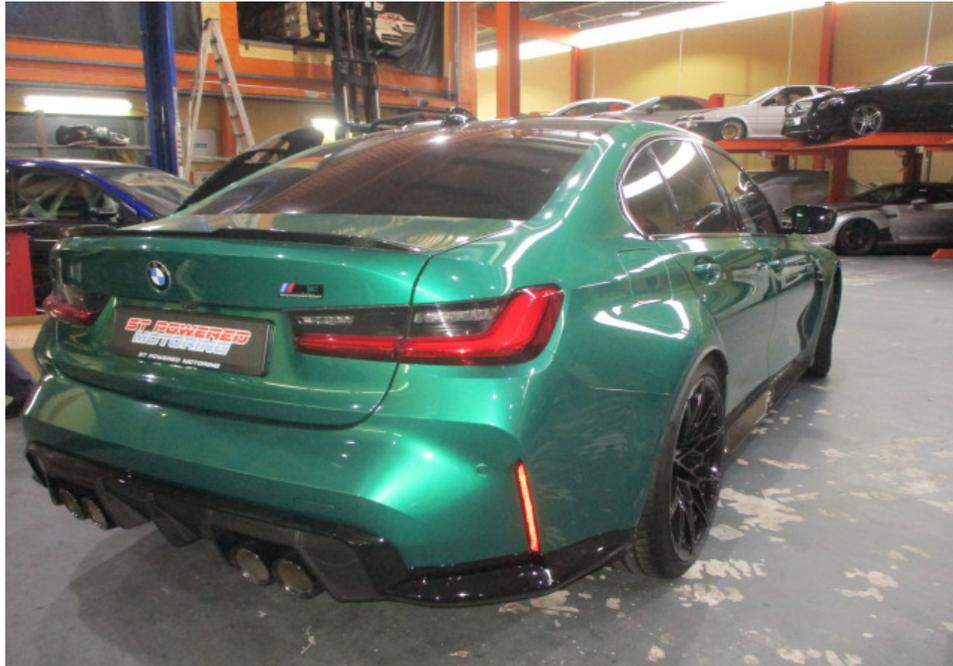
Photo 12 shows a general view of the rear right body of the Motor Car at the time of my inspection. The Motor Car was observed to be in a relatively good general condition with no loose exterior fittings observed. The mileage of the Motor Car recorded at the time of my inspection was 4,277km.

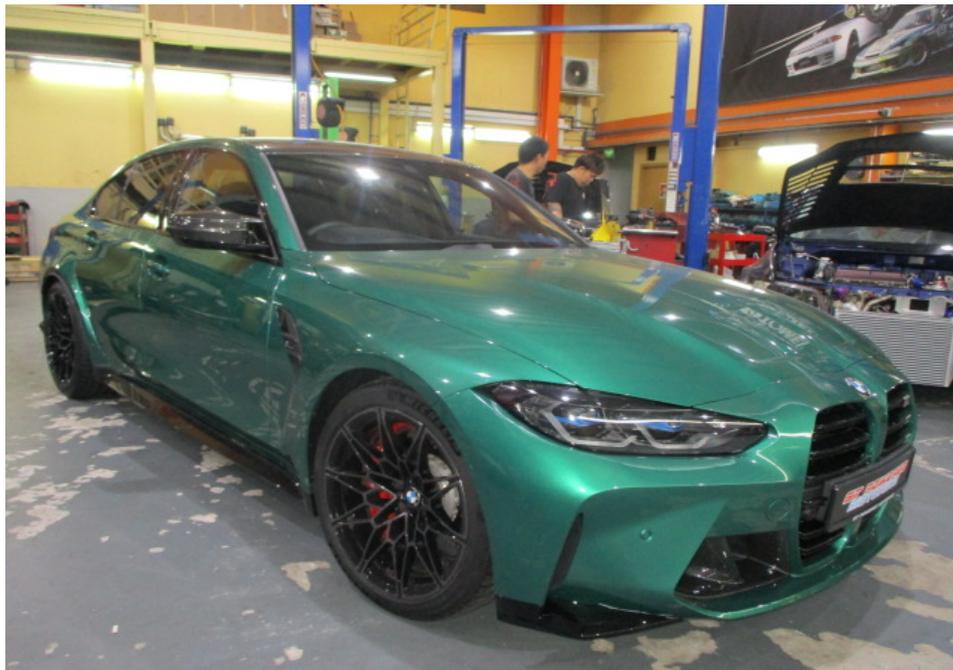
Photo 13 shows a general view of the front right body of the Motor Car at the time of my inspection. The Motor Car was observed to be in a relatively good general condition with no loose exterior fittings observed. The mileage of the Motor Car recorded at the time of my inspection was 4,277km.

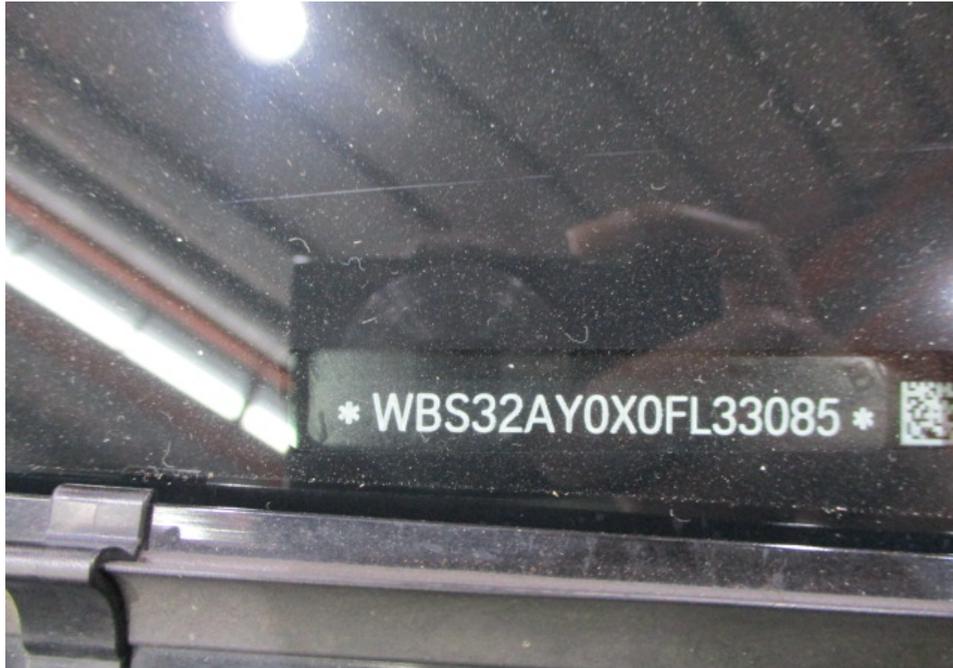
Photo 14 shows the chassis number of the Motor Car. The chassis number recorded was WBS32AY0X0FL33085.

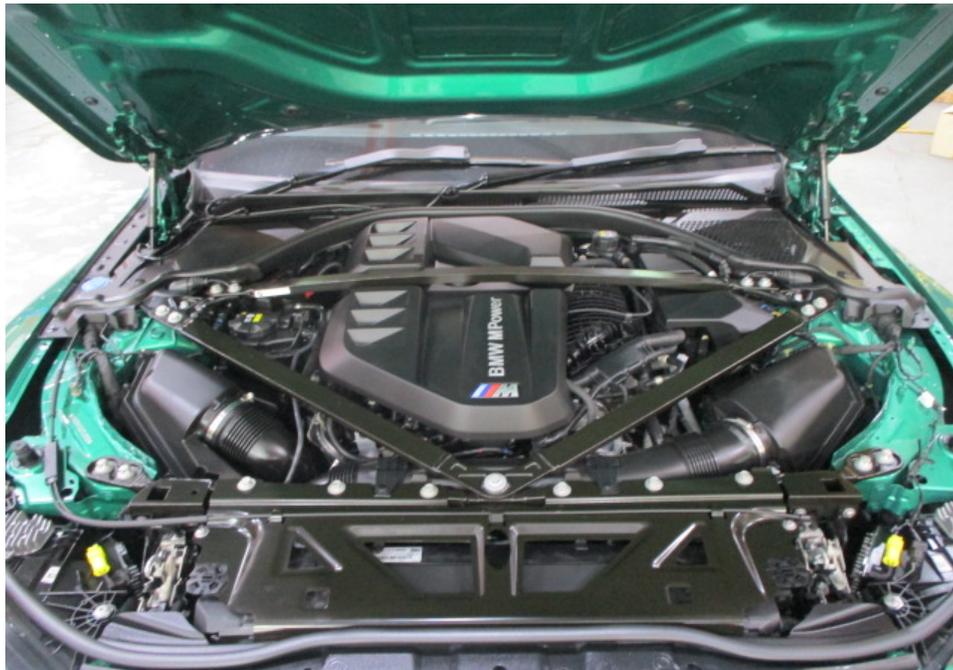
Photo 15 shows a general view of the engine compartment of the Motor Car at the time of my inspection. The various parts and components inside the engine compartment were all observed to be intact and properly fitted. There was also no sign(s) or indication(s) of fluid leak and/or fluid stain found inside the engine compartment.

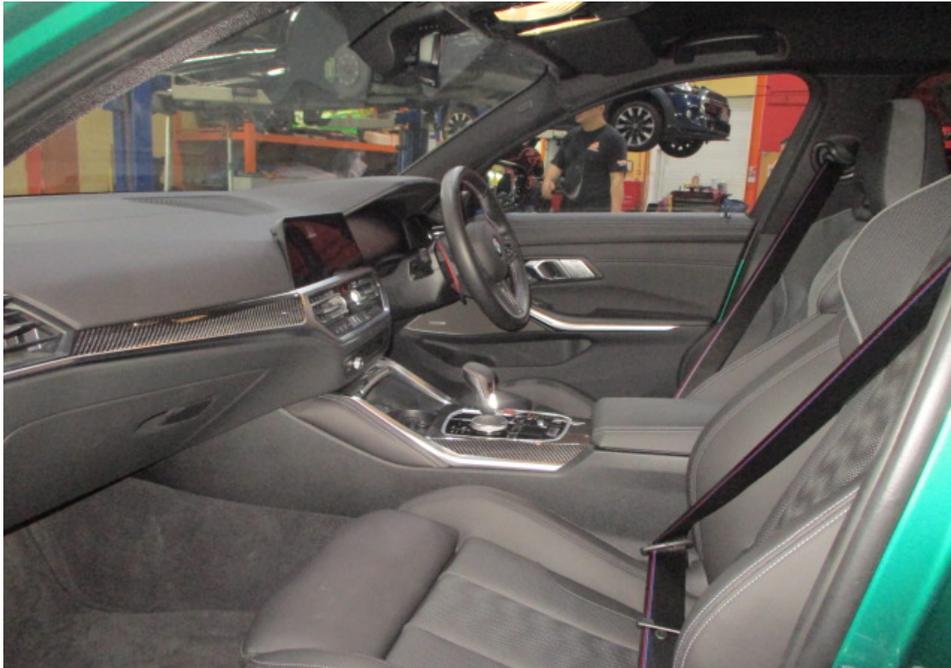
Photo 16 shows the interior compartment of the Motor Car at the time of my inspection. The various parts and components, trims, carpet, and upholstery inside the interior compartment were all observed to be intact and properly fitted.

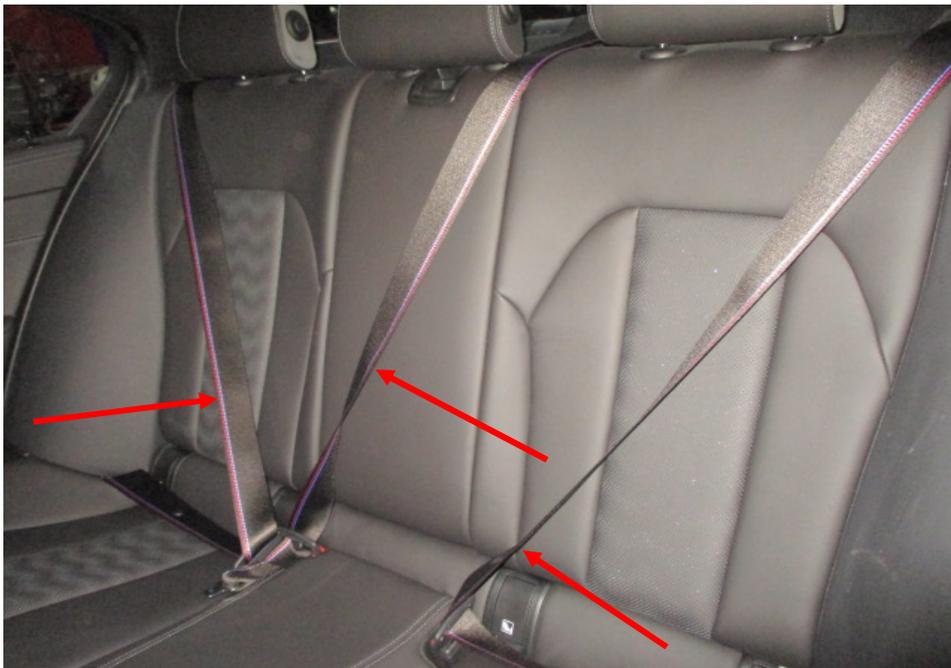
Photo 17 shows the rear seats of the Motor Car. All the seats of the Motor Car were secured via seat rails to the floorboard. They were also fitted with a retractable seat belt reel and a pre-tensioner. The seat belts (arrowed) were tested and were able to be fastened into the respective pre-tensions that were fitted on the side of each individual seat.

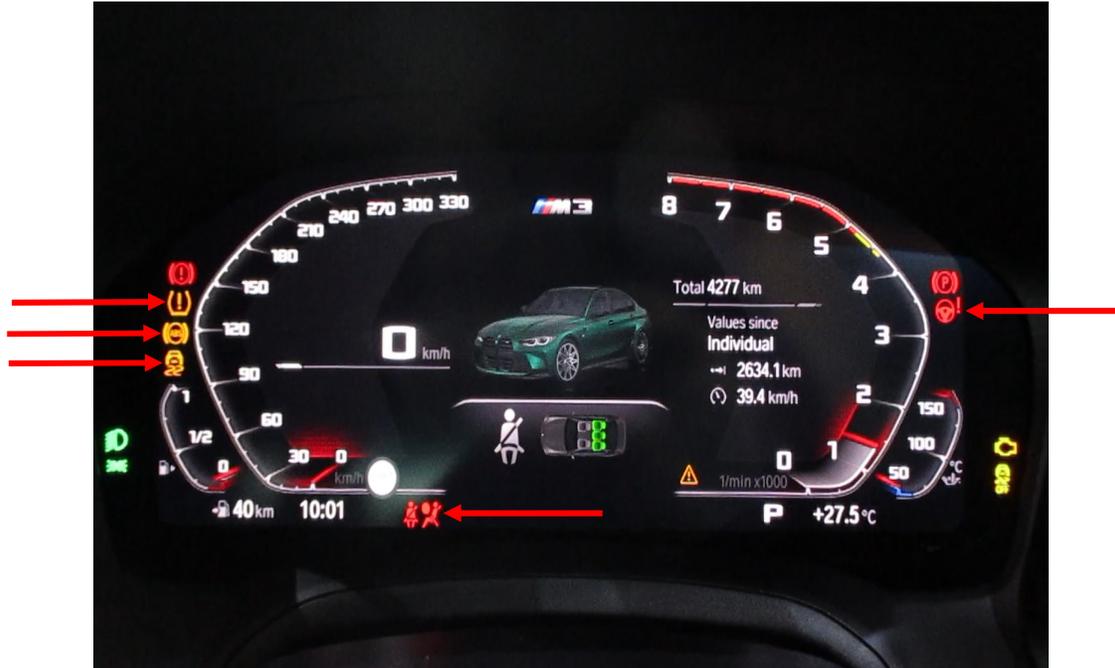
Photo 18 shows the warning lights for the various electronic safety features appearing on the instrument panel of the Motor Car during its self-test when the engine is cranked, in particular the ABS, SRS, IAS, TPM and DSC lights (arrowed).

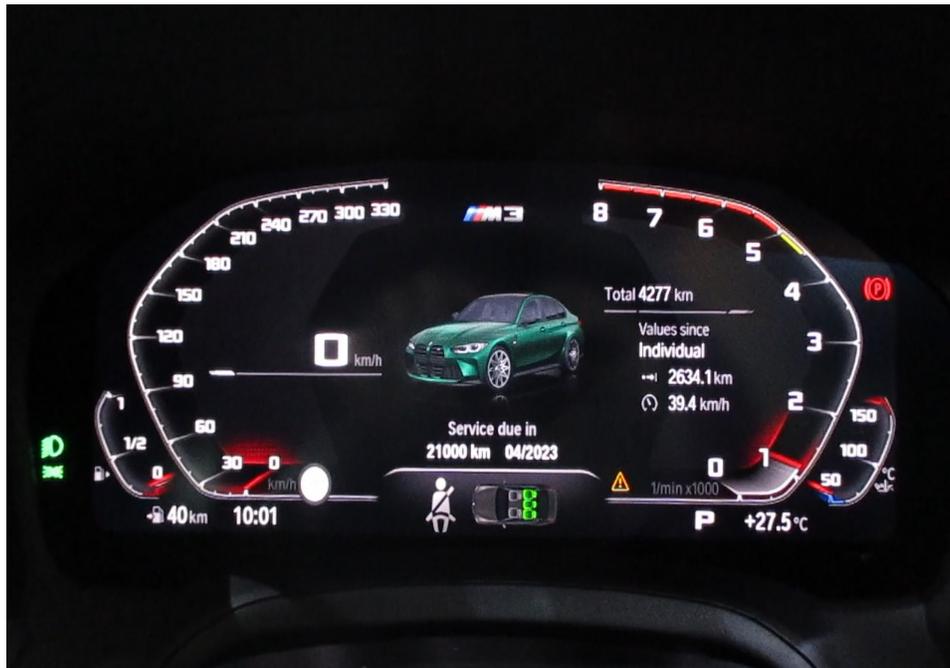
Photo 19 shows the respective warning lights no longer illuminated, indicating that there is no fault detected to the ABS, SRS, IAS, TPM and DSC systems of the Motor Car during the self-test. These electronic systems were hence in working condition at the time of my inspection.

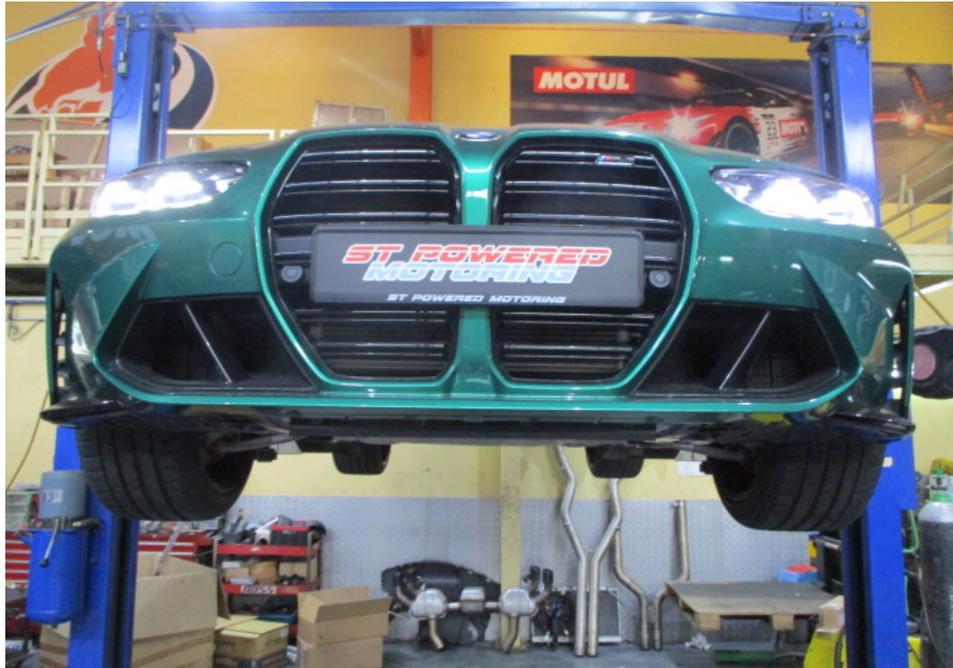
Photo 20 shows the Motor Car hoisted up for checks on its undercarriage. There was no sign(s) or indication(s) of fluid leakage and/or fluid stain(s) on the underside of the Motor Car. The undercarriage components of the Motor Car were also all observed to be intact and secured in an appropriate manner.

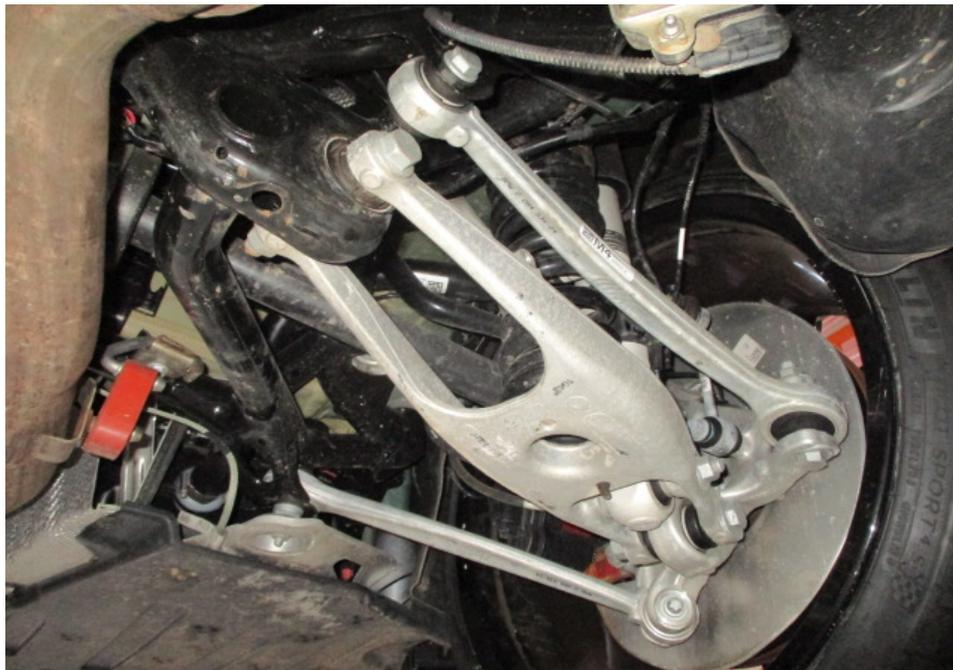
Photo 21 shows a general view of the control arms and linkages at the rear right wheel of the Motor Car. I did not observe any fluid leak and/or fluid stain on the underside of the Motor Car. All of the Motor Car's undercarriage components were observed to be intact and secured in an appropriate manner.

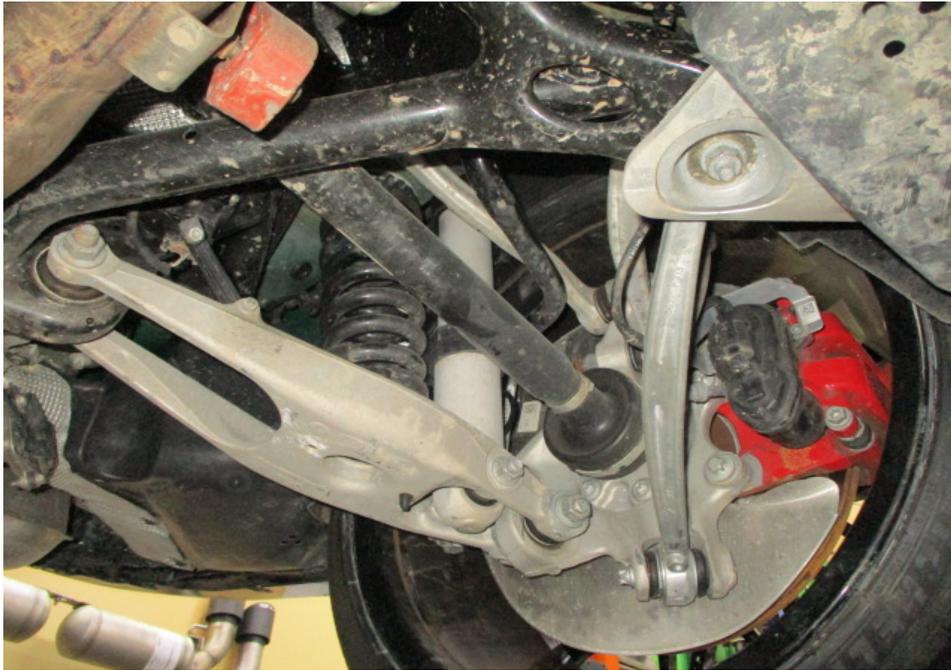
Photo 22 shows a general view of the control arms and linkages at the rear left wheel of the Motor Car. I did not observe any fluid leak and/or fluid stain on the underside of the Motor Car. All of the Motor Car's undercarriage components were observed to be intact and secured in an appropriate manner.

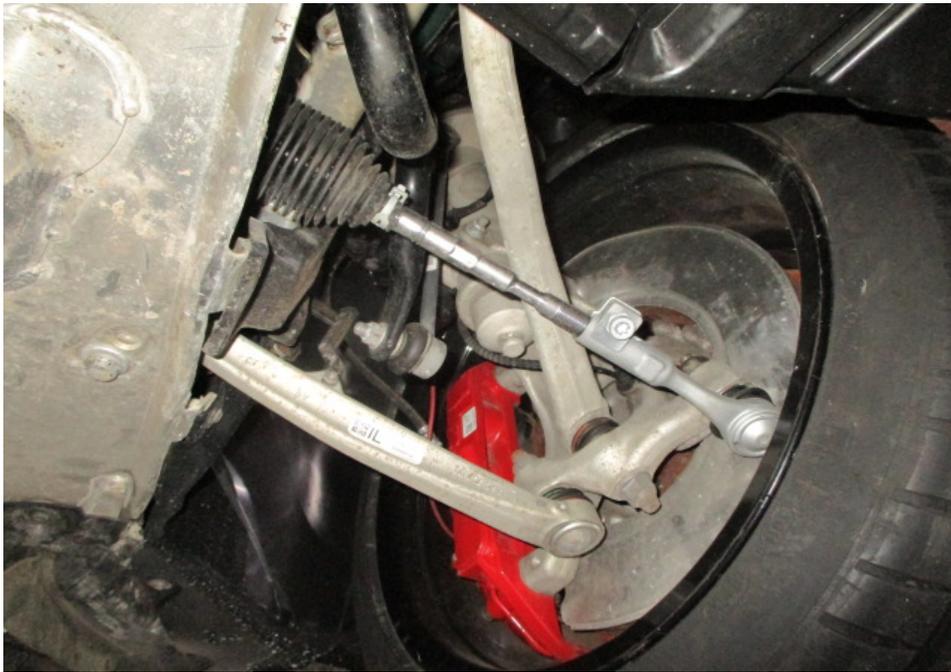
Photo 23 shows the various undercarriage components at the front left wheel of the Motor Car. The mechanical components, control arms and linkages were all found to be intact and secured in an appropriate manner.

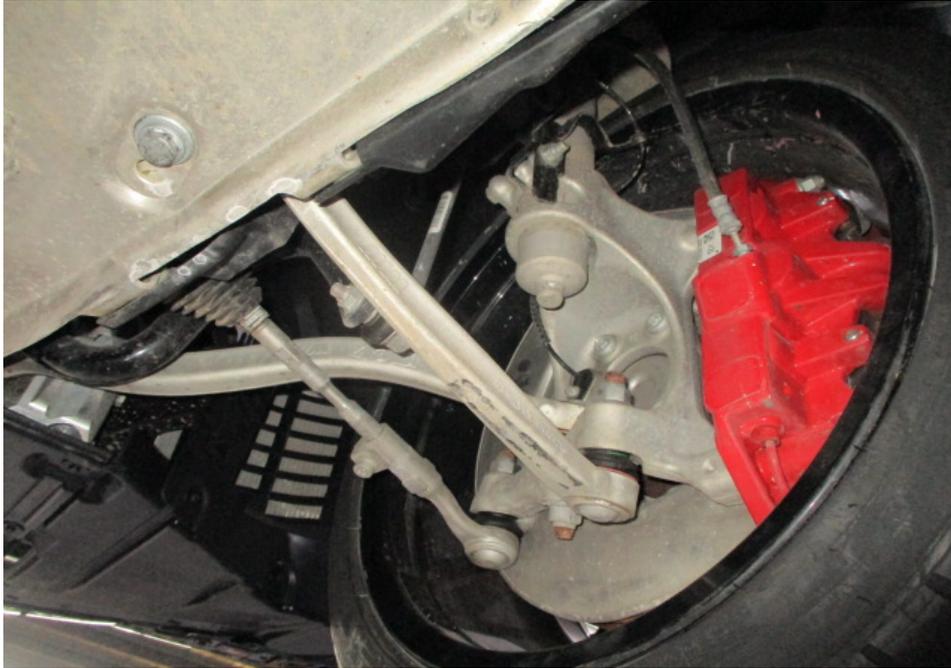
Photo 24 shows the various undercarriage components at the front right wheel of the Motor Car. The mechanical components, control arms and linkages were all found to be intact and secured in an appropriate manner. I also did not observe any fluid leak and/or fluid stain on the underside of the Motor Car.

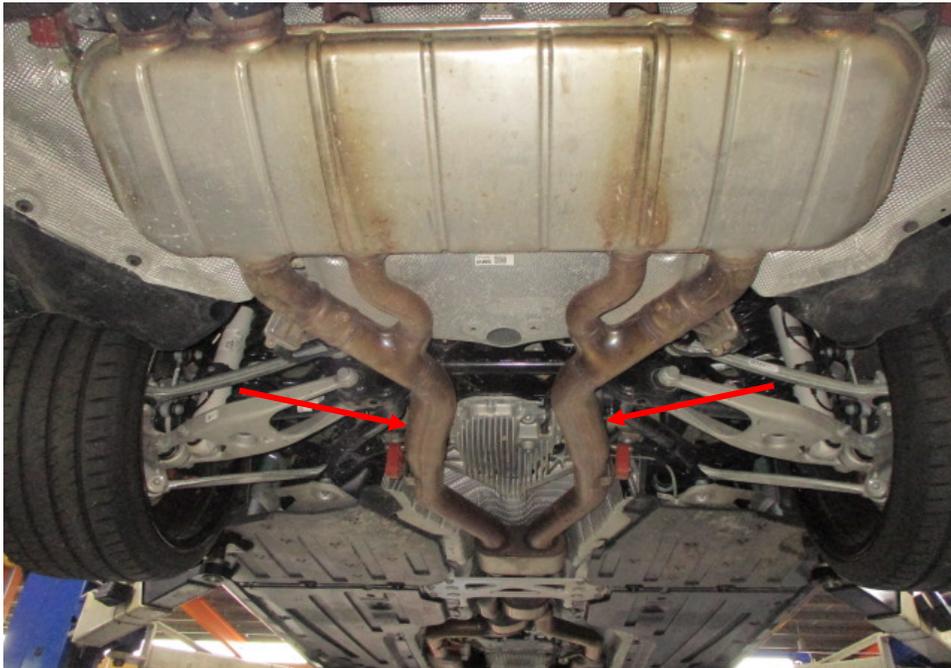
Photo 25 shows the rear section of the Motor Car's exhaust system. My examination of the Motor Car's exhaust system revealed no sign(s) or indication(s) of any cut or weld marks along its exhaust pipes (arrowed), on its rear muffler, on its centre resonator boxes and on its catalytic converters.

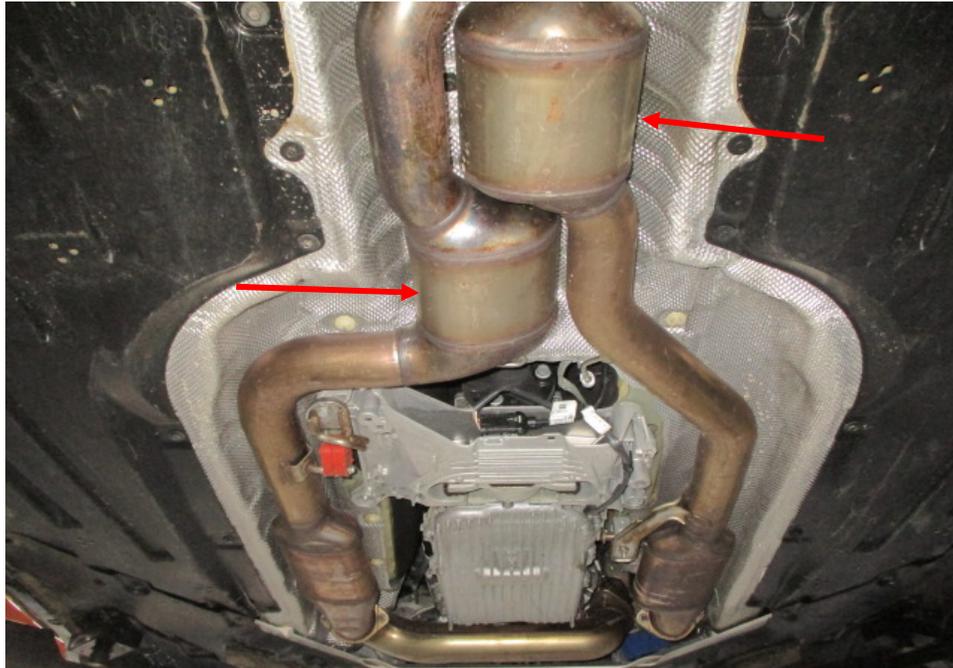
Photo 26 shows the front section of the Motor Car's exhaust system. My examination of the Motor Car's exhaust system revealed no sign(s) or indication(s) of any cut or weld marks along its exhaust pipes, on its rear muffler, on its centre resonator boxes (arrowed) and on its catalytic converters.

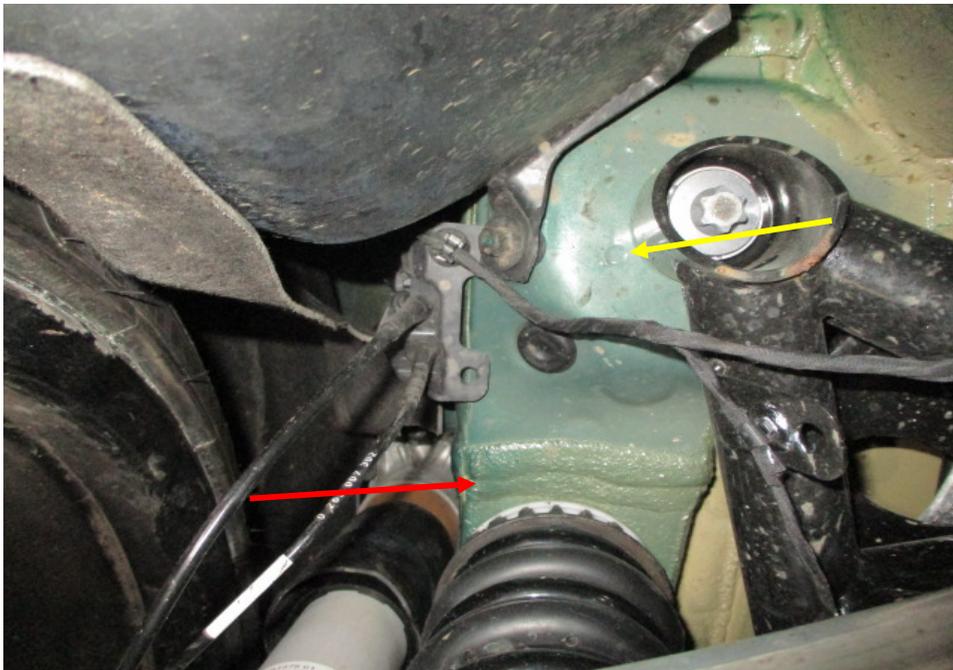
Photo 27 shows the chassis/structural body at the underside rear right of the Motor Car. I did not find any weld marks other than original spot weld marks (yellow arrow) on the chassis/structural body of the Motor Car. The original factory sealant (red arrow) at the joints along the chassis/structural body was untouched, indicating no work was done on the chassis/structural body of the Motor Car and that the chassis/structural body was originally fitted.

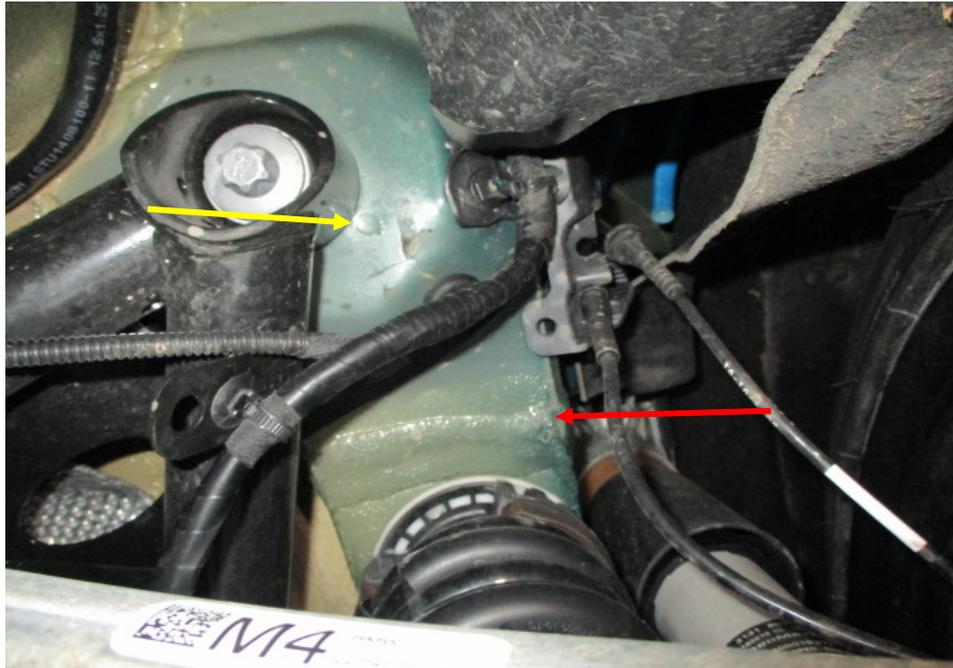
Photo 28 shows the chassis/structural body at the underside rear left of the Motor Car. I did not find any weld marks other than original spot weld marks (yellow arrow) on the chassis/structural body of the Motor Car. The original factory sealant (red arrow) at the joints along the chassis/structural body was untouched, indicating no work was done on the chassis/structural body of the Motor Car and that the chassis/structural body was originally fitted.

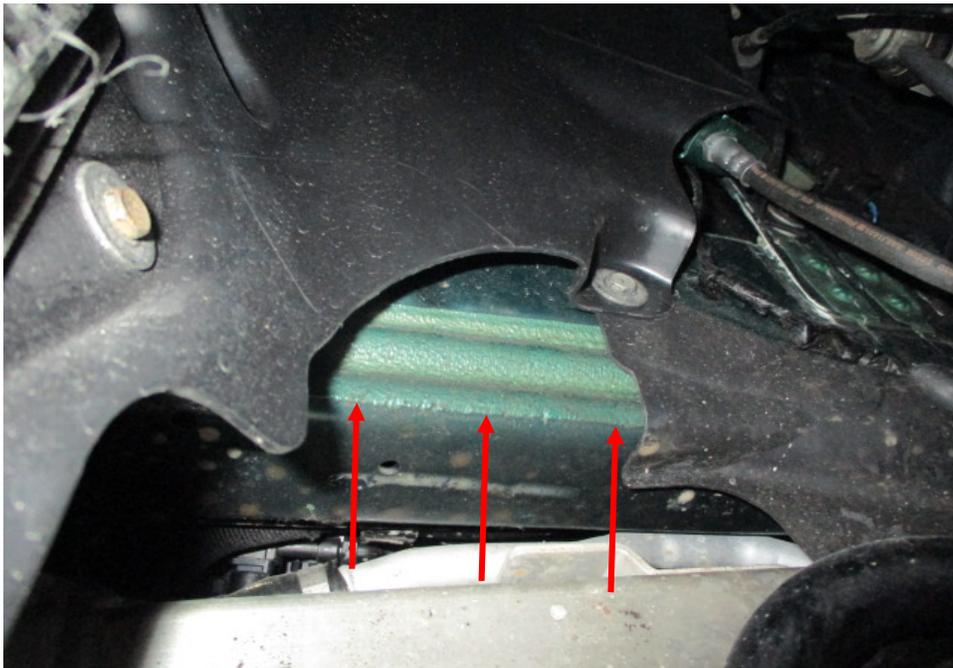
Photo 29 shows the chassis/structural body at the underside front left of the Motor Car. The original factory sealant (arrowed) at the joints along the chassis/structural body was observed to be untouched. In general, I had found no work was carried out on the chassis/structural body of the Motor Car. The chassis/structural body of the Motor Car was originally fitted.
