Your Ref: BMW M3
(chassis number WBS32AY0X0FL33085)
Our Ref : CI/TP22010265/D

17 October 2022

INSPECTION REPORT OF AN UNREGISTERED BMW M3 MOTOR CAR WITH CHASSIS NUMBER WBS32AY0X0FL33085

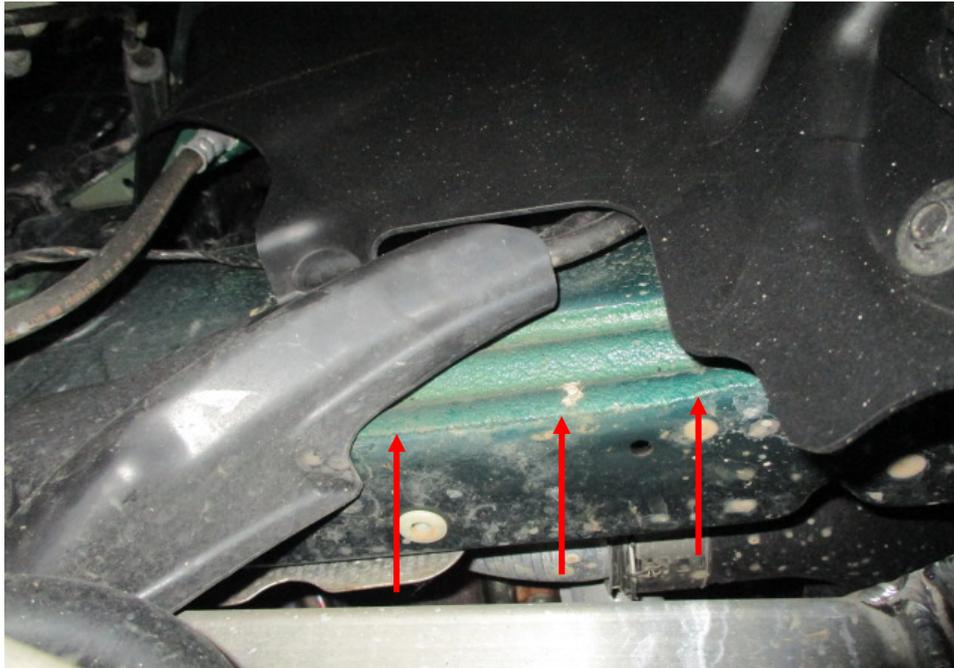
Photo 30 shows the chassis/structural body at the underside front right of the Motor Car. The original factory sealant (arrowed) at the joints along the chassis/structural body was observed to be untouched. In general, I had found no work was carried out on the chassis/structural body of the Motor Car. The chassis/structural body of the Motor Car was originally fitted.

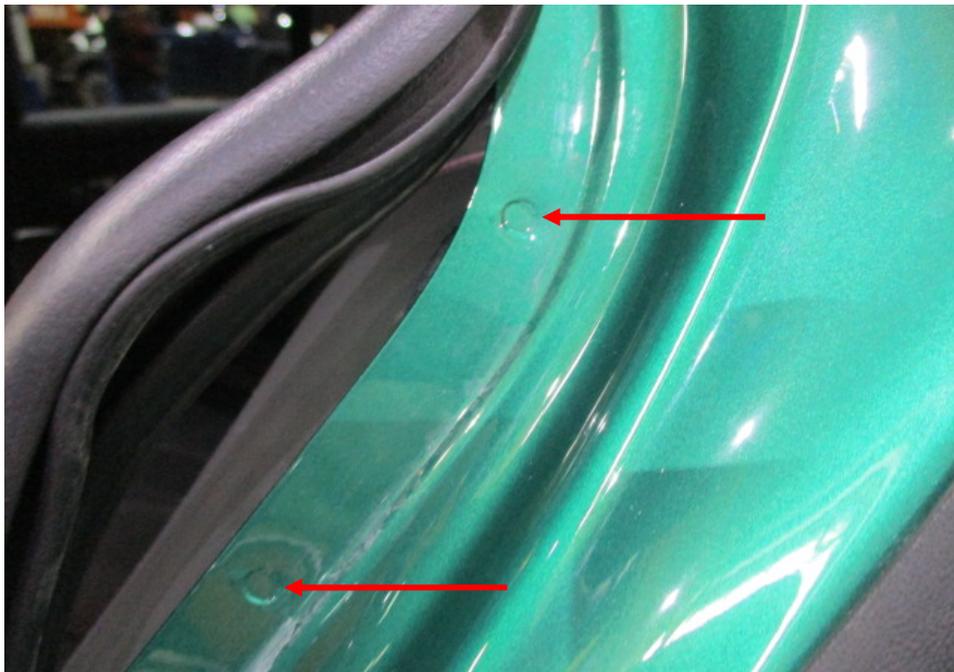
Photo 31 shows the left side "C" pillar of the Motor Car. I did not find any weld marks other than original spot weld marks (arrowed) on the left side "C" pillar of the Motor Car, which indicates that there was no re-welding works carried out. In general, I had found all the non-detachable body panels of the Motor Car to be originally fitted at the time of my inspection.

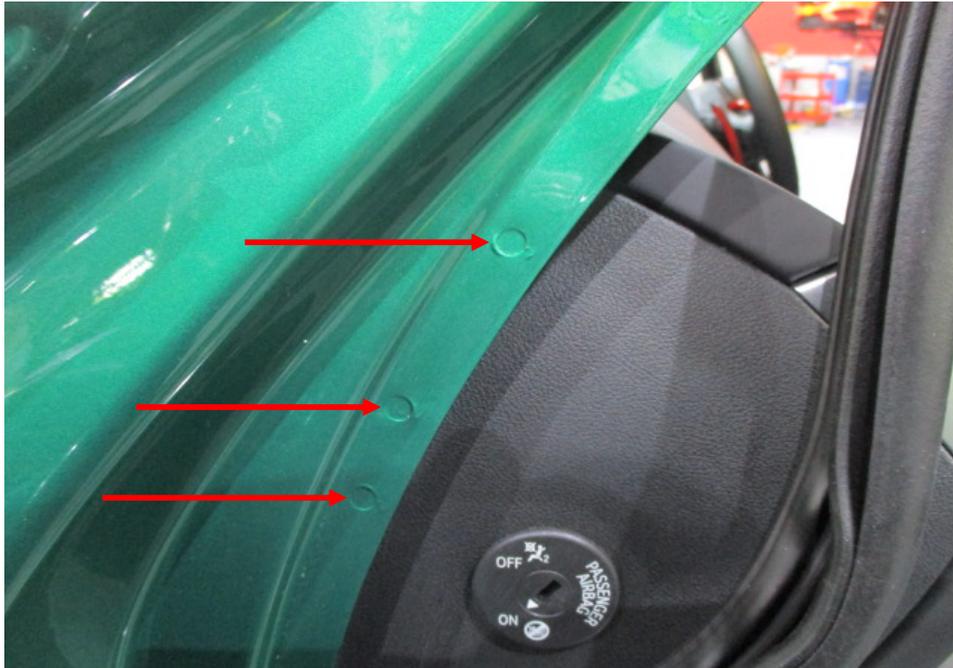
Photo 32 shows the left side “A” pillar of the Motor Car. I did not find any weld marks other than original spot weld marks (arrowed) on the left side “A” pillar of the Motor Car, which indicates that there was no re-welding works carried out. In general, I had found all the non-detachable body panels of the Motor Car to be originally fitted at the time of my inspection.

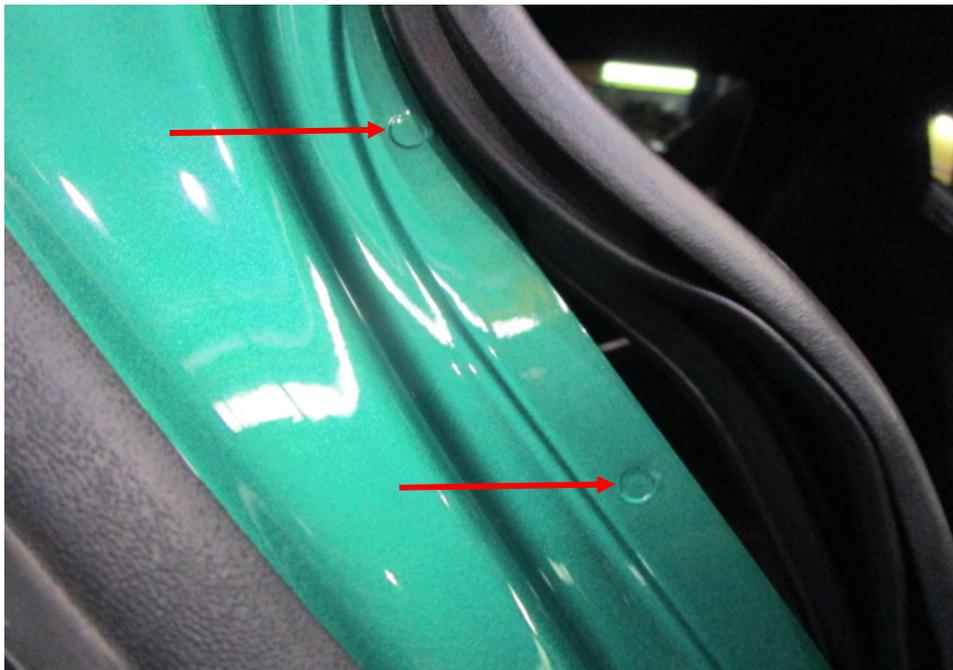
Photo 33 shows the right side “C” pillar of the Motor Car. I did not find any weld marks other than original spot weld marks (arrowed) on the right side “C” pillar of the Motor Car, which indicates that there was no re-welding works carried out. In general, I had found all the non-detachable body panels of the Motor Car to be originally fitted at the time of my inspection.

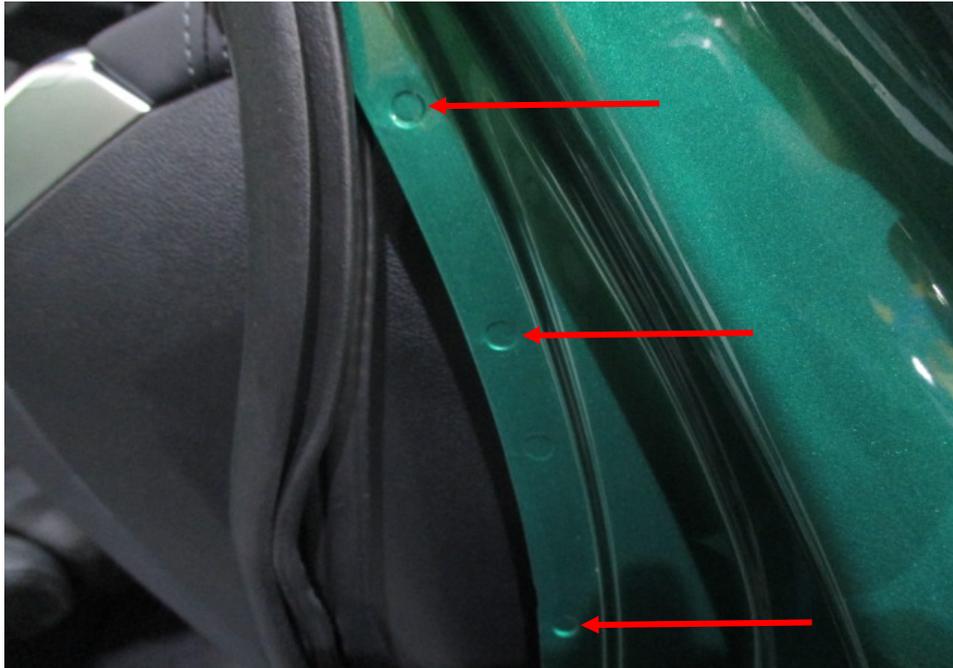
Photo 34 shows the right side "A" pillar of the Motor Car. I did not find any weld marks other than original spot weld marks (arrowed) on the right side "A" pillar of the Motor Car, which indicates that there was no re-welding works carried out. In general, I had found all the non-detachable body panels of the Motor Car to be originally fitted at the time of my inspection.
