Your Ref: Porsche 911 Turbo S Cabriolet  
(chassis number WP0ZZZ99ZMS262744)  
Our Ref : CI/TP22010306/D

18 October 2022

**INSPECTION REPORT OF AN UNREGISTERED PORSCHE 911 TURBO S  
CABRIOLET MOTOR CAR WITH CHASSIS NUMBER WP0ZZZ99ZMS262744**

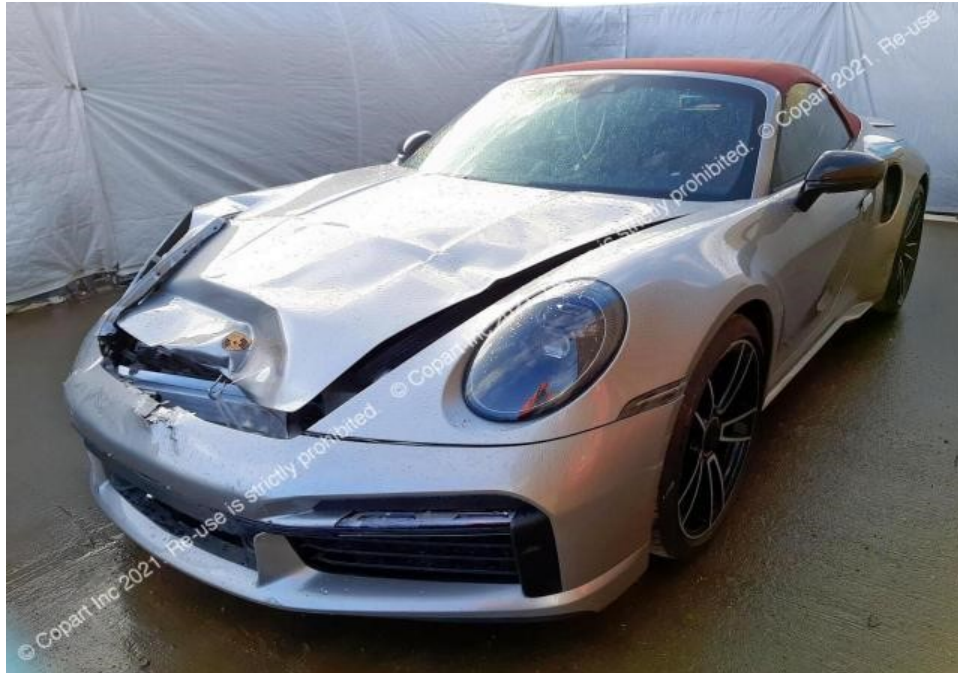
**Photo 1** shows the front left body of the Motor Car (photograph provided to me). The Motor Car was observed to have sustained damage at its frontal portion. The front bumper, front bonnet, front bonnet lock and front centre panel were amongst the body parts that were observed to have been damaged.

24. The body parts at the frontal portion of the Motor Car were visually examined and it was noted that the repair/restoration works carried out to the damaged area of the Motor Car (refer to photograph 1 & 2 above) were reasonably adequate and in order.

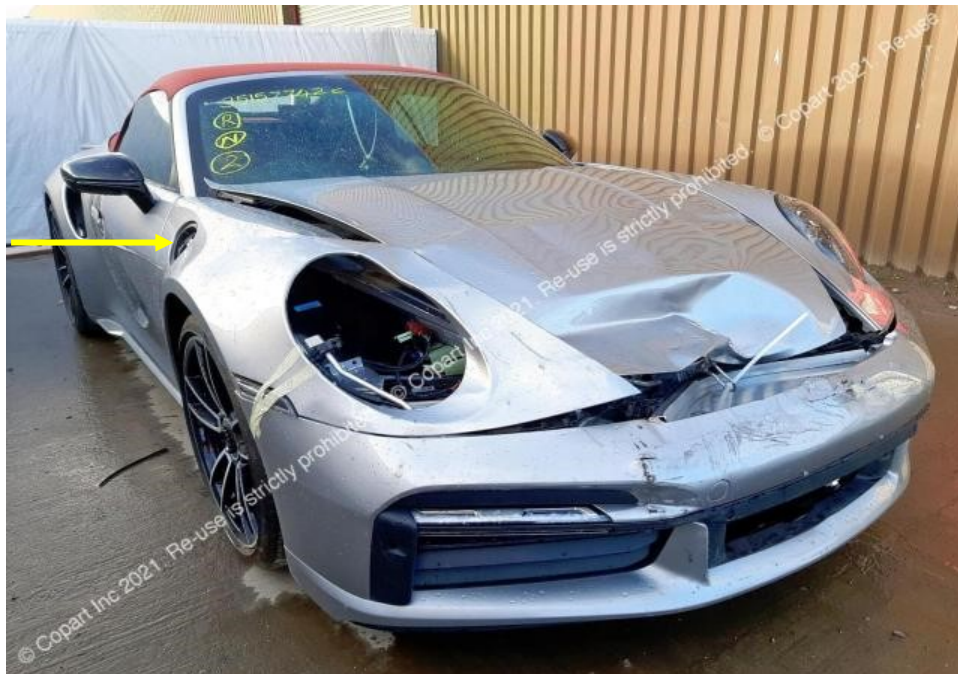
**Photo 2** shows the front right body of the Motor Car (photograph provided to me). The Motor Car was observed to have sustained damage at its frontal portion. The front bumper, front bumper centre lower air duct, front right day light, front right headlamp, front right fender, front bonnet and front centre panel were amongst the body parts that were observed to have been damaged. The fuel filler cover (arrowed), located at the Motor Car's front right fender, was also observed to be dislodged/missing/damaged.

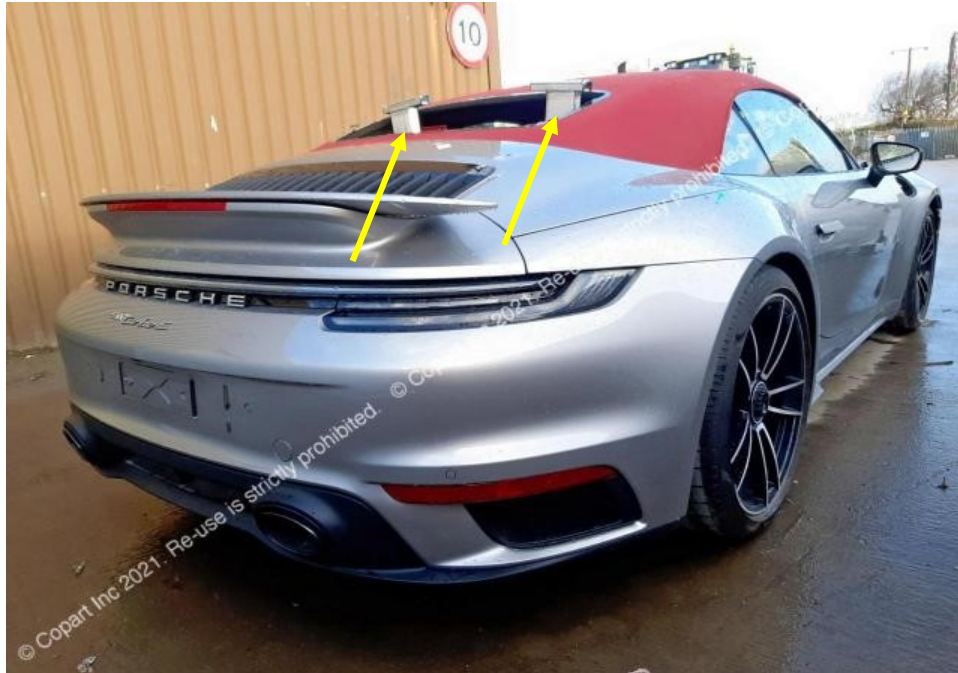
**Photo 3** shows the rear right body of the Motor Car (photograph provided to me). Apart for the frontal portion, there was no physical damage observed to other areas of the Motor Car. I did however observe that the Motor Car's rear windscreen was shattered due to the activation of the rear collision support (arrowed), which would indicate that the airbag(s) of the Motor Car was deployed.

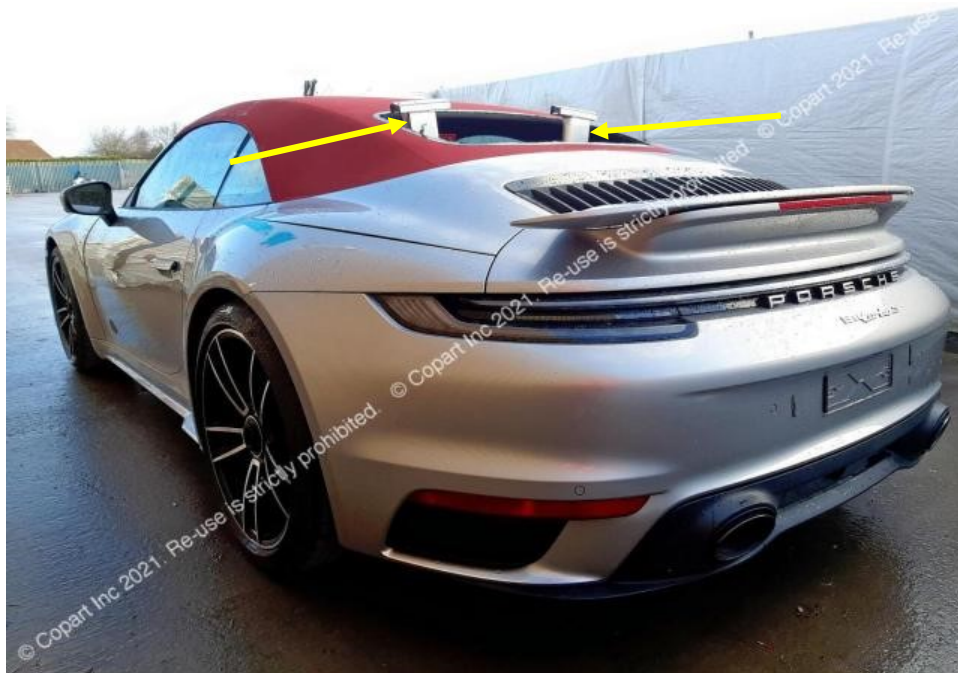
**Photo 4** shows the rear left body of the Motor Car (photograph provided to me). Apart for the frontal portion, there was no physical damage observed to other areas of the Motor Car. I did however observe that the Motor Car's rear windscreen was shattered due to the activation of the rear collision support (arrowed), which would indicate that the airbag(s) of the Motor Car was deployed.

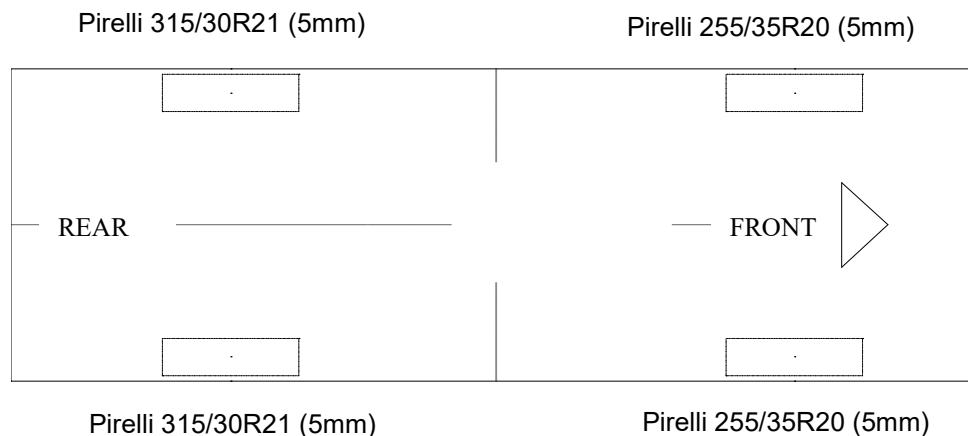
10. The Motor Car was fitted with 20inch (front) and 21inch (rear) sport wheel rims that were wrapped with tyres that were observed to be of serviceable condition. The tyres were also sufficiently inflated for vehicular operation. The tyre brand, tyre size and approximate remaining tread depth of the 4 tyres of the Motor Car were recorded as follows: -

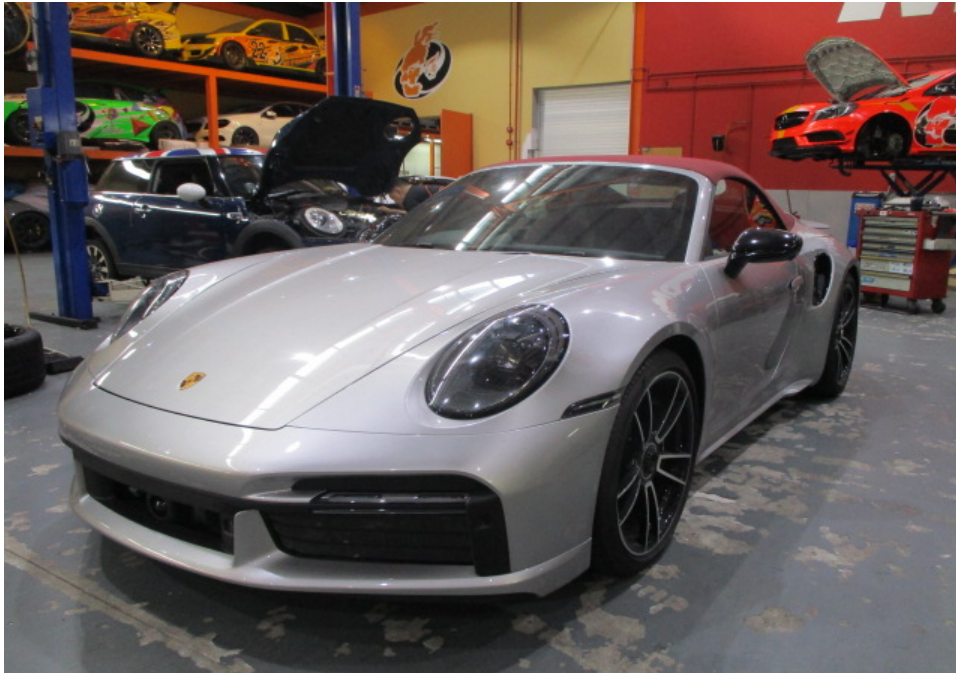
**Photo 5** shows a general view of the front left body of the Motor Car at the time of my inspection. The Motor Car was observed to be in a relatively good general condition with no loose exterior fittings observed. The body parts at the frontal portion of the Motor Car were visually examined and it was observed that the repair/restoration works carried out to the damaged area of the Motor Car (refer to photograph 1 & 2 above) were reasonably adequate and in order.

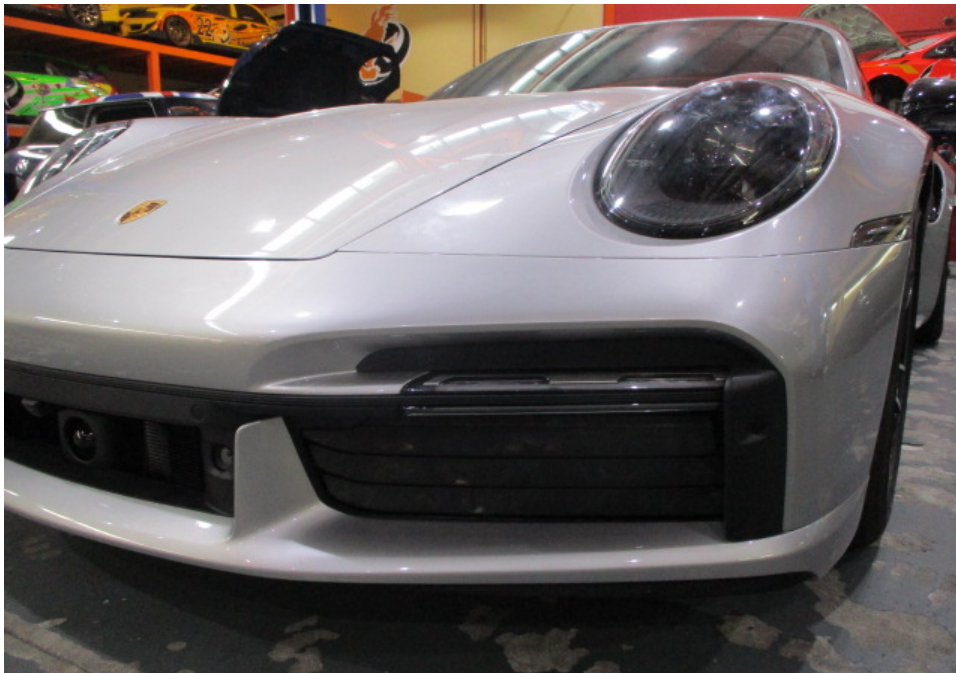
**Photo 6** shows a closer view of the Motor Car's front bumper, front left day light, front left headlamp and front bonnet. The body parts at the frontal portion of the Motor Car were visually examined and it was observed that the repair/restoration works carried out to the damaged area of the Motor Car (refer to photograph 1 & 2 above) were reasonably adequate and in order.

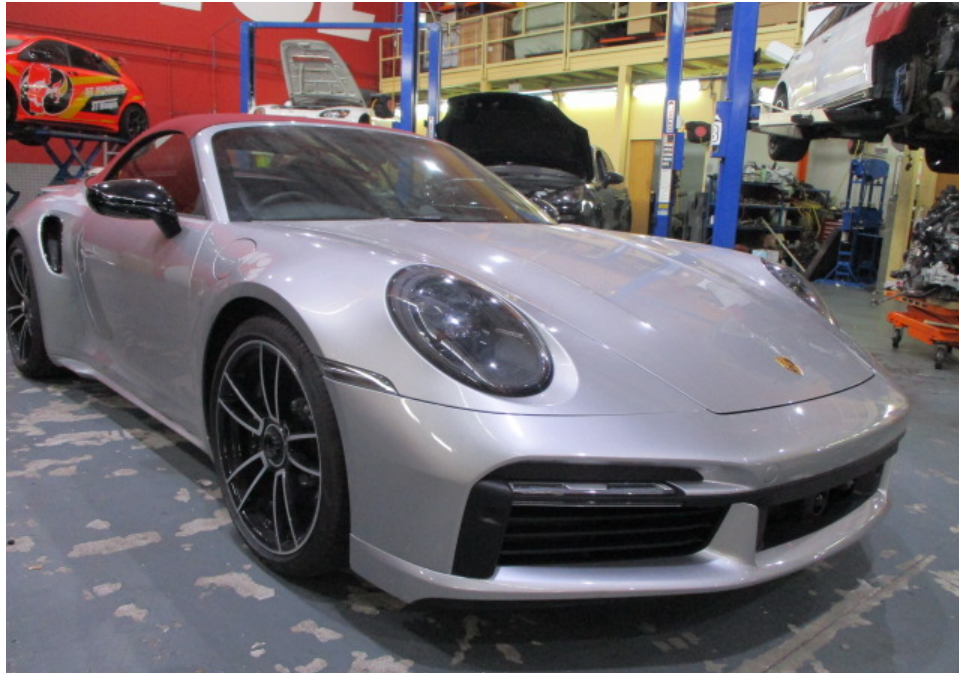
**Photo 7** shows a general view of the front right body of the Motor Car at the time of my inspection. The Motor Car was observed to be in a relatively good general condition with no loose exterior fittings observed. The body parts at the frontal portion of the Motor Car were visually examined and it was observed that the repair/restoration works carried out to the damaged area of the Motor Car (refer to photograph 1 & 2 above) were reasonably adequate and in order.

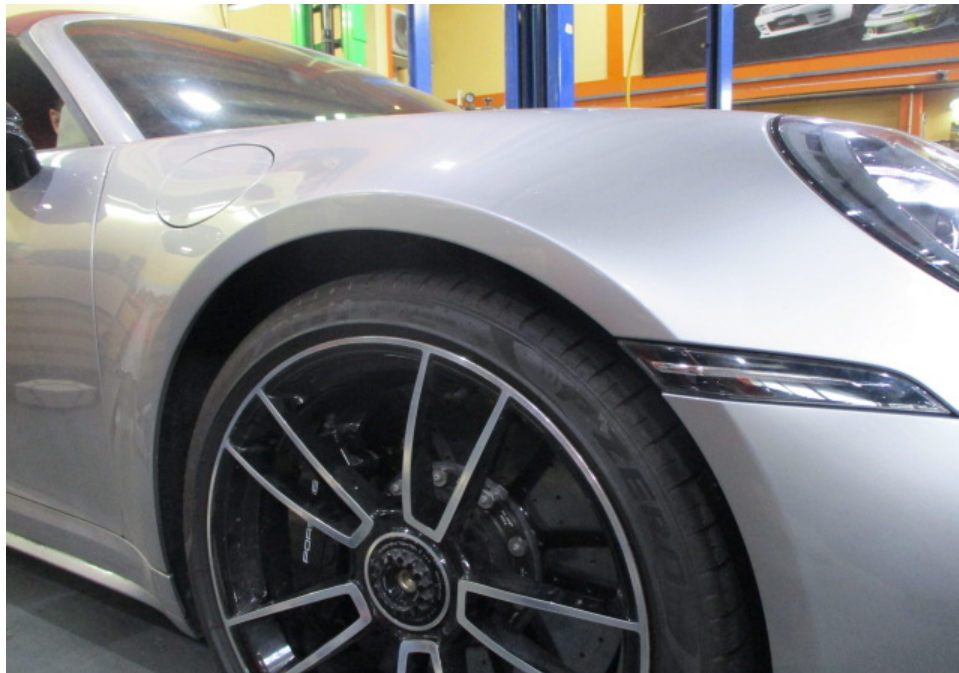
**Photo 8** shows a closer view of the Motor Car's front right signal lamp, front right fender, fuel filler cover and front right wheel rim. The body parts at the frontal portion of the Motor Car were visually examined and it was observed that the repair/restoration works carried out to the damaged area of the Motor Car (refer to photograph 1 & 2 above) were reasonably adequate and in order.

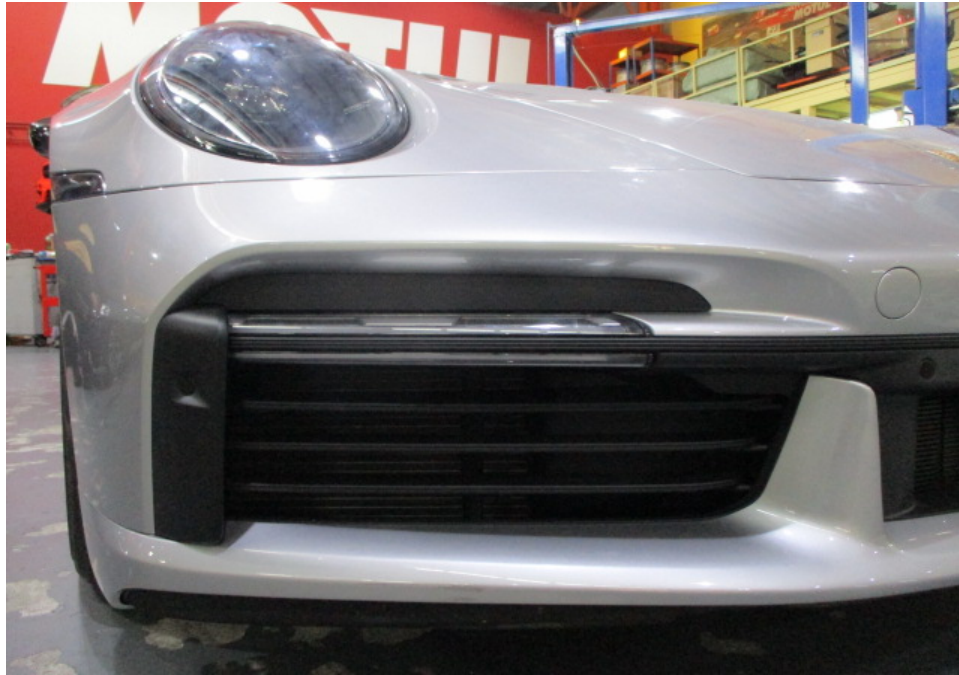
**Photo 9** shows a closer view of the Motor Car's front bumper, front bumper right lower grille, front right day light and front right headlamp. The body parts at the frontal portion of the Motor Car were visually examined and it was observed that the repair/restoration works carried out to the damaged area of the Motor Car (refer to photograph 1 & 2 above) were reasonably adequate and in order.

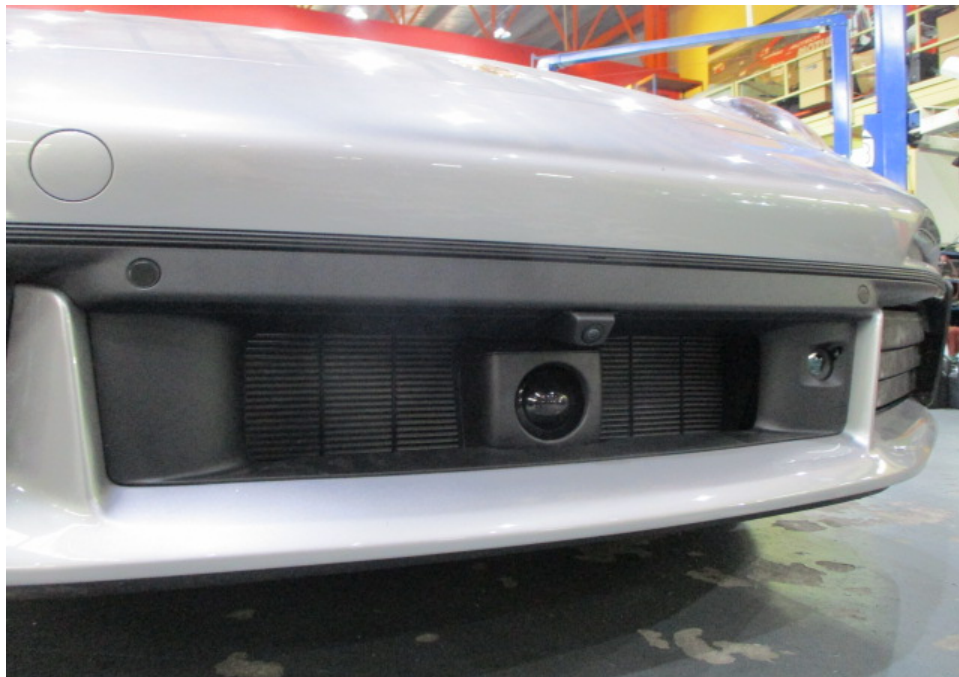
**Photo 10** shows a closer view of the Motor Car's front bumper, front bumper centre lower air duct and front radar/sensor unit. The body parts at the frontal portion of the Motor Car were visually examined and it was observed that the repair/restoration works carried out to the damaged area of the Motor Car (refer to photograph 1 & 2 above) were reasonably adequate and in order.

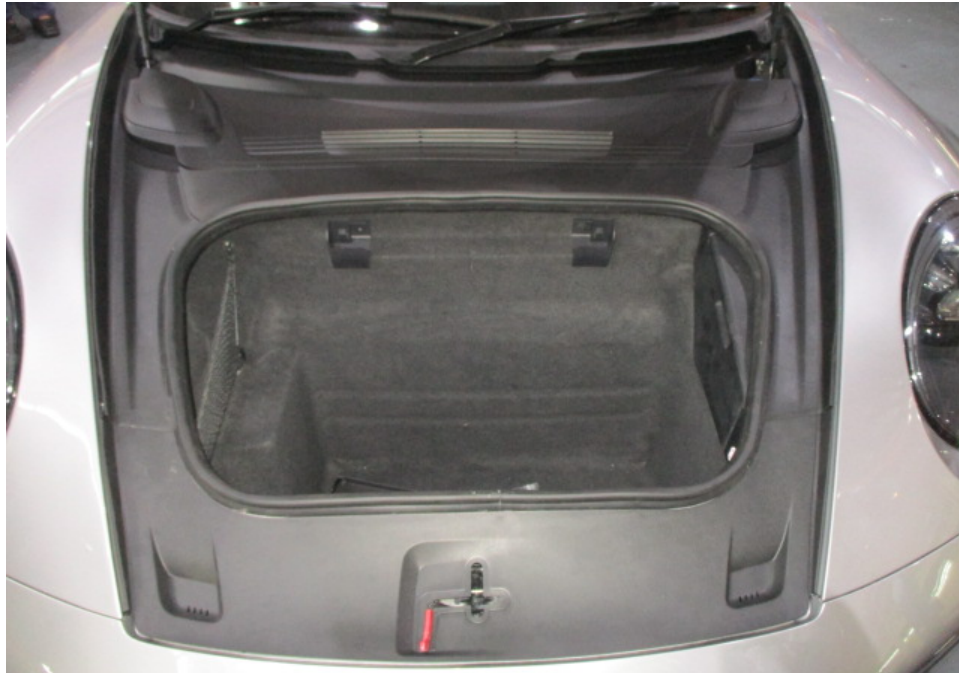
**Photo 11** shows a general view of the Motor Car's front bonnet compartment at the time of my inspection. All inner trims, garnishes and upholstery etc were observed to be properly fitted.

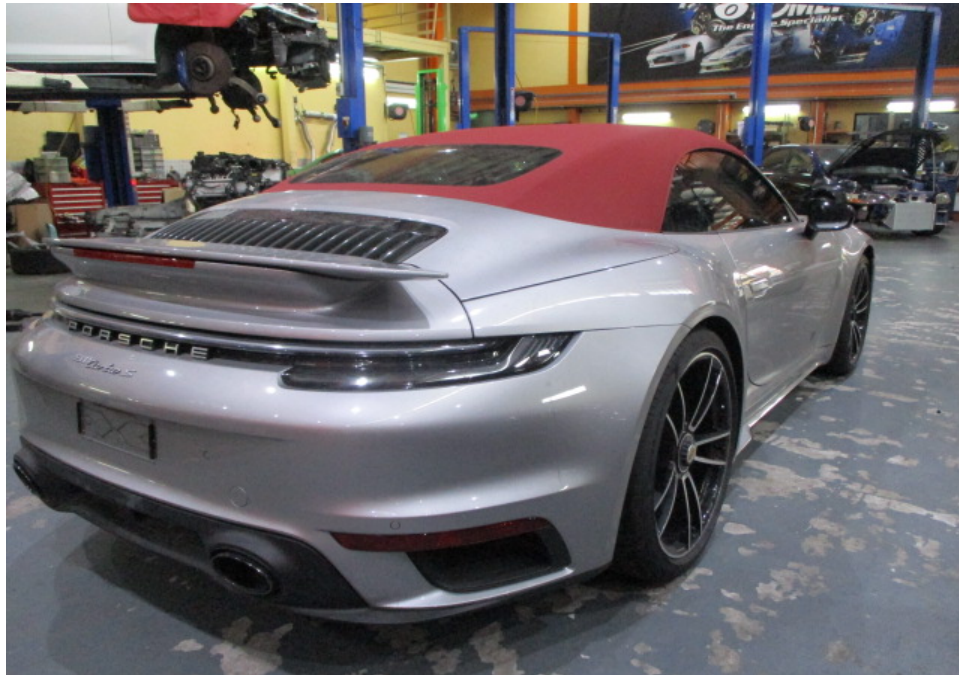
**Photo 12** shows a general view of the rear right body of the Motor Car at the time of my inspection. The Motor Car was observed to be in a relatively good general condition with no loose exterior fittings observed. The mileage of the Motor Car recorded at the time of my inspection was 2,386km.

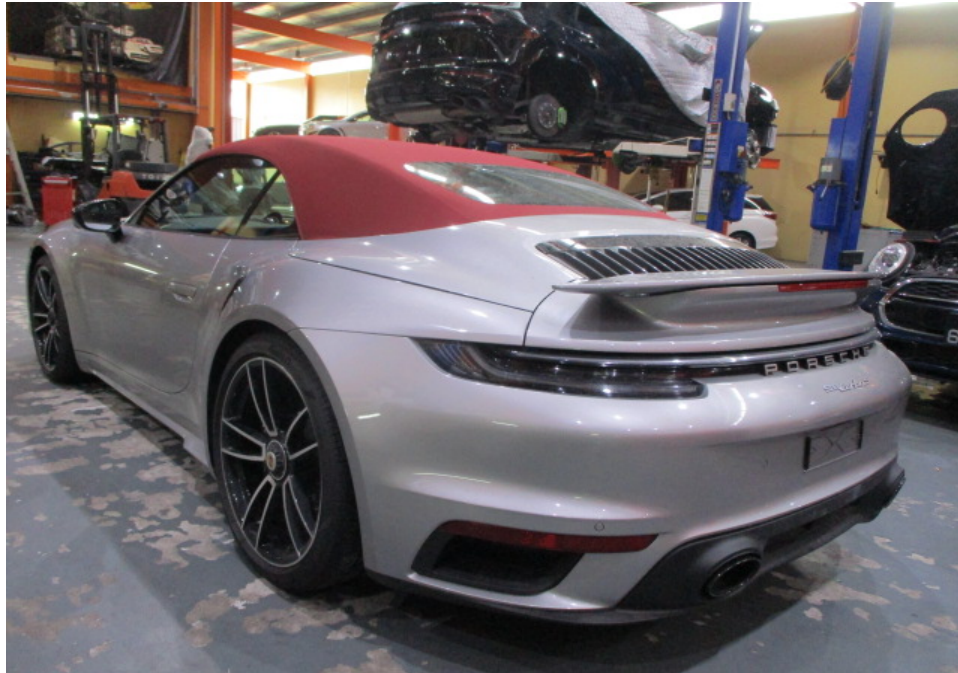
**Photo 13** shows a general view of the rear left body of the Motor Car at the time of my inspection. The Motor Car was observed to be in a relatively good general condition with no loose exterior fittings observed. The mileage of the Motor Car recorded at the time of my inspection was 2,386km.

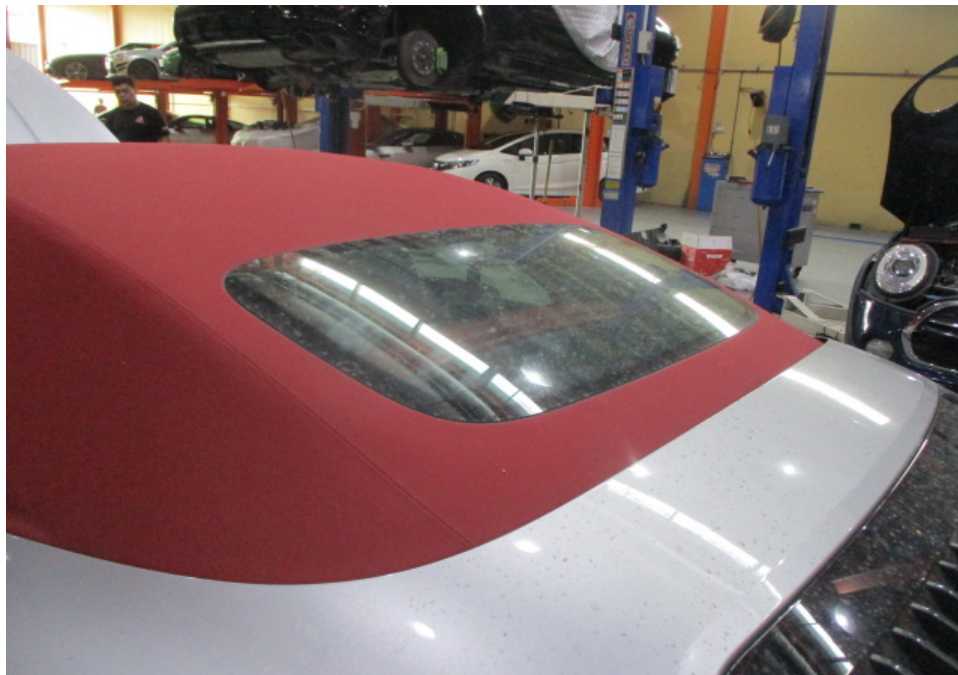
**Photo 14** shows a closer view of the Motor Car's rear windscreen and soft top roof. The body parts at the rear portion of the Motor Car were visually examined and it was observed that the repair/restoration works carried out to the damaged area of the Motor Car (refer to photograph 3 & 4 above) were reasonably adequate and in order.

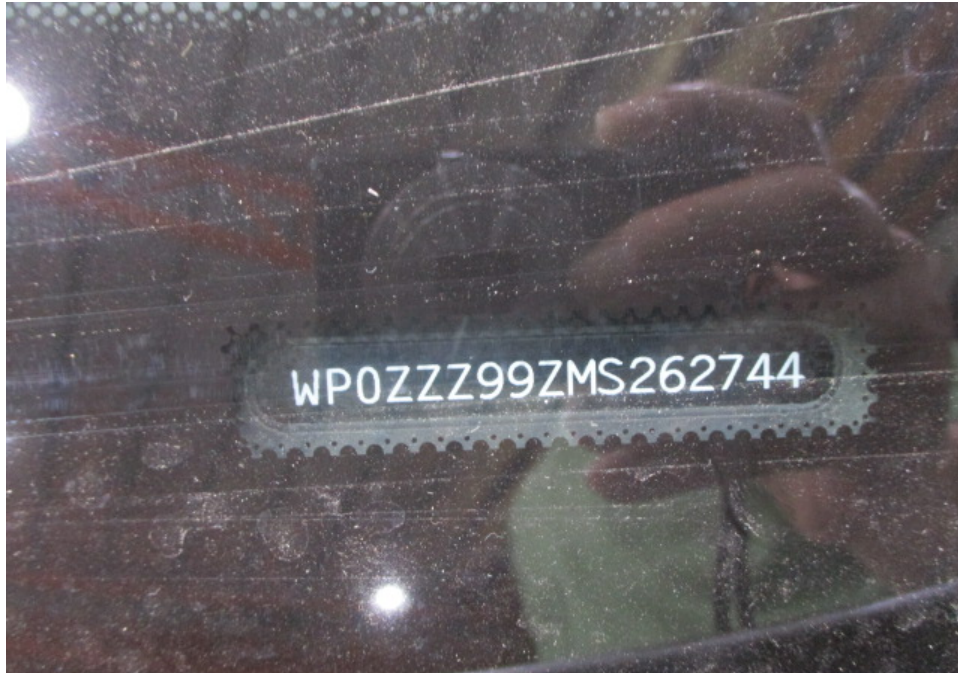
**Photo 15** shows the chassis number of the Motor Car. The chassis number recorded was WP0ZZZ99ZMS262744.

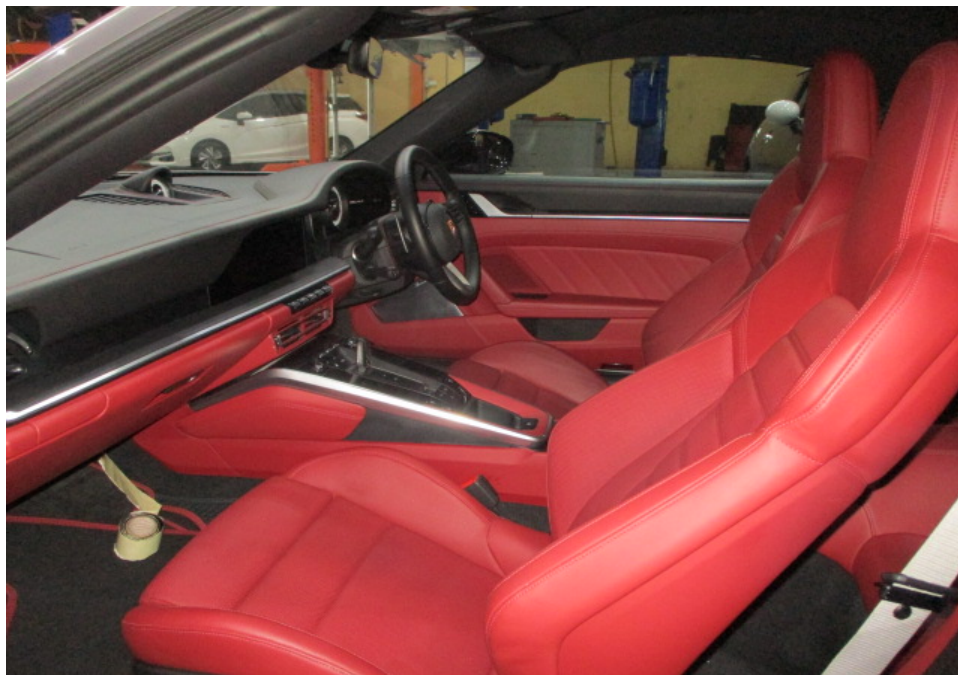
**Photo 16** shows the interior compartment of the Motor Car at the time of my inspection. The various parts and components, trims, carpet, and upholstery inside the interior compartment were all observed to be intact and properly fitted.

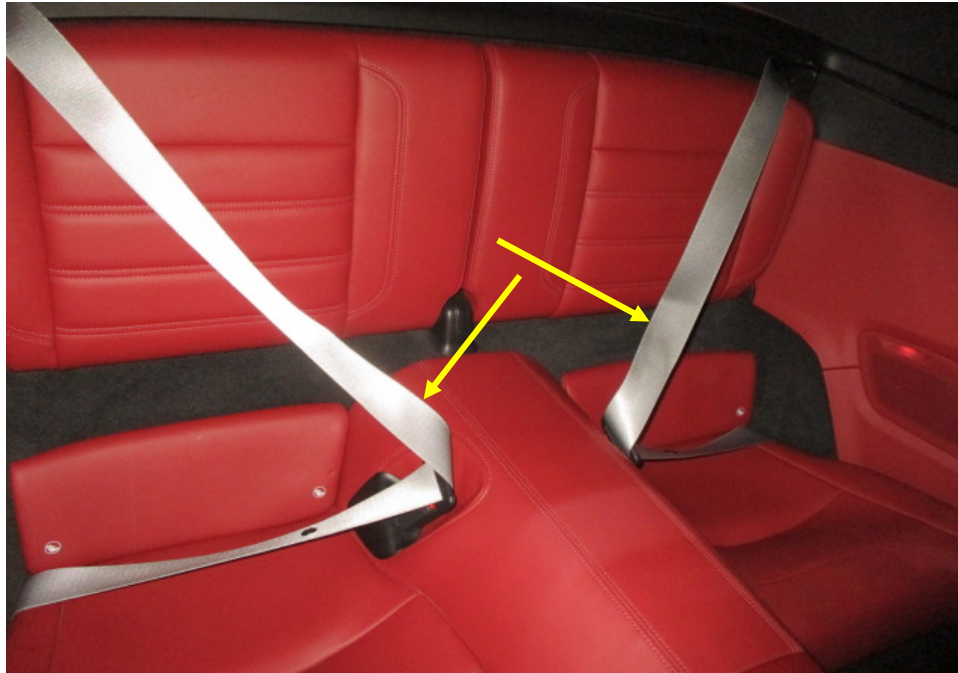
**Photo 17** shows the rear seats of the Motor Car. All the seats of the Motor Car were secured via seat rails to the floorboard. They were also fitted with a retractable seat belt reel and a pre-tensioner. The seat belts (arrowed) were tested and were able to be fastened into the respective pre-tensions that were fitted on the side of each individual seat.

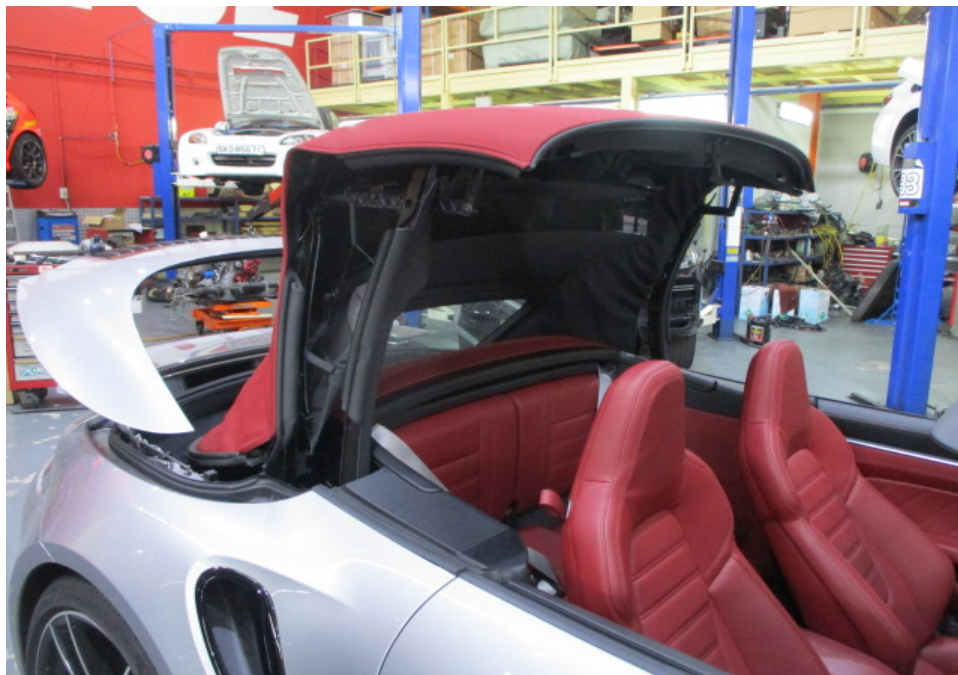
**Photo 18** shows the Motor Car's soft top roof being tested. It was observed that as a safety feature, the soft top roof could only open and close when the Motor Car was in a stationary position. When opened, the soft top roof is completely folded into the rear compartment with no parts protruding out of the Motor Car's body. The soft top roof was also found adequately secured to the "A" pillar after closing.

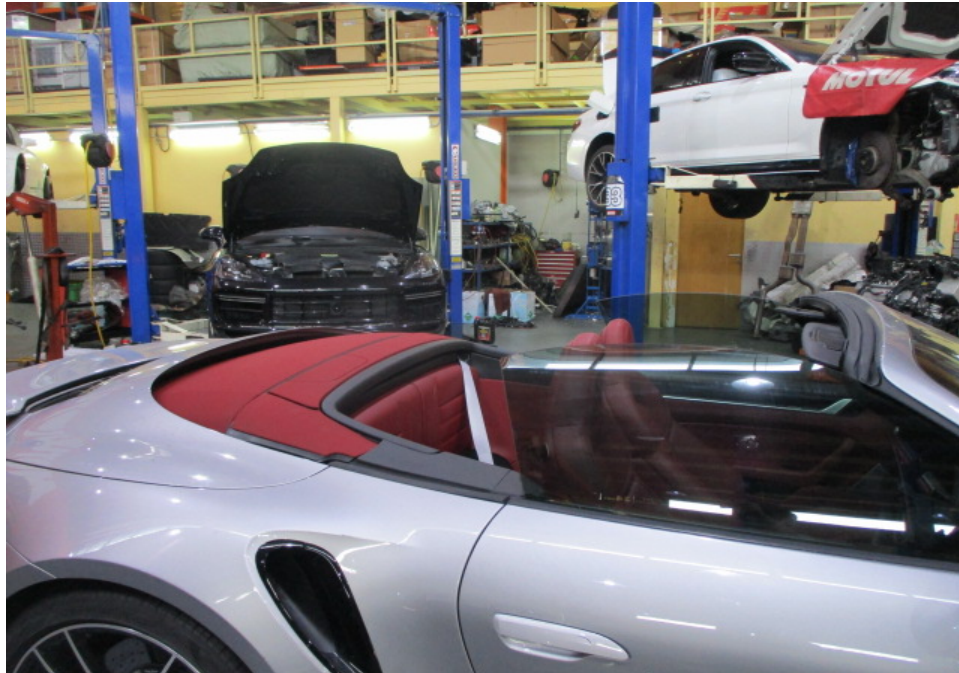
**Photo 19** shows the Motor Car with its soft top roof completely folded. It was observed that as a safety feature, the soft top roof could only open and close when the Motor Car was in a stationary position. When opened, the soft top roof is completely folded into the rear compartment with no parts protruding out of the Motor Car's body. The soft top roof was also found adequately secured to the "A" pillar after closing.

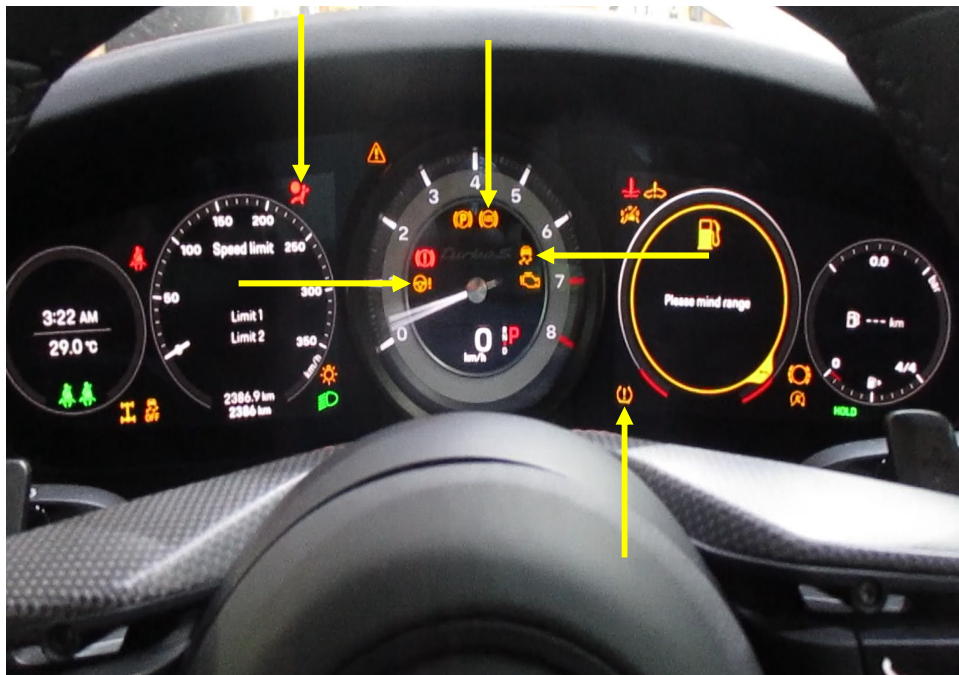
**Photo 20** shows the warning lights for the various electronic safety features appearing on the instrument panel of the Motor Car during its self-test when the engine is cranked, in particular the ABS, SRS, EPS, TPM and TCS lights (arrowed).

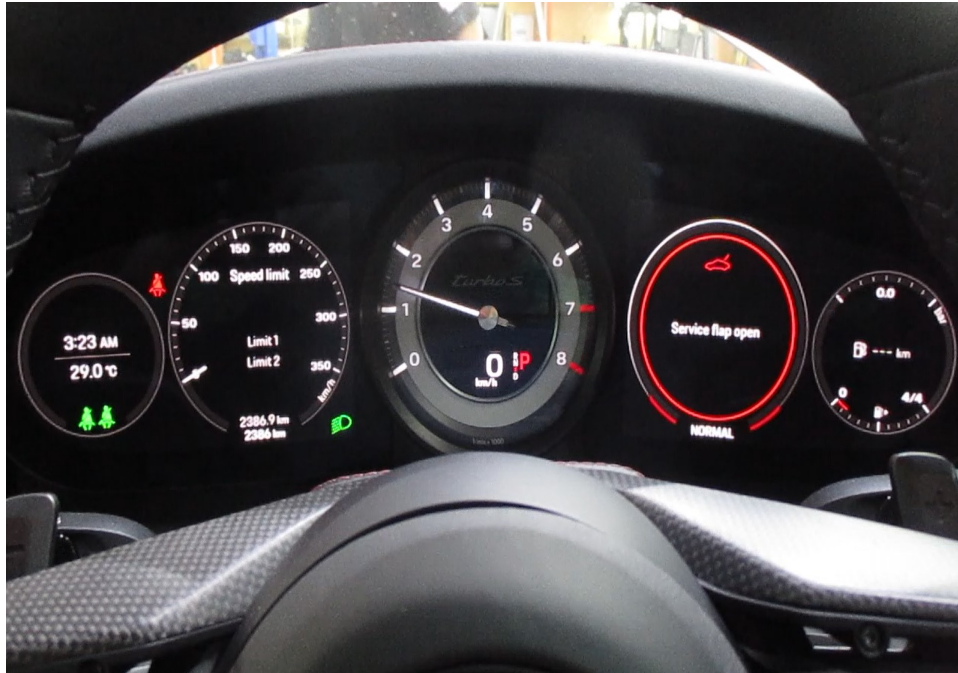
**Photo 21** shows the respective warning lights no longer illuminated, indicating that there is no fault detected to the ABS, SRS, EPS, TPM and TCS systems of the Motor Car during the self-test. These electronic systems were hence in working condition at the time of my inspection.

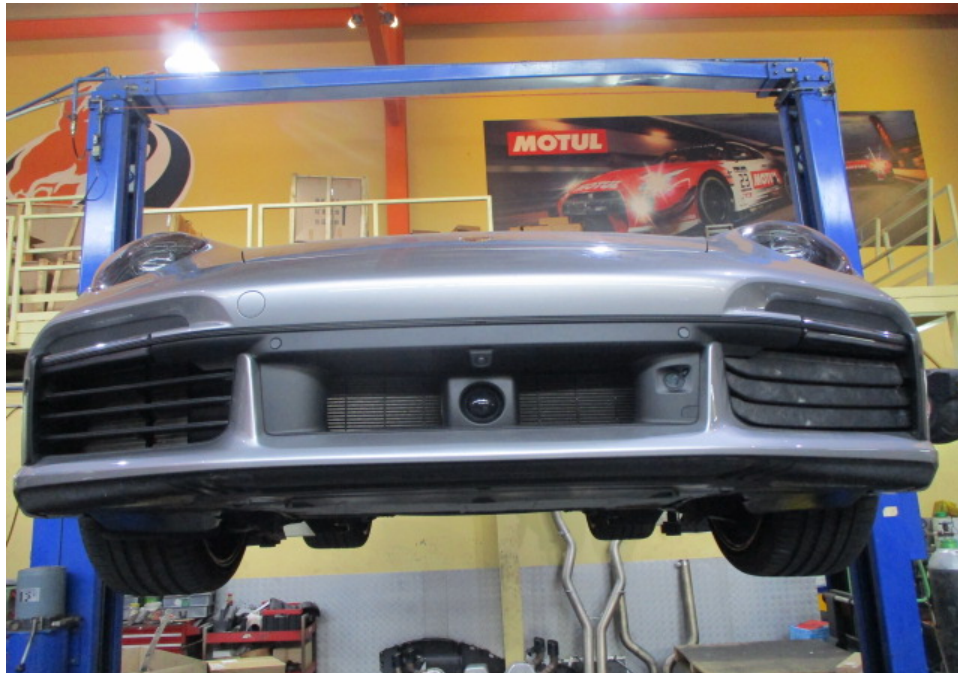
**Photo 22** shows the Motor Car hoisted up for checks on its undercarriage. There was no sign(s) or indication(s) of fluid leakage and/or fluid stain(s) on the underside of the Motor Car. The undercarriage components of the Motor Car were also all observed to be intact and secured in an appropriate manner.

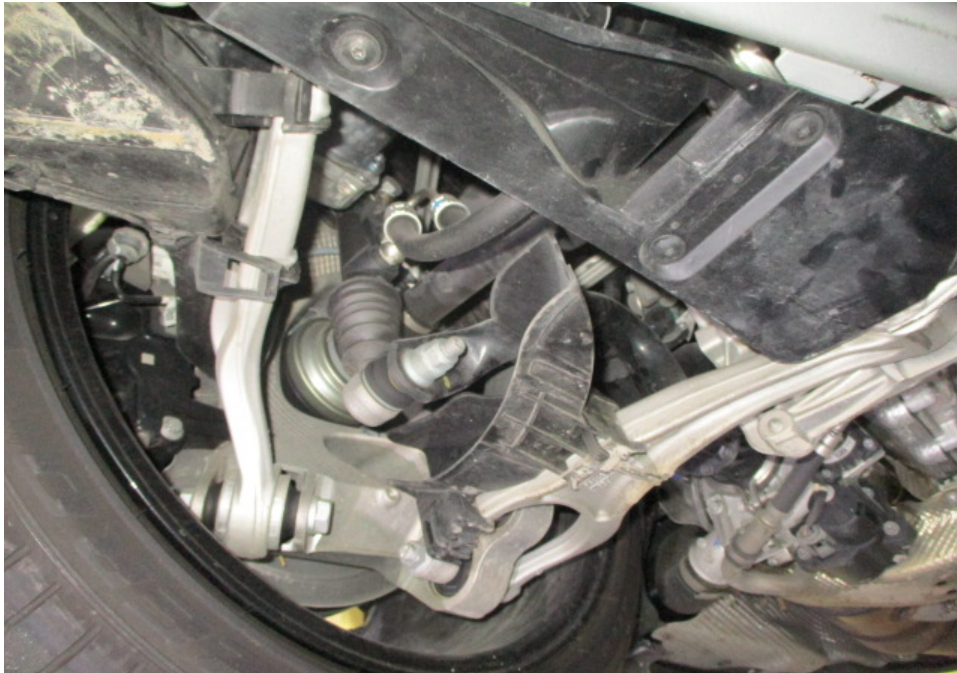
**Photo 23** shows a general view of the control arms and linkages at the rear right wheel of the Motor Car. I did not observe any fluid leak and/or fluid stain on the underside of the Motor Car. All of the Motor Car's undercarriage components were observed to be intact and secured in an appropriate manner.

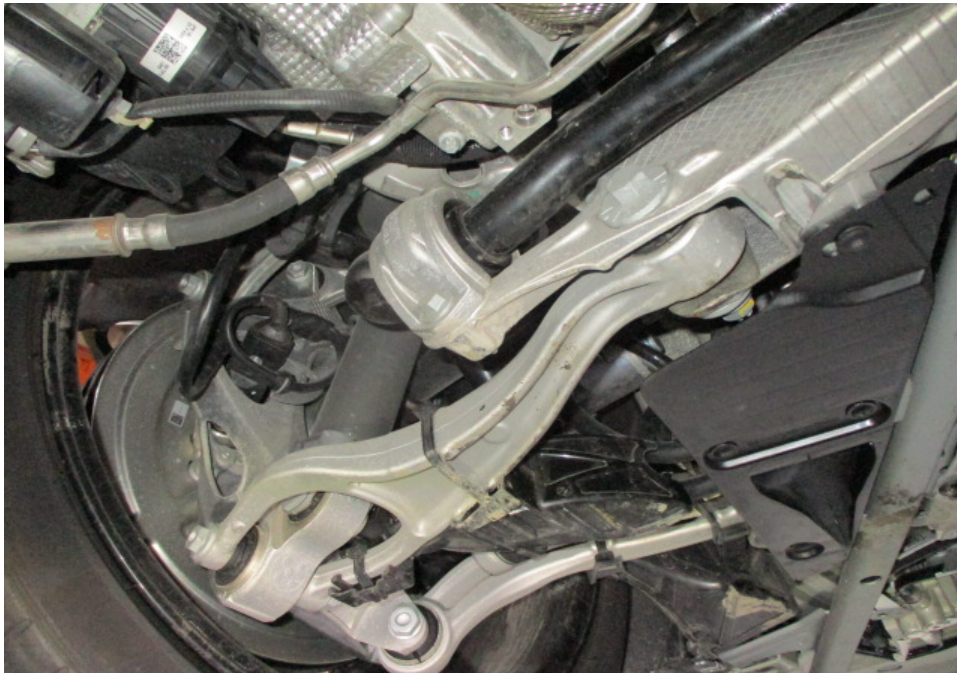
**Photo 24** shows a general view of the control arms and linkages at the rear left wheel of the Motor Car. I did not observe any fluid leak and/or fluid stain on the underside of the Motor Car. All of the Motor Car's undercarriage components were observed to be intact and secured in an appropriate manner.

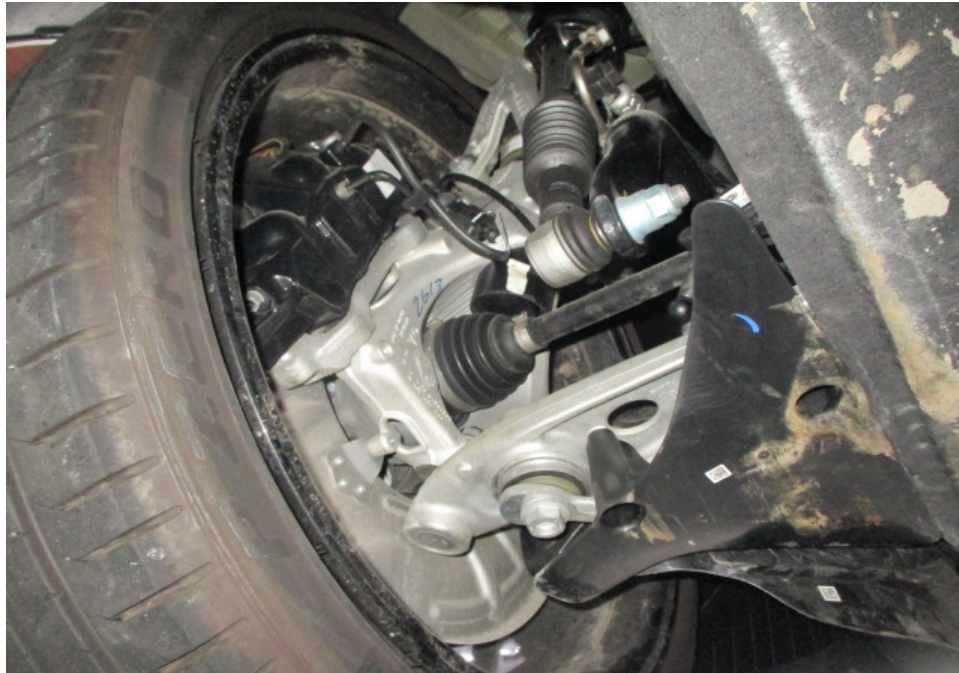
**Photo 25** shows the various undercarriage components at the front left wheel of the Motor Car. The mechanical components, control arms and linkages were all found to be intact and secured in an appropriate manner.

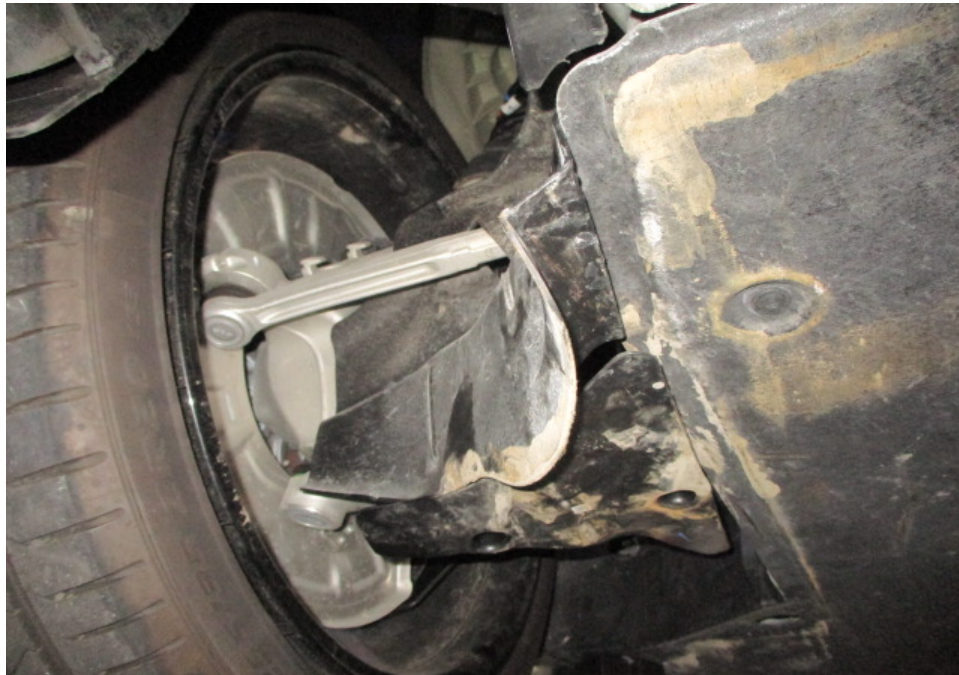
**Photo 26** shows the various undercarriage components at the front right wheel of the Motor Car. The mechanical components, control arms and linkages were all found to be intact and secured in an appropriate manner. I also did not observe any fluid leak and/or fluid stain on the underside of the Motor Car.

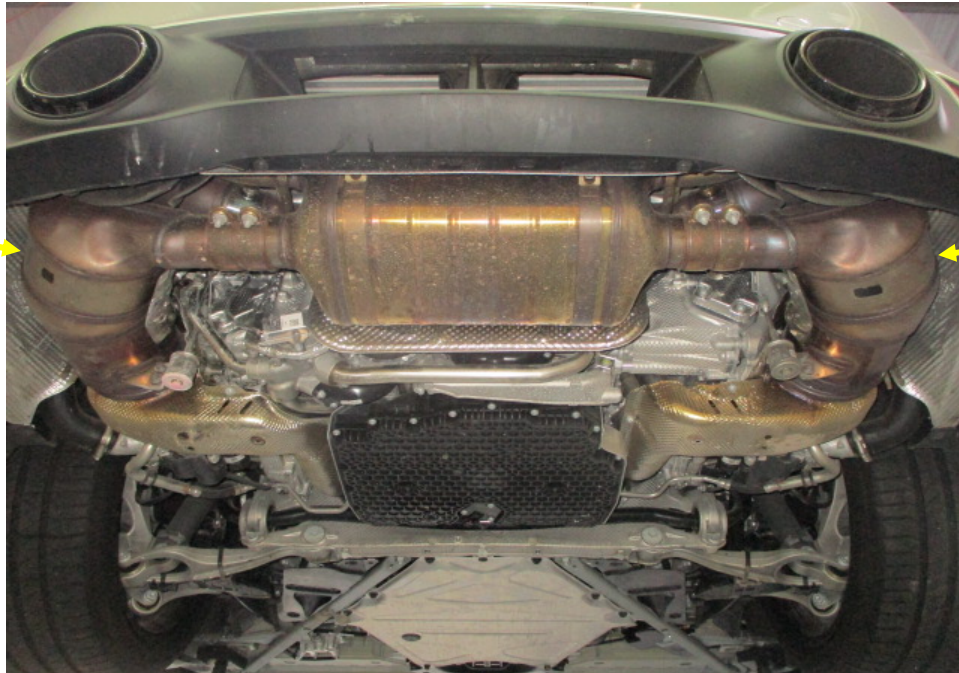
**Photo 27** shows the Motor Car's exhaust system. My examination of the Motor Car's exhaust system revealed no sign(s) or indication(s) of any cut or weld marks along its exhaust pipes, on its catalytic converters (arrowed) and on its rear muffler.

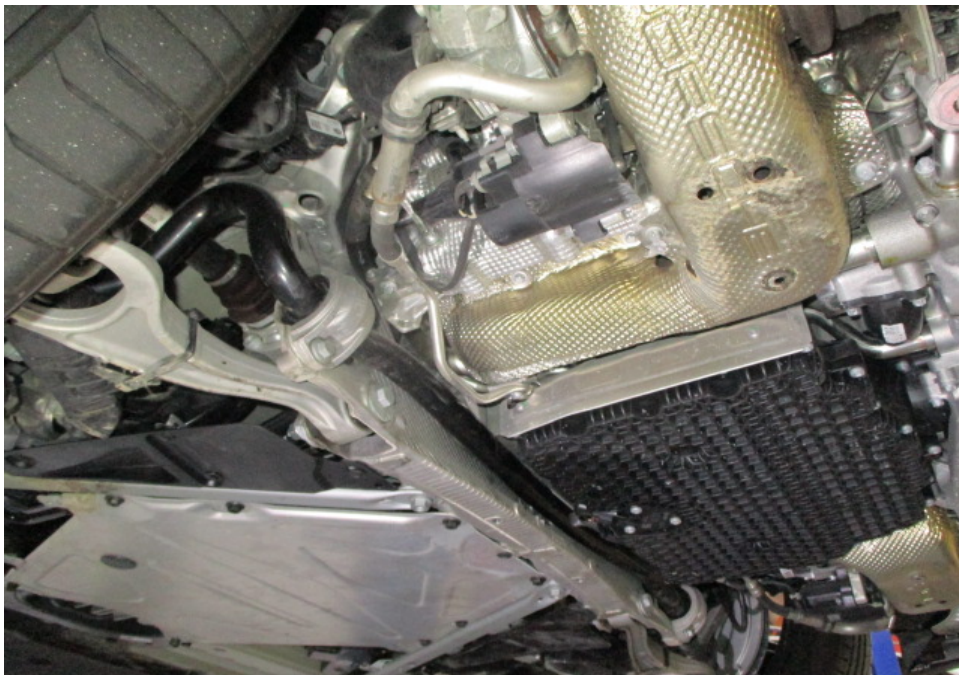
**Photo 28** shows a general view of the Motor Car's engine compartment. The engine compartment was at the rear underside of the Motor Car. The various parts and components within the engine compartment were all observed to be intact and properly fitted. There was also no sign(s) or indication(s) of fluid leak and/or fluid stain found inside the engine compartment.

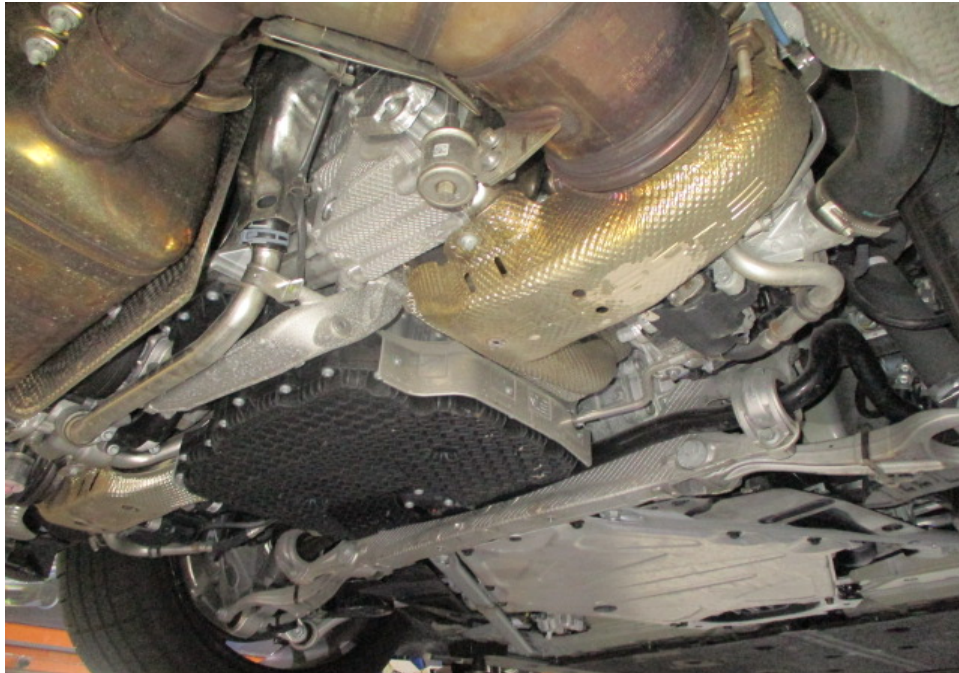
**Photo 29** shows another view of the Motor Car's engine compartment. The engine compartment was at the rear underside of the Motor Car. The various parts and components within the engine compartment were all observed to be intact and properly fitted. There was also no sign(s) or indication(s) of fluid leak and/or fluid stain found inside the engine compartment.

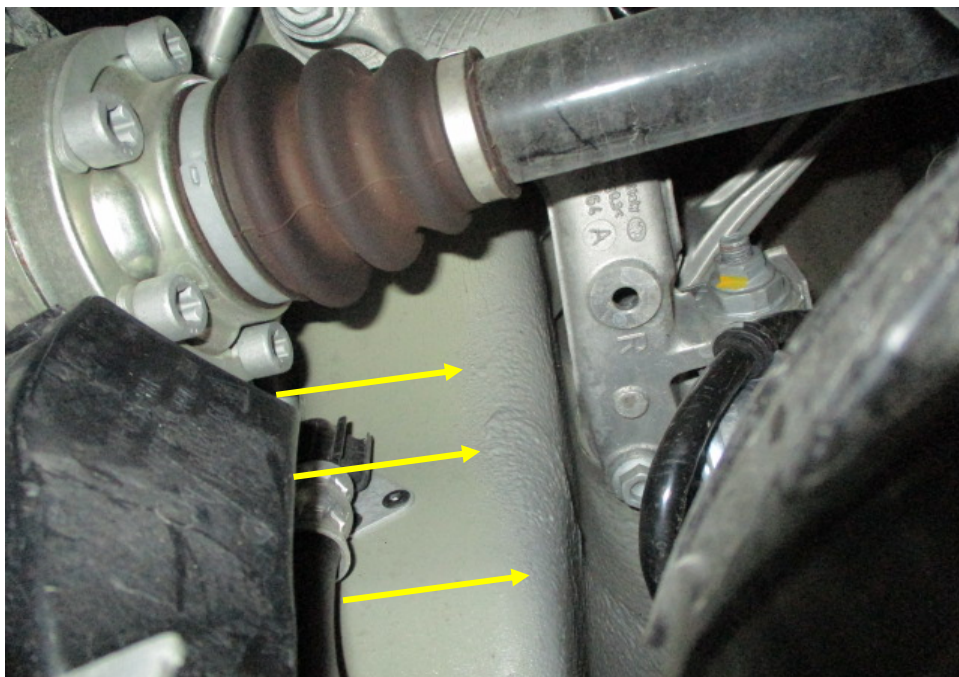
**Photo 30** shows the chassis/structural body at the underside rear right of the Motor Car. I did not find any weld marks other than original spot weld marks on the chassis/structural body of the Motor Car. The original factory sealant (arrowed) at the joints along the chassis/structural body was untouched, indicating no work was done on the chassis/structural body of the Motor Car and that the chassis/structural body was originally fitted.
