Your Ref: Porsche 911 Turbo S Cabriolet  
(chassis number WP0ZZZ99ZMS262744)  
Our Ref : CI/TP22010306/D

18 October 2022

**INSPECTION REPORT OF AN UNREGISTERED PORSCHE 911 TURBO S  
CABRIOLET MOTOR CAR WITH CHASSIS NUMBER WP0ZZZ99ZMS262744**

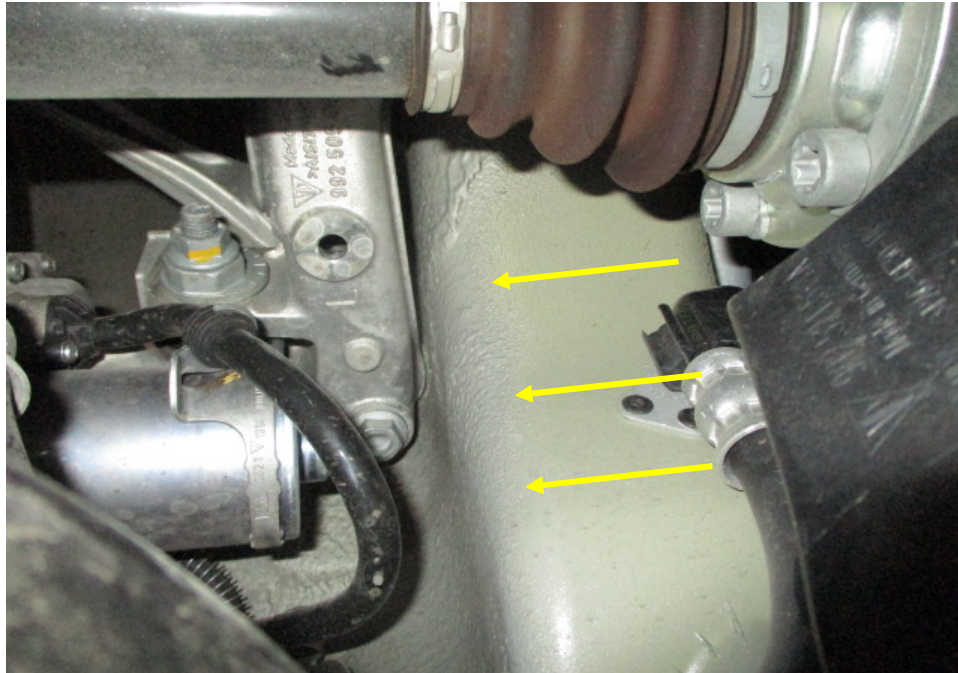
**Photo 31** shows the chassis/structural body at the underside rear left of the Motor Car. The original factory sealant (arrowed) at the joints along the chassis/structural body was observed to be untouched. In general, I had found no work was carried out on the chassis/structural body of the Motor Car. The chassis/structural body of the Motor Car was originally fitted.

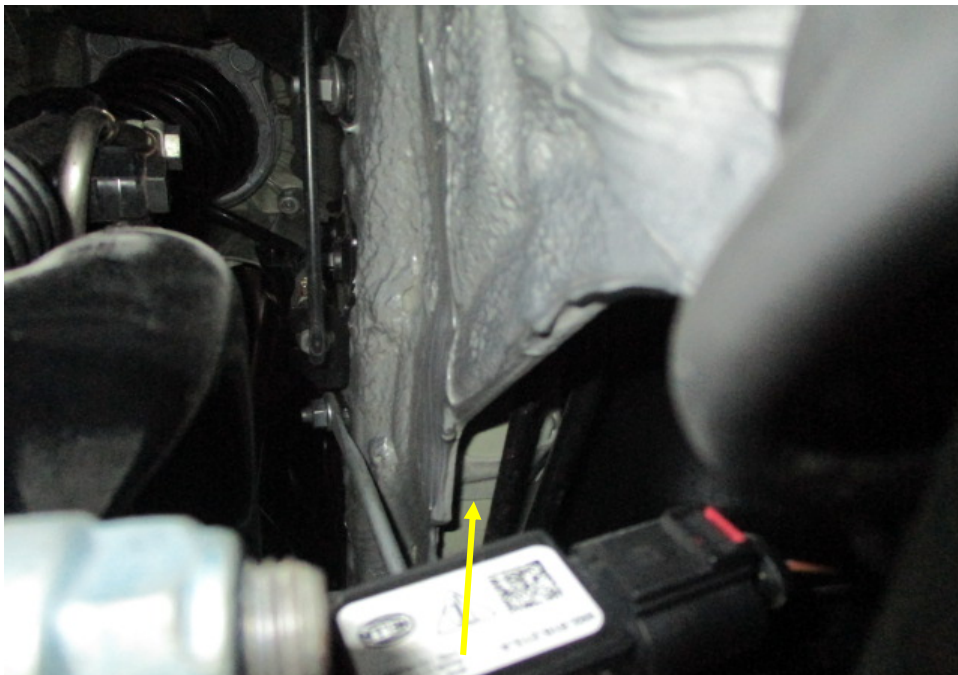
**Photo 32** shows the chassis/structural body at the underside front left of the Motor Car. I did not find any weld marks other than original spot weld marks on the chassis/structural body of the Motor Car. The original factory sealant (arrowed) at the joints along the chassis/structural body was untouched, indicating no work was done on the chassis/structural body of the Motor Car and that the chassis/structural body was originally fitted.

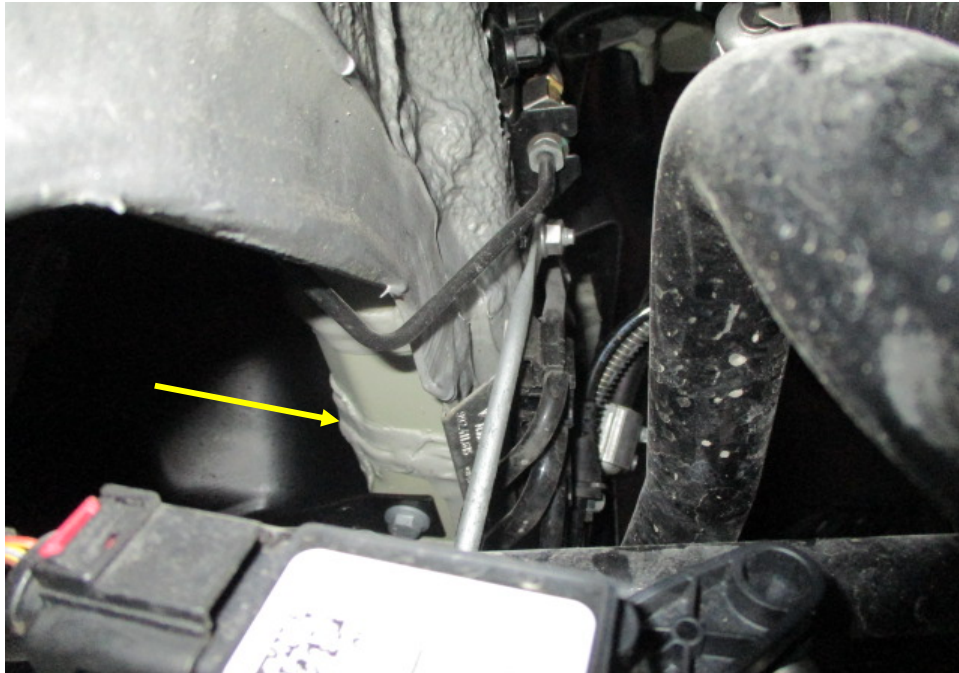
**Photo 33** shows the chassis/structural body at the underside front right of the Motor Car. The original factory sealant (arrowed) at the joints along the chassis/structural body was observed to be untouched. In general, I had found no work was carried out on the chassis/structural body of the Motor Car. The chassis/structural body of the Motor Car was originally fitted.
