Your Ref: TP/IP/08897/2022
Our Ref : CI/TPD22010314/N

18 October 2022

Fatal Accident Investigation Team

INSPECTION REPORT OF MOTORCYCLE FX 9090H

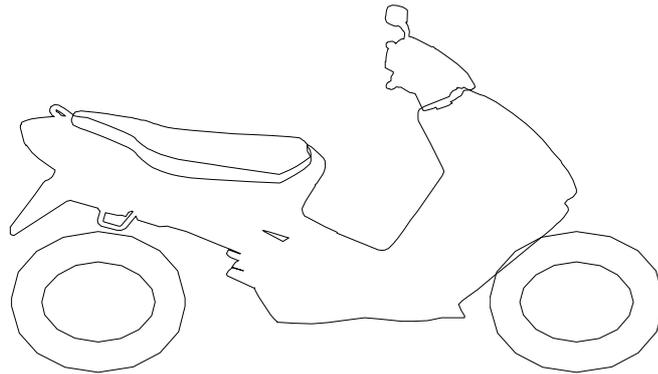
7. The tyre brand, tyre size and remaining tread depth of the 2 tyres were recorded as follows:-

Metzeler 140/70 - 17 (5mm)

Metzeler 110/70 - 17 (4mm)

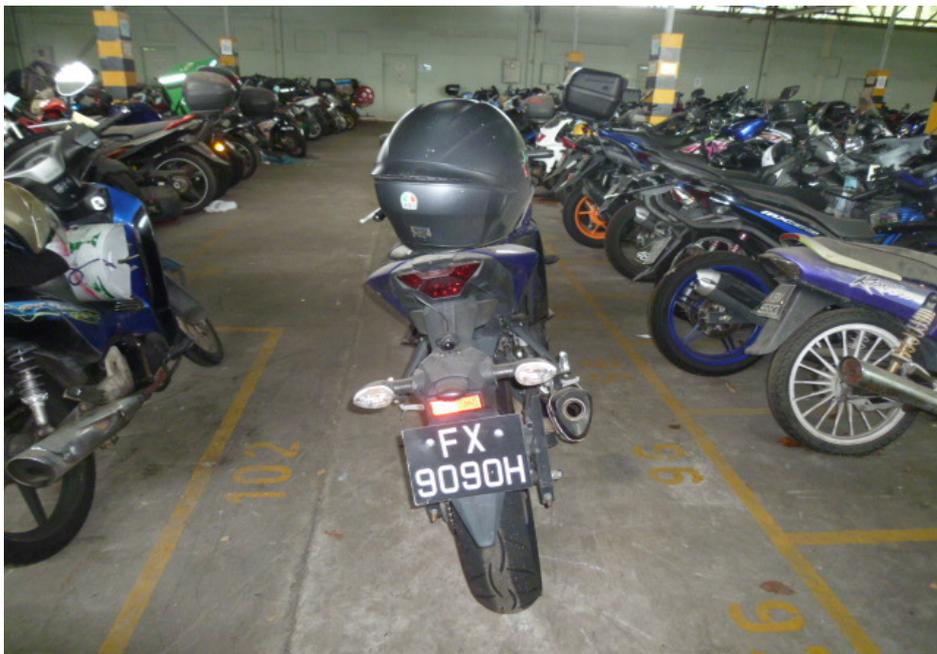
Photo 1 shows a general view of the rear portion of the Motorcycle at the time of our inspection. The Motorcycle was observed to have sustained damages at its

51 UBI AVE 1, #01-25 PAYA UBI INDUSTRIAL PARK, SINGAPORE 408933 TEL : (065) 62563561 FAX : (065) 67414108
frontal portion and left body. The mileage of the Motorcycle could not be recorded at the time of our inspection due to the unavailability of the ignition key.

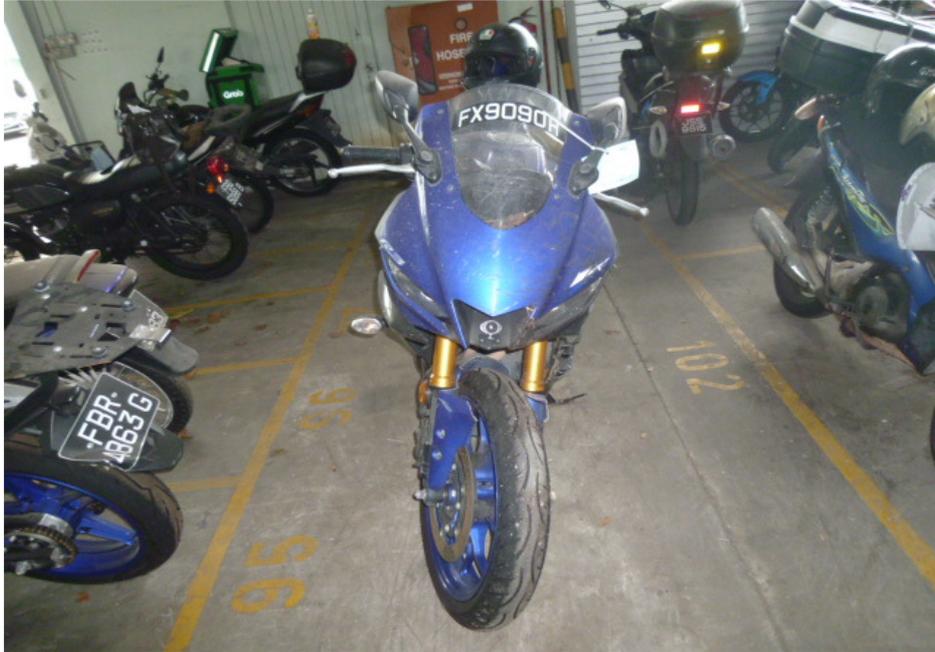
Photo 2 shows a general view of the frontal portion of the Motorcycle at the time of our inspection. The Motorcycle was observed to have sustained damages at its frontal portion and left body.

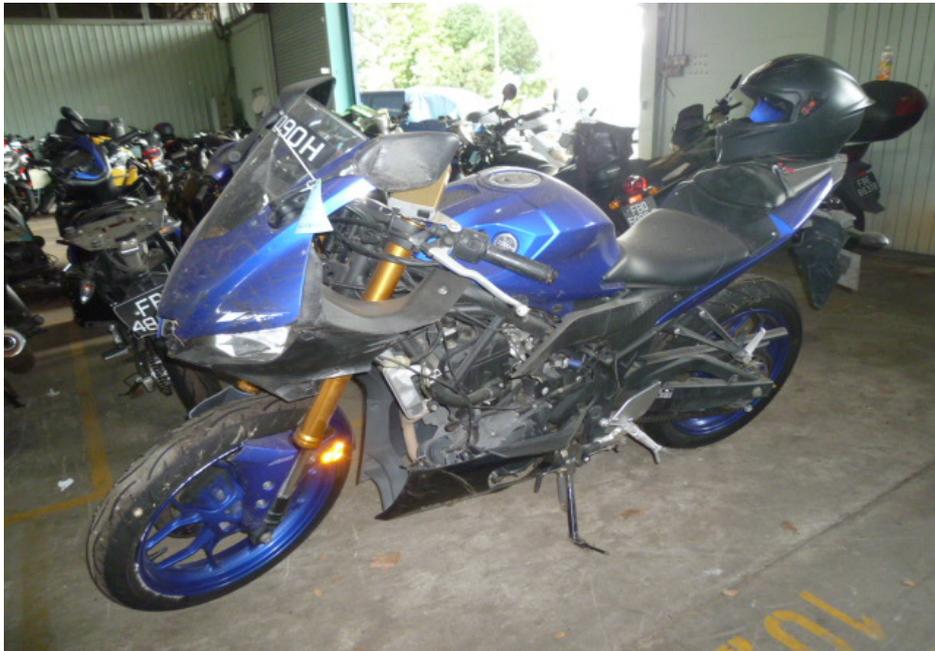
Photo 3 shows a general view of the left body of the Motorcycle at the time of our inspection. The Motorcycle was observed to have sustained damages at its frontal portion and left body.

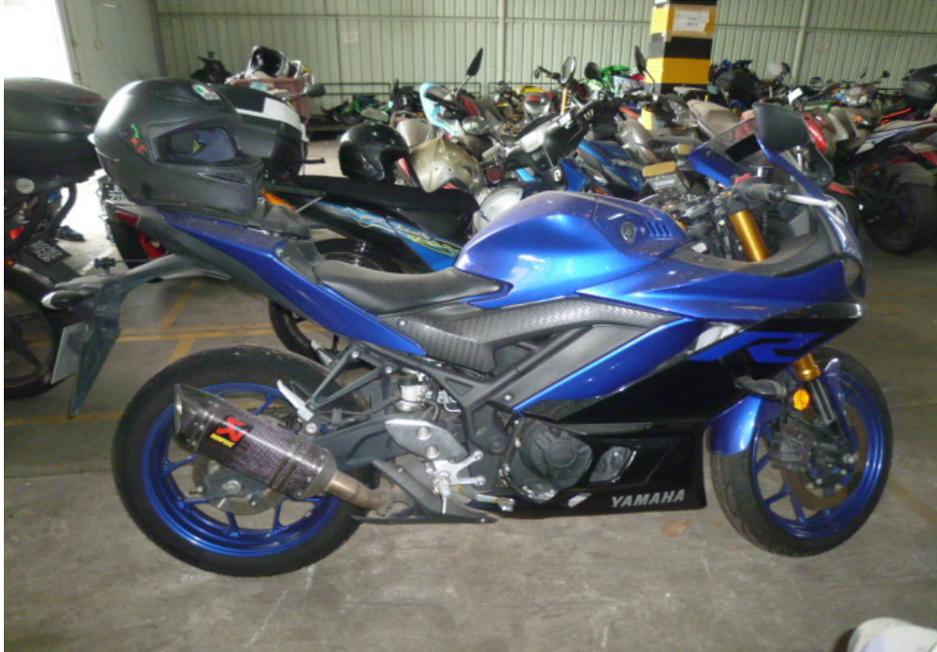
Photo 4 shows a general view of the right body of the Motorcycle at the time of our inspection. The Motorcycle was observed to have sustained damages at its frontal portion and left body. The body parts that were found to have been damaged include its head cowling, front mudguard, left cowling, left side mirror, clutch lever, petrol tank, gear shift pedal and left rear side cover, amongst others.

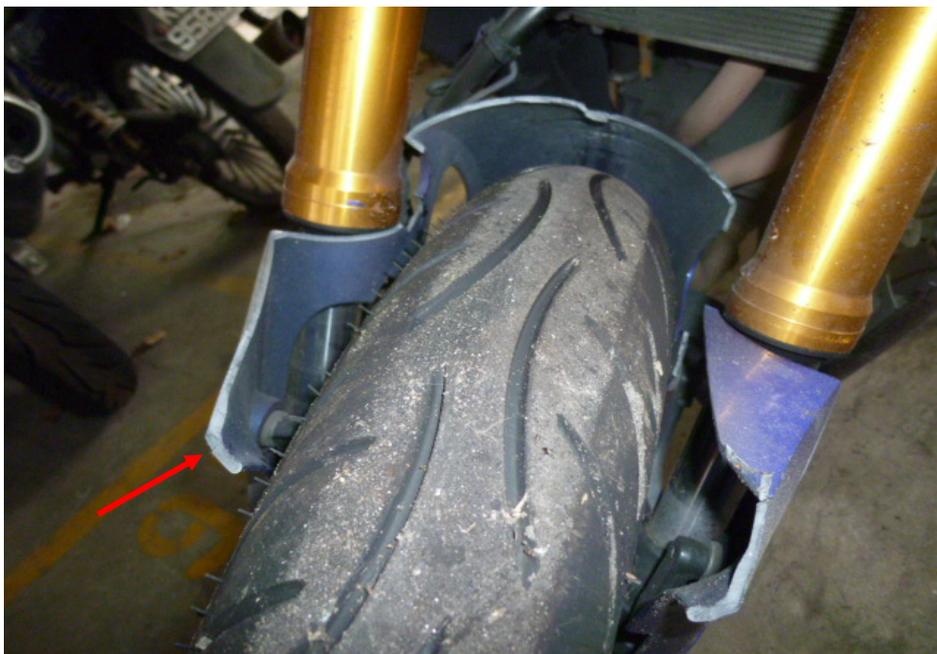
Photo 5 shows a closer view of the cracked front mudguard (arrowed) which was amongst the body parts of the Motorcycle that had sustained damage as a result of the accident.

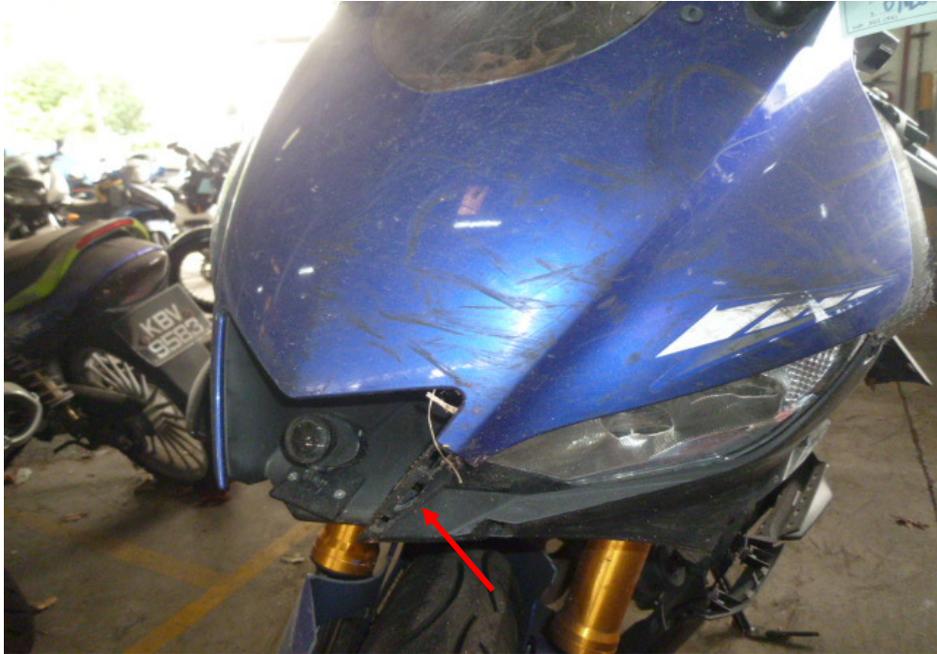
Photo 6 shows the grazed head cowling (arrowed), which was amongst the body parts of the Motorcycle that had sustained damage as a result of the accident.

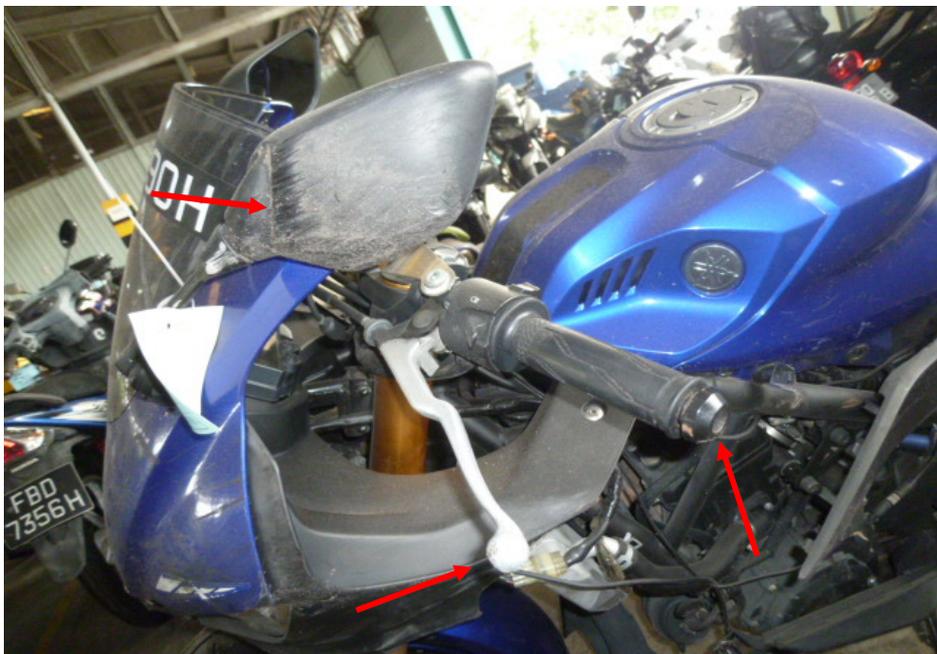
Photo 7 shows the left handlebar end, clutch lever and left side mirror (arrowed), which were amongst the body parts of the Motorcycle that had sustained damage as a result of the accident.

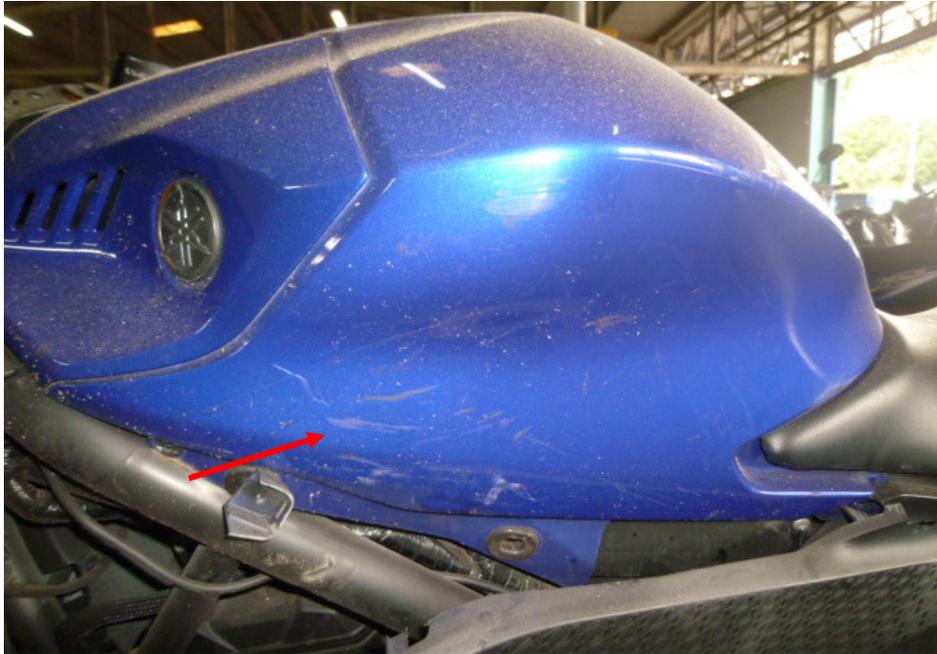
Photo 8 shows the grazed petrol tank (arrowed), which was amongst the body parts of the Motorcycle that had sustained damage as a result of the accident.

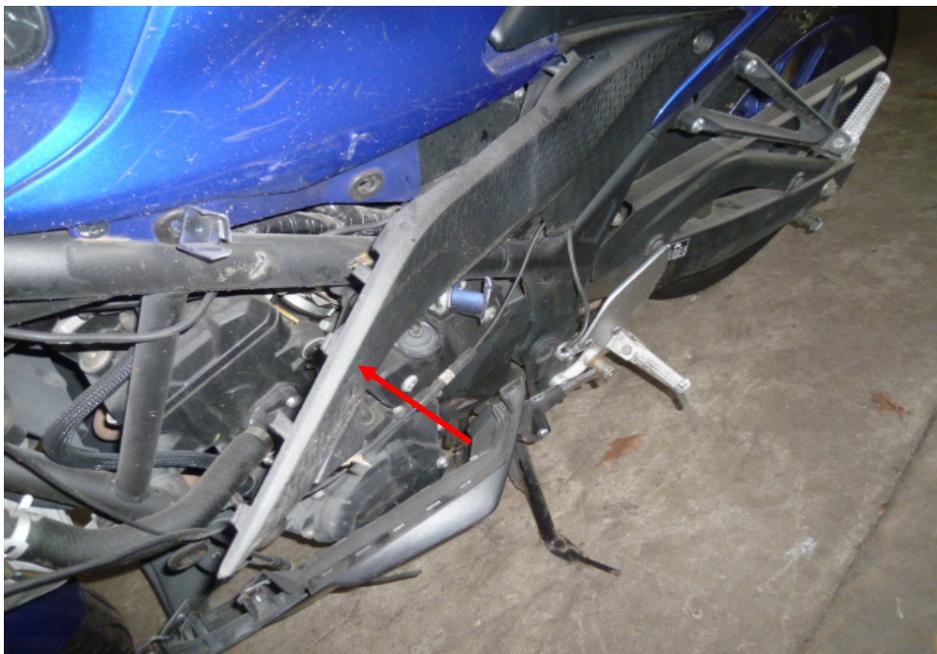
Photo 9 shows a closer view of the cracked left centre cover of the Motorcycle as a result of the accident (arrowed).

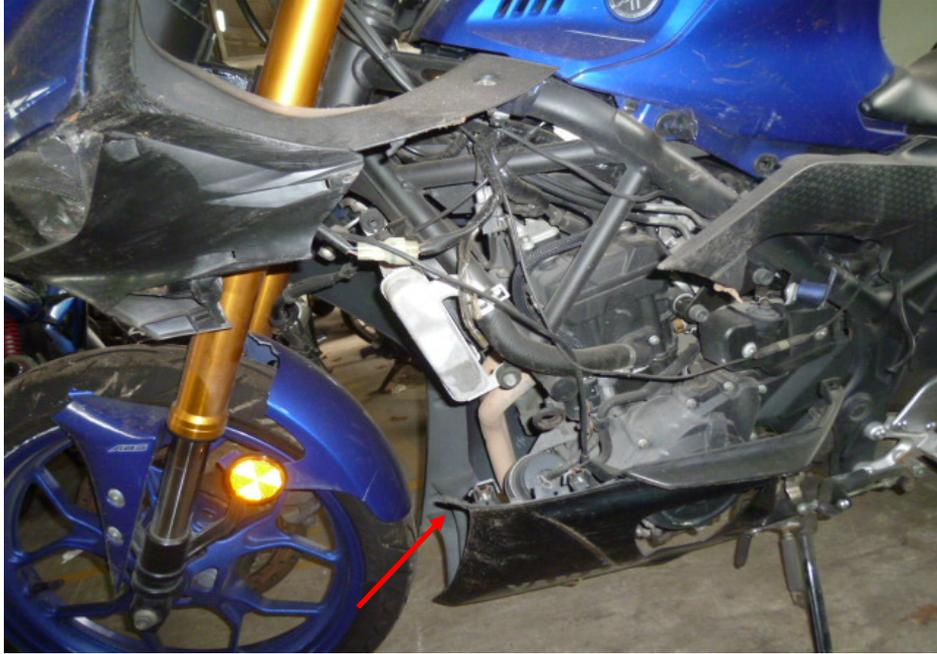
Photo 10 shows a closer view of the grazed left cowling of the Motorcycle as a result of the accident (arrowed).

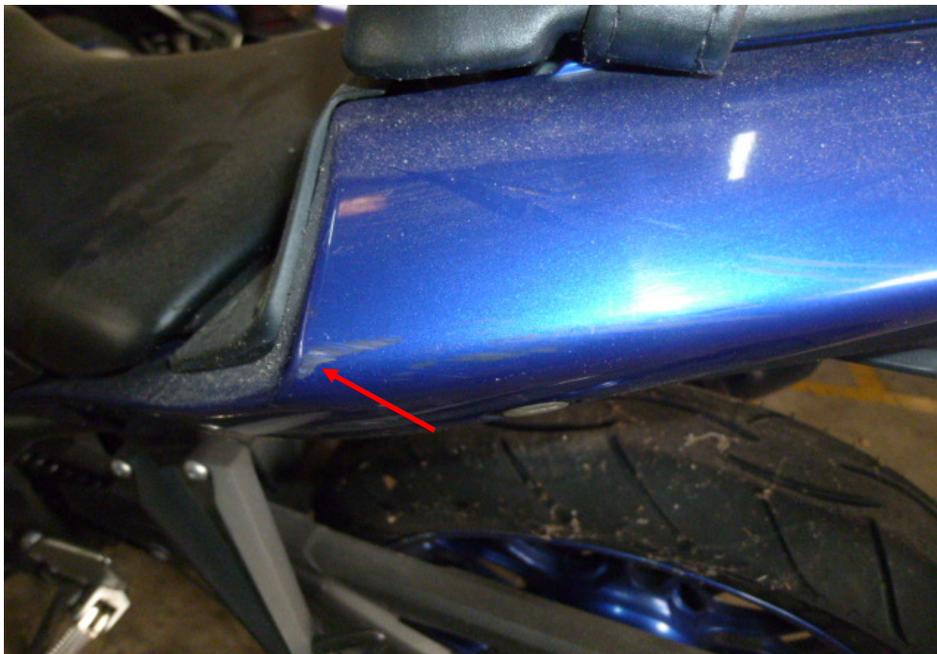
Photo 11 shows a closer view of the grazed left rear side cover of the Motorcycle as a result of the accident (arrowed).

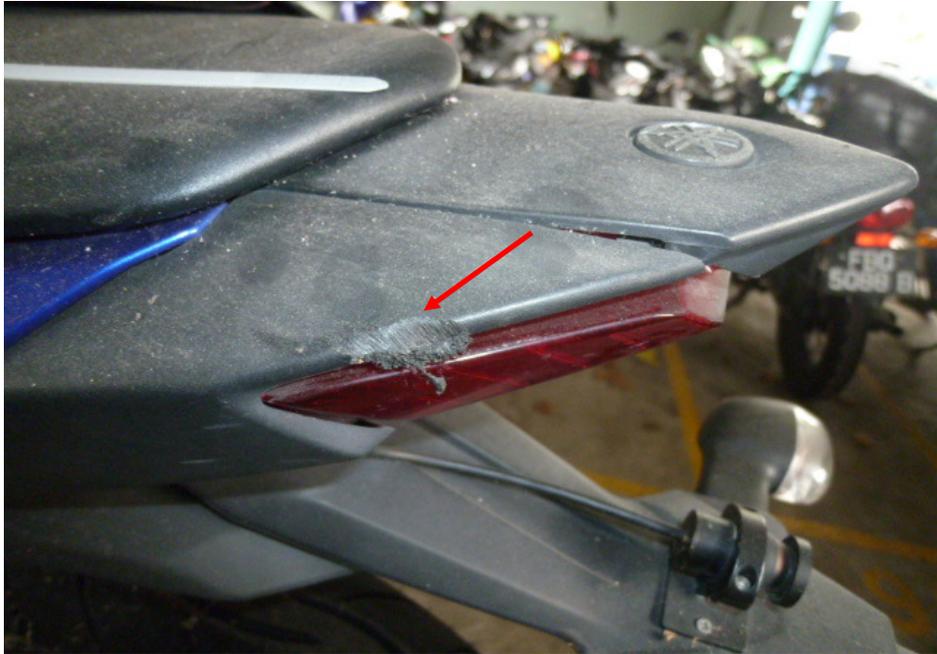
Photo 12 shows a closer view of grazed left tail light cover (arrowed) of the Motorcycle as a result of the accident.

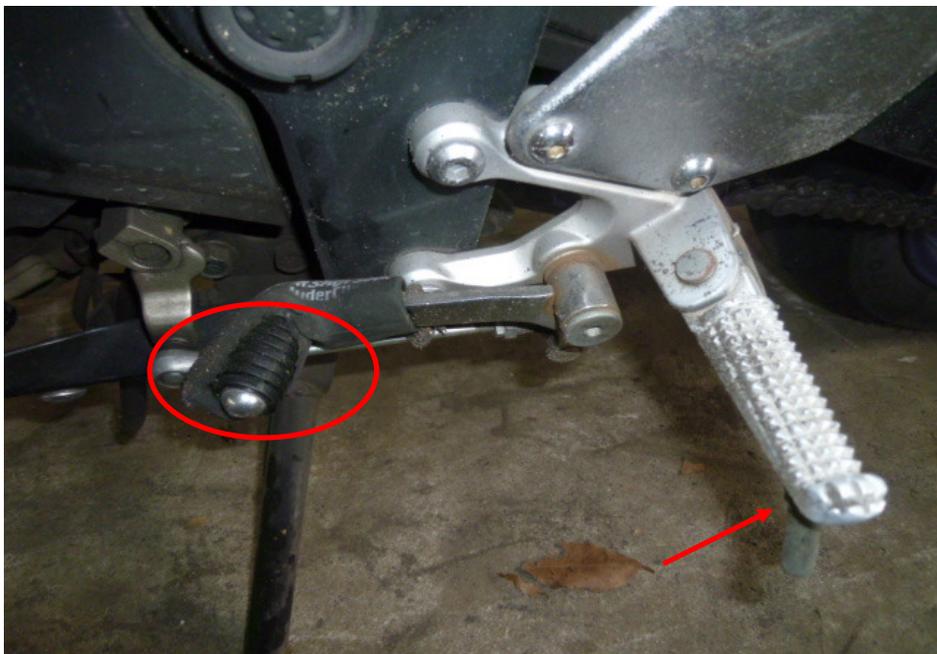
Photo 13 shows the bent gear shift pedal (circled) and left front footrest (arrowed) of the Motorcycle as a result of the accident.

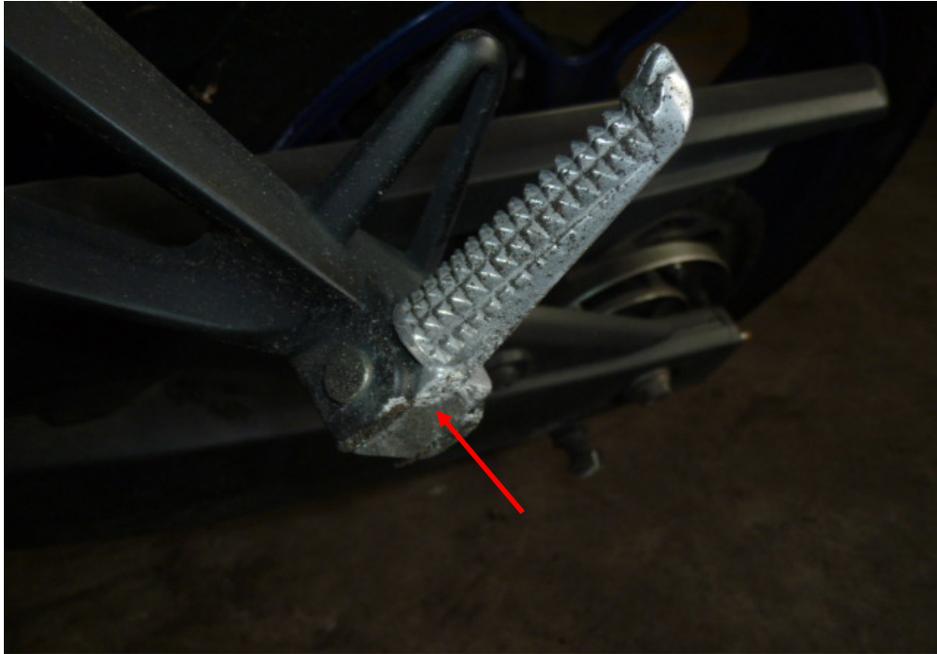
Photo 14 shows the grazed left pillion foot peg of the Motorcycle as a result of the accident (arrowed).

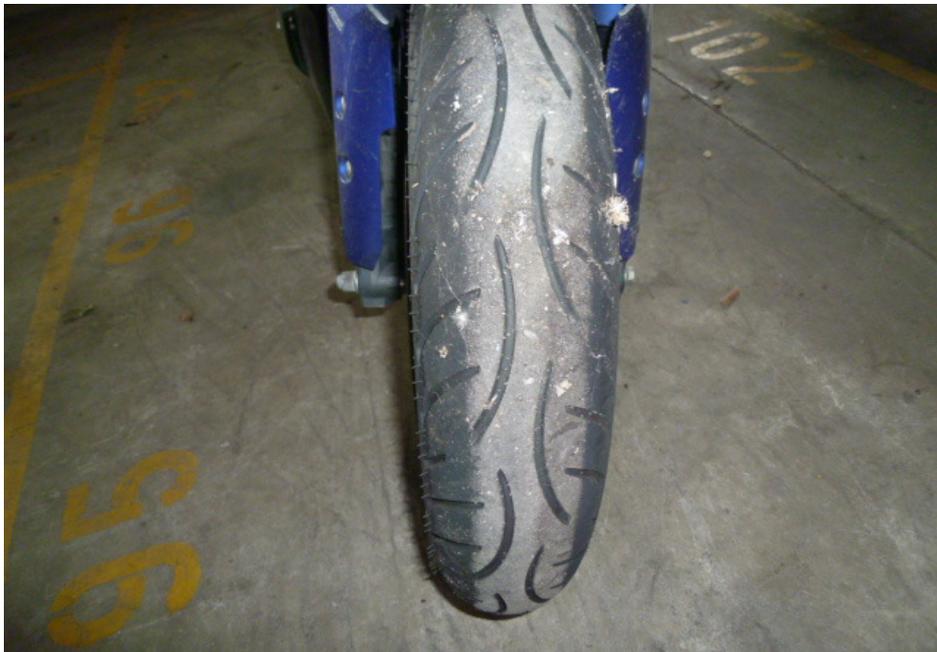
Photo 15 shows the front tyre of the Motorcycle at the time of our inspection. The front tyre was observed to be in serviceable condition with remaining tread depth of approximately 4mm. The pattern of the tread was also clearly visible. There was no tear, burst mark(s) and/or punctured hole(s) on the sidewalls as well as across the tread of the front tyre.

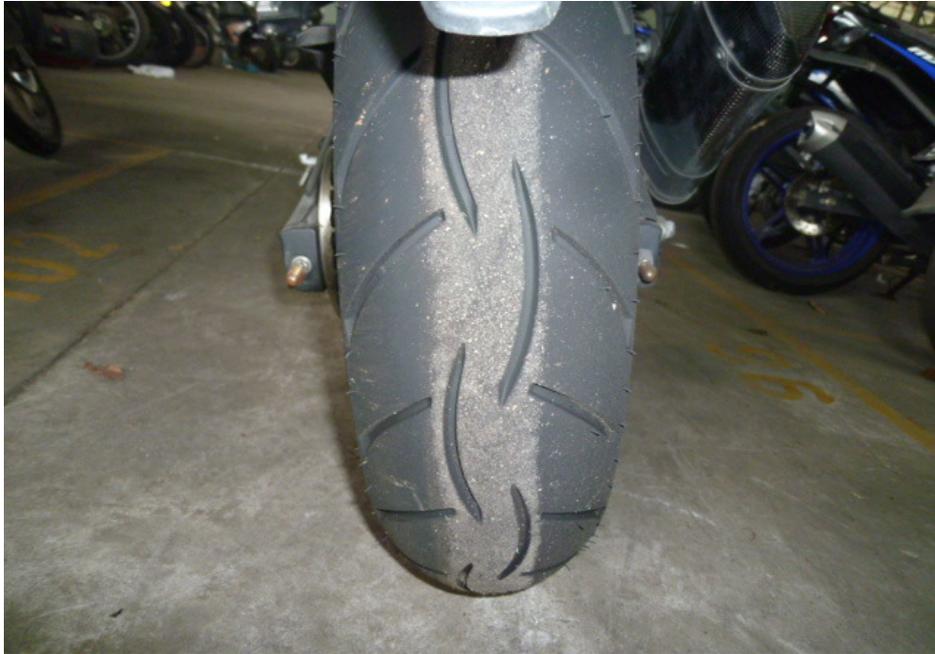
Photo 16 shows the condition of the Motorcycle's rear tyre. The rear tyre was observed to be in serviceable condition with remaining tread depth of approximately 5mm. The tyre was also observed to be sufficiently inflated for vehicular operation. We did not observe any tear, burst mark(s) and/or punctured hole(s) on the sidewalls as well as across the tread of the rear tyre.

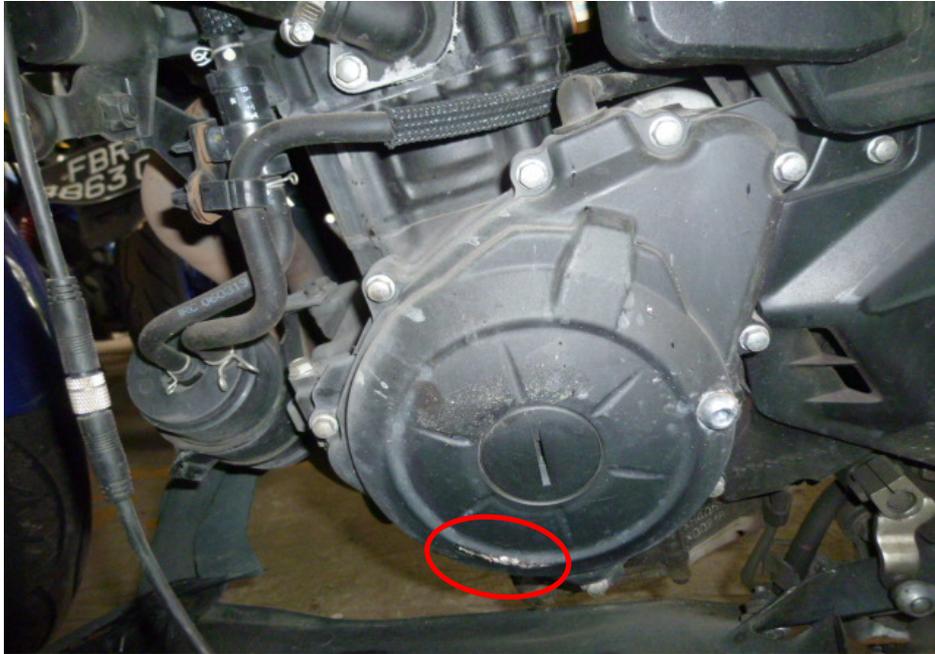
Photo 17 shows the left side of the engine of the Motorcycle at the time of our inspection. The various left engine components had sustained damage of grazing nature as a result of the accident (circled) however the engine components were still intact. There was also no fluid leak and/or fluid stain found around the left engine area of the Motorcycle.

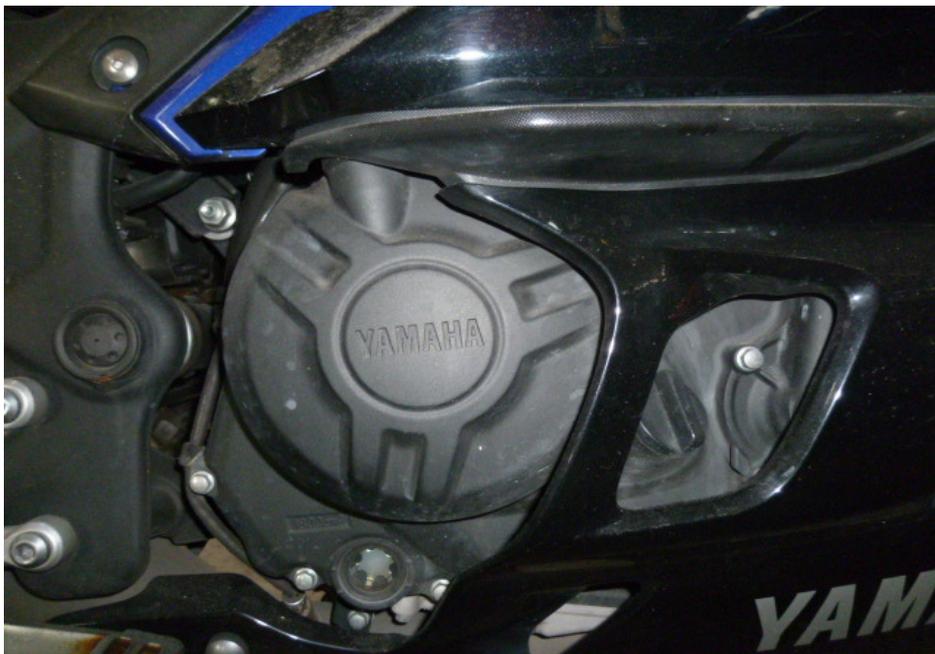
Photo 18 shows the right side of the engine of the Motorcycle at the time of our inspection. The various engine related parts and components were found to be

51 UBI AVE 1, #01-25 PAYA UBI INDUSTRIAL PARK, SINGAPORE 408933 TEL : (065) 62563561 FAX : (065) 67414108
intact with no visible damage. There was also no sign(s) or indication(s) of fluid leak observed around the right engine area of the Motorcycle.

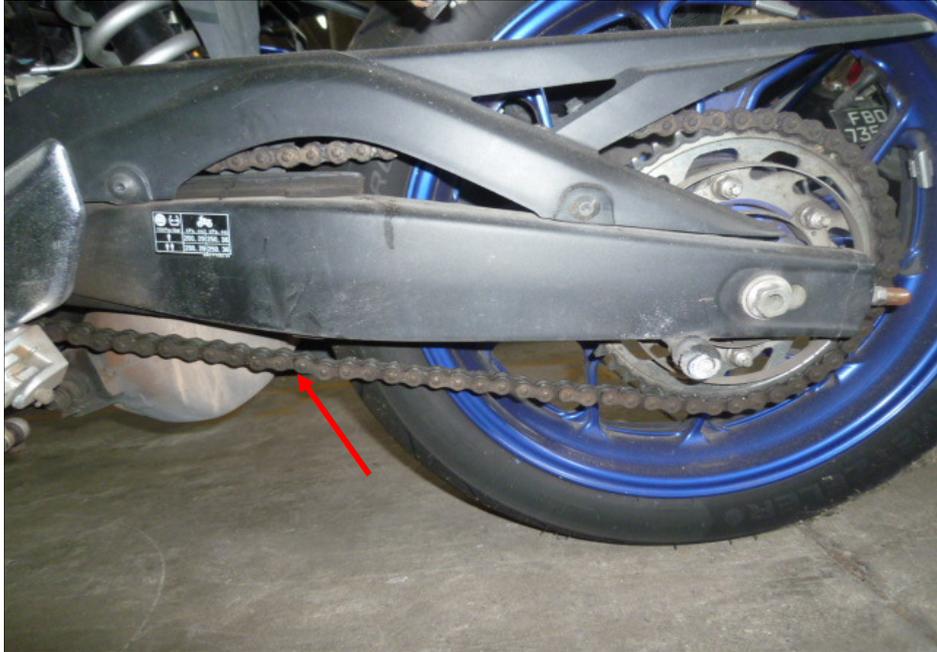
Photo 19 shows the general view of the gear train (arrowed) of the Motorcycle, which was observed to be intact with no misalignment. It was also adequately lubricated for operating purposes. The gear train rotates the rear wheel of the Motorcycle

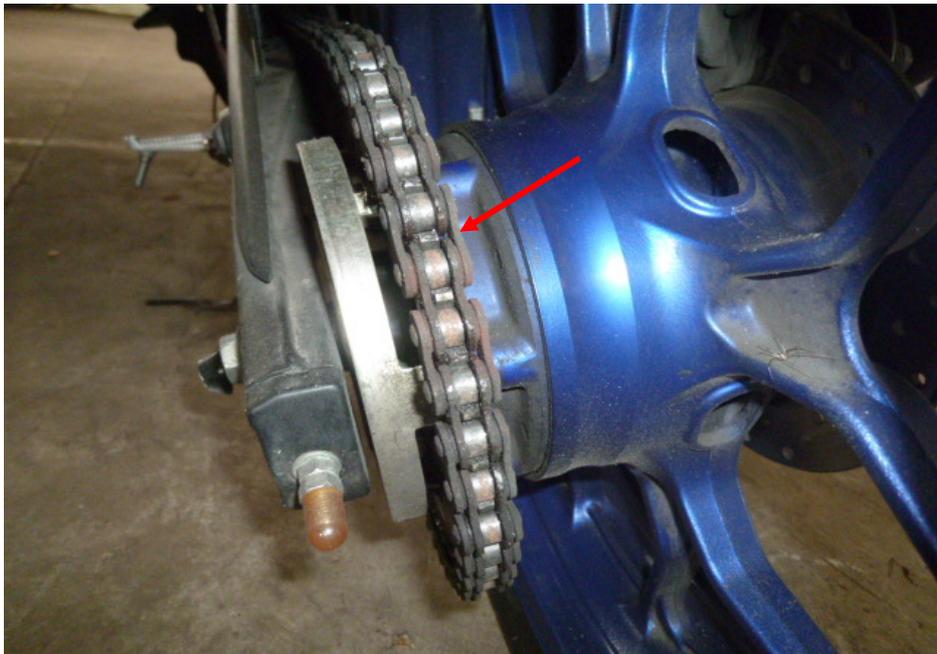
Photo 20 shows a closer view of the gear train (arrowed) of the Motorcycle, which was observed to be intact with no misalignment. It was also adequately lubricated for operating purposes.

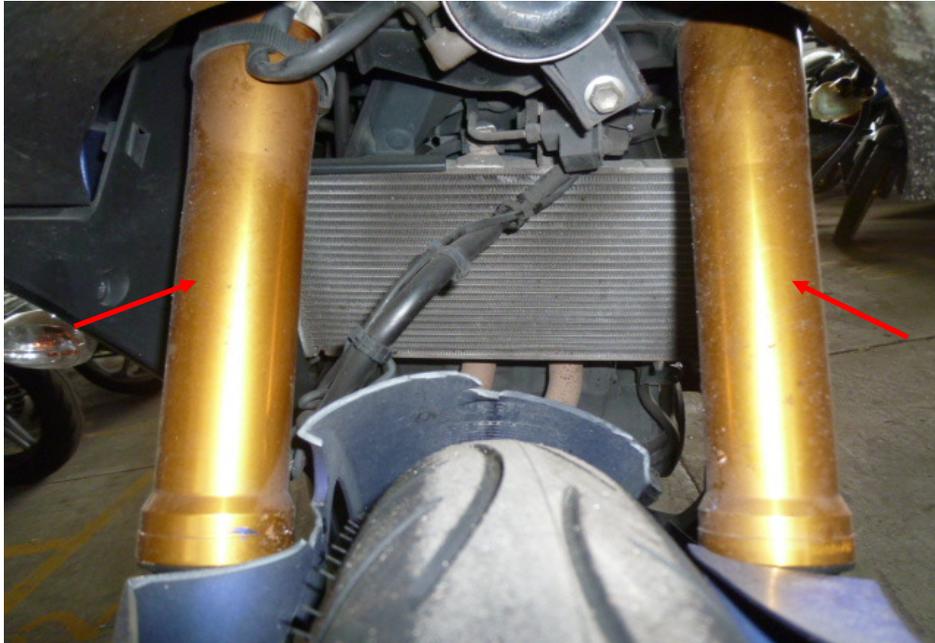
Photo 21 shows the front forks (arrowed) of the Motorcycle. The front forks and fork bracket of the Motorcycle were both found to be intact and undamaged. Turning the Motorcycle's handle bar towards the left and right did not produce any abnormal free play. The steering system of the Motorcycle was in serviceable condition at the time of our inspection.

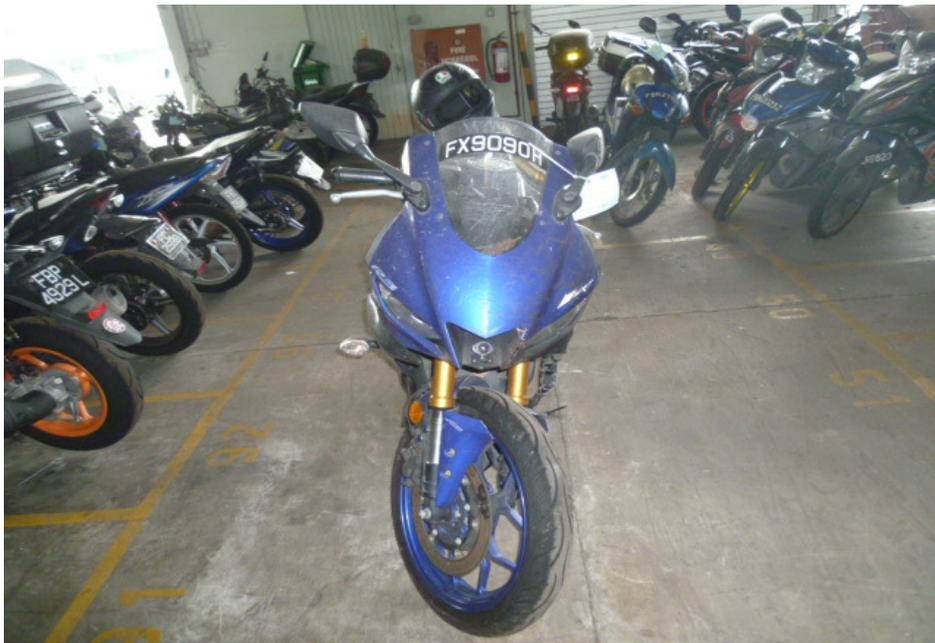
Photo 22 shows the front wheel of the Motorcycle turned towards its full left. Turning the Motorcycle's handle bar towards the left did not produce any

abnormal free play and/or resistance. This would indicate that the steering system of the Motorcycle was in serviceable condition at the time of our inspection.

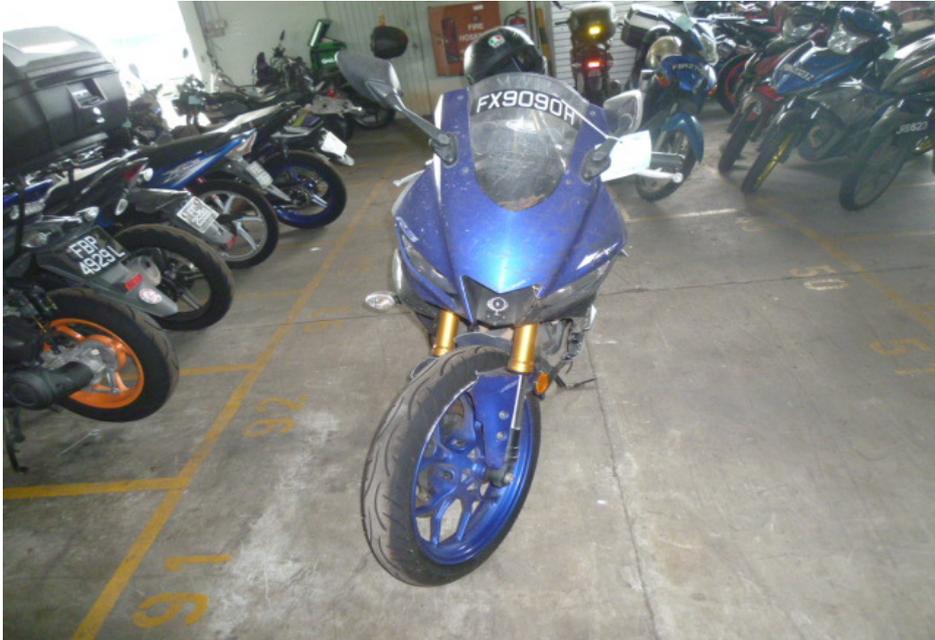
Photo 23 shows the front wheel of the Motorcycle turned towards its full right. Turning the Motorcycle's handle bar towards the right did not produce any abnormal free play and/or resistance. This would indicate that the steering system of the Motorcycle was in serviceable condition at the time of our inspection.

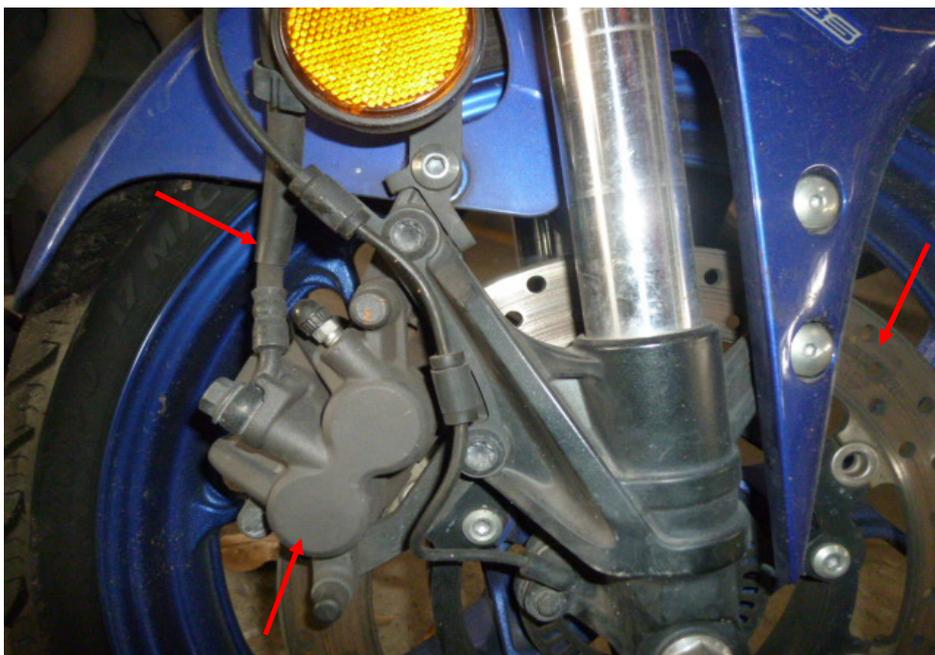
Photo 24 shows a close up view of the front brake caliper, front brake disc and front brake hose (arrowed) of the Motorcycle, which are all part of the

components in the hydraulic front brake system of the Motorcycle. Our visual checks of these various components had revealed all to be intact with no visible damage. No leakage of brake fluid was also observed.

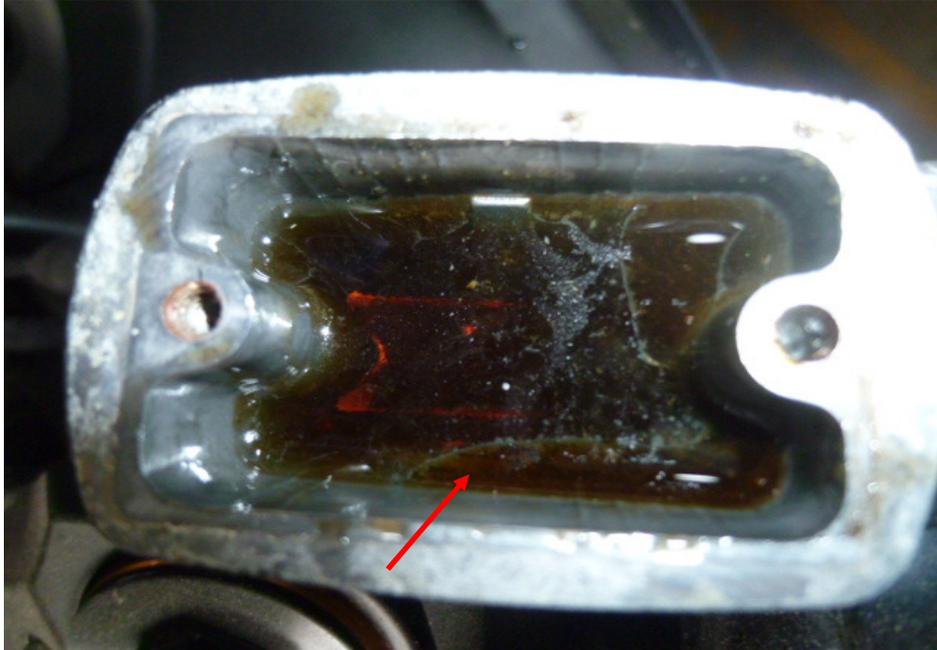
14. The brake fluid for the front brake and rear brake was observed to be of sufficient level for operational purposes. However the brake fluid for the front brake and rear brake was found to be slightly contaminated.

Photo 25 shows a close up view of the brake fluid reservoir for the front brake of the Motorcycle. The brake fluid was observed to be of sufficient level for operational purposes. However it was found to be slightly contaminated (arrowed).

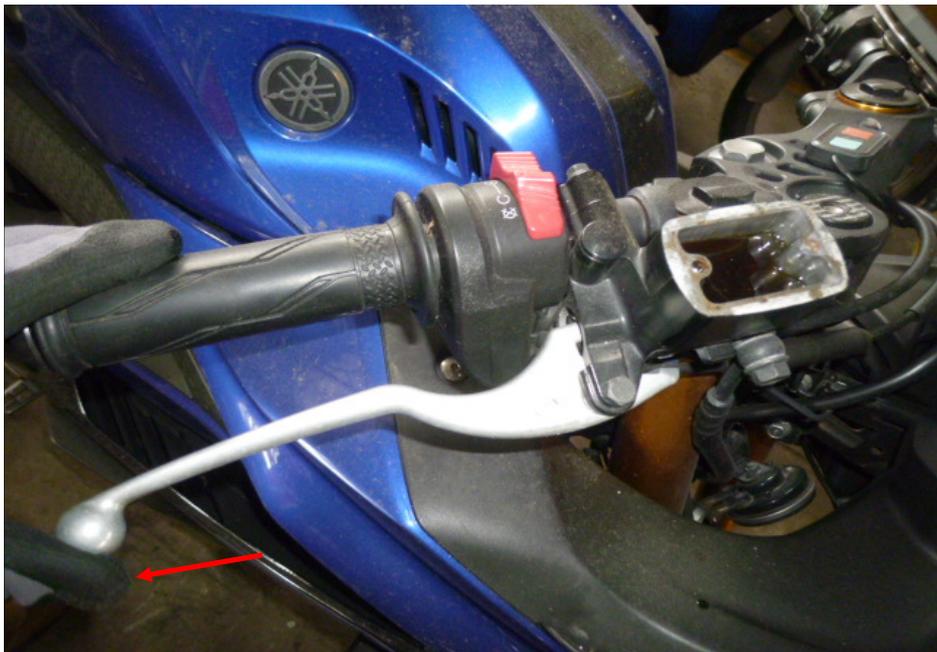
Photo 26 shows the front brake lever being depressed. There was some resistance felt (spongy like feel) upon pressing the front brake lever (arrowed).

This would indicate that there is no leakage of pressure/vacuum in the front brake system.

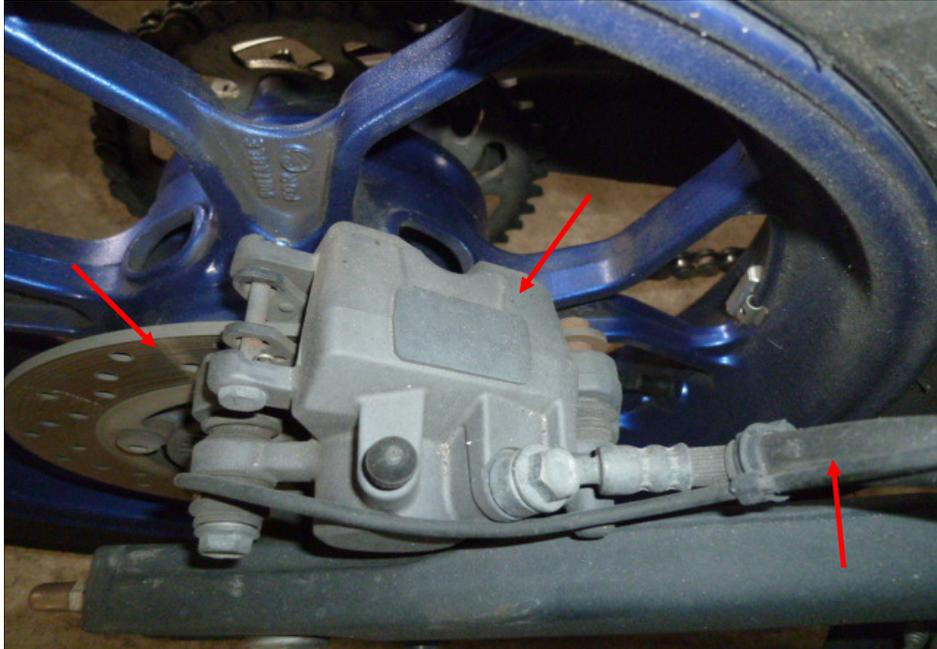
Photo 27 shows a close up view of the rear brake caliper, rear brake disc and rear brake hose (arrowed) of the Motorcycle, which are all part of the components in the hydraulic rear brake system of the Motorcycle. Our visual checks of these various components had revealed all to be intact with no visible damage. No leakage of brake fluid was also observed.

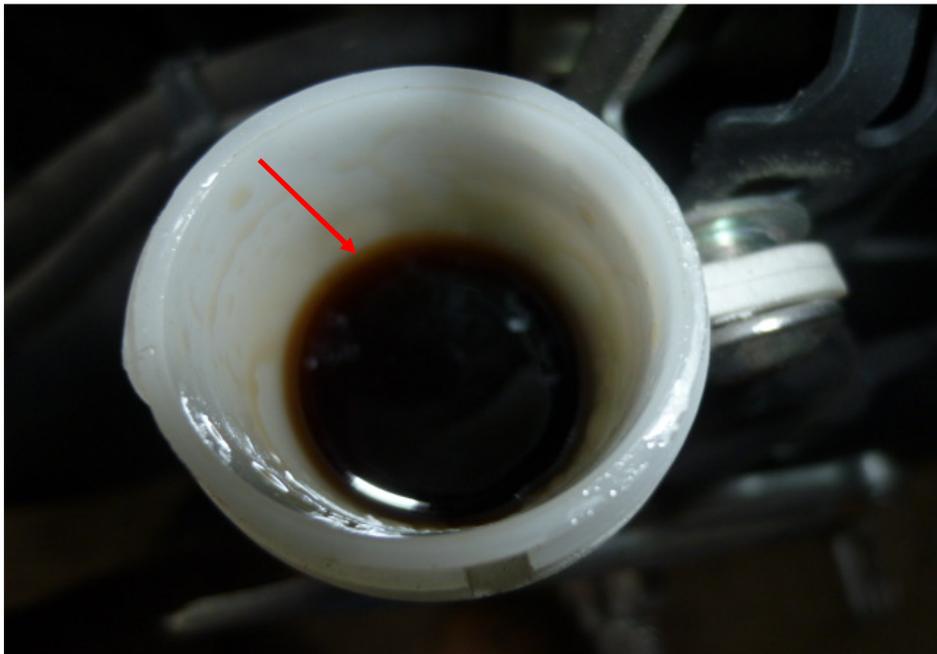
Photo 28 shows a close up view of the brake fluid reservoir for the rear brake of the Motorcycle. The rear brake fluid was observed to be of sufficient level for operational purposes. However it was found to be slightly contaminated (arrowed).
