Our Reference : KAAS/KT/6277/2820/TP/08.21
Date : 06 September 2021

VEHICLE APPRAISAL REPORT

Registration No.	: SMV 2820S	Chassis Frame No.	: ZWR800434571
Make / Model	: Toyota Noah Hybrid 7-Seater 1.8X CVT	Engine No. (Logcard)	: 2ZR0F29361
Year of Manufacture/Reg	: 2020	Odometer Reading	: 70,644 KM
Colour	: White		
Class / Type	: MPV

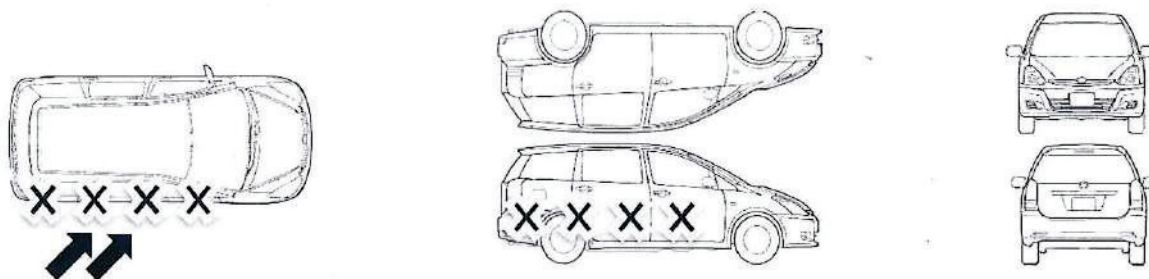
Damages sustained were consistent with the subject vehicle being involved in a collision with another vehicle and the impact was delivered **Diagonally to the RH Side from rear to front; right to left;** portion of the vehicle.

The general area of damages is at the **RH Side portion**
(Please refer to the parts list and photographs as attached for more information)
