Your Ref: M11D00052210
Our Ref: CS4/UOI22010525/N

21 November 2022

**TECHNICAL INVESTIGATION REPORT OF FIRE INCIDENT INVOLVING THE
INSURED VEHICLE GBG 499J ON 30 SEPTEMBER 2022**

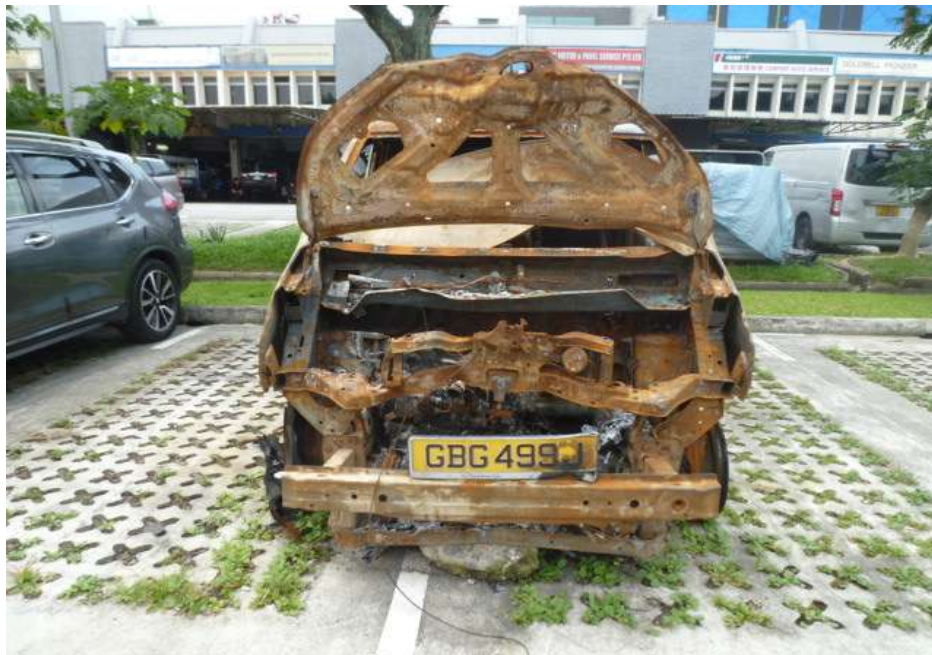
Photo 1 shows the general view of the frontal portion of the Insured Vehicle at the time of our inspection. The Insured Vehicle was observed to have sustained extensive fire damage all around. Its engine compartment and interior compartment were completely burnt. Rust had accumulated all over the Insured Vehicle as a result of exposure to environmental condition for a period of time.

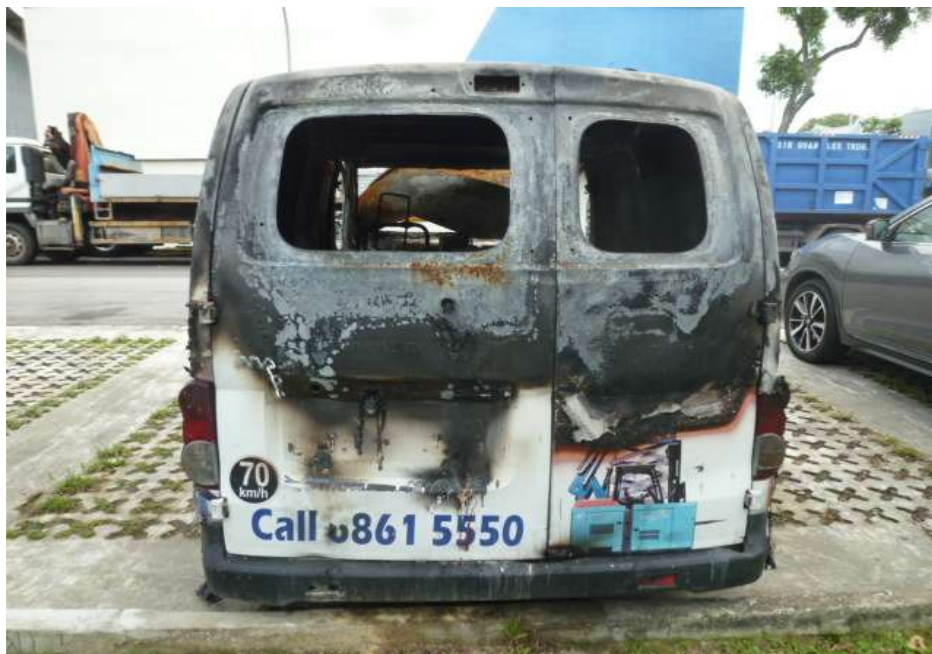
Photo 2 shows the general view of the rear portion of the Insured Vehicle at the time of our inspection. The Insured Vehicle was observed to have sustained extensive fire damage all around. Rust had accumulated all over the Insured Vehicle as a result of exposure to environmental condition for a period of time.

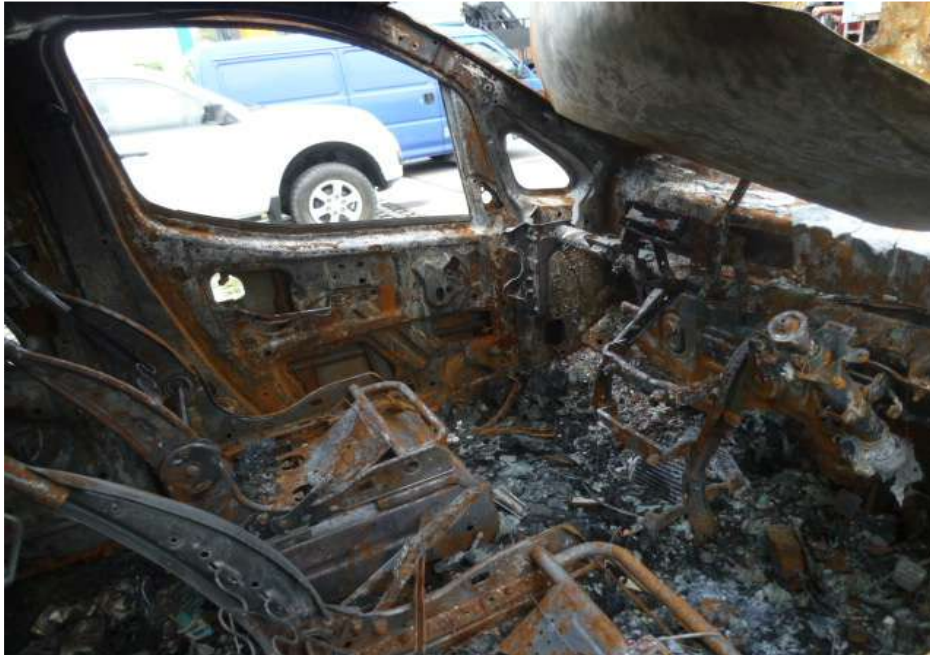
Photo 3 shows the general view of the interior compartment of the Insured Vehicle at the time of our inspection. Its interior compartment was completely burnt.

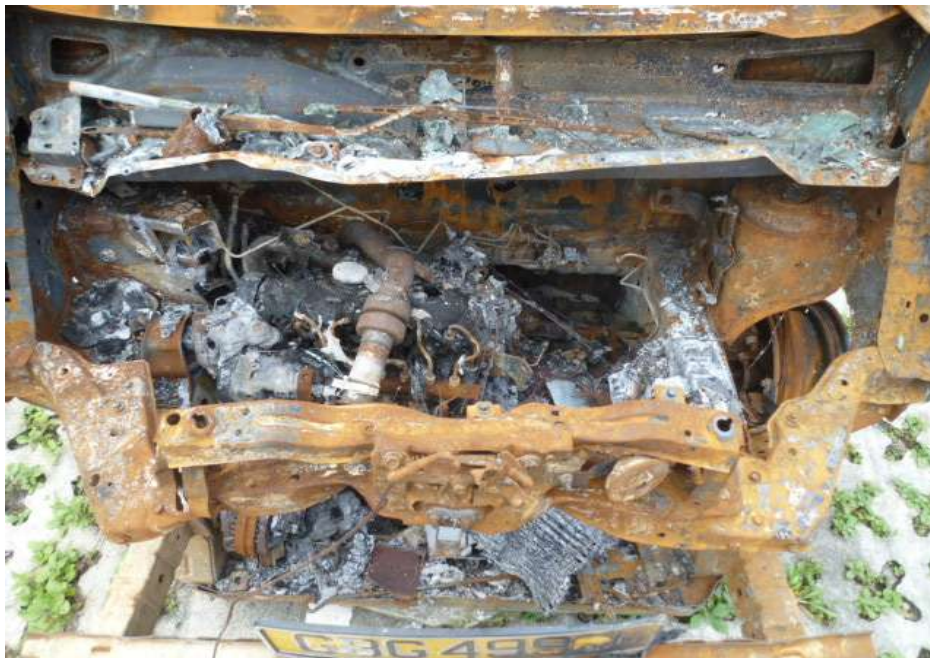
Photo 4 shows the engine compartment of the Insured Vehicle at the time of our inspection. The entire engine compartment of the Insured Vehicle was observed to be severely burnt. Most of the parts inside the engine compartment were found to be burnt and/or melted as a result of the fire.

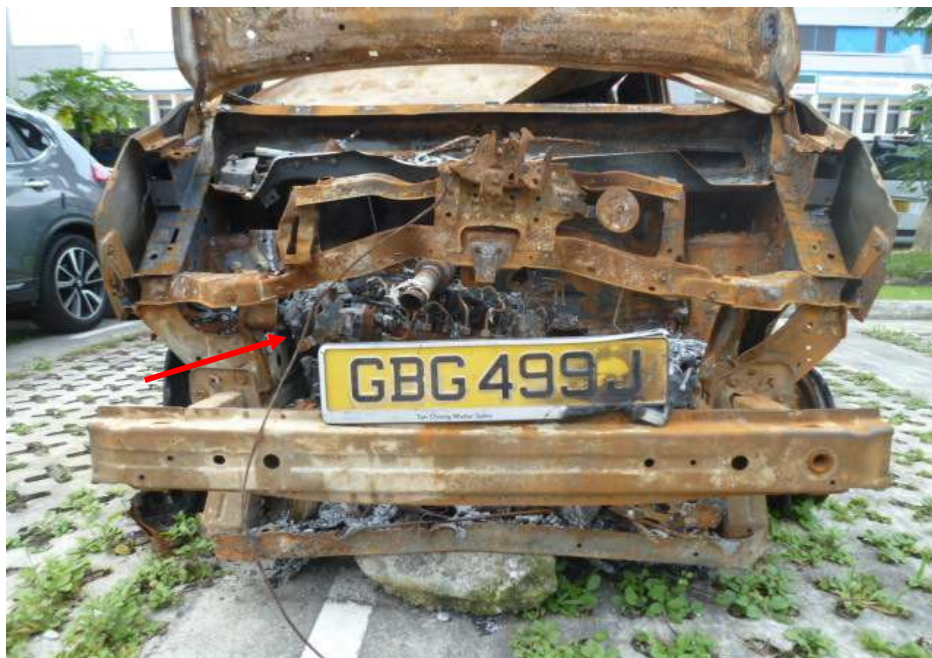
7. For this particular case, the fire appears to have originated within the engine compartment of the Insured Vehicle due to the nature of the fire damage which was more extensive at the engine compartment. See photo 5 below.

Photo 5 shows a closer view of the frontal portion of the Insured Vehicle. The fire appears to have originated within the engine compartment of the Insured Vehicle due to the nature of the fire damage which was more extensive at the engine compartment (arrowed).

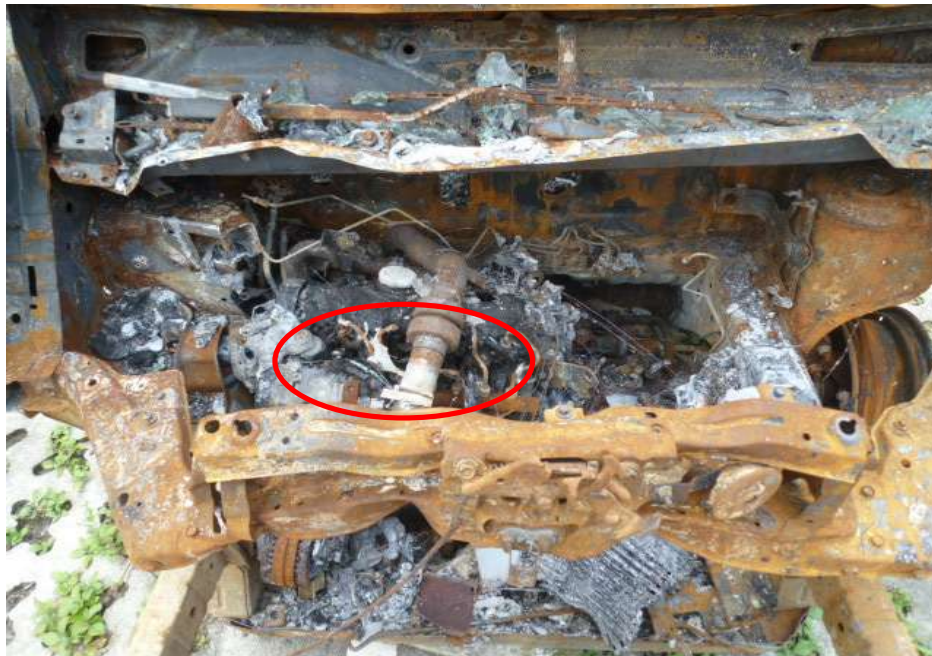
8. Upon closer examination of the engine compartment, in particular at the centre portion, we had found traces of greenish residue on several burnt stretches of original factory fitted wirings around the centre portion of the engine compartment. The presence of such greenish residue indicates internal heating of copper wires, a sign of an electrical short circuit occurring. The greenish residue is normally left behind from oxidation as a result of chemical reaction involving the copper wires. This physical evidence would then appear to suggest that the cause of fire to the Insured Vehicle could have possibly been due to electrical in nature. See photos 6 - 10 below.

Photo 6 shows the burnt stretches of original factory fitted wirings at the centre portion of the engine compartment, which is in the immediate vicinity where the fire to the Insured Vehicle had likely started. Traces of greenish residue were found on some of the wirings (circled). The presence of greenish residue indicates internal heating of copper wires, a sign of an electrical short circuit occurring. The greenish residue is normally left behind from oxidation as a result of chemical reaction involving the copper wires.

22. The possibility of the fire being due to electrical in nature would then seem more likely given that engine overheating and external factors would both seem unlikely. The fire being due to electrical nature is also supported by the faint traces of greenish residue that were found on several burnt stretches of original factory fitted wirings around the centre portion of the engine compartment of the Insured Vehicle, which was earlier discussed in paragraph 8 above.

24. Having investigated and technically analysed the damages of burnt nature to the Insured Vehicle, we are of the view that the cause of fire to the Insured Vehicle was of electrical in nature. For this particular case, the fire had originated along the wirings around the engine compartment. The wirings were original factory wirings around the centre portion of the engine compartment of the Insured Vehicle.
25. We did not find any evidence which had suggested that the cause of fire to the Insured Vehicle was due to poor maintenance and/or recurring electrical problem.

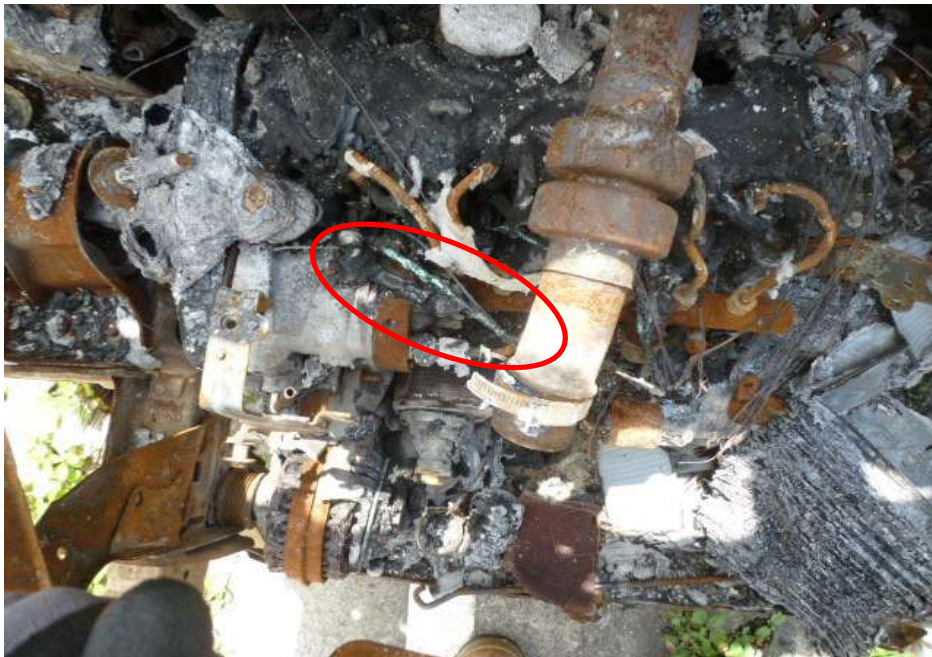
Photo 7 shows a closer view of the burnt stretches of original factory fitted wirings at the centre portion of the engine compartment, which is in the immediate vicinity where the fire to the Insured Vehicle had likely started. Traces of greenish residue were found on some of the wirings (circled).

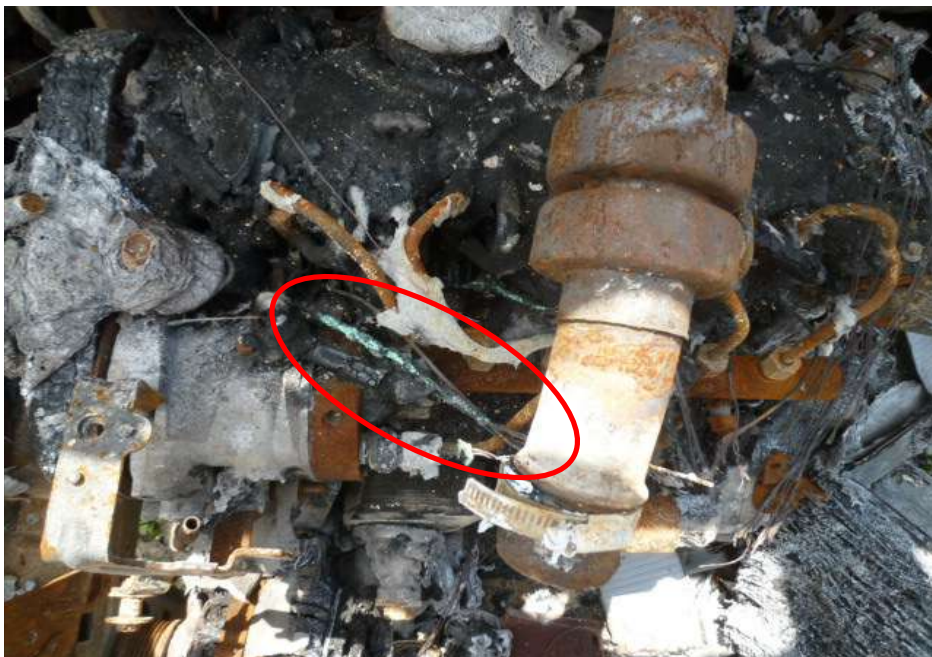
Photo 8 shows a closer view of the greenish residue found on some of the burnt wirings at the centre portion of the engine compartment (circled). The presence of such greenish residue suggests occurrence of an electrical short circuit.

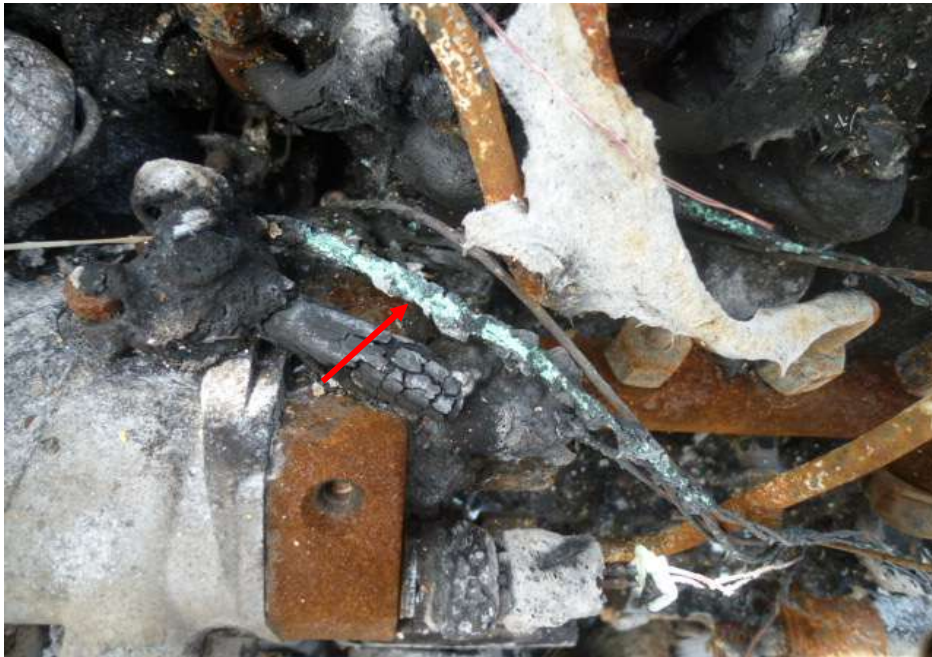
Photo 9 shows a close up view of the greenish residue found on some of the burnt wirings at the centre portion of the engine compartment (arrowed). The presence of such greenish residue suggests occurrence of an electrical short circuit.

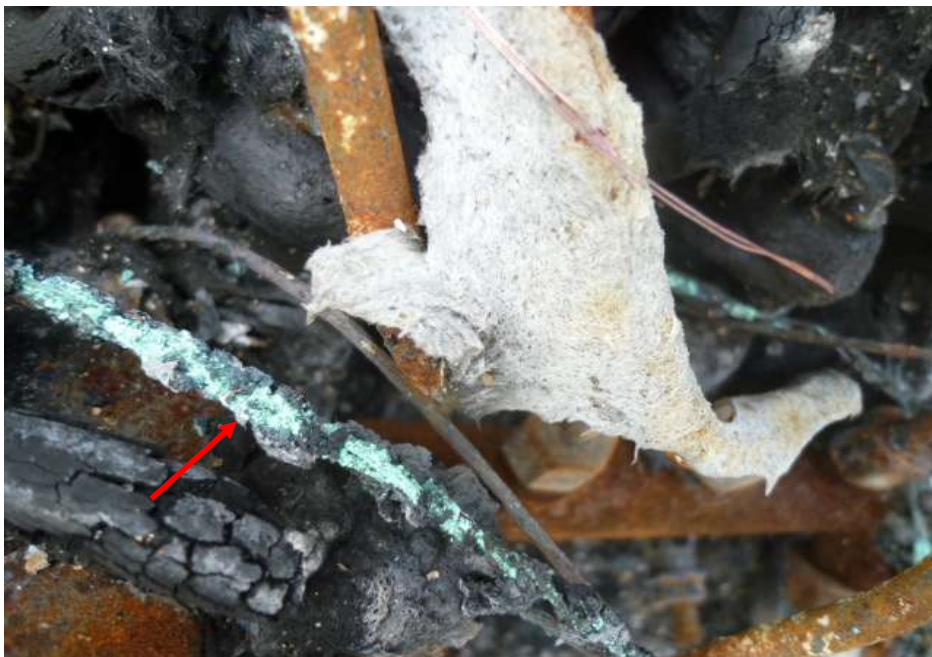
Photo 10 show shows a close up view of the greenish residue found on some of the burnt wirings at the centre portion of the engine compartment (arrowed). The presence of such greenish residue suggests occurrence of an electrical short circuit.

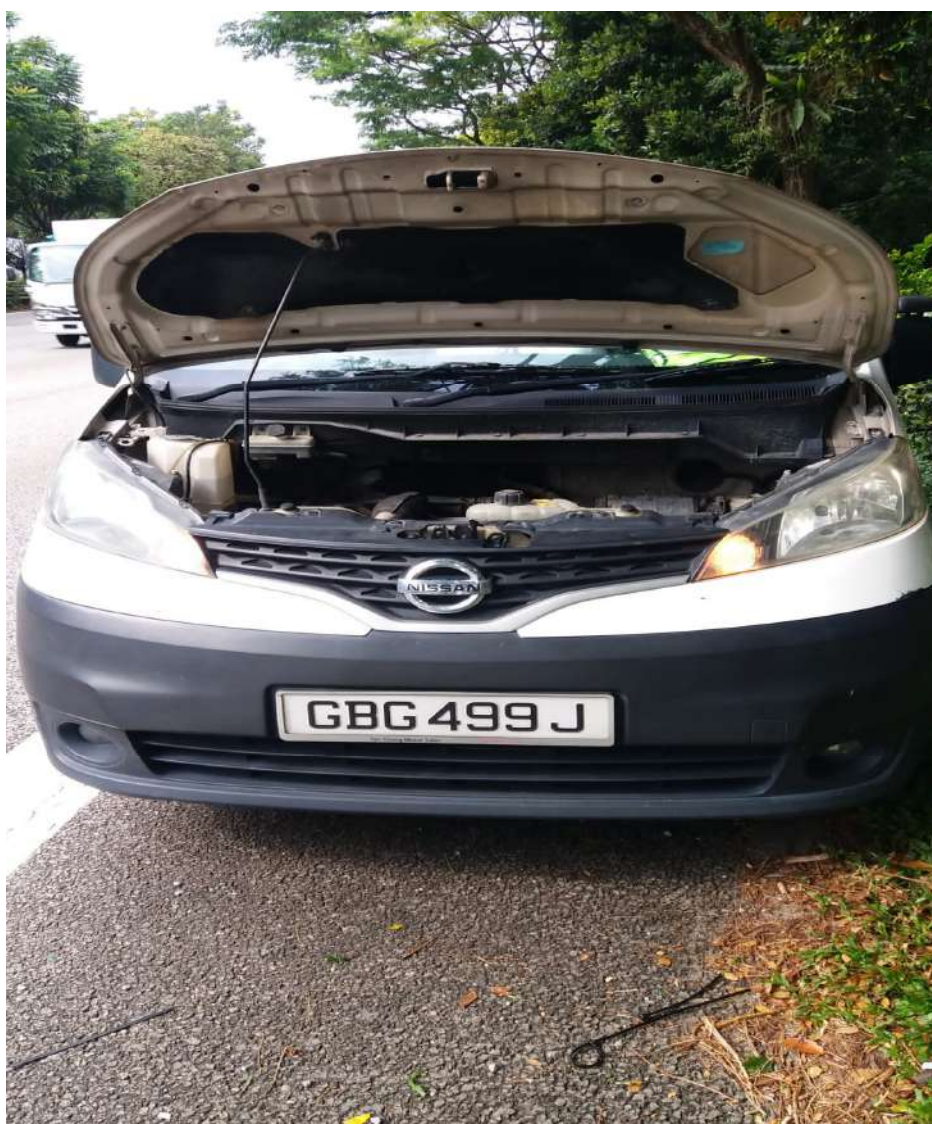
Photo 11 shows the Insured Vehicle which was waiting to be towed along the PIE on 29 September 2022. In general, the information that could be gathered from this photograph had corresponded to the events that were related to us by Mr Hashari, which is the Insured Vehicle had broken down along the PIE on 29 September 2022.

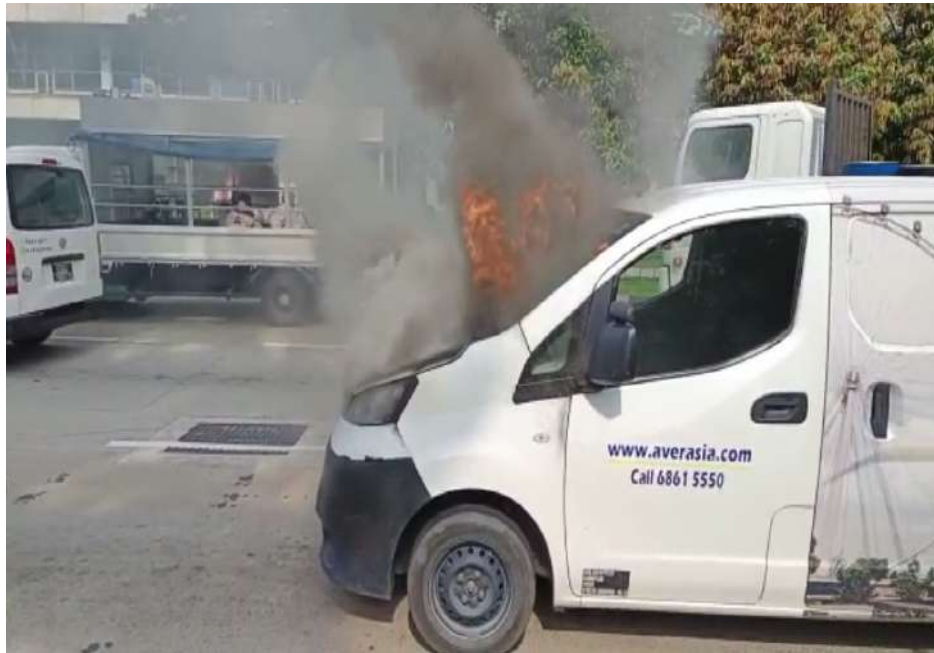
Photo 12 shows the Insured Vehicle on fire before the arrival of the SCDF. In general, the information that could be gathered from this photograph had corresponded to the events that were related to us by Mr Tan which is the fire had started from the engine compartment of the Insured Vehicle (arrowed).

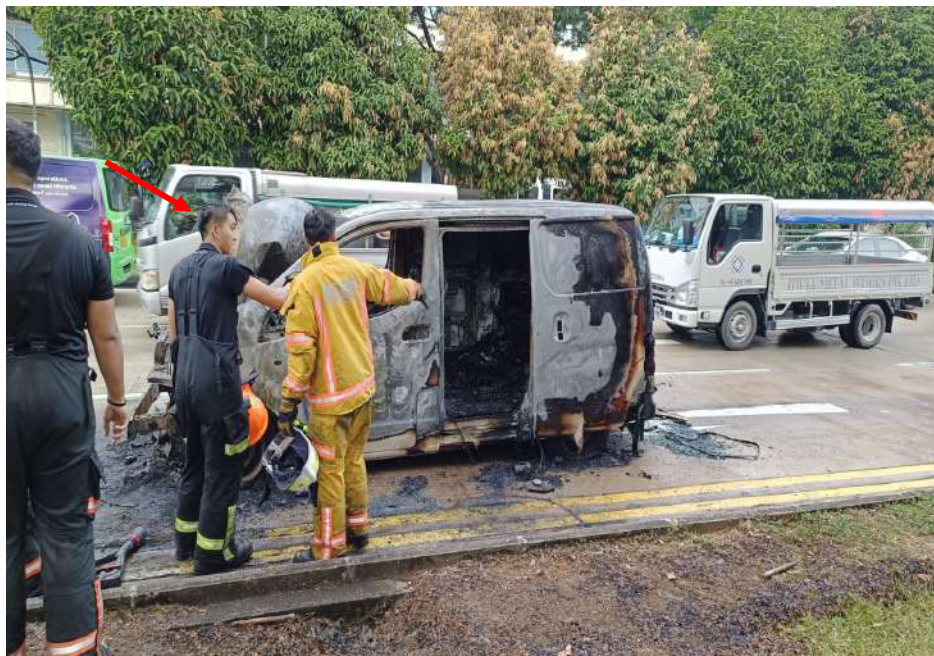
Photo 13 shows the Insured Vehicle post- incident. In general, the information that could be gathered from this photograph had corresponded to the events that were related to us by Mr Tan which is the SCDF were present at the incident location (arrowed).
