You're Ref: TP/IP/22498/2022
Our Ref: CI/TPD22010877/P

19th January 2023

MECHANICAL INSPECTION REPORT OF MOTOR CAR SNF 5084C

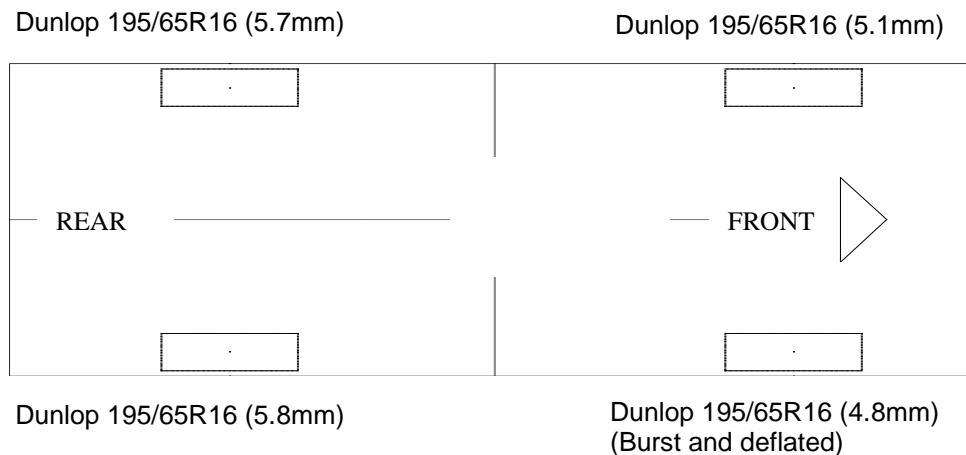
6. The front right tyre and wheel rim was damaged with a burst mark on the outer side wall of the tyre and a dent on the wheel rim due to the impact sustain as a result of the accident. However, the condition of the Motor Car's front left, both rear left and right tyres was observed to be in serviceable condition. I did not find any tear, cut or burst mark(s) on the outer and the inner sidewalls as well as across the tread of the front left, both rear left and right tyres. The front left, both rear left and right tyres were also observed to be sufficiently inflated for vehicular operation. The tyre brand, tyre size and remaining tread depth of the 4 tyres were recorded as follows:-

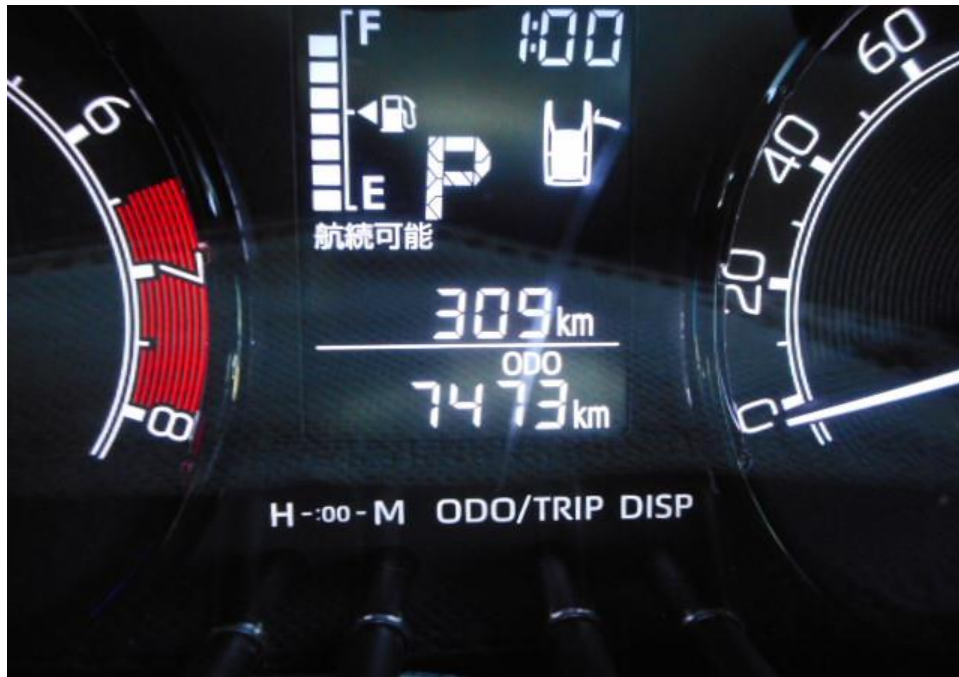
Photo 1 shows the mileage of the Motor Car at the time of my inspection. The mileage observed was 7,473km.

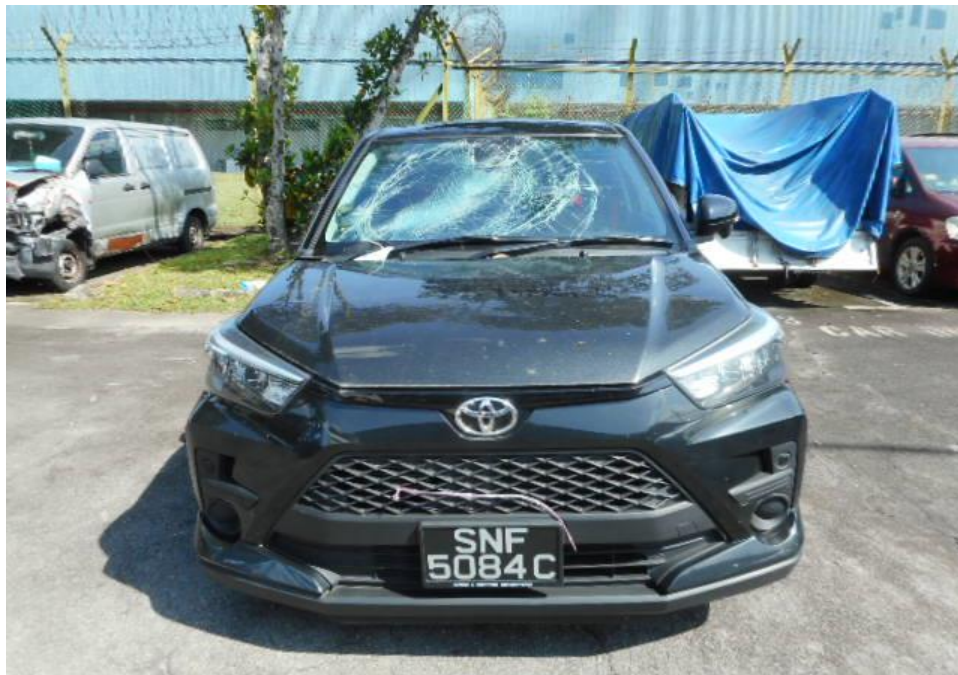
Photo 2 shows a general view of the Motor Car's front body at the time of my inspection. Its front and right portion. Its front windscreen, front right front door, its front right door windscreen, front right fender and right rear view mirror was the body parts that were damaged as a result of the accident.

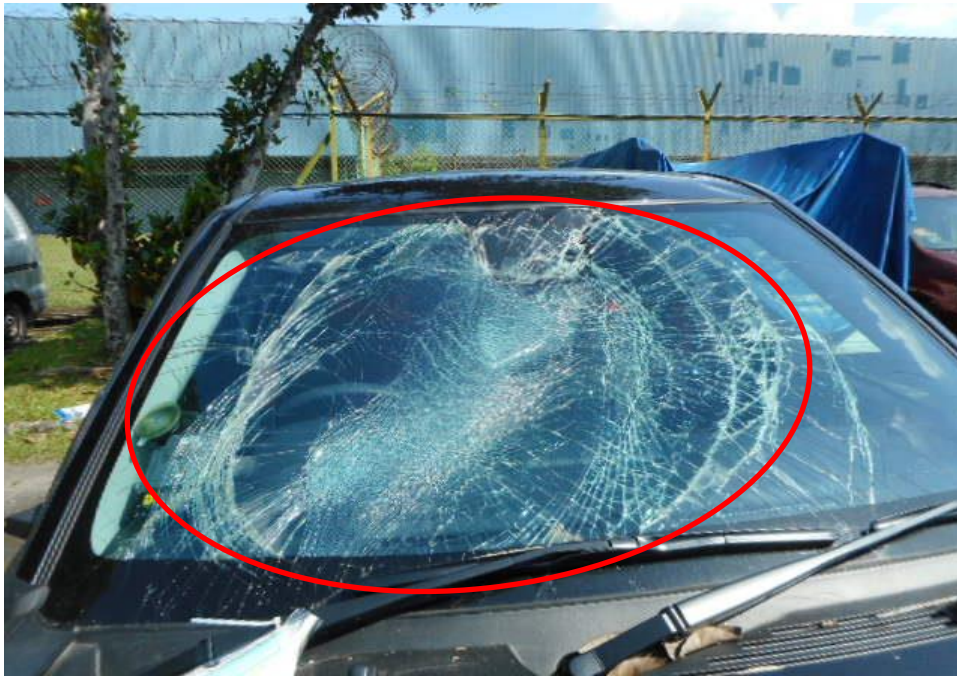
Photo 3 shows a close up view of the Motor Car's front body at the time of my inspection. The front portion of the Motor Car was observed to have sustained damage. Its front windscreen (circled) was the body parts that were damaged as a result of the accident.

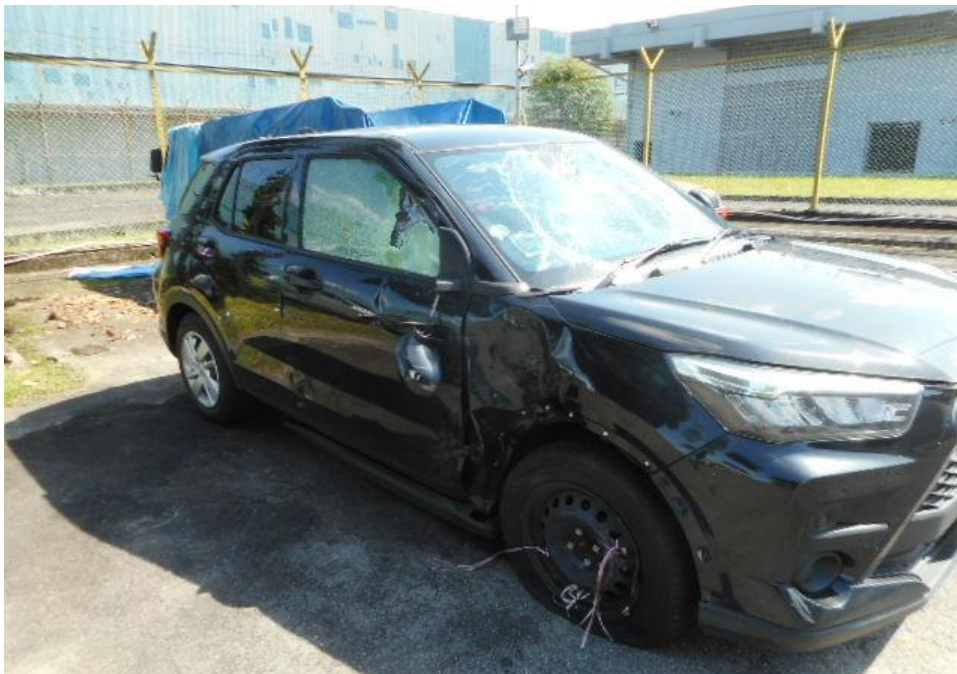
Photo 4 shows a general view of the Motor Car's right body at the time of my inspection. The Motor Car was observed to have sustained damage at its right portion. Its front right door, its front right door windscreen, front right fender and right rear view mirror was the body parts that were damaged as a result of the accident.

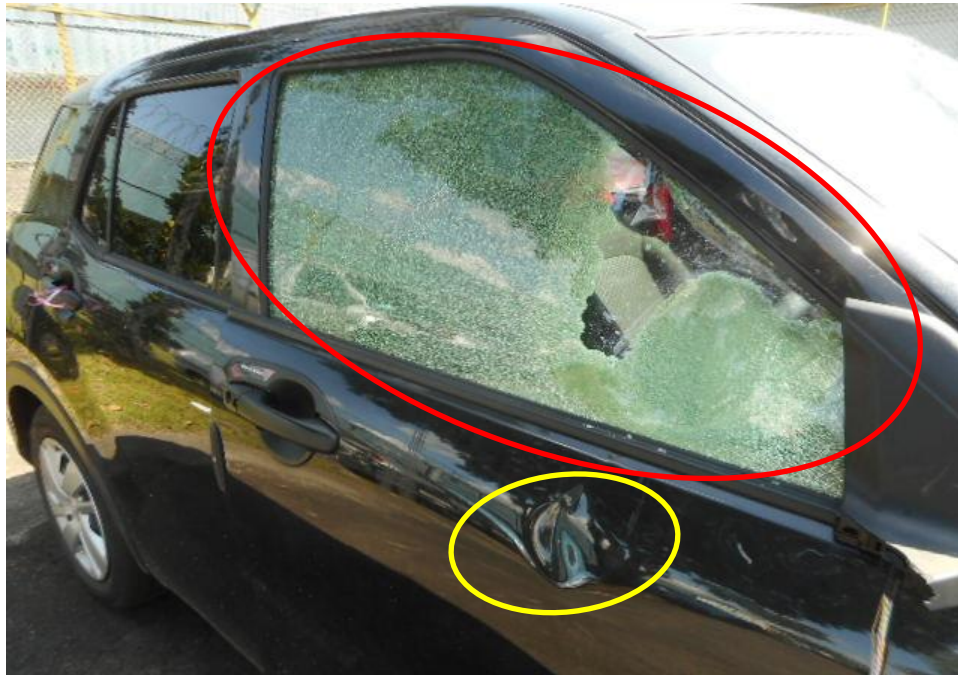
Photo 5 shows a close up view of the Motor Car's right body at the time of my inspection. The Motor Car was observed to have sustained damage at its right portion. Its front right door (yellow circle), its front right door windscreen (red circle) was the body parts that were damaged as a result of the accident.

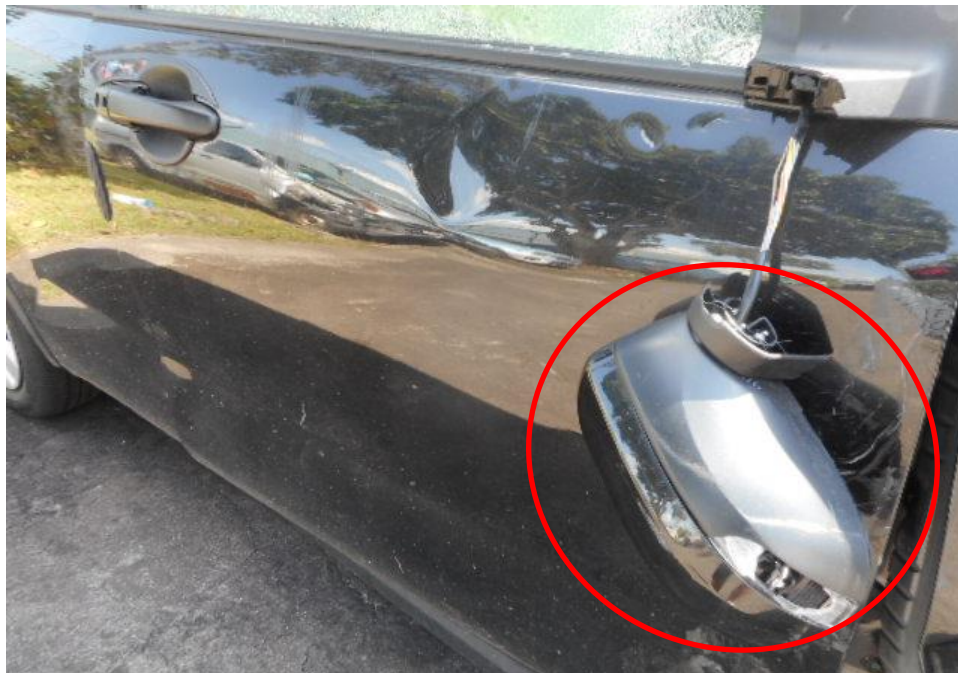
Photo 6 shows a close up view of the Motor Car's right body at the time of my inspection. The Motor Car was observed to have sustained damage at its right portion. Its right rear view mirror (circled) was the body parts that were damaged as a result of the accident.

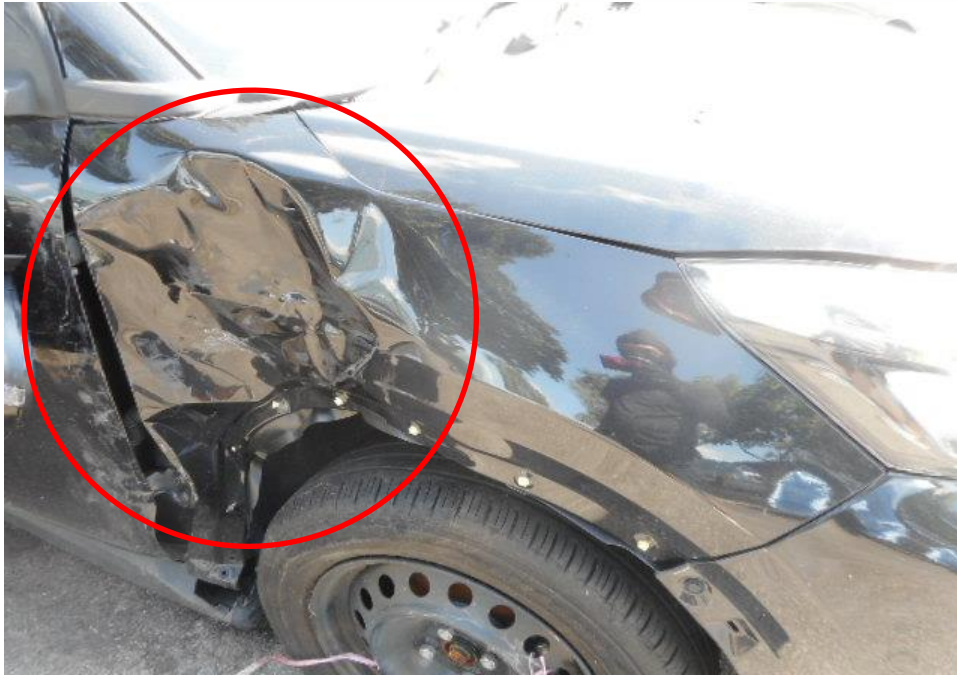
Photo 7 shows a close up view of the Motor Car's right body at the time of my inspection. The Motor Car was observed to have sustained damage at its right portion. Its front right fender (circled) was the body parts that were damaged as a result of the accident.

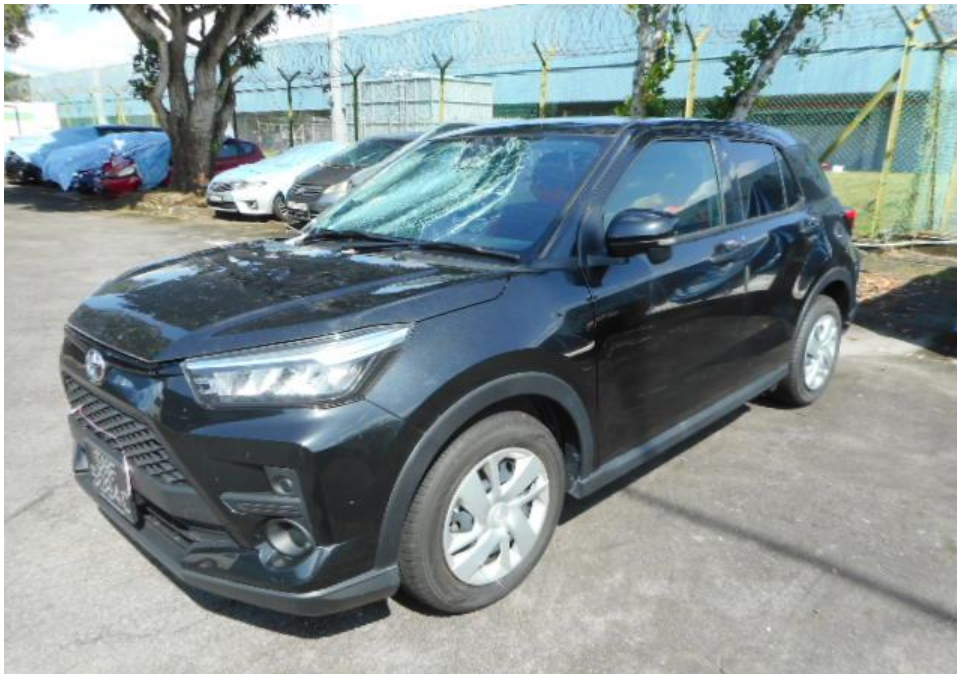
Photo 8 shows a general view of the Motor Car's left body at the time of my inspection. The left portion of the Motor Car was observed to have been unaffected by the accident.

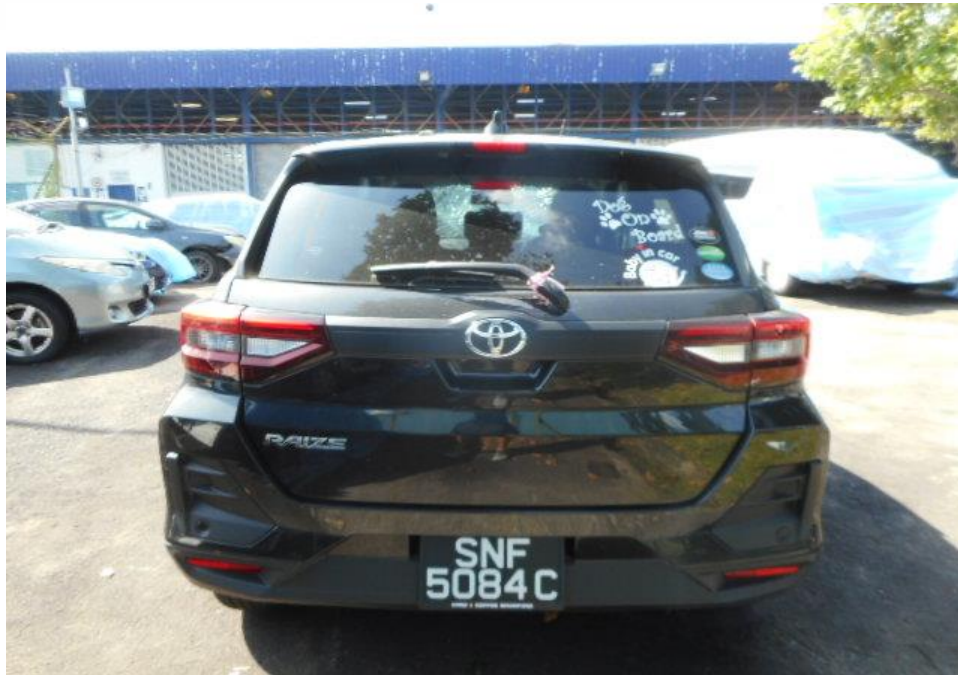
Photo 9 shows the general view of the Motor Car's rear body at the time of my inspection. The Motor Car rear was observed to be unaffected by the accident.

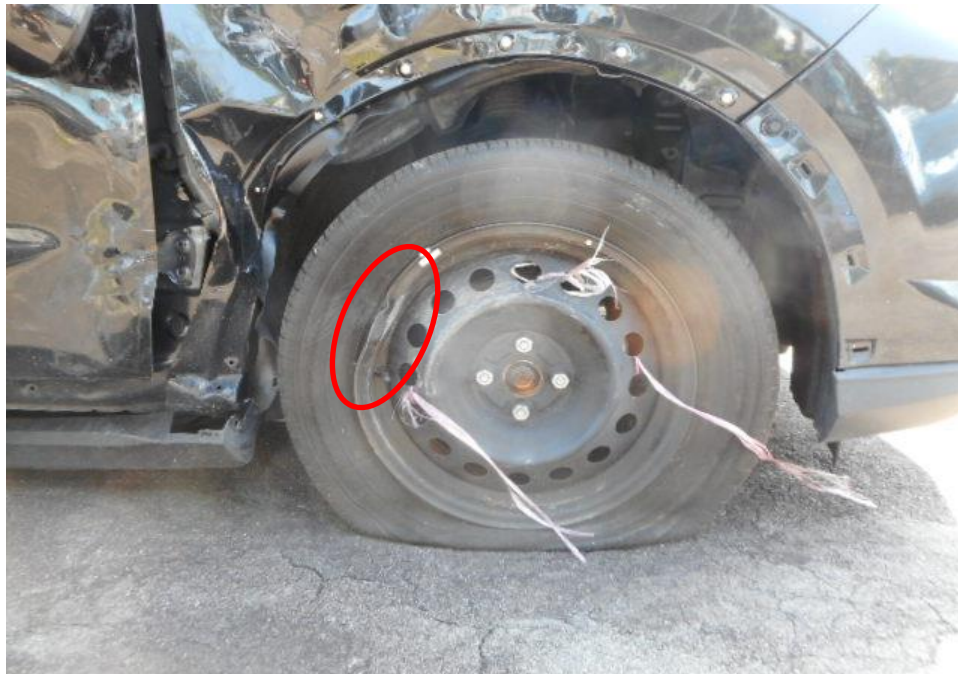
7. The front right tyre and wheel rim was damaged with a burst mark on the outer side wall of the tyre and a dent on the wheel rim due to the impact sustain as a result of the accident. However, the front left, both rear left and right tyres were observed to be wrapped around standard alloy wheel rims that were found to be without any damage. See photo 1 – 14 below.

Photo 10 shows the general view of the front right tyre and wheel rim which was damaged with a burst mark on the outer side wall of the tyre and a dent on the wheel rim (circled) due to the impact sustain as a result of the accident. Its remaining tread depth was of approximately 4.8mm.

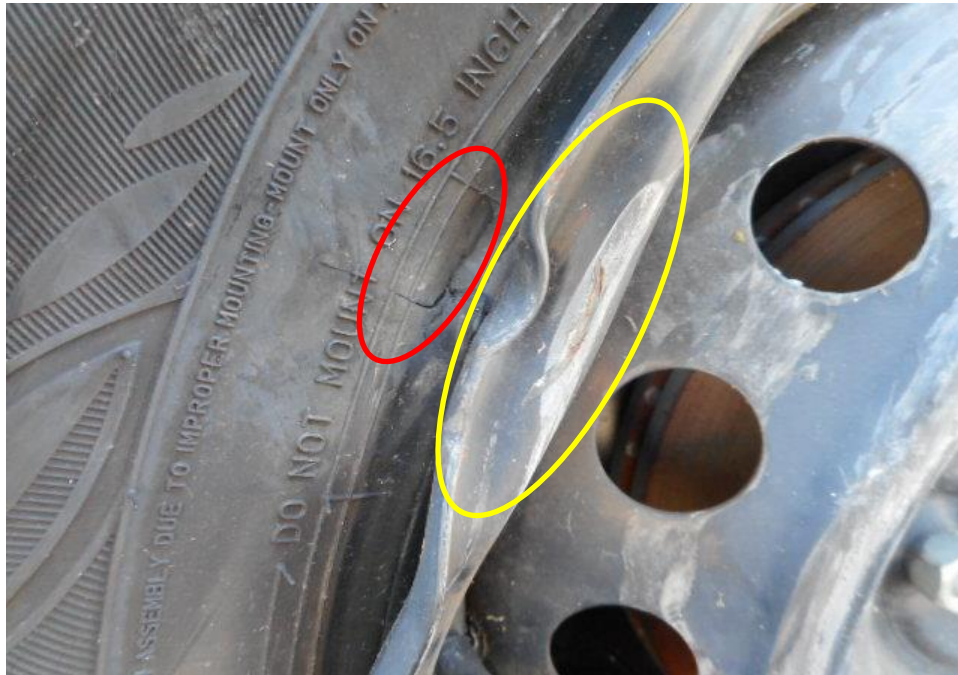
Photo 11 shows the close up view of the front right tyre and wheel rim which was damaged with a burst mark (red circle) on the outer side wall of the tyre and a dent (yellow circle) on the wheel rim due to the impact sustain as a result of the accident. Its remaining tread depth was of approximately 4.8mm.

19. The front right tyre and wheel rim was damaged with a burst mark on the outer side wall of the tyre and a dent on the wheel rim due to the impact sustain as a result of the accident. However, front left, both rear left and right tyres of the Motor Car were also found to be in serviceable condition. I did not find any tear, cut or burst mark(s) on the outer and the inner sidewalls as well as across the tread of front left, both rear left and right tyres. The front left, both rear left and right tyres were also observed to be sufficiently inflated for vehicular operation with remaining tread depth of approximately 5.1mm to 5.8mm and the front right tyre remaining tread depth was of approximately 4.8mm

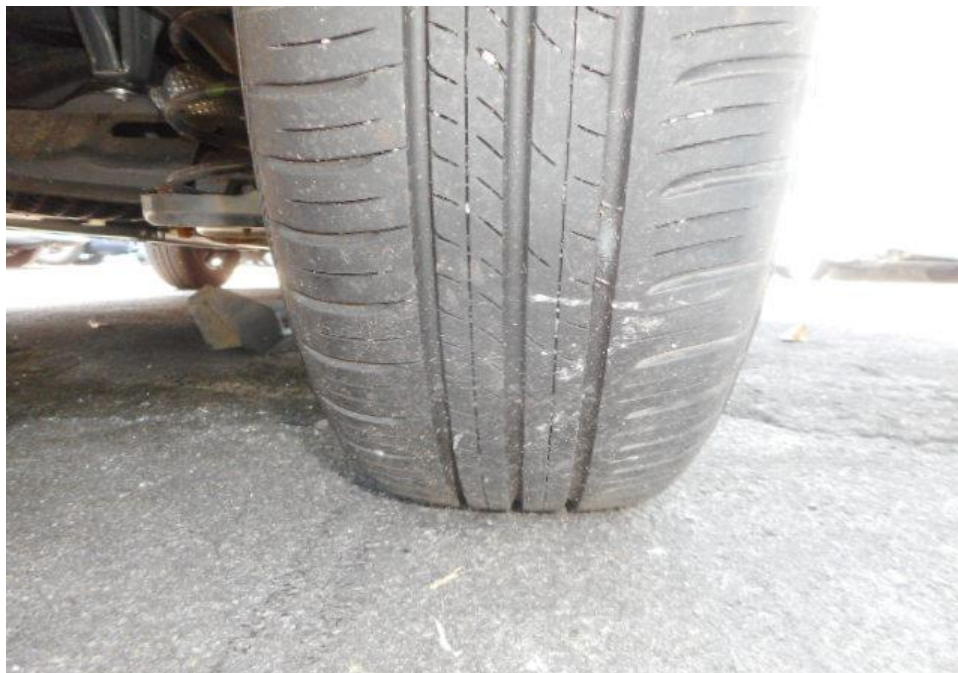
Photo 12 shows the condition of the rear right tyre of the Motor Car, which was observed to be in serviceable condition with remaining tread depth of approximately 5.8mm. The tyre was also observed to be sufficiently inflated for vehicular operation with no tear, cut or burst mark(s).

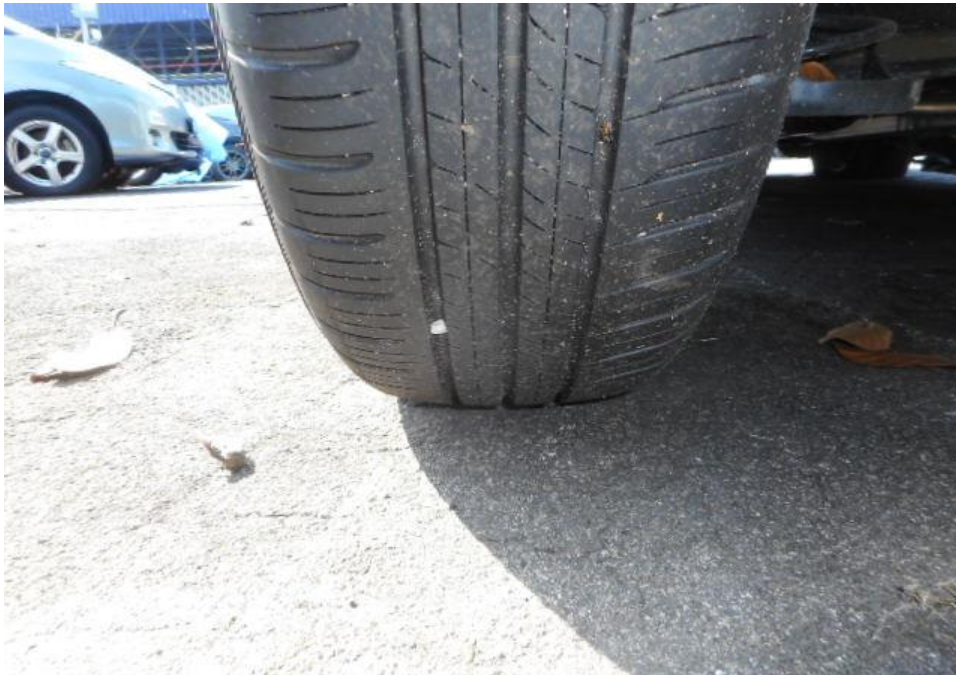
Photo 13 shows the condition of the rear left tyre of the Motor Car, which was observed to be in serviceable condition with remaining tread depth of approximately 5.7mm. The tyre, which was wrapped around alloy wheel rim, was also observed to be sufficiently inflated for vehicular operation.

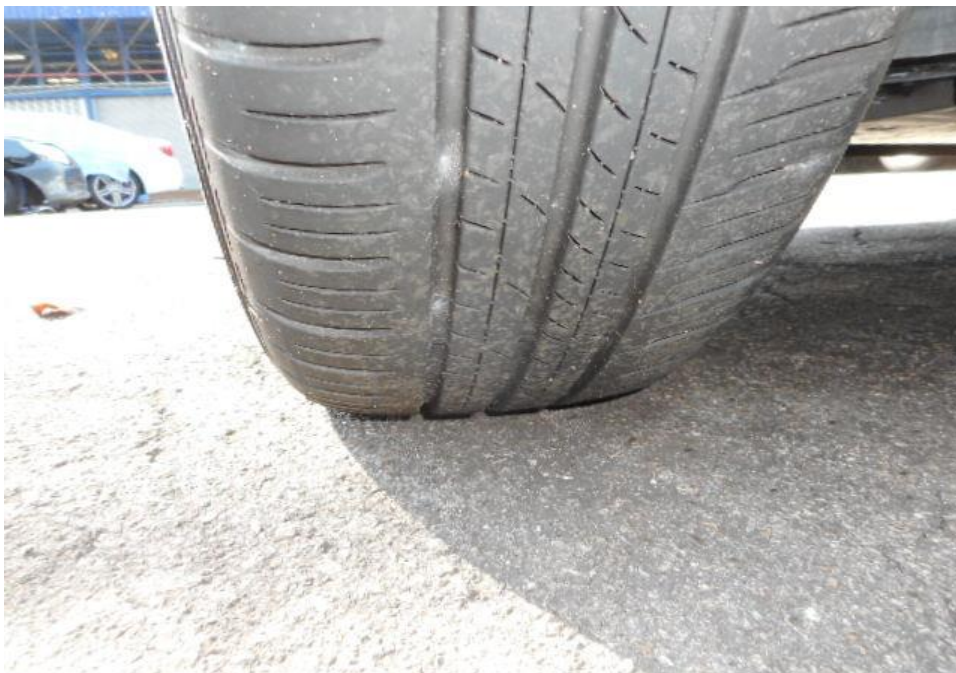
Photo 14 shows the condition of the front left tyre of the Motor Car, which was observed to be in serviceable condition with remaining tread depth of approximately 5.1mm. The tyre, which was wrapped around alloy wheel rim, was also observed to be sufficiently inflated for vehicular operation.

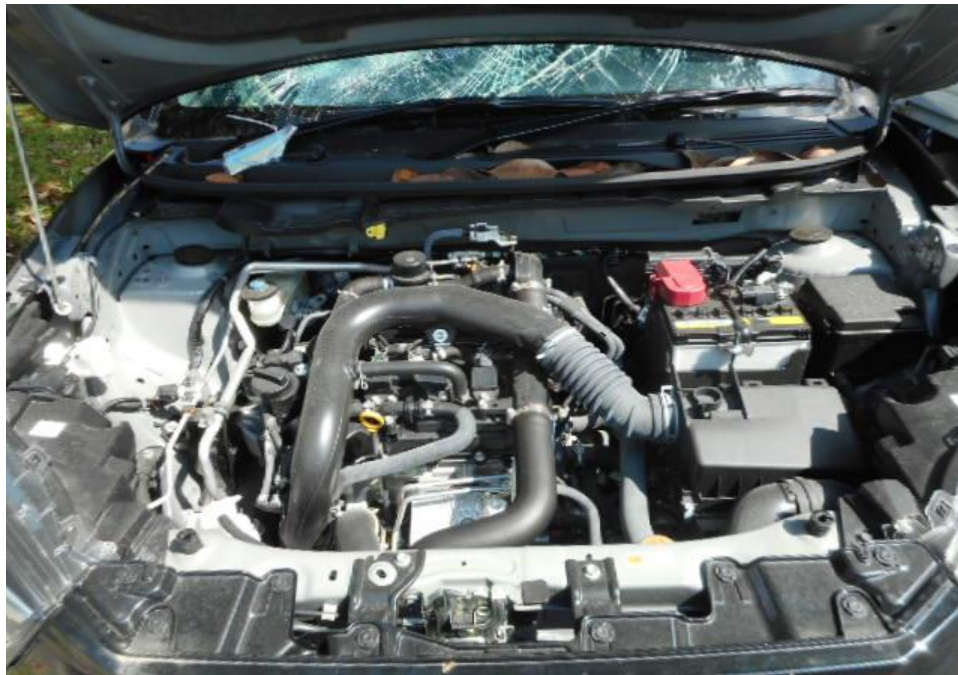
Photo 15 shows a general view of the Motor Car's engine compartment. The various parts and components inside the engine compartment were unaffected by the accident. There was also no sign(s) or indication(s) of fluid leakage and/or fluid stain within the engine compartment.

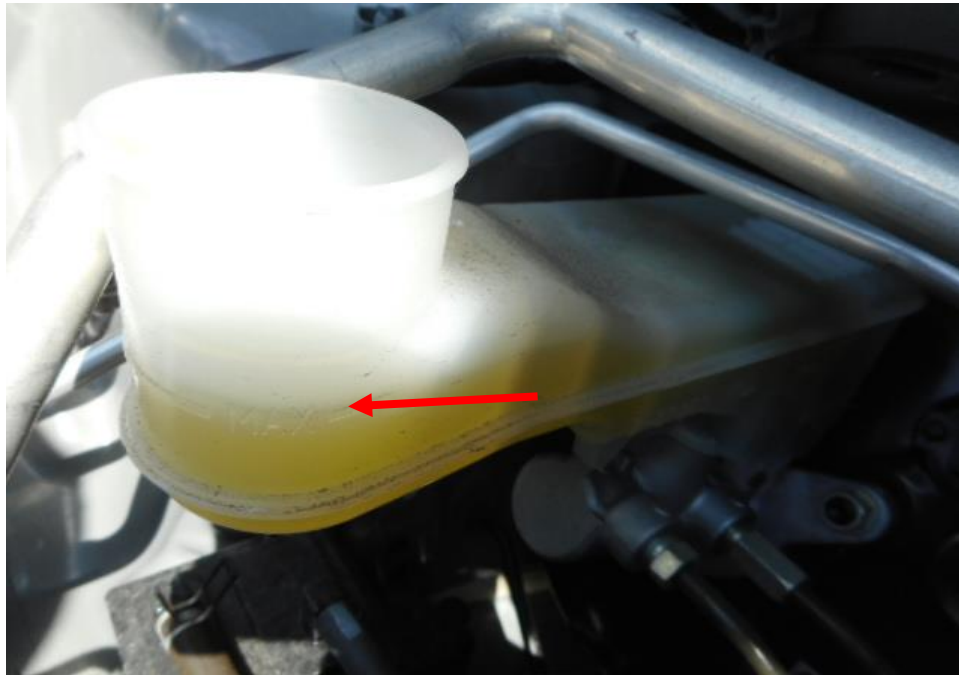
Photo 16 shows the brake fluid reservoir of the Motor Car at the time of my inspection. The brake fluid was observed to be of sufficient level (arrowed) and without any visible contamination.

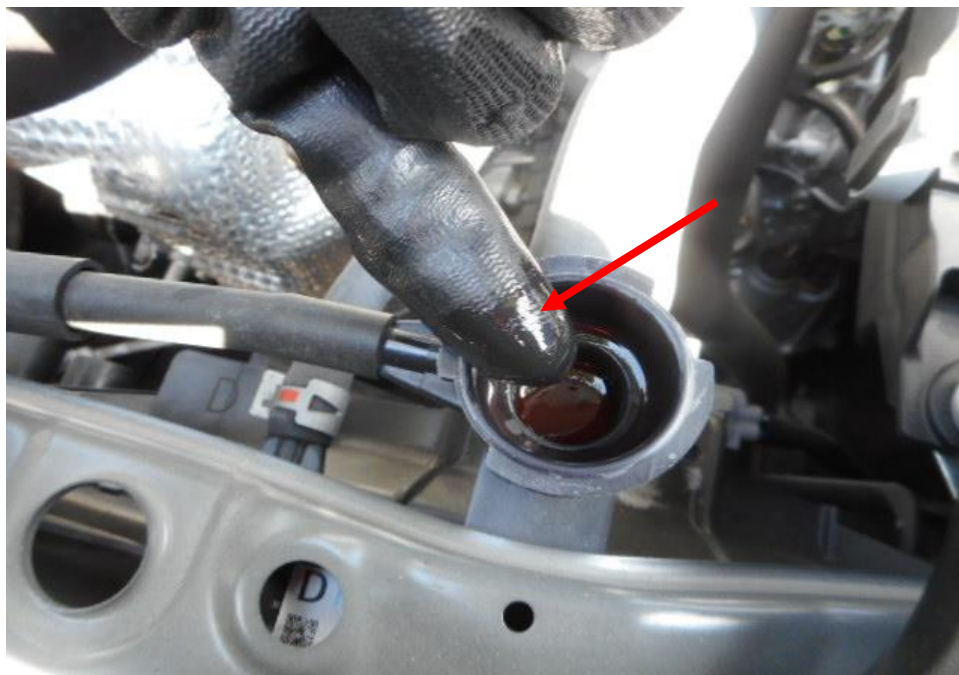
Photo 17 shows checks being carried out to the engine coolant of the Motor Car at the time of my inspection. The engine coolant was observed to be of sufficient level (arrowed) and without any visible contamination.

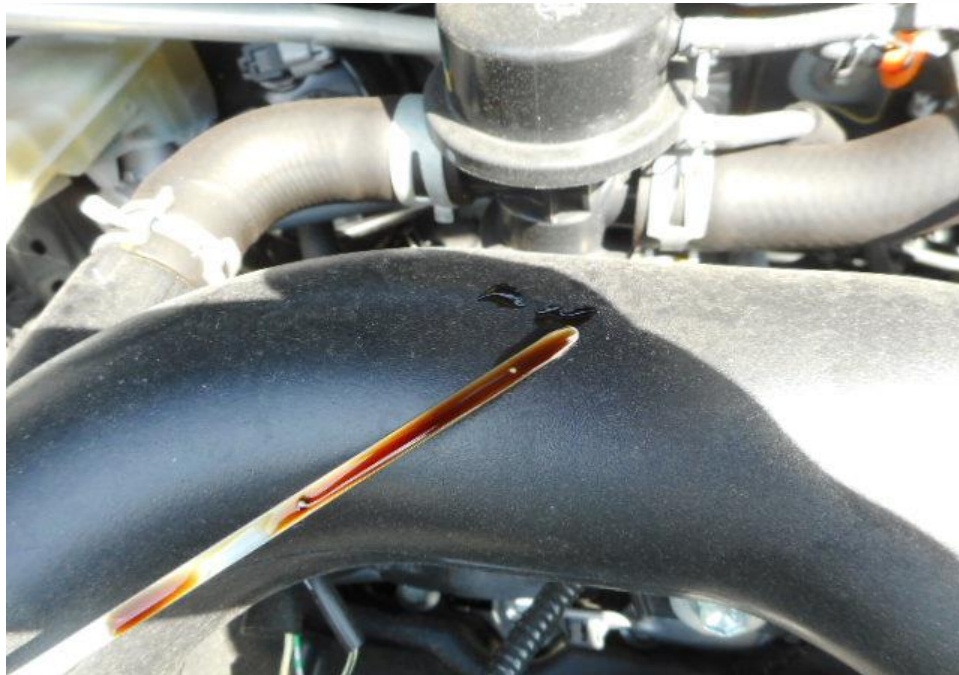
Photo 18 shows the engine oil dipstick of the Motor Car at the time of my inspection. The engine oil was observed to be of sufficient level and without any visible contamination.

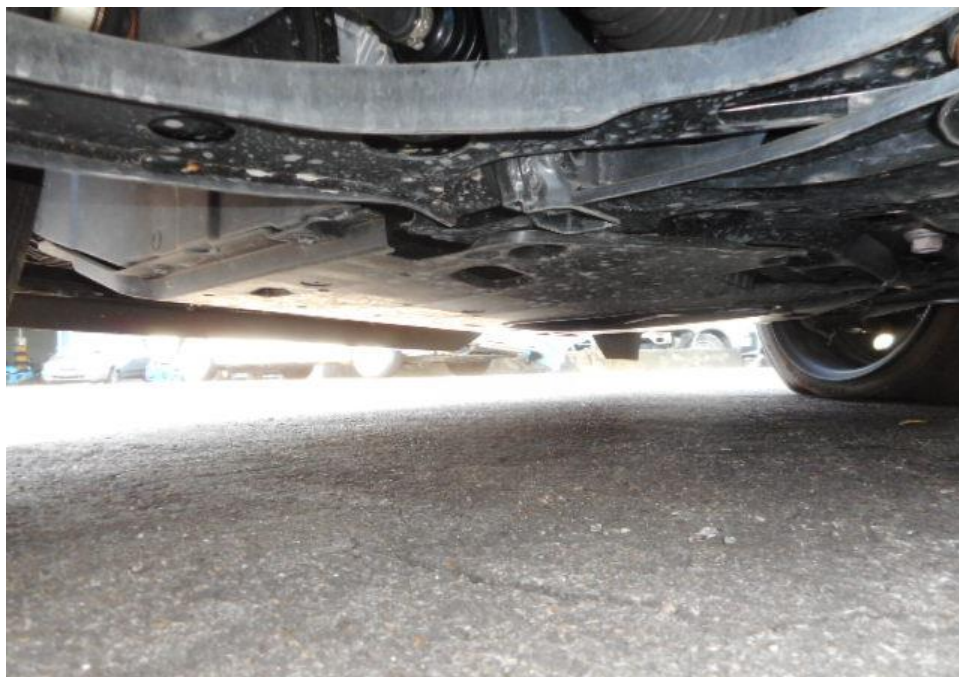
Photo 19 shows the undercarriage of the Motor Car, at the area where the engine housing and transmission housing are located. I did not find any sign(s) or indication(s) of fluid leak and/or fluid stain(s) on the underside of the Motor Car.

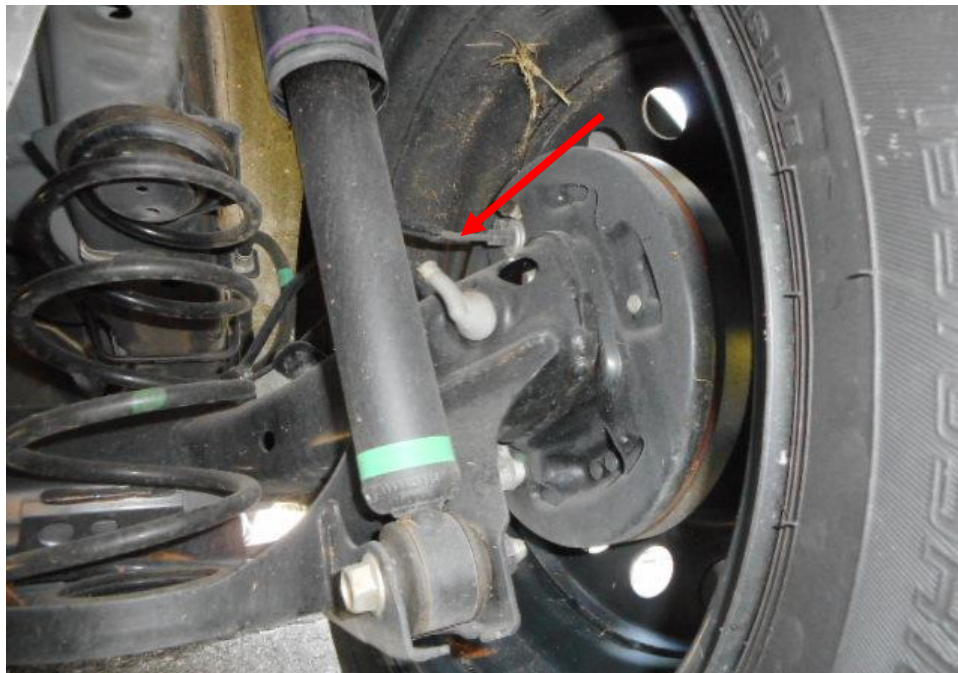
Photo 20 shows the brake hose/pipe (arrowed) at the rear right wheel of the Motor Car. No leakage of brake fluid was observed. Visual examination of the various components of the braking system like the drum brake, brake booster, brake pedal etc. had revealed all to be intact and without visible damage.

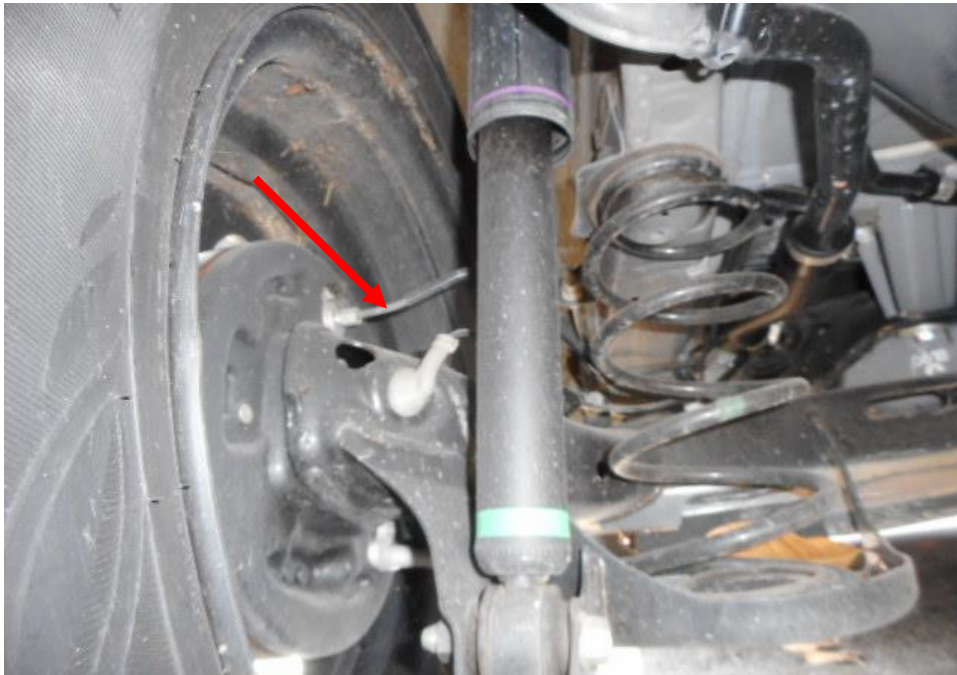
Photo 21 shows the brake hose/pipe (arrowed) at the rear left wheel of the Motor Car. I did not observe any leakage of brake fluid at the time of my inspection of the Motor Car. Static tests of the Motor Car's braking system had indicated that there was no internal leakage of pressure/vacuum. The undercarriage components of the Motor Car were also all found to be intact and without any visible damage.

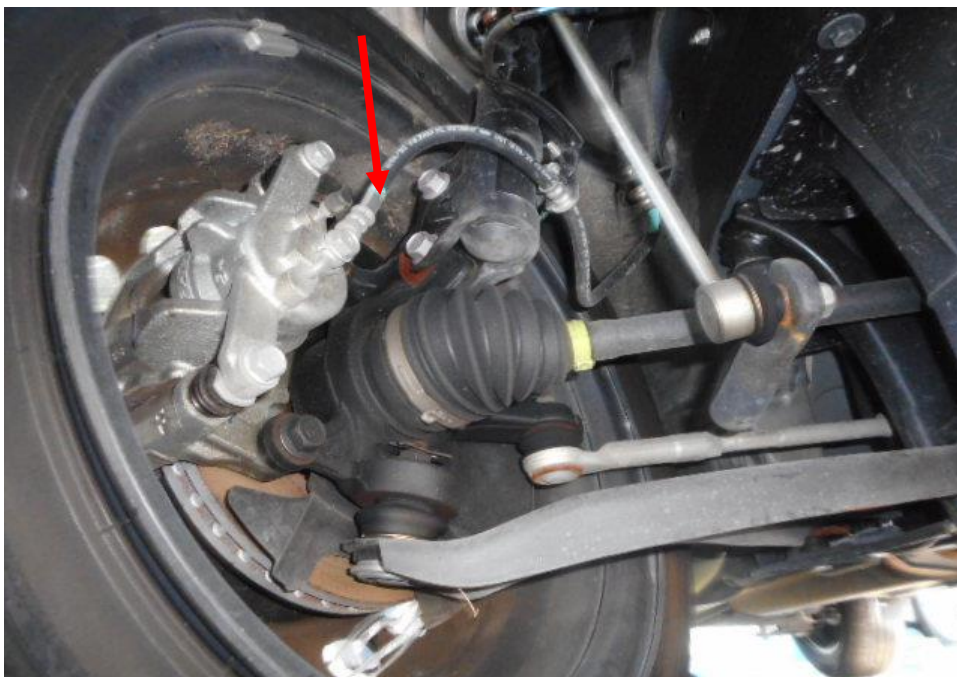
Photo 22 shows the brake hose/pipe (arrowed) at the front right wheel of the Motor Car. I did not observe any leakage of brake fluid at the time of my inspection of the Motor Car. Static tests of the Motor Car's braking system had indicated that there was no internal leakage of pressure/vacuum. The undercarriage components of the Motor Car were also all found to be intact and without any visible damage.

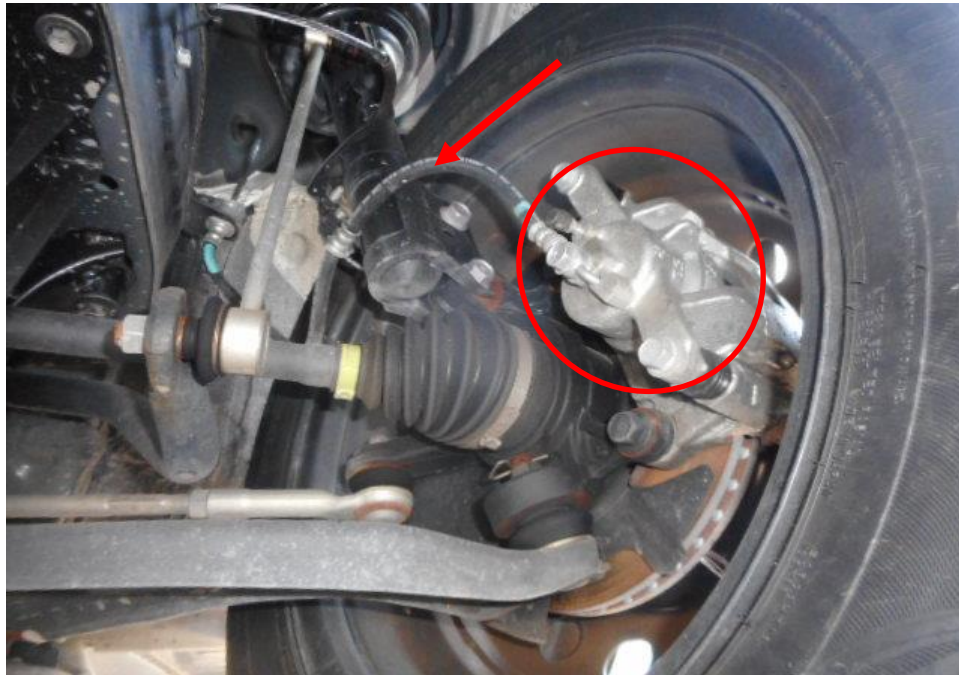
Photo 23 shows the brake hose/pipe (arrowed) at the front left wheel of the Motor Car. No leakage of brake fluid was observed. Visual examination of the various components of the braking system like the brake caliper (circled), brake booster, brake pedal etc had revealed all to be intact and without visible damage.

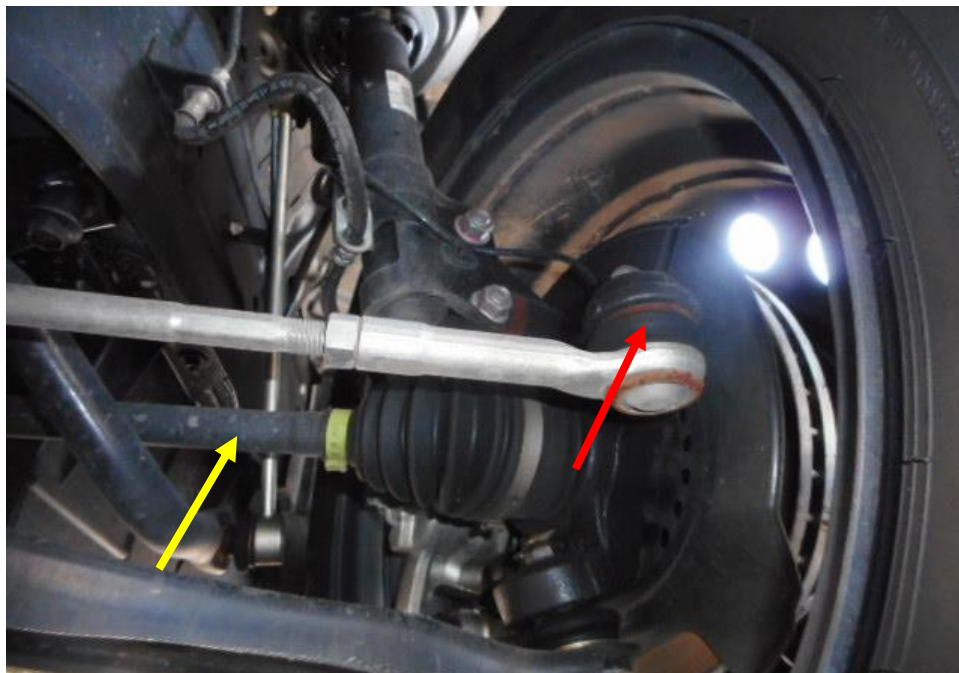
Photo 24 shows the various undercarriage components at the front right wheel of the Motor Car, in particular the steering tie rod (red arrow) and drive shaft (yellow arrow). The various steering components were all found to be intact and there was also no sign of fluid stain observed on the various undercarriage components at the front right wheel of the Motor Car.

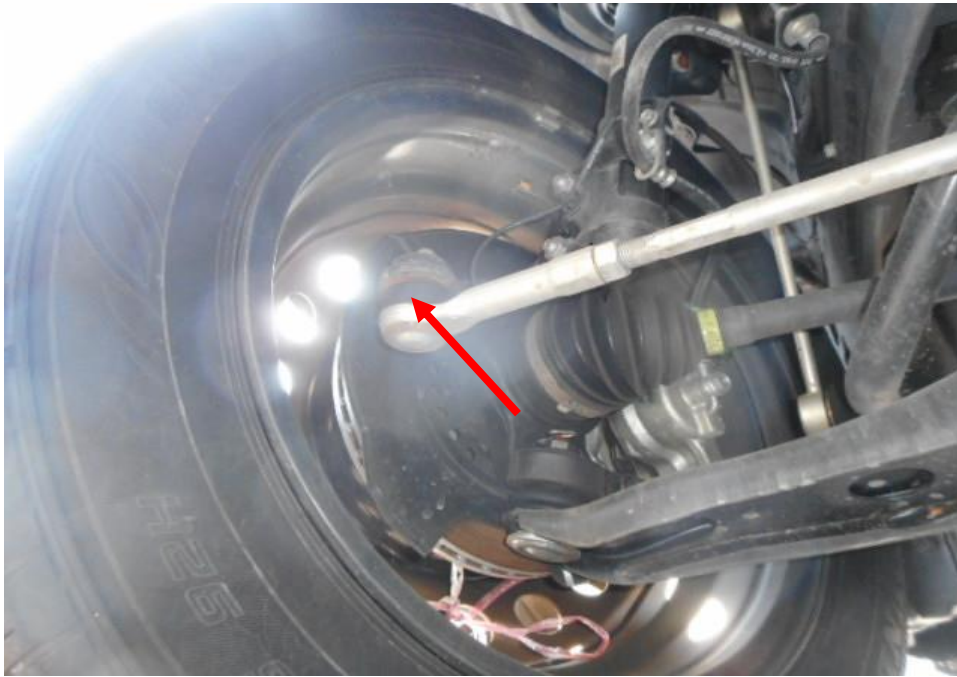
Photo 25 shows the various undercarriage components at the front left wheel of the Motor Car, which had included the steering tie rod (red arrow). The various undercarriage components of the Motor Car were all found to be intact without any visible damage.

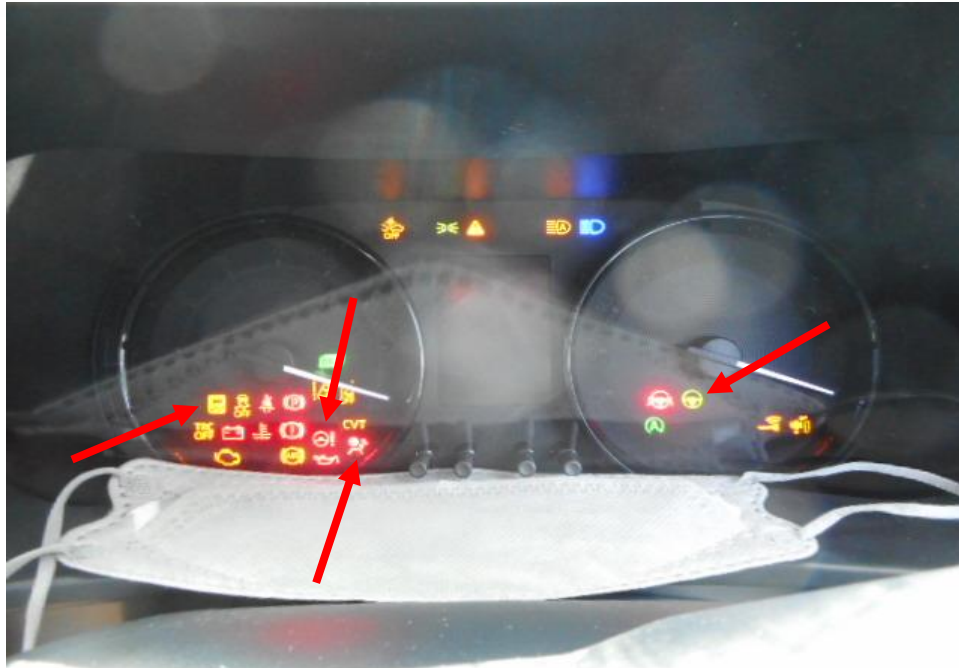
Photo 26 shows the warning light for Anti-Lock Brake System (ABS), Traction Control System (TCS), Electric Power Steering System (EPS) and Supplemental Restraint System (SRS) (arrowed) appearing on the instrument panel of the Motor Car during the self-test of its various electronic operating systems when its engine was cranked.

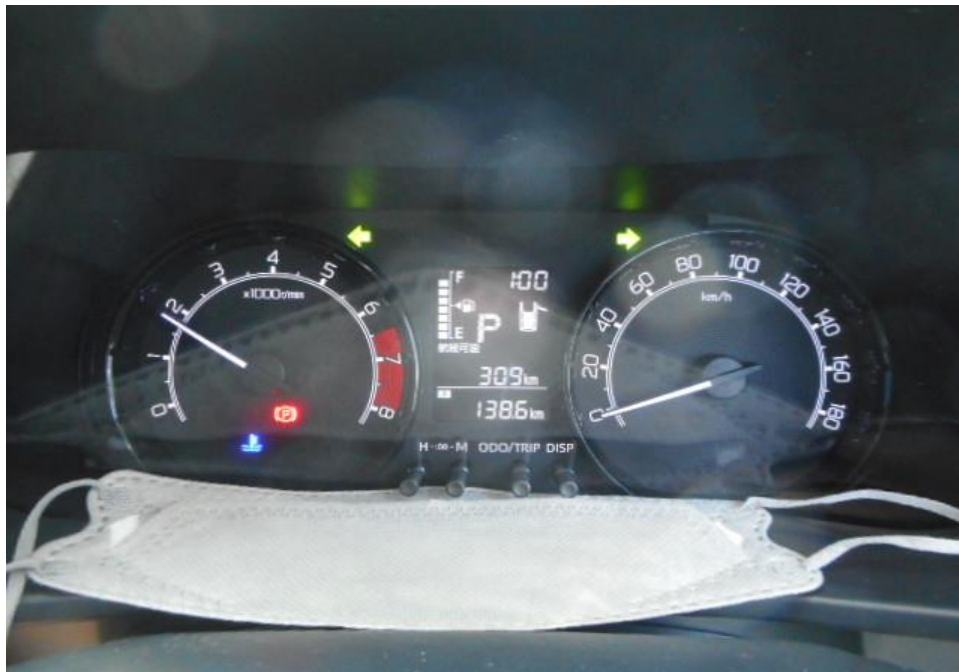
Photo 27 shows no warning lights illuminated on the instrument panel of the Motor Car after the engine was cranked. This would suggest that there was no abnormality to the electronic operating system of the Motor Car, like the ABS, EPS, TCS and SRS etc.
