Your Ref: TP/IP/27047/2022
Our Ref : CI/TPD22010879/P

Fatal Accident Investigation Team

MECHANICAL INSPECTION REPORT OF MOTOR LORRY YQ 4358G

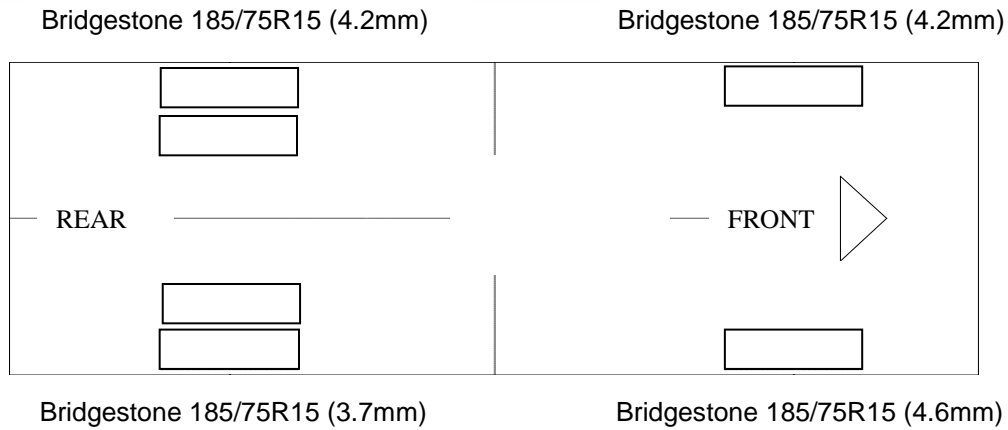
7. The 6 tyres of the Motor Lorry were observed to be in serviceable condition and sufficiently inflated for vehicular operation. I did not find any tear, cut or burst mark(s) on the outer and the inner sidewalls as well as across the tread of the 6 tyres. The tyre brand, tyre size and remaining tread depth of the 6 tyres of the Motor Lorry were recorded as follows:-

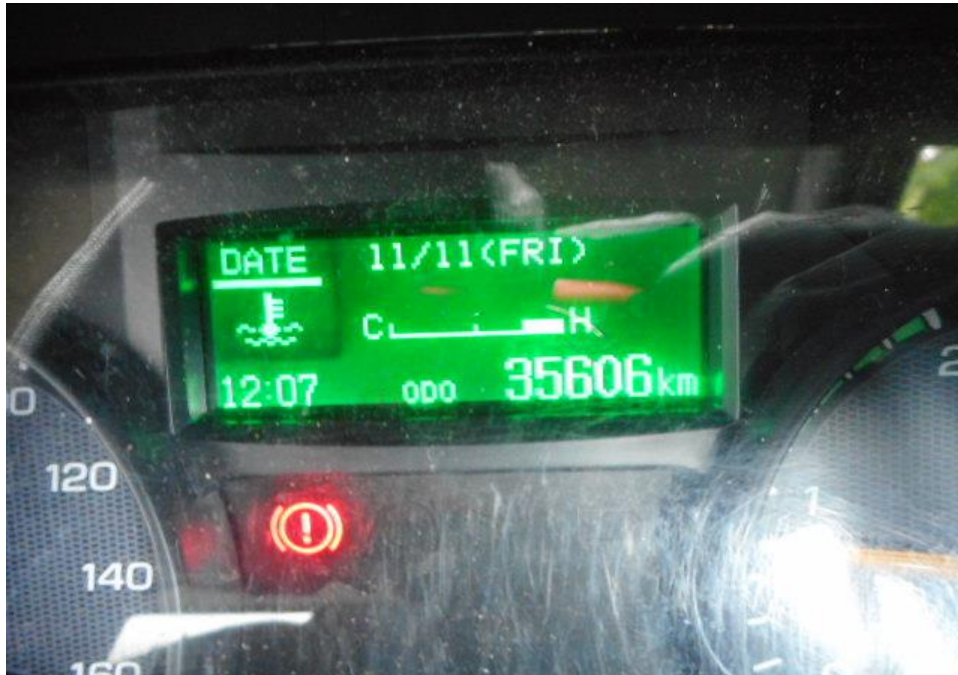
Photo 1 shows a general view of the instrument cluster of the Motor Lorry at the time of my inspection. The mileage of the Motor Lorry was 35,606km

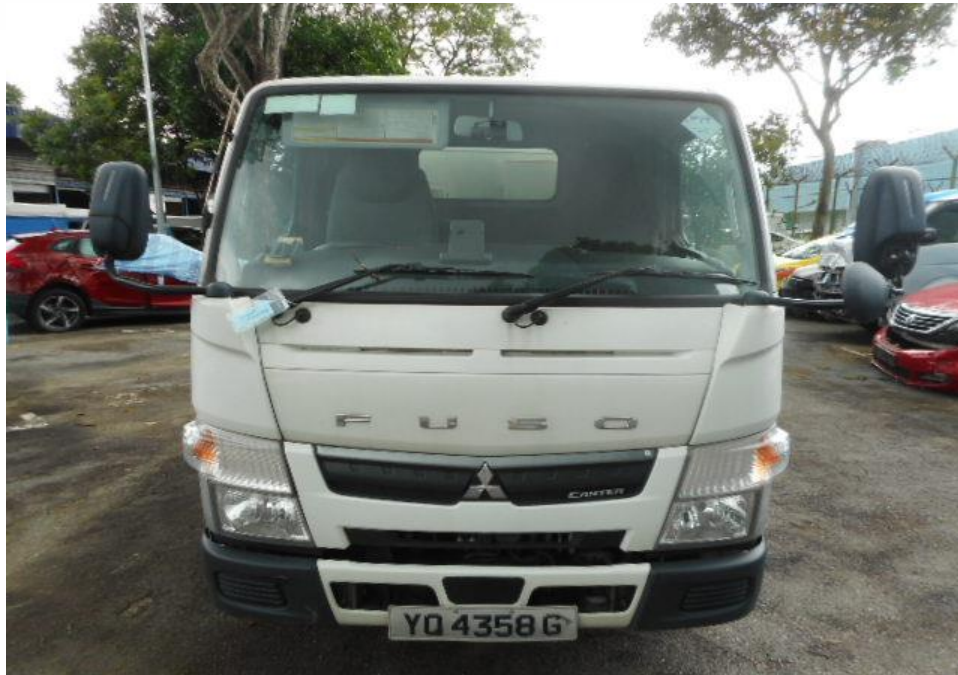
Photo 2 shows a general view of the Motor Lorry's frontal portion at the time of my inspection. The Motor Lorry was observed to be intact and unaffected by the accident.

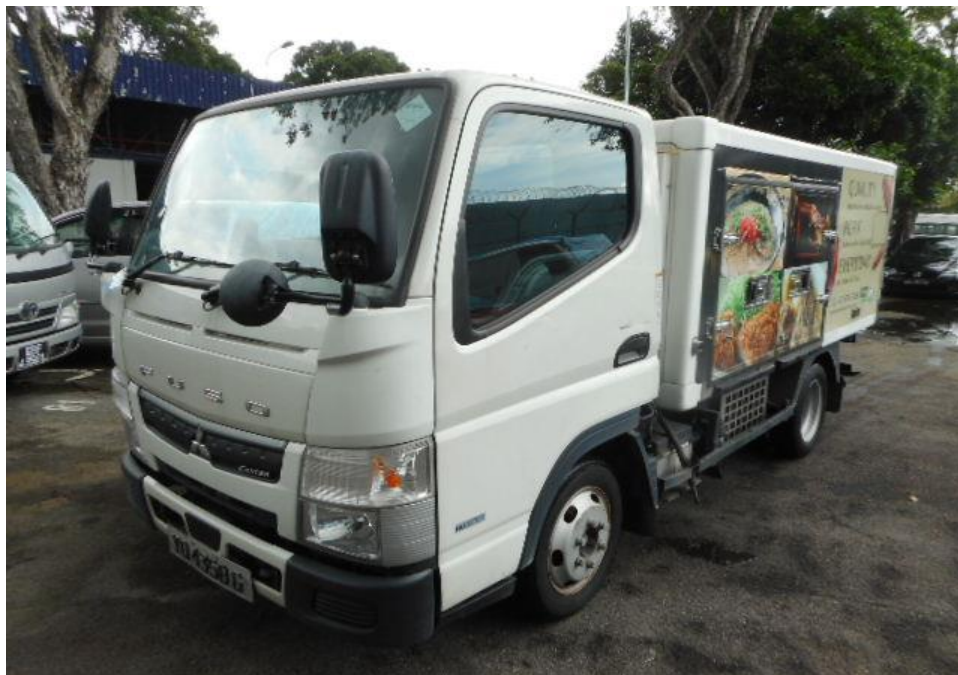
Photo 3 shows a general view of the left body of the Motor Lorry at the time of my inspection. The Motor Lorry was observed to be intact and unaffected by the accident.

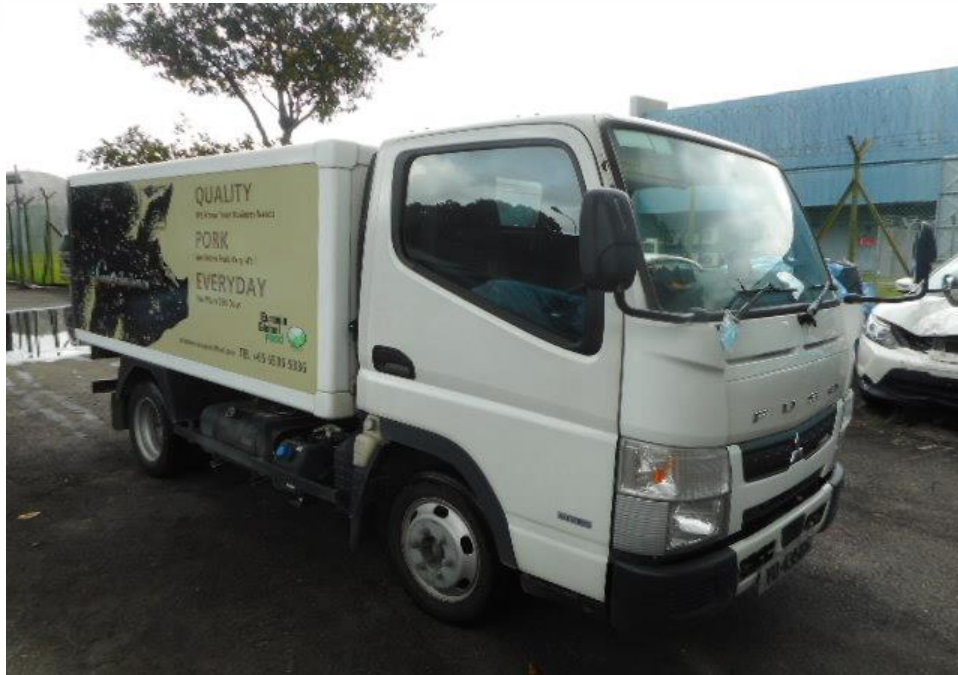
Photo 4 shows a general view of the Motor Lorry's right portion at the time of my inspection. The Motor Lorry was observed to be intact and unaffected by the accident.

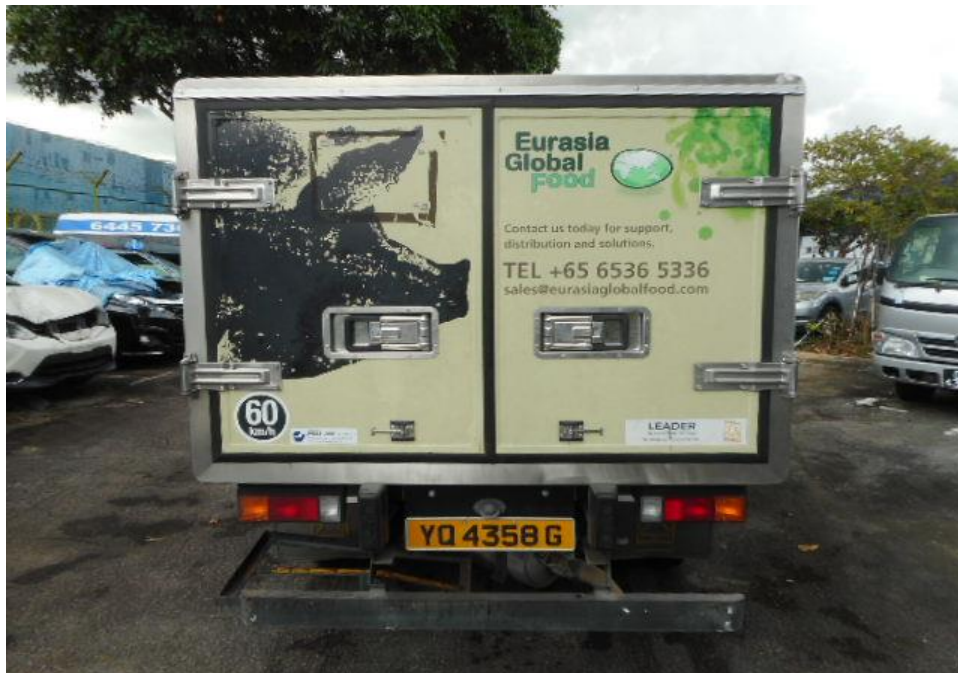
Photo 5 shows a general view of the Motor Lorry's rear portion at the time of my inspection. The Motor Lorry was observed to be intact and unaffected by the accident.

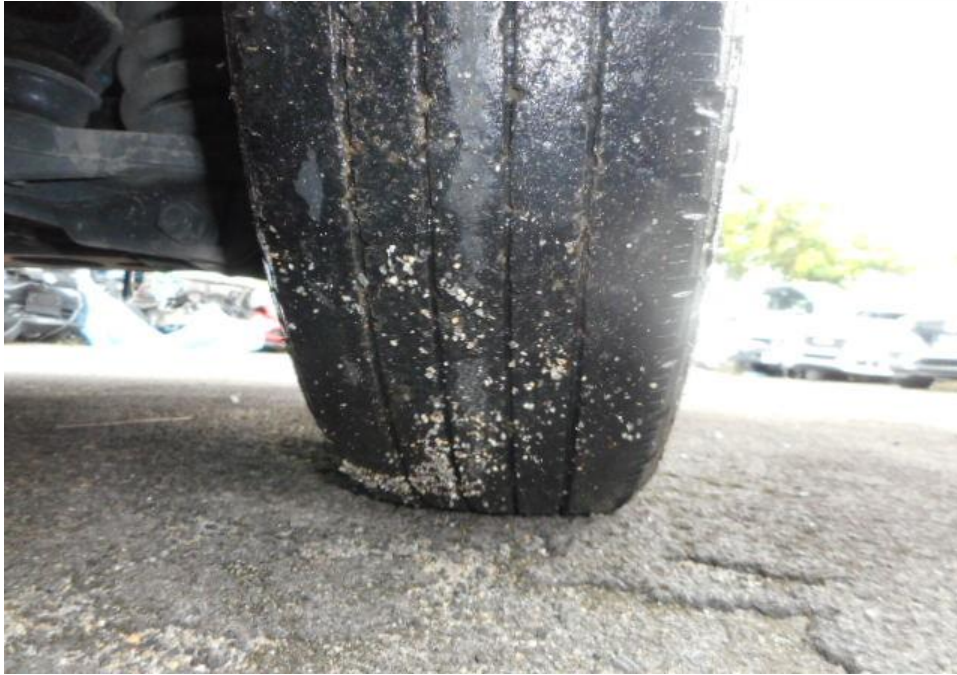
Photo 6 shows the condition of the front right tyre of the Motor Lorry, which was observed to be in serviceable condition with remaining tread depth of approximately 4.6mm. The tyre, which was wrapped around standard steel wheel rim, it was observed to be sufficiently inflated for vehicular operation.

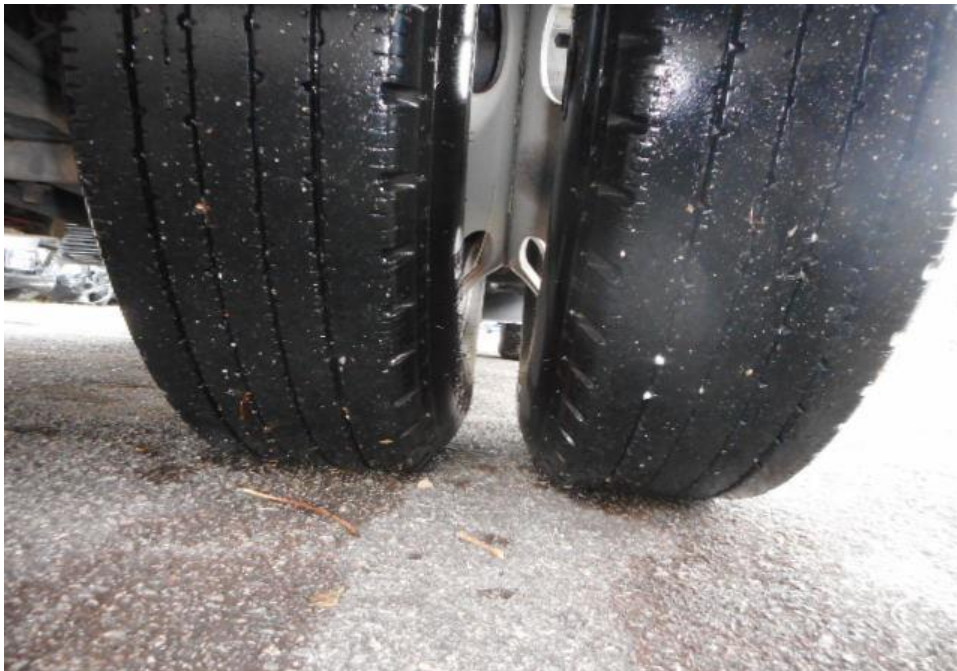
Photo 7 shows the condition of the rear right tyre of the Motor Lorry, which was observed to be in serviceable condition with remaining tread depth of approximately 3.7mm. The tyre, which was wrapped around standard steel wheel rim, it was observed to be sufficiently inflated for vehicular operation.

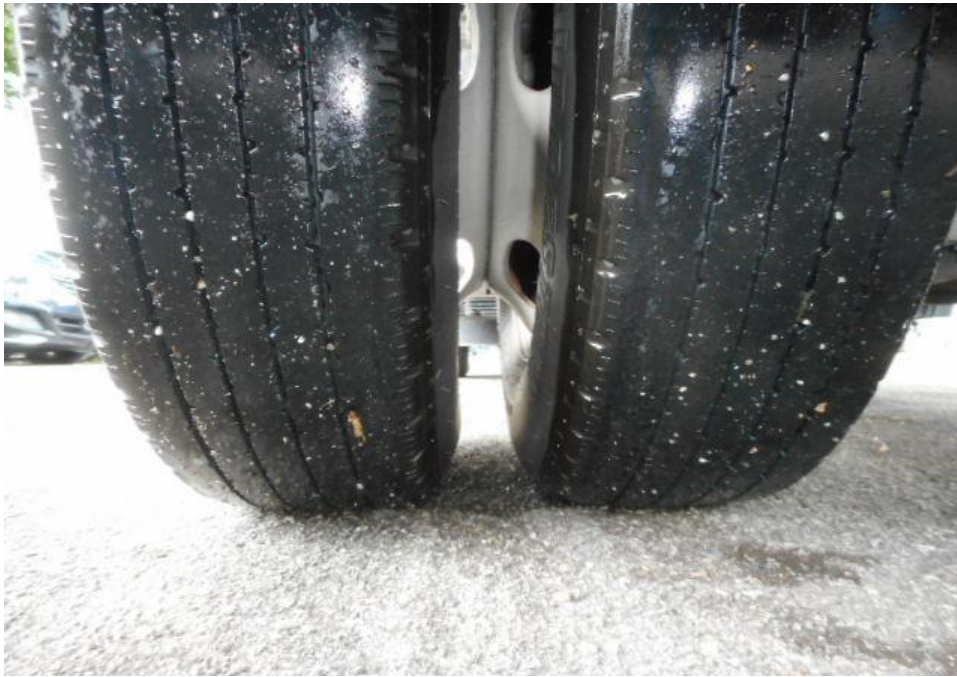
Photo 8 shows the condition of the rear left tyres of the Motor Lorry, which was observed to be in serviceable condition with remaining tread depth of approximately 4.2mm. The tyres, which were wrapped around standard steel wheel rim, were also observed to be sufficiently inflated for vehicular operation.

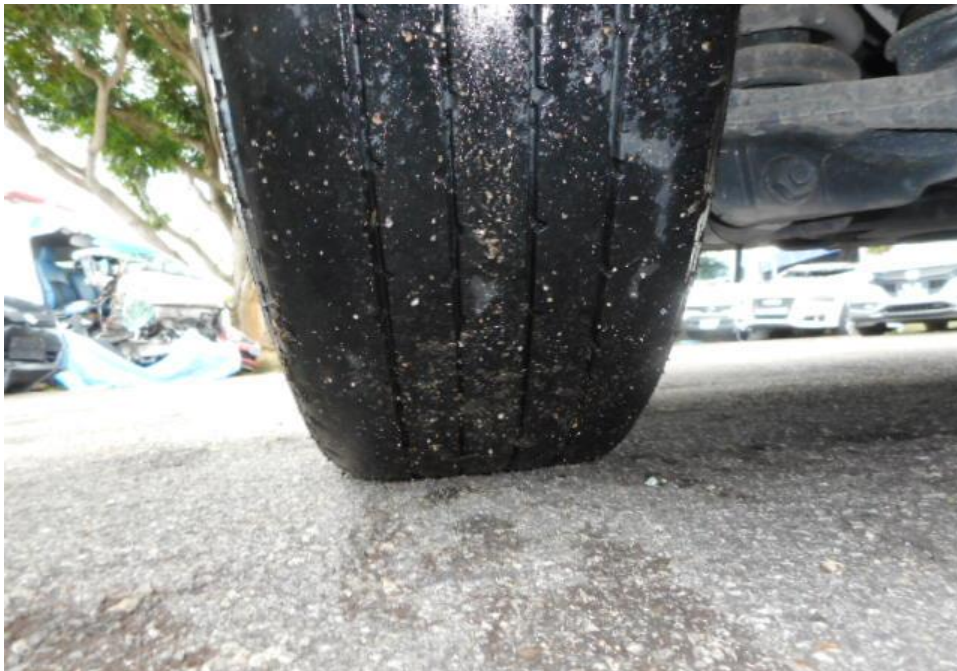
Photo 9 shows the condition of the front right tyre of the Motor Lorry, which was observed to be in serviceable condition with remaining tread depth of approximately 4.2mm. The tyres, which were wrapped around standard steel wheel rim, were also observed to be sufficiently inflated for vehicular operation.

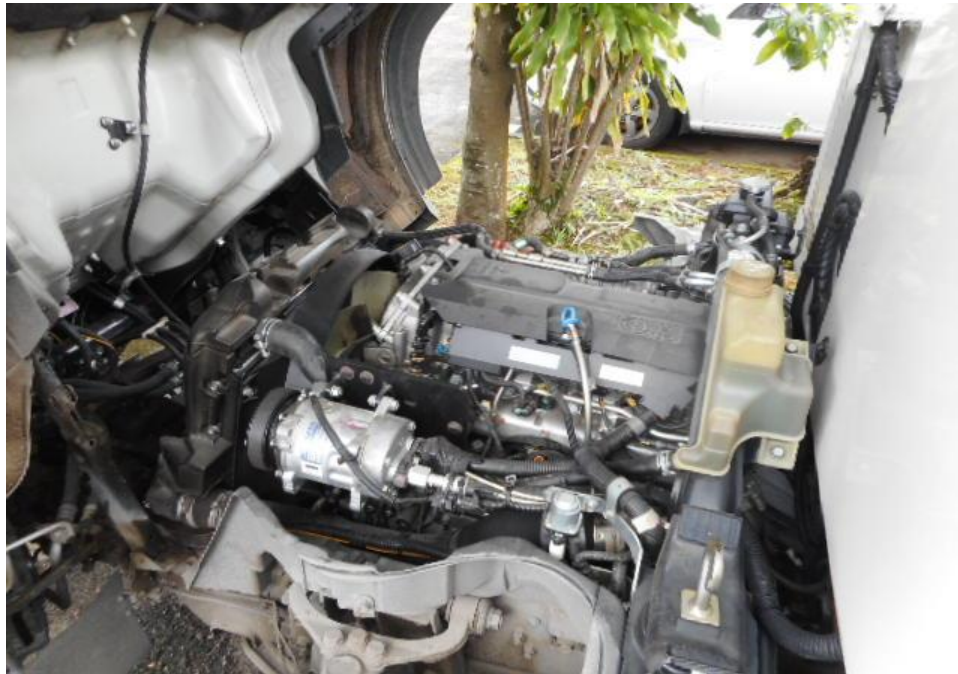
Photo 10 shows a general view of the Motor Lorry's engine compartment, which was accessed by lifting the front cabin of the Motor Lorry. The various parts and components inside the engine compartment were unaffected by the accident. There was also no sign(s) or indication(s) of fresh fluid leakage and/or fluid stain within the engine compartment

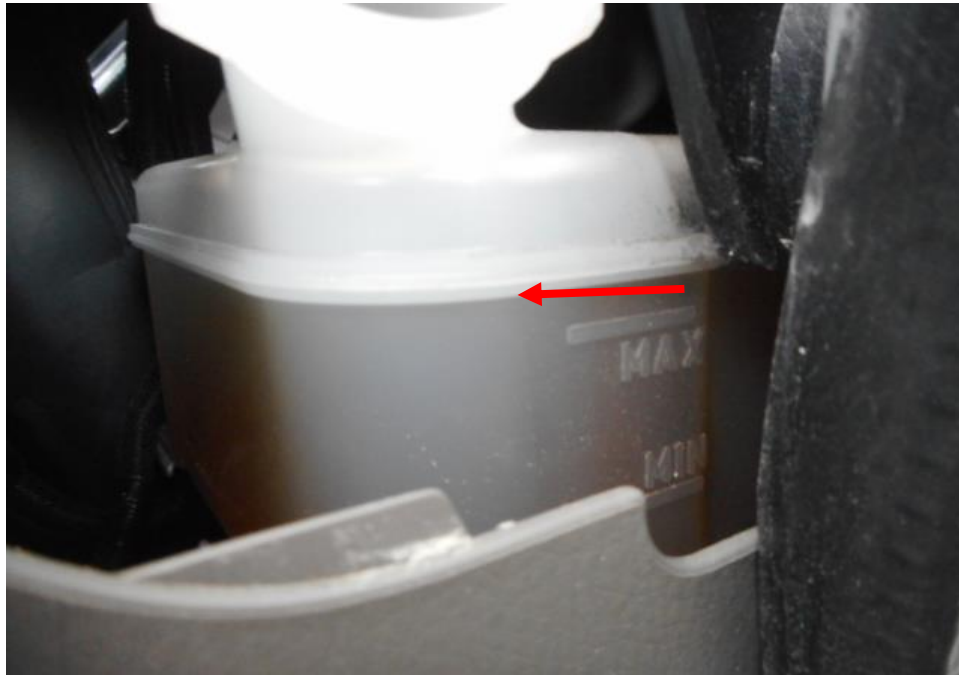
Photo 11 shows the brake fluid reservoir of the Motor Lorry at the time of my inspection. The brake fluid was observed to be of sufficient level (arrowed) and without any visible contamination.

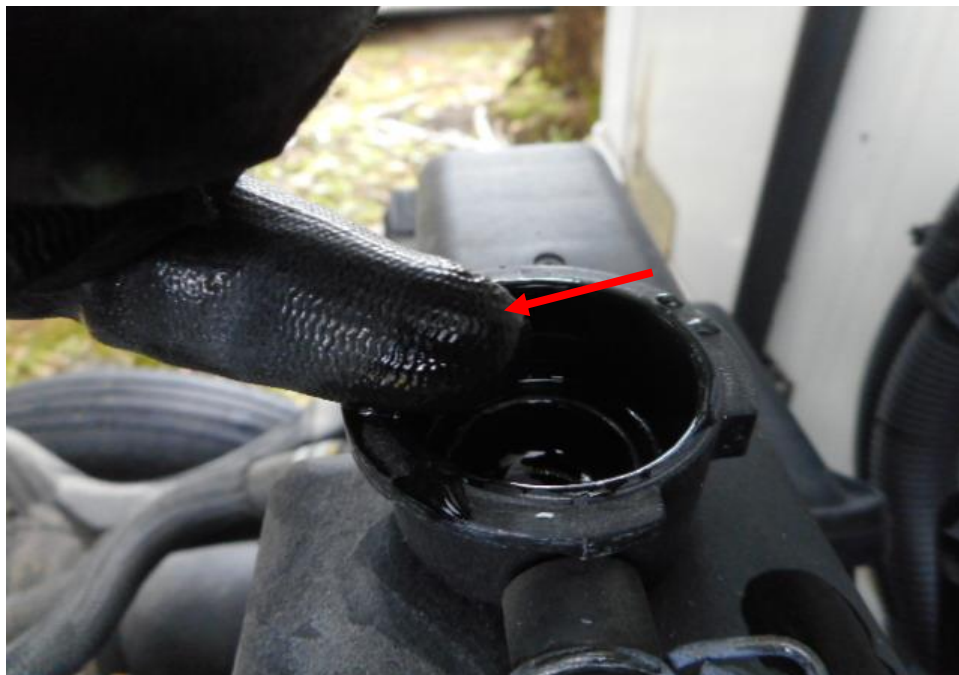
Photo 12 shows the engine coolant reservoir of the Motor Lorry at the time of my inspection. The engine coolant was observed to be of sufficient level (arrowed) and without any visible contamination.

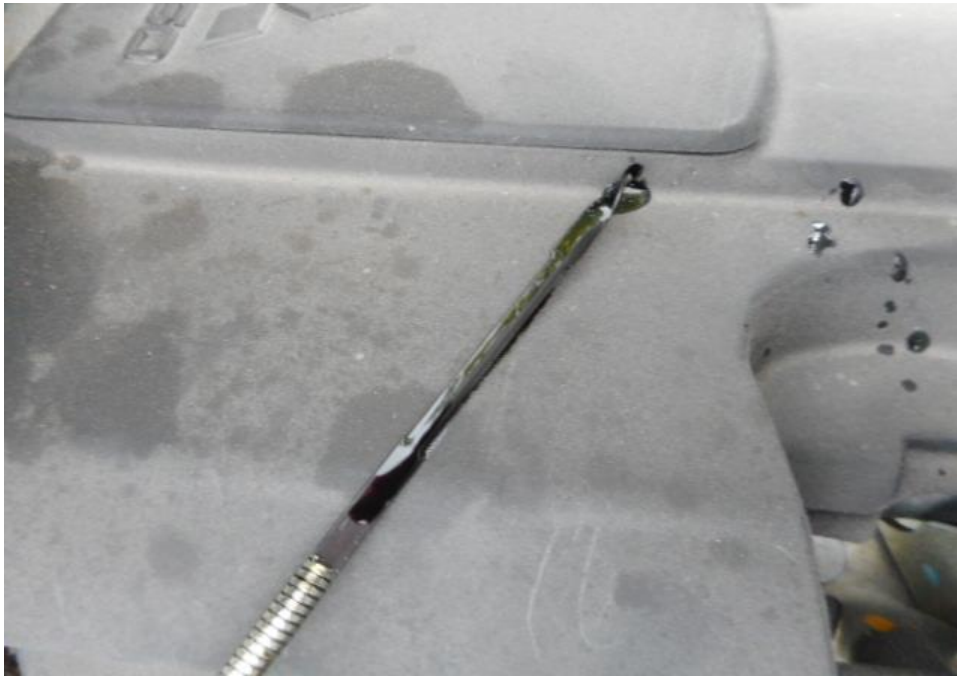
Photo 13 shows the engine oil dip stick of the Motor Lorry at the time of my inspection. The engine oil was observed to be of sufficient level and without any visible contamination.

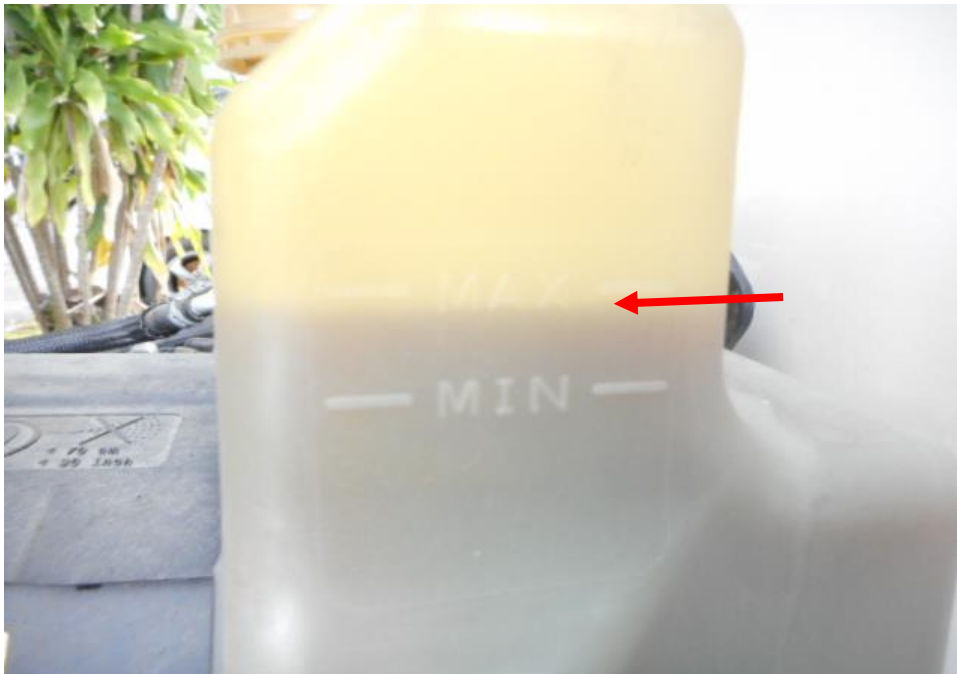
Photo 14 shows the power steering fluid reservoir of the Motor Lorry at the time of my inspection. The power steering fluid (arrowed) was observed to be of sufficient level and without any visible contamination.

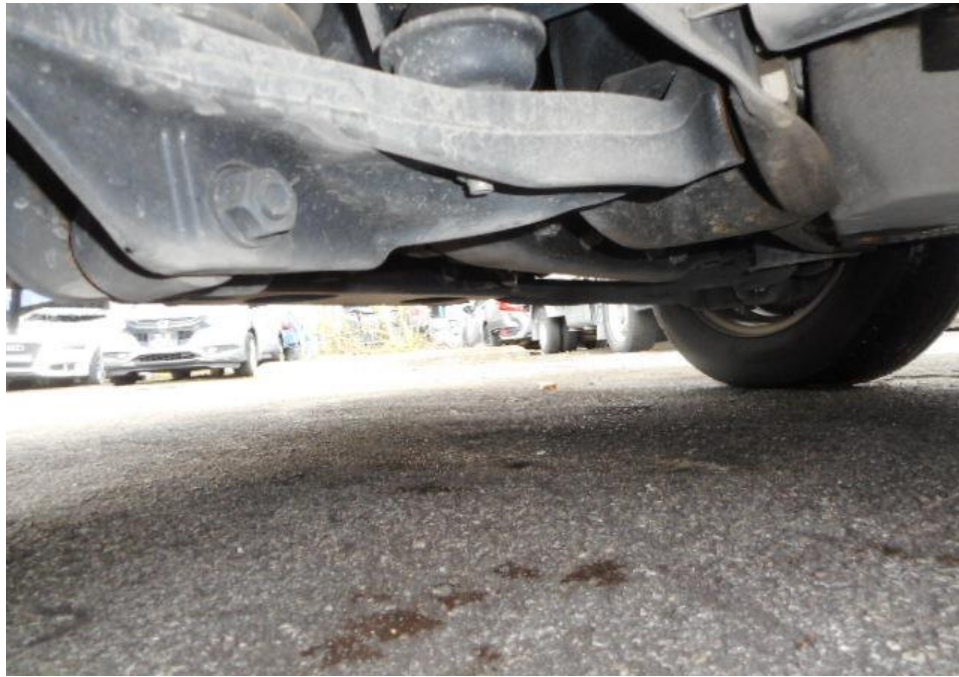
Photo 15 shows the undercarriage of the Motor Lorry, at the area where the engine housing and transmission housing are located. I did not find any sign(s) or indication(s) of fluid leak and/or fluid stain(s) on the underside of the Motor Lorry.

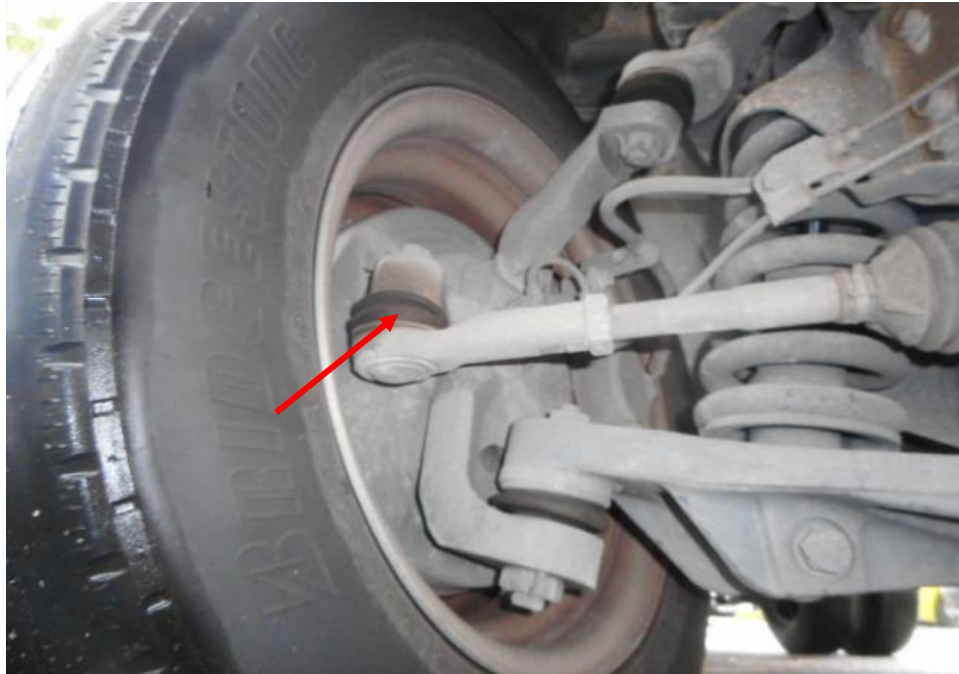
Photo 16 shows the various undercarriage components at the front right wheel of the Motor Lorry, in particular the steering tie rod end (arrowed). The various steering components were all found to be intact, suggesting that the steering system of the Motor Lorry was likely to be in serviceable condition at the material time of accident. There was also no sign of fluid stain(s) observed on the various undercarriage components.

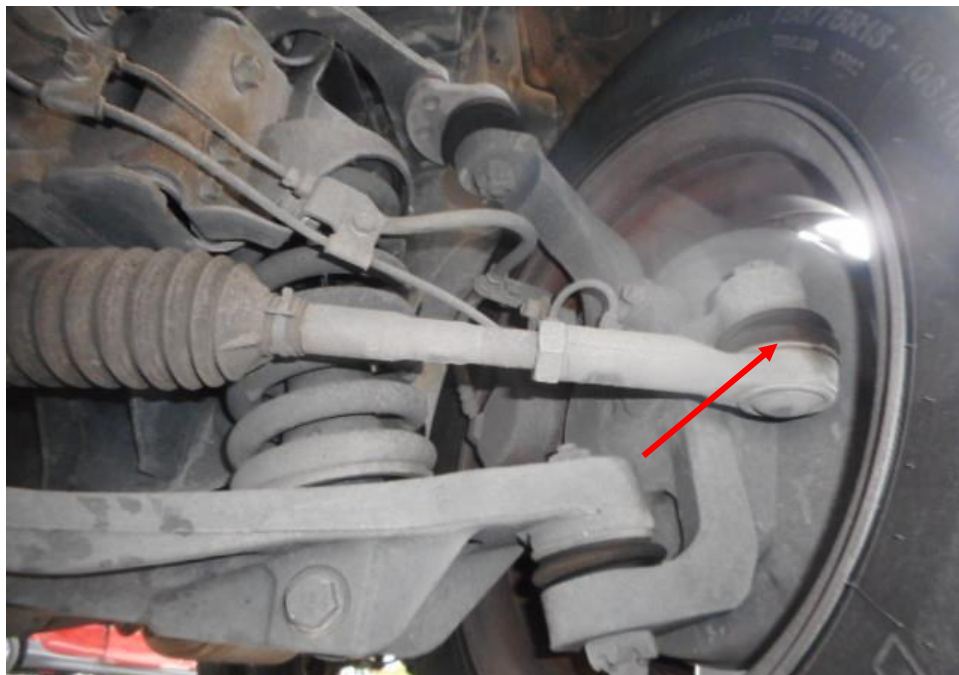
Photo 17 shows the various undercarriage components at the front left wheel of the Motor Lorry, in particular the steering tie rod end (arrowed). The various undercarriage components of the Motor Lorry were all found to be intact without any visible damage. There was also no sign of fluid stain(s) observed on the various undercarriage components.

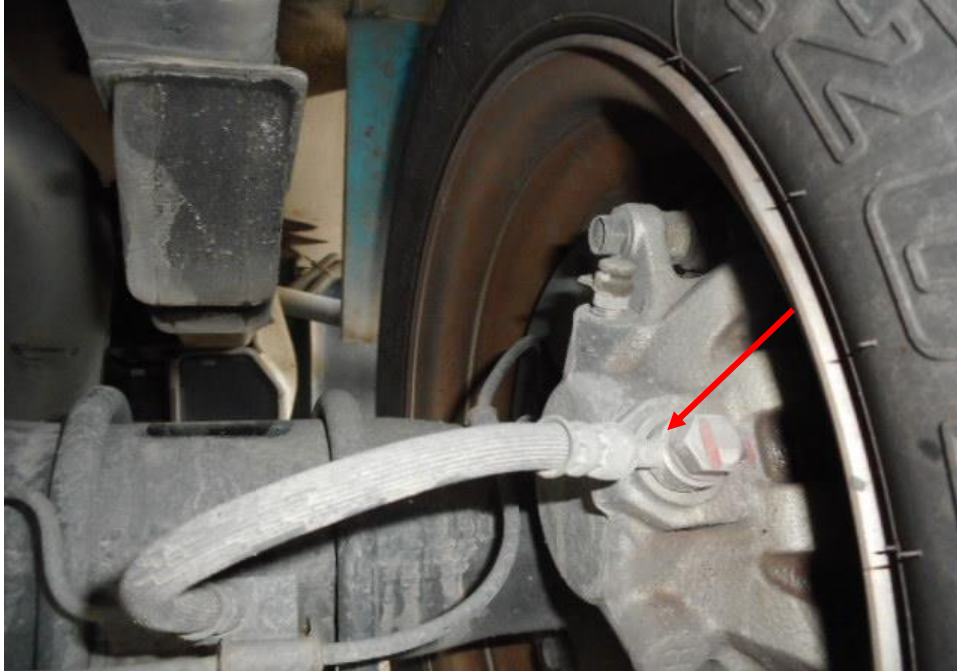
Photo 18 shows the brake pipe (arrowed) at the rear right wheel of the Motor Lorry. I did not observe any leakage of brake fluid at the time of my inspection of the Motor Lorry. My static tests of the Motor Lorry's braking system, along with my visual examination of the various mechanical components in the braking system, had indicated that there was no internal leakage of pressure/vacuum. Hence the braking system of the Motor Lorry was likely to be in serviceable condition at the material time of accident.

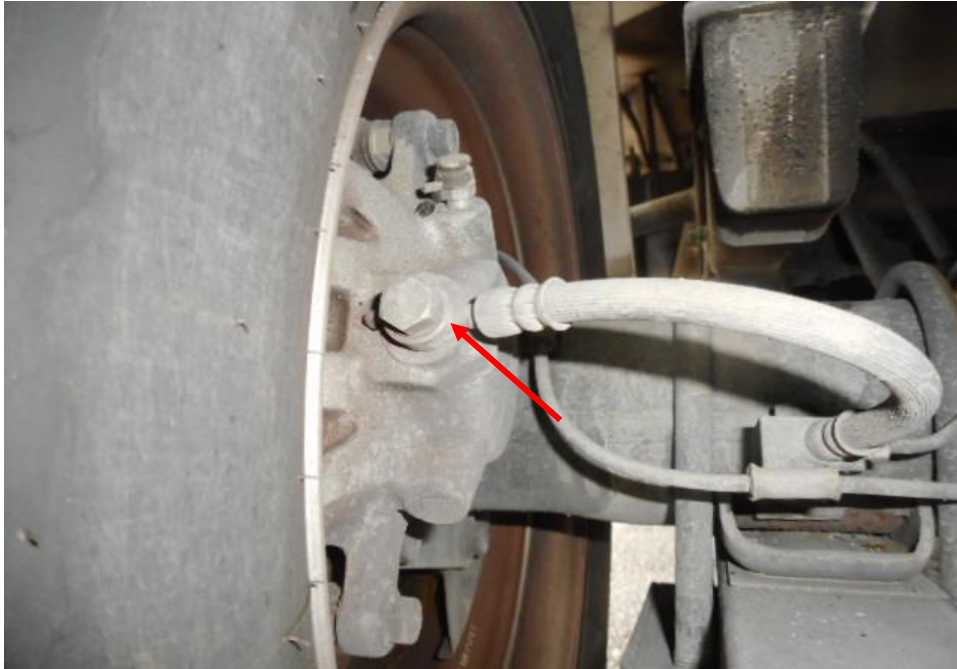
Photo 19 shows the brake pipe (arrowed) at the rear left wheel of the Motor Lorry. I did not observe any leakage of brake fluid at the time of my inspection of the Motor Lorry. My static tests of the Motor Lorry's braking system, along with my visual examination of the various mechanical components in the braking system had indicated that there was no internal leakage of pressure/vacuum. Hence the braking system of the Motor Lorry was likely to be in serviceable condition at the material time of accident.

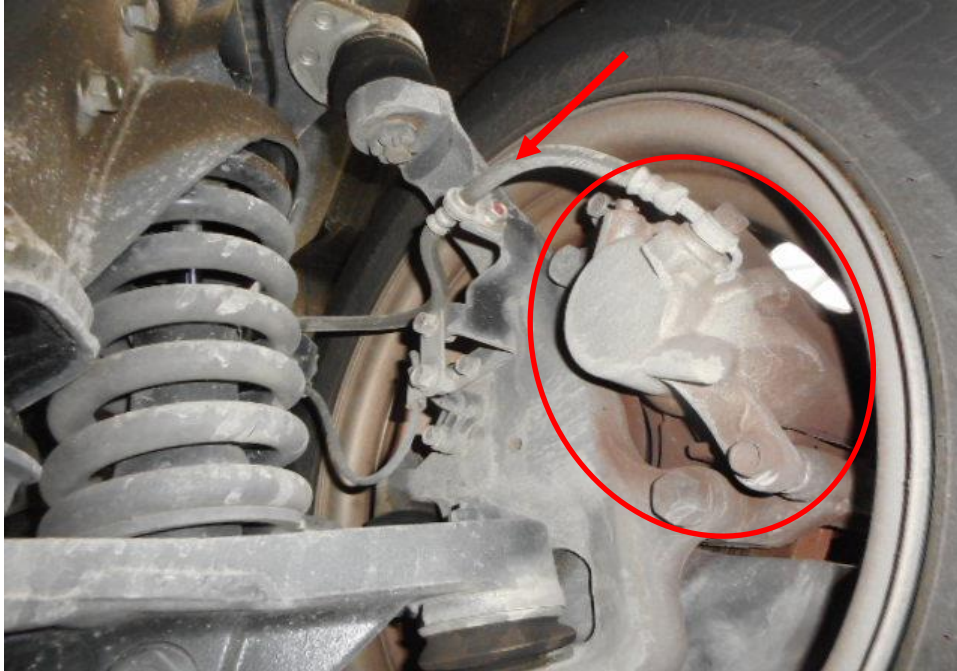
Photo 20 shows the brake hose/pipe (arrowed) at the front right wheel of the Motor Lorry. No leakage of brake fluid was observed. Visual examination of the various components of the braking system like the brake caliper (circled), brake booster, brake pedal etc had revealed all to be intact and without visible damage at the time of accident. There was also no sign of fluid stain(s) observed on the various undercarriage components.

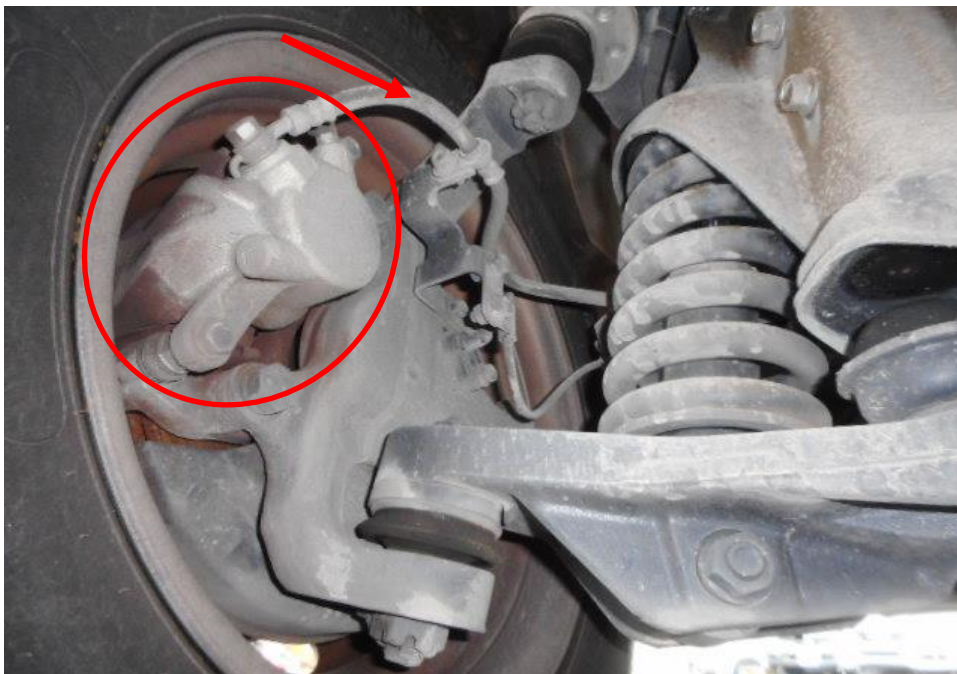
Photo 21 shows the brake hose/pipe (arrowed) at the front left wheel of the Motor Lorry. No leakage of brake fluid was observed. Visual examination of the various components of the braking system like the brake caliper (circled), brake booster, brake pedal etc had revealed all to be intact and without visible damage at the time of accident. There was also no sign of fluid stain(s) observed on the various undercarriage components.

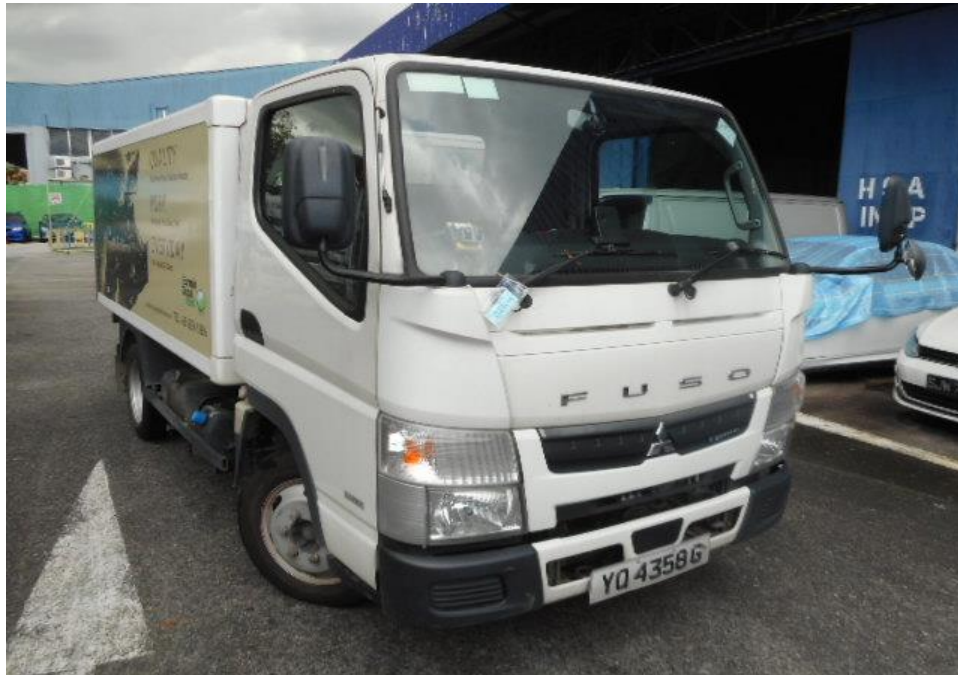
Photo 22 shows the front right wheel of the Motor Lorry turned to its full left. During my steering system test, I did not experience any abnormal free play and/or resistance when I had turned the steering wheel towards the left and right. This would suggest that the steering system of the Motor Lorry was likely to be in serviceable condition at the material time of accident.

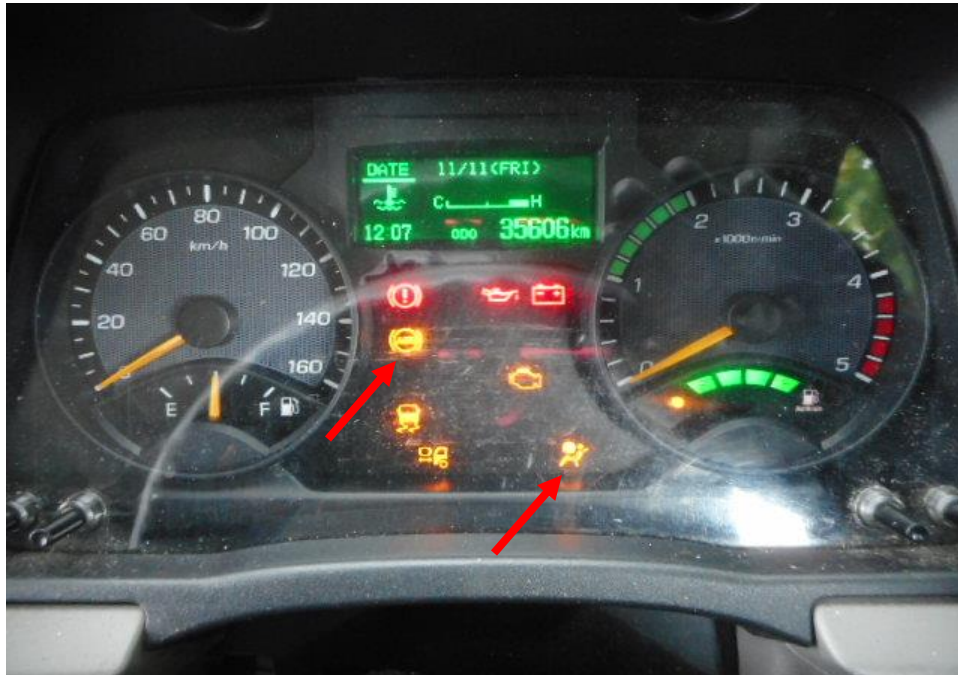
Photo 23 shows the warning light for Anti-Lock Brake System (ABS) and Supplemental Restraint System (SRS) (arrowed) appearing on the instrument panel of the Motor Lorry during the self-test of its various electronic operating systems when its engine was cranked.

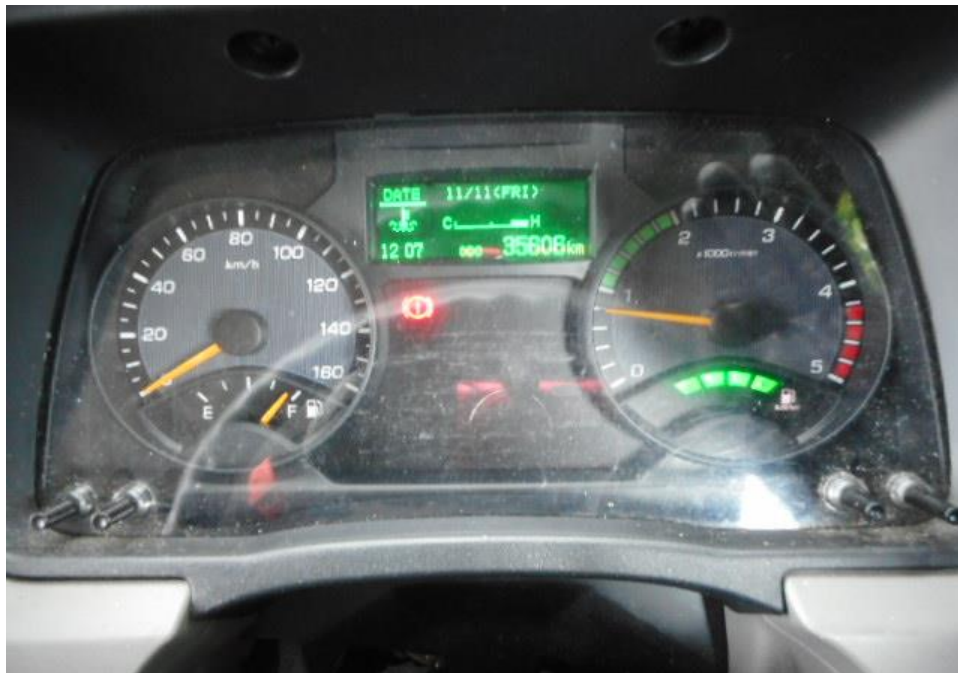
Photo 24 shows no warning lights illuminated on the instrument panel of the Motor Lorry after the engine was cranked. This would suggest that there was no abnormality to the electronic operating system of the Motor Van, like the ABS, SRS and etc.
