Your Ref: TP/IP/27983/2022  
Our Ref : CI/TPD22010881/P

14<sup>th</sup> November 2022

**Fatal Accident Investigation Team**

**MECHANICAL INSPECTION REPORT OF MOTOR VAN GBJ 3333T**

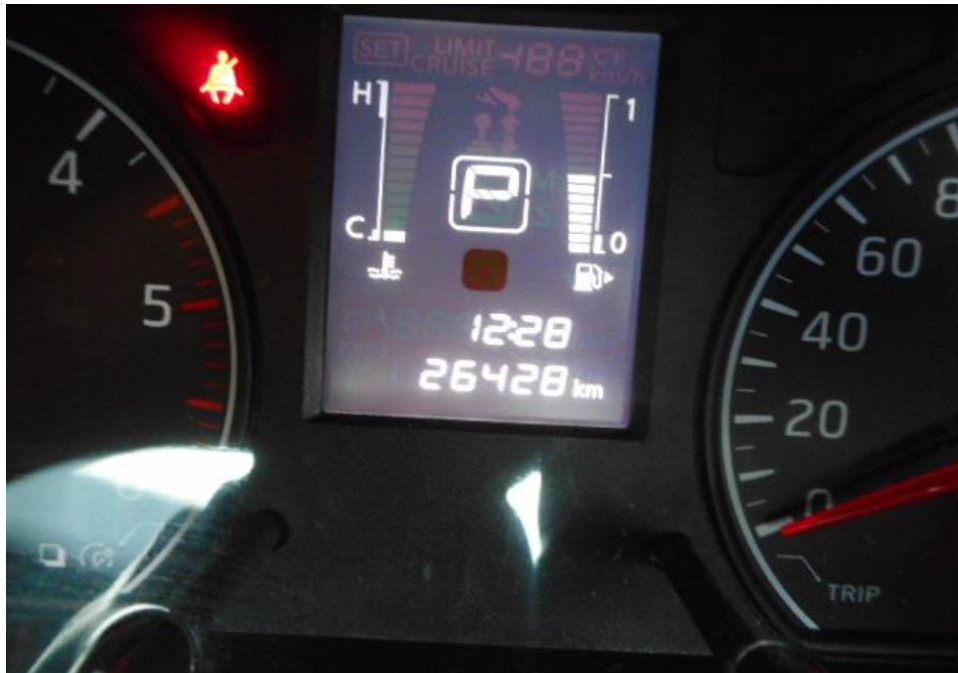
4. The mileage of the Motor Van at the time of my inspection was 26,428km.
5. The Motor Van appeared to have sustained damage at its frontal portion. Its front body panel was damaged at the time of my inspection.

**Photo 1** shows a general view of the instrument cluster of the Motor Van at the time of my inspection. The mileage of the Motor Van was 26,428km

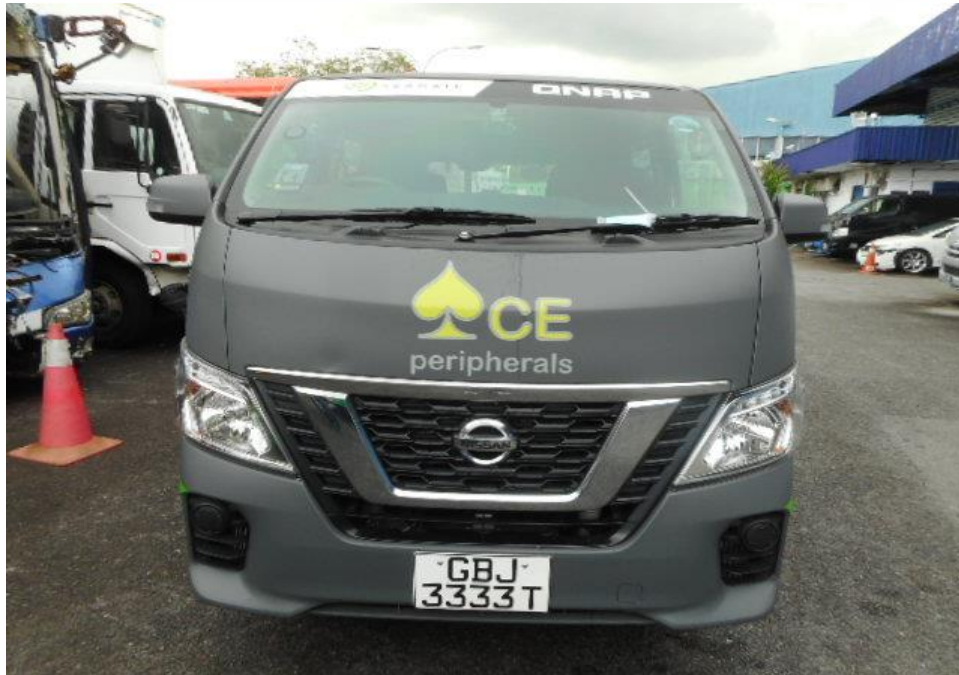
**Photo 2** shows a general view of the Motor Van's frontal portion at the time of my inspection. It appeared to have sustained damage at its frontal portion. Its front body panel and front bumper were also damage at the time of my inspection.

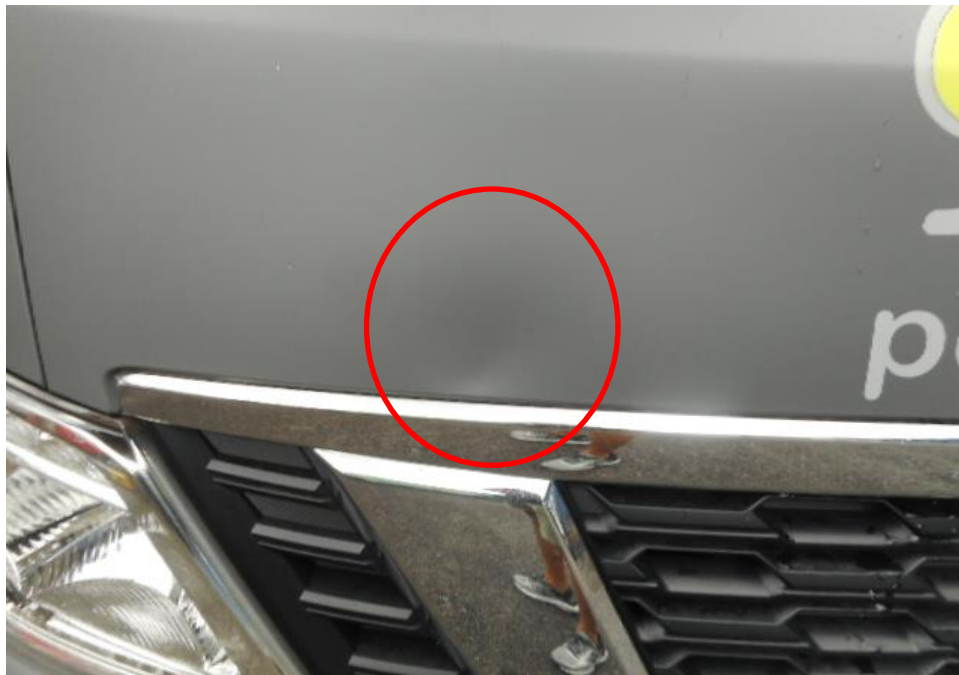
**Photo 3** shows a close up view of the Motor Van's frontal portion at the time of my inspection. It appeared to have sustained damage at its frontal portion. Its front body panel (circled) was damage at the time of my inspection as a result of the accident.

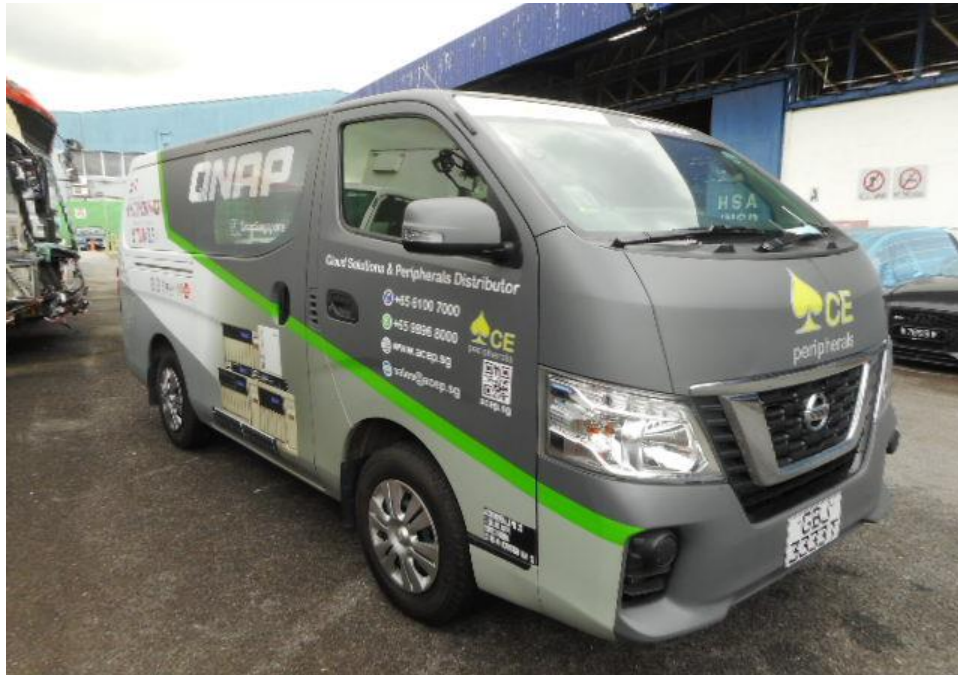
**Photo 4** shows a general view of the right body of the Motor Van at the time of my inspection. The Motor Van was observed to be intact and unaffected by the accident.

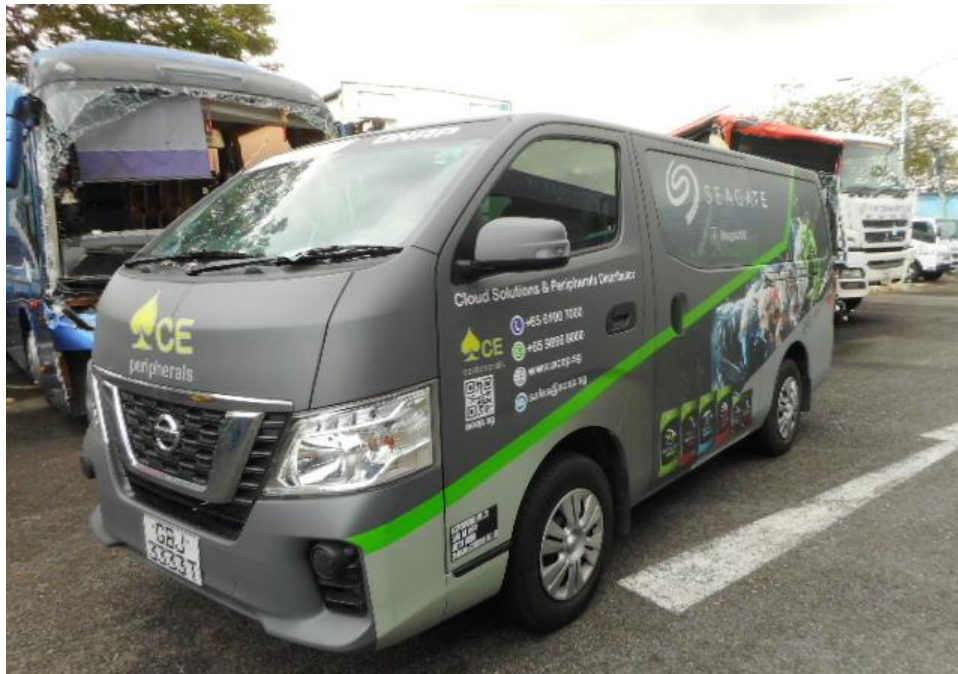
**Photo 5** shows a general view of the left body of the Motor Van at the time of my inspection. The Motor Van was observed to be intact and unaffected by the accident.

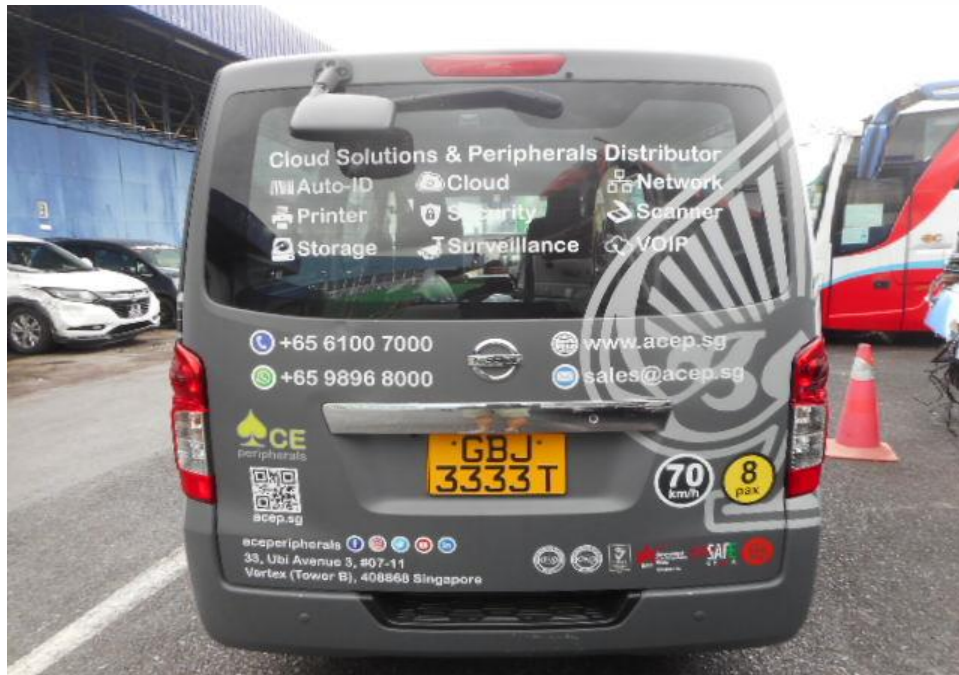
**Photo 6** shows a general view of the rear body of the Motor Van at the time of my inspection. The Motor Van was observed to be intact and unaffected by the accident.

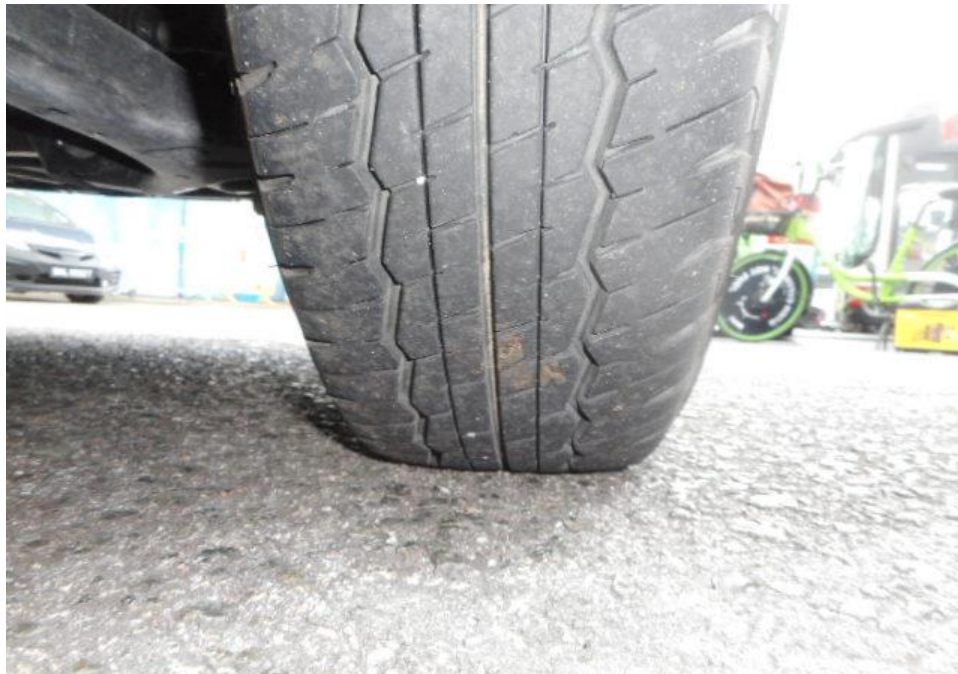
**Photo 7** shows the condition of the front right tyre of the Motor Van, which was observed to be in serviceable condition with remaining tread depth of approximately 5.4mm. The tyre, which was wrapped around standard steel wheel rim, was also observed to be sufficiently inflated for vehicular operation. There was no tear, cut or burst mark(s) on the outer and the inner sidewalls as well as across the tread of the 4 tyres that were fitted on the Motor Van.

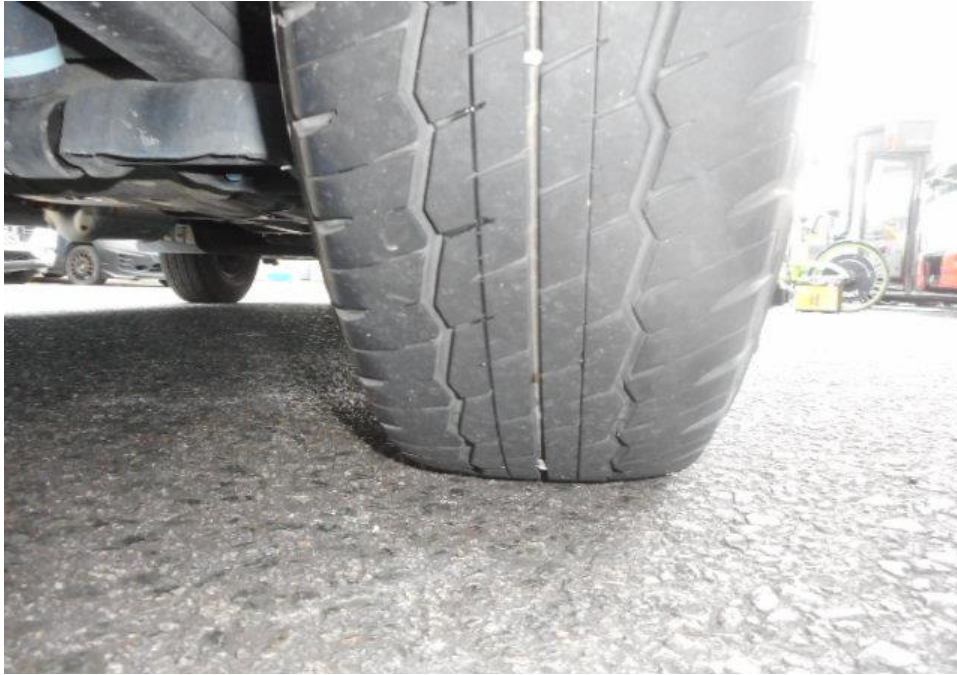
**Photo 8** shows the condition of the rear right tyre of the Motor Van, which was observed to be in serviceable condition with remaining tread depth of approximately 5mm. The tyre, which was wrapped around standard steel wheel rim, it was observed to be sufficiently inflated for vehicular operation.

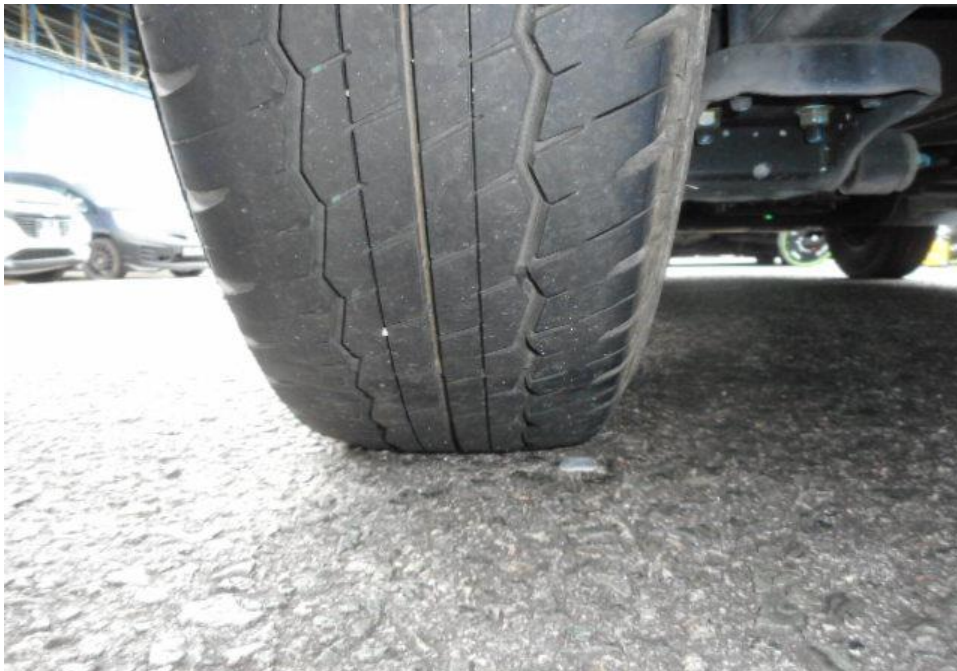
**Photo 9** shows the condition of the rear left tyres of the Motor Van, which was observed to be in serviceable condition with remaining tread depth of approximately 4.7mm. The tyres, which were wrapped around standard steel wheel rim, were also observed to be sufficiently inflated for vehicular operation. There was also no damage found on all 4 steel wheel rims of the Motor Van.

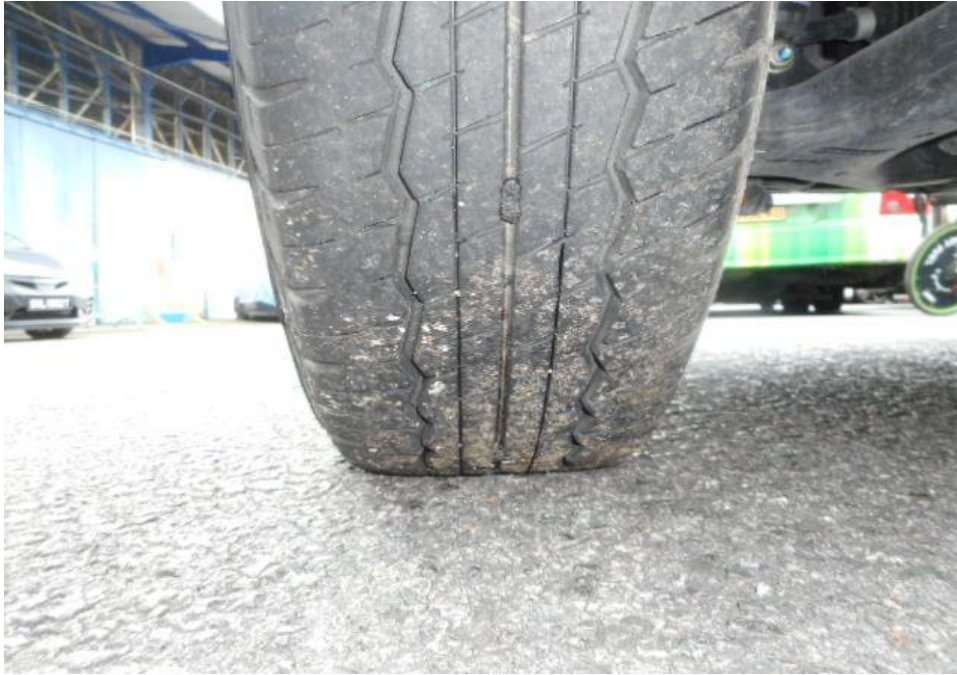
**Photo 10** shows the condition of the rear right tyres of the Motor Van, which were observed to be in serviceable condition with remaining, tread depth of approximately 4.8mm. There was also no tear, cut or burst mark(s) on the outer and the inner sidewalls as well as across the tread of the 4 tyres that were fitted on the Motor Van.

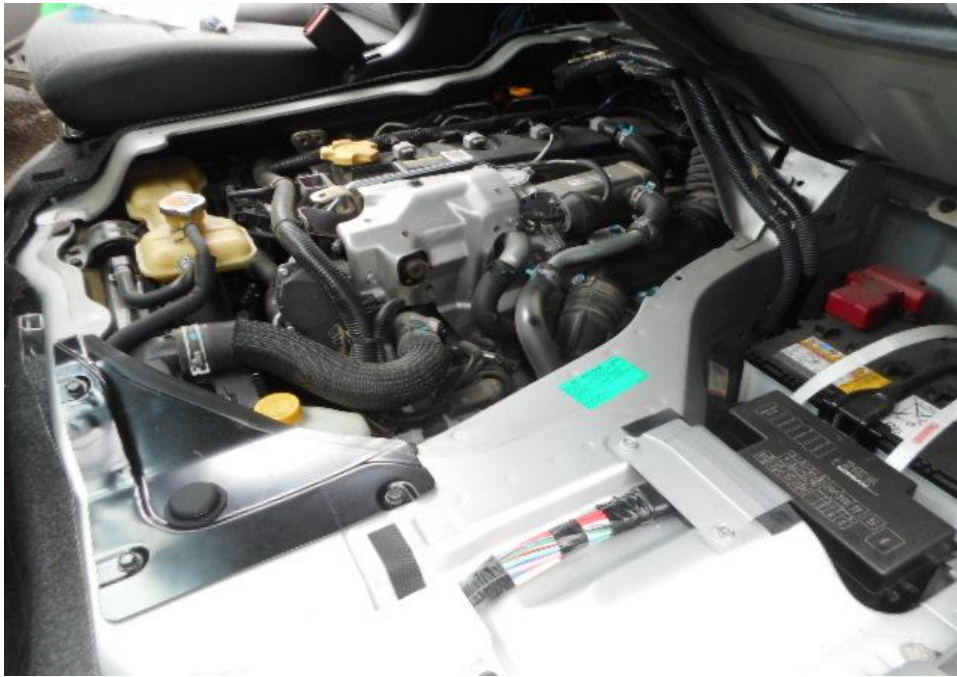
**Photo 11** shows a general view of the Motor Van's engine compartment, which was accessed by lifting the front cabin of the Motor Van. The various parts and components inside the engine compartment were unaffected by the accident. There was also no sign(s) or indication(s) of fresh fluid leakage and/or fluid stain within the engine compartment

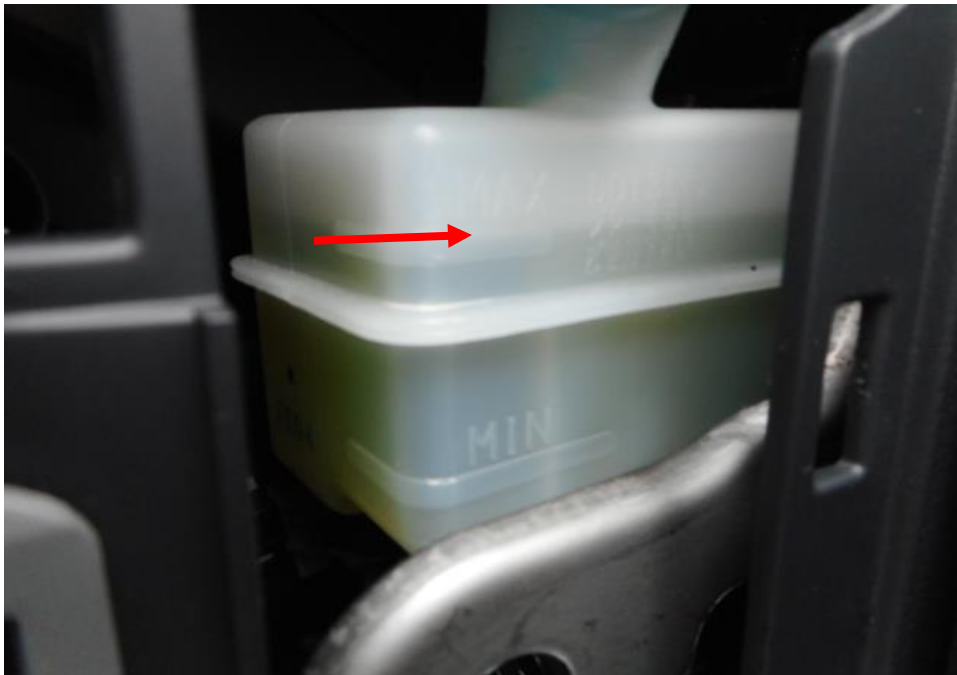
**Photo 12** shows the brake fluid reservoir of the Motor Van at the time of my inspection. The brake fluid was observed to be of sufficient level (arrowed) and without any visible contamination.

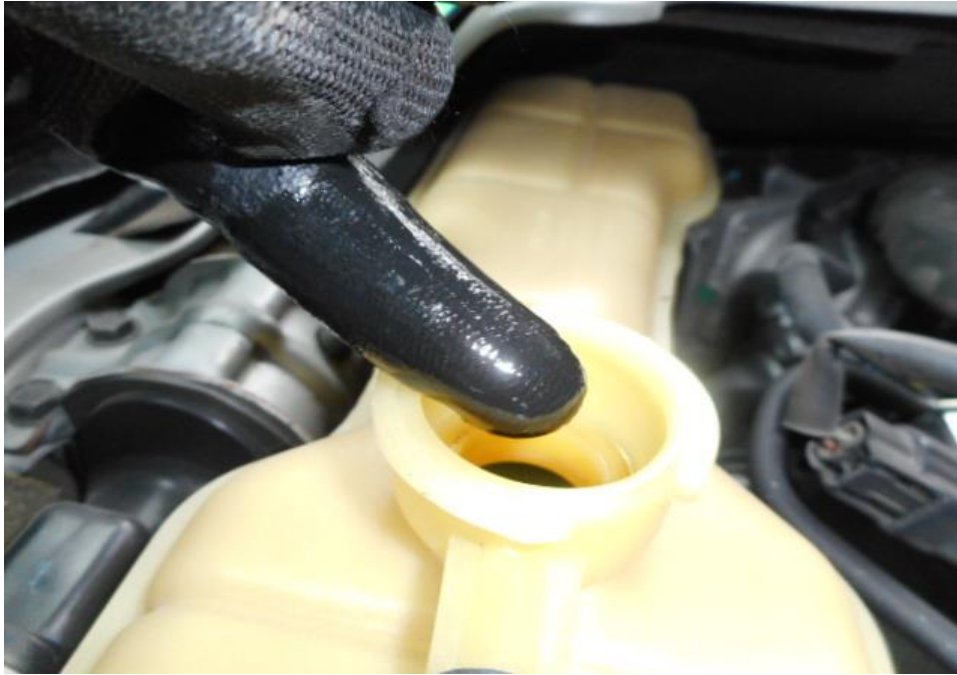
**Photo 13** shows the engine coolant of the Motor Van at the time of my inspection. The engine coolant was observed to be of sufficient level and without any visible contamination.

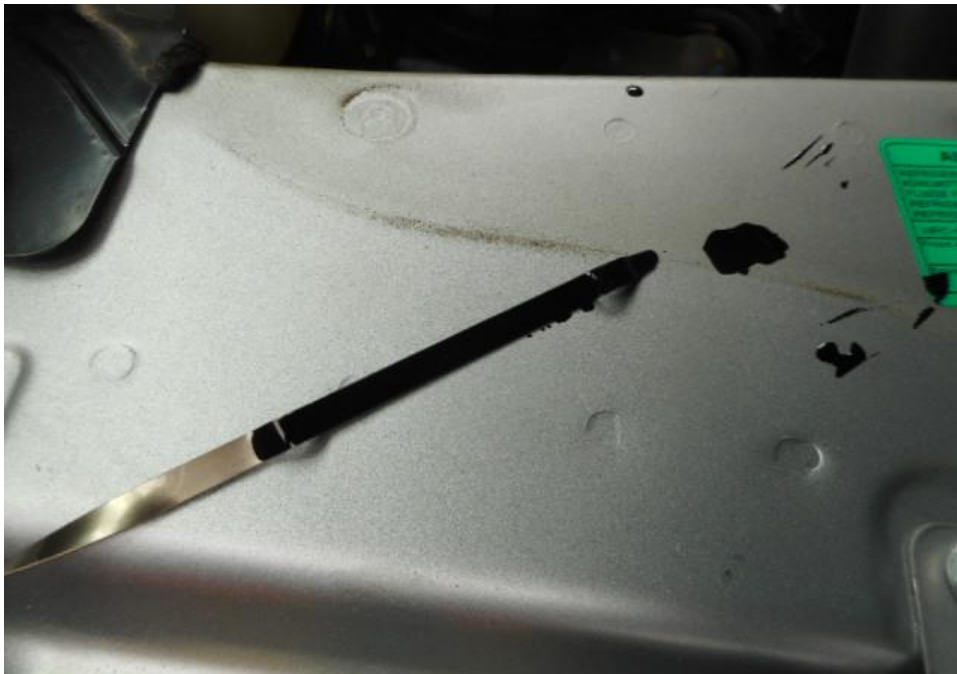
**Photo 14** shows the engine oil dip stick of the Motor Van at the time of my inspection. The engine oil was observed to be of sufficient level and without any visible contamination.

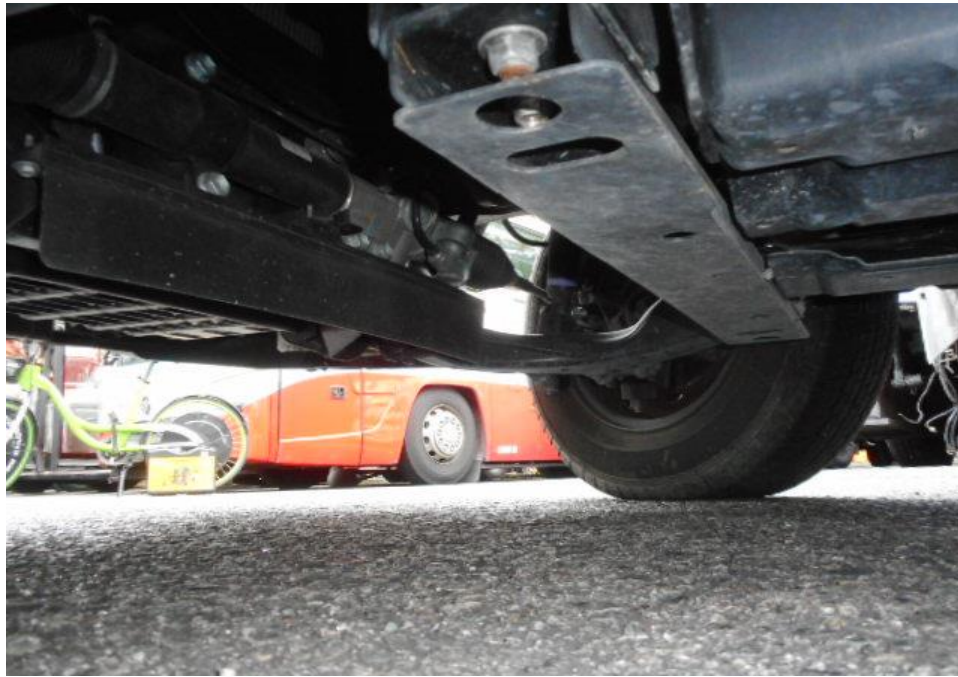
**Photo 15** shows the undercarriage of the Motor Van, at the area where the engine housing and transmission housing are located. . I did not find any sign(s) or indication(s) of fluid leak and/or fluid stain(s) on the underside of the Motor Van.

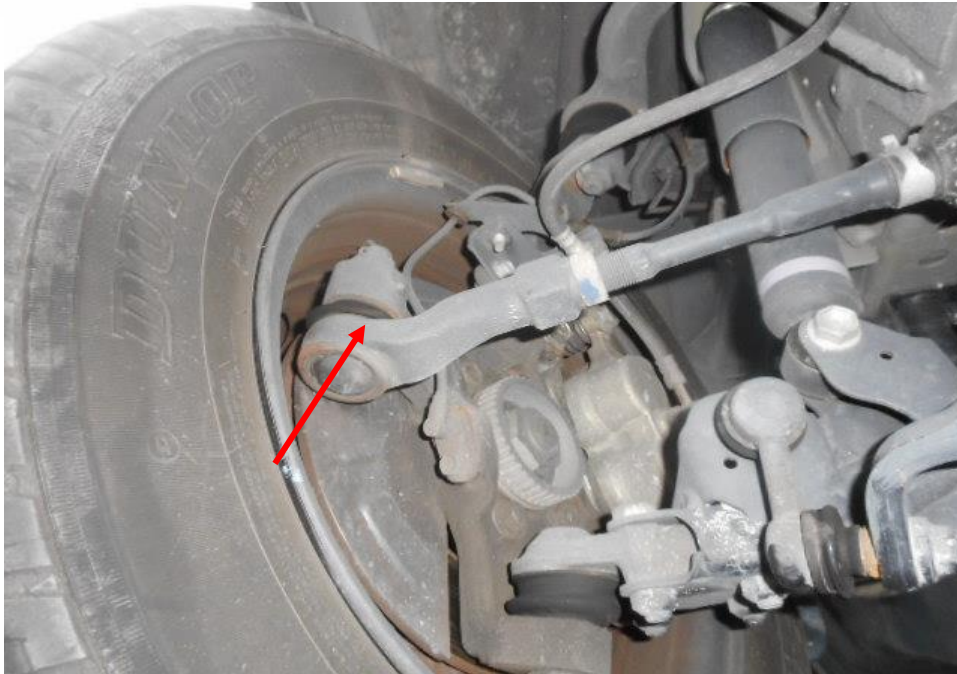
**Photo 16** shows the various undercarriage components at the front right wheel of the Motor Van, in particular the steering tie rod end (arrowed). The various steering components were all found to be intact, suggesting that the steering system of the Motor Van was likely to be in serviceable condition at the material time of accident. There was also no sign of fluid stain(s) observed on the various undercarriage components.

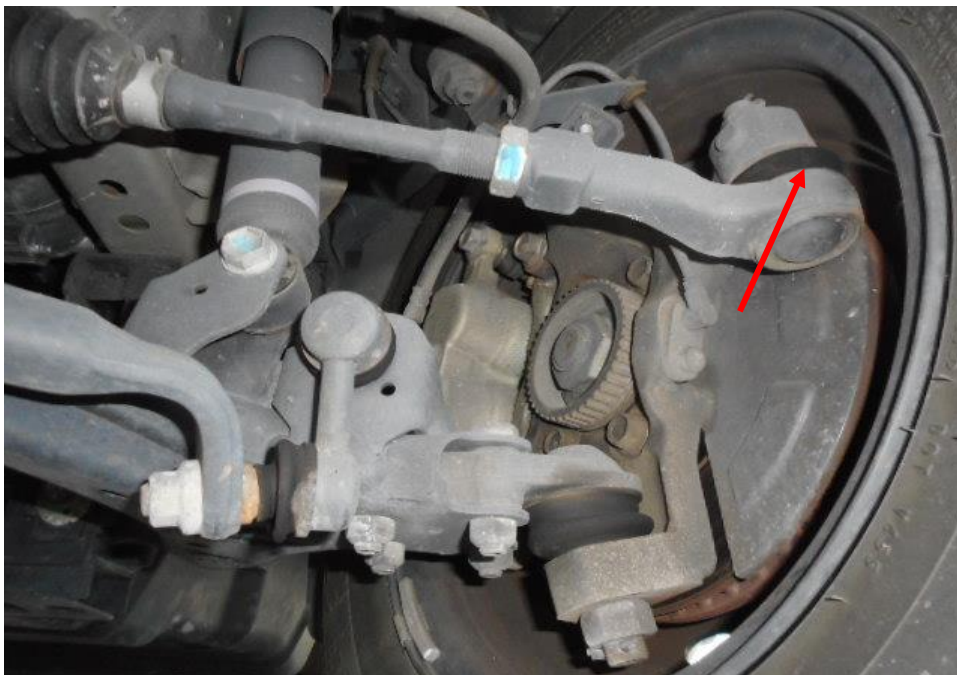
**Photo 17** shows the various undercarriage components at the front left wheel of the Motor Van, in particular the steering tie rod end (arrowed). The various undercarriage components of the Motor Van were all found to be intact without any visible damage. There was also no sign of fluid stain(s) observed on the various undercarriage components.

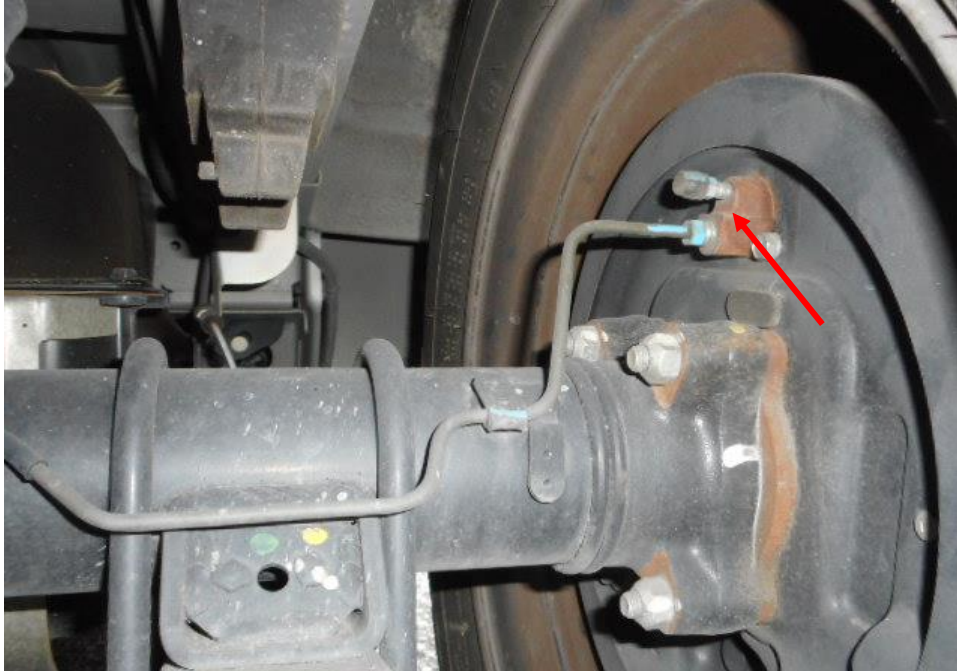
**Photo 18** shows the brake pipe (arrowed) at the rear right wheel of the Motor Van. I did not observe any leakage of brake fluid at the time of my inspection of the Motor Van. My static tests of the Motor Van's braking system, along with my visual examination of the various mechanical components in the braking system, had indicated that there was no internal leakage of pressure/vacuum. Hence the braking system of the Motor Van was likely to be in serviceable condition at the material time of accident.

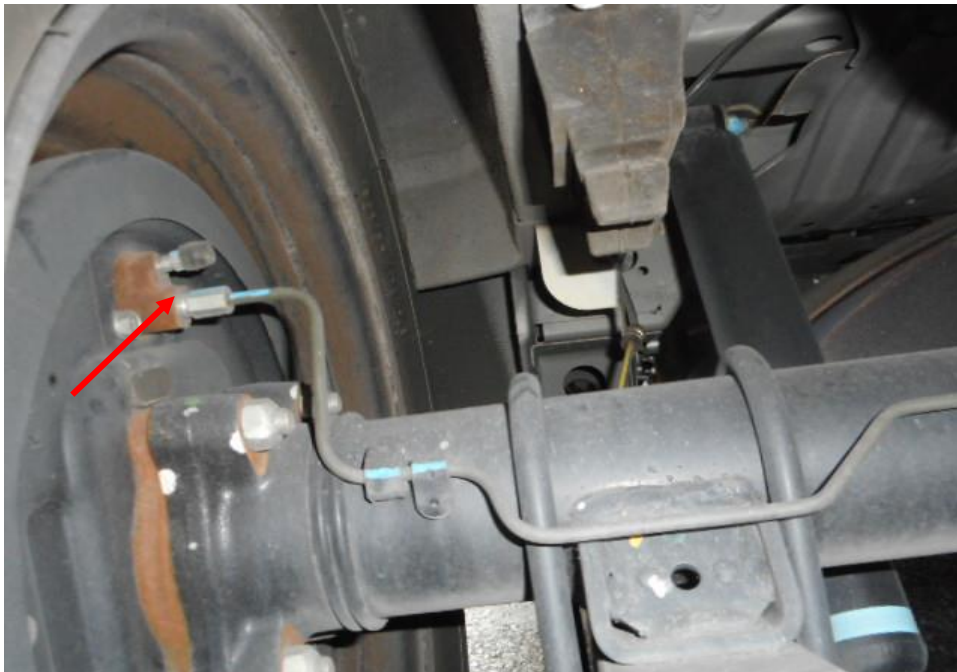
**Photo 19** shows the brake pipe (arrowed) at the rear left wheel of the Motor Van. I did not observe any leakage of brake fluid at the time of my inspection of the Motor Van. My static tests of the Motor Van's braking system, along with my visual examination of the various mechanical components in the braking system had indicated that there was no internal leakage of pressure/vacuum. Hence the braking system of the Motor Van was likely to be in serviceable condition at the material time of accident.

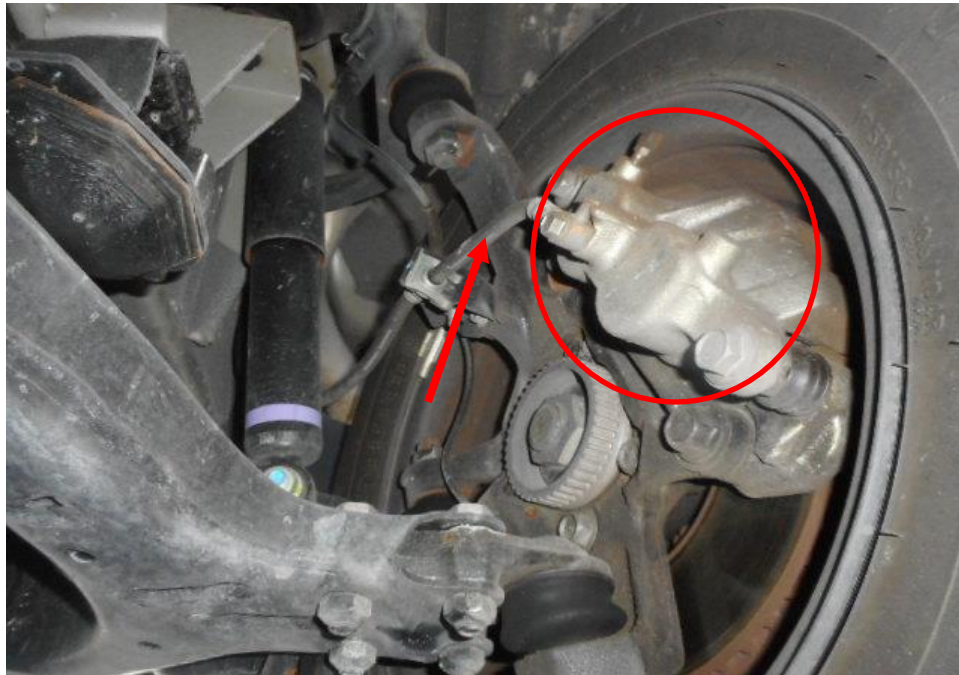
**Photo 20** shows the brake hose/pipe (arrowed) at the front right wheel of the Motor Van. No leakage of brake fluid was observed. Visual examination of the various components of the braking system like the brake caliper (circled), brake booster, brake pedal etc had revealed all to be intact and without visible damage at the time of accident. There was also no sign of fluid stain(s) observed on the various undercarriage components.

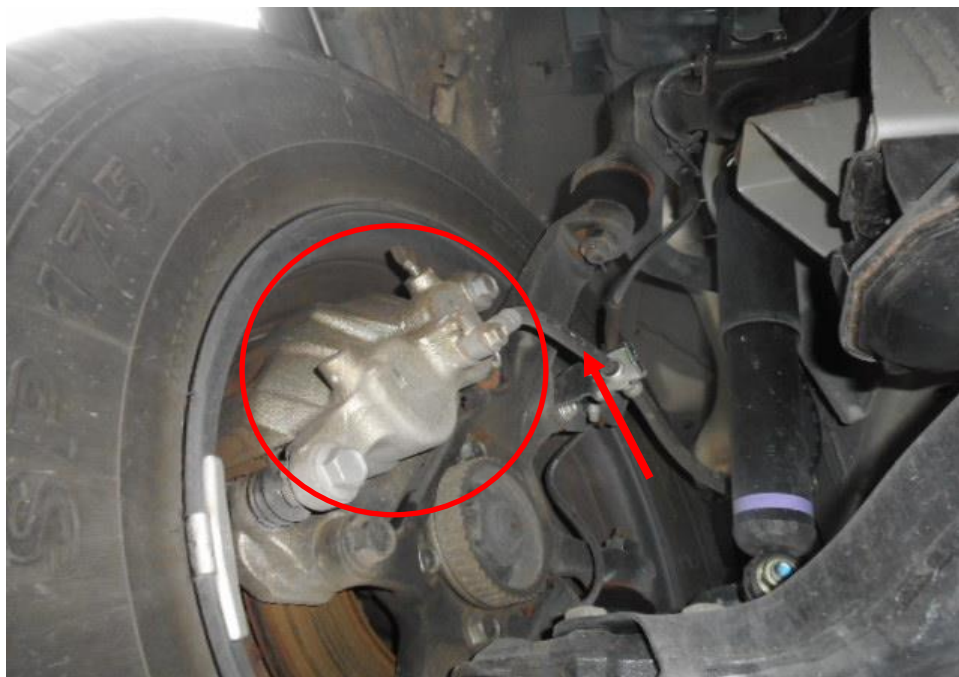
**Photo 21** shows the brake hose/pipe (arrowed) at the front left wheel of the Motor Van. No leakage of brake fluid was observed. Visual examination of the various components of the braking system like the brake caliper (circled), brake booster, brake pedal etc had revealed all to be intact and without visible damage at the time of accident. There was also no sign of fluid stain(s) observed on the various undercarriage components.

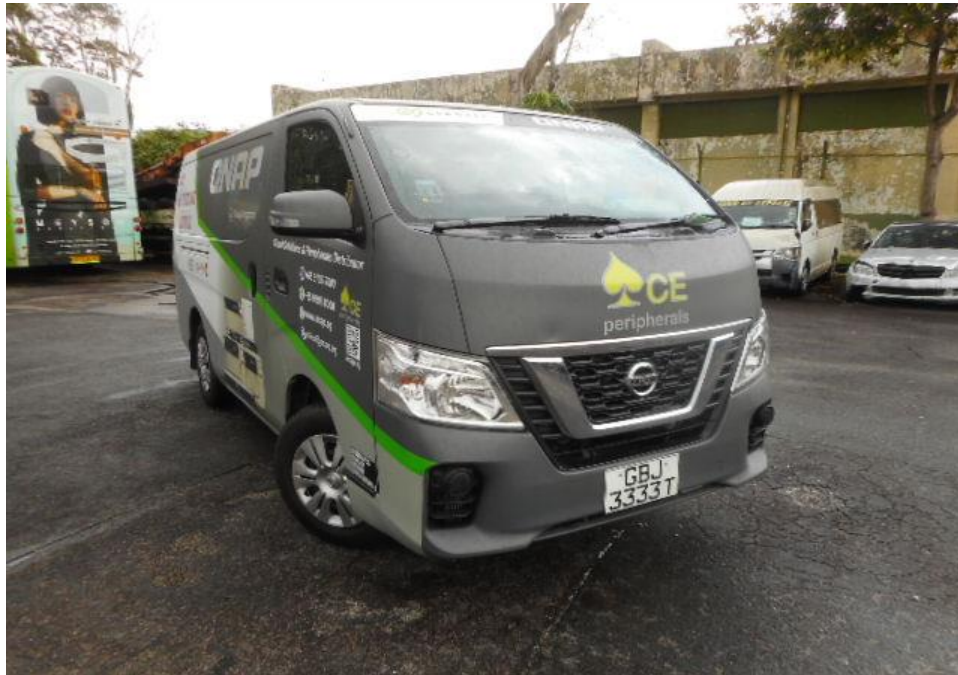
**Photo 22** shows the front right wheel of the Motor Van turned to its full left. During my steering system test, I did not experience any abnormal free play and/or resistance when I had turned the steering wheel towards full left and full right. This would suggest that the steering system of the Motor Van was likely to be in serviceable condition at the material time of accident.

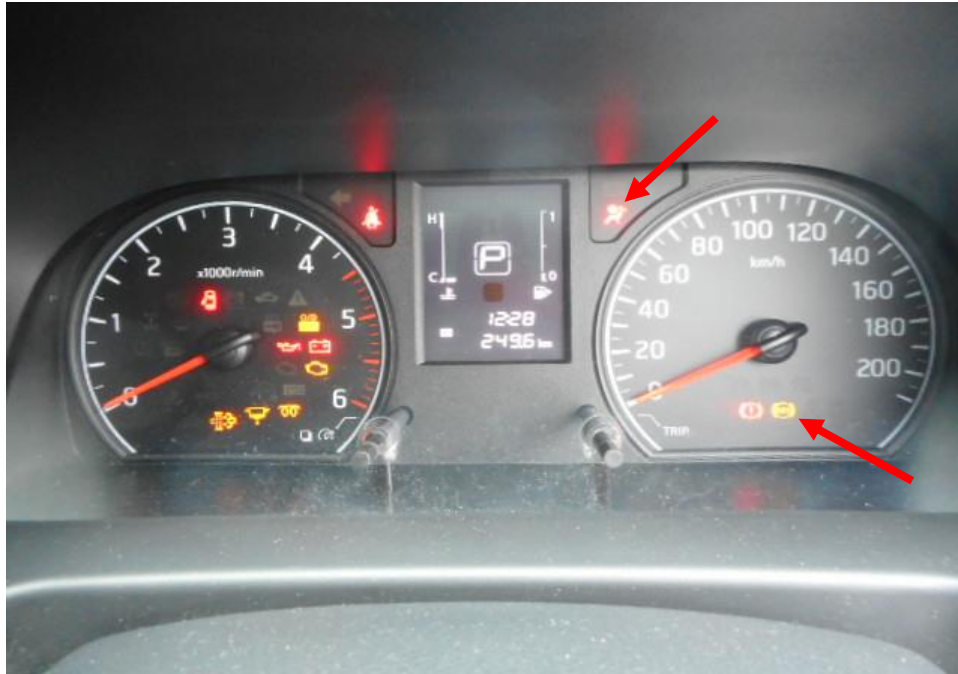
**Photo 23** shows the warning light for Anti-Lock Brake System (ABS) and Supplemental Restraint System (SRS) (arrowed) appearing on the instrument panel of the Motor Van during the self-test of its various electronic operating systems when its engine was cranked.

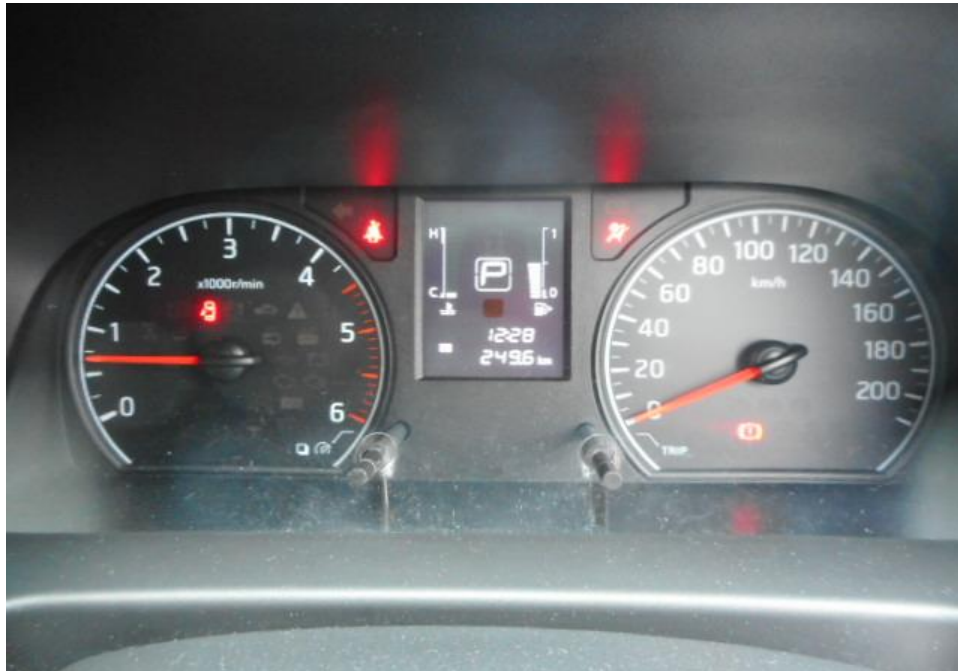
**Photo 24** shows no warning lights illuminated on the instrument panel of the Motor Van after the engine was cranked. This would suggest that there was no abnormality to the electronic operating system of the Motor Van, like the ABS, SRS and etc.
