You're Ref: TP/IP/20423/2022
Our Ref: CI/TPD22010882/P

13th February 2023

MECHANICAL INSPECTION REPORT OF MOTOR CAR SBJ 2T

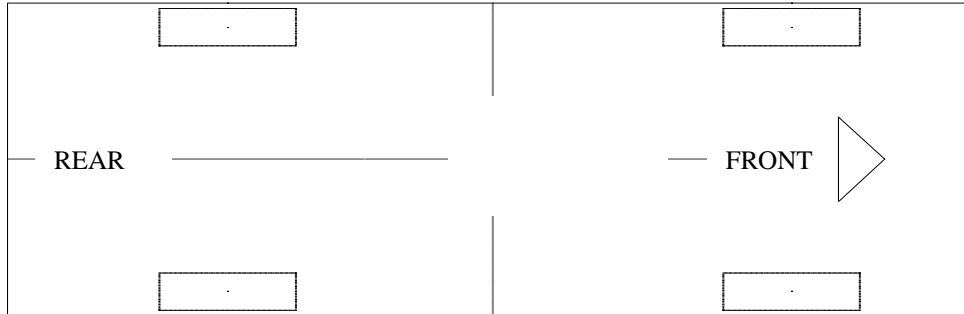
Dunlop 215/60R16 (4.9mm)

Dunlop 215/60R16 (4.1mm)

Dunlop 215/60R16 (4.6mm)

Dunlop 215/60R16 (3.8mm) (Cut and deflated)

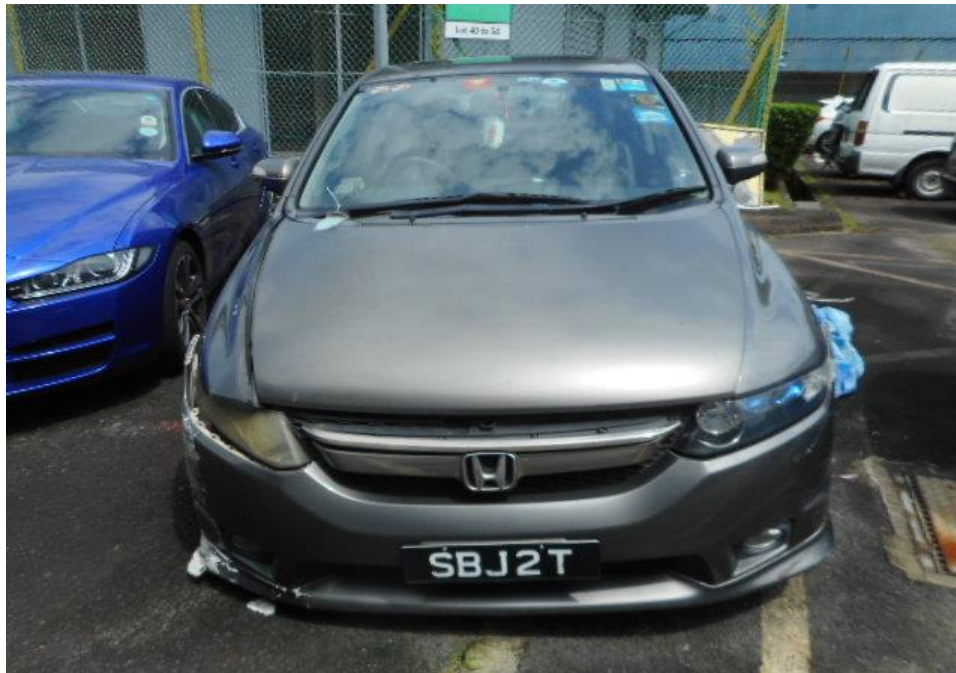
Photo 1 shows a general view of the Motor Car's front body at the time of my inspection. The Motor Car was observed to have sustained damage at its front portion. Its front bumper, front right headlamp front right fender and right rear view mirror was amongst the body parts that were damaged as a result of the accident.

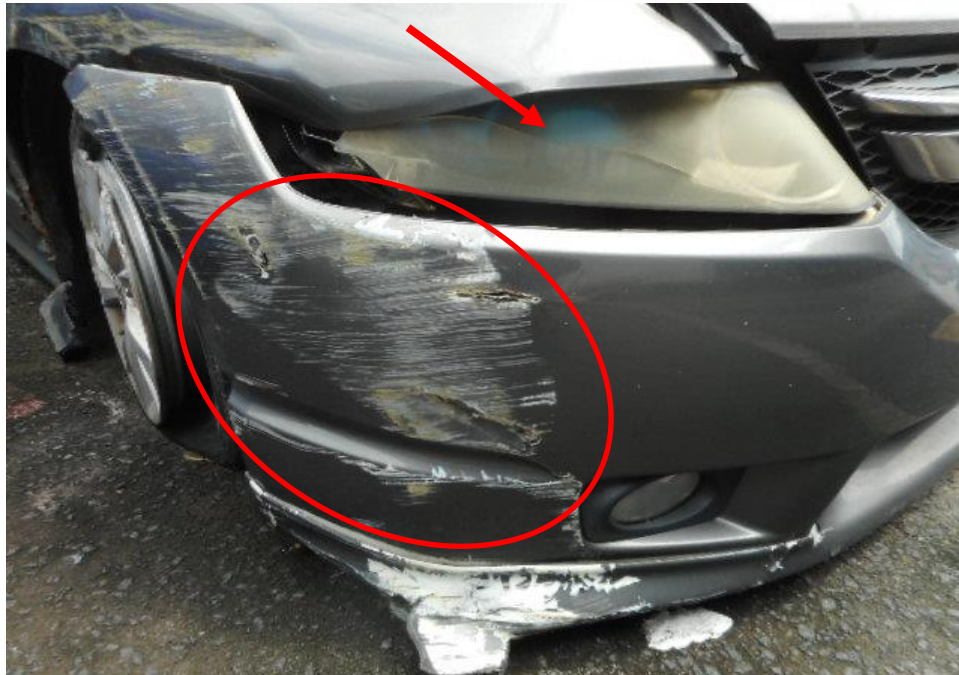
Photo 2 shows a close up view of the Motor Car's front body at the time of my inspection. The front portion of the Motor Car was observed to have sustained damage. Its front bumper (circled) and front right headlamp (arrowed) was amongst the body parts that were damaged as a result of the accident.

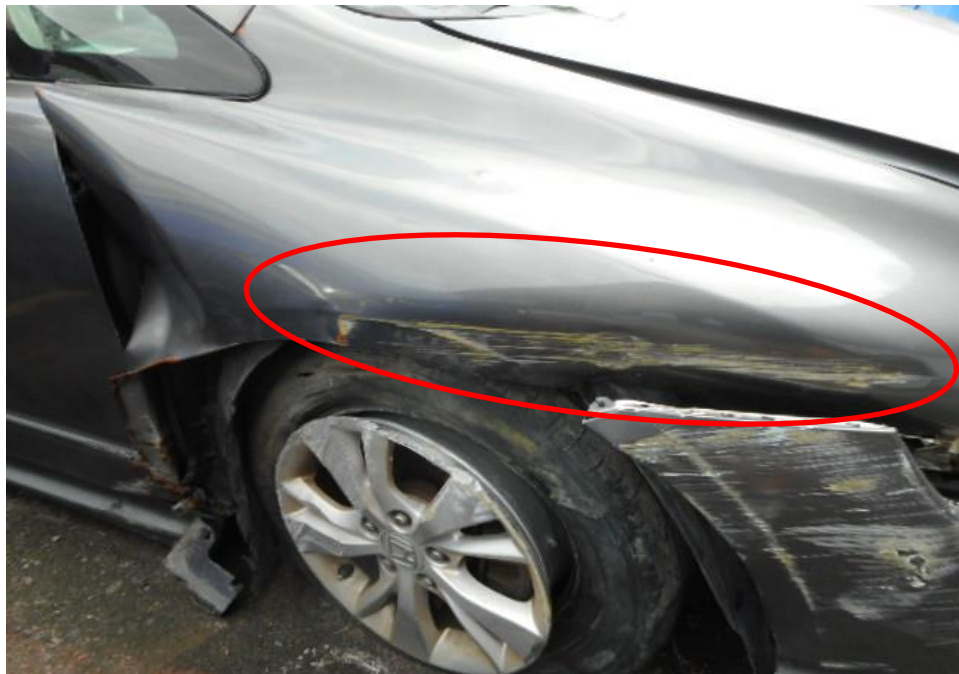
Photo 3 shows a close up view of the Motor Car's front body at the time of my inspection. The front portion of the Motor Car was observed to have sustained damage. Its front right fender (circled) was amongst the body parts that were damaged as a result of the accident.

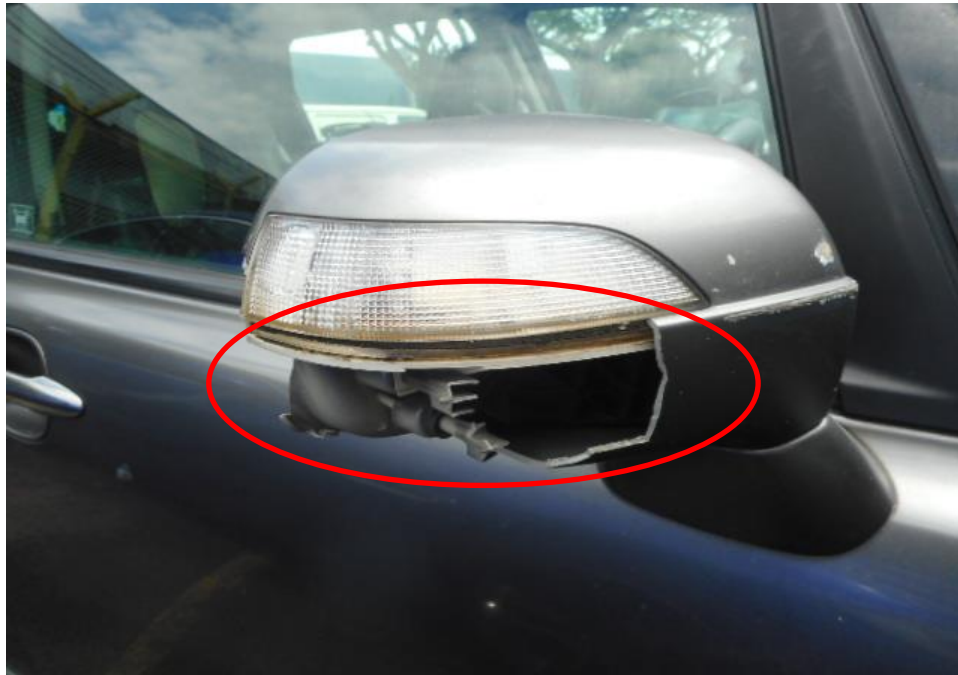
Photo 4 shows a close up view of the Motor Car's front body at the time of my inspection. The front portion of the Motor Car was observed to have sustained damage. Its front right rear view mirror (circled) was amongst the body parts that were damaged as a result of the accident.

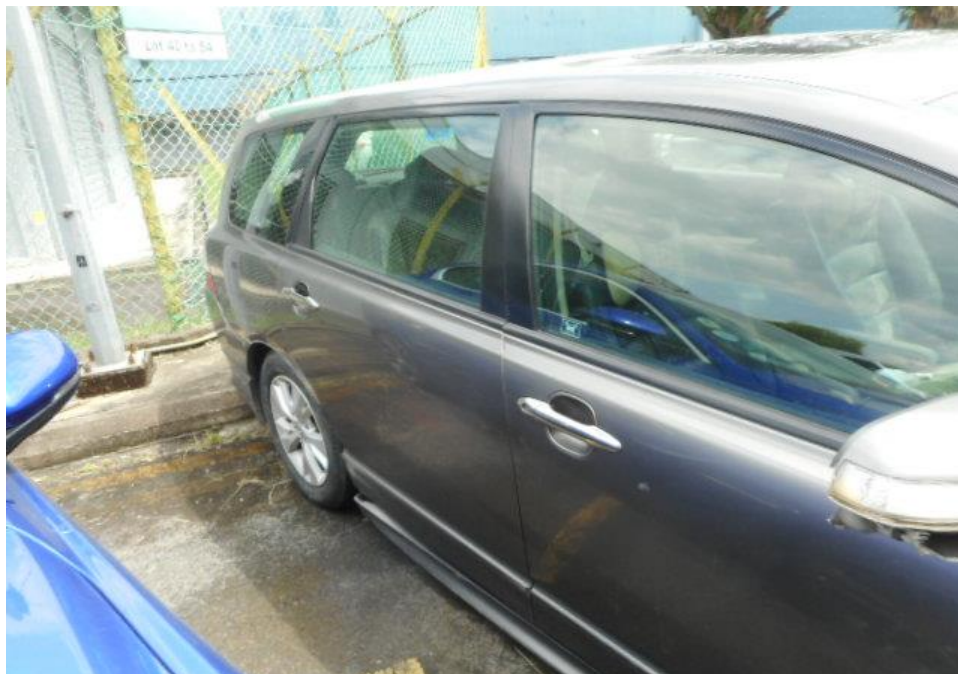
Photo 5 shows a general view of the Motor Car's right body at the time of my inspection. The Motor Car rear was observed to be unaffected by the accident.

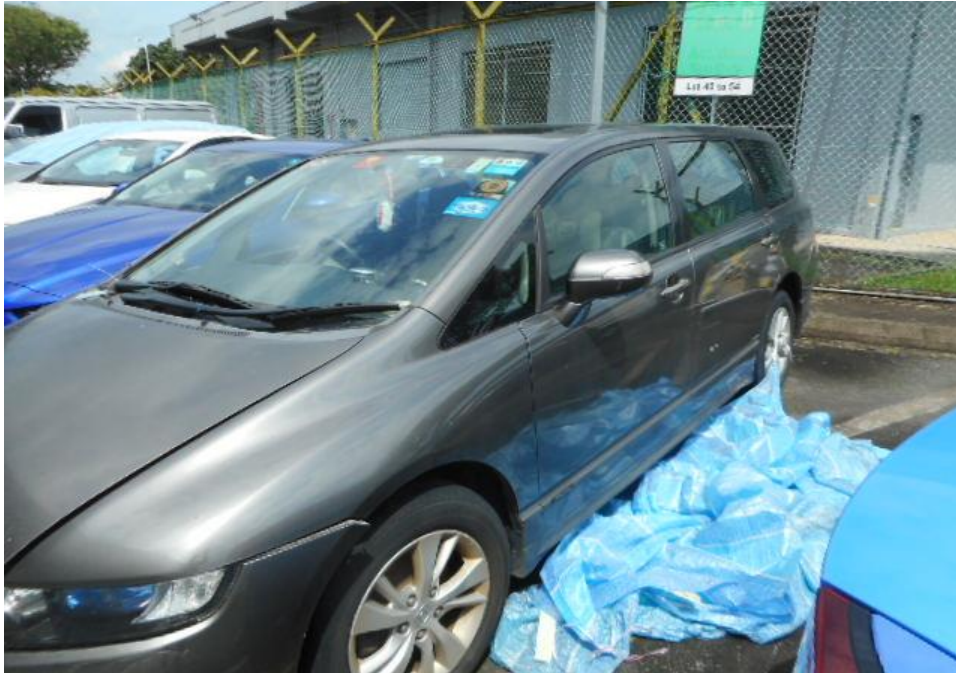
Photo 6 shows the general view of the Motor Car's left body at the time of my inspection. The Motor Car rear was observed to be unaffected by the accident.

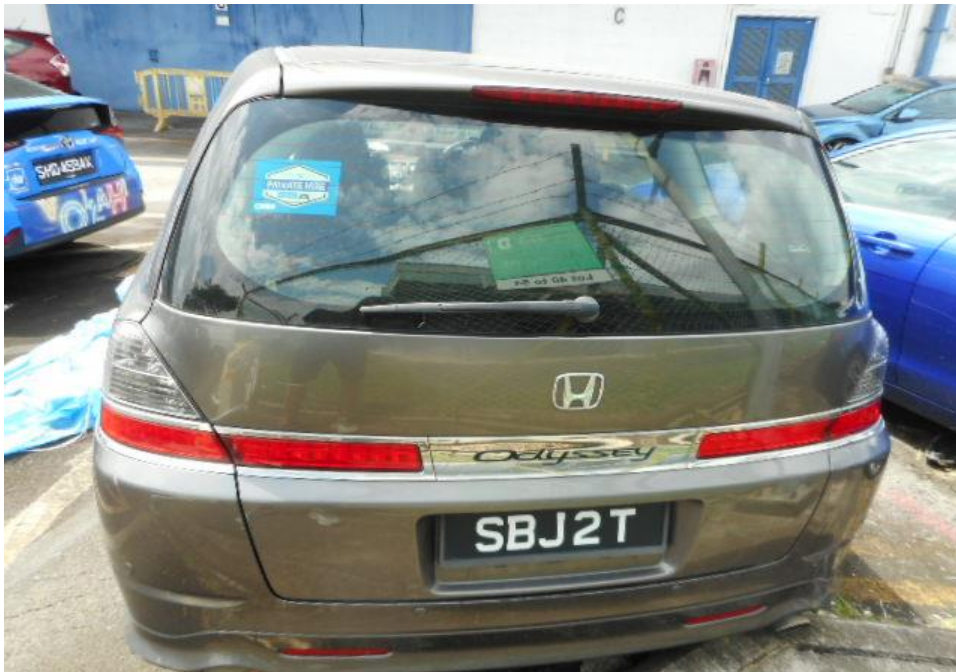
Photo 7 shows the general view of the Motor Car's rear body at the time of my inspection. The Motor Car rear was observed to be unaffected by the accident.

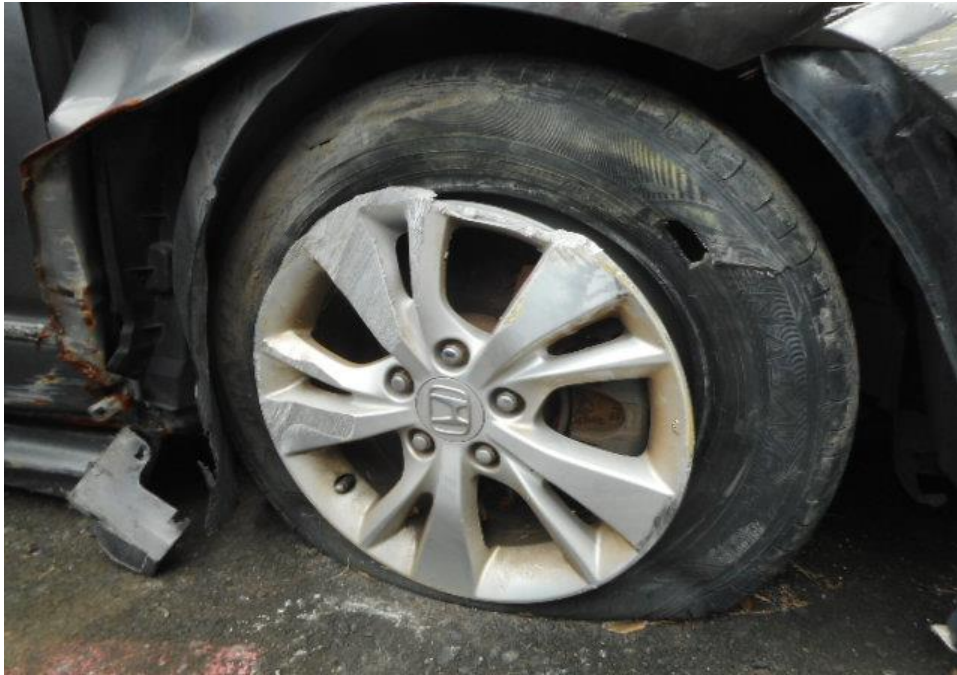
Photo 8 shows the condition of the front right tyre of the Motor Car, which was observed to be in unserviceable condition with remaining tread depth of approximately 3.8mm. The tyre was also observed to be deflated with cut marks and the wheel rim was also damaged as a result of the accident.

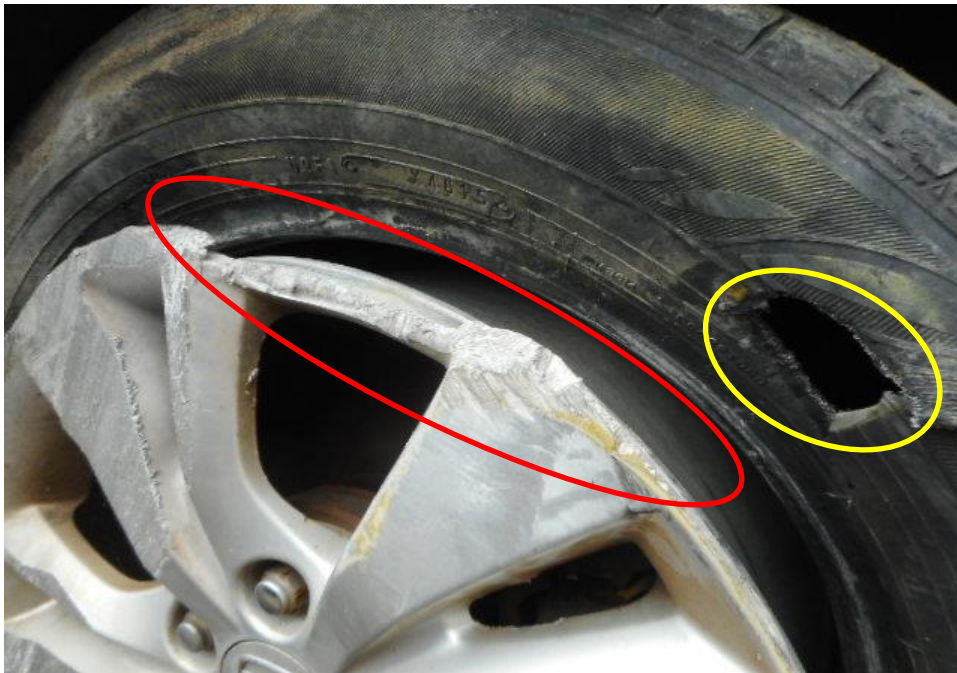
Photo 9 shows the close up condition of the front right tyre of the Motor Car, which was observed to be in unserviceable condition with remaining tread depth of approximately 3.8mm. The tyre was also observed to be deflated with cut marks (yellow circle) and the wheel rim (red circle) was also damaged as a result of the accident.

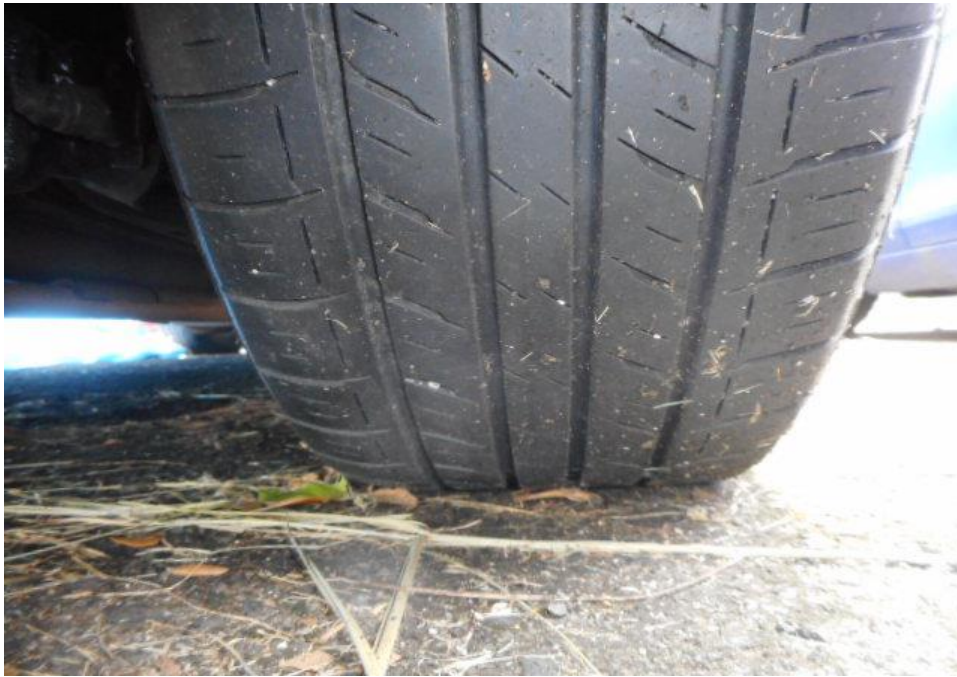
Photo 10 shows the condition of the rear right tyre of the Motor Car, which was observed to be in serviceable condition with remaining tread depth of approximately 4.6mm. The tyre was also observed to be sufficiently inflated for vehicular operation with no tear, cut or burst mark(s).

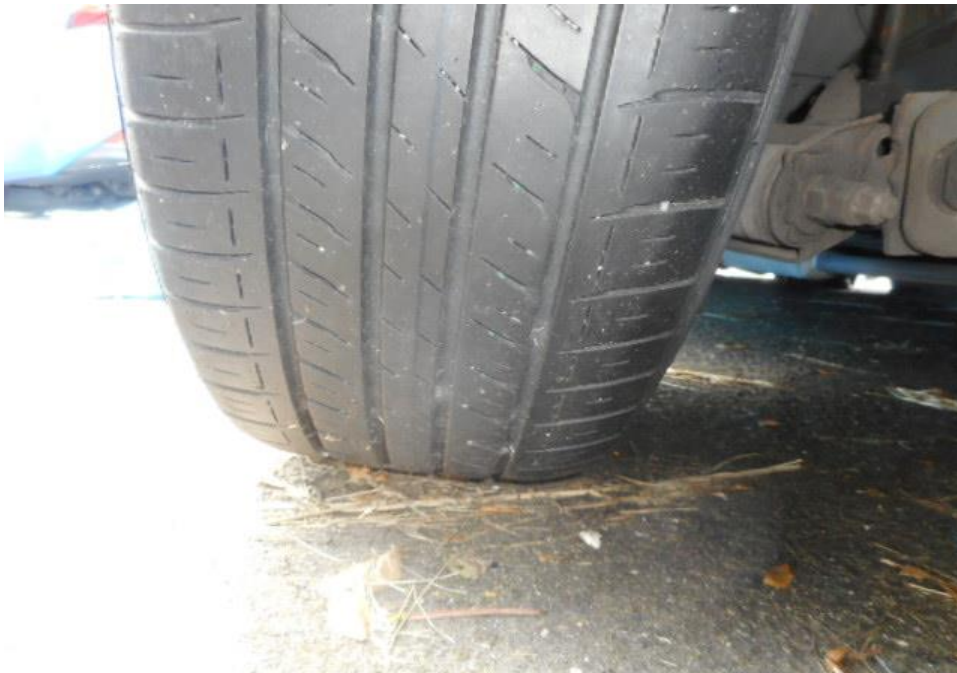
Photo 11 shows the condition of the rear left tyre of the Motor Car, which was observed to be in serviceable condition with remaining tread depth of approximately 4.9mm. The tyre, which was wrapped around alloy wheel rim, was also observed to be sufficiently inflated for vehicular operation. The 4 tyres of the Motor Car were wrapped around standard alloy wheel rims.

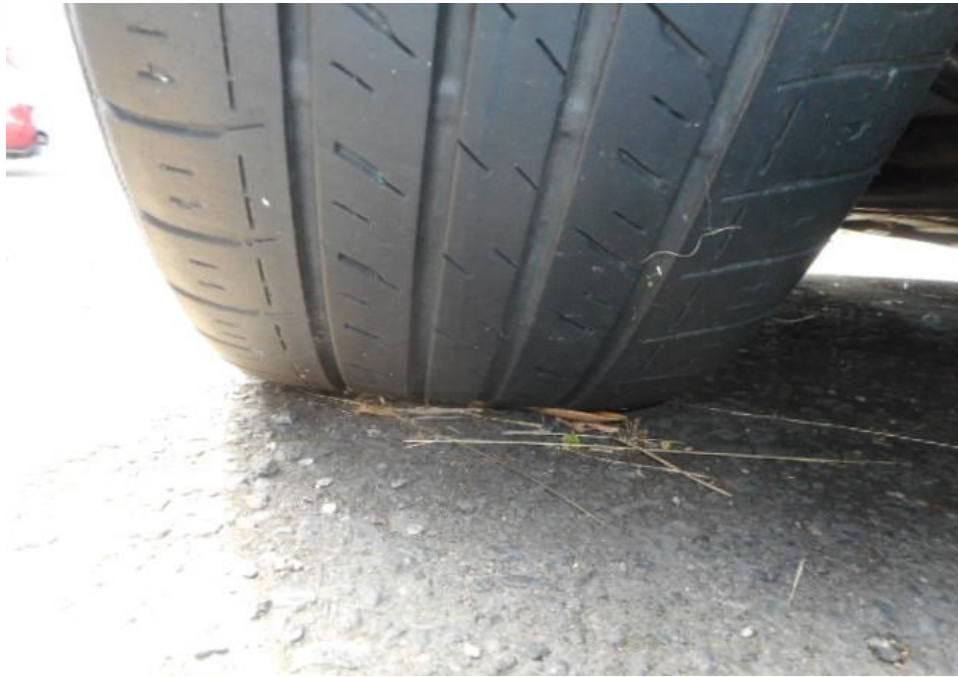
Photo 12 shows the condition of the front left tyre of the Motor Car, which was observed to be in serviceable condition with remaining tread depth of approximately 4.1mm. There was also no tear, cut or burst mark(s) on the outer and the inner sidewalls as well as across the tread of the Motor Car's 4 tyres.

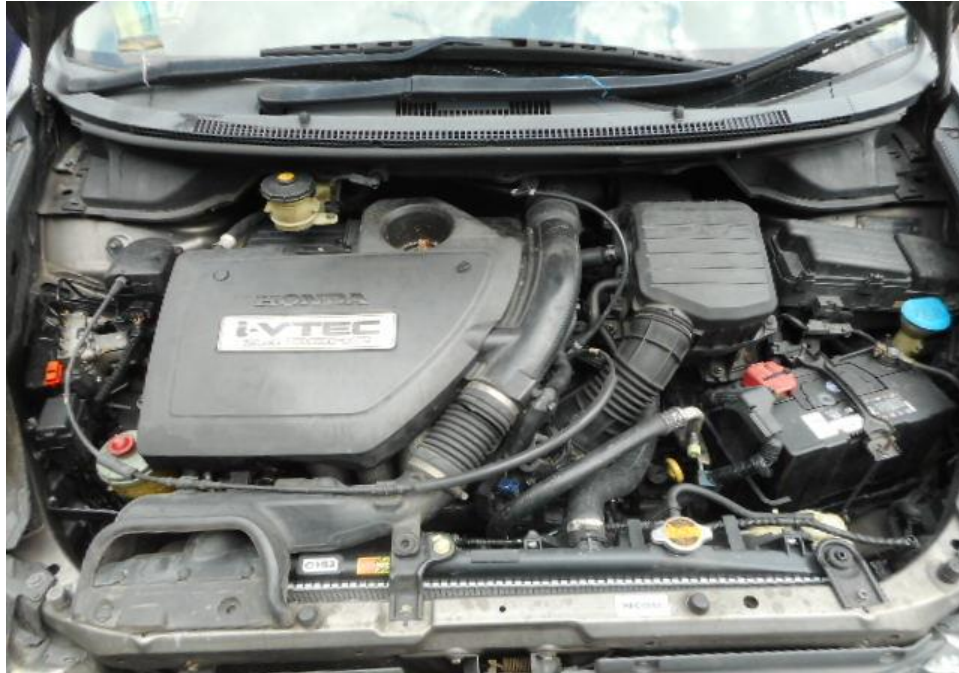
Photo 13 shows a general view of the Motor Car's engine compartment. The various parts and components inside the engine compartment were unaffected by the accident. There was also no sign(s) or indication(s) of fluid leakage and/or fluid stain within the engine compartment.

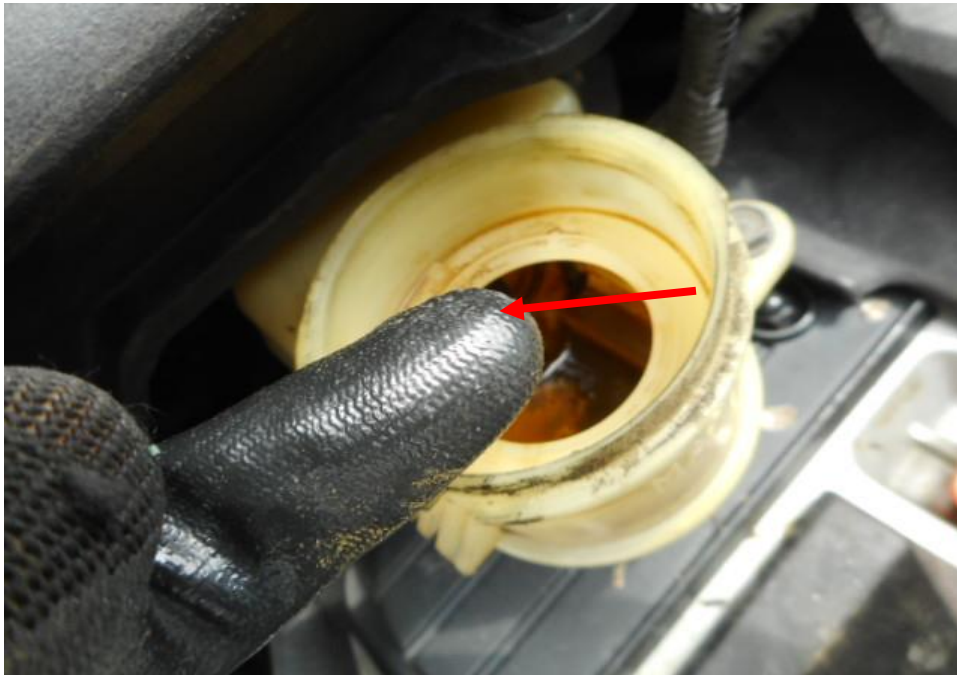
Photo 14 shows the brake fluid reservoir of the Motor Car at the time of my inspection. The brake fluid was observed to be of insufficient level (arrowed) however, we did not observed any leakage to the braking components

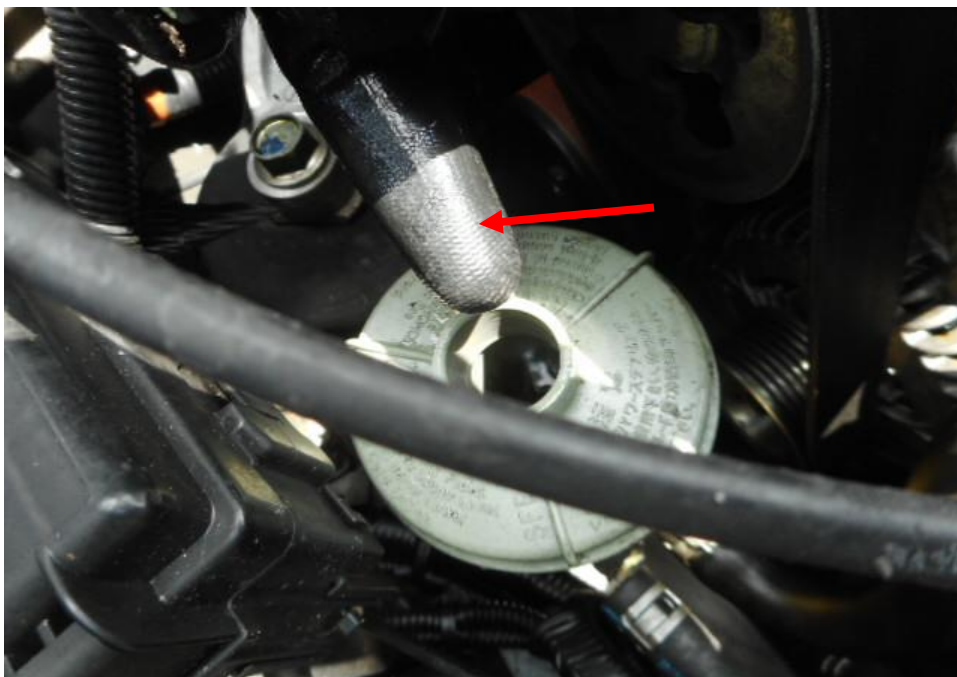
9. Further examination of the engine compartment revealed that the a hose belonging to the power steering fluid reservoir was observed to be broken off and had resulted the power steering fluid to leak out and become insufficient. From our understanding, due to wear and tear the power steering reservoir and its hose had previously broken the power steering fluid reservoir but was patched up prior to the accident. In our opinion, the hose had broken off again due to wear and tear resulting in the power steering fluid to leak out and causing the driver to lose control of the steering abilities of the Motor Car.

Photo 15 shows the power steering fluid level of the Motor Car at the time of my inspection. The power steering fluid was observed to be of insufficient level (arrowed) as result of a broken hose of the power steering system which had causing all the power steering fluid to leak out.

16. From my physical inspection of the Motor Car, I have found evidence of possible mechanical failure. As the broken hose of the power steering fluid reservoir had caused the fluid leakage resulting in the driver losing the steering abilities of the Motor Car that have caused and contributed to the accident.

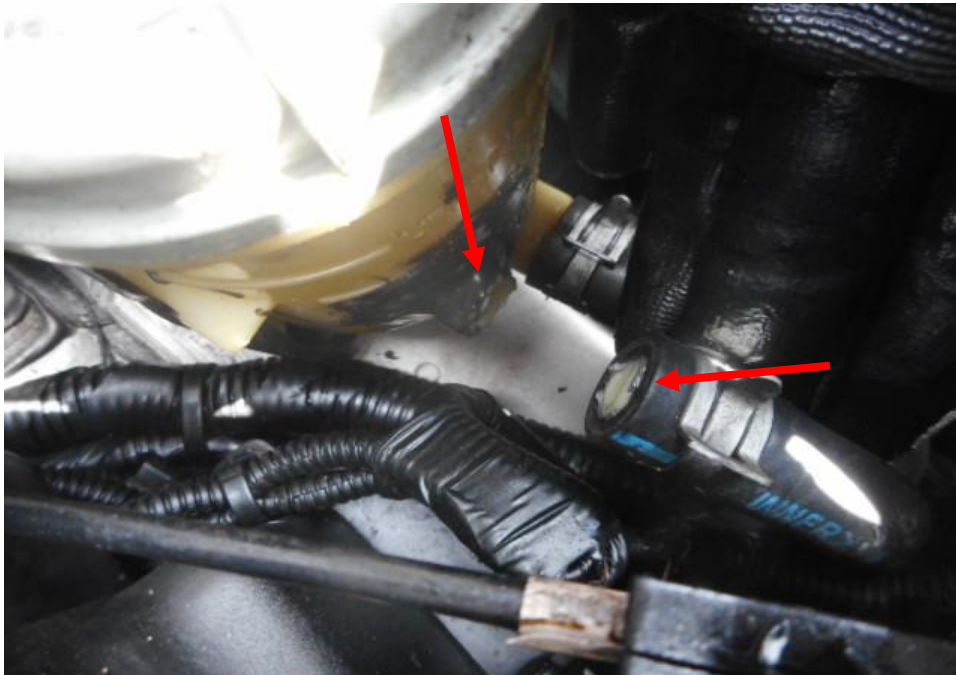
Photo 16 shows the power steering fluid level of the Motor Car at the time of my inspection. The power steering fluid was observed to be of insufficient level as its hose had previously broken but was patched up prior to the accident. In our opinion, the hose had broken off the power steering fluid reservoir again due to wear and tear resulting in the power steering fluid to leak out and causing the driver to lose control of the steering abilities of the Motor Car.

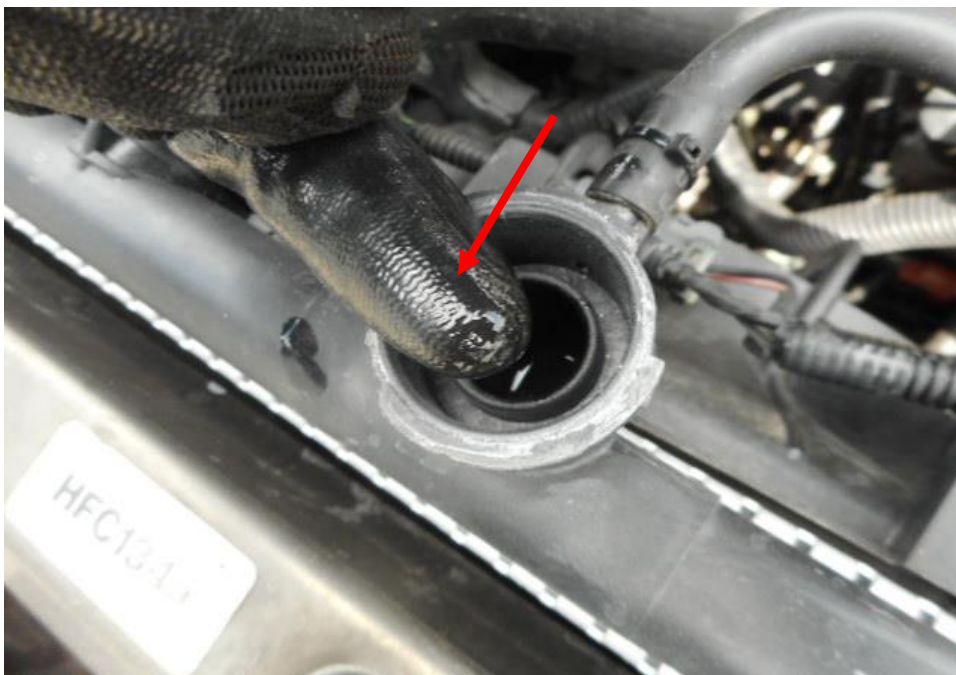
Photo 17 shows checks being carried out to the engine coolant of the Motor Car at the time of my inspection. The engine coolant was observed to be of sufficient level (arrowed) and without any visible contamination.

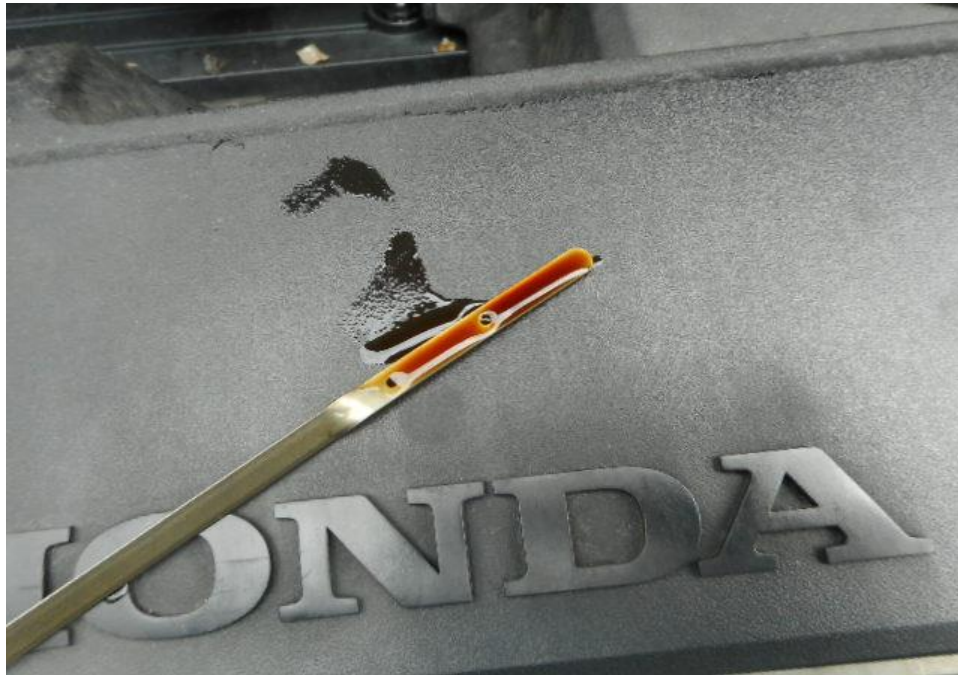
Photo 18 shows the engine oil level dipstick of the Motor Car at the time of my inspection. The engine oil was observed to be of sufficient level and without any visible contamination.

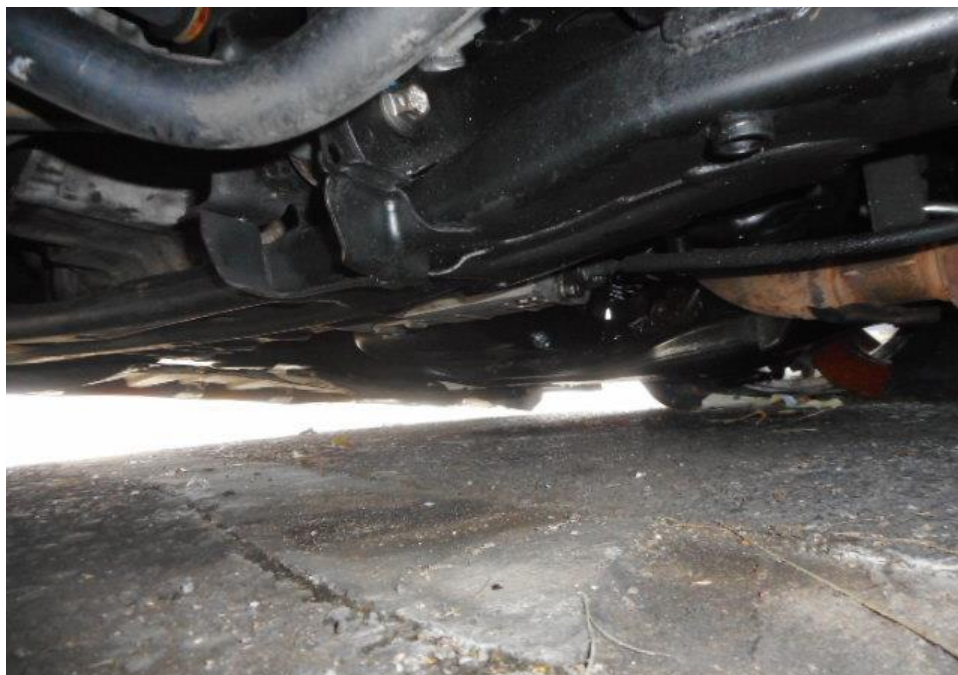
Photo 19 shows the undercarriage of the Motor Car, at the area where the engine housing and transmission housing are located. I did not find any sign(s) or indication(s) of fluid leak and/or fluid stain(s) on the underside of the Motor Car.

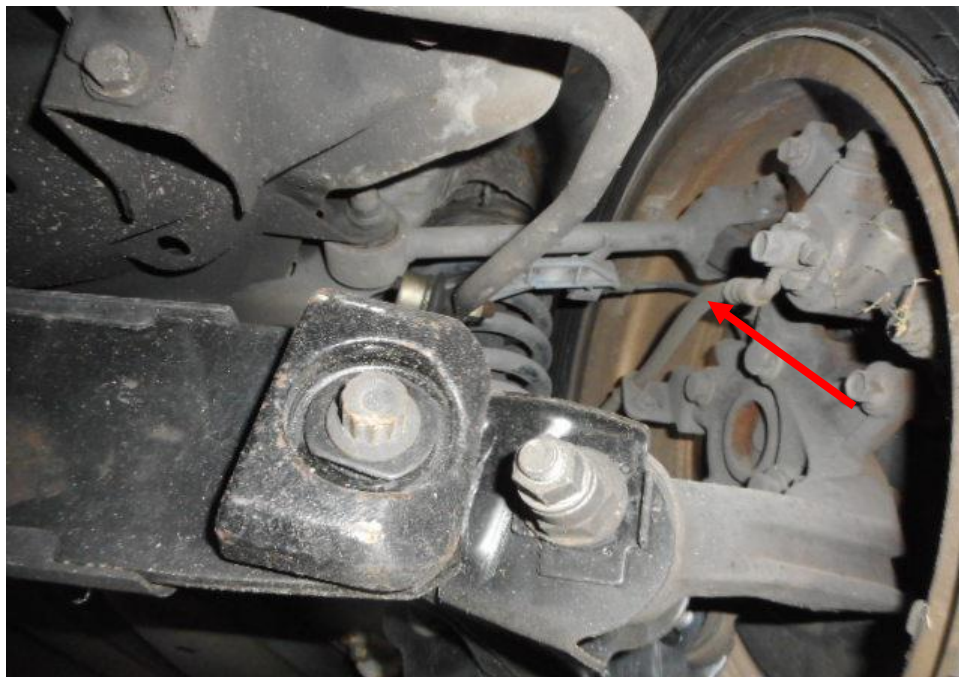
Photo 20 shows the brake hose/pipe (arrowed) at the rear right wheel of the Motor Car. No leakage of brake fluid was observed. The undercarriage components of the Motor Car were also all found to be intact and without any visible damage.

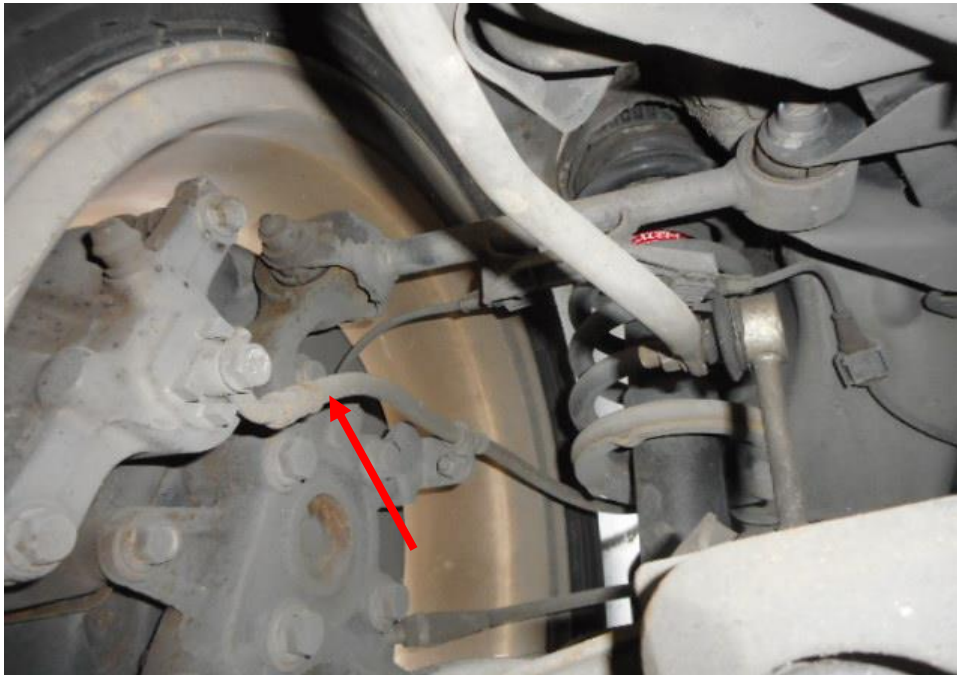
Photo 21 shows the brake hose/pipe (arrowed) at the rear left wheel of the Motor Car. I did not observe any leakage of brake fluid at the time of my inspection of the Motor Car. The undercarriage components of the Motor Car were also all found to be intact and without any visible damage.

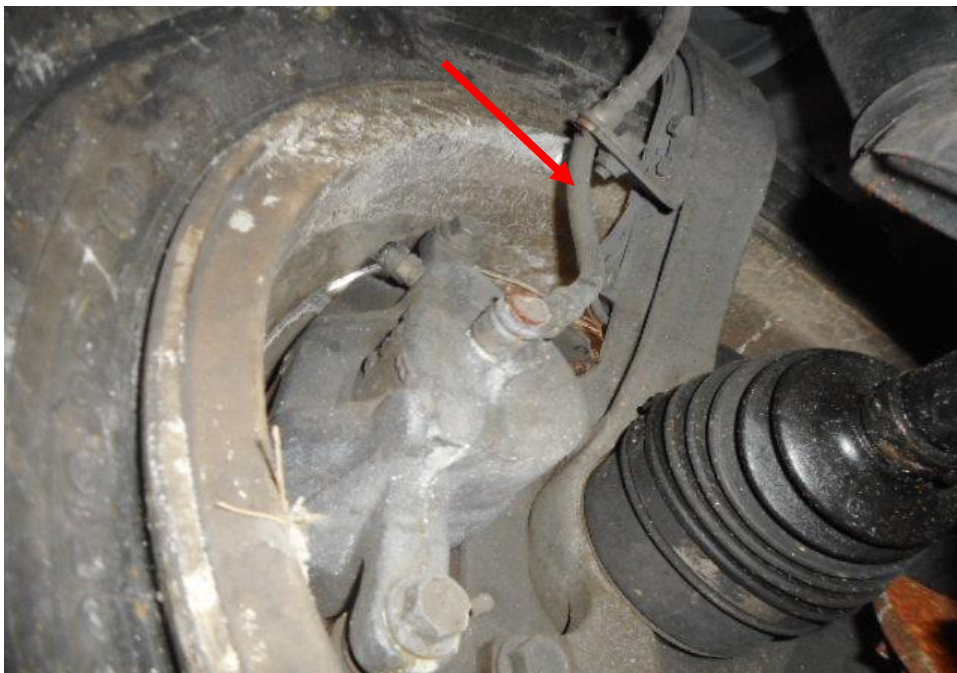
Photo 22 shows the brake hose/pipe (arrowed) at the front right wheel of the Motor Car. I did not observe any leakage of brake fluid at the time of my inspection of the Motor Car. The undercarriage components of the Motor Car were also all found to be intact and without any visible damage.

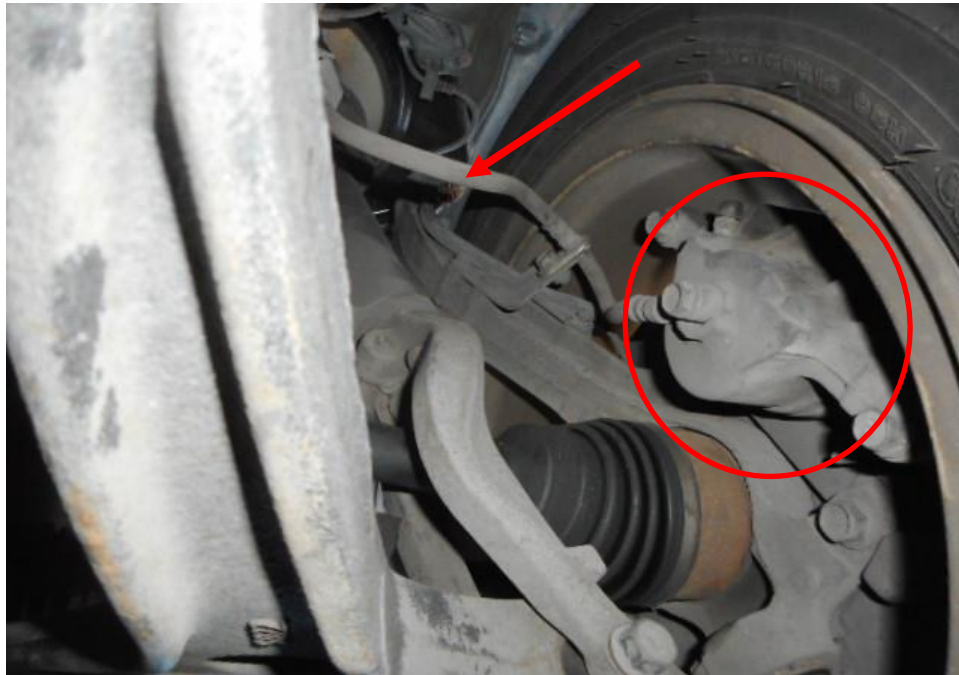
Photo 23 shows the brake hose/pipe (arrowed) at the front left wheel of the Motor Car. No leakage of brake fluid was observed. Visual examination of the various components of the braking system like the brake caliper (circled), brake booster, brake pedal etc had revealed all to be intact and without visible damage.

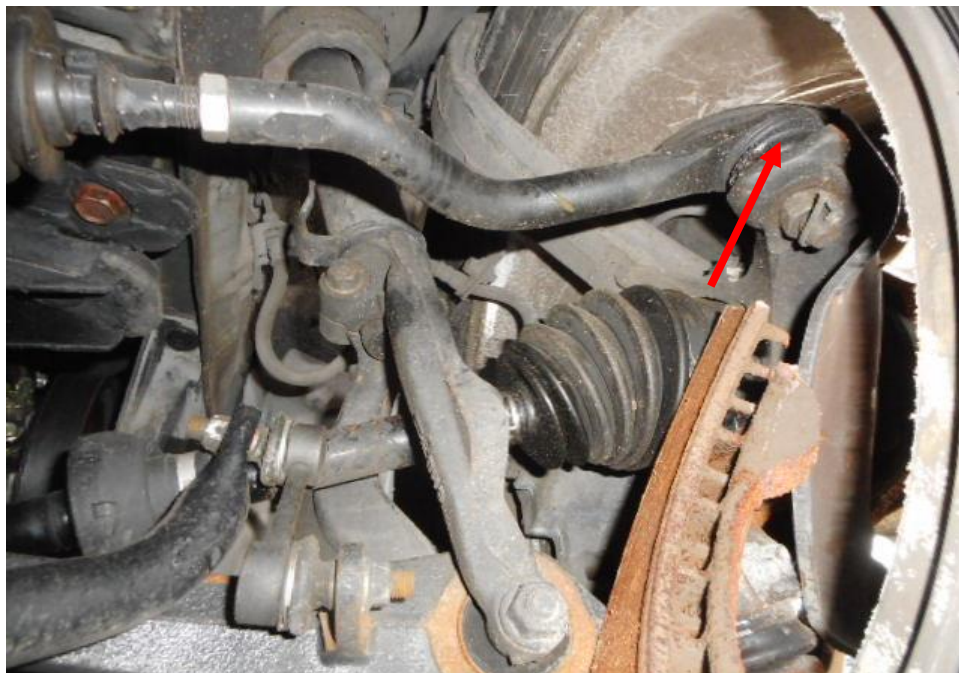
Photo 24 shows the various undercarriage components at the front right wheel of the Motor Car, in particular the steering tie rod (arrowed). The various steering components were all found to be intact. There was also no sign of fluid stain observed on the various undercarriage components at the front right wheel of the Motor Car.

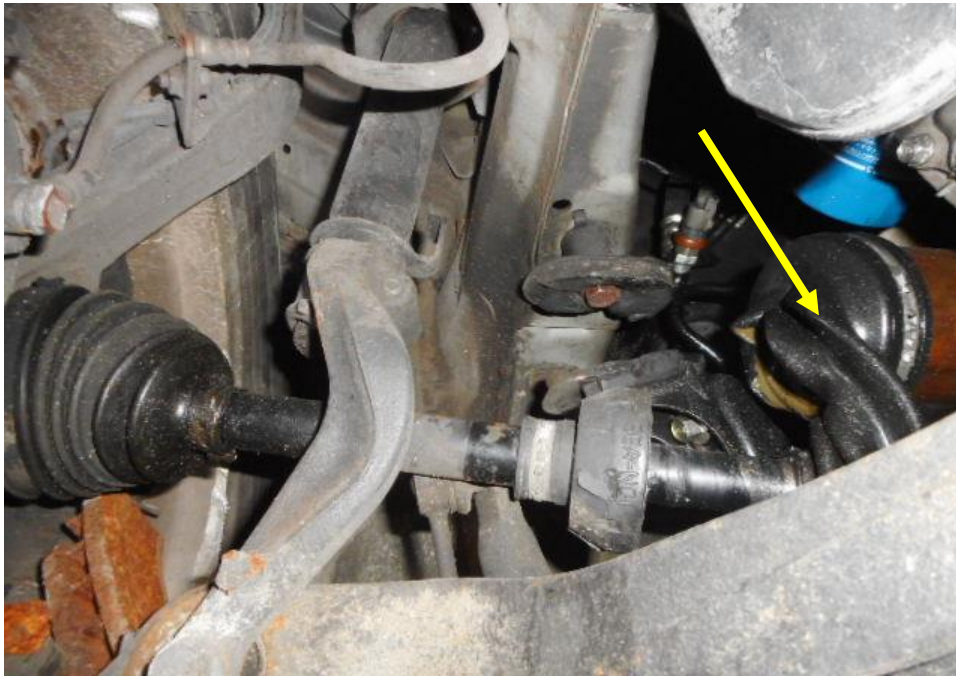
Photo 25 shows the various undercarriage components at the front right wheel of the Motor Car, in particular the drive shaft (arrowed) was observed to be damaged as a result of the accident.

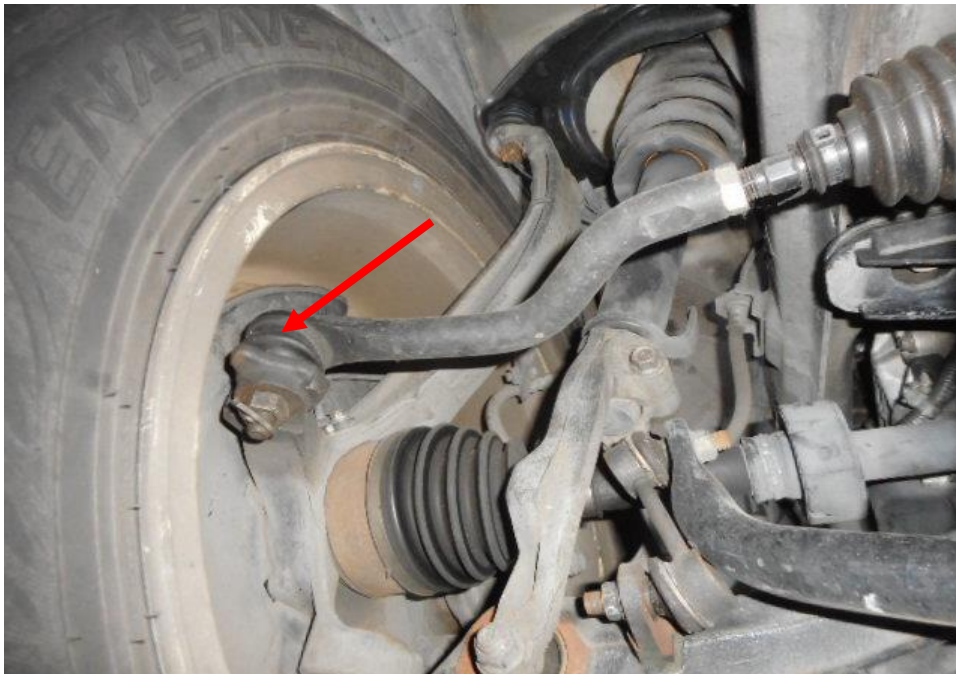
Photo 26 shows the various undercarriage components at the front left wheel of the Motor Car, which had included the steering tie rod (arrowed). The various undercarriage components of the Motor Car were all found to be intact without any visible damage.
