You're Ref: TP/IP/18415/2022  
Our Ref: CI/TPD22010895/P

29<sup>th</sup> November 2022

**MECHANICAL INSPECTION REPORT OF MOTOR CAR SMF 6553X**

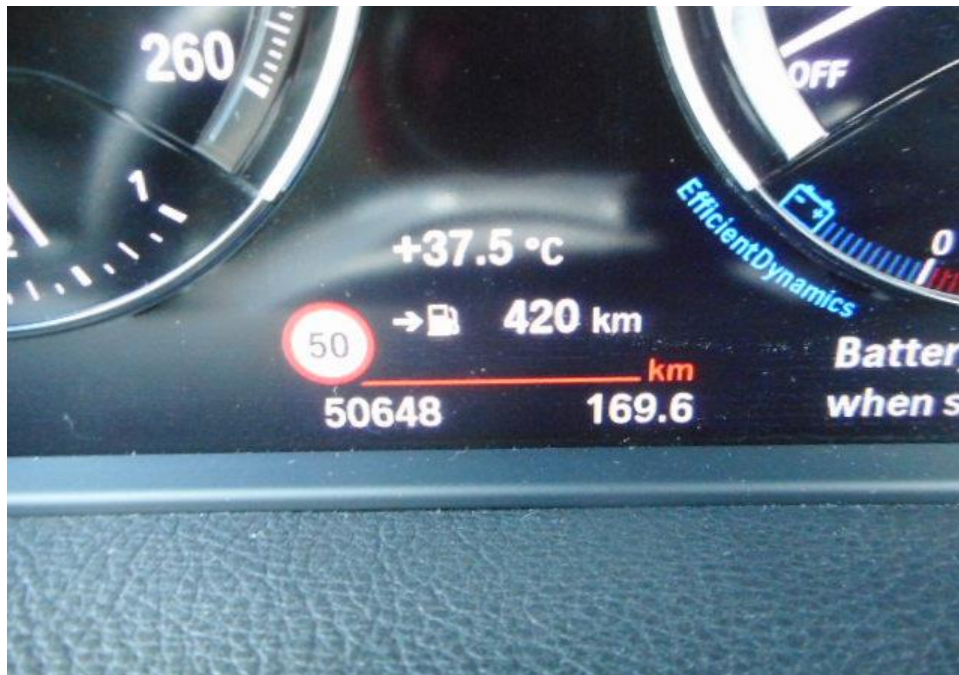
**Photo 1** shows the mileage of the Motor Car at the time of my inspection. The mileage observed was 50,648km.

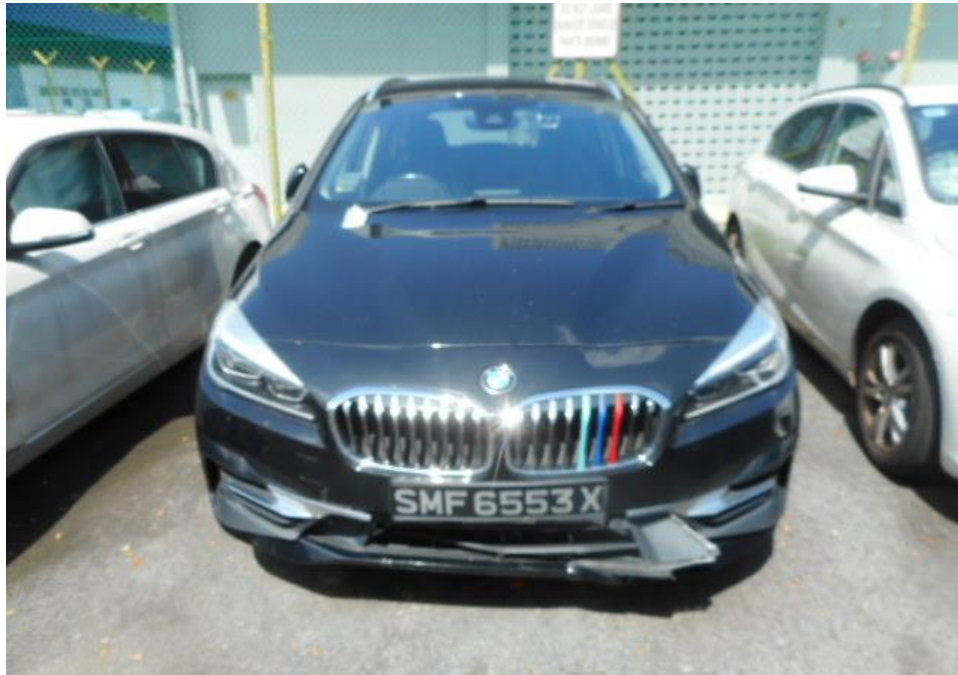
4. The mileage of the Motor Car at the time of my inspection was 50,648km.
5. The Motor Car was observed to have sustained damage at its front portion. Its front bumper was amongst the body part and the engine coolant radiator component that were damaged as a result of the accident.

**Photo 2** shows a general view of the Motor Car's front body at the time of my inspection. The front portion of the Motor Car was observed to have sustained damage. Its front bumper and was amongst the body part and engine coolant radiator component that were damaged as a result of the accident.

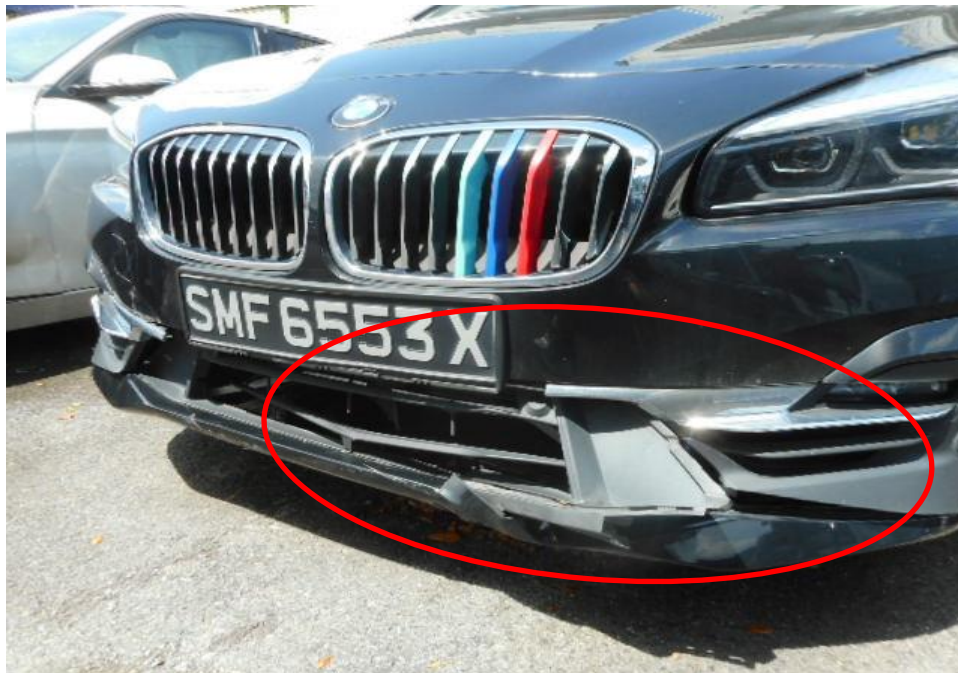
**Photo 3** shows a close up view of the Motor Car's front body at the time of my inspection. The front portion of the Motor Car was observed to have sustained damage. Its front bumper (circled) was the body part that were damaged as a result of the accident.

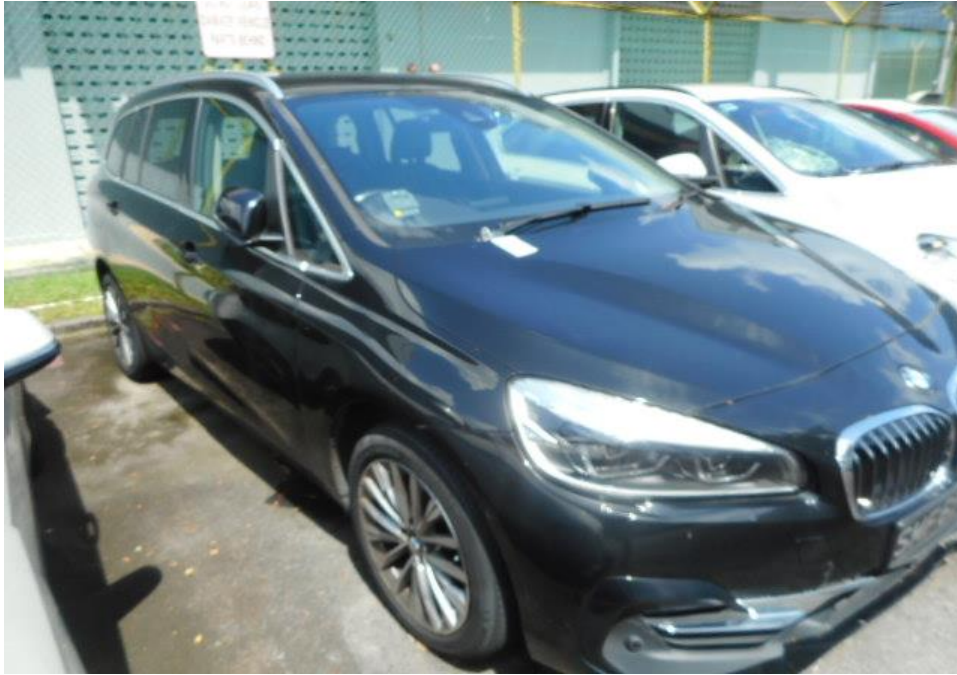
**Photo 4** shows a general view of the Motor Car's right body at the time of my inspection. The right portion of the Motor Car was observed to have been unaffected by the accident.

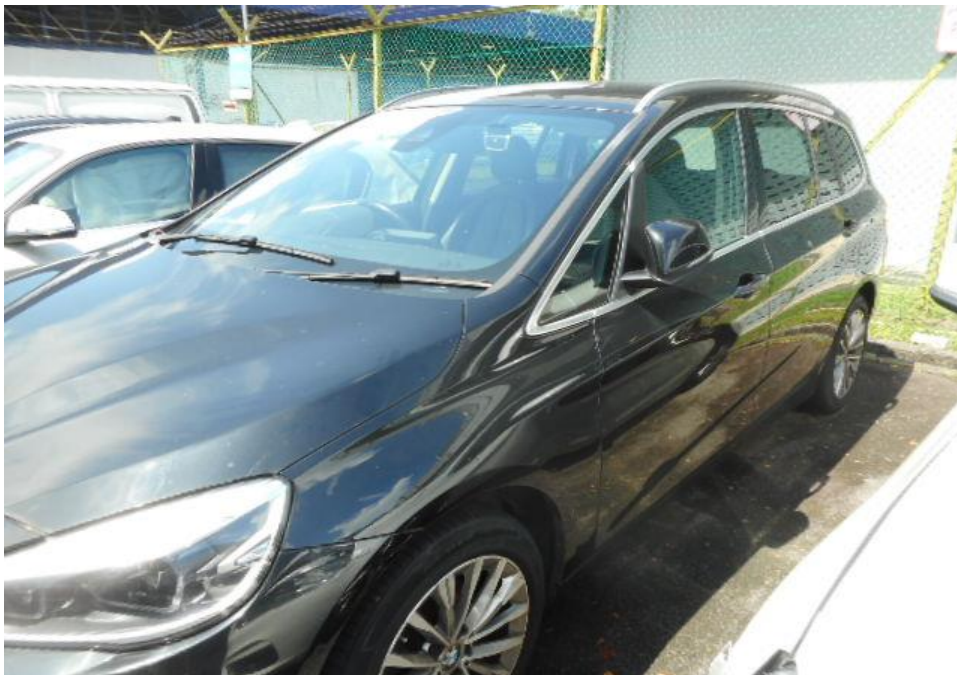
**Photo 5** shows a general view of the Motor Car's left body at the time of my inspection. The left portion of the Motor Car was observed to have been unaffected by the accident.

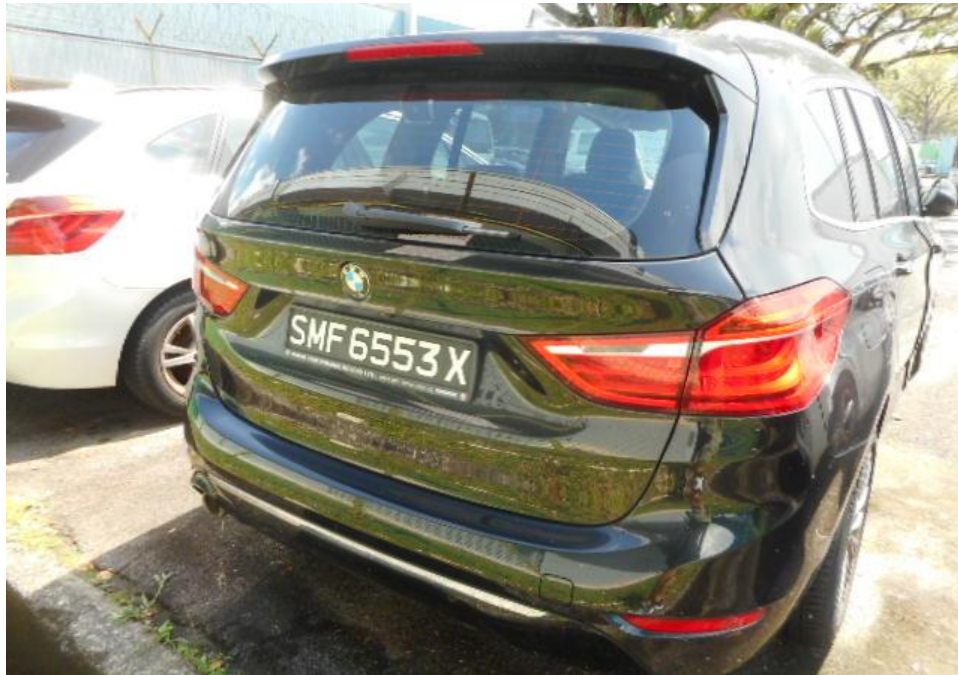
**Photo 6** shows the general view of the Motor Car's rear body at the time of my inspection. The Motor Car rear was observed to be unaffected by the accident.

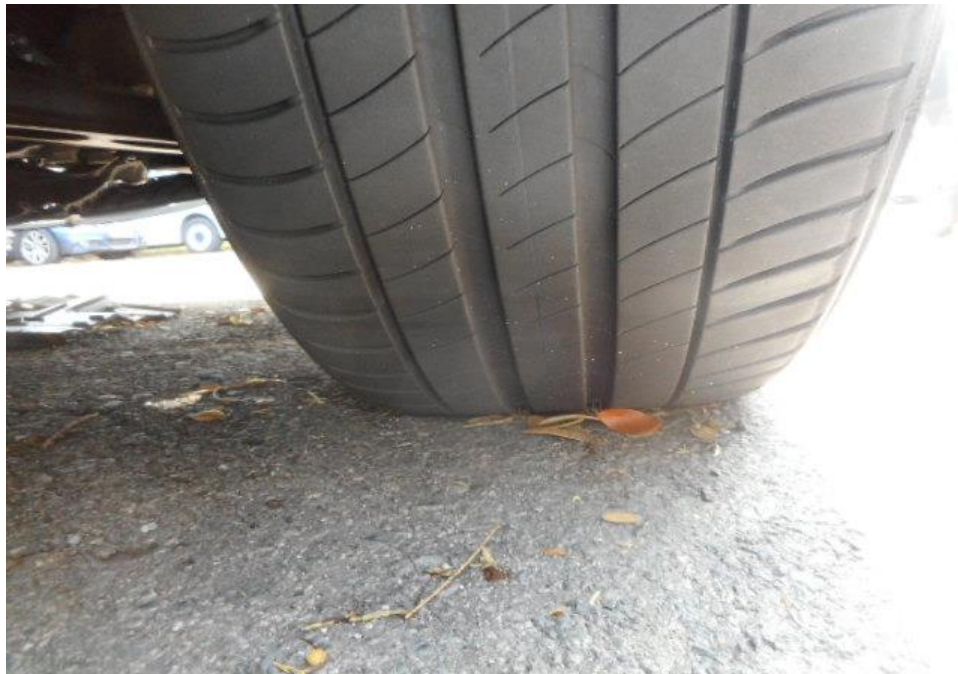
**Photo 7** shows the condition of the front right tyre of the Motor Car, which was observed to be in serviceable condition with remaining tread depth of approximately 5.3mm. The tyre was sufficiently inflated for vehicular operation with no tear, cut or burst mark(s) on the outer and the inner sidewalls as well as across the tread. The 4 tyres of the Motor Car were wrapped around standard steel wheel rims without any damage.

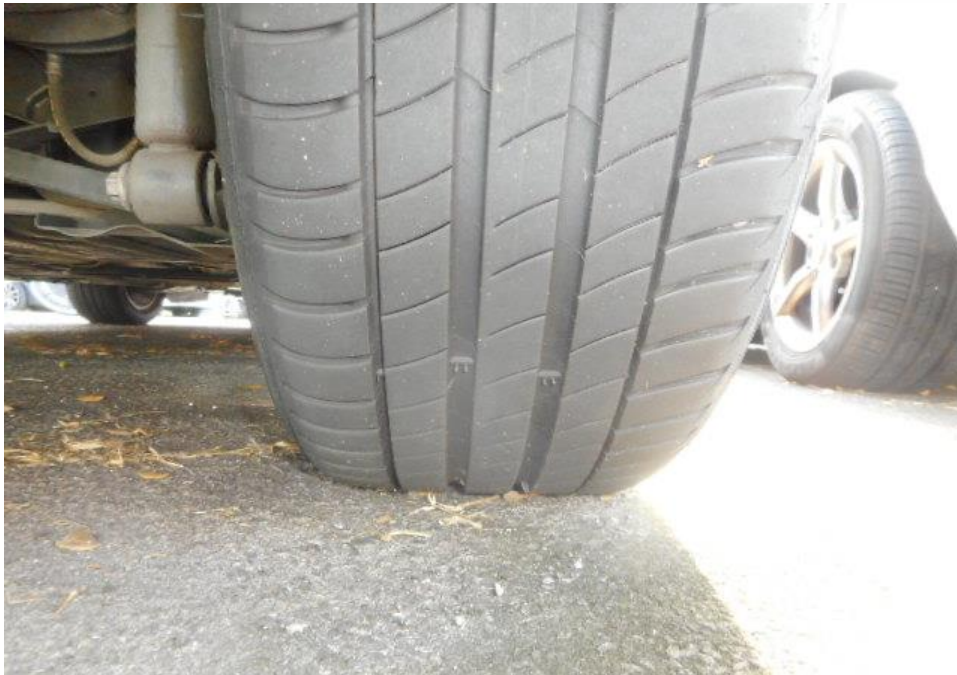
**Photo 8** shows the condition of the rear right tyre of the Motor Car, which was observed to be in serviceable condition with remaining tread depth of approximately 6.3mm. The tyre was also observed to be sufficiently inflated for vehicular operation with no tear, cut or burst mark(s).

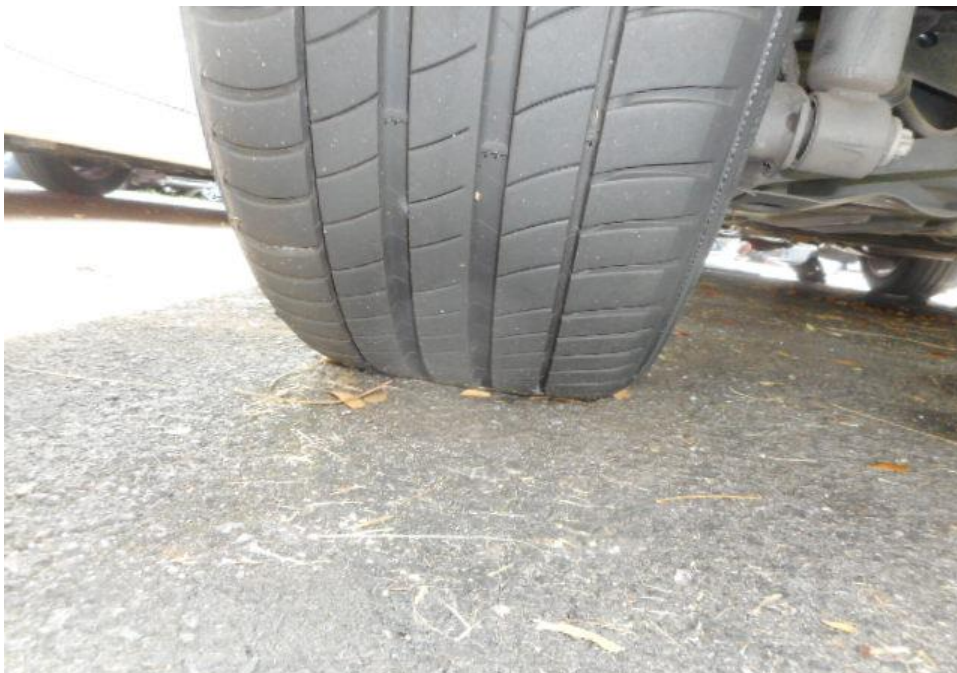
**Photo 9** shows the condition of the rear left tyre of the Motor Car, which was observed to be in serviceable condition with remaining tread depth of approximately 6.2mm. The tyre, which was wrapped around steel wheel rim, was also observed to be sufficiently inflated for vehicular operation. The 4 tyres of the Motor Car were wrapped around standard steel wheel rims.

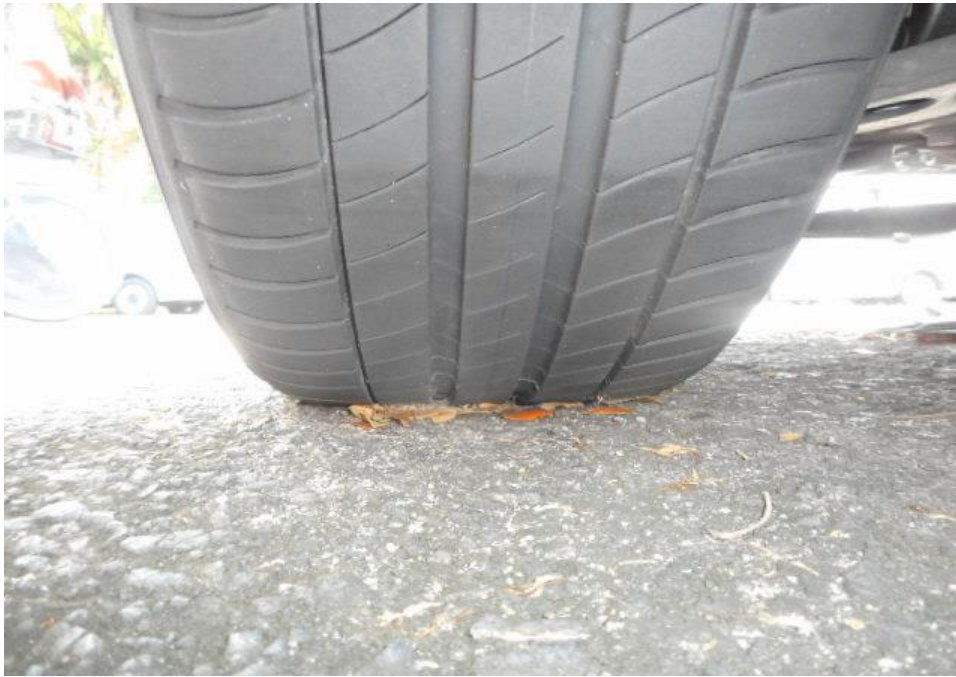
**Photo 10** shows the condition of the front left tyre of the Motor Car, which was observed to be in serviceable condition with remaining tread depth of approximately 5.2mm. There was also no tear, cut or burst mark(s) on the outer and the inner sidewalls as well as across the tread of the Motor Car's 4 tyres.

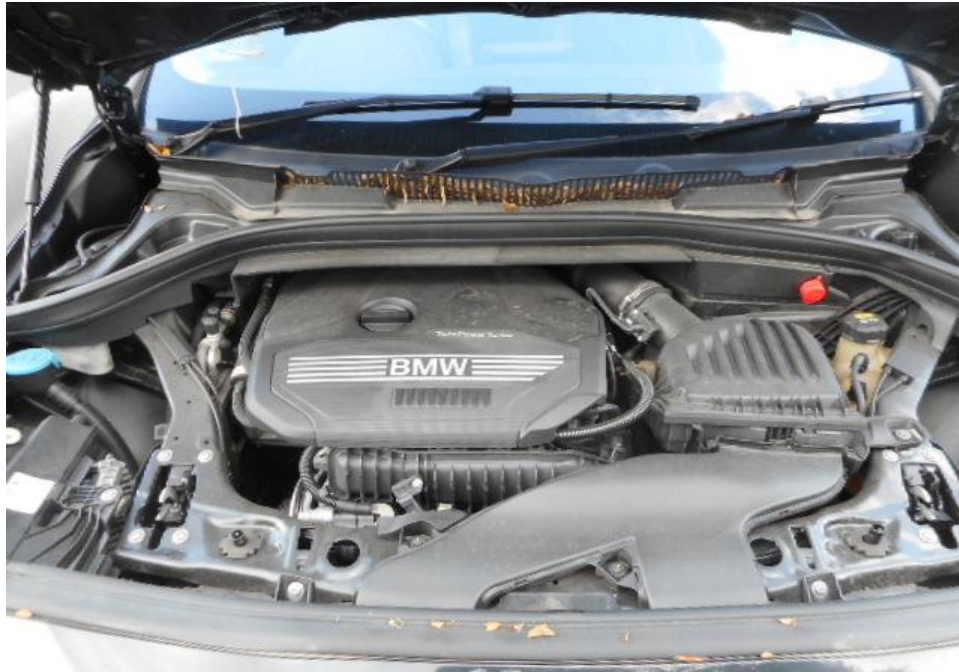
**Photo 11** shows a general view of the Motor Car's engine compartment. The various parts and components inside the engine compartment were unaffected by the accident. There was also no sign(s) or indication(s) of fluid leakage and/or fluid stain within the engine compartment.

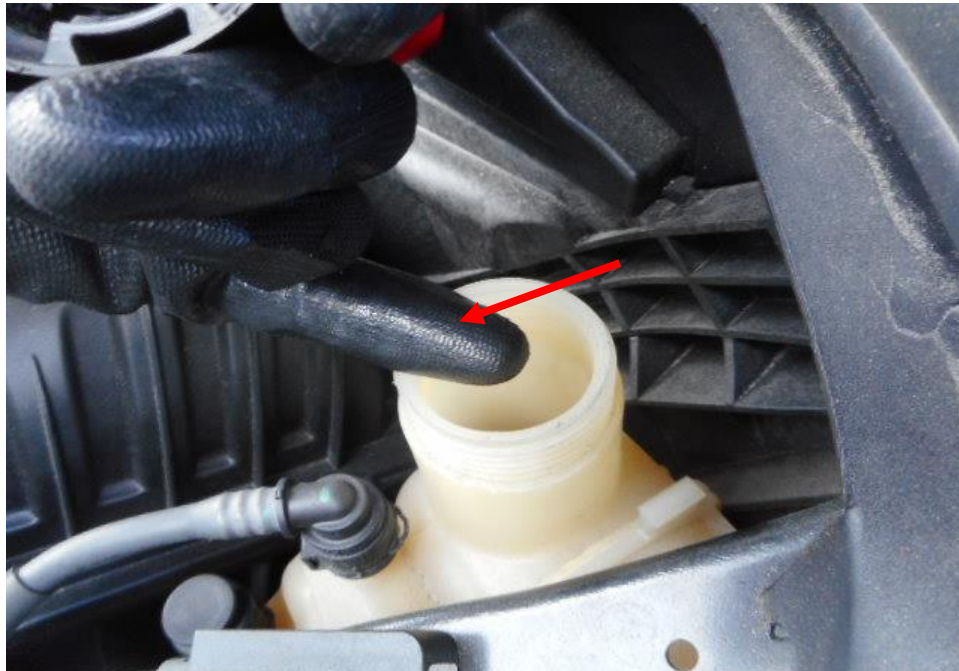
8. Upon examination of the engine compartment of the Motor Car, I had observed all the parts and components inside the engine compartment to be intact and unaffected by the accident. The brake fluid and engine oil were all found to be of sufficient level for operating purposes. Visually, there was also no contamination found to these fluids. However, the engine coolant was observed to be insufficient due to the damaged engine coolant radiator as a result of the accident.

**Photo 12** shows checks being carried out to the engine coolant of the Motor Car at the time of my inspection. The engine coolant was observed to be of insufficient level (arrowed) as the engine coolant radiator was damaged as a result of the accident.

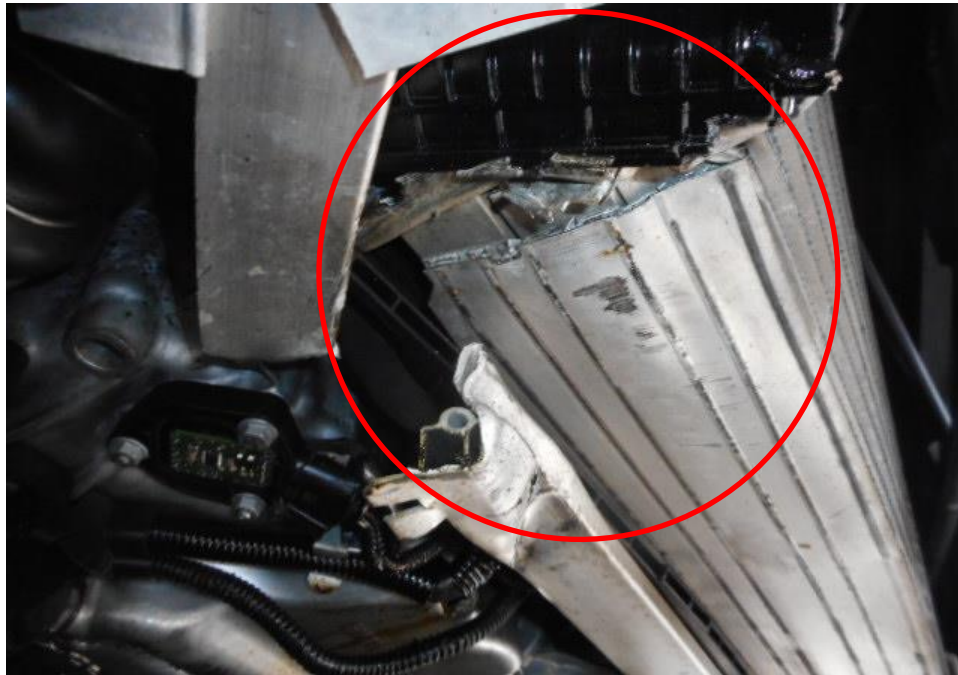
**Photo 13** shows checks being carried out to the engine coolant of the Motor Car at the time of my inspection. The engine coolant radiator (circled) was damaged as a result of the accident.

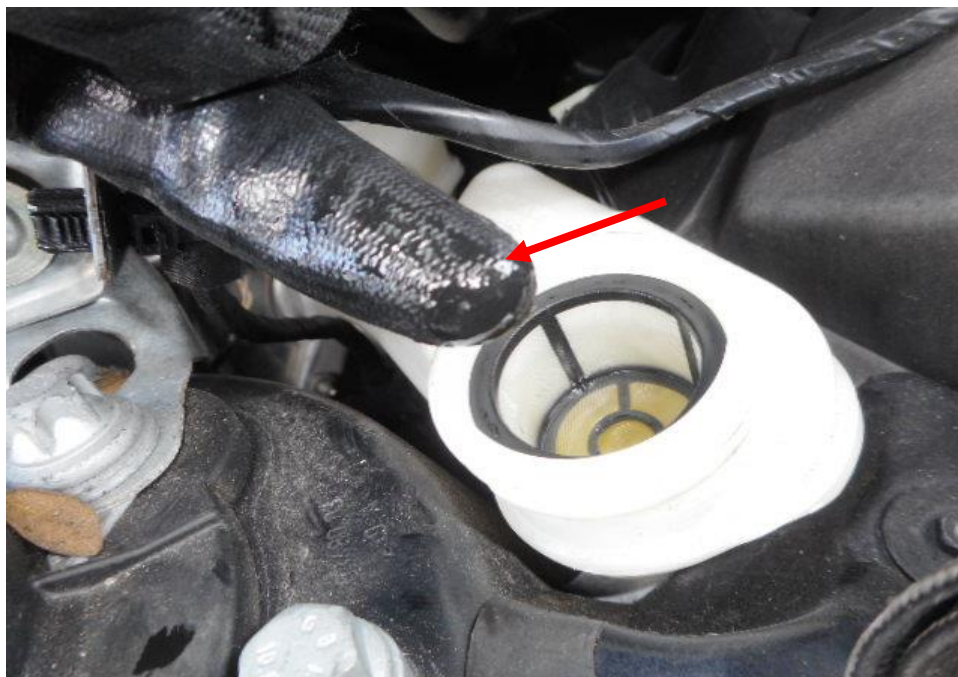
**Photo 14** shows the brake fluid reservoir of the Motor Car at the time of my inspection. The brake fluid was observed to be of sufficient level (arrowed) and without any visible contamination.

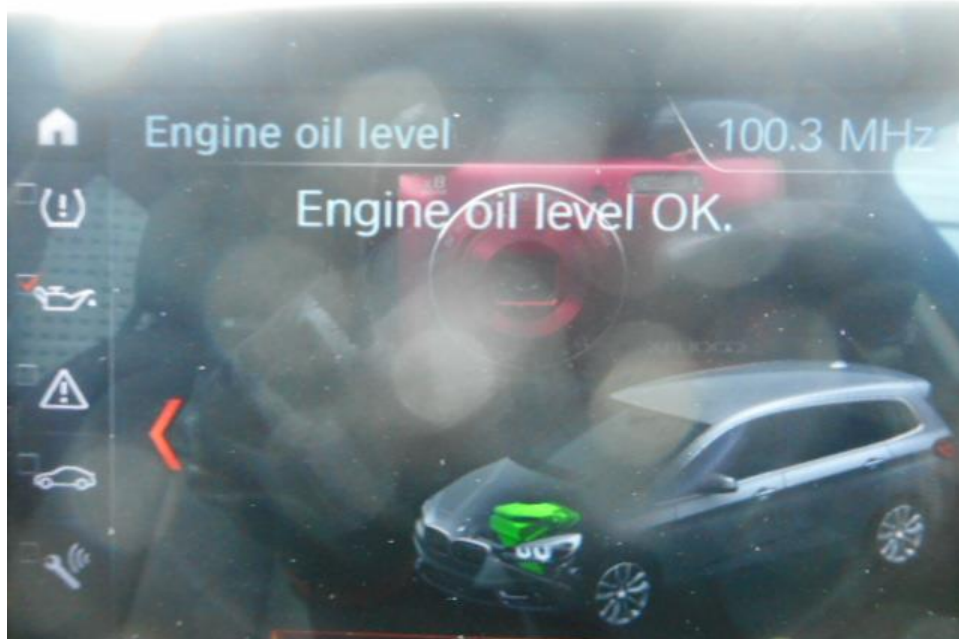
**Photo 15** shows the engine oil display of the Motor Car at the time of my inspection. The engine oil was observed to be of sufficient level.

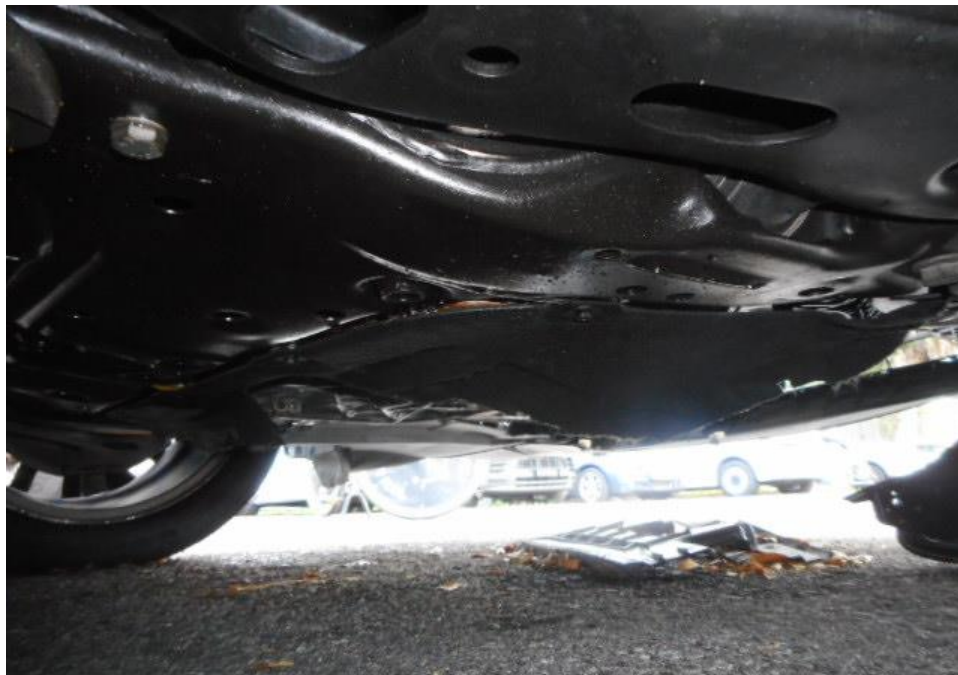
**Photo 16** shows the undercarriage of the Motor Car, at the area where the engine housing and transmission housing are located. I did not find any sign(s) or indication(s) of fluid leak and/or fluid stain(s) on the underside of the Motor Car.

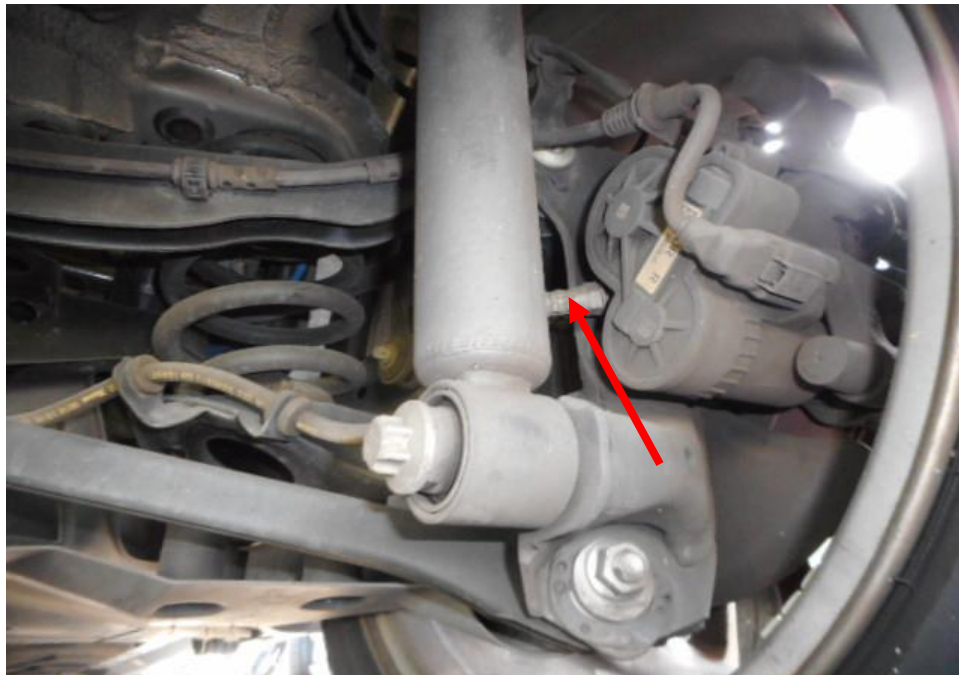
**Photo 17** shows the brake hose/pipe (arrowed) at the rear right wheel of the Motor Car. No leakage of brake fluid was observed. Visual examination of the various components of the braking system like the drum brake, brake booster, brake pedal etc. had revealed all to be intact and without visible damage.

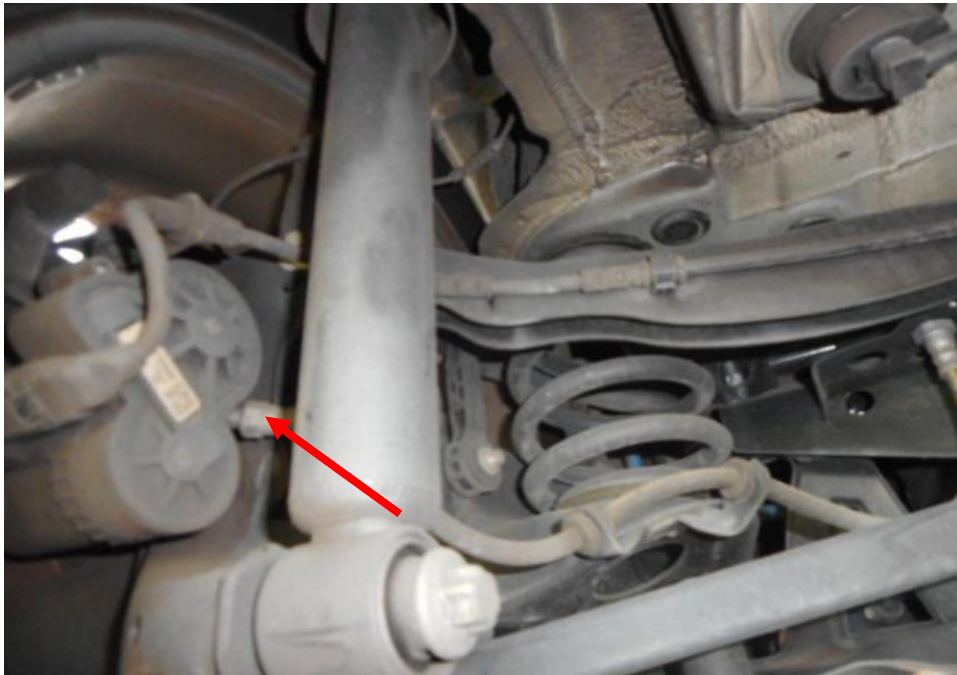
**Photo 18** shows the brake hose/pipe (arrowed) at the rear left wheel of the Motor Car. I did not observe any leakage of brake fluid at the time of my inspection of the Motor Car. Static tests of the Motor Car's braking system had indicated that there was no internal leakage of pressure/vacuum. The undercarriage components of the Motor Car were also all found to be intact and without any visible damage.

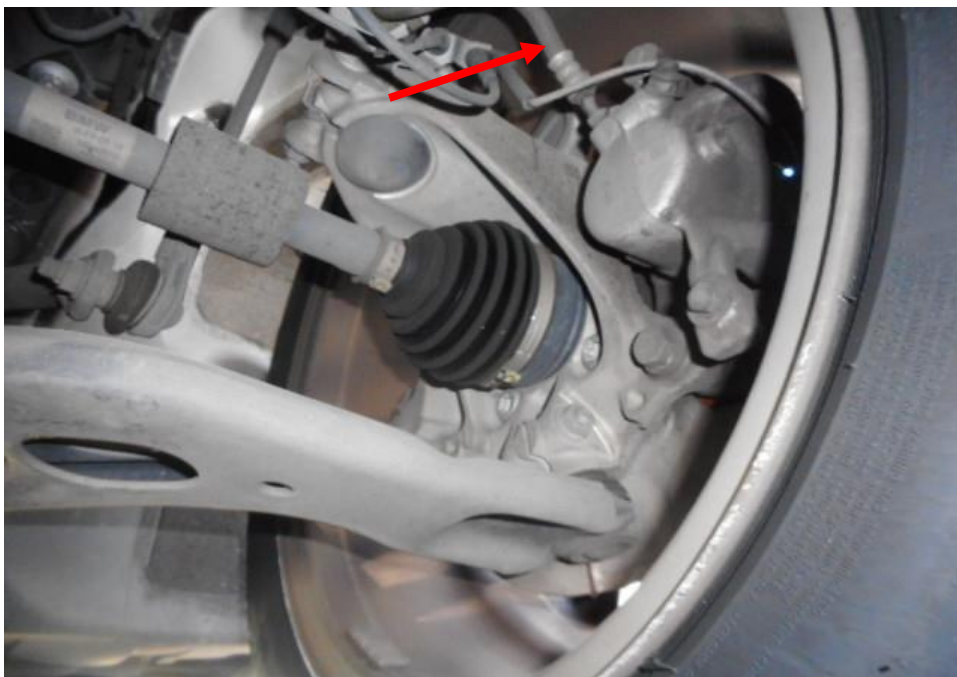
**Photo 19** shows the brake hose/pipe (arrowed) at the front right wheel of the Motor Car. I did not observe any leakage of brake fluid at the time of my inspection of the Motor Car. Static tests of the Motor Car's braking system had indicated that there was no internal leakage of pressure/vacuum. The undercarriage components of the Motor Car were also all found to be intact and without any visible damage.

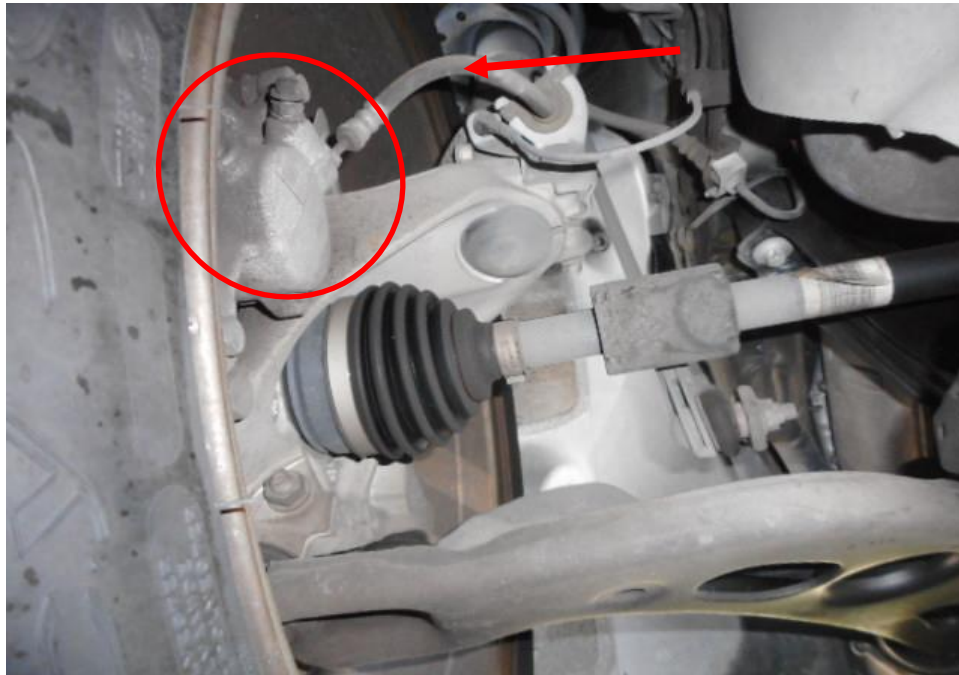
**Photo 20** shows the brake hose/pipe (arrowed) at the front left wheel of the Motor Car. No leakage of brake fluid was observed. Visual examination of the various components of the braking system like the brake caliper (circled), brake booster, brake pedal etc had revealed all to be intact and without visible damage.

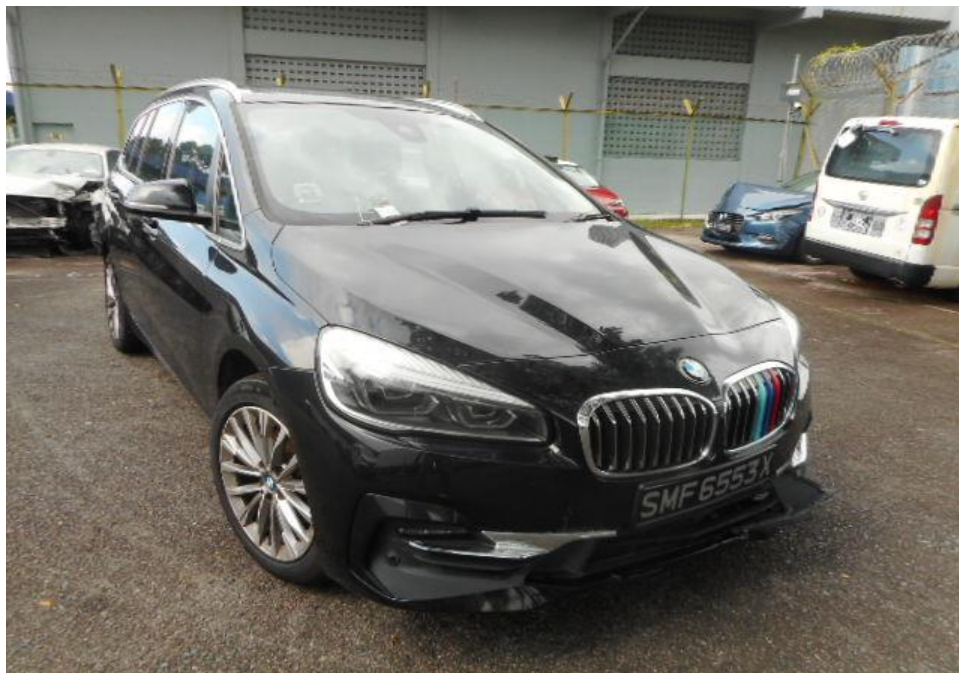
**Photo 21** shows the front right wheel of the Motor Car turned to its full left. During my steering system test, I did not experience any abnormal free play and/or resistance when I had turned the steering wheel towards the left and right. This would suggest that the steering system of the Motor Car was likely to be in serviceable condition at the material time of accident.

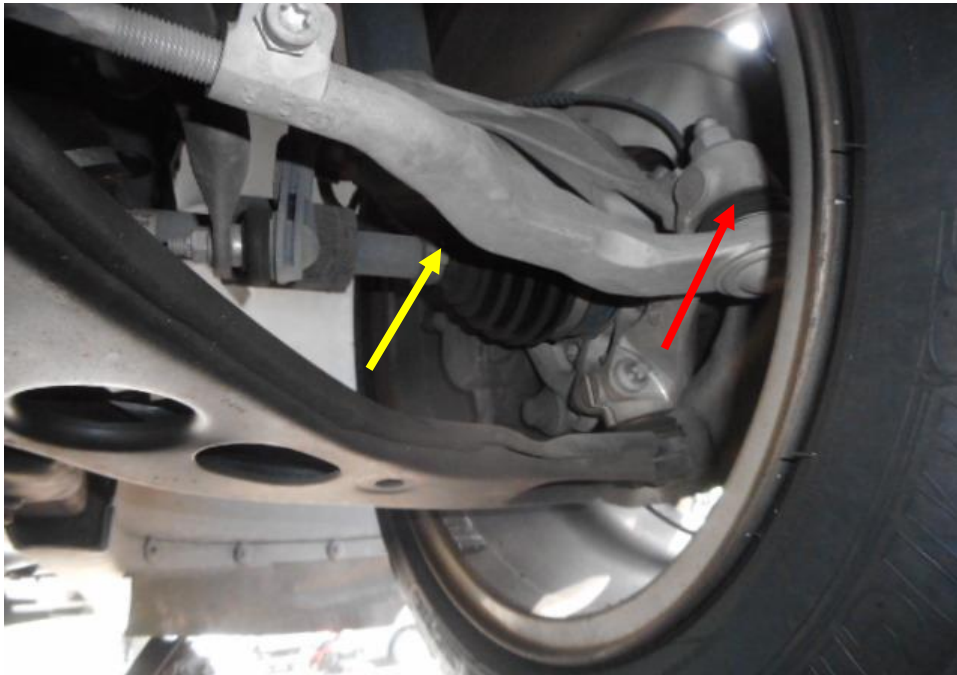
**Photo 22** shows the various undercarriage components at the front right wheel of the Motor Car, in particular the steering tie rod (red arrow) and drive shaft (yellow arrow). The various steering components were all found to be intact, suggesting that the steering system of the Motor Car was likely to be in serviceable condition at the material time of accident. There was also no sign of fluid stain observed on the various undercarriage components at the front right wheel of the Motor Car.

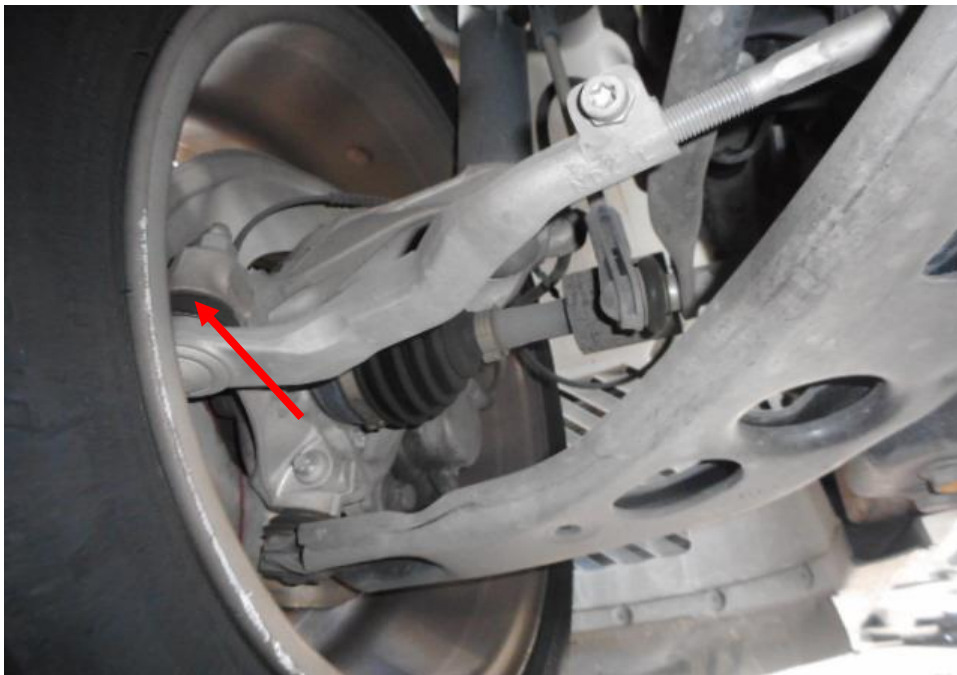
**Photo 23** shows the various undercarriage components at the front left wheel of the Motor Car, which had included the steering tie rod (red arrow). The various undercarriage components of the Motor Car were all found to be intact without any visible damage.

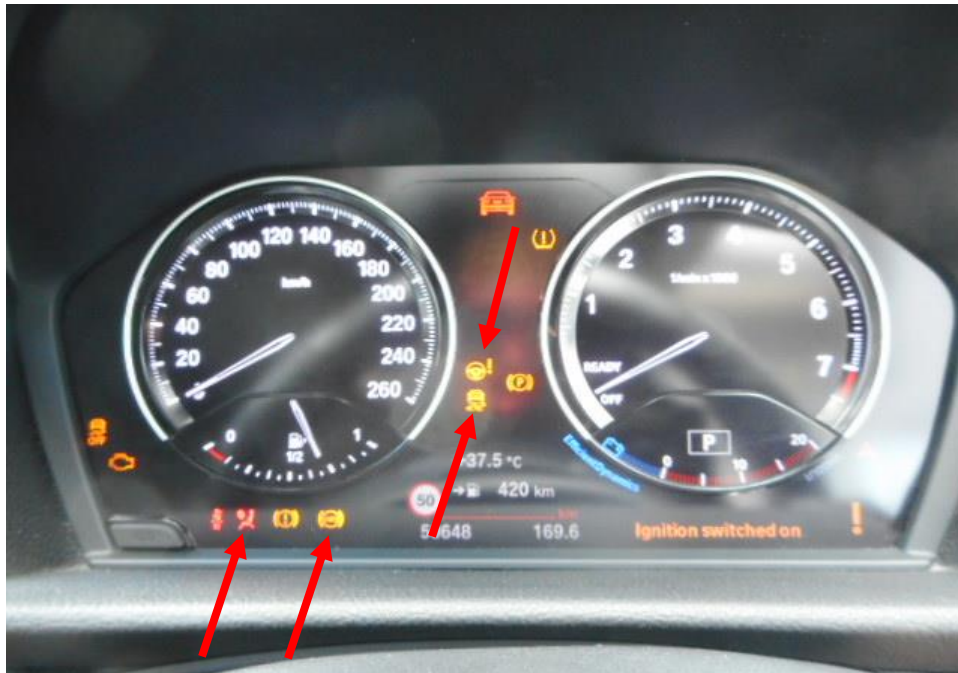
**Photo 24** shows the warning light for Anti-Lock Brake System (ABS), Electric Power Steering System (EPS), Traction Control System (TCS) and Supplemental Restraint System (SRS) (arrowed) appearing on the instrument panel of the Motor Car during the self-test of its various electronic operating systems when its engine was cranked.

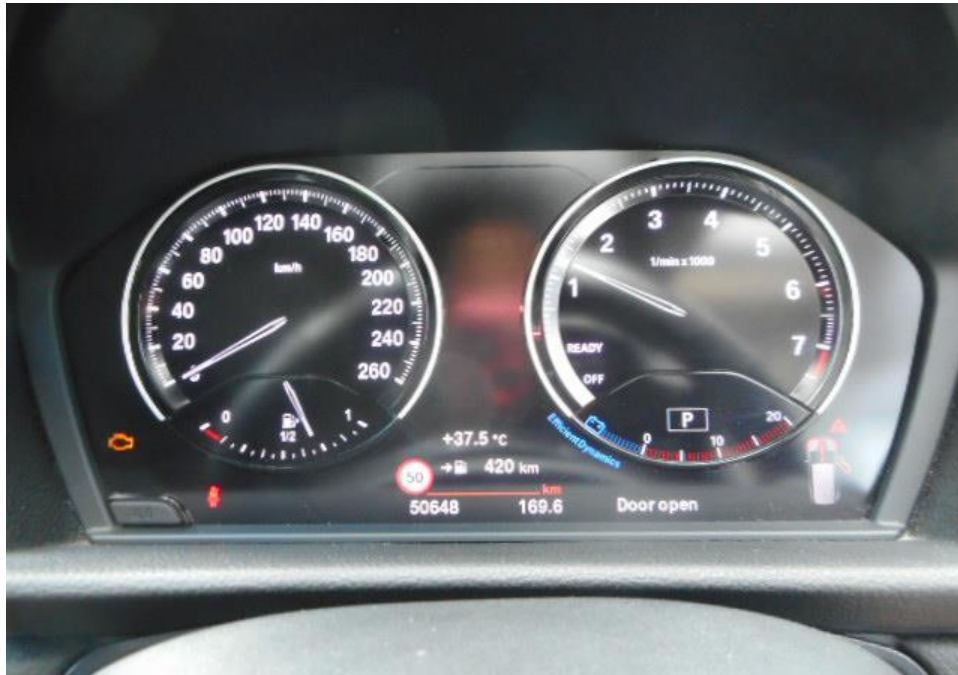
**Photo 25** shows no warning lights illuminated on the instrument panel of the Motor Car after the engine was cranked. This would suggest that there was no abnormality to the electronic operating system of the Motor Car, like the ABS, EPS, TCS and SRS etc.
