Your Ref: TP/IP/26593/2022
Our Ref : CI/TPD22010886/P

28th December 2022

MECHANICAL INSPECTION REPORT OF MOTOR BUS PC 203B

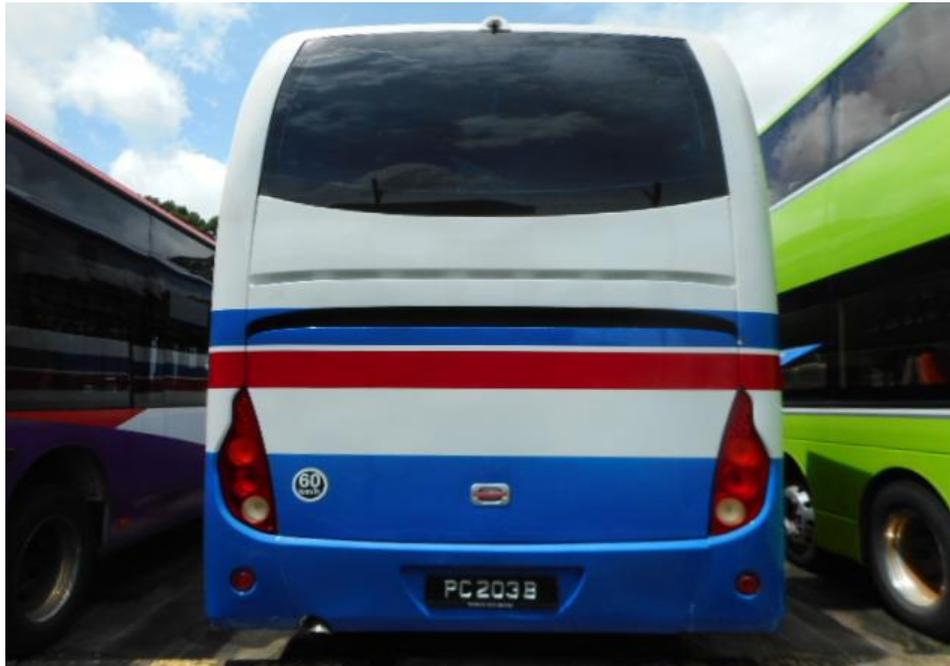
Photo 1 shows a general view of the rear portion of the Motor Bus at the time of our inspection. The right portion of the Motor Bus was observed to have been unaffected by the accident.

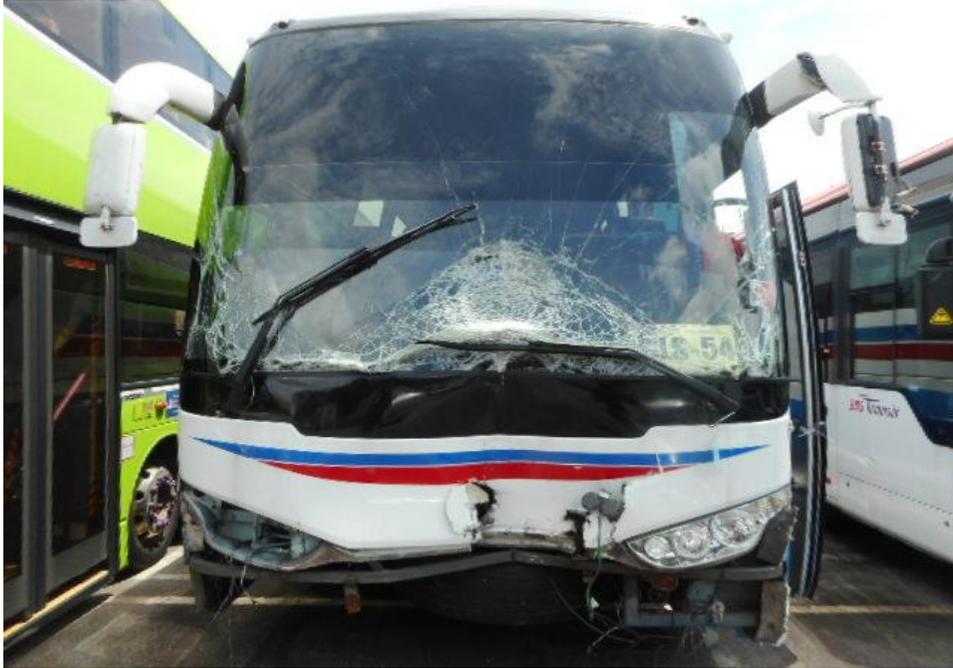
4. The mileage of the Motor Bus at the time of my inspection was not record as the engine of the vehicle was unable to be jumpstarted up despite multiple attempts in jumpstarting it.
5. The Motor Bus was observed to have sustained damages at its front portion. Its front windscreen, front bumper, front body panel and front right headlamp as well as its windscreens was observed to be damaged at time of our inspection.

Photo 2 shows a general view of the front body of the Motor Bus at the time of our inspection. The Motor Bus was observed to have sustained damages at its front portion. Its front windscreen, front bumper, front body panel and front right headlamp as well as its windscreens was observed to be damaged at time of our inspection.

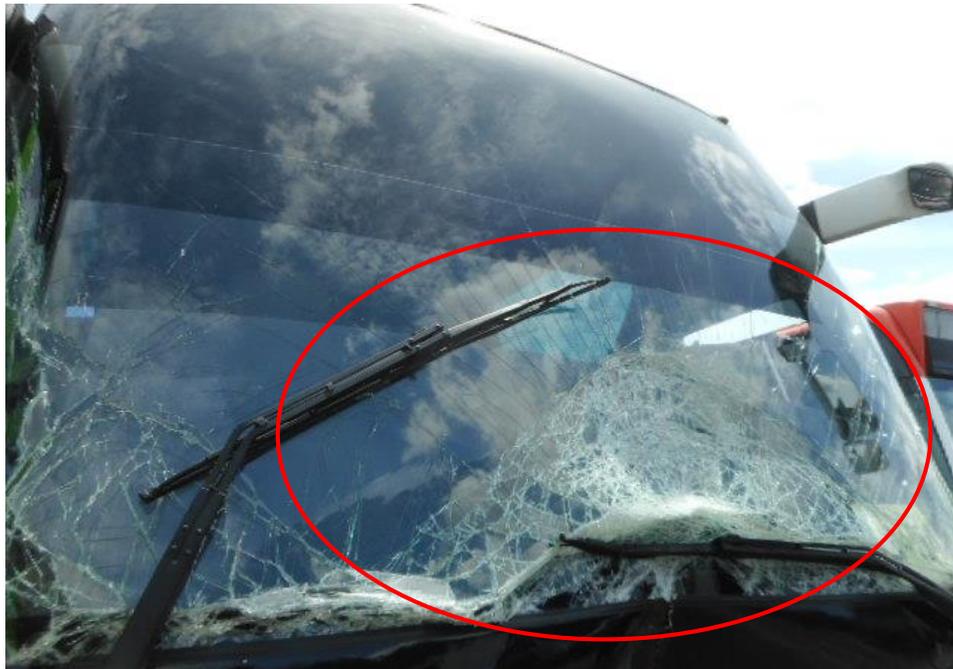
Photo 3 shows a close up view of the front body of the Motor Bus at the time of our inspection. The Motor Bus was observed to have sustained damages at its front windscreen (circled) as a result of the accident.

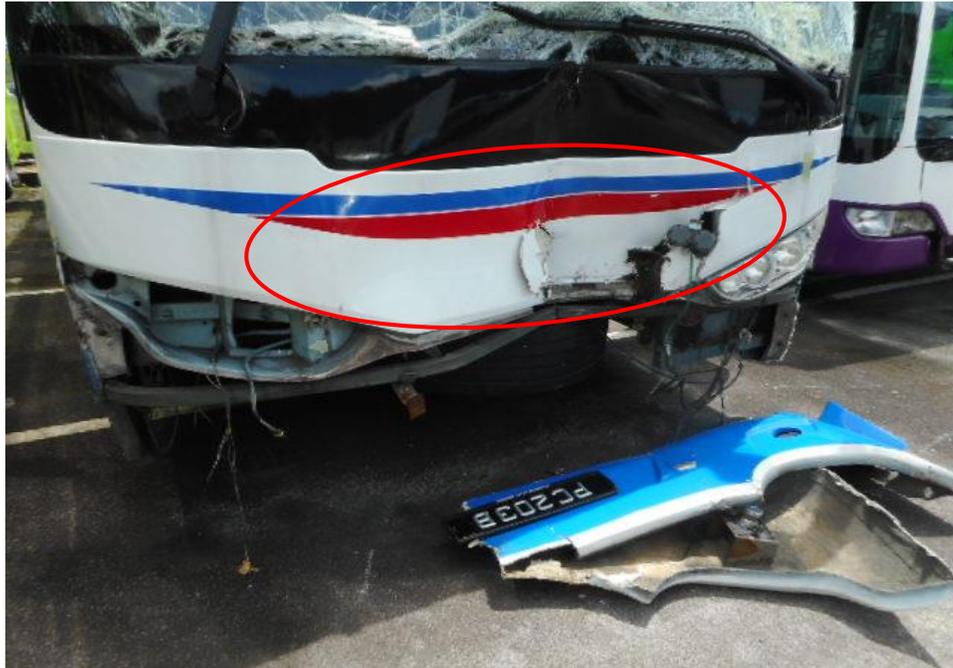
Photo 4 shows a close up view of the front body of the Motor Bus at the time of our inspection. The Motor Bus was observed to have sustained damages at its front bumper (circled) as a result of the accident.

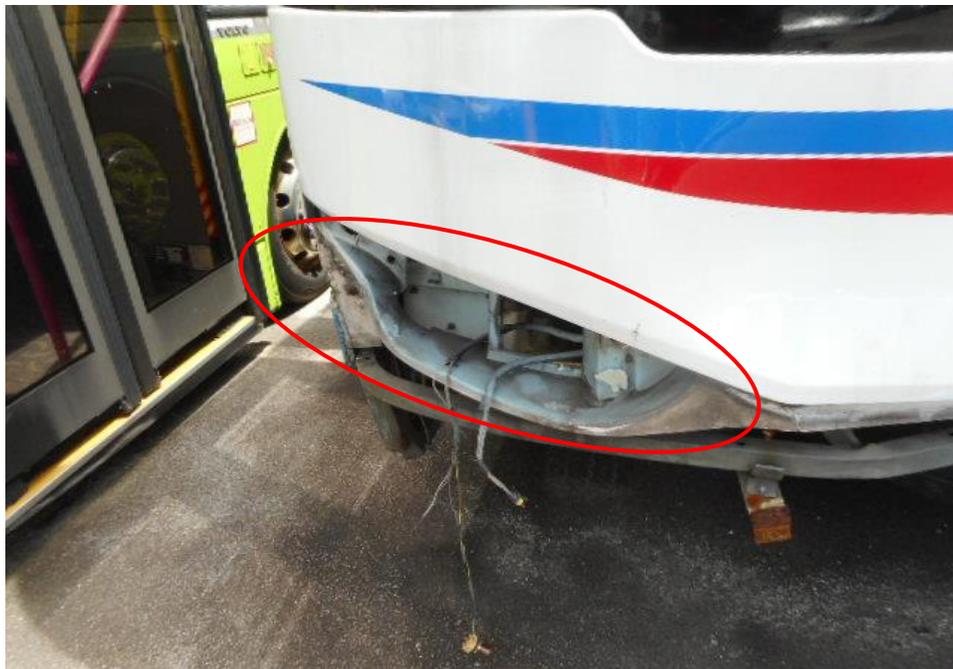
Photo 5 shows a close up view of the front body of the Motor Bus at the time of our inspection. The Motor Bus was observed to have sustained damages at its front right headlamp (circled) as a result of the accident.

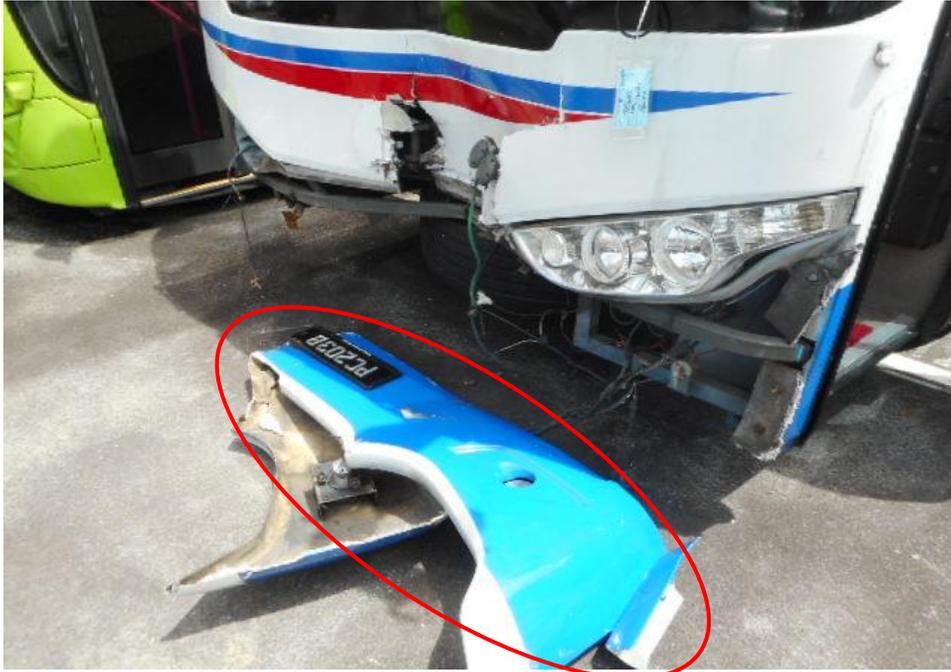
Photo 6 shows a close up view of the front body of the Motor Bus at the time of our inspection. The Motor Bus was observed to have sustained damages at its front bumper (circled) as a result of the accident.

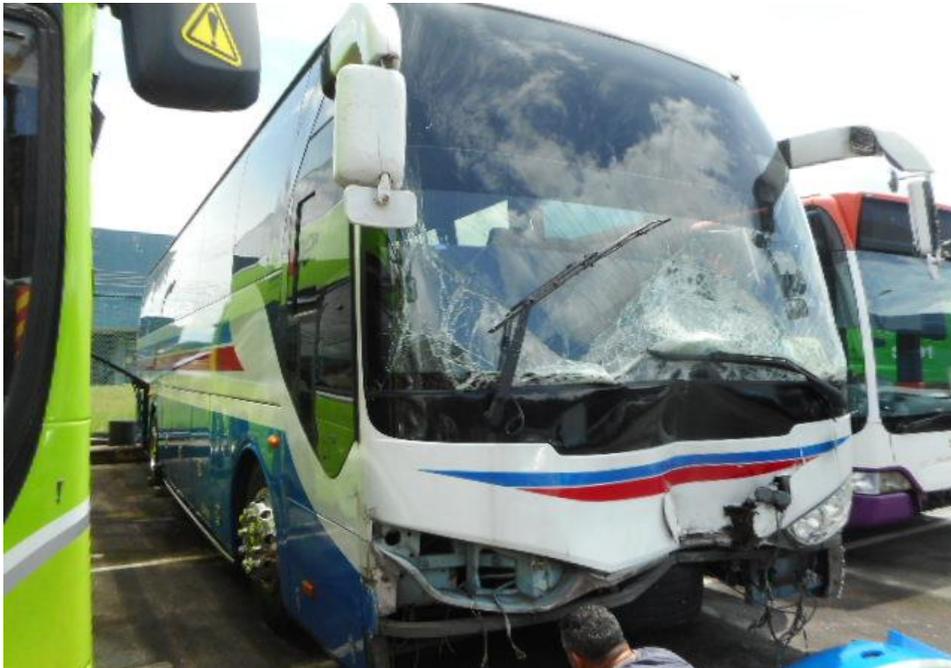
Photo 7 shows a general view of the right portion of the Motor Bus at the time of our inspection. The right portion of the Motor Bus was observed to have been unaffected by the accident.

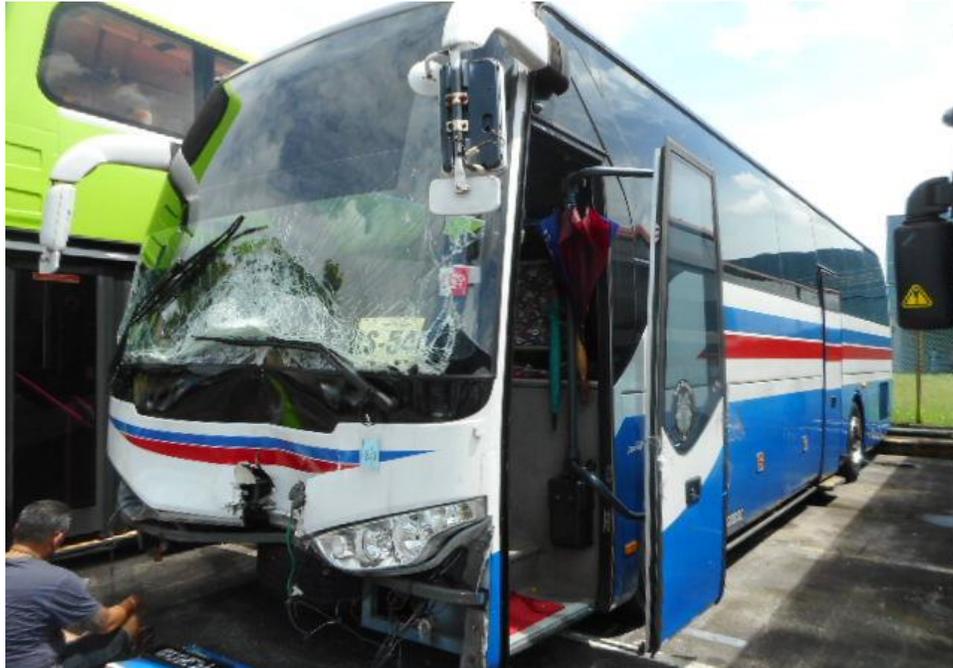
Photo 8 shows a general view of the left portion of the Motor Bus at the time of our inspection. The right portion of the Motor Bus was observed to have been unaffected by the accident.

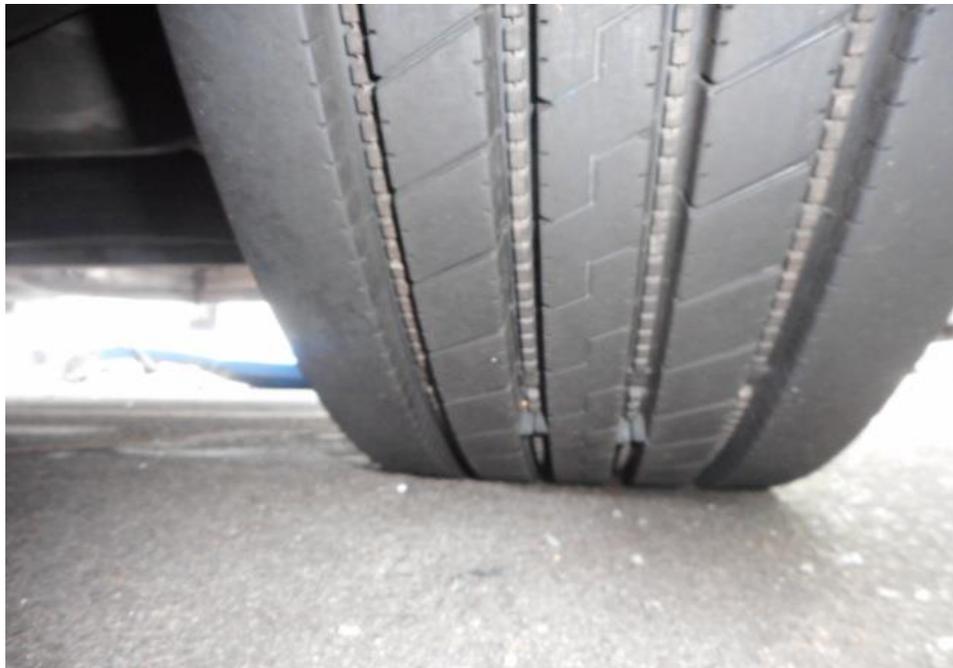
Photo 9 shows the condition of the front right tyre of the Motor Bus, which was observed to be in serviceable condition with remaining tread depth of approximately 12.9mm. The tyre was also observed to be sufficiently inflated for vehicular operation.

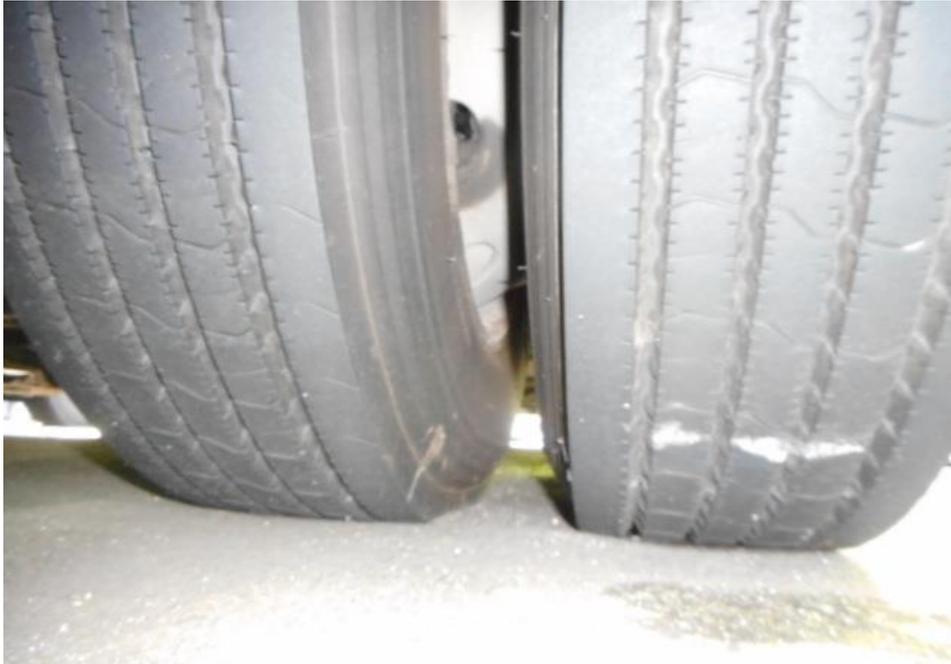
Photo 10 shows the condition of the rear right tyre of the Motor Bus, which was observed to be in serviceable condition with remaining tread depth of approximately 9.9mm. The tyre was also observed to be sufficiently inflated for vehicular operation.

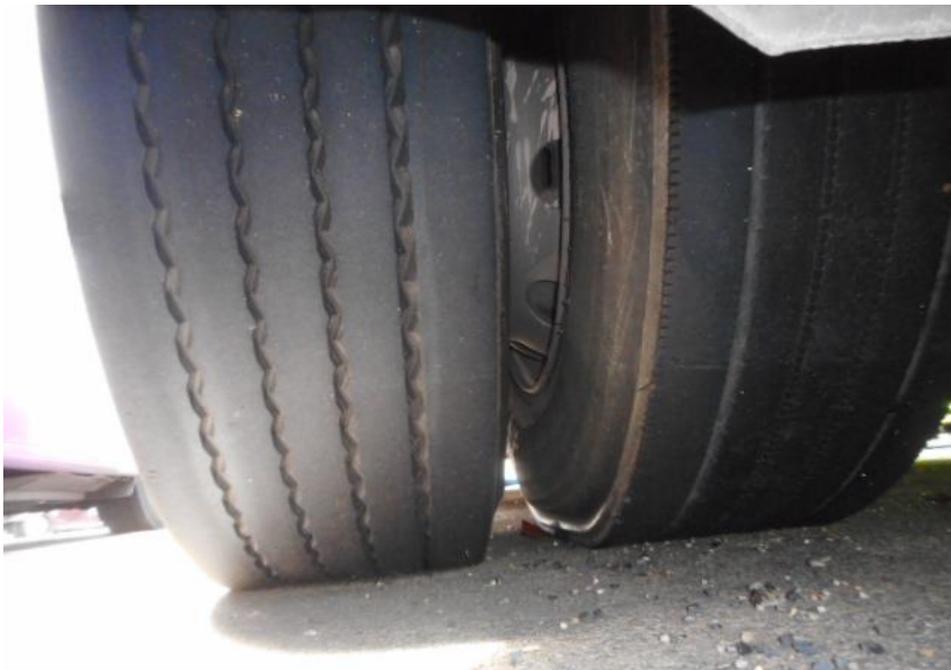
Photo 11 shows the condition of the rear right tyres of the Motor Bus, which were observed to be in serviceable condition with remaining tread depth of approximately 4.8mm. The tyres, which were wrapped around standard alloy wheel rims, were also observed to be sufficiently inflated for vehicular operation.

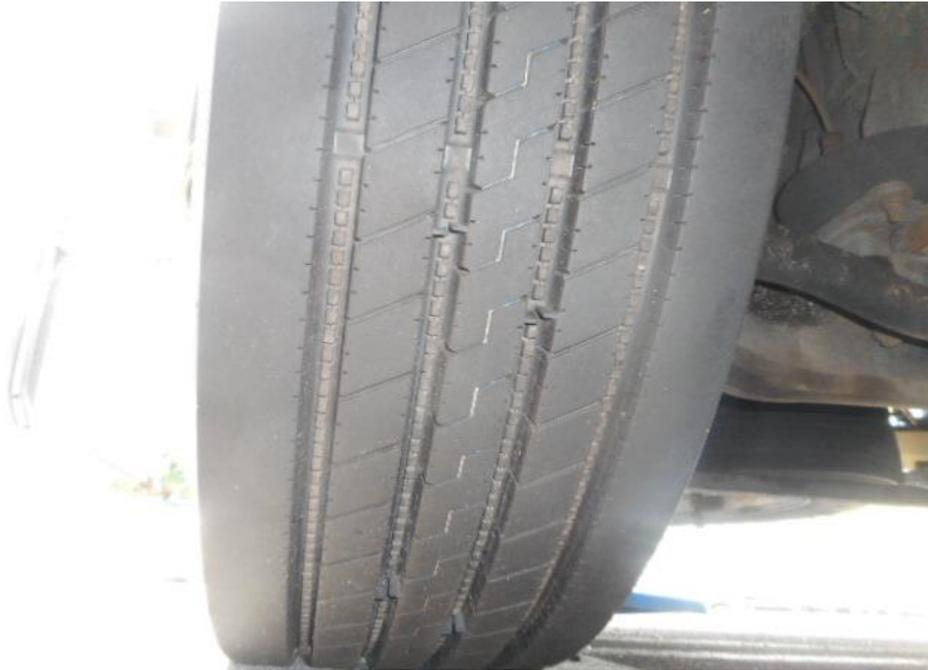
Photo 12 shows the condition of the front left tyre of the Motor Bus, which was observed to be in serviceable condition with remaining tread depth of approximately 14.4mm. The tyre was also observed to be sufficiently inflated for vehicular operation.

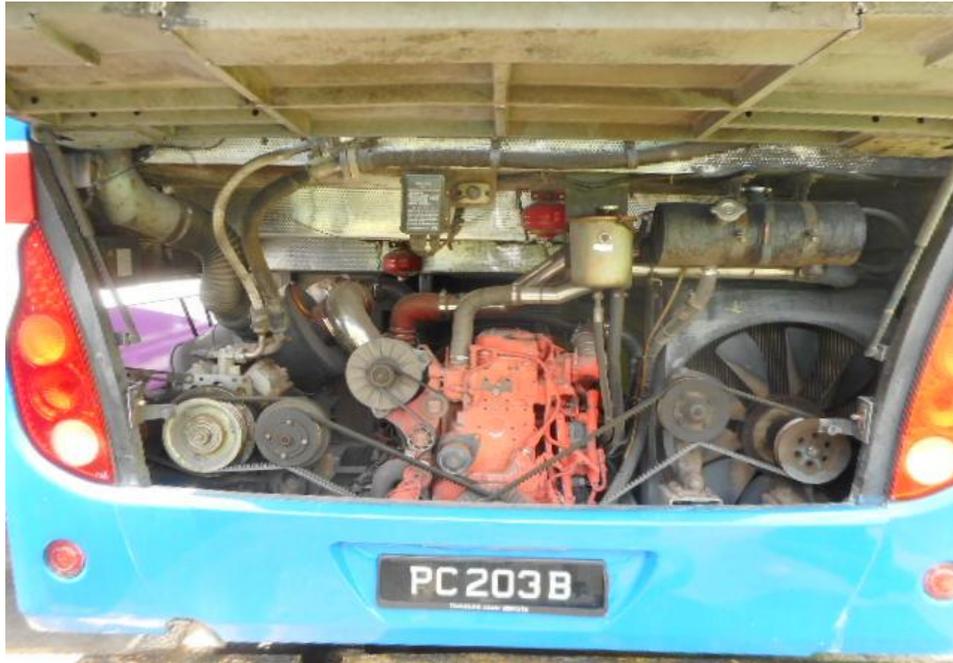
Photo 13 shows a general view of the Motor Bus engine compartment. The various parts and components inside the engine compartment were unaffected by the accident. There was also no sign(s) or indication(s) of fluid leakage and/or fluid stain within the engine compartment.

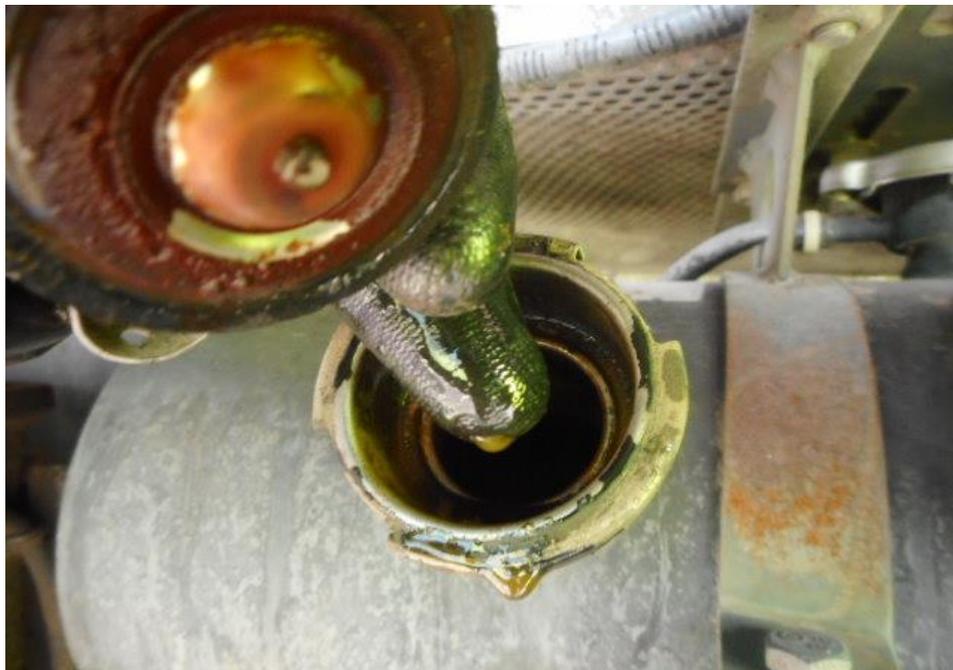
Photo 14 shows checks being carried out to the engine coolant of the Motor Bus at the time of my inspection. The engine coolant was observed to be of sufficient level and without any visible contamination.

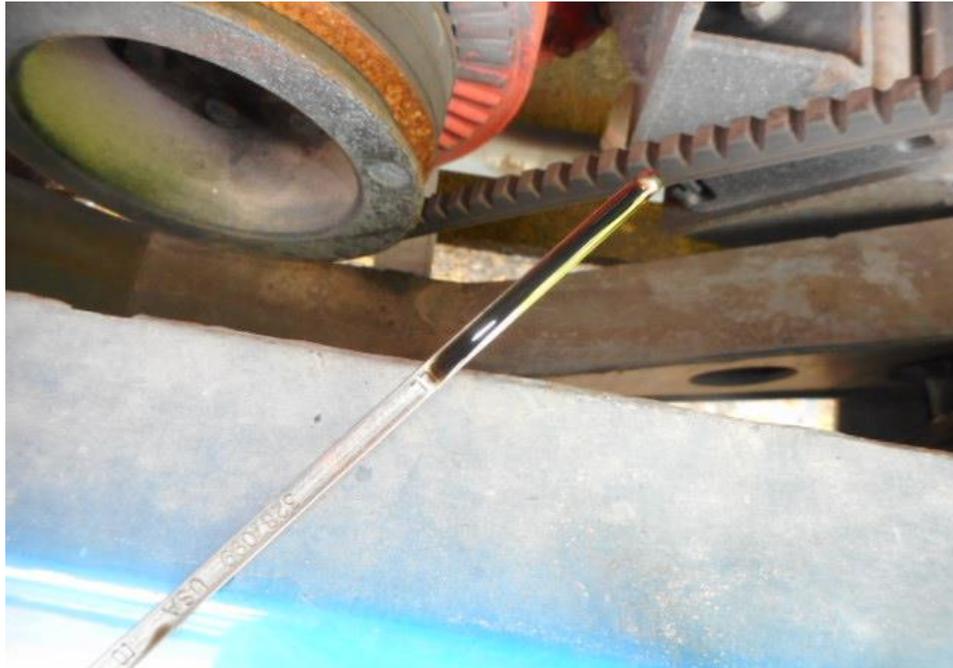
Photo 15 shows the engine oil dipstick of the Motor Bus at the time of my inspection. The engine oil was observed to be of sufficient level and without any visible contamination.

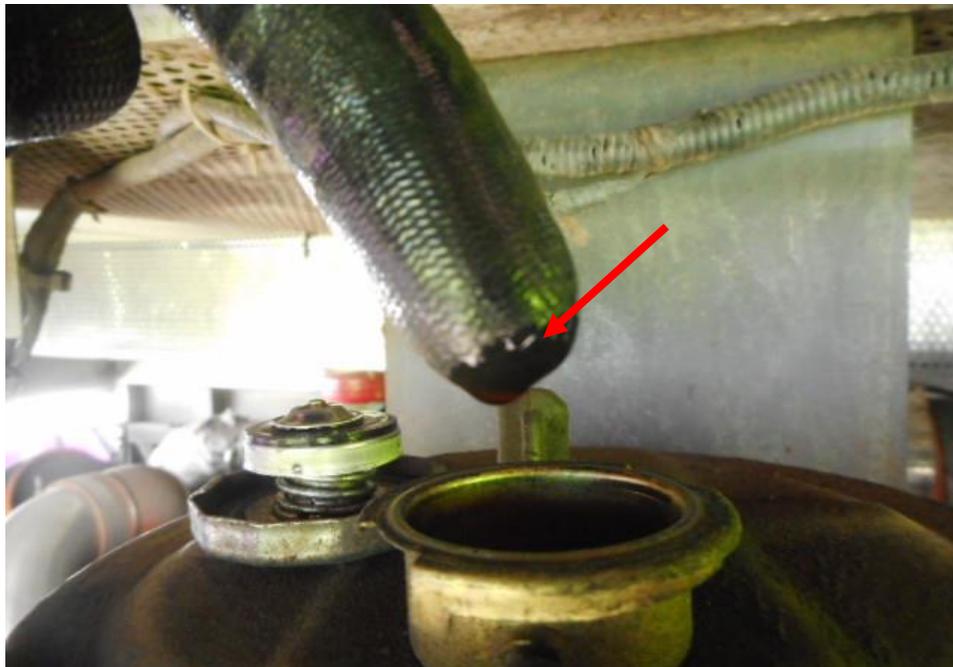
Photo 16 shows the power steering fluid reservoir of the Motor Bus at the time of my inspection. The power steering fluid was observed to be of sufficient level (arrowed) and without any visible contamination.

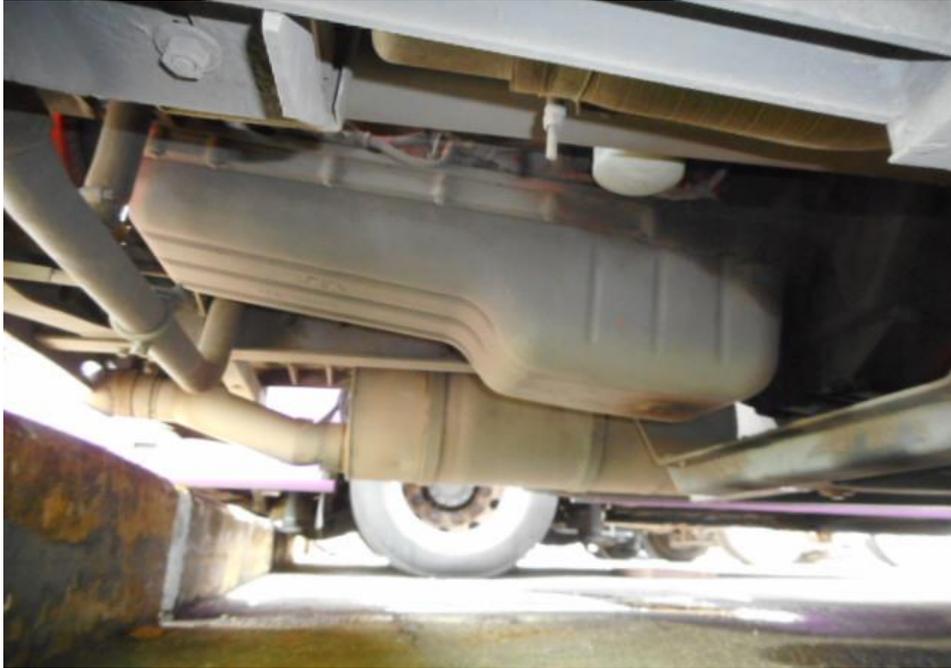
Photo 17 shows the undercarriage of the Motor Bus, at the area where the engine housing and transmission housing are located. I did not find any sign(s) or indication(s) of fluid leak and/or fluid stain(s) on the underside of the Motor Bus.

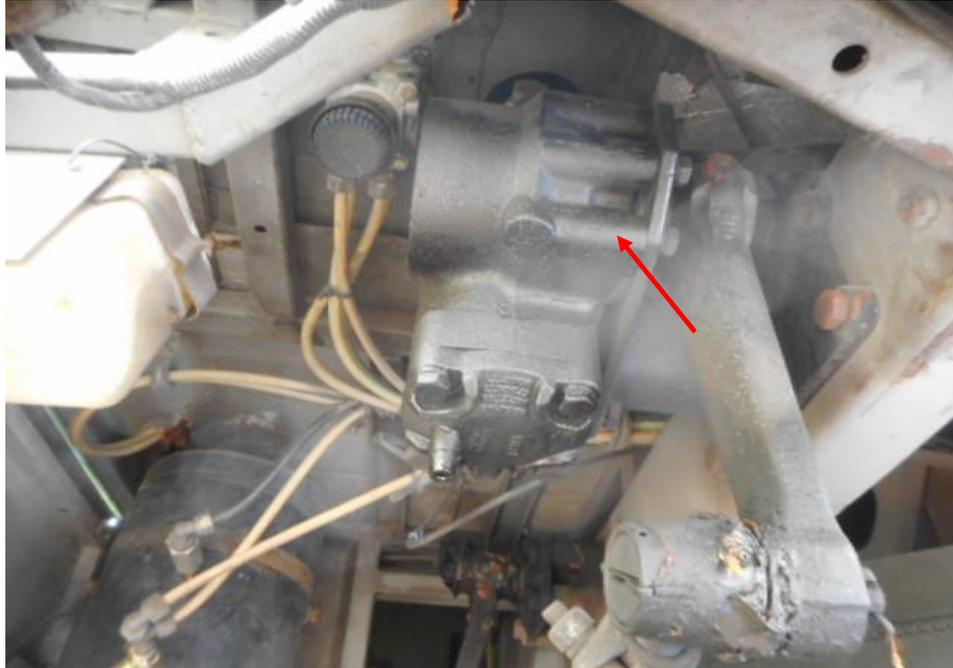
Photo 18 shows the steering box components (arrowed) of the Motor Bus's steering system. The steering system of the Motor Bus shows to be intact and not damaged by the accident.

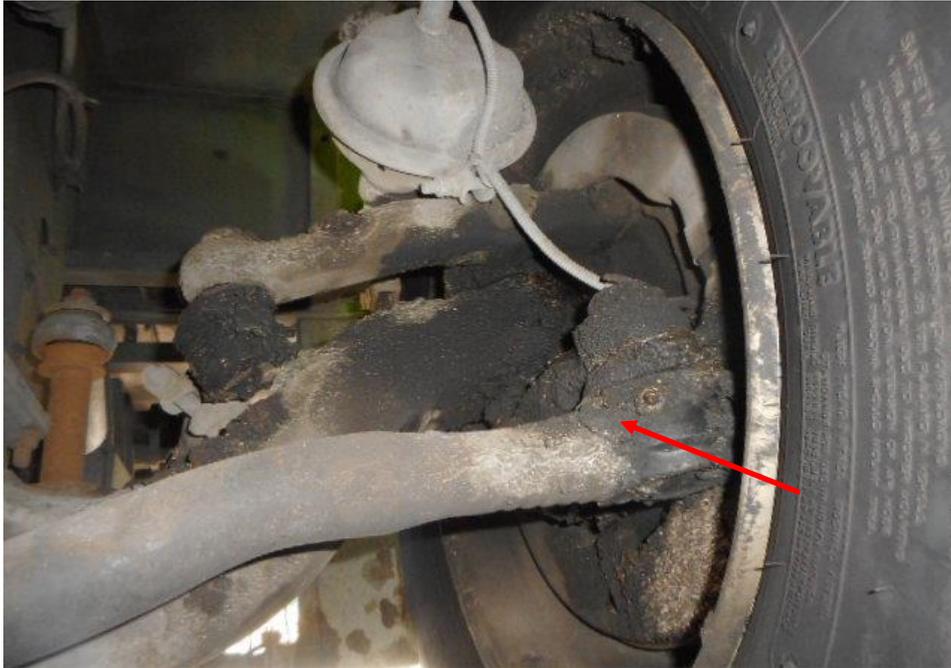
Photo 19 shows the front right wheel components of the front steering system of the Motor Bus. The various undercarriage components of the Motor Bus were all observed to be intact and without any visible damage. This had included the steering rack and steering ball joints (arrowed) of the Motor Bus, which were observed to be securely attached to the front right wheel.

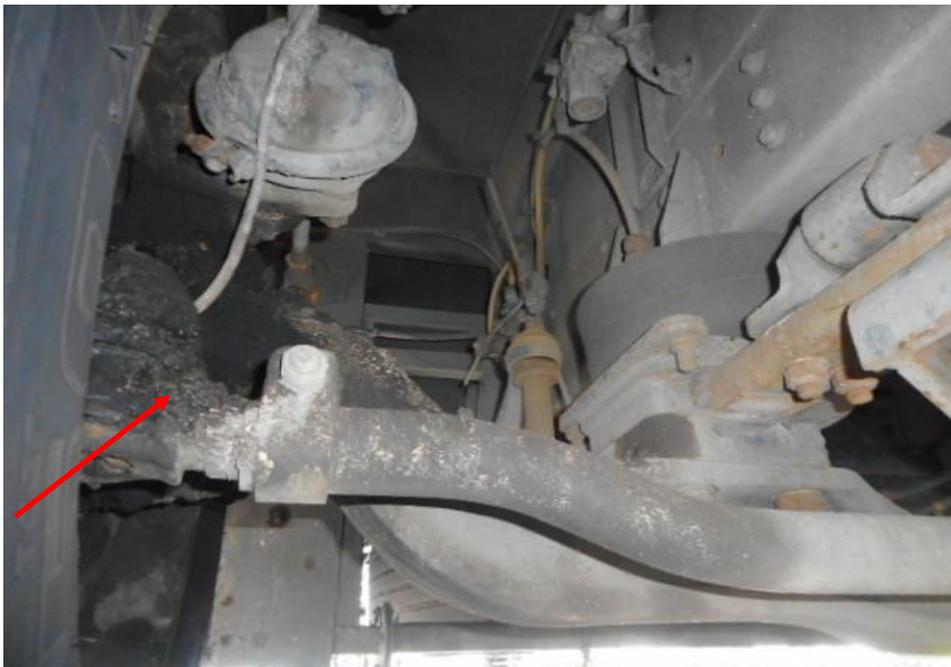
Photo 20 shows the front left wheel components of the front steering system of the Motor Bus. The various undercarriage components of the Motor Bus were all observed to be intact and without any visible damage. This had included the steering rack and steering ball joints (arrowed) of the Motor Bus, which were observed to be securely attached to the front left wheel.

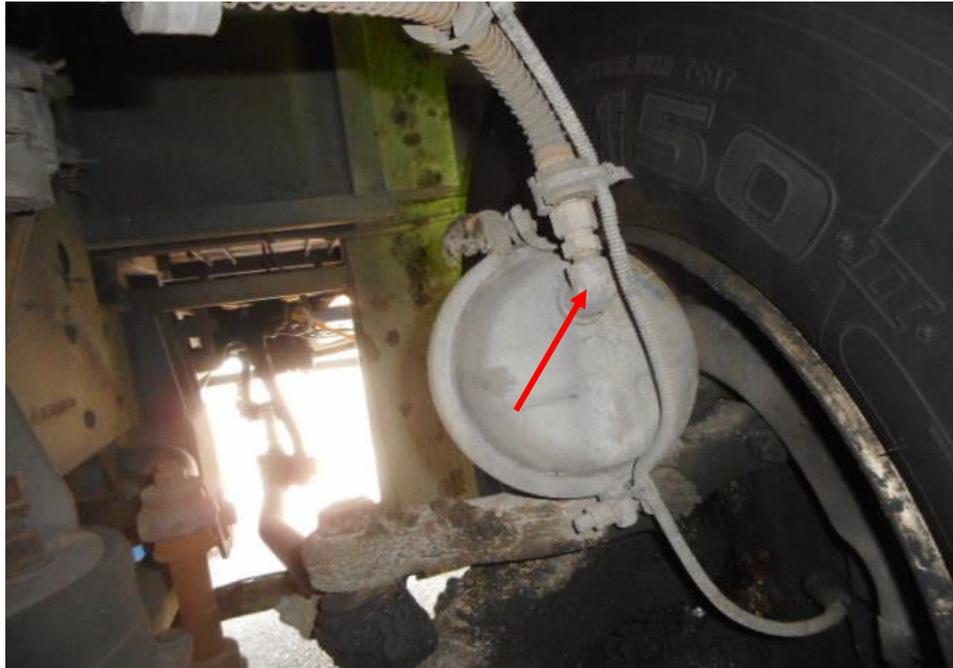
Photo 21 shows the brake pipe (arrowed) at the front right wheel of the Motor Bus. I did not observe any leakage of brake fluid/air at the time of my inspection of the Motor Bus and the various mechanical components was observed to be intact.

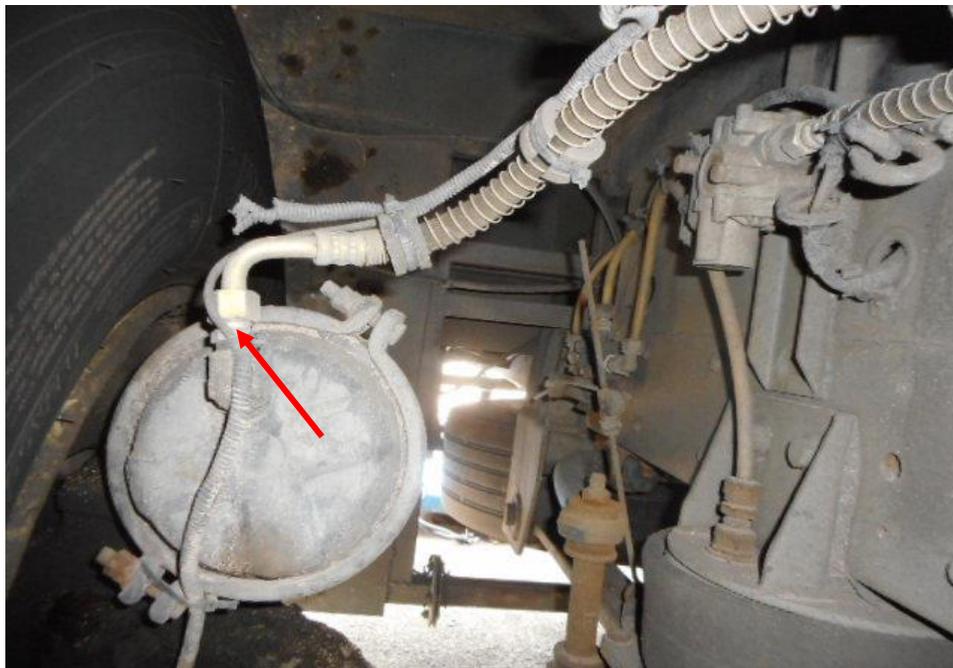
Photo 22 shows the brake pipe (arrowed) at the front left wheel of the Motor Bus. I did not observe any leakage of brake fluid/air at the time of my inspection of the Motor Bus and the various mechanical components was observed to be intact.

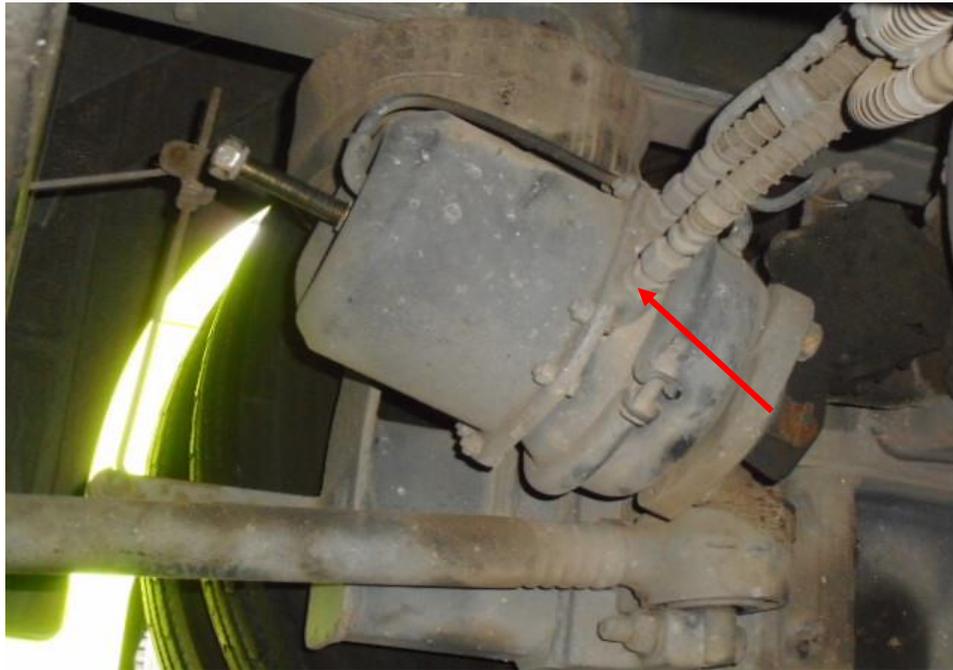
Photo 23 shows the brake pipe (arrowed) at the rear right wheel of the Motor Bus. I did not observe any leakage of brake fluid at the time of my inspection of the Motor Bus and the various mechanical components was observed to be intact.

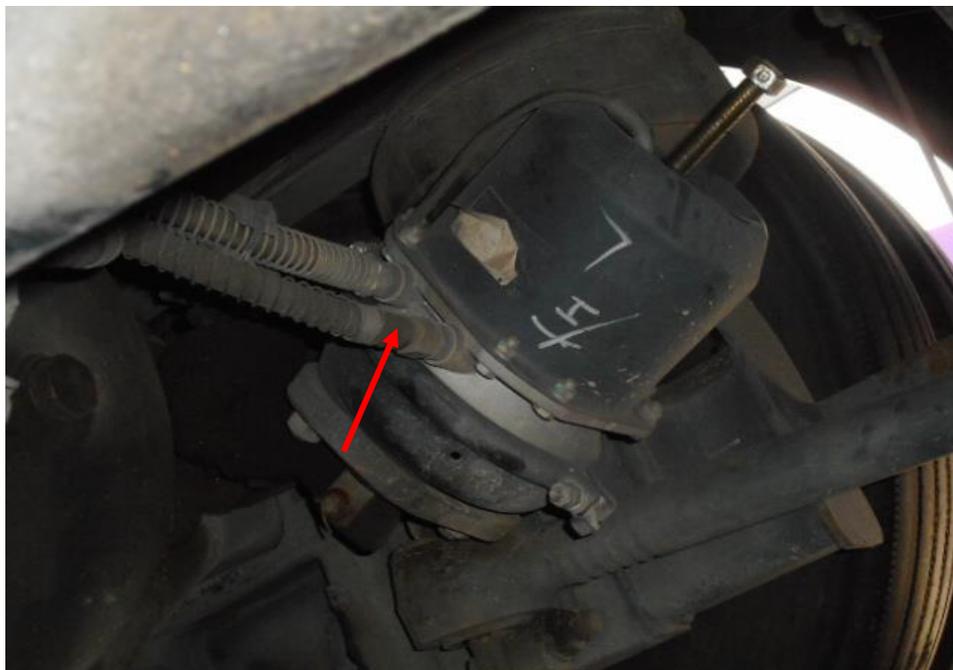
Photo 24 shows the brake pipe (arrowed) at the rear left wheel of the Motor Bus. I did not observe any leakage of brake fluid at the time of my inspection of the Motor Bus and the various mechanical components was observed to be intact.

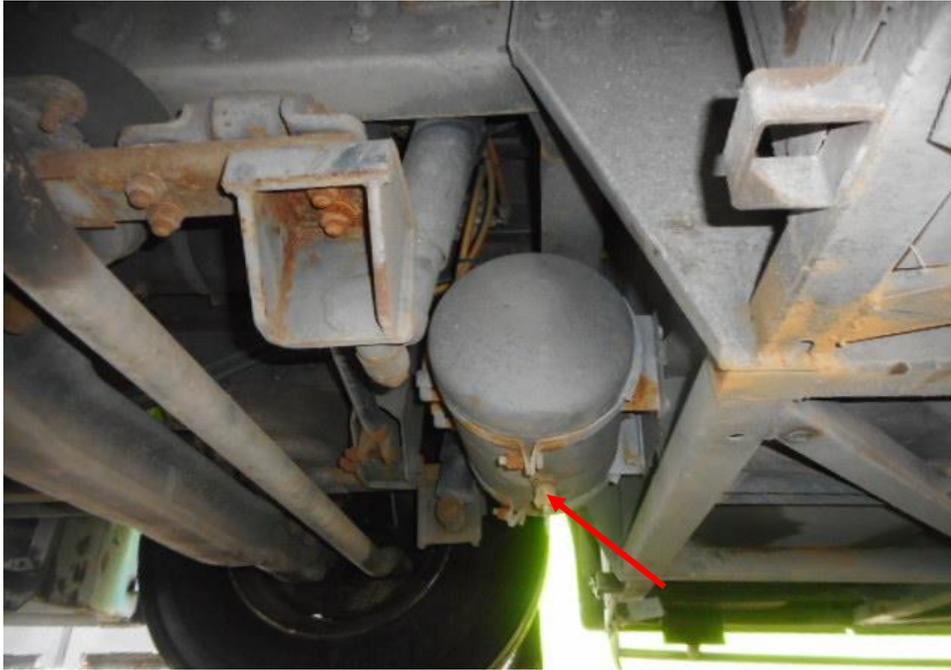
Photo 25 shows the air brake cylinders (arrowed) at the undercarriage of the Motor Bus. I did not observe any leakage of brake fluid at the time of my inspection of the Motor Bus and the various mechanical components was observed to be intact.
