Your Ref: TP/IP/22829/2022
Our Ref : CI/TPD22010887/P

29th November 2022

MECHANICAL INSPECTION REPORT OF MOTOR CAR SNE 6080L

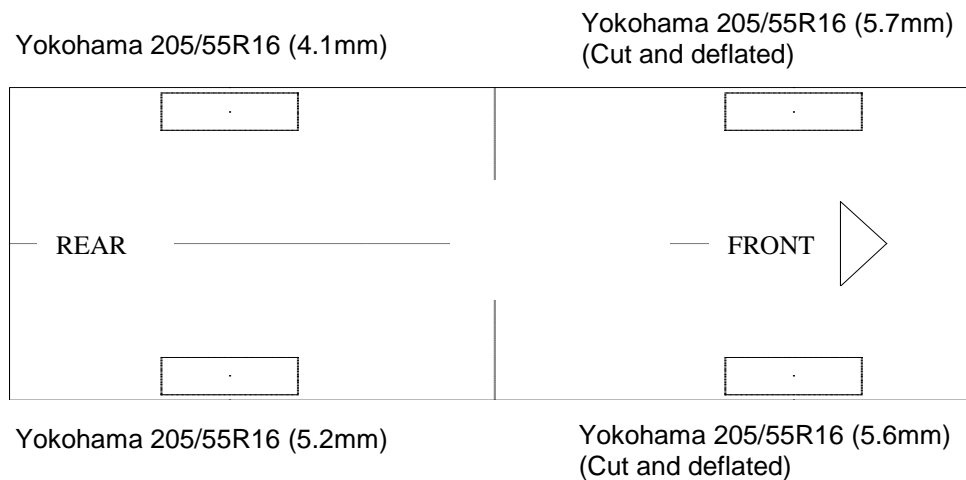
6. The front right and left tyre was observed to be damaged as a result of the accident. The condition of the Motor Car's rear right and left tyres was observed to be in serviceable condition. I did not find any tear, cut or burst mark(s) on the outer and the inner sidewalls as well as across the tread of the rear tyres. The rear tyres were also observed to be sufficiently inflated for vehicular operation. The tyre brand, tyre size and remaining tread depth of the 4 tyres were recorded as follows:-

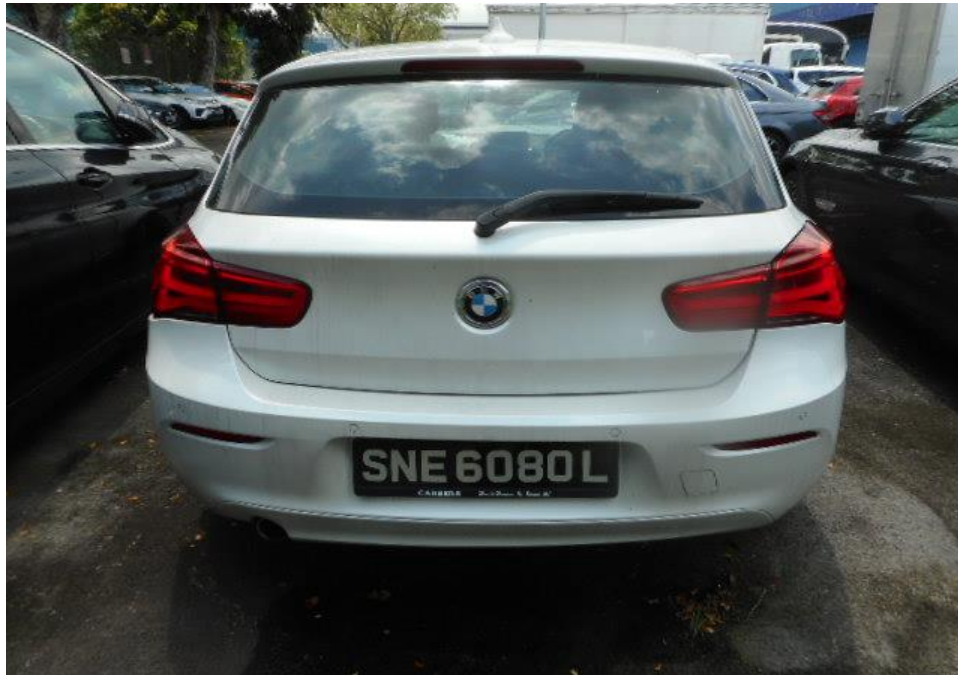
Photo 1 shows a general view of the Motor Car's rear body at the time of my inspection. The rear portion of the Motor Car was observed to have been undamaged by the accident.

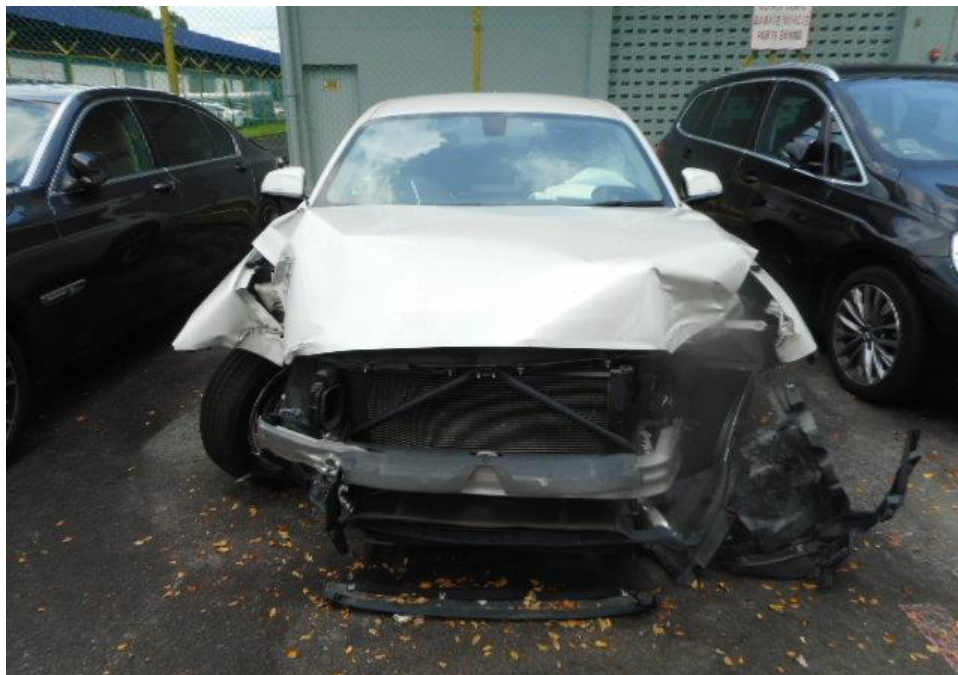
Photo 2 shows a general view of the Motor Car's front body at the time of my inspection. The Motor car was observed to have sustained damage at its front and left portion. Its front windscreen, front bonnet, front bumper, front left and right fender, front left and right headlamp was amongst the body parts and various engine components were also damaged as a result of the accident. The Supplemental Restraint System (SRS) was activated as a result of the accident.

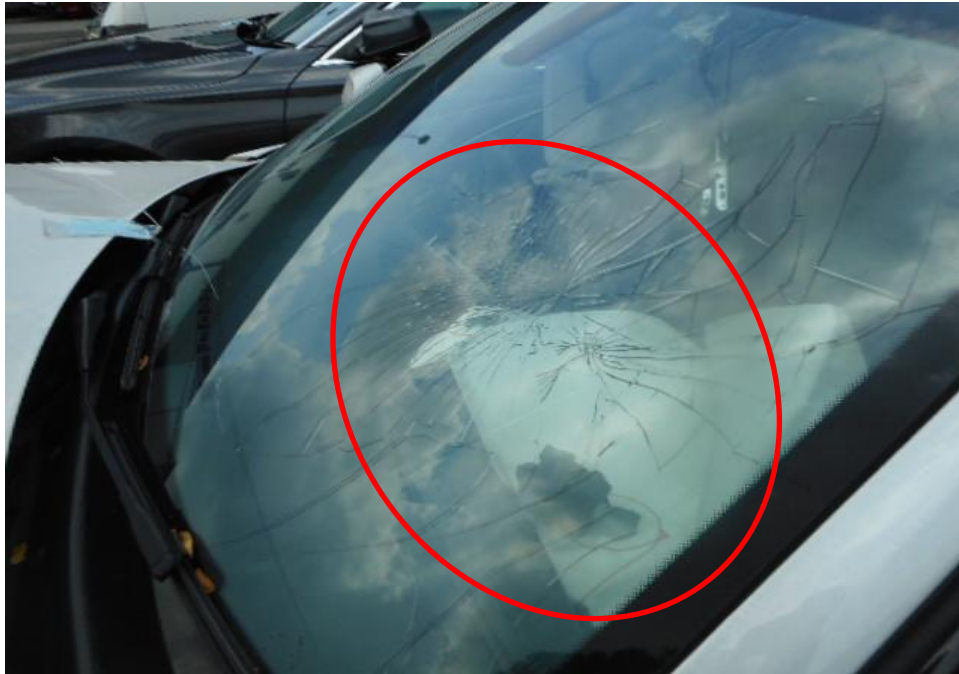
Photo 3 shows the close up view of the Motor Car's front body at the time of my inspection. The Motor car was observed to have sustained damage at its front portion. Its front windscreen (circled) was damaged as a result of the accident.

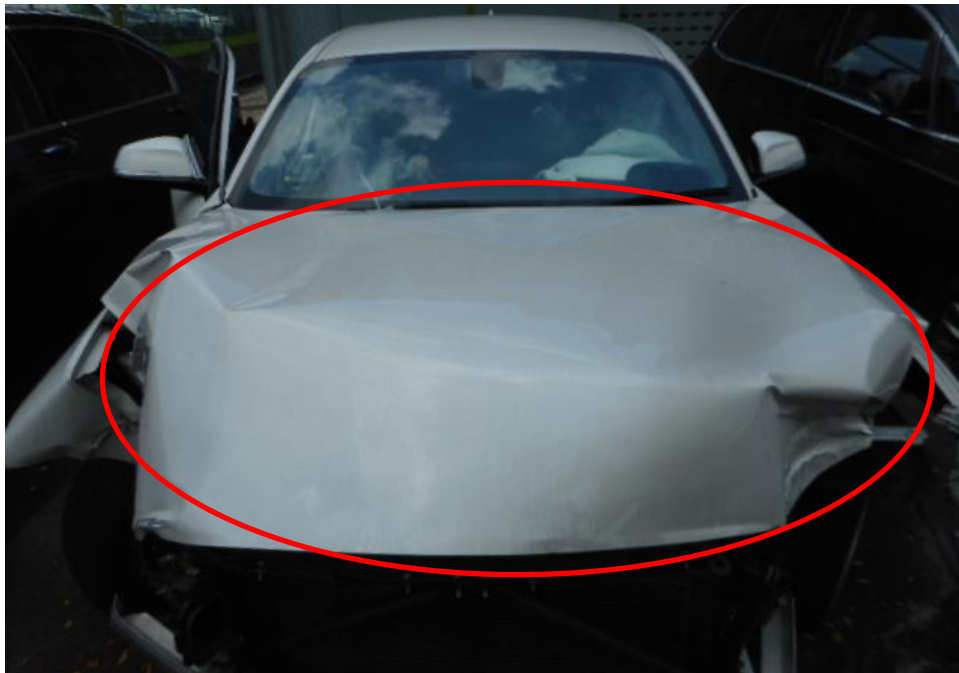
Photo 4 shows the close up view of the Motor Car's front body at the time of my inspection. The Motor car was observed to have sustained damage at its front portion. Its front bonnet (circled) was damaged as a result of the accident.

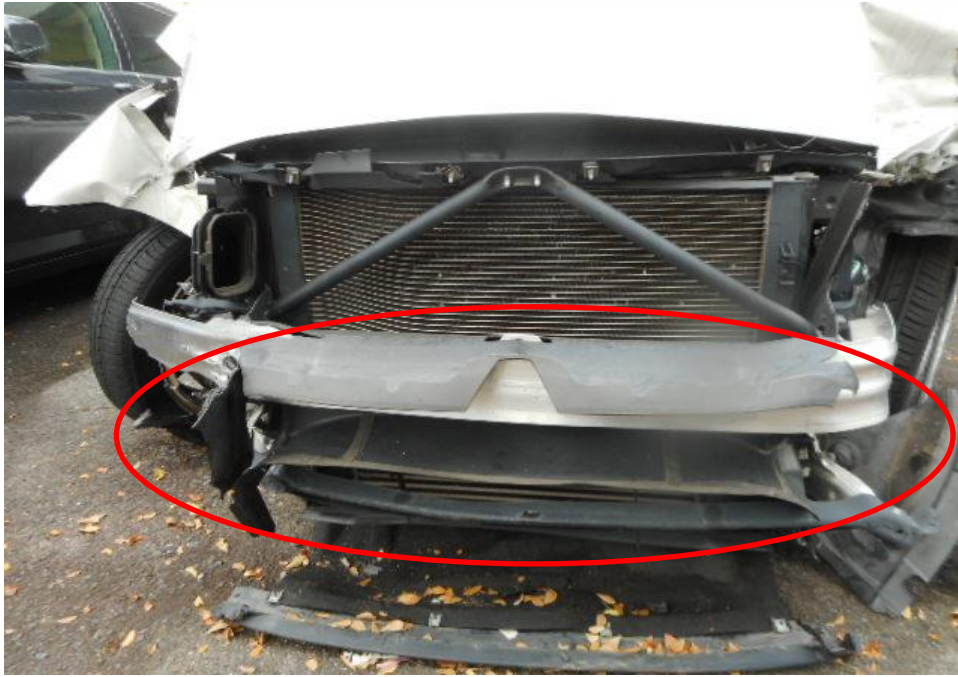
Photo 5 shows the close up view of the Motor Car's front body at the time of my inspection. The Motor car was observed to have sustained damage at its front portion. Its front bumper (circled) was damaged as a result of the accident.

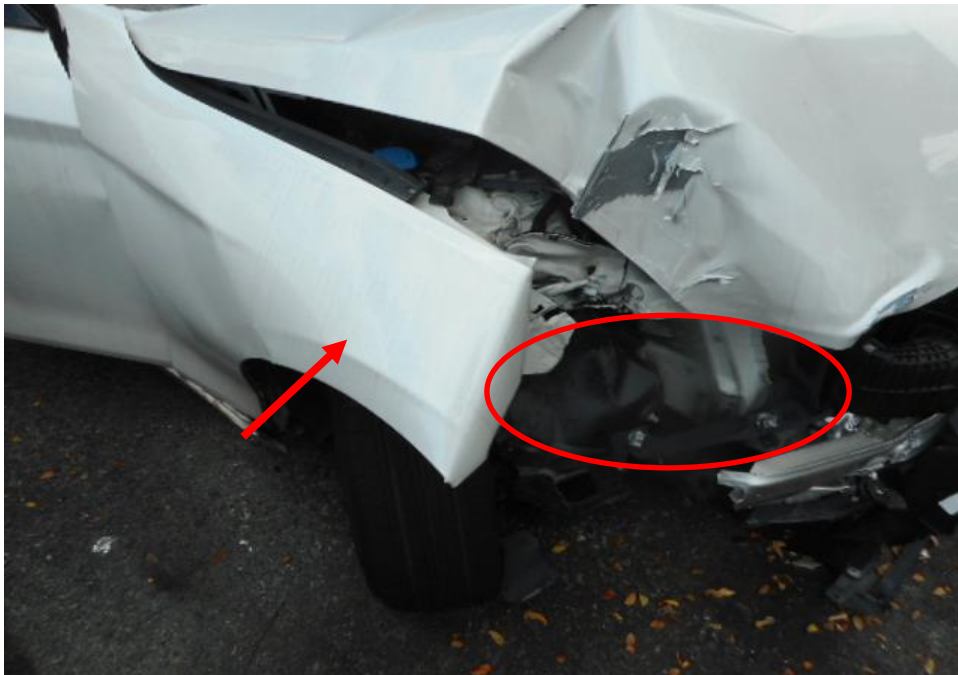
Photo 6 shows the close up view of the Motor Car's front body at the time of my inspection. The Motor car was observed to have sustained damage at its front portion. Its front right headlamp (circled) and front right fender (arrowed) was amongst the body parts and various components in the engine compartments were also damaged as a result of the accident.

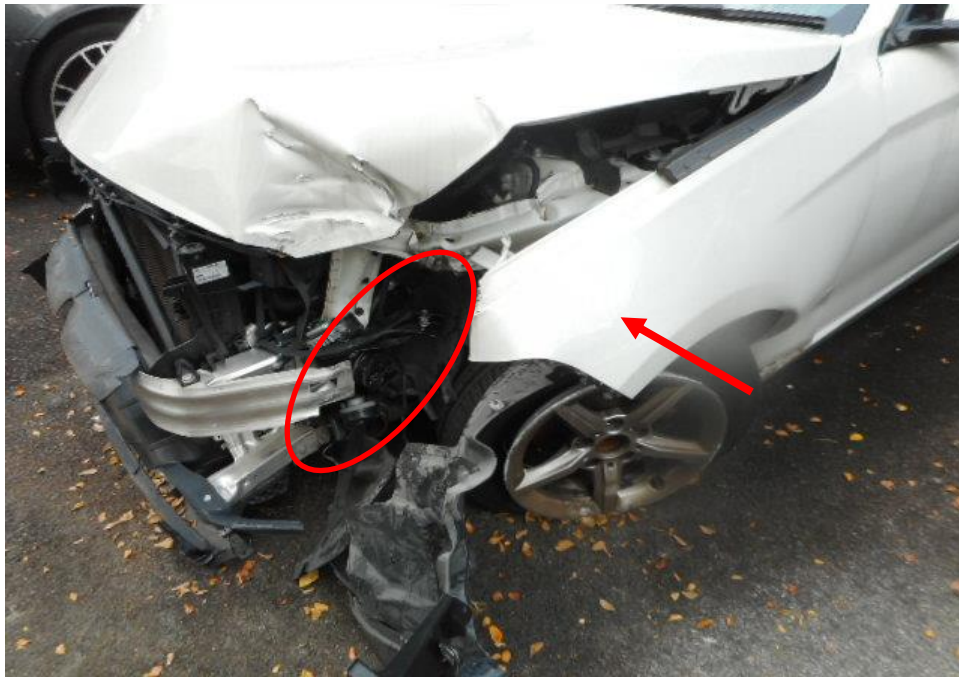
Photo 7 shows the close up view of the Motor Car's front body at the time of my inspection. The Motor car was observed to have sustained damage at its front portion. Its front left headlamp (circled) and front left fender (arrowed) was amongst the body parts and various components in the engine compartments were also damaged as a result of the accident.

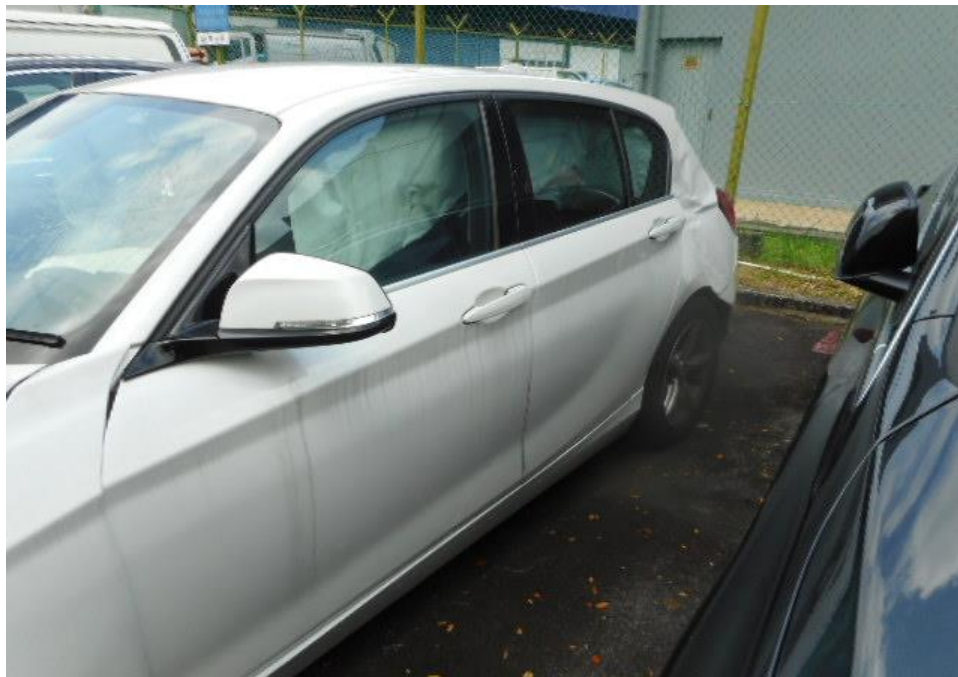
Photo 8 shows a general view of the Motor Car's left body at the time of my inspection. The Motor car was observed to have sustained damage at its left portion. Its left body panel was damaged as a result of the accident.

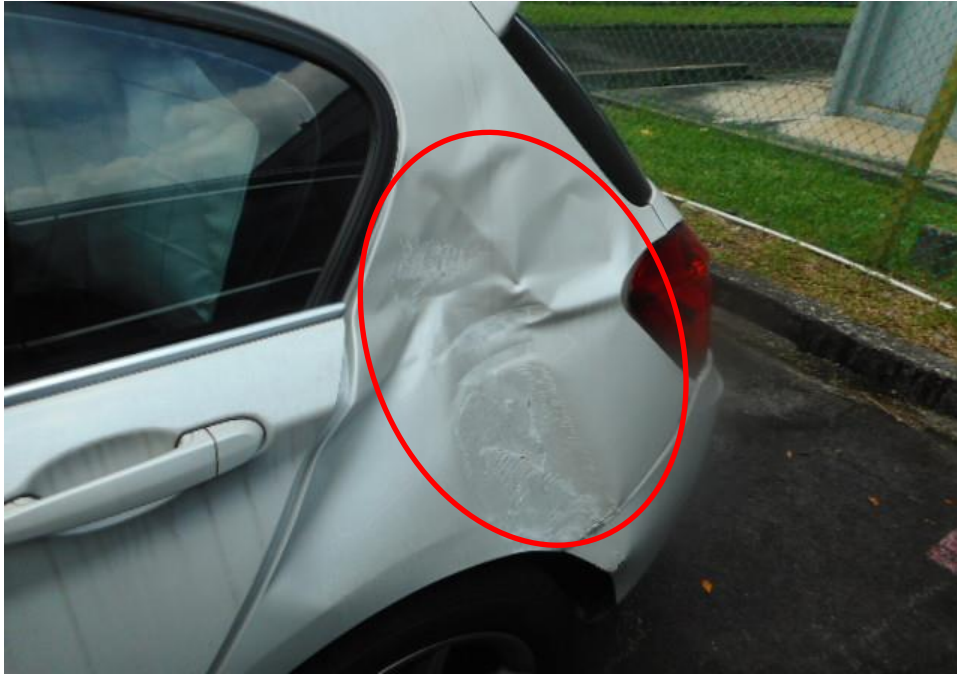
Photo 9 shows a general view of the Motor Car's left body at the time of my inspection. The Motor car was observed to have sustained damage at its left portion. Its left body panel (circled) was damaged as a result of the accident.

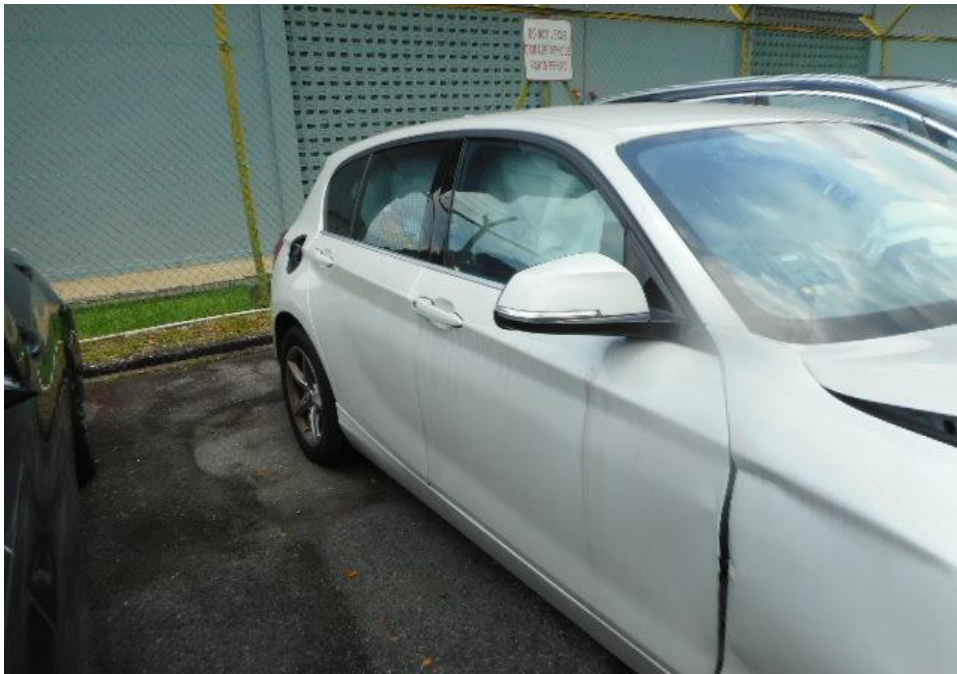
Photo 10 shows a general view of the Motor Car's right body at the time of my inspection. The right portion of the Motor Car was observed to have been undamaged by the accident.

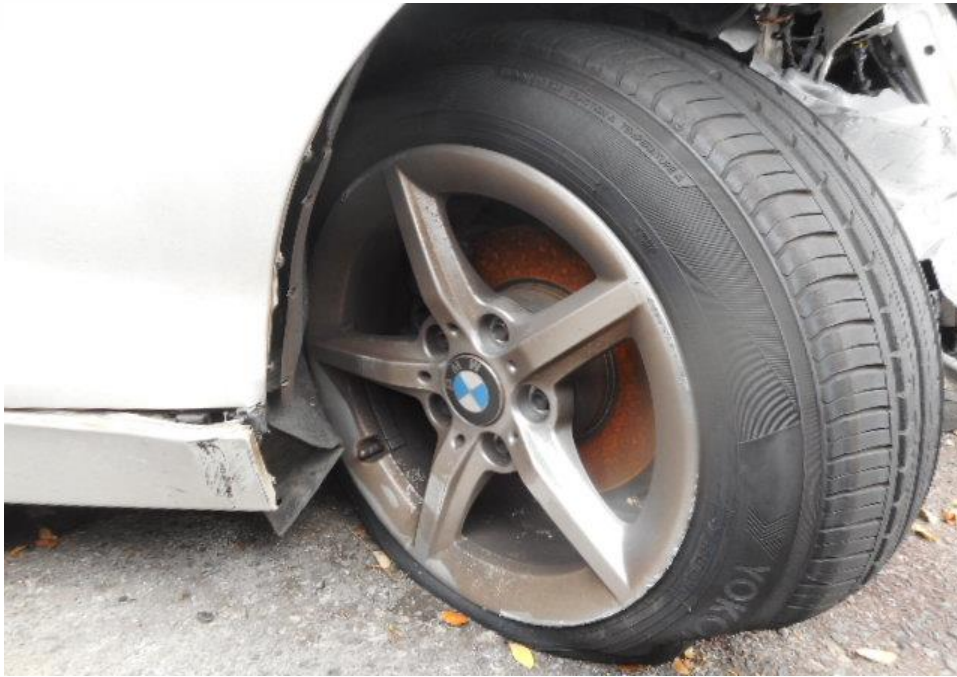
Photo 11 shows the general condition of the front right tyre of the Motor Car, which was observed to be deflated due to the damaged rim as a result of the accident. The tyre was also observed with cut mark(s) with remaining tread depth of approximately 5.6mm.

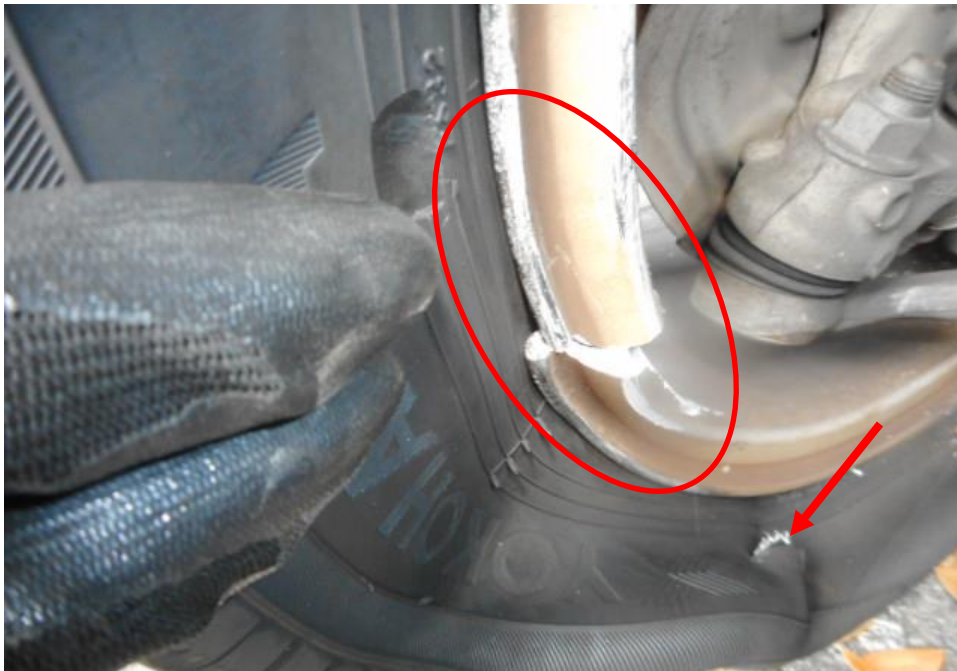
Photo 12 shows the close up condition of the front right tyre of the Motor Car, which was observed to be deflated due to the damaged rim (circled) as a result of the accident. The tyre was also observed with cut mark (arrowed) with remaining tread depth of approximately 5.6mm.

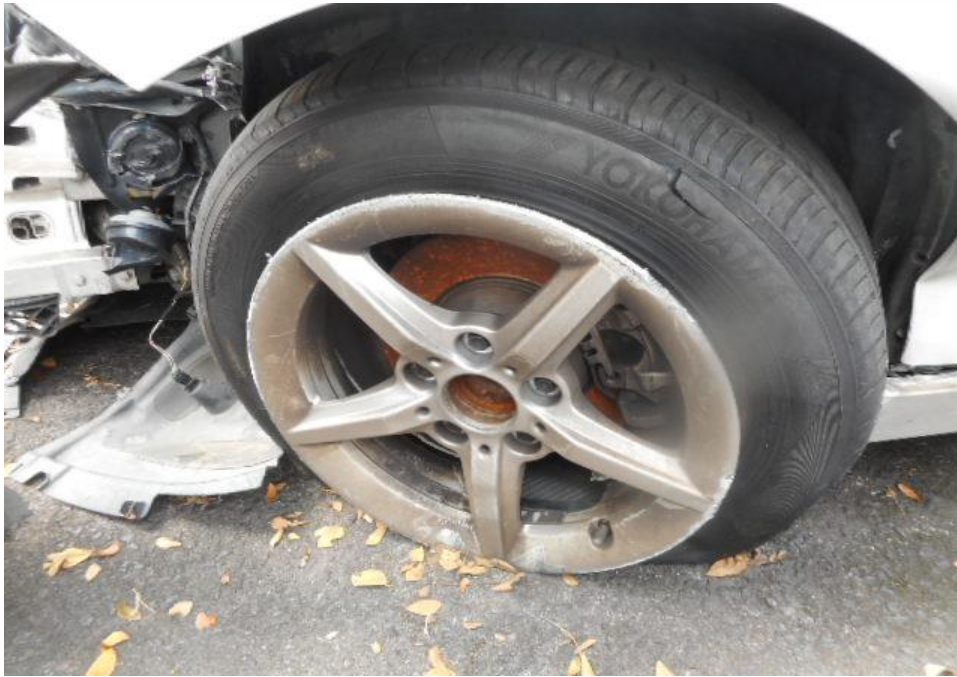
Photo 13 shows the general condition of the front left tyre of the Motor Car, which was observed to be deflated due to the damaged rim as a result of the accident. The tyre was also observed with cut mark(s) with remaining tread depth of approximately 5.7mm.

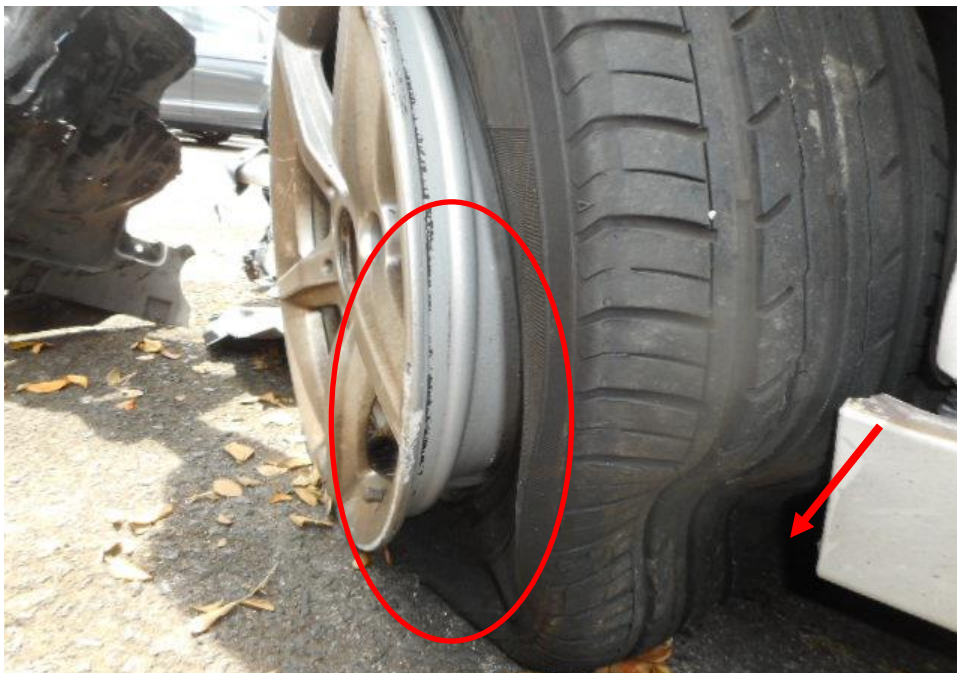
Photo 14 shows the close up condition of the front left tyre of the Motor Car, which was observed to be deflated due to the damaged rim (circled) as a result of the accident. The tyre was also observed with cut mark (arrowed) with remaining tread depth of approximately 5.7mm.

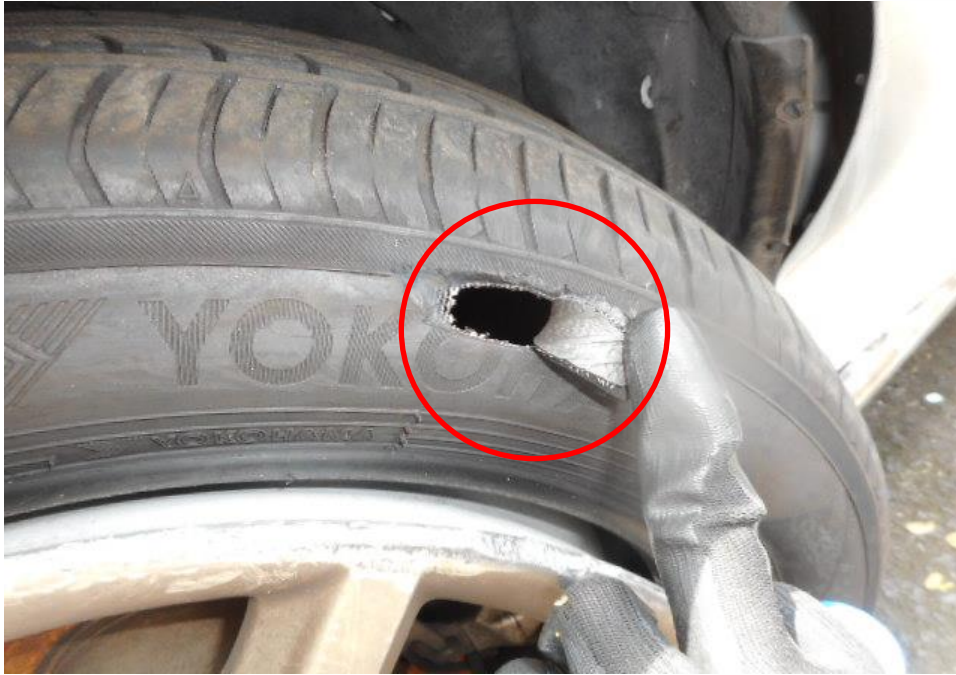
Photo 15 shows the close up condition of the front left tyre of the Motor Car, which was observed to be deflated due to the damaged rim as a result of the accident. The tyre was also observed with cut mark (circled) with remaining tread depth of approximately 5.7mm.

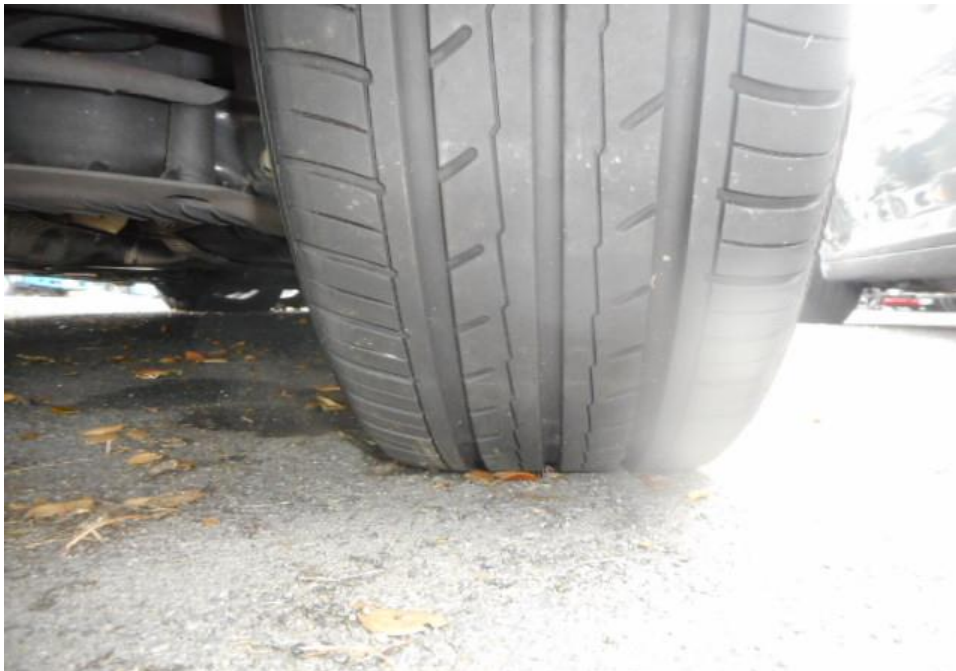
Photo 16 shows the condition of the rear right tyre of the Motor Car, which was observed to be in serviceable condition with remaining tread depth of approximately 5.2mm. The tyre was also observed to be sufficiently inflated for vehicular operation with no tear, cut or burst mark(s).

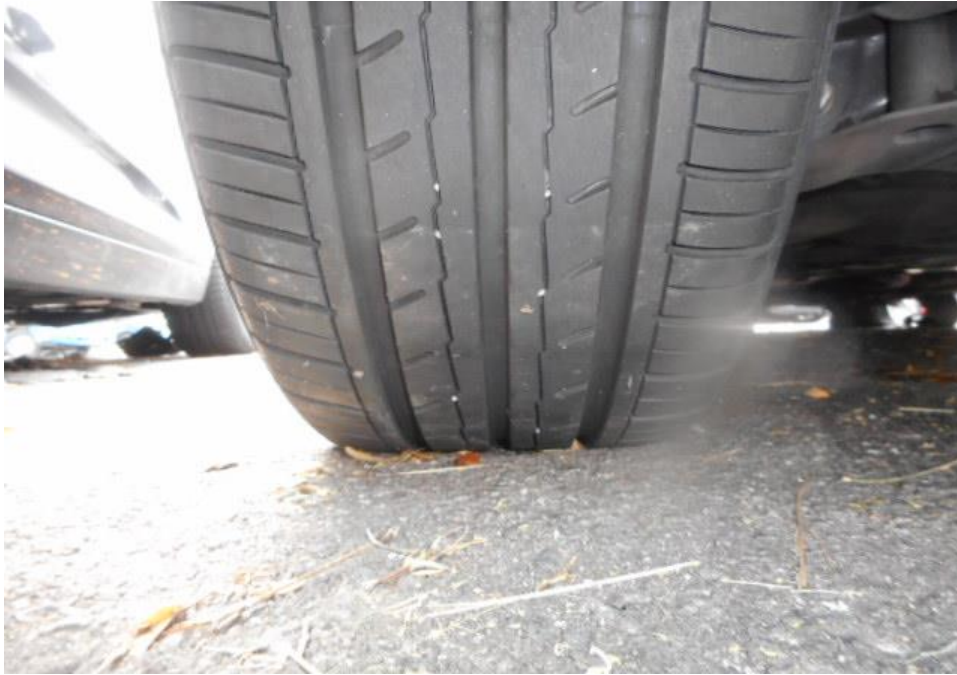
Photo 17 shows the condition of the rear left tyre of the Motor Car, which was observed to be in serviceable condition with remaining tread depth of approximately 4.1mm. The tyre was also observed to be sufficiently inflated for vehicular operation with no tear, cut or burst mark(s).

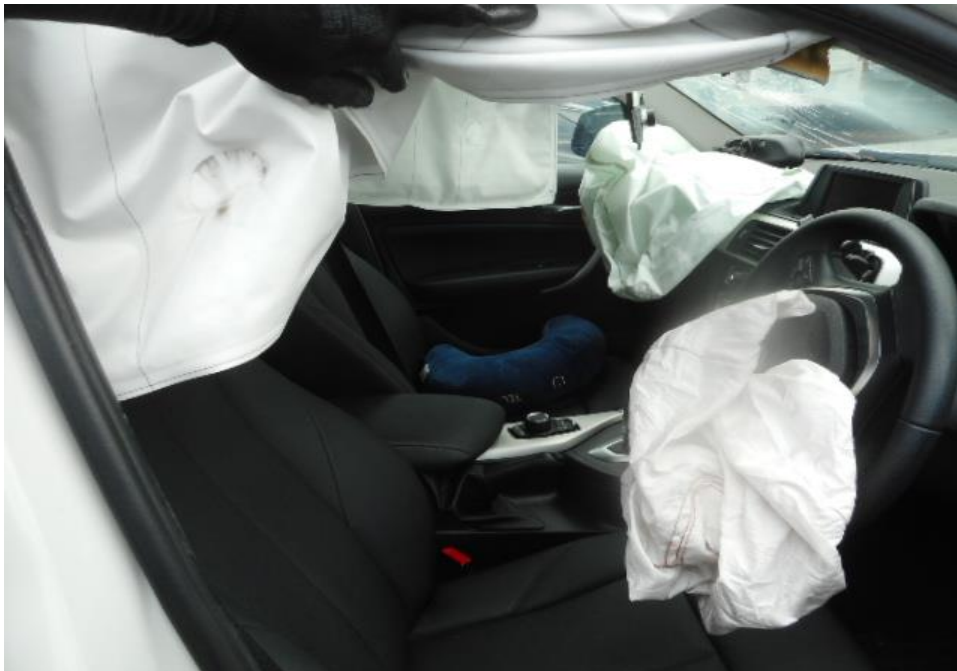
Photo 18 shows the deployment of the Supplemental Restraint System (SRS) airbag in the Motor Car as a result of the accident.

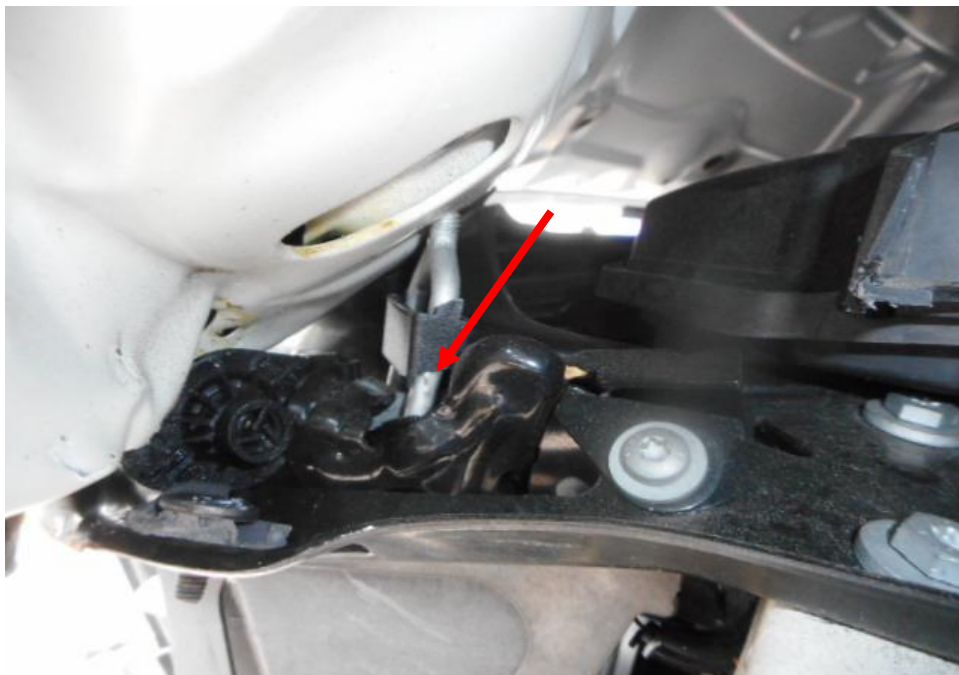
8. We were unable to raise the front bonnet of the Motor car to conduct the examination of the Motor Car's engine compartment because the damage caused by the accident had resulted in the damages to the lock mechanism of the bonnet and the structure of the engine compartment. (Unable to open).
9. During our inspection, we observed that the engine system was damaged as a result of the induced impact from the accident. We also tried to jumpstart the engine of the vehicle as it was unable to be jumpstarted up despite multiple attempts in jumpstarting it.
10. My subsequent checks on the underside of the Motor Car revealed sign(s) or indication(s) of fluid leak and/or fluid stain(s) from the damaged engine as a result of the accident. See photo 19 -22 below.

Photo 19 shows the close up view of the damaged front bonnet lock mechanism (arrowed) and the structure of the engine compartment of the Motor Car at the time of my inspection resulting it unable to open a result of the accident. (Unable to open)

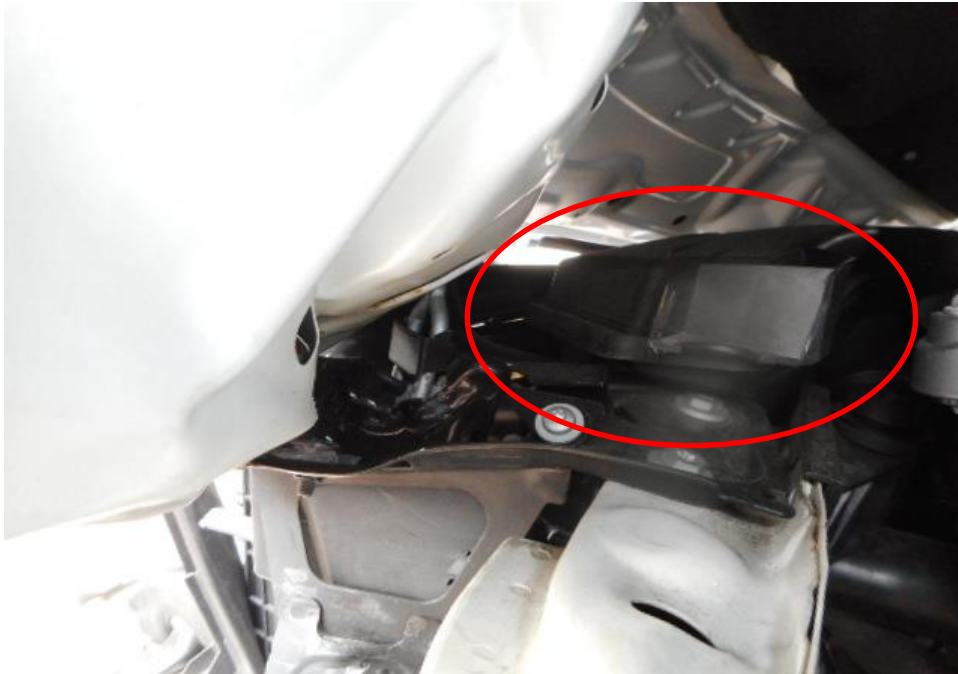
Photo 20 shows the close up view of the Motor Car's front body at the time of my inspection. The Motor car was observed to have sustained damage at its front portion. Its engine (circled) was amongst the various components in the engine compartments were also damaged as a result of the accident.

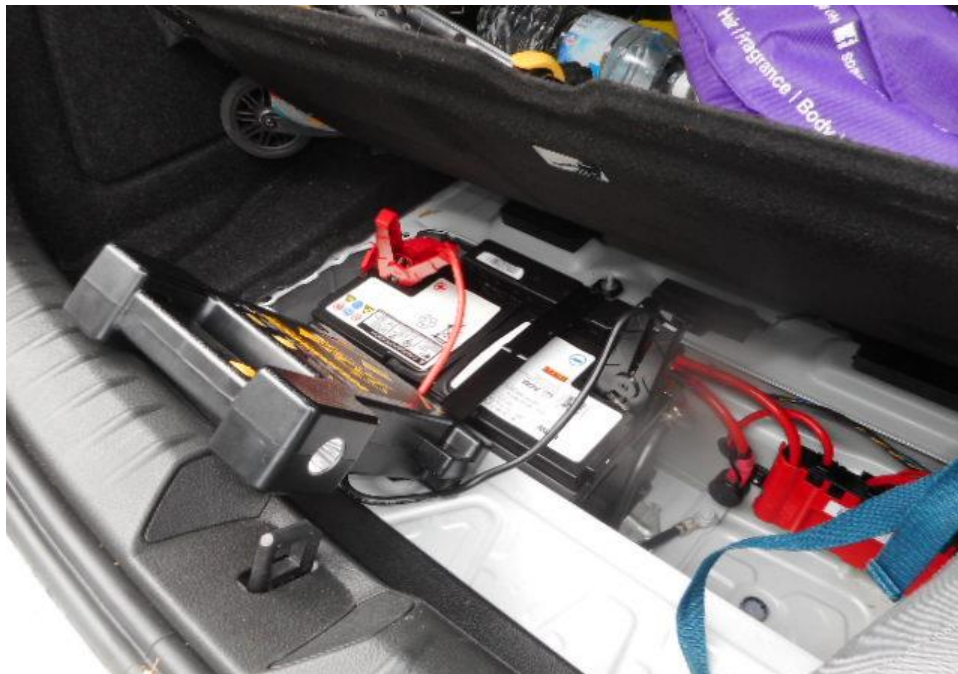
Photo 21 shows the jumpstarting of the Motor Car using a jump starter. The engine of the Motor Car was unable to be started up despite multiple attempts in jumpstarting it.

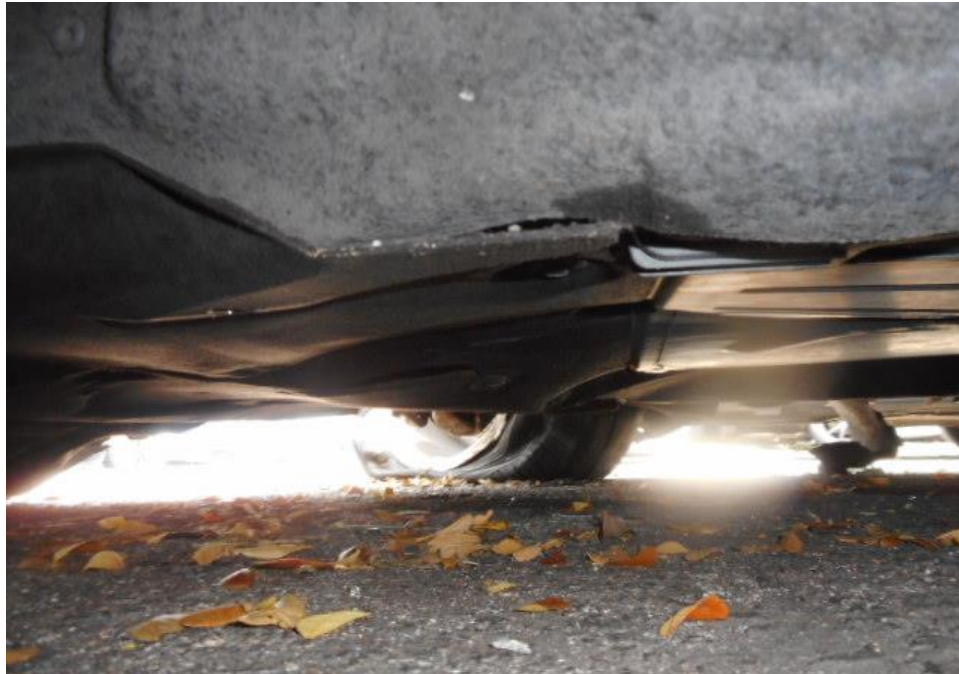
Photo 22 shows the undercarriage of the Motor Car, at the area where the engine housing and transmission housing are located. I did not find any sign(s) or indication(s) of fluid leak and/or fluid stain(s) on the underside of the Motor Car.

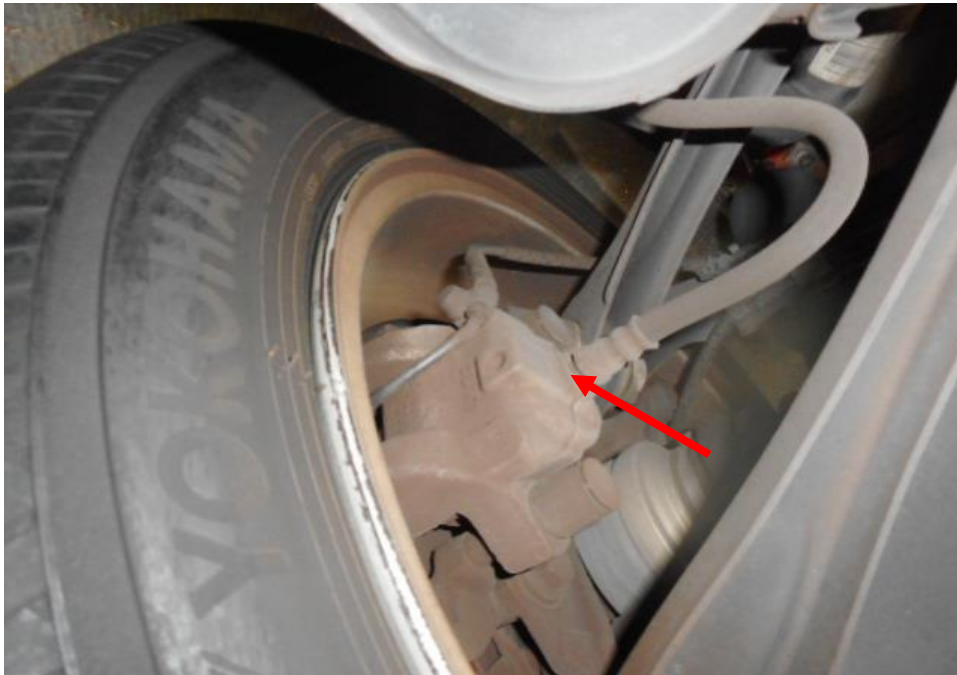
Photo 23 shows the brake hose/pipe (arrowed) at the rear left wheel of the Motor Car. No leakage of brake fluid was observed. Visual examination of the various components of the braking system like the brake caliper to be intact and without visible damage.

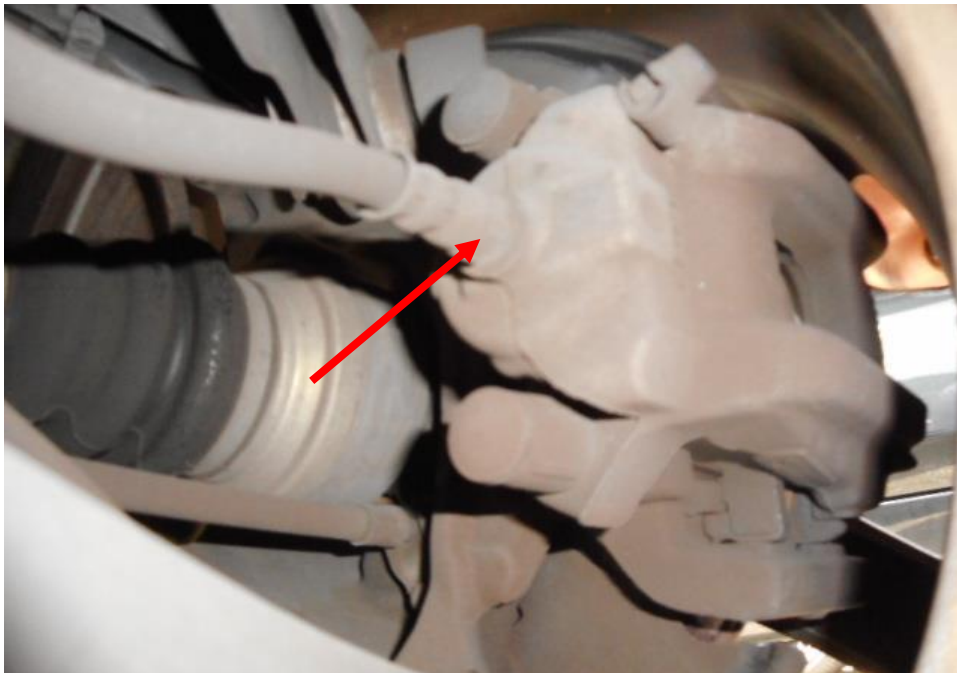
Photo 24 shows the brake hose/pipe (arrowed) at the rear right wheel of the Motor Car. No leakage of brake fluid was observed. Visual examination of the various components of the braking system like the brake caliper to be intact and without visible damage.

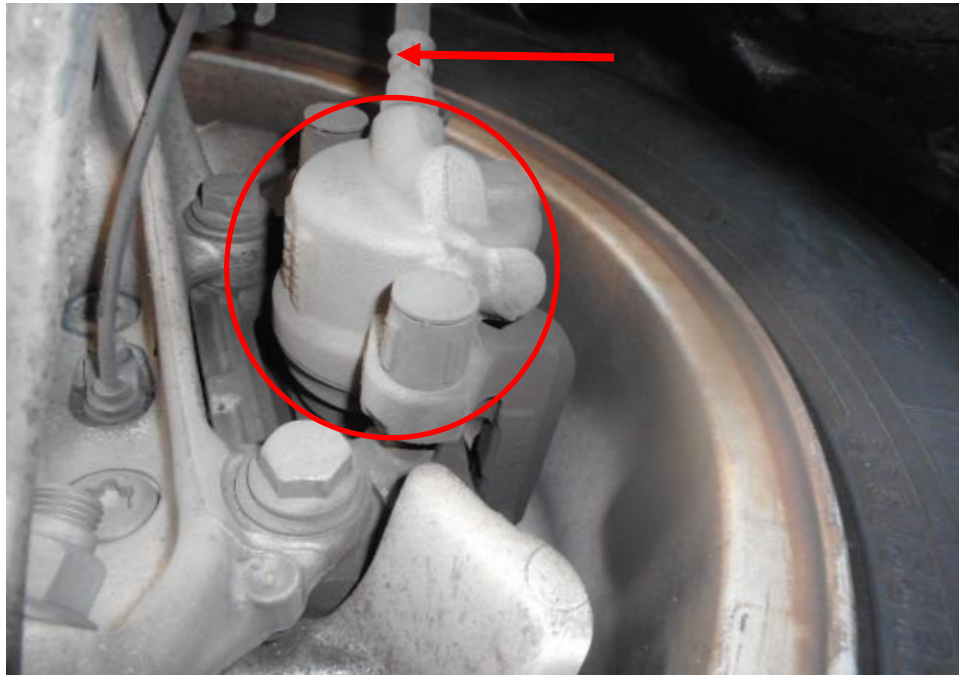
Photo 25 shows the brake hose/pipe (arrowed) at the front right wheel of the Motor Car. I did not observe any leakage of brake fluid at the time of my inspection of the Motor Car. Visual examination of the various components of the braking system the brake caliper (circled) to be intact and without visible damage.

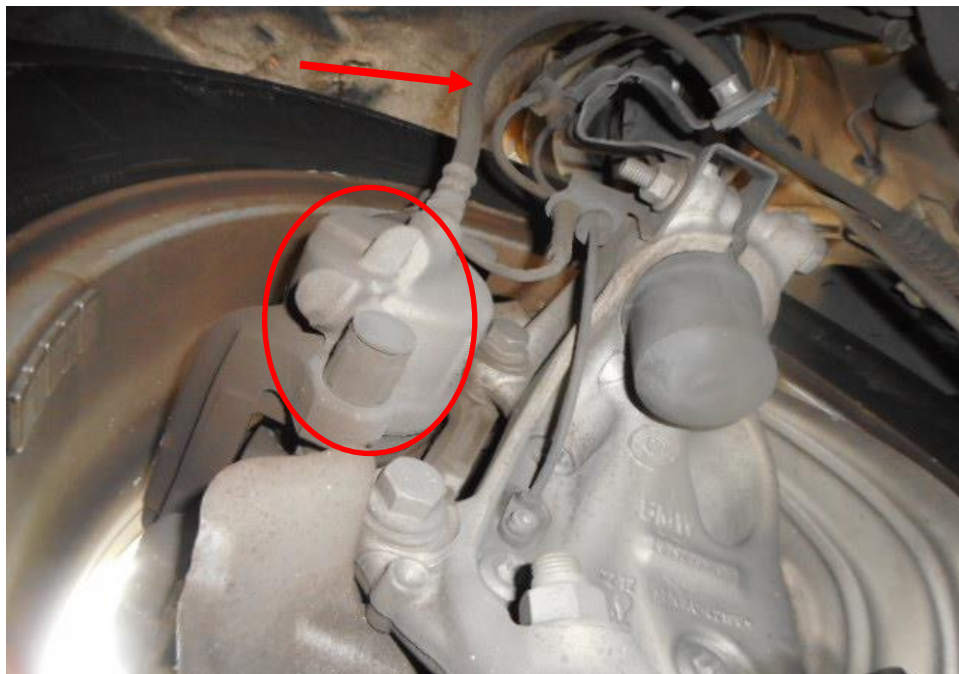
Photo 26 shows the brake hose/pipe (arrowed) at the front left wheel of the Motor Car. No leakage of brake fluid was observed. Visual examination of the various components of the braking system the brake caliper (circled) to be intact and without visible damage.

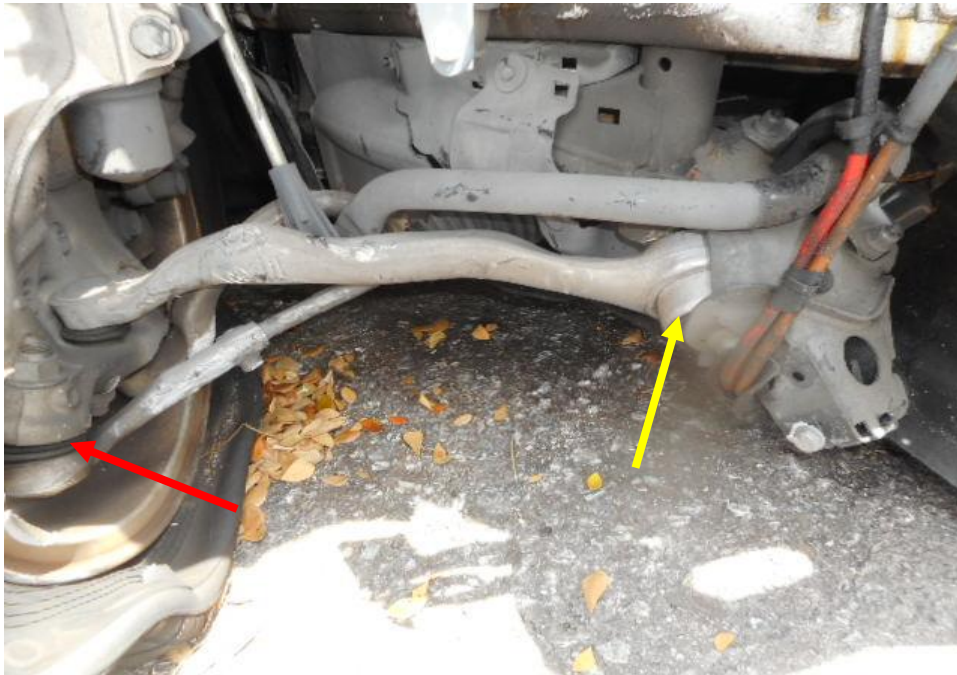
Photo 27 shows the various undercarriage components at the front right wheel of the Motor Car, in particular the steering tie rod (red arrow) was found to be intact. However, the lower control arm was observed to be damaged as result of the accident (yellow arrow). There was also no sign of fluid stain observed on the various undercarriage components at the front right wheel of the Motor Car.

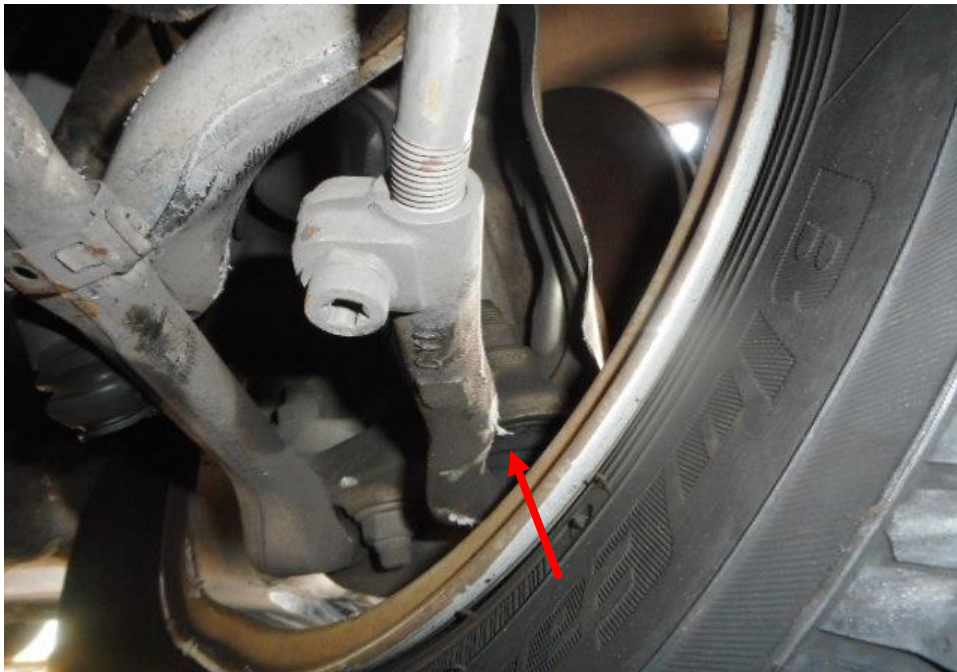
Photo 28 shows the various undercarriage components the front left wheel of the Motor Car, in particular the steering tie rod (arrowed) was found to be intact. However, the lower control arm was observed to be damaged as result of the accident. There was also no sign of fluid stain observed on the various undercarriage components at the front right wheel of the Motor Car.

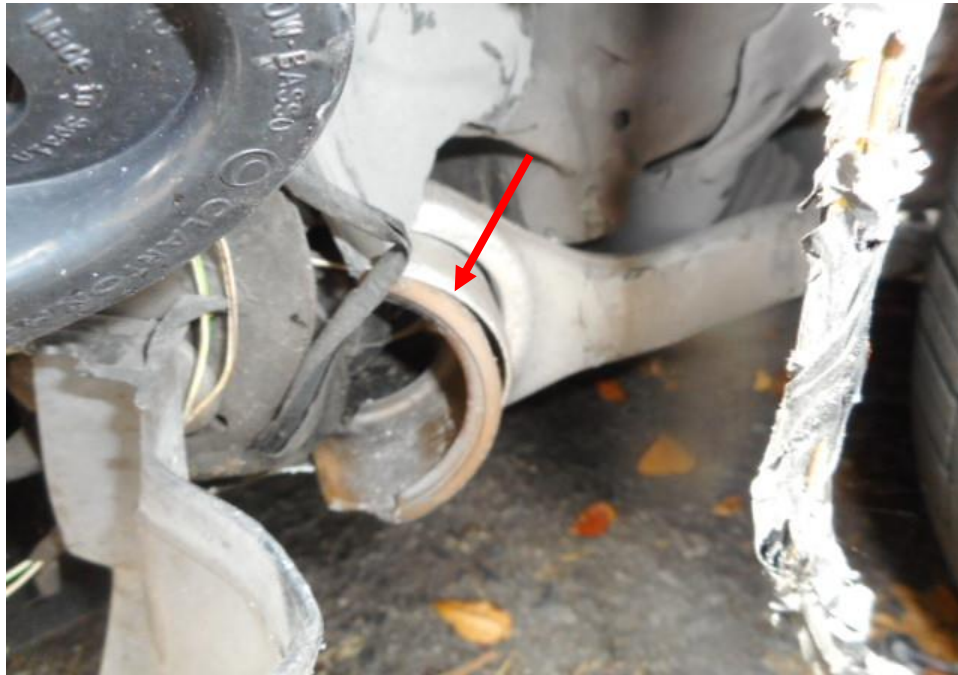
Photo 29 shows the various undercarriage components the front left wheel of the Motor Car, the lower control arm (arrowed) was observed to be damaged as result of the accident.

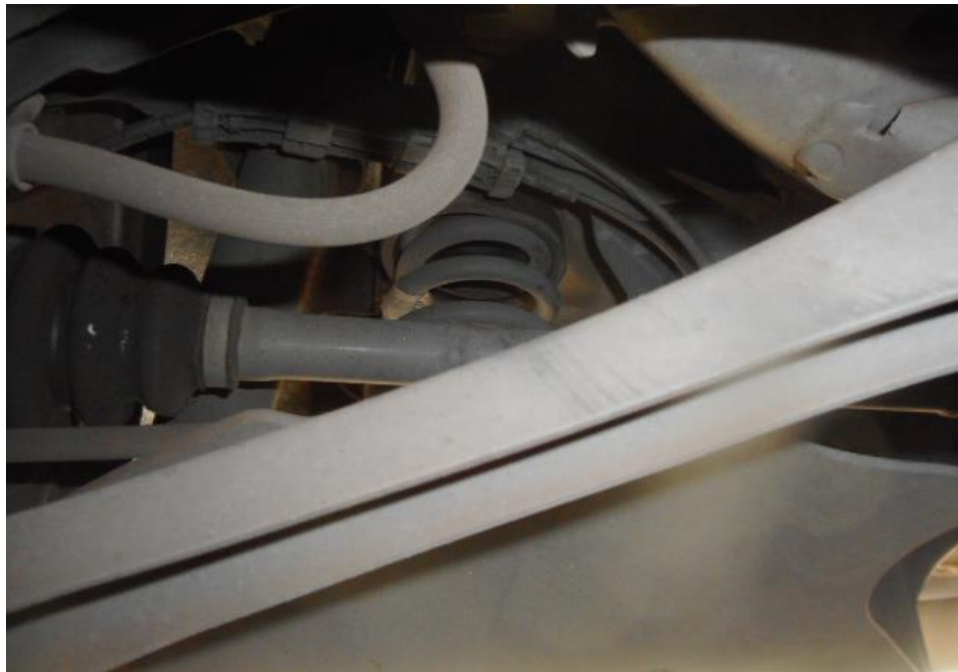
Photo 30 shows the various undercarriage components at the front right wheel of the Motor Car, the driveshaft (arrowed) was observed to be intact. There was also no sign of fluid stain observed on the various undercarriage components at the rear left wheel of the Motor Car.

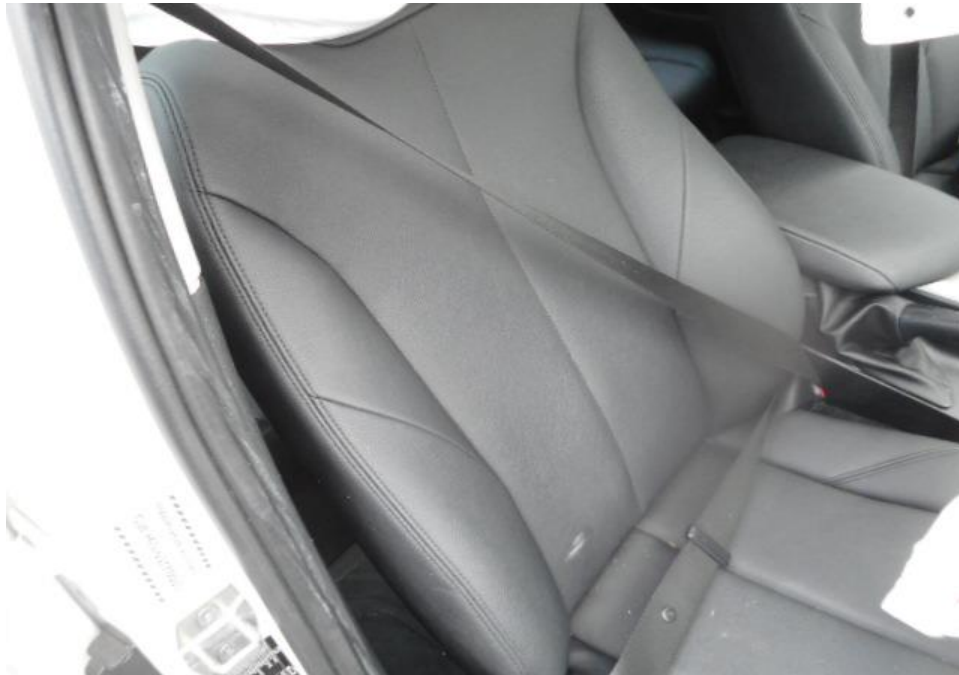
Photo 31 shows that the seat belt on the right seat were able to be fastened securely into the respective pre-tensioners that were fitted at the sides of each seat.
