Your Ref: TP/IP/22829/2022
Our Ref : CI/TPD22010887/P

29th November 2022

MECHANICAL INSPECTION REPORT OF MOTOR CAR SNE 6080L

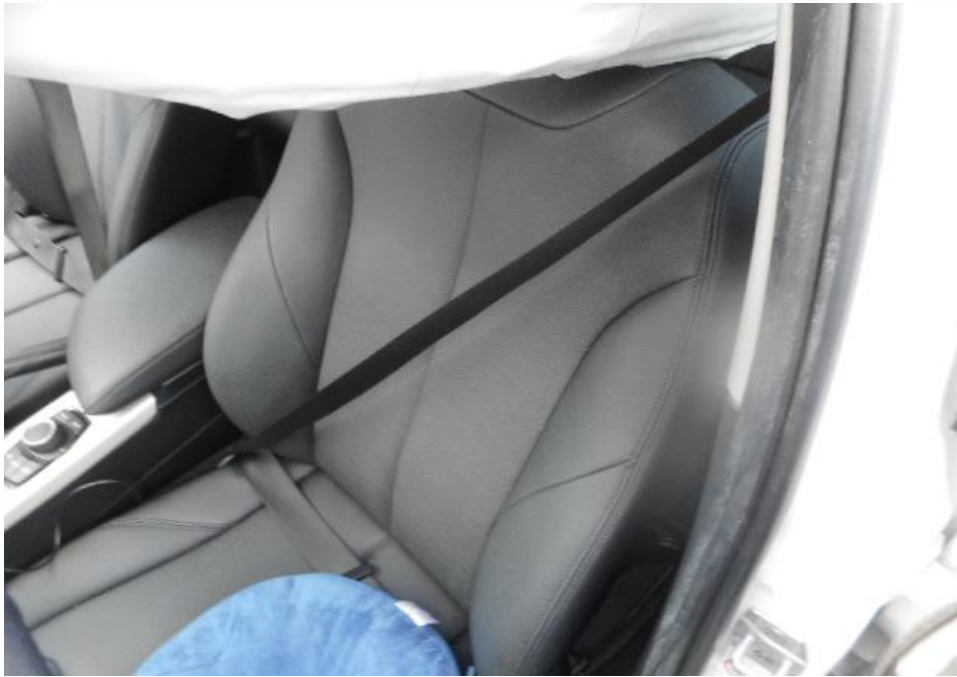
Photo 32 shows that the seat belt on the left seat were able to be fastened securely into the respective pre-tensioners that were fitted at the sides of each seat.
