You're Ref: TP/IP/27456/2022
Our Ref: CI/TPD22010888/P

14th November 2022

MECHANICAL INSPECTION REPORT OF ELECTRIC TAXI SHA 8586Z

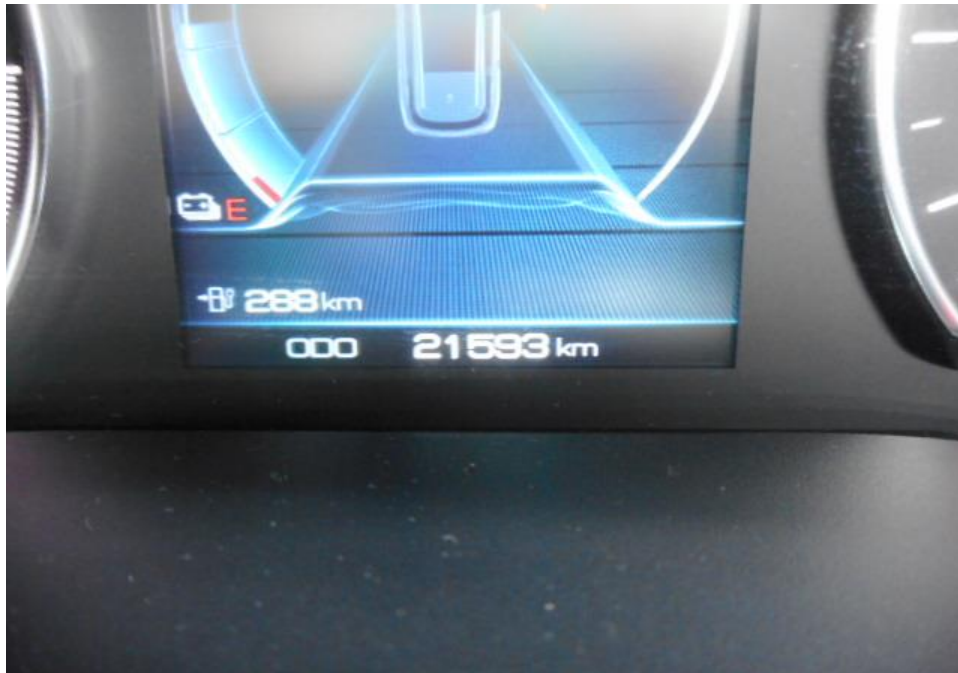
Photo 1 shows the mileage of the Electric Taxi at the time of my inspection. The mileage observed was 215,593km.

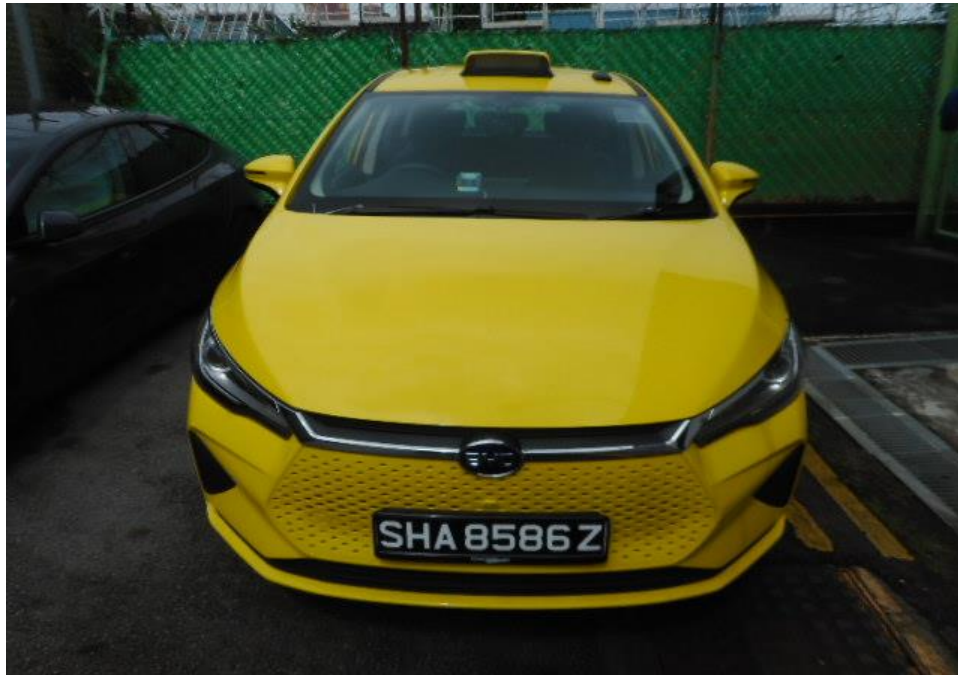
Photo 2 shows a general view of the Electric Taxi's front body at the time of my inspection. The front portion of the Electric Taxi was observed to have sustained damage. The front bumper was the body part that were damaged as a result of the accident.

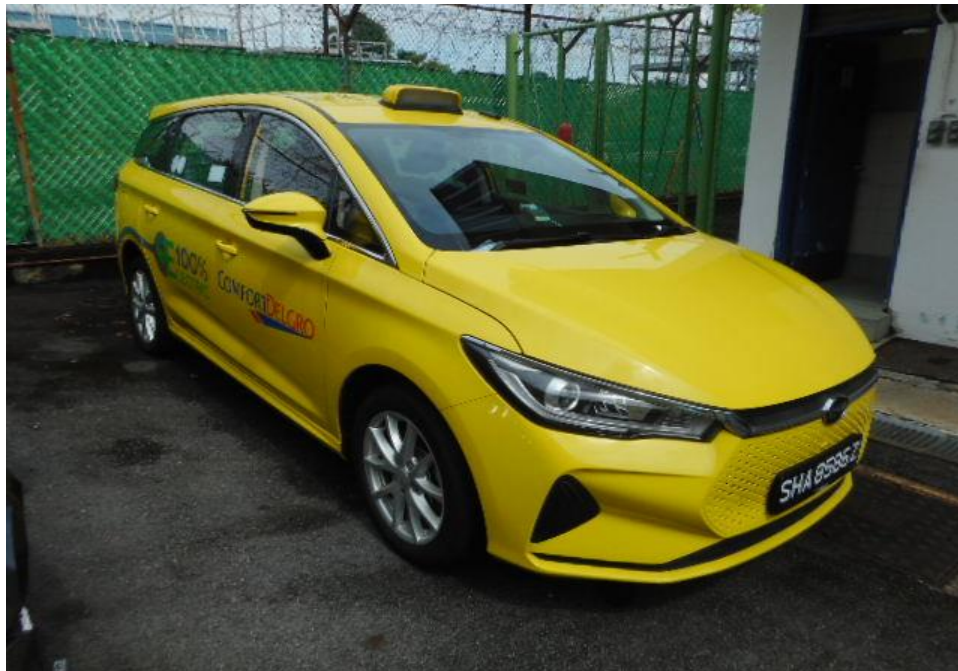
Photo 3 shows a general view of the Electric Taxi's right body at the time of my inspection. The right portion of the Electric Taxi was observed to have been unaffected by the accident.

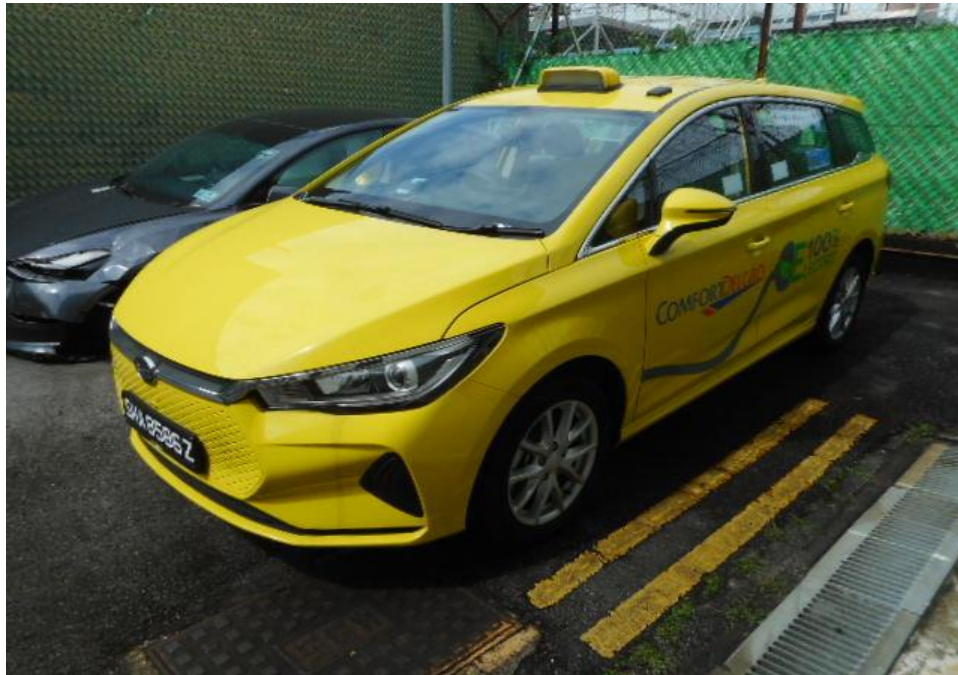
Photo 4 shows a general view of the Electric Taxi's left body at the time of my inspection. The left portion of the Electric Taxi was observed to have been unaffected by the accident.

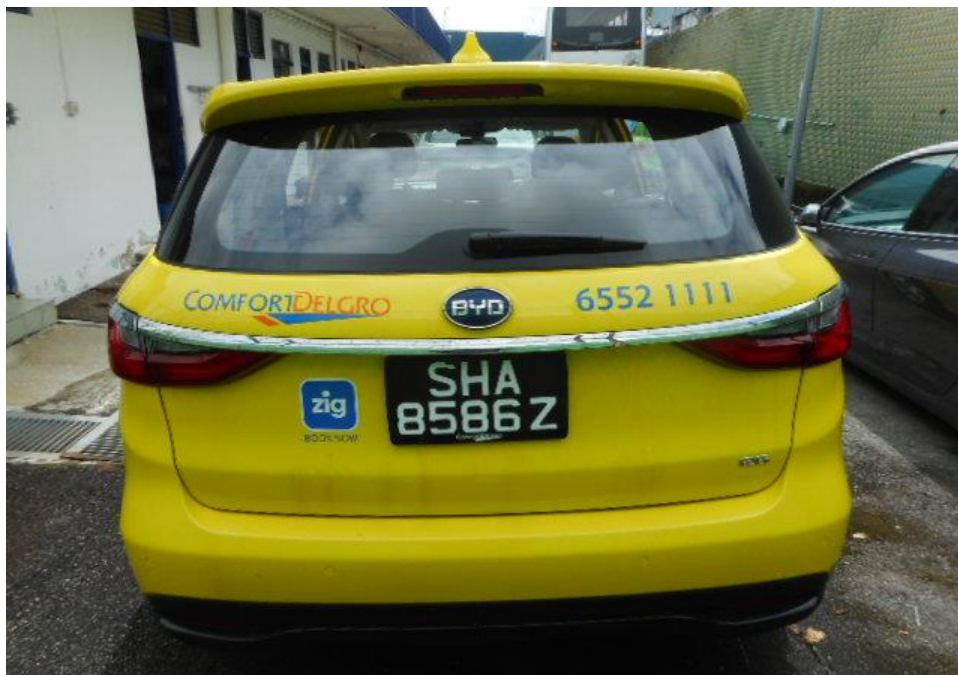
Photo 5 shows the general view of the Electric Taxi's rear body at the time of my inspection. The Electric Taxi rear was observed to be unaffected by the accident.

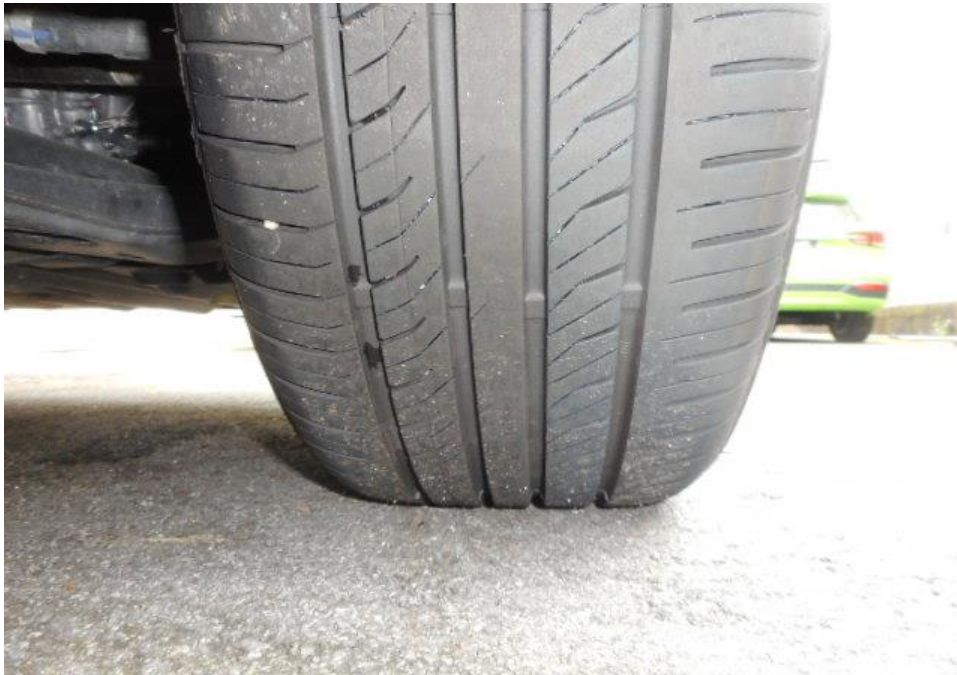
Photo 6 shows the condition of the front right tyre of the Electric Taxi, which was observed to be in serviceable condition with remaining tread depth of approximately 6.2mm. The tyre was sufficiently inflated for vehicular operation with no tear, cut or burst mark(s) on the outer and the inner sidewalls as well as across the tread. The 4 tyres of the Electric Taxi were wrapped around standard steel wheel rims without any damage.

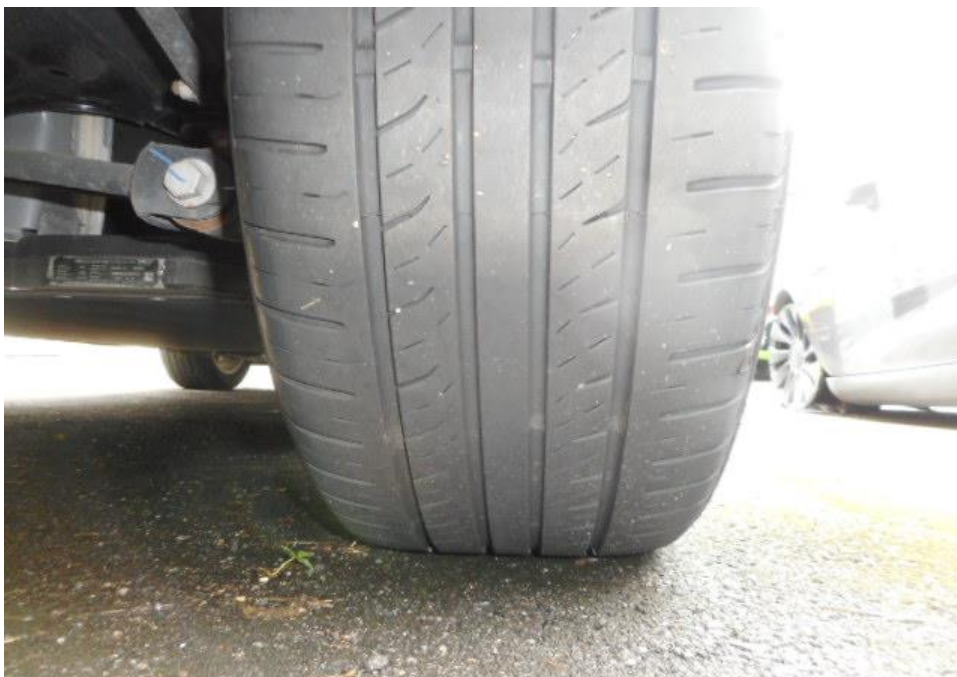
Photo 7 shows the condition of the rear right tyre of the Electric Taxi, which was observed to be in serviceable condition with remaining tread depth of approximately 4.3mm. The tyre was also observed to be sufficiently inflated for vehicular operation with no tear, cut or burst mark(s).

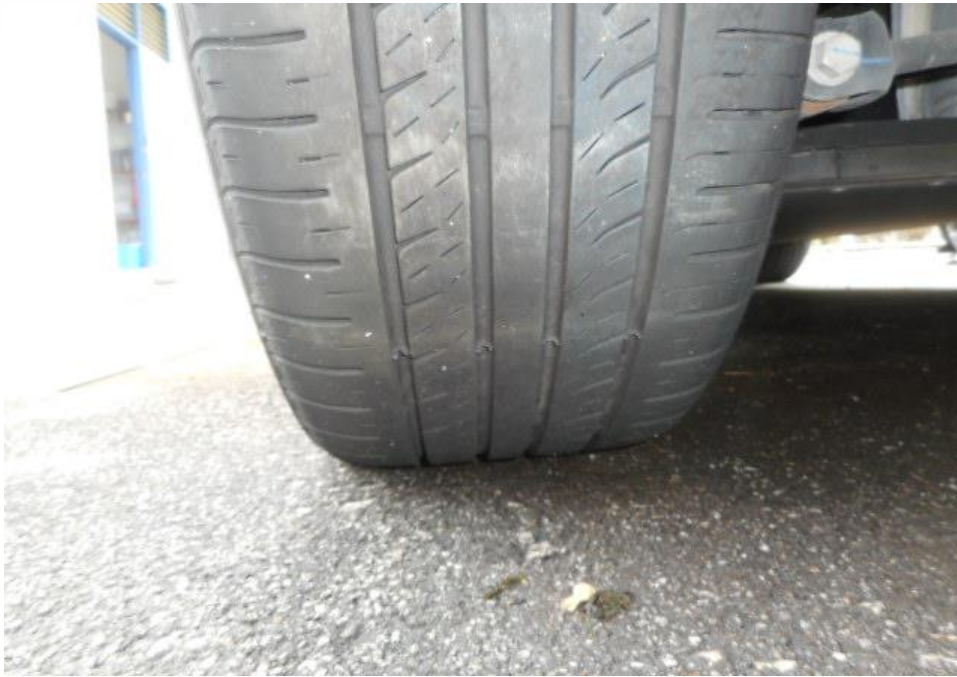
Photo 8 shows the condition of the rear left tyre of the Electric Taxi, which was observed to be in serviceable condition with remaining tread depth of approximately 3.8mm. The tyre, which was wrapped around steel wheel rim, was also observed to be sufficiently inflated for vehicular operation. The 4 tyres of the Electric Taxi were wrapped around standard steel wheel rims.

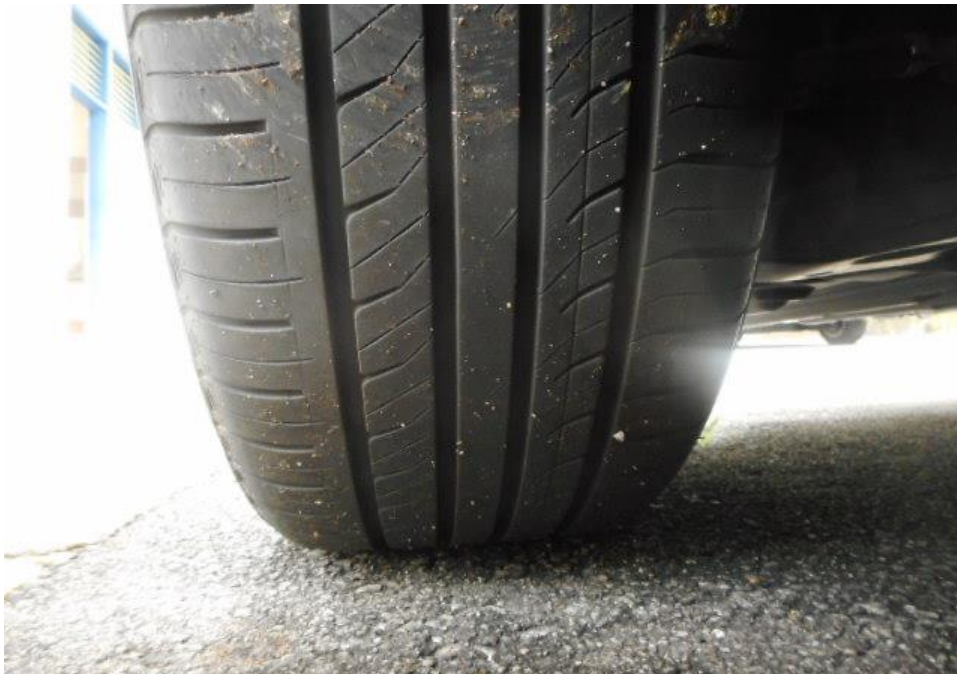
Photo 9 shows the condition of the front left tyre of the Electric Taxi, which was observed to be in serviceable condition with remaining tread depth of approximately 6.1mm. There was also no tear, cut or burst mark(s) on the outer and the inner sidewalls as well as across the tread of the Electric Taxi's 4 tyres.

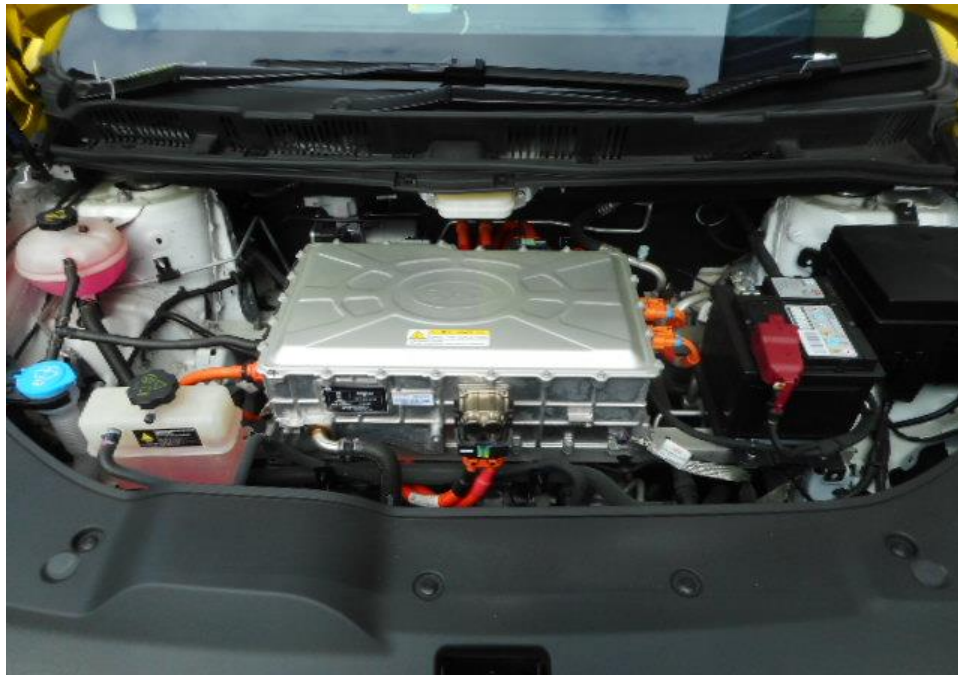
Photo 10 shows a general view of the Electric Taxi's engine compartment. The various parts and components inside the engine compartment were unaffected by the accident. There was also no sign(s) or indication(s) of fluid leakage and/or fluid stain within the engine compartment.

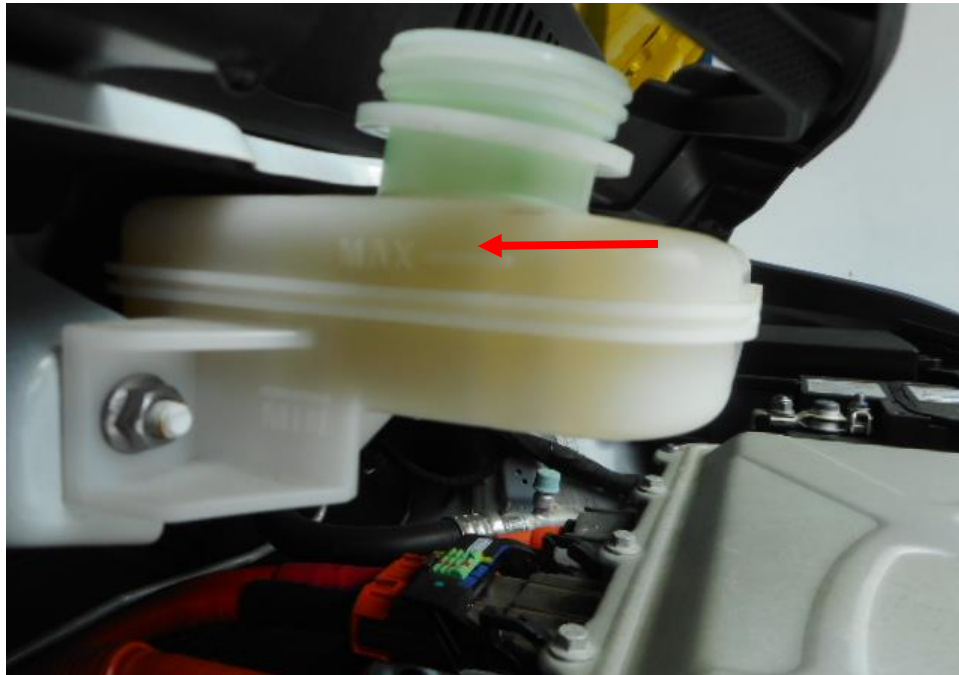
Photo 11 shows the brake fluid reservoir of the Electric Taxi at the time of my inspection. The brake fluid was observed to be of sufficient level (arrowed) and without any visible contamination.

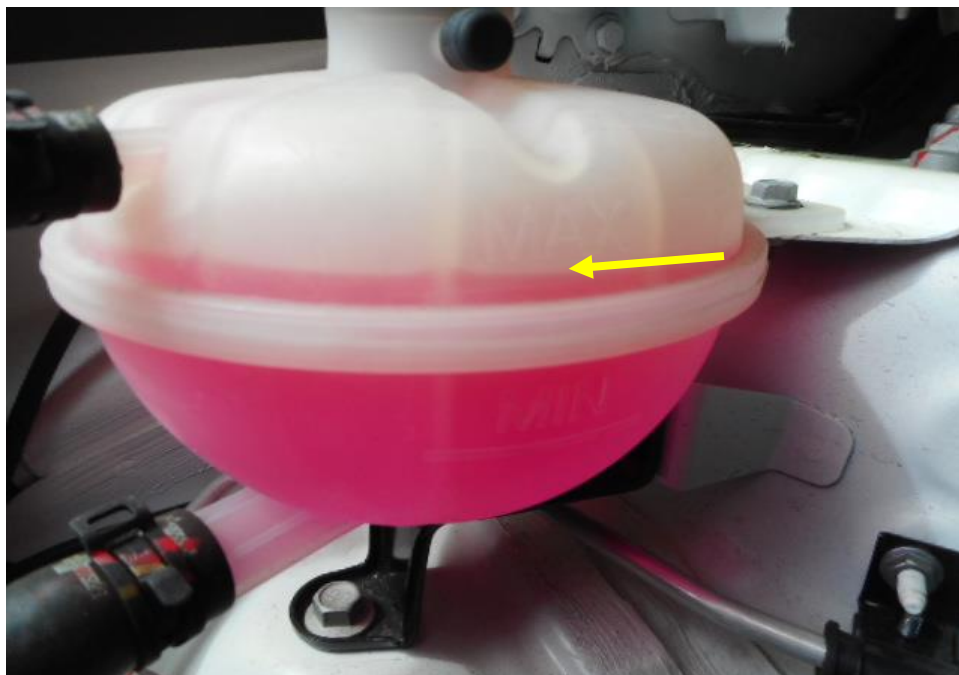
Photo 12 shows checks being carried out to the engine coolant of the Electric Taxi at the time of my inspection. The engine coolant was observed to be of sufficient level (arrowed) and without any visible contamination.

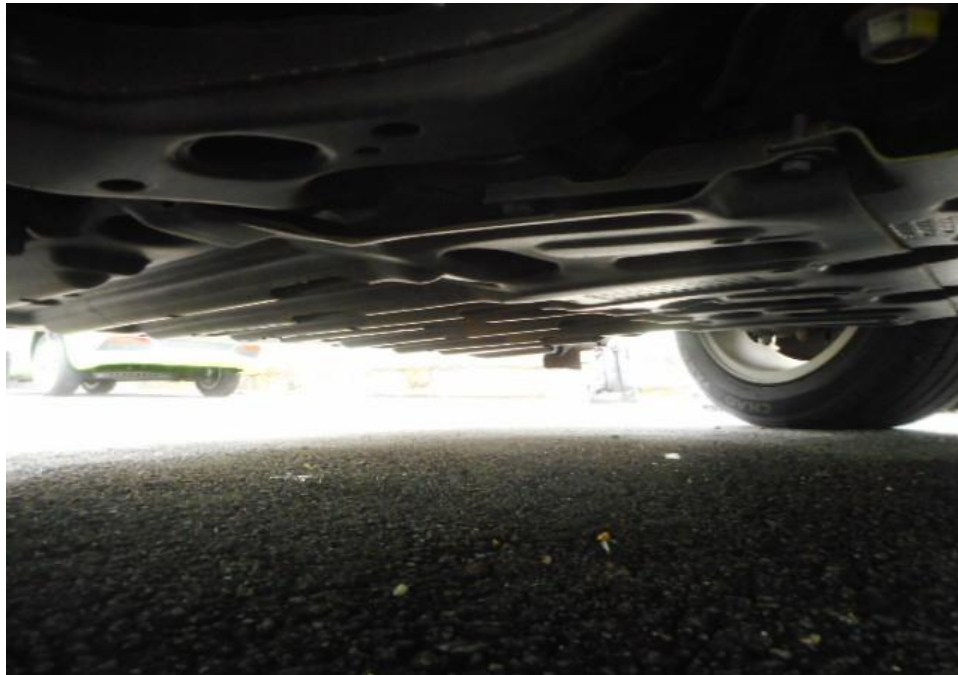
Photo 13 shows the undercarriage of the Electric Taxi, at the area where the electric motor housing are located. I did not find any sign(s) or indication(s) of fluid leak and/or fluid stain(s) on the underside of the Electric Taxi.

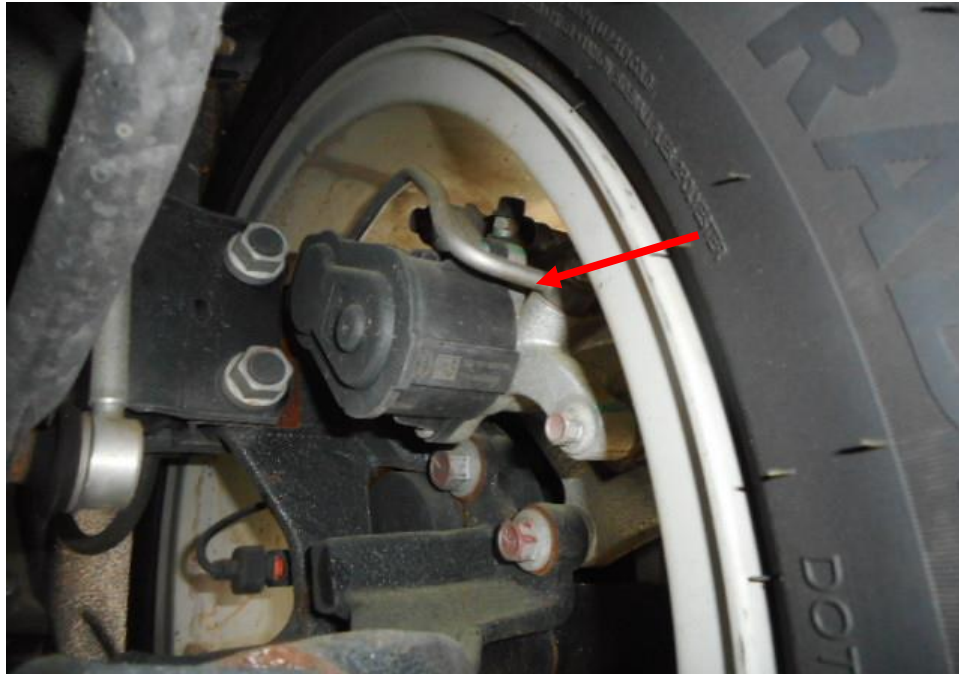
Photo 14 shows the brake hose/pipe (arrowed) at the rear right wheel of the Electric Taxi. No leakage of brake fluid was observed. Visual examination of the various components of the braking system like the drum brake, brake booster, brake pedal etc. had revealed all to be intact and without visible damage.

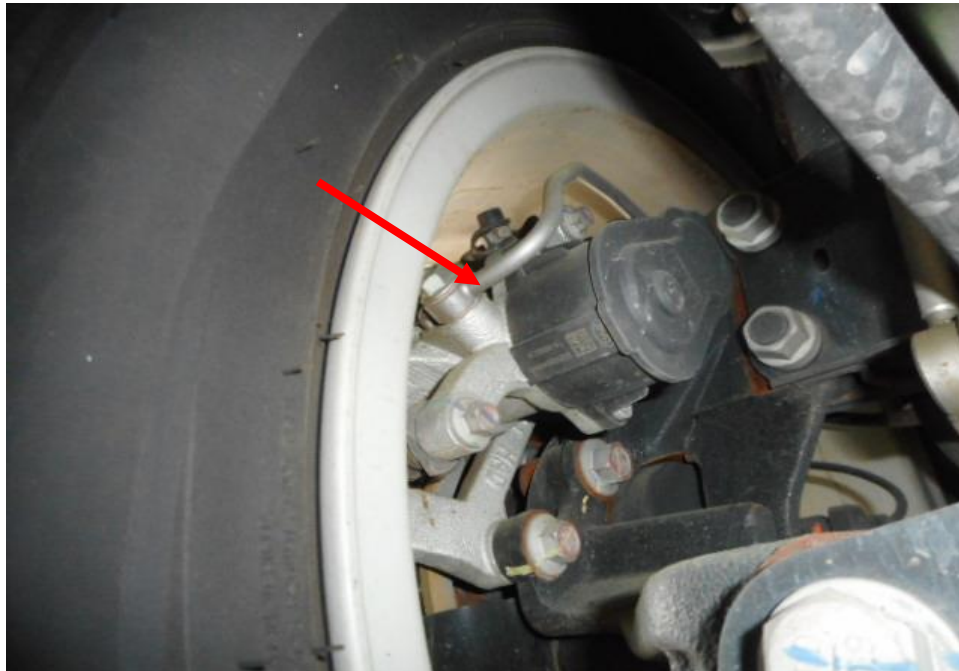
Photo 15 shows the brake hose/pipe (arrowed) at the rear left wheel of the Electric Taxi. I did not observe any leakage of brake fluid at the time of my inspection of the Electric Taxi. Static tests of the Electric Taxi's braking system had indicated that there was no internal leakage of pressure/vacuum. The undercarriage components of the Electric Taxi were also all found to be intact and without any visible damage.

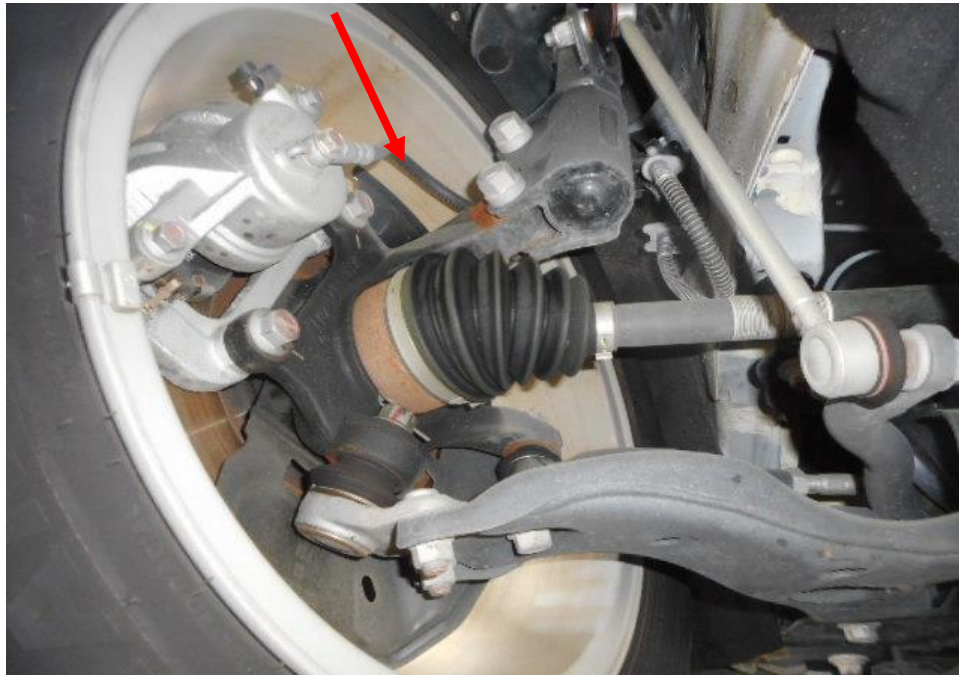
Photo 16 shows the brake hose/pipe (arrowed) at the front right wheel of the Electric Taxi. I did not observe any leakage of brake fluid at the time of my inspection of the Electric Taxi. Static tests of the Electric Taxi's braking system had indicated that there was no internal leakage of pressure/vacuum. The undercarriage components of the Electric Taxi were also all found to be intact and without any visible damage.

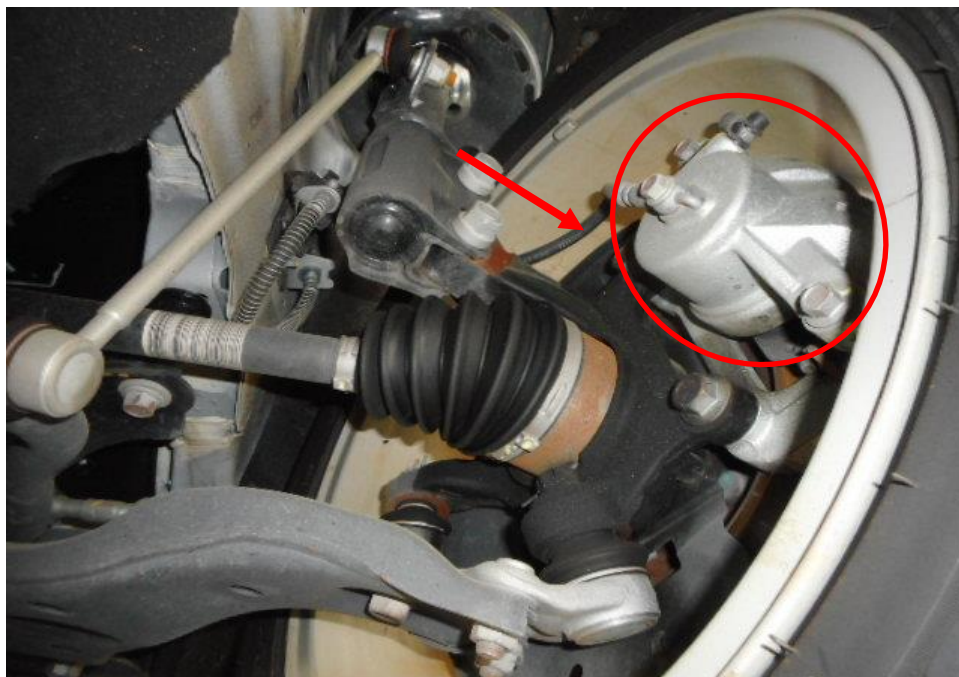
Photo 17 shows the brake hose/pipe (arrowed) at the front left wheel of the Electric Taxi. No leakage of brake fluid was observed. Visual examination of the various components of the braking system like the brake caliper (circled), brake booster, brake pedal etc had revealed all to be intact and without visible damage.

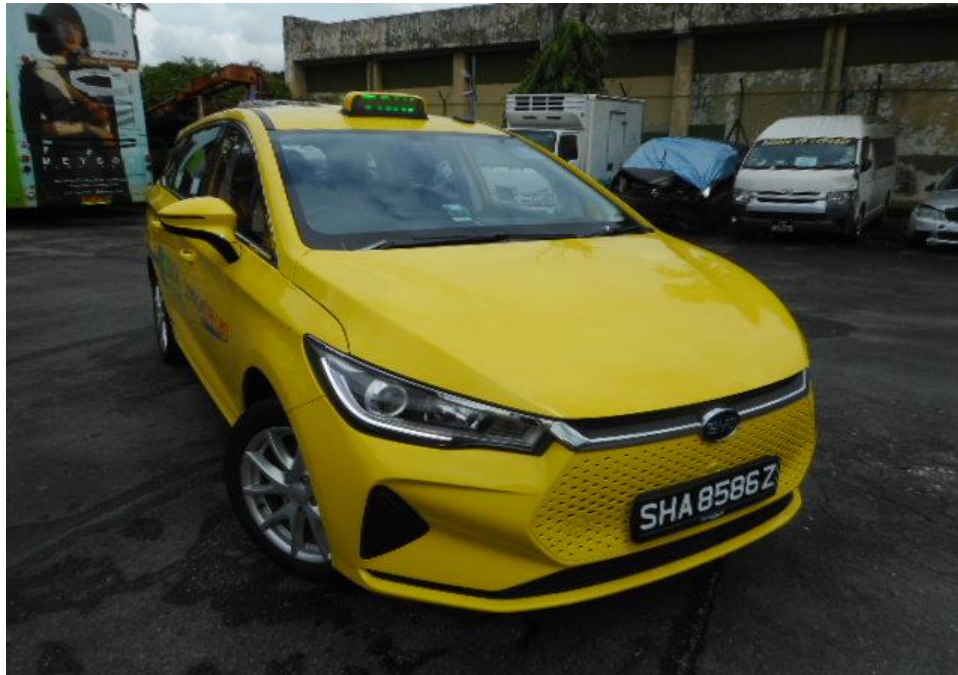
Photo 18 shows the front right wheel of the Electric Taxi turned to its full left. During my steering system test, I did not experience any abnormal free play and/or resistance when I had turned the steering wheel towards the left and right. This would suggest that the steering system of the Electric Taxi was likely to be in serviceable condition at the material time of accident.

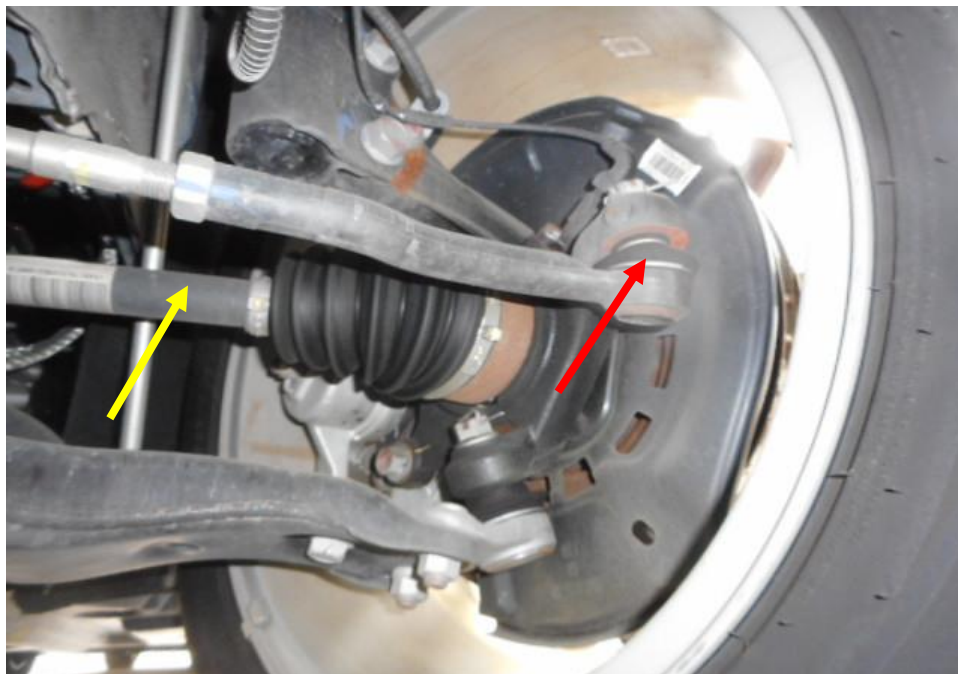
Photo 19 shows the various undercarriage components at the front right wheel of the Electric Taxi, in particular the steering tie rod (red arrow) and drive shaft (yellow arrow). The various steering components were all found to be intact, suggesting that the steering system of the Electric Taxi was likely to be in serviceable condition at the material time of accident. There was also no sign of fluid stain observed on the various undercarriage components at the front right wheel of the Electric Taxi.

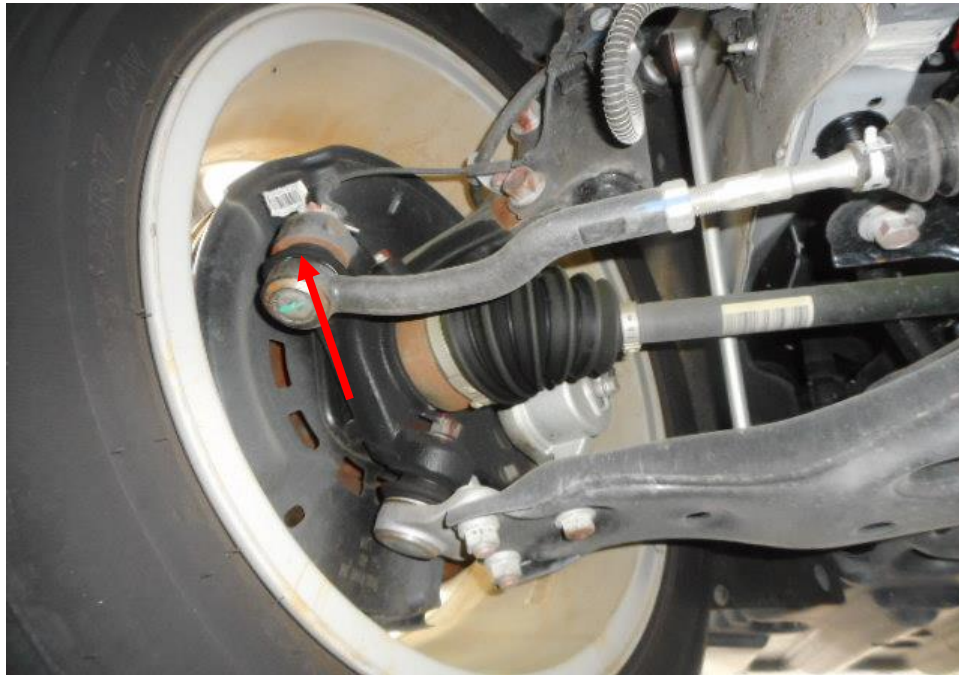
Photo 20 shows the various undercarriage components at the front left wheel of the Electric Taxi, which had included the steering tie rod (arrowed). The various undercarriage components of the Electric Taxi were all found to be intact without any visible damage.

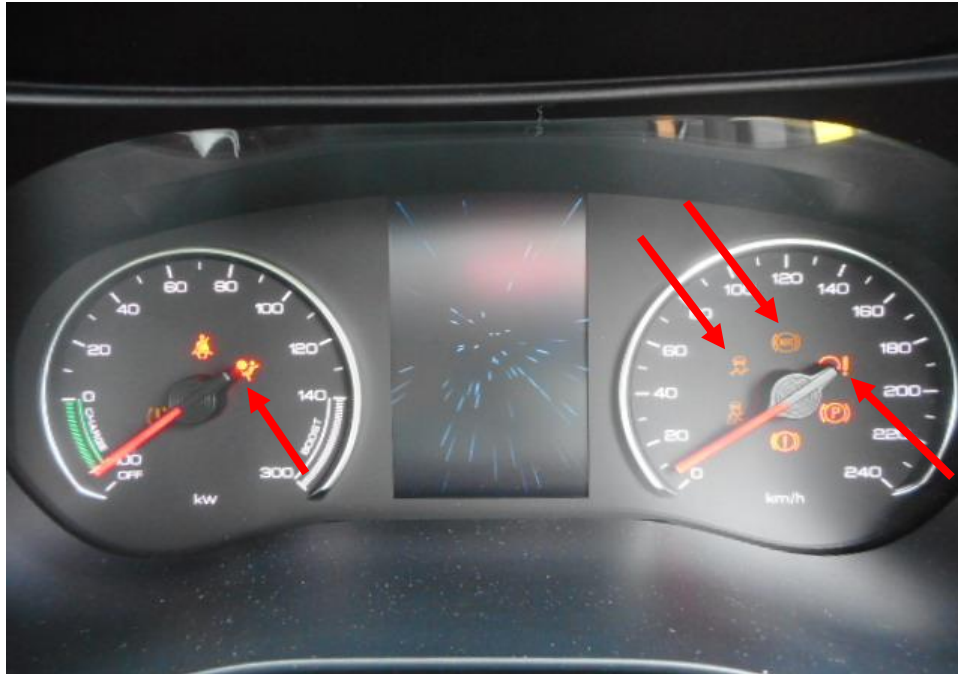
Photo 21 shows the warning light for Anti-Lock Brake System (ABS) and Power Steering System (EPS), Supplemental Restraint System (SRS) and Traction Control (TC) (arrowed) appearing on the instrument panel of the Electric Taxi during the self-test of its various electronic operating systems when its engine was cranked.

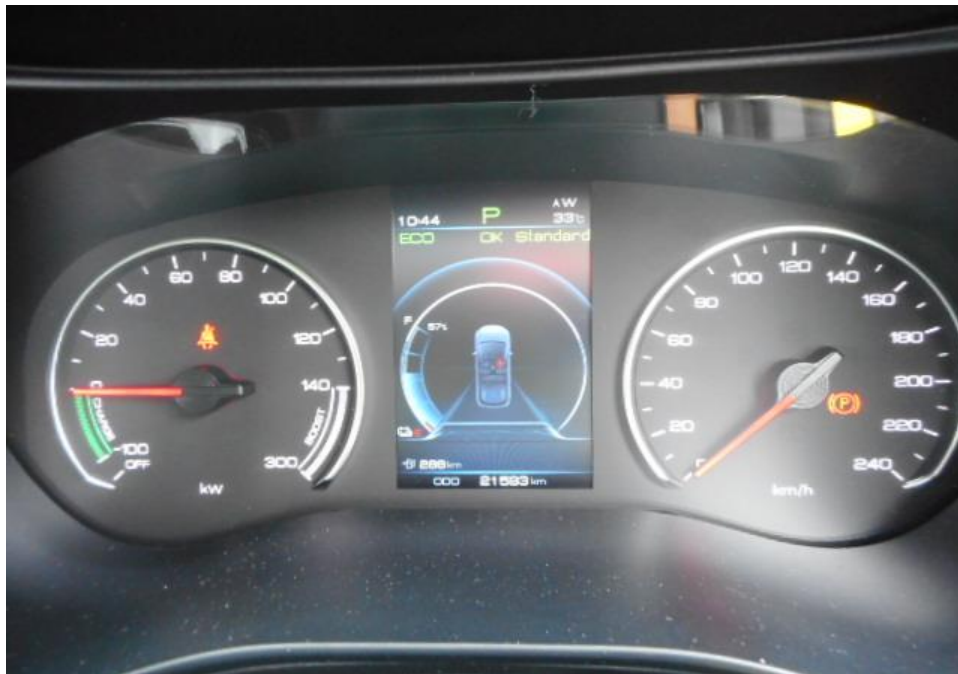
Photo 22 shows no warning lights illuminated on the instrument panel of the Electric Taxi after the engine was cranked. This would suggest that there was no abnormality to the electronic operating system of the Electric Taxi, like the ABS, EPS, SRS, and TC etc.
