Your Ref: TP/IP/20597/2022
Our Ref : CI/TPD22010889/P

13th February 2023

MECHANICAL INSPECTION REPORT OF MOTOR TAXI SHA 3398H

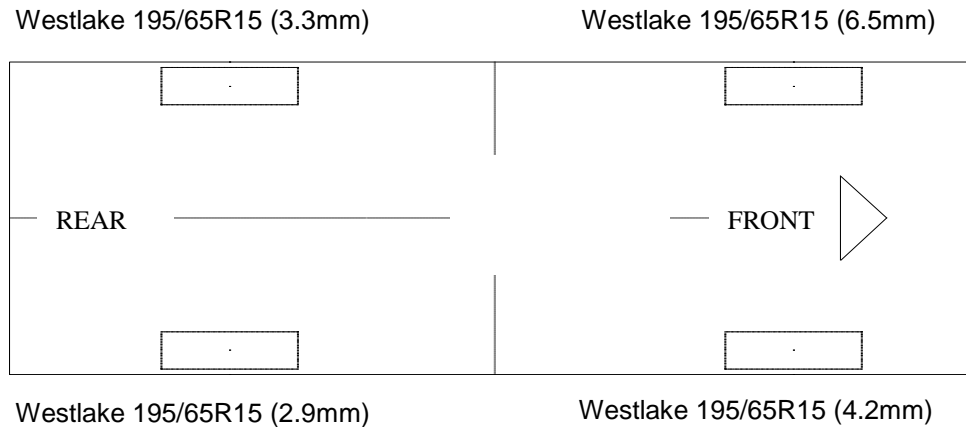
6. The condition of the Motor Taxi's 4 tyres was observed to be in serviceable condition. I did not find any tear, cut or burst mark(s) on the outer and the inner sidewalls as well as across the tread of the 4 tyres. The 4 tyres were also observed to be sufficiently inflated for vehicular operation. The tyre brand, tyre size and remaining tread depth of the 4 tyres were recorded as follows:-

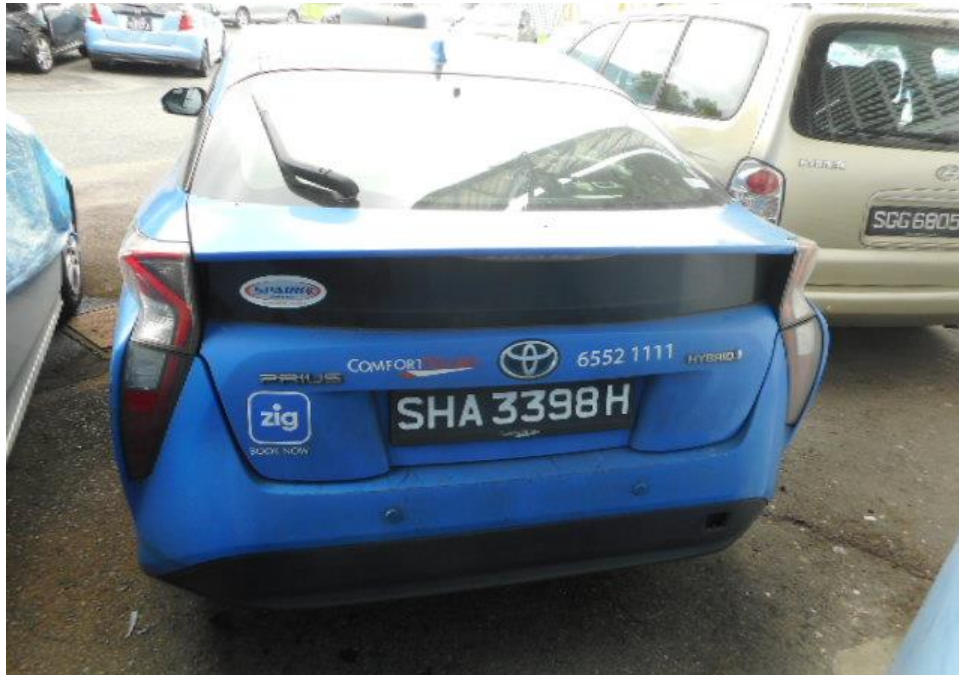
Photo 1 shows a general view of the Motor Taxi's rear body at the time of my inspection. The rear portion of the Motor Taxi was observed to have been undamaged by the accident.

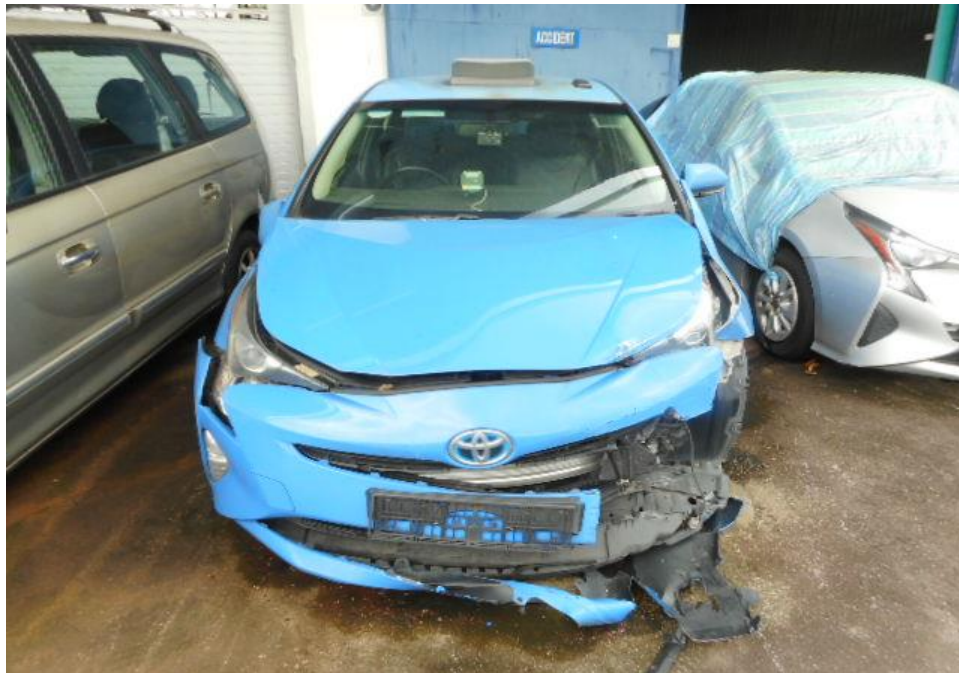
Photo 2 shows a general view of the Motor Taxi's front body at the time of my inspection. The Motor Taxi was observed to have sustained damage at its front and right portion. Its front bonnet, front bumper, front grille, front left fender and front left headlamp also its right door panel and right rear view mirror was amongst the body parts and various ignition system components were also damaged as a result of the accident.

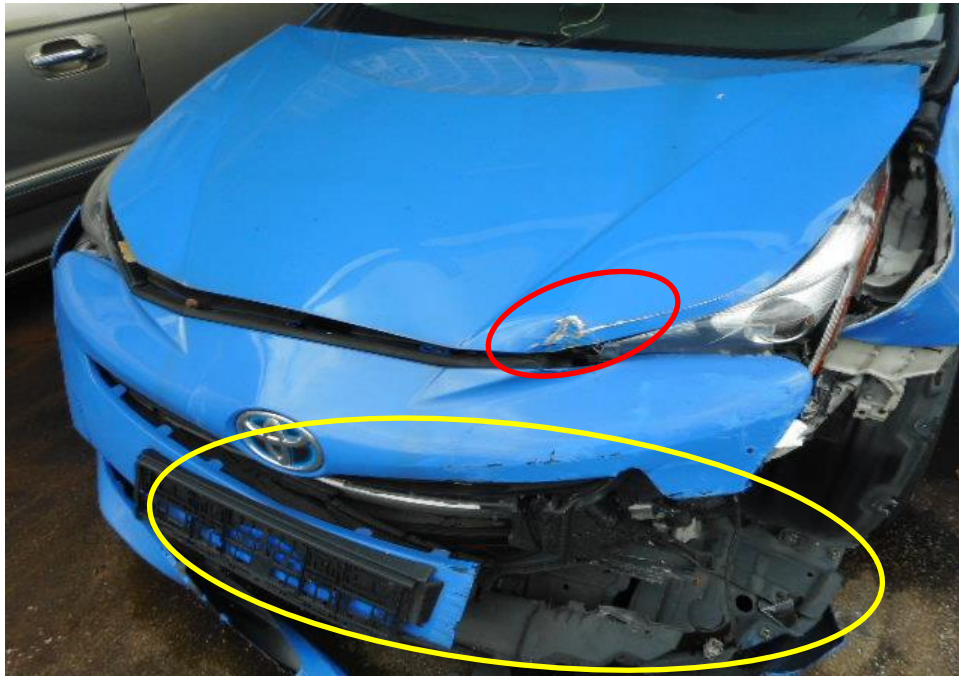
Photo 3 shows the close up view of the Motor Taxi's front body at the time of my inspection. The Motor Taxi was observed to have sustained damage at its front portion. Its front bonnet (red circle) and front bumper (yellow circle) was damaged as a result of the accident.

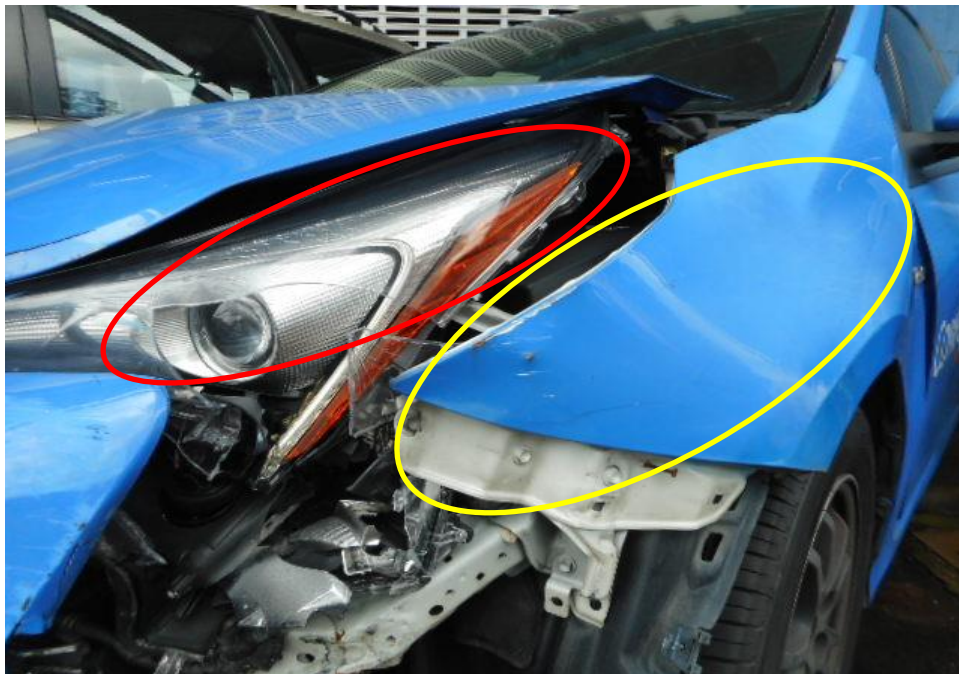
Photo 4 shows the close up view of the Motor Taxi's front body at the time of my inspection. The Motor Taxi was observed to have sustained damage at its front portion. Its front left headlamp (red circle) and front left fender (yellow circle) was damaged as a result of the accident.

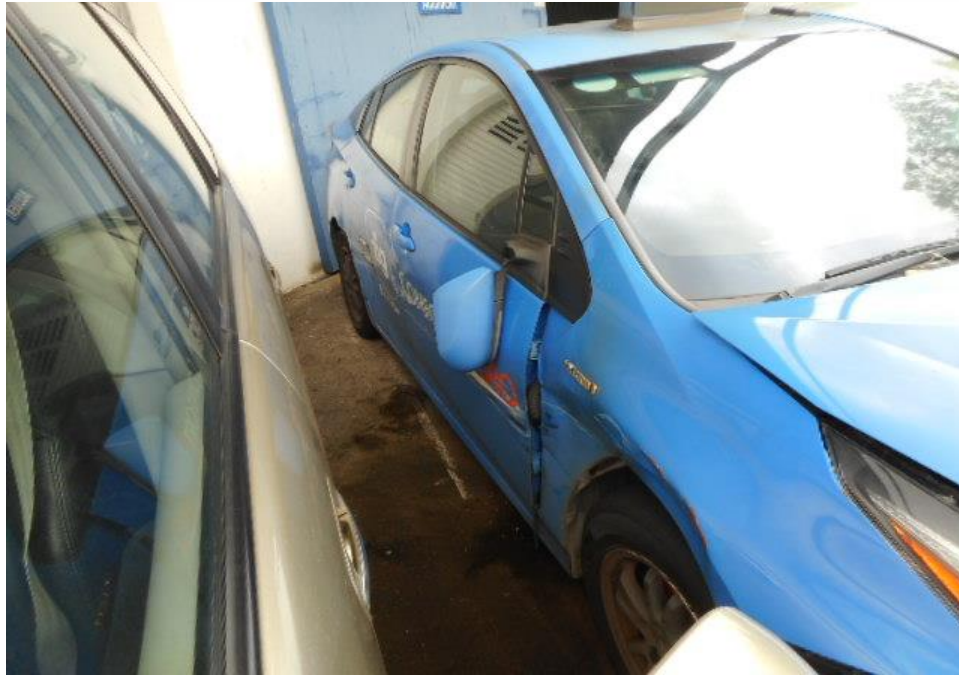
Photo 5 shows a general view of the Motor Taxi's right body at the time of my inspection. The right portion of the Motor Taxi was observed to have sustained damages as a result of the accident. Its right door panel and its right rear view mirror was damaged as a result of the accident.

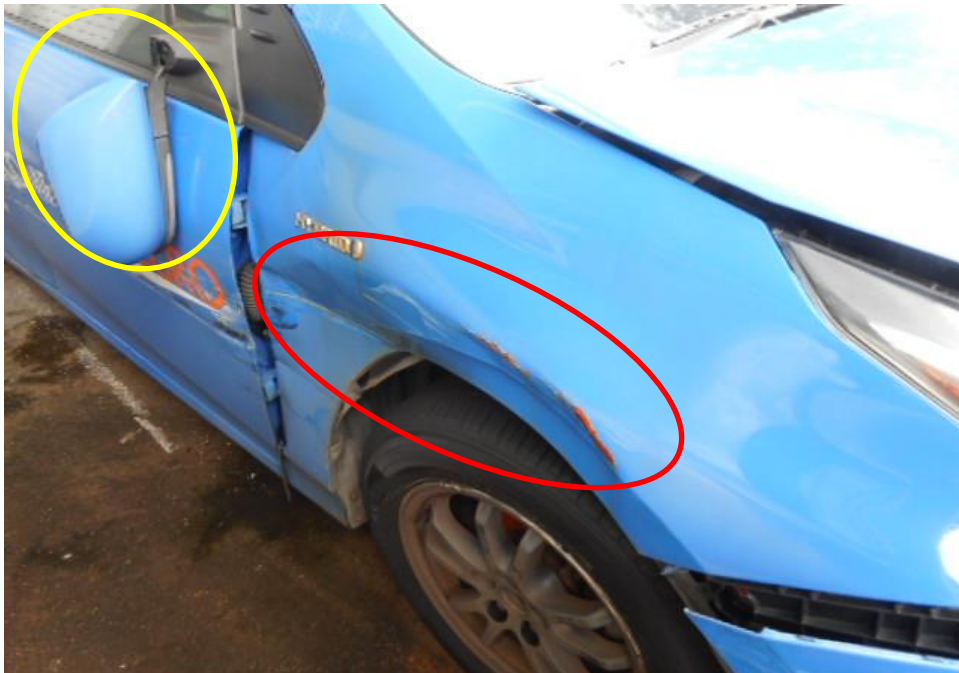
Photo 6 shows the close up view of the Motor Taxi's right body at the time of my inspection. The Motor Taxi was observed to have sustained damage at its right portion. Its right fender (red circle) and its right rear view mirror (yellow circle) was damaged as a result of the accident.

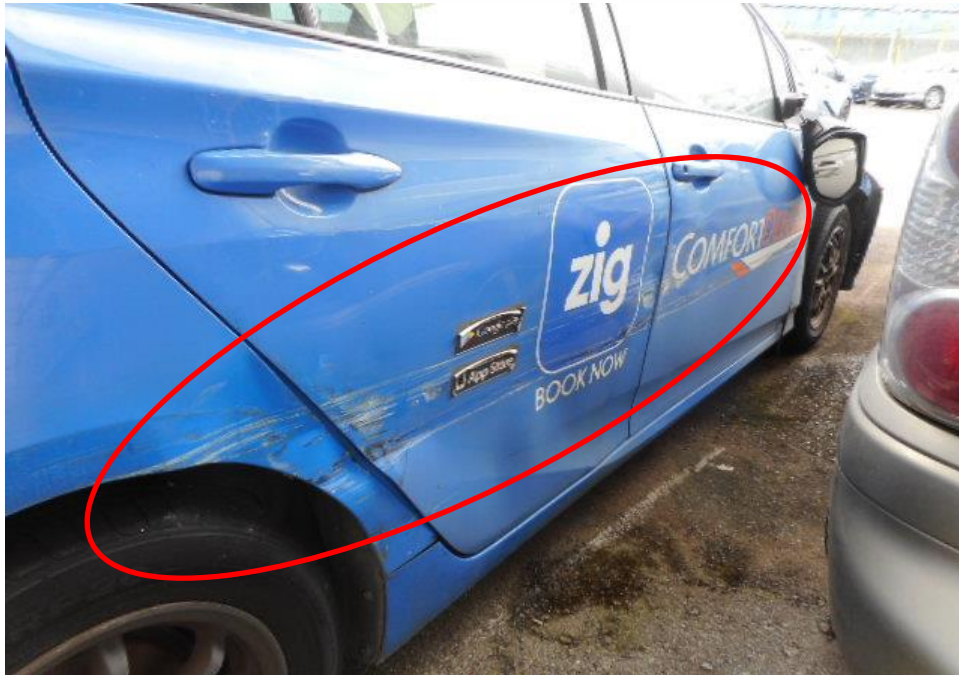
Photo 7 shows the close up view of the Motor Taxi's right body at the time of my inspection. The Motor Taxi was observed to have sustained damage at its right portion. Its right body panel (circled) was damaged as a result of the accident.

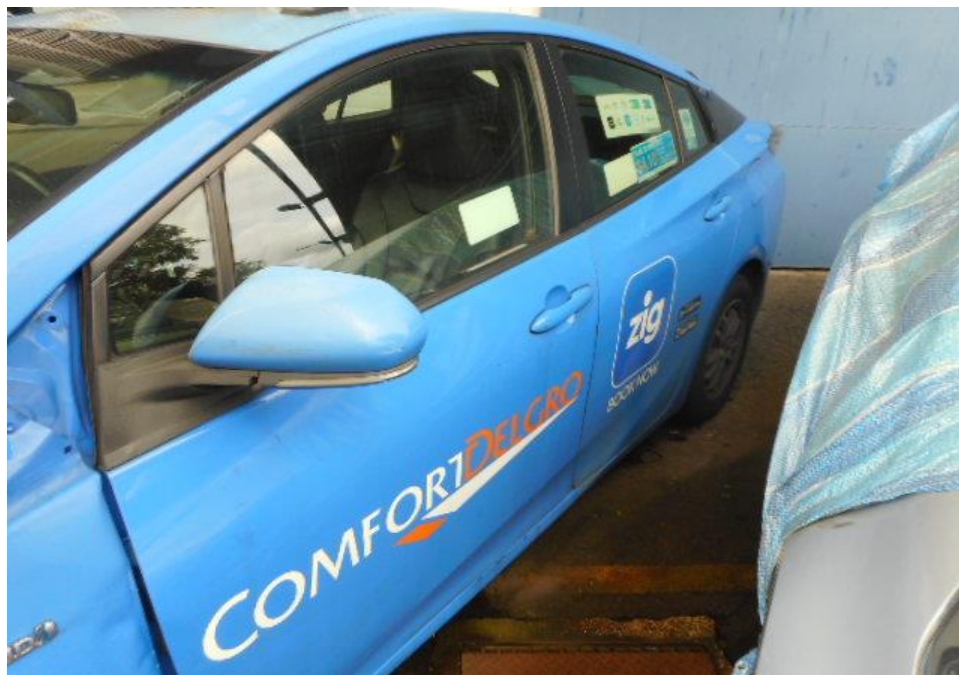
Photo 8 shows a general view of the Motor Taxi's left body at the time of my inspection. The left portion of the Motor Taxi was observed to have been undamaged by the accident.

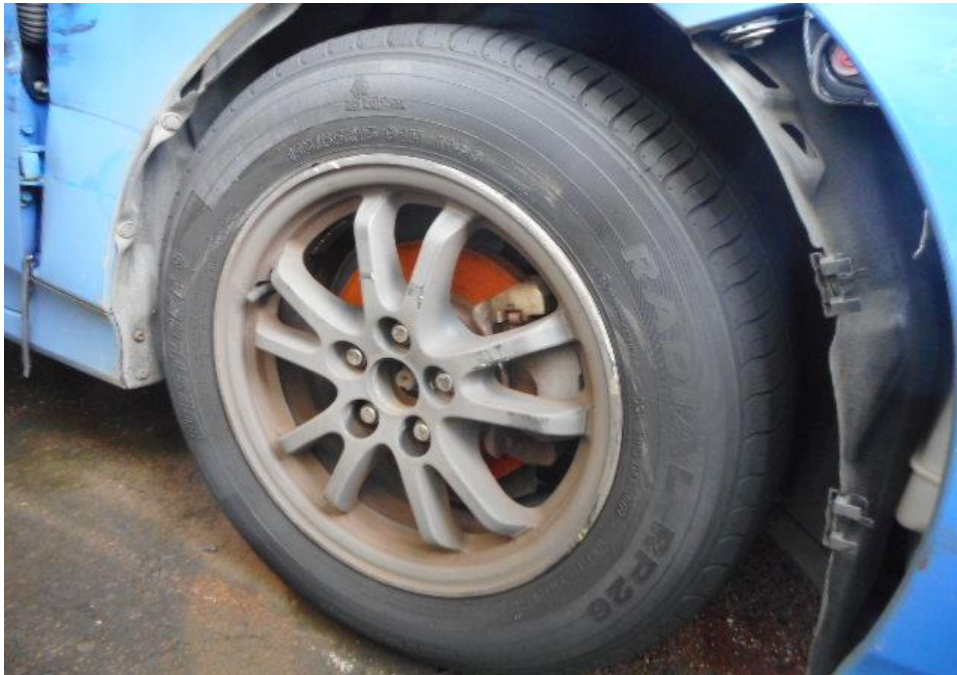
7. The front right rim was observed to sustained damages as a result of the accident. However, the 4 tyres were observed to be wrapped around alloy wheel rims that were found to be without any damage. See photo 1 – 14 below.

Photo 9 shows the condition of the front right tyre of the Motor Taxi, which was observed to be in serviceable condition with remaining tread depth of approximately 4.2mm. The tyre, which was wrapped around alloy wheel rim, was also observed to be sufficiently inflated for vehicular operation. The right wheel rim was observed to sustained minor damages as a result of the accident.

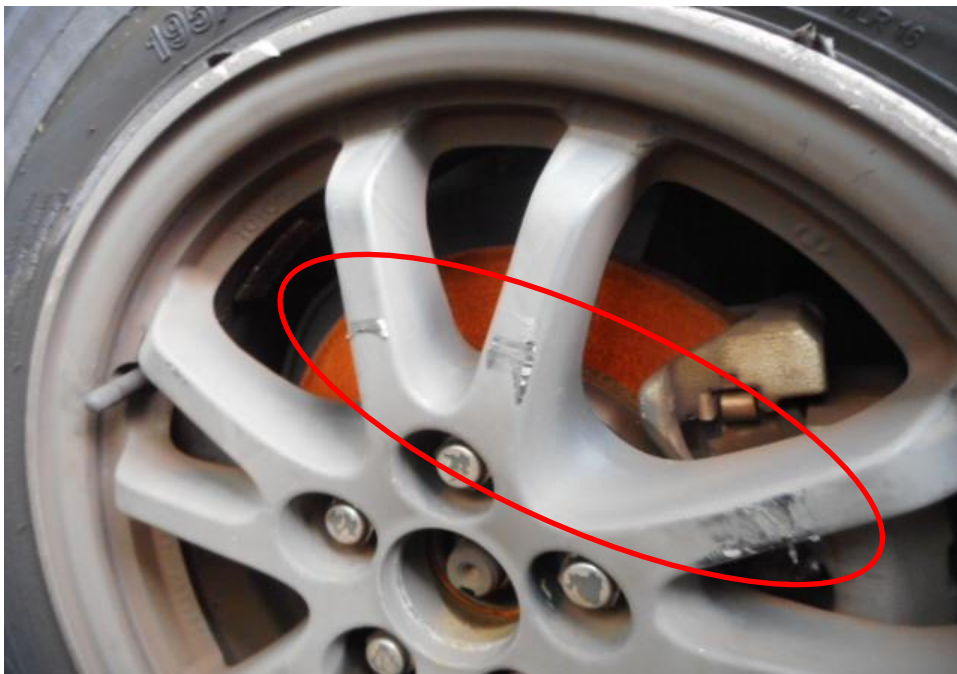
Photo 10 shows the close up condition of the front wheel rim of the Motor Taxi. The wheel rim (circled) was observed to sustained minor damages as a result of the accident.

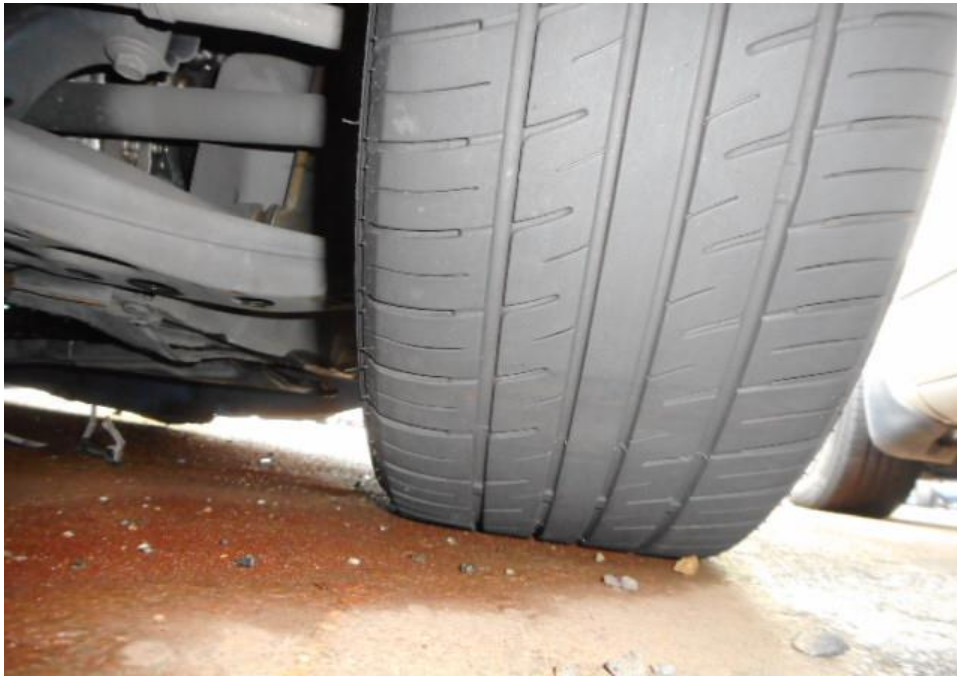
Photo 11 shows the condition of the front right tyre of the Motor Taxi, which was observed to be in serviceable condition with remaining tread depth of approximately 4.2mm. The tyre, which was wrapped around alloy wheel rim, was also observed to be sufficiently inflated for vehicular operation.

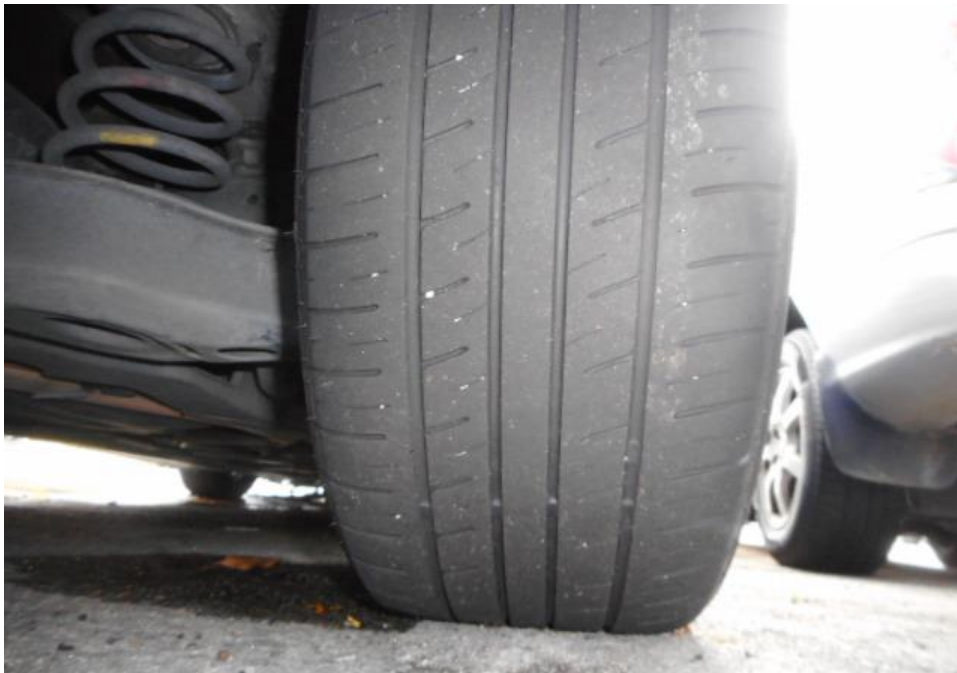
Photo 12 shows the condition of the rear right tyre of the Motor Taxi, which was observed to be in serviceable condition with remaining tread depth of approximately 2.9mm. The tyre was also observed to be sufficiently inflated for vehicular operation with no tear, cut or burst mark(s).

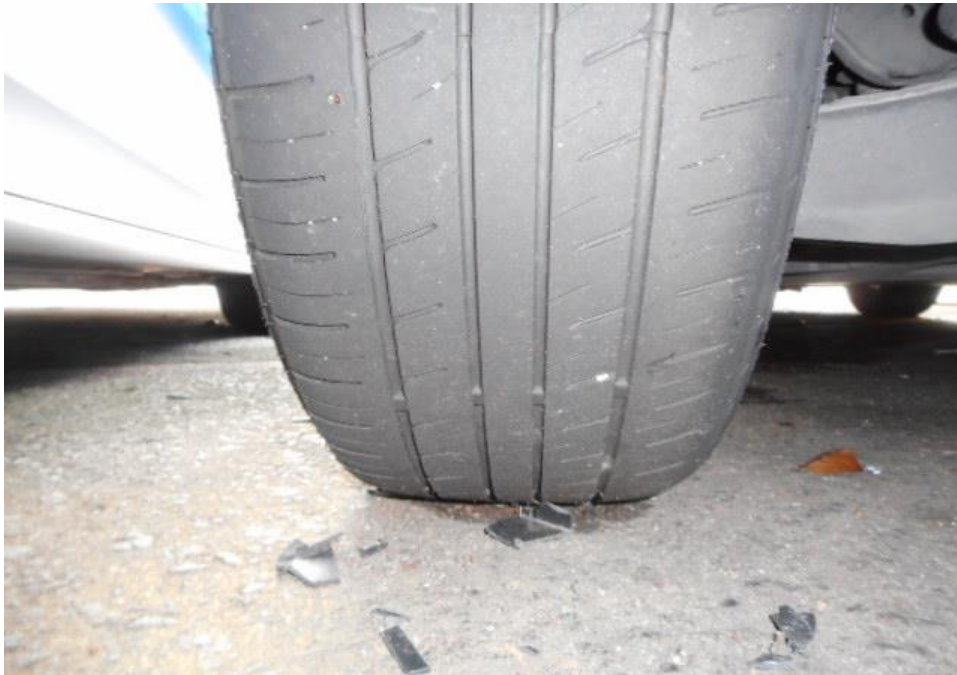
Photo 13 shows the condition of the rear left tyre of the Motor Taxi, which was observed to be in serviceable condition with remaining tread depth of approximately 3.3mm. The tyre was also observed to be sufficiently inflated for vehicular operation with no tear, cut or burst mark(s).

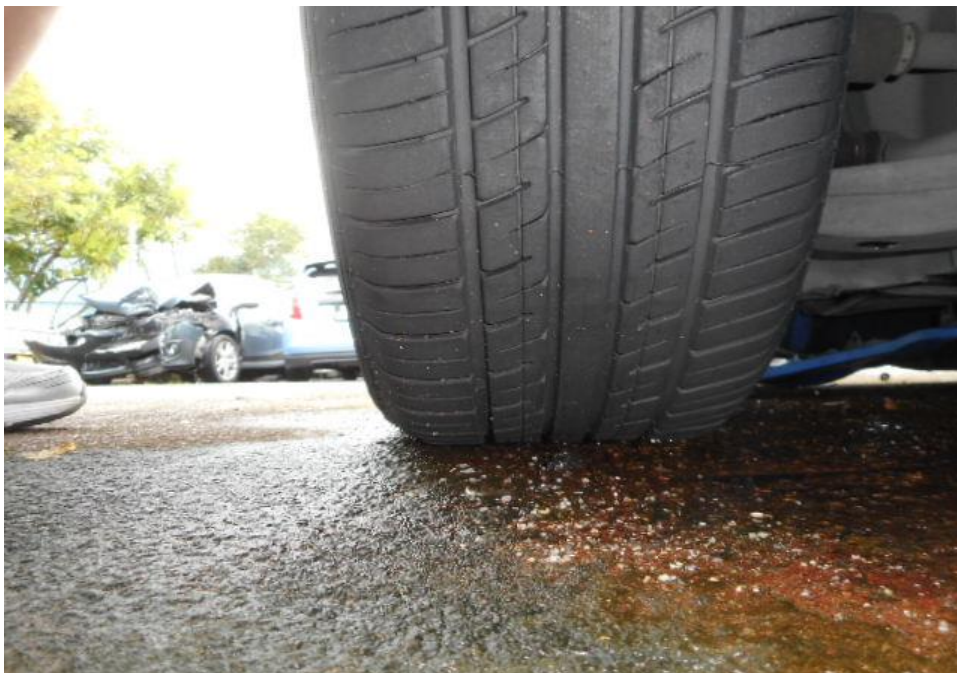
Photo 14 shows the condition of the front left tyre of the Motor Taxi, which was observed to be in serviceable condition with remaining tread depth of approximately 6.5mm. The tyre was also observed to be sufficiently inflated for vehicular operation with no tear, cut or burst mark(s).

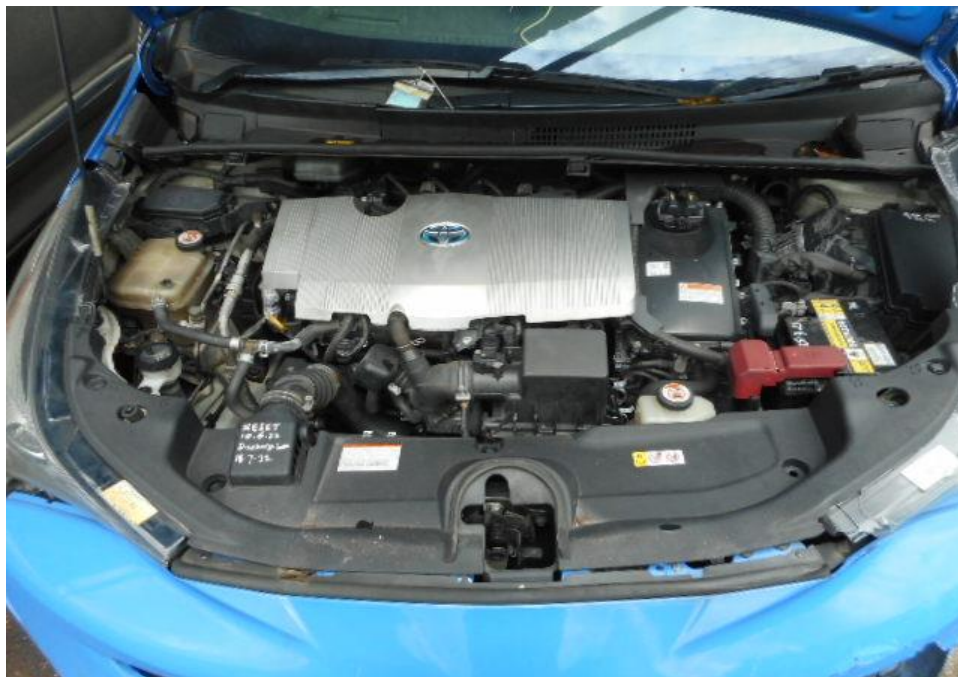
Photo 15 shows a general view of the Motor Taxi's engine compartment. The various parts and components inside the engine compartment were unaffected by the accident. There was also no sign(s) or indication(s) of fluid leakage and/or fluid stain within the engine compartment.

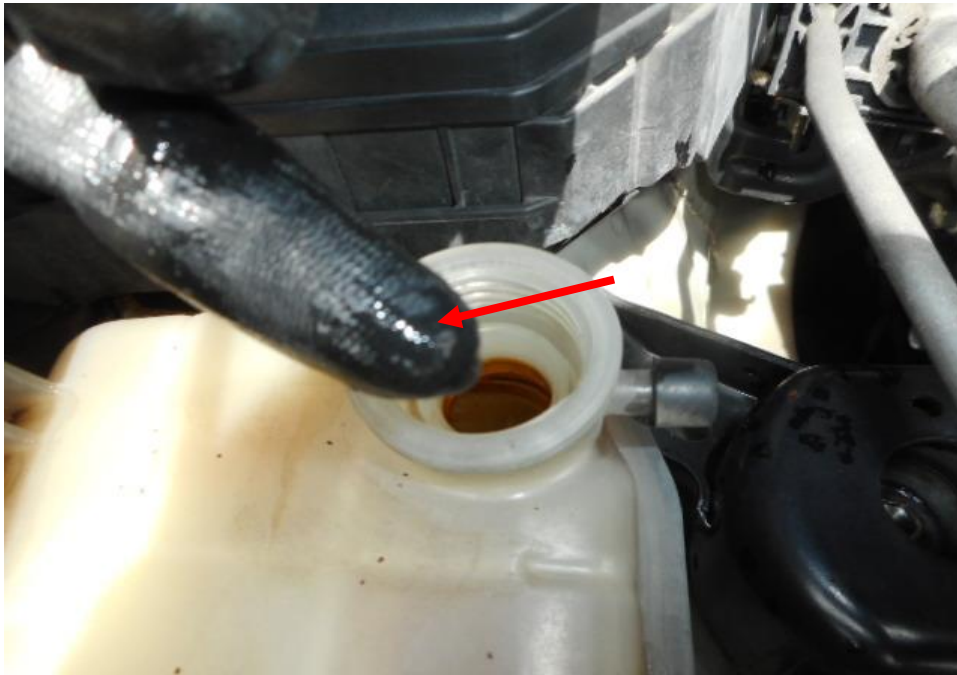
Photo 16 shows the coolant reservoir of the Motor Taxi at the time of my inspection. The coolant fluid was observed to be of sufficient level (arrowed) and without any visible contamination.

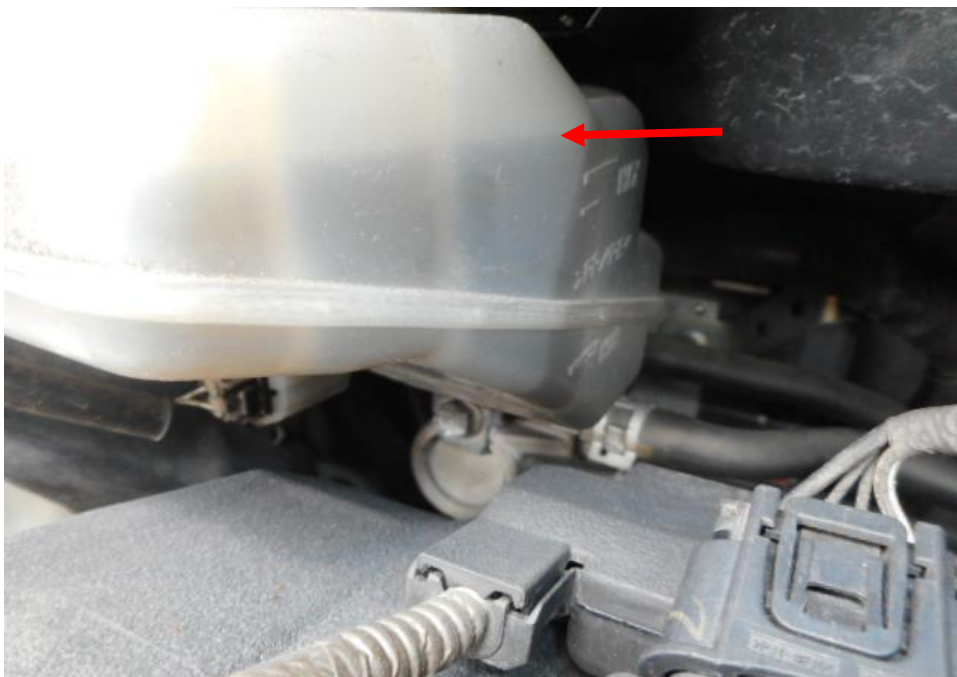
Photo 17 shows the brake fluid reservoir of the Motor Taxi at the time of my inspection. The brake fluid was observed to be of sufficient level (arrowed) and without any visible contamination.

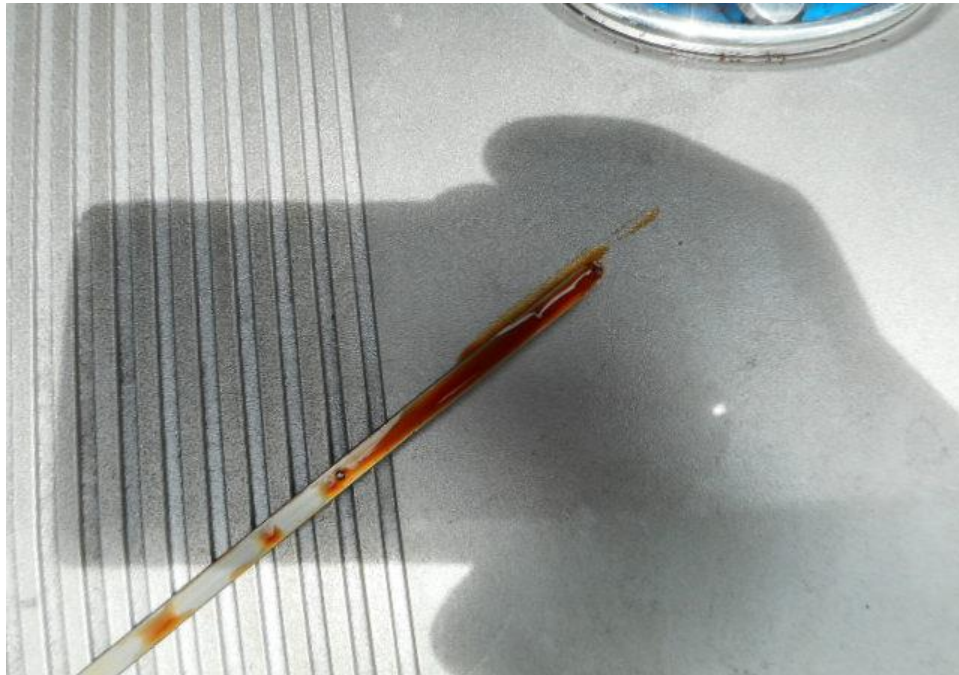
Photo 18 shows the engine oil dip stick of the Motor Taxi at the time of my inspection. The engine oil was observed to be of sufficient level and without any visible contamination.

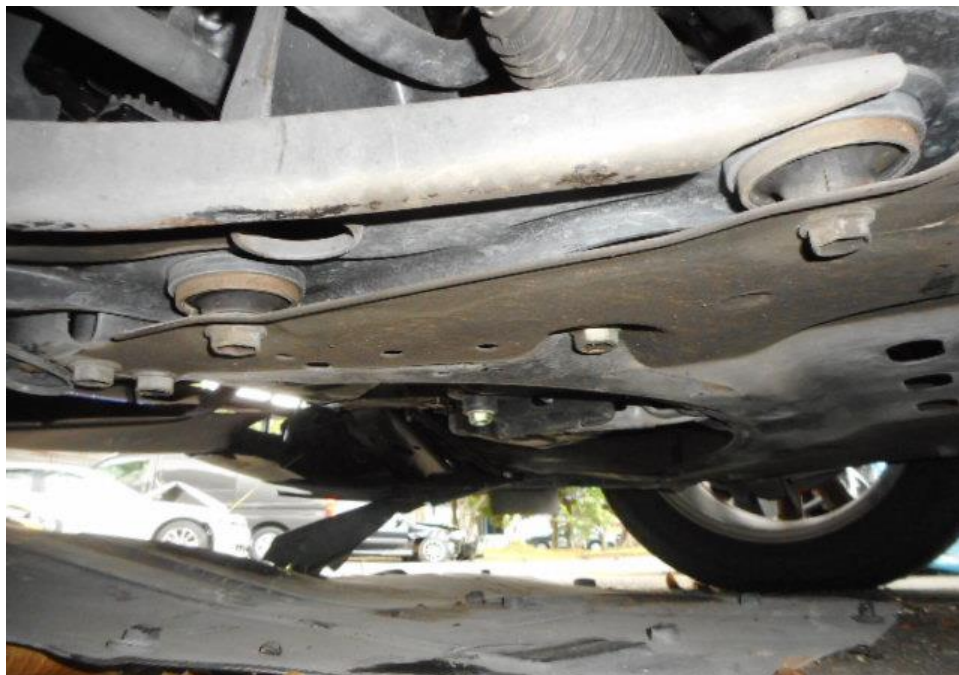
Photo 19 shows the undercarriage of the Motor Taxi, at the area where the engine housing and transmission housing are located. I did not find any sign(s) or indication(s) of fluid leak and/or fluid stain(s) on the underside of the Motor Taxi.

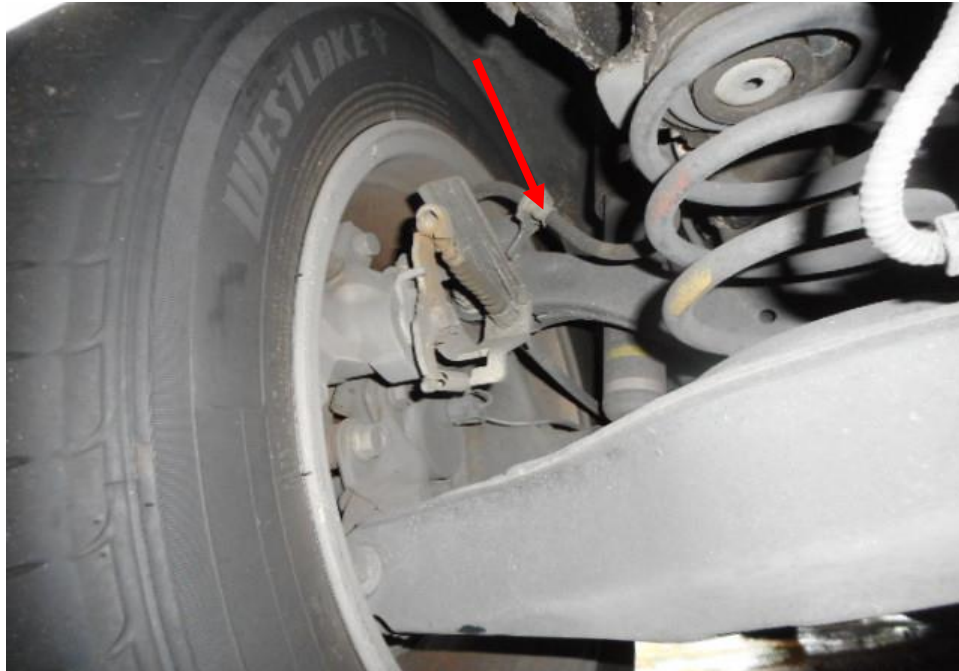
Photo 20 shows the brake hose/pipe (arrowed) at the rear left wheel of the Motor Taxi. No leakage of brake fluid was observed. Visual examination of the various components of the braking system like the drum brake, brake booster, brake pedal etc. had revealed all to be intact and without visible damage.

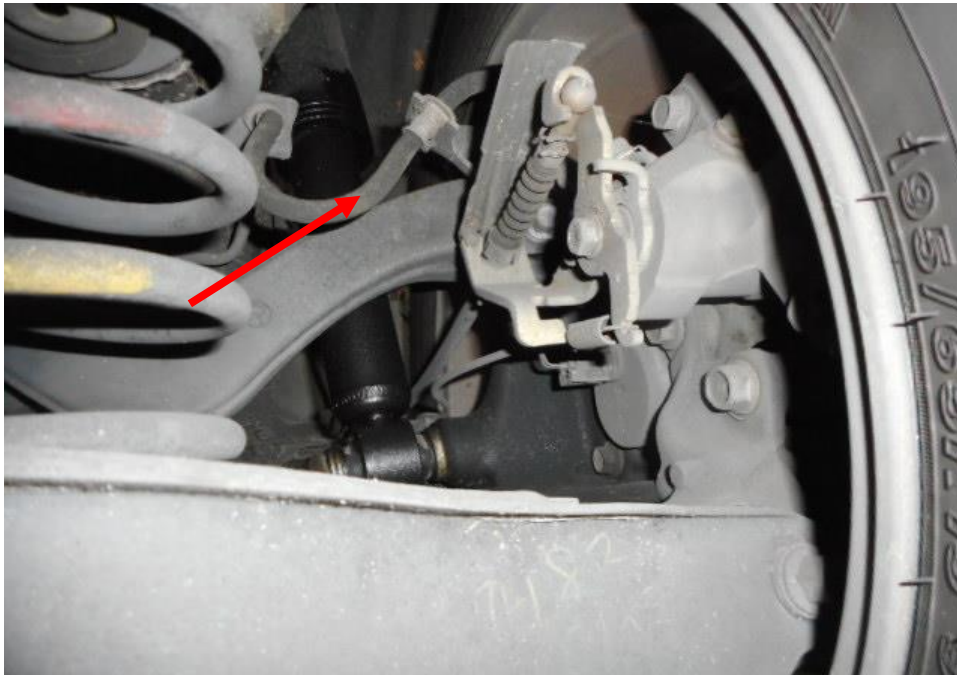
Photo 21 shows the brake hose/pipe (arrowed) at the rear right wheel of the Motor Taxi. No leakage of brake fluid was observed. Visual examination of the various components of the braking system like the drum brake, brake booster, brake pedal etc. had revealed all to be intact and without visible damage.

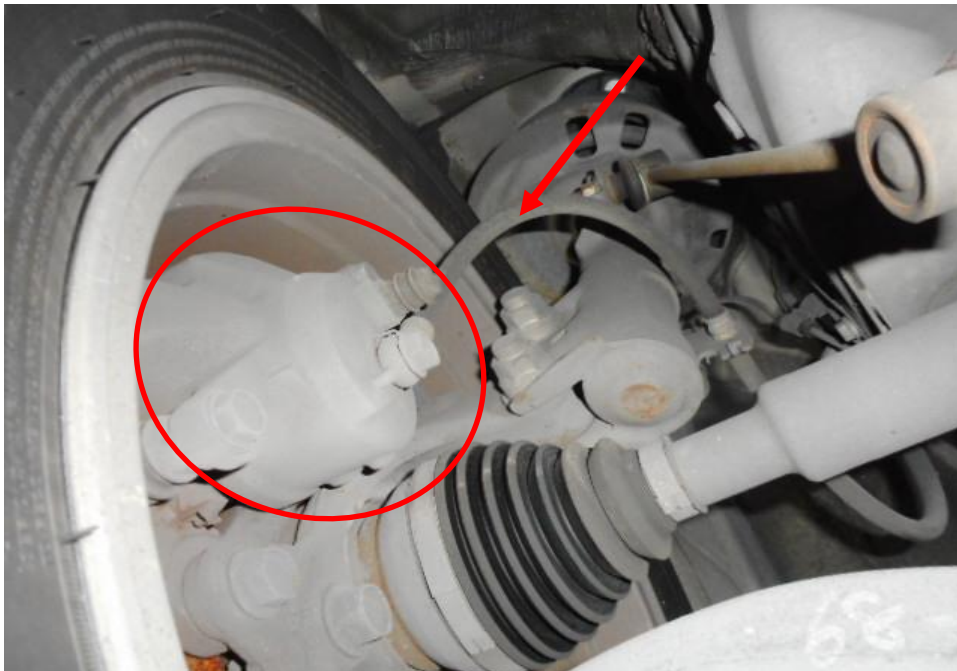
Photo 22 shows the brake hose/pipe (arrowed) at the front right wheel of the Motor Taxi. I did not observe any leakage of brake fluid at the time of my inspection of the Motor Taxi. Static tests of the Motor Taxi's braking system had indicated that there was no internal leakage of pressure/vacuum.

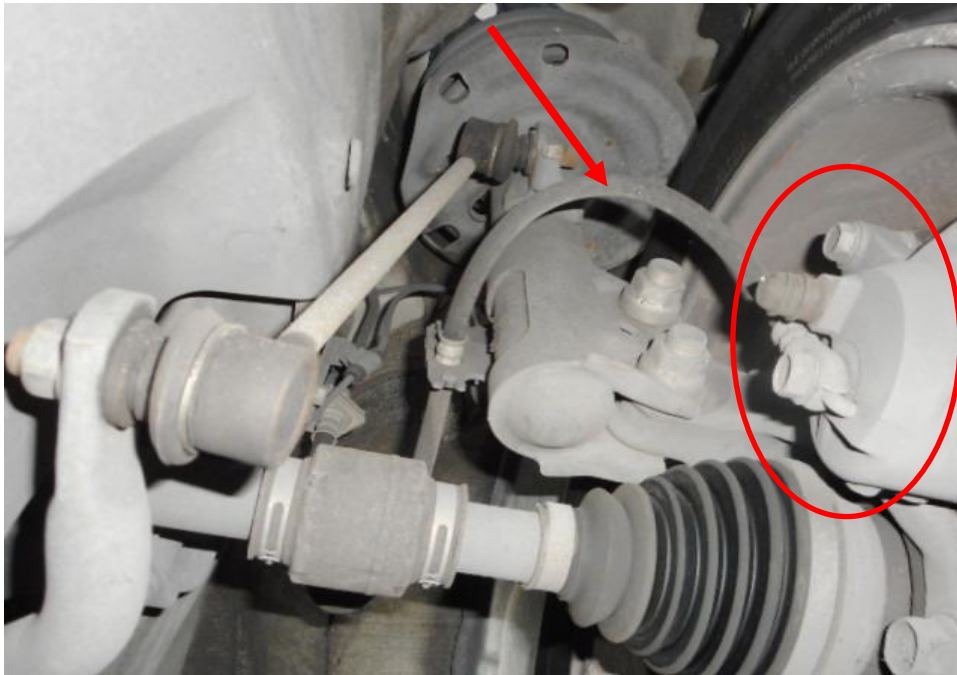
Photo 23 shows the brake hose/pipe (arrowed) at the front left wheel of the Motor Taxi. No leakage of brake fluid was observed. Visual examination of the various components of the braking system like the brake caliper (circled), brake booster, brake pedal etc had revealed all to be intact and without visible damage.

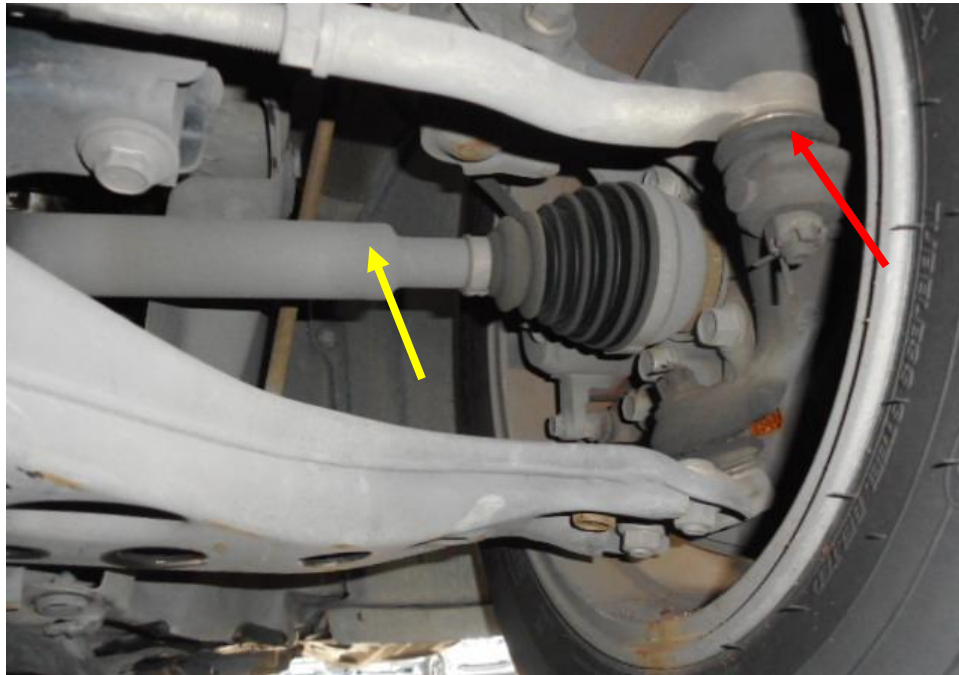
Photo 25 shows the various undercarriage components at the front right wheel of the Motor Taxi, in particular the steering tie rod (red arrow) and the driveshaft (yellow arrow). The various steering components were all found to be intact, suggesting that the steering system of the Motor Taxi was likely to be in serviceable condition at the material time of accident. There was also no sign of fluid stain observed on the various undercarriage components at the front right wheel of the Motor Taxi.

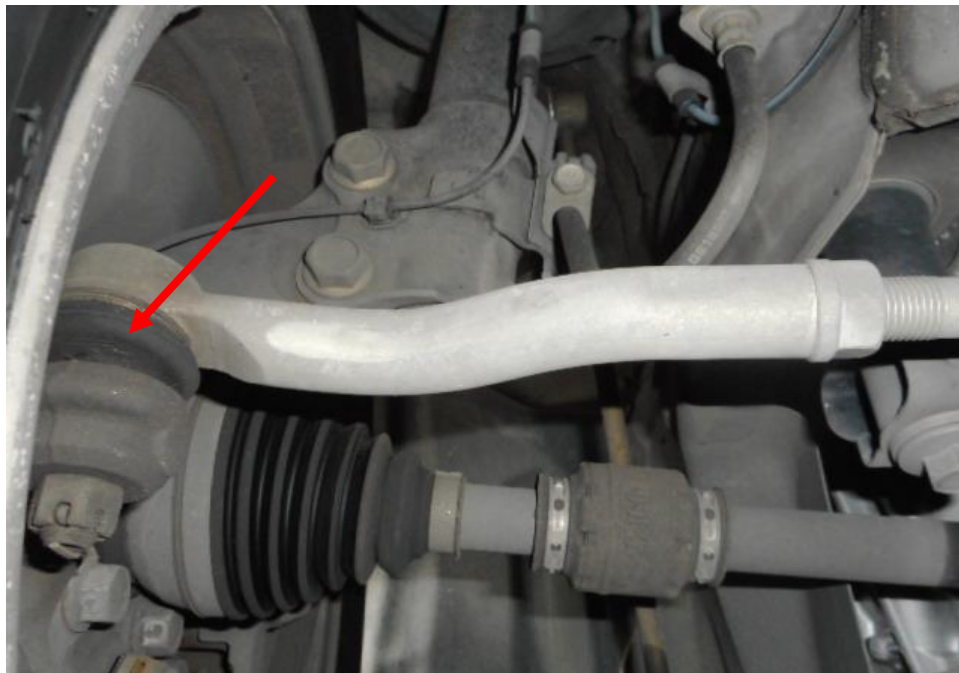
Photo 26 shows the various undercarriage components at the front left wheel of the Motor Taxi, in particular the steering tie rod end (arrowed). The various undercarriage components of the Motor Taxi were all found to be intact without any visible damage. There was also no sign of fluid stain(s) observed on the various undercarriage components.

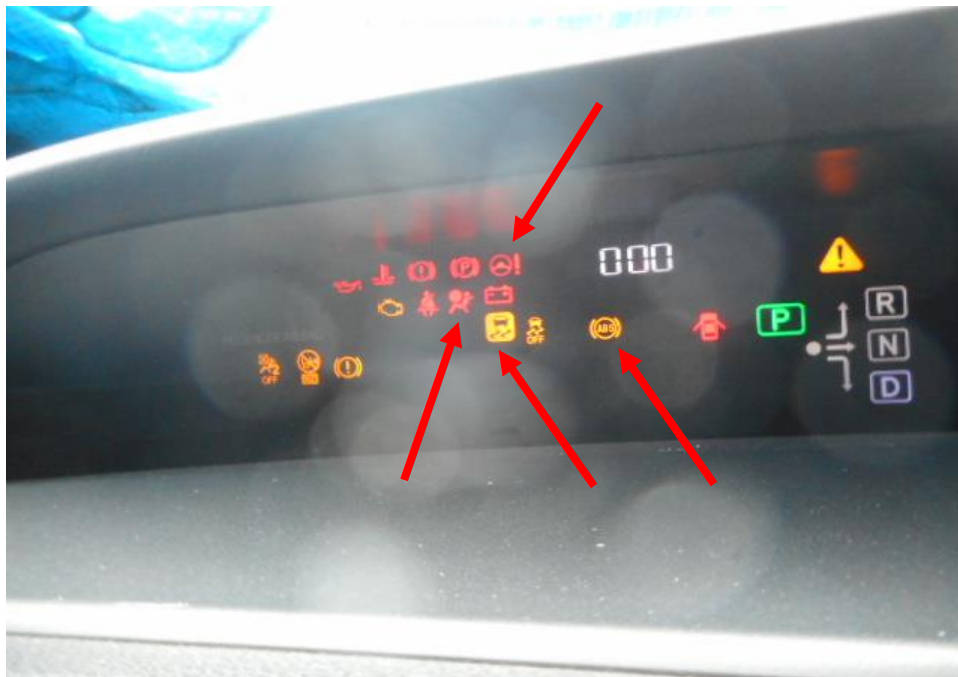
Photo 27 shows the warning light for Anti-Lock Brake System (ABS), Electric Power Steering System (EPS), Traction Control System (TCS) and Supplemental Restraint System (SRS) (arrowed) appearing on the instrument panel of the Motor Taxi during the self-test of its various electronic operating systems when its engine was cranked.

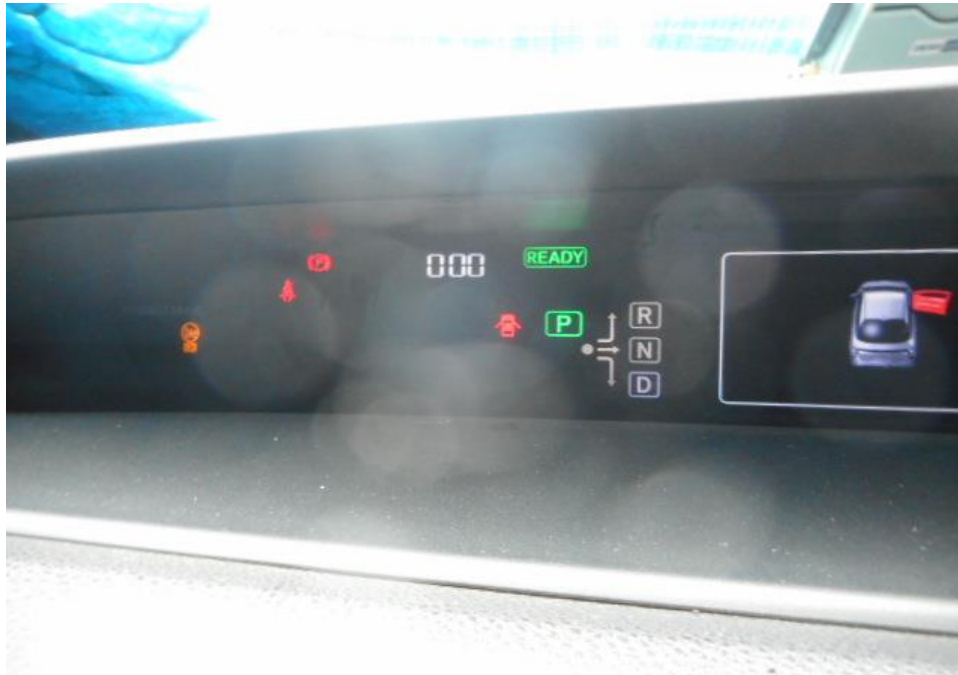
Photo 28 shows no warning lights illuminated on the instrument panel of the Motor Taxi after the engine was cranked. This would suggest that there was no abnormality to the electronic operating system of the Motor Taxi, like the ABS, EPS, TCS and SRS etc.
