Your Ref: 2022 22007815  
Our Ref : CS4/AIS22010890/N

11 November 2022

**TECHNICAL INVESTIGATION REPORT OF FIRE INCIDENT INVOLVING THE  
INSURED VEHICLE EP 8338E ON 30 OCTOBER 2022**

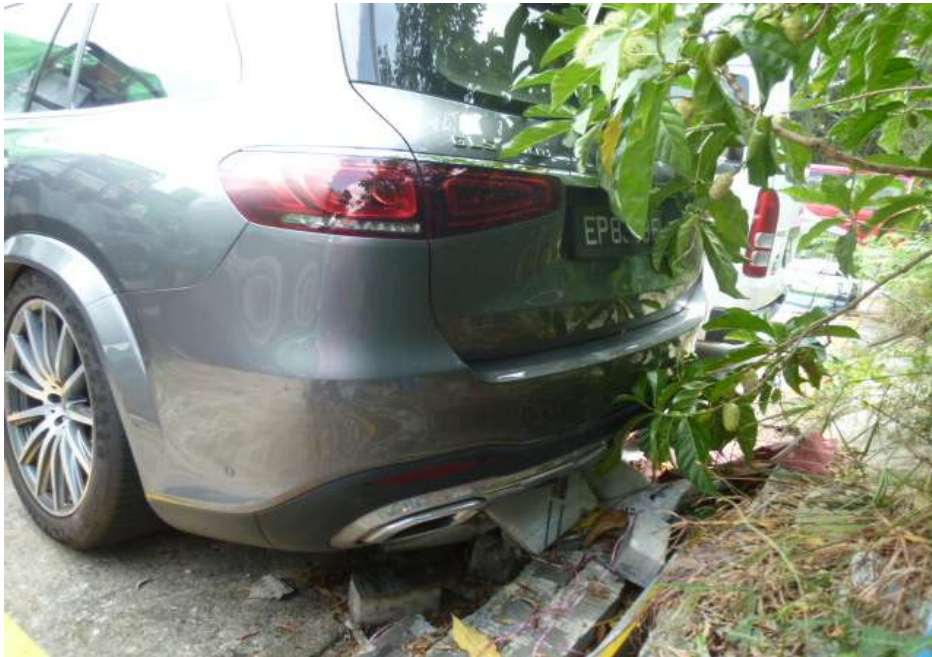
**Photo 1** shows the general view of the rear portion of the Insured Vehicle at the time of our inspection. The rear portion of the Insured Vehicle was relatively unaffected by the fire.

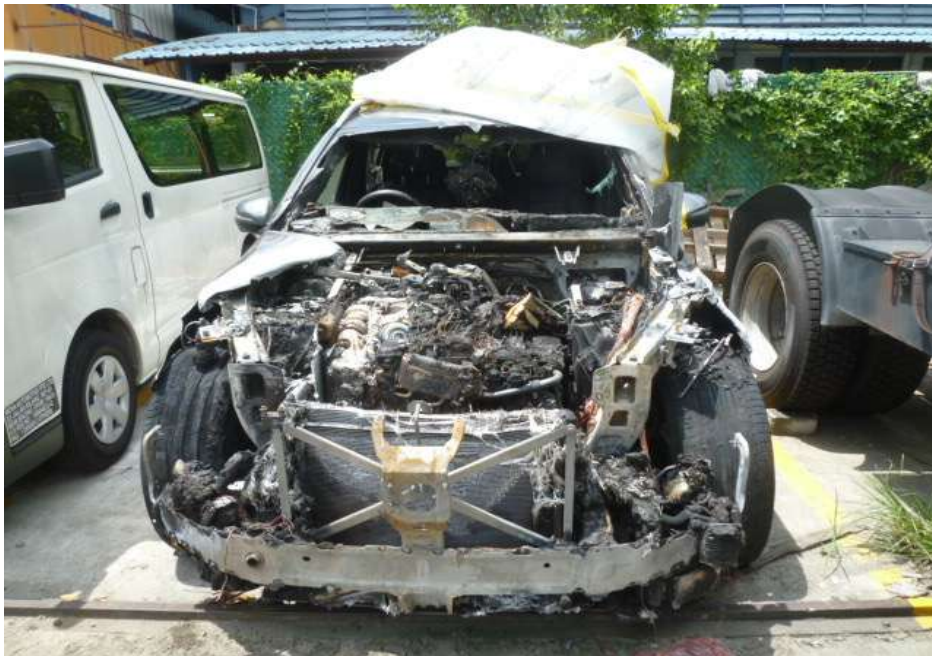
5. The Insured Vehicle was noted to have sustained fire damage that was confined to its frontal portion. The entire engine compartment of the Insured Vehicle was observed to be severely burnt while the interior compartment was observed to be severely affected by the fire.
6. The fire had resulted in the body parts at the frontal portion of the Insured Vehicle to be burnt. This had included its front bumper, front bonnet, front support panel, front grille, front headlamps, front windscreen, front wheel rims, front fenders and front tyres, amongst others. See photos 1 – 6 below.

**Photo 2** shows the general view of the frontal portion of the Insured Vehicle at the time of our inspection. The fire damage to the Insured Vehicle was confined to its frontal portion. The entire engine compartment of the Insured Vehicle was observed to be severely burnt while the interior compartment was observed to be seriously affected by the fire.

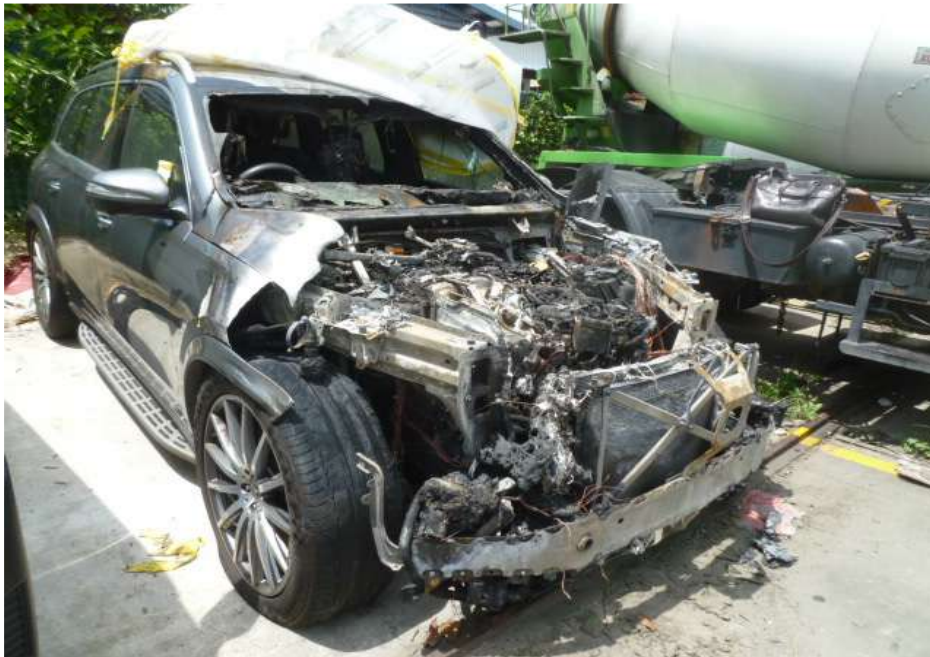
**Photo 3** shows the closer view of the right front body of the Insured Vehicle at the time of our inspection. The fire damage to the Insured Vehicle was confined to its frontal portion. Its front bumper, front bonnet, front support panel, front grille, front headlamps, front windscreen, front wheel rims, front fenders and front tyres, amongst others were amongst the body parts that were found to have been affected by the fire.

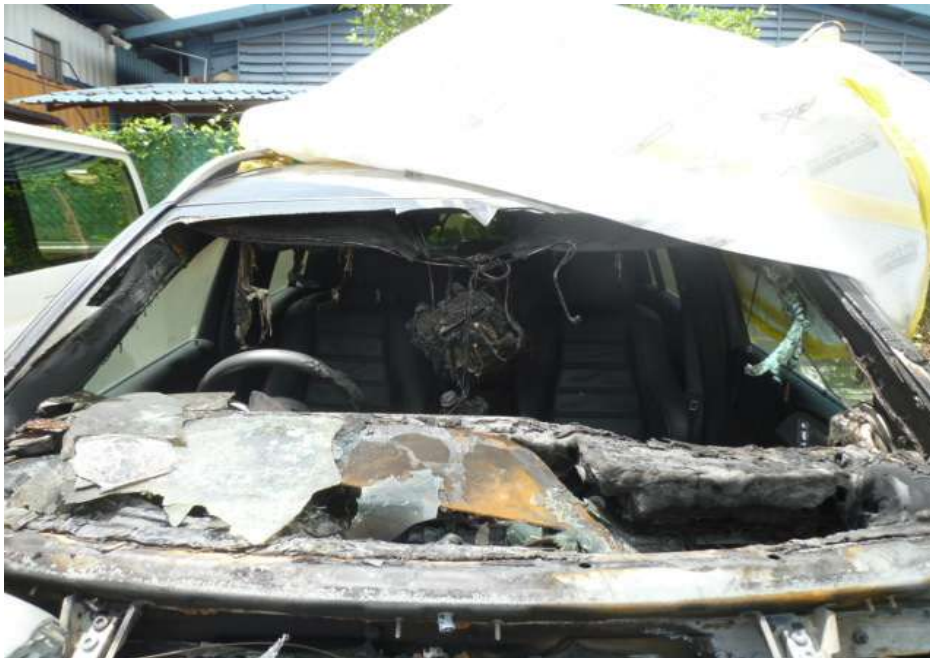
**Photo 4** shows the general view of the front windscreen of the Insured Vehicle at the time of our inspection. The fire damage to the front windscreen was extensive.

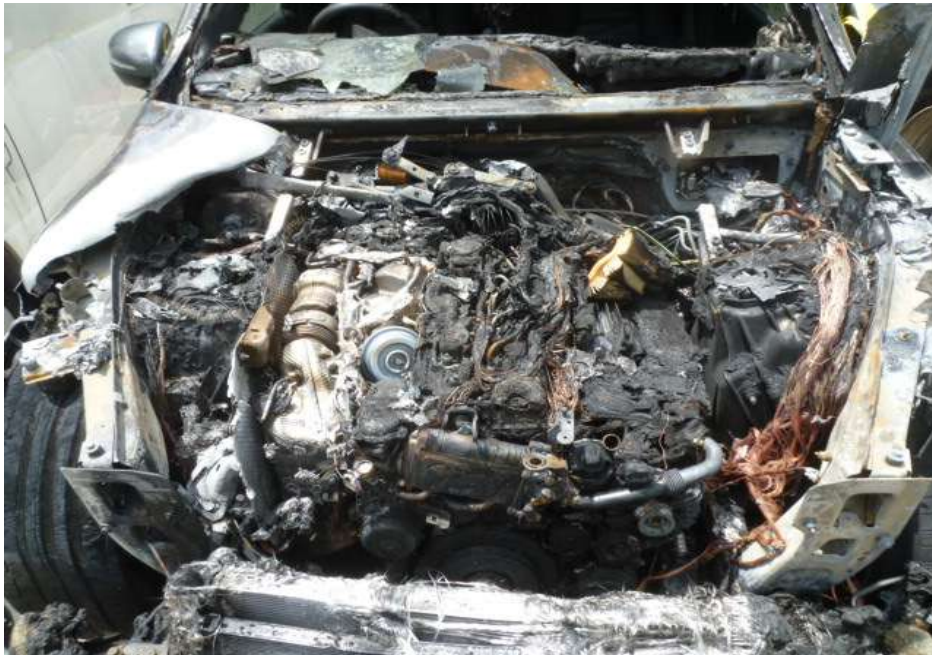
**Photo 5** shows the engine compartment of the Insured Vehicle at the time of our inspection. The entire engine compartment of the Insured Vehicle was observed to be severely burnt. Most of the parts inside the engine compartment were found to be burnt and/or melted as a result of the fire.

8. For this particular case, the fire appears to have originated within the engine compartment of the Insured Vehicle as this was the area where the damage of fire nature was most severe.
9. Upon closer examination of the rear left portion of the engine compartment which was where the fire to the Insured Vehicle had likely started, we had found several stretches of wirings with greenish residue. These wirings were original factory fitted wirings of the Insured Vehicle. The presence of greenish residue indicates internal heating of copper wires, a sign of an electrical short circuit occurring. The greenish residue is normally left behind from oxidation as a result of chemical reaction involving the copper wires. This physical evidence would appear to suggest that the cause of fire to the Insured Vehicle could have possibly been due to electrical in nature. See photos 7 – 11 below.

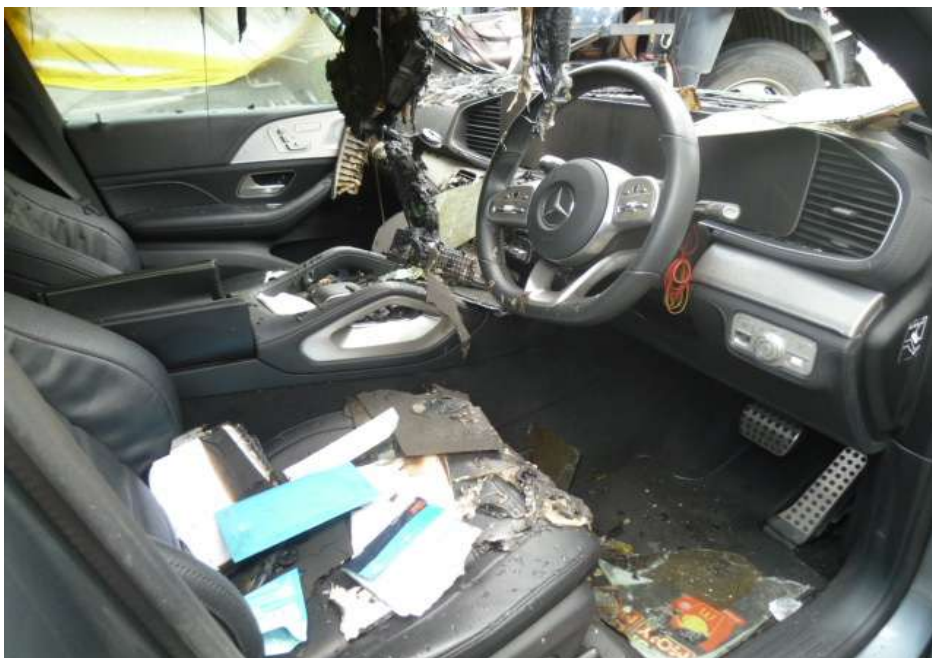
**Photo 6** shows the interior compartment of the Insured Vehicle, which was seriously affected by the fire.

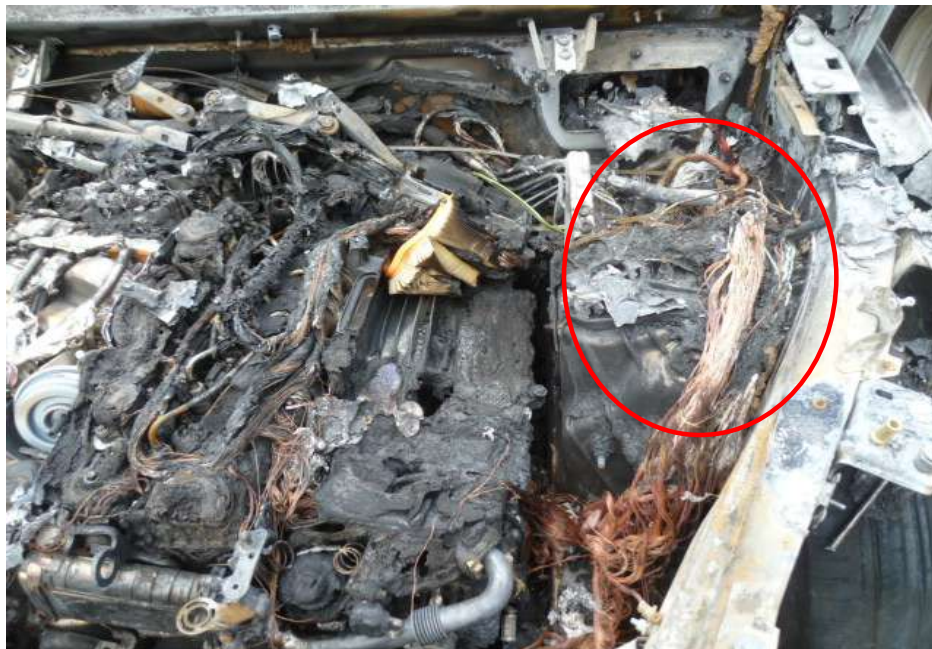
**Photo 7** shows the wirings around the rear left portion of the engine compartment which is near to the vicinity where the fire to the Insured Vehicle had likely started. We observed greenish residue on some of the burnt wirings of the Insured Vehicle (circled). The presence of greenish residue indicates internal heating of copper wires, a sign of an electrical short circuit occurring.

24. The possibility of the fire being due to electrical in nature would then seem more likely given that engine overheating and external factors would both seem unlikely. The fire being due to electrical nature is also supported by the condition of the wirings that were found in the engine compartment of the Insured Vehicle, which was earlier discussed in paragraph 9 above.

26. Having investigated and technically analysed the damages to the Insured Vehicle, we are of the view that the cause of fire to the Insured Vehicle was of electrical in nature. For this particular case, the fire had originated along the wirings inside the engine compartment. The wirings were original factory wirings of the Insured Vehicle.

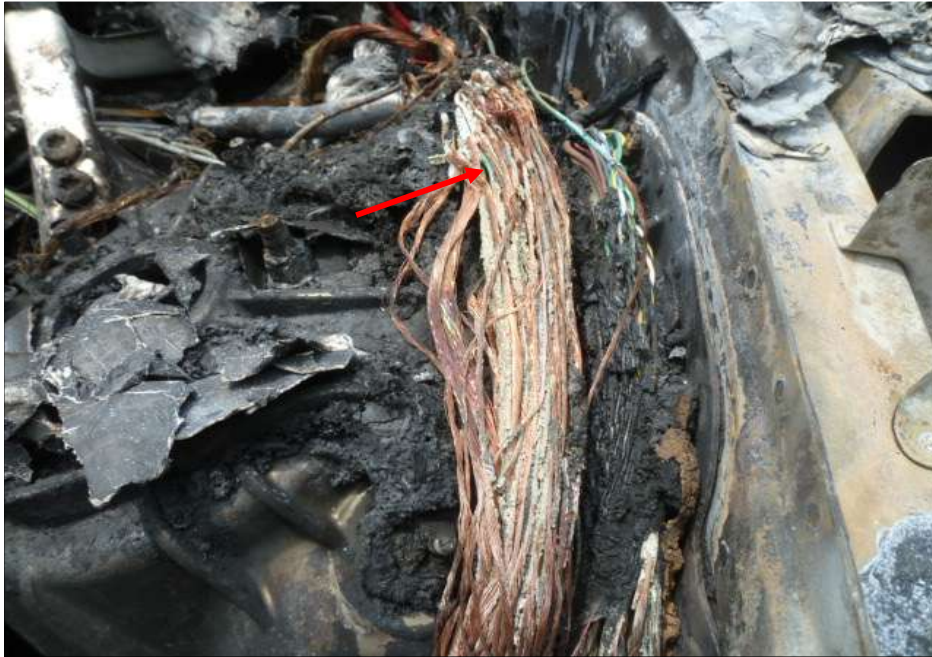
**Photo 8** shows a closer view of the greenish residue on some of the burnt wirings of the Insured Vehicle (arrowed). The presence of greenish residue indicates internal heating of copper wires, a sign of an electrical short circuit occurring. The greenish residue is normally left behind from oxidation as a result of chemical reaction involving the copper wires.

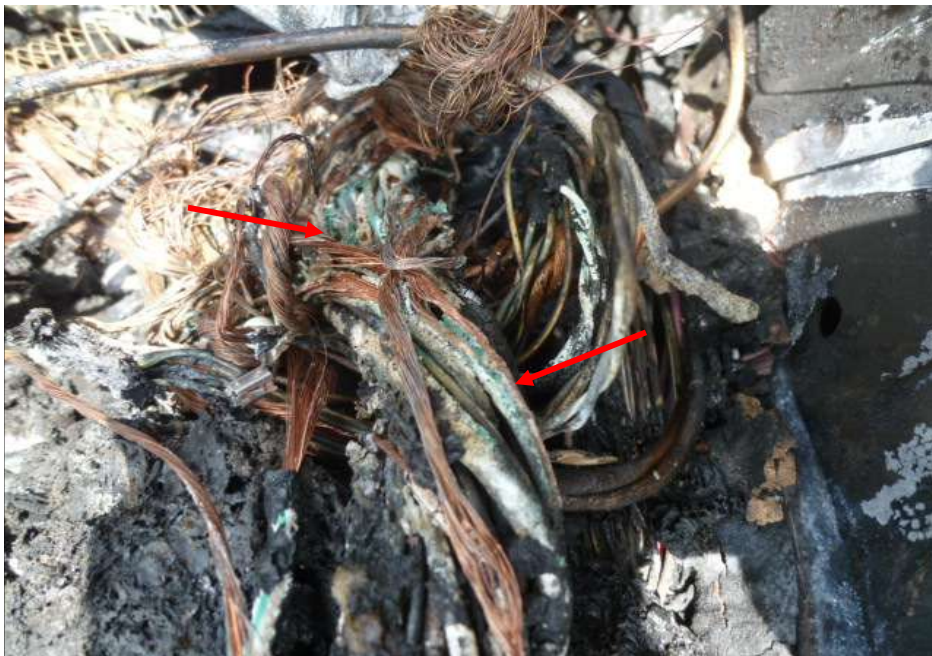
**Photo 9** shows a closer view of the greenish residue on the wirings of the Insured Vehicle (red arrows). The presence of such greenish residue suggests occurrence of an electrical short circuit.

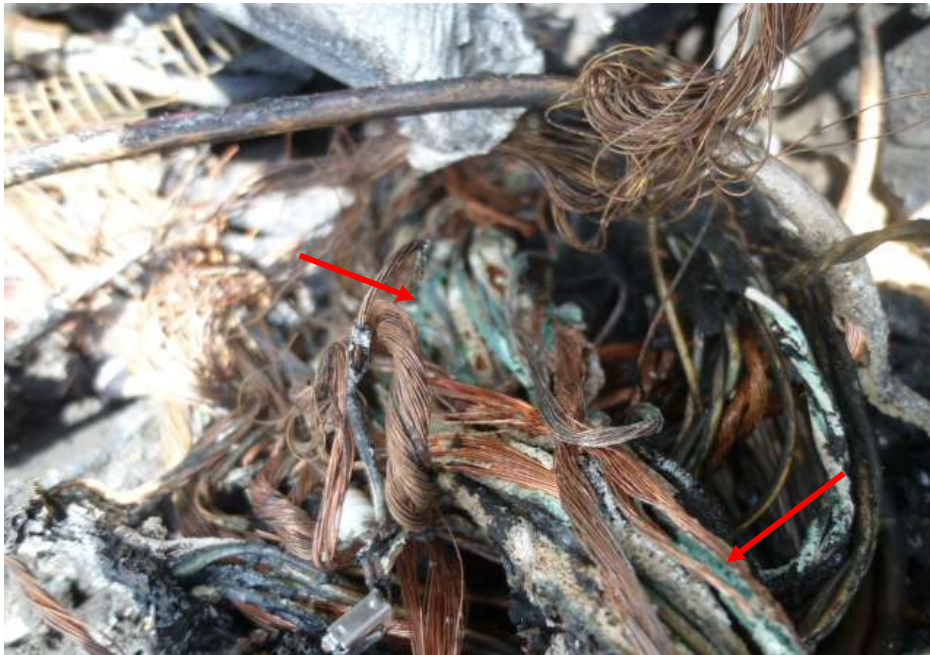
**Photo 10** shows a close up view of the greenish residue on the wirings of the Insured Vehicle (red arrows). The presence of such greenish residue suggests occurrence of an electrical short circuit.

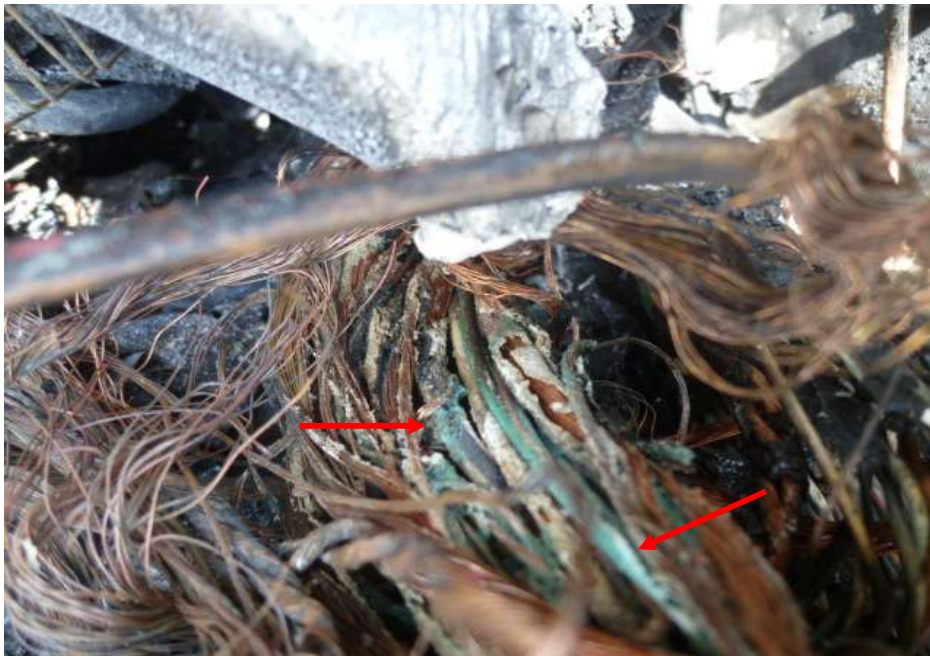
**Photo 11** shows a close up view of the greenish residue on the wirings of the Insured Vehicle (red arrows). The presence of such greenish residue suggests occurrence of an electrical short circuit.

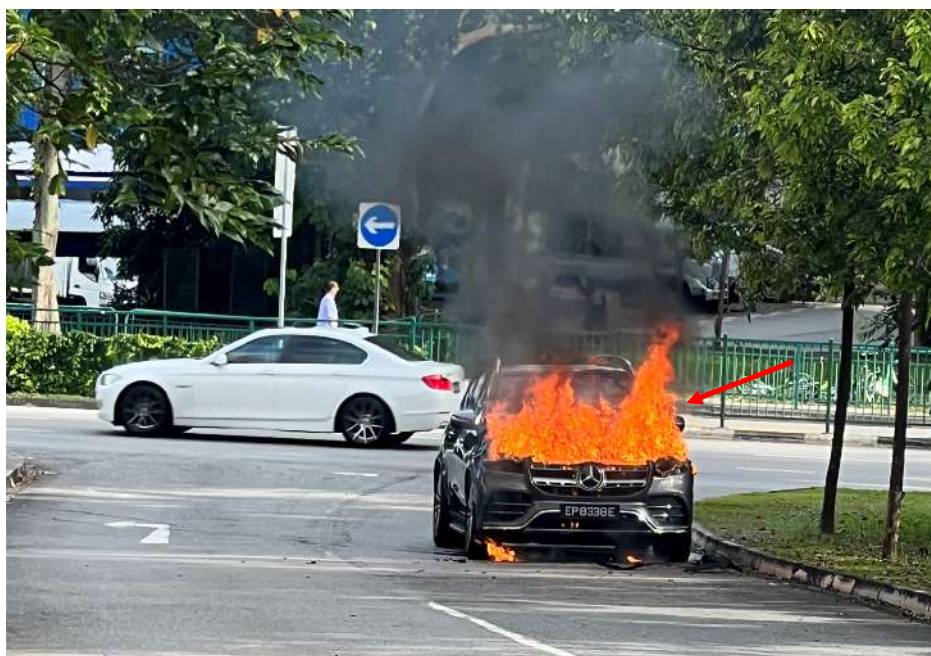
**Photo 12** shows the Insured Vehicle on fire before the arrival of the SCDF. In general, the information that could be gathered from this photograph had corresponded to the events that were related to us by Mr Lee which is the fire had started from the engine compartment of the Insured Vehicle (arrowed).

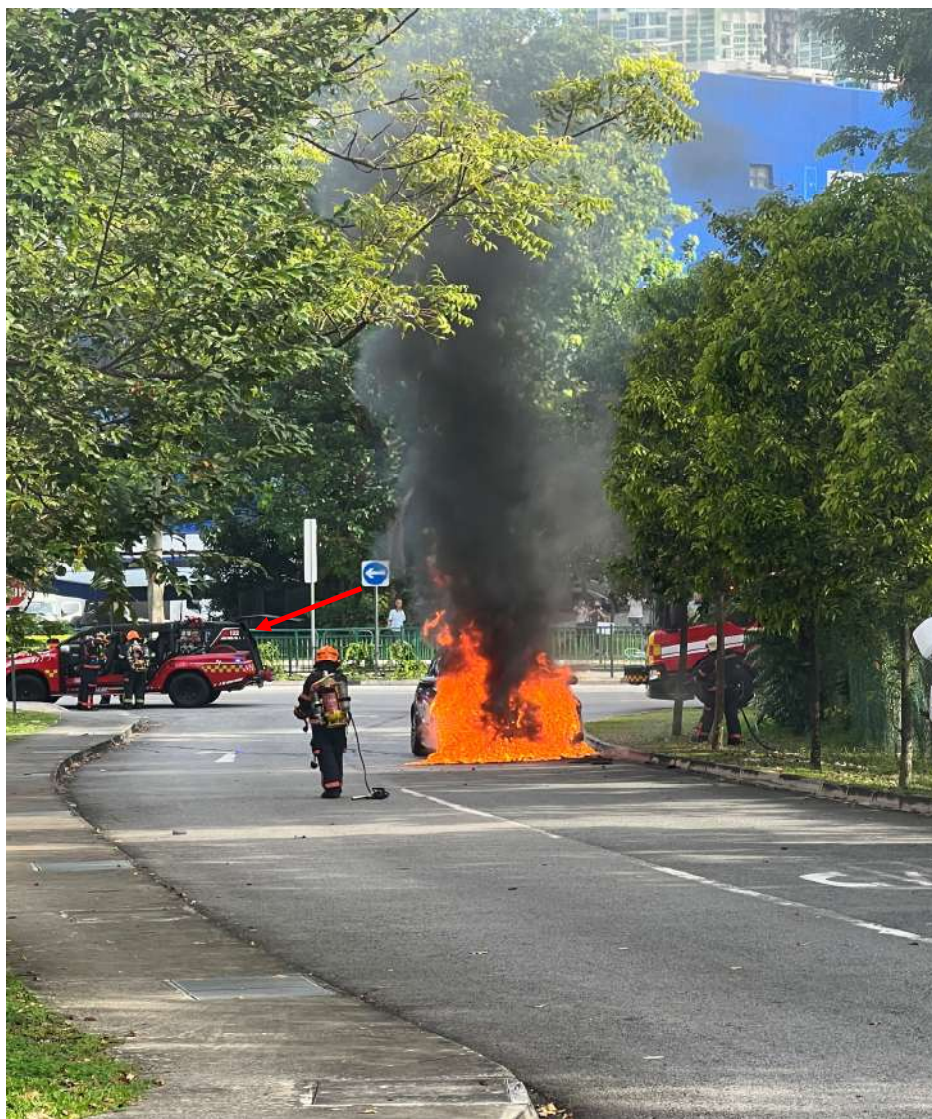
**Photo 13** shows the arrival of the SCDF at the incident scene. In general, the information that could be gathered from this photograph had corresponded to the events that were related to us by Mr Lee which is the SCDF had responded to the incident (arrowed).

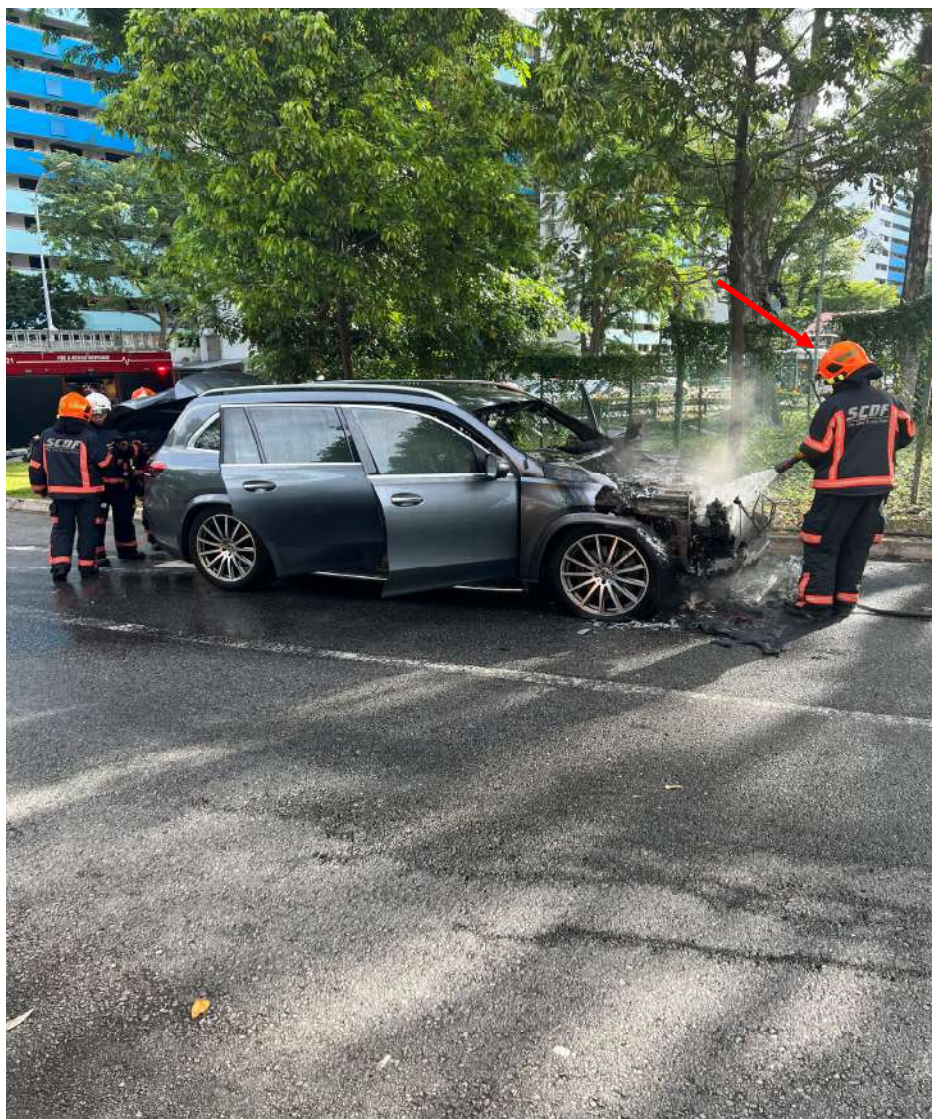
**Photo 14** shows the SCDF dousing the engine compartment with water after putting out the fire to the Insured Vehicle. In general, the information that could be gathered from this photograph had corresponded to the events that were related to us by Mr Lee which is the SCDF were attempting to lower the temperature of the Insured Vehicle after the fire was extinguished (arrowed).
