Your Ref: 2022 22007815
Our Ref : CS4/AIS22010890/N

11 November 2022

TECHNICAL INVESTIGATION REPORT OF FIRE INCIDENT INVOLVING THE INSURED VEHICLE EP 8338E ON 30 OCTOBER 2022

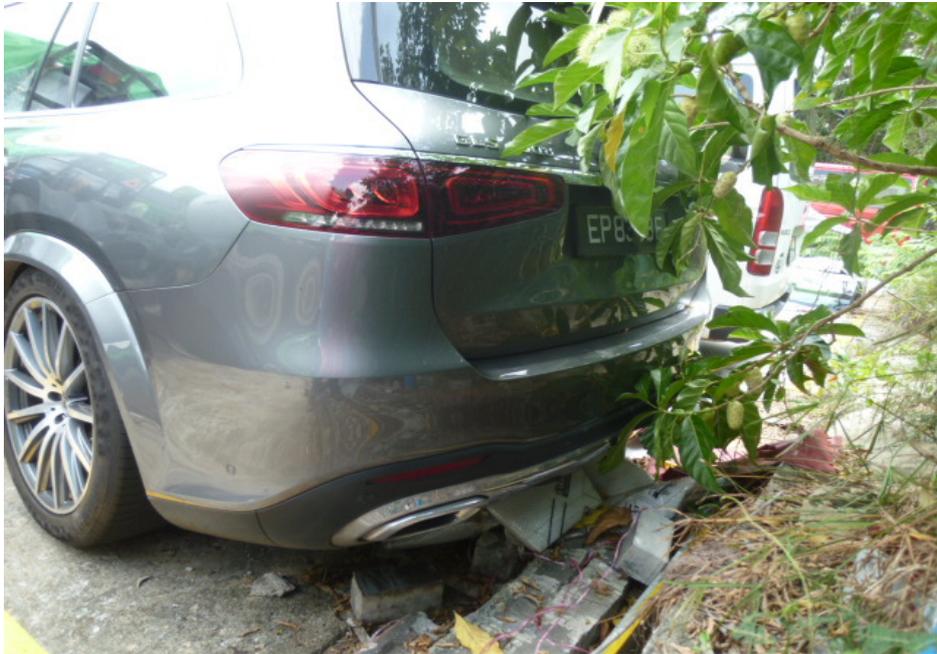
Photo 1 shows the general view of the rear portion of the Insured Vehicle at the time of our inspection. The rear portion of the Insured Vehicle was relatively unaffected by the fire.

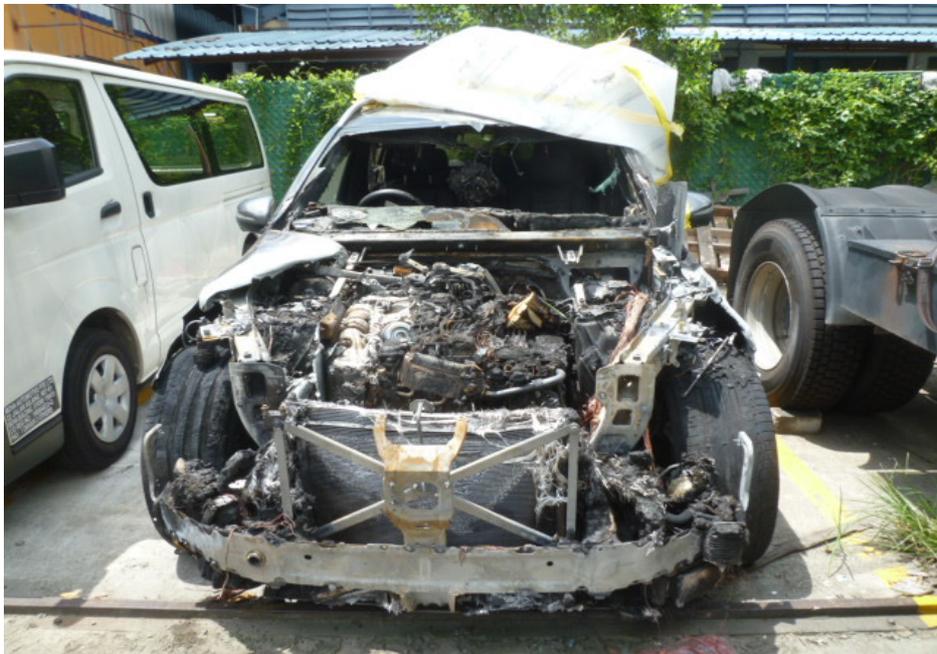
Photo 2 shows the general view of the frontal portion of the Insured Vehicle at the time of our inspection. The fire damage to the Insured Vehicle was confined to its frontal portion. The entire engine compartment of the Insured Vehicle was observed to be severely burnt while the interior compartment was observed to be seriously affected by the fire.

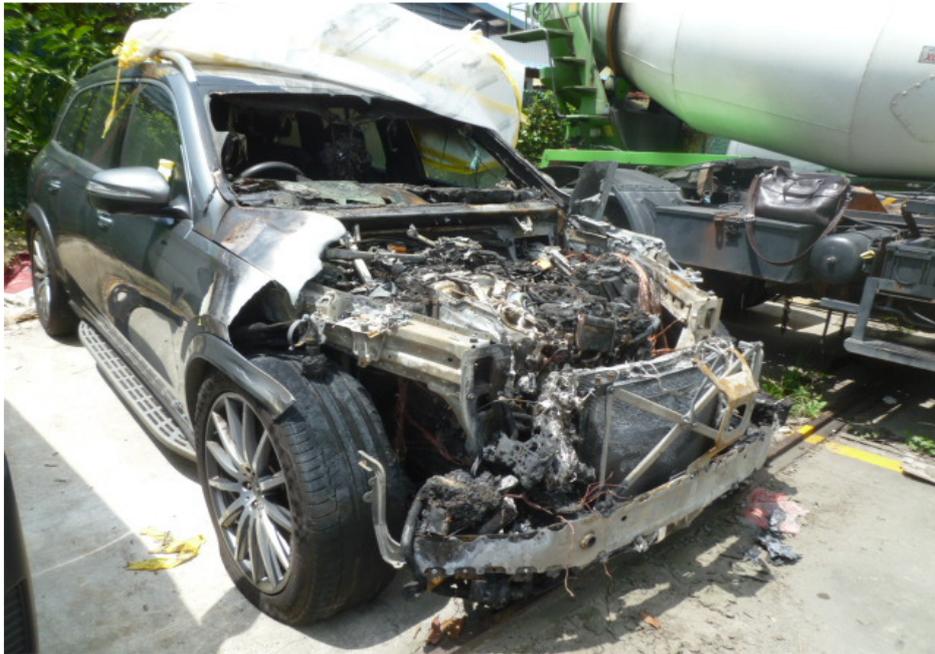
Photo 3 shows the closer view of the right front body of the Insured Vehicle at the time of our inspection. The fire damage to the Insured Vehicle was confined to its frontal portion. Its front bumper, front bonnet, front support panel, front grille, front headlamps, front windscreen, front wheel rims, front fenders and front tyres, amongst others were amongst the body parts that were found to have been affected by the fire.

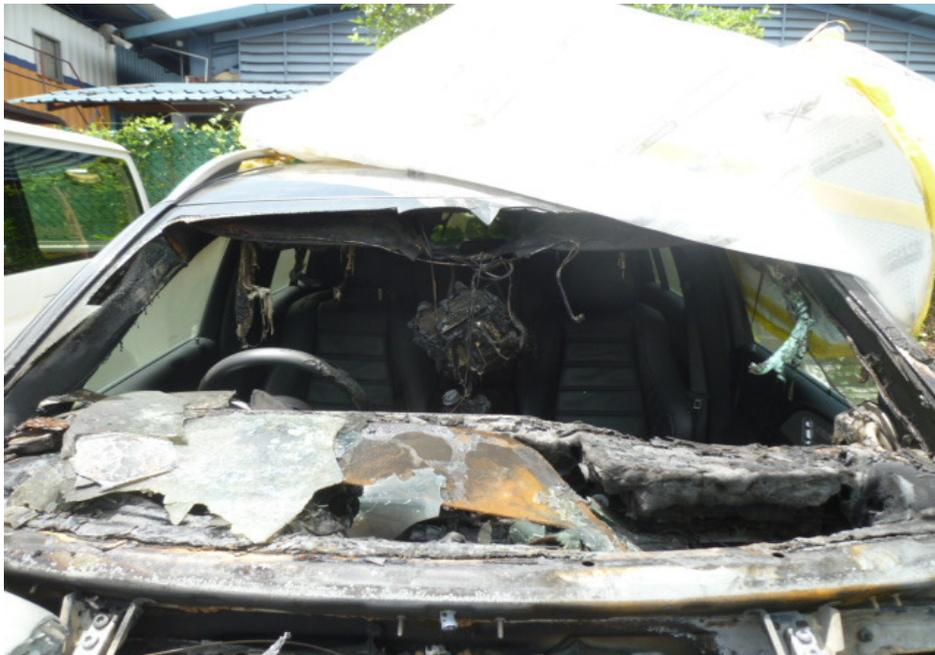
Photo 4 shows the general view of the front windscreen of the Insured Vehicle at the time of our inspection. The fire damage to the front windscreen was extensive.

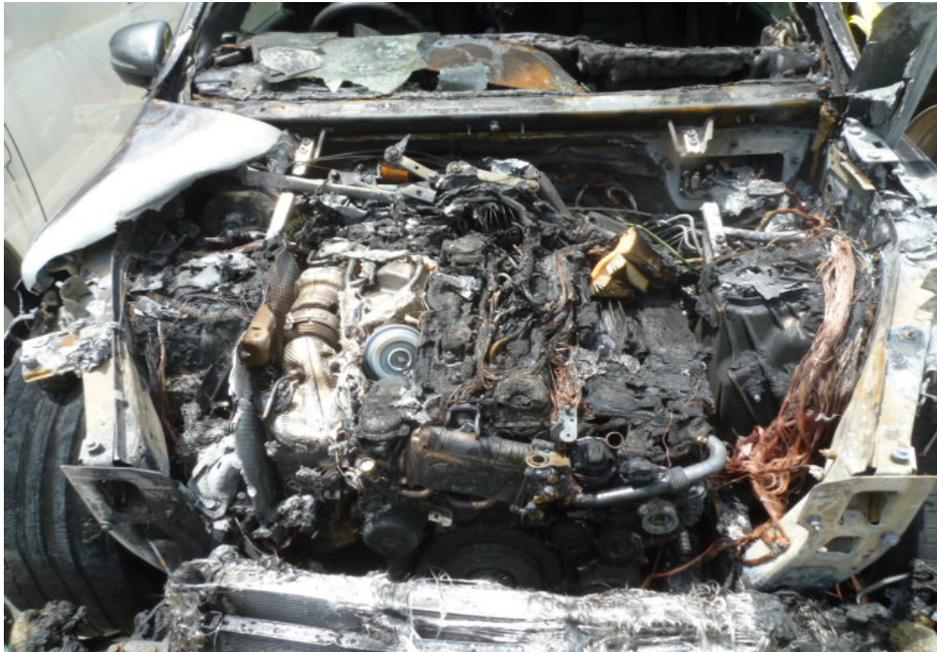
Photo 5 shows the engine compartment of the Insured Vehicle at the time of our inspection. The entire engine compartment of the Insured Vehicle was observed to be severely burnt. Most of the parts inside the engine compartment were found to be burnt and/or melted as a result of the fire.

8. For this particular case, the fire appears to have originated within the engine compartment of the Insured Vehicle as this was the area where the damage of fire nature was most severe.
9. Upon closer examination of the rear left portion of the engine compartment which was where the fire to the Insured Vehicle had likely started, we had found several stretches of wirings with greenish residue. These wirings were original factory fitted wirings of the Insured Vehicle. The presence of greenish residue indicates internal heating of copper wires, a sign of an electrical short circuit occurring. The greenish residue is normally left behind from oxidation as a result of chemical reaction involving the copper wires. This physical evidence would appear to suggest that the cause of fire to the Insured Vehicle could have possibly been due to electrical in nature. See photos 7 – 11 below.

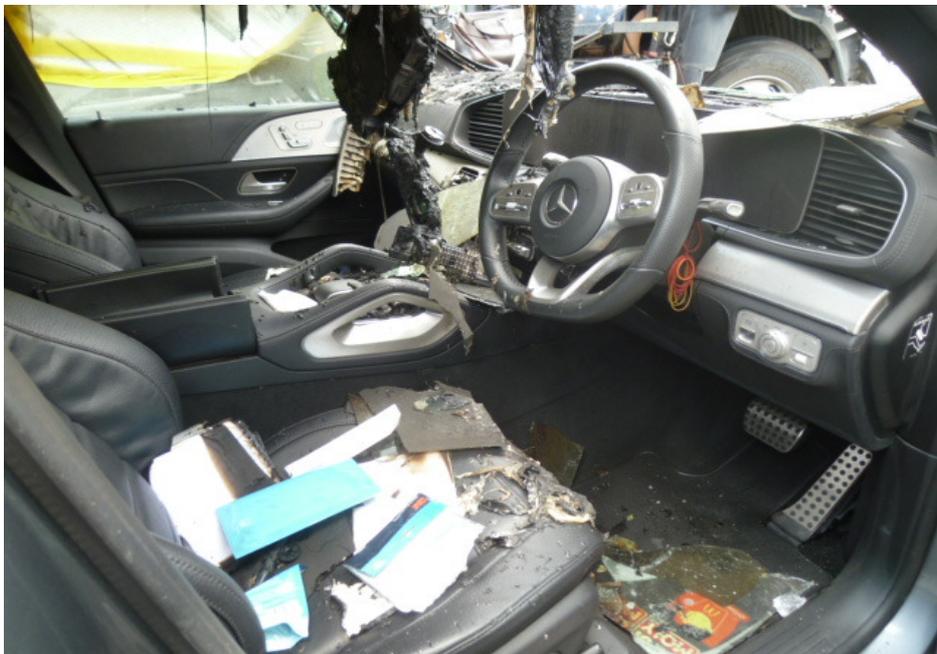
Photo 6 shows the interior compartment of the Insured Vehicle, which was seriously affected by the fire.

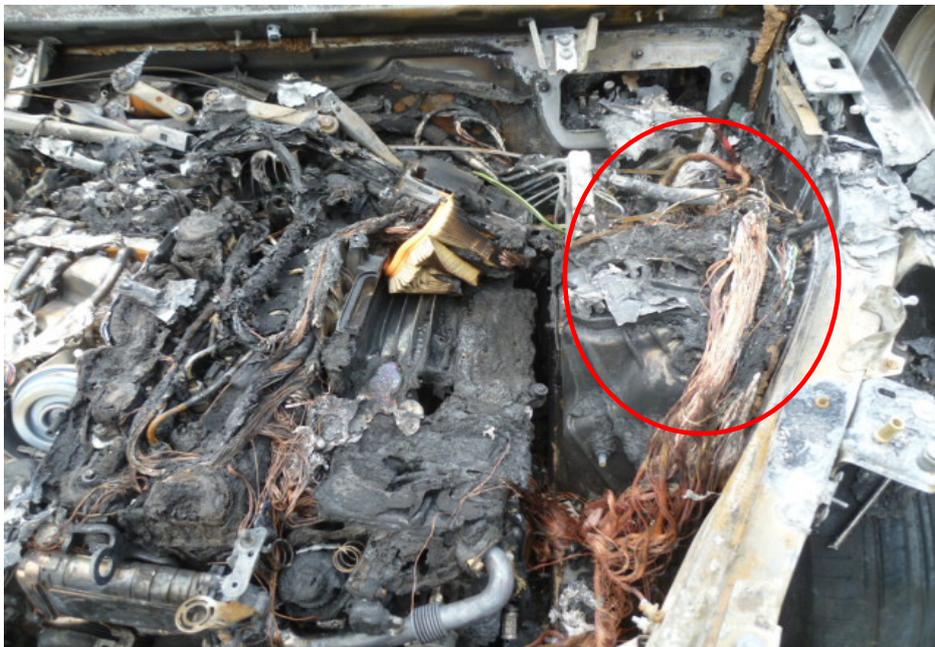
Photo 7 shows the wirings around the rear left portion of the engine compartment which is near to the vicinity where the fire to the Insured Vehicle had likely started. We observed greenish residue on some of the burnt wirings of the Insured Vehicle (circled). The presence of greenish residue indicates internal heating of copper wires, a sign of an electrical short circuit occurring.

24. The possibility of the fire being due to electrical in nature would then seem more likely given that engine overheating and external factors would both seem unlikely. The fire being due to electrical nature is also supported by the condition of the wirings that were found in the engine compartment of the Insured Vehicle, which was earlier discussed in paragraph 9 above.

26. Having investigated and technically analysed the damages to the Insured Vehicle, we are of the view that the cause of fire to the Insured Vehicle was of electrical in nature. For this particular case, the fire had originated along the wirings inside the engine compartment. The wirings were original factory wirings of the Insured Vehicle.

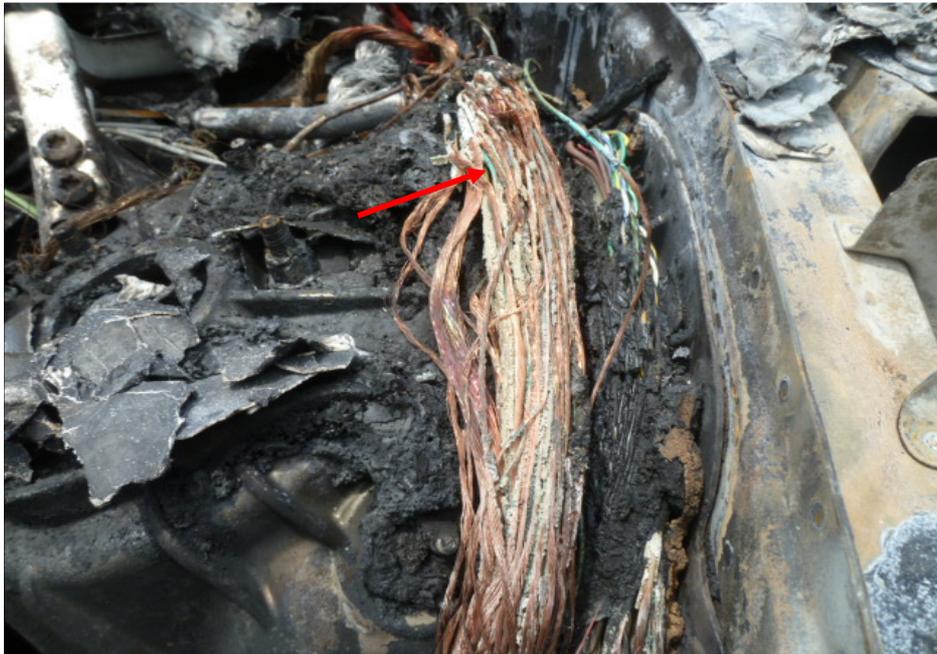
Photo 8 shows a closer view of the greenish residue on some of the burnt wirings of the Insured Vehicle (arrowed). The presence of greenish residue indicates internal heating of copper wires, a sign of an electrical short circuit occurring. The greenish residue is normally left behind from oxidation as a result of chemical reaction involving the copper wires.

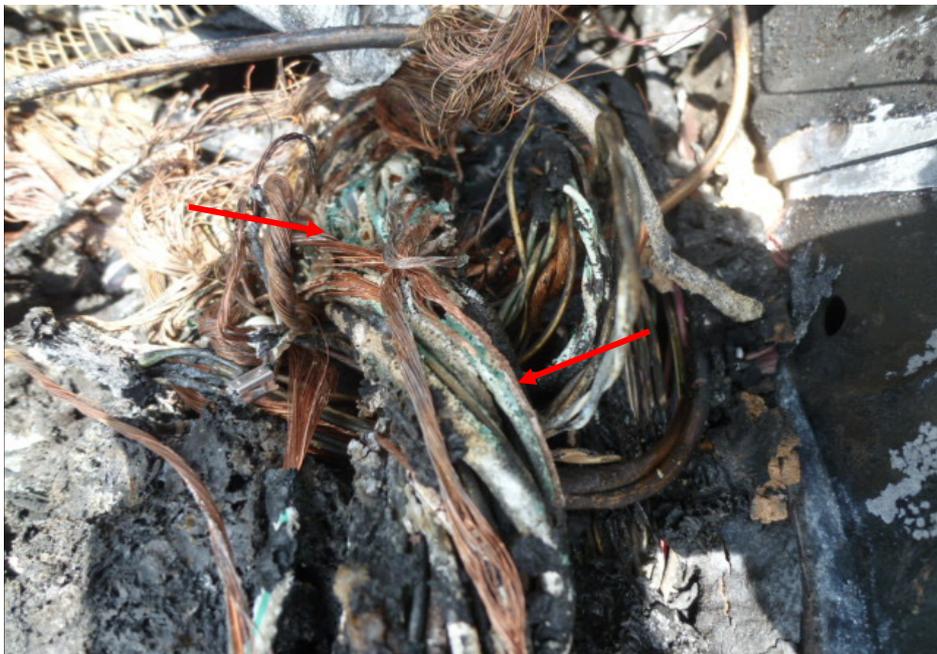
Photo 9 shows a closer view of the greenish residue on the wirings of the Insured Vehicle (red arrows). The presence of such greenish residue suggests occurrence of an electrical short circuit.

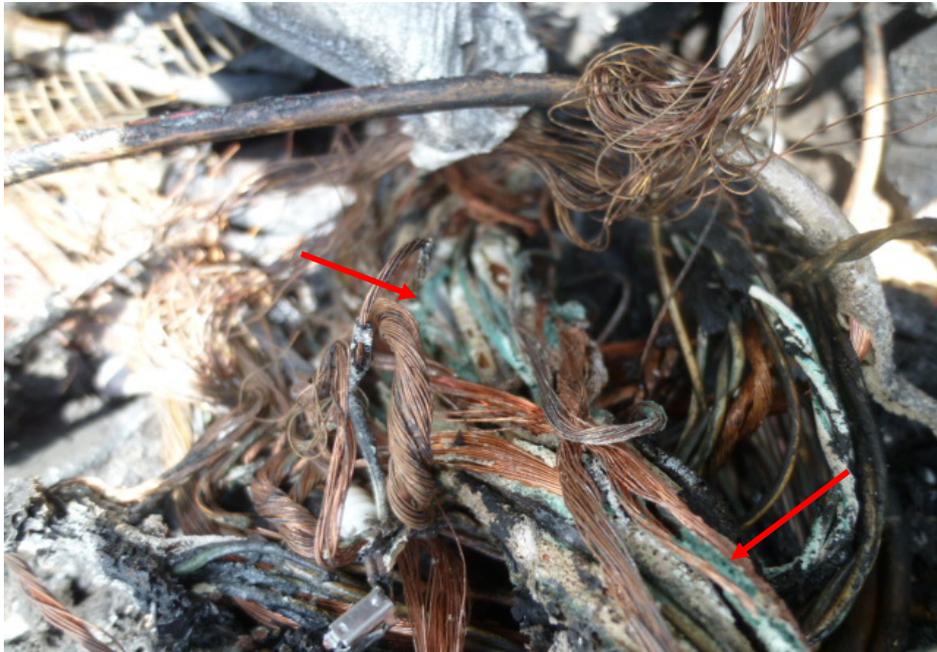
Photo 10 shows a close up view of the greenish residue on the wirings of the Insured Vehicle (red arrows). The presence of such greenish residue suggests occurrence of an electrical short circuit.

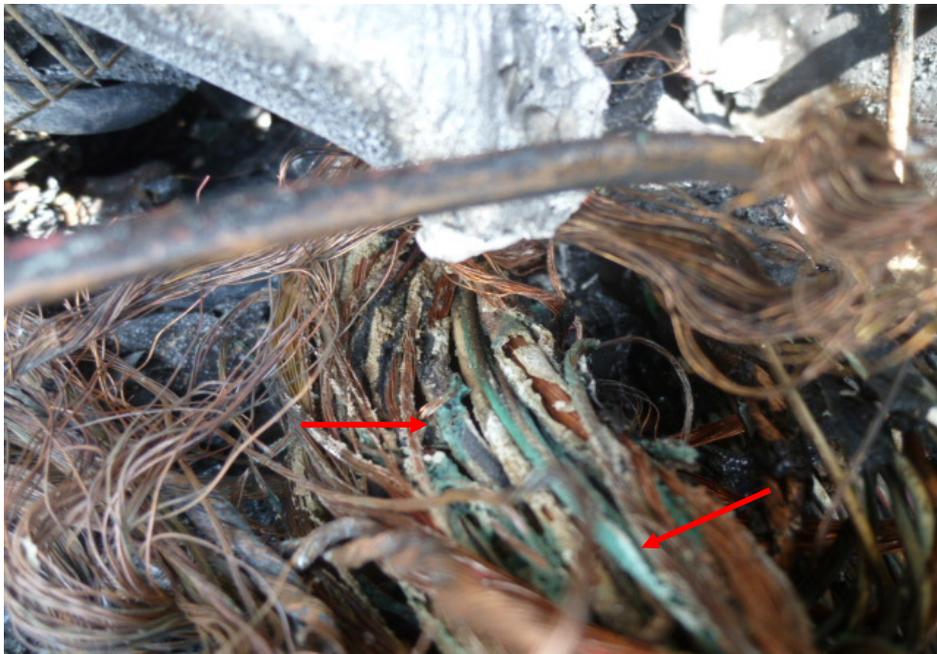
Photo 11 shows a close up view of the greenish residue on the wirings of the Insured Vehicle (red arrows). The presence of such greenish residue suggests occurrence of an electrical short circuit.

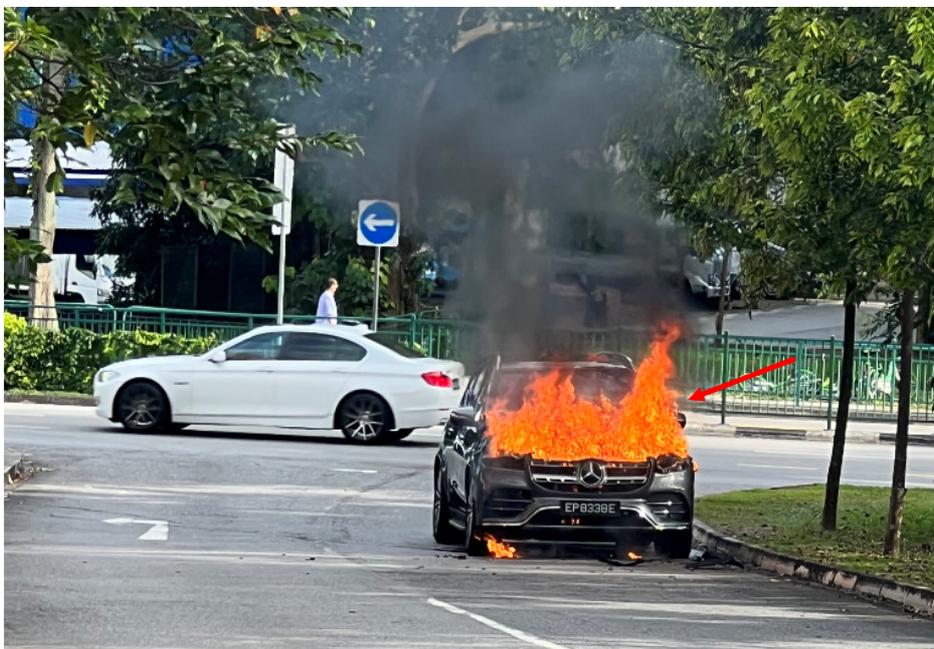
Photo 12 shows the Insured Vehicle on fire before the arrival of the SCDF. In general, the information that could be gathered from this photograph had corresponded to the events that were related to us by Mr Lee which is the fire had started from the engine compartment of the Insured Vehicle (arrowed).

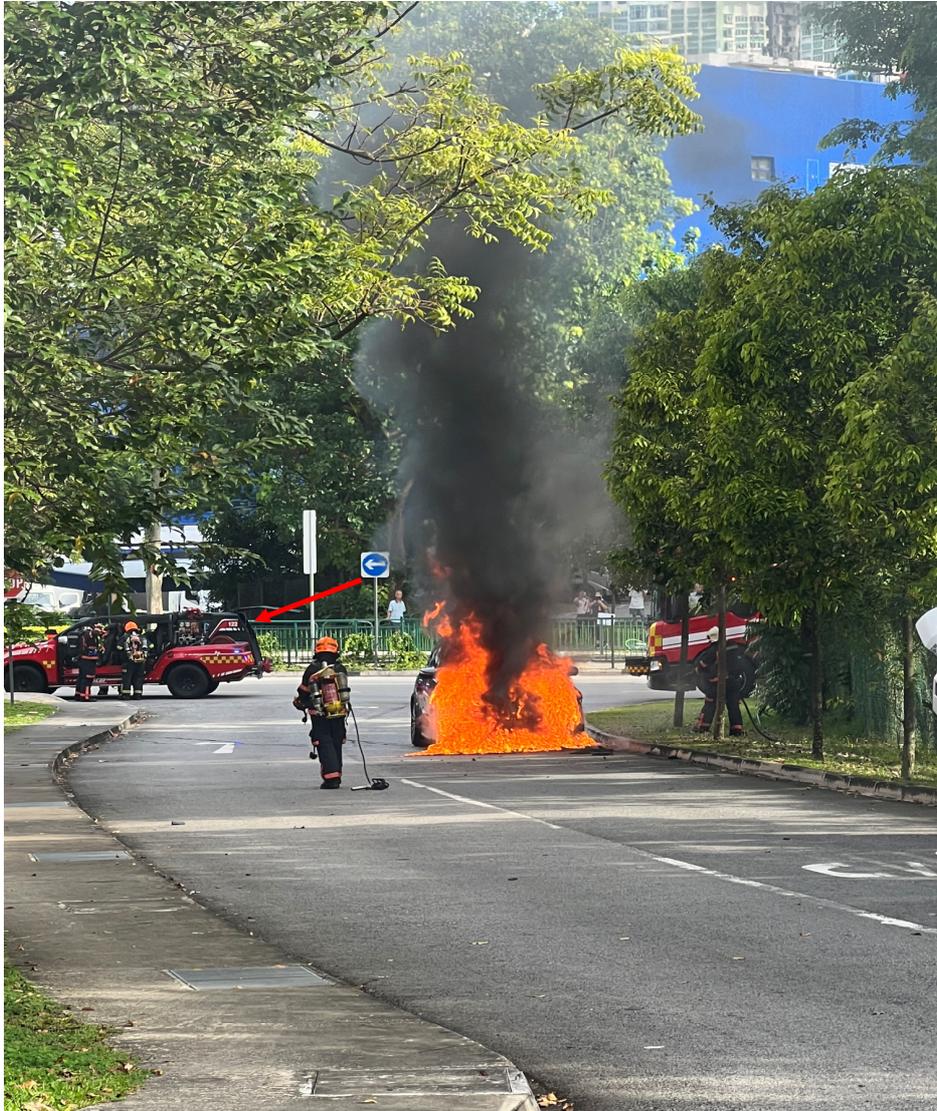
Photo 13 shows the arrival of the SCDF at the incident scene. In general, the information that could be gathered from this photograph had corresponded to the events that were related to us by Mr Lee which is the SCDF had responded to the incident (arrowed).

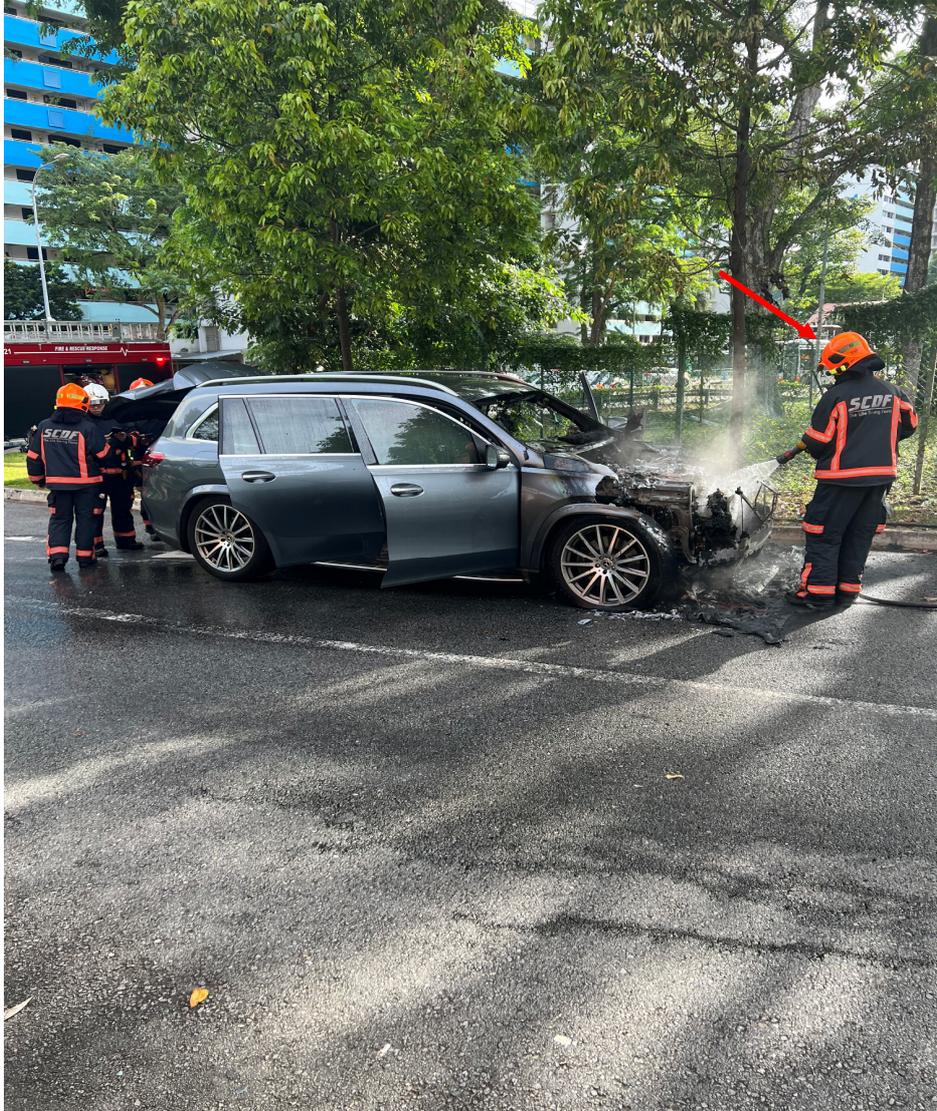
Photo 14 shows the SCDF dousing the engine compartment with water after putting out the fire to the Insured Vehicle. In general, the information that could be gathered from this photograph had corresponded to the events that were related to us by Mr Lee which is the SCDF were attempting to lower the temperature of the Insured Vehicle after the fire was extinguished (arrowed).
