You're Ref: TP/IP/23316/2022
Our Ref: CI/TPD22010893/P

Fatal Accident Investigation Team

MECHANICAL INSPECTION REPORT OF MOTOR LORRY GR 6833X

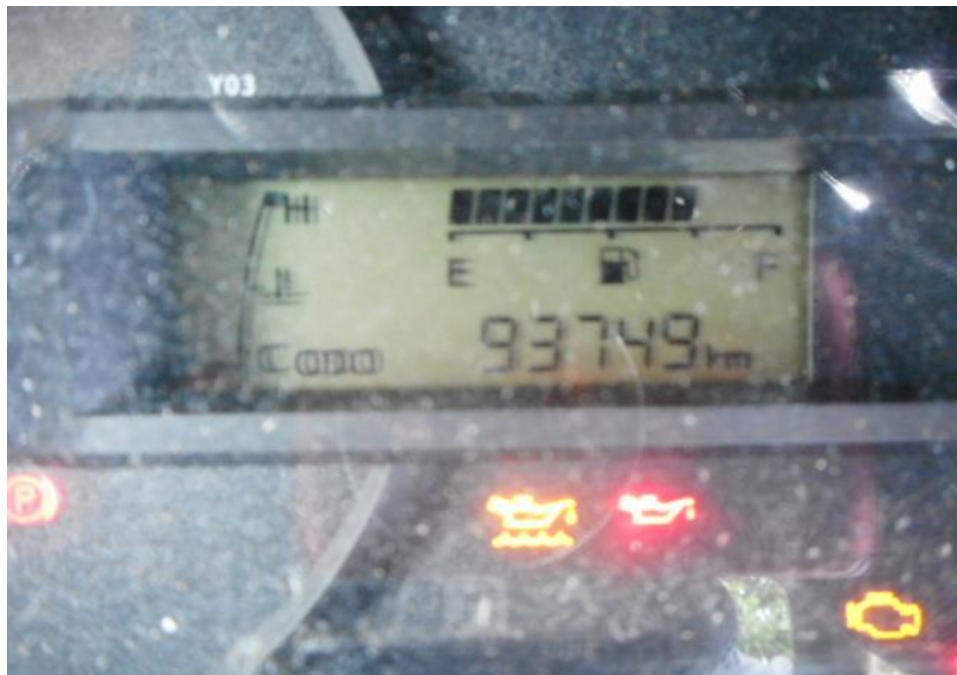
4. The mileage of the Motor Lorry at the time of my inspection was 93,749km.
5. There was no visible damage observed on Motor Lorry at the time of my inspection.

Photo 1 shows the mileage of the Motor Lorry at the time of my inspection. The mileage observed was 93,749km.

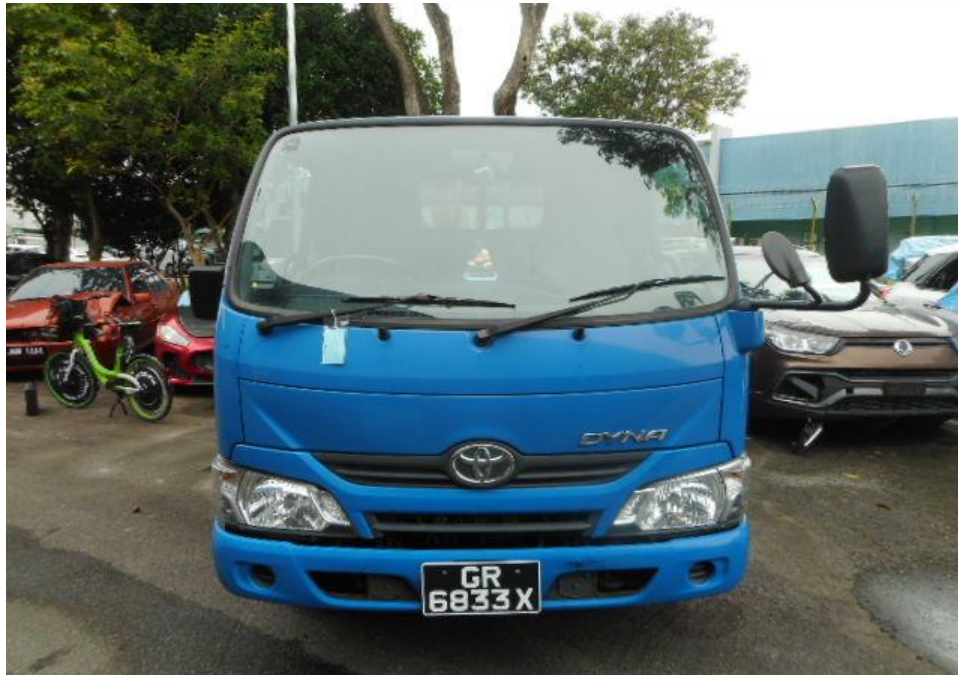
Photo 2 shows a general view of the Motor Lorry's front body at the time of my inspection. The front portion of the Motor Lorry was observed to have been unaffected by the accident.

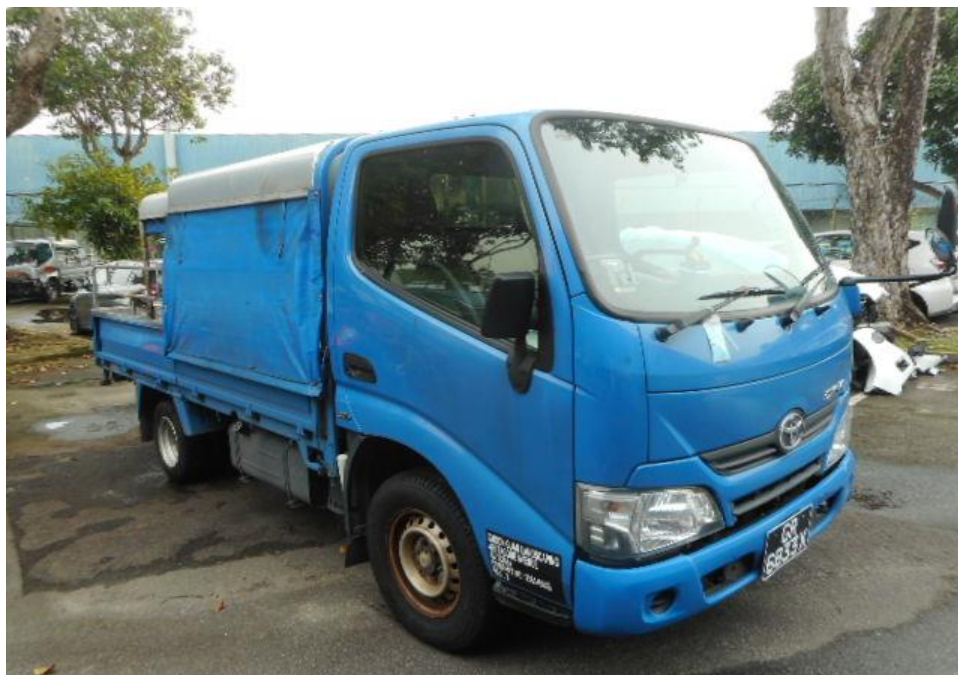
Photo 3 shows a general view of the Motor Lorry's right body at the time of my inspection. The right portion of the Motor Lorry was observed to have been unaffected by the accident.

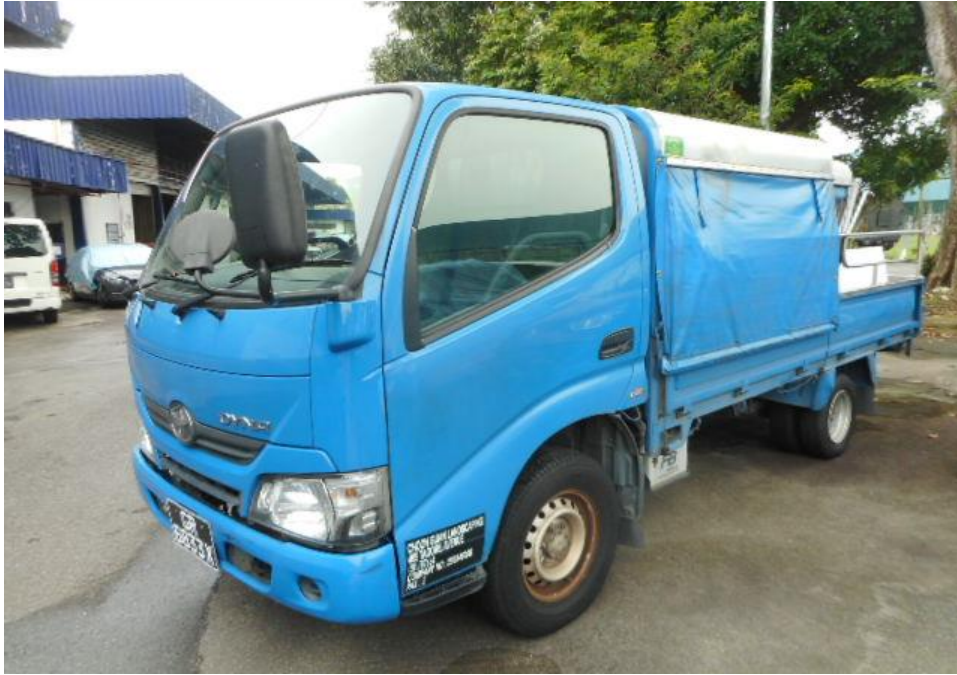
Photo 4 shows a general view of the Motor Lorry's left body at the time of my inspection. The left portion of the Motor Lorry was observed to have been unaffected by the accident.

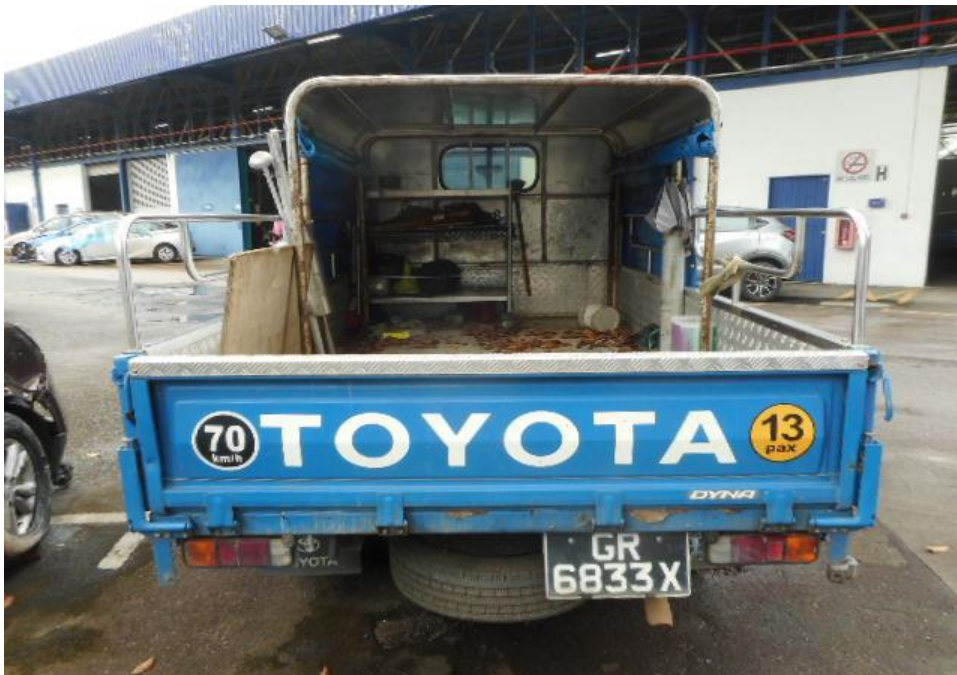
Photo 5 shows the general view of the Motor Lorry's rear body at the time of my inspection. The Motor Lorry rear was observed to be unaffected by the accident.

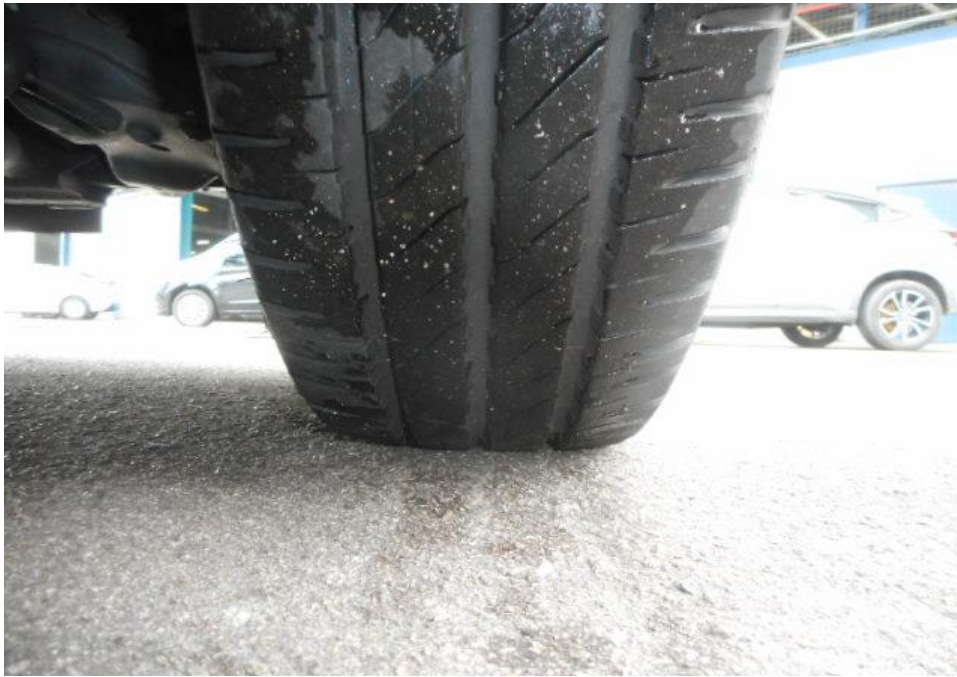
Photo 6 shows the condition of the front right tyre of the Motor Lorry, which was observed to be in serviceable condition with remaining tread depth of approximately 6.3mm. The tyre was sufficiently inflated for vehicular operation with no tear, cut or burst mark(s) on the outer and the inner sidewalls as well as across the tread. The 6 tyres of the Motor Lorry were wrapped around standard steel wheel rims without any damage.

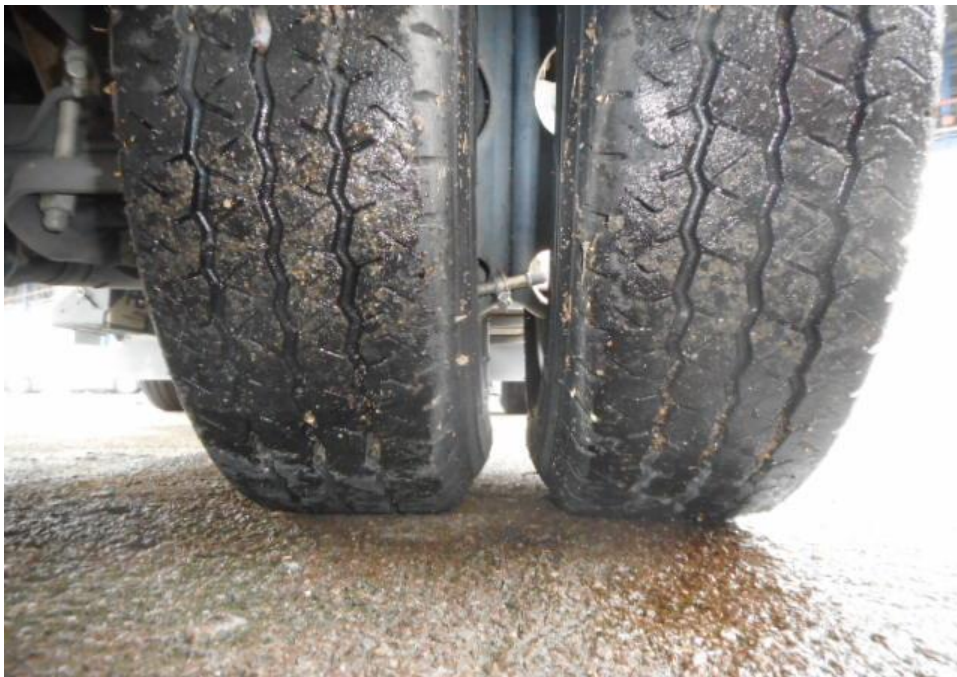
Photo 7 shows the condition of the rear right tyre of the Motor Lorry, which was observed to be in serviceable condition with remaining tread depth of approximately 3.5mm. The tyre was also observed to be sufficiently inflated for vehicular operation with no tear, cut or burst mark(s).

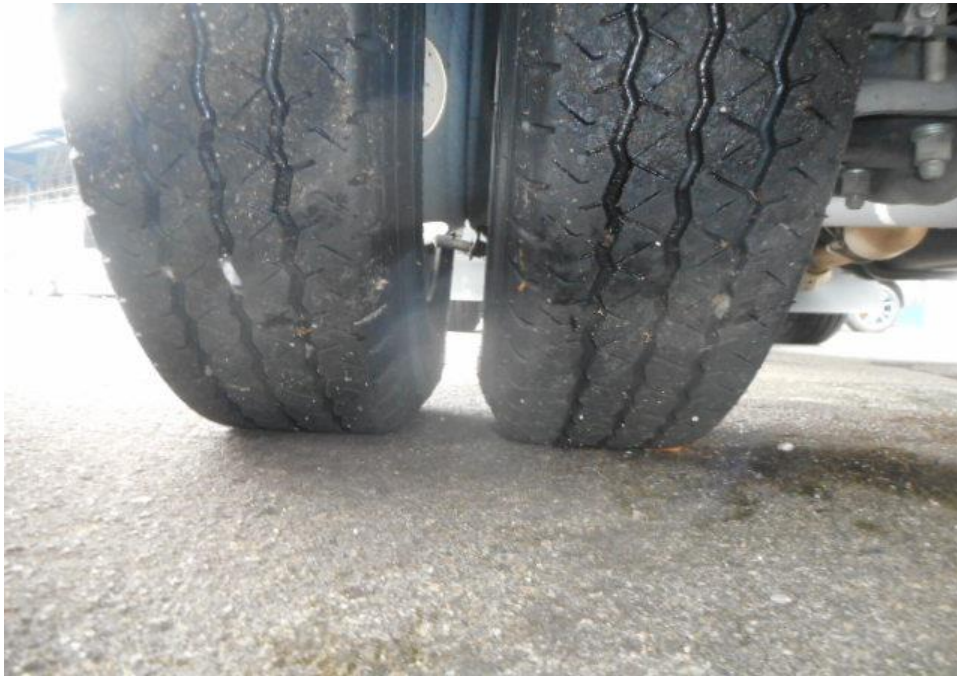
Photo 8 shows the condition of the rear left tyre of the Motor Lorry, which was observed to be in serviceable condition with remaining tread depth of approximately 3.1mm. The tyre, which was wrapped around steel wheel rim, was also observed to be sufficiently inflated for vehicular operation. The 6 tyres of the Motor Lorry were wrapped around standard steel wheel rims.

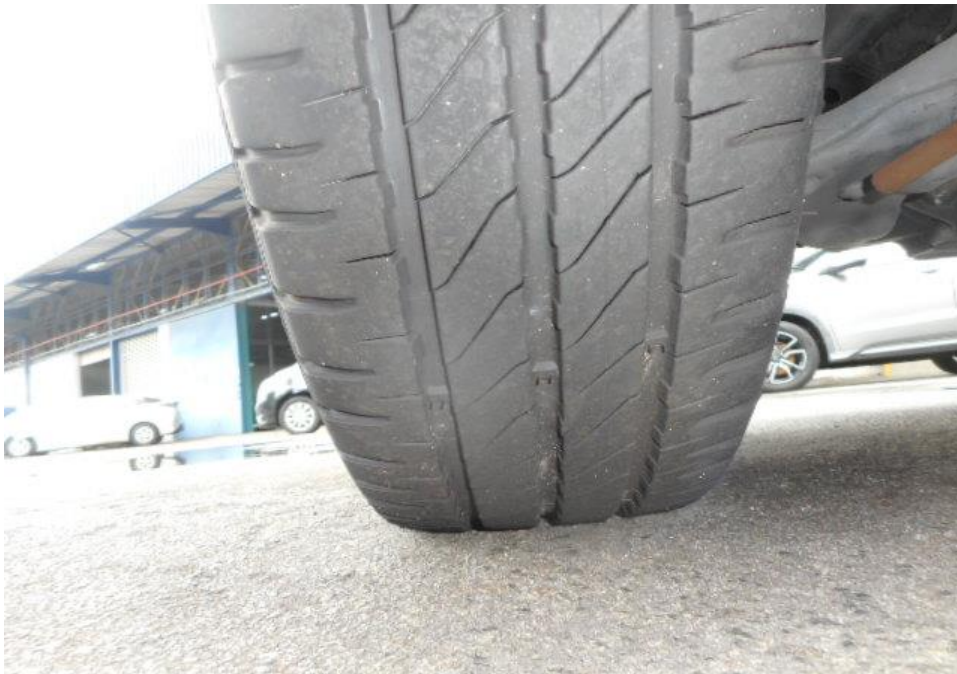
Photo 9 shows the condition of the front left tyre of the Motor Lorry, which was observed to be in serviceable condition with remaining tread depth of approximately 5.8mm. There was also no tear, cut or burst mark(s) on the outer and the inner sidewalls as well as across the tread of the Motor Lorry's 6 tyres.

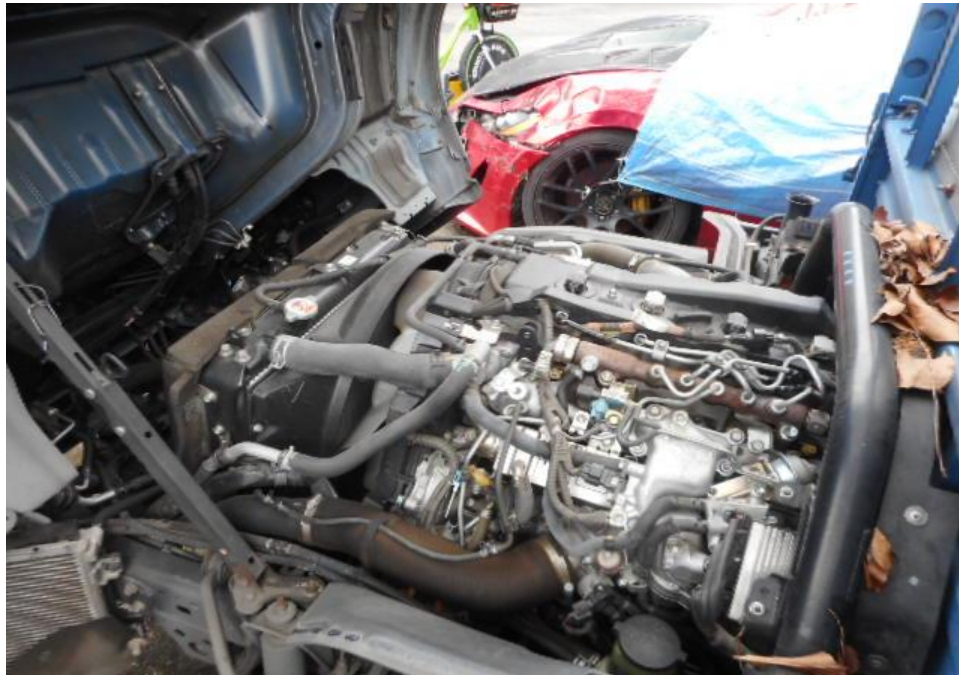
Photo 10 shows a general view of the Motor Lorry's engine compartment. The various parts and components inside the engine compartment were unaffected by the accident. There was also no sign(s) or indication(s) of fluid leakage and/or fluid stain within the engine compartment.

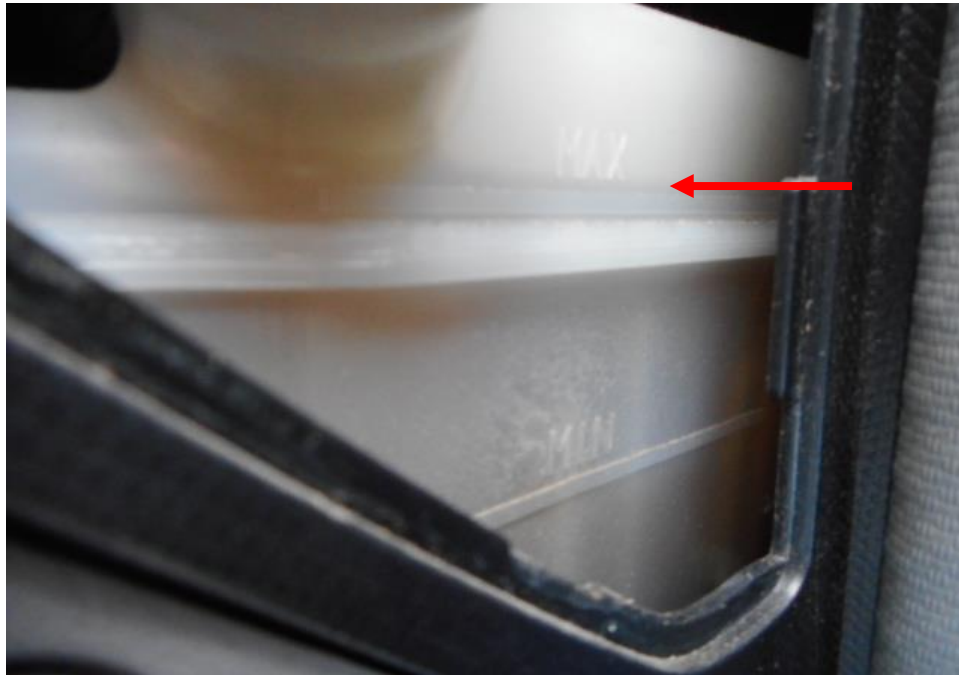
Photo 11 shows the brake fluid reservoir of the Motor Lorry at the time of my inspection. The brake fluid was observed to be of sufficient level (arrowed) and without any visible contamination.

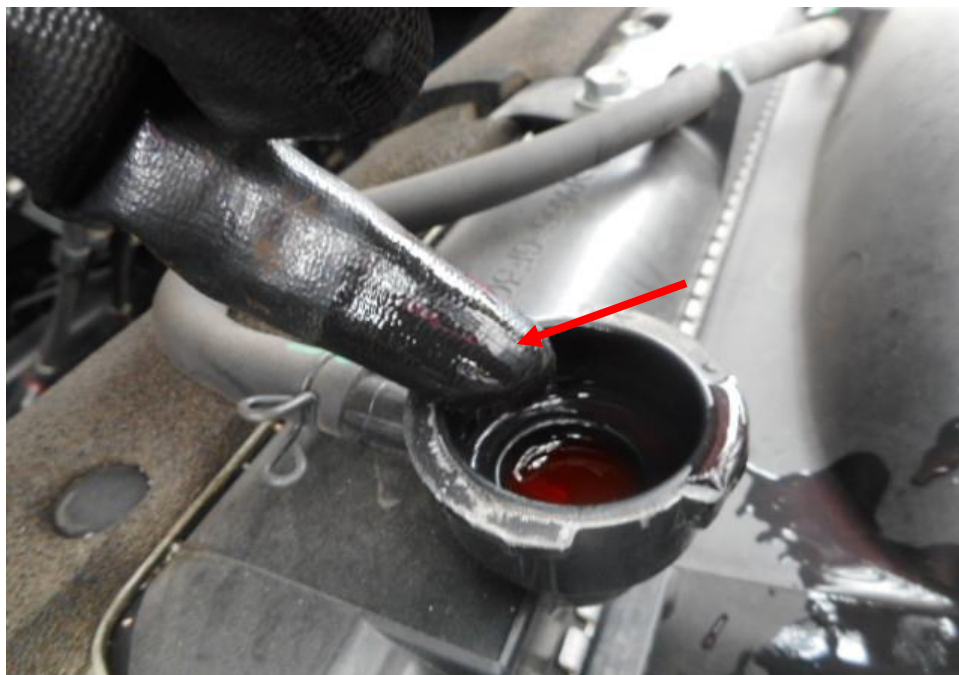
Photo 12 shows checks being carried out to the engine coolant of the Motor Lorry at the time of my inspection. The engine coolant was observed to be of sufficient level (arrowed) and without any visible contamination.

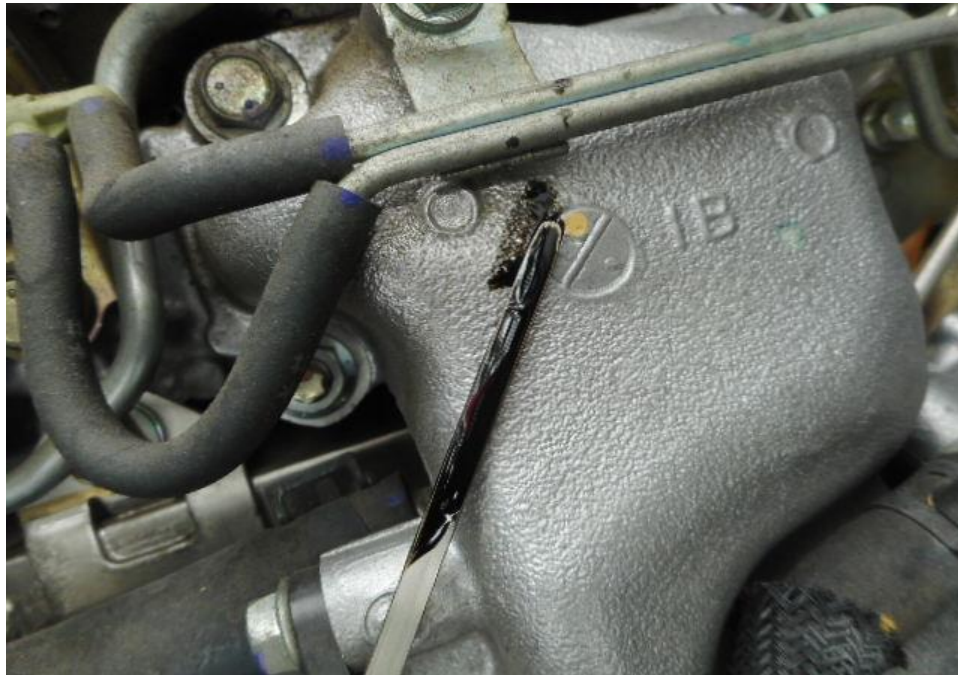
Photo 13 shows the engine oil dip stick of the Motor Lorry at the time of my inspection. The engine oil was observed to be of sufficient level and without any visible contamination.

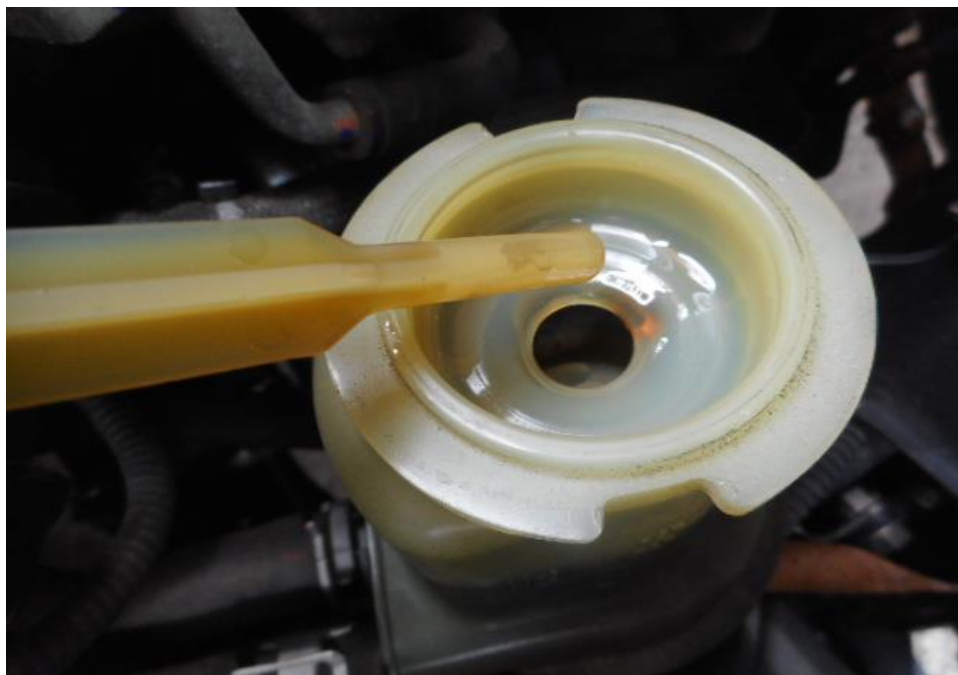
Photo 14 shows the power steering fluid dip stick of the Motor Lorry at the time of my inspection. The power steering fluid was observed to be of sufficient level and without any visible contamination.

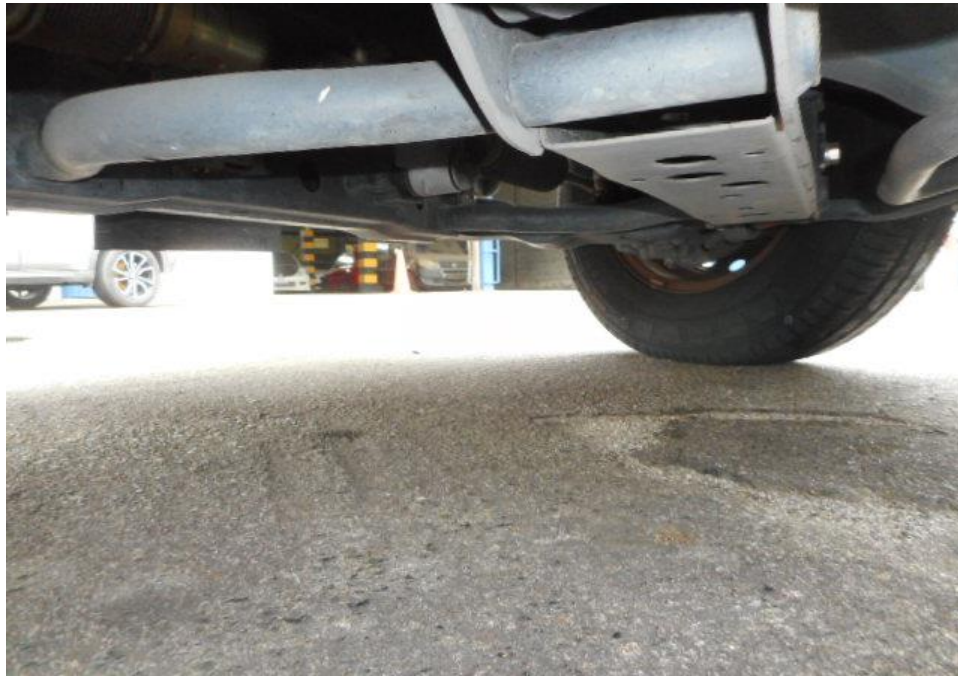
Photo 15 shows the undercarriage of the Motor Lorry, at the area where the engine housing and transmission housing are located. I did not find any sign(s) or indication(s) of fluid leak and/or fluid stain(s) on the underside of the Motor Lorry.

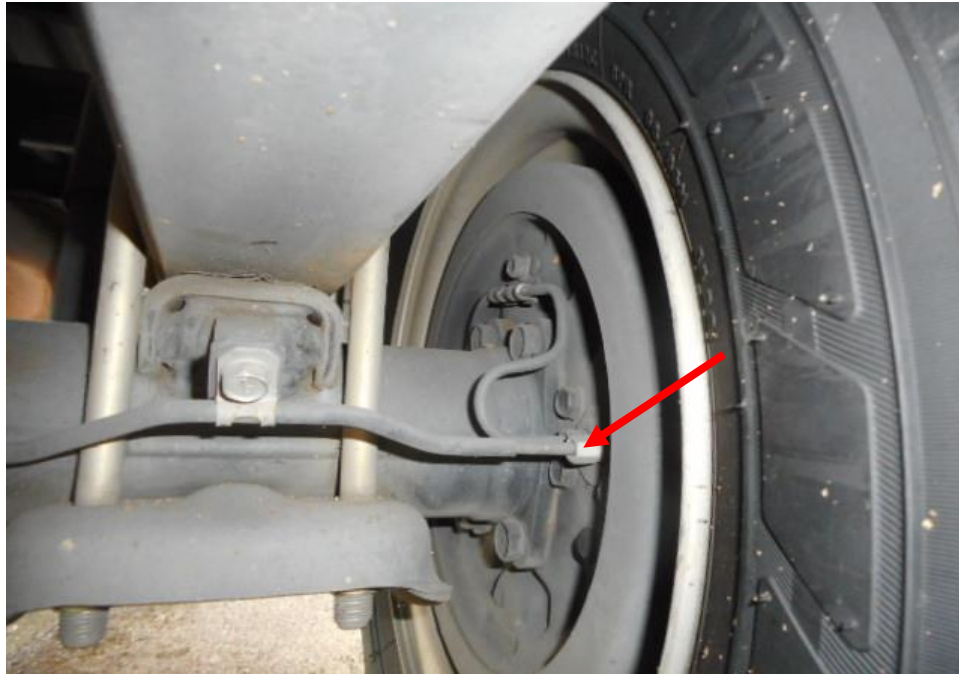
Photo 16 shows the brake hose/pipe (arrowed) at the rear right wheel of the Motor Lorry. No leakage of brake fluid was observed. Visual examination of the various components of the braking system like the drum brake, brake booster, brake pedal etc. had revealed all to be intact and without visible damage.

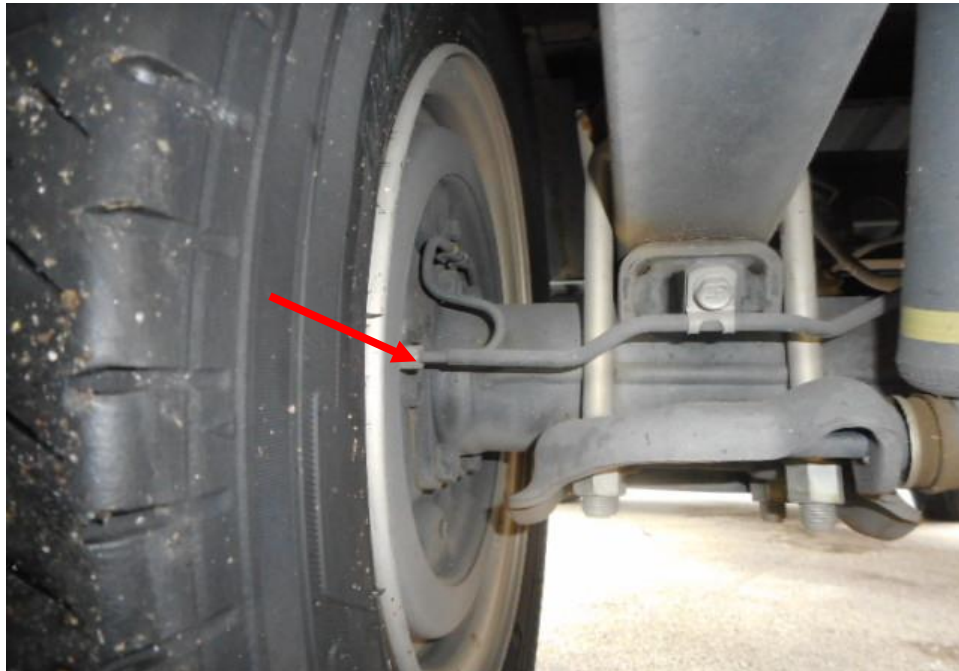
Photo 17 shows the brake hose/pipe (arrowed) at the rear left wheel of the Motor Lorry. I did not observe any leakage of brake fluid at the time of my inspection of the Motor Lorry. Static tests of the Motor Lorry's braking system had indicated that there was no internal leakage of pressure/vacuum. The undercarriage components of the Motor Lorry were also all found to be intact and without any visible damage.

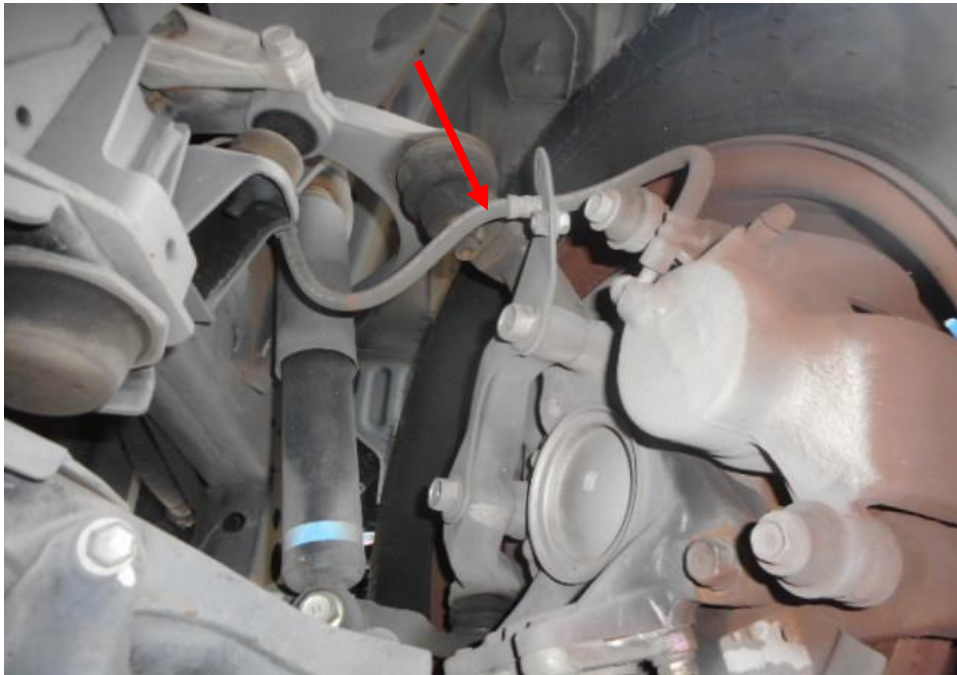
Photo 18 shows the brake hose/pipe (arrowed) at the front right wheel of the Motor Lorry. I did not observe any leakage of brake fluid at the time of my inspection of the Motor Lorry. Static tests of the Motor Lorry's braking system had indicated that there was no internal leakage of pressure/vacuum. The undercarriage components of the Motor Lorry were also all found to be intact and without any visible damage.

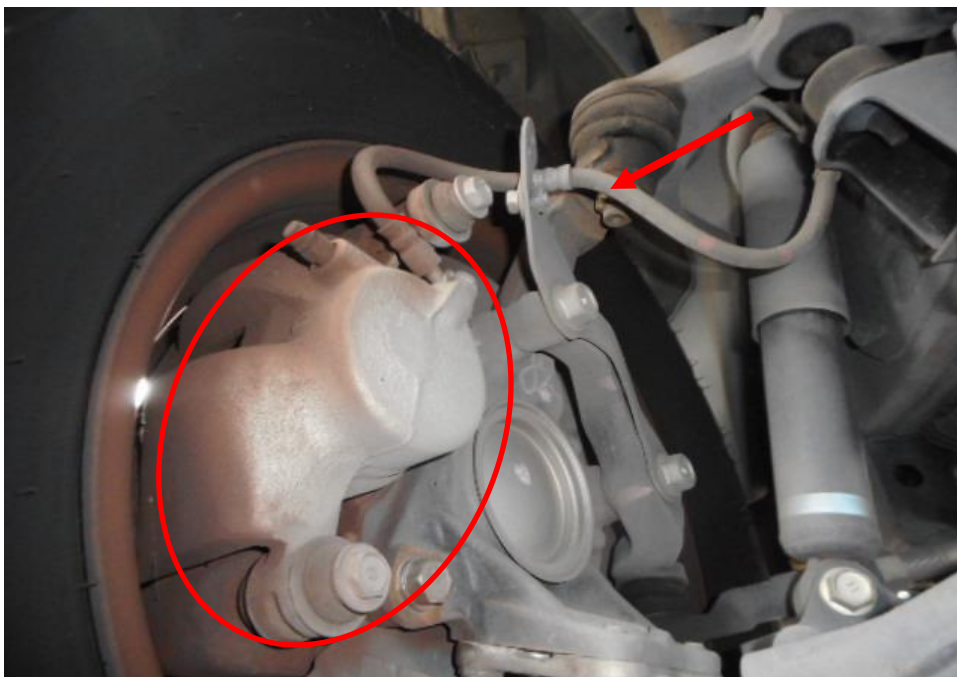
Photo 19 shows the brake hose/pipe (arrowed) at the front left wheel of the Motor Lorry. No leakage of brake fluid was observed. Visual examination of the various components of the braking system like the brake caliper (circled), brake booster, brake pedal etc had revealed all to be intact and without visible damage.

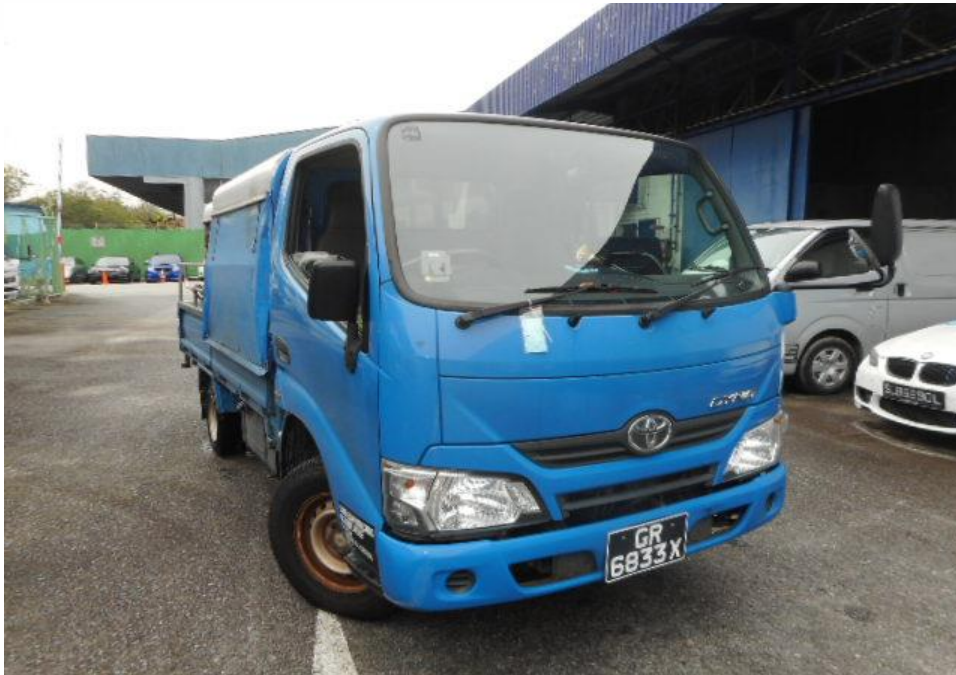
Photo 20 shows the front right wheel of the Motor Lorry turned to its full left. During my steering system test, I did not experience any abnormal free play and/or resistance when I had turned the steering wheel towards the left and right. This would suggest that the steering system of the Motor Lorry was likely to be in serviceable condition at the material time of accident.

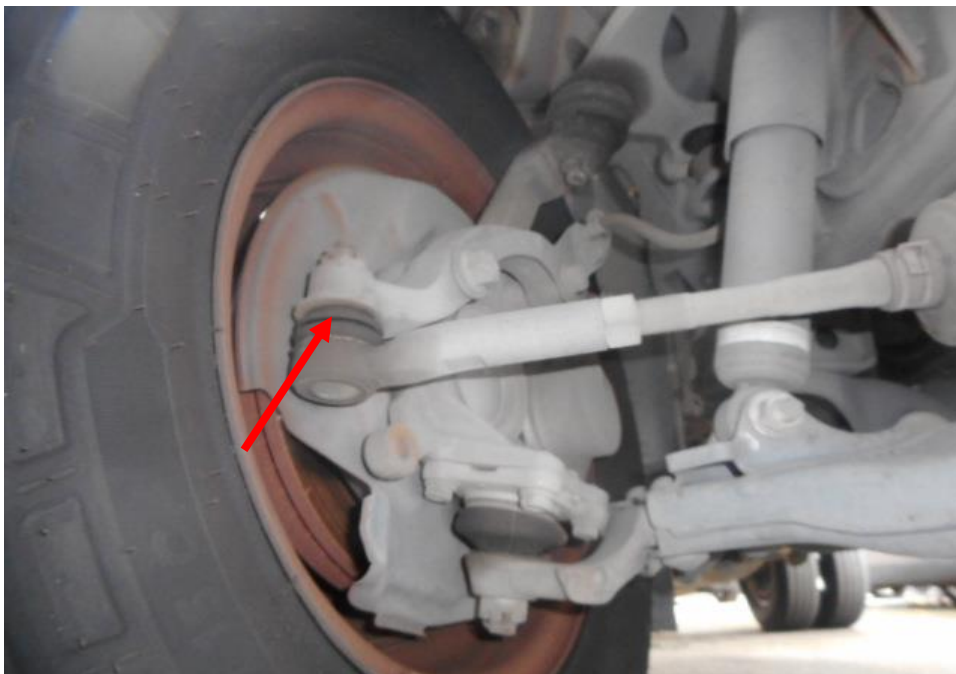
Photo 21 shows the various undercarriage components at the front right wheel of the Motor Lorry, in particular the steering tie rod (arrowed). The various steering components were all found to be intact, suggesting that the steering system of the Motor Lorry was likely to be in serviceable condition at the material time of accident. There was also no sign of fluid stain observed on the various undercarriage components at the front right wheel of the Motor Lorry.

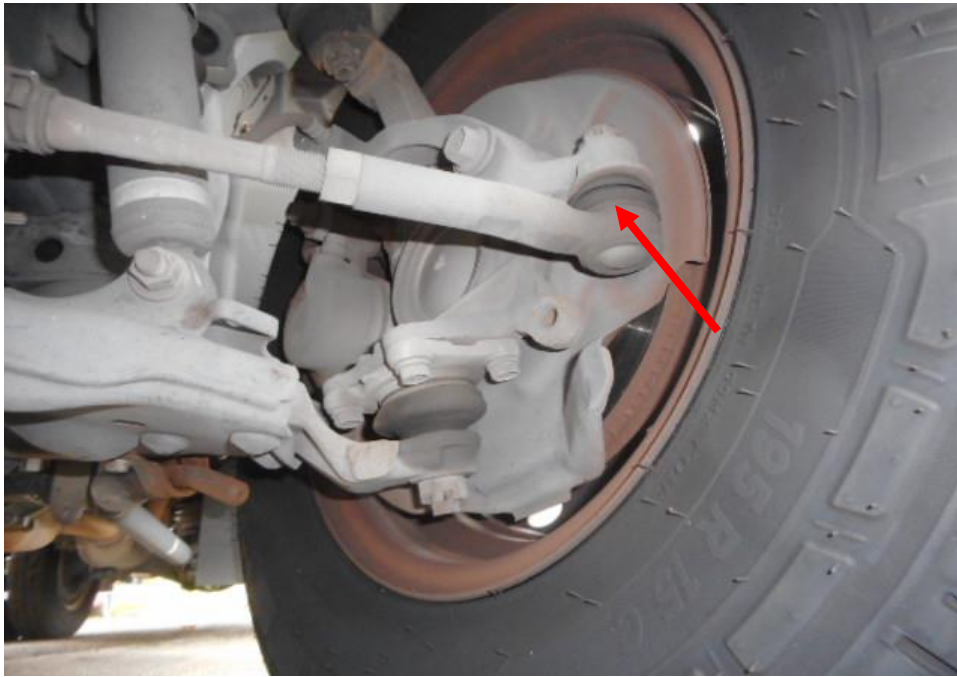
Photo 22 shows the various undercarriage components at the front left wheel of the Motor Lorry, which had included the steering tie rod (arrowed). The various undercarriage components of the Motor Lorry were all found to be intact without any visible damage.

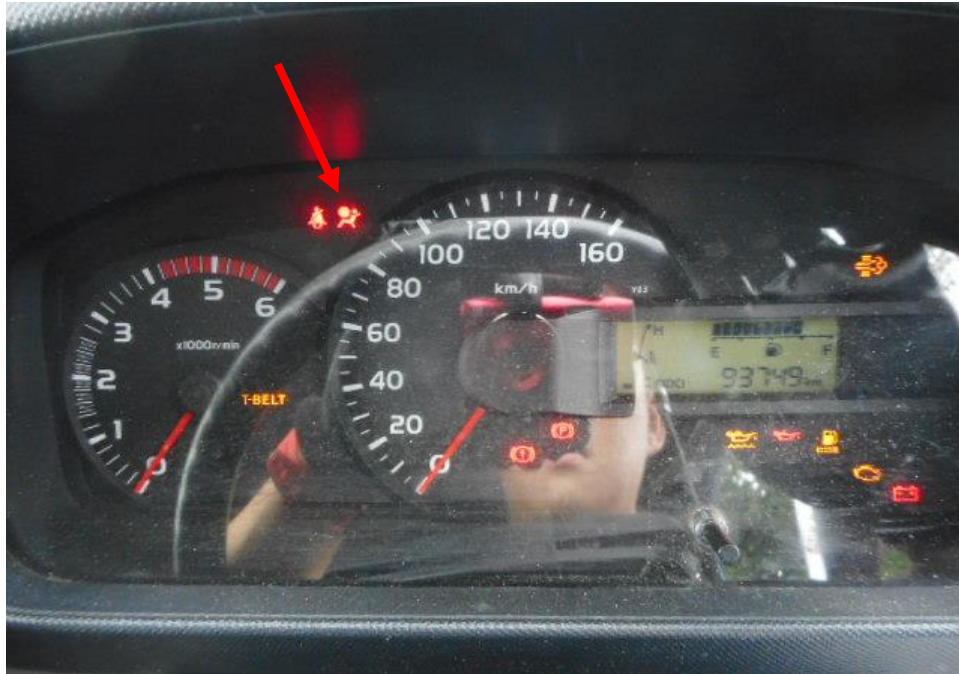
Photo 23 shows the warning light for Supplemental Restraint System (SRS) (arrowed) appearing on the instrument panel of the Motor Lorry during the self-test of its various electronic operating systems when its engine was cranked.

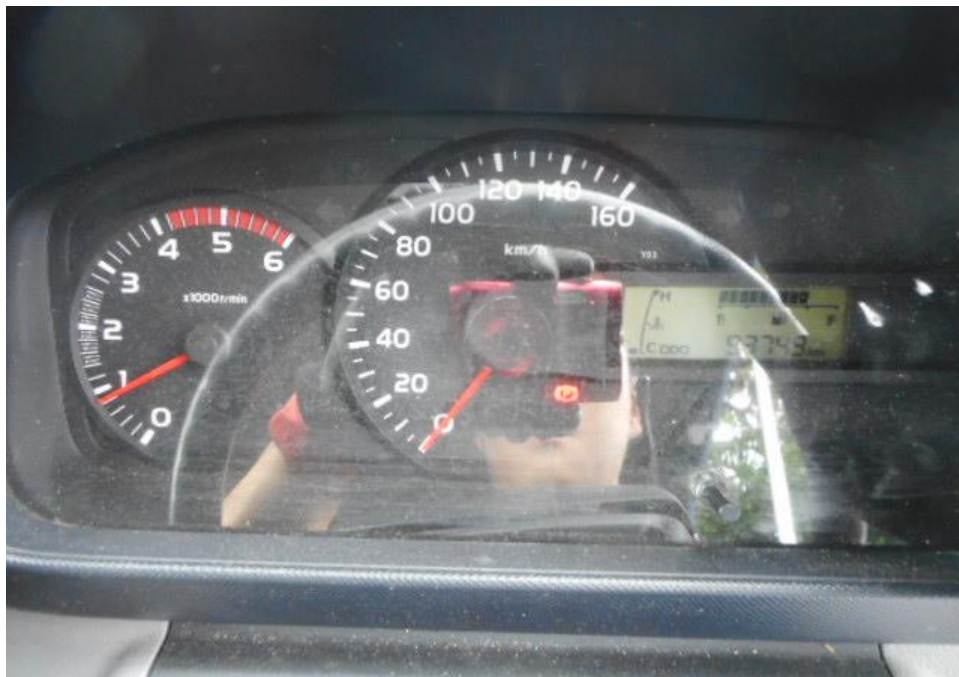
Photo 24 shows no warning lights illuminated on the instrument panel of the Motor Lorry after the engine was cranked. This would suggest that there was no abnormality to the electronic operating system of the Motor Lorry, like the SRS and etc.
