You're Ref: TP/IP/25951/2022  
Our Ref: CI/TPD22010895/P

**Fatal Accident Investigation Team**

**MECHANICAL INSPECTION REPORT OF MOTOR CAR SKU 1914R**

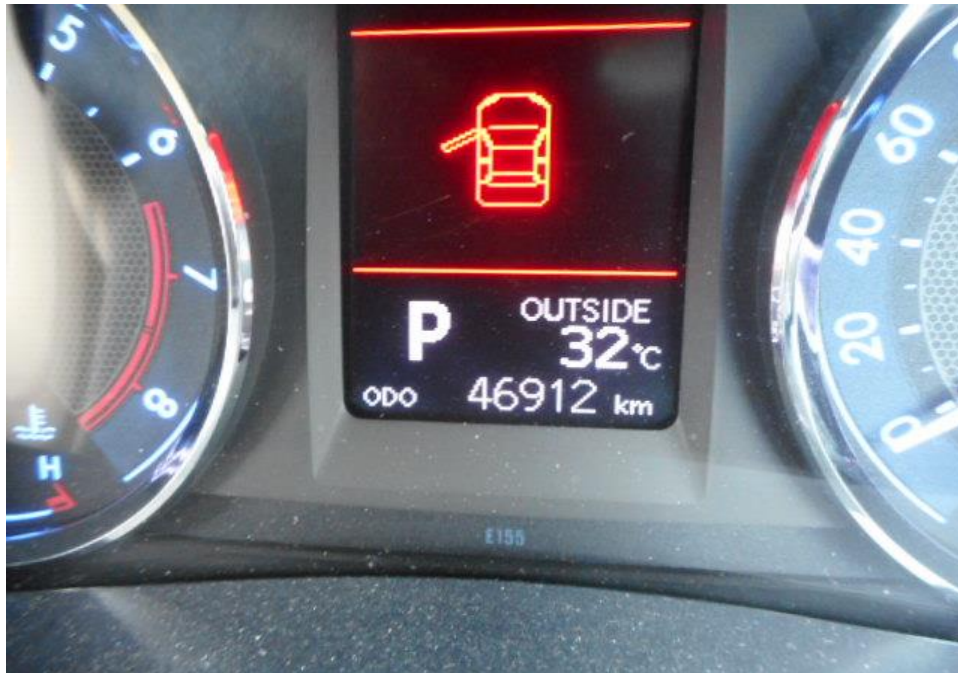
**Photo 1** shows the mileage of the Motor Car at the time of my inspection. The mileage observed was 46,912km.

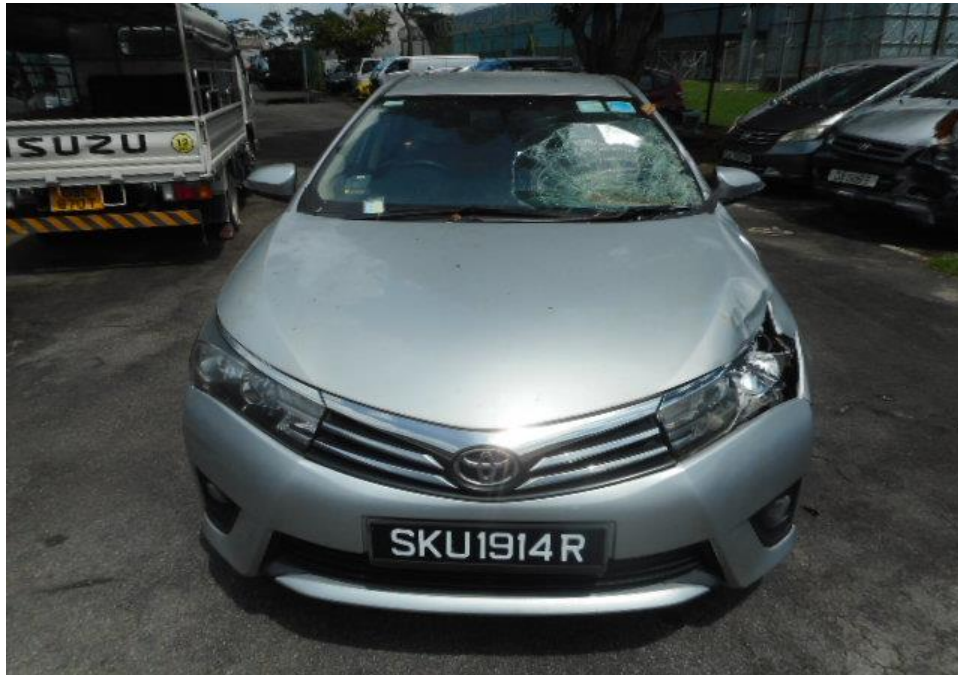
4. The mileage of the Motor Car at the time of my inspection was 46,912km.
5. The Motor Car was observed to have sustained damage at its front portion. Its front windscreen, front bonnet, front bumper, front left fender and front left headlamp plate was amongst the body parts that were damaged as a result of the accident.

**Photo 2** shows a general view of the Motor Car's front body at the time of my inspection. The front portion of the Motor Car was observed to have sustained damage. Its front windscreen, front bonnet, front bumper, front left fender and front left headlamp plate was amongst the body parts that were damaged as a result of the accident.

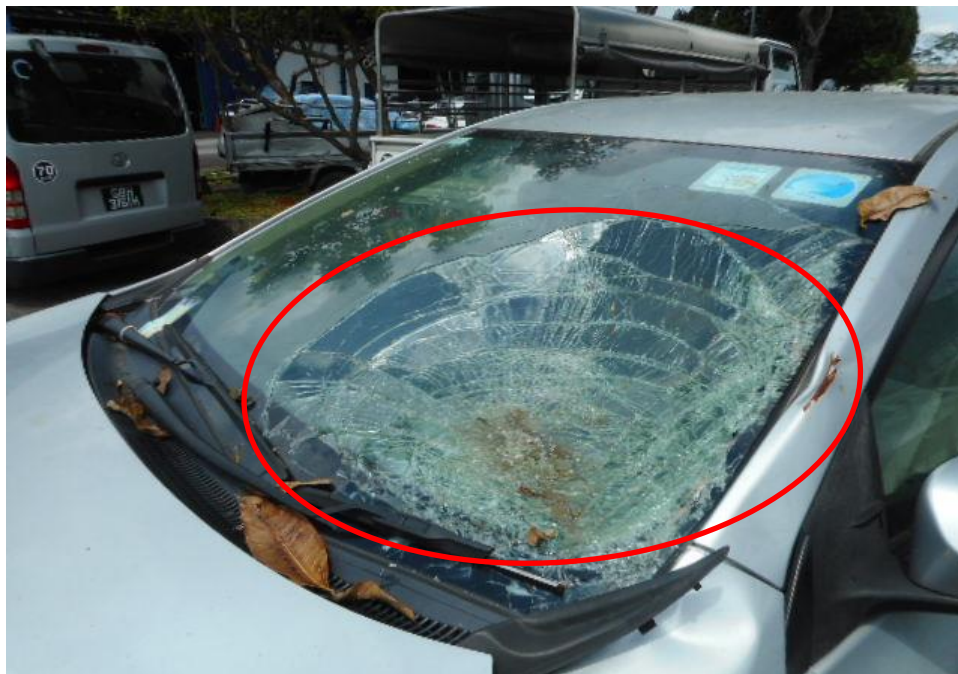
**Photo 3** shows a close up view of the Motor Car's front body at the time of my inspection. The front portion of the Motor Car was observed to have sustained damage. Its front windscreen (circled) was the body parts that were damaged as a result of the accident.

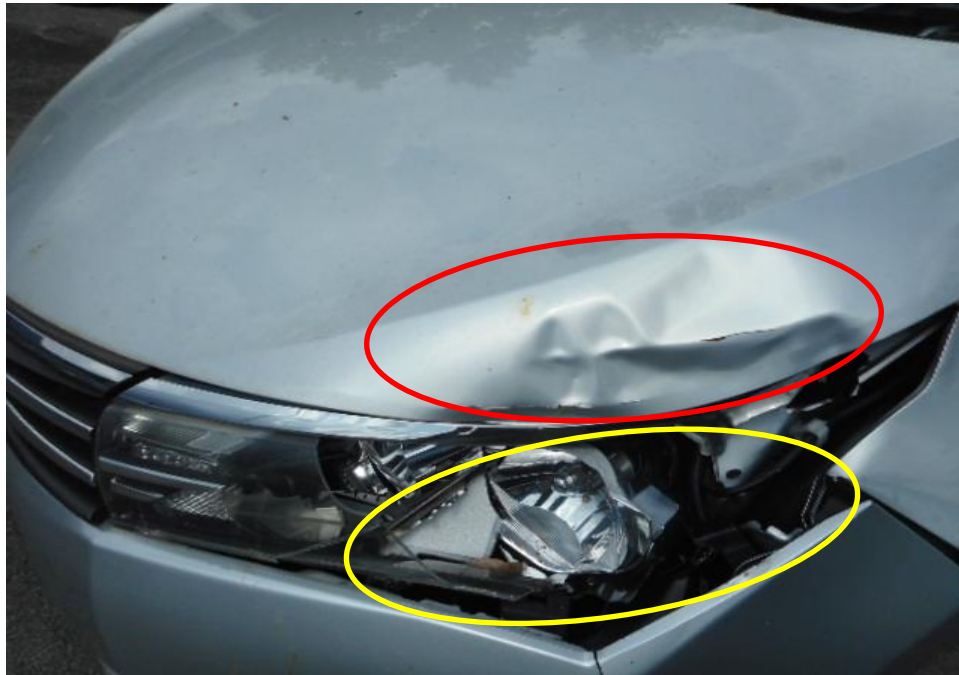
**Photo 4** shows a close up view of the Motor Car's front body at the time of my inspection. The front portion of the Motor Car was observed to have sustained damage. Its front bonnet (red circle) and front left headlamp (yellow circle) was the body parts that were damaged as a result of the accident.

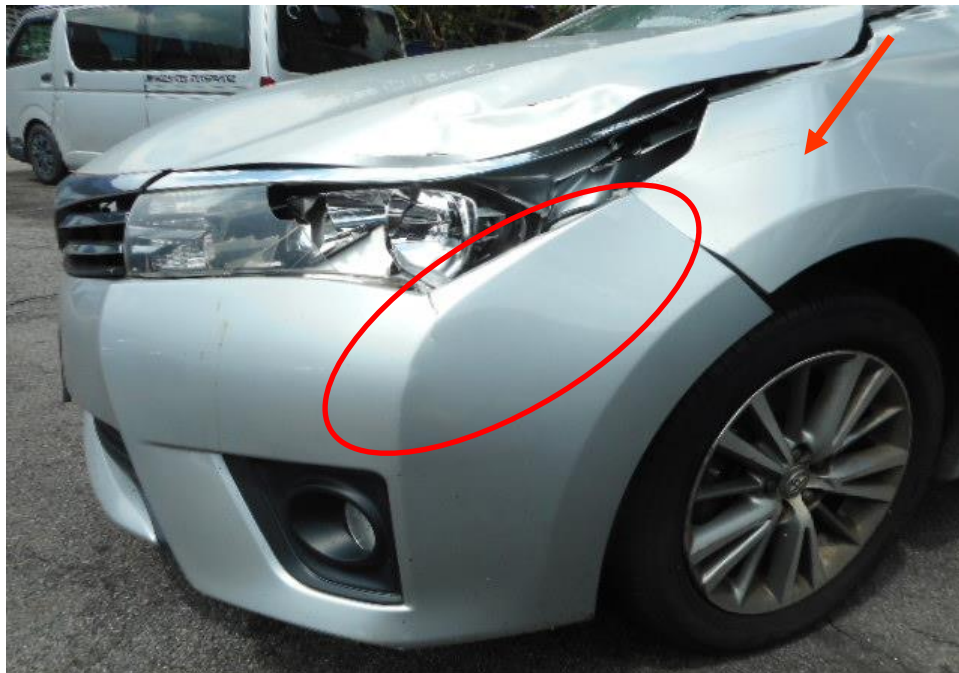
**Photo 5** shows a close up view of the Motor Car's front body at the time of my inspection. The front portion of the Motor Car was observed to have sustained damage. Its front bumper (circled) and front left fender (arrowed) was the body parts that were damaged as a result of the accident.

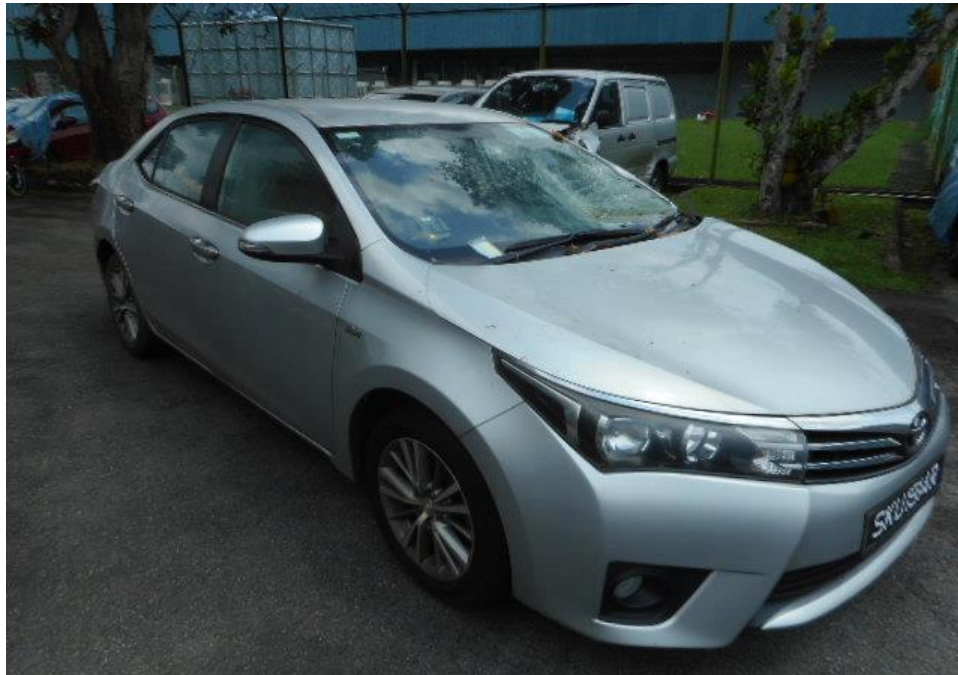
**Photo 6** shows a general view of the Motor Car's right body at the time of my inspection. The right portion of the Motor Car was observed to have been unaffected by the accident.

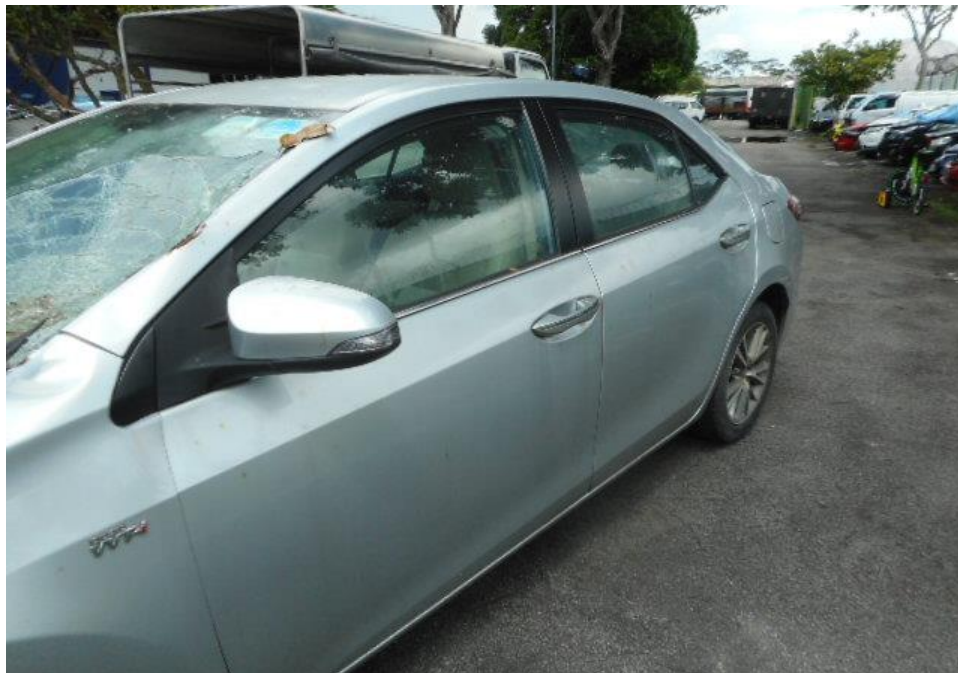
**Photo 7** shows a general view of the Motor Car's left body at the time of my inspection. The left portion of the Motor Car was observed to have been unaffected by the accident.

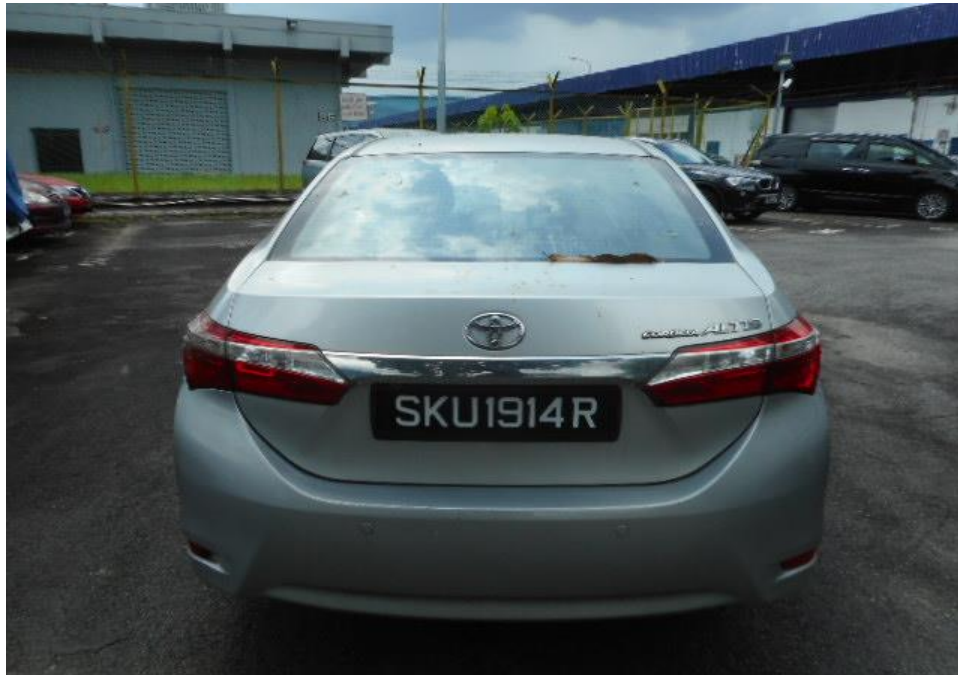
**Photo 8** shows the general view of the Motor Car's rear body at the time of my inspection. The Motor Car rear was observed to be unaffected by the accident.

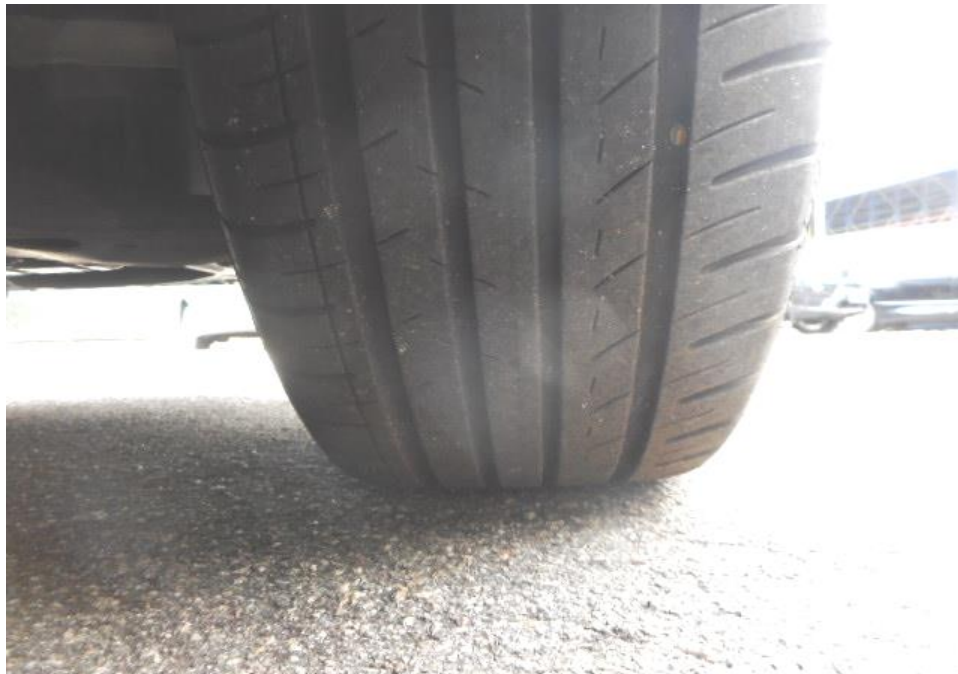
**Photo 9** shows the condition of the front right tyre of the Motor Car, which was observed to be in serviceable condition with remaining tread depth of approximately 4.8mm. The tyre was sufficiently inflated for vehicular operation with no tear, cut or burst mark(s) on the outer and the inner sidewalls as well as across the tread. The 4 tyres of the Motor Car were wrapped around standard steel wheel rims without any damage.

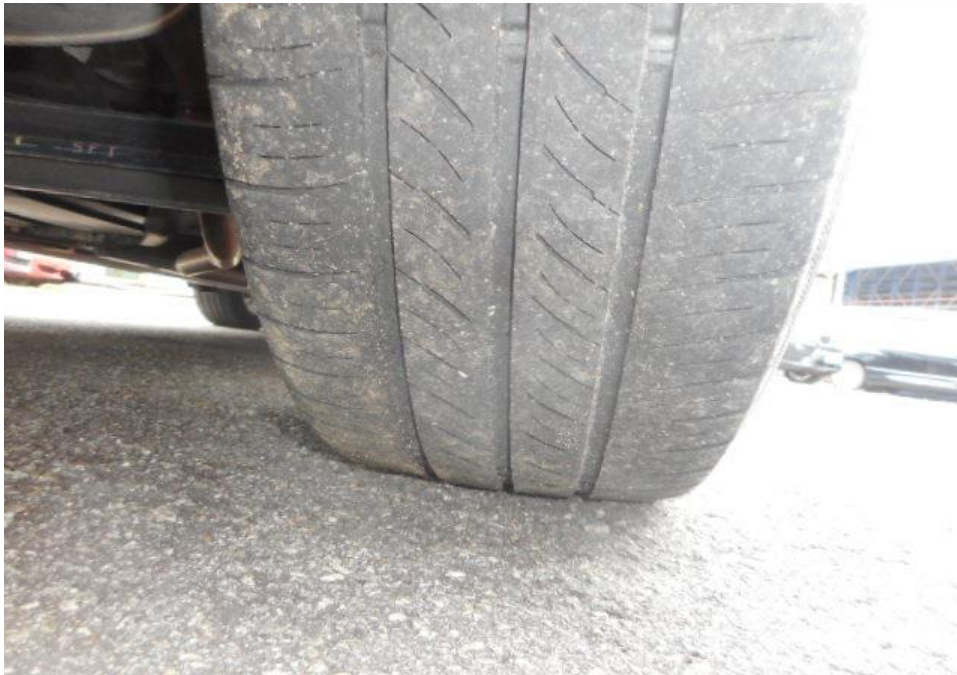
**Photo 10** shows the condition of the rear right tyre of the Motor Car, which was observed to be in serviceable condition with remaining tread depth of approximately 4mm. The tyre was also observed to be sufficiently inflated for vehicular operation with no tear, cut or burst mark(s).

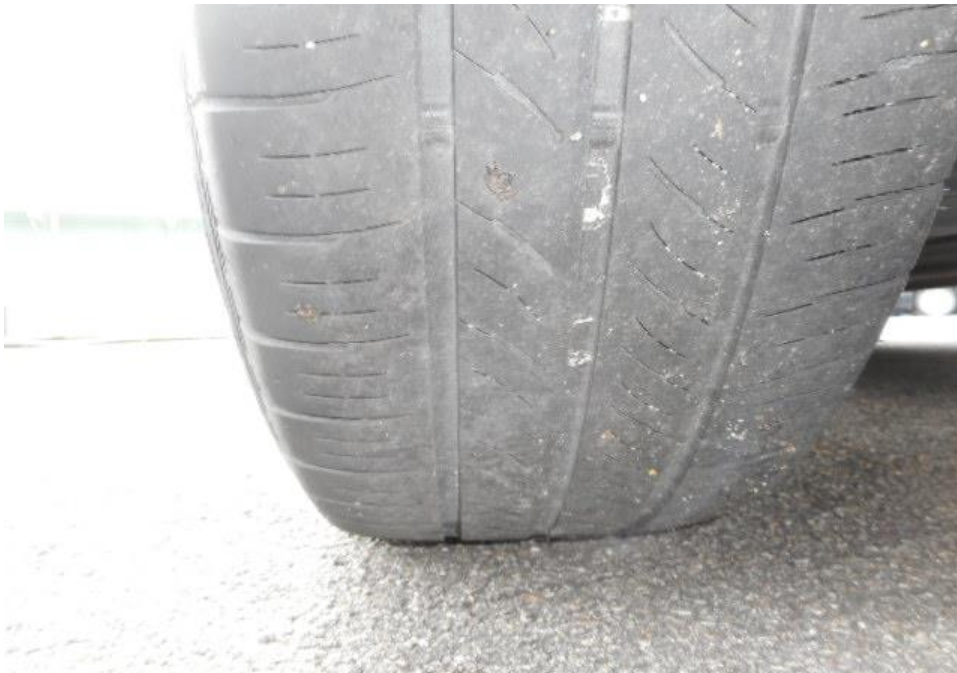
**Photo 11** shows the condition of the rear left tyre of the Motor Car, which was observed to be in serviceable condition with remaining tread depth of approximately 2.6mm. The tyre, which was wrapped around steel wheel rim, was also observed to be sufficiently inflated for vehicular operation. The 4 tyres of the Motor Car were wrapped around standard steel wheel rims.

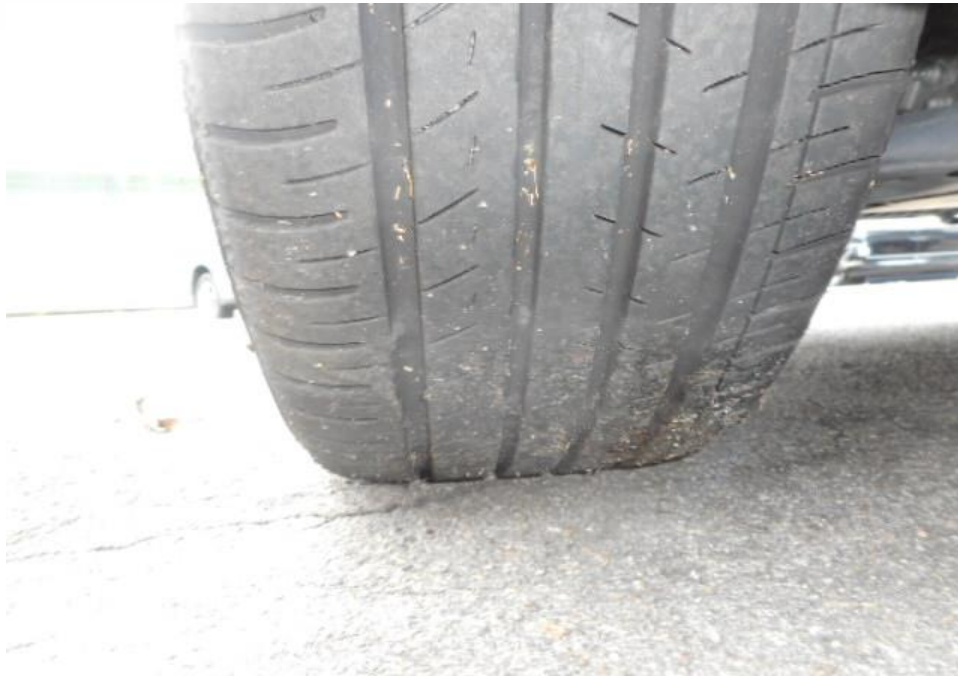
**Photo 12** shows the condition of the front left tyre of the Motor Car, which was observed to be in serviceable condition with remaining tread depth of approximately 5.5mm. There was also no tear, cut or burst mark(s) on the outer and the inner sidewalls as well as across the tread of the Motor Car's 4 tyres.

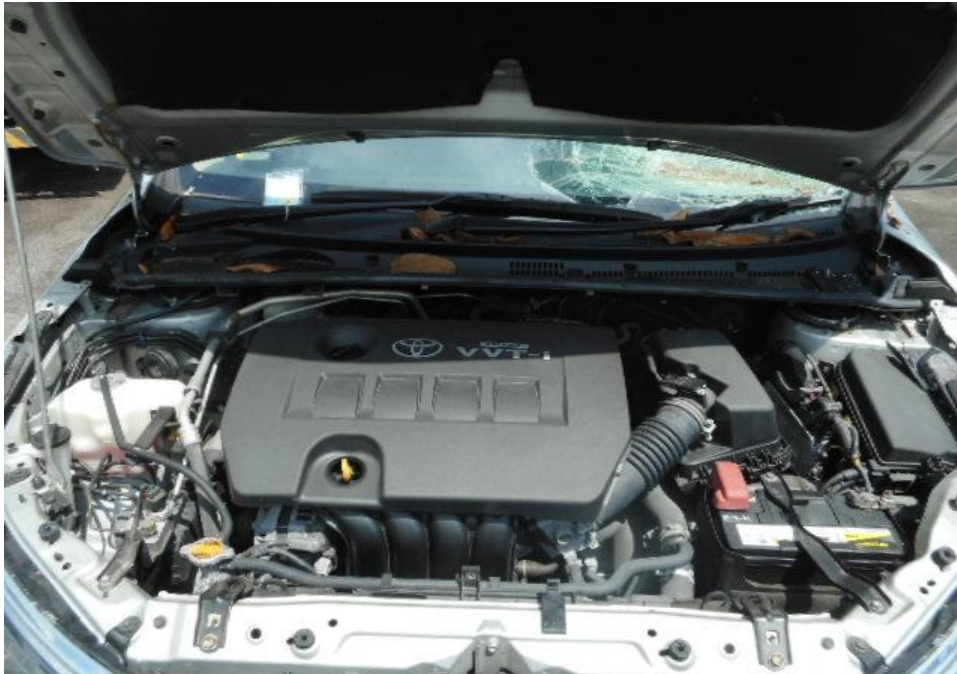
**Photo 13** shows a general view of the Motor Car's engine compartment. The various parts and components inside the engine compartment were unaffected by the accident. There was also no sign(s) or indication(s) of fluid leakage and/or fluid stain within the engine compartment.

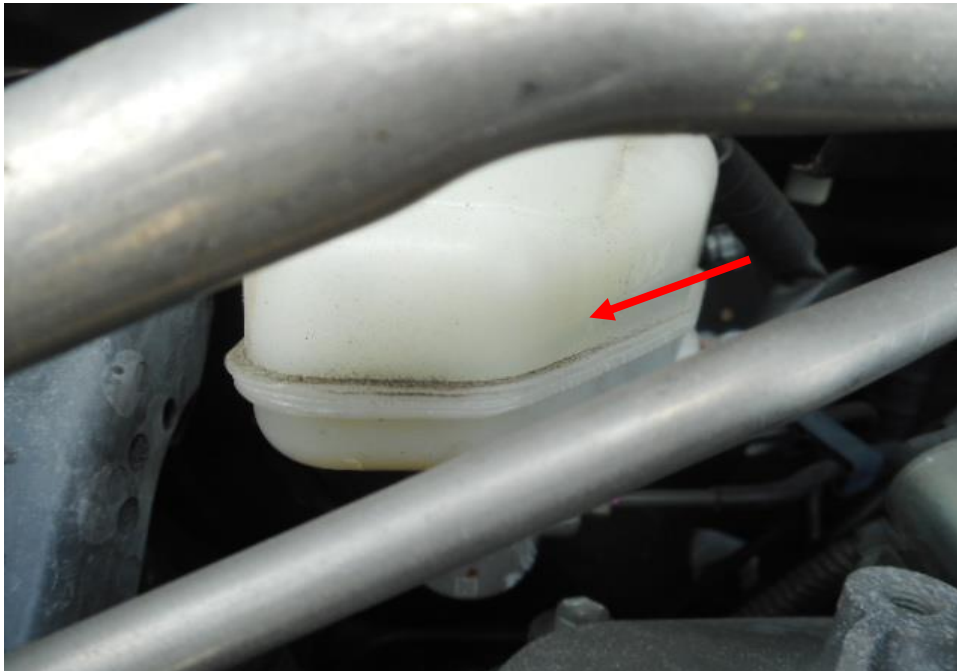
**Photo 14** shows the brake fluid reservoir of the Motor Car at the time of my inspection. The brake fluid was observed to be of sufficient level (arrowed) and without any visible contamination.

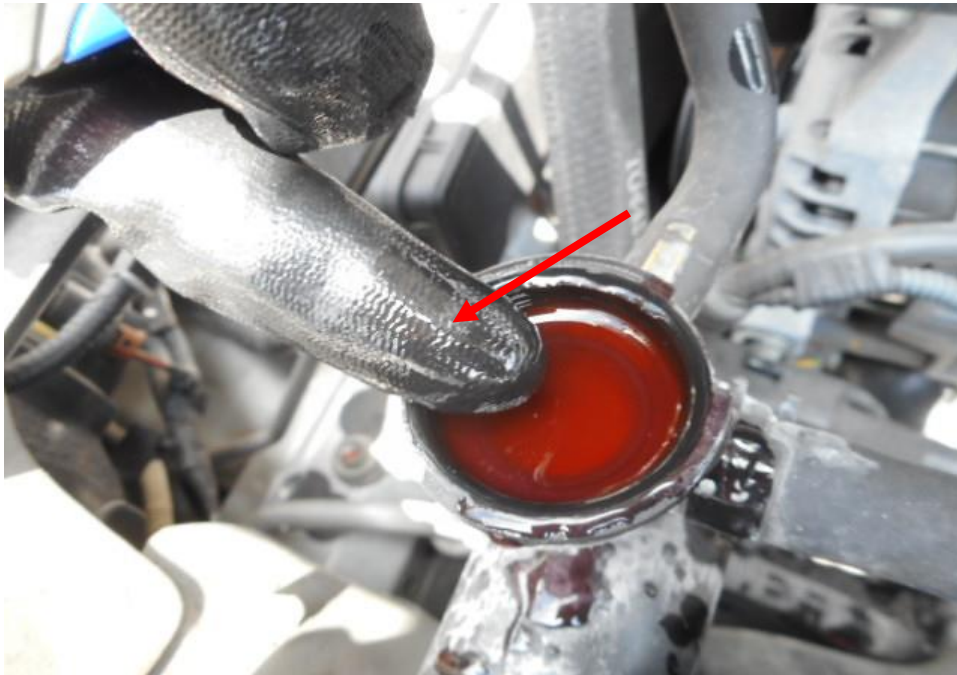
**Photo 15** shows checks being carried out to the engine coolant of the Motor Car at the time of my inspection. The engine coolant was observed to be of sufficient level (arrowed) and without any visible contamination.

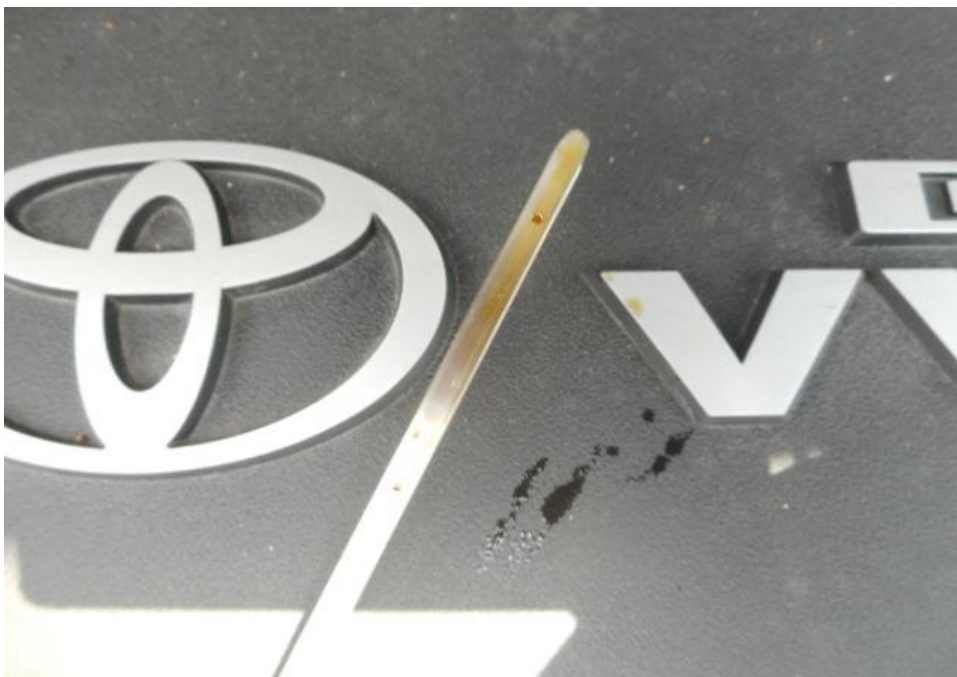
**Photo 16** shows the engine oil dipstick of the Motor Car at the time of my inspection. The engine oil was observed to be of sufficient level and without any visible contamination.

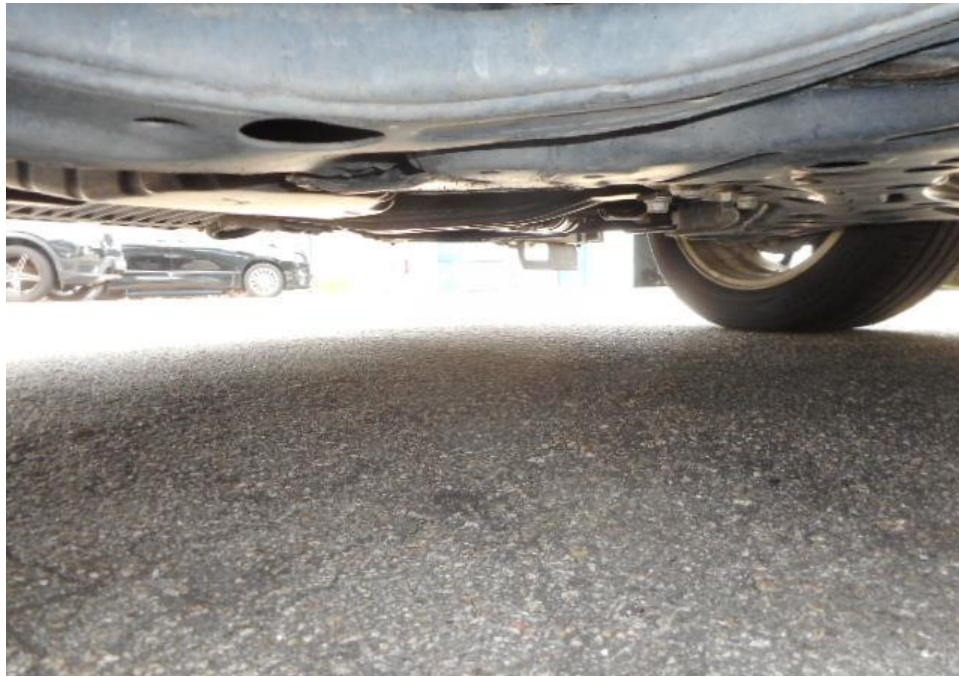
**Photo 17** shows the undercarriage of the Motor Car, at the area where the engine housing and transmission housing are located. I did not find any sign(s) or indication(s) of fluid leak and/or fluid stain(s) on the underside of the Motor Car.

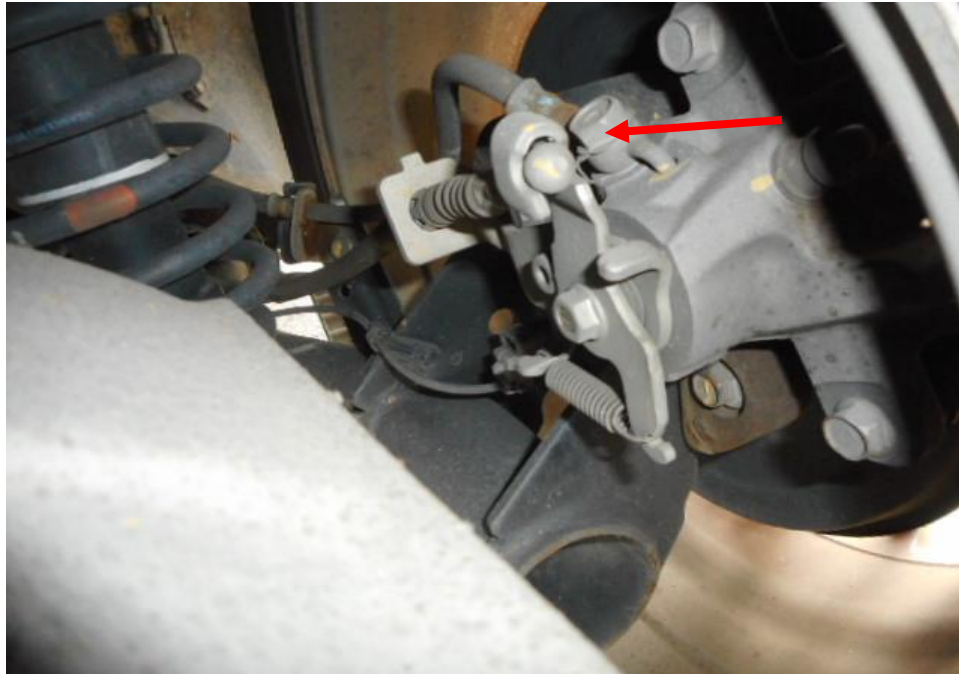
**Photo 18** shows the brake hose/pipe (arrowed) at the rear right wheel of the Motor Car. No leakage of brake fluid was observed. Visual examination of the various components of the braking system like the drum brake, brake booster, brake pedal etc. had revealed all to be intact and without visible damage.

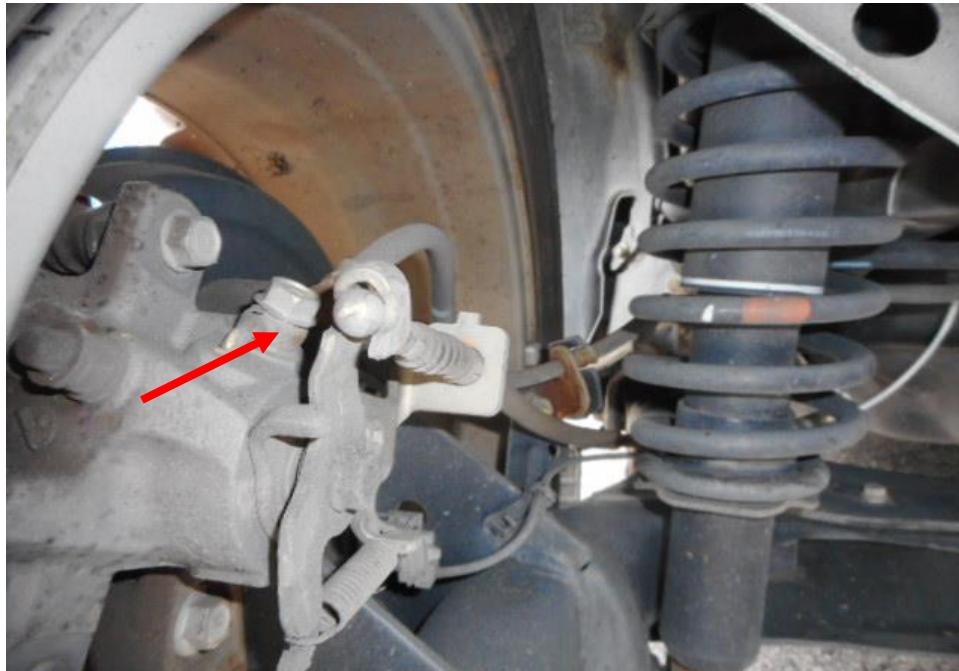
**Photo 19** shows the brake hose/pipe (arrowed) at the rear left wheel of the Motor Car. I did not observe any leakage of brake fluid at the time of my inspection of the Motor Car. Static tests of the Motor Car's braking system had indicated that there was no internal leakage of pressure/vacuum. The undercarriage components of the Motor Car were also all found to be intact and without any visible damage.

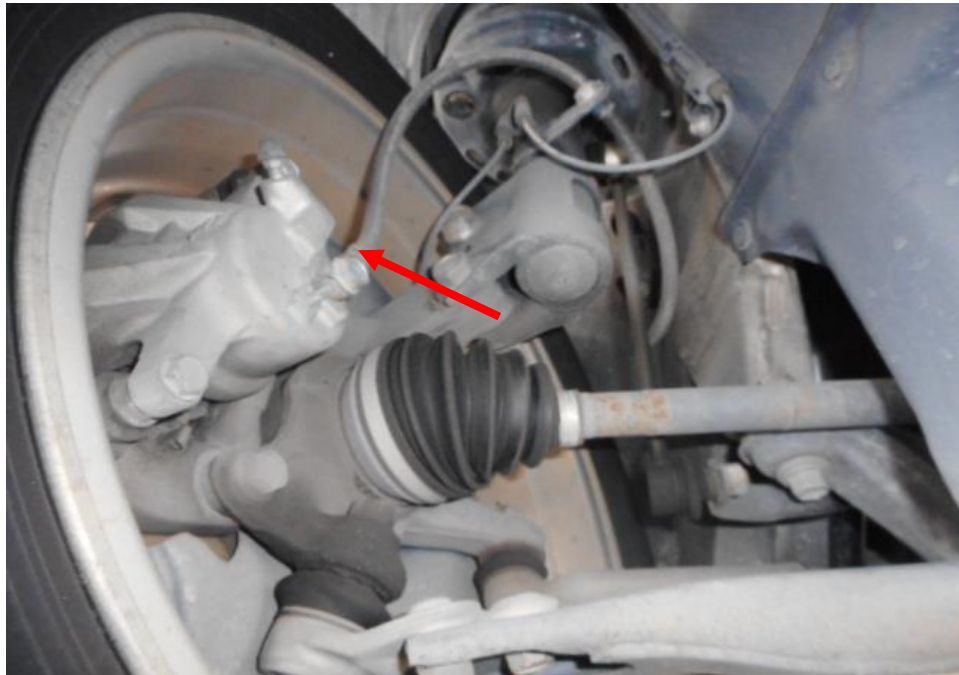
**Photo 20** shows the brake hose/pipe (arrowed) at the front right wheel of the Motor Car. I did not observe any leakage of brake fluid at the time of my inspection of the Motor Car. Static tests of the Motor Car's braking system had indicated that there was no internal leakage of pressure/vacuum. The undercarriage components of the Motor Car were also all found to be intact and without any visible damage.

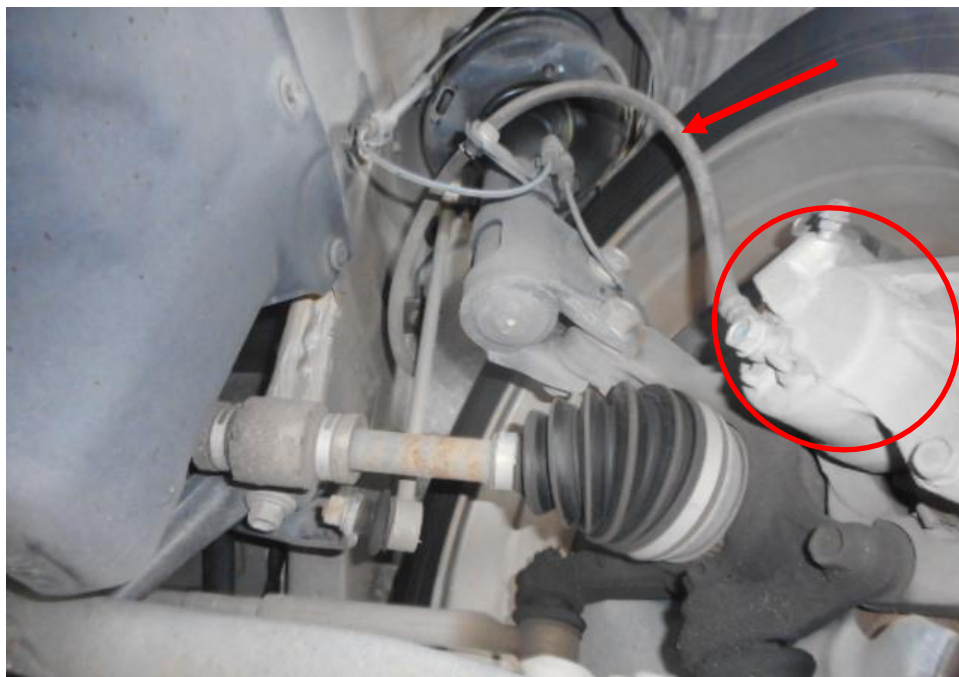
**Photo 21** shows the brake hose/pipe (arrowed) at the front left wheel of the Motor Car. No leakage of brake fluid was observed. Visual examination of the various components of the braking system like the brake caliper (circled), brake booster, brake pedal etc had revealed all to be intact and without visible damage.

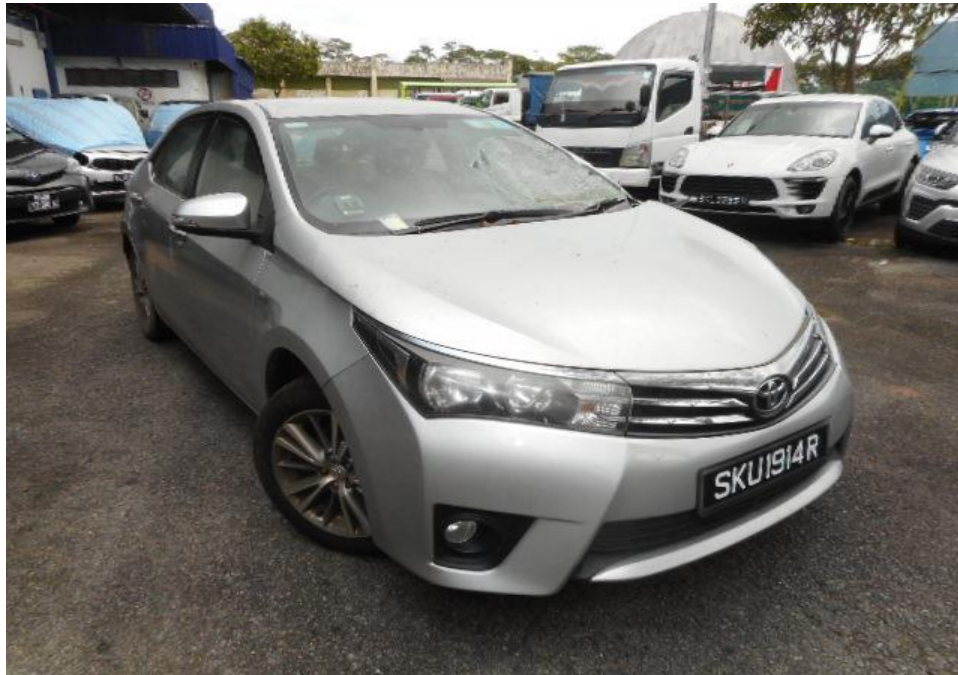
**Photo 22** shows the front right wheel of the Motor Car turned to its full left. During my steering system test, I did not experience any abnormal free play and/or resistance when I had turned the steering wheel towards the left and right. This would suggest that the steering system of the Motor Car was likely to be in serviceable condition at the material time of accident.

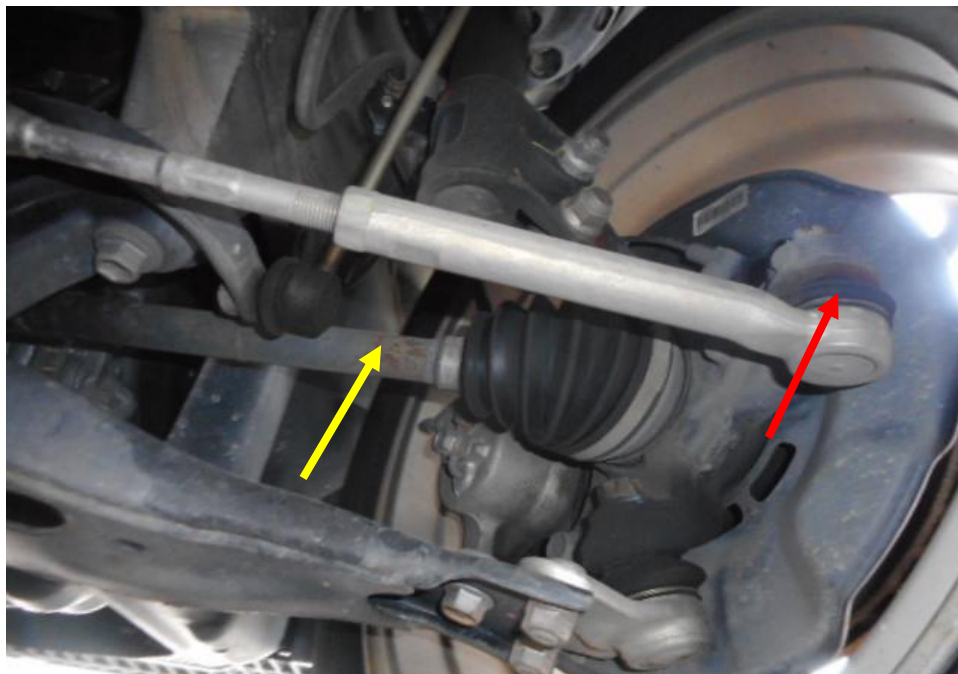
**Photo 23** shows the various undercarriage components at the front right wheel of the Motor Car, in particular the steering tie rod (red arrow) and drive shaft (yellow arrow). The various steering components were all found to be intact, suggesting that the steering system of the Motor Car was likely to be in serviceable condition at the material time of accident. There was also no sign of fluid stain observed on the various undercarriage components at the front right wheel of the Motor Car.

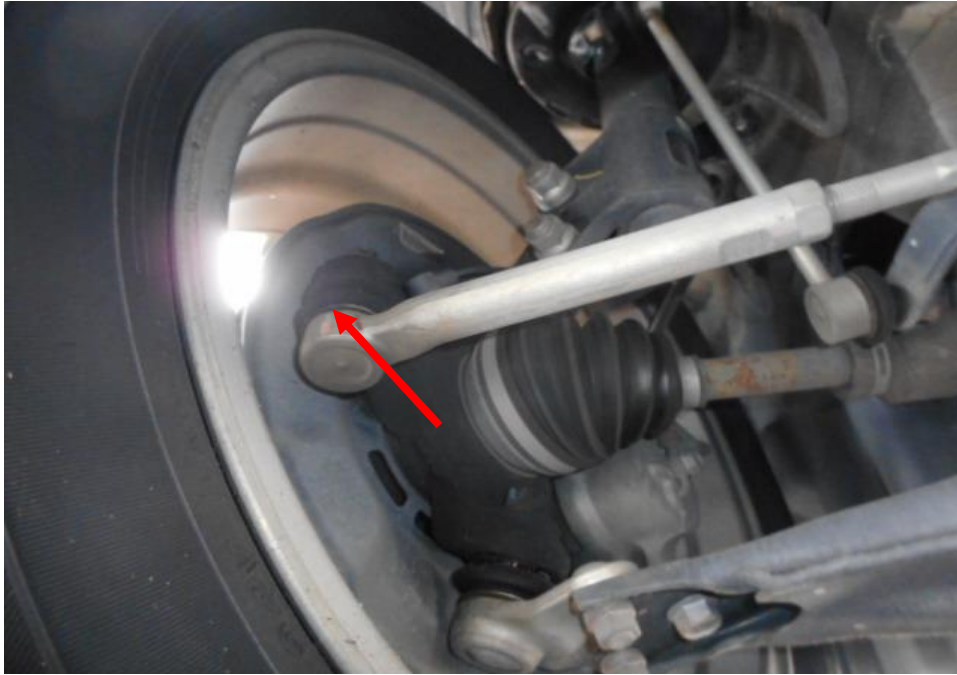
**Photo 24** shows the various undercarriage components at the front left wheel of the Motor Car, which had included the steering tie rod (red arrow). The various undercarriage components of the Motor Car were all found to be intact without any visible damage.

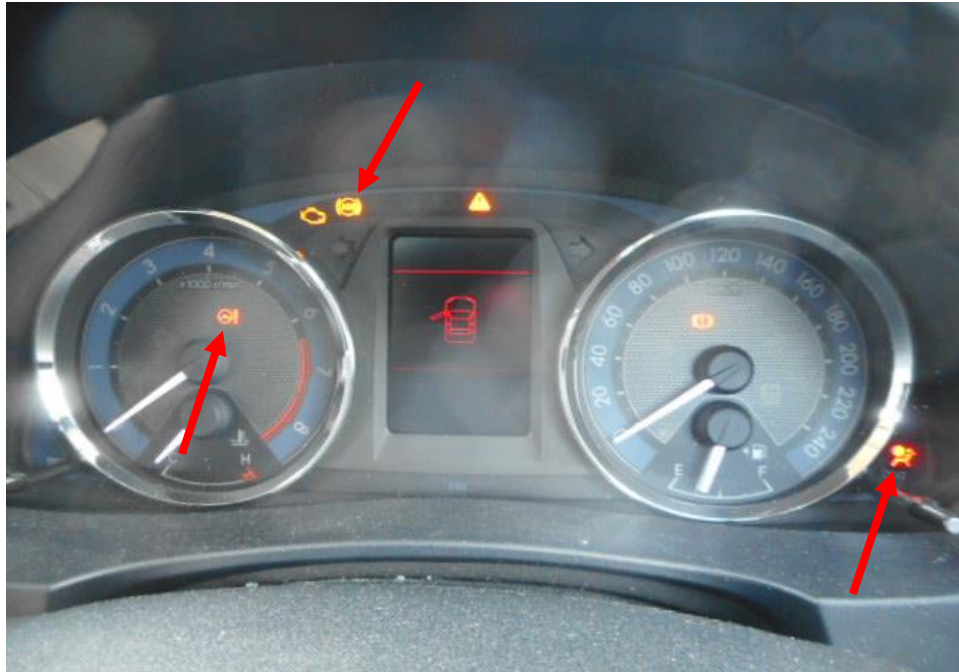
**Photo 25** shows the warning light for Anti-Lock Brake System (ABS), Electric Power Steering System (EPS) and Supplemental Restraint System (SRS) (arrowed) appearing on the instrument panel of the Motor Car during the self-test of its various electronic operating systems when its engine was cranked.

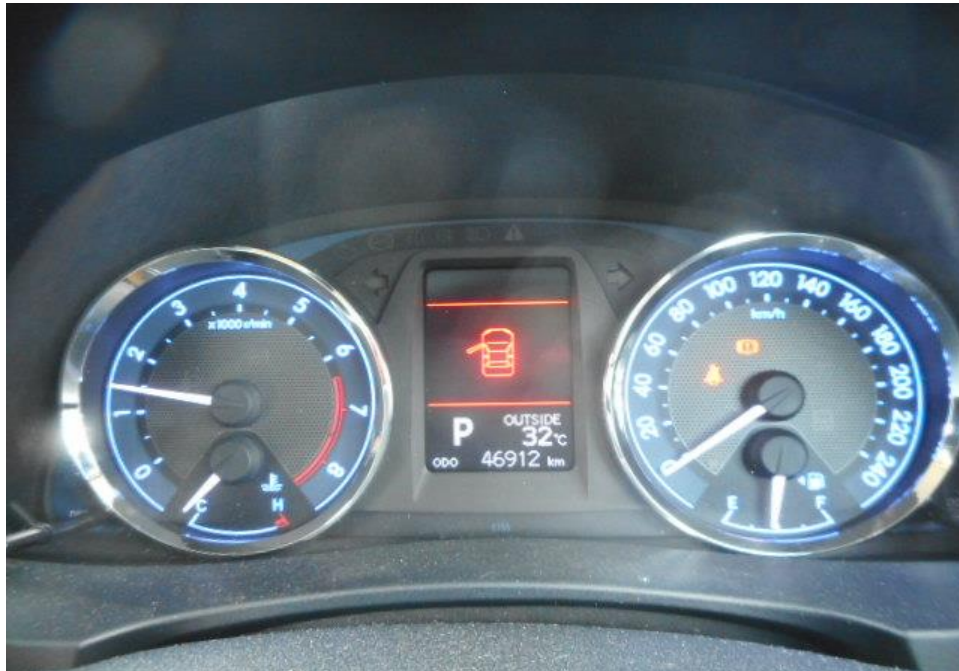
**Photo 26** shows no warning lights illuminated on the instrument panel of the Motor Car after the engine was cranked. This would suggest that there was no abnormality to the electronic operating system of the Motor Car, like the ABS, TCS and SRS etc.
