Your Ref: TP/IP/27360/2022  
Our Ref : CI/TPD22010898/P

**Fatal Accident Investigation Team**

**MECHANICAL INSPECTION REPORT OF MOTOR BUS SG 1226Y**

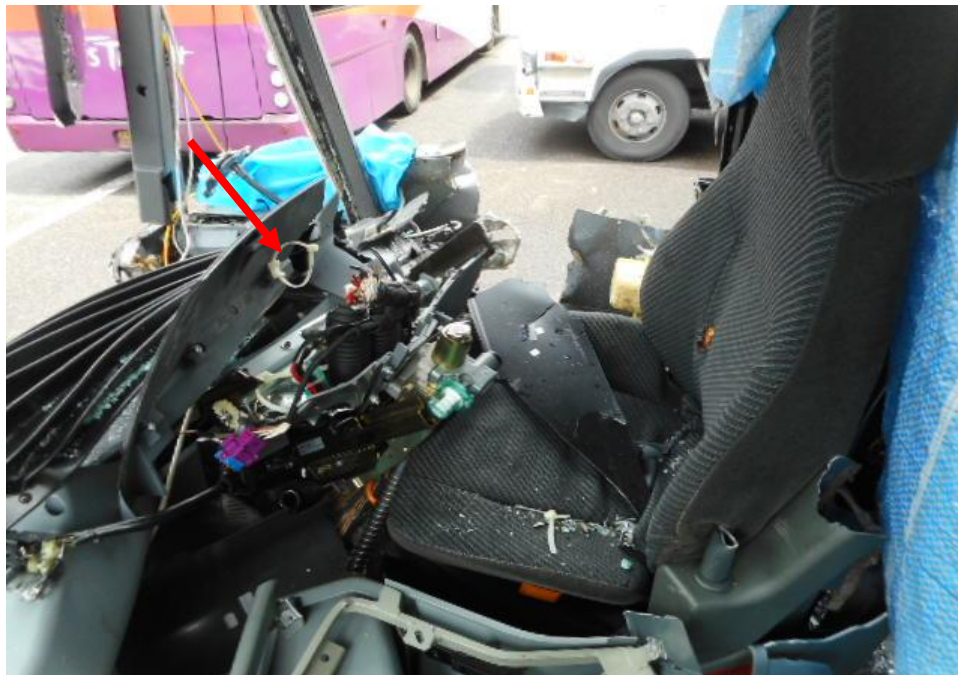
4. The mileage of the Motor Bus at the time of our inspection was not able to be recorded as the whole dashboard including the odometer has been damaged by the accident.
5. The Motor Bus was observed to sustained damage at its front portion. Its front cabin structure, front windscreen, front bumper, front body panel and front door was damaged as a result of the accident.

**Photo 1** shows the damaged instrument cluster (arrowed). Therefore no mileage is recorded at the time of our inspection.

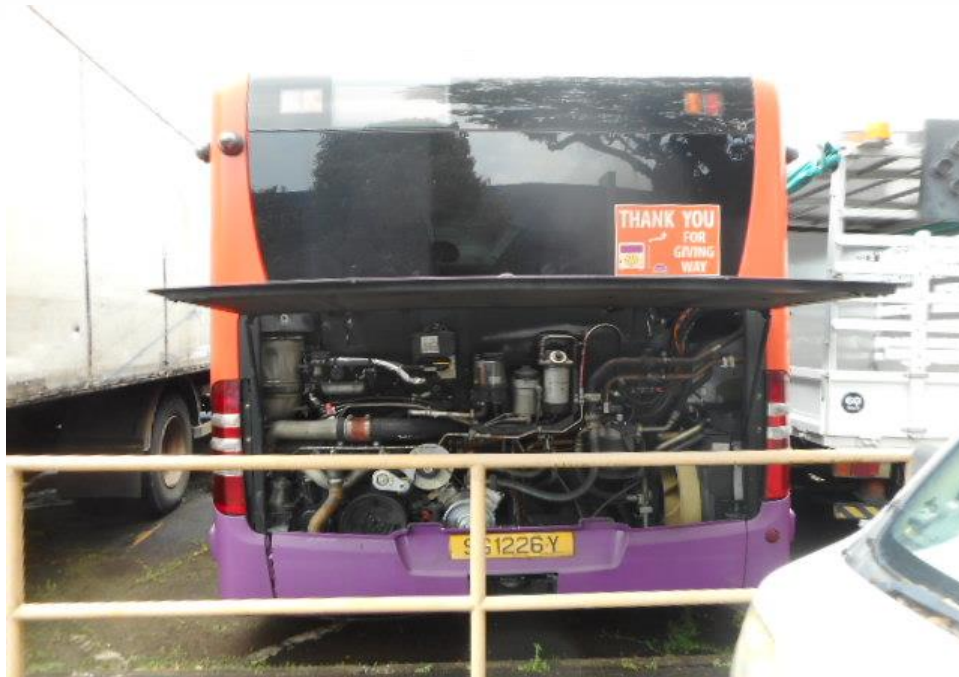
**Photo 2** shows a close up view of the rear portion of the Motor Bus at the time of our inspection. The rear portion of the Motor Bus was observed to have been unaffected by the accident

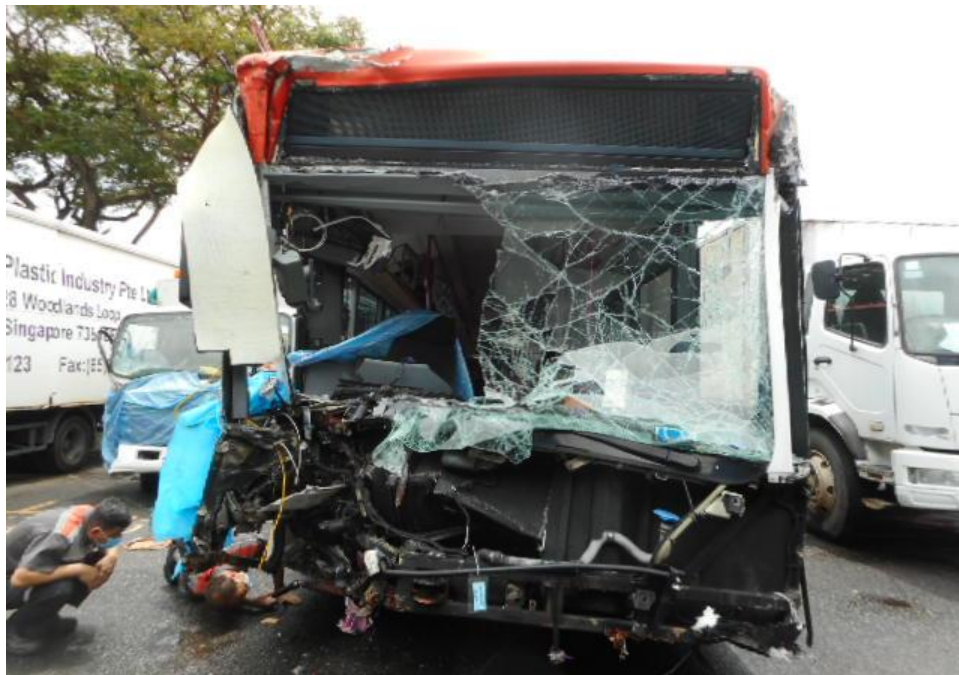
**Photo 3** shows a general view of the front body of the Motor Bus at the time of my inspection. The Motor Bus was observed to sustained damage at its front portion. Its front cabin structure, front windscreen, front bumper, front body panel, front door was damaged as a result of the accident.

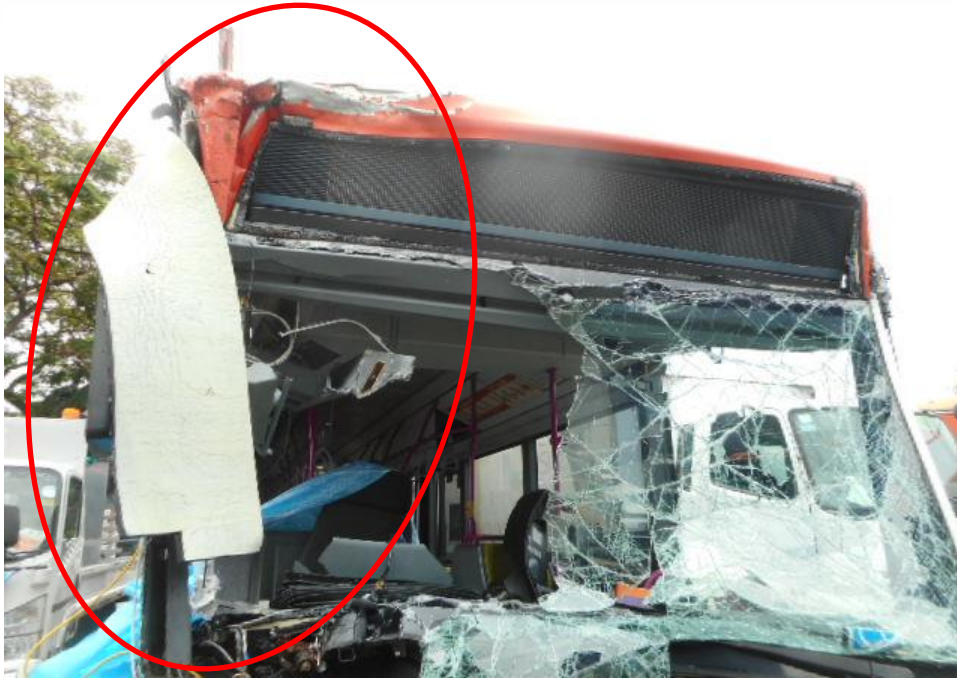
**Photo 4** shows a close up view of the front body of the Motor Bus at the time of my inspection. The Motor Bus was observed to sustained damage at its front portion. Its front cabin structure (circled) were damage at the time of my inspection as a result of the accident.

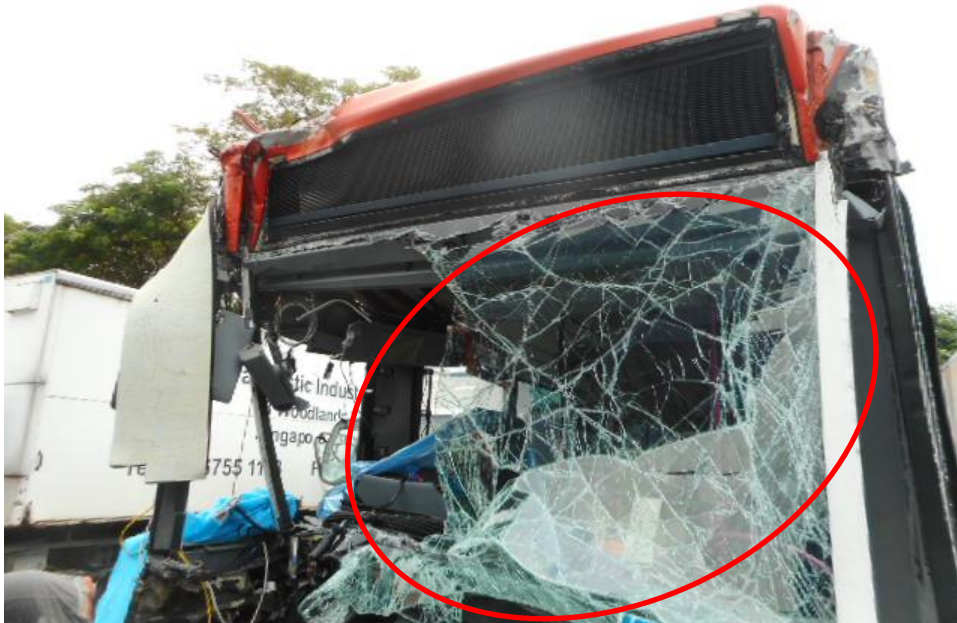
**Photo 5** shows a close up view of the front body of the Motor Bus at the time of my inspection. The Motor Bus was observed to sustained damage at its front portion. Its front windscreen (circled) were damage at the time of my inspection as a result of the accident.

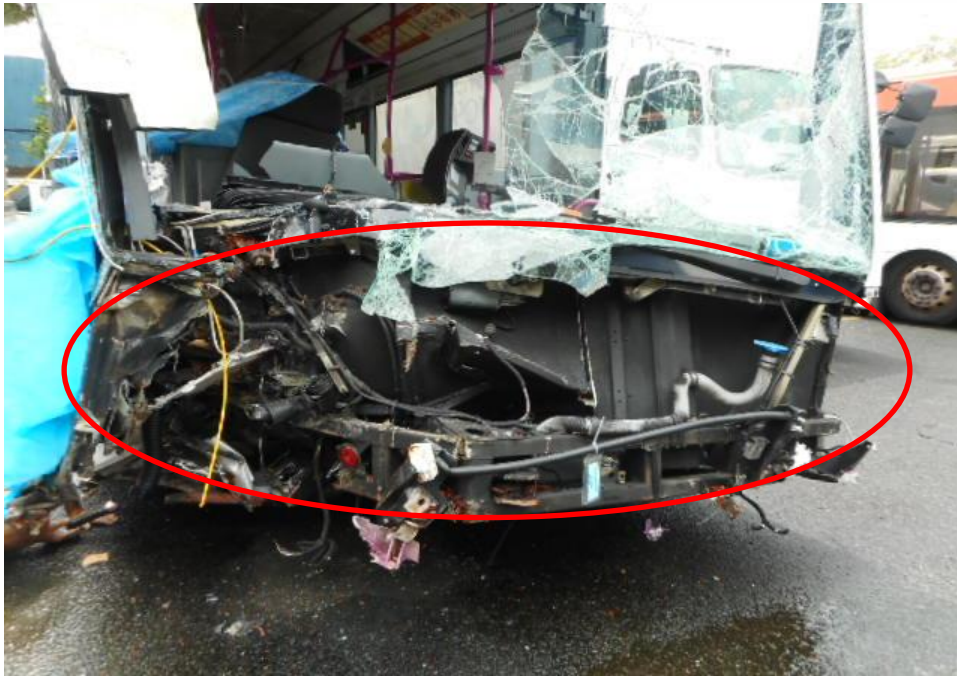
**Photo 6** shows a close up view of the front body of the Motor Bus at the time of my inspection. The Motor Bus was observed to sustained damage at its front portion. Its front bumper and front body panel (circled) were damage at the time of my inspection as a result of the accident.

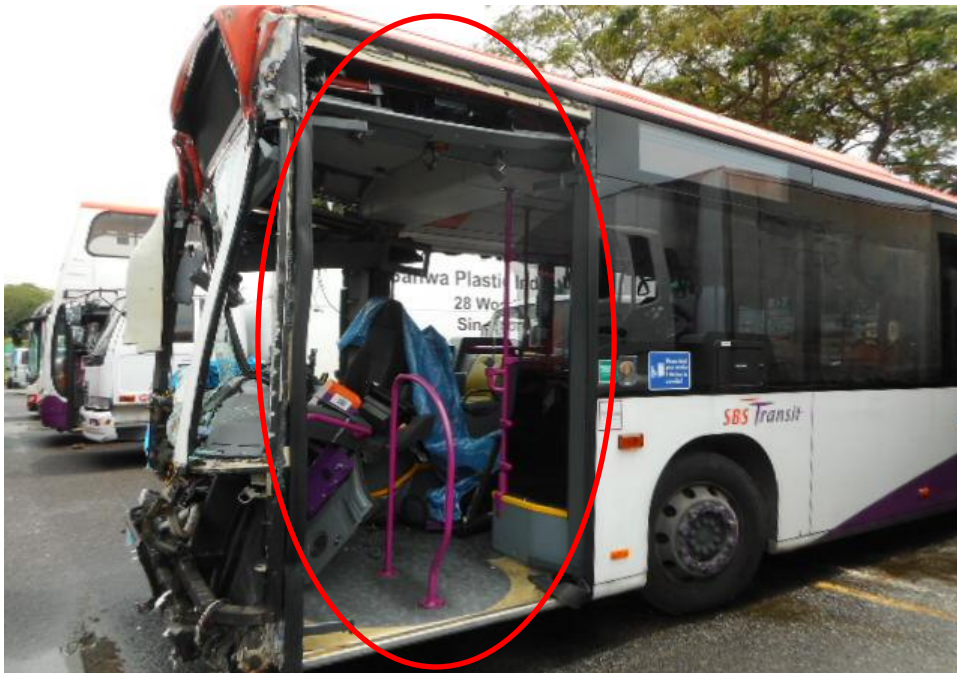
**Photo 7** shows a close up of the left body of the Motor Bus at the time of my inspection. The Motor Bus was observed to sustained damage at its front portion. Its front door (circled) were damage at the time of my inspection as a result of the accident.

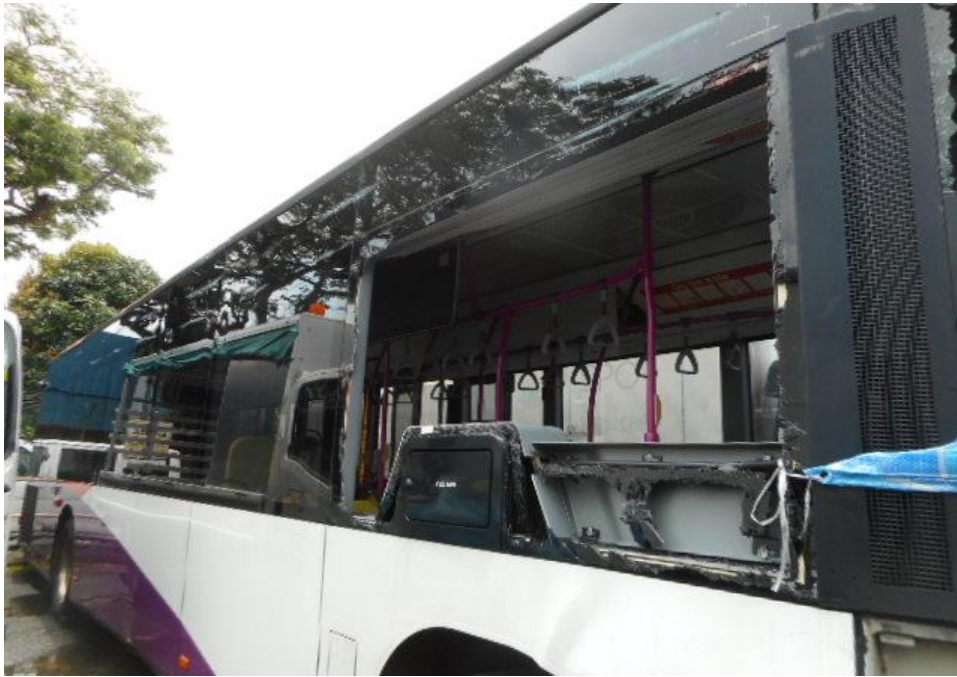
**Photo 8** shows a close up view of the right portion of the Motor Bus at the time of our inspection. The right portion of the Motor Bus was observed to have been unaffected by the accident. However, the windscreen was removed by the SCDF officers for rescue procedures.

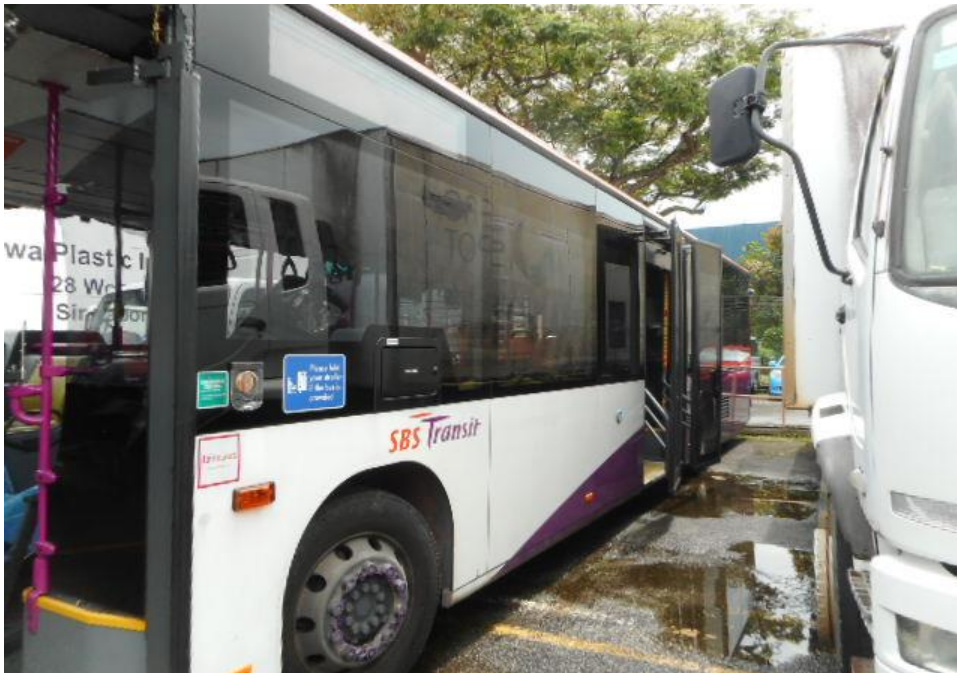
**Photo 9** shows a close up view of the left portion of the Motor Bus at the time of our inspection. The left portion of the Motor Bus was observed to have been unaffected by the accident

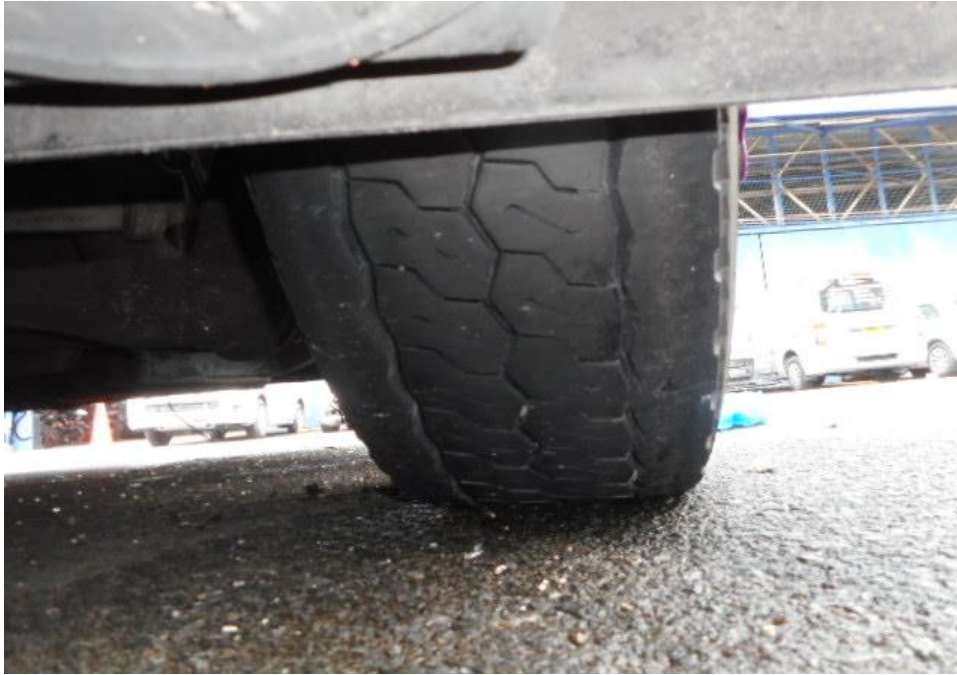
**Photo 10** shows the condition of the front right tyre of the Motor Bus, which was observed to be in serviceable condition with remaining tread depth of approximately 11.5mm. The tyre, which was wrapped around standard steel wheel rim, was also observed to be sufficiently inflated for vehicular operation. There was no tear, cut or burst mark(s) on the outer and the inner sidewalls as well as across the tread of the 6 tyres that were fitted on the Motor Bus.

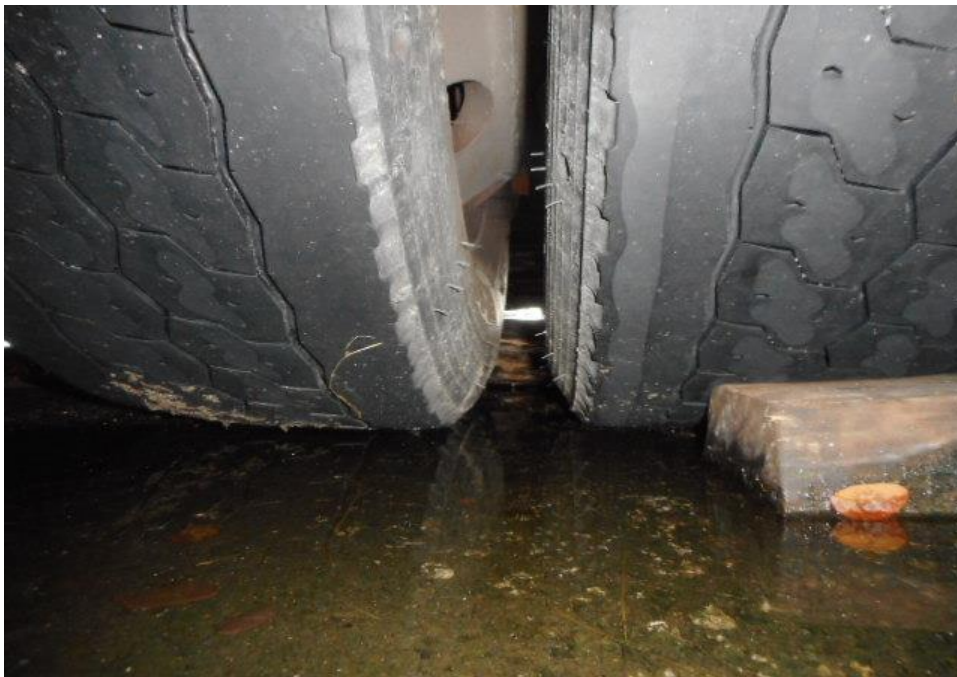
**Photo 11** shows the condition of the rear right tyre of the Motor Bus, which was observed to be in serviceable condition with remaining tread depth of approximately 5.7mm. The tyre, which was wrapped around standard steel wheel rim, was also observed to be sufficiently inflated for vehicular operation.

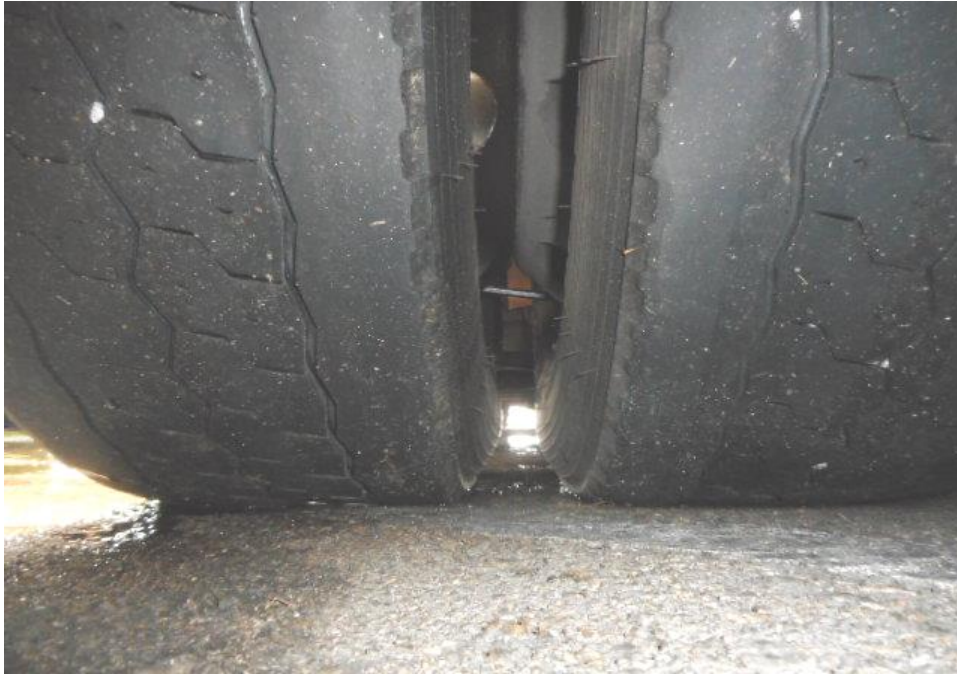
**Photo 12** shows the condition of the rear left tyres of the Motor Bus, which was observed to be in serviceable condition with remaining tread depth of approximately 6.1mm. The tyres, which were wrapped around standard steel wheel rim, were also observed to be sufficiently inflated for vehicular operation. There was also no damage found on all 6 steel wheel rims of the Motor Bus.

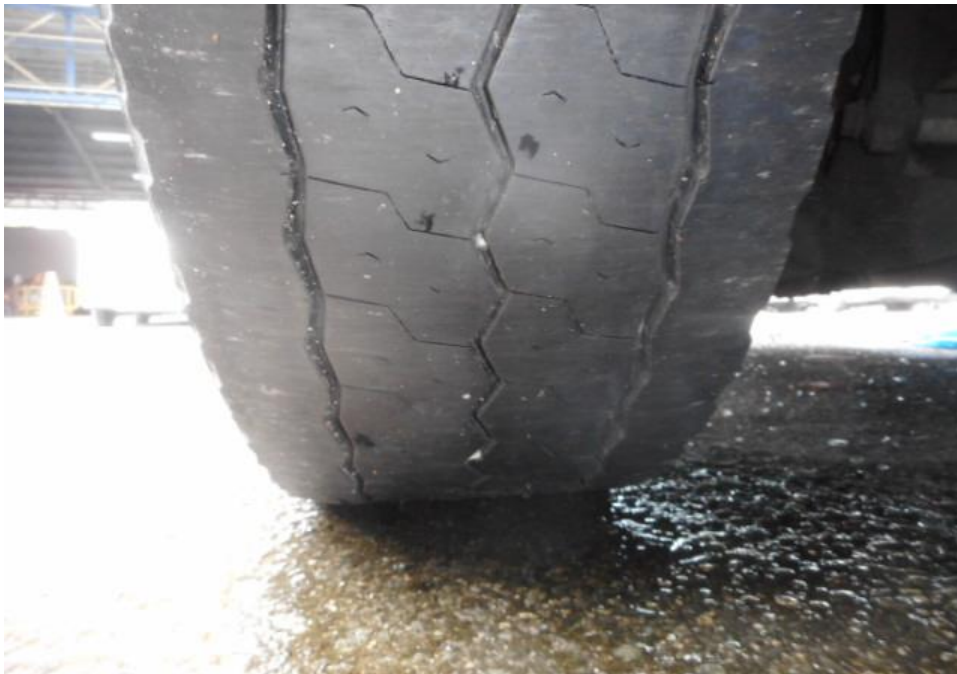
**Photo 13** shows the condition of the front left tyres of the Motor Bus, which were observed to be in serviceable condition with remaining tread depth of approximately 7.5mm. There was also no tear, cut or burst mark(s) on the outer and the inner sidewalls as well as across the tread of the 6 tyres that were fitted on the Motor Bus.

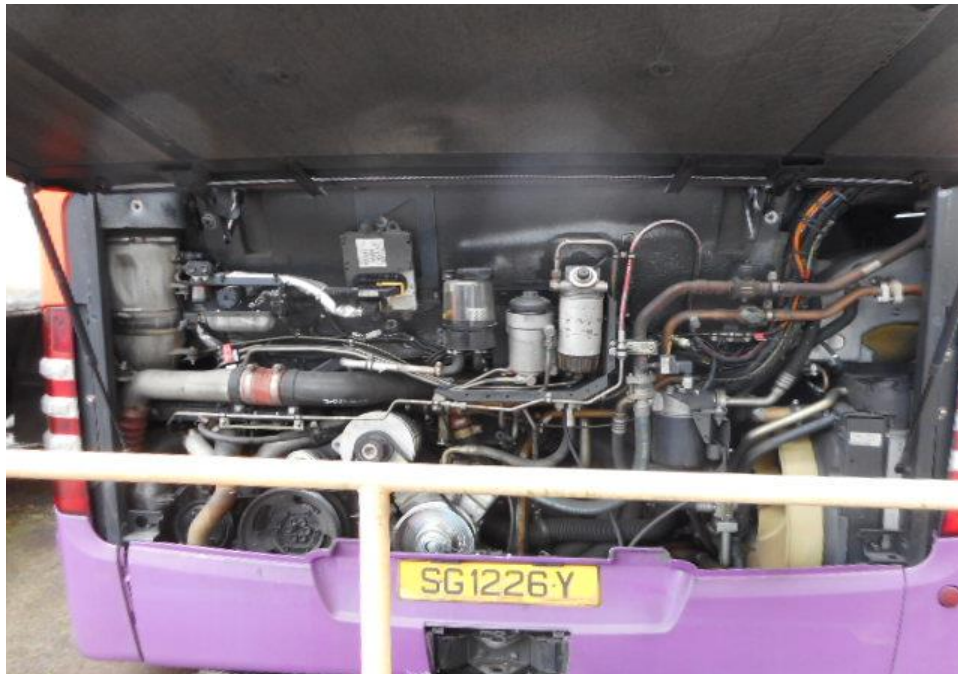
**Photo 14** shows a general view of the Motor Bus's engine compartment, which was accessed by lifting the rear of the Motor Bus. The various parts and components inside the engine compartment were unaffected by the accident. There was also no sign(s) or indication(s) of fresh fluid leakage and/or fluid stain within the engine compartment

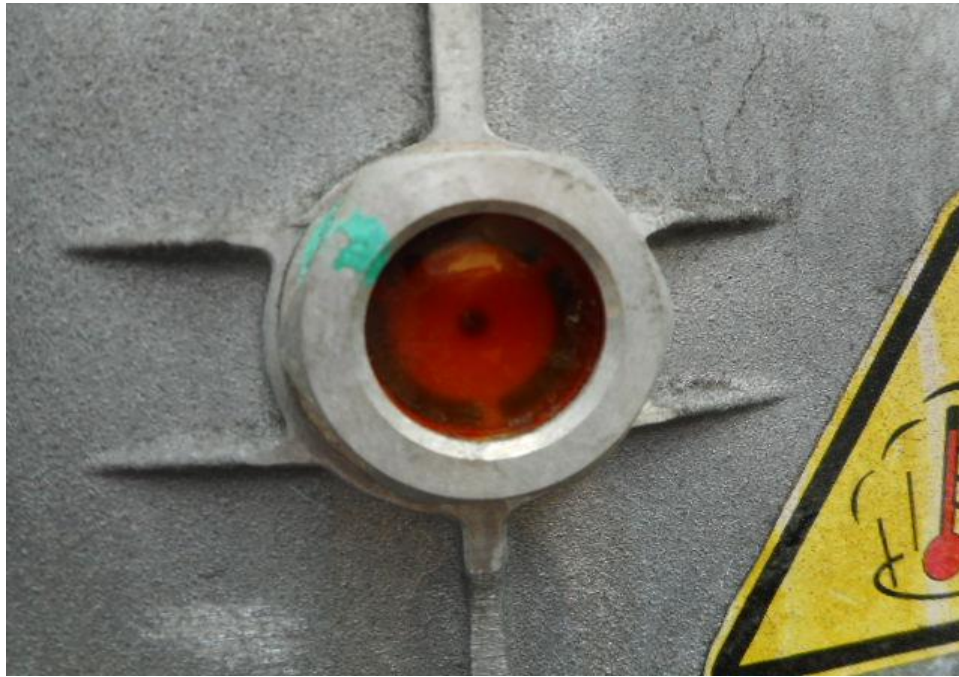
**Photo 15** shows the engine coolant reservoir of the Motor Bus at the time of my inspection. The engine coolant was observed to be sufficient for operation and without any visible contamination.

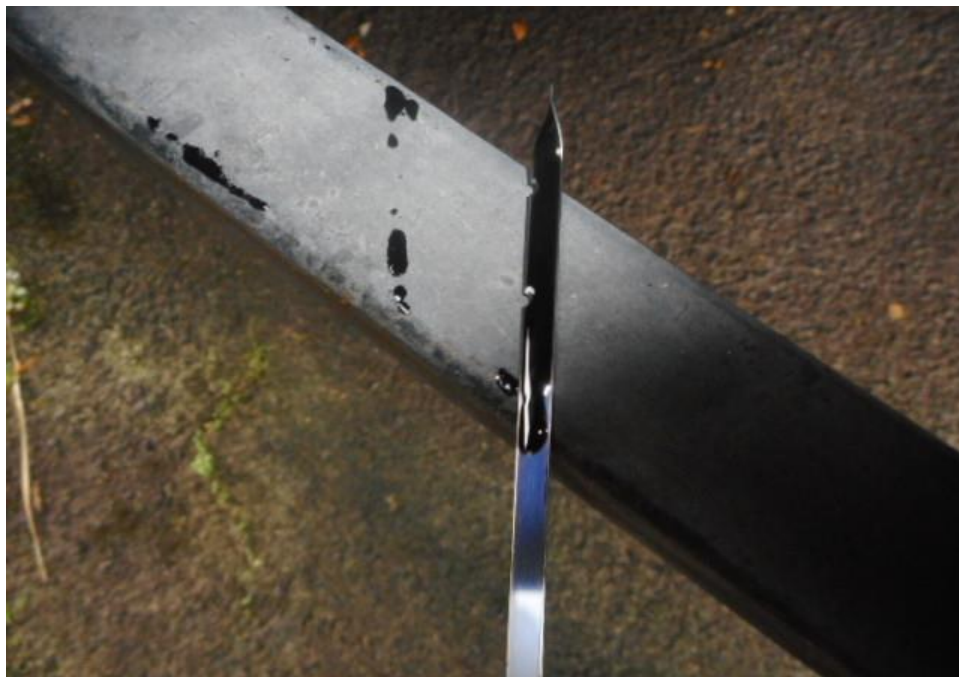
**Photo 16** shows the engine oil dip stick system of the Motor Bus at the time of my inspection. The engine oil was observed to be sufficient for operation and without any visible contamination.

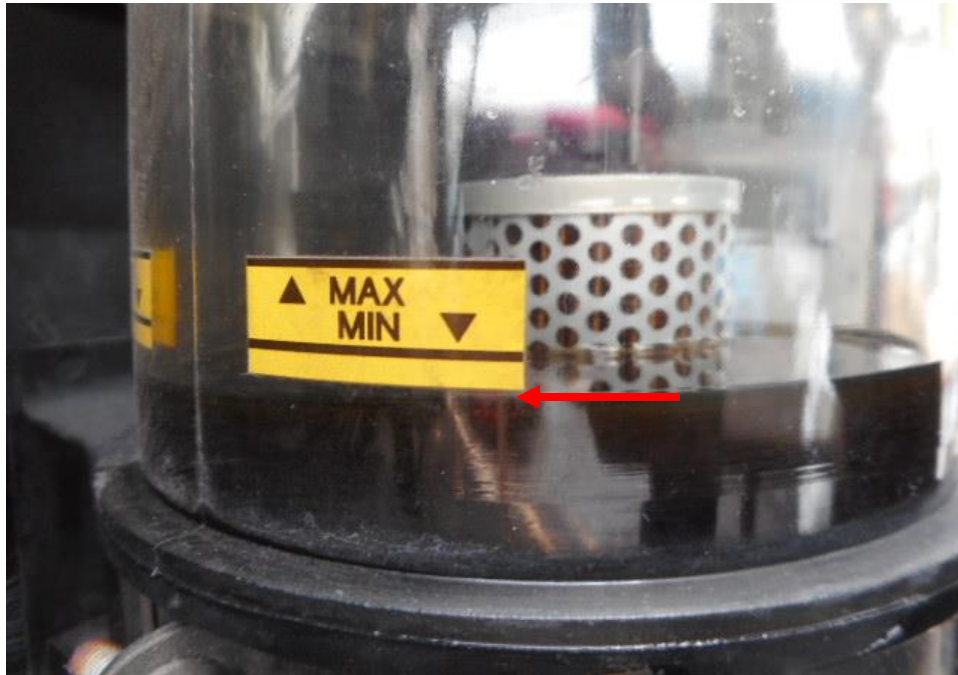
8. Upon examination of the Motor Bus's engine compartment, I had observed all the parts and components inside the engine compartment to be intact and unaffected by the accident. The engine oil and engine coolant were found to be of sufficient level for operating purposes and visually, there was also no contamination found to these fluids. However, the power steering fluid was observed to be insufficient level as there was leakage of fresh fluid at the power steering box as a result of the accident.

**Photo 17** shows the power steering fluid of the Motor Bus at the time of my inspection. The power steering fluid (arrowed) was observed to be of insufficient level due to a leakage at the power steering box as a result of the accident.

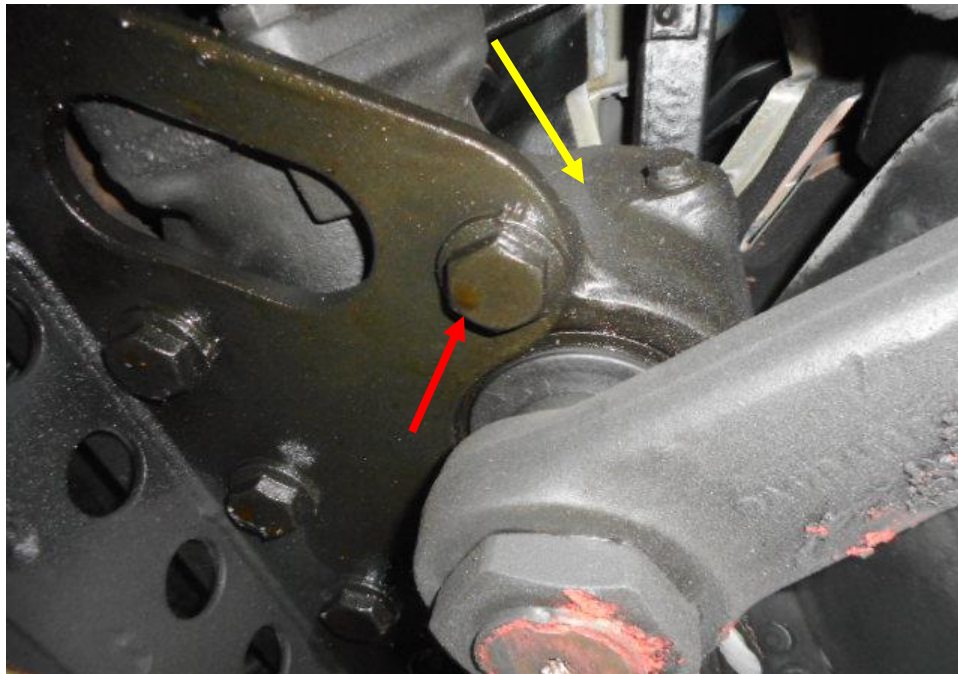
10. My subsequent checks on the underside of the Motor Bus also revealed only power steering fluid stain from the power steering box. Visually, all the other various undercarriage components of the Motor Bus were all observed to be intact and without any visible damage. See photo 14 – 19 below.

**Photo 18** shows the power steering fluid of the Motor Bus at the time of my inspection. The power steering fluid (red arrow) was observed to be of insufficient level due to a leakage at the power steering box (yellow arrow) as a result of the accident.

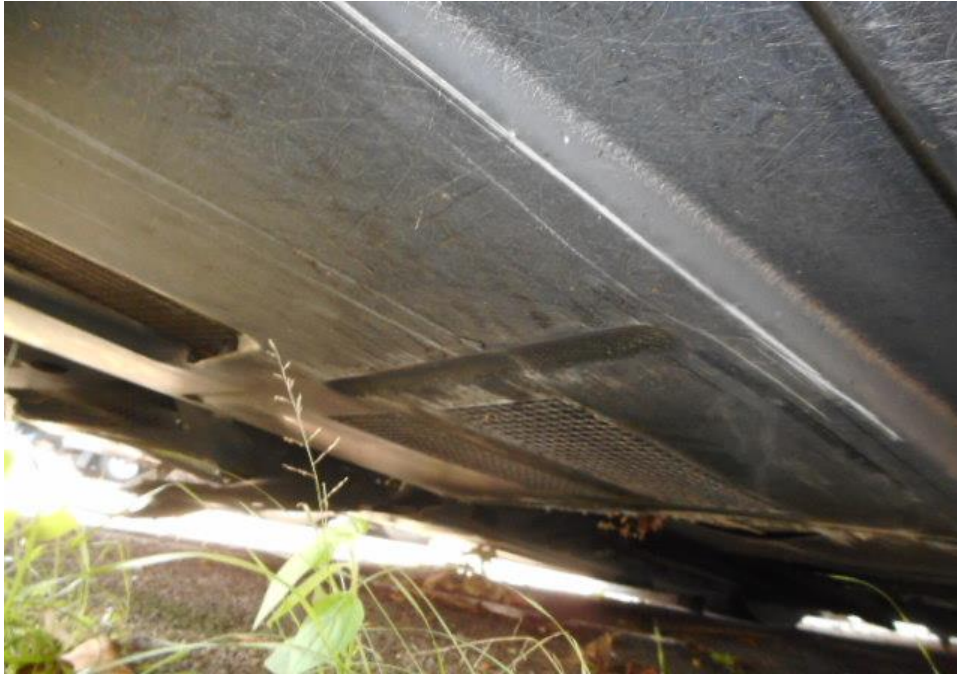
**Photo 19** shows the undercarriage of the Motor Bus, at the area where the engine housing and transmission housing are located. I did not find any sign(s) or indication(s) of fluid leak and/or fluid stain(s) on the underside of the Motor Bus.

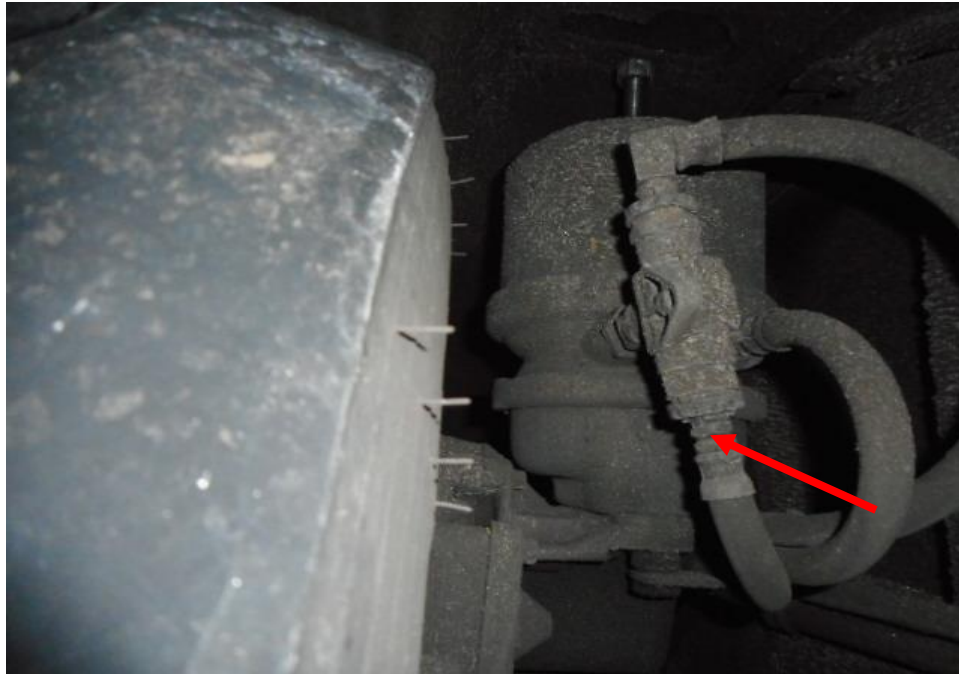
**Photo 20** shows the brake pipe (arrowed) at the rear right wheel of the Motor Bus. I did not observe any leakage of brake fluid at the time of my inspection of the Motor Bus. My visual examination of the various mechanical components of the braking system where generally intact and unaffected by the accident.

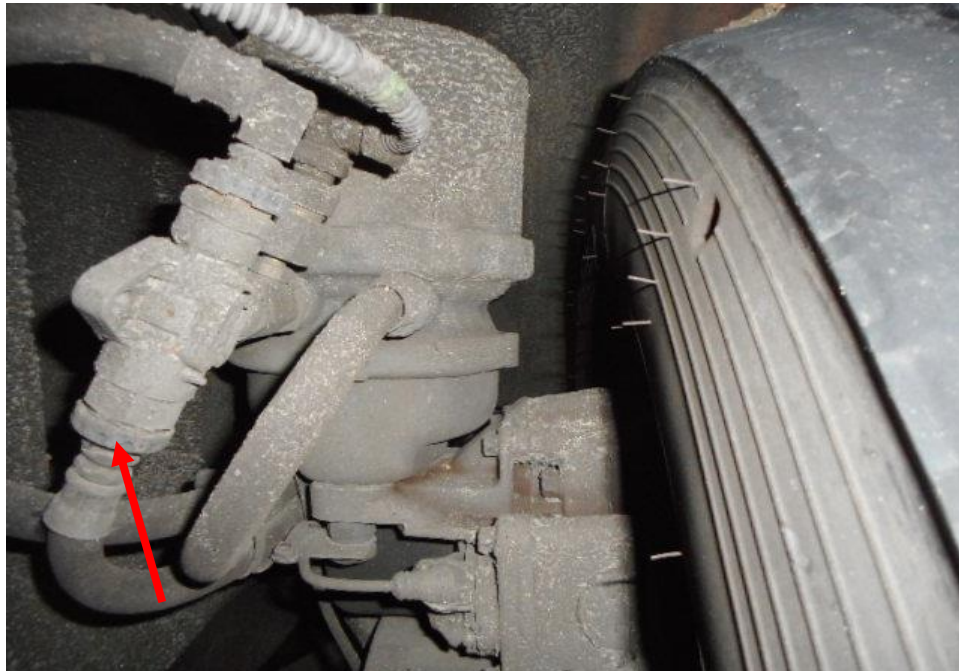
**Photo 21** shows the brake pipe (arrowed) at the rear left wheel of the Motor Bus. I did not observe any leakage of brake fluid at the time of my inspection of the Motor Bus. My visual examination of the various mechanical components of the braking system where generally intact and unaffected by the accident.

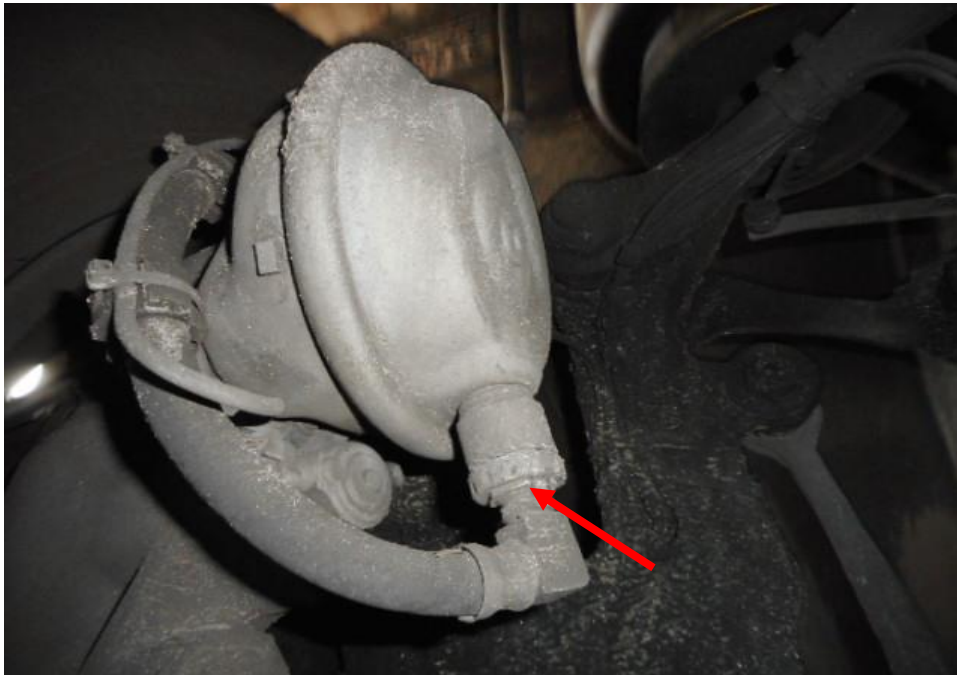
**Photo 22** shows the brake pipe (arrowed) at the front right wheel of the Motor Bus. I did not observe any leakage of brake fluid at the time of my inspection of the Motor Bus. My visual examination of the various mechanical components of the braking system where generally intact and unaffected by the accident.

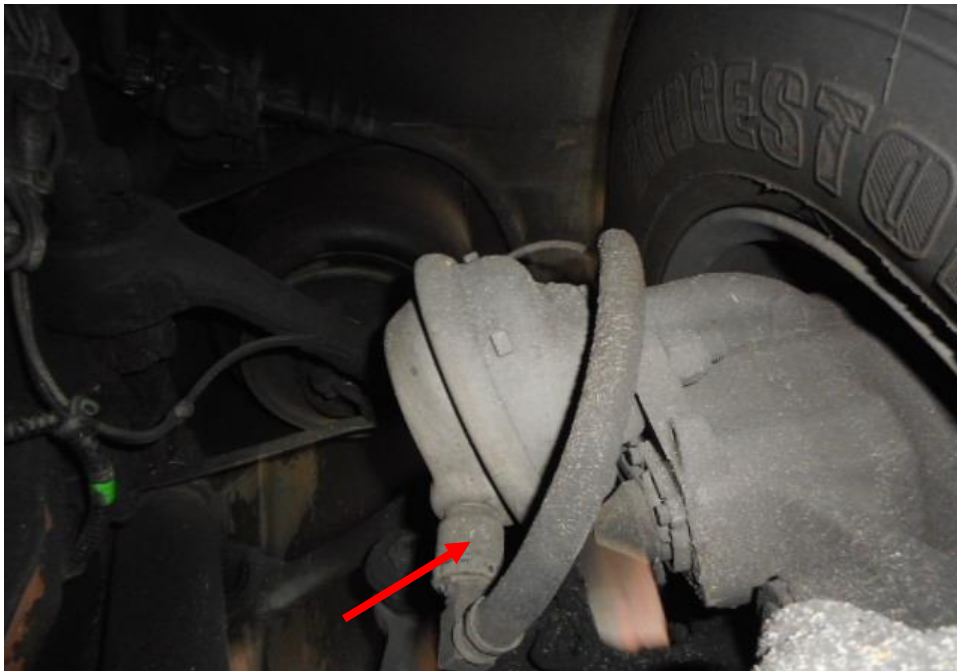
**Photo 23** shows the brake pipe (arrowed) at the front left wheel of the Motor Bus. I did not observe any leakage of brake fluid at the time of my inspection of the Motor Bus. My visual examination of the various mechanical components of the braking system where generally intact and unaffected by the accident.

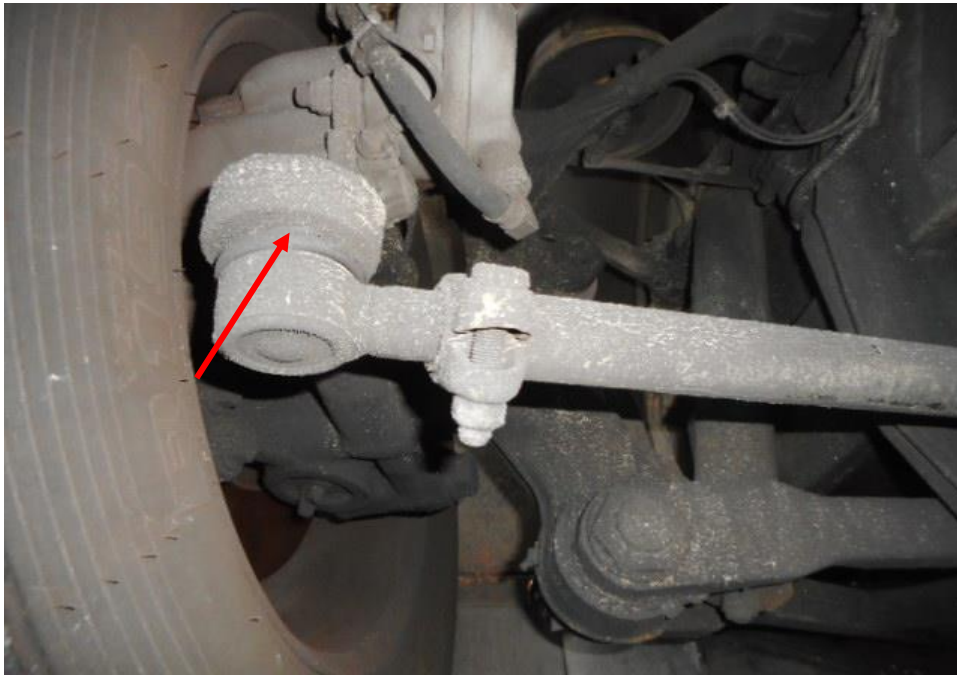
**Photo 24** shows the various undercarriage components at the front right wheel of the Motor Bus, in particular the steering tie rod end (arrowed). The various steering components were all found to be intact. There was also no sign of fluid stain(s) observed on the various undercarriage components.

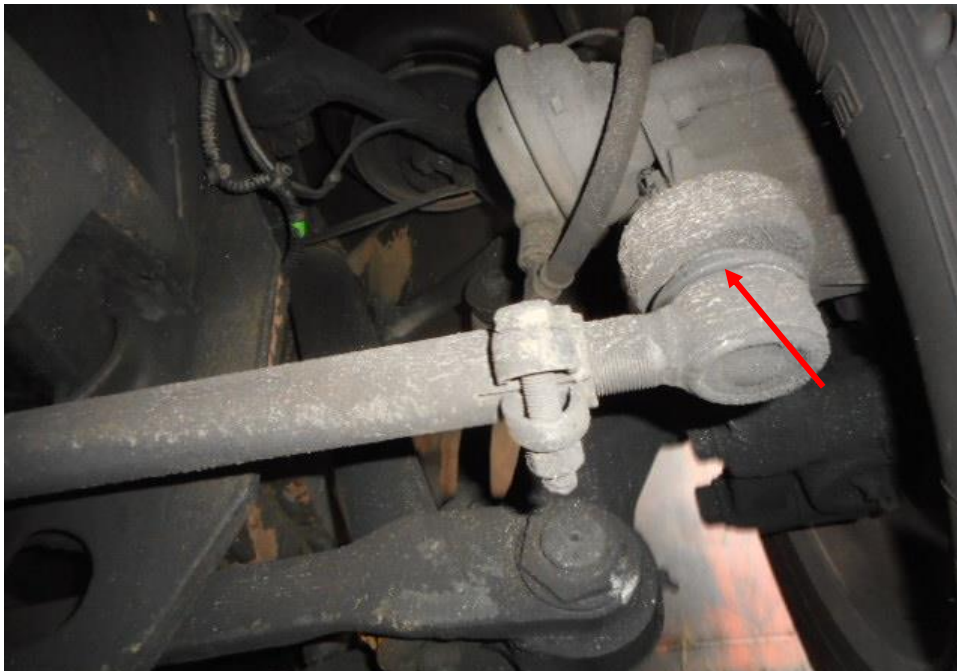
**Photo 25** shows the various undercarriage components at the front left wheel of the Motor Bus, in particular the steering tie rod end (arrowed). The various steering components were all found to be intact. There was also no sign of fluid stain(s) observed on the various undercarriage components.

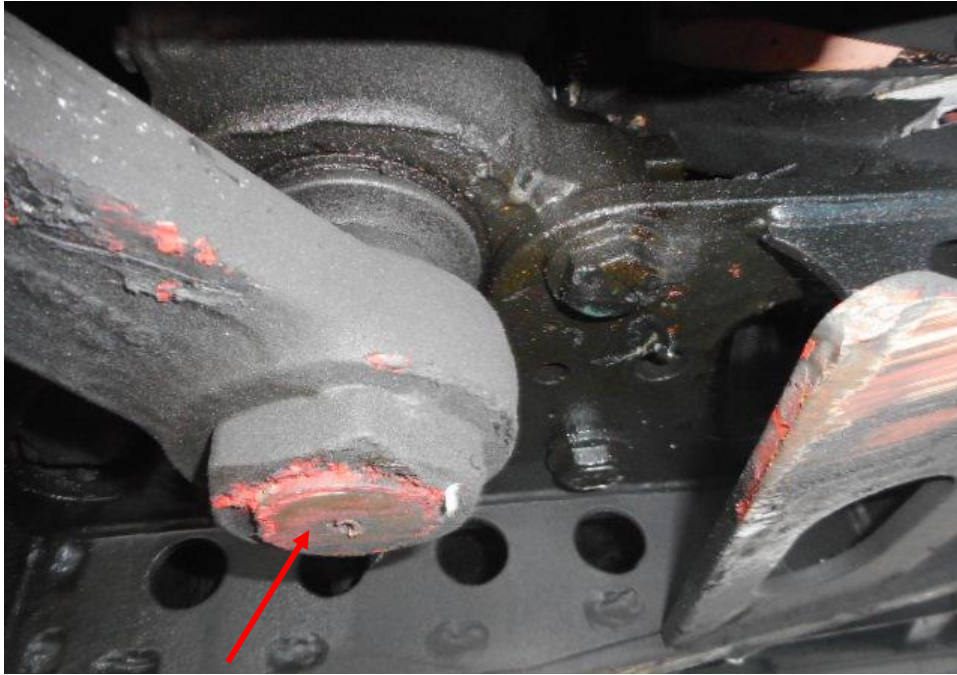
**Photo 26** shows the steering box component (arrowed) at the undercarriage of the Motor Bus was found to sustained damages as a result of the accident and there was sign of fresh fluid stain observed on the component.
