Your Ref: TP/IP/28113/2022
Our Ref : CI/TPD22010900/P

Fatal Accident Investigation Team

MECHANICAL INSPECTION REPORT OF MOTOR CAR SLG 5447H

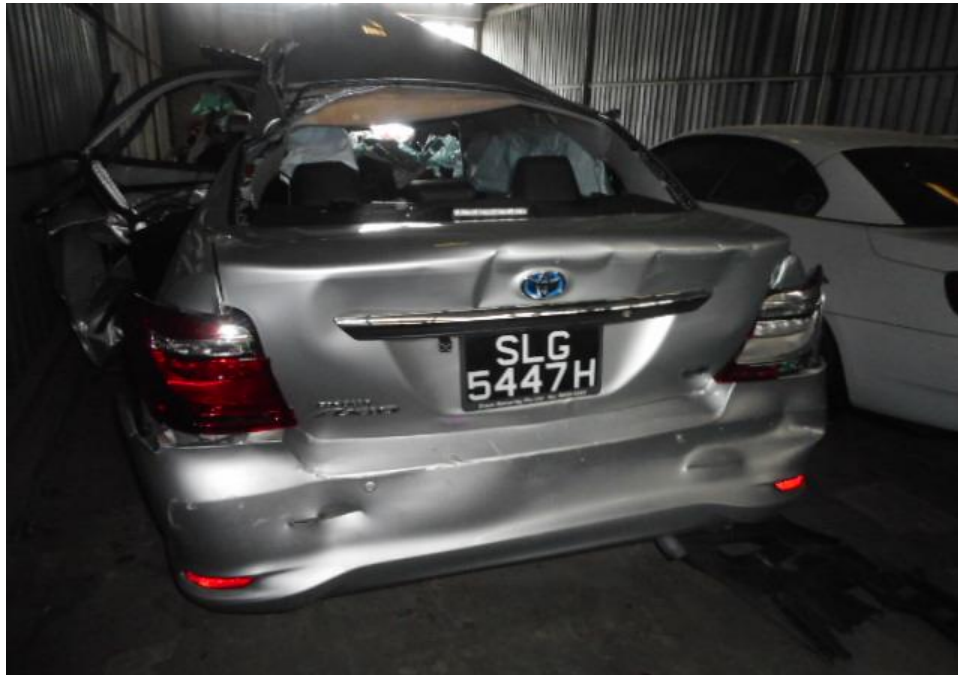
Photo 1 shows a general view of the Motor Car's rear body at the time of my inspection. The rear portion of the Motor Car was observed to sustain damages as a result of the accident. Its rear windscreen, rear boot, rear bumper, rear both brake lamps were damaged as a result of the accident.

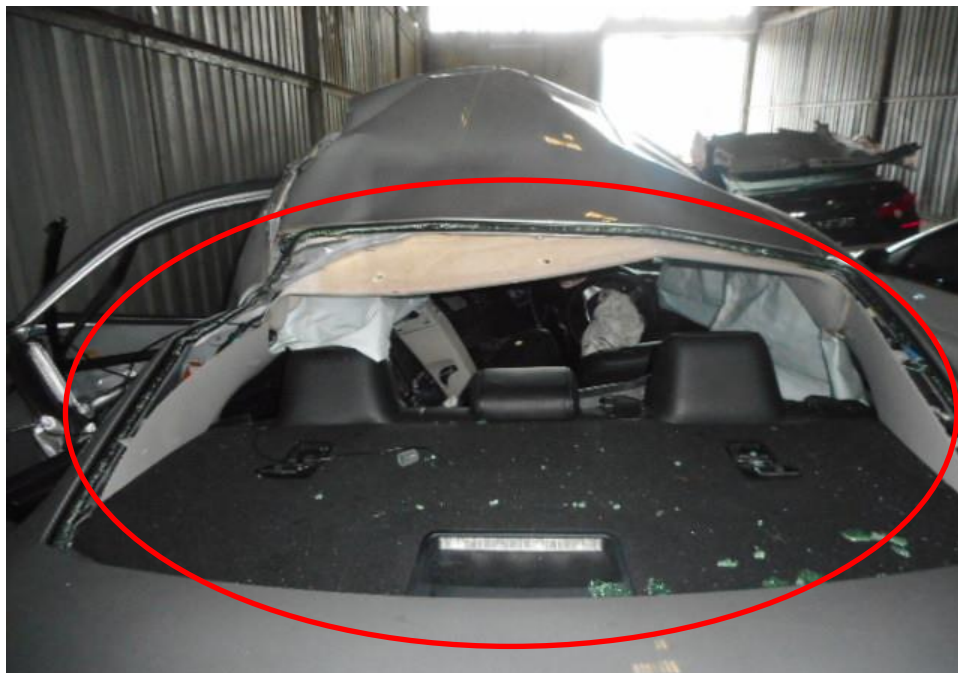
Photo 2 shows a close up view of the Motor Car's rear body at the time of my inspection. The rear portion of the Motor Car was observed to sustain damages as a result of the accident. Its rear windscreen (circled) were damaged as a result of the accident.

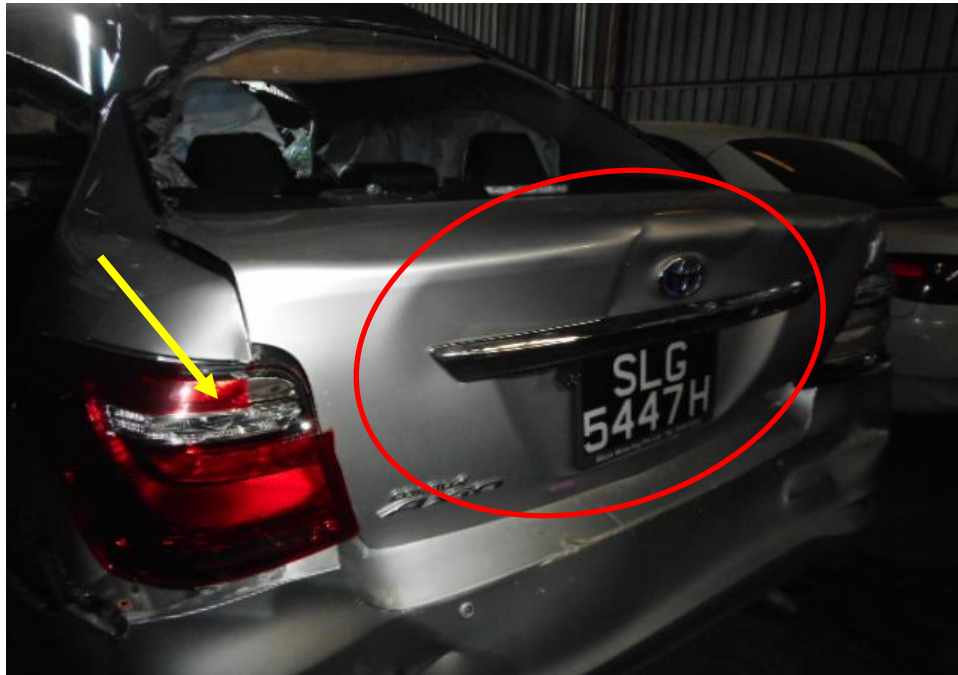
Photo 3 shows a close up view of the Motor Car's rear body at the time of my inspection. The rear portion of the Motor Car was observed to sustain damages as a result of the accident. Its rear boot (circled) and rear left brake lamp (arrowed) were damaged as a result of the accident.

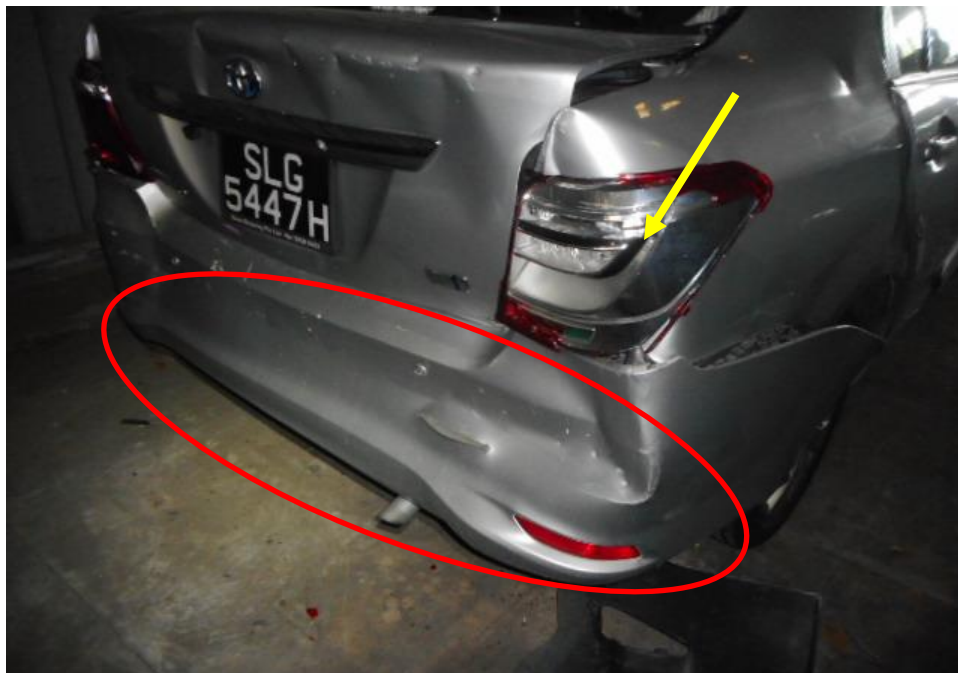
Photo 4 shows a close up view of the Motor Car's rear body at the time of my inspection. The rear portion of the Motor Car was observed to sustain damages as a result of the accident. Its rear bumper (circled) and rear right brake lamp (arrowed) were damaged as a result of the accident.

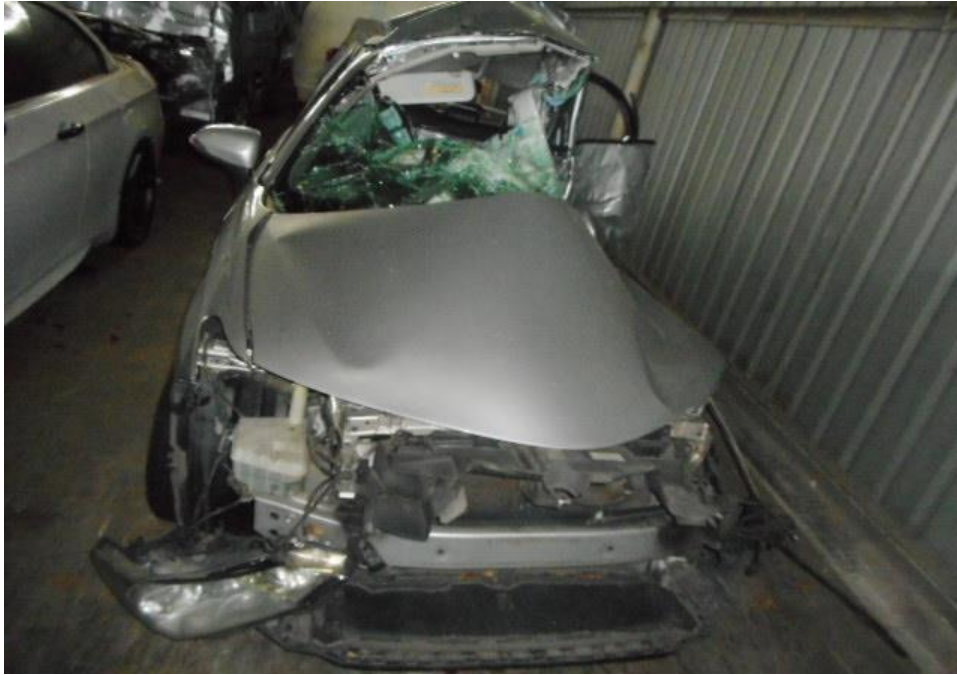
Photo 5 shows a general view of the Motor Car's front body at the time of my inspection. The Motor car was observed to have sustained damage at its front and roof portion. Its front windscreen, front bonnet, front bumper, front left fender, front left, right headlamp and roof panel was amongst the body parts that were damaged as a result of the accident. The Supplemental Restraint System (SRS) was activated as a result of the accident.

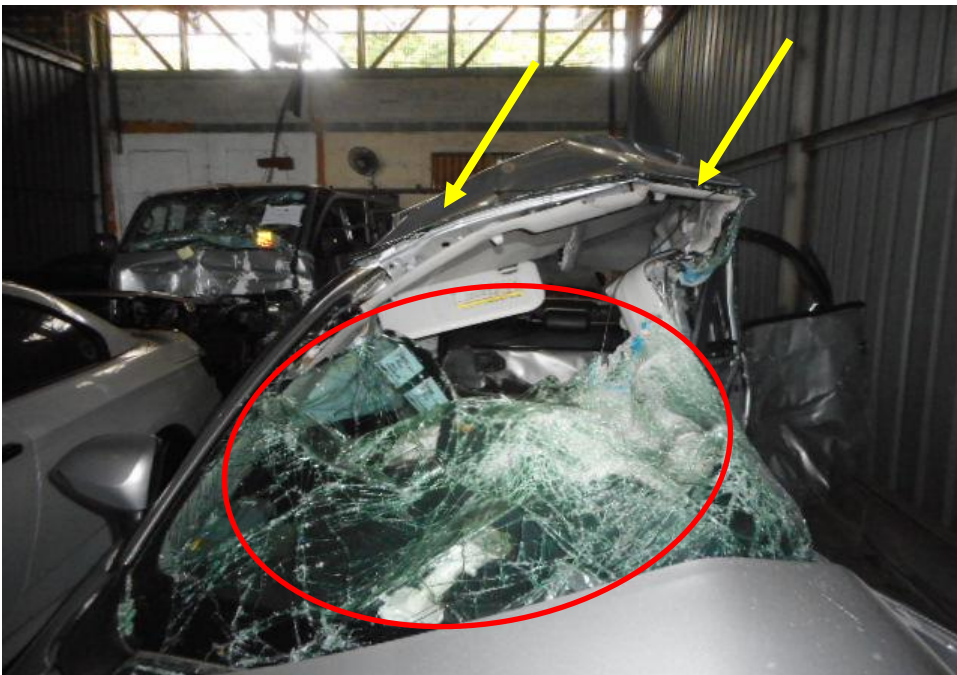
Photo 6 shows the close up view of the Motor Car's front body and roof panel at the time of my inspection. The Motor car was observed to have sustained damage at its front portion. Its front windscreen (circled) and front panel (arrowed) was damaged as a result of the accident.

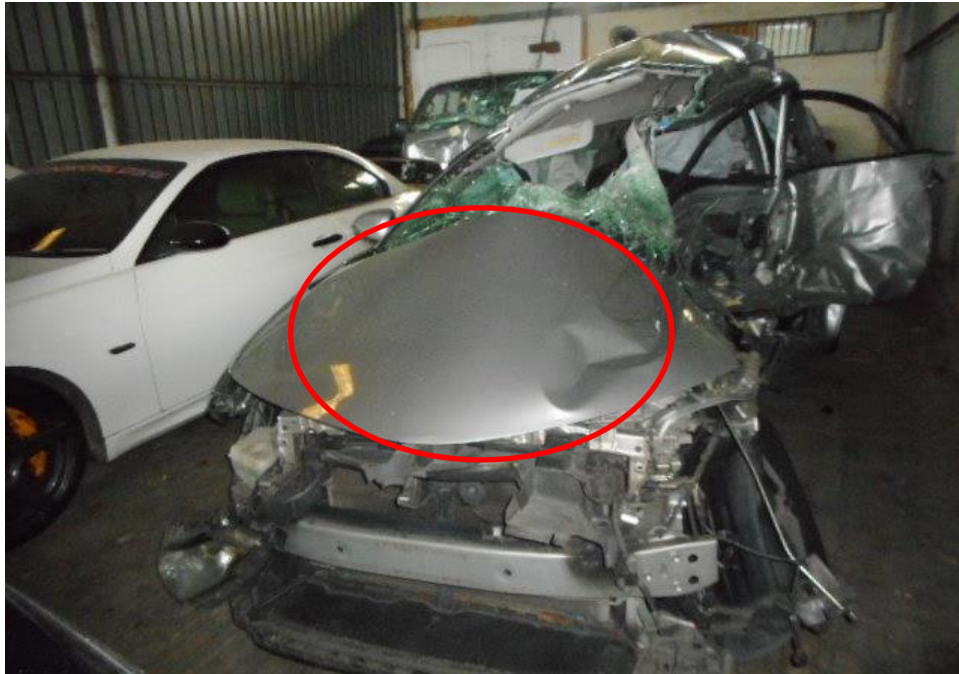
Photo 7 shows the close up view of the Motor Car's front body at the time of my inspection. The Motor car was observed to have sustained damage at its front portion. Its front bonnet (circled) was damaged as a result of the accident.

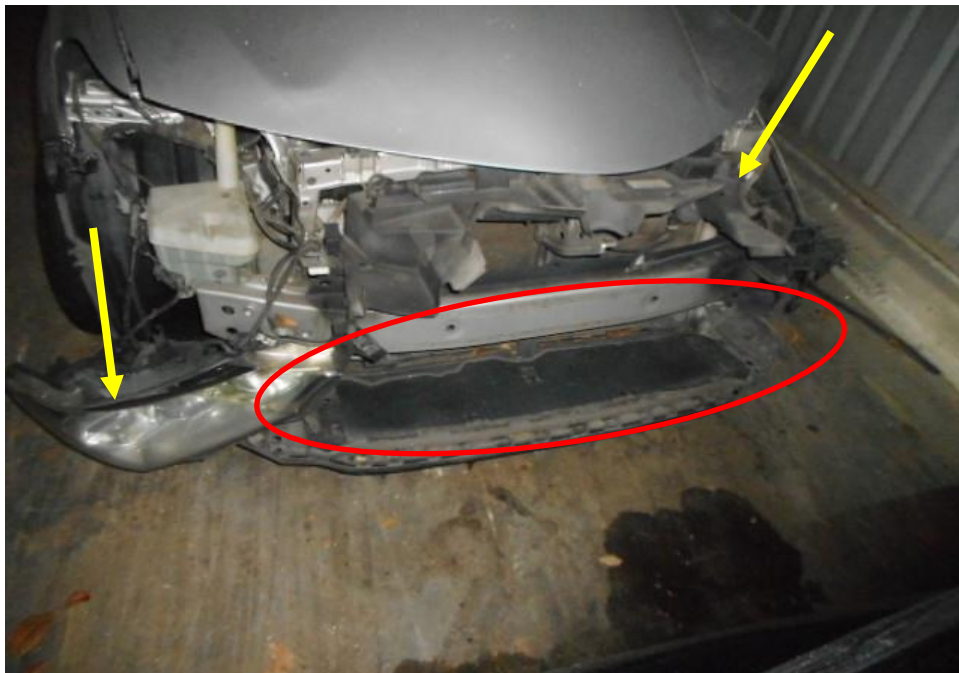
Photo 8 shows the close up view of the Motor Car's front body at the time of my inspection. The Motor car was observed to have sustained damage at its front portion. Its front bumper (circled) and its front left and right headlamps (arrowed) was damaged as a result of the accident.

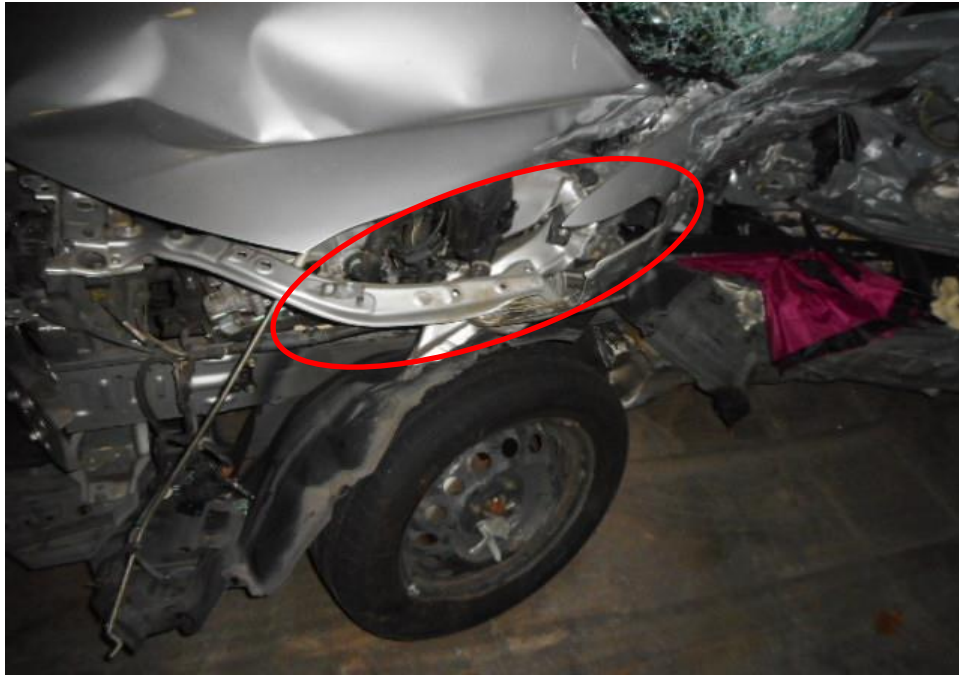
Photo 9 shows the close up view of the Motor Car's front body at the time of my inspection. The Motor car was observed to have sustained damage at its front portion. Its front right fender (circled) was amongst the body part damaged as a result of the accident.

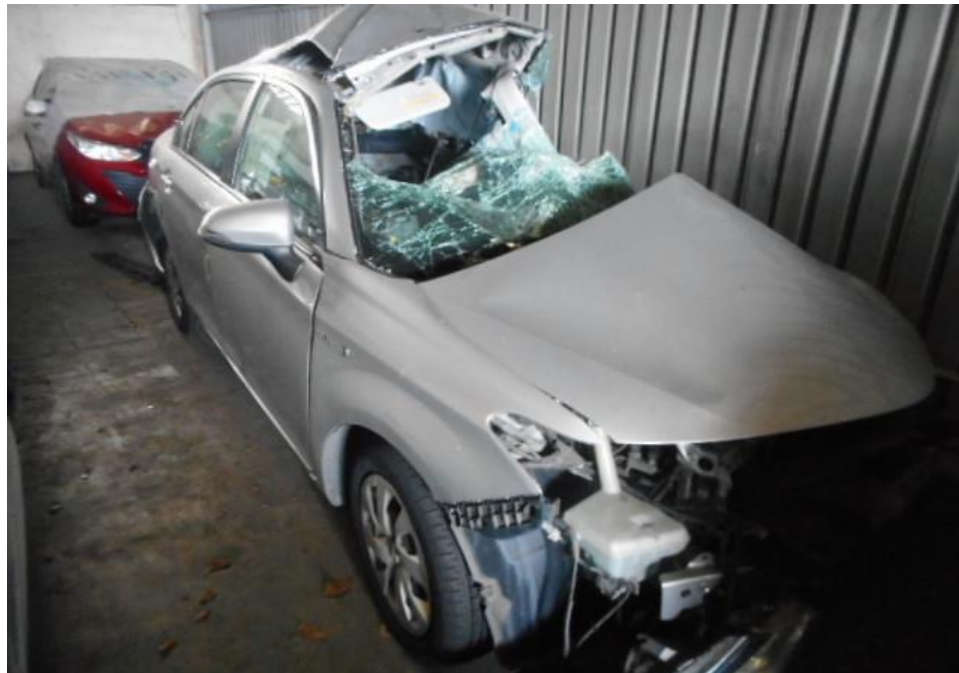
Photo 10 shows a general view of the Motor Car's right body at the time of my inspection. The right portion of the Motor Car was observed to have been removed due to the accident.

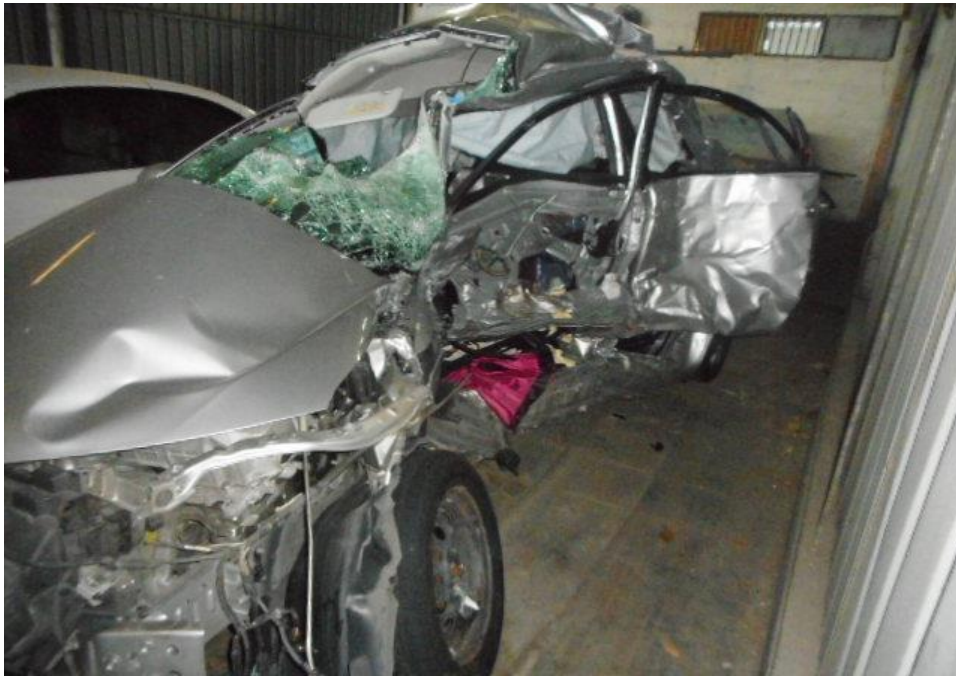
Photo 11 shows a general view of the Motor Car's left body at the time of my inspection. The Motor car was observed to have sustained damage at its left portion. Its left doors and left chassis was amongst the body parts damaged as a result of the accident.

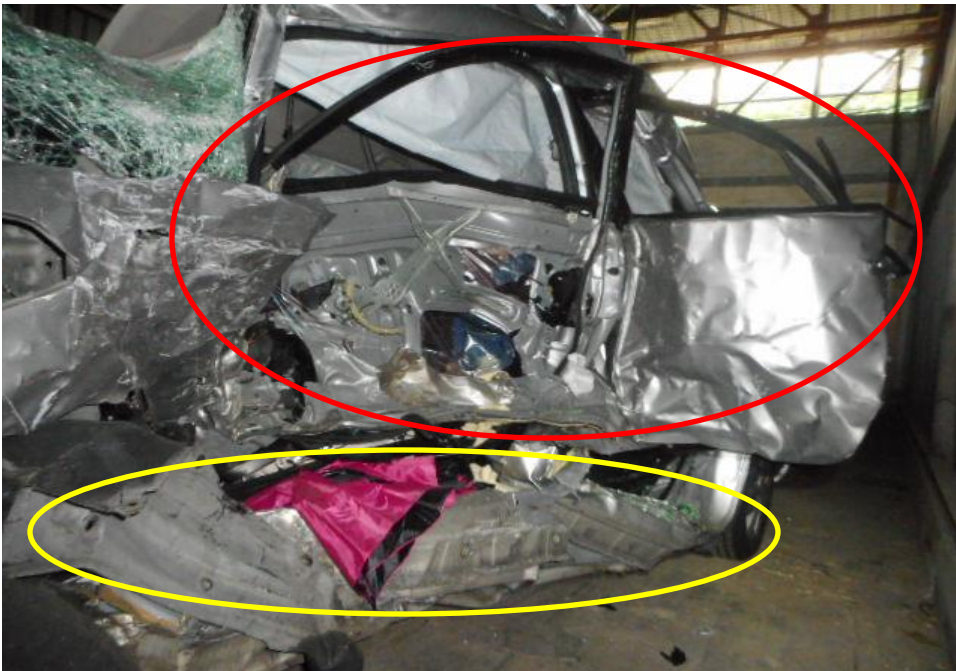
Photo 12 shows the close up view of the Motor Car's left body at the time of my inspection. The Motor car was observed to have sustained damage at its left portion. Its right doors (red circle) and left chassis (yellow circle) was amongst the body parts damaged as a result of the accident.

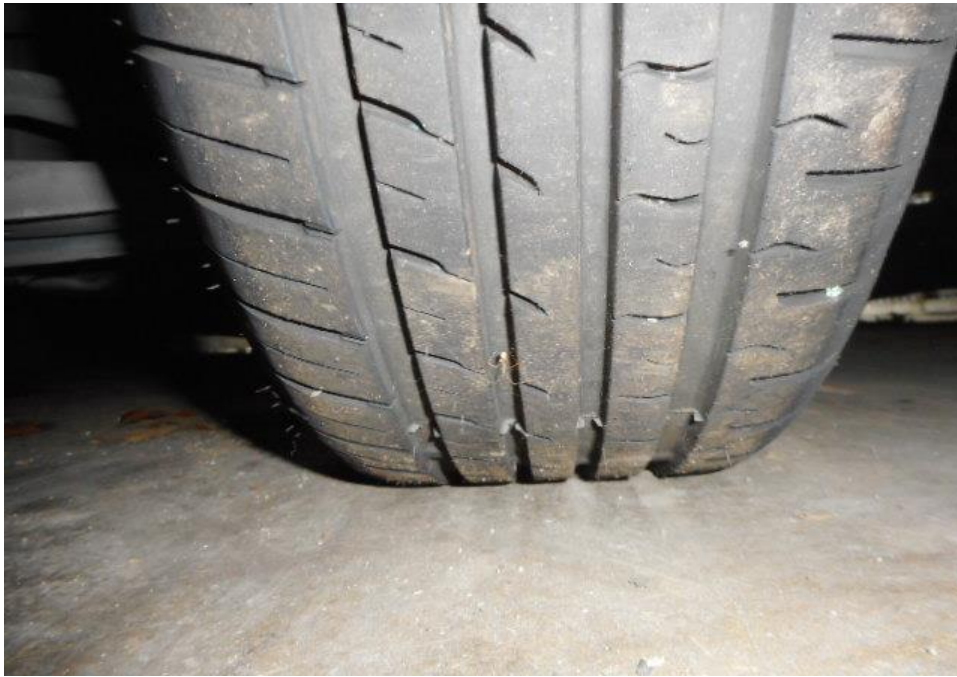
Photo 13 shows the condition of the front right tyre of the Motor Car, which was observed to be in serviceable condition with remaining tread depth of approximately 5.7mm. The tyre, which was wrapped around alloy wheel rim, was also observed to be sufficiently inflated for vehicular operation.

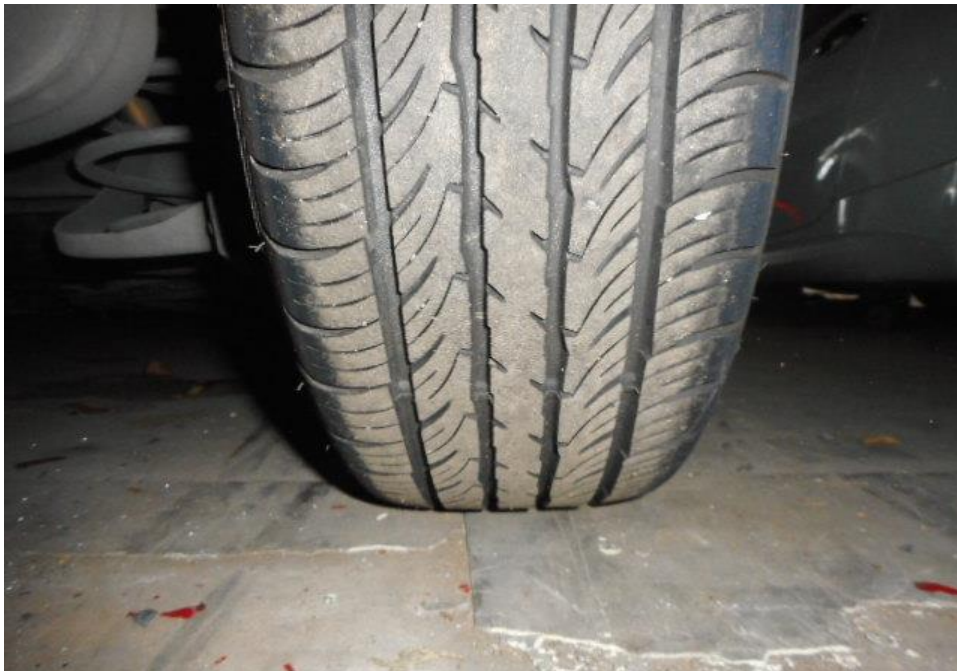
Photo 14 shows the condition of the rear right tyre of the Motor Car, which was observed to be in serviceable condition with remaining tread depth of approximately 6mm. The tyre was also observed to be sufficiently inflated for vehicular operation with no tear, cut or burst mark(s).

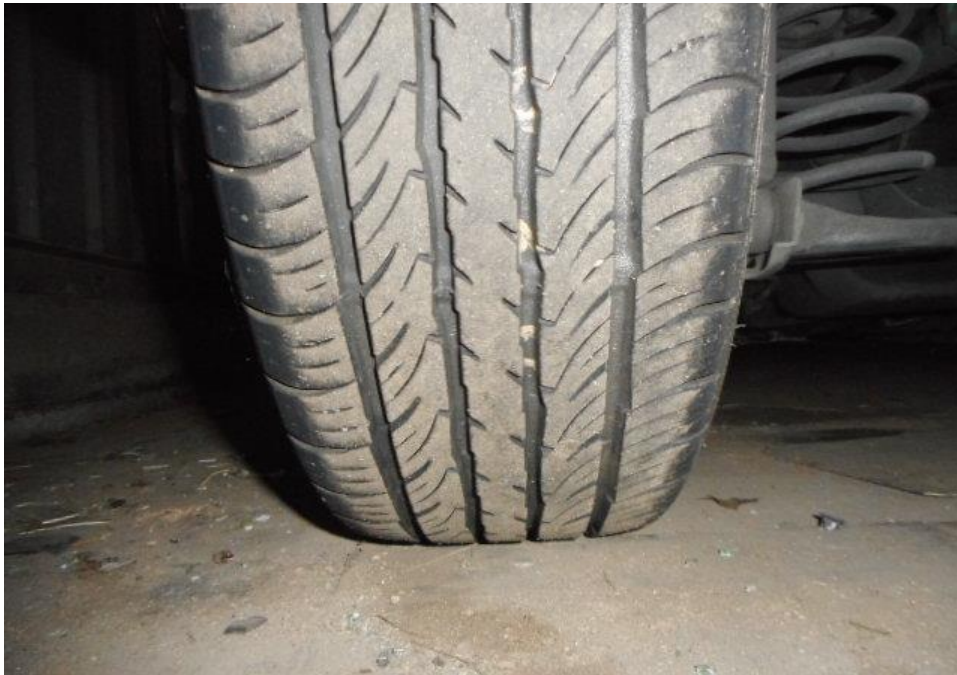
Photo 15 shows the condition of the rear left tyre of the Motor Car, which was observed to be in serviceable condition with remaining tread depth of approximately 5.7mm. The tyre was also observed to be sufficiently inflated for vehicular operation with no tear, cut or burst mark(s).

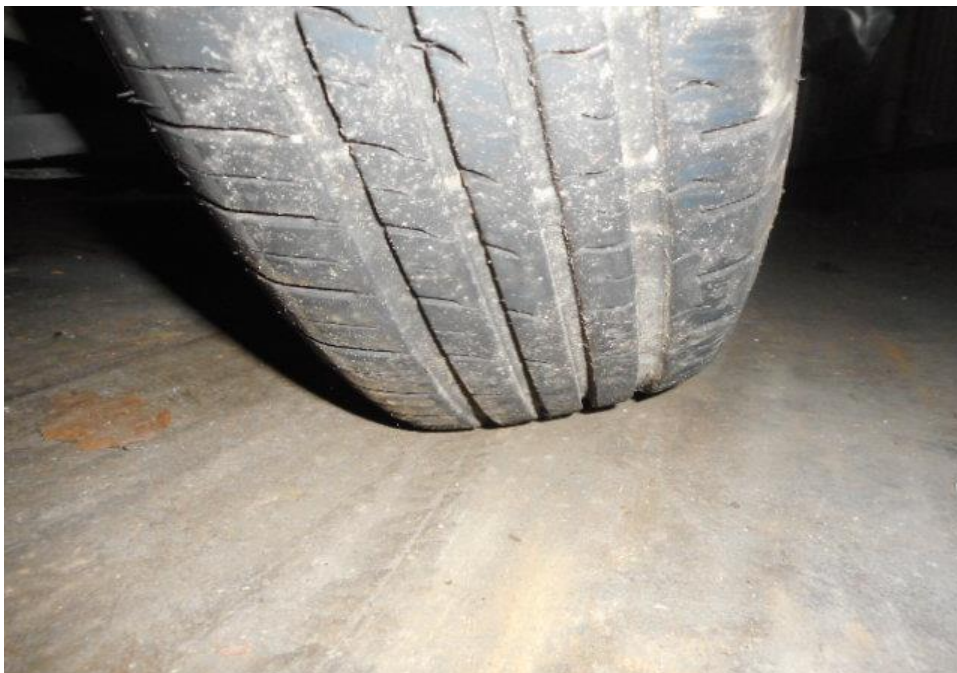
Photo 16 shows the condition of the front left tyre of the Motor Car, which was observed to be in serviceable condition with remaining tread depth of approximately 5.8mm. The tyre was also observed to be sufficiently inflated for vehicular operation with no tear, cut or burst mark(s).

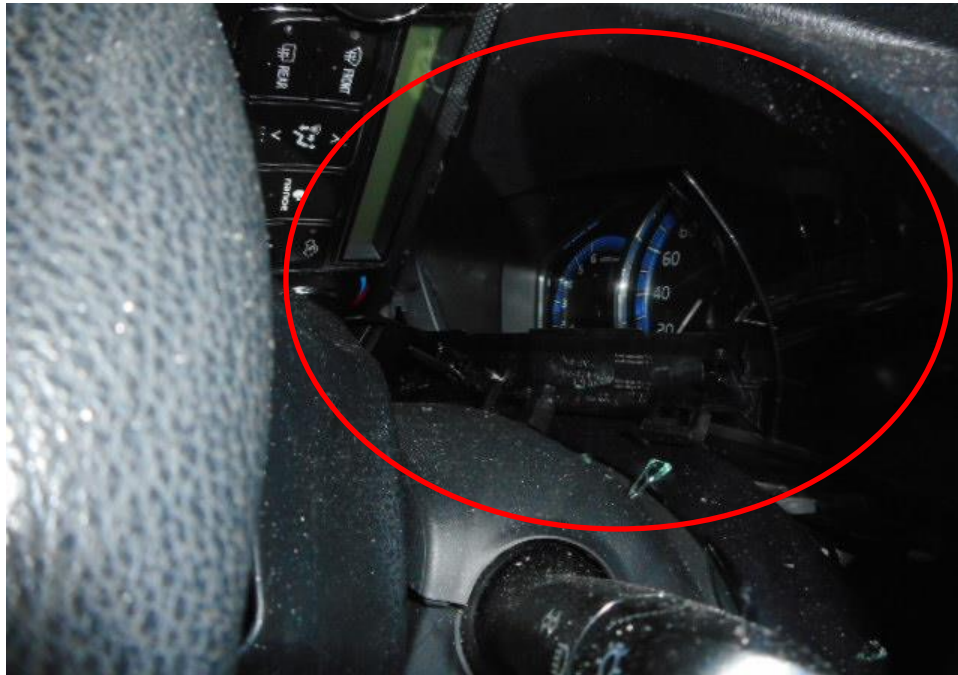
Photo 17 shows a close up view of the Motor Car's dashboard at the time of my inspection. Its dashboard (circled) was observed to be damaged as a result of the accident.

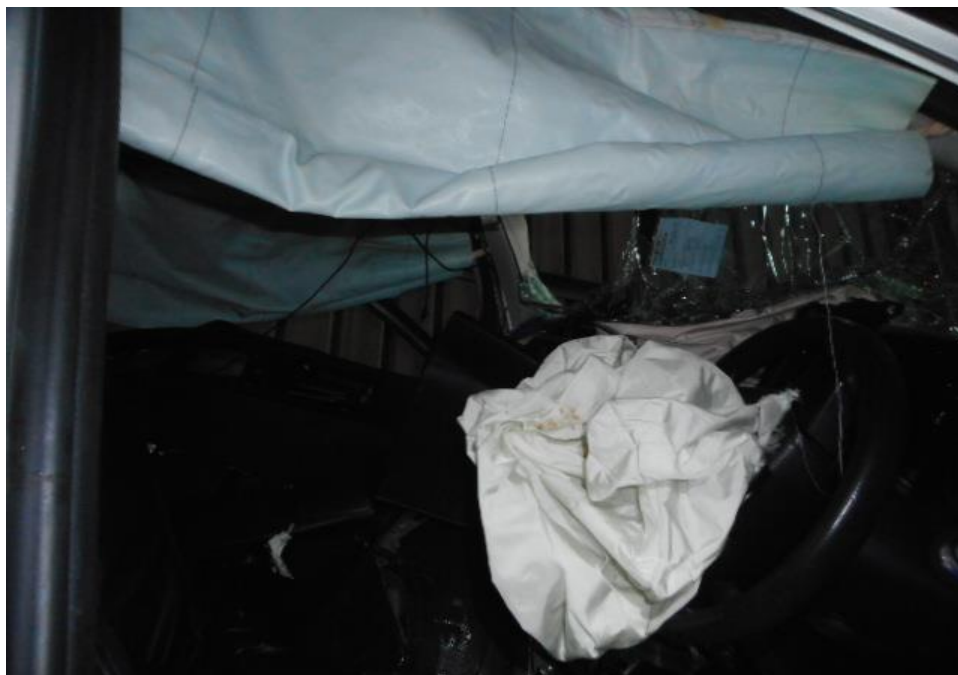
Photo 18 shows the deployment of the Supplemental Restraint System (SRS) airbag in the Motor Car as a result of the accident.

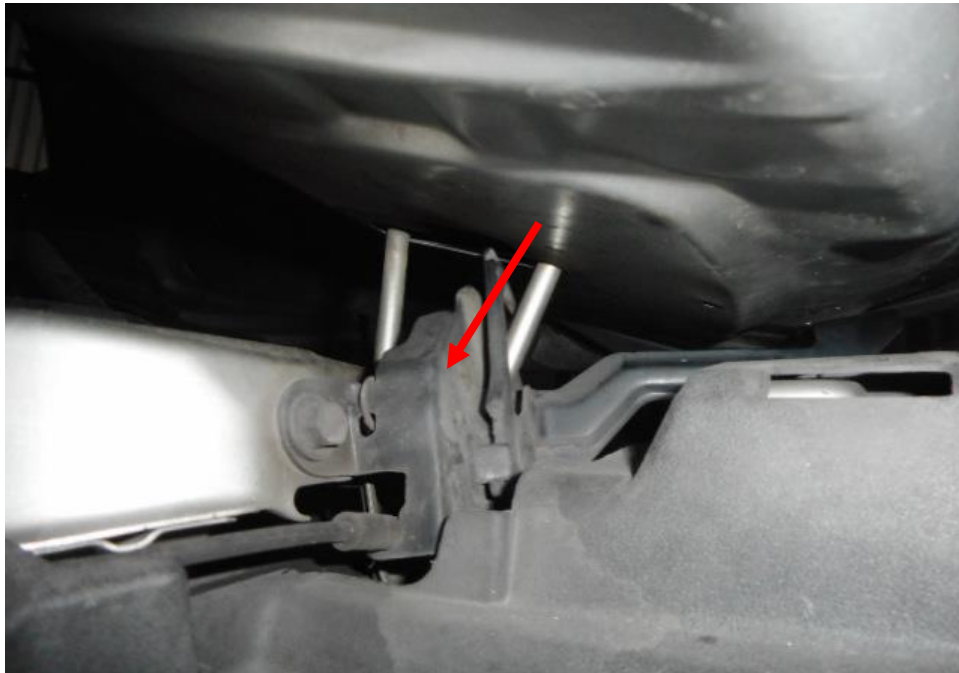
8. We were unable to raise the front bonnet of the Motor car to conduct the examination of the Motor Car's engine compartment because the damage caused by the accident had resulted in the damages to the lock mechanism of the bonnet and the structure of the engine compartment. (Unable to open).
9. During our inspection, we observed that the engine and ignition system was damaged as a result of the induced impact from the accident.
10. My subsequent checks on the underside of the Motor Car revealed sign(s) or indication(s) of fluid leak and/or fluid stain(s) from the damaged engine as a result of the accident. See photo 19 -20 below.

Photo 19 shows the close up view of the damaged front bonnet lock mechanism (arrowed) and the structure of the engine compartment of the Motor Car at the time of my inspection resulting it unable to open a result of the accident. (Unable to open)

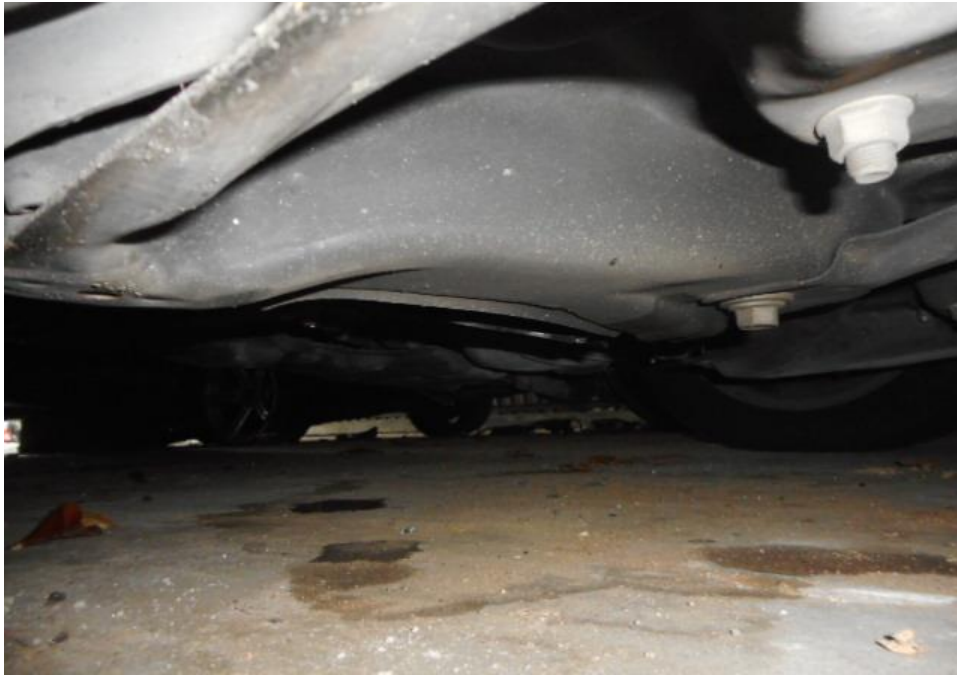
Photo 20 shows the undercarriage of the Motor Car, at the area where the engine housing and transmission housing are located. I did not find any sign(s) or indication(s) of fluid leak and/or fluid stain(s) on the underside of the Motor Car.

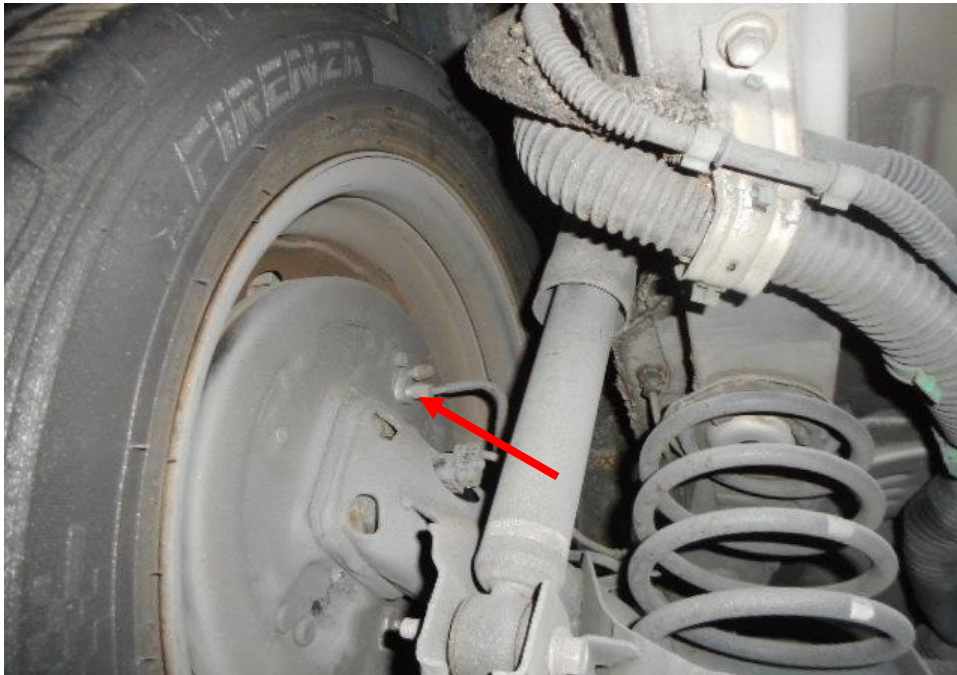
Photo 21 shows the brake hose/pipe (arrowed) at the rear left wheel of the Motor Car. No leakage of brake fluid was observed. Visual examination of the various components of the braking system like the brake drum to be intact and without visible damage.

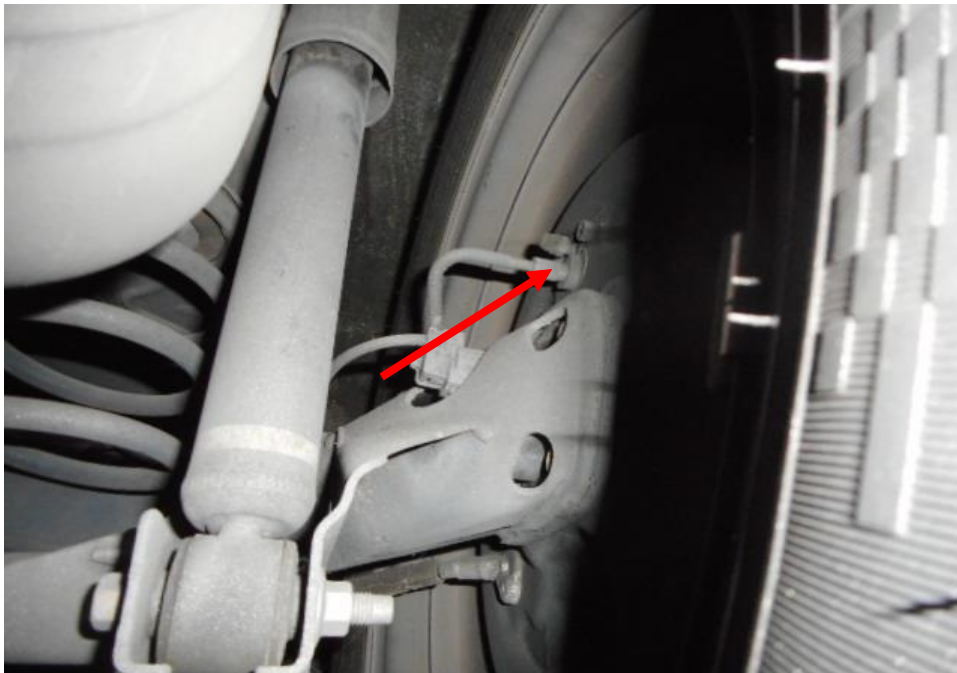
Photo 22 shows the brake hose/pipe (arrowed) at the rear right wheel of the Motor Car. No leakage of brake fluid was observed. Visual examination of the various components of the braking system like the brake drum to be intact and without visible damage.

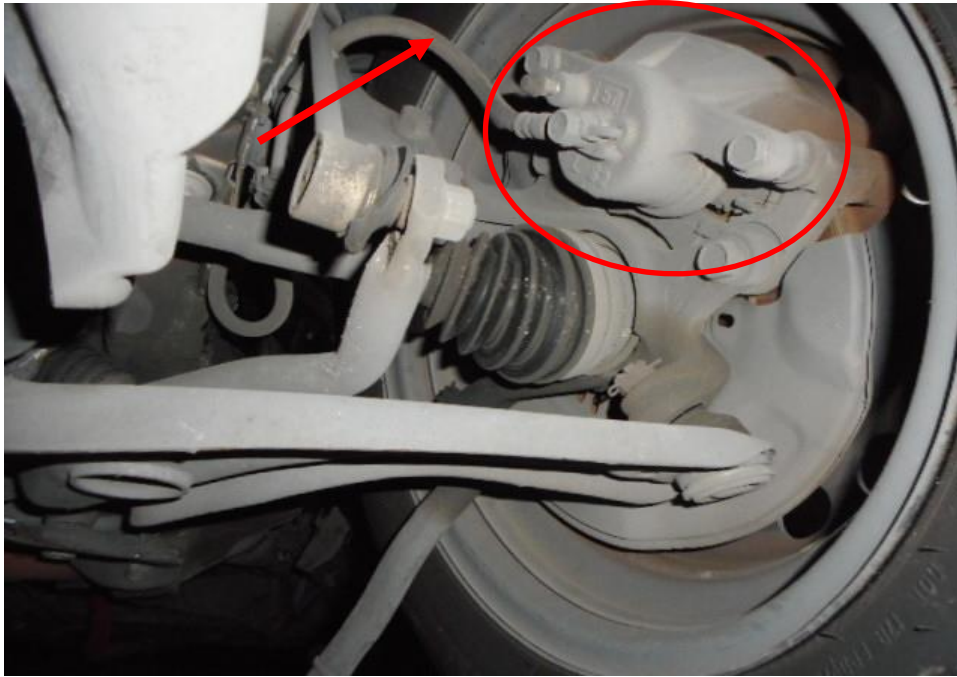
Photo 23 shows the brake hose/pipe (arrowed) at the front right wheel of the Motor Car. I did not observe any leakage of brake fluid at the time of my inspection of the Motor Car. Visual examination of the various components of the braking system the brake caliper (circled) to be intact and without visible damage.

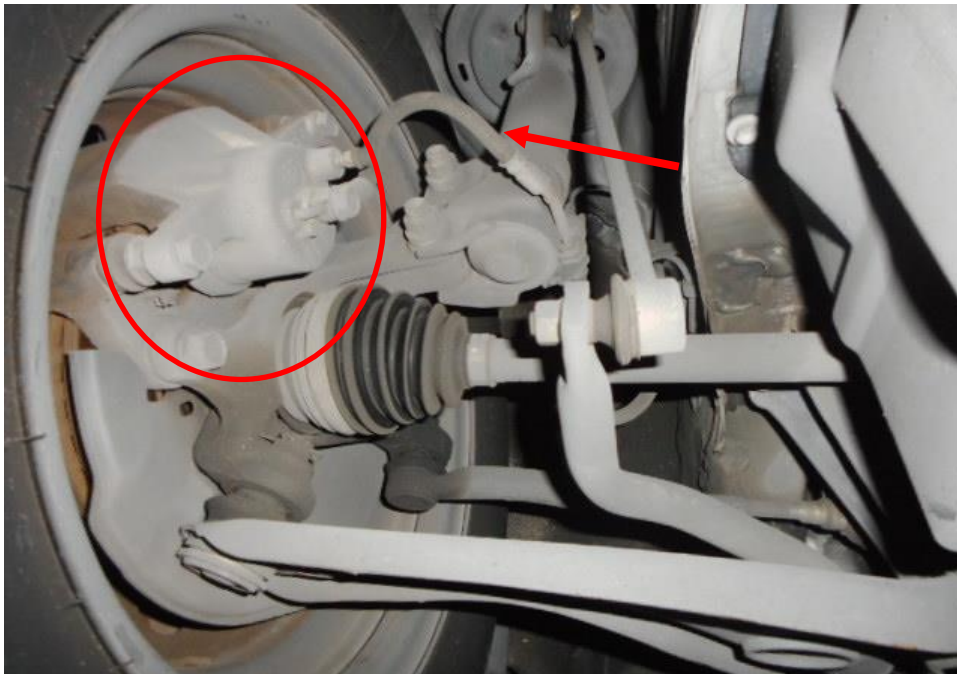
Photo 24 shows the brake hose/pipe (arrowed) at the front left wheel of the Motor Car. No leakage of brake fluid was observed. Visual examination of the various components of the braking system like the brake caliper (circled), brake booster, brake pedal etc had revealed all to be intact and without visible damage.

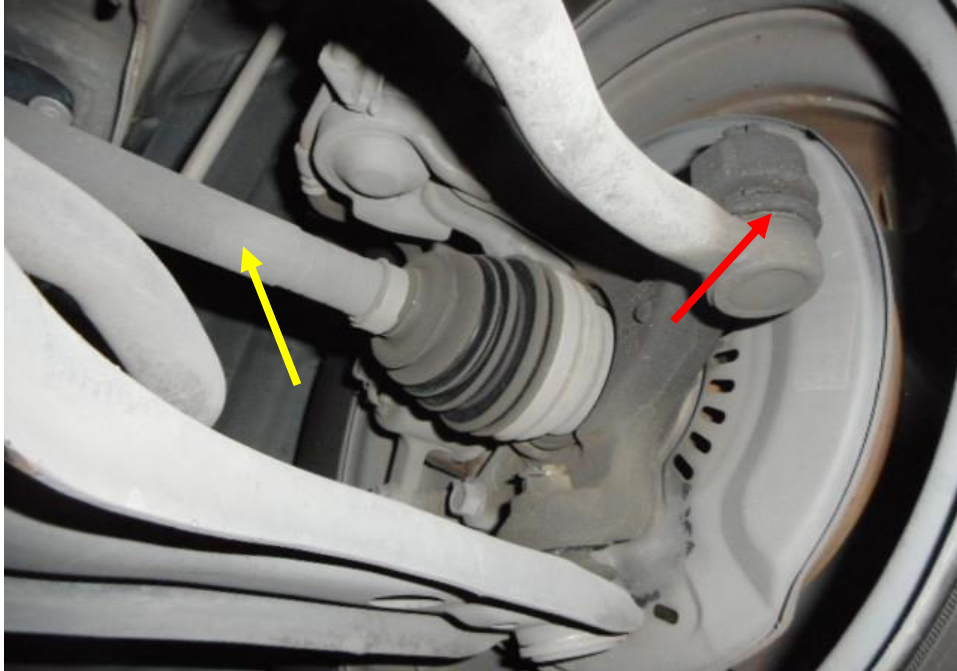
Photo 25 shows the various undercarriage components at the front right wheel of the Motor Car, in particular the steering tie rod (red arrow) and the driveshaft (yellow arrow). The various steering components were all found to be intact, suggesting that the steering system of the Motor Car was likely to be in serviceable condition at the material time of accident. There was also no sign of fluid stain observed on the various undercarriage components at the front right wheel of the Motor Car.

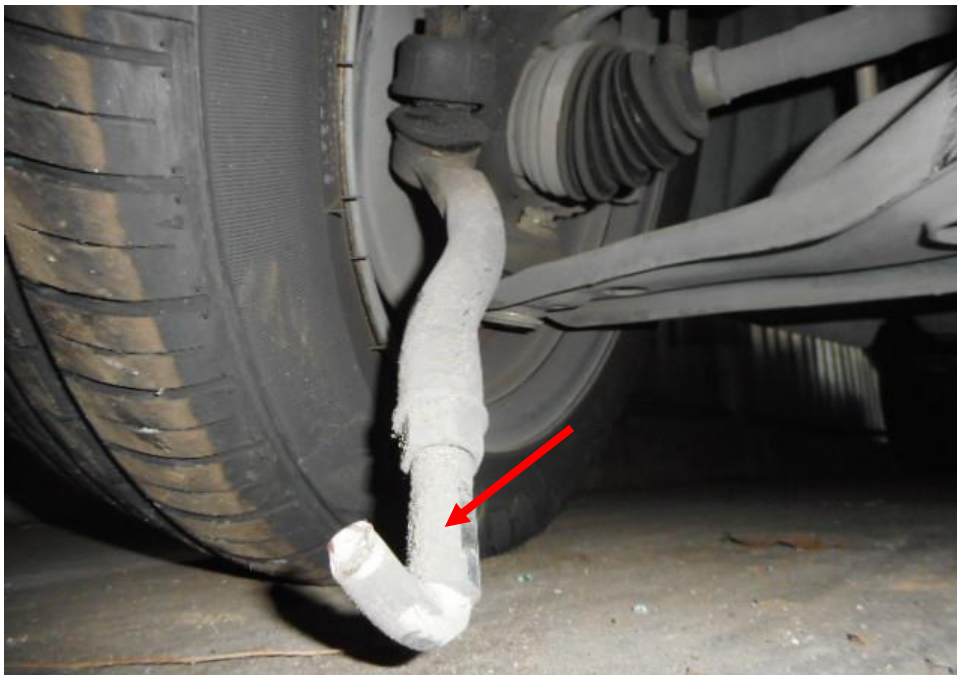
Photo 26 shows the various undercarriage components at the front left wheel of the Motor Car, in particular the steering tie rod end (arrowed) was observed to be damaged as a result of the accident.

15. Operational test to primarily determine whether there was any abnormality to the engine system, transmission system and braking system of the Motor Car could not be conducted given the engine was unable to be started, the chassis was damaged and the front left steering tie rod was also damaged as a result of the accident.

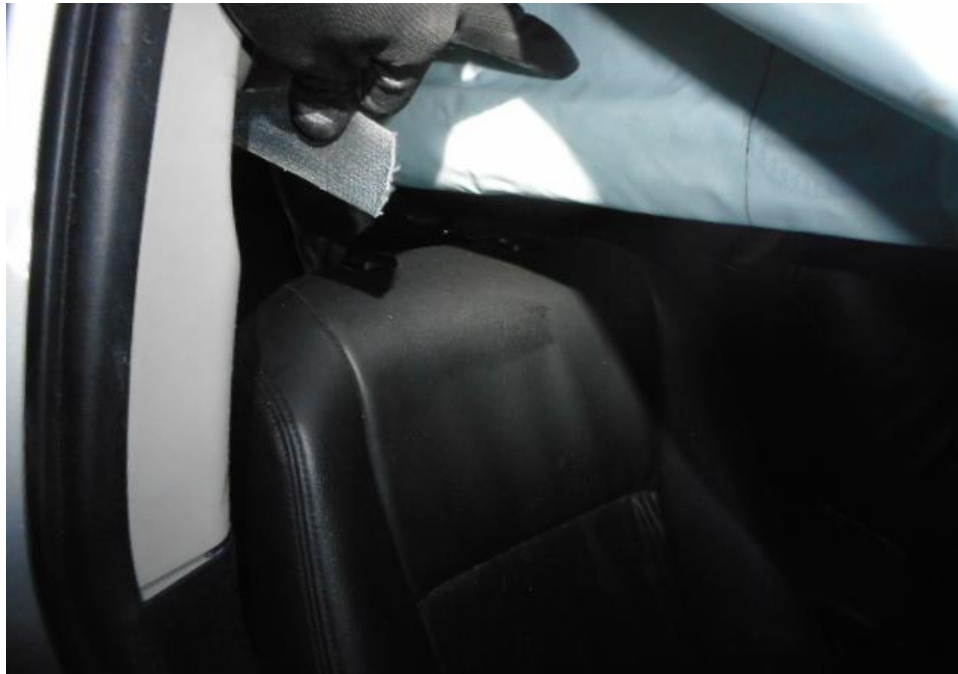
14. The front right was observed to be worn at the material time of accident as the respective pre-tensioners that were fitted at the side of each seat was activated upon the material time. The left seat belt of the "Motor Car" was unable to check as the seat belt of the right seat was observed to be cut and the left seat belt was observed to be missing at the time of our inspection. See photo 27 and 28 below.

Photo 27 shows that the seat belt on the right seat was worn at the material time of accident as the safety pre-tensioners was activated at the moment of impact and caused the seat belt to be locked into the last position.

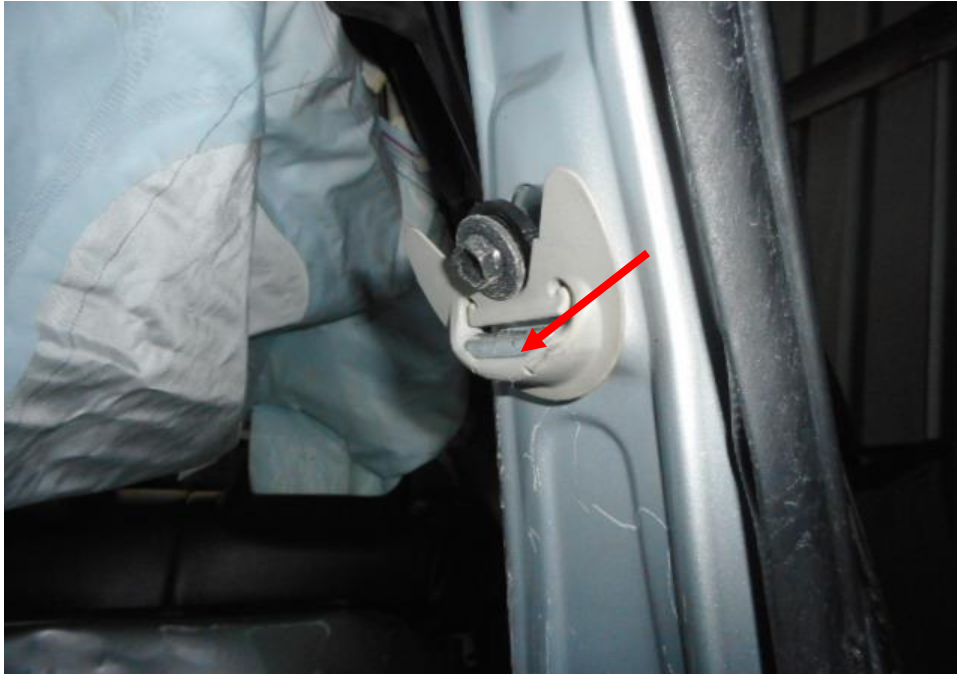
Photo 28 shows that the seat belt on the left seat was observed to be missing at the time of our inspection.
