Your Ref: TP/IP/26329/2022
Our Ref : CI/TPD22010905/P

9th March 2023

MECHANICAL INSPECTION REPORT OF MOTOR CAR SHF 111L

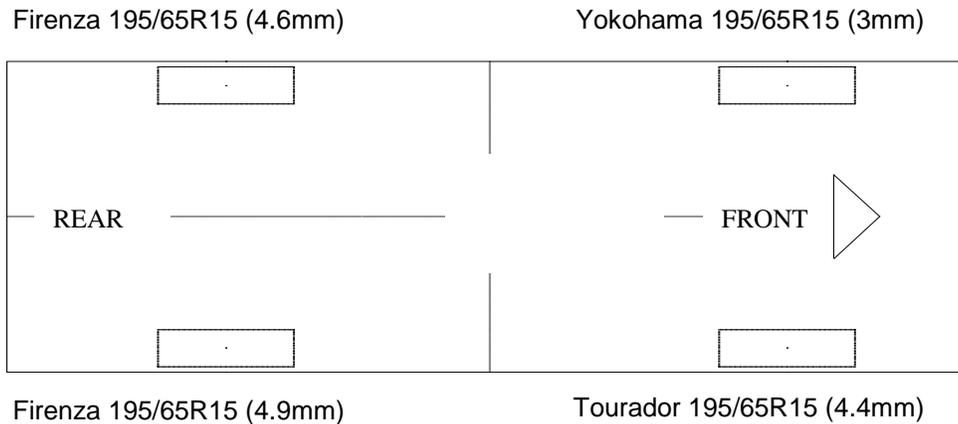
6. The condition of the Motor Car's 4 tyres was observed to be in serviceable condition. I did not find any tear, cut or burst mark(s) on the outer and the inner sidewalls as well as across the tread of the 4 tyres. The 4 tyres were also observed to be sufficiently inflated for vehicular operation. The tyre brand, tyre size and remaining tread depth of the 4 tyres were recorded as follows:-

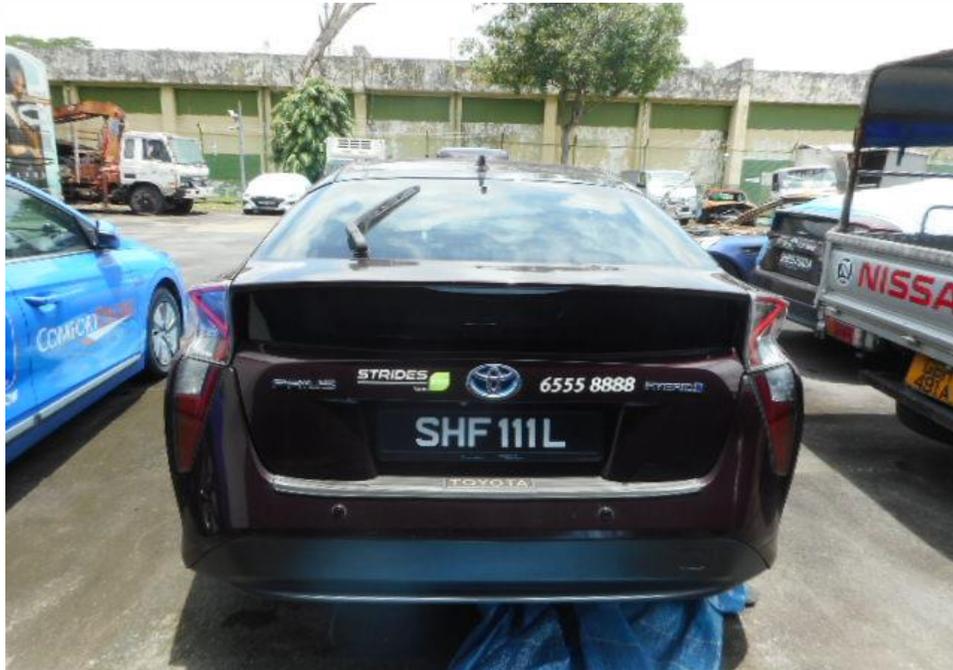
Photo 1 shows a general view of the Motor Car's rear body at the time of my inspection. The rear portion of the Motor Car was observed to have been undamaged by the accident.

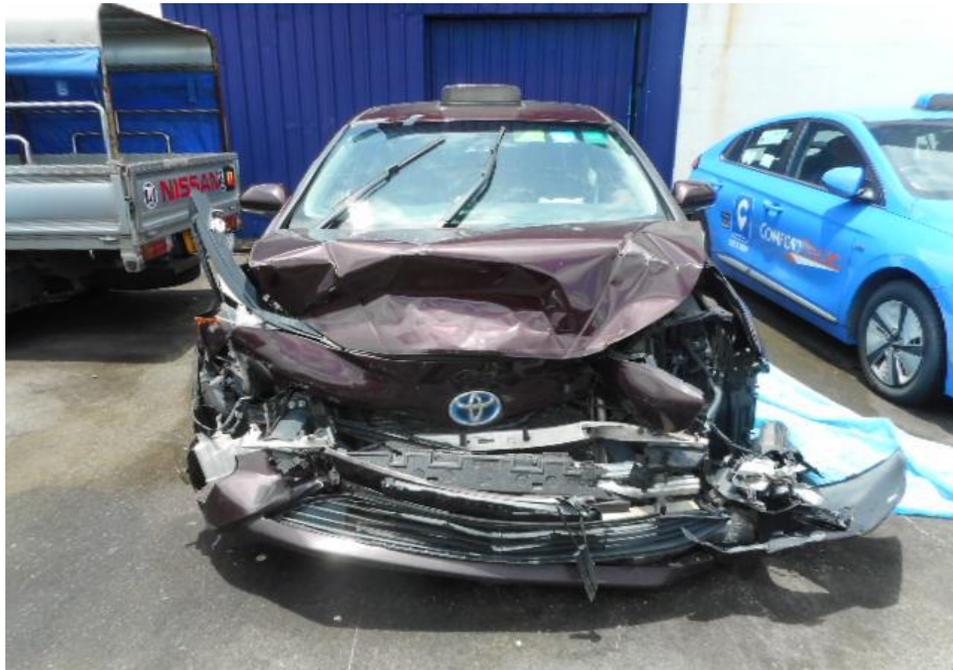
Photo 2 shows a general view of the Motor Car's front body at the time of my inspection. The Motor car was observed to have sustained damage at its front portion. Its front bonnet, front bumper, front left and right headlamp and front right fender was amongst the body parts and various engine components were also damaged as a result of the accident. The Supplemental Restraint System (SRS) was activated as a result of the accident.

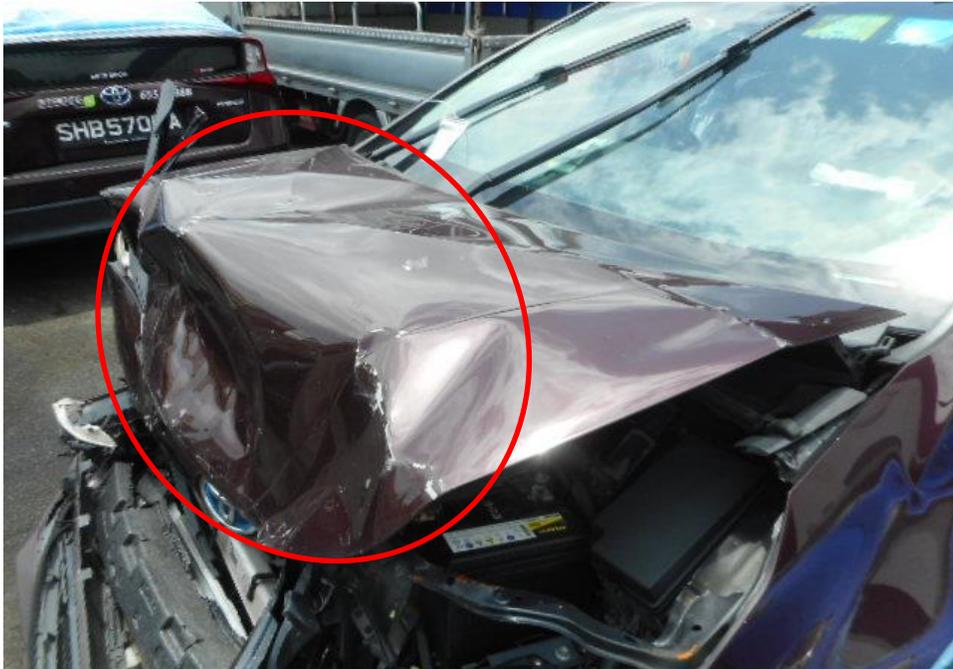
Photo 3 shows the close up view of the Motor Car's front body at the time of my inspection. The Motor car was observed to have sustained damage at its front portion. Its front bonnet (circled) was damaged as a result of the accident.

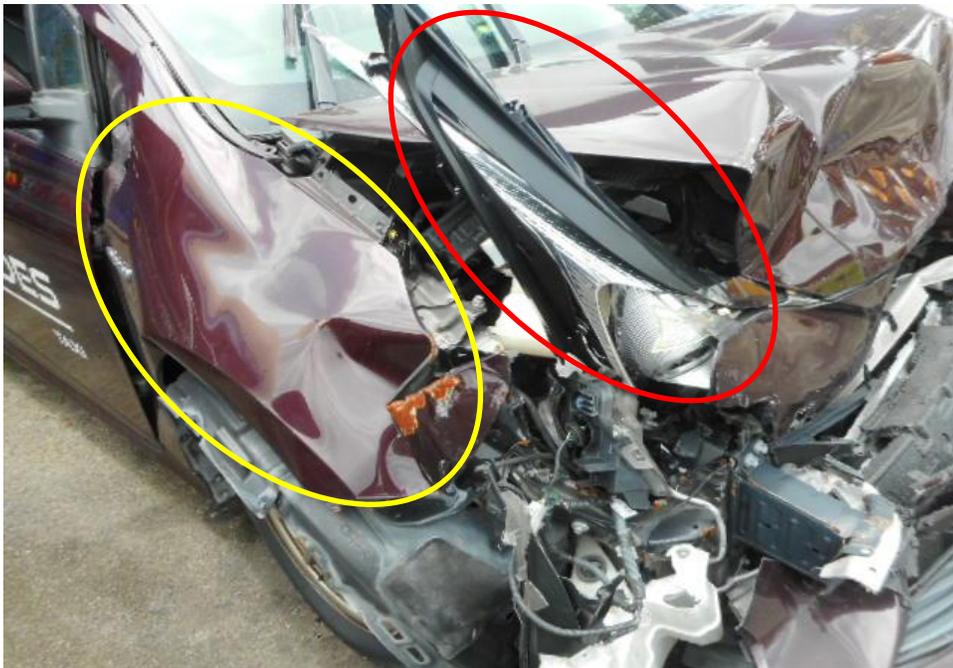
Photo 4 shows the close up view of the Motor Car's front body at the time of my inspection. The Motor car was observed to have sustained damage at its front portion. Its front right headlamp (red circle) and front right fender (yellow circle) was damaged as a result of the accident.

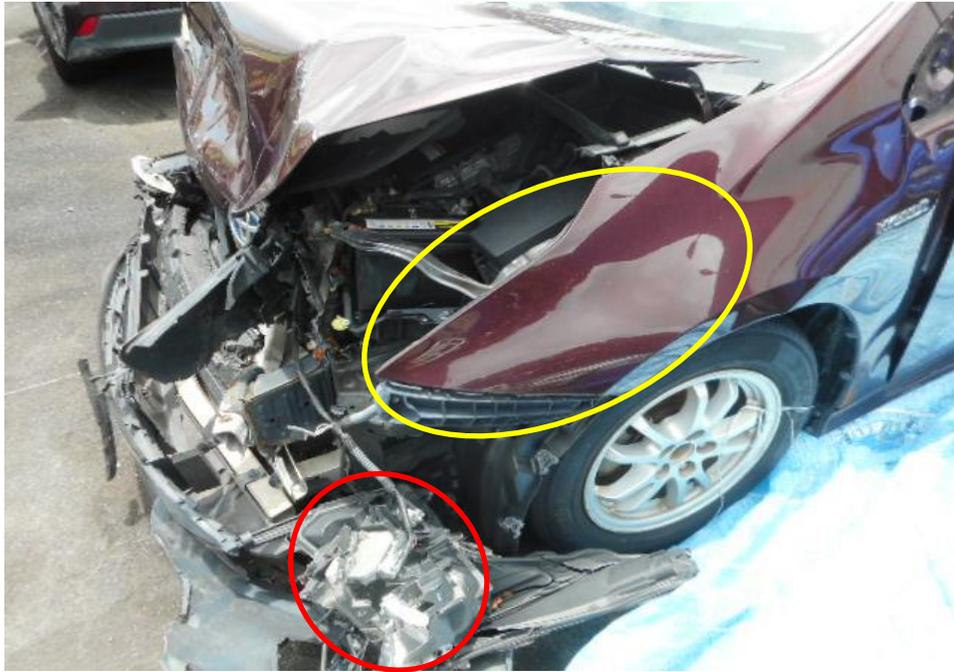
Photo 5 shows the close up view of the Motor Car's front body at the time of my inspection. The Motor car was observed to have sustained damage at its front portion. Its front left headlamp (red circle) and front left fender (yellow circle) was damaged as a result of the accident.

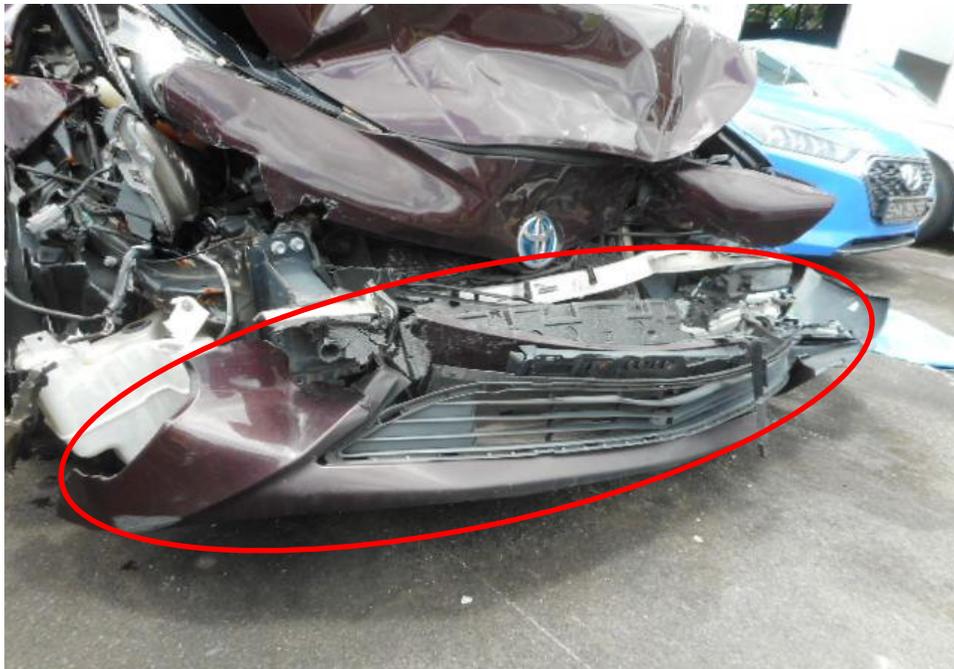
Photo 6 shows the close up view of the Motor Car's front body at the time of my inspection. The Motor car was observed to have sustained damage at its front portion. Its front bumper (circled) was damaged as a result of the accident.

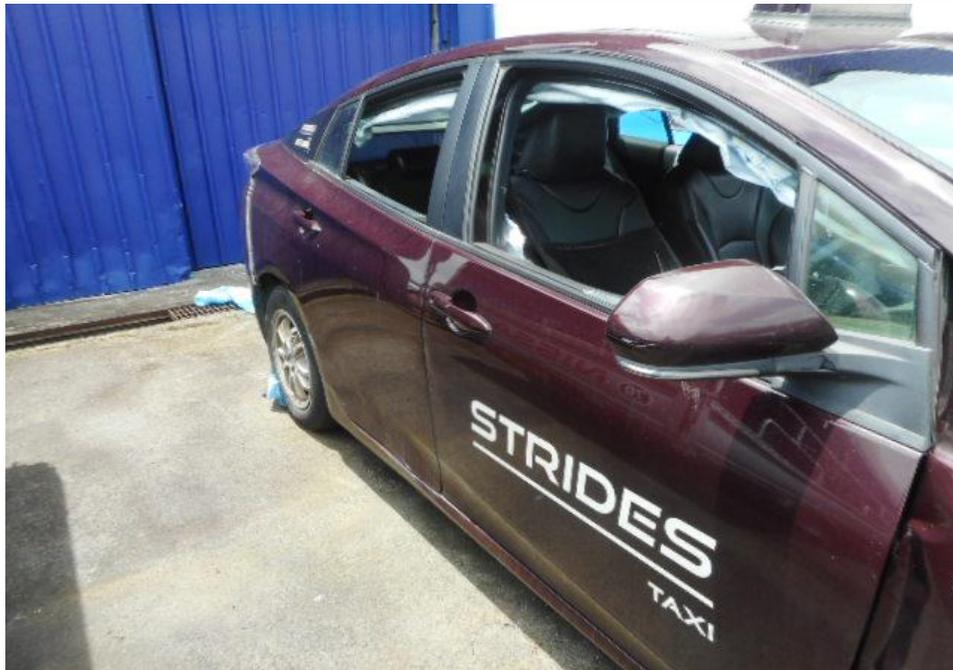
Photo 7 shows a general view of the Motor Car's right body at the time of my inspection. The right portion of the Motor Car was observed to have been undamaged by the accident.

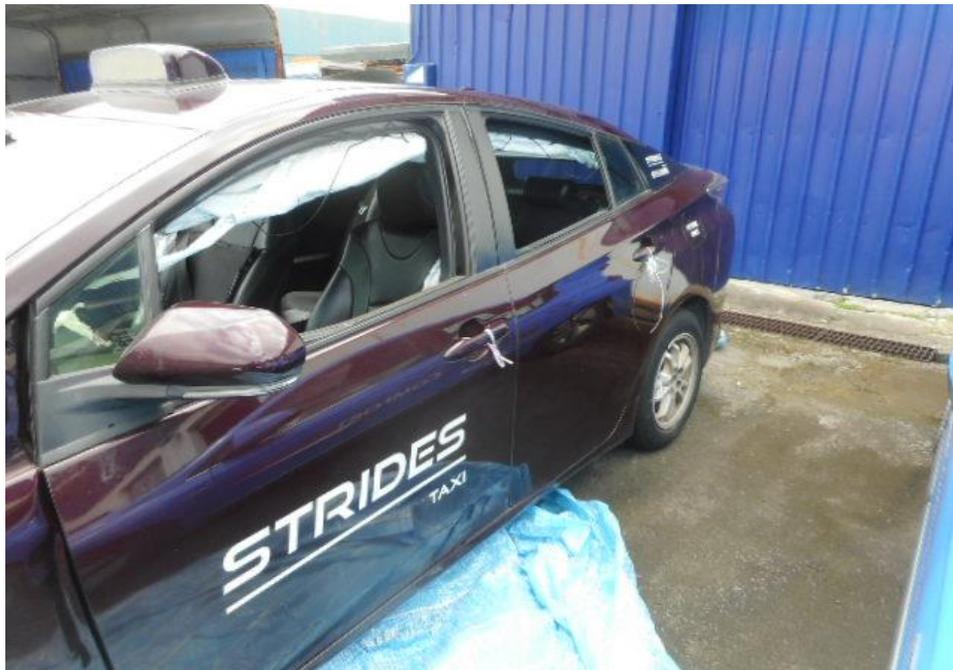
Photo 8 shows a general view of the Motor Car's left body at the time of my inspection. The left portion of the Motor Car was observed to have been undamaged by the accident.

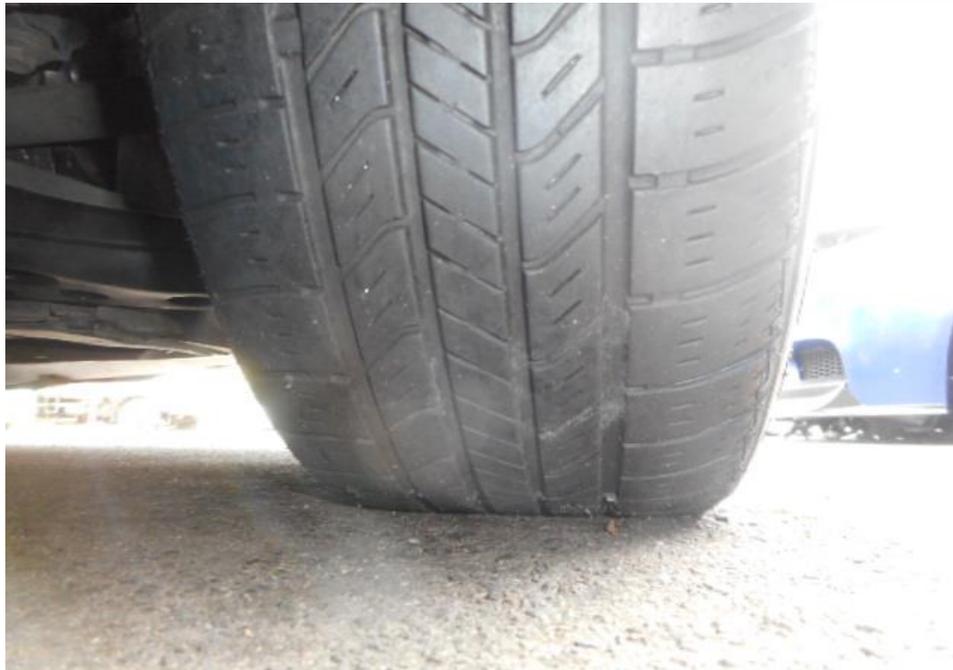
Photo 9 shows the condition of the front right tyre of the Motor Car, which was observed to be in serviceable condition with remaining tread depth of approximately 4.4mm. The tyre, which was wrapped around alloy wheel rim, was also observed to be sufficiently inflated for vehicular operation.

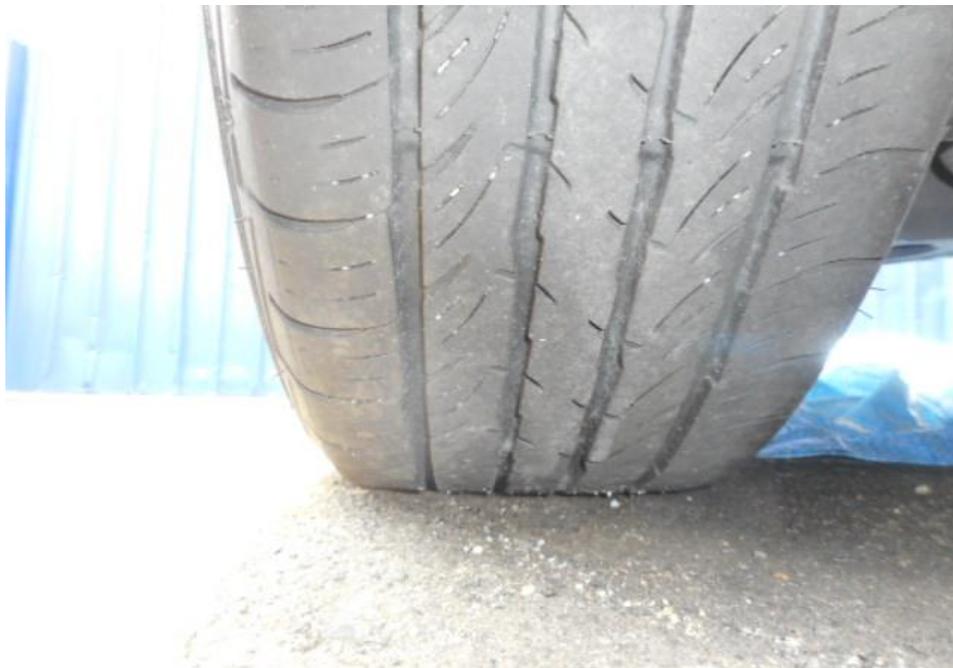
Photo 10 shows the condition of the rear right tyre of the Motor Car, which was observed to be in serviceable condition with remaining tread depth of approximately 4.9mm. The tyre was also observed to be sufficiently inflated for vehicular operation with no tear, cut or burst mark(s).

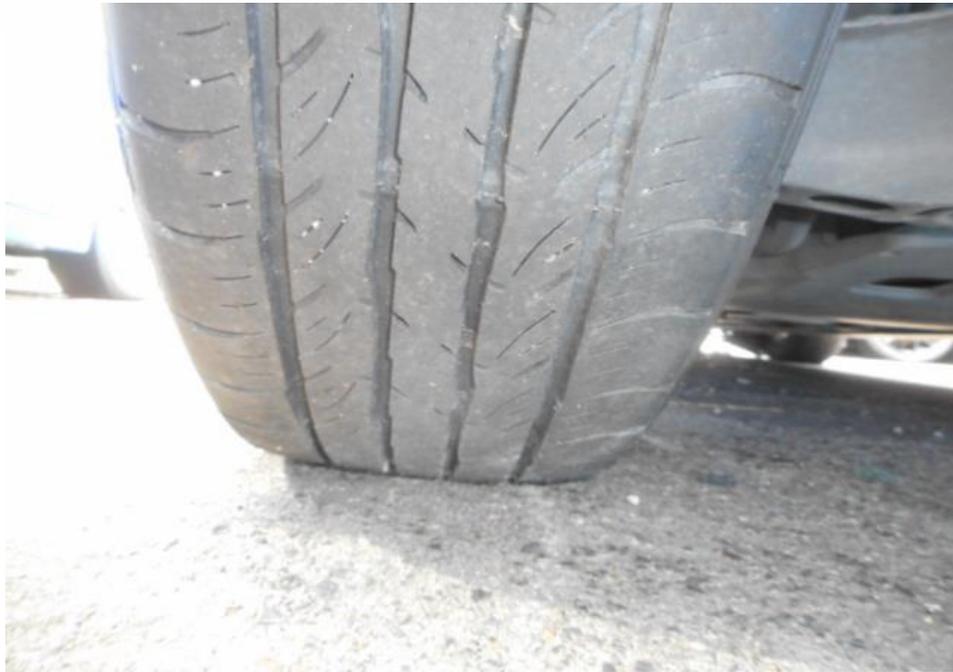
Photo 11 shows the condition of the rear left tyre of the Motor Car, which was observed to be in serviceable condition with remaining tread depth of approximately 4.6mm. The tyre was also observed to be sufficiently inflated for vehicular operation with no tear, cut or burst mark(s).

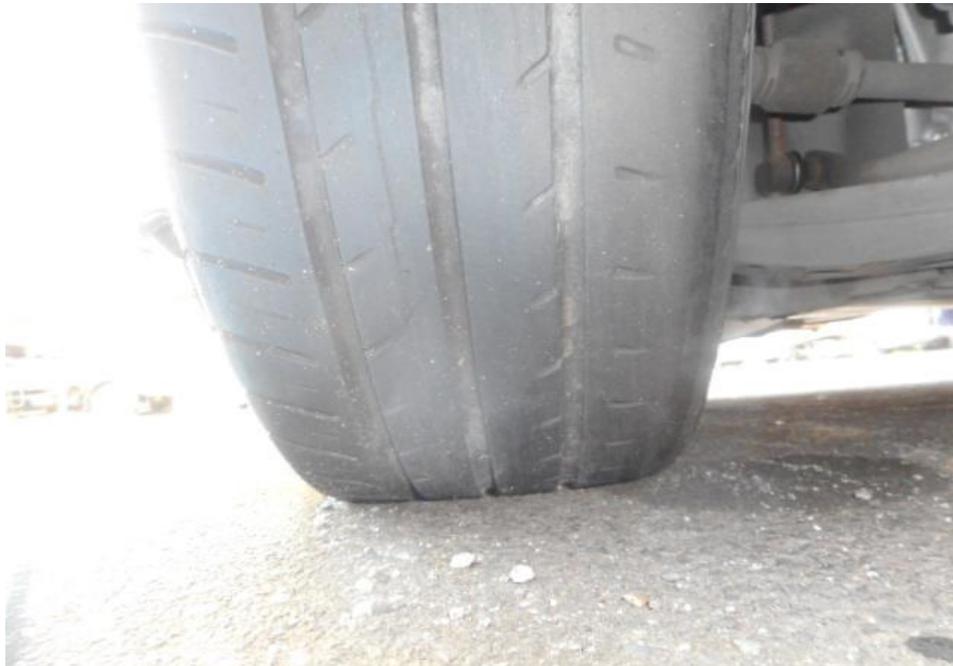
Photo 12 shows the condition of the front left tyre of the Motor Car, which was observed to be in serviceable condition with remaining tread depth of approximately 3mm. The tyre was also observed to be sufficiently inflated for vehicular operation with no tear, cut or burst mark(s).

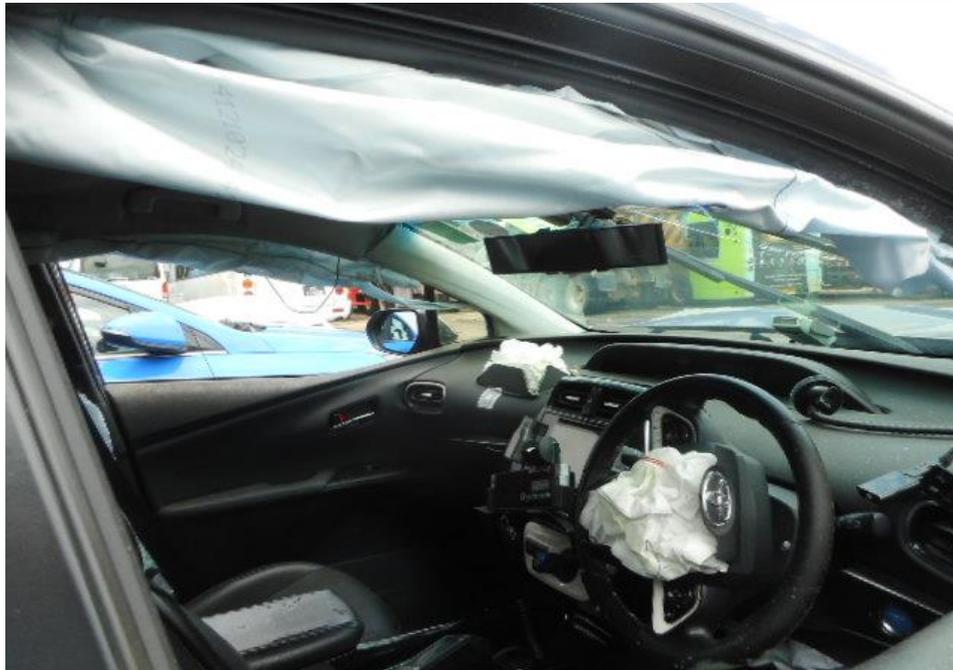
Photo 13 shows the deployment of the Supplemental Restraint System (SRS) airbag in the Motor Car as a result of the accident.

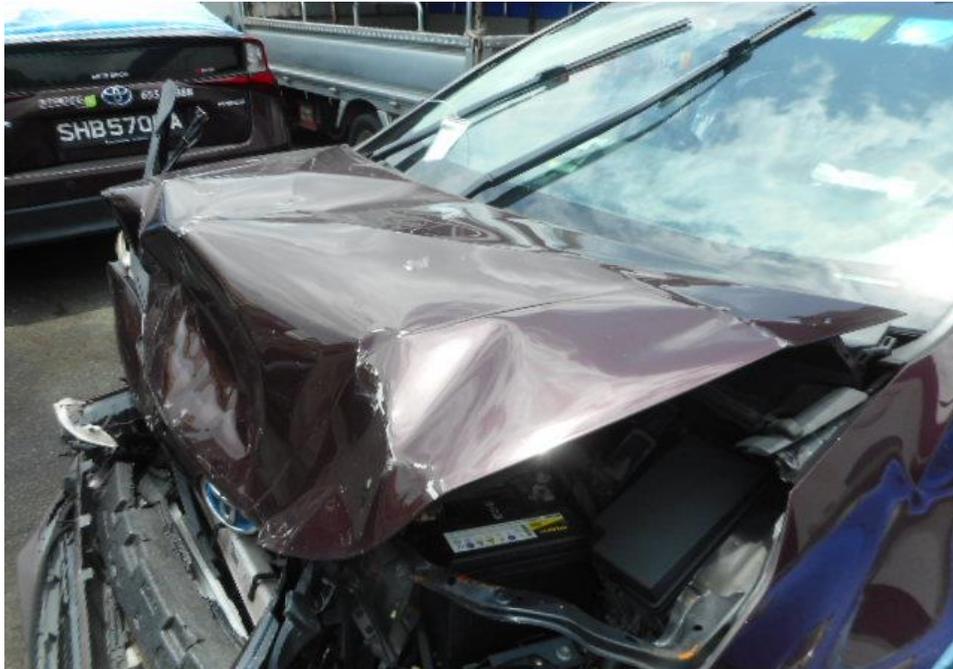
8. We were unable to raise the front bonnet of the Motor car to conduct the examination of the Motor Car's engine compartment because the damage caused by the accident had resulted in the damages to the bonnet and the structure of the engine compartment. (Unable to open).
9. During our inspection, we observed that the engine and ignition system was damaged as a result of the induced impact from the accident.
10. My subsequent checks on the underside of the Motor Car also revealed no sign(s) or indication(s) of fluid leak and/or fluid stain(s). Visually, the various undercarriage components of the Motor Car were all observed to be intact and without any visible damage. See photo 14 -16 below.

Photo 14 shows the general view of the Motor Car's front bonnet which was damaged as a result of the accident causing the bonnet unable to be opened at the time of my inspection. Its engine and components were crushed and damaged as a result of the accident.

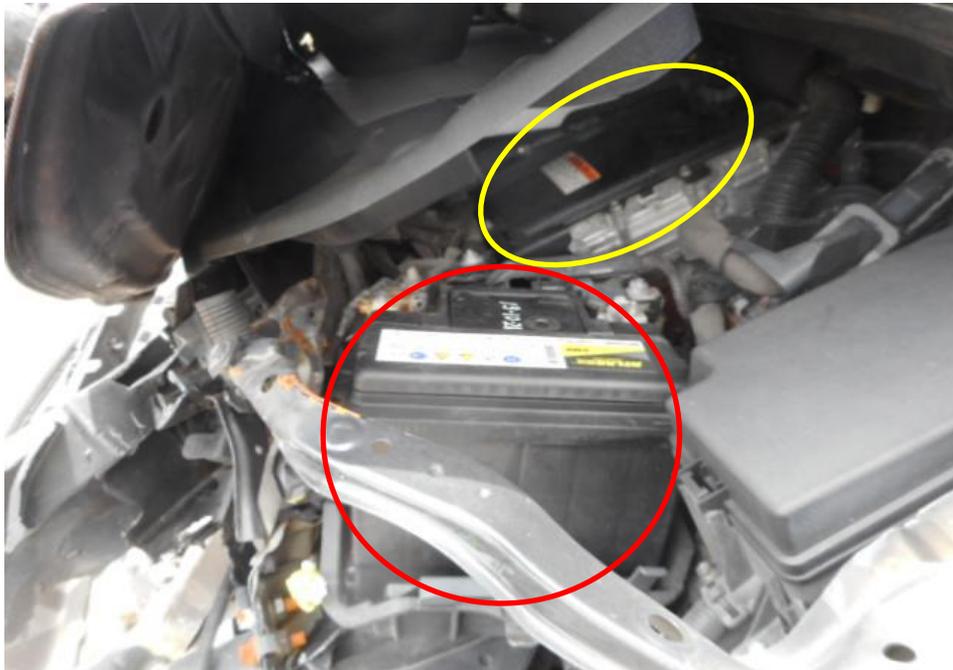
Photo 15 shows the close up view of the Motor Car's front body at the time of my inspection. The Motor car was observed to have sustained damage at its front portion. Its ignition system battery (red circle) and engine (yellow circle) was amongst the various components in the engine compartments were also damaged as a result of the accident.

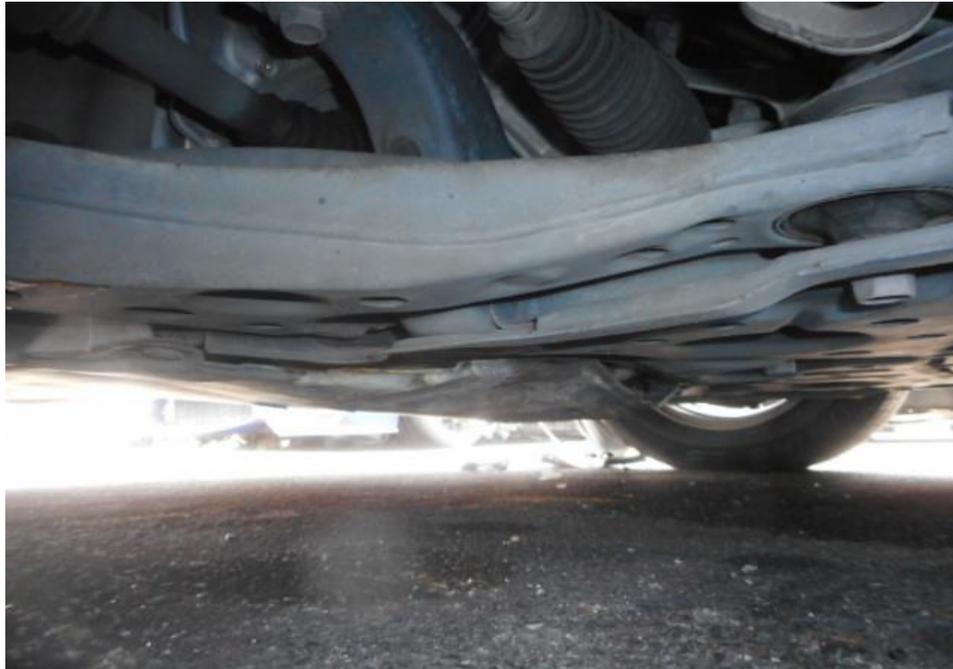
Photo 16 shows the undercarriage of the Motor Car, at the area where the engine housing and transmission housing are located. I did not find any sign(s) or indication(s) of fluid leak and/or fluid stain(s) on the underside of the Motor Car.

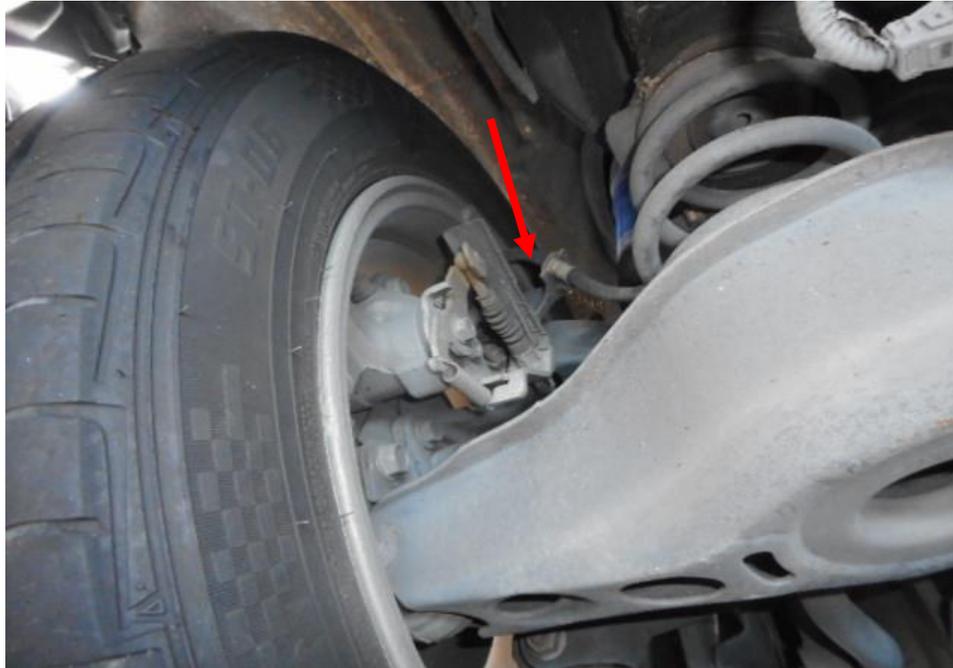
Photo 17 shows the brake hose/pipe (arrowed) at the rear left wheel of the Motor Car. No leakage of brake fluid was observed. Visual examination of the various components of the braking system like the drum brake and brake pedal etc had revealed all to be intact and without visible damage.

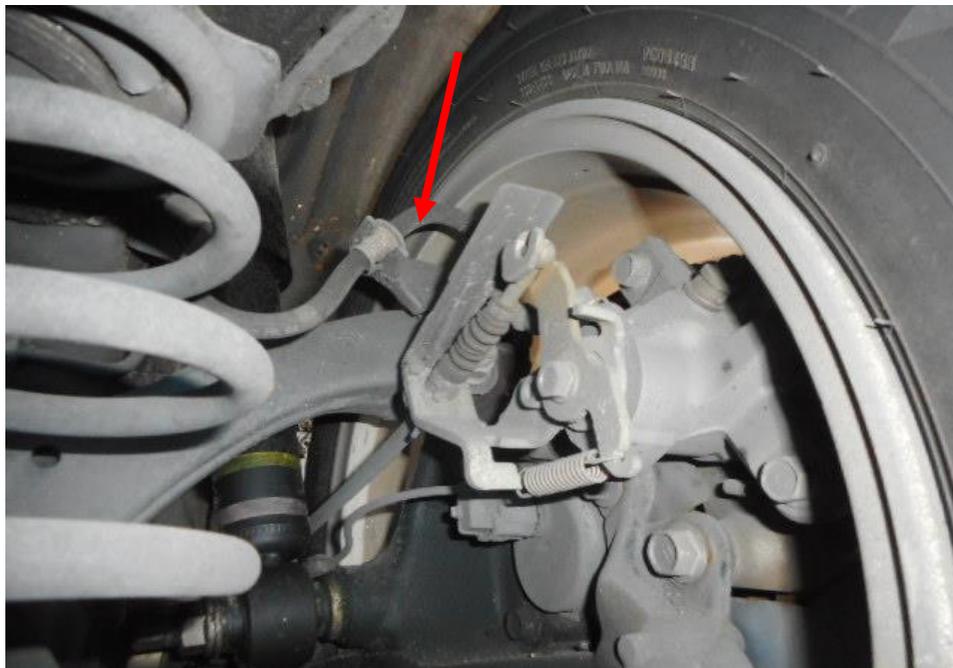
Photo 18 shows the brake hose/pipe (arrowed) at the rear right wheel of the Motor Car. No leakage of brake fluid was observed. Visual examination of the various components of the braking system like the drum brake and brake pedal etc had revealed all to be intact and without visible damage.

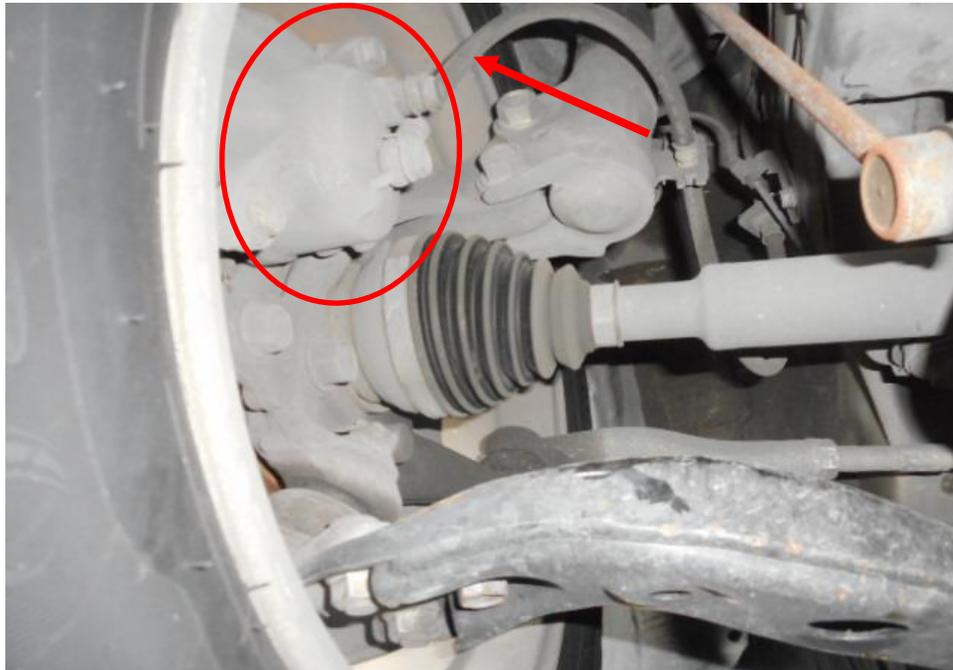
Photo 19 shows the brake hose/pipe (arrowed) at the front right wheel of the Motor Car. I did not observe any leakage of brake fluid at the time of my inspection of the Motor Car. Visual examination of the various components of the braking system like the drum brake and brake pedal etc had revealed all to be intact and without visible damage.

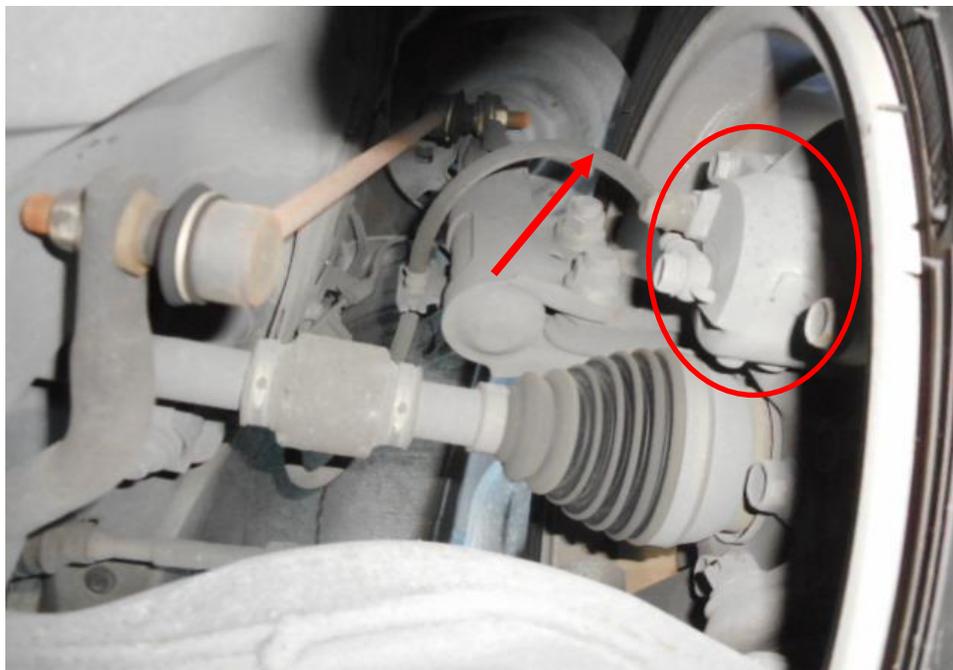
Photo 20 shows the brake hose/pipe (arrowed) at the front left wheel of the Motor Car. No leakage of brake fluid was observed. Visual examination of the various components of the braking system like the brake caliper (circled) and brake pedal etc had revealed all to be intact and without visible damage.

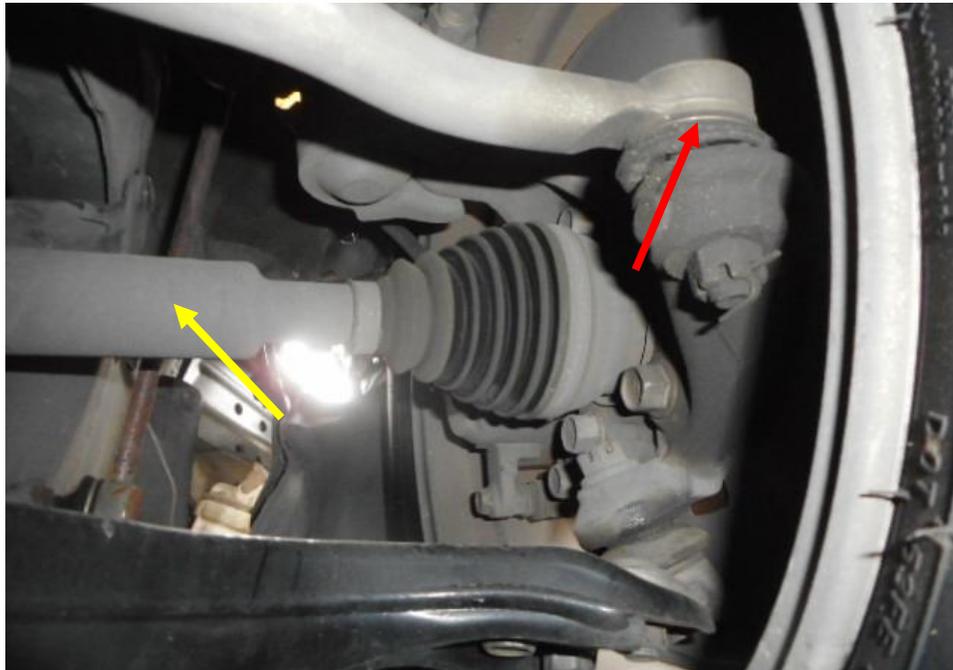
Photo 21 shows the various undercarriage components at the front right wheel of the Motor Car, in particular the steering tie rod (red arrow) and the driveshaft (yellow arrow). The various steering components were all found to be intact. There was also no sign of fluid stain observed on the various undercarriage components at the front right wheel of the Motor Car.

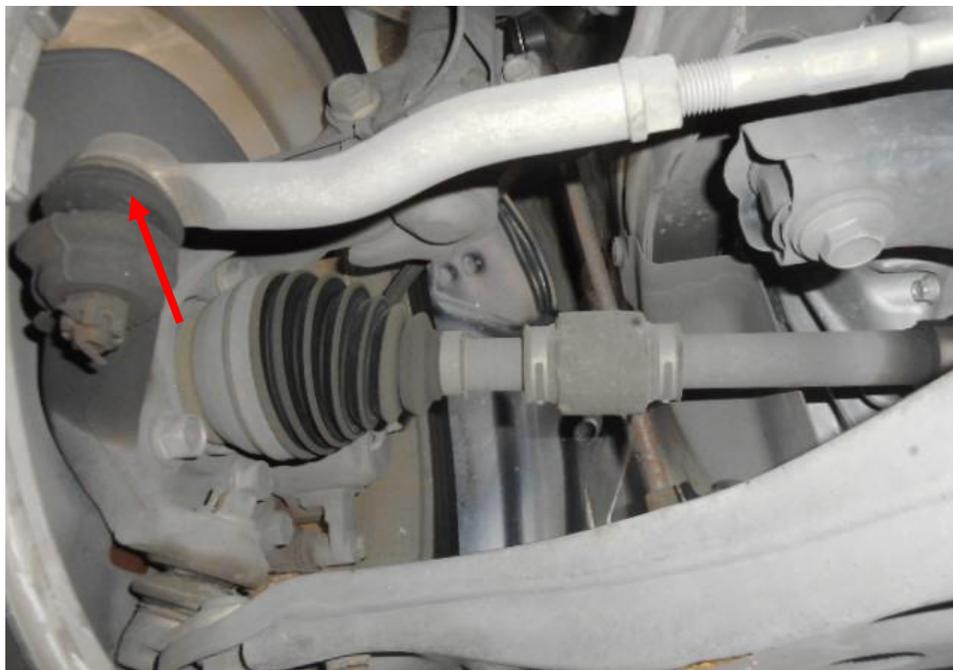
Photo 22 shows the various undercarriage components at the front left wheel of the Motor Car, in particular the steering tie rod end (arrowed). The various undercarriage components of the Motor Car were all found to be intact without any visible damage. There was also no sign of fluid stain(s) observed on the various undercarriage components.

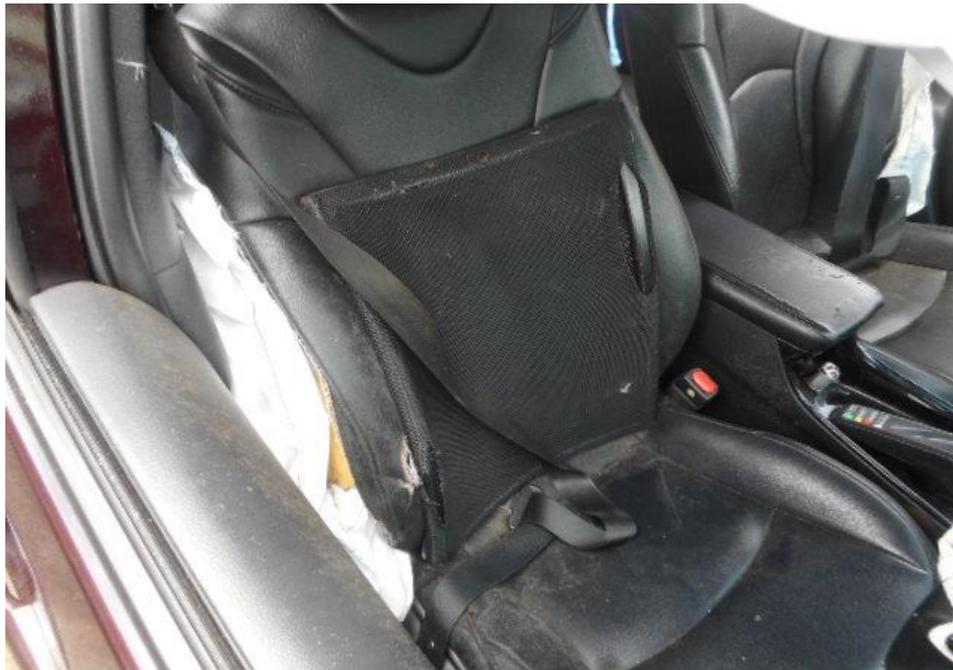
14. The front left and right seat belt of the "Motor Car" was worn at the material time of accident as the respective pre-tensioners that were fitted at the side of each seat was activated upon the material time. See photo 23 and 24 below.

Photo 23 shows that the seat belt on the right seat was worn at the material time of accident as the safety pre-tensioners was activated at the moment of impact and caused the seat belt to be locked into the last position.

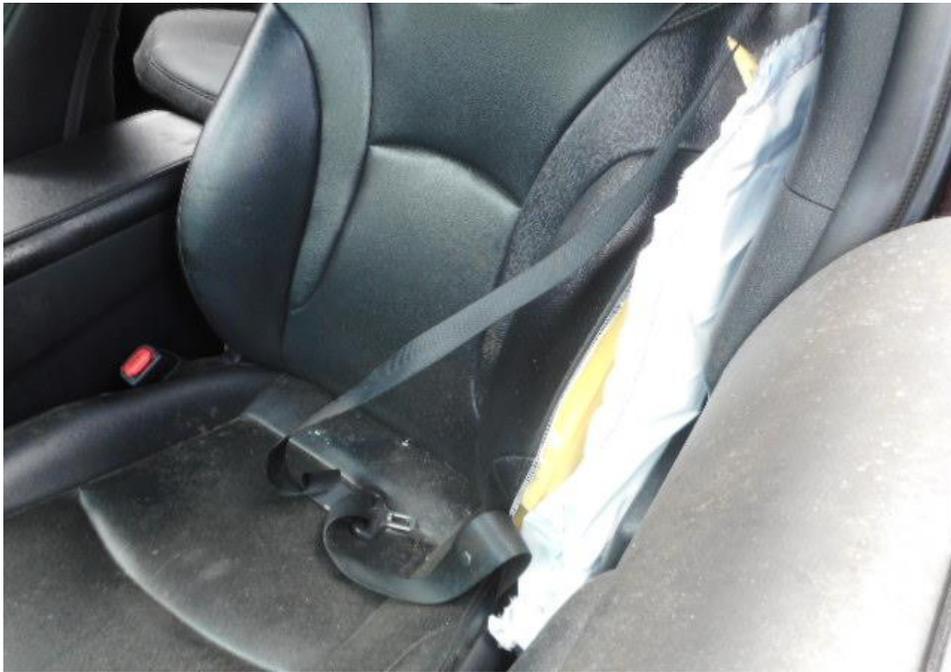
Photo 24 shows that the seat belt on the left seat was worn at the material time of accident as the safety pre-tensioners was activated at the moment of impact and caused the seat belt to be locked into the last position.
