Your Ref: TP/IP/23213/2022
Our Ref : CI/TPD22010907/P

Fatal Accident Investigation Team

MECHANICAL INSPECTION REPORT OF MOTOR CAR SLZ 6560G

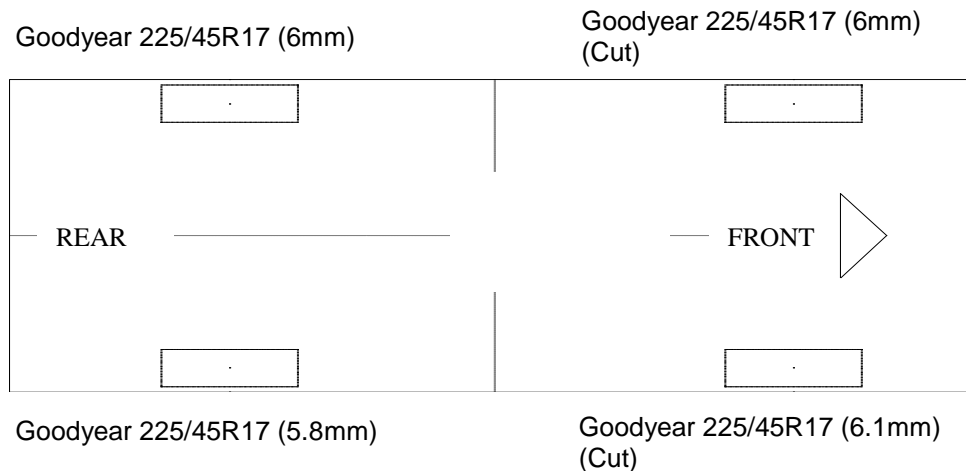
6. The condition of the Motor Car's front right and left tyres was observed to be cut as a result of the accident. However, the rear right and left tyres was observed to be in serviceable condition. I did not find any tear, cut or burst mark(s) on the outer and the inner sidewalls as well as across the tread of the 2 rear tyres. The 2 rear tyres were also observed to be sufficiently inflated for vehicular operation. The tyre brand, tyre size and remaining tread depth of the 4 tyres were recorded as follows:-

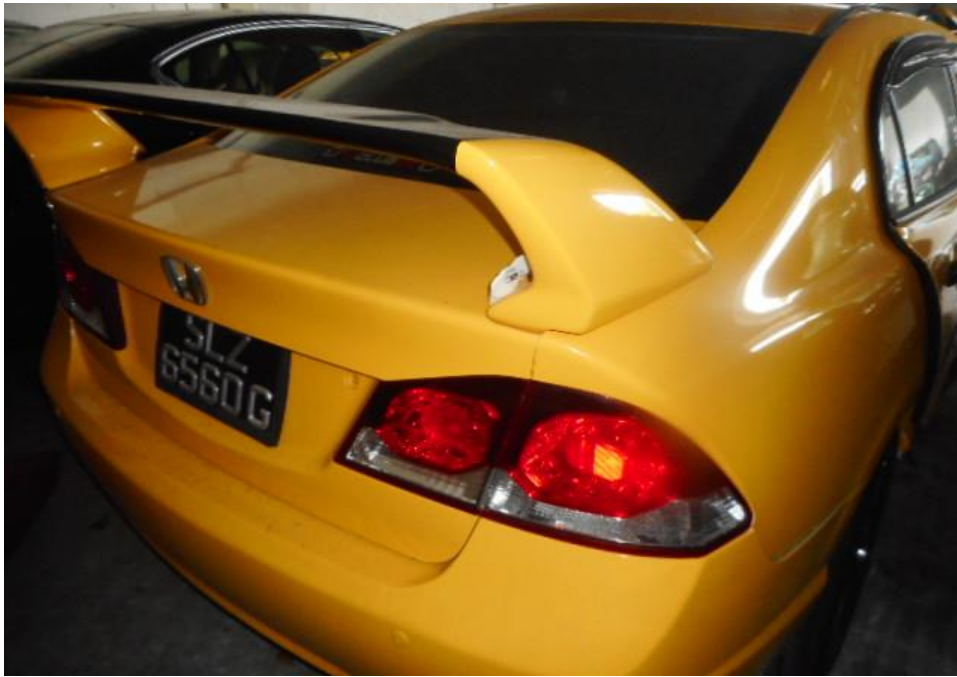
Photo 1 shows a general view of the Motor Car's rear body at the time of my inspection. The rear portion of the Motor Car was observed to have been undamaged by the accident.

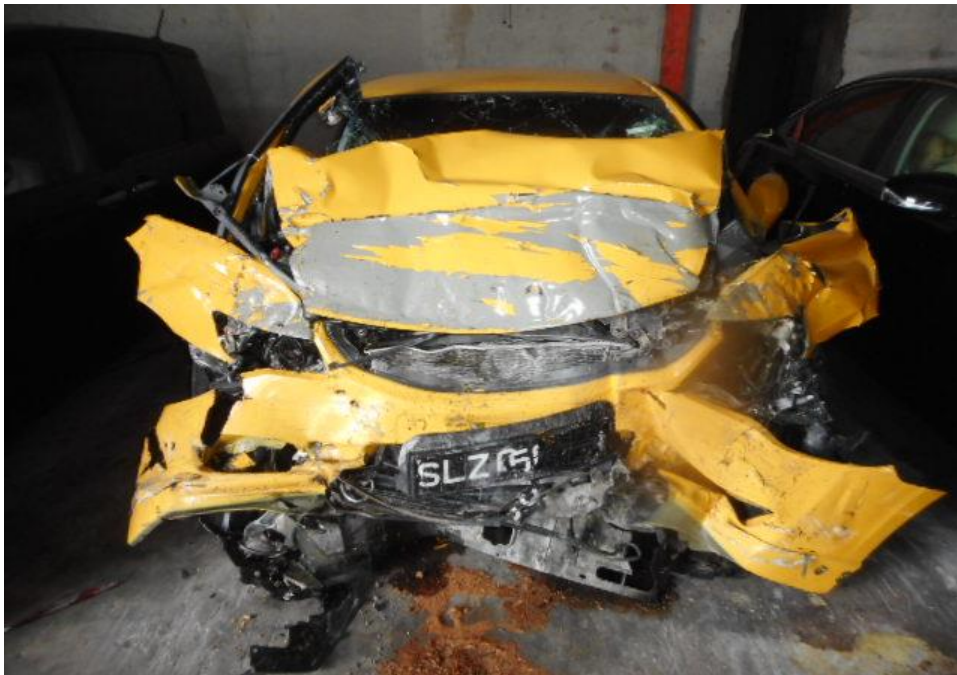
Photo 2 shows a general view of the Motor Car's front body at the time of my inspection. The Motor car was observed to have sustained damage at its front portion. Its front windscreen, front bonnet, front bumper, front left and right fender, front left and right headlamp was amongst the body parts and various engine components were also damaged as a result of the accident. The Supplemental Restraint System (SRS) was activated as a result of the accident.

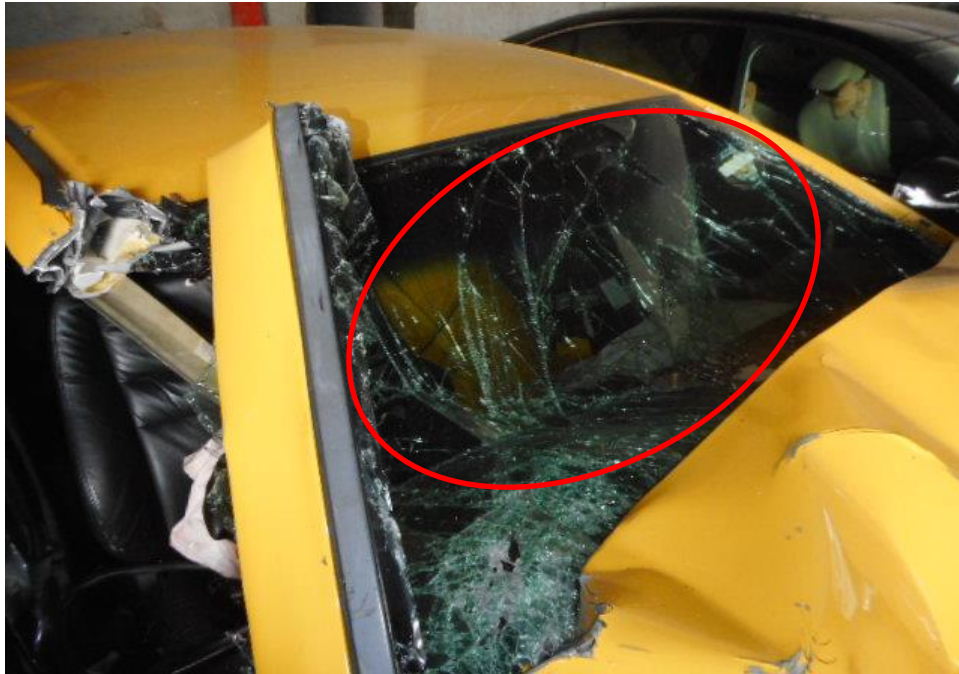
Photo 3 shows the close up view of the Motor Car's front body at the time of my inspection. The Motor car was observed to have sustained damage at its front portion. Its front windscreen (circled) was damaged as a result of the accident.

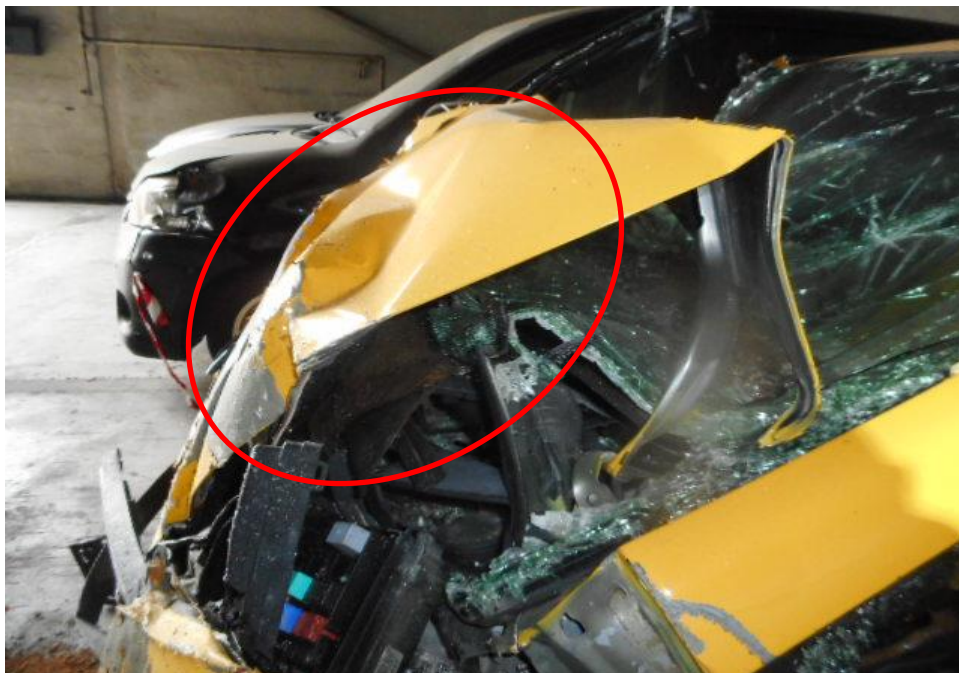
Photo 4 shows the close up view of the Motor Car's front body at the time of my inspection. The Motor car was observed to have sustained damage at its front portion. Its front bonnet (circled) was damaged as a result of the accident.

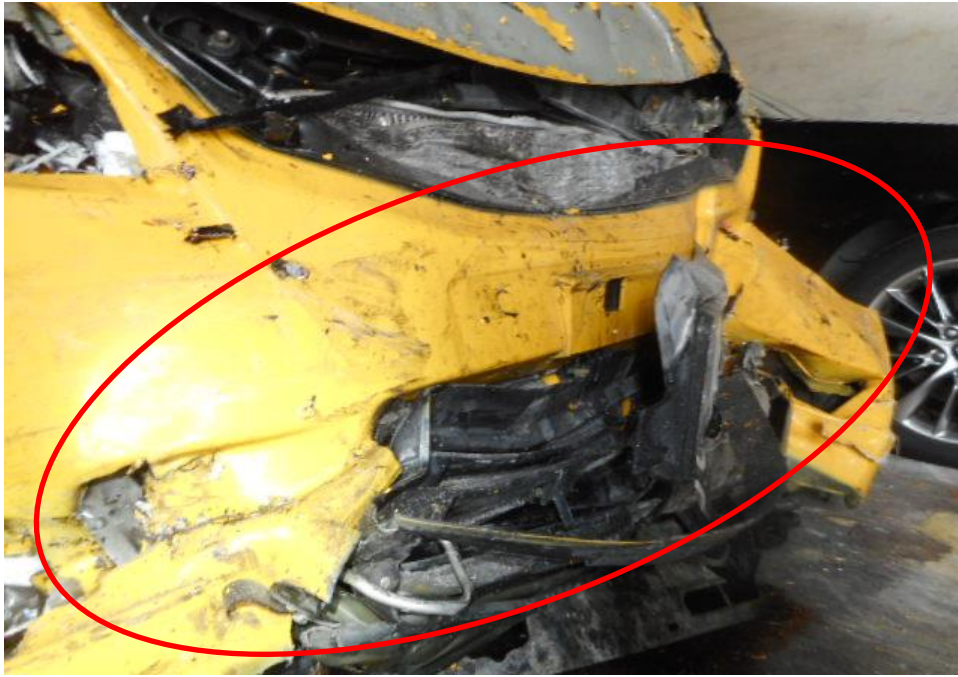
Photo 5 shows the close up view of the Motor Car's front body at the time of my inspection. The Motor car was observed to have sustained damage at its front portion. Its front bumper (circled) was damaged as a result of the accident.

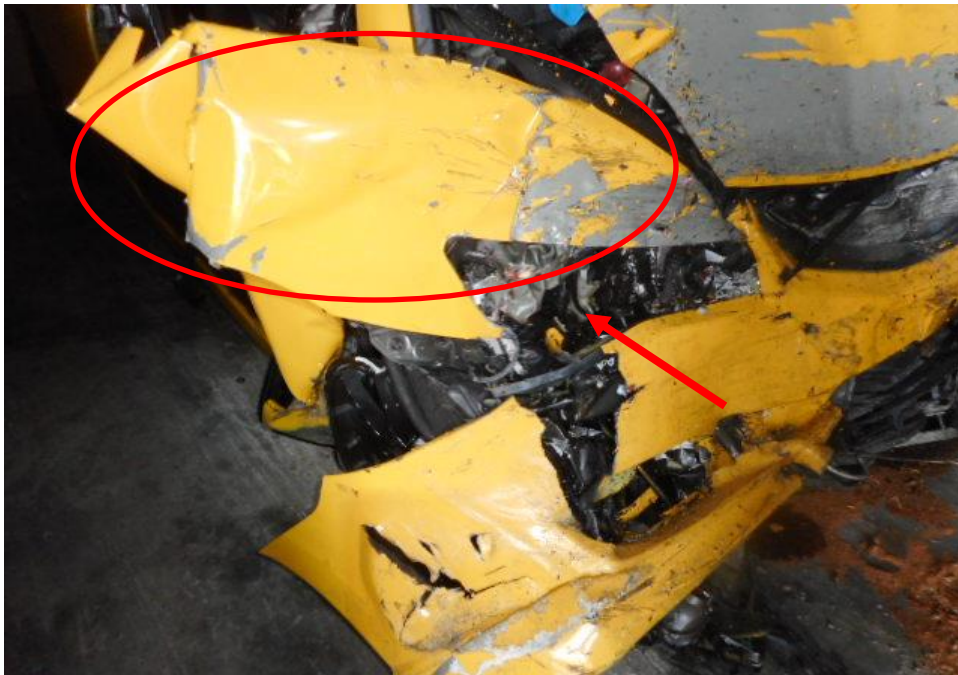
Photo 6 shows the close up view of the Motor Car's front body at the time of my inspection. The Motor car was observed to have sustained damage at its front portion. Its front right headlamp (circled) and front right fender (arrowed) was amongst the body parts and various components in the engine compartments were also damaged as a result of the accident.

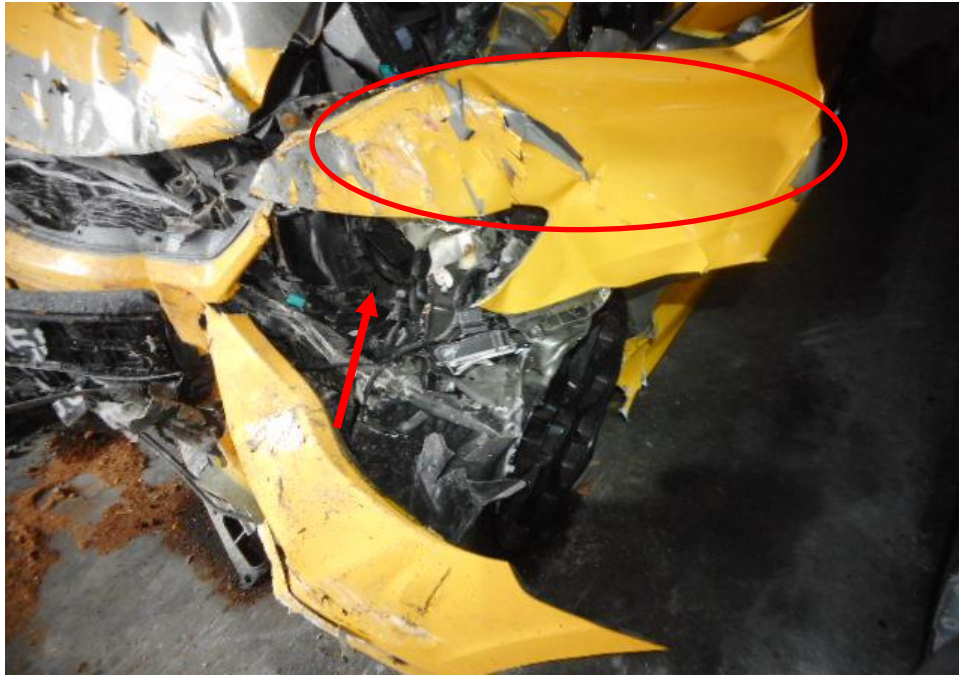
Photo 7 shows the close up view of the Motor Car's front body at the time of my inspection. The Motor car was observed to have sustained damage at its front portion. Its front left headlamp (circled) and front left fender (arrowed) was amongst the body parts and various components in the engine compartments were also damaged as a result of the accident.

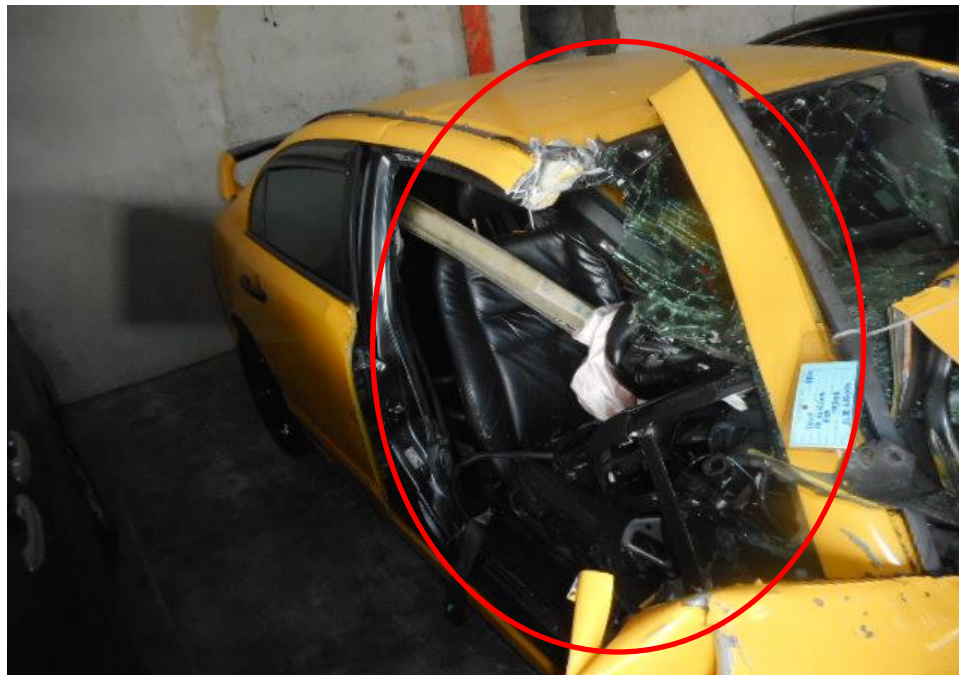
Photo 8 shows a general view of the Motor Car's right body at the time of my inspection. The right portion of the Motor Car was observed to have been removed by the SCDF due to the accident.

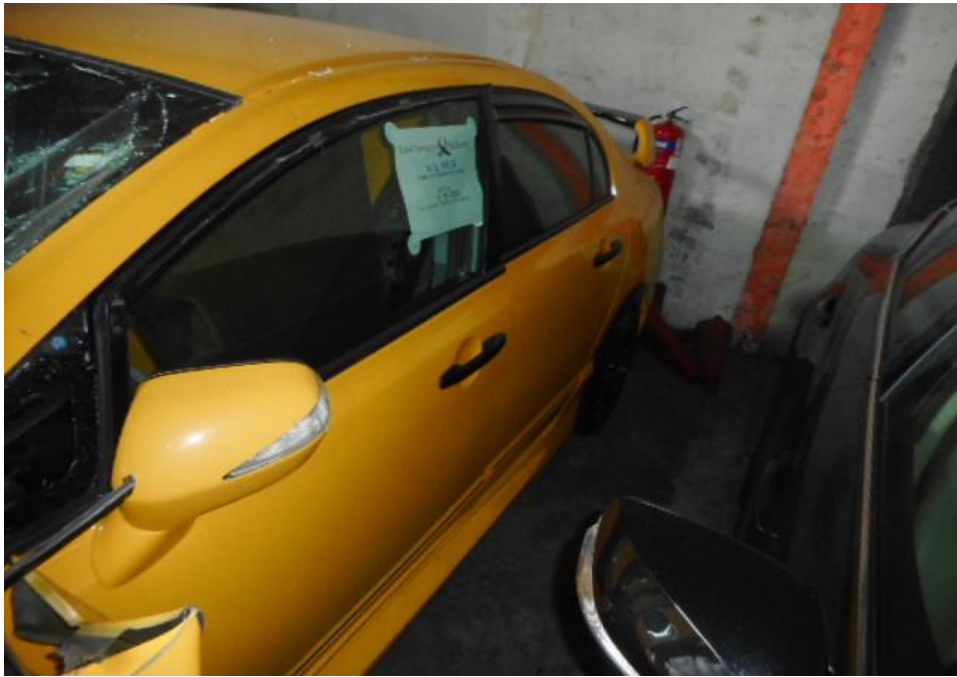
Photo 9 shows a general view of the Motor Car's left body at the time of my inspection. The left portion of the Motor Car was observed to have been undamaged by the accident.

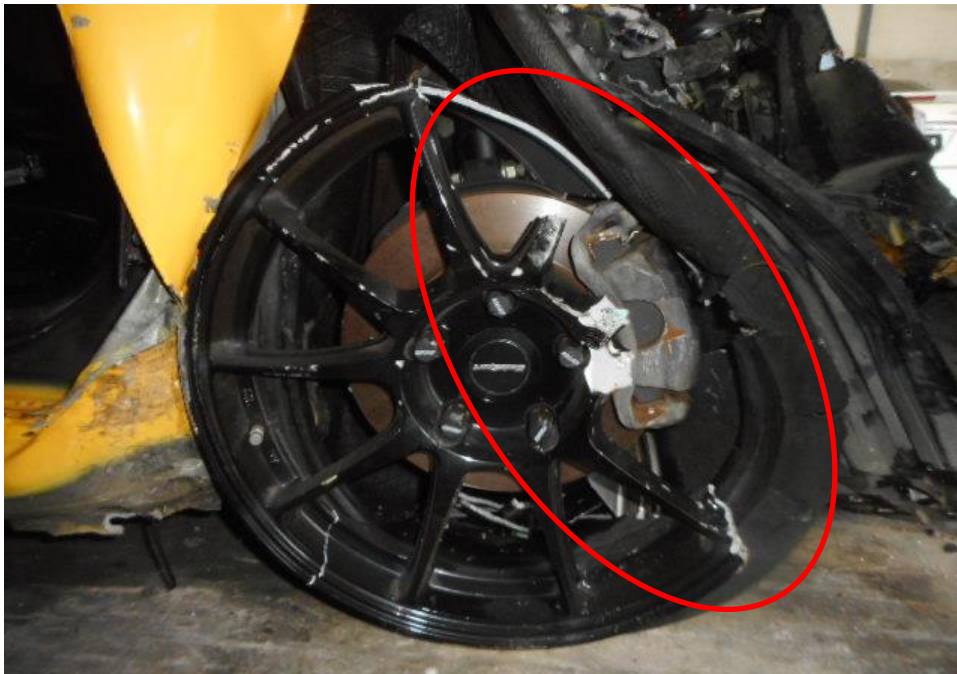
Photo 10 shows the general condition of the front right tyre of the Motor Car, which was observed to be deflated due to the damaged rim (circled) as a result of the accident. The tyre was also observed with cut mark(s) with remaining tread depth of approximately 6.1mm.

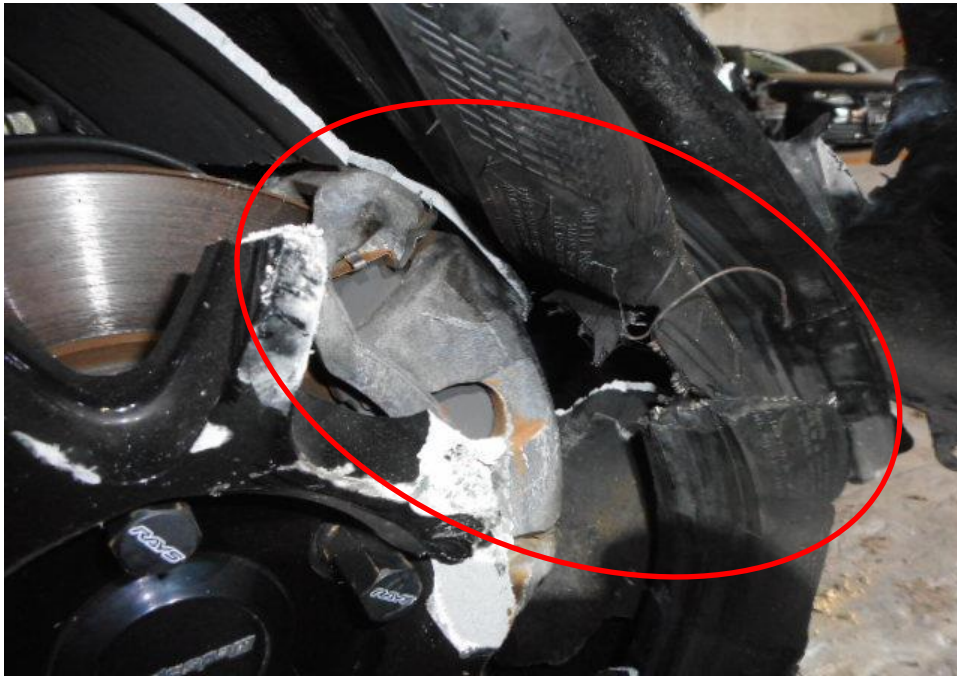
Photo 11 shows the close up condition of the front right tyre of the Motor Car, which was observed to be deflated due to the damaged rim (circled) as a result of the accident. The tyre was also observed with cut mark(s) with remaining tread depth of approximately 6.1mm.

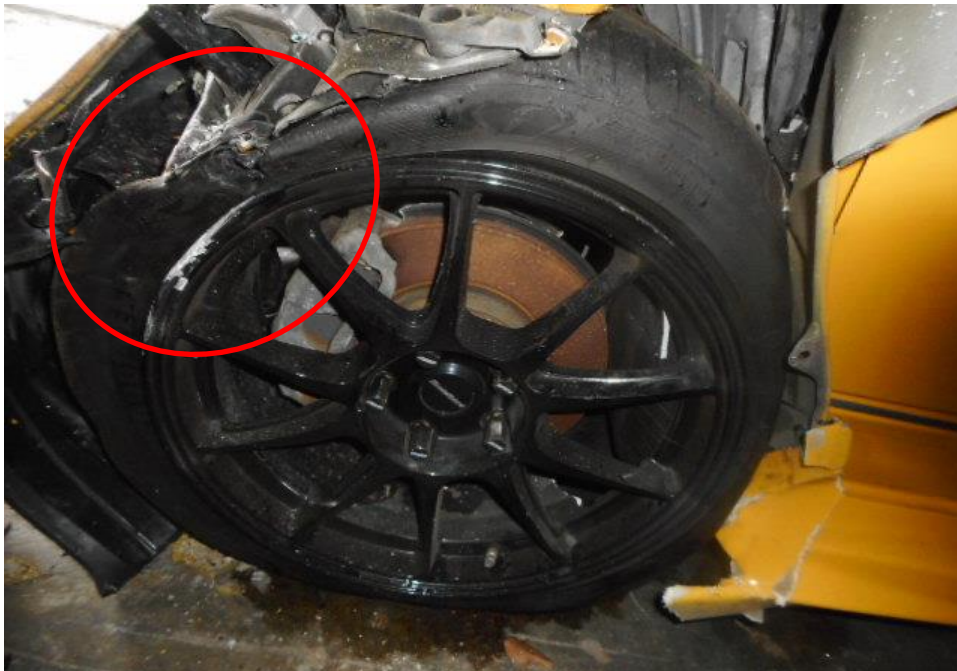
Photo 12 shows the general condition of the front left tyre of the Motor Car, which was observed to be deflated due to the damaged rim (circled) as a result of the accident. The tyre was also observed with cut mark(s) with remaining tread depth of approximately 6mm.

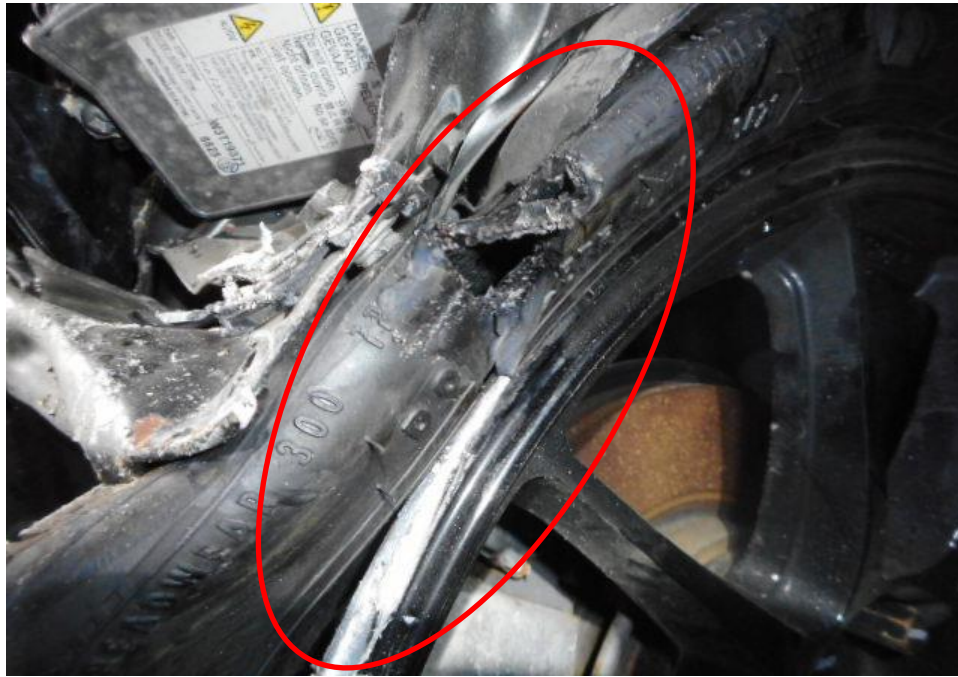
Photo 13 shows the close up condition of the front left tyre of the Motor Car, which was observed to be deflated due to the damaged rim (circled) as a result of the accident. The tyre was also observed with cut mark(s) with remaining tread depth of approximately 6mm.

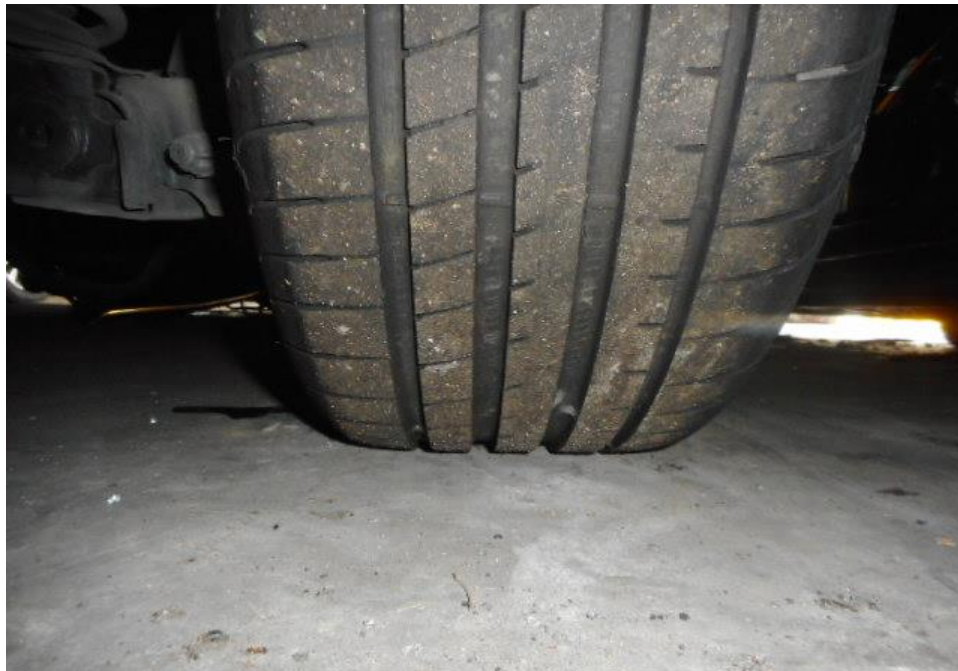
Photo 14 shows the condition of the rear right tyre of the Motor Car, which was observed to be in serviceable condition with remaining tread depth of approximately 5.8mm. The tyre was also observed to be sufficiently inflated for vehicular operation with no tear, cut or burst mark(s).

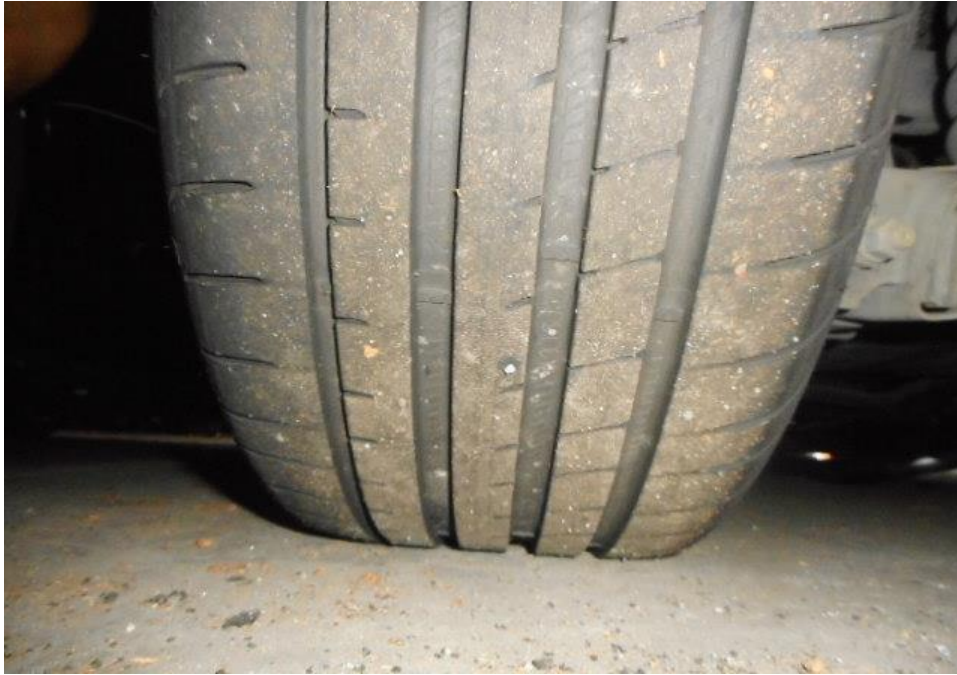
Photo 15 shows the condition of the rear left tyre of the Motor Car, which was observed to be in serviceable condition with remaining tread depth of approximately 6mm. The tyre was also observed to be sufficiently inflated for vehicular operation with no tear, cut or burst mark(s).

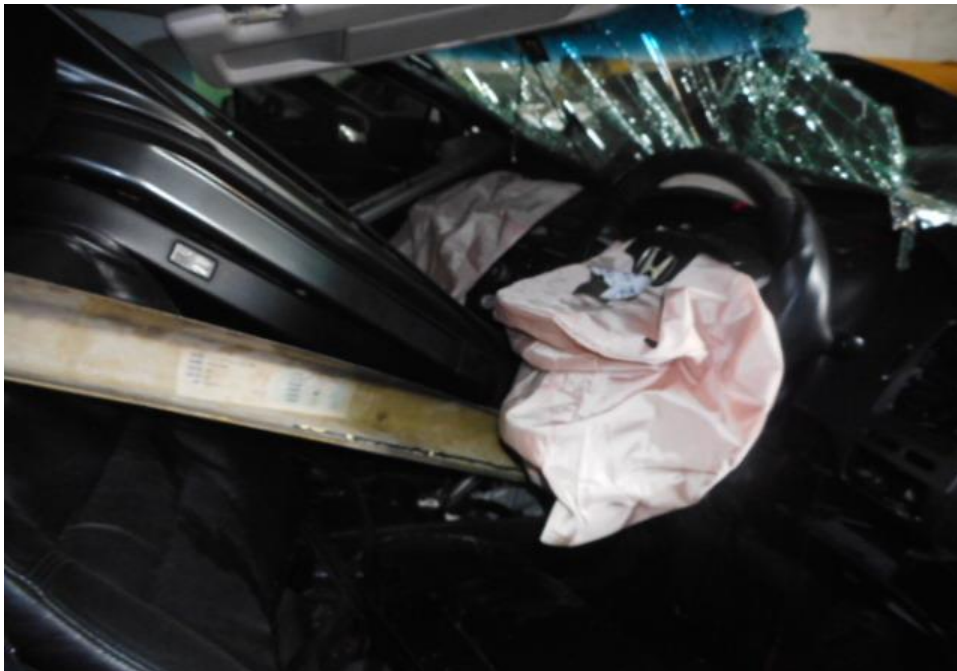
Photo 16 shows the deployment of the Supplemental Restraint System (SRS) airbag in the Motor Car as a result of the accident.

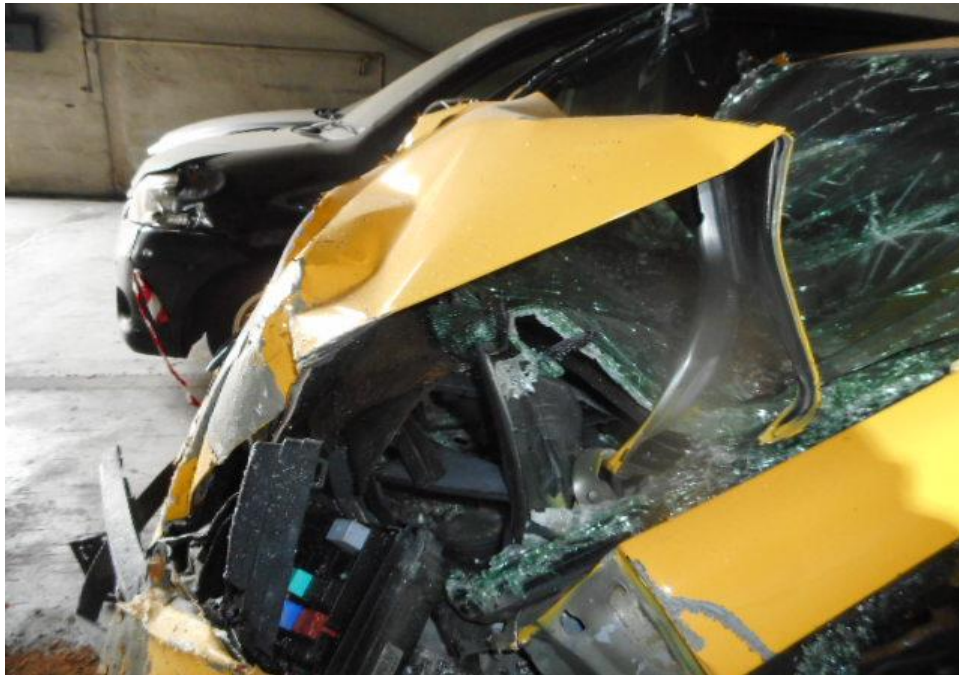
Photo 17 shows the close up view of the Motor Car's engine compartment at the time of my inspection. Its engine and components were crushed and damaged as a result of the accident.

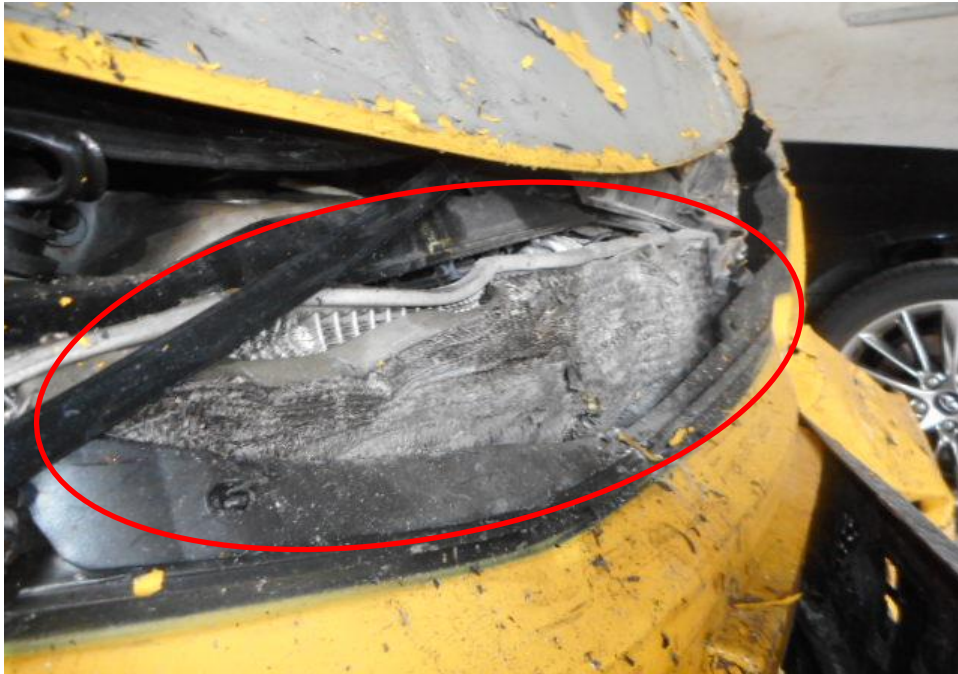
Photo 18 shows the close up view of the Motor Car's front body at the time of my inspection. The Motor car was observed to have sustained damage at its front portion. Its engine (circled) was amongst the various components in the engine compartments were also damaged as a result of the accident.

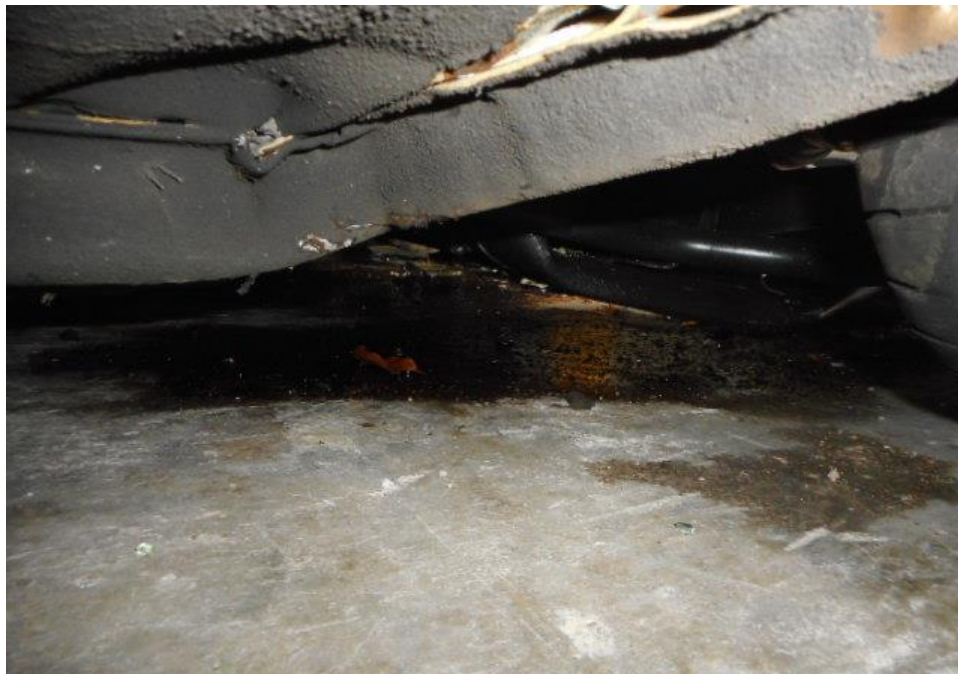
Photo 19 shows the undercarriage of the Motor Car, at the area where the engine housing and transmission housing are located. I found sign(s) or indication(s) of fluid leak and/or fluid stain(s) on the underside of the Motor Car due to the damaged engine as a result of the accident.

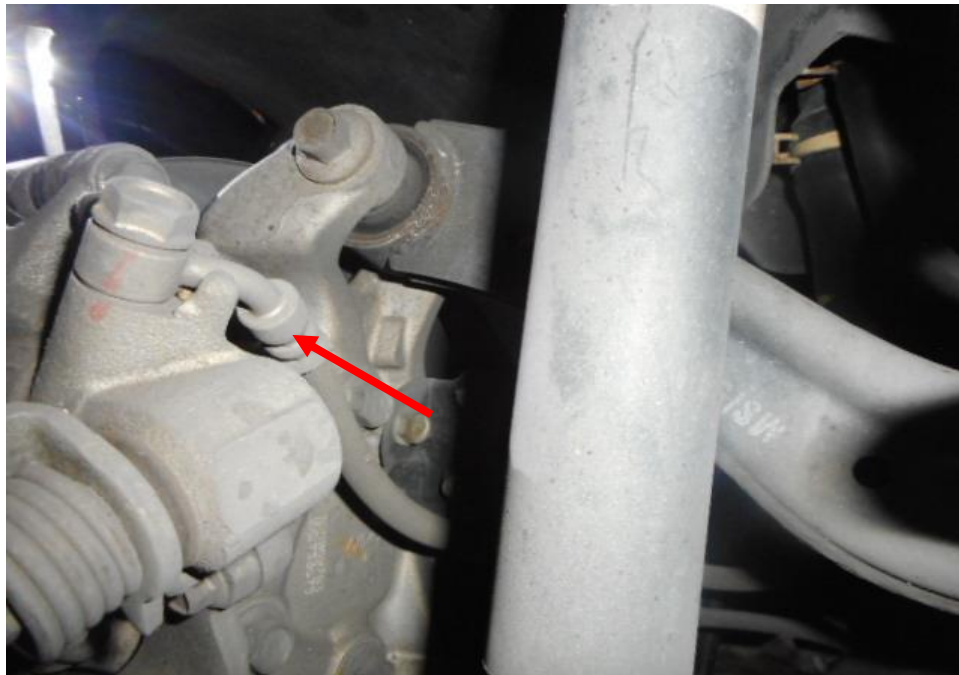
Photo 20 shows the brake hose/pipe (arrowed) at the rear left wheel of the Motor Car. No leakage of brake fluid was observed. Visual examination of the various components of the braking system like the brake caliper to be intact and without visible damage.

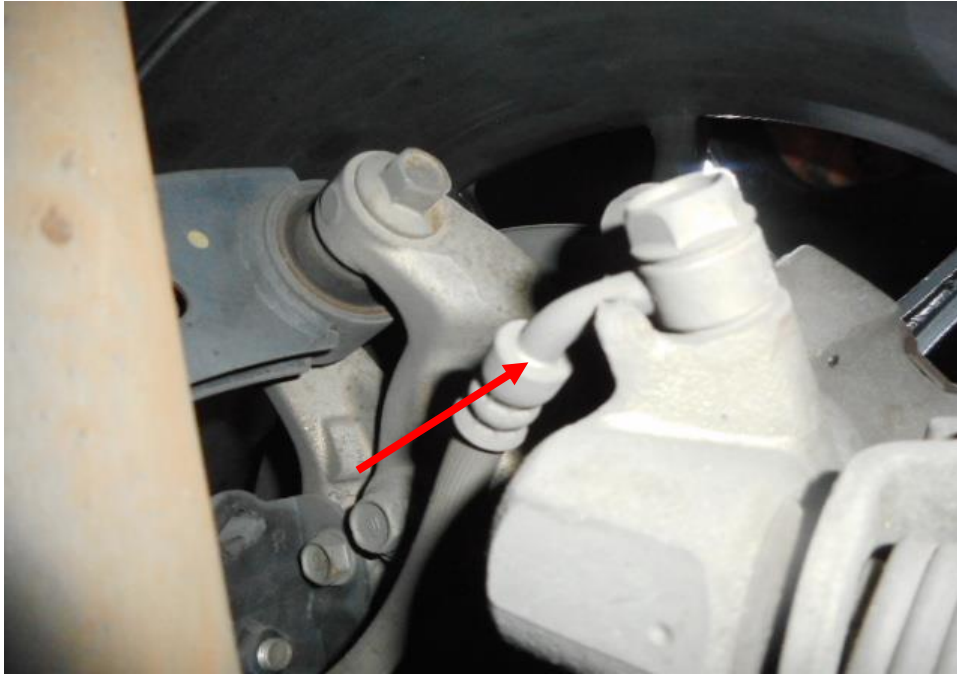
Photo 21 shows the brake hose/pipe (arrowed) at the rear right wheel of the Motor Car. No leakage of brake fluid was observed. Visual examination of the various components of the braking system like the brake caliper to be intact and without visible damage.

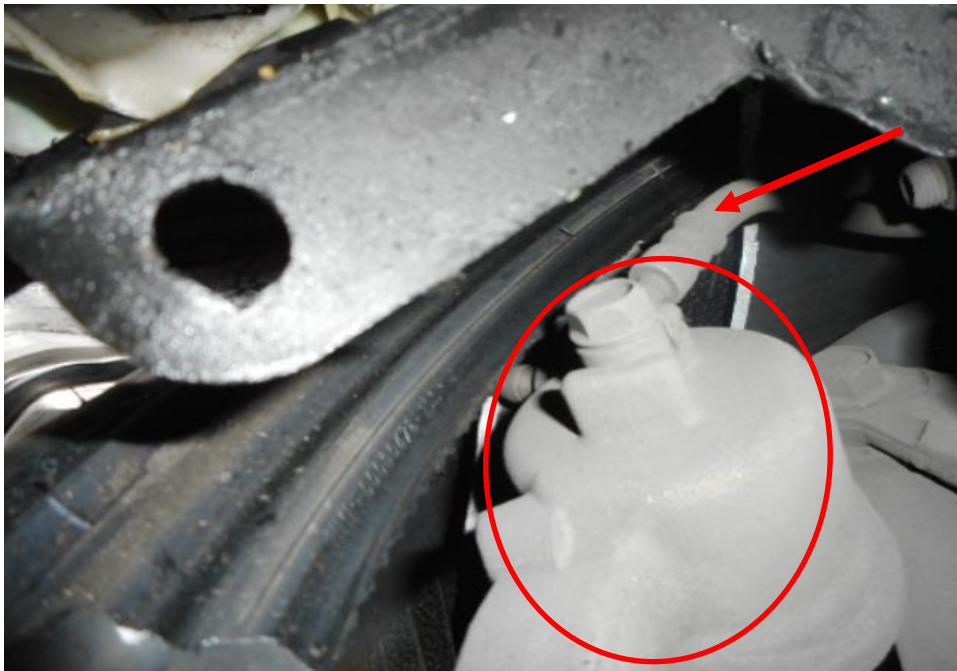
Photo 22 shows the brake hose/pipe (arrowed) at the front right wheel of the Motor Car. No leakage of brake fluid was observed. Visual examination of the various components of the braking system like the brake caliper (circled) was observed to be intact and without visible damage.

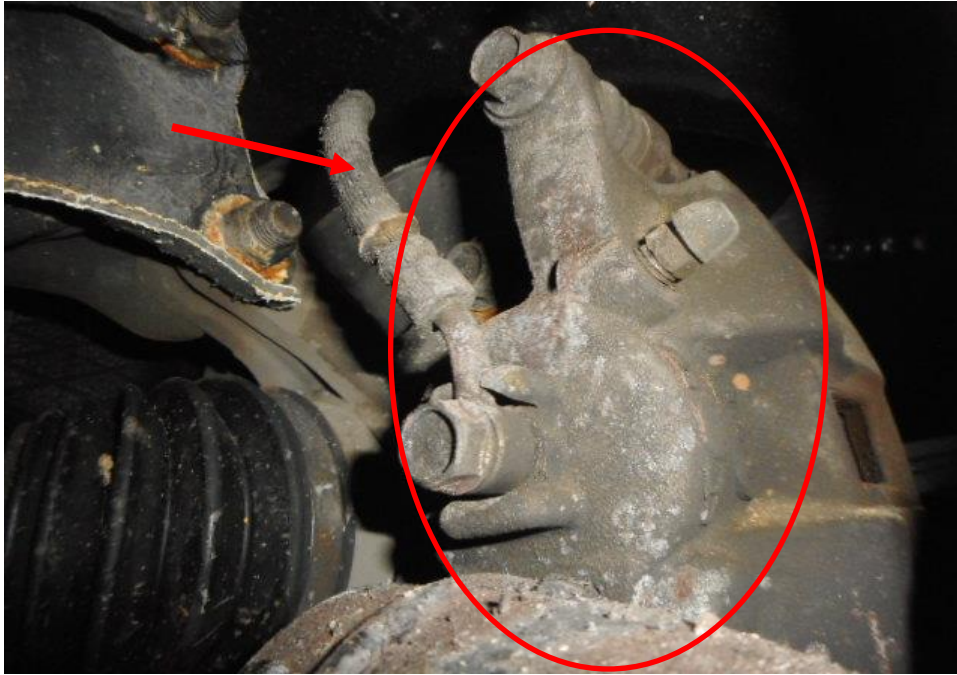
Photo 23 shows the brake hose/pipe (arrowed) at the front left wheel of the Motor Car. No leakage of brake fluid was observed. Visual examination of the various components of the braking system like the brake caliper (circled) was observed to be intact and without visible damage.

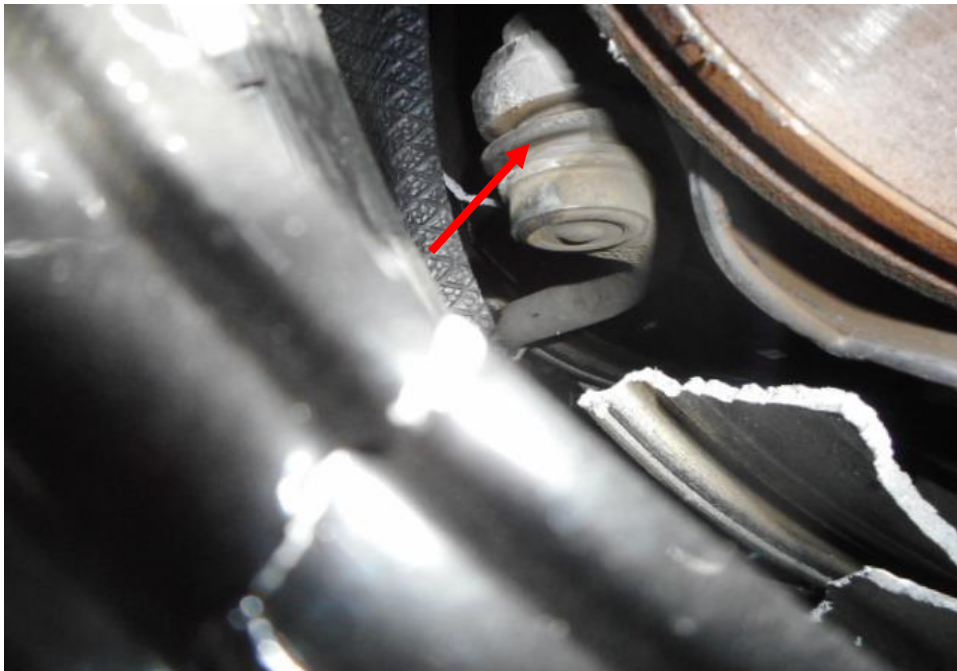
Photo 24 shows the various undercarriage components at the front right wheel of the Motor Car, in particular the steering tie rod (arrowed) was observed to be intact and without visible damage.

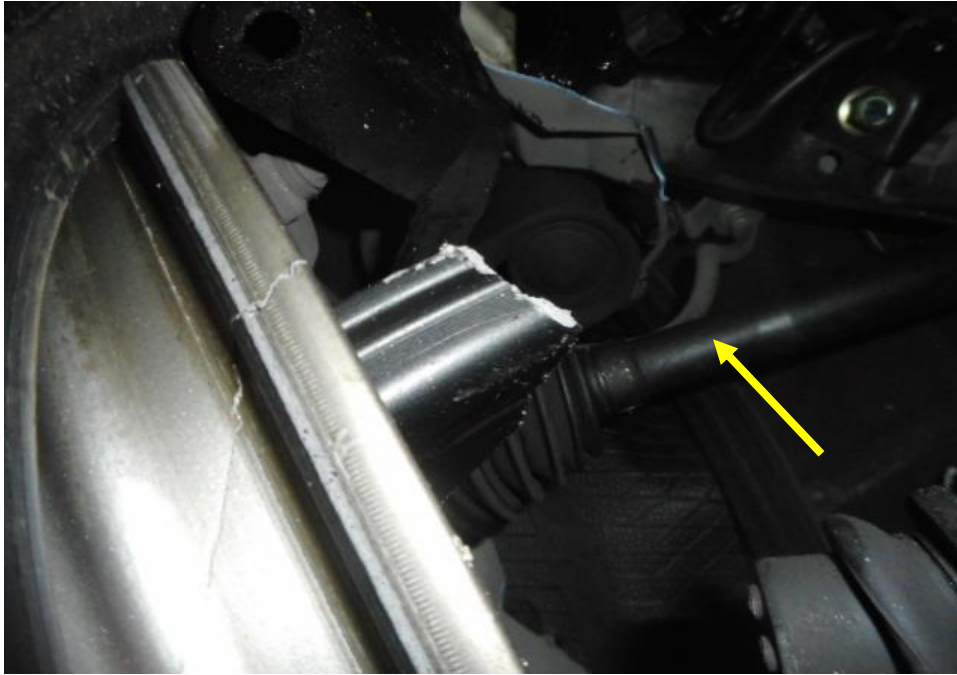
Photo 25 shows the various undercarriage components at the front right wheel of the Motor Car, in particular the driveshaft (arrowed) was observed to be intact and without visible damage.

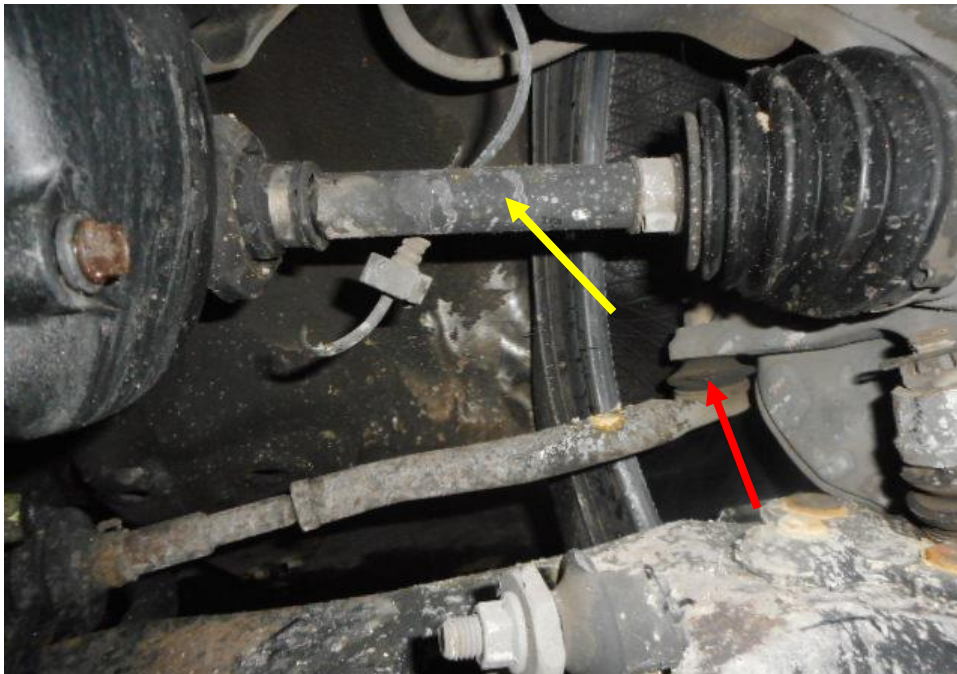
Photo 26 shows the various undercarriage components at the front left wheel of the Motor Car, in particular the steering tie rod end (red arrow) and the driveshaft (yellow arrow). The various undercarriage components of the Motor Car were all found to be intact without any visible damage. There was also no sign of fluid stain(s) observed on the various undercarriage components.

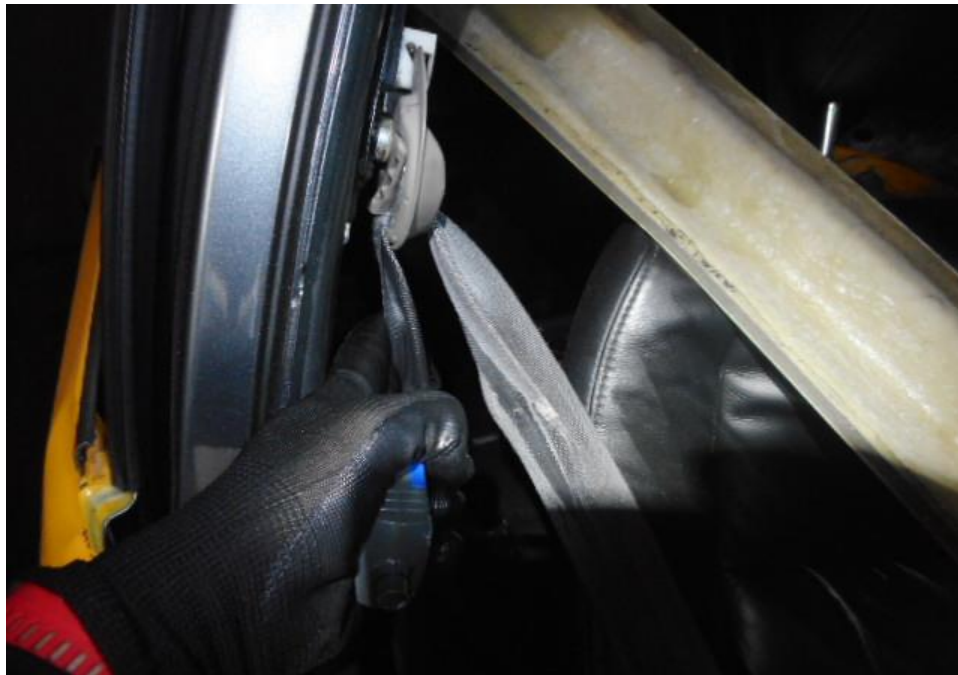
Photo 27 shows that the seat belt on the right seat was worn at the material time of accident as the safety pre-tensioners was activated at the moment of impact and caused the seat belt to be locked into the last position.

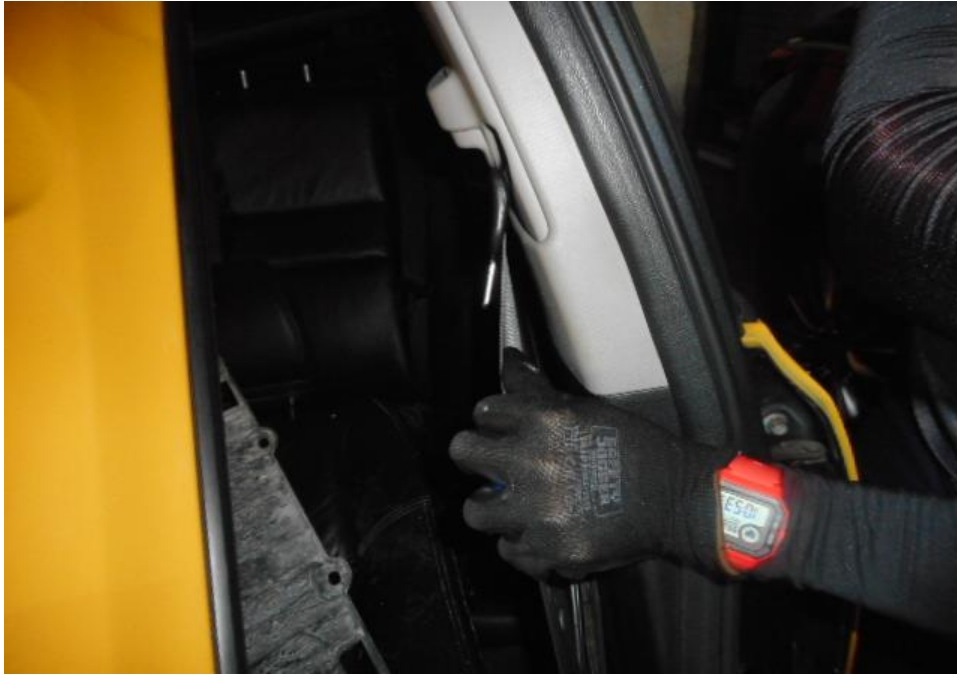
Photo 28 shows that the seat belt on the left seat was not worn at the material time of accident as the safety pre-tensioners was activated at the moment of impact and caused the seat belt to be locked into the last position.
